## Kyle Park, Hornby

### Desktop Ground Contamination and Geotechnical Study

Prepared for  
Christchurch City Council

Prepared by  
Tonkin & Taylor Ltd

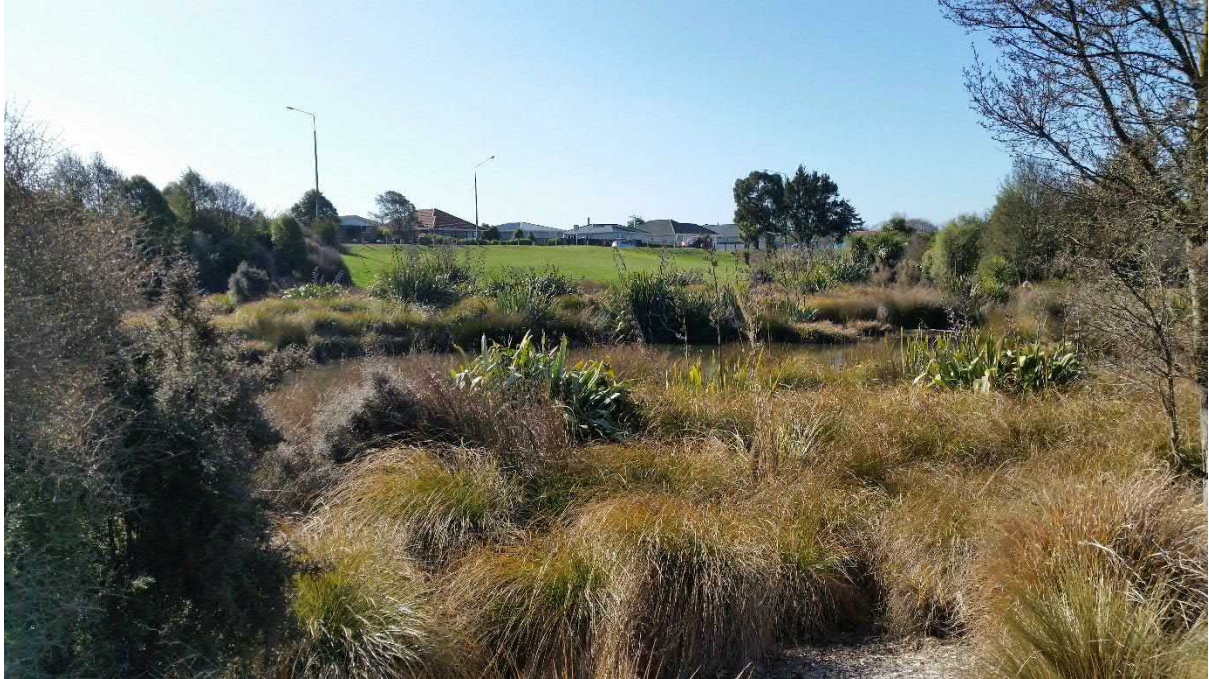
*Photograph 1: A stormwater retention pond on the site. Date taken: 27/08/15; photo facing north.*

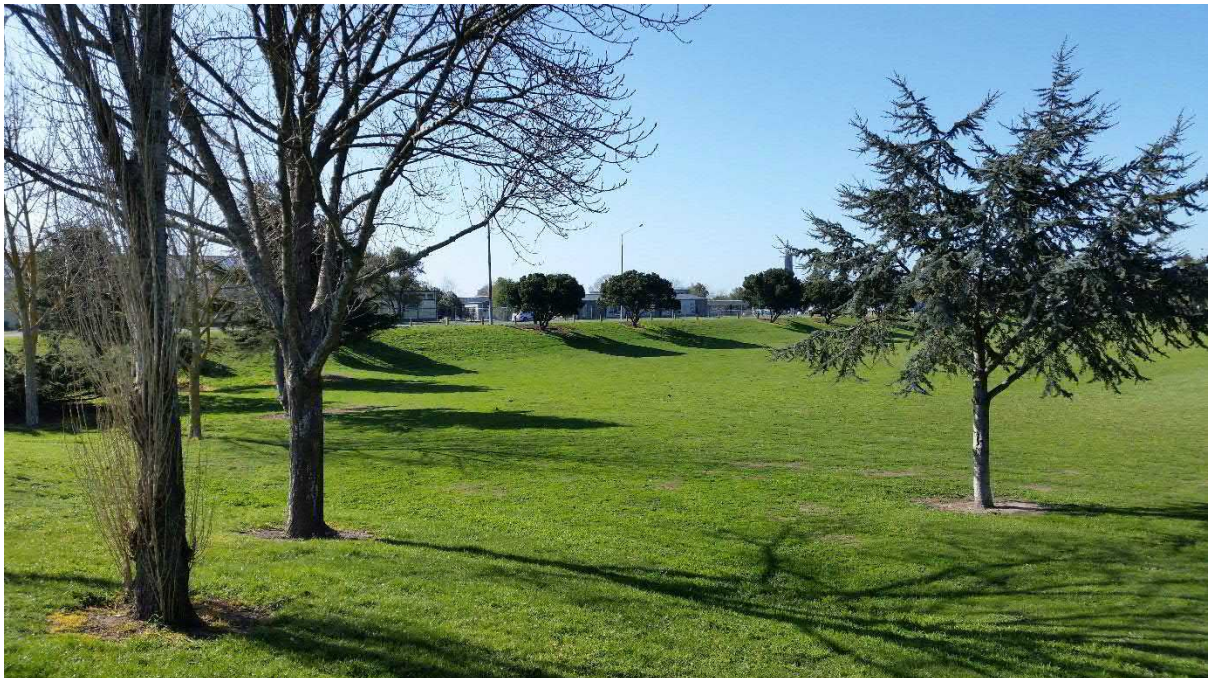
*Photograph 2: The different topography of the site to its surrounds. Date taken: 27/08/15; photo facing the northeast.*

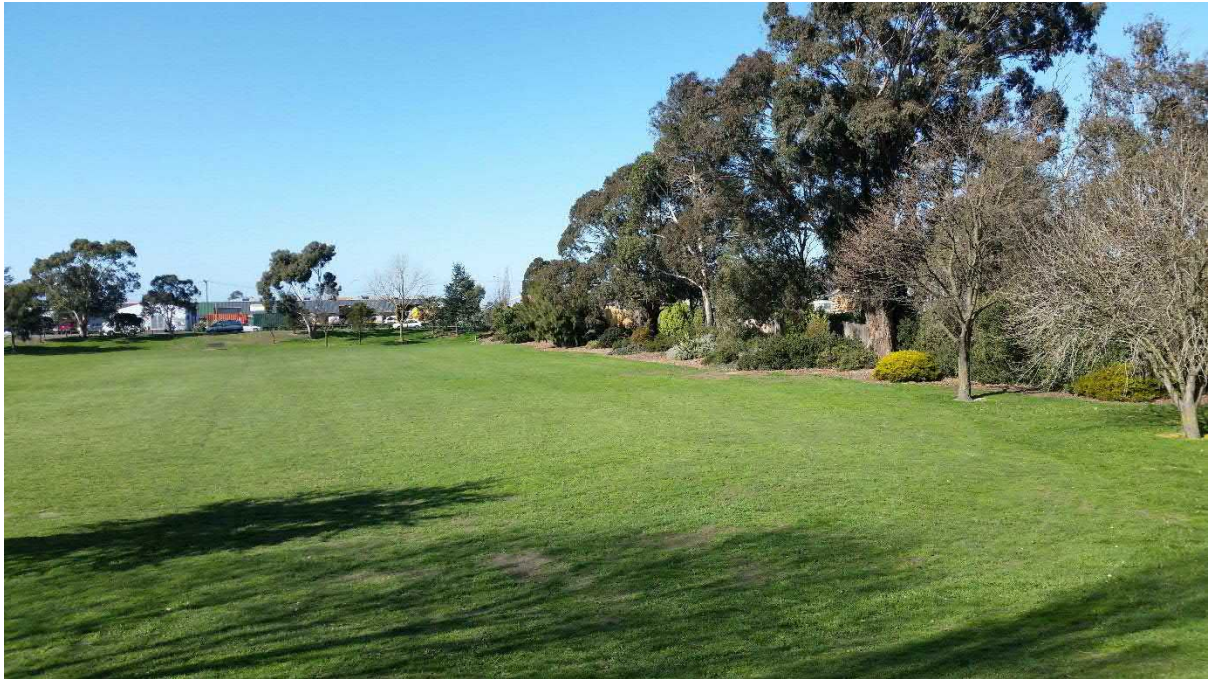
- The majority of the site was covered with grass. Mature trees are scattered across the area with high density stands in the eastern and western ends of the site. Sporadic patches of what appeared to be stressed vegetation were observed at various locations, with an example shown in Photograph 3 (Appendix A). At the time of the site walkover the cause of the stressed vegetation was not apparent.

*Photograph 3: An area of stressed vegetation is visible on the field. Date taken: 27/08/15; photo facing the east.*

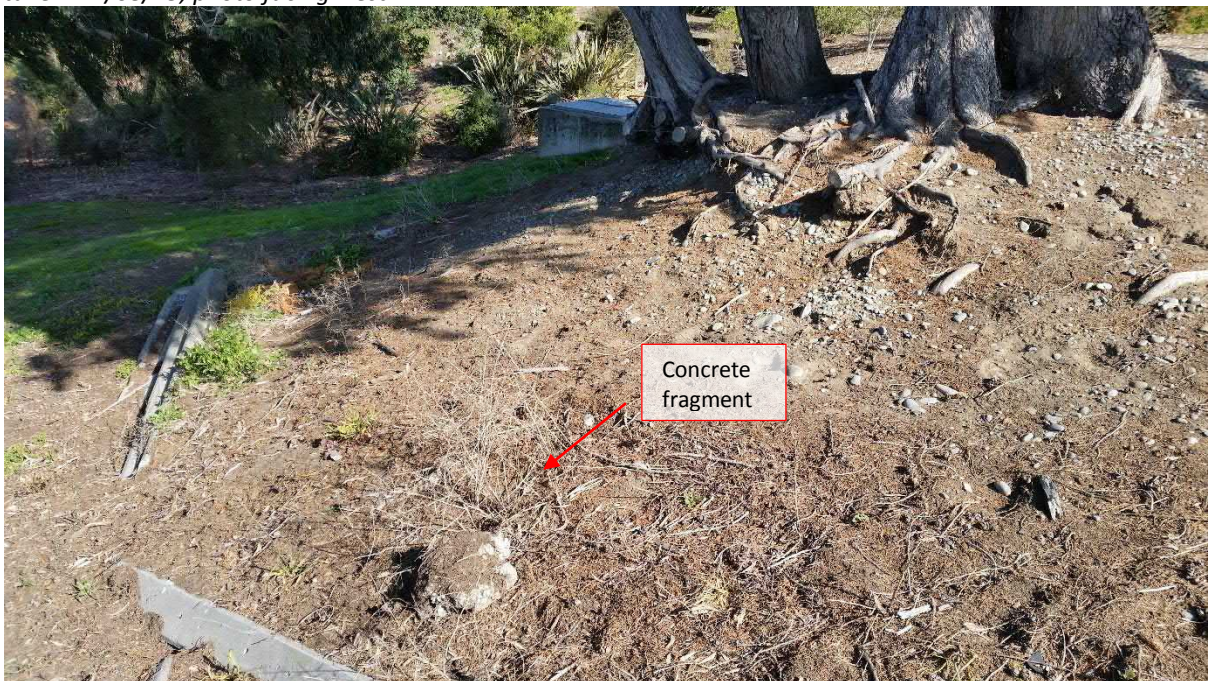
- Waste materials (such as concrete fragments, bricks, and glass) were observed along the embankment at the southeastern site boundary.
- Waste materials (such as concrete fragments, bricks, plastic, and glass) were observed along the embankment at the southwestern site boundary (Photograph 5). A fragment of friable fibreboard was found on the ground surface at this location (refer Figure A1 and Photographs 5-6, Appendix A). The fibreboard was tested for asbestos presence/absence at IANZ accredited laboratory. The results indicated that the fibreboard contained amosite, chrysotile and crocidolite (white, brown and blue) asbestos (refer to Appendix B for laboratory test results).

- It is not clear from our brief walkover whether the demolition materials observed at the southeast and southwest embankments were placed on top of the embankment (i.e. fly-tipped) or were exposed due to ground surface disturbance.

*Photograph 4: A concrete fragment visible on the ground surface by the southwestern embankment. Date taken: 27/08/15; photo facing west.*

Given that the site is currently used as a recreational park then there is a potential for the friable asbestos, if present in further quantities, to be disturbed and for site users to be exposed to the disturbed and surficial asbestos material. As a specific assessment of the site for the presence of asbestos has not been completed, the extent and potential risk associated with further additional asbestos material (if present) on the site cannot be assessed. However, as a precautionary approach, T+T recommends that the embankment areas where building/demolition materials were observed are fenced to prevent public access as a matter of urgency.

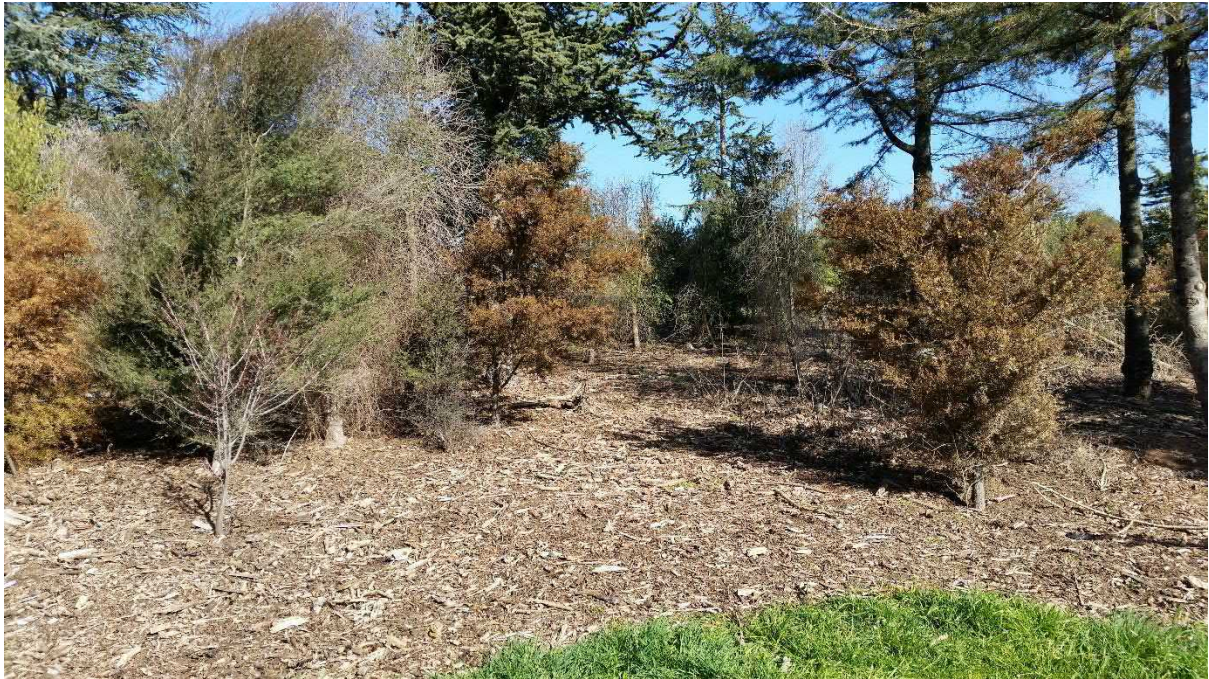
Surface debris	Asbestos.	During a site walkover, a piece of asbestos fibreboard was observed on an embankment at the northwestern site boundary. It was noted that the same embankment also had visible surface debris typically associated with demolition material (i.e. concrete and brick) on it.  As only a brief site walkover was undertaken, there is a potential for more asbestos containing materials to be present on-site.	Yes Activity I – land that has been subject to the intentional or accidental release of hazardous substance in sufficient quantity that it could be a risk to human health or the environment.

*Photograph 5: A photograph of the embankment where the asbestos fibreboard was found. Date taken: 27/08/15; photo facing south.*

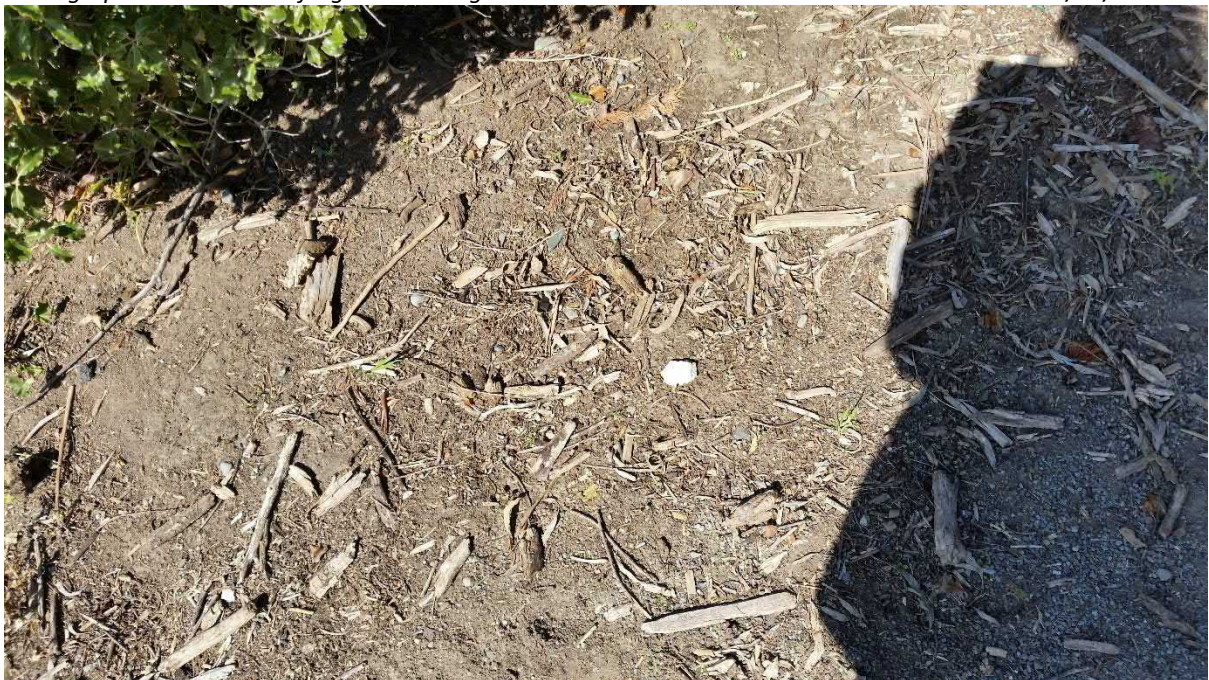
*Photograph 6: An asbestos fragment amongst the bark mulch on the embankment. Date taken: 27/08/15.*

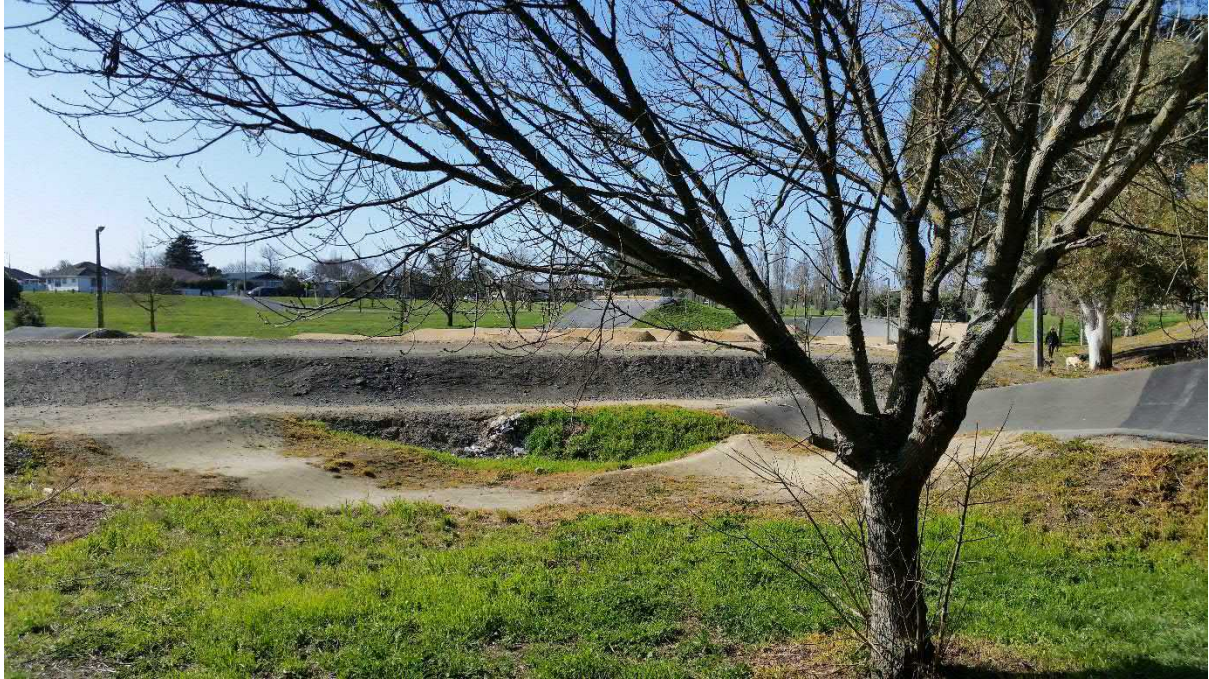
- A small pile of refuse materials was observed to the south of the BMX track, which appeared to be recently placed (Photograph 7).

*Photograph 7: A small stockpile of rubbish next to be BMX track.*
