Grand National Stand - Detailed Damage Evaluation

3D Response Spectrum, 3D Non-linear Pushover & Vertical
analysis

Client: Canterbury Jockey Club

27-Jan-2015

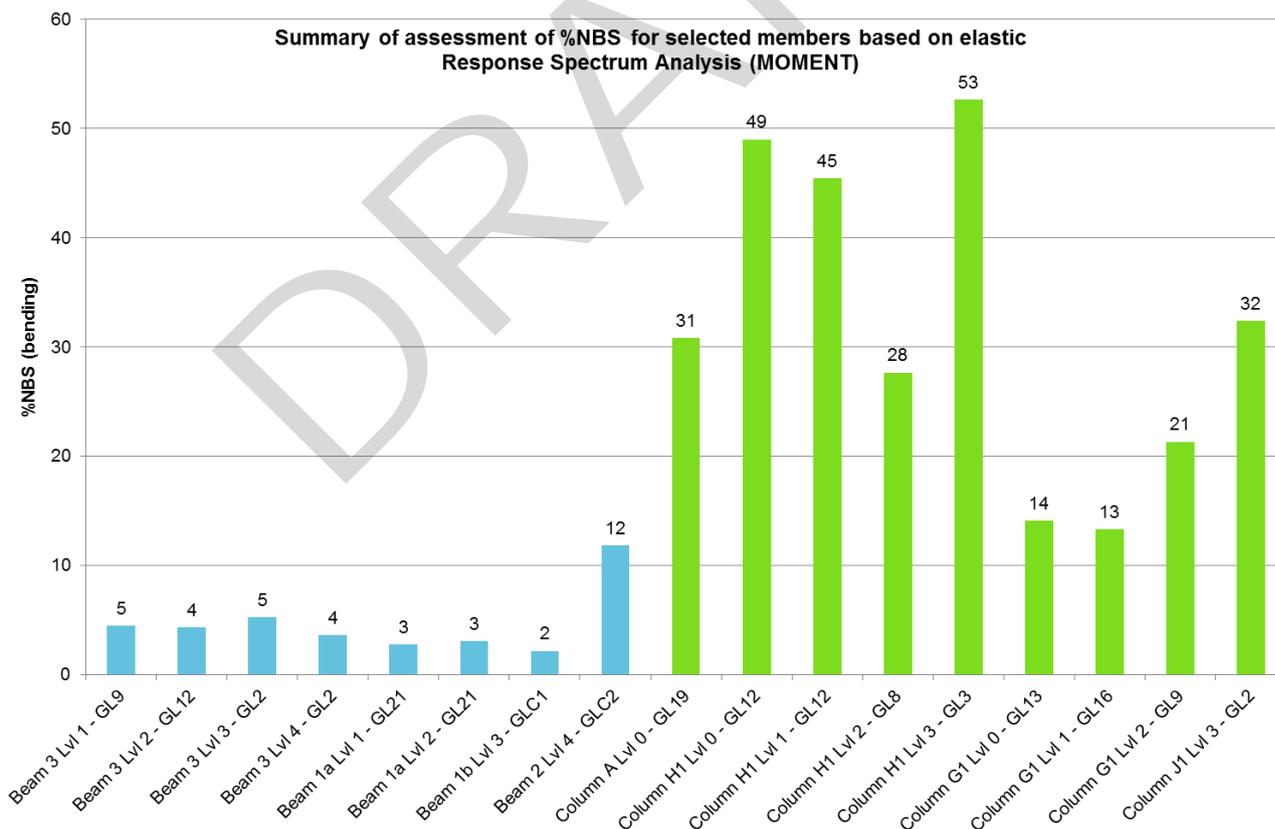
Figure 4-3 RSA selected member moment capacities

It should be noted that the transverse concrete encased steel beams (BEAM 3) have their moment capacity limited by the moment transferring ability of the beam-column joint. The exterior spandrel beams (BEAM 1A, 1B and 2) have a large depth but have only nominal top longitudinal reinforcement, resulting in a low moment capacity and %NBS when seismic conditions are considered (these perform satisfactorily under gravity conditions).

The columns perform better than the beams in bending apart from the lower level exterior columns (COL G1). Larger inter-storey displacements are experienced at the lower levels of the structure and the type G1 columns have a single embedded angle compared to the type H1 columns which have double angles.

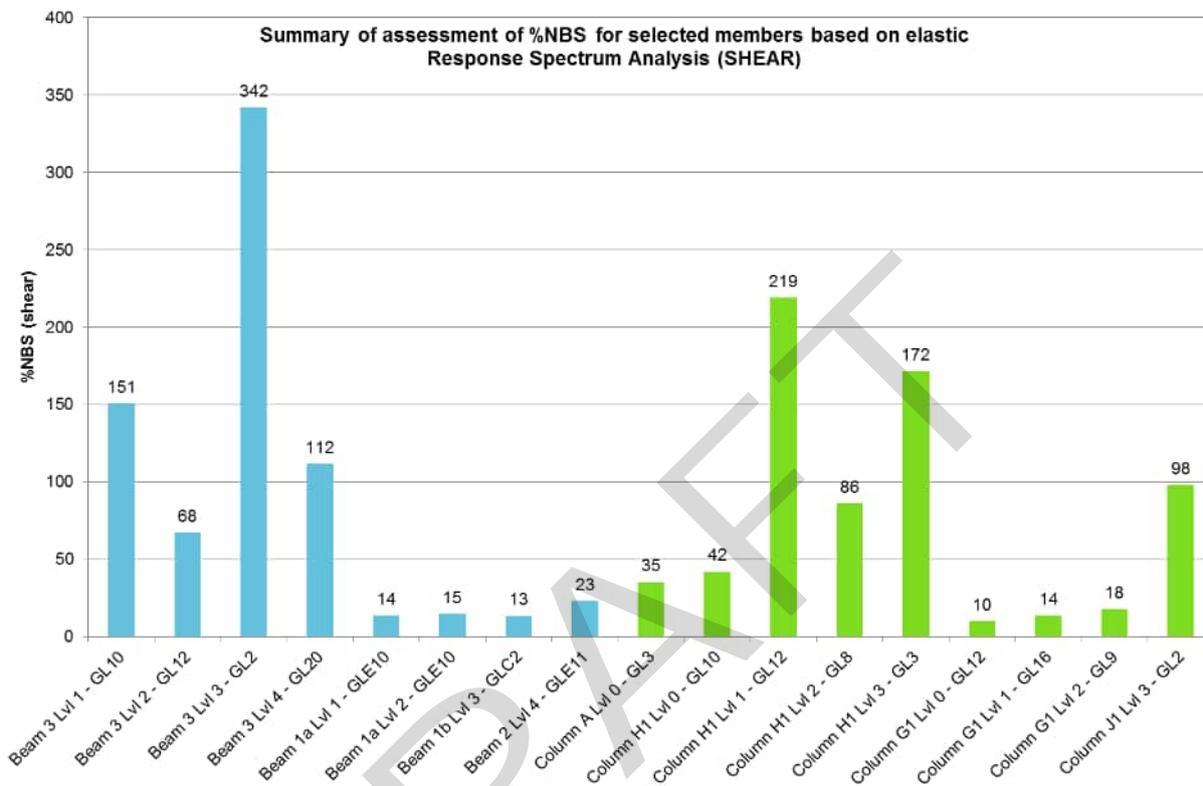
Figure 4-4 RSA selected member shear capacities

The transverse concrete encased steel beams (BEAM 3) performed well in shear because of the embedded steel beam. The exterior spandrel beams (BEAM 1A, 1B and 2) have nominal amounts of transverse reinforcement, resulting in a low shear capacity and %NBS.

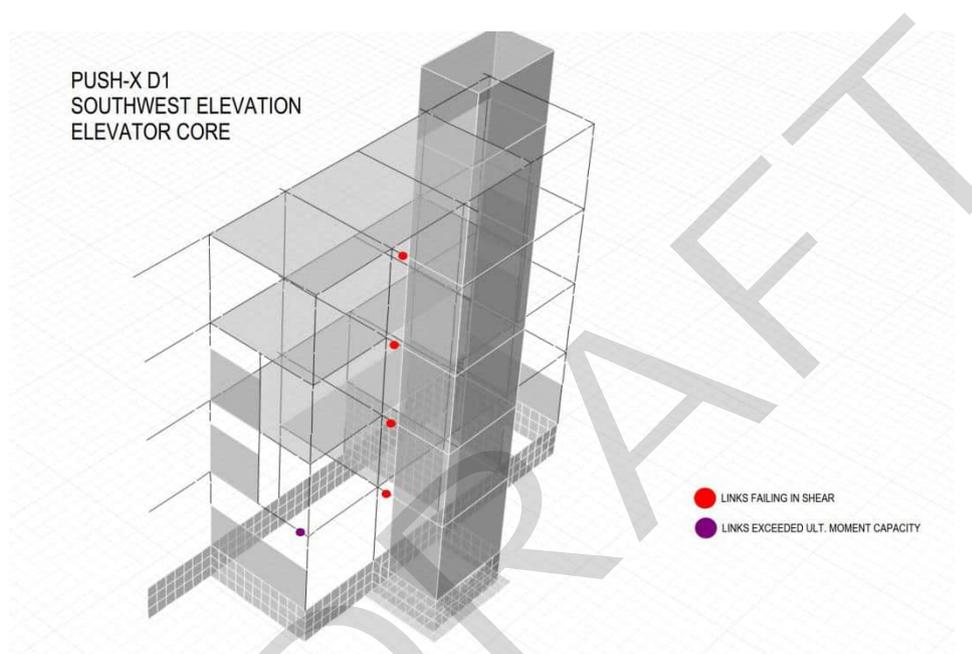
Figure 4-10 Links failing in shear push in east direction

The progression of the inelastic behaviour within the structure is demonstrated in Table 4-8 which shows the development of links and their status at different drift levels. As the structure is analysed a total number of 246 links yielded and 26 exceeded their ultimate capacity.

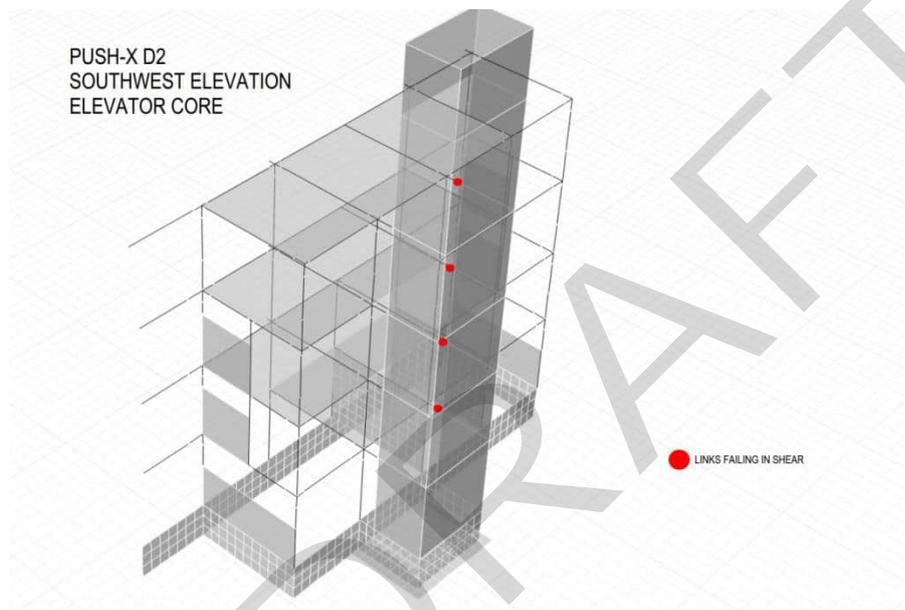
Figure 4-13 Links failing in shear push in west direction

The progression of the inelastic behaviour within the structure is demonstrated in Table 4-10 which shows the development of links and their status at different drift levels. As the structure is analysed a total number of 255 links yielded and 49 exceeded their ultimate capacity.

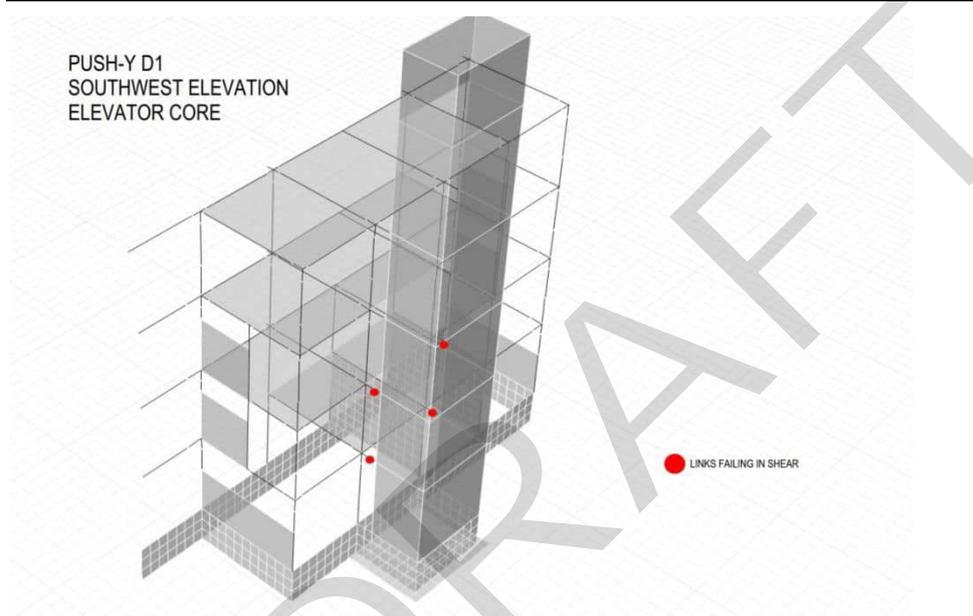
Figure 4-16 Links failing in shear – analysis in north direction

The progression of the inelastic behaviour within the structure is demonstrated in Table 4-12 which shows the development of links and their status at different drift levels. As the structure is analysed a total number of 167 links yielded and 5 exceeded their ultimate capacity.

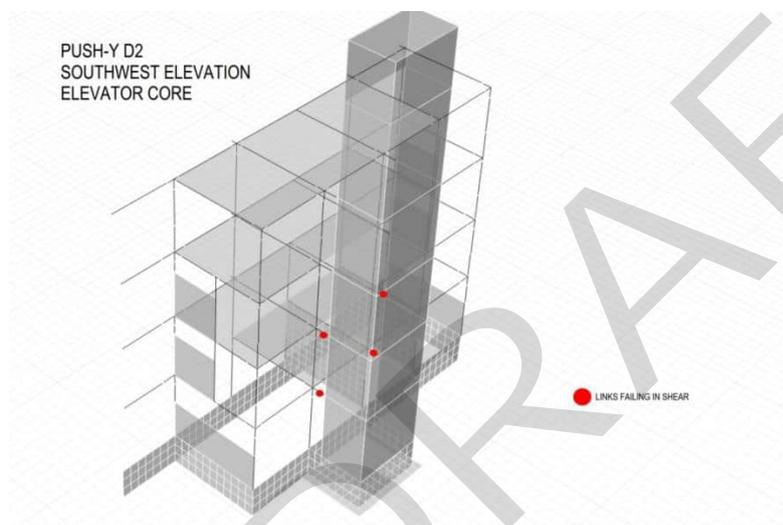
Figure 4-19 Links failing in shear push in the south direction

The progression of the inelastic behaviour within the structure is demonstrated in Table 4-14 which shows the development of links and their status at different drift levels. As the structure is analysed a total number of 251 links yielded and 30 exceeded their ultimate capacity.

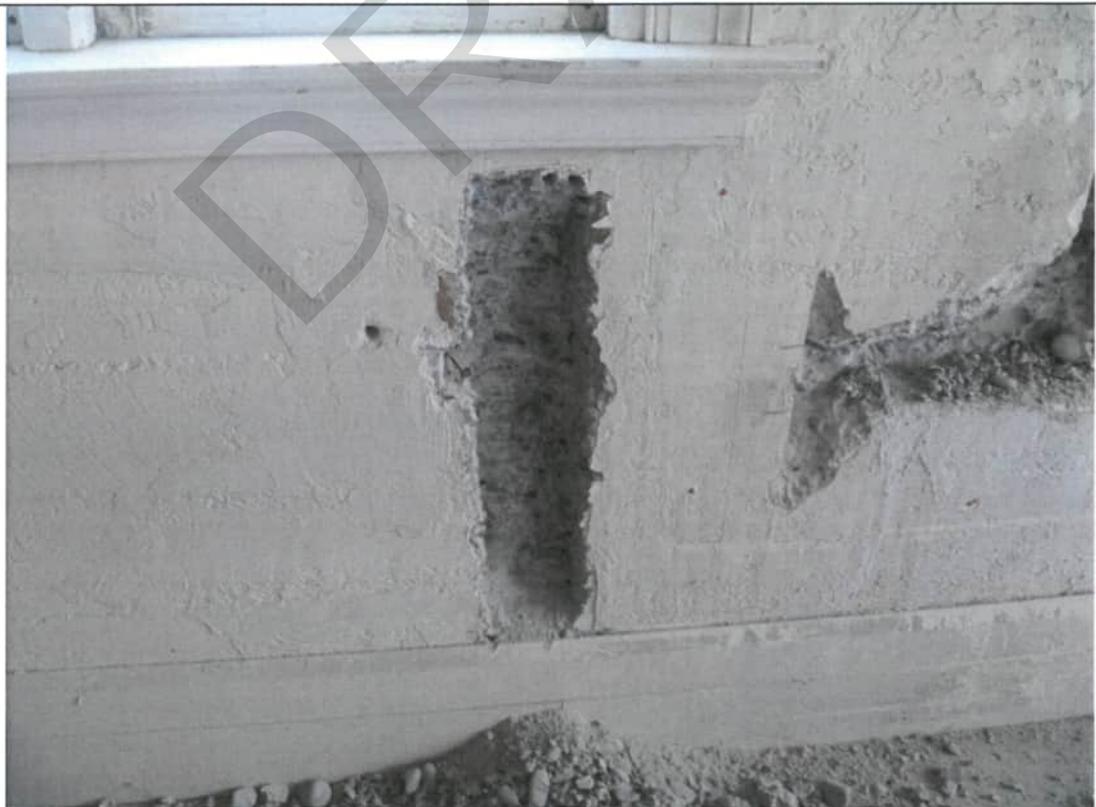
Photo 4 Broken out strip on spandrel beam, approximately 110mm deep

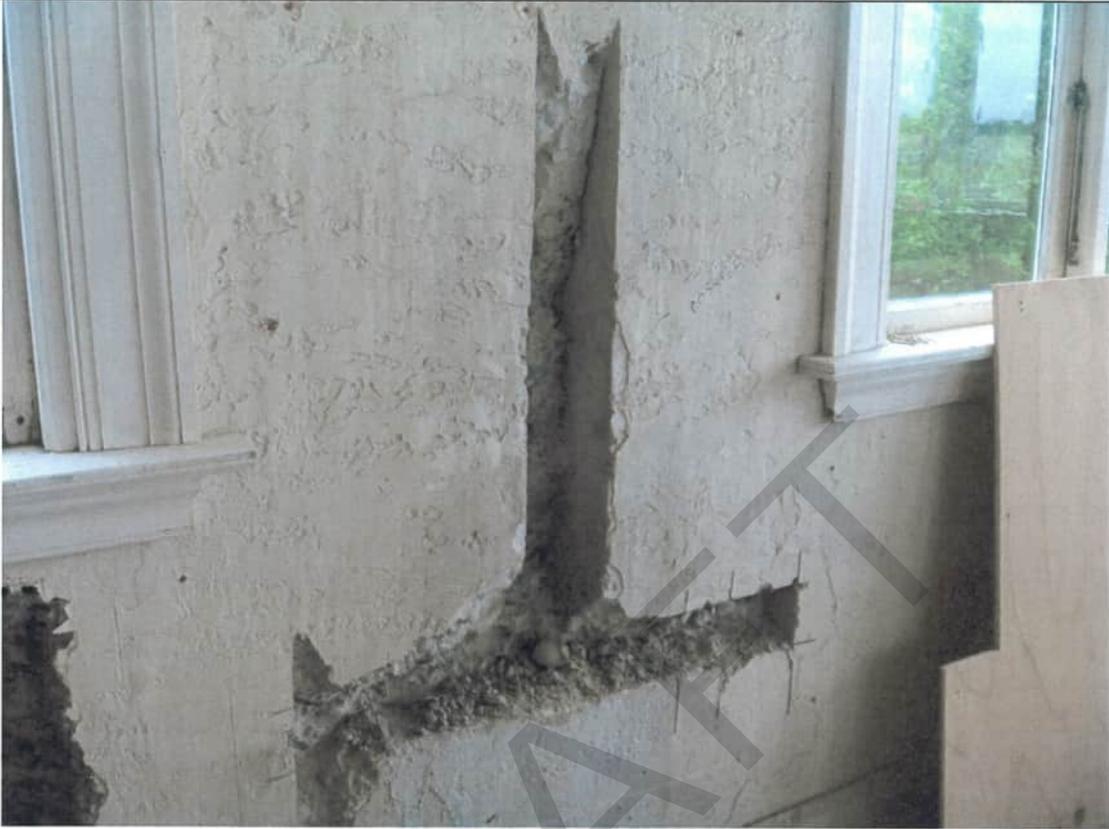
Photo 5 Broken out inverted T on beam column connection approximately 110 – 130mm deep

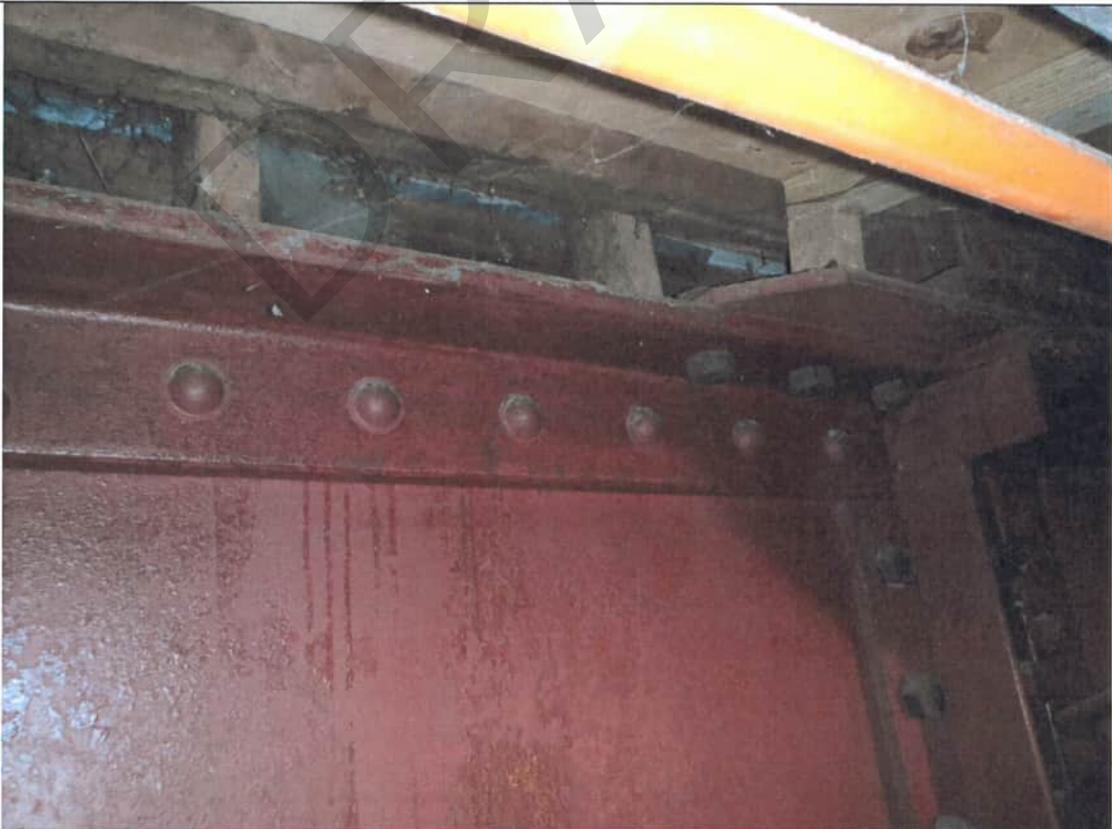
Photo 6 Top plate at column connection, terminating adjacent to column

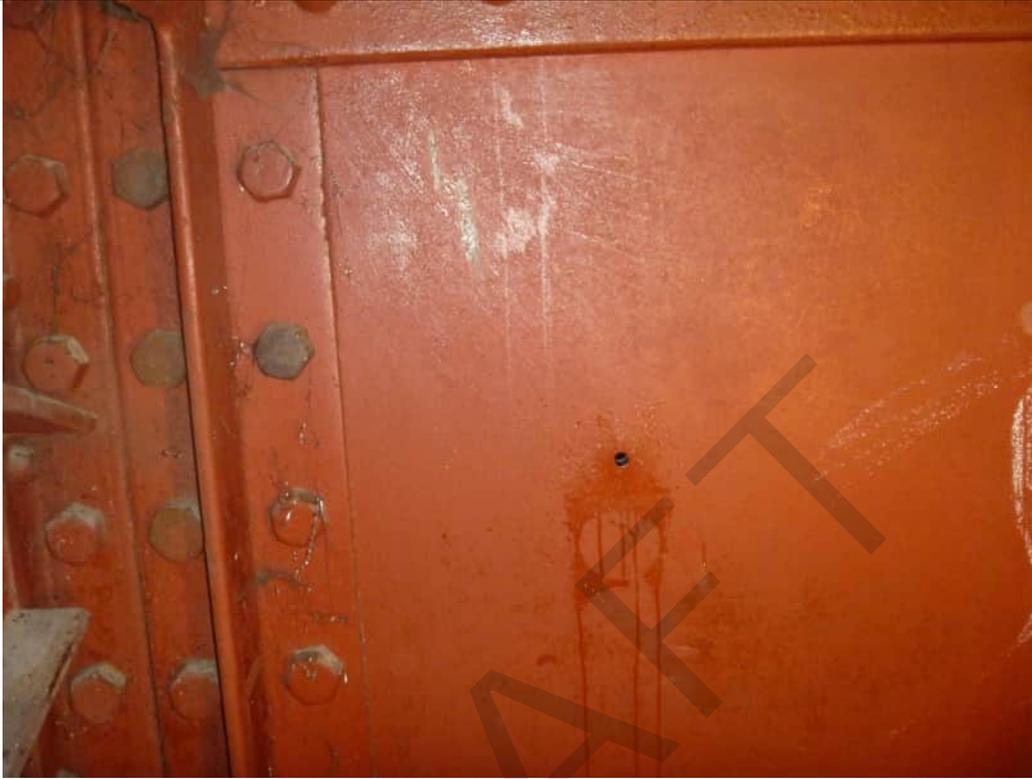
Photo 3 Hole in web of plate girder

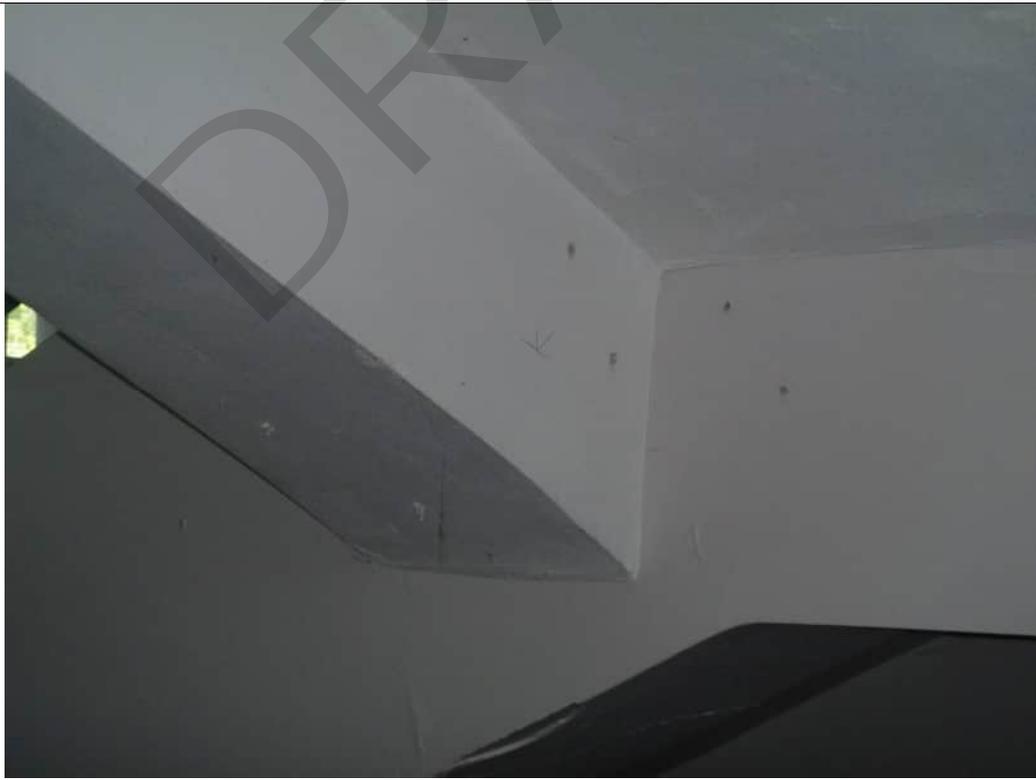
Photo 6 Six 8mm diameter holes in lower beam connection of internal stairs

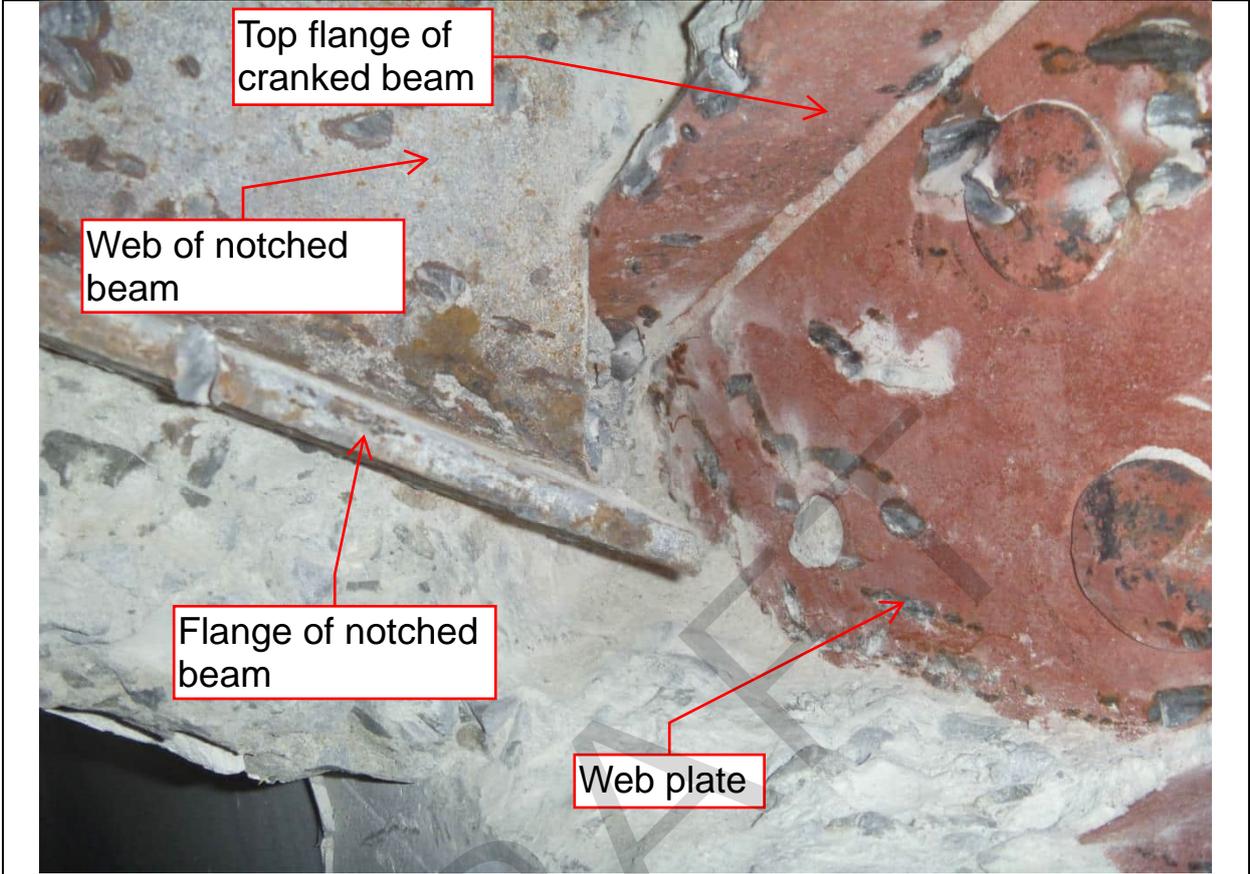
Photo 3 Adjacent stringer beam showing notch through bottom flange and part of web

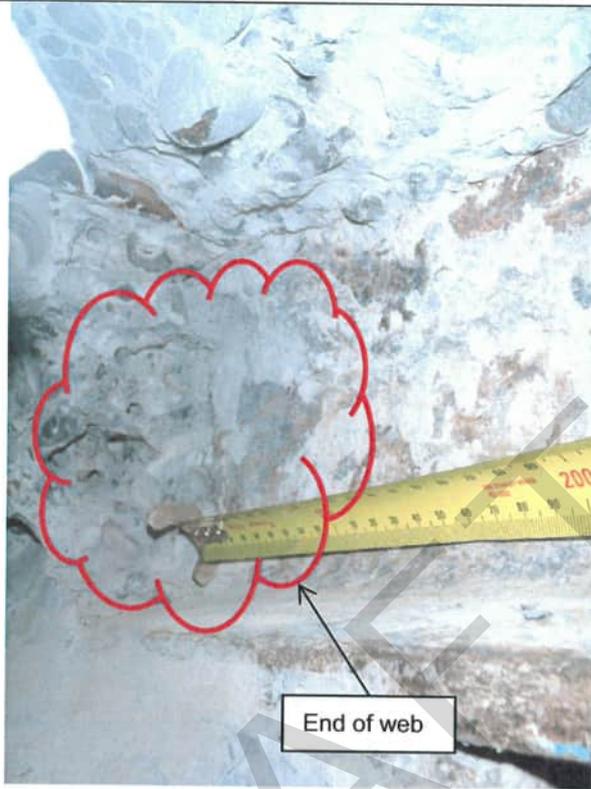
Photo 5 End of steel beam in column, no connection or column steel.

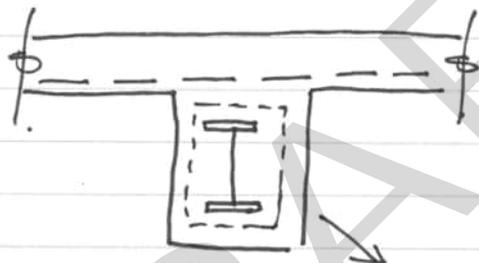
TOP OF STEEL BEAM EXPOSED FROM TOP OF SLAB & NO SHEAR STUDS PRESENT

SECTION AS FOUND ONSITE.
NO SHEAR STUDS.
