Detailed Damage Evaluation

Quantitative Seismic Analysis of Grand National (Public) Stand

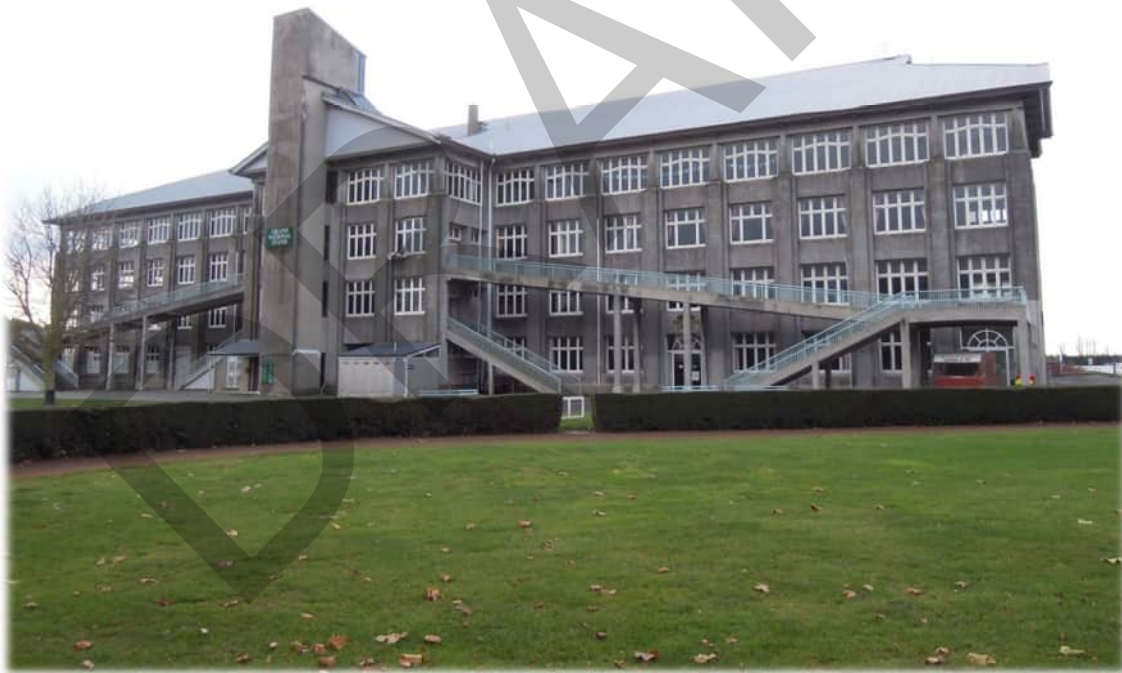
DRAFT**Detailed Damage Evaluation**

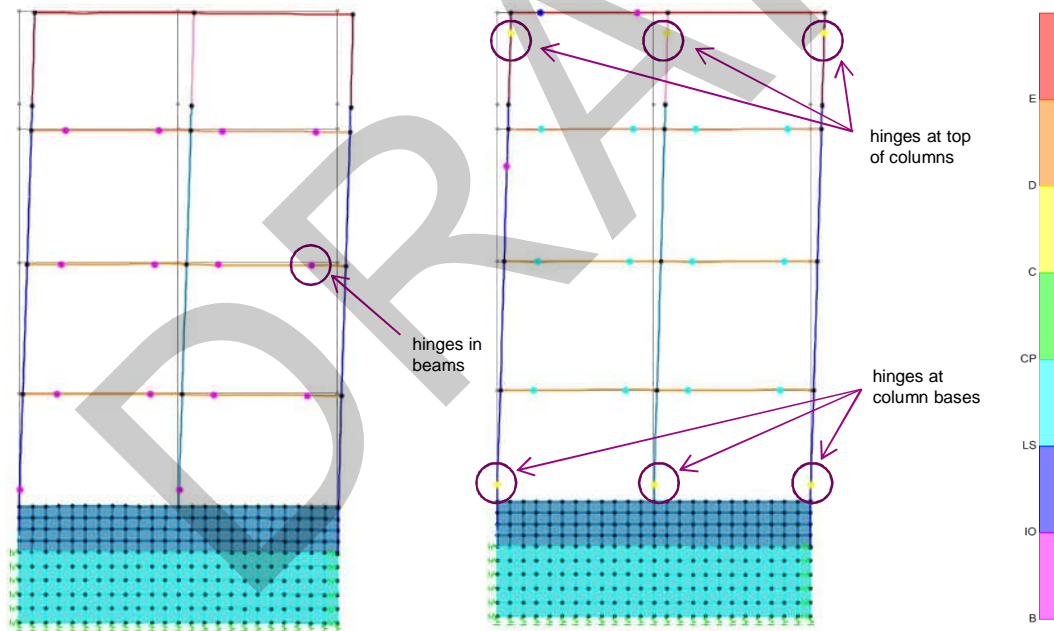
Figure 3-1: Post-elastic deformation of frame on gridline 1 frame at displacements of 10mm and 200mm

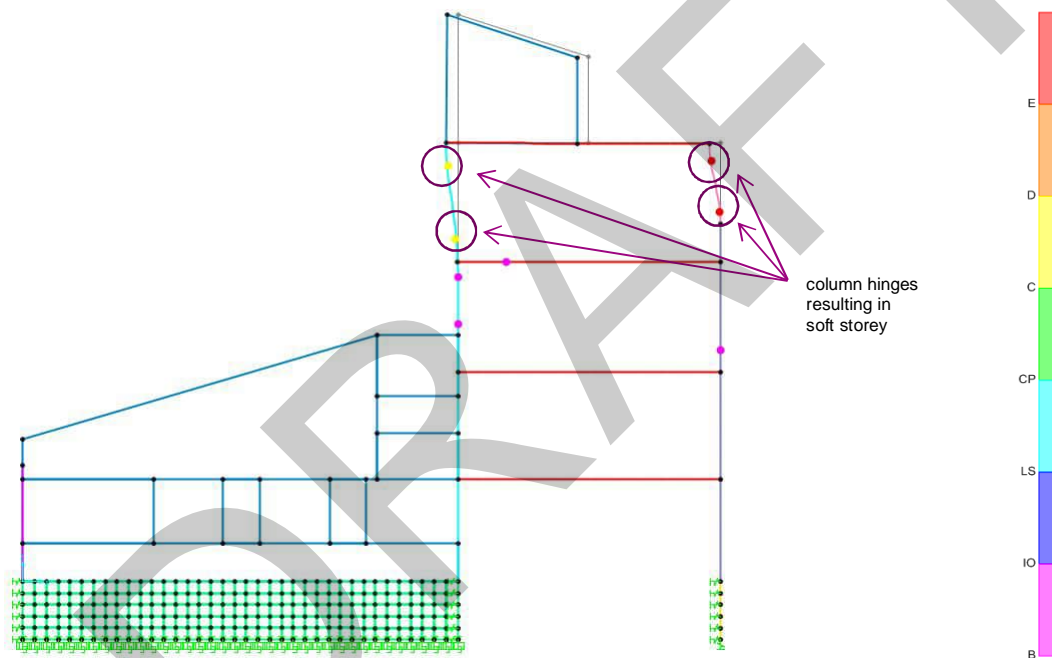
Figure 3-3: Failure mechanism of frame on gridline 2

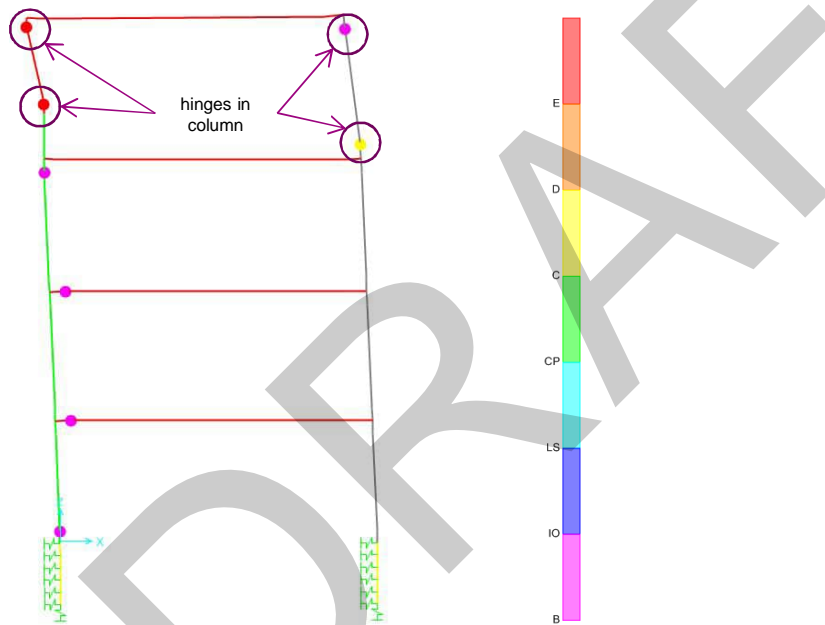
Figure 3-6: Post-elastic deformation of frame on gridline 4 (pushover in the southerly direction)

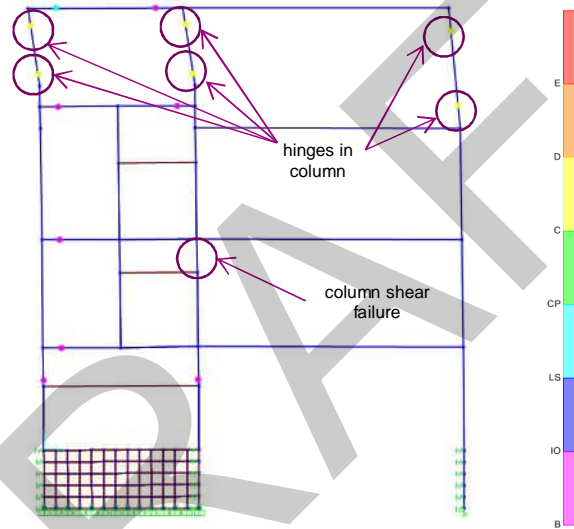
Figure 3-8: Failure mode for the frame on gridline 13

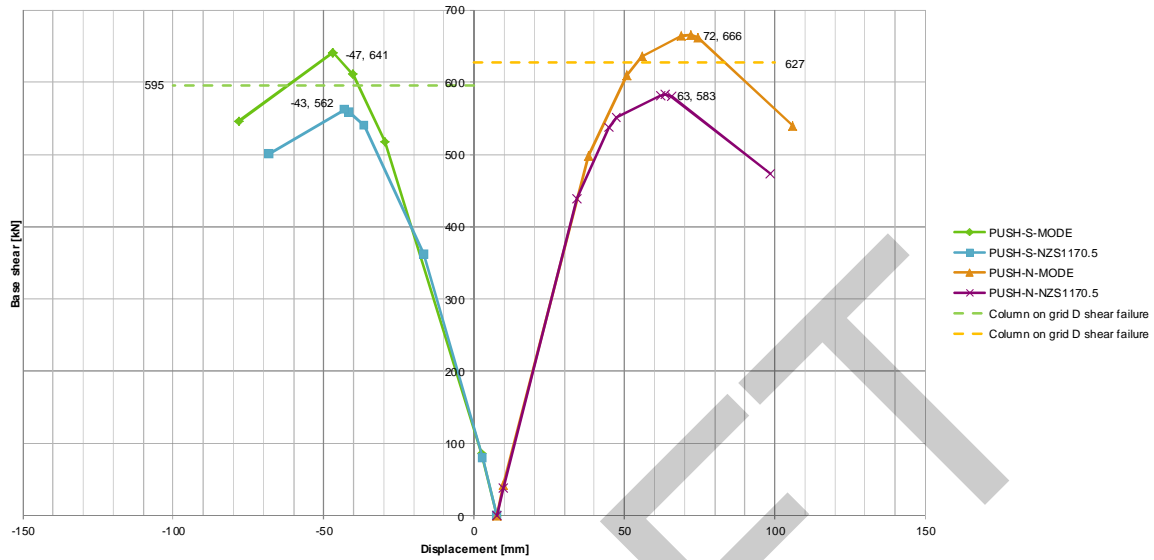
Figure 3-9: Pushover curves for frame on gridline 13

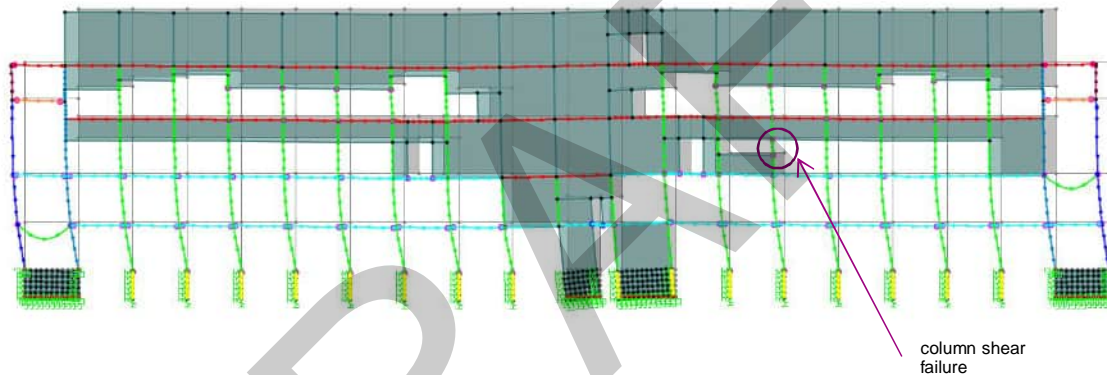
Figure 3-10: Failure mode for frame on gridline C

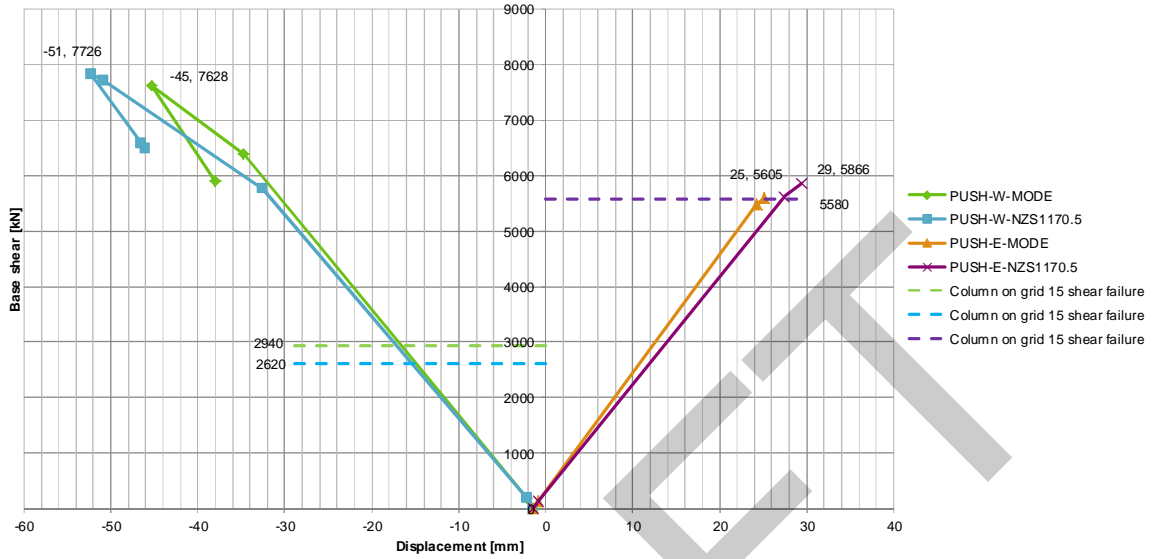
Figure 3-11: Pushover curves for frame on gridline C

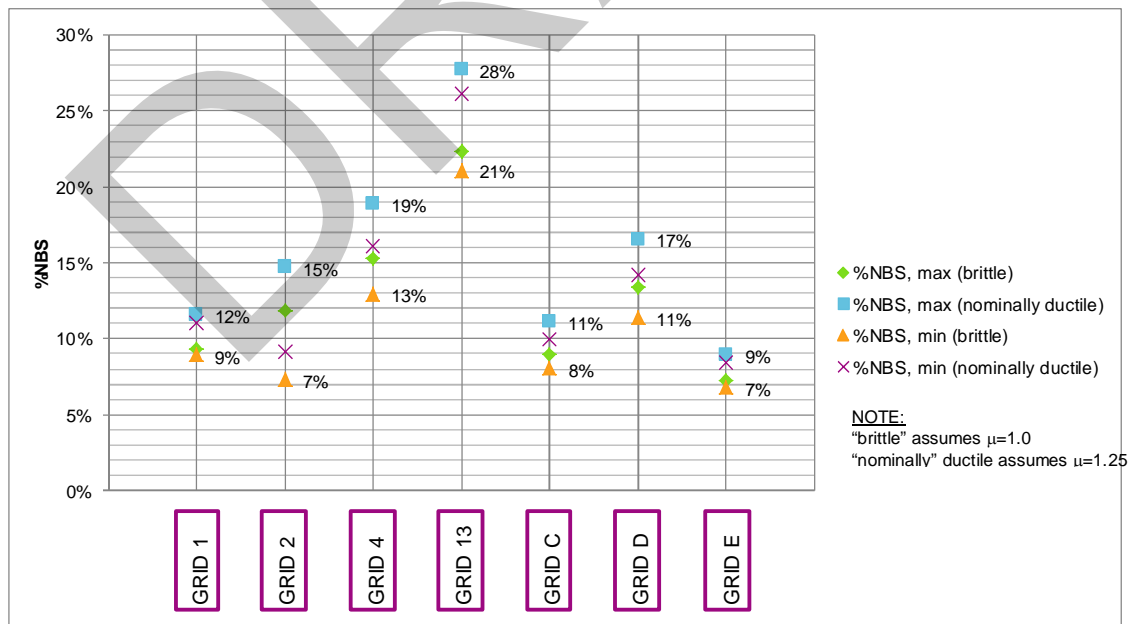
Figure 3-16: Summary of seismic capacities of individual frames

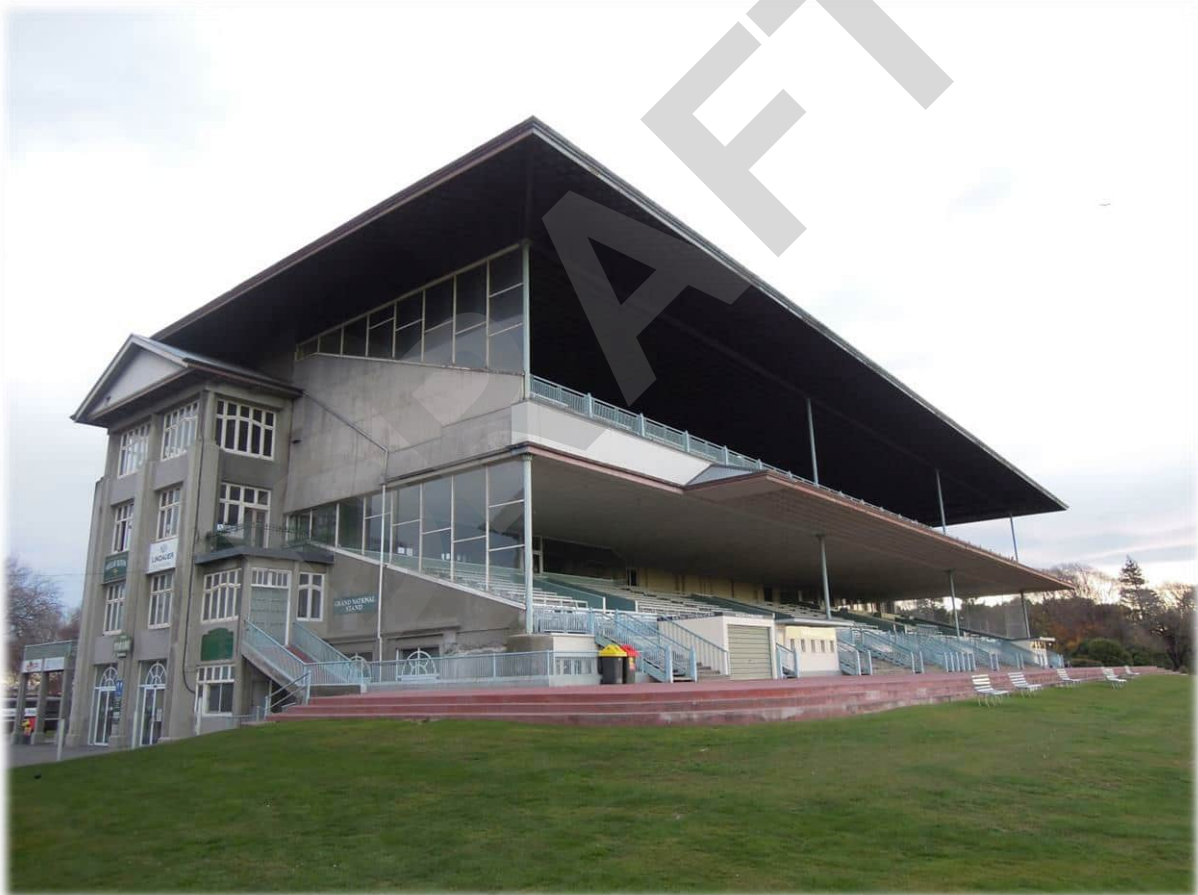
Grand National (Public) Stand

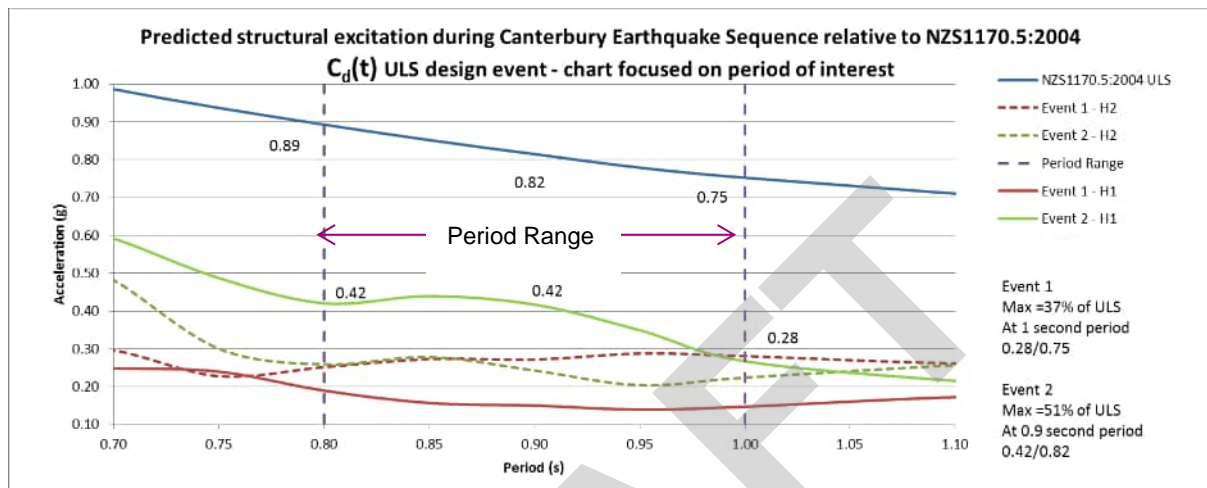
Figure 3: Ground Motion Excitation

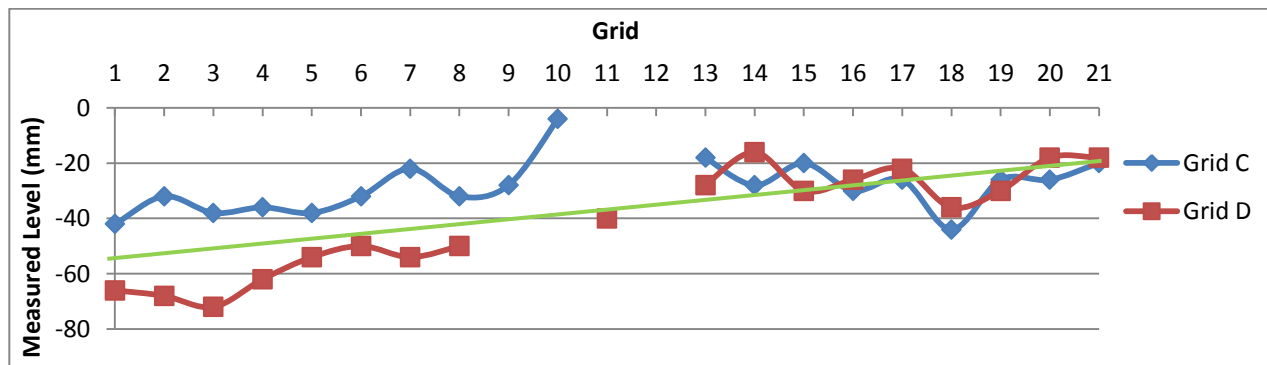
Figure 17: Ground Level Change in Floor Level along Grids

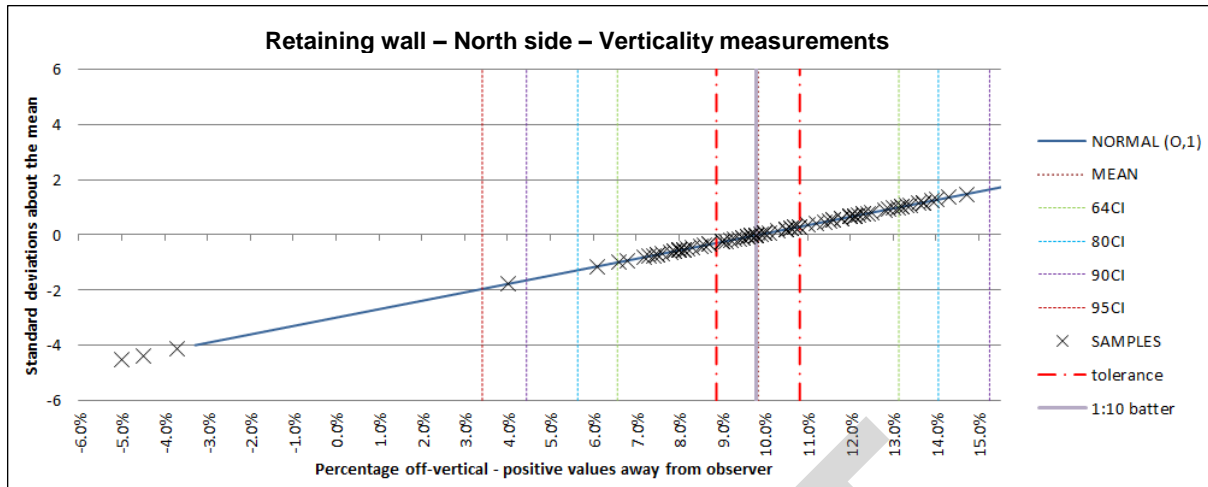
Figure 27: Northern retaining wall verticality measurements

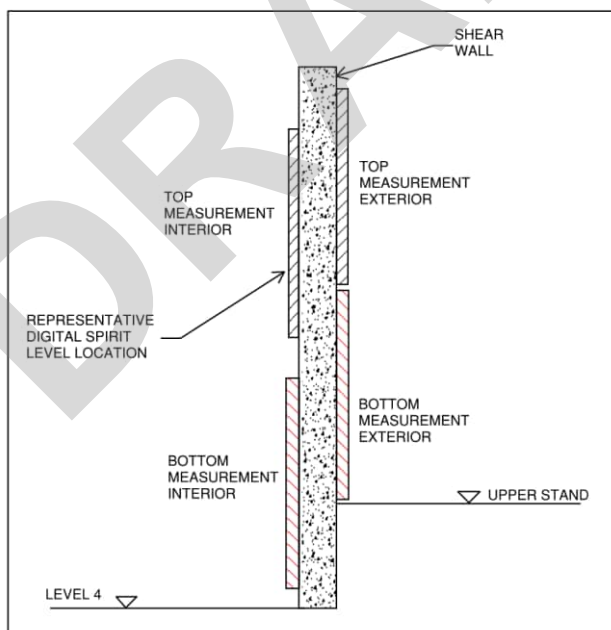
Figure 28: Location of spirit level for each measurement

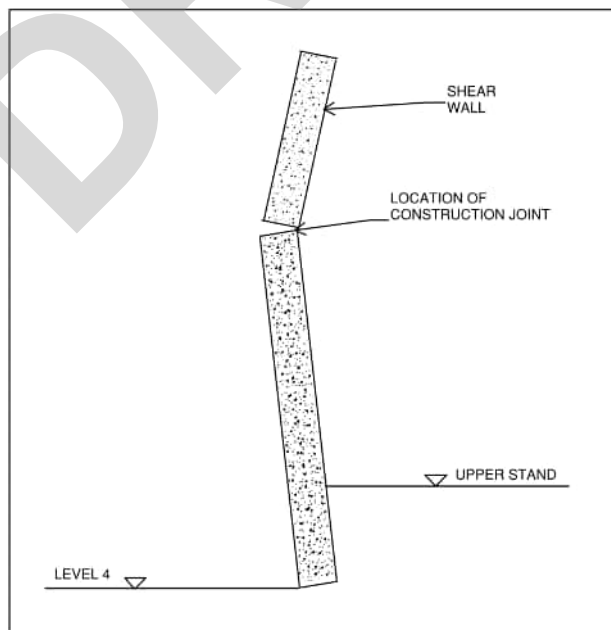
Figure 30: Hinging inferred from verticalities and crack patterns

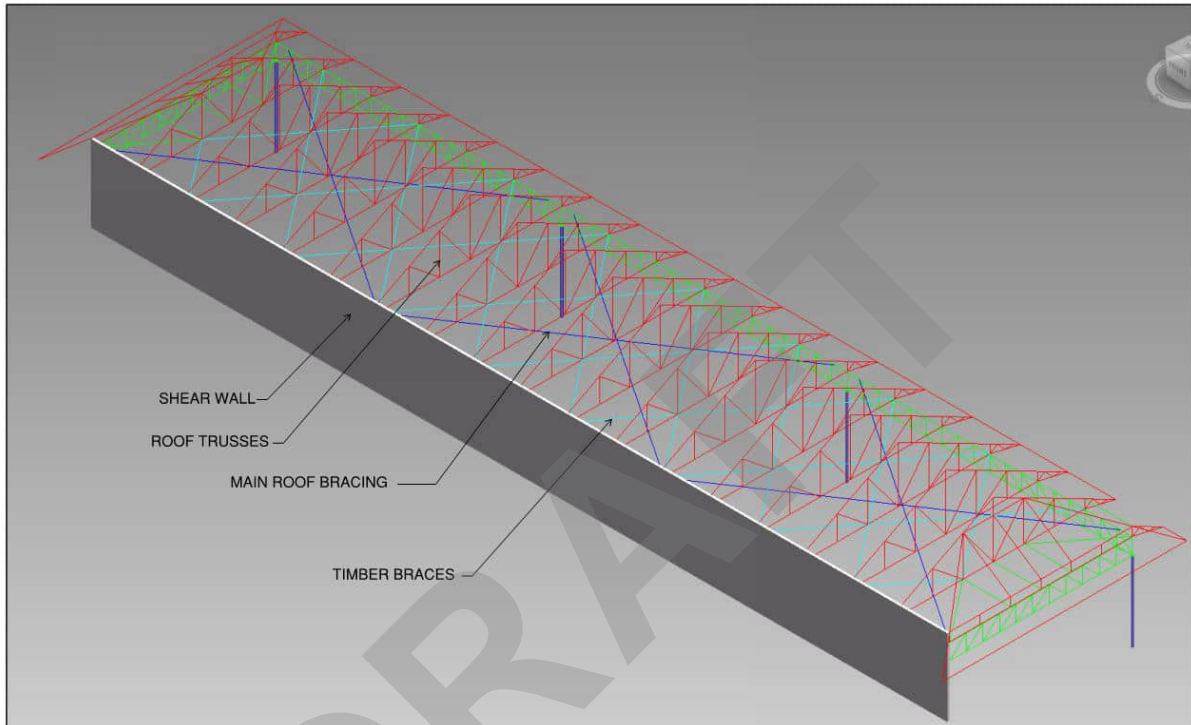
Figure 31: Shear wall and roof framing

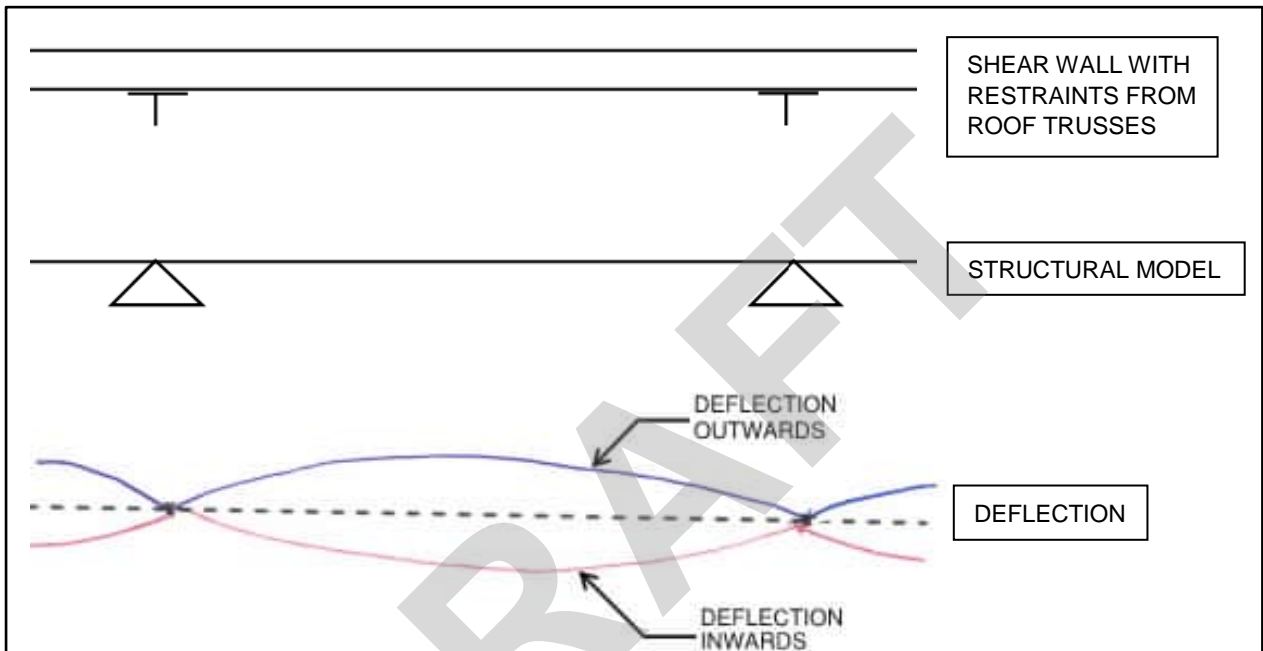
Figure 34: Panel behaviour of a wall element

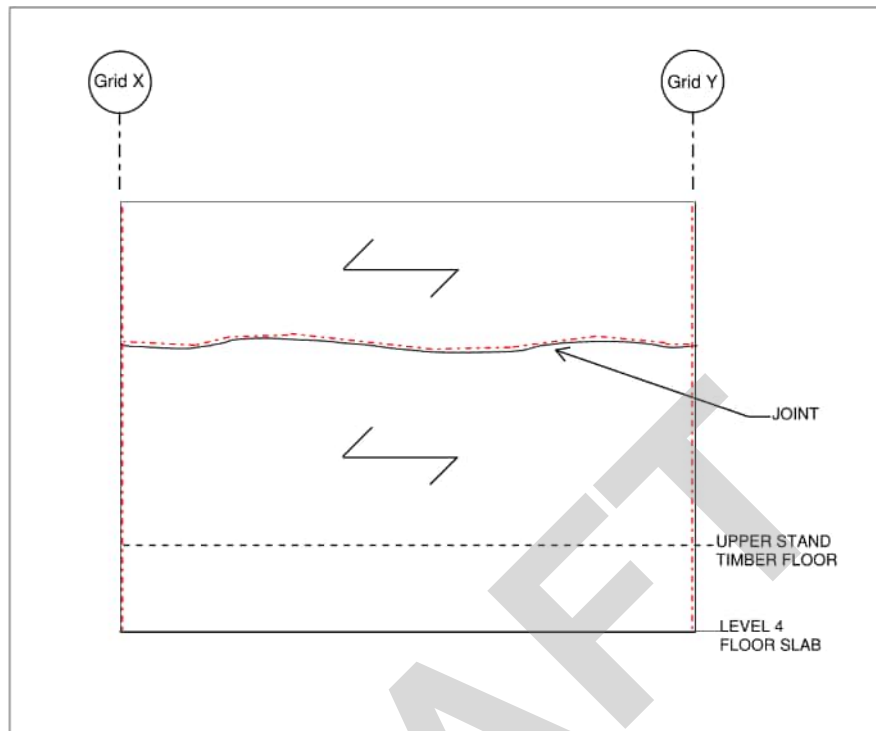
Figure 36: Observed Yield Line Pattern

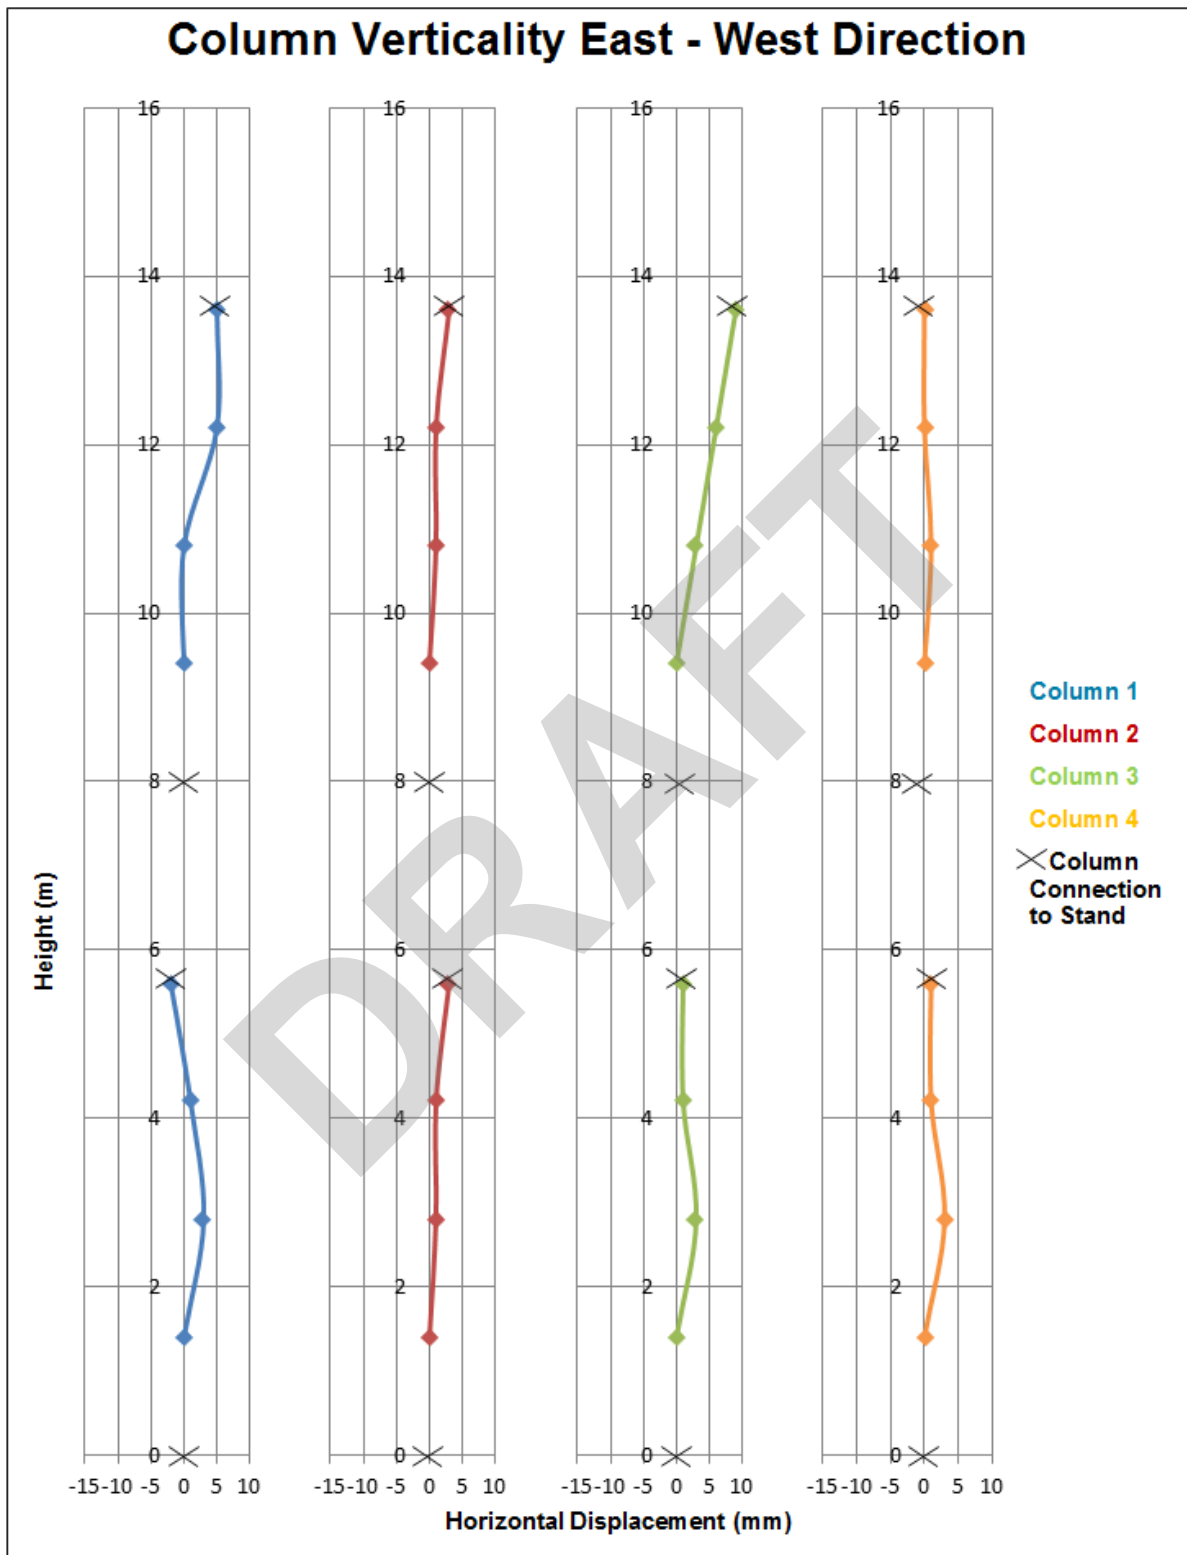
Figure 38: Column East-West Deflections

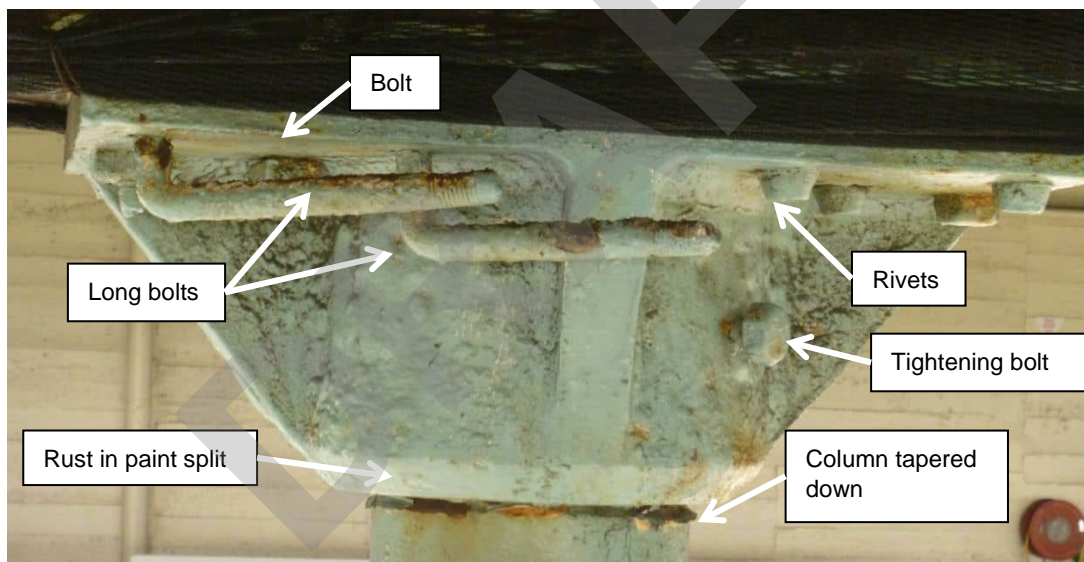
Figure 41: Cast iron collar connection

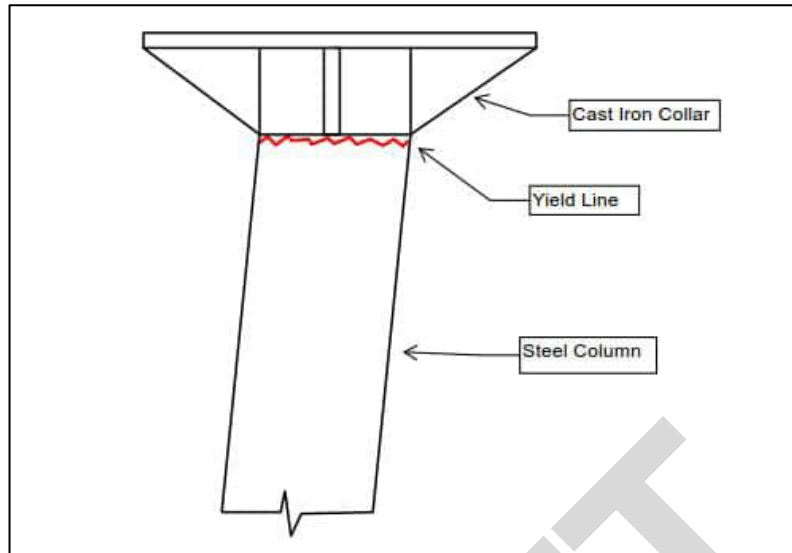
Figure 42: Likely yield mechanism of column

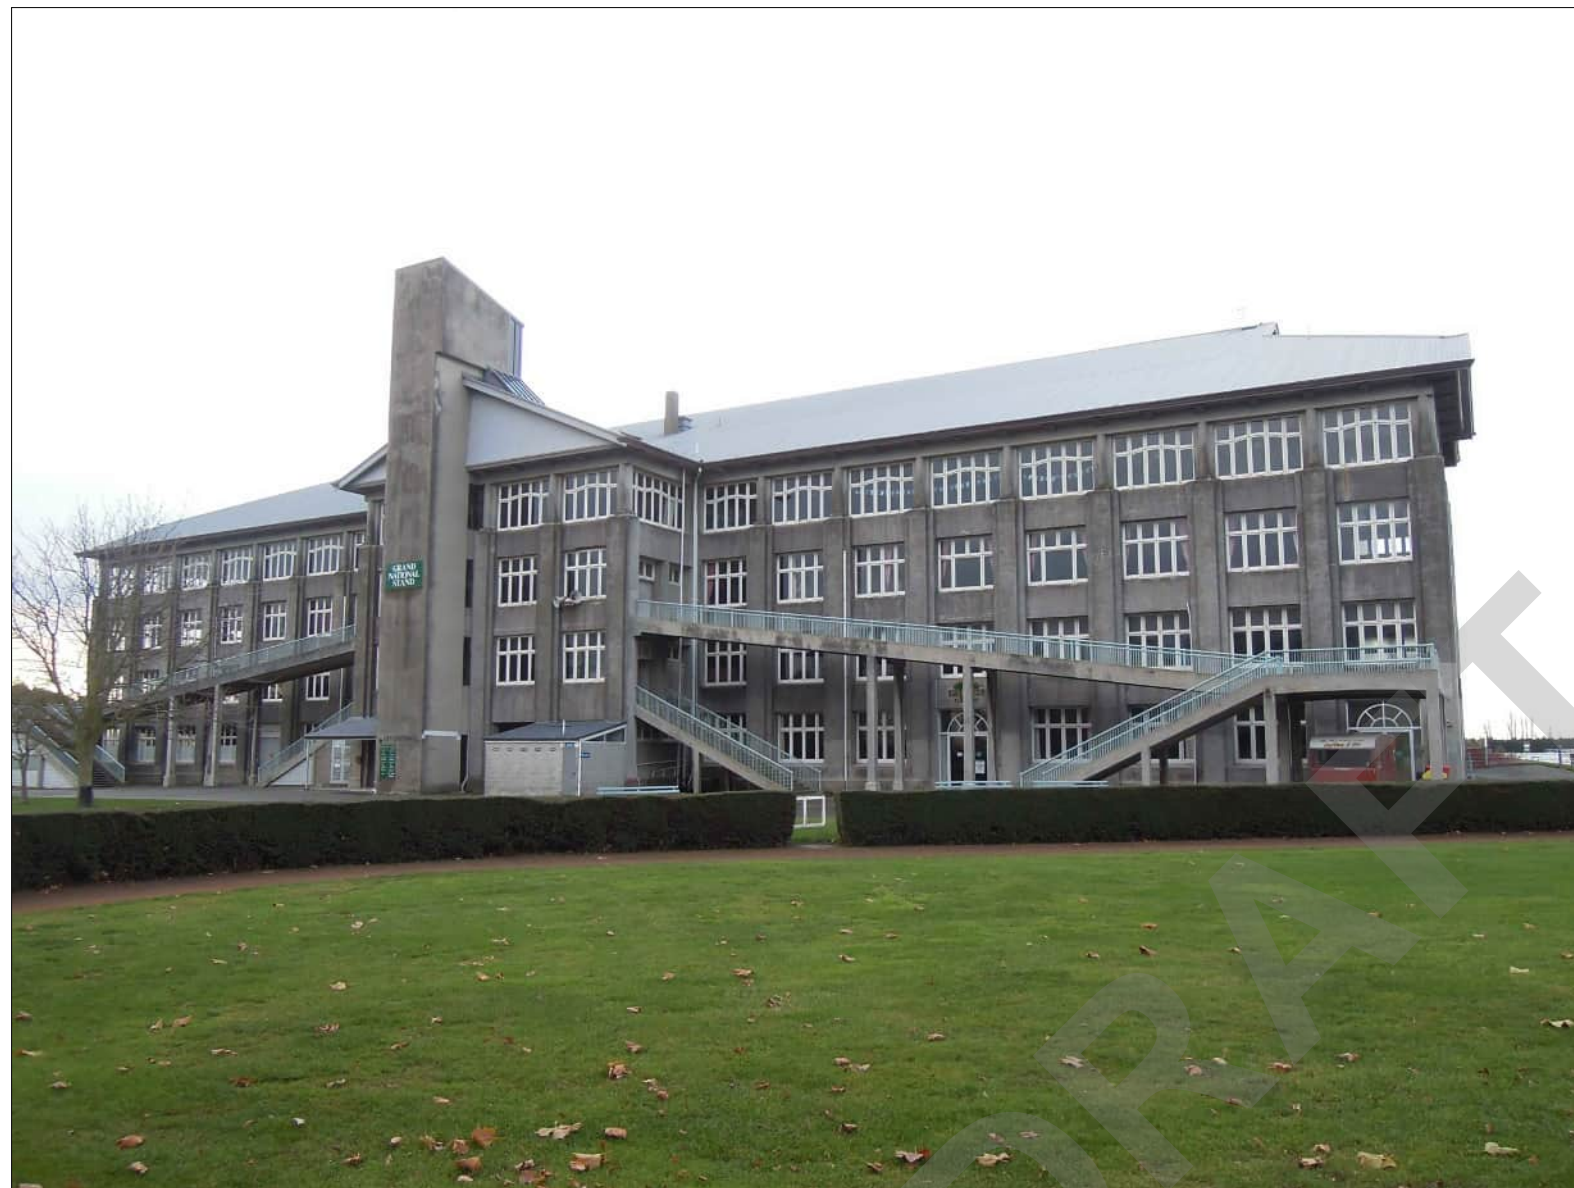
STRUCTURAL ASSESSMENT GRAND NATIONAL STAND CANTERBURY JOCKEY CLUB, CHRISTCHURCH

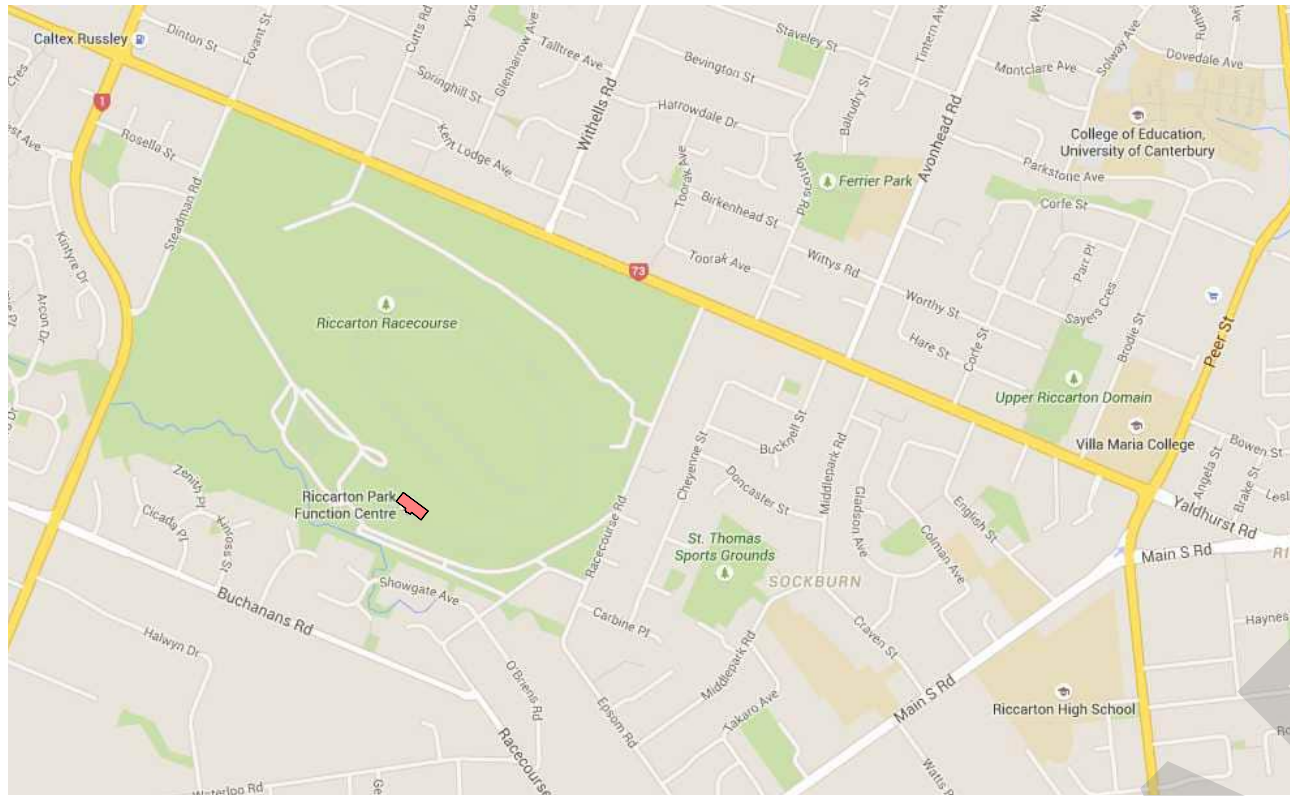
A.440-A.449	DAMAGE ASSESSMENTS AND CRACK MAPPING	ROOF DAMAGE ASSESSMENT
A.500-A.509	DAMAGE ASSESSMENT - PHOTOS	GROUND LEVEL
A.510-A.519	DAMAGE ASSESSMENT - PHOTOS	LEVEL 1
A.520-A.529	DAMAGE ASSESSMENT - PHOTOS	LEVEL 2
A.530-A.539	DAMAGE ASSESSMENT - PHOTOS	LEVEL 3
A.540-A.549	DAMAGE ASSESSMENT - PHOTOS	LEVEL 4
A.550-A.559	DAMAGE ASSESSMENT - PHOTOS	ELEVATIONS
A.600-A.609	INTRUSIVE WORKS LOCATIONS AND INITIAL DAMAGE LOCATIONS FOLLOW UP	PLANS
A.700-A.709	RETAINING WALL ASSESSMENT	DAMAGE ASSESSMENT
A.710-A.719	RETAINING WALL ASSESSMENT	PHOTOS
A.800-A.809	EXTERIOR RAMPS, STEPS AND COLUMN SURVEY	DAMAGE ASSESSMENT
A.810-A.819	EXTERIOR RAMPS, STEPS AND COLUMN SURVEY	PHOTOS

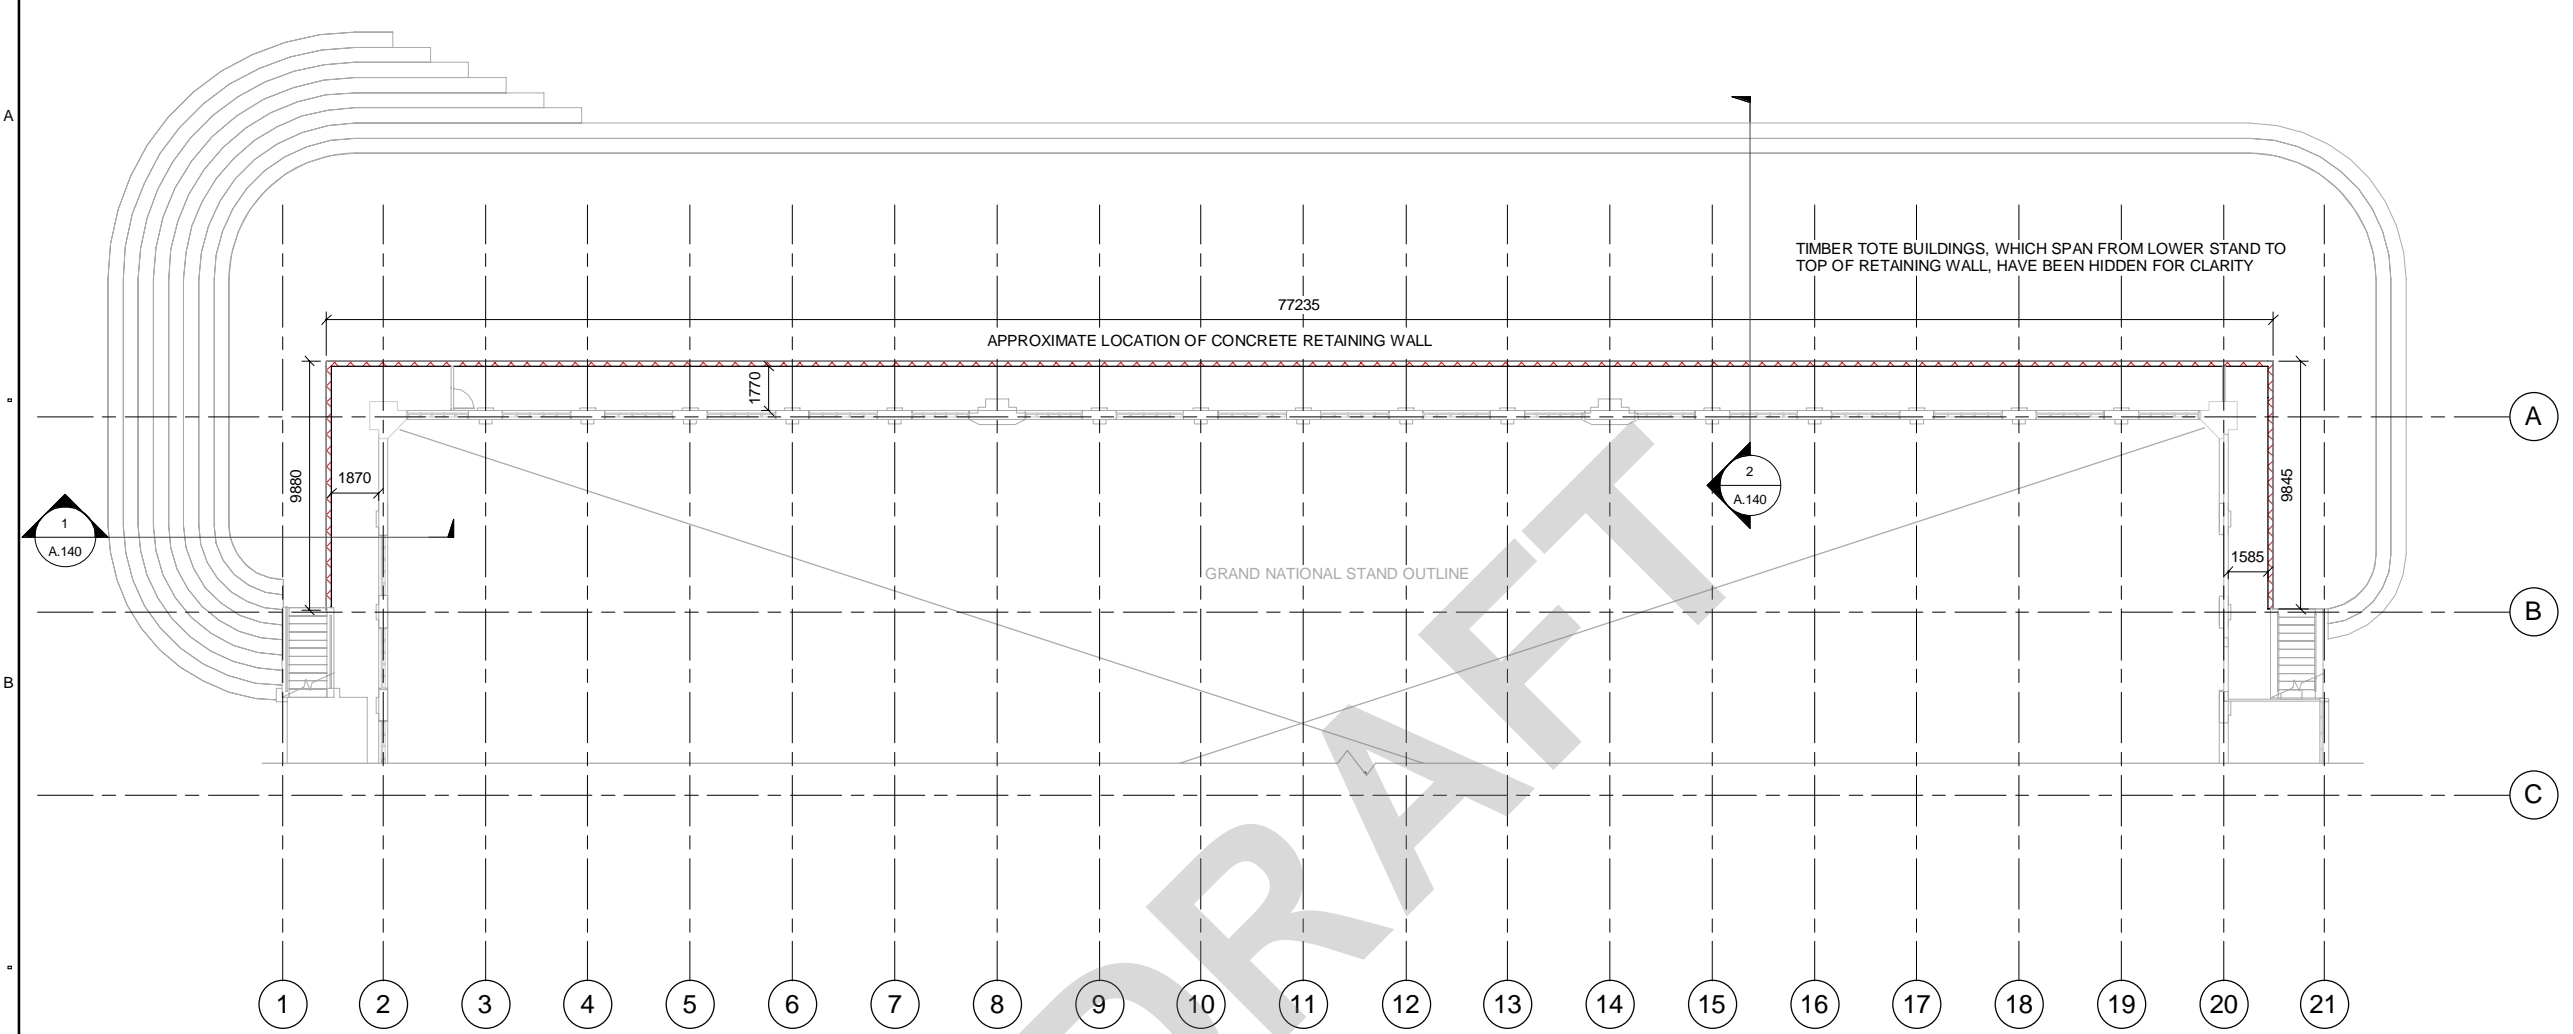
RETAINING WALL - PLAN
Scale: 1 : 150

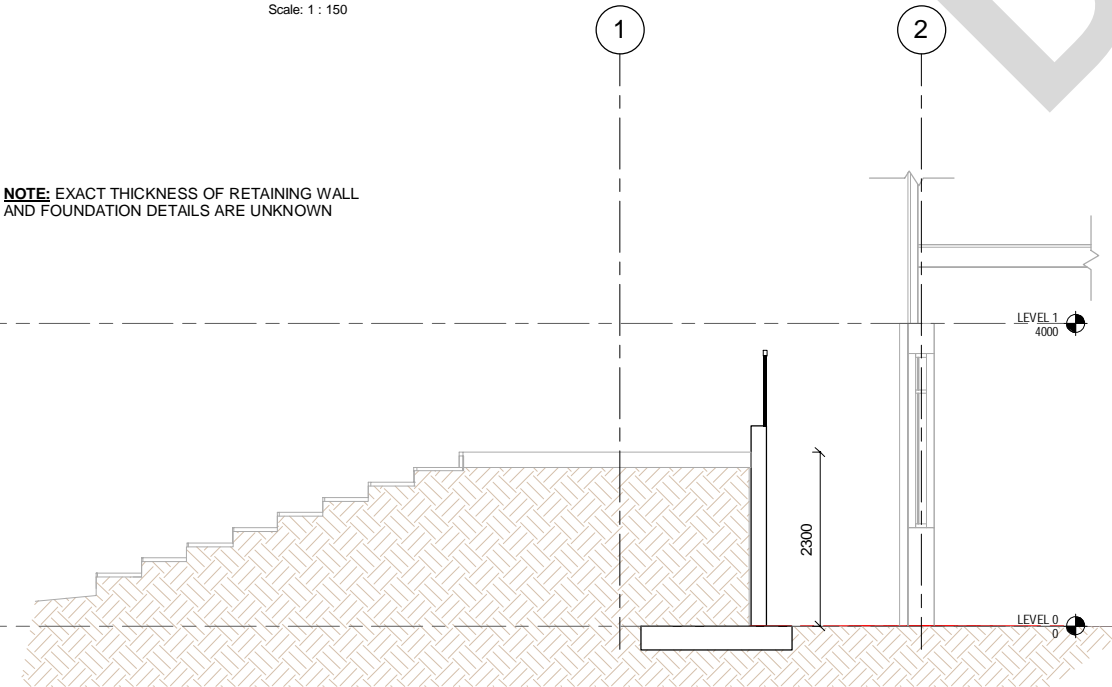
WALL SECTION 1
Scale: 1 : 50

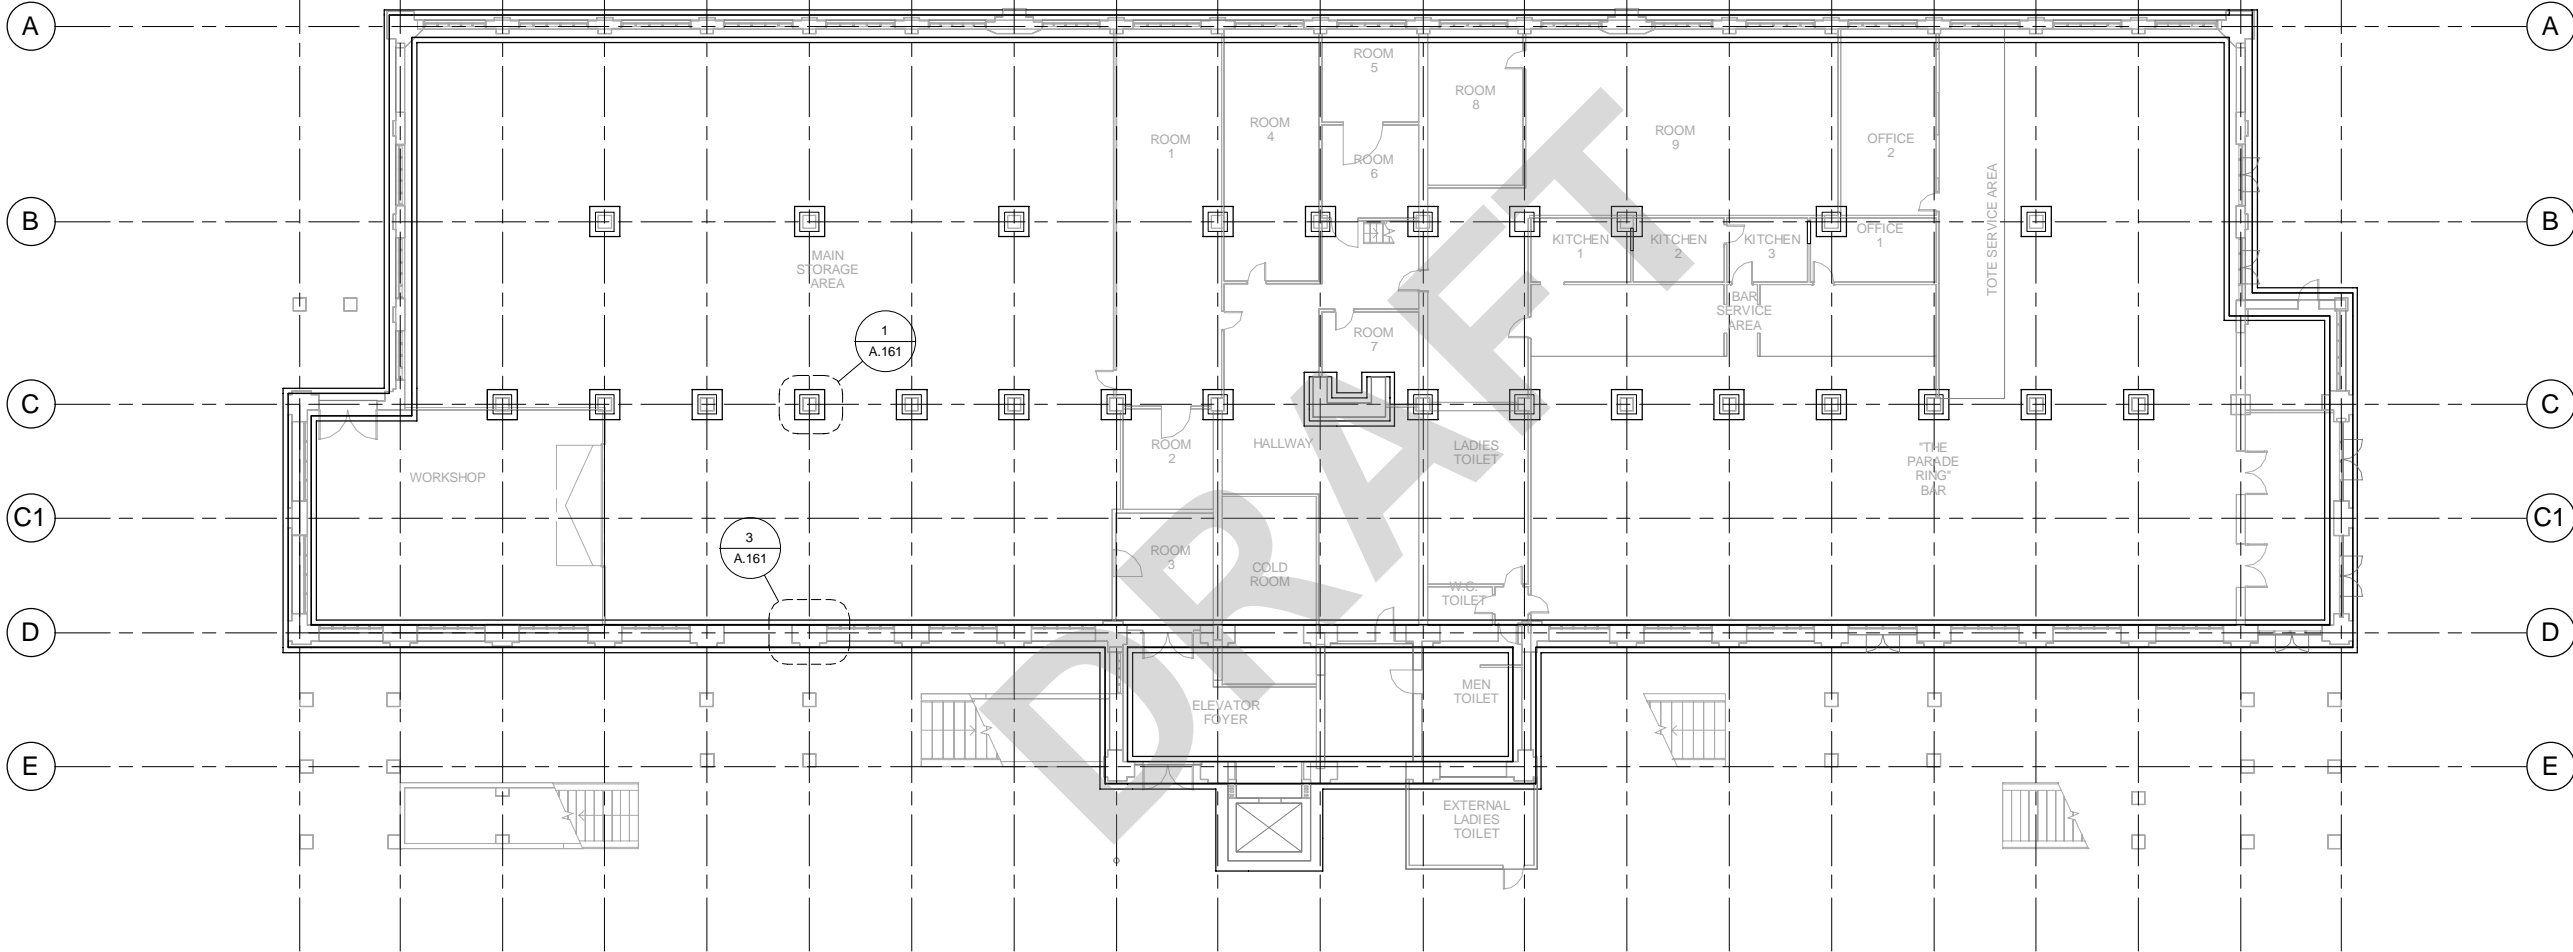
FOUNDATION PLAN (INFERRED FROM LIMITED FOUNDATION EXPOSURE)
