Detailed Damage Evaluation

Quantitative Seismic Analysis of Grand National (Public) Stand

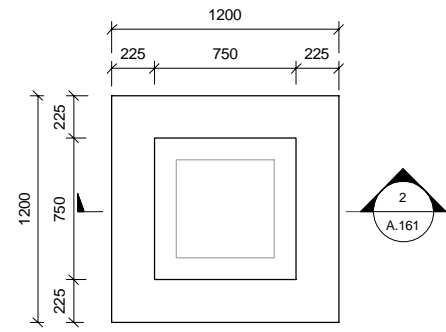
1 TYPICAL COLUMN FOUNDATION - PLAN

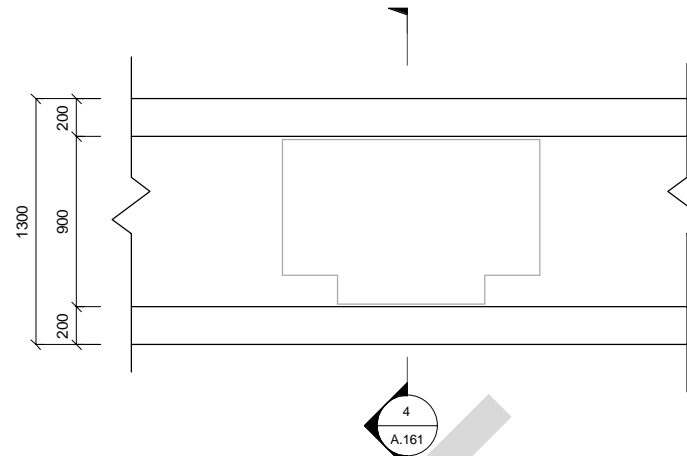
3 TYPICAL WALL FOUNDATION - PLAN

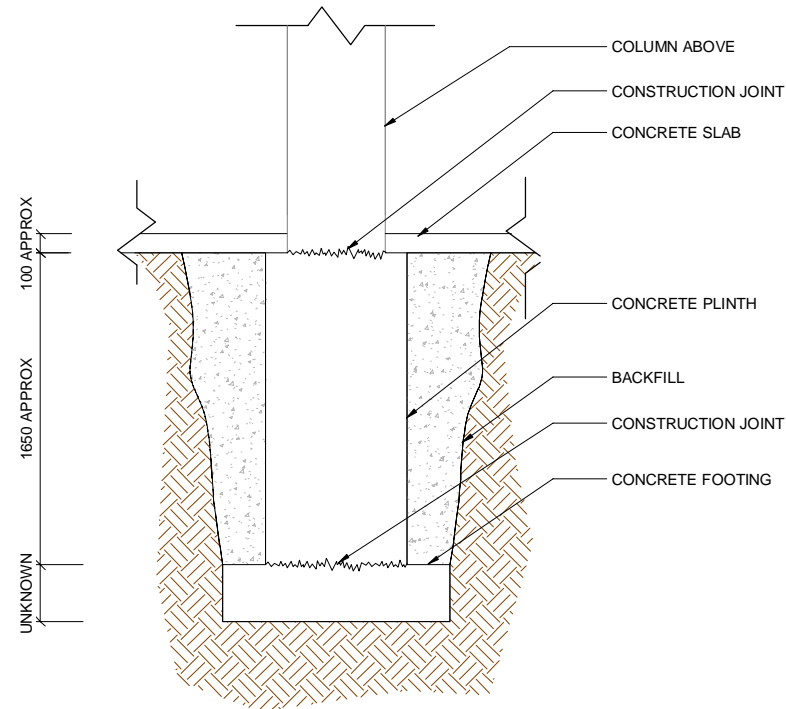
2 TYPICAL COLUMN FOUNDATION - SECTION

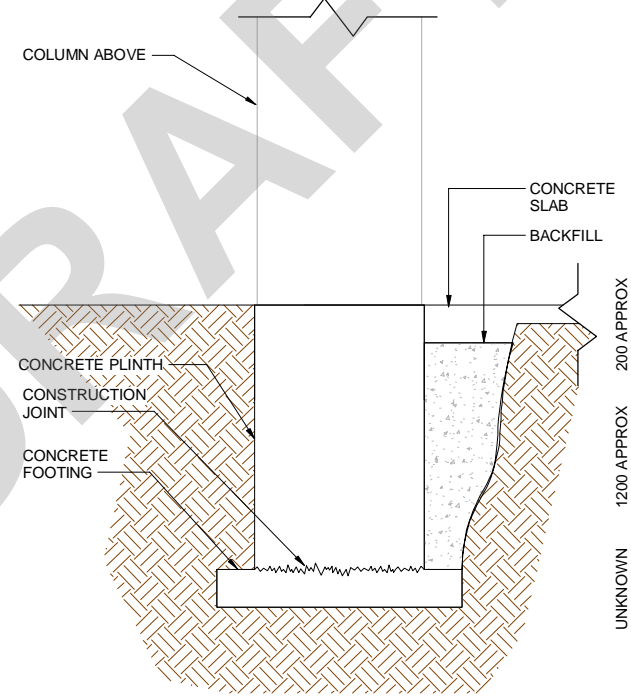
4 TYPICAL WALL FOUNDATION - SECTION

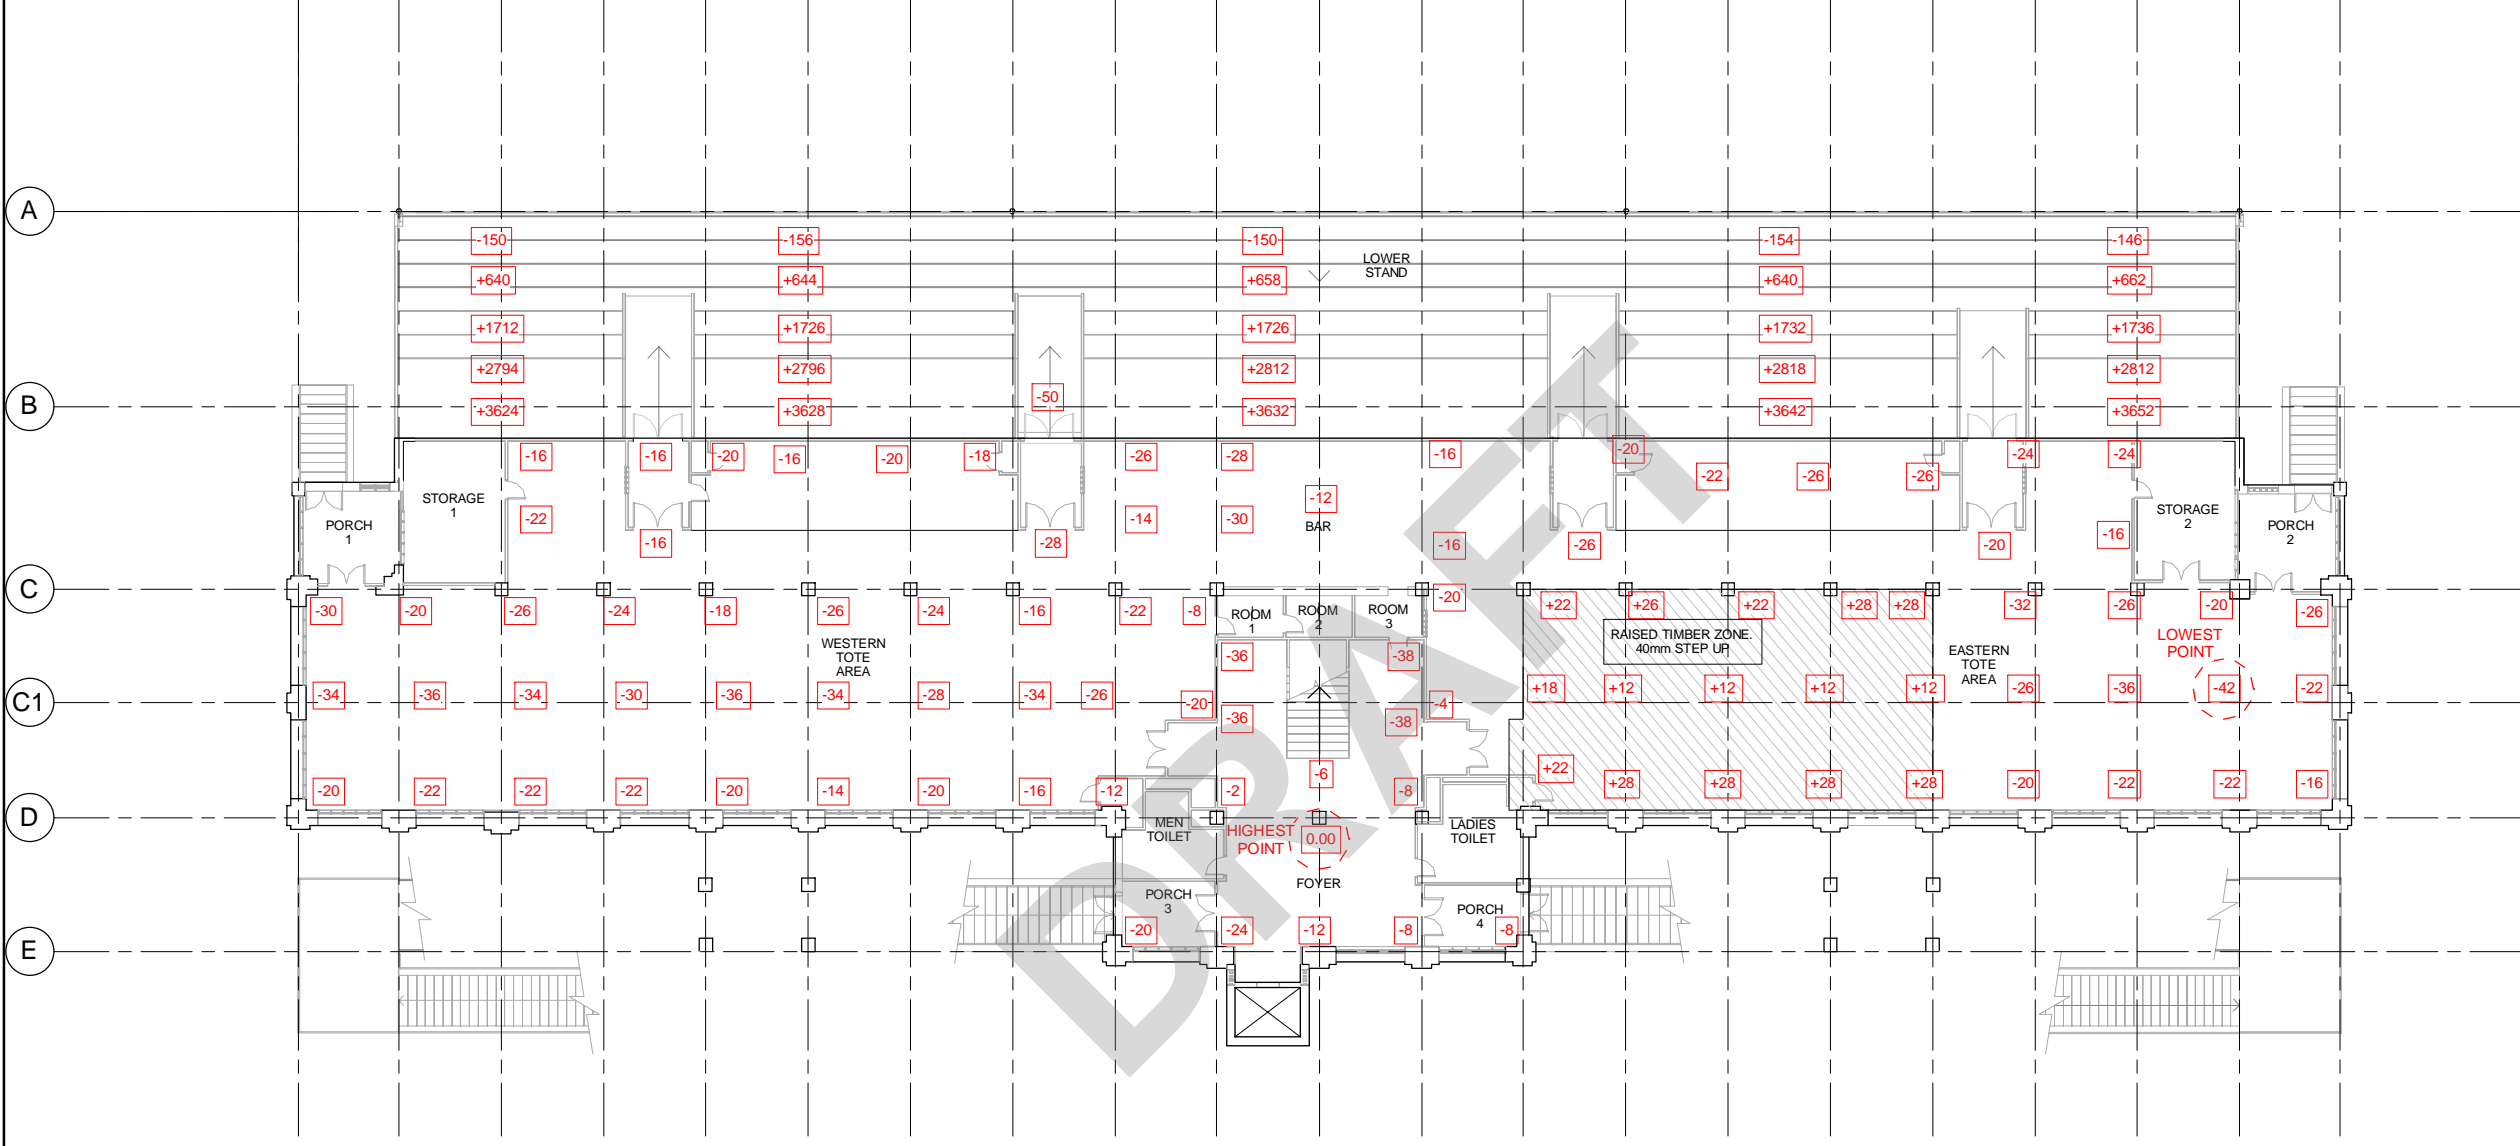
FLOOR LEVELS SURVEY - FLOOR 1
 NOTIONAL DATUM - D11 = 4.000 m Scale: 1 : 150

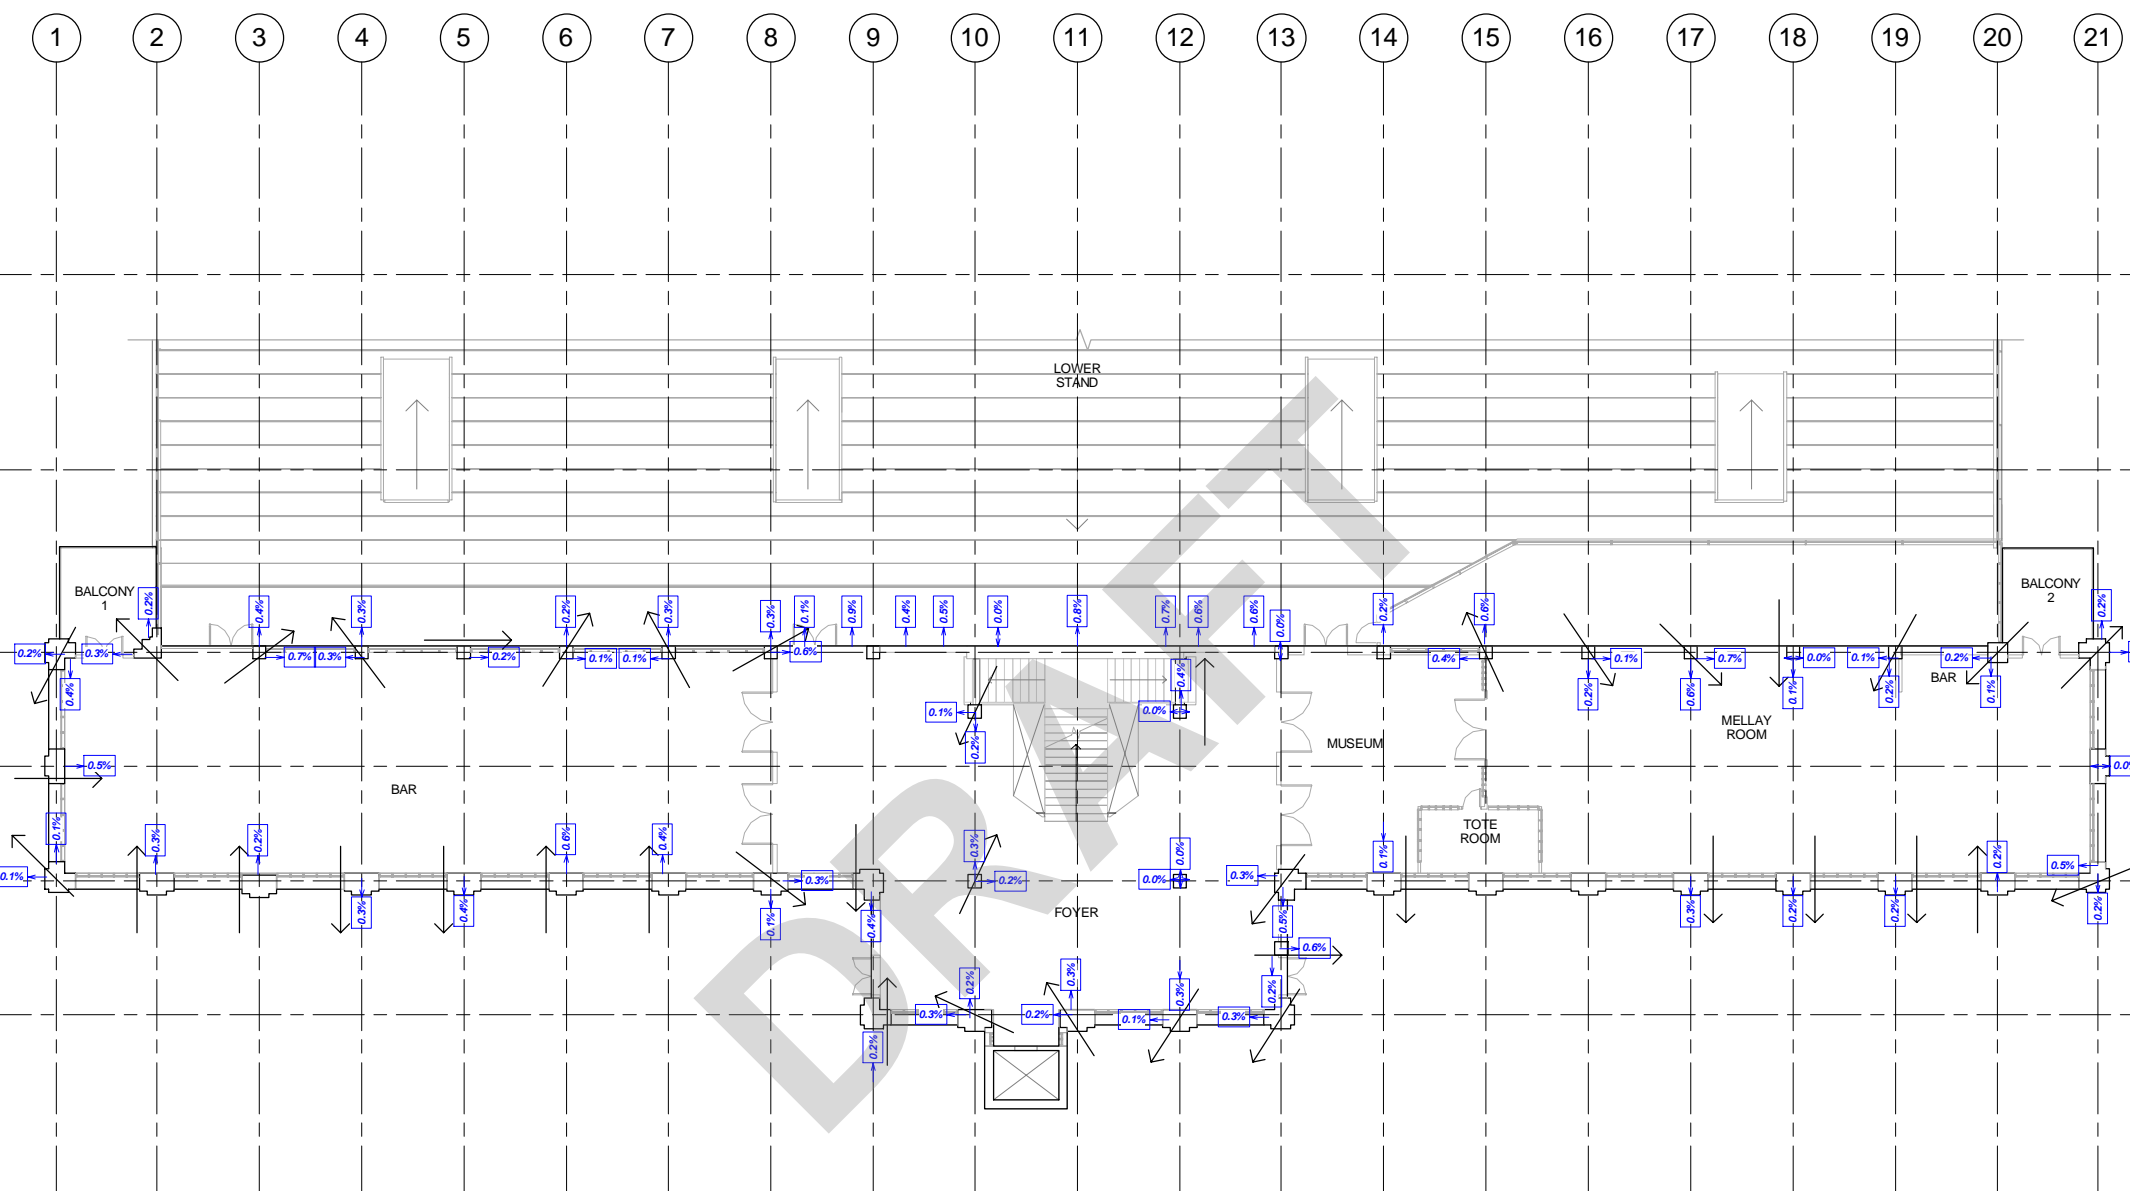
COLUMN AND WALL VERTICALITY SURVEY - FLOOR 2
Scale: 1 : 150

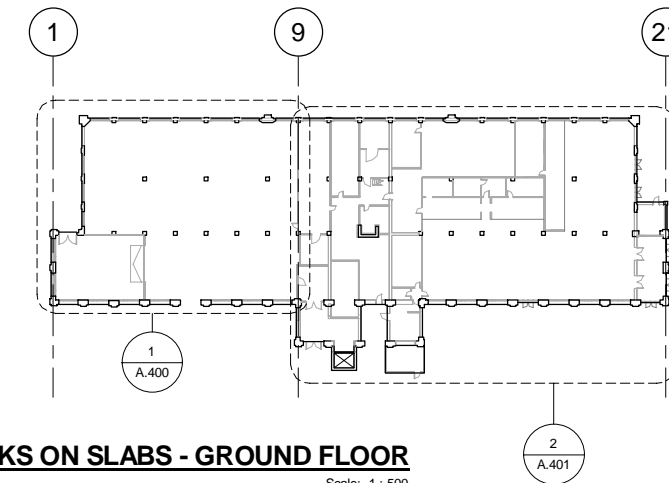
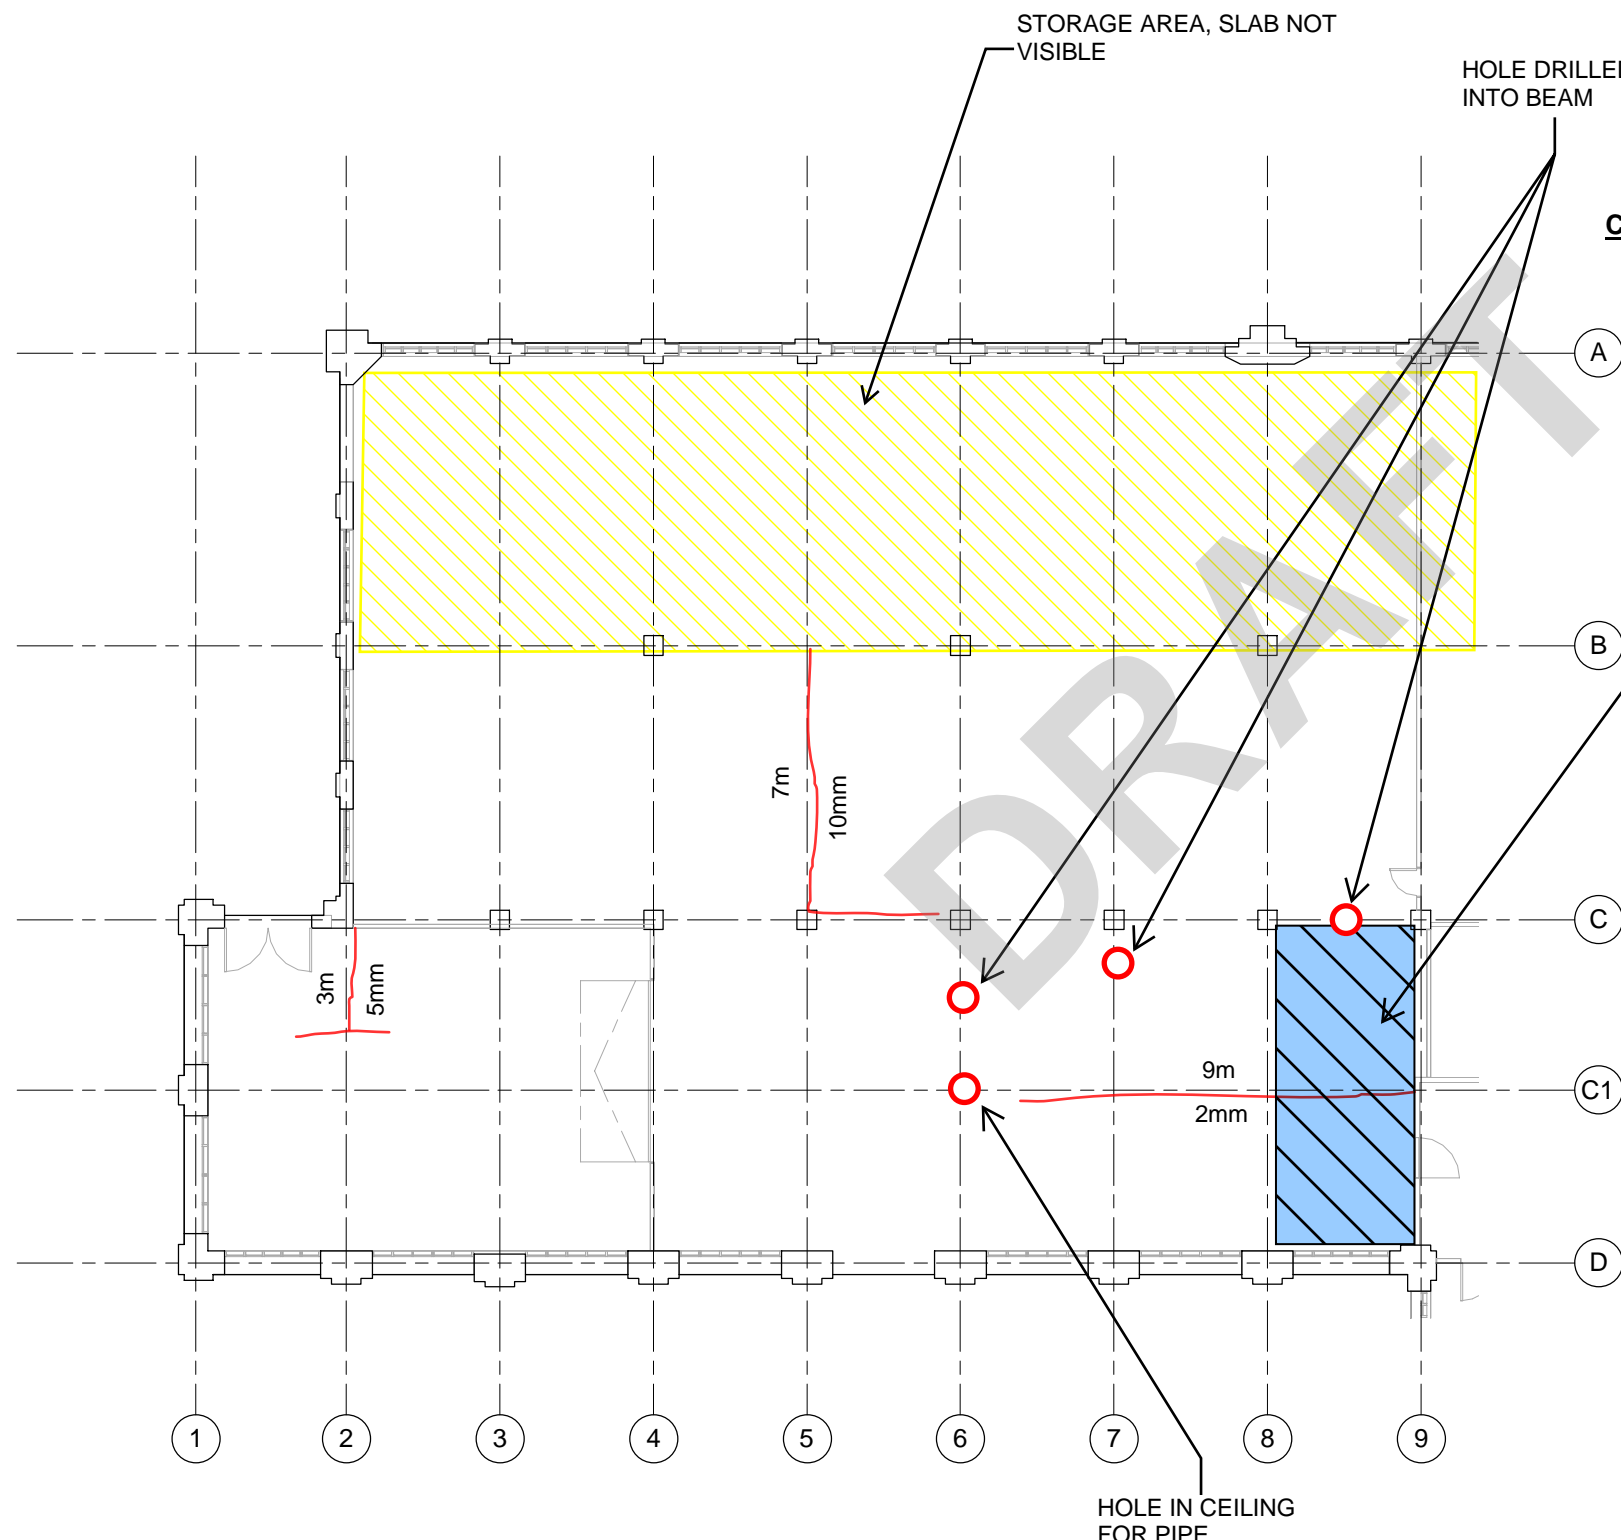
CRACK LEGEND: ALL DRAWINGS A.400 TO A.409

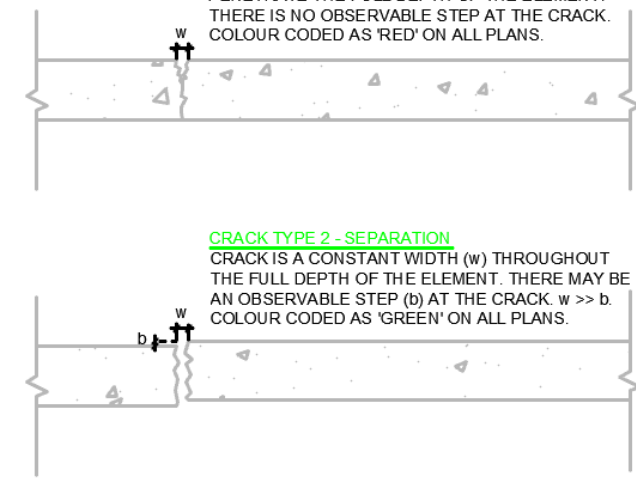
CRACK TYPE 2 - SEPARATION
CRACK IS A CONSTANT WIDTH (w) THROUGHOUT THE FULL DEPTH OF THE ELEMENT. THERE MAY BE AN OBSERVABLE STEP (b) AT THE CRACK. $w \gg b$. COLOUR CODED AS 'GREEN' ON ALL PLANS.

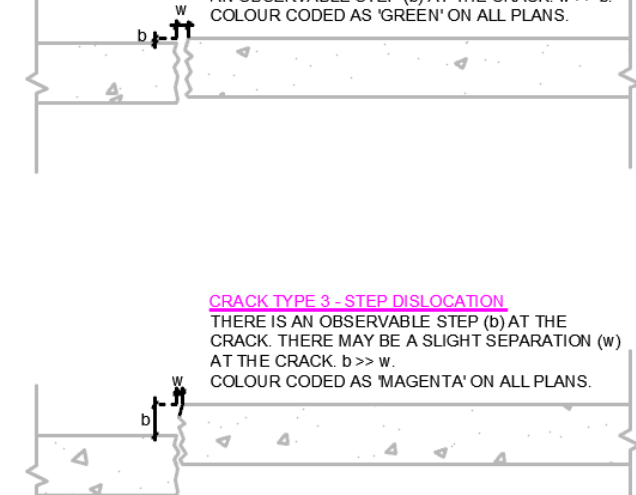
CRACK TYPE 3 - STEP DISLOCATION
THERE IS AN OBSERVABLE STEP (b) AT THE CRACK. THERE MAY BE A SLIGHT SEPARATION (w) AT THE CRACK. $b \gg w$. COLOUR CODED AS 'MAGENTA' ON ALL PLANS.

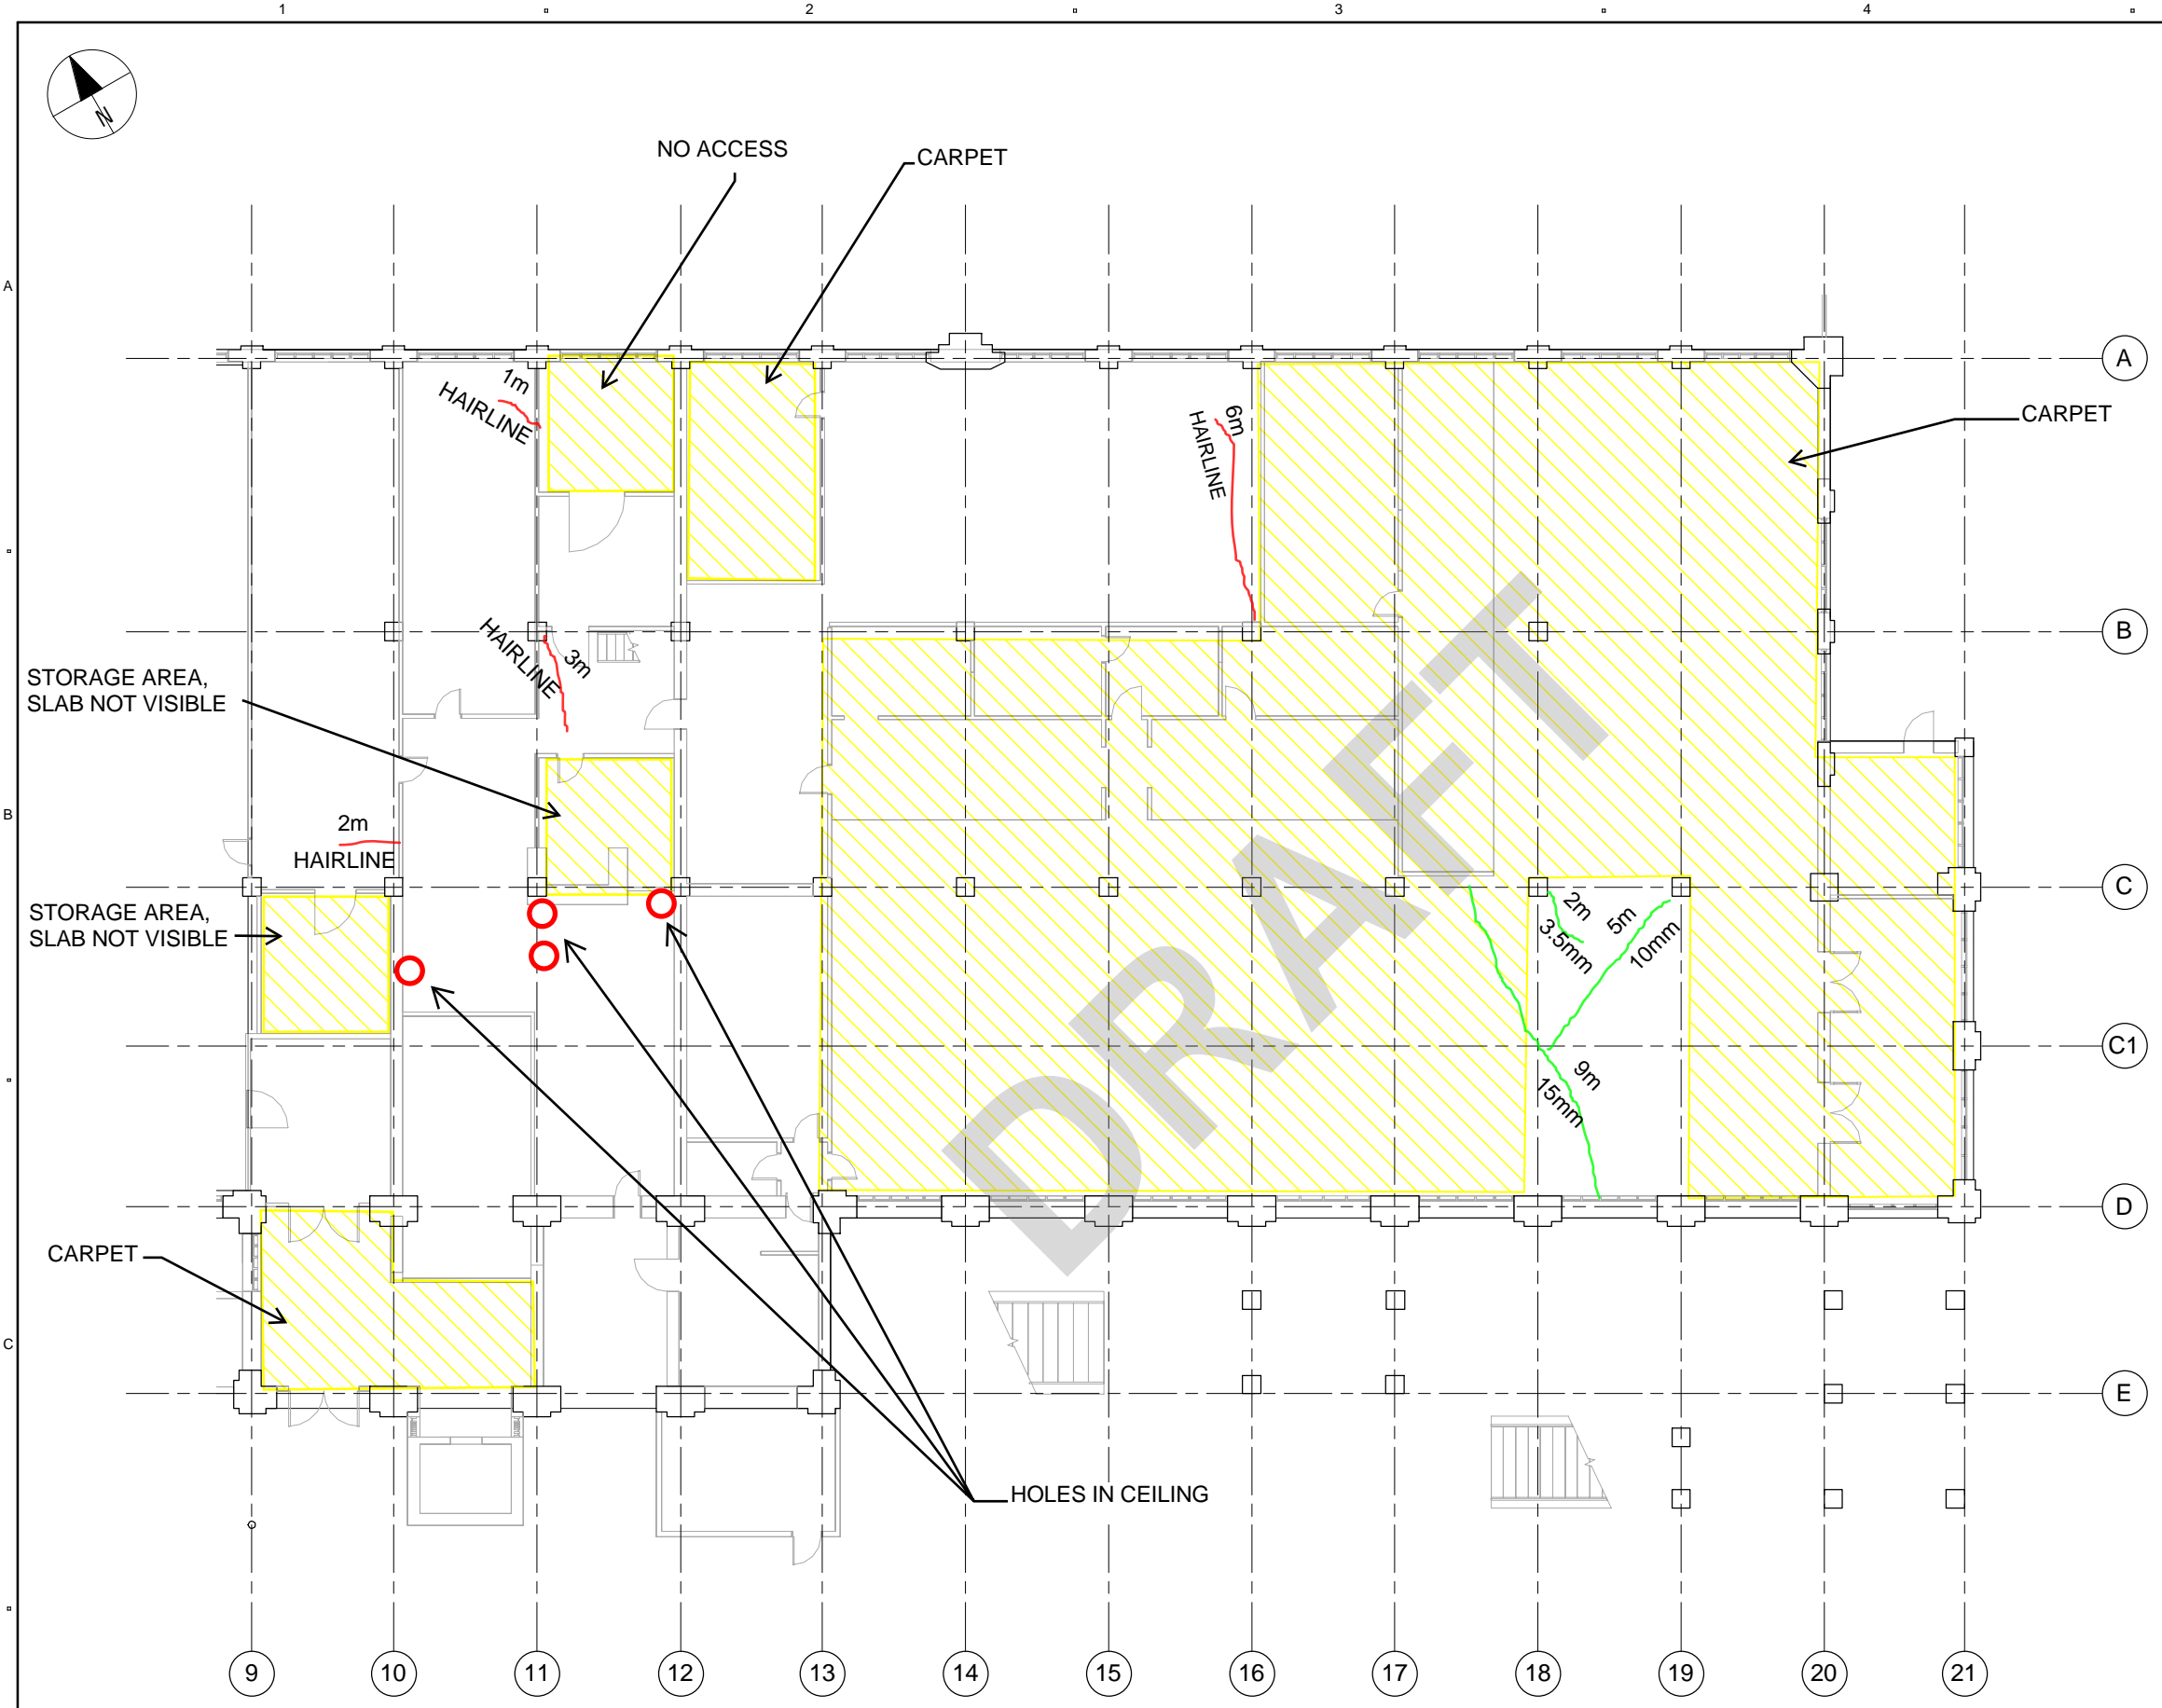
2 | CRACKS ON SLABS - GROUND FLOOR - GRID 9 TO GRID 21
A.401 REF: A.400 Scale: 1 : 100

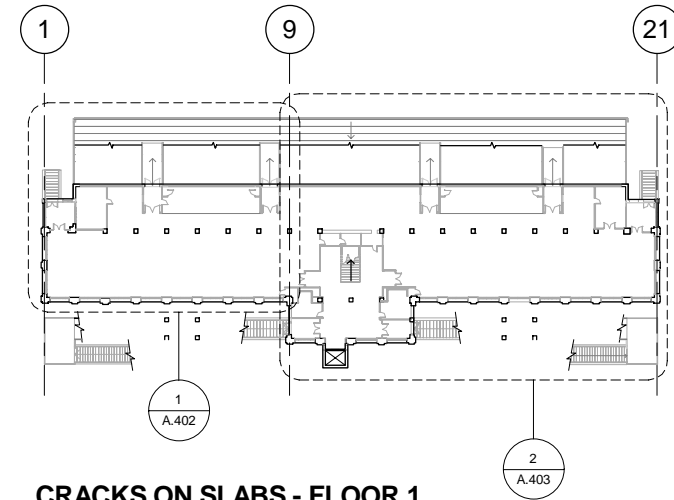
CRACKS ON SLABS - FLOOR 1

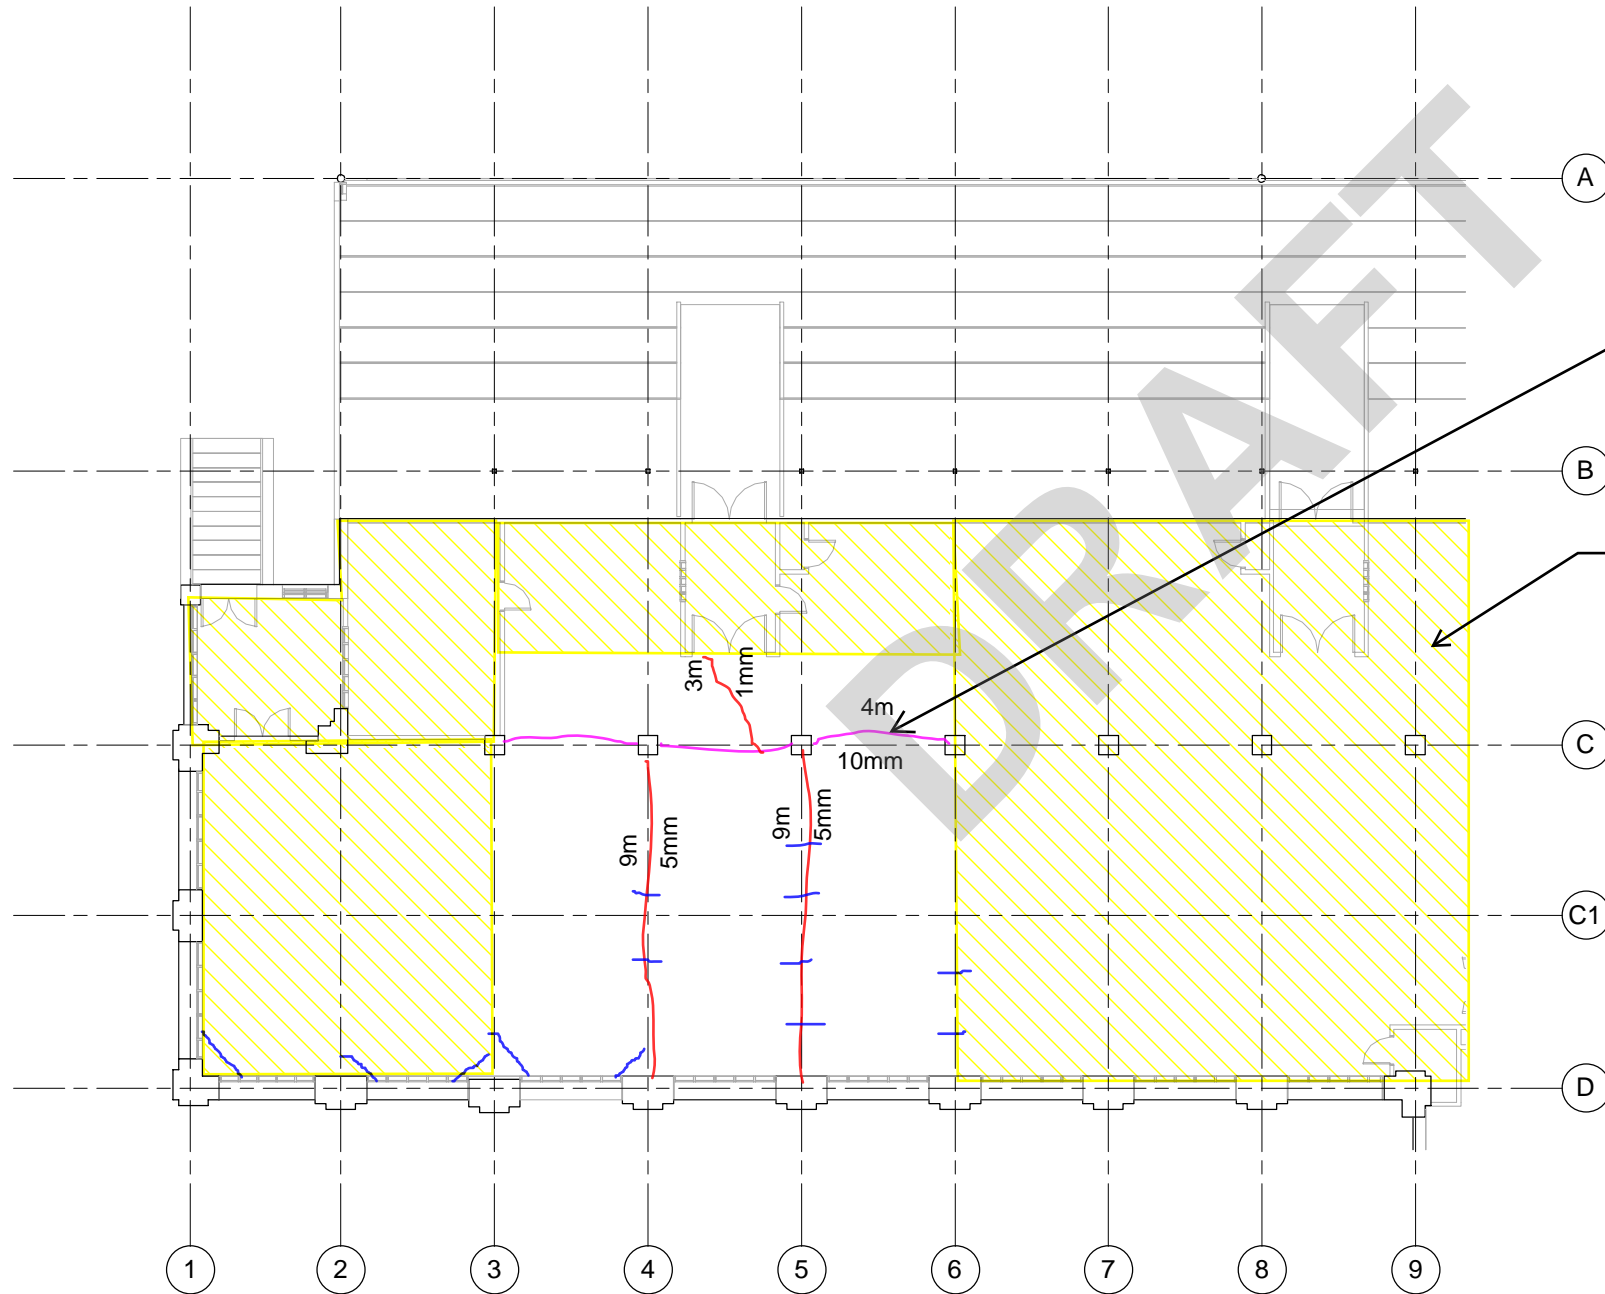
1 | CRACKS ON SLABS - FLOOR 1 - GRID 1 TO GRID 9

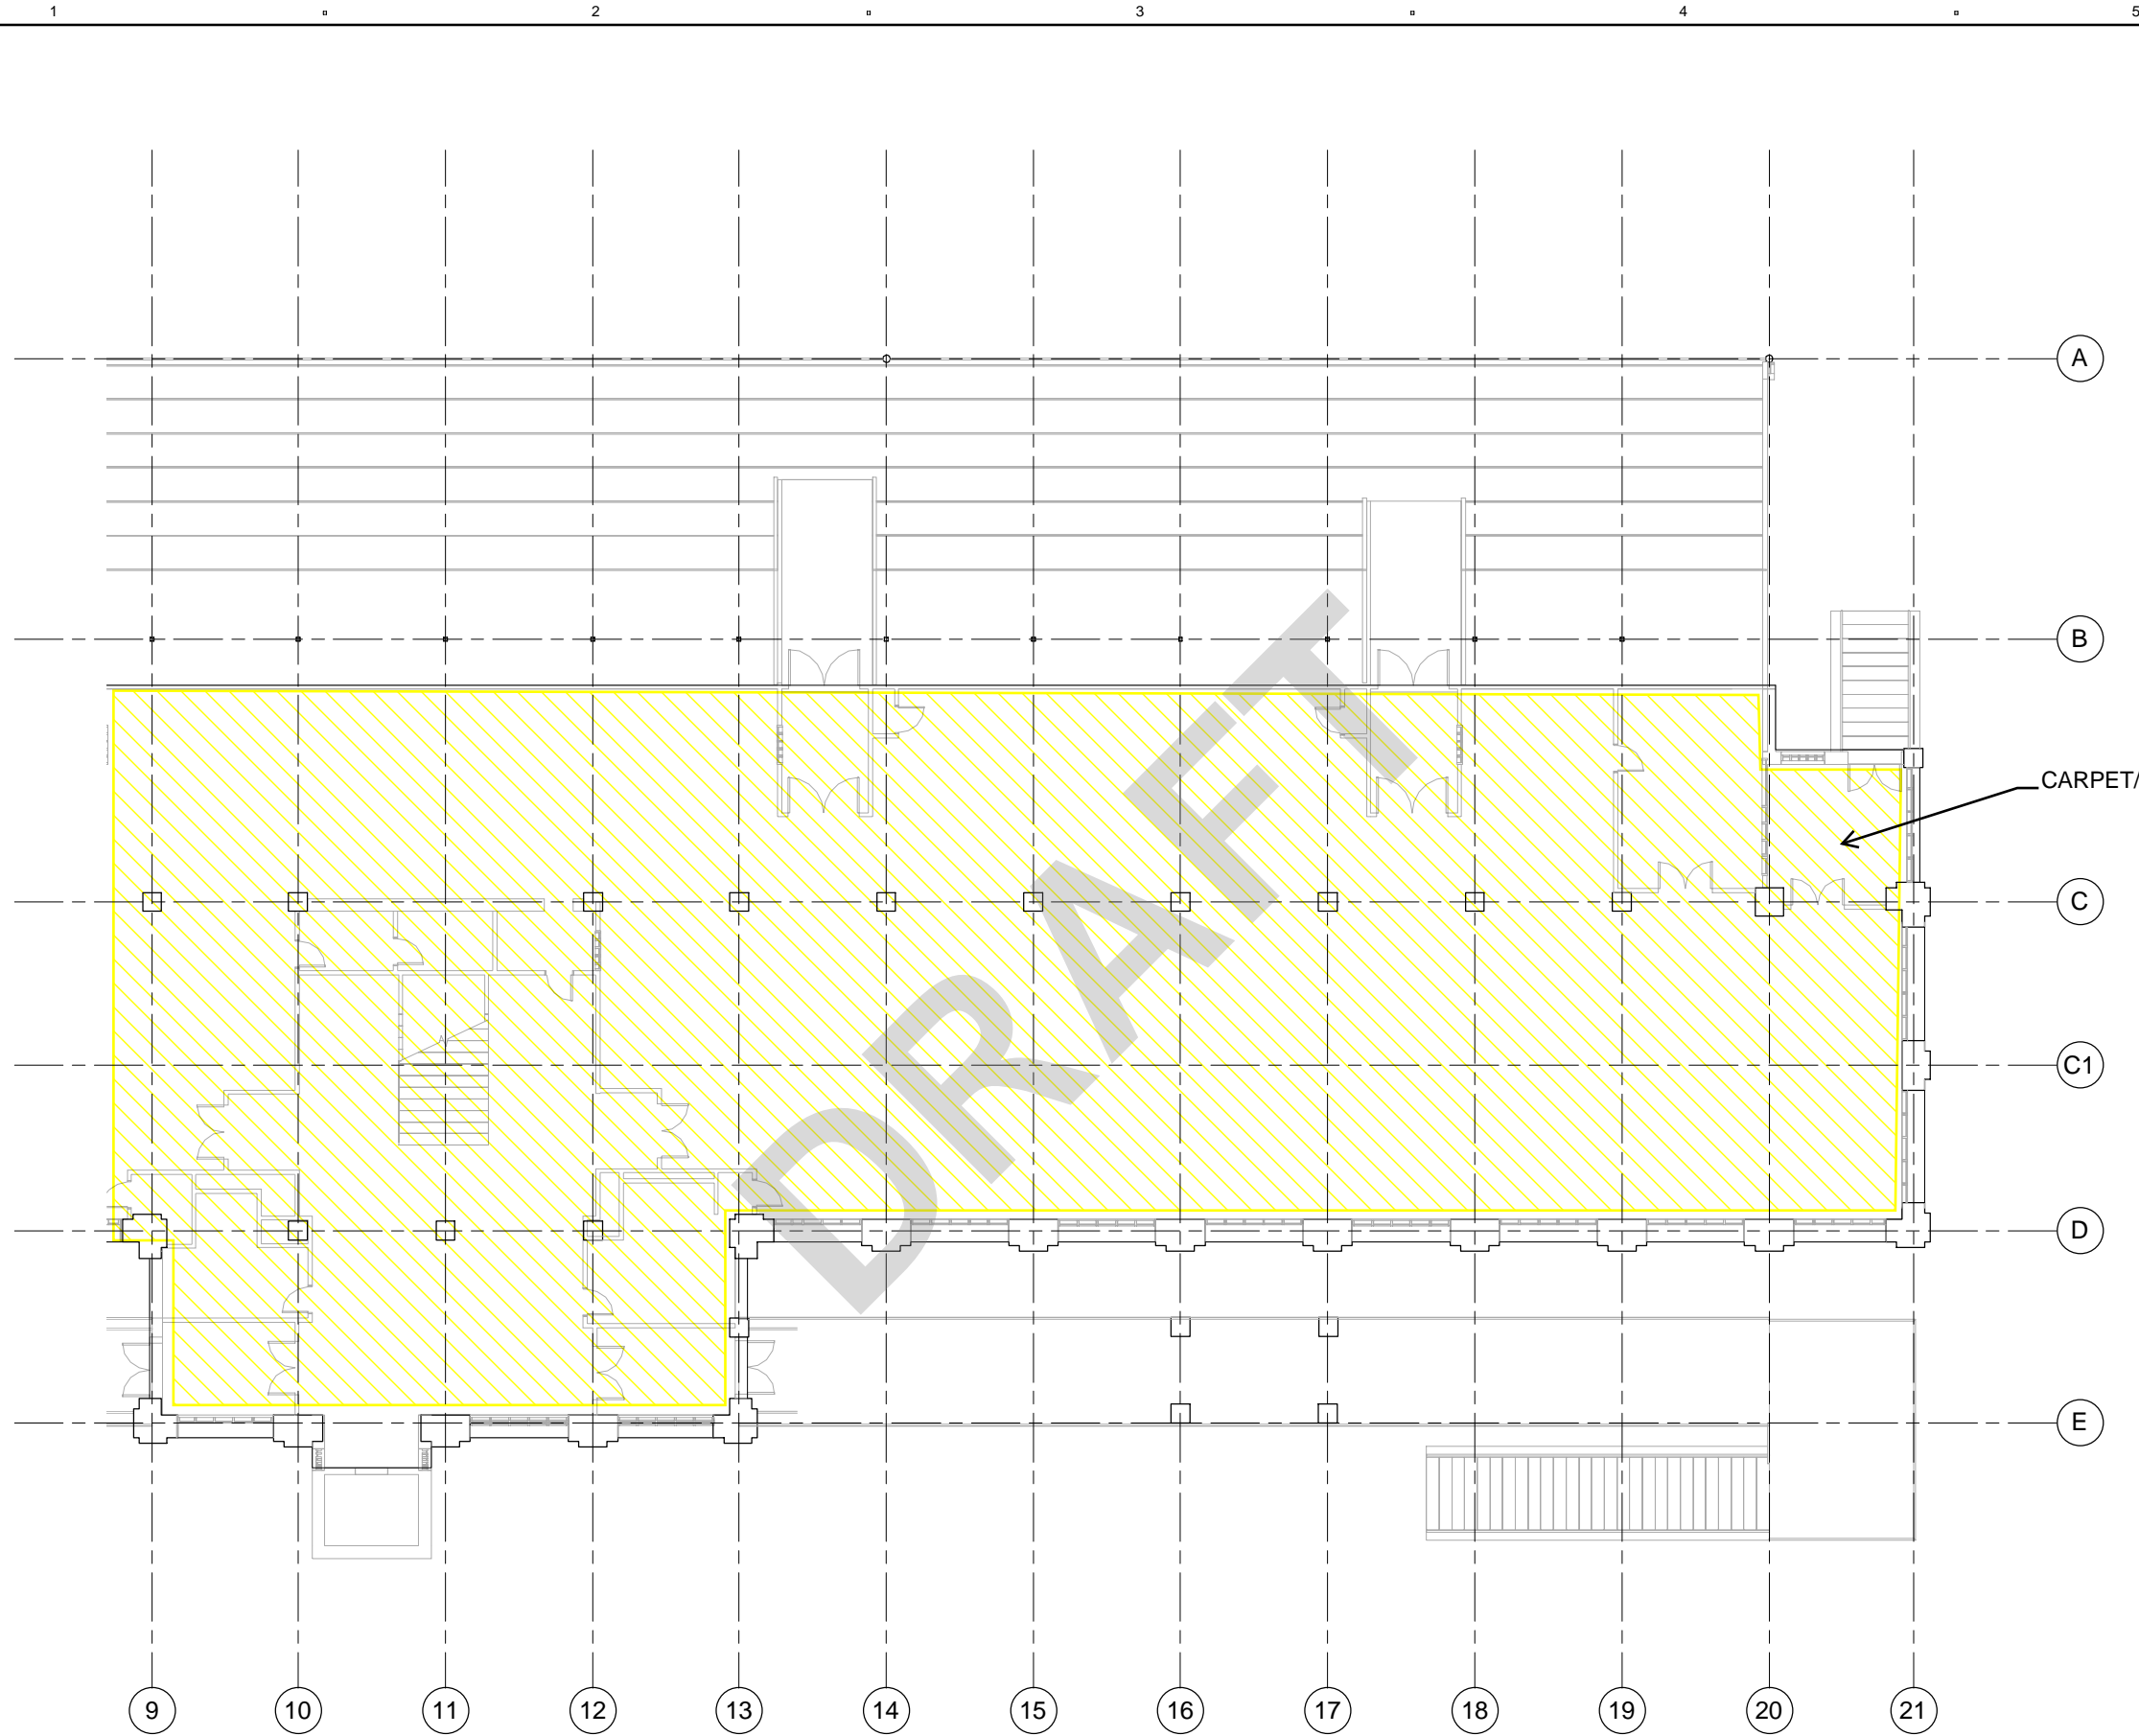
This drawing is confidential and shall only be used for the purpose of this project. The signing of this title block confirms the design and drafting of this project have been prepared and checked in accordance with the AECOM quality assurance system to ISO 9001:2000.

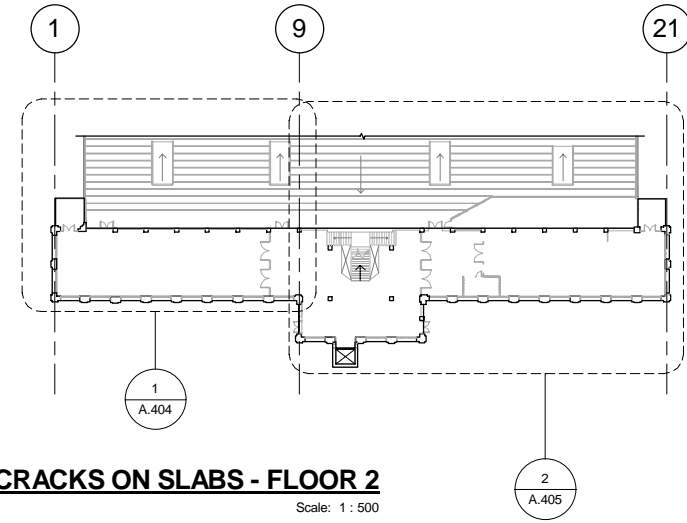
CRACKS ON SLABS - FLOOR 2
Scale: 1 : 500

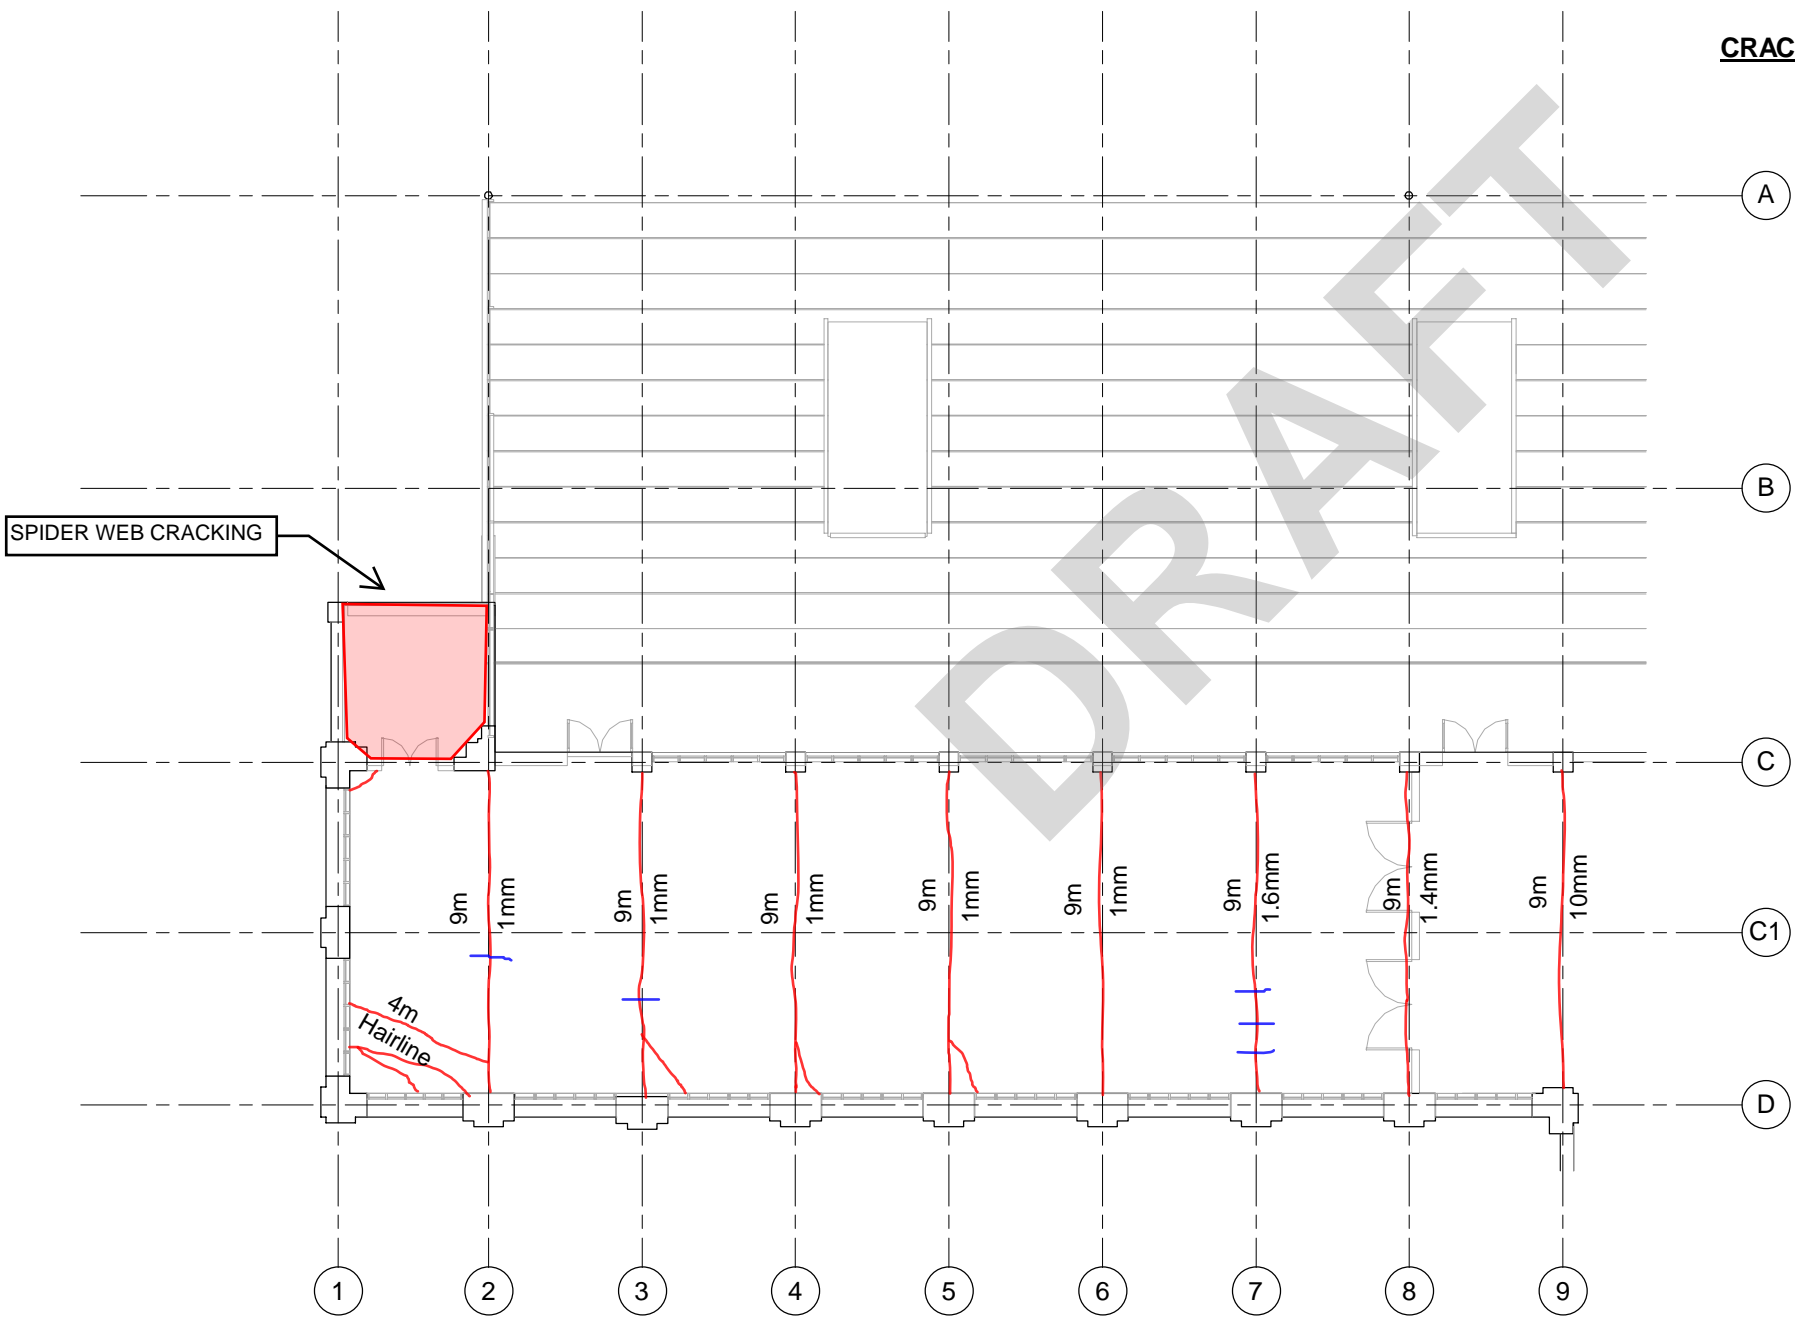
1 | CRACKS ON SLABS - FLOOR 2 - GRID 1 TO GRID 9
