Detailed Damage Evaluation

Quantitative Seismic Analysis of Grand National (Public) Stand

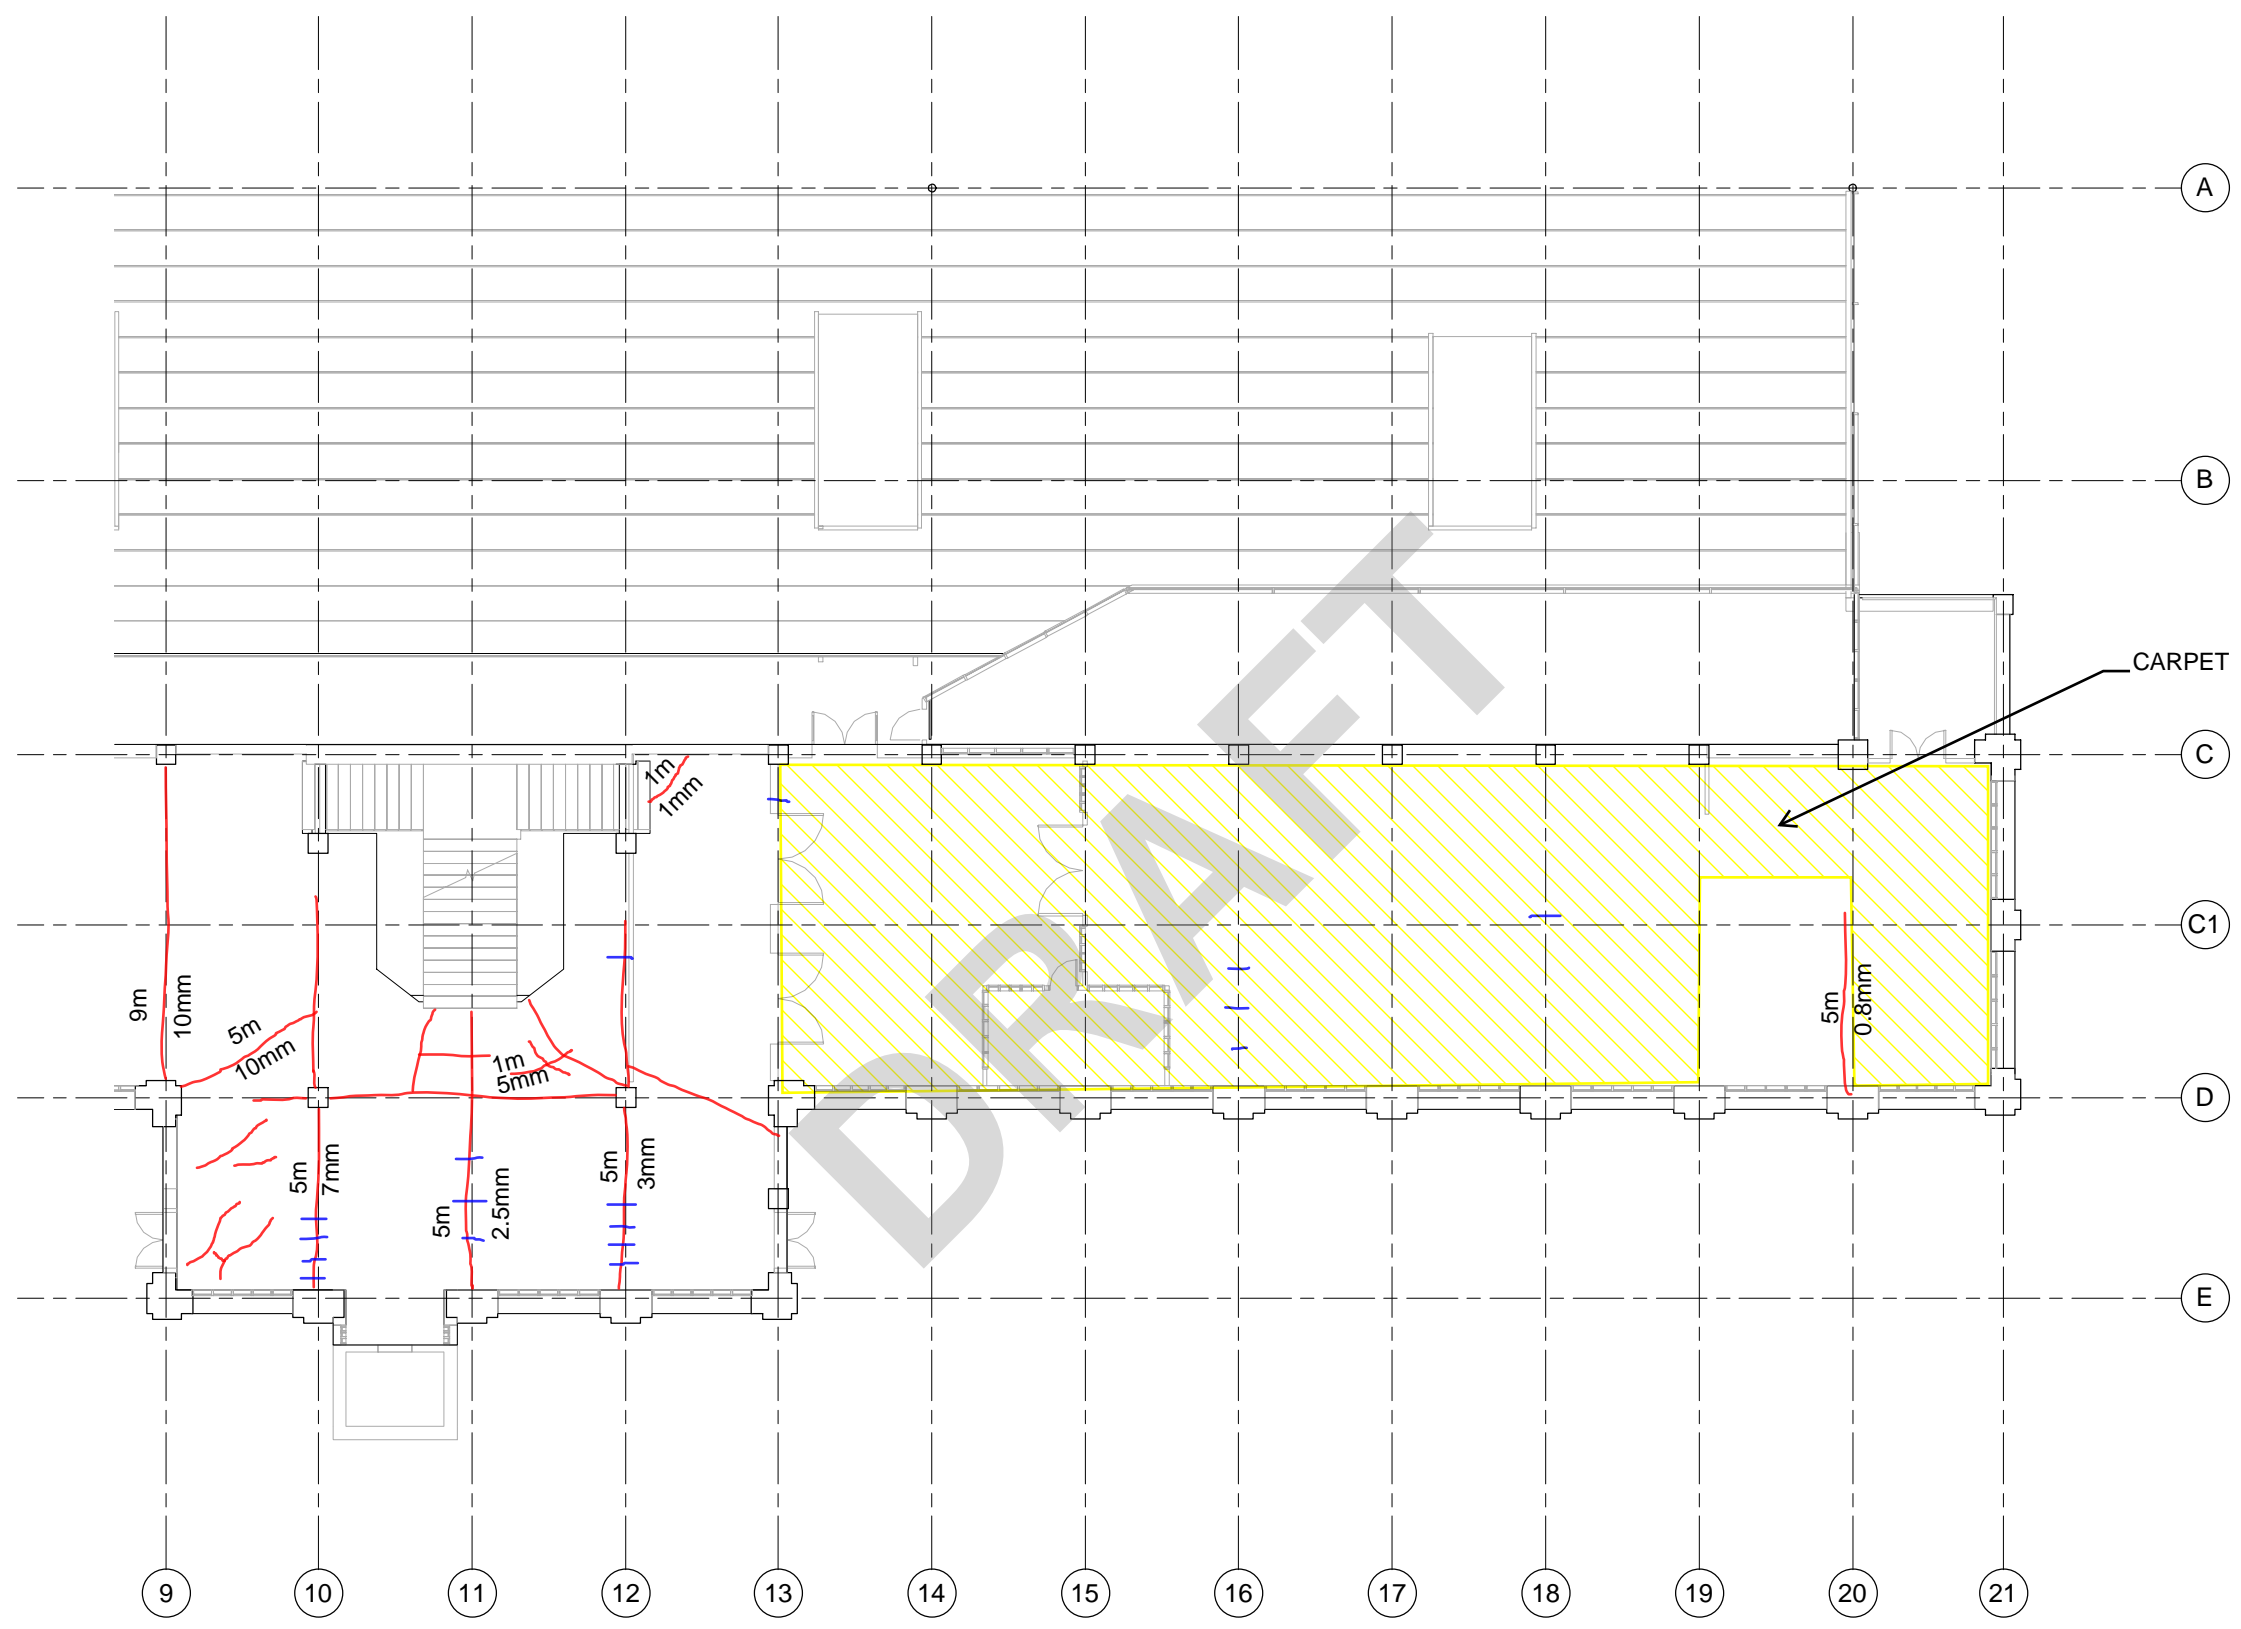
2 | CRACKS ON SLABS - FLOOR 2 - GRID 9 TO GRID 21
A.405 REF: A.404 Scale: 1 : 100

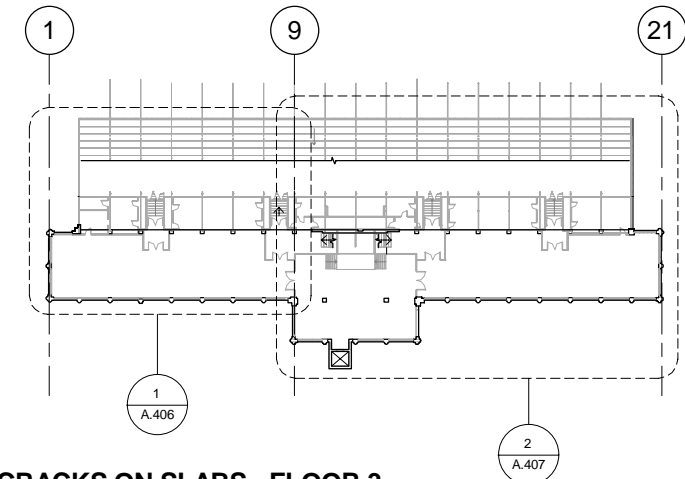
CRACKS ON SLABS - FLOOR 3
Scale: 1 : 500

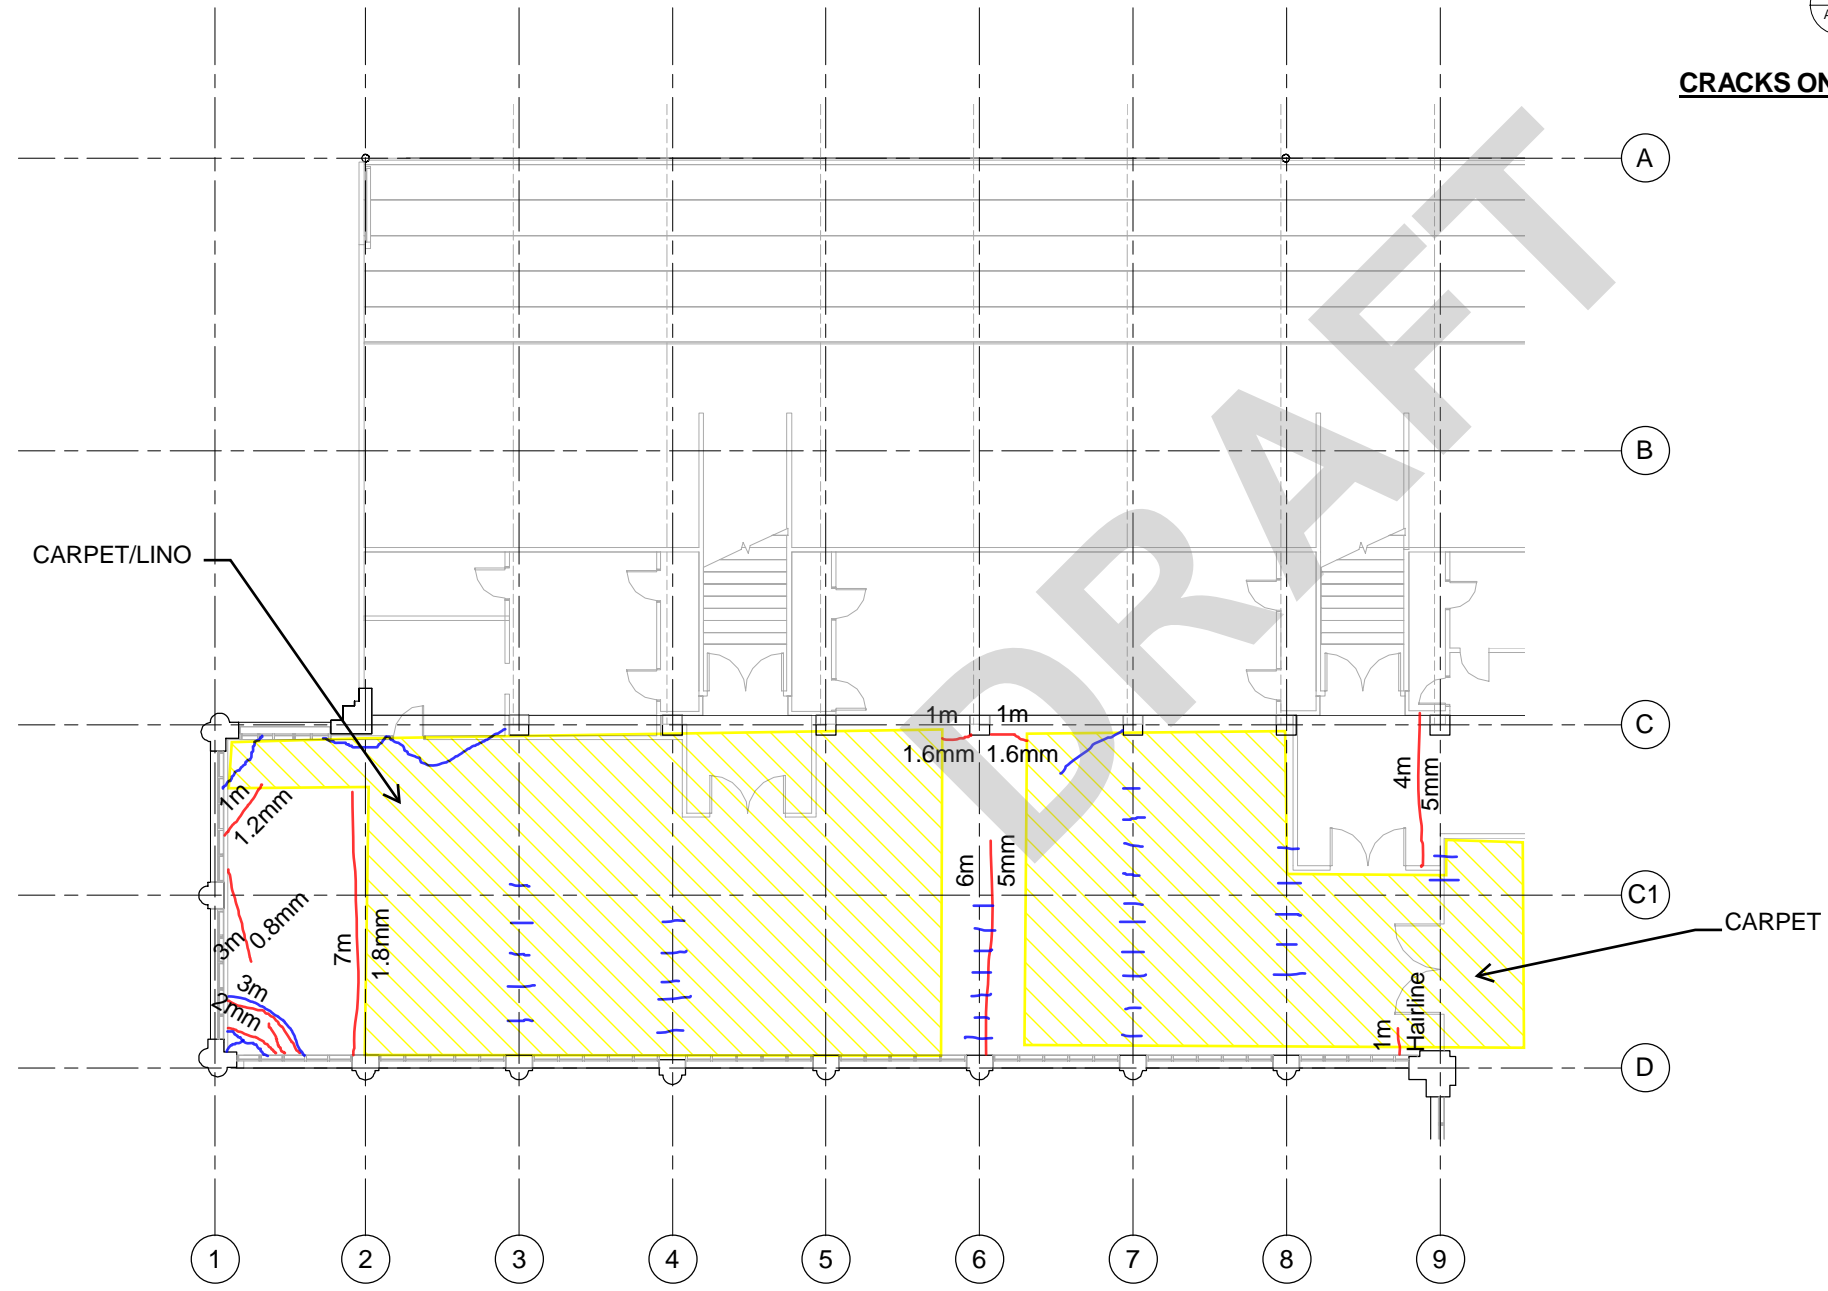
1 | CRACKS ON SLABS - FLOOR 3 - GRID 1 TO GRID 9
A.406 REF: A.406 Scale: 1 : 100

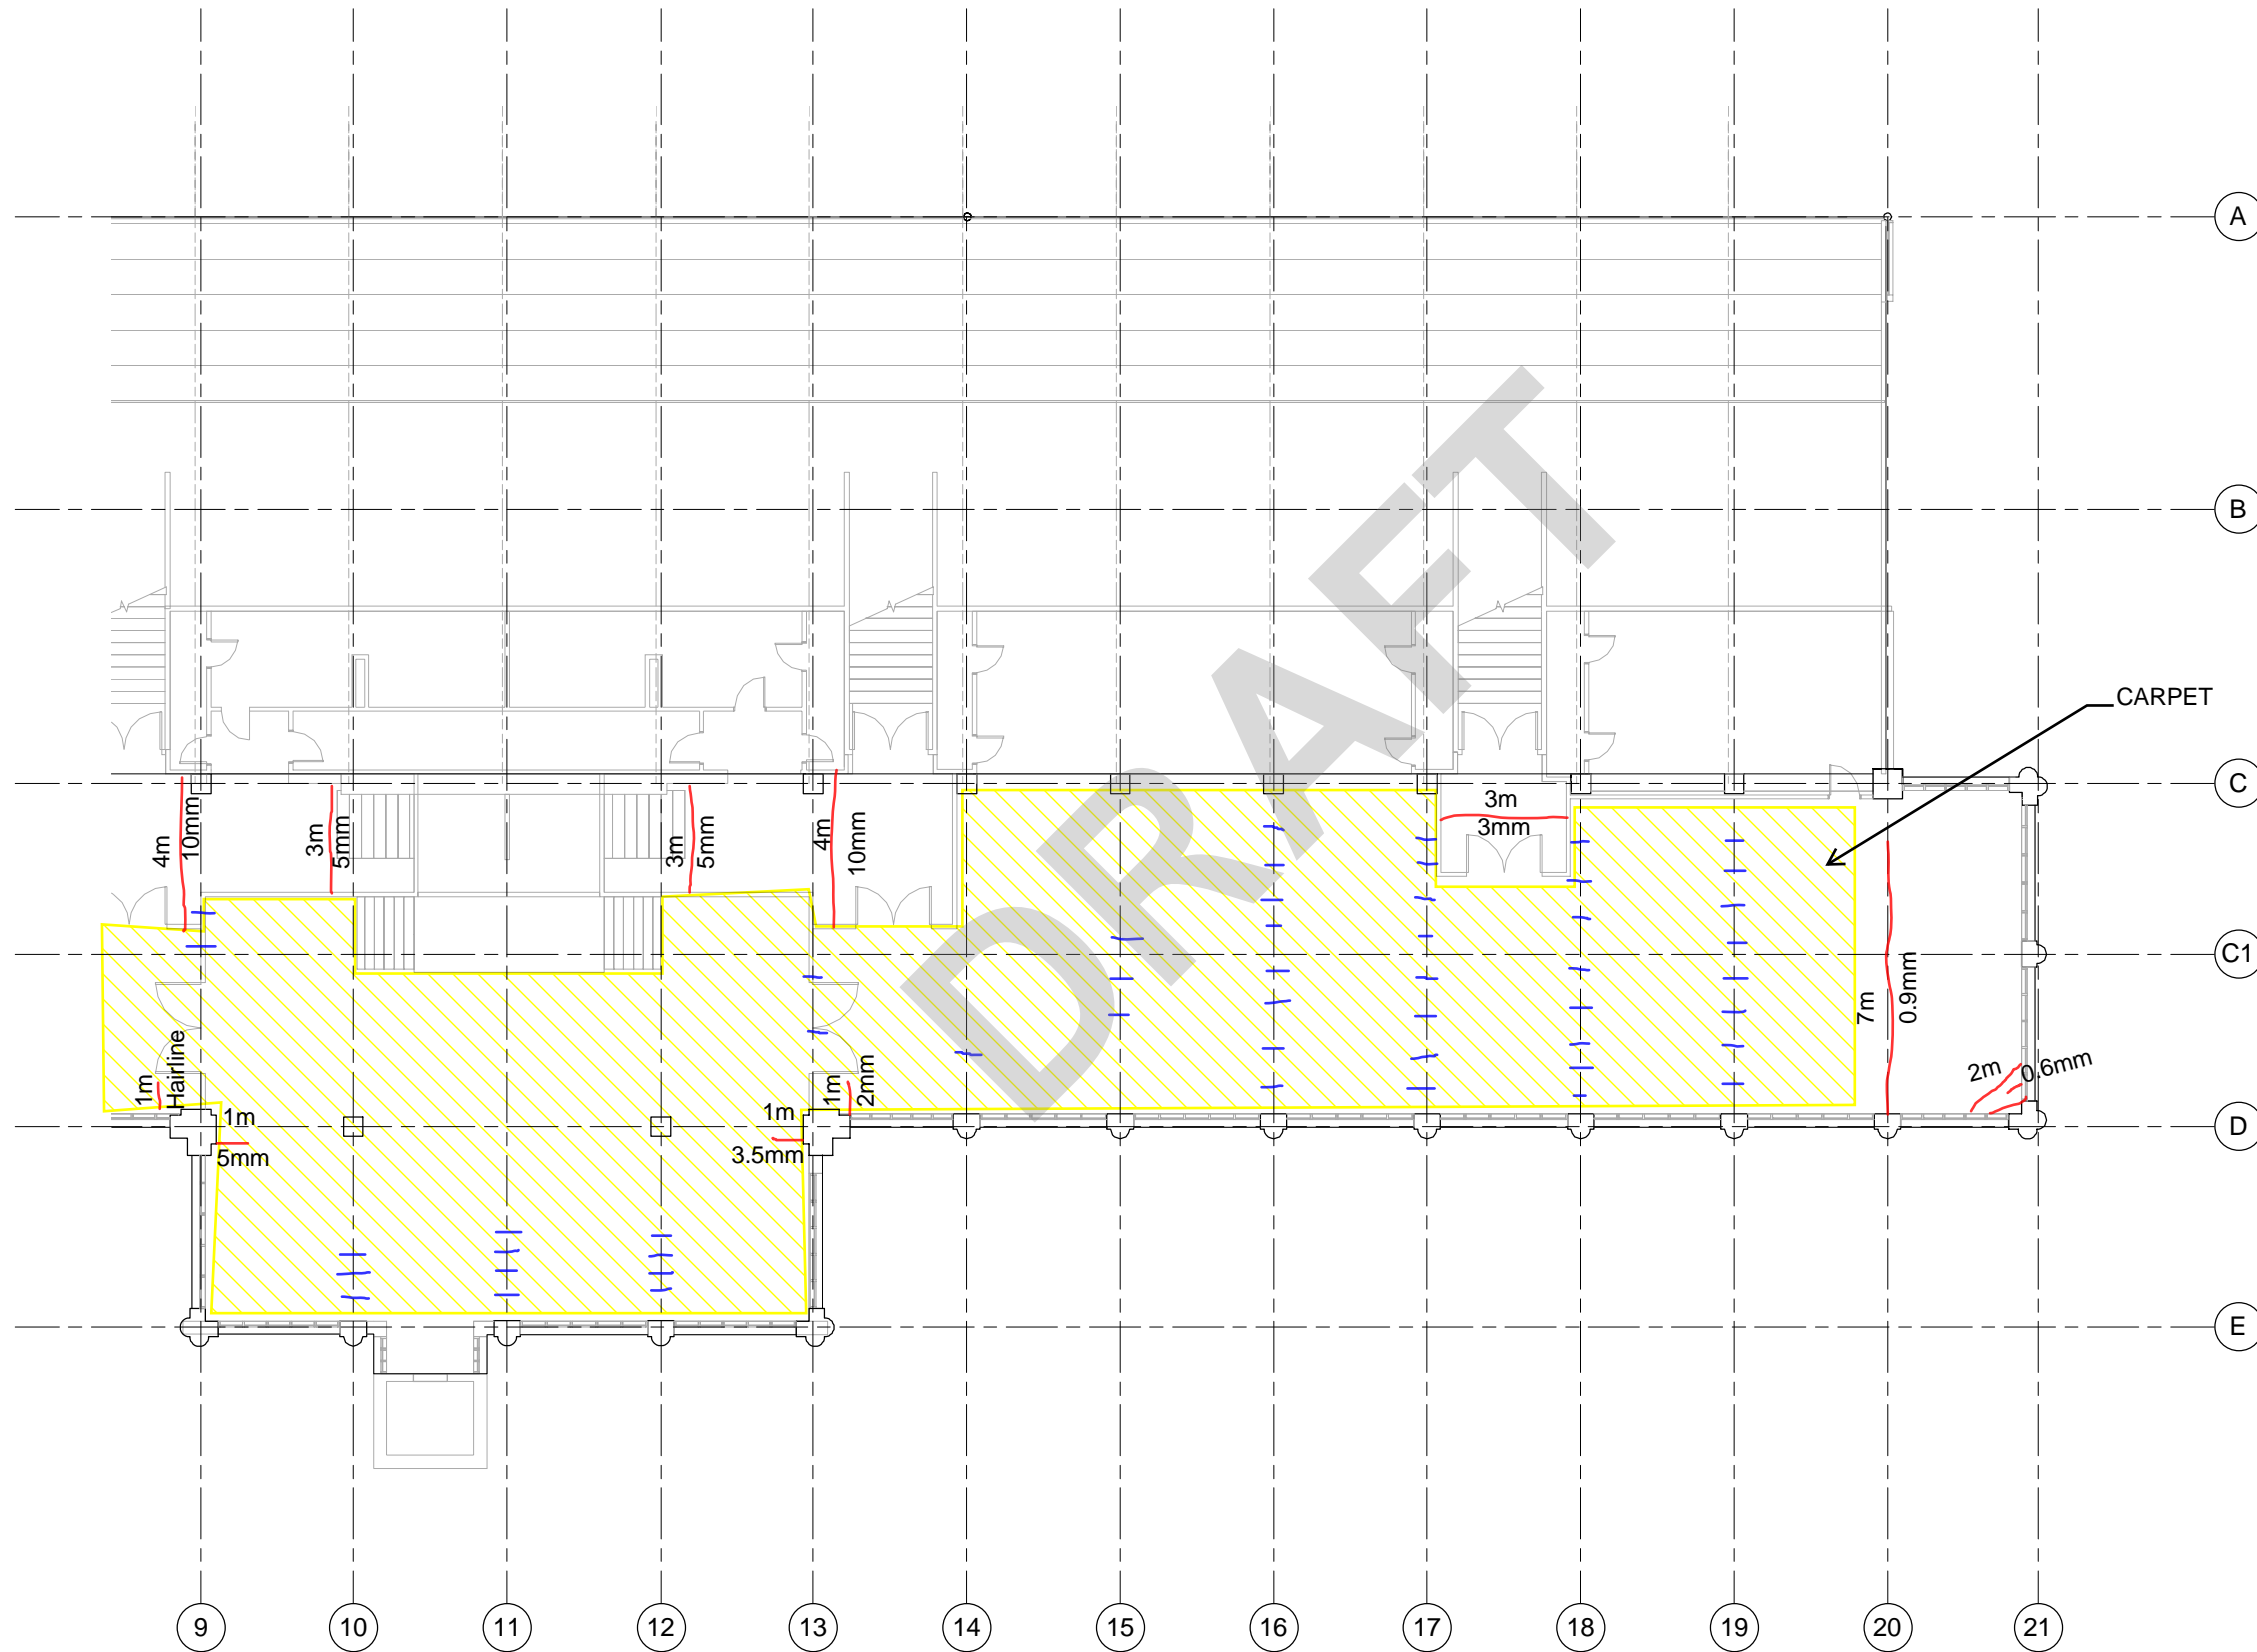
PROJECT MANAGEMENT INITIALS

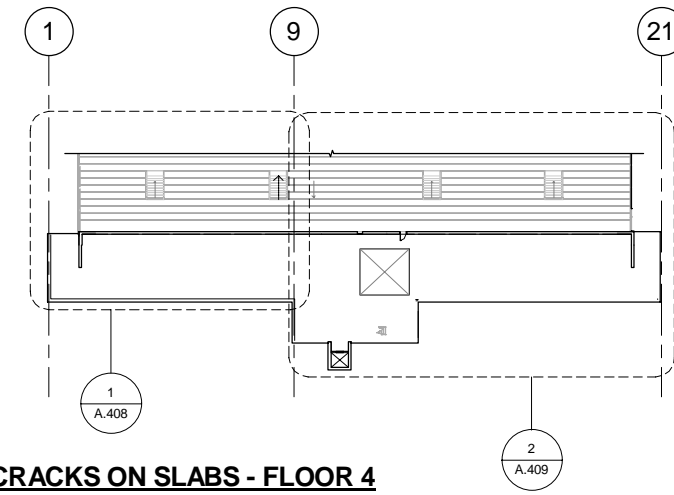
CRACKS ON SLABS - FLOOR 4

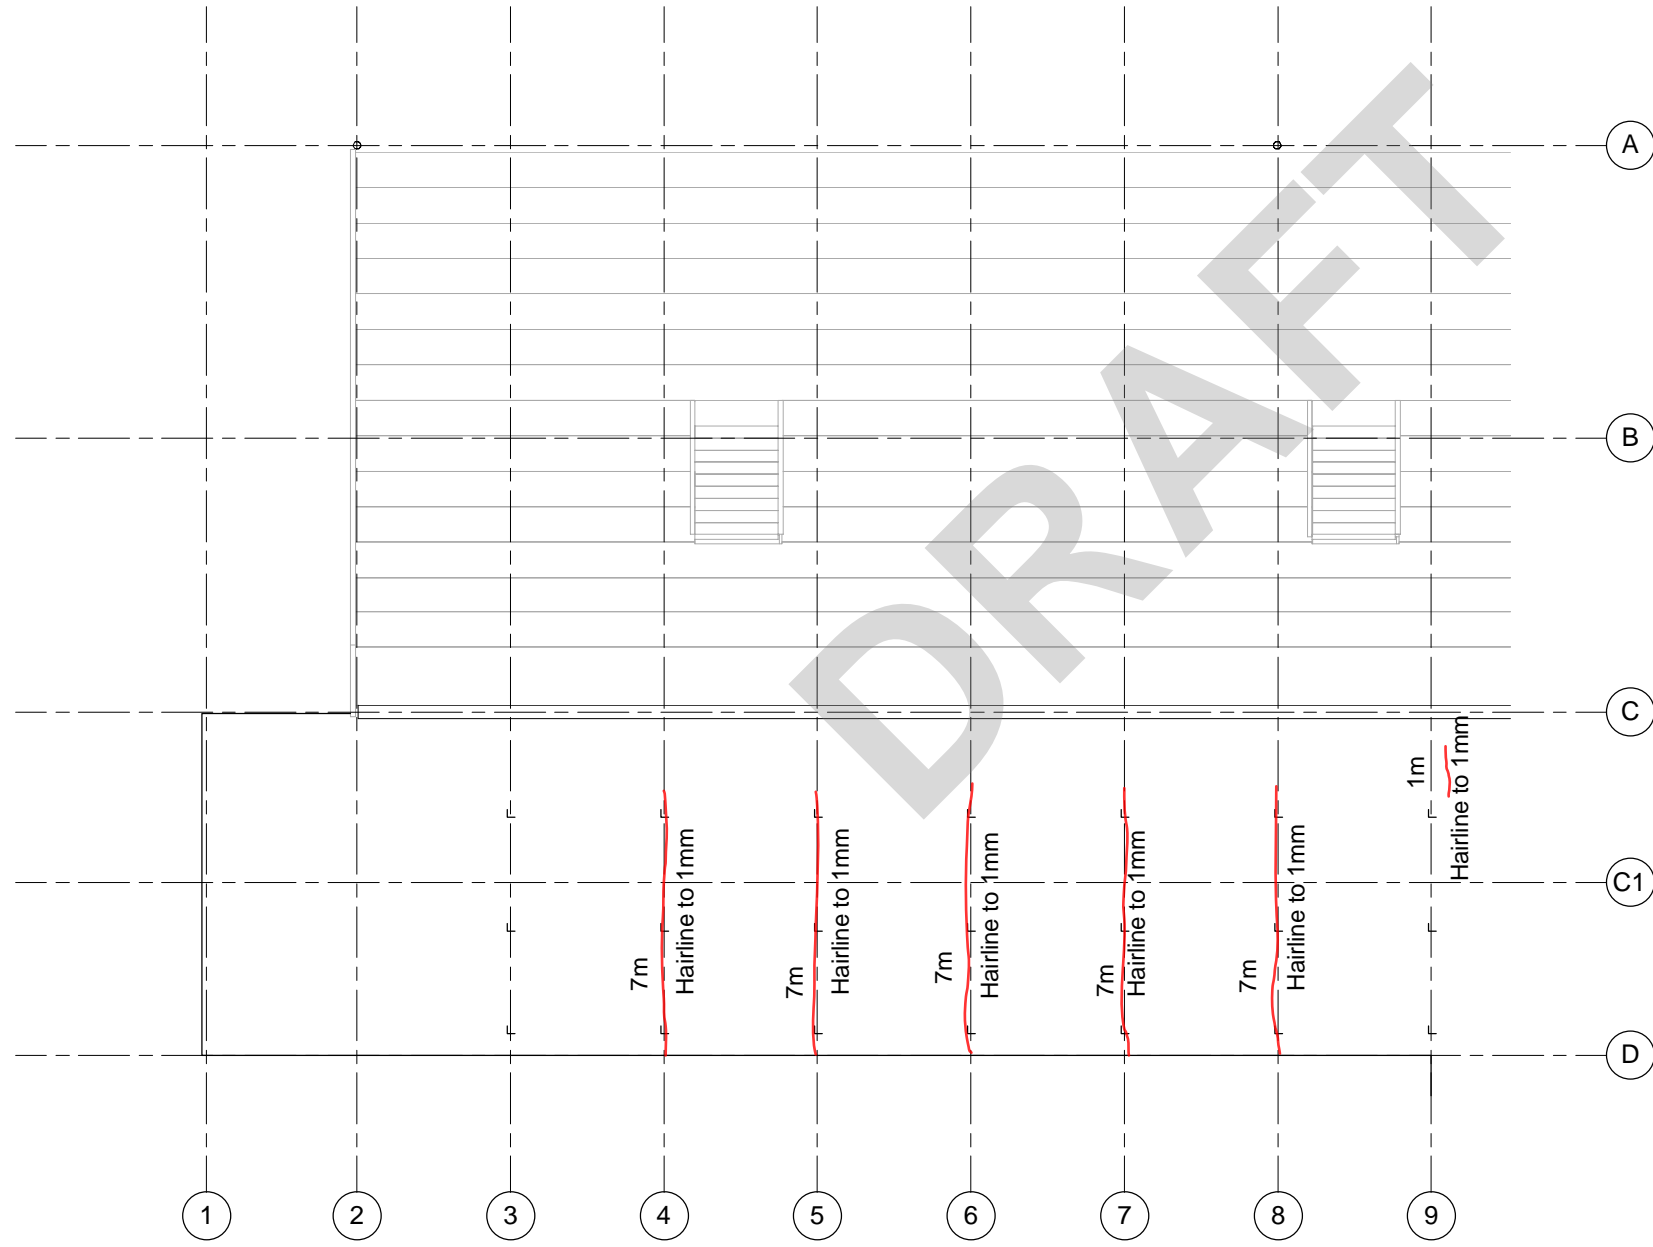
1 | CRACKS ON SLABS - FLOOR 4 - GRID 1 TO GRID 9

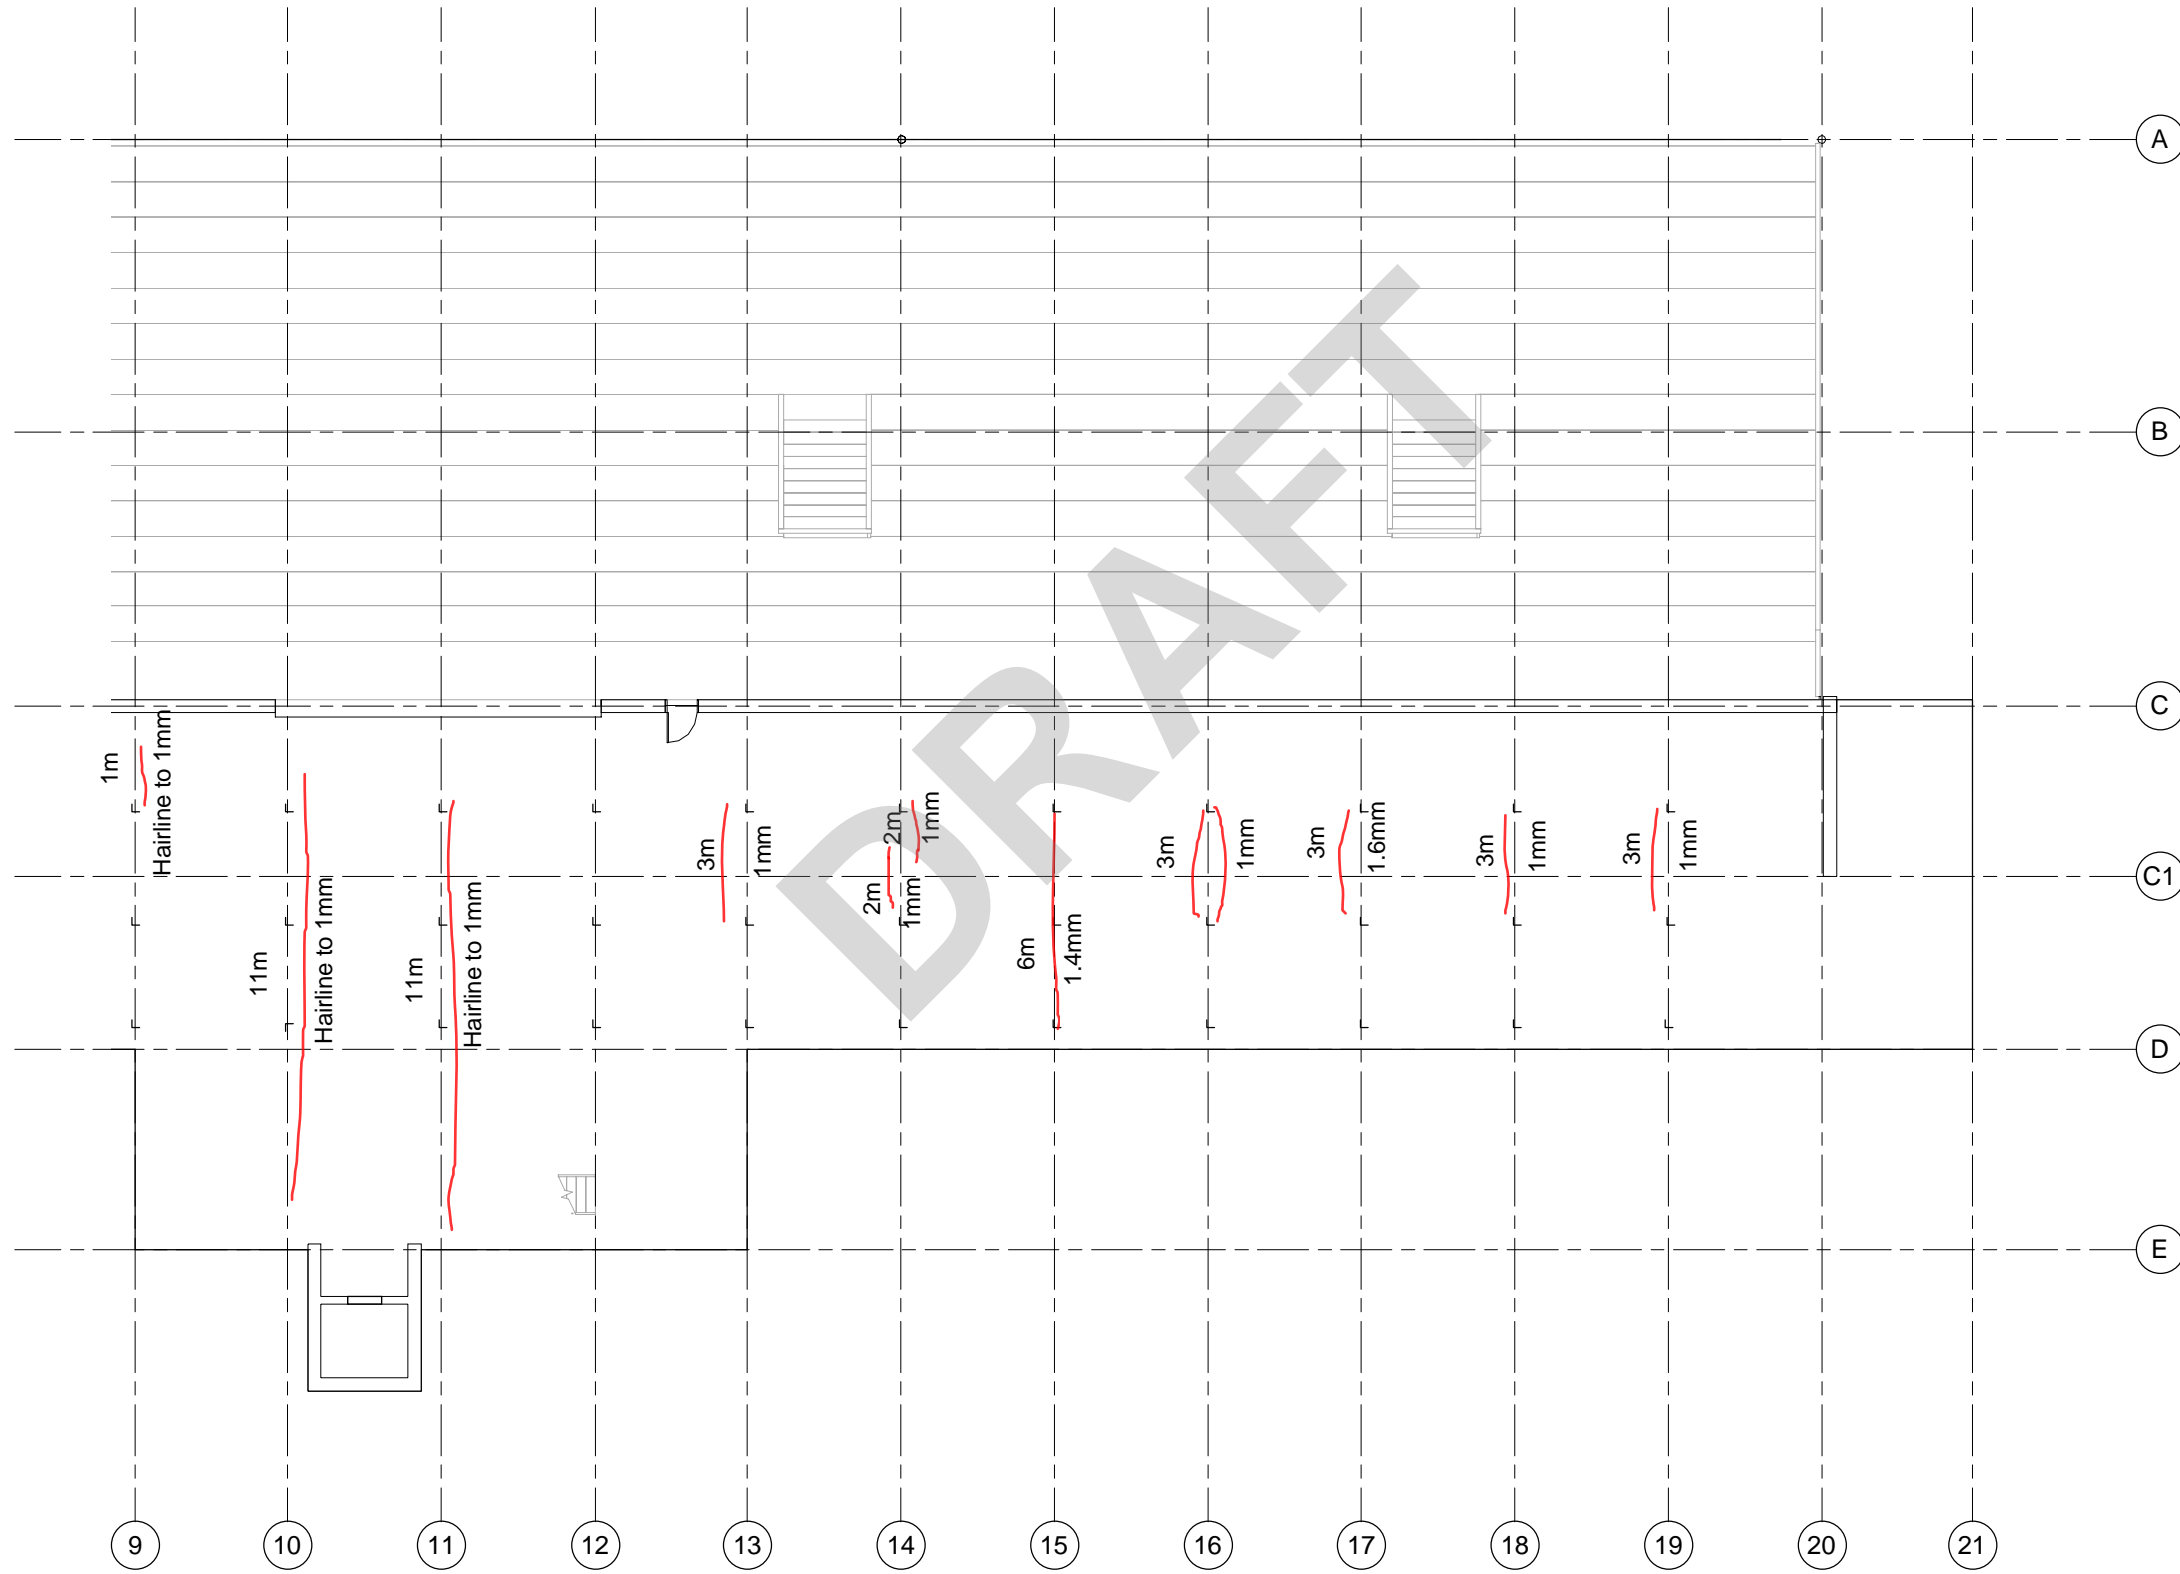
2 | CRACKS ON SLABS - FLOOR 4 - GRID 9 TO GRID 21

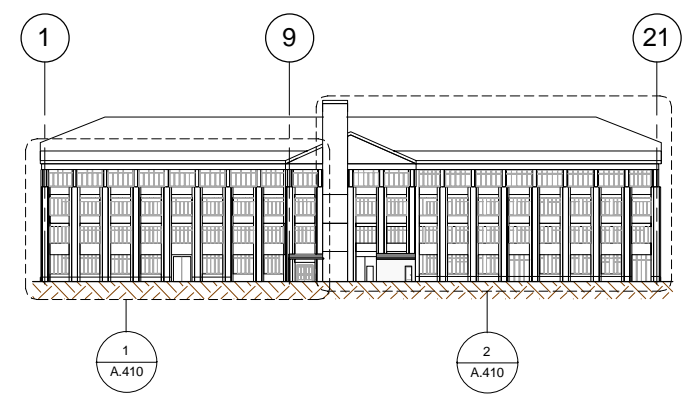
DAMAGE ON ELEVATIONS - ELEVATION SOUTH
 Scale: 1 : 500

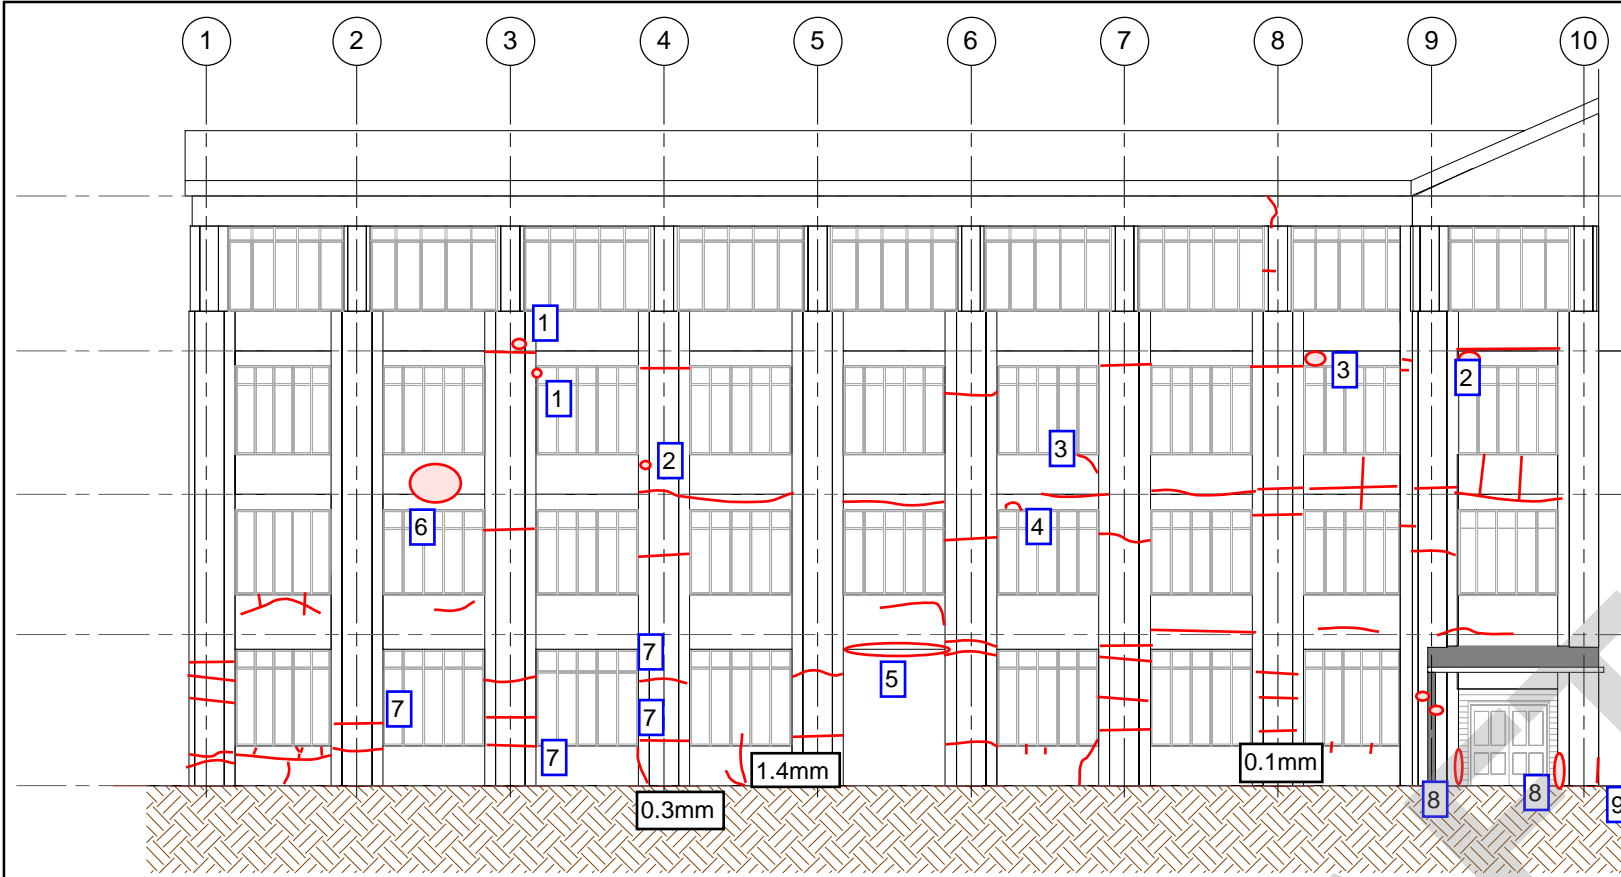
1 DAMAGE ON ELEVATIONS - ELEVATION SOUTH - GRID 1 TO GRID 9
 A.410 REF: A.410 Scale: 1 : 100

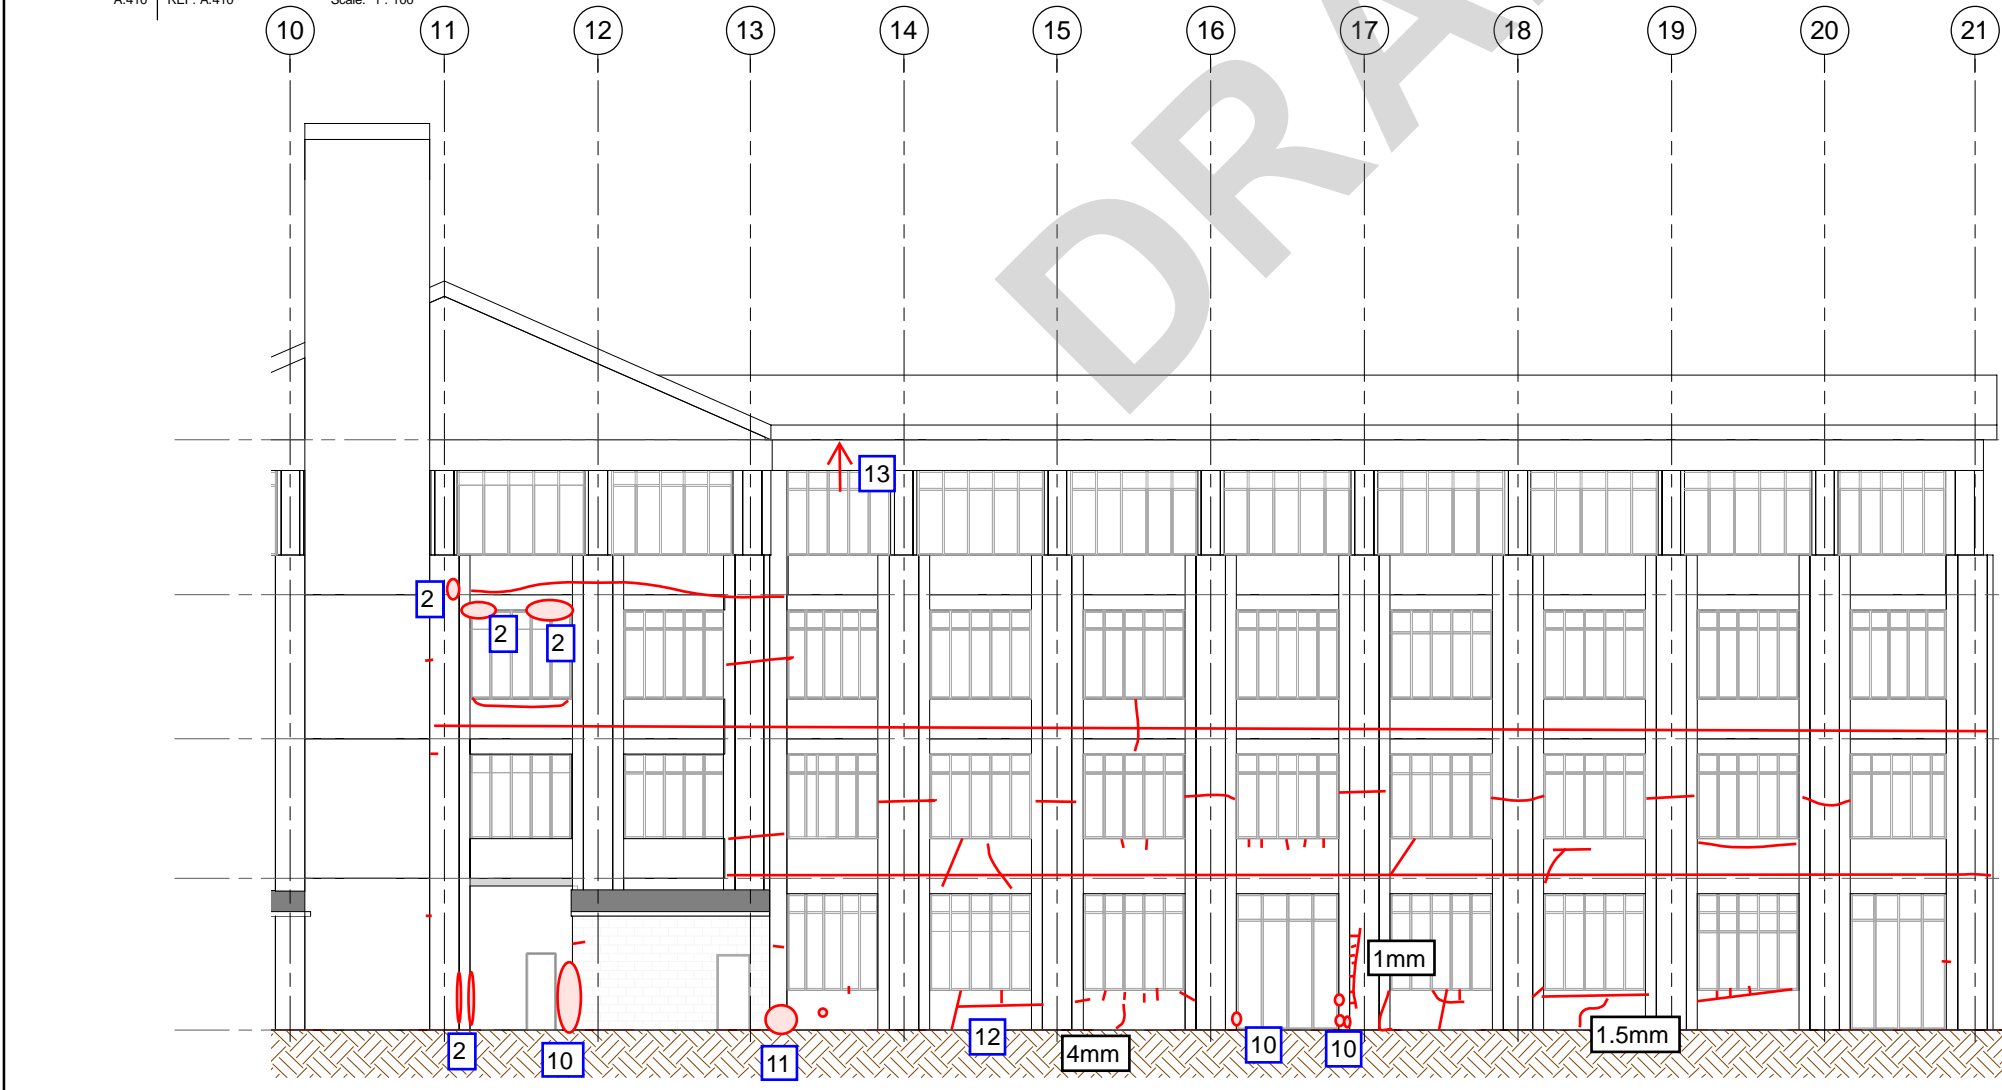
2 DAMAGE ON ELEVATIONS - ELEVATION SOUTH - GRID 9 TO GRID 21
 A.410 REF: A.410 Scale: 1 : 100

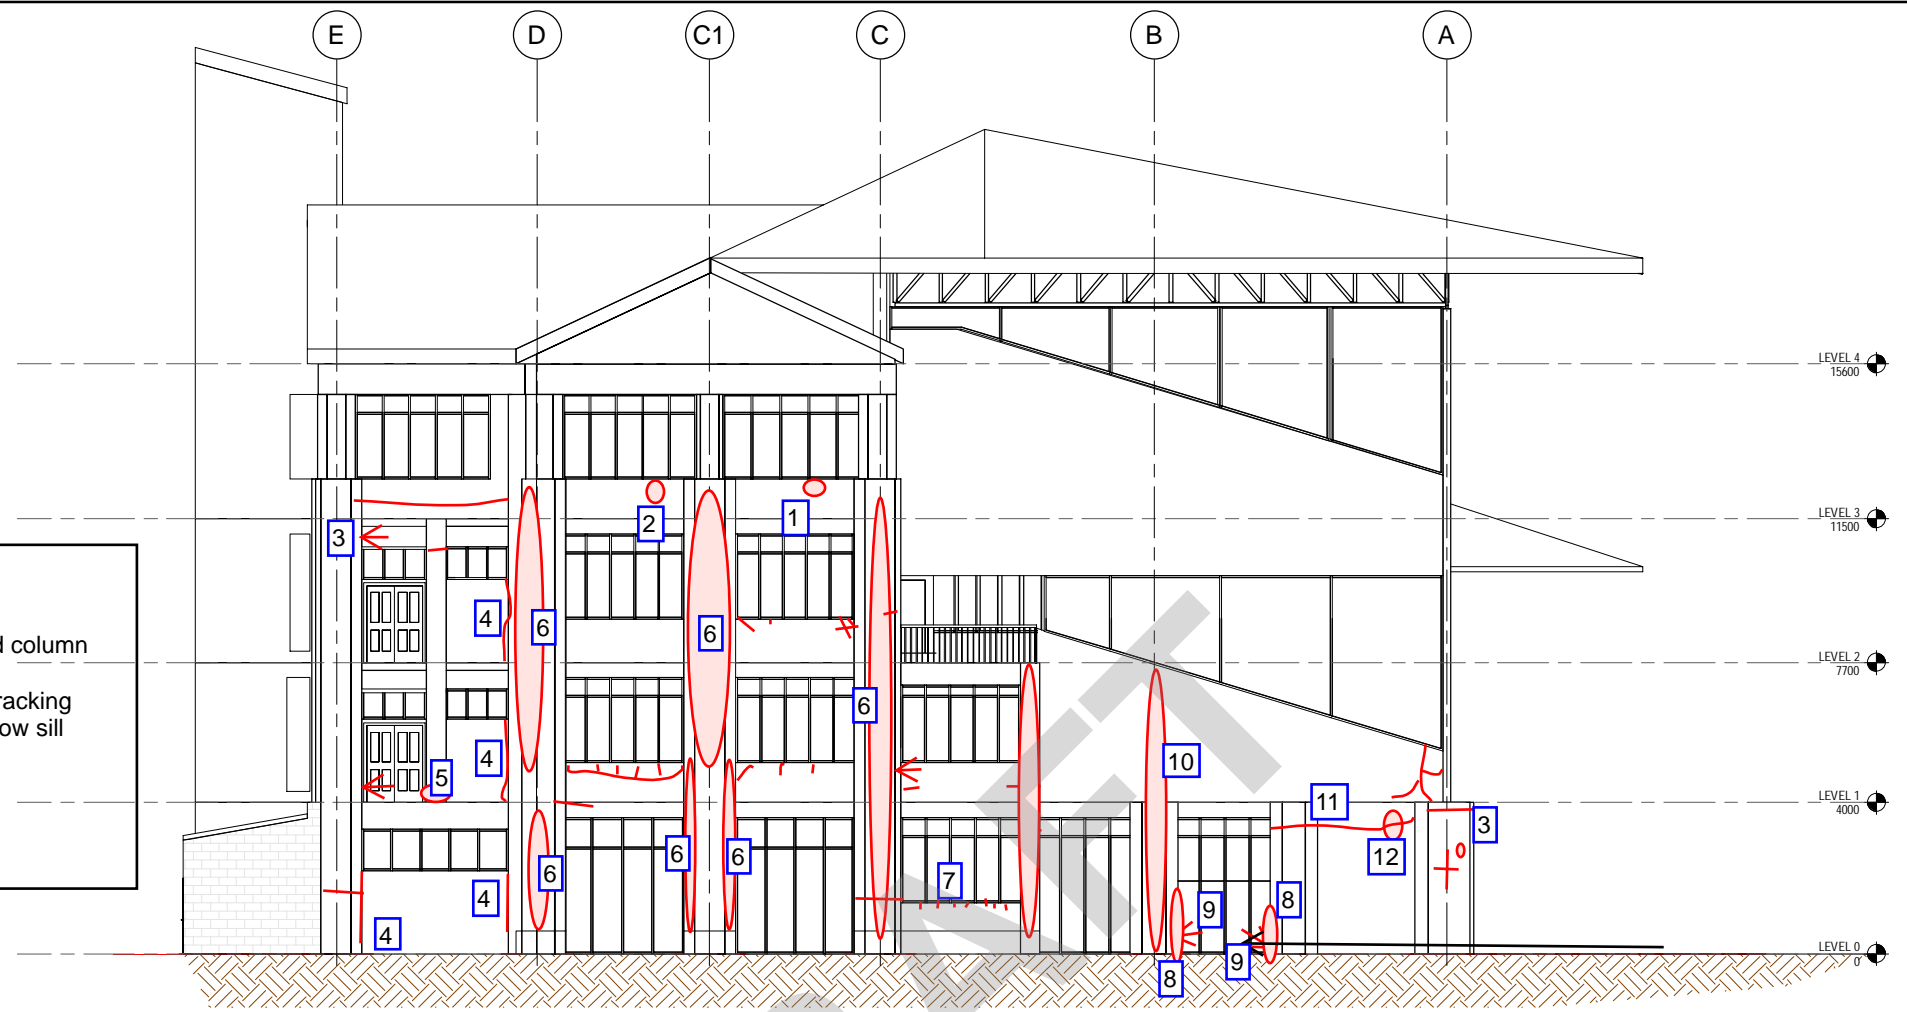
DAMAGE ON ELEVATIONS - ELEVATION EAST
(See A.111 For Location) Scale: 1 : 100
