Detailed Damage Evaluation

Quantitative Seismic Analysis of Grand National (Public) Stand

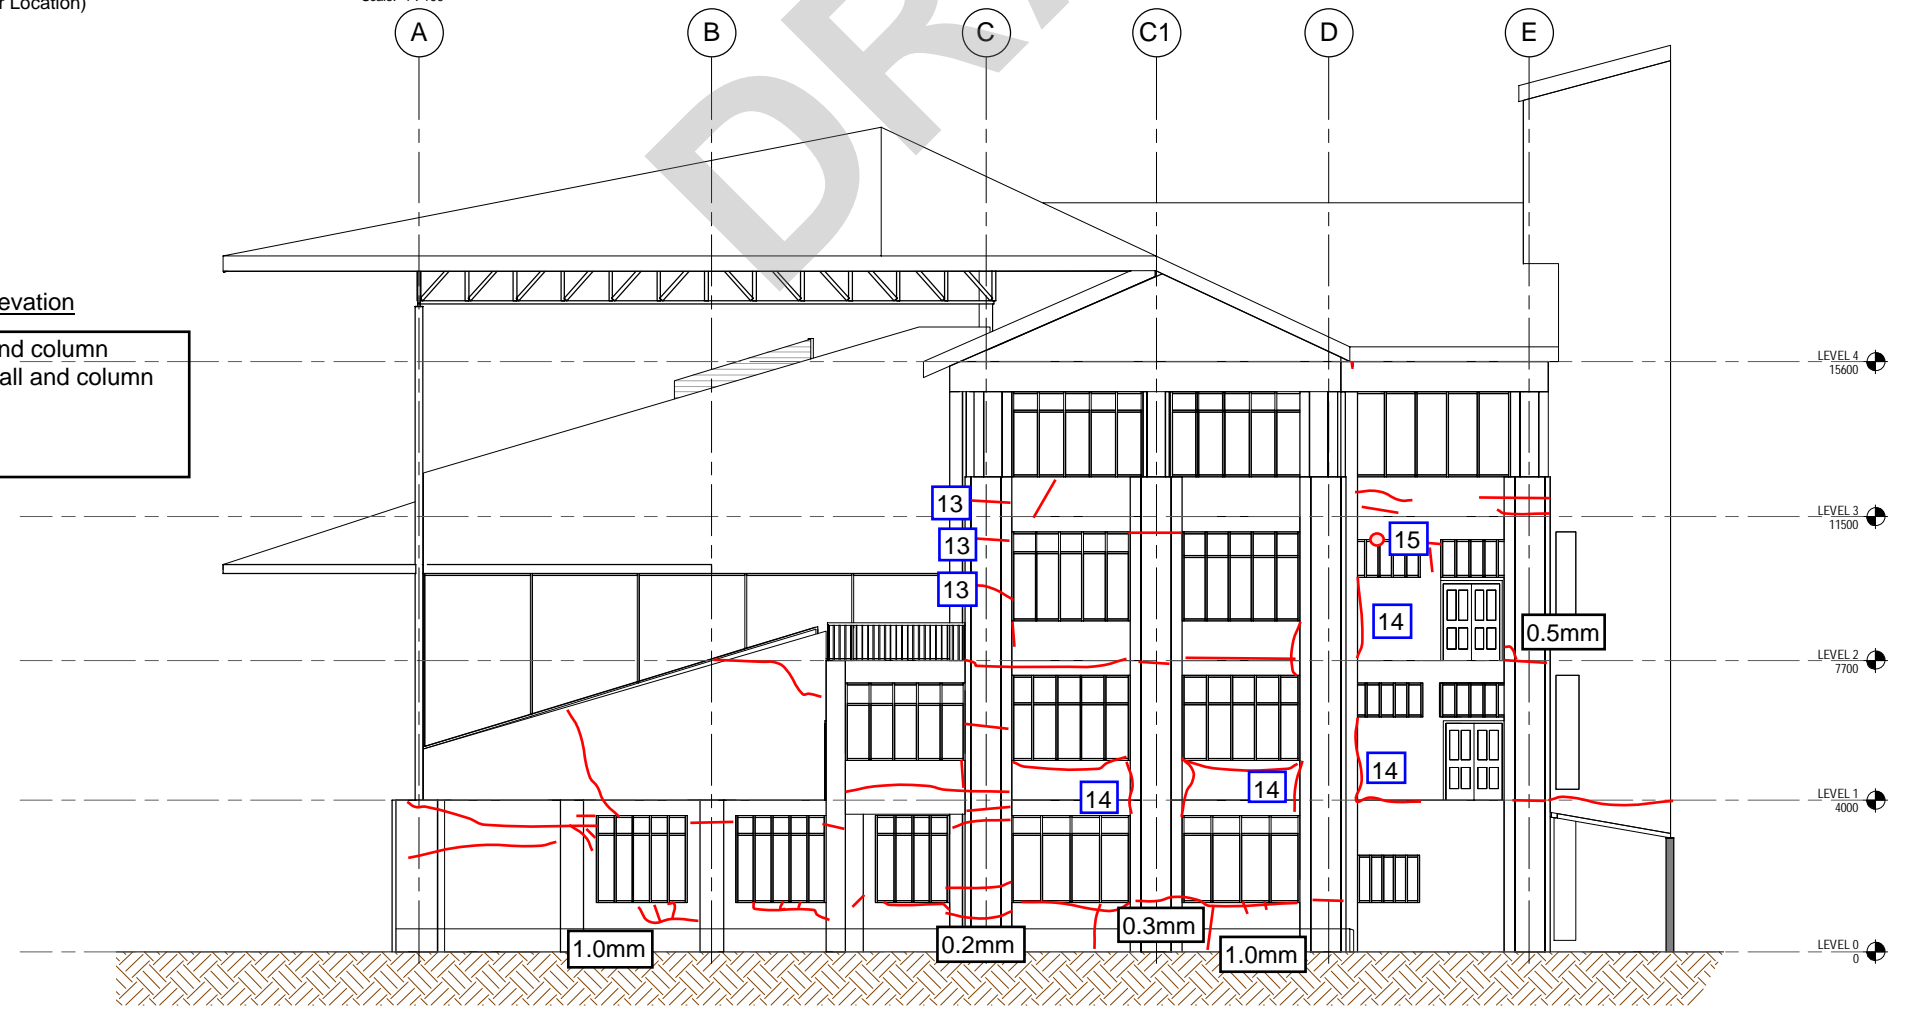
DAMAGE ON ELEVATIONS - ELEVATION WEST
(See A.110 For Location) Scale: 1 : 100

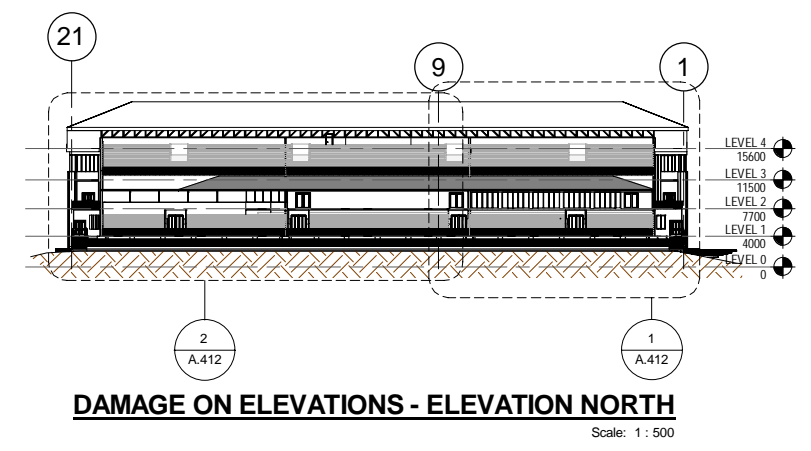
DAMAGE ON ELEVATIONS - ELEVATION NORTH
 Scale: 1 : 500

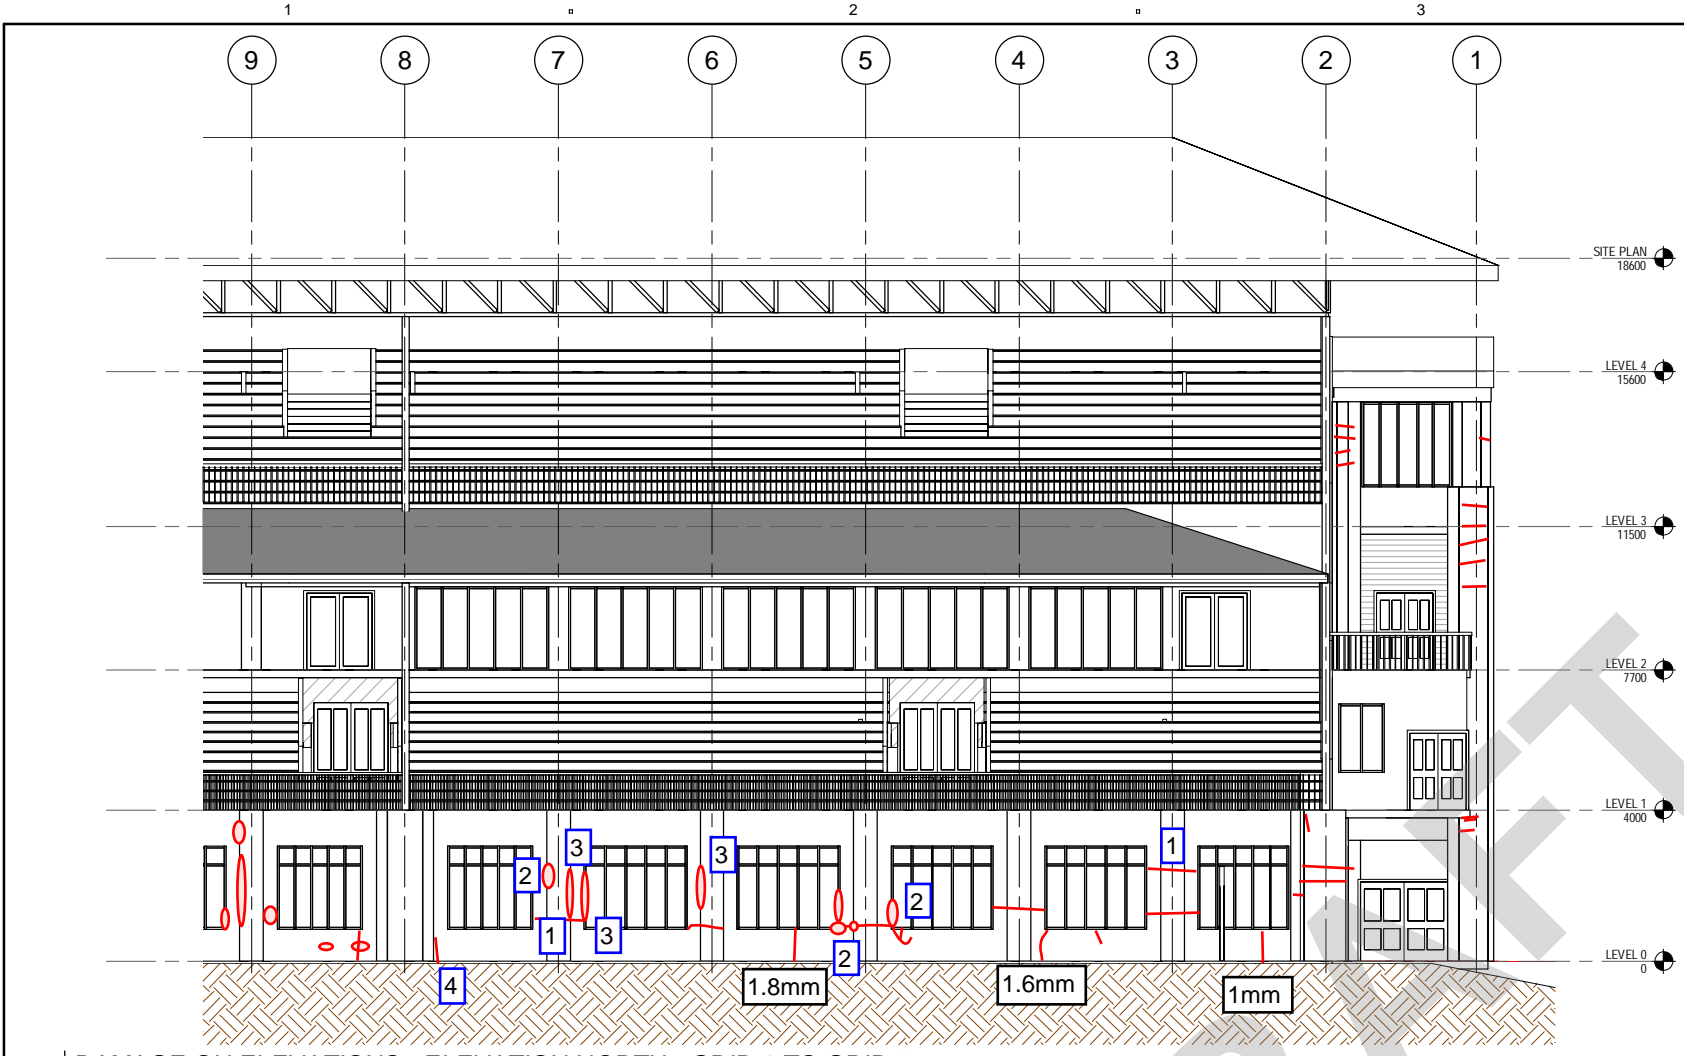
1 DAMAGE ON ELEVATIONS - ELEVATION NORTH - GRID 1 TO GRID 9
 A.412 REF: A.412 Scale: 1 : 100

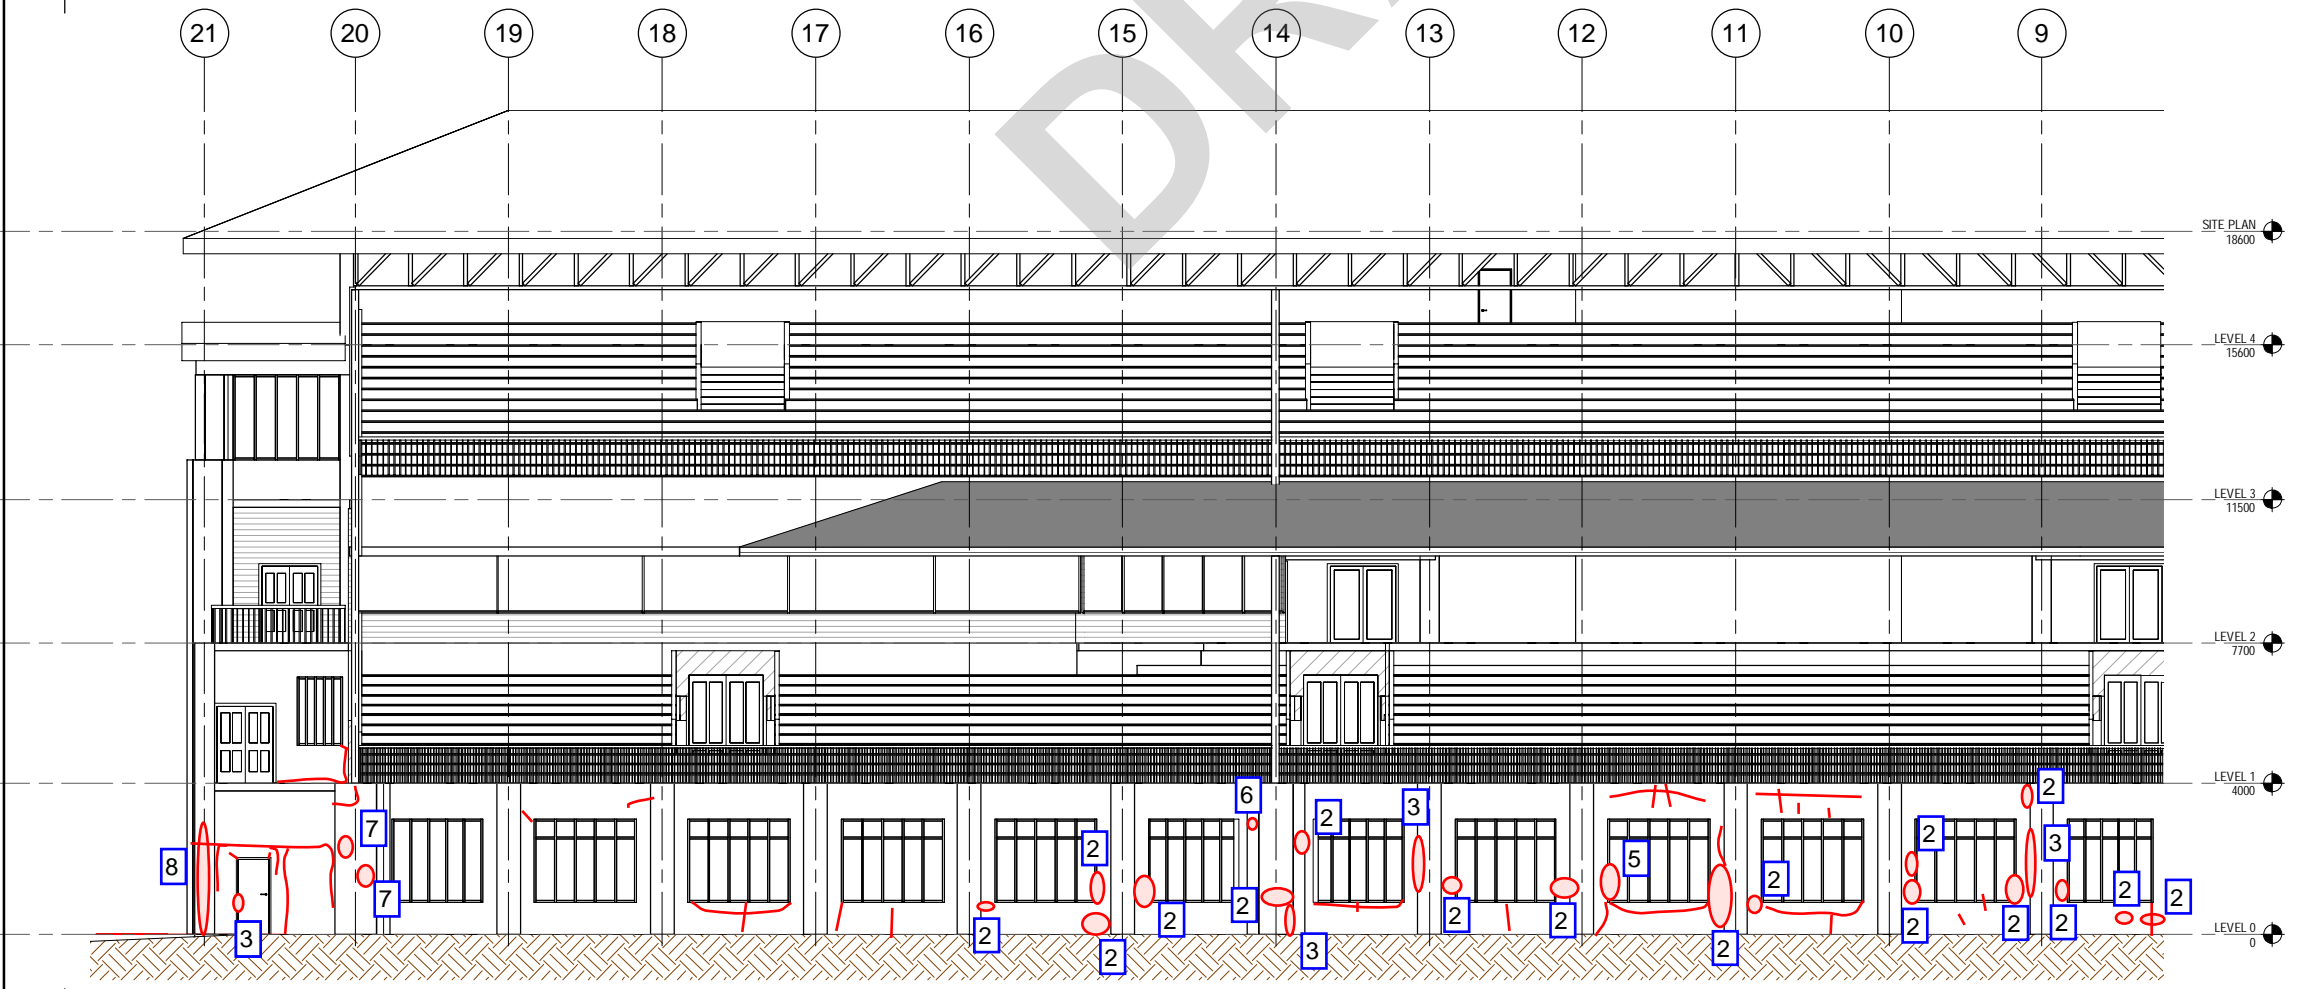
2 DAMAGE ON ELEVATIONS - ELEVATION NORTH - GRID 9 TO 21
 A.412 REF: A.412 Scale: 1 : 100

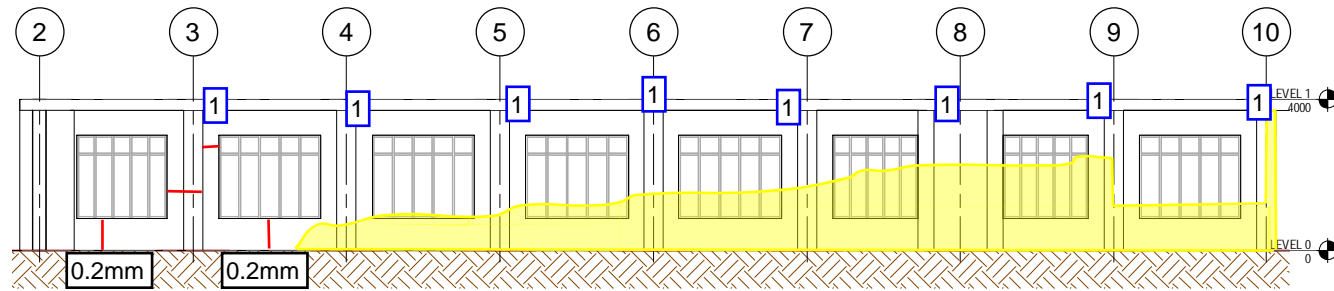
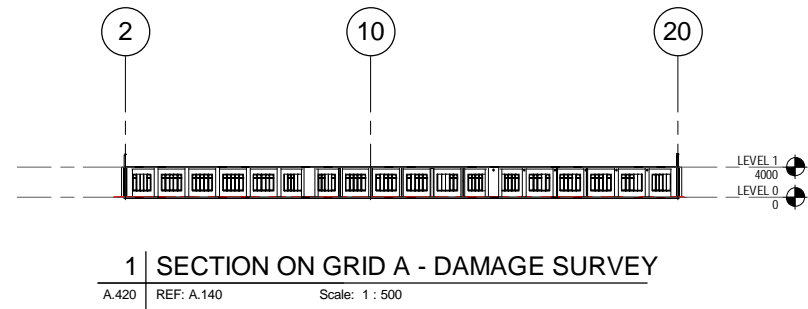
2 | SECTION ON GRID A - GRID 2 TO GRID 10 - DAMAGE SURVEY
A.420 Scale: 1 : 100

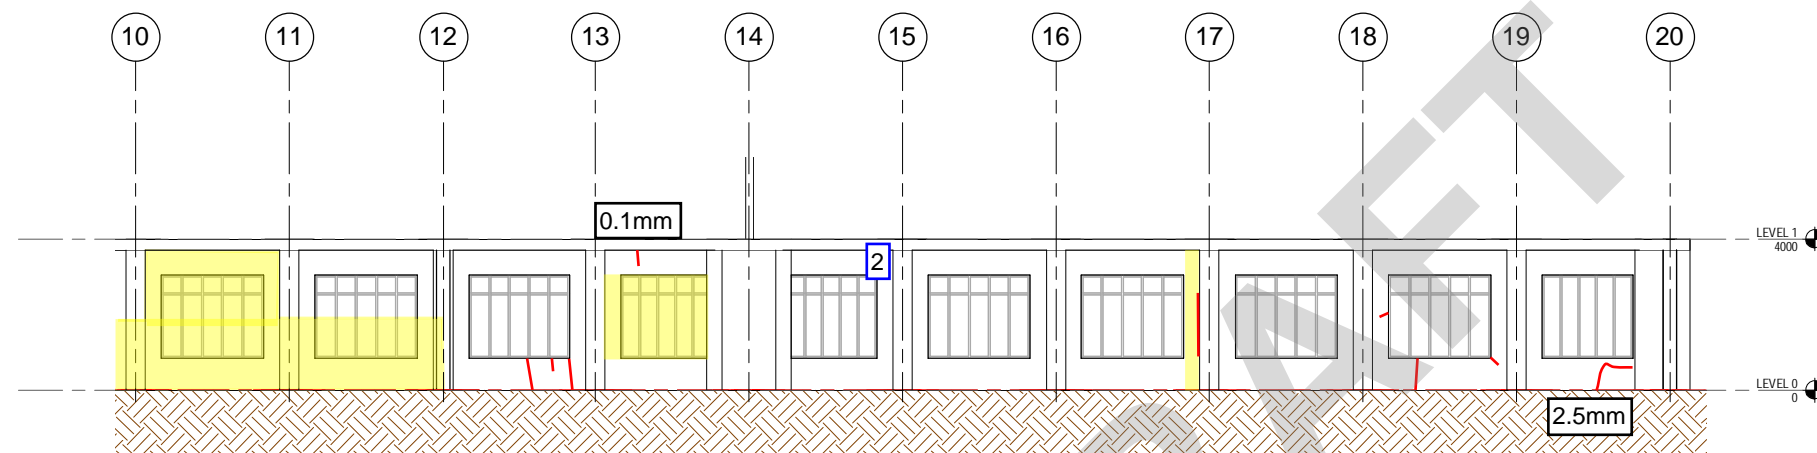
- Legend**
1. Top of column, poor quality concrete
 2. Poor quality concrete on edge
 3. Pipe cast in column, cover spalled
 4. Spalled at corner
 5. Poor compaction of concrete

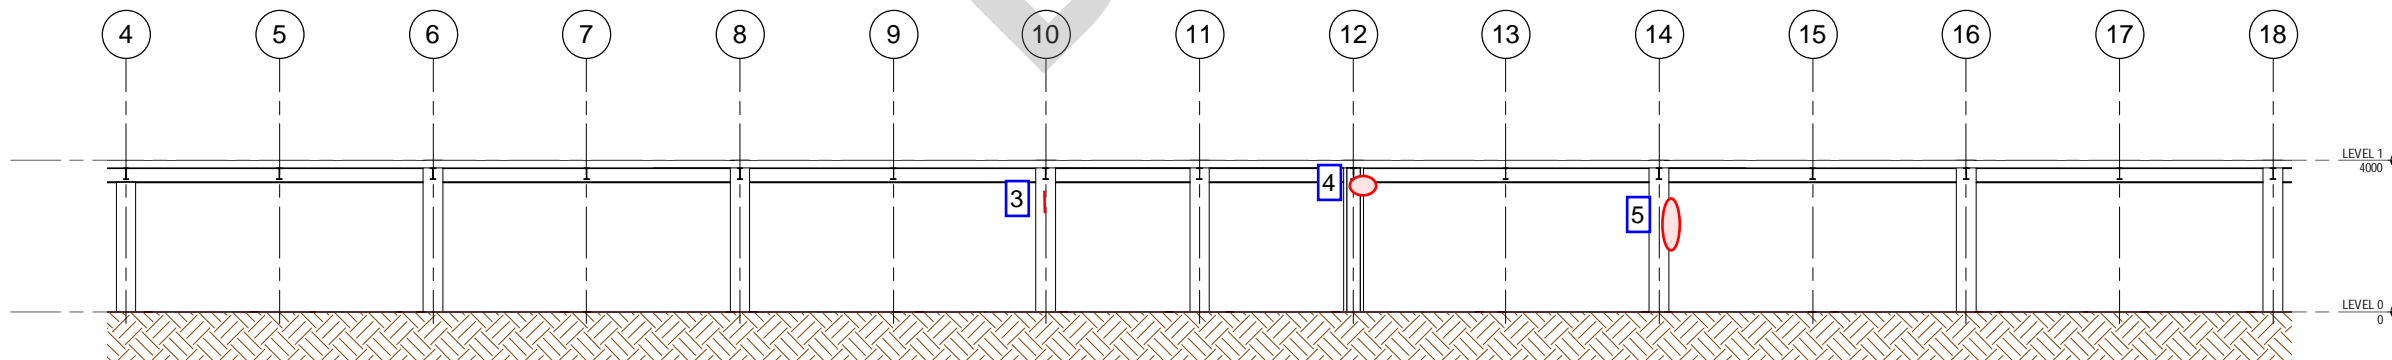
4 | SECTION ON GRID B - DAMAGE SURVEY
A.420 REF: A.140 Scale: 1 : 100

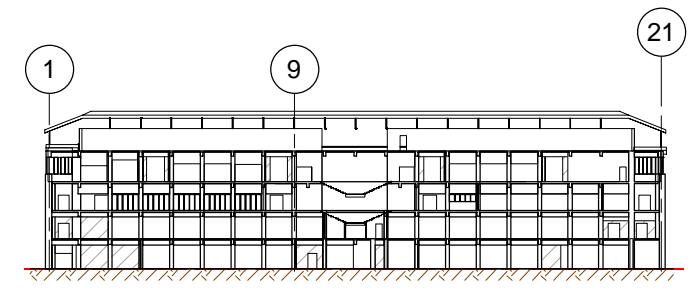
5 DAMAGE SURVEY - SECTION ON GRID C
 A.421 REF: A.140 Scale: 1 : 500

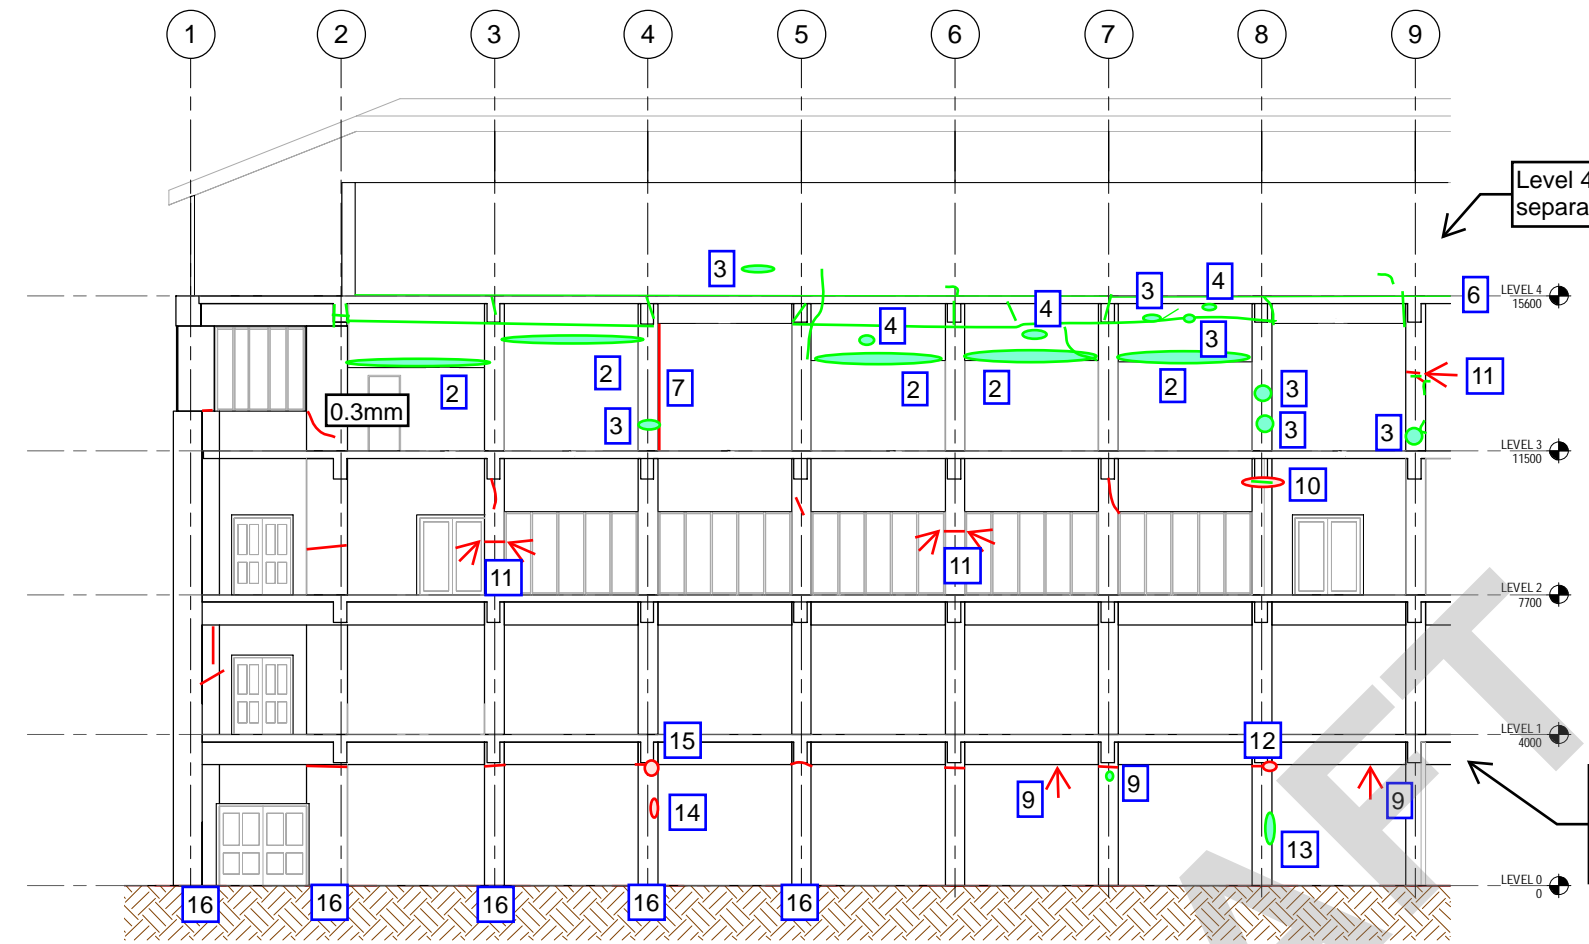
6 DAMAGE SURVEY - SECTION ON GRID C - GRID 1 TO GRID 9
 A.421 Scale: 1 : 100

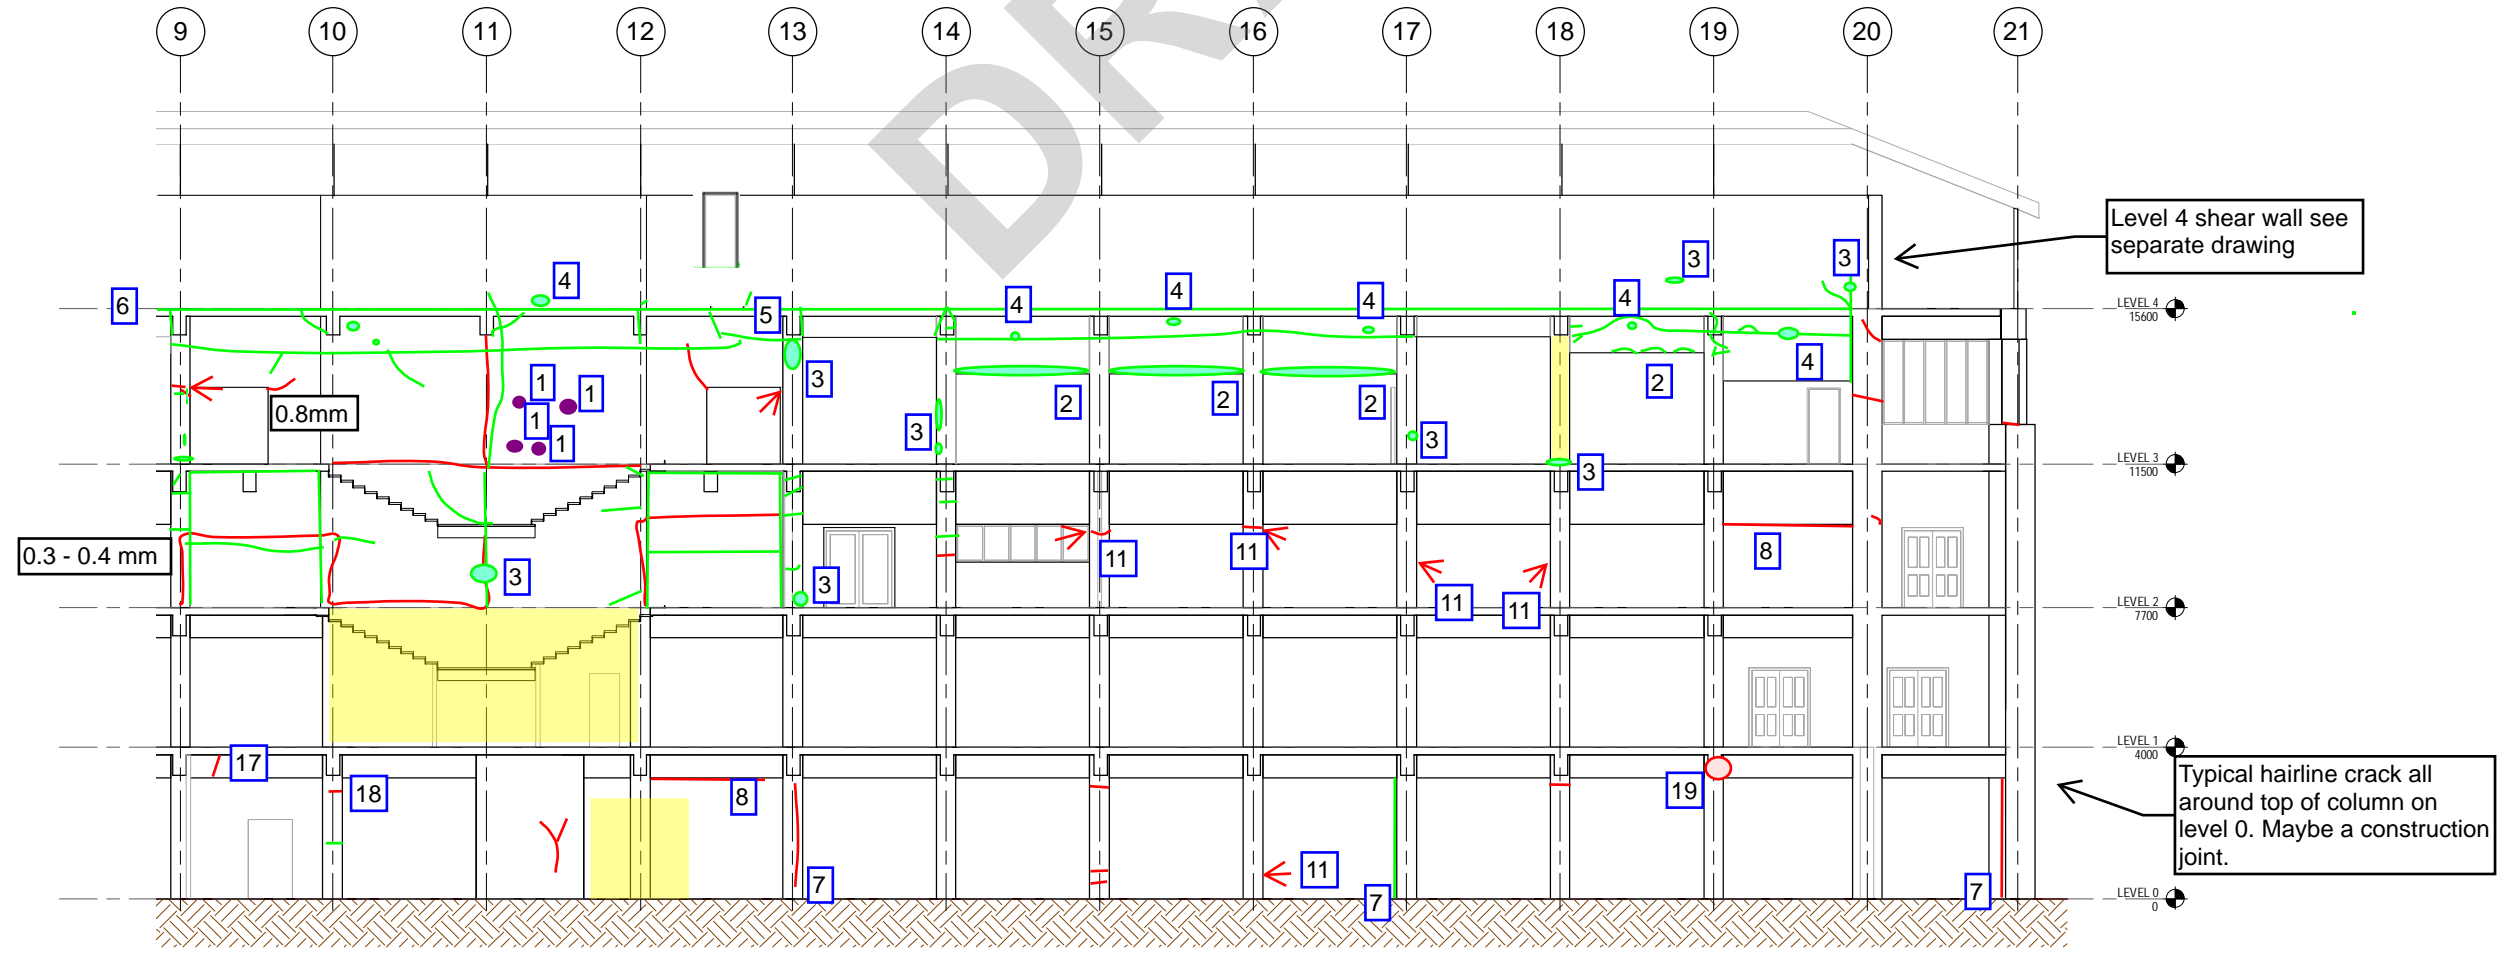
7 DAMAGE SURVEY - SECTION ON GRID C - GRID 9 TO 21
 A.421 Scale: 1 : 100

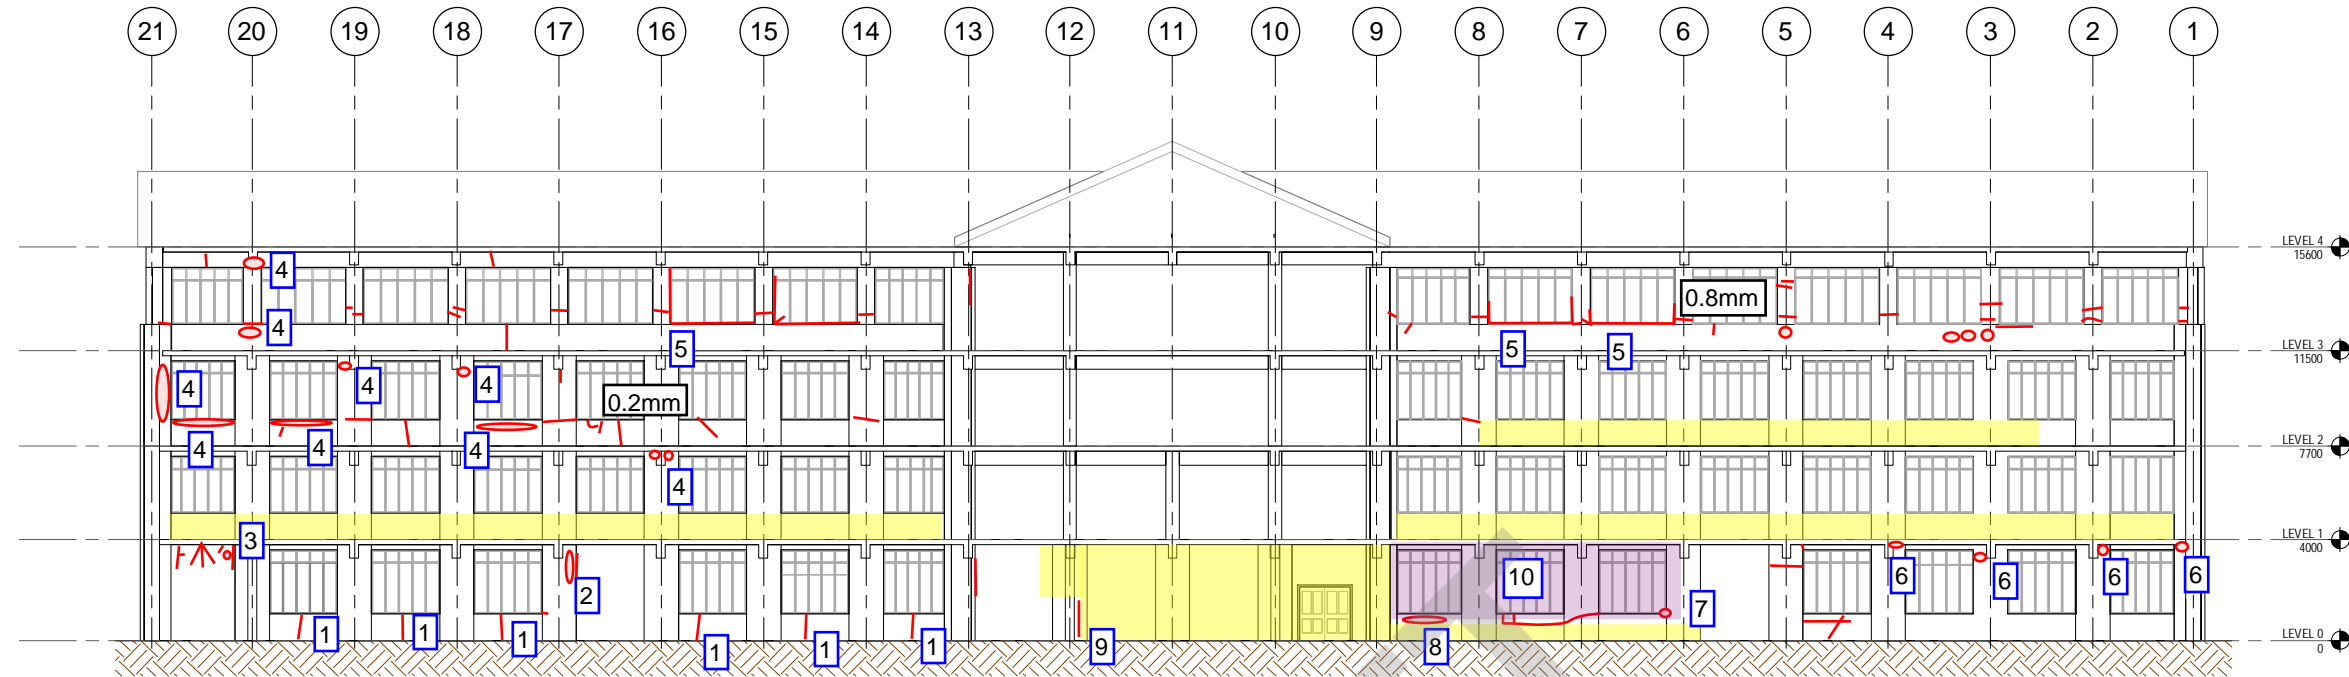
8 | DAMAGE SURVEY - SECTION ON GRID D FROM INTERIOR

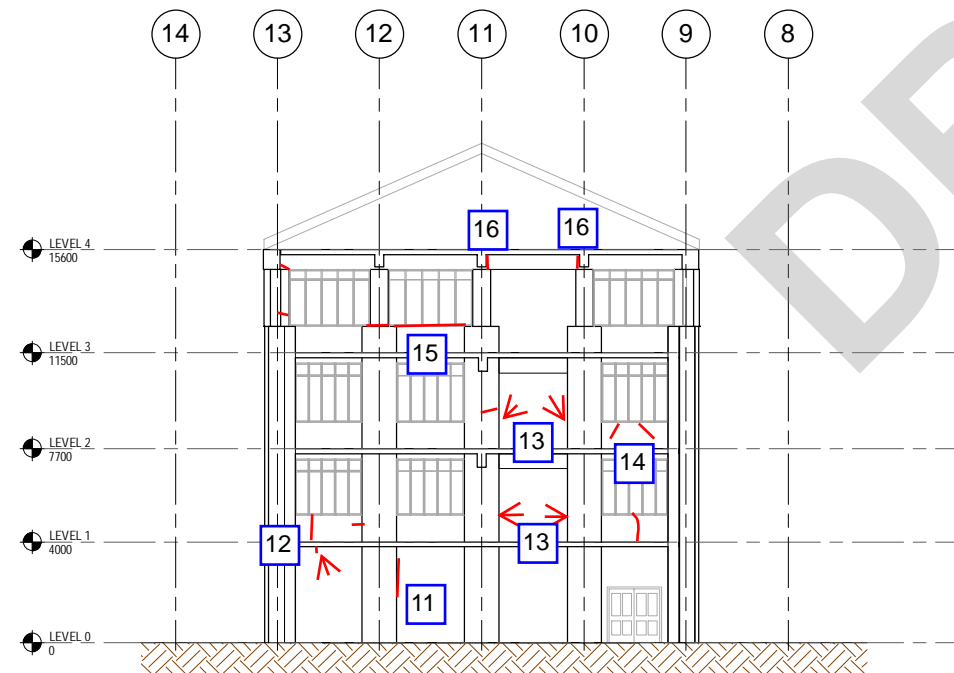
9 | DAMAGE SURVEY - SECTION ON GRID E

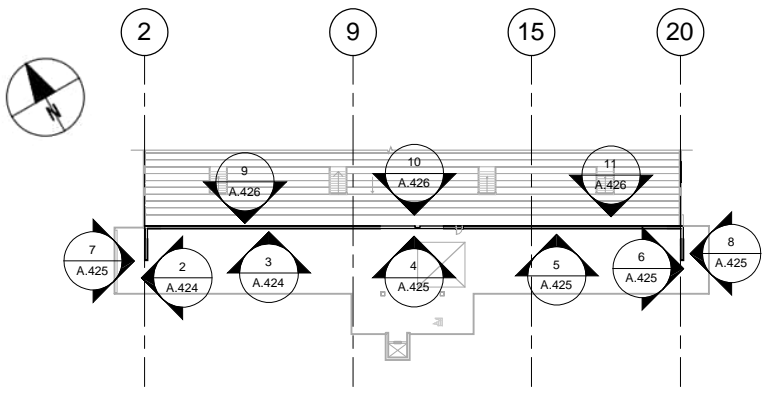
SHEAR WALL ON LEVEL 4 - LOCATION
 Scale: 1 : 500

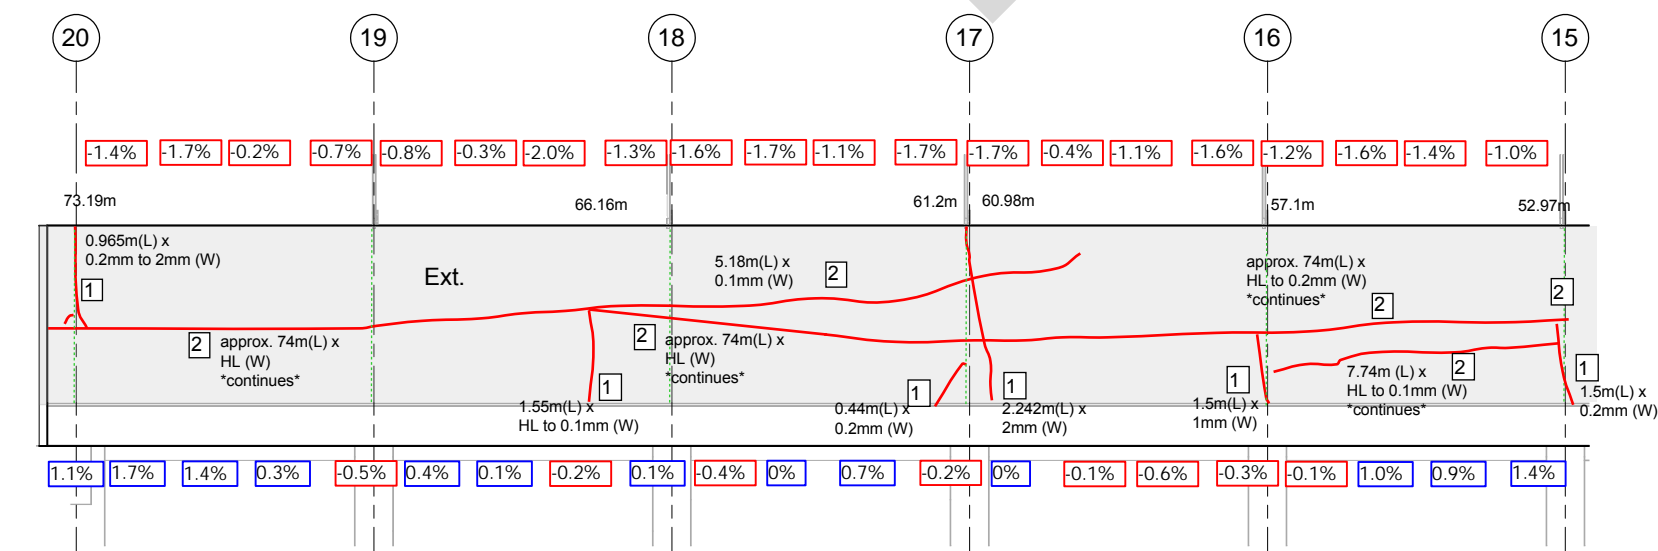
11 SHEAR WALL - EXTERIOR - GRID 15 TO GRID 20
 A.426 REF: A.424 Scale: 1 : 50

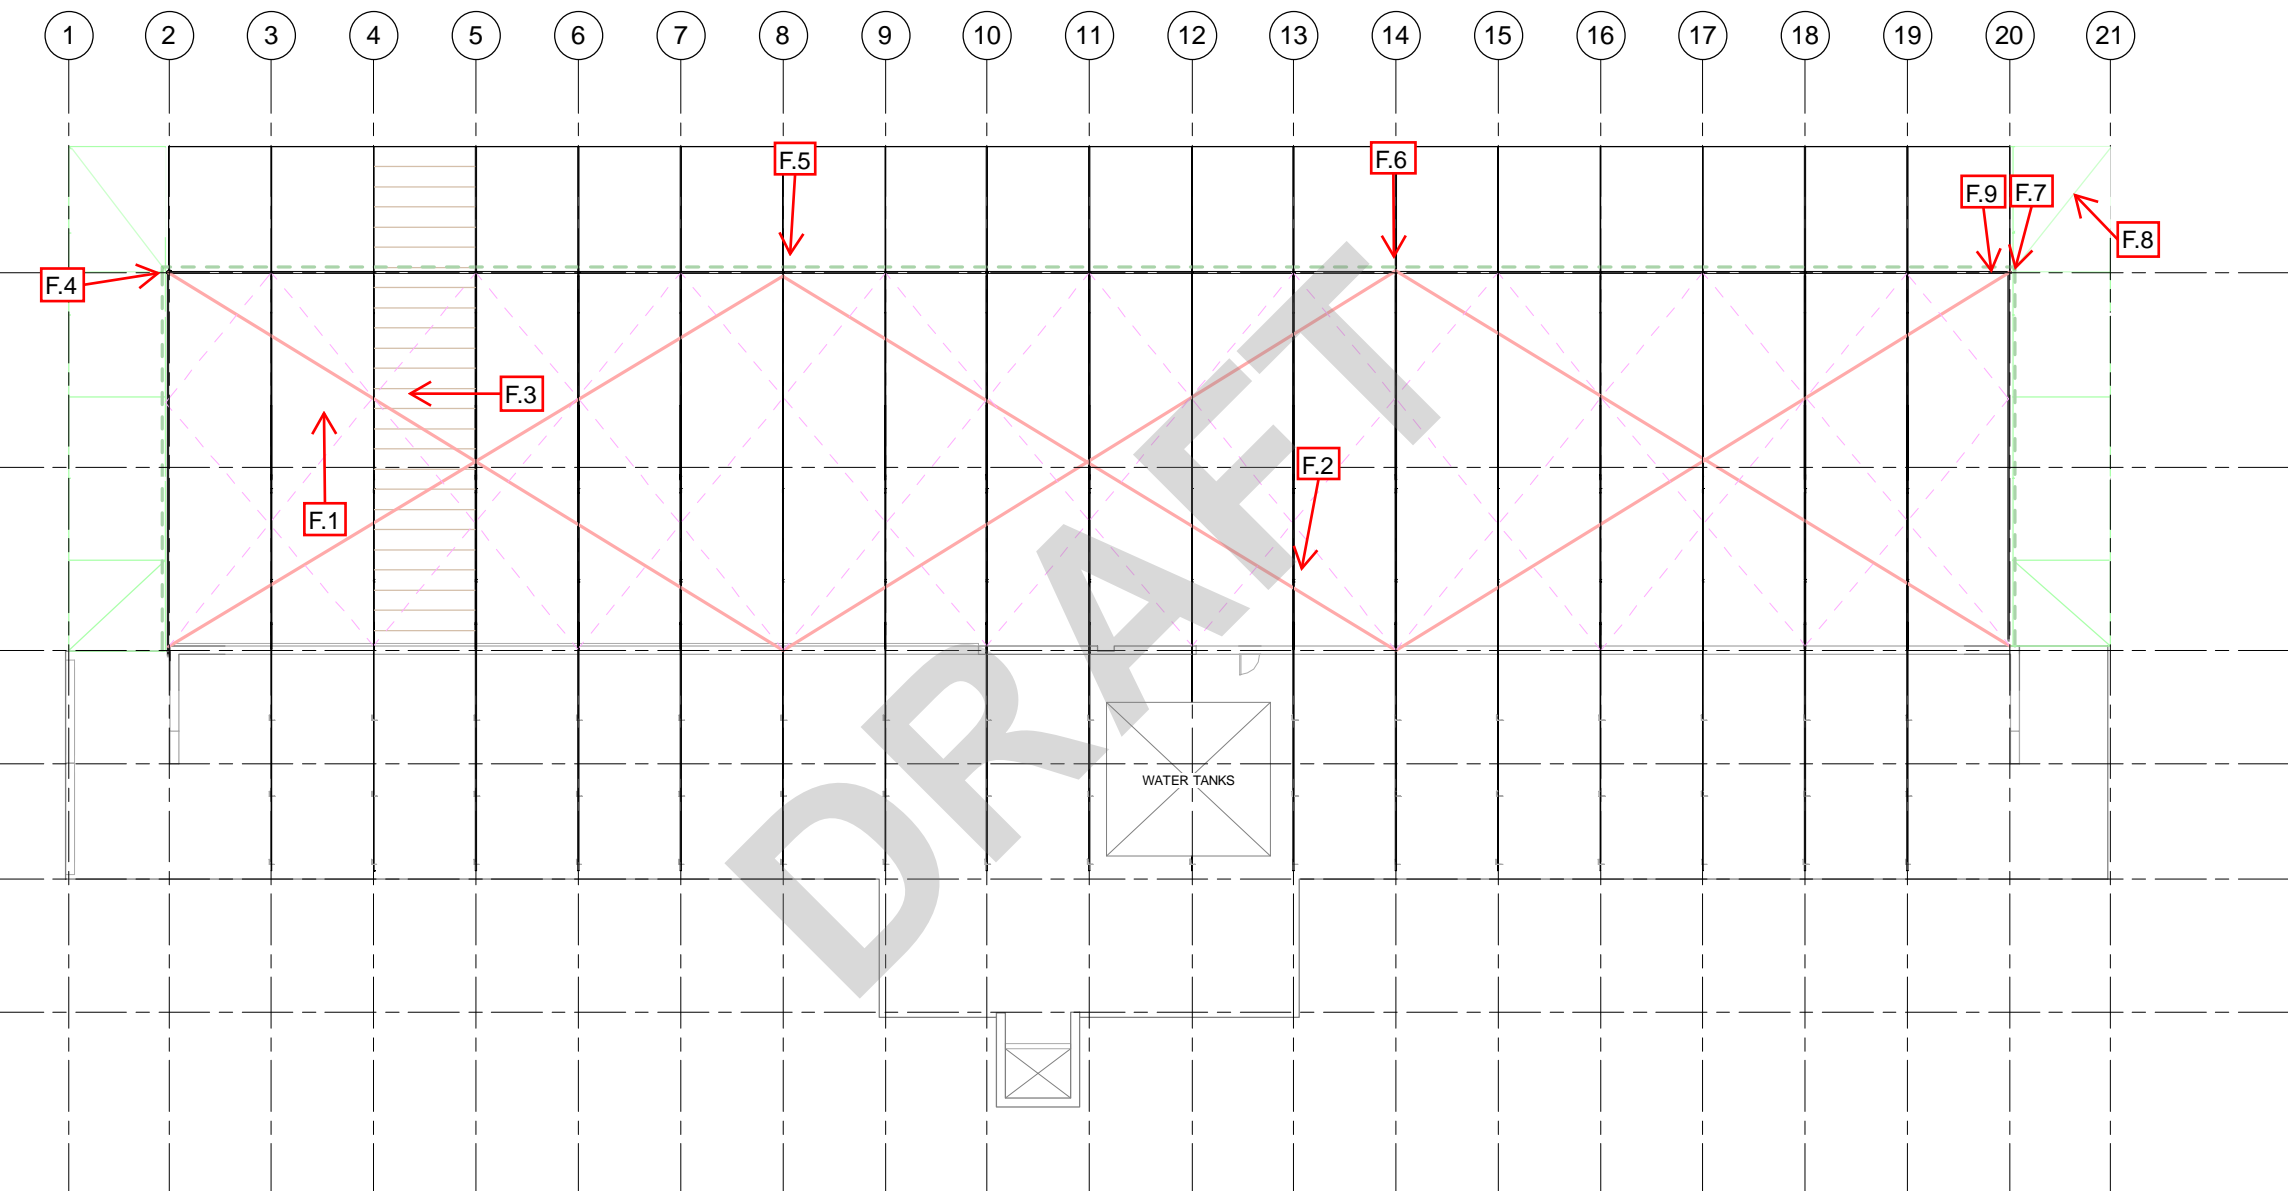
UPPER STAND ROOF - DAMAGE PHOTO KEYPLAN

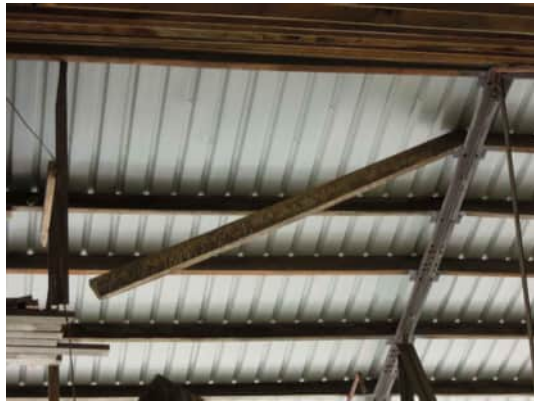
F.1
A.441 | TIMBER PURLIN END CONNECTION FAILED

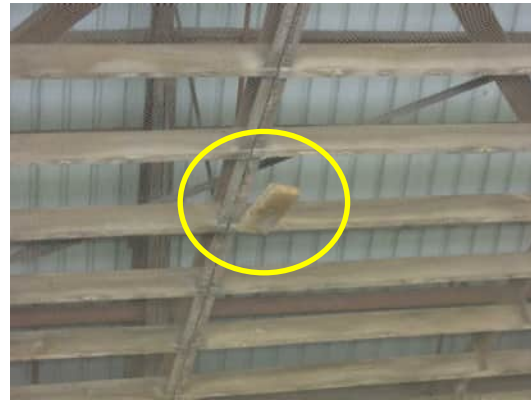
F.2
A.441 | TIMBER BLOCKING SUPPORTING BRACE FALLEN ONTO NET

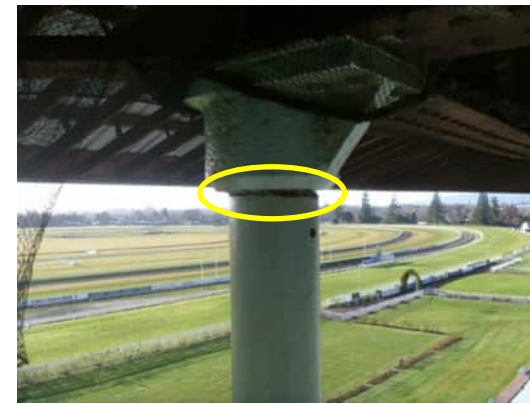
F.4
A.441 | COLUMN COLLAR CONNECTION GRID 2, PAINT SPLIT WITH RUST

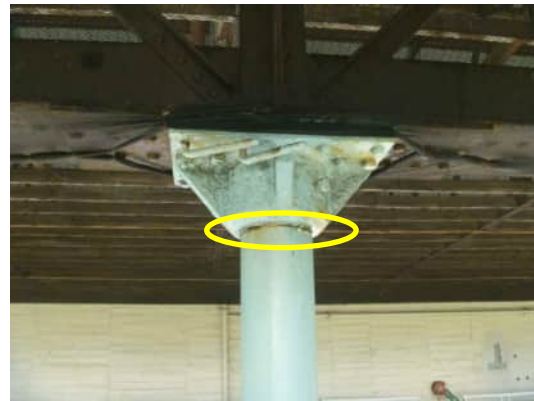
F.5
A.441 | COLUMN COLLAR CONNECTION GRID 8, PAINT SPLIT WITH RUST

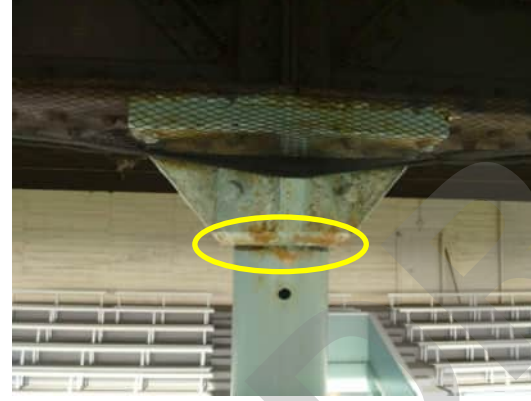
F.6
A.441 | COLUMN COLLAR CONNECTION GRID 14, PAINT SPLIT WITH RUST

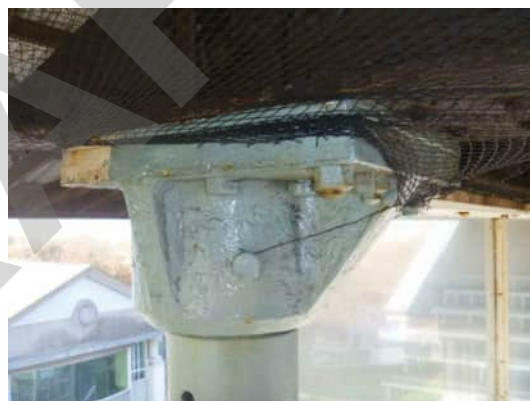
F.7
A.441 | COLUMN COLLAR CONNECTION GRID 20 RUST

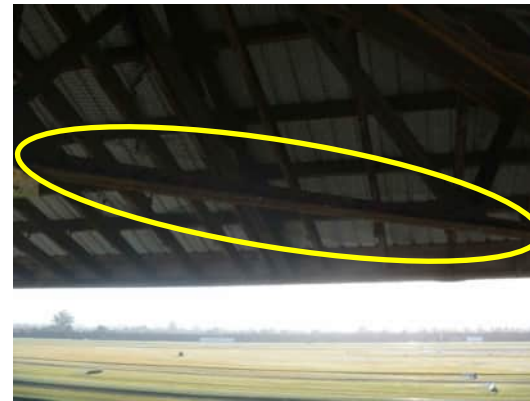
F.8
A.441 | SIGNIFICANT RUSTING TO GRID 20 TO 21 CORNER TRUSS

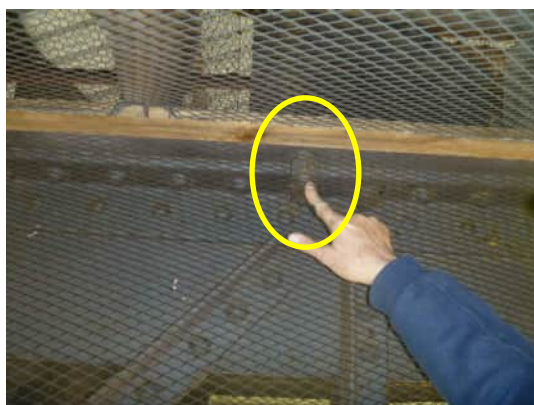
F.9
A.441 | BRACE CONNECTION TO TRUSS, LOOSE BOLT
