Detailed Damage Evaluation

Quantitative Seismic Analysis of Grand National (Public) Stand

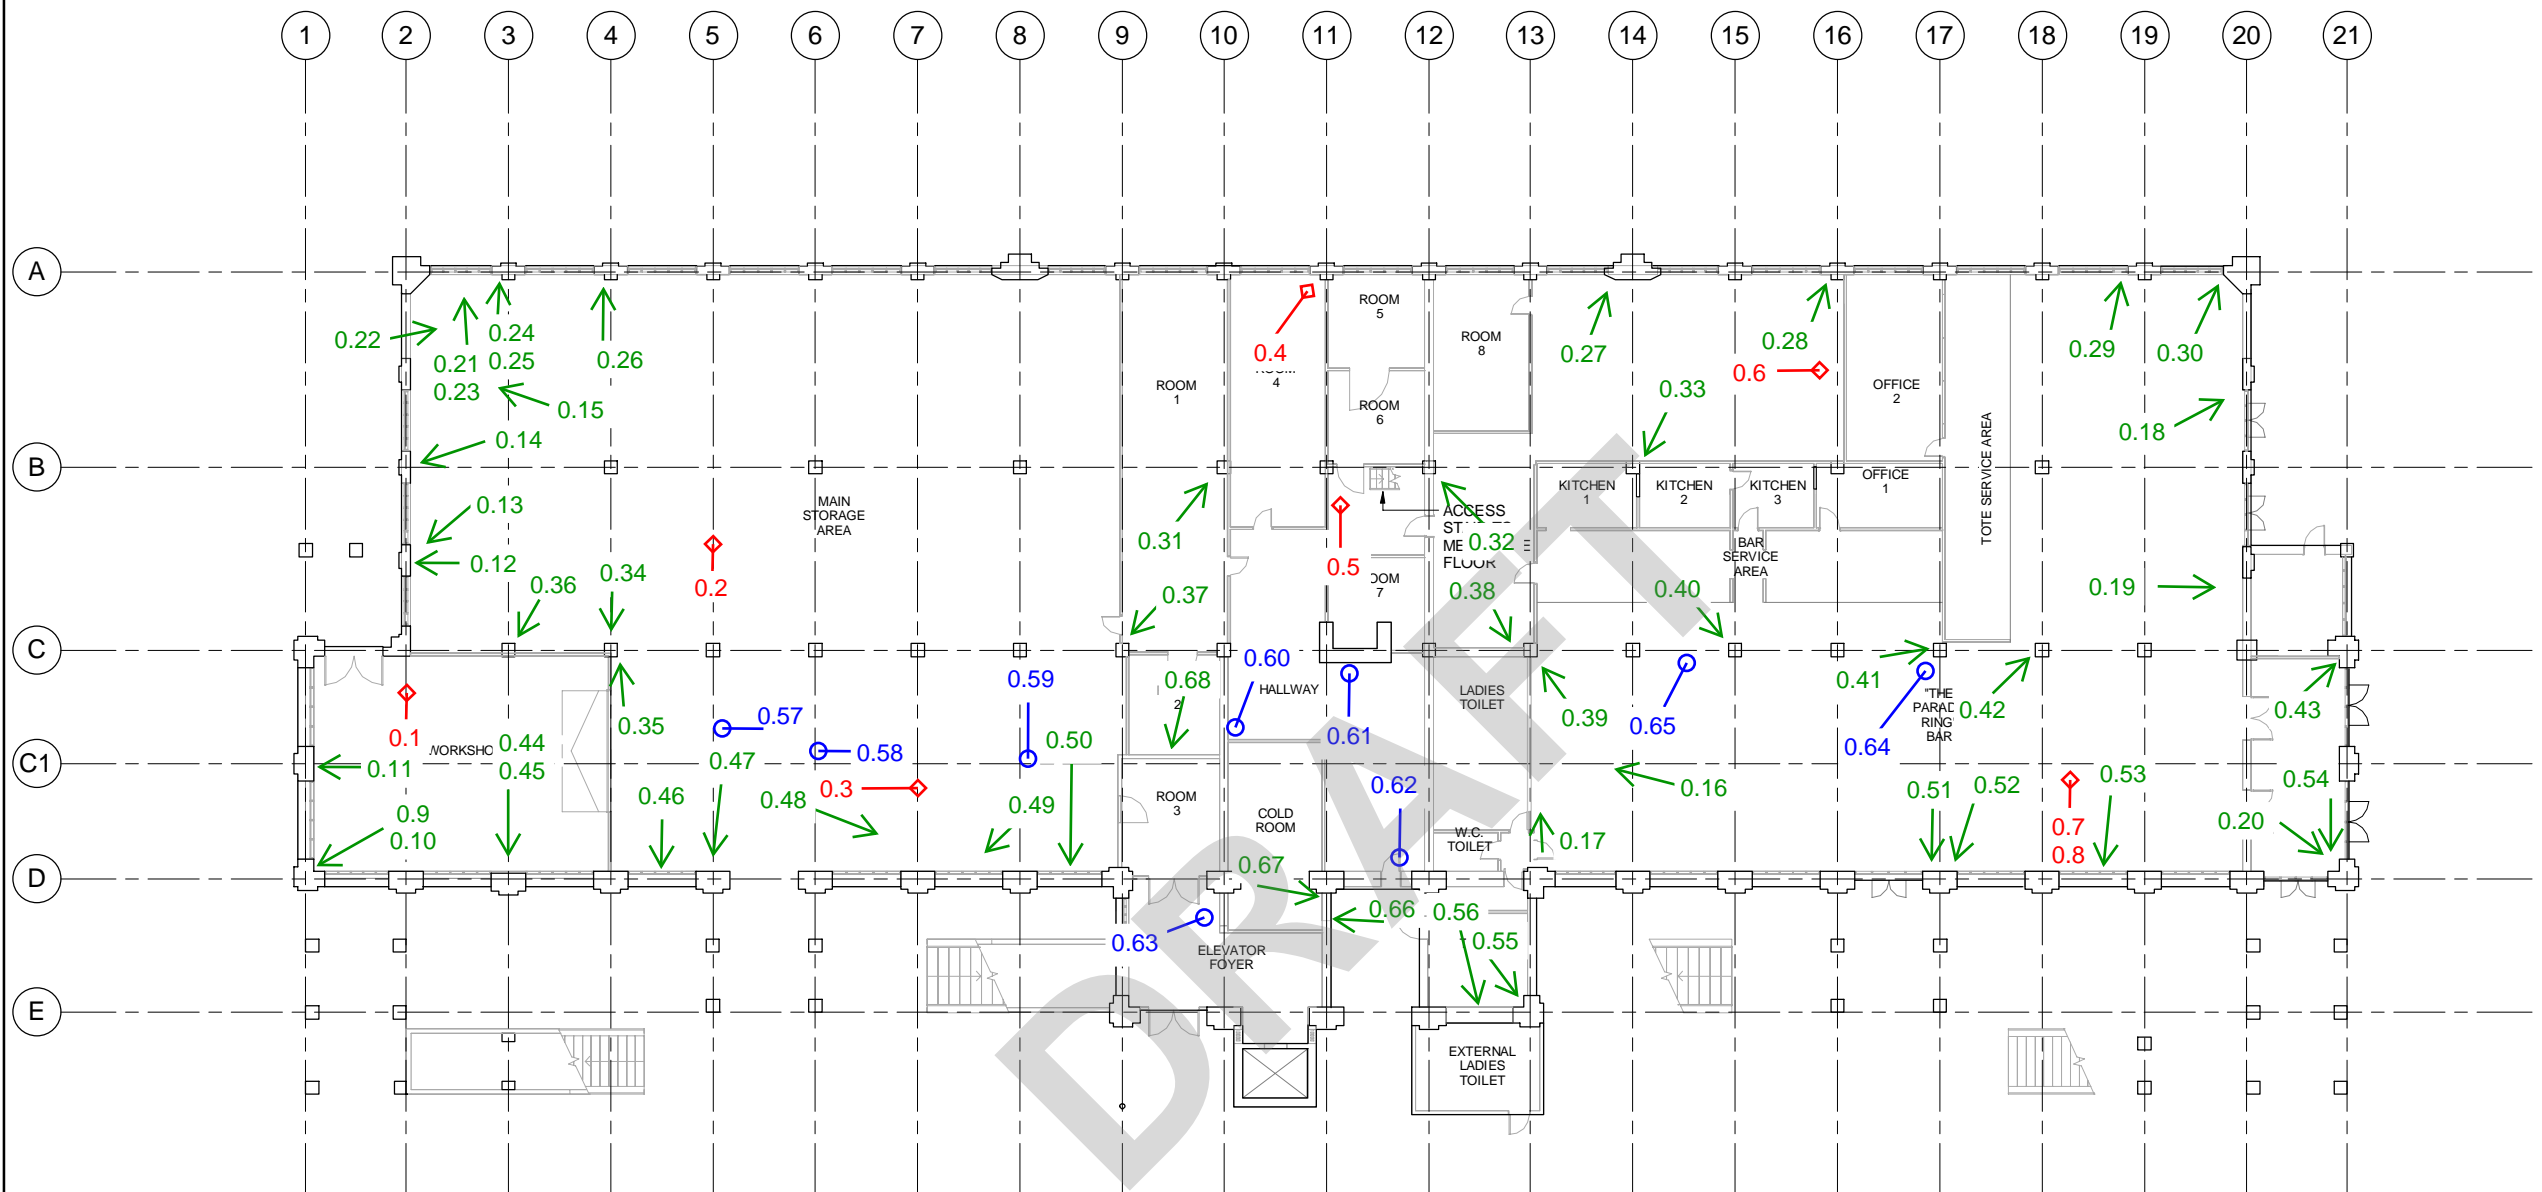
DAMAGE PHOTO KEYPLAN - GROUND LEVEL

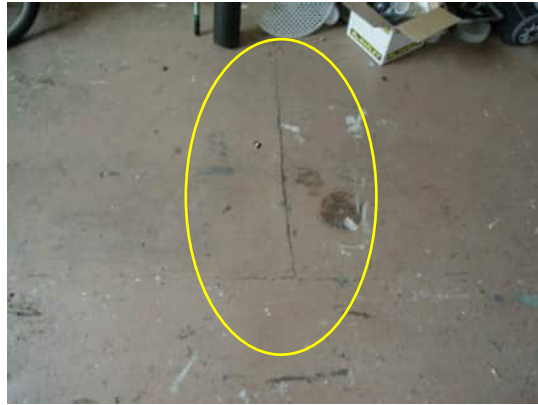
0.1
A-500 | 1.5mm WIDE CRACK

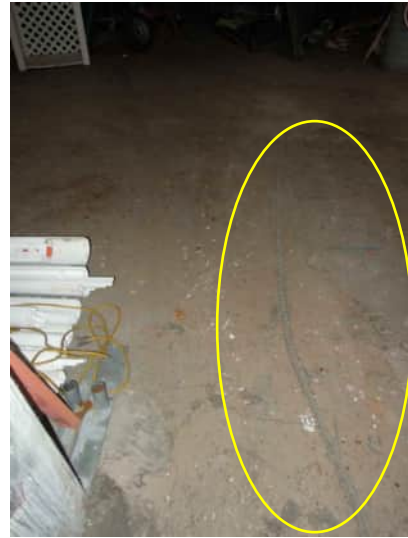
0.2
A-500 | DAMAGE TO FLOOR, 10mm WIDE ON SURFACE ONLY

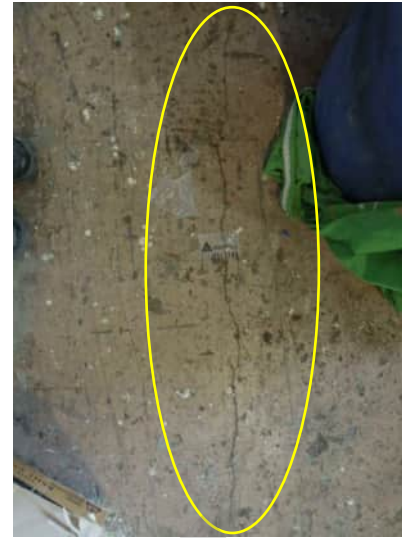
0.3
A-500 | CRACK IN SLAB, UP TO 2mm WIDE

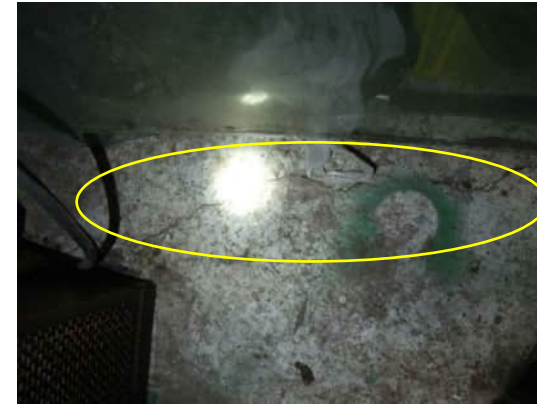
0.4
A-500 | MINOR CRACK IN SLAB

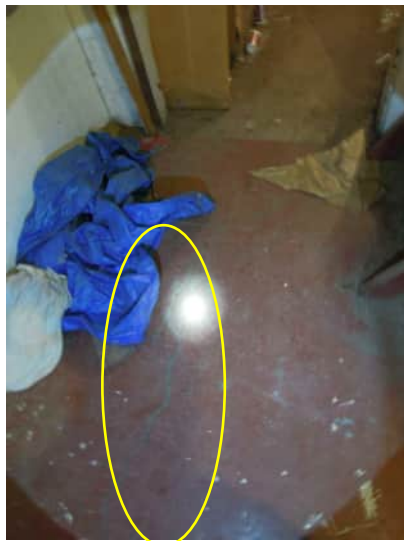
0.5
A-500 | MINOR CRACK TO SURFACE COATING ONLY

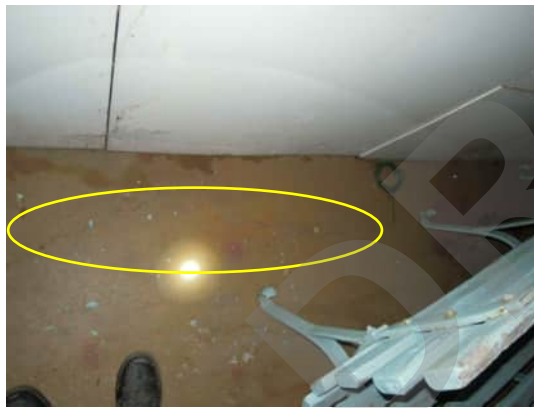
0.6
A-500 | MINOR CRACK TO SURFACE COATING ONLY

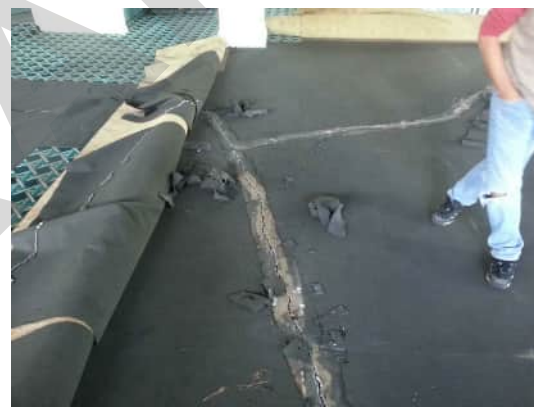
0.7
A-500 | SIGNIFICANT CRACKS IN SLAB WHERE CARPET HAS BEEN PULLED UP

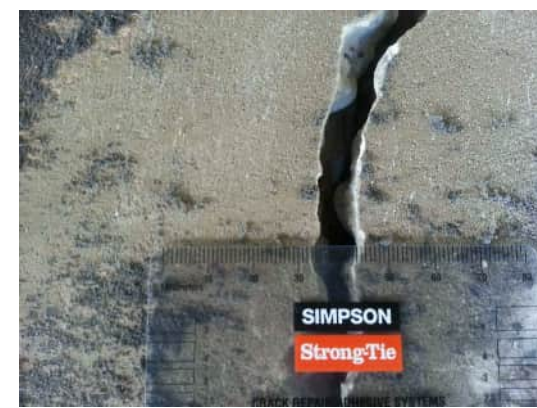
0.8
A-500 | CRACK UP TO 15mm

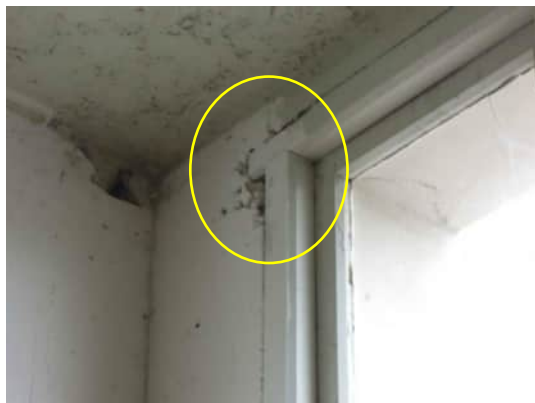
0.9
A-500 | POORLY COMPACTED CONCRETE AROUND WINDOW FRAME AT TOP OF GRID D COLUMN

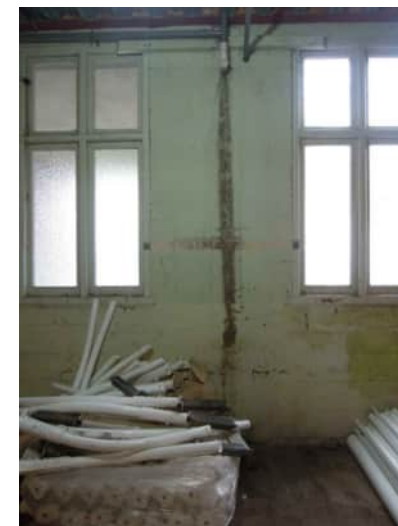
0.12
A-500 | PIPE AT TOP OF COLUMN BETWEEN GRID B AND C, WITH WATER DAMAGE BELOW

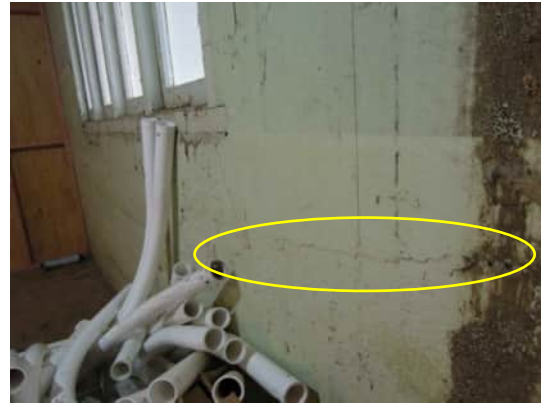
0.13 HORIZONTAL CRACK IN WALL BETWEEN GRID B AND C
A-500

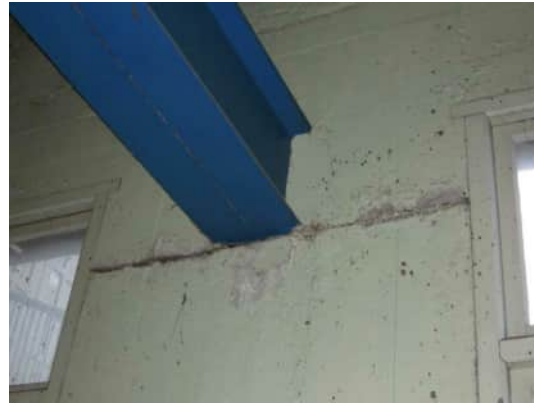
0.14 HORIZONTAL CRACK AT TOP OF WALL AT GRID B IN CONSTRUCTION JOINT, BELOW CAST-IN STEEL BEAM.
A-500

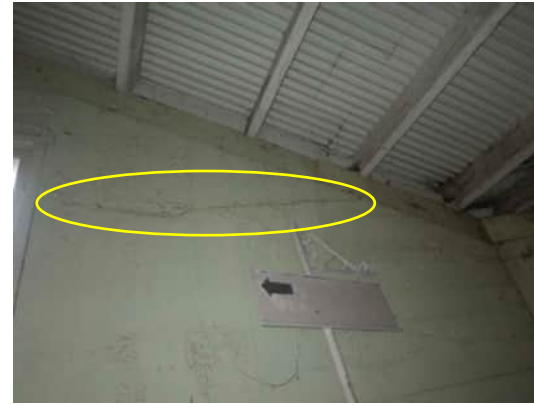
0.15 HORIZONTAL CRACK TO TOP OF WALL AT GRID A
A-500

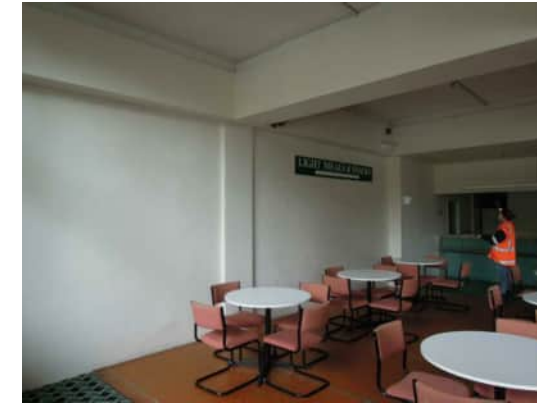
0.16 VIEW OF GRID 13 BETWEEN GRID C AND D
A-500

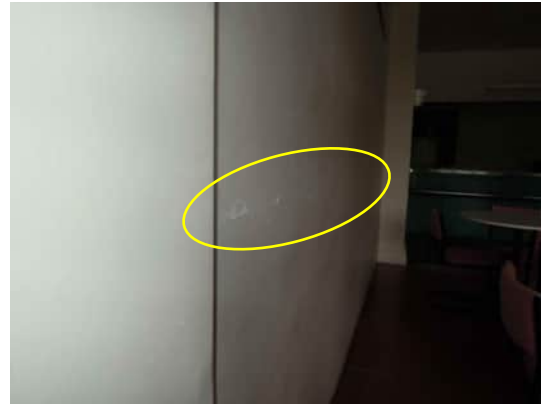
0.17 CRACK TO THE PLASTER
A-500

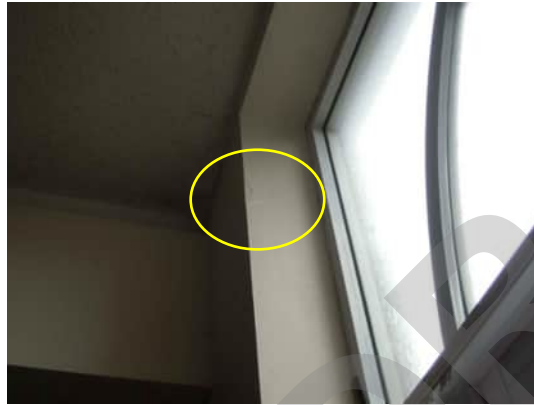
0.18 CRACKS IN DOOR FRAME BETWEEN GRID A AND B
A-500

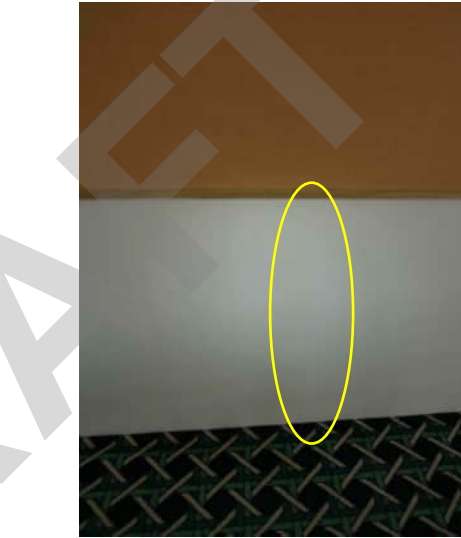
0.19 VERTICAL CRACK IN WALL BETWEEN GRID B AND C
A-500

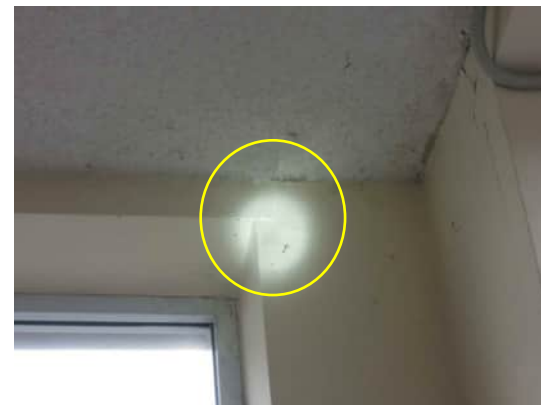
0.20 CRACK ABOVE DOOR FRAME AT GRID D
A-500

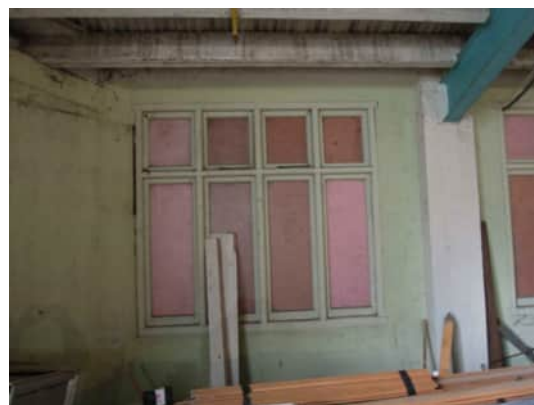
0.21 VIEW OF TYPICAL GRID A BAY
A-500

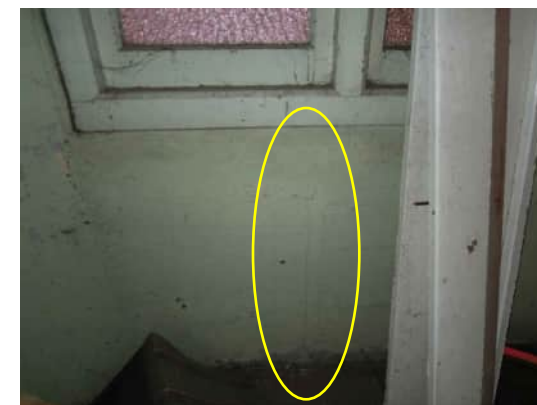
0.23 0.2mm VERTICAL CRACK BELOW WINDOW BETWEEN GRID 2 AND 3
A-500

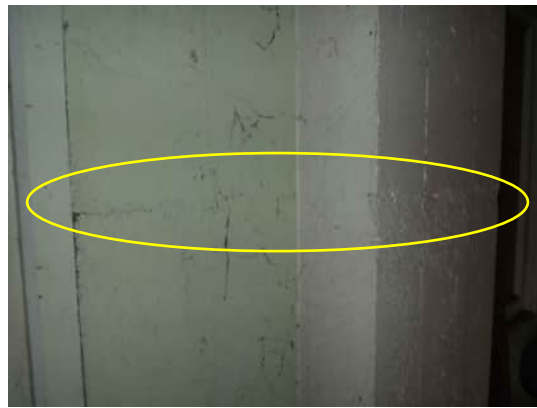
0.24
A-500 | HAIRLINE HORIZONTAL CRACK AT LOCATION OF CONSTRUCTION JOINT ON GRID 3

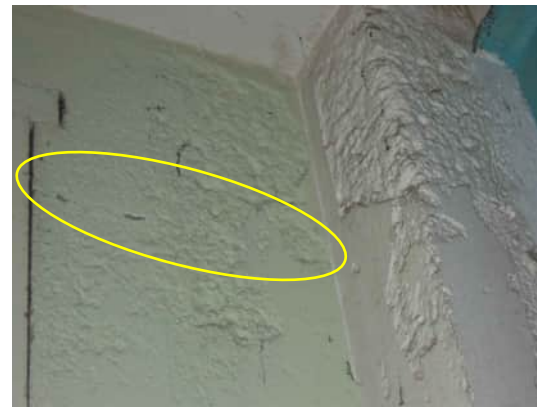
0.25
A-500 | HAIRLINE HORIZONTAL CRACK NEAR TOP OF WINDOW AT GRID 3

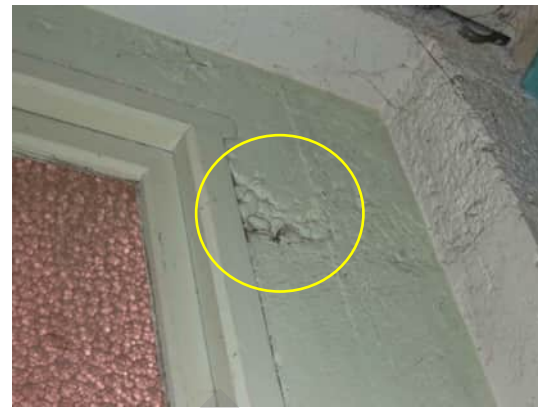
0.26
A-500 | TYPICAL POORLY COMPACTED CONCRETE WITH EXPOSED AGGREGATE NEAR TOP OF COLUMNS

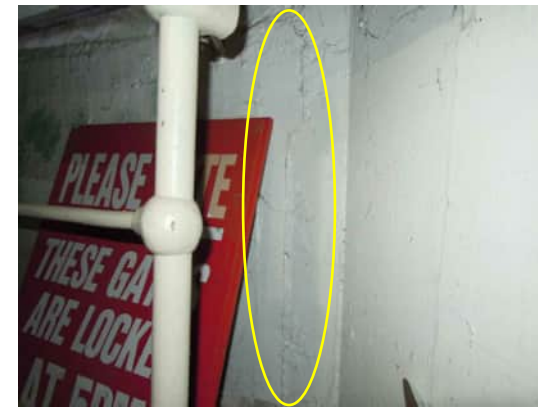
0.27
A-500 | VERTICAL CRACKS BELOW WINDOW BETWEEN GRID 13 AND 14

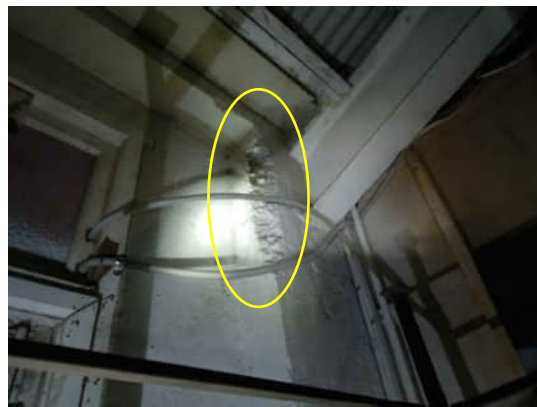
0.28
A-500 | POORLY COMPACTED CONCRETE ON EDGE OF GRID 16 COLUMN

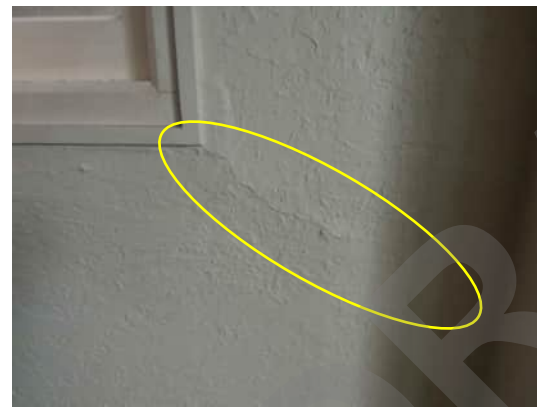
0.29
A-500 | HAIRLINE DIAGONAL CRACK FROM CORNER OF WINDOW BETWEEN GRID 18 AND 19

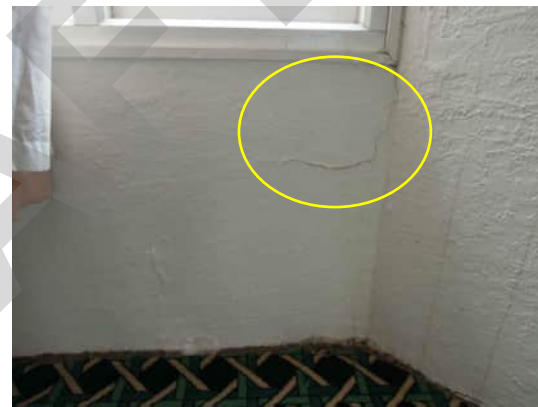
0.30
A-500 | CRACK UP TO 2.5mm BELOW WINDOW ON GRID 20

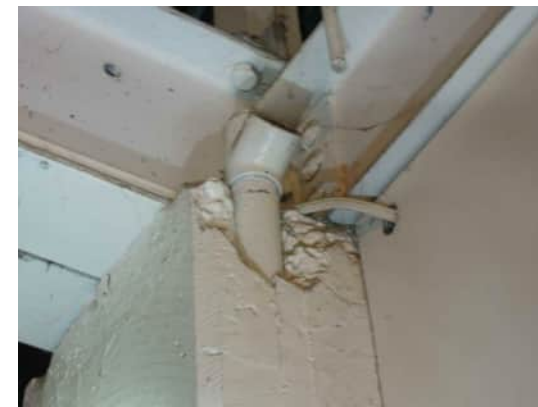
0.31
A-500 | DAMAGE AROUND PIPE CAST INTO COLUMN ON GRID 10

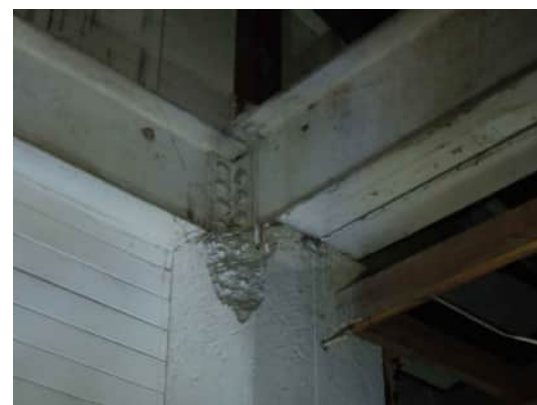
0.32
A-500 | DAMAGE TO TOP OF GRID 12 COLUMN

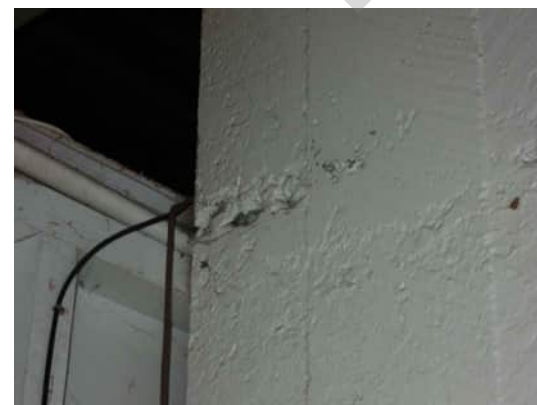
0.33
A-500 | POORLY COMPACTED CONCRETE ON GRID 14 COLUMN

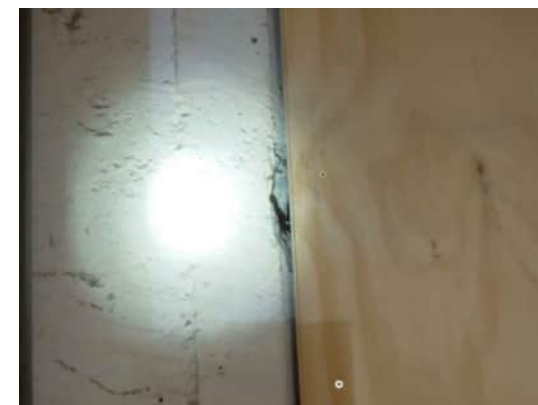
0.35
A-500 | DAMAGE AROUND NAIL WHERE TIMBER PANELS ARE CONNECTED TO THE COLUMNS, OCCURS FROM GRID 2 TO GRID 5

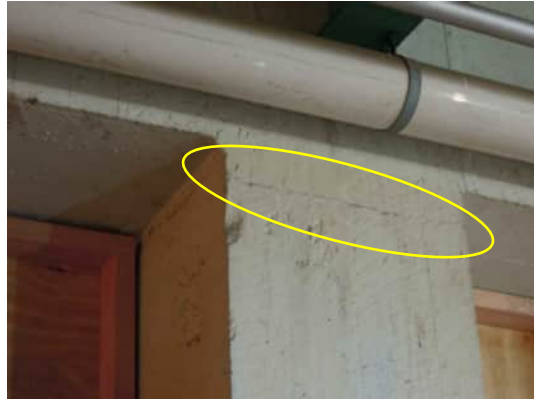
0.36 TYPICAL CRACK NEAR TOP OF COLUMN, ON ALL FACES OF COLUMN
A-500

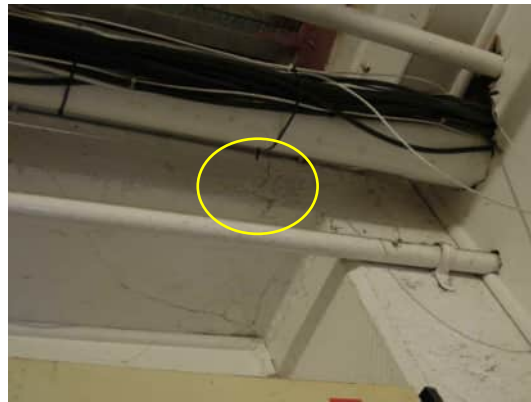
0.37 SIGNIFICANT CRACK TO BEAM NEAR BEAM COLUMN JOINT ON GRID 9
A-500

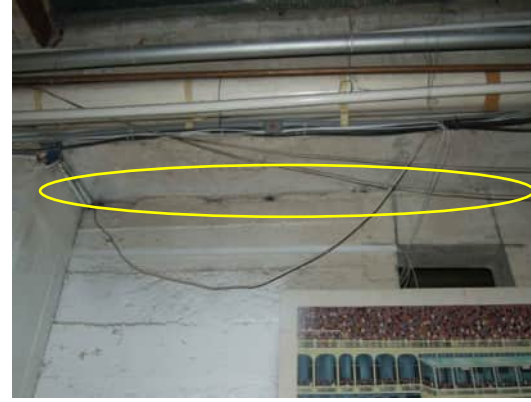
0.38 SEPARATION BETWEEN CONCRETE WALL AND BEAM/COLUMNS BETWEEN GRID 12 AND 13
A-500

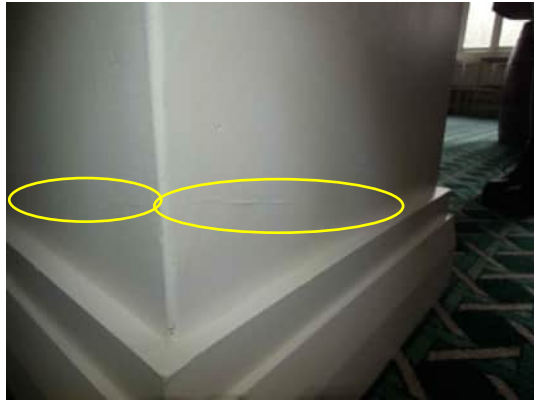
0.40 HAIRLINE CRACKING TO GIB LINING AROUND BASE OF COLUMN ON GRID 15
A-500

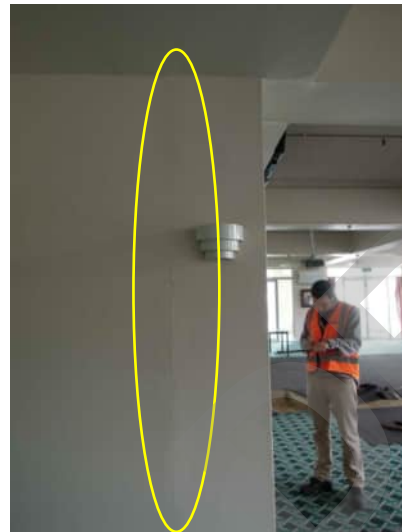
0.41 SEPARATION TO GIB LINING BETWEEN GRID 17 COLUMN AND WALL
A-500

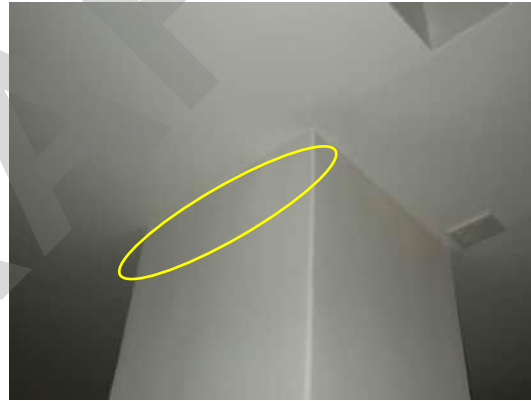
0.42 HAIRLINE CRACKING TO GIB LINING NEAR TOP OF COLUMN ON GRID 18
A-500

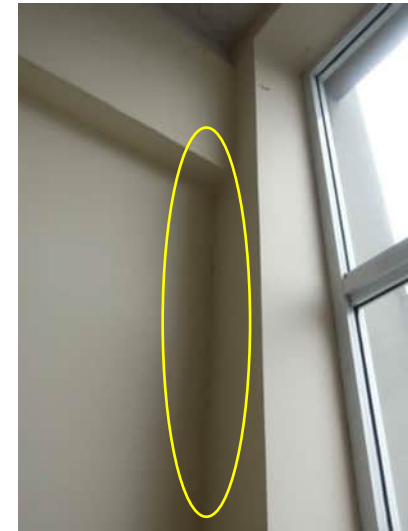
0.43 SEPARATION BETWEEN GRID 21 COLUMN AND WALL
A-500

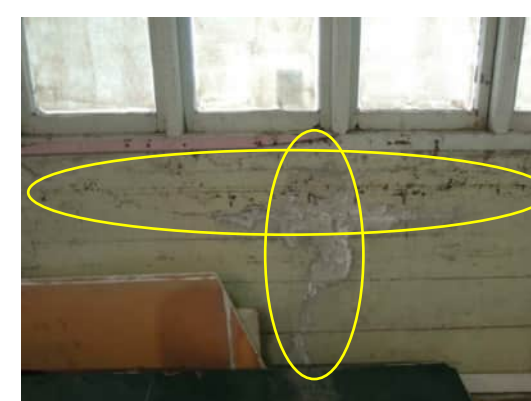
0.46 HORIZONTAL AND VERTICAL CRACK BELOW WINDOW BETWEEN GRID 4 AND 5
A-500

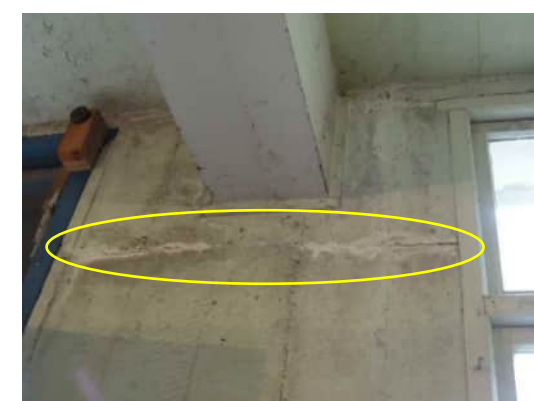
0.47 CRACK IN CONSTRUCTION JOINT ON GRID 5 COLUMN
A-500

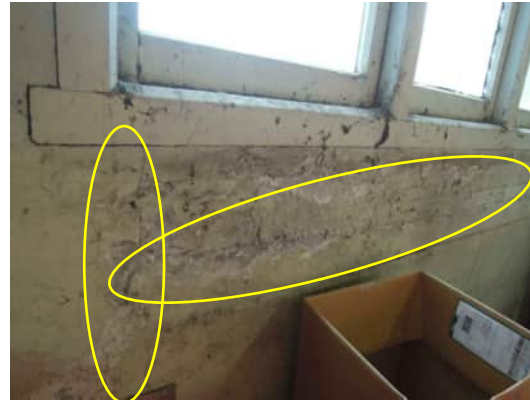
0.49 | HORIZONTAL AND VERTICAL CRACK BELOW WINDOW BETWEEN GRID 7 AND 8
A-500

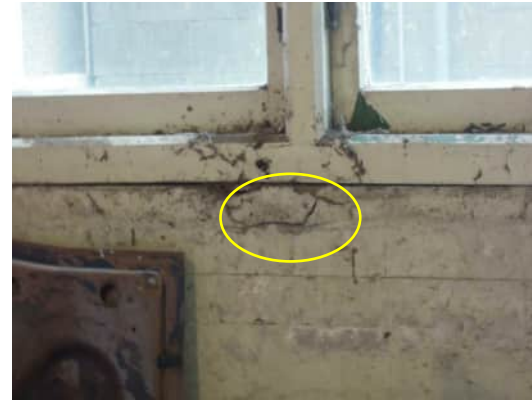
0.50 | SIGNIFICANT CRACK BELOW WINDOW BETWEEN GRID 8 AND 9
A-500

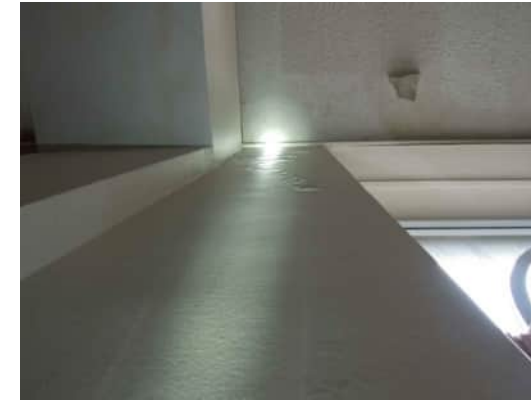
0.51 | SIGN OF MOISTURE DAMAGE TO TOP OF COLUMN ON GRID 17, ALSO OCCURS AT GRID 20
A-500

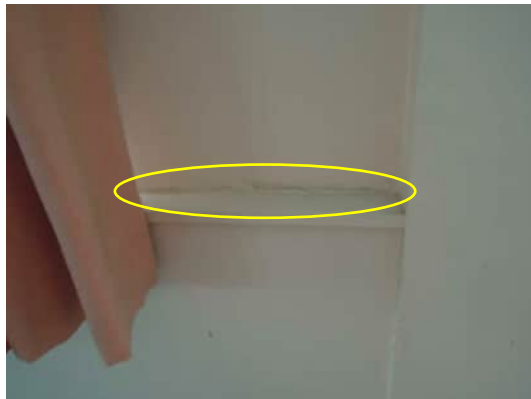
0.52 | HORIZONTAL CRACK IN WALL ON GRID 17 IN LINE WITH BOTTOM OF WINDOW
A-500

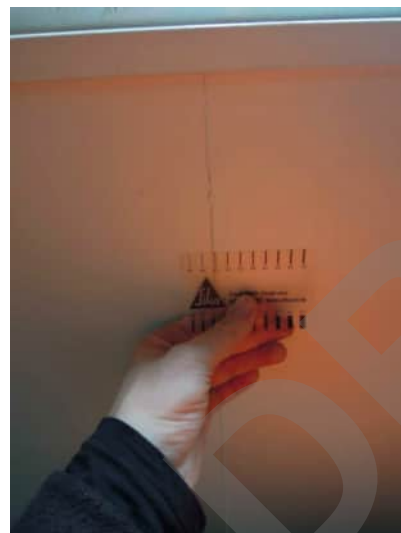
0.53 | TYPICAL SEPARATION BETWEEN PLASTER BOARD PANELS, OCCURS FROM GRID 13 TO GRID 20
A-500

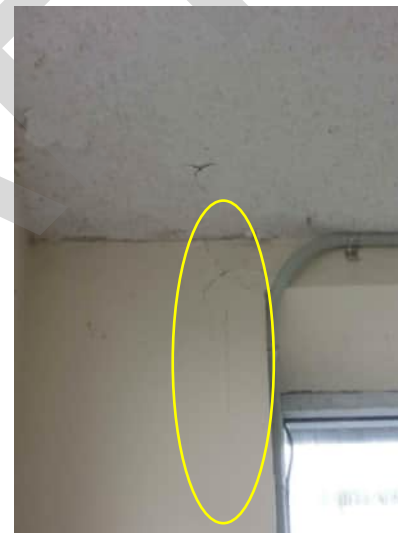
0.54 | CRACKS AT TOP OF GRID 21 COLUMN
A-500

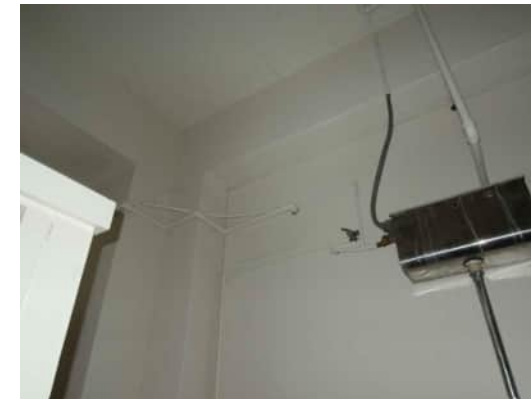
0.55 | VIEW OF BEAM COLUMN JOINT AT GRID 13
A-500

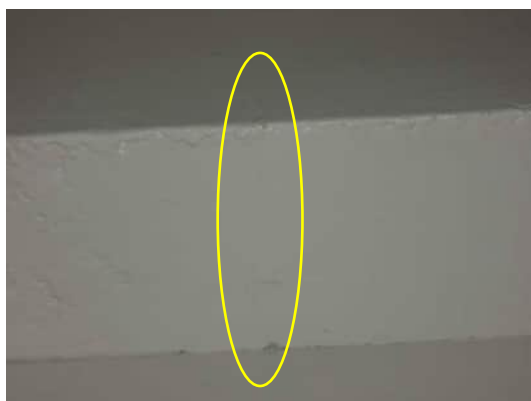
0.56 | CRACK TO BEAM BETWEEN GRID 12 AND 13
A-500

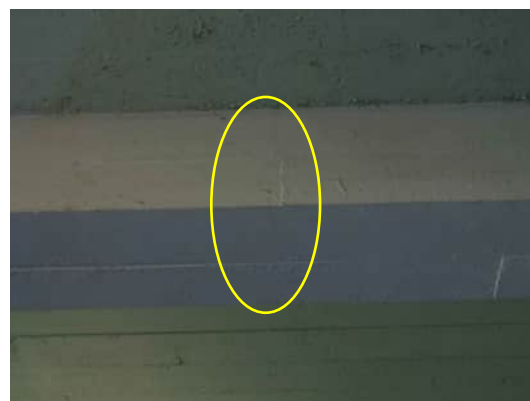
0.57 | VERTICAL CRACK AROUND BEAM ON GRID 4 (GRID 5 AND 6 SIMILAR, ALONG THEIR LENGTH)
A-500

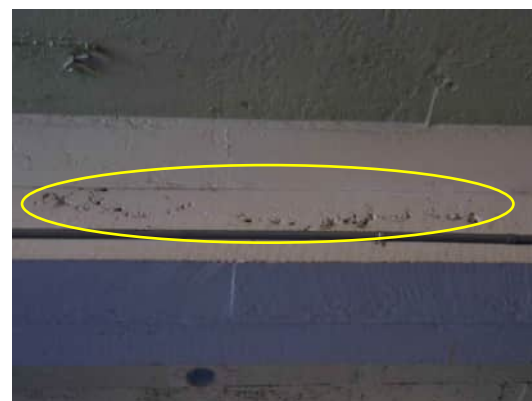
0.58 | POORLY COMPACTED CONCRETE ALONG BEAM AT GRID 6 (GRID 8 SIMILAR)
A-500

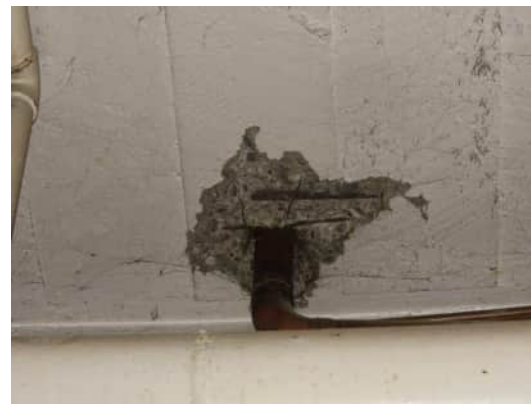
0.61 PIPE THROUGH CEILING WITH SPALLING WHICH HAS EXPOSED REINFORCING
A-500

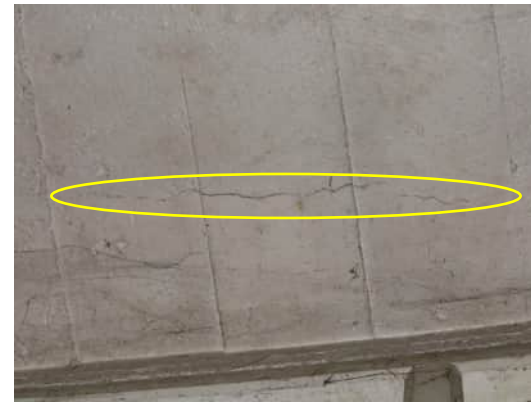
0.62 SIGNIFICANT CRACKS IN THE CEILING NEAR GRID 12/D
A-500

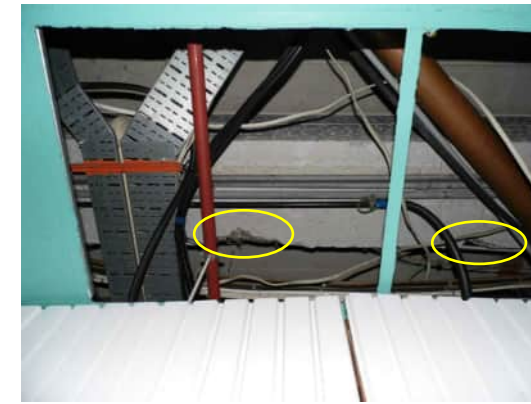
0.63 CORNER OF BEAM ON GRID 10 HAS BROKEN OUT IN TWO LOCATIONS BETWEEN GRID D AND GRID E
A-500

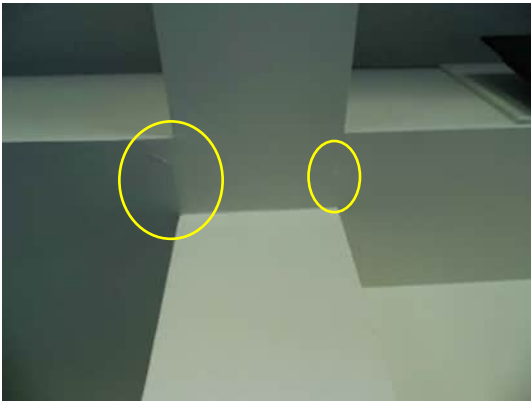
0.64 CRACK IN CASING AT BEAM COLUMN JOINT AT GRID 17 (GRID 13, 16 AND 19 SIMILAR)
A-500

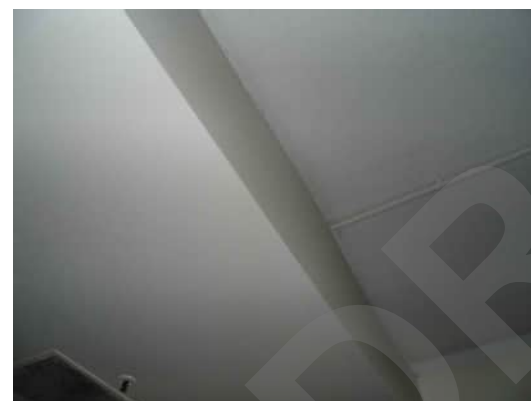
0.65 TYPICAL BEAM WITH CASING BOWING OUTWARDS
A-500

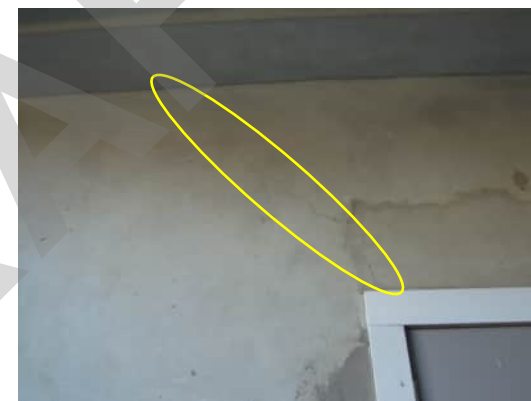
0.66 DIAGONAL CRACK ON EXTERIOR FACE OF CONCRETE WALL
A-500

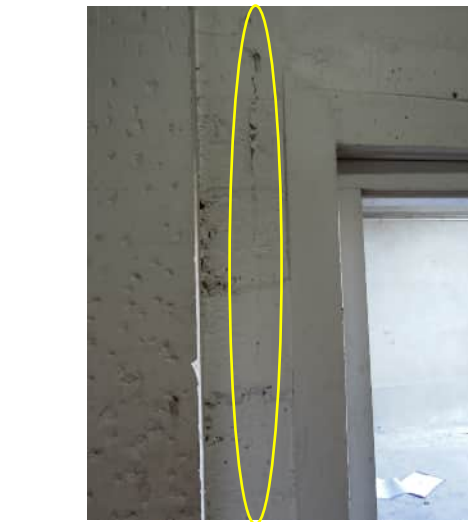
0.67 VERTICAL FULL HEIGHT CRACK IN CONCRETE WALL PANEL ON INTERIOR FACE
A-500

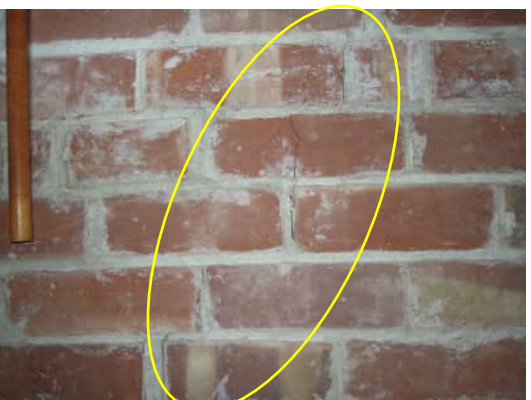
0.68 DIAGONAL STEP CRACKING IN RED BRICK INFILL PANEL
A-500

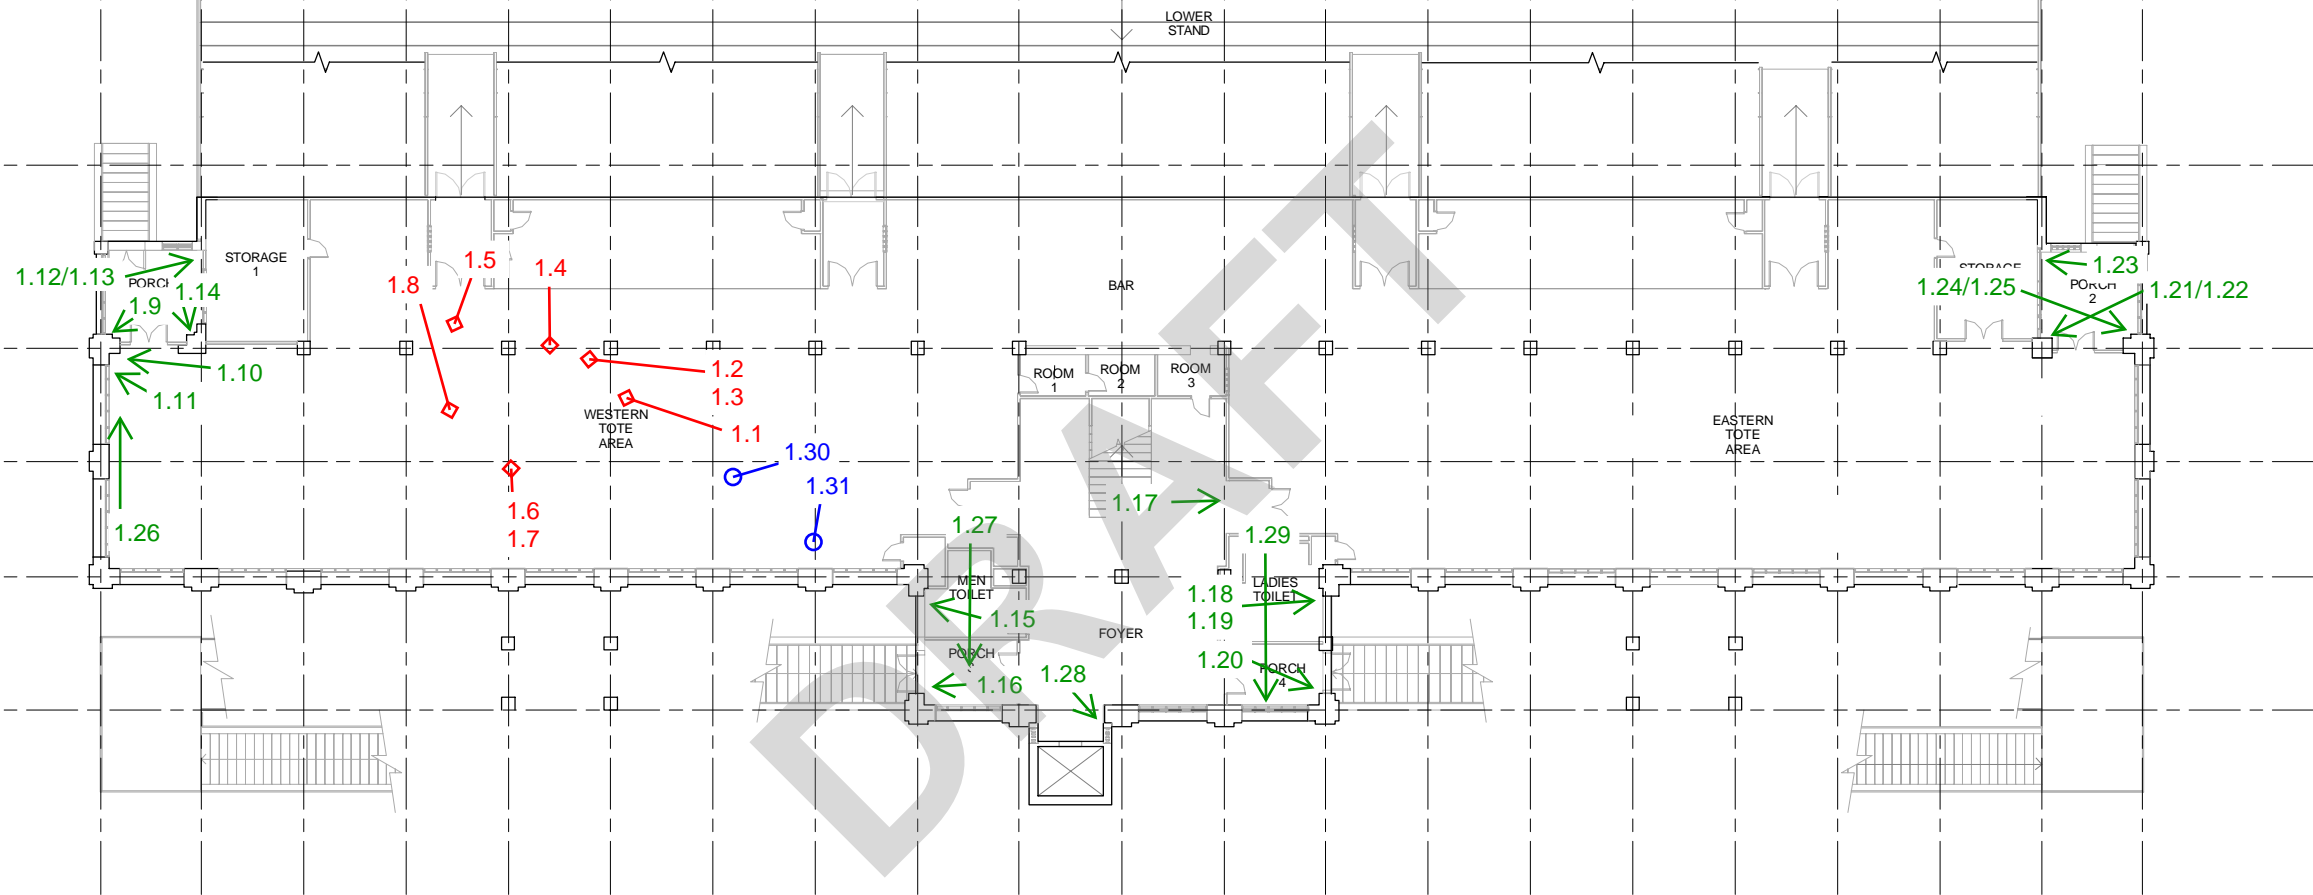
FOR DAMAGE ASSESSMENT OF SLAB AND CEILING SEE DRG-A-402 TO DRG-A-403
 FOR DAMAGE ASSESSMENT OF FRAMES SEE DRG-A-420 TO DRG-A-422

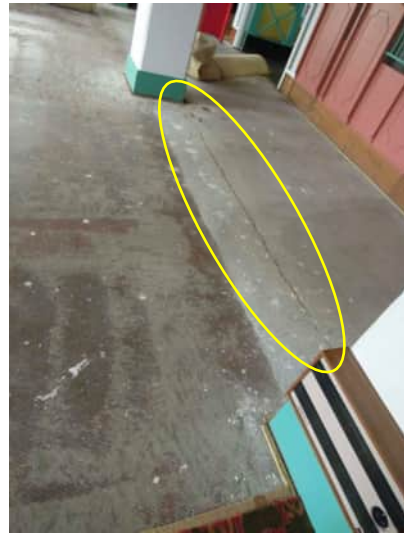
1.2 | LOCATION OF CRACK BETWEEN GRID C COLUMNS
A-510

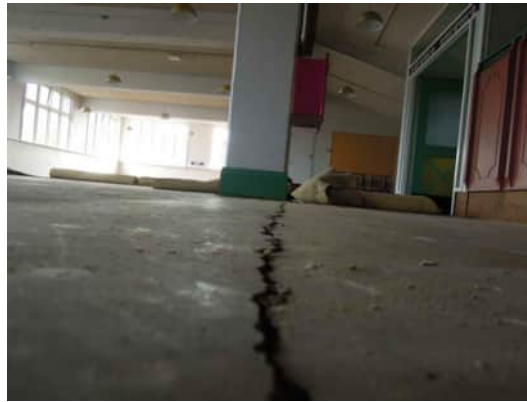
1.3 | CRACK BETWEEN GRID C COLUMNS UP TO 10MM WIDE WITH 5MM VERTICAL DISPLACEMENT
A-510

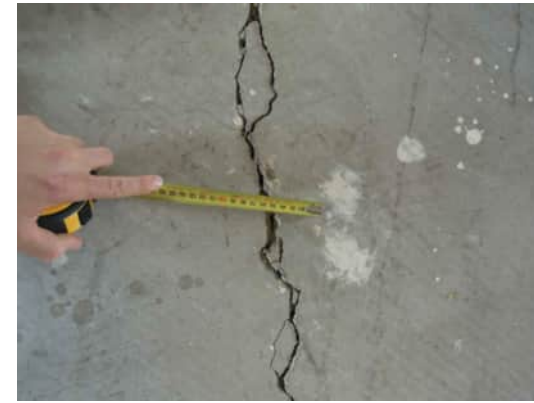
1.4 | SPALLING OF CRACK BETWEEN GRID C COLUMNS
A-510

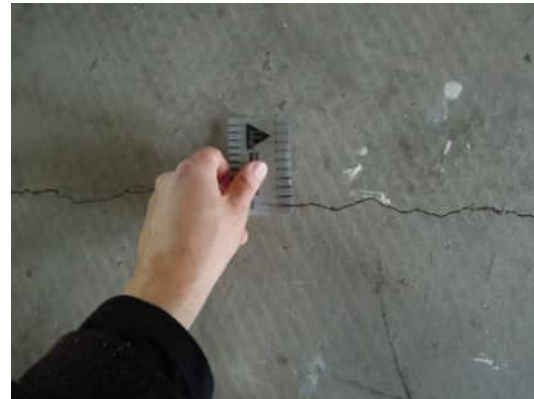
1.5 | CRACK UP TO 1MM PERPENDICULAR TO THE CRACKS BETWEEN GRID C COLUMNS
A-510

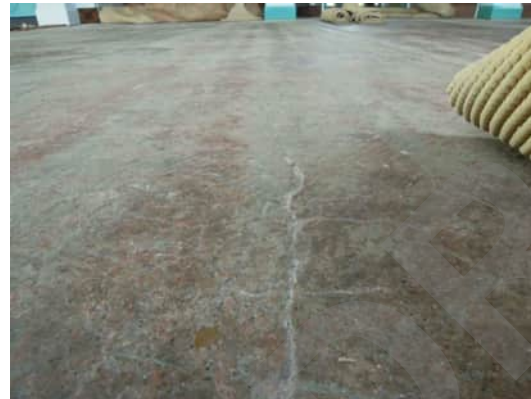
1.6 | TYPICAL CRACK OVER THE CENTRE OF BEAMS RUNNING BETWEEN GRID C AND GRID D
A-510

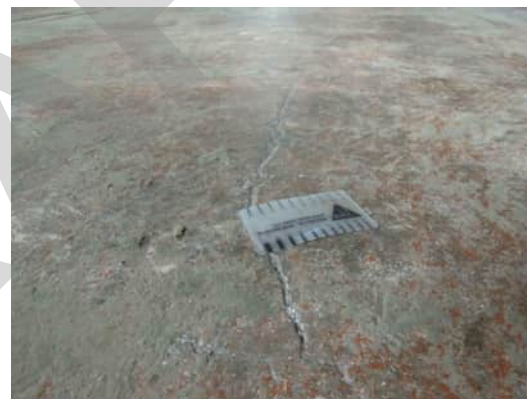
1.7 | CRACKS ARE UP TO 5MM ON THE SURFACE
A-510

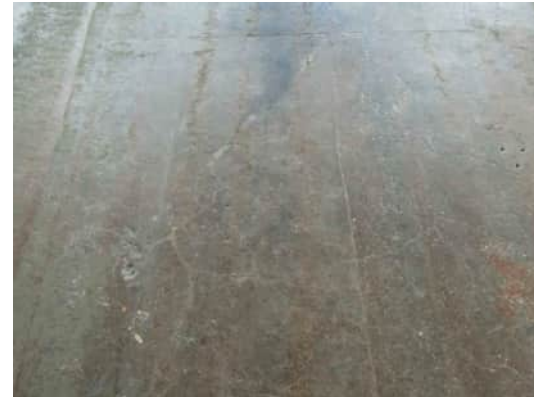
1.8 | CRAZED CRACK PATTERN ON SLAB BETWEEN GRID 4 AND 5
A-510

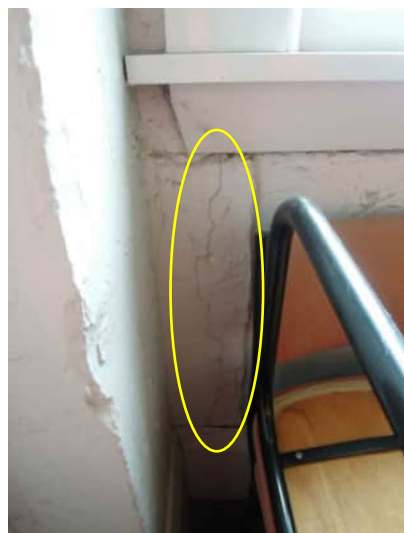
1.9 | 0.9MM VERTICAL CRACK FROM BOTTOM OF WINDOW IN GRID C COLUMN
A-510

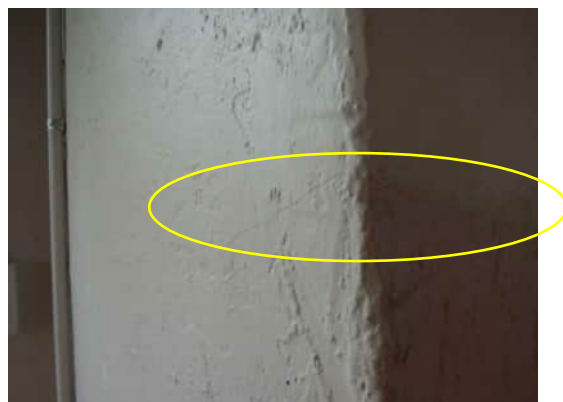
1.10 | HAIRLINE HORIZONTAL CRACK AROUND COLUMN AT MID HEIGHT
A-510

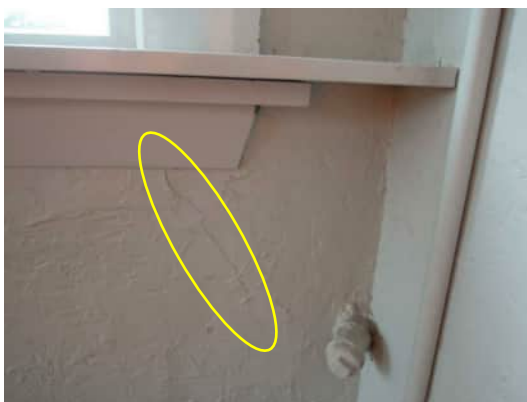
1.11 | 0.3MM DIAGONAL CRACK FROM BOTTOM OF WINDOW IN GRID C COLUMN
A-510

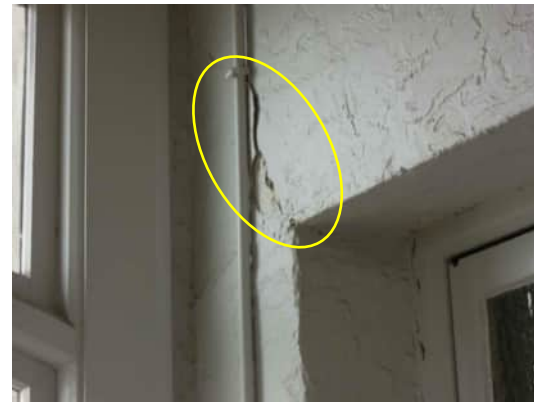
1.12 | DIAGONAL CRACK FROM TOP CORNER OF WINDOW IN WALL BETWEEN GRID B AND C
A-510

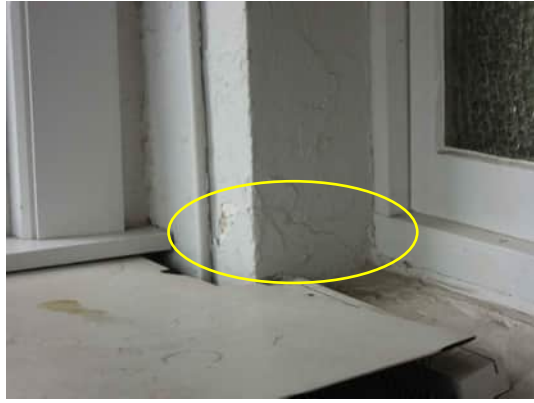
1.13 | CRACK FROM BOTTOM CORNER OF WINDOW
IN WALL BETWEEN GRID B AND C
A-510

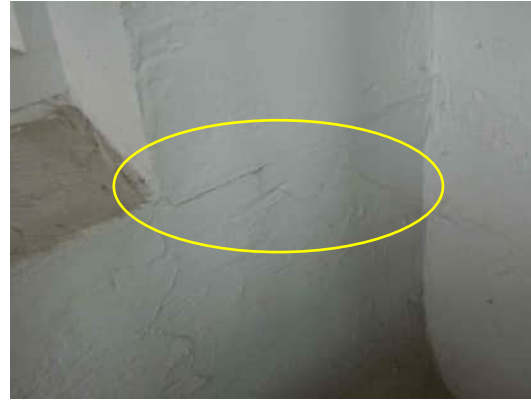
1.14 | CRACK FROM BOTTOM CORNER OF WINDOW
IN GRID C COLUMN
A-510

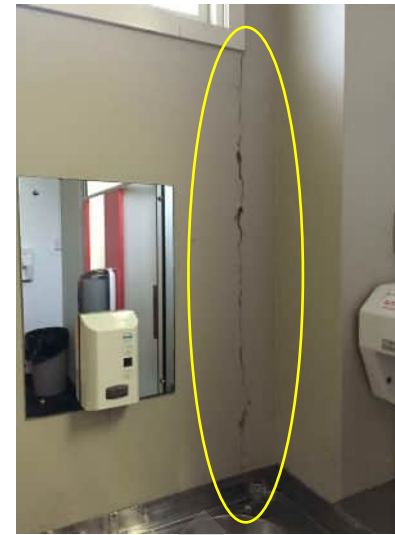
1.15 | CRACK BETWEEN GRID D COLUMN AND WALL 2-3MM
WIDE WITH SPALLING UP TO 25MM ON SURFACE
A-510

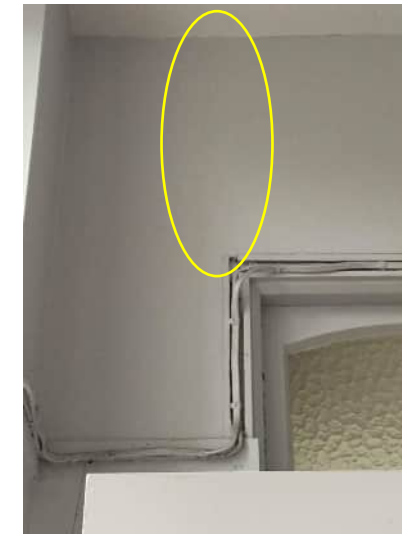
1.16 | CRACK IN GRID E COLUMN ABOVE WINDOW FRAME
A-510

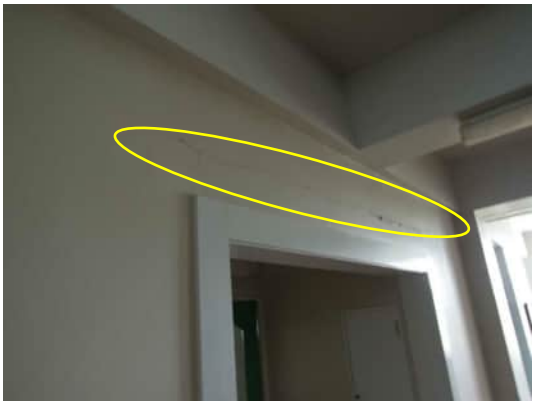
1.17 | HORIZONTAL CRACK ALONG WALL BELOW THE BEAM
ABOVE OPENING
A-510

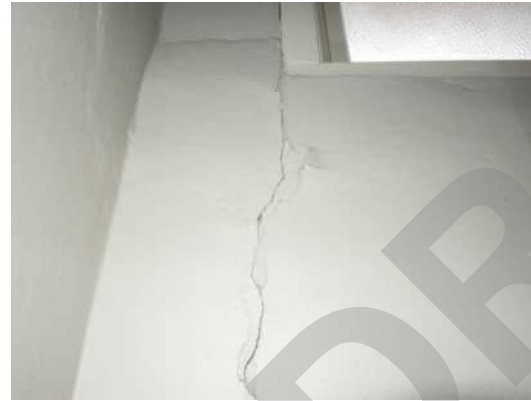
1.18 | 1.6MM VERTICAL CRACK BETWEEN WALL AND COLUMN
AT GRID D
A-510

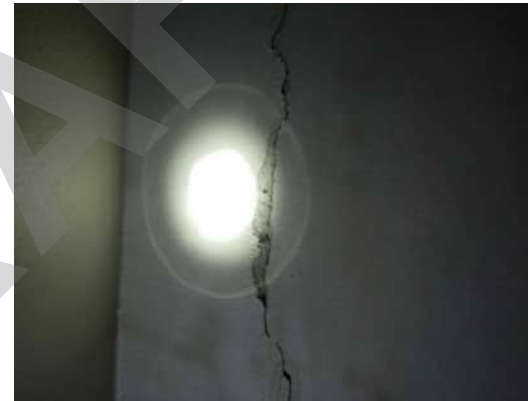
1.19 | SPALLING OF CRACK BETWEEN WALL AND COLUMN AT
GRID D
A-510

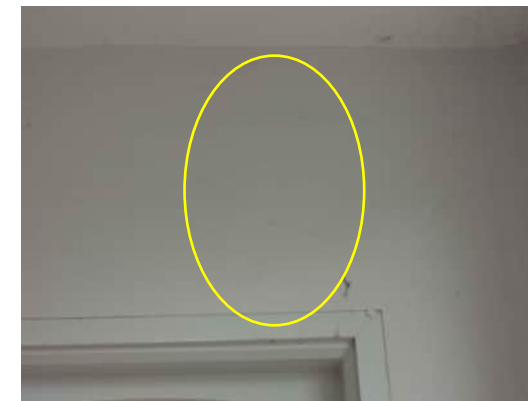
1.20 | CRACK IN WALL NEAR GRID E ABOVE WINDOW FRAME
A-510
