Detailed Damage Evaluation

Quantitative Seismic Analysis of Grand National (Public) Stand

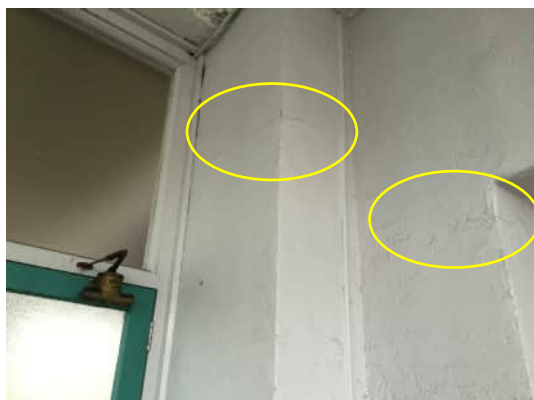
1.21 | HORIZONTAL CRACK IN GRID C COLUMN 0.5m FROM TOP
OF COLUMN. CRACK IN WALL NEAR TOP OF WINDOW FRAME
A-510

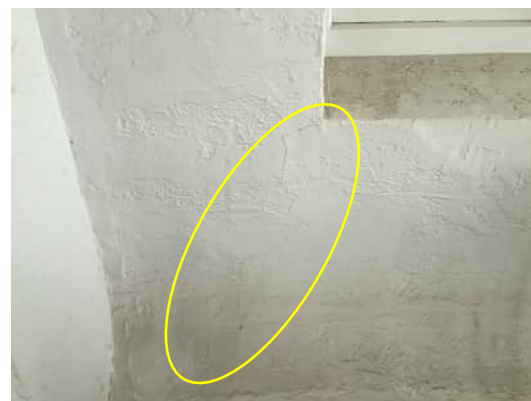
1.22 | DIAGONAL CRACK FROM BOTTOM CORNER OF WINDOW
IN GRID C COLUMN
A-510

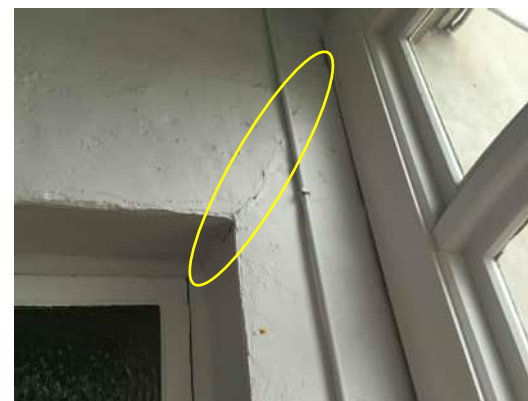
1.23 | DIAGONAL CRACK FROM TOP CORNER OF WINDOW IN
WALL BETWEEN GRID B AND C
A-510

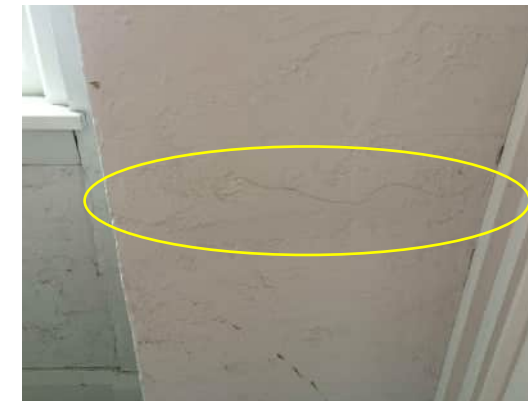
1.24 | HORIZONTAL CRACK AROUND GRID C COLUMN 1m
FROM FLOOR
A-510

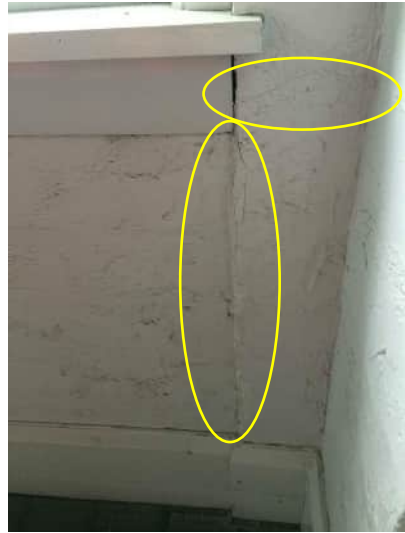
1.25 | CRACK IN CORNER OF GRID C COLUMN BELOW WINDOW
A-510

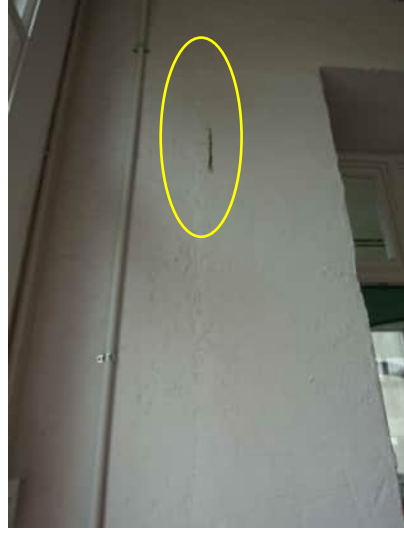
1.26 | DAMAGE TO SURFACE BETWEEN GRID 1 COLUMN AND CONCRETE DOOR FRAME
A-510

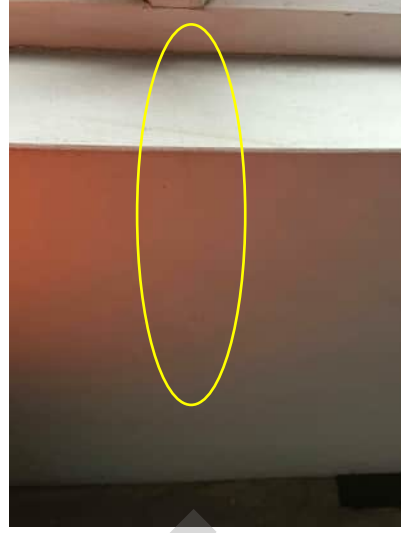
1.27 | HAIRLINE VERTICAL CRACK BELOW WINDOW BETWEEN GRID 9 AND 10
A-510

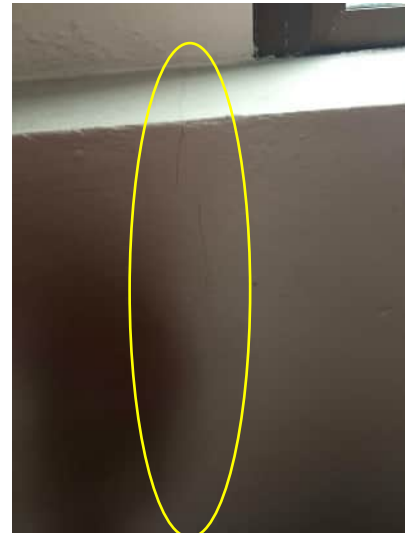
1.28 | VERTICAL CRACK UP TO 0.2mm BELOW WINDOW AT GRID 11 IN LIFT SHAFT EXTENSION
A-510

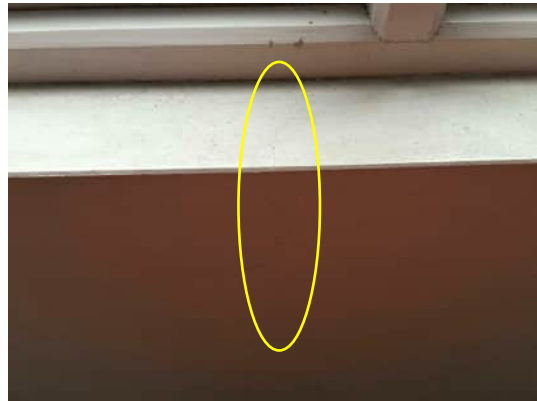
1.29 | HAIRLINE VERTICAL CRACK BELOW WINDOW BETWEEN GRID 12 AND 13
A-510

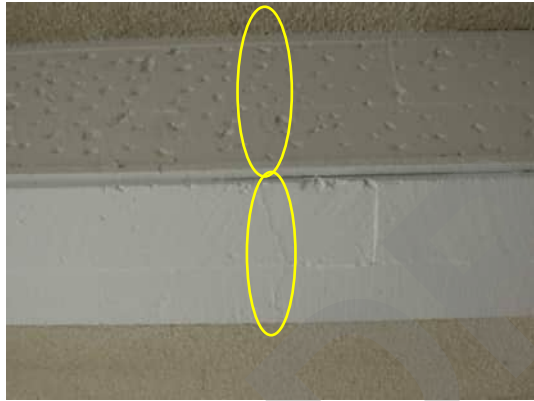
1.30 | EXAMPLE OF A TYPICAL VERTICAL CRACK ON THE BOTTOM AND SIDES OF BEAMS
A-510

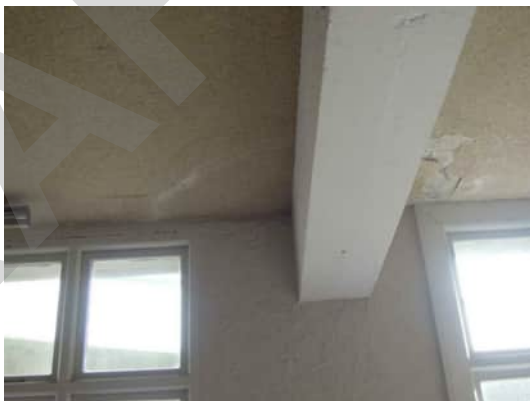
1.31 | TYPICAL MOISTURE DAMAGE TO CEILING AT BEAM COLUMN JOINTS ALONG GRID D
A-510

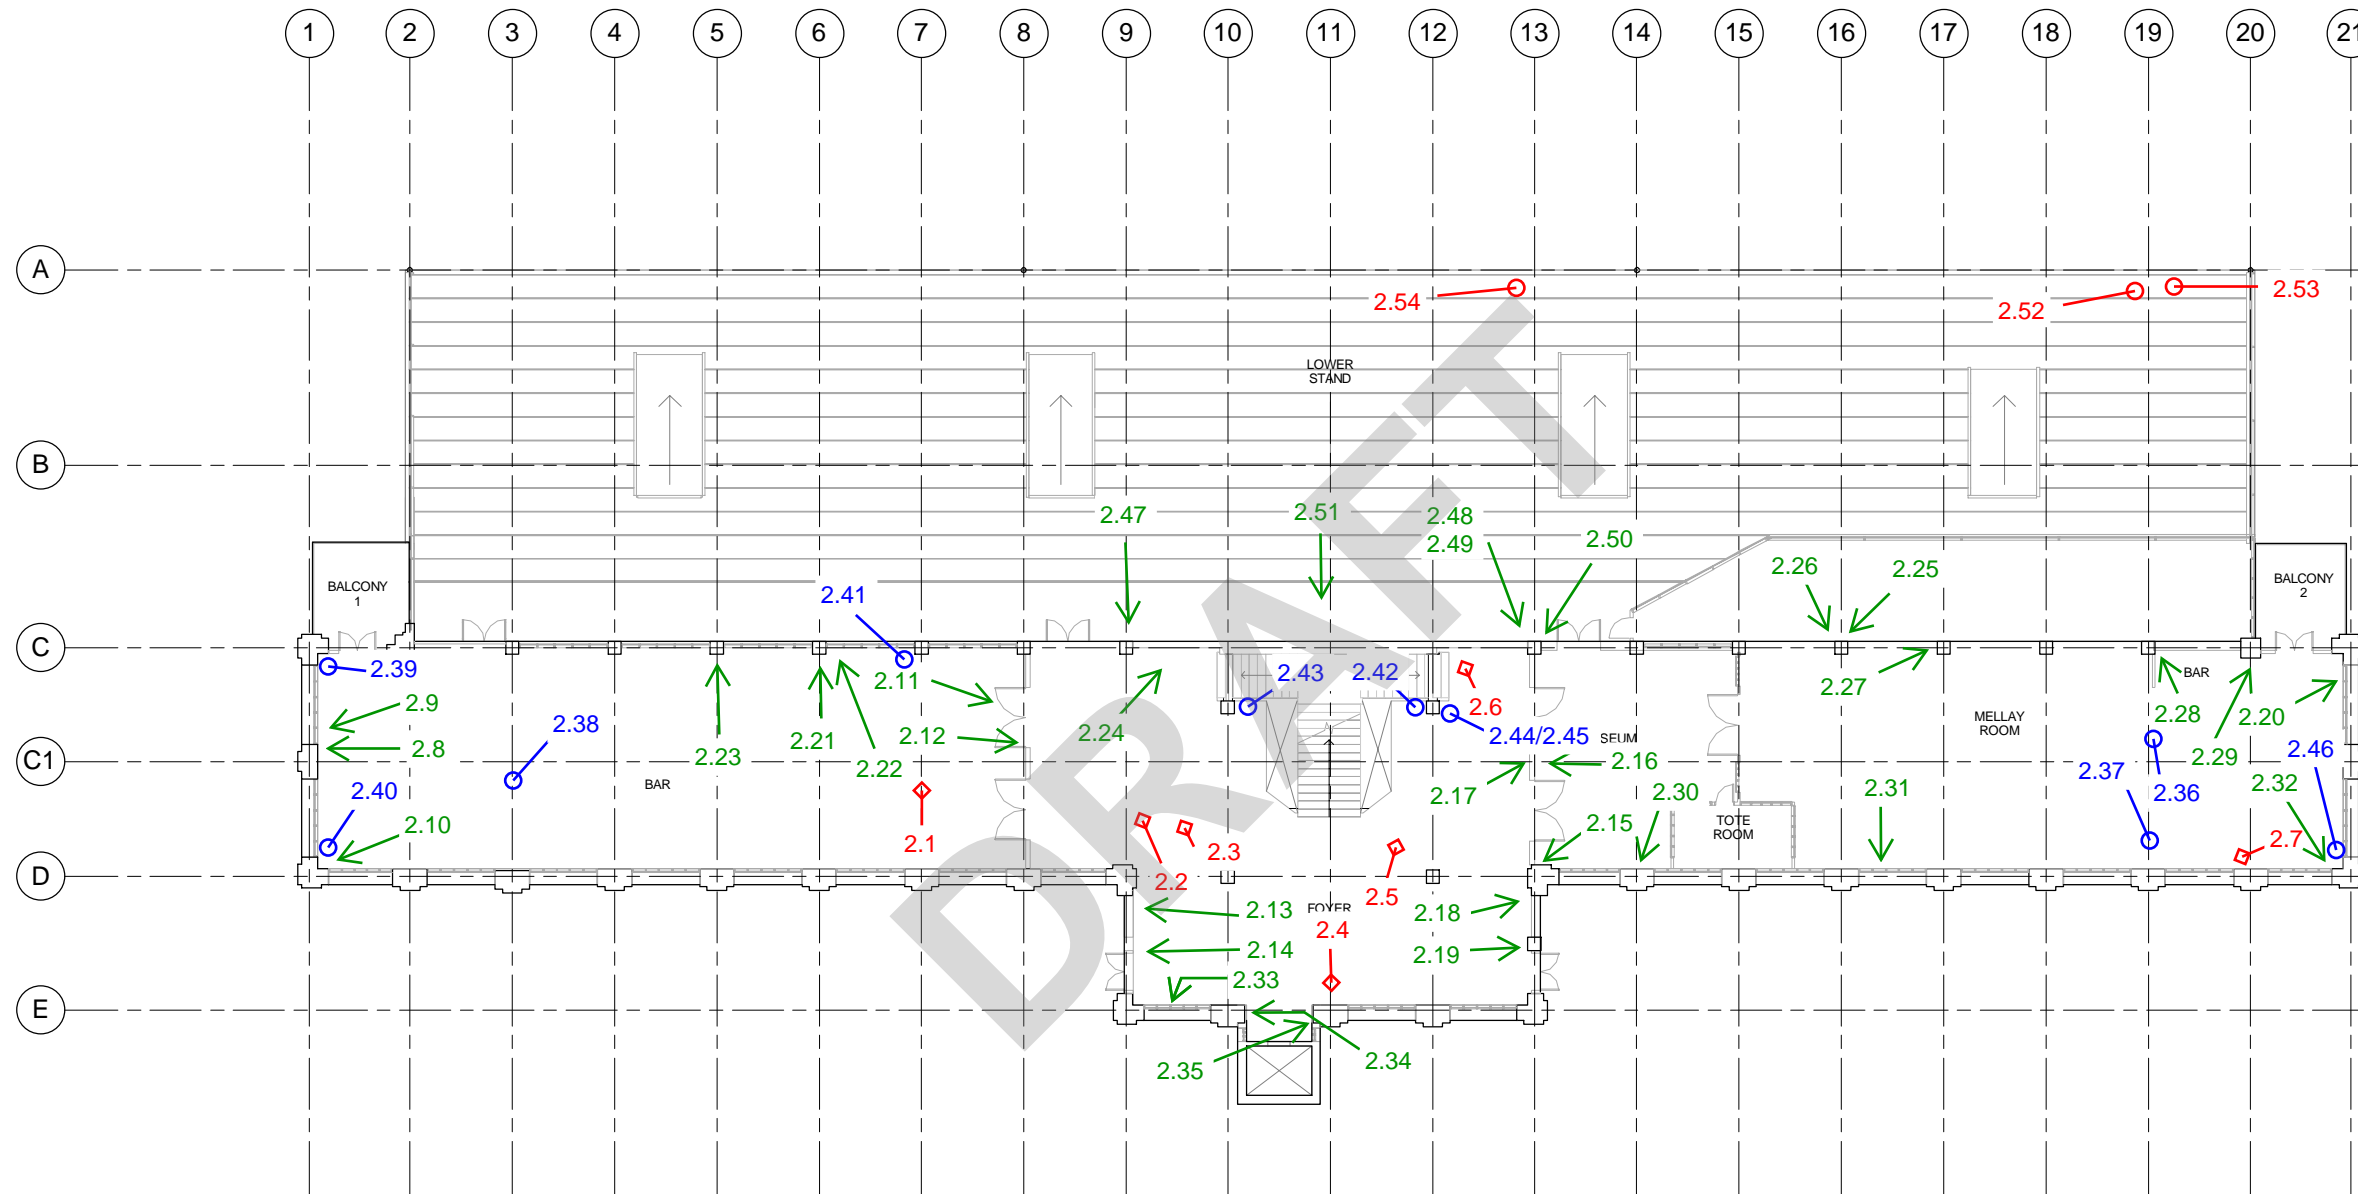
FOR DAMAGE ASSESSMENT OF SLAB AND CEILING SEE DRG-A-404 TO DRG-A-405
FOR DAMAGE ASSESSMENT OF FRAMES SEE DRG-A-420 TO DRG-A-422

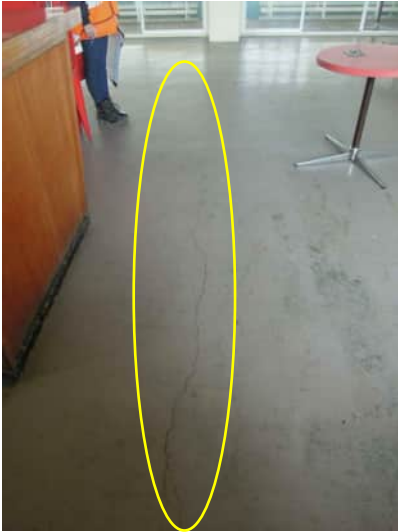
2.1 | TYPICAL CRACK ABOVE BEAM ON GRID 7, UP TO 1.6MM
A-520 | TYPICAL FOR GRIDS 2-12

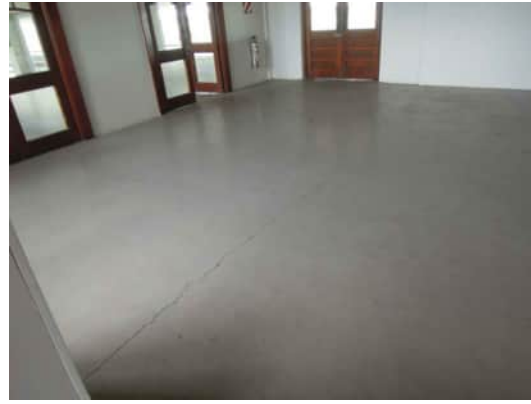
2.2 | CRACK ABOVE BEAM ON GRID 9, UP TO 10MM
A-520

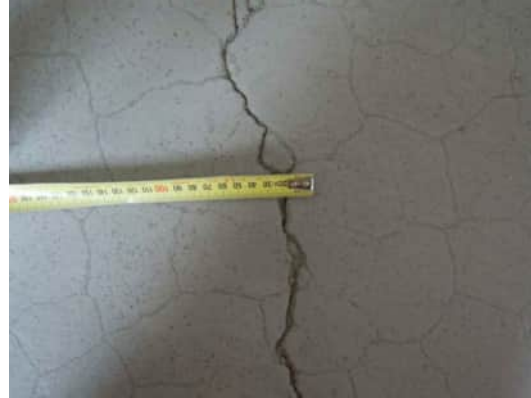
2.3 | CRACK RUNNING DIAGONALLY ACROSS SLAB, UP TO 10MM
A-520

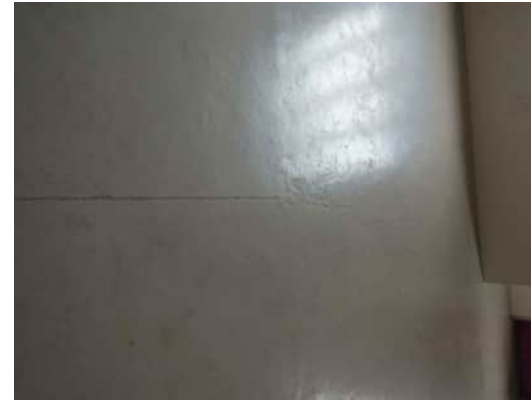
2.4 | CRACK ABOVE BEAM AT CONSTRUCTION JOINT UP TO 2.5MM
A-520

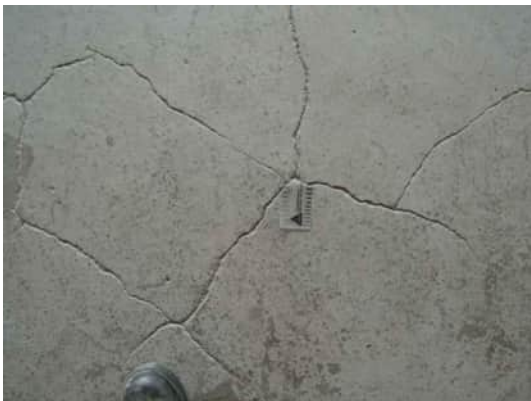
2.5 | CRACKING TO SLAB UP TO 5MM
A-520

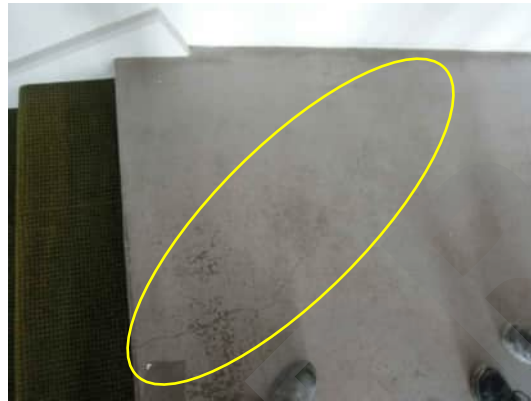
2.6 | CRACK AT TOP OF STAIRS UP TO 1.6MM
A-520

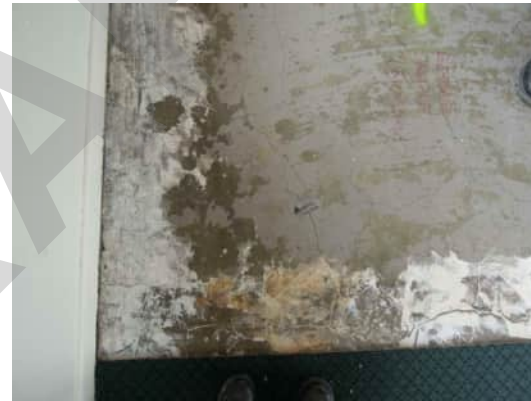
2.7 | PARTIALLY FILLED CRACKS ON SLAB, UP TO 0.8MM
A-520

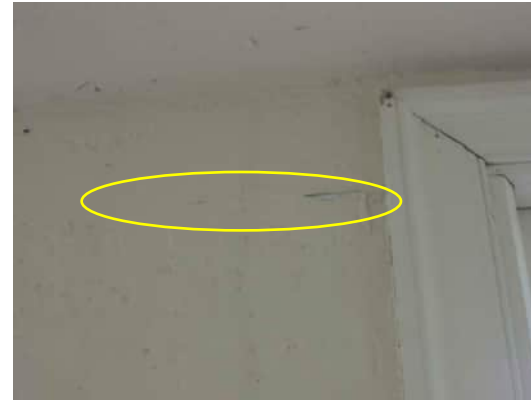
2.8 | CRACK NEAR TOP OF WINDOW ON COLUMN BETWEEN GRID C AND GRID D
A-520

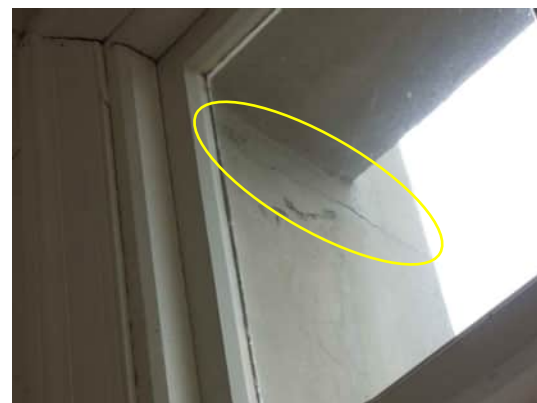
2.9 | CRACK NEAR TOP OF WINDOW ON COLUMN BETWEEN GRID C AND GRID D CONTINUES TO EXTERIOR
A-520

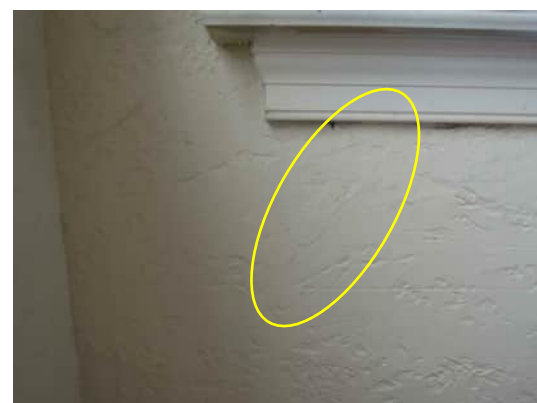
2.10 | 0.1MM DIAGONAL CRACK FROM BOTTOM OF WINDOW AT GRID D
A-520

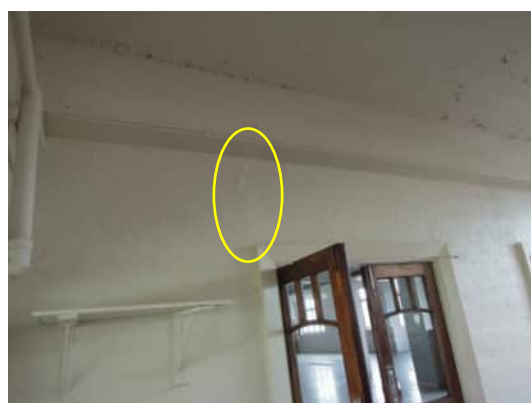
2.11 | CRACKS ABOVE DOOR FRAME IN WALL ALONG GRID 8 BETWEEN GRID C AND GRID D
A-520

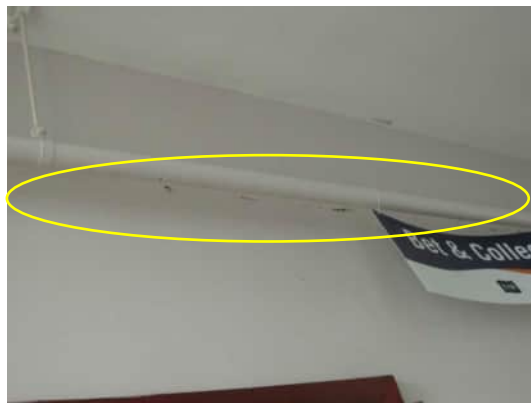
2.12 | SEPARATION BETWEEN WALL AND BEAM BETWEEN GRID C AND GRID D
A-520

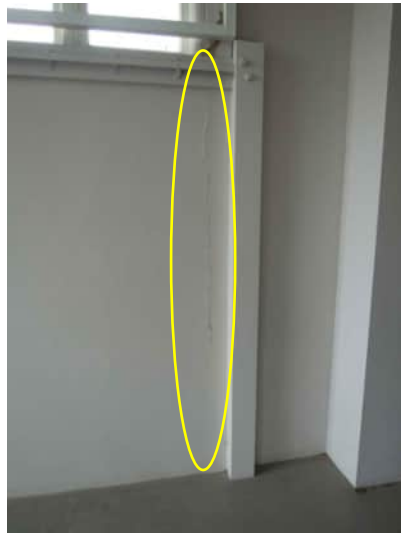
2.13 | VERTICAL CRACK BETWEEN GRID D COLUMN AND WALL
A-520 | AVERAGE 2MM, UP TO 3.5MM

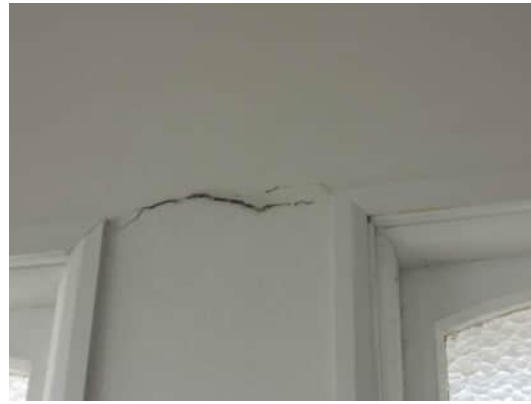
2.14 | SIGNIFICANT HORIZONTAL CRACK WITH SPALLING ON WALL
A-520 | BETWEEN WINDOWS BETWEEN GRID D AND GRID E

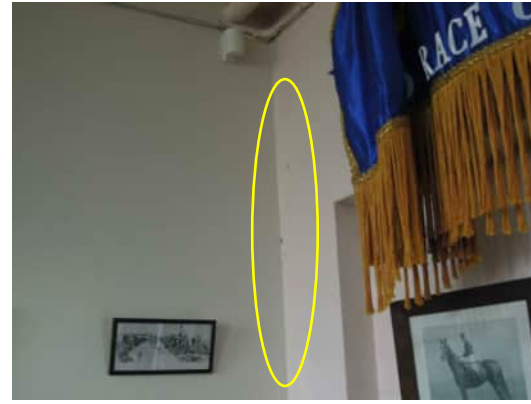
2.15 | SEPARATION BETWEEN GRID D COLUMN AND WALL
A-520

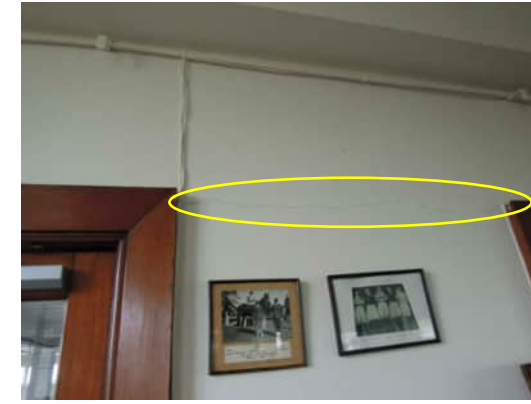
2.16 | CRACK IN WALL BETWEEN GRID C AND GRID D,
A-520 | BETWEEN DOOR FRAMES

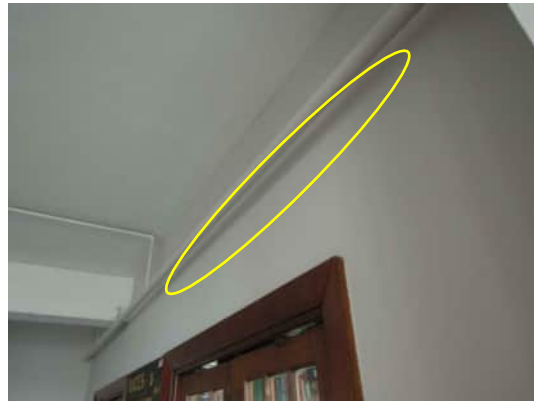
2.17 | SEPARATION BETWEEN WALL AND BEAM BETWEEN
A-520 | GRID C AND GRID D

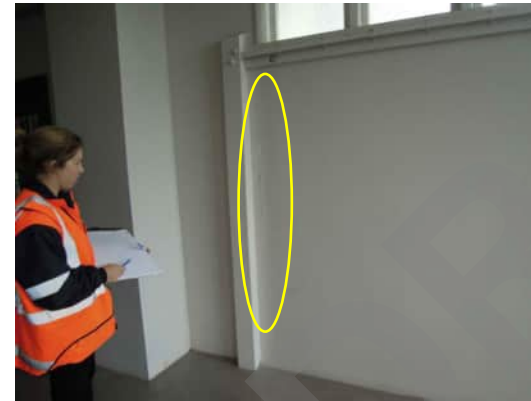
2.18 | 0.7MM VERTICAL CRACK BETWEEN GRID D COLUMN AND
A-520 | WALL

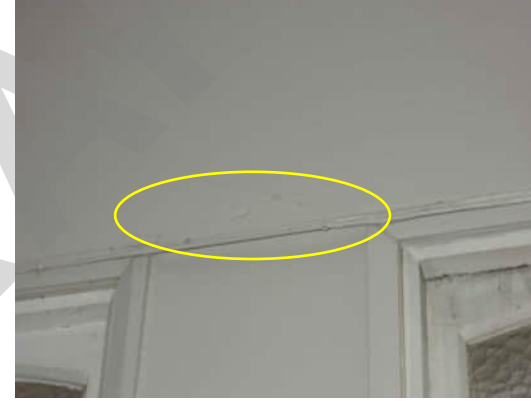
2.19 | CRACK BETWEEN WINDOWS BETWEEN GRID D AND
A-520 | GRID E

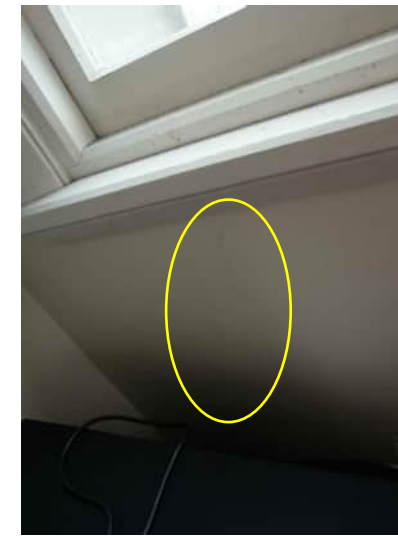
2.20 | HAIRLINE DIAGONAL CRACK BELOW WINDOW NEXT TO
A-520 | GRID C COLUMN

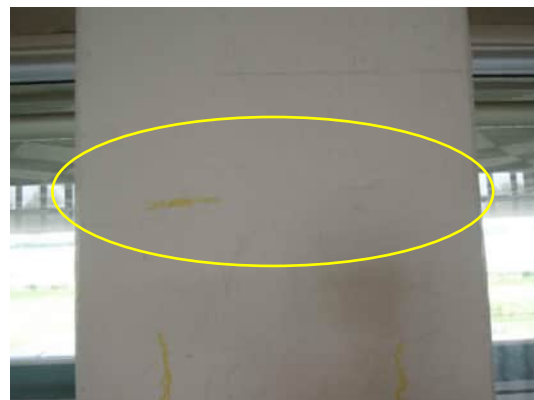
2.21 | HAIRLINE CRACK AROUND GRID 6 COLUMN
A-520 | (GRID 3, 14 AND 15 COLUMNS SIMILAR)

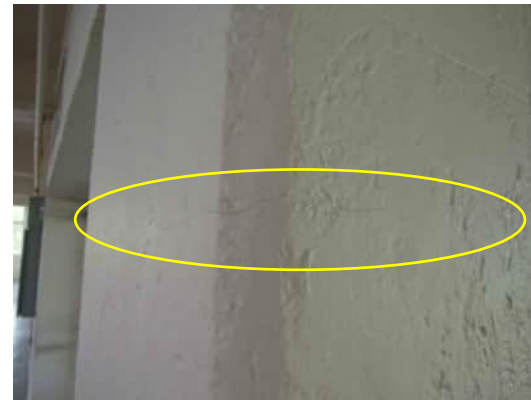
2.22 | HAIRLINE CRACK CONTINUES AROUND GRID 6 COLUMN
A-520 | (GRID 3, 14 AND 15 COLUMNS SIMILAR)

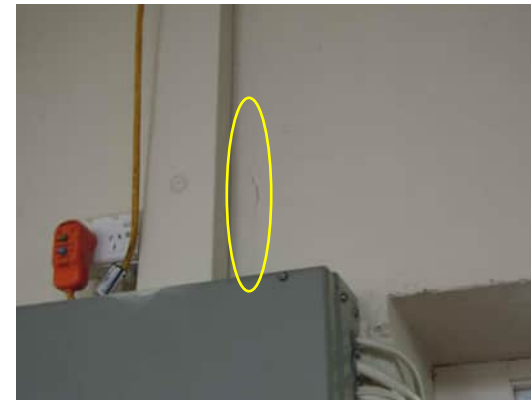
2.23 | VERTICAL CRACK IN BEAM ABOVE GRID 5 COLUMN
A-520

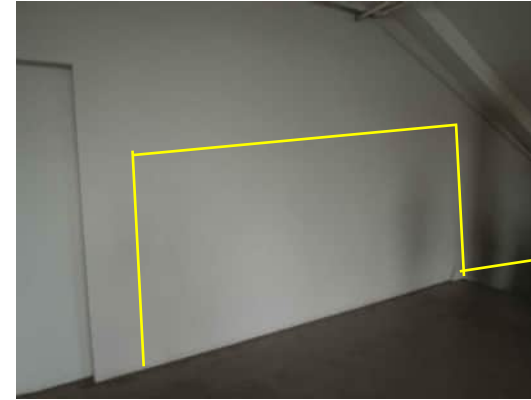
2.24 | 0.3-0.4mm CRACK IN SHEAR WALL AT LOCATION WHERE
A-520 | WALL THICKENS, BETWEEN GRID 8-9 (GRID 12-13 SIMILAR)

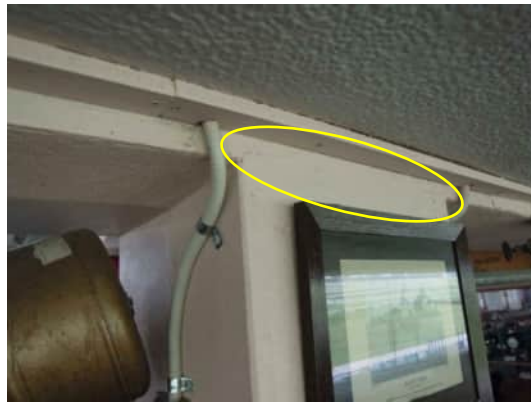
2.25 | CRACK IN BEAM COLUMN JOINT AT GRID 16
A-520

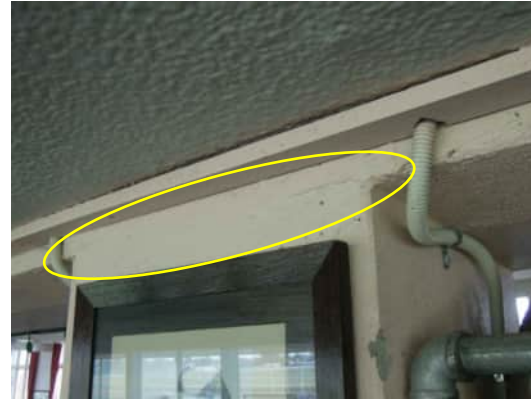
2.26 | CRACK IN BEAM COLUMN JOINT AT GRID 16
A-520

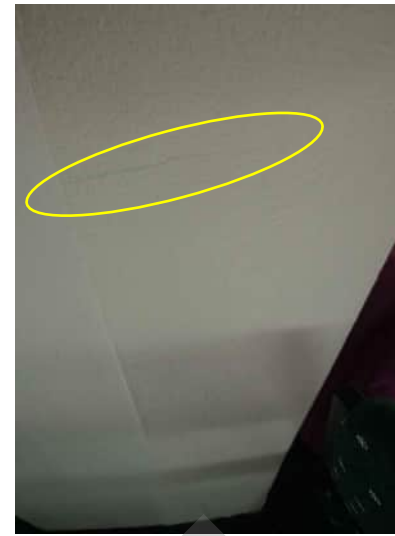
2.27 | MULTIPLE HAIRLINE HORIZONTAL CRACKS DOWN SIDE
OF COLUMN ON GRID 16 (GRID 17 SIMILAR)
A-520

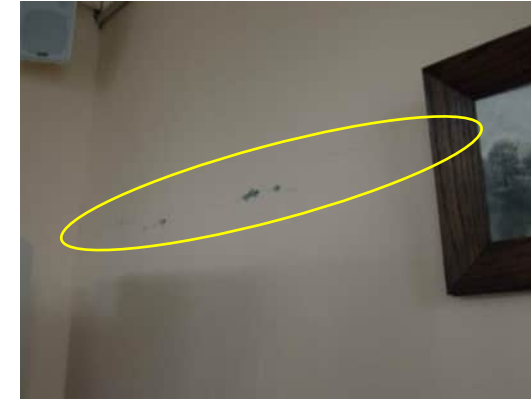
2.28 | CRACK BETWEEN BEAM AND WALL BETWEEN GRID 19
AND 20
A-520

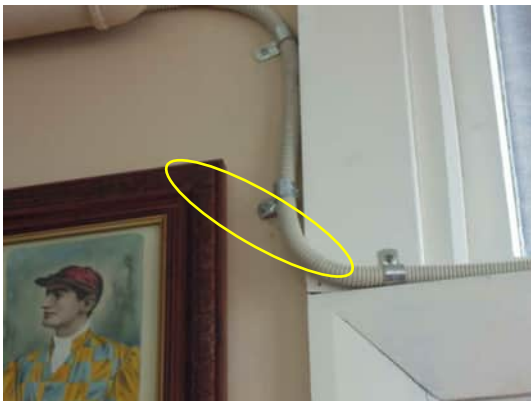
2.29 | DIAGONAL CRACK FROM CORNER OF WINDOW IN GRID
20 COLUMN
A-520

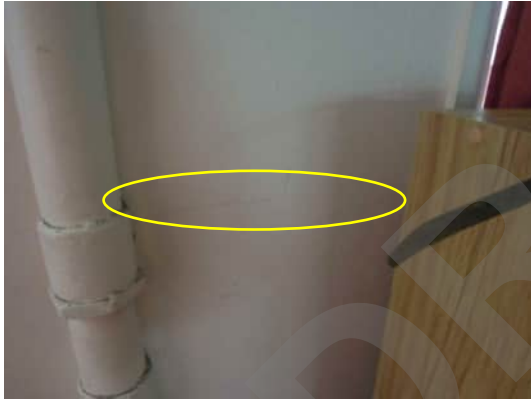
2.30 | HORIZONTAL HAIRLINE CRACK IN COLUMN AT GRID 14
(GRID 8, 17 AND 19 SIMILAR)
A-520

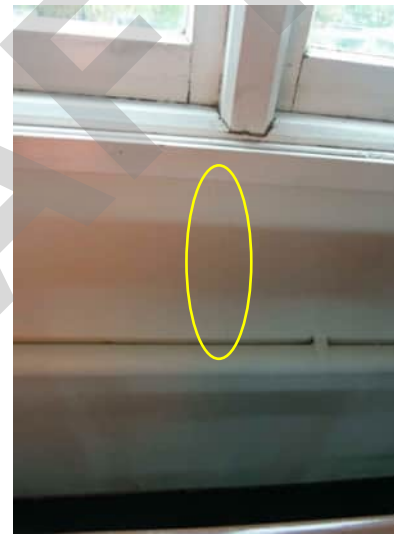
2.31 | 0.1-0.2mm WIDE VERTICAL CRACK BELOW WINDOW
BETWEEN GRID 16 AND 17
A-520

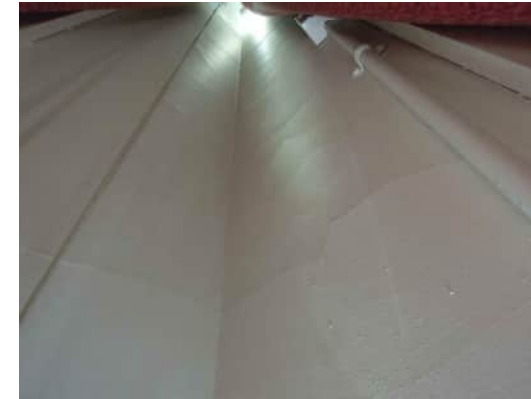
2.32 | CRAZED CRACKS UP WHOLE HEIGHT OF COLUMN
AT GRID 21
A-520

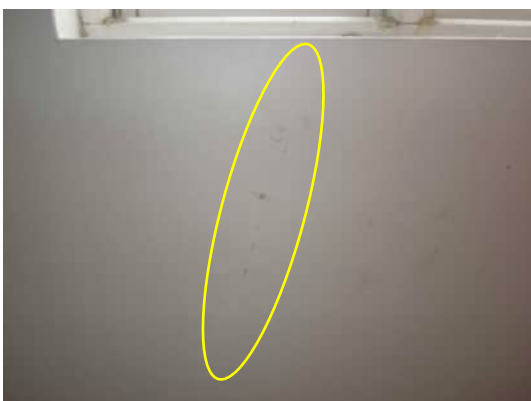
2.33 | HAIRLINE DIAGONAL CRACK BELOW WINDOW BETWEEN
GRID 9 AND 10 WITH SOME MOISTURE SEEPAGE
A-520

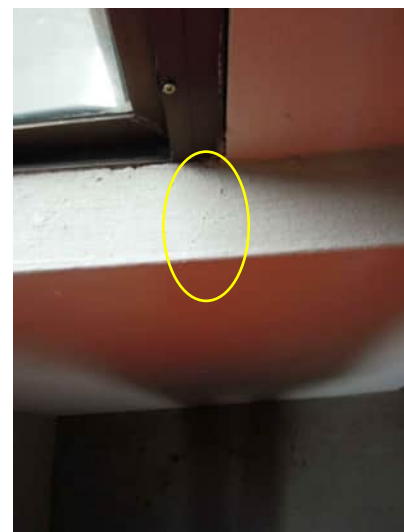
2.34 | HAIRLINE CRACK BELOW WINDOW IN LIFT SHAFT WALL
ON GRID 10
A-520

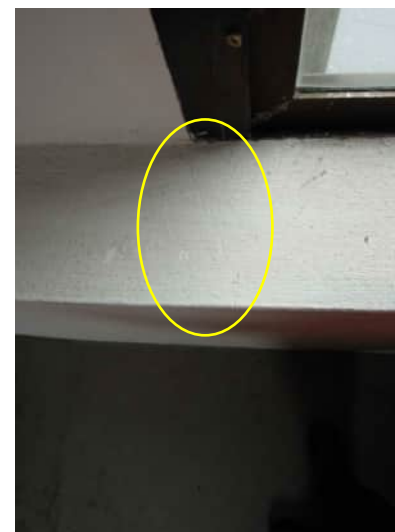
2.35 | HAIRLINE CRACK BELOW WINDOW IN LIFT SHAFT WALL
ON GRID 11
A-520

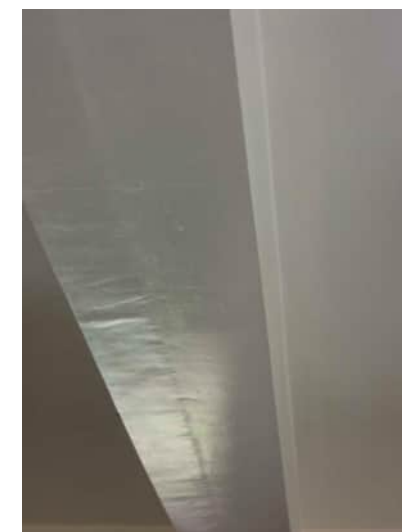
2.36 | TYPICAL CRACKS ALONG LENGTH OF BEAM
A-520

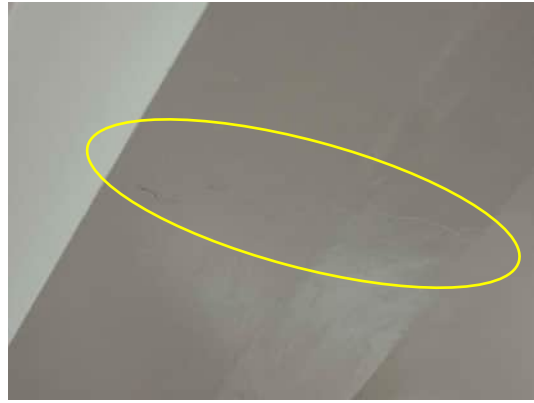
2.37
A-520 | TYPICAL CRACK IN PLASTER FINISH TO BEAM

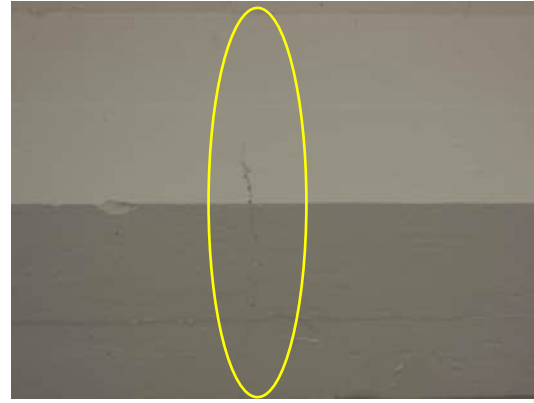
2.38
A-520 | TYPICAL CRACK IN EXPOSED BEAM

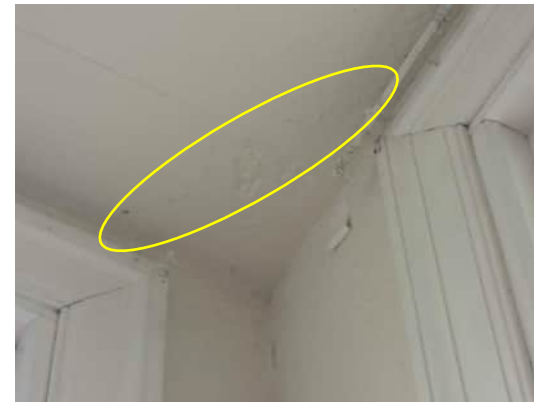
2.39
A-520 | CRACK IN CORNER OF SLAB SOFFIT AT GRID 1/C

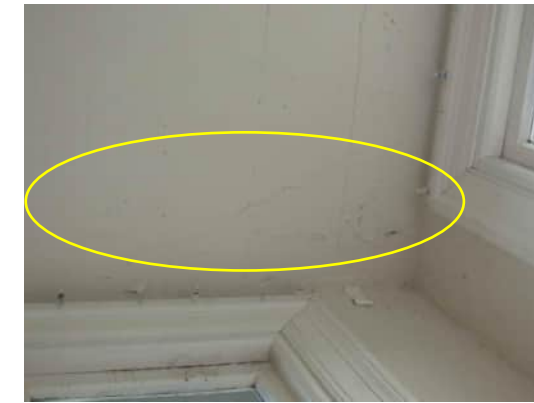
2.40
A-520 | CRACK IN CORNER OF SLAB SOFFIT AT GRID 1/D

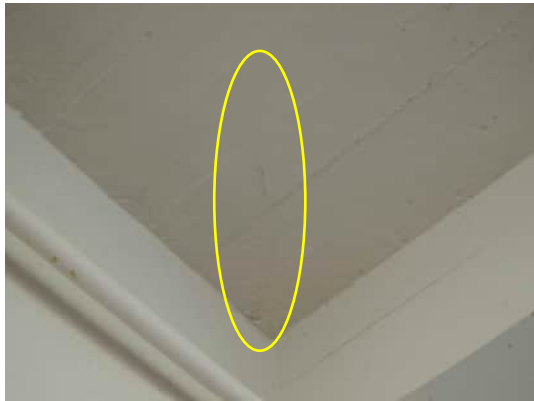
2.41
A-520 | CRACK FROM CORNER OF SLAB SOFFIT AT GRID 7/C

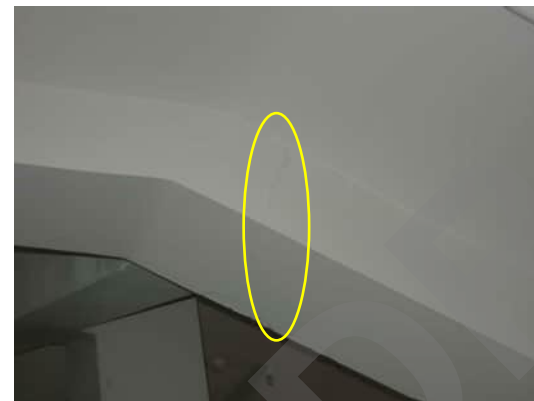
2.42
A-520 | CRACK ON BEAM UNDER STAIRS

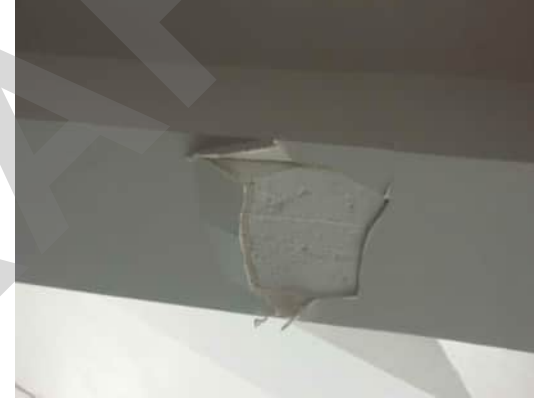
2.43
A-520 | PLASTER BREAKING OFF BEAM UNDERNEATH STAIRS

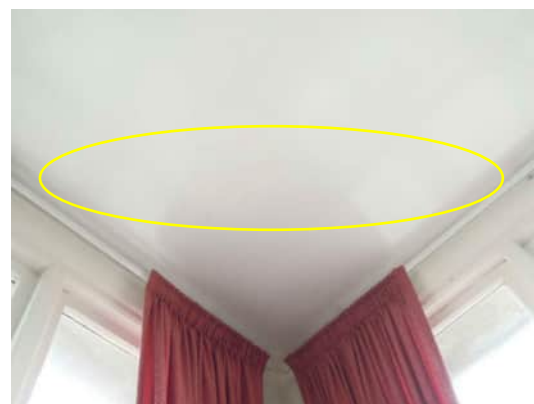
2.46
A-520 | CRACKING TO PLASTER IN CORNER OF SLAB SOFFIT AT GRID 21/D

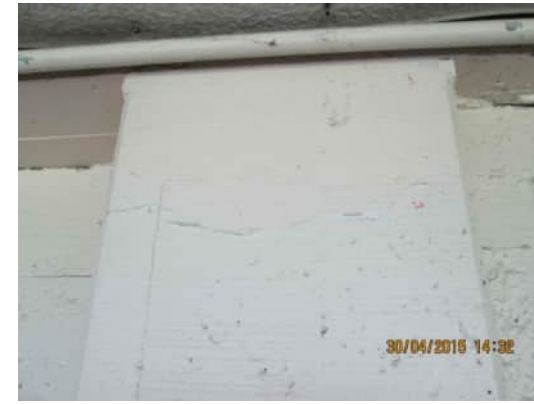
2.47
A-520 | CRACKING TO COLUMN AT GRID 9

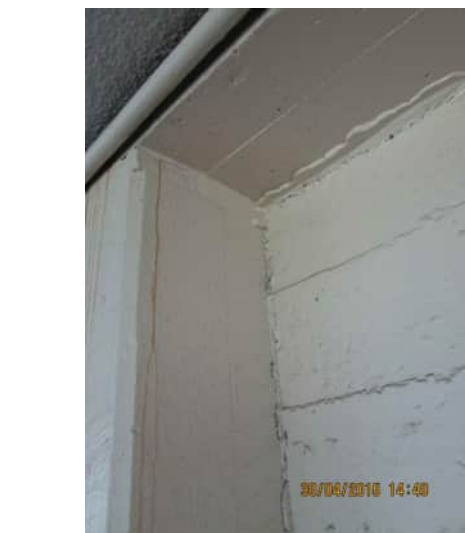
2.48
A-520 | CRACKING TO COLUMN AT GRID 13 AND ADJACENT SHEAR WALL

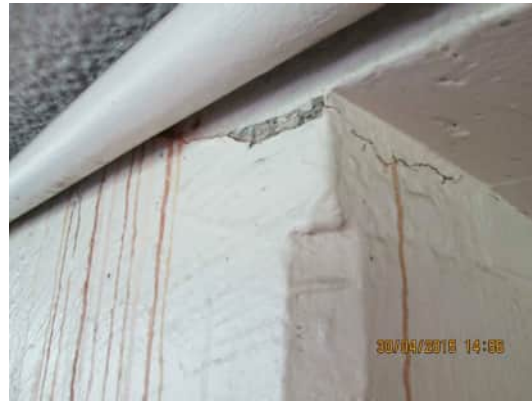
2.49
A-520 | CRACKING TO TOP OF COLUMN AT GRID 13

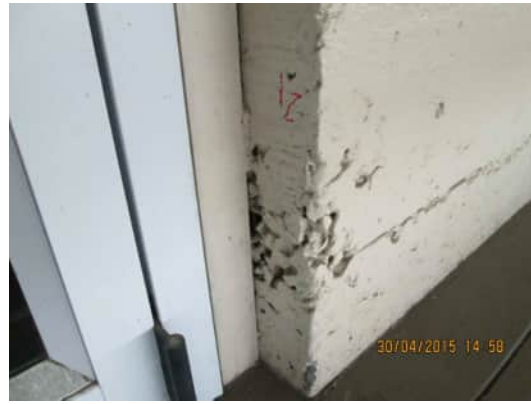
2.50
A-520 | CONCRETE SEGREGATION AT THE BOTTOM OF SHEAR WALL

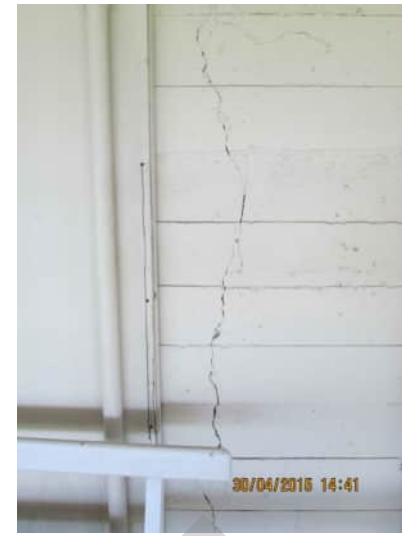
2.51
A-520 | VERTICAL 3.5mm WIDE CRACK TO SHEAR WALL

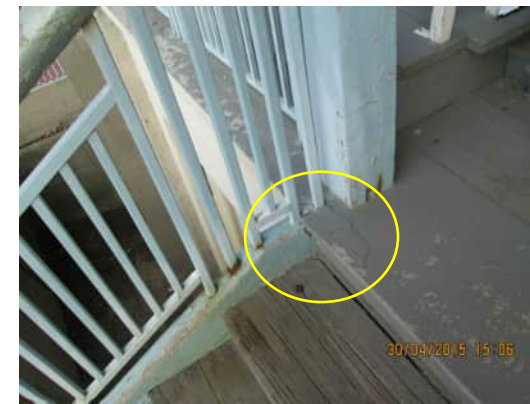
2.52
A-520 | LOWER STAND SLAB EDGE CRACKING

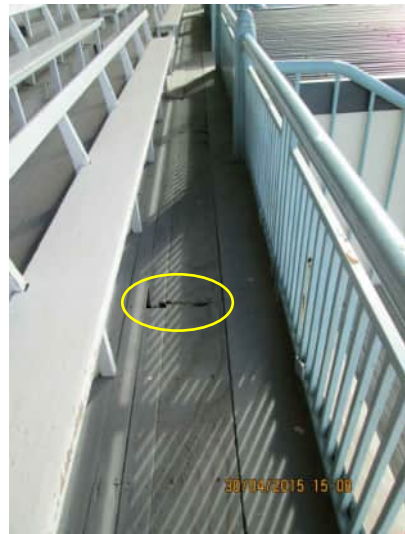
2.53
A-520 | LOWER STAND DAMAGE TO TIMBER DECKING

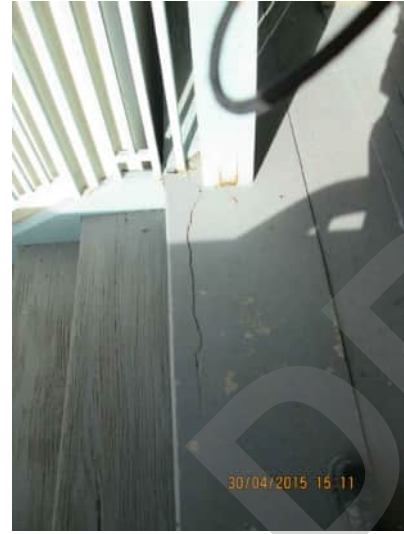
2.54
A-520 | LOWER STAND SLAB EDGE CRACKING

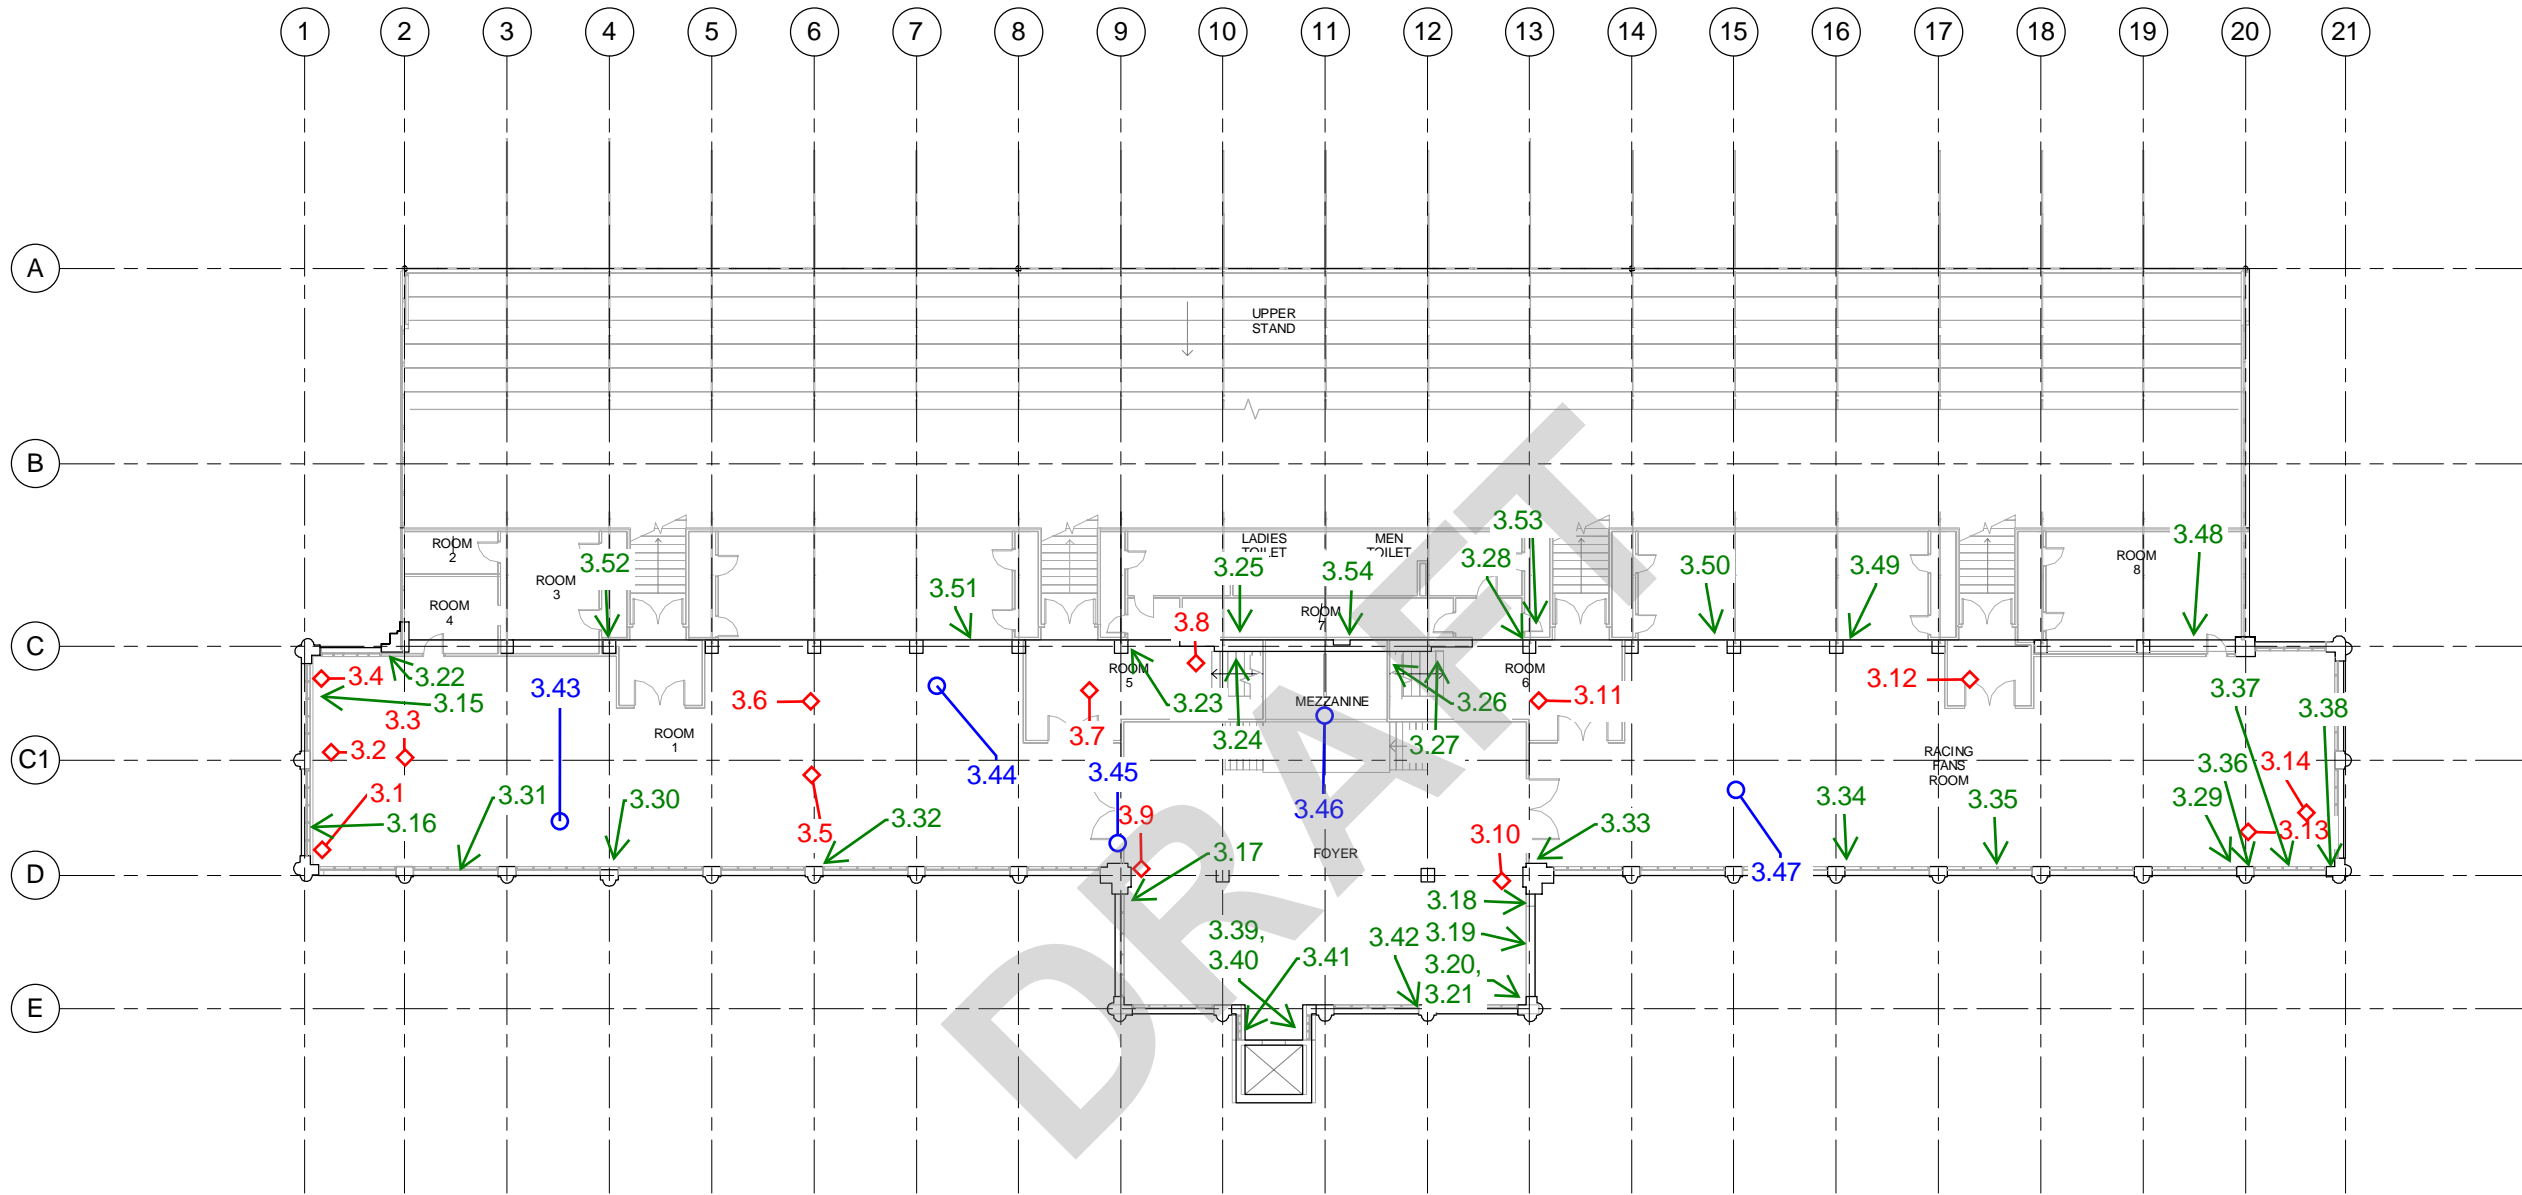
DAMAGE PHOTO KEYPLAN - FLOOR 3

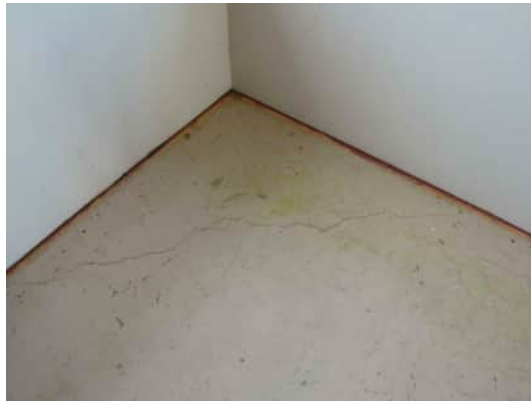
3.1 | DIAGONAL CRACKS AT CORNER OF BUILDING UP TO 3MM
A-530

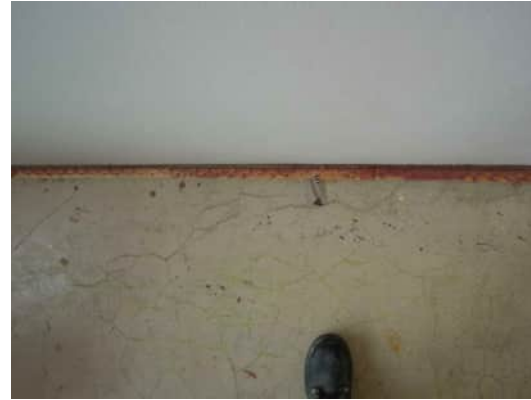
3.2 | CRACK UP TO 0.8MM ALONG GRID 1
A-530

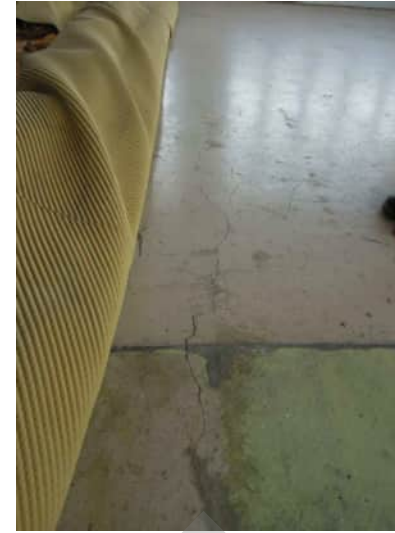
3.3 | CRACK ALONG GRID 2 UP TO 1.8MM WIDE
A-530

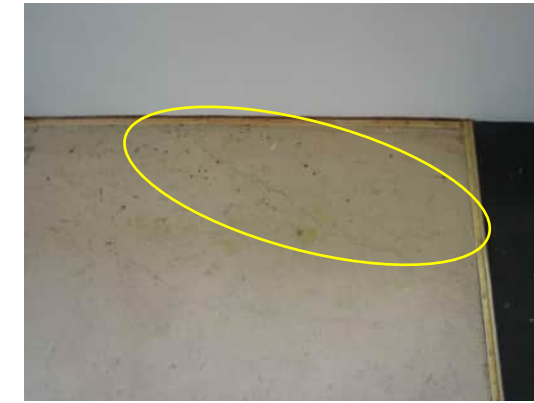
3.4 | DIAGONAL CRACK IN CORNER UP TO 1.2MM
A-530

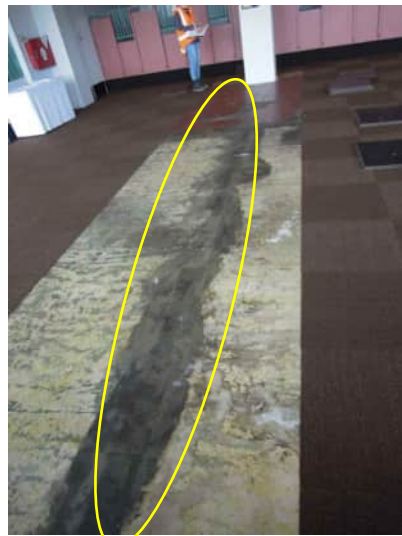
3.5 | CRACK ABOVE GRID 6 BEAM WHICH HAS BEEN PARTIALLY REPAIRED
A-530

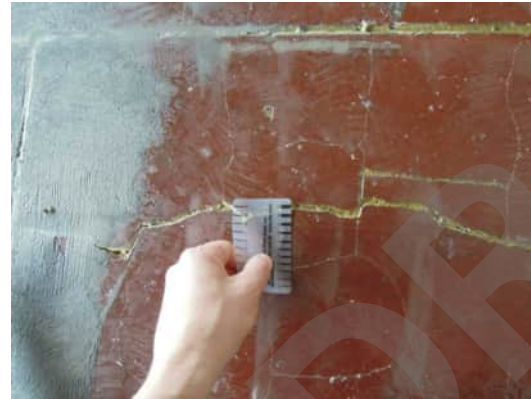
3.6 | CRACK ABOVE GRID 6 BEAM IS UP TO 5MM WIDE
A-530

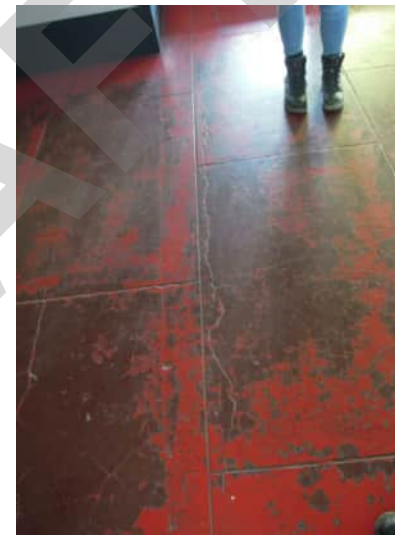
3.7 | CRACK IN COATING, SPALLING UP TO 10MM WIDE AT SURFACE
A-530

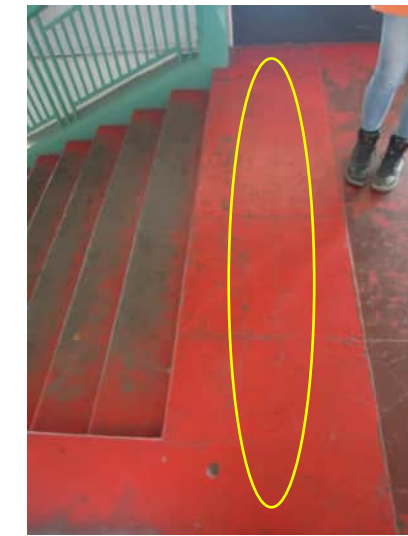
3.8 | CRACK IN COATING ALONG TOP OF STAIRS SPALLING UP TO 10MM WIDE AT SURFACE
A-530

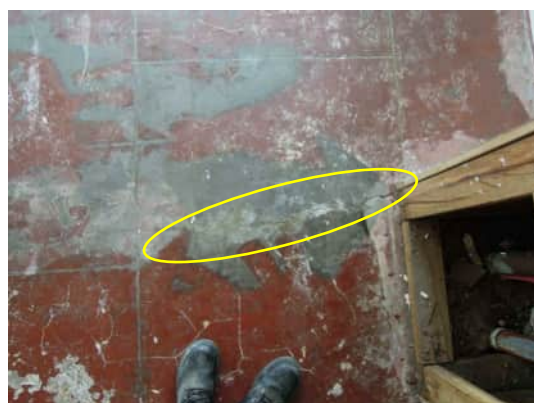
3.9 | CRACK UP TO 5MM WHICH HAS PREVIOUSLY BEEN PARTIALLY REPAIRED
A-530

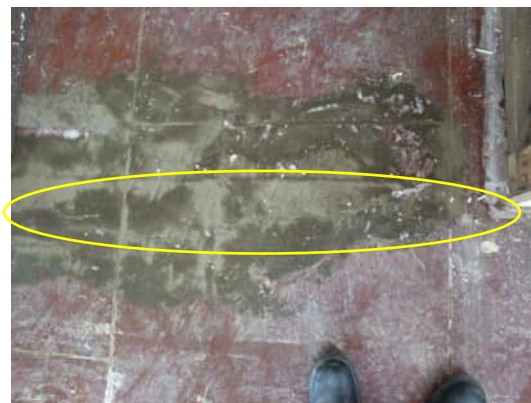
3.10 | CRACK UP TO 2MM WHICH HAS BEEN PREVIOUSLY REPAIRED
A-530

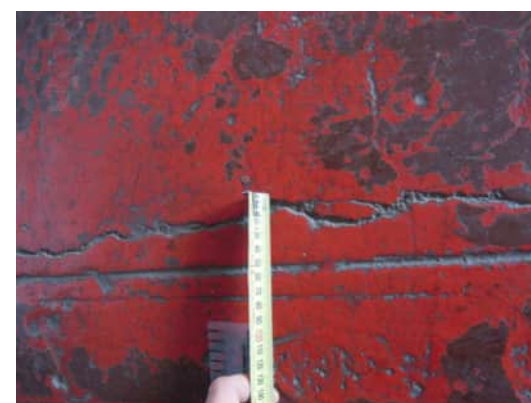
3.11 | CRACK IN COATING SPALLING UP TO 10MM WIDE AT SURFACE
A-530
