Detailed Damage Evaluation

Quantitative Seismic Analysis of Grand National (Public) Stand

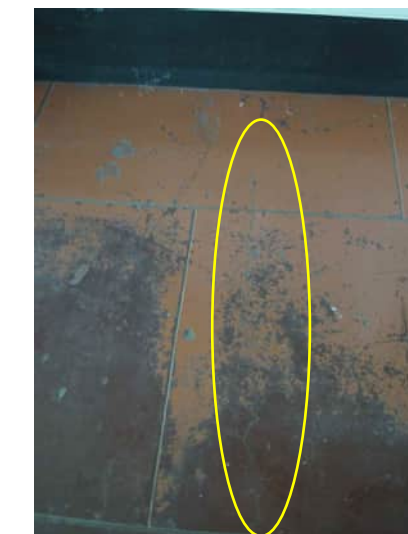
3.12 | CRACK IN COATING UP TO 3MM WIDE
A-530

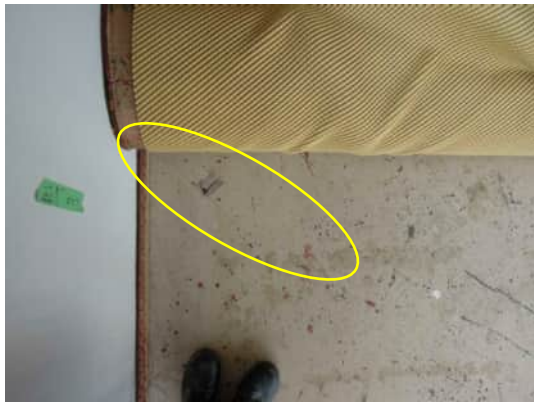
3.13 | CRACK ALONG GRID 20 UP TO 0.9MM WIDE
A-530

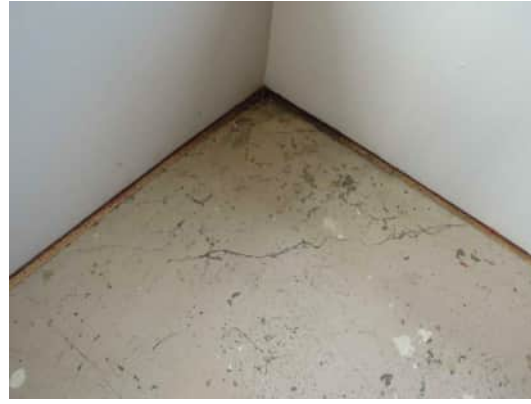
3.14 | CRACKS IN CORNER UP TO 0.6MM
A-530

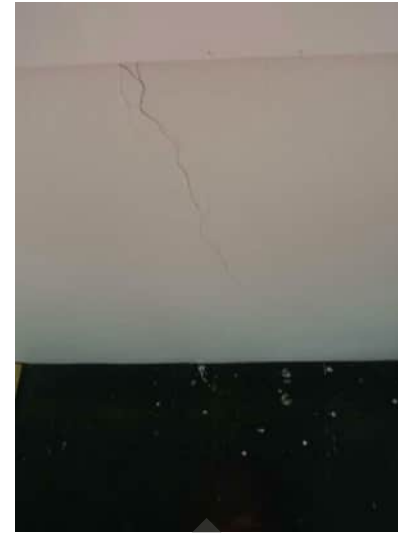
3.15 | VERTICAL CRACK BELOW WINDOW UP TO 0.4MM NEAR GRID C
A-530

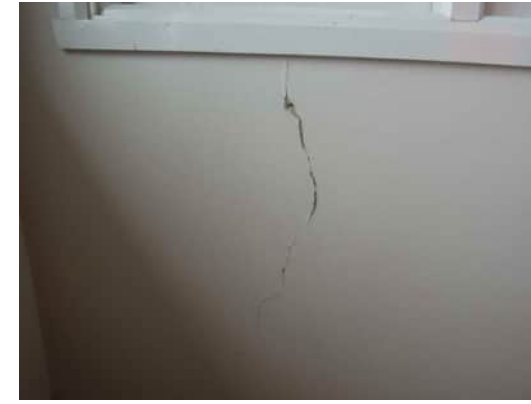
3.16 | 3MM VERTICAL CRACK BELOW WINDOW, CRACK HAS SPALLED UP TO 15MM
A-530

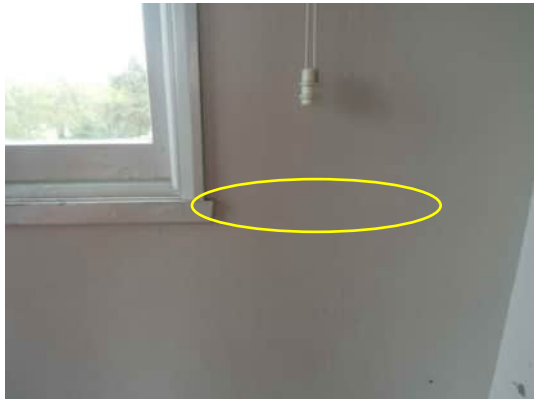
3.17 | HORIZONTAL HAIRLINE CRACK IN GRID D COLUMN AT BOTTOM OF WINDOW
A-530

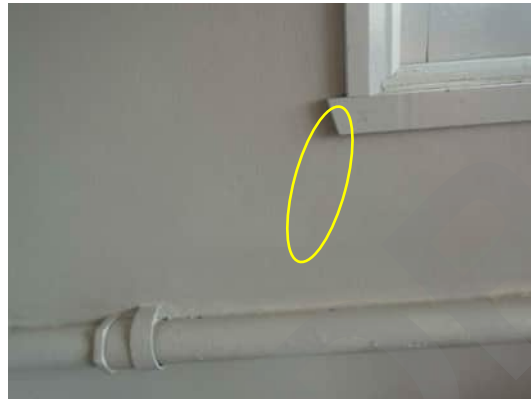
3.18 | HAIRLINE CRACK FROM CORNER OF WINDOW IN GRID D COLUMN
A-530

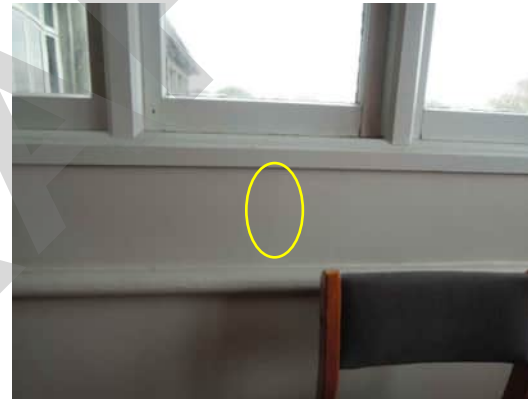
3.19 | HAIRLINE CRACK IN WALL BELOW WINDOW BETWEEN GRID D AND E
A-530

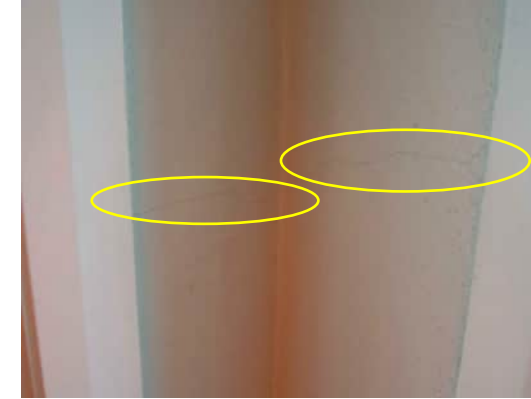
3.20 | HAIRLINE CRACK AROUND 300MM ABOVE BOTTOM WINDOW IN GRID E COLUMN
A-530

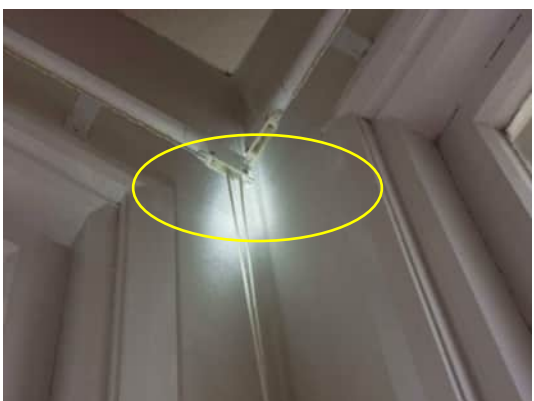
3.21 | HAIRLINE CRACK NEAR TOP OF WINDOW IN GRID E COLUMN
A-530

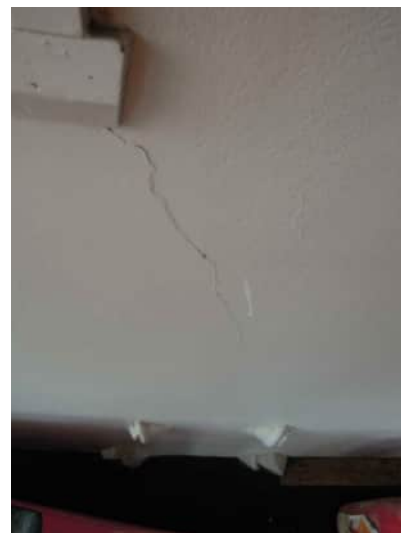
3.22 | 0.3MM DIAGONAL CRACK FROM BOTTOM OF WINDOW AT GRID 2 COLUMN
A-530

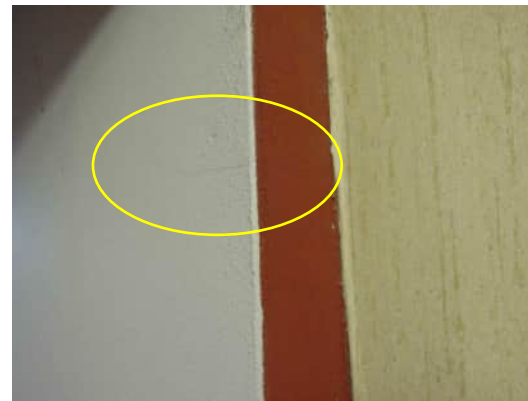
3.23 | HAIRLINE HORIZONTAL CRACK 2M UP THE GRID 9 COLUMN
A-530

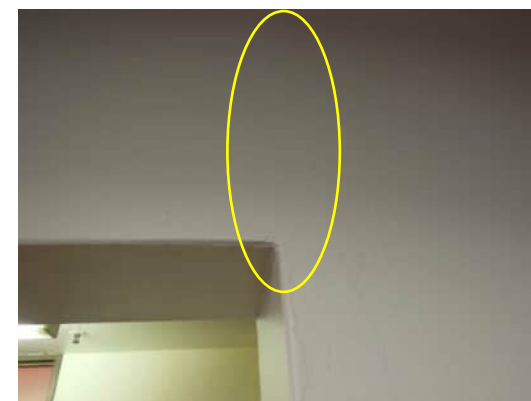
3.24 | DIAGONAL HAIRLINE CRACK IN SHEAR WALL FROM CORNER OF DOORWAY AT GRID 10
A-530

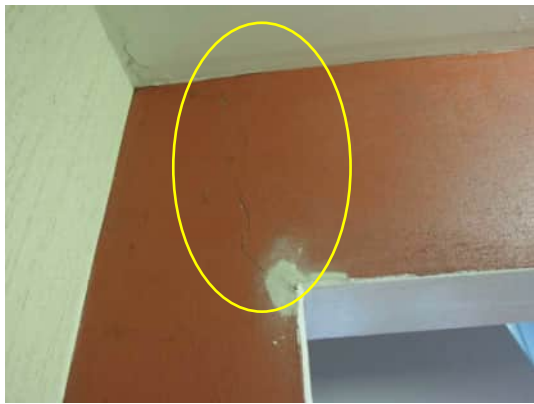
3.25 | 0.8MM DIAGONAL CRACK ON BACK OF SHEAR WALL FROM CORNER OF DOORWAY AT GRID 10
A-530

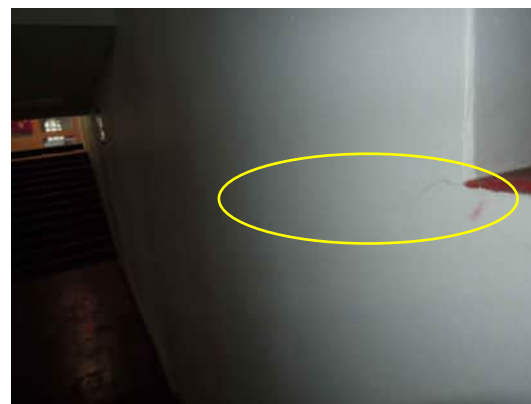
3.26 | HORIZONTAL HAIRLINE CRACK ALONG SHEAR WALL FROM GRID 10 TO GRID 12
A-530

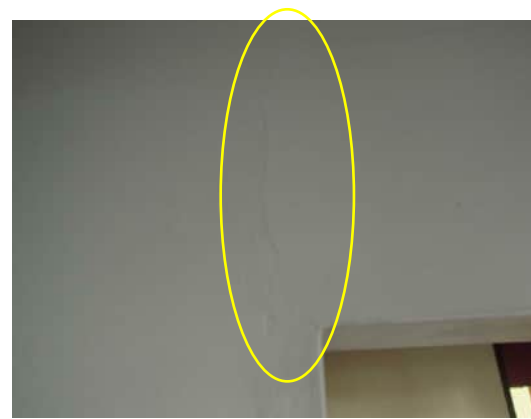
3.27 | VERTICAL CRACK IN SHEAR WALL ABOVE DOOR OPENING NEAR GRID 12
A-530

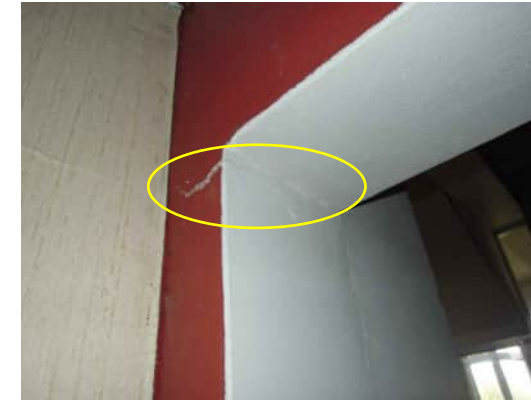
3.28 | HORIZONTAL CRACK AROUND SIDE AND BACK OF GRID 13 COLUMN
A-530

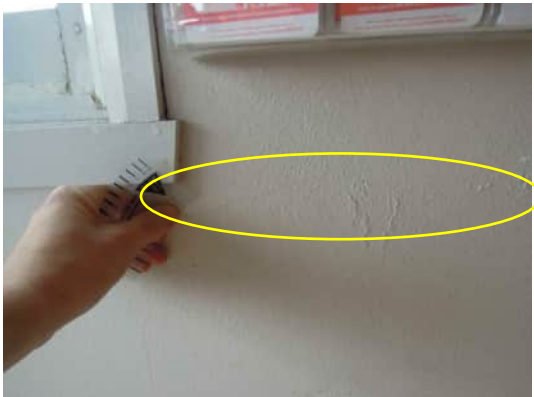
3.29 | HORIZONTAL HAIRLINE CRACK ALONG GRID 20 COLUMN AT BOTTOM OF WINDOW (GRID 1, 2, 3 AND 21 SIMILAR)
A-530

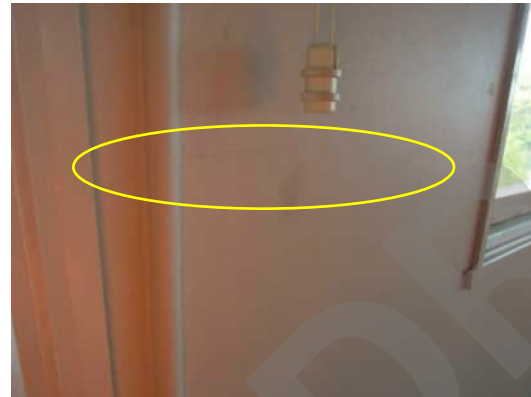
3.30 | HORIZONTAL HAIRLINE CRACK ALONG GRID 4 COLUMN AROUND 300MM ABOVE BOTTOM OF WINDOW (GRIDS 1-9 AND GRIDS 14-19 SIMILAR)
A-530

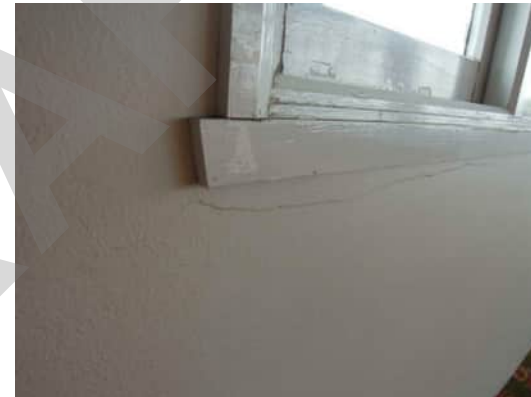
3.31 | HORIZONTAL CRACK IN WALL BELOW WINDOW BETWEEN GRID 2 AND GRID 3
A-530

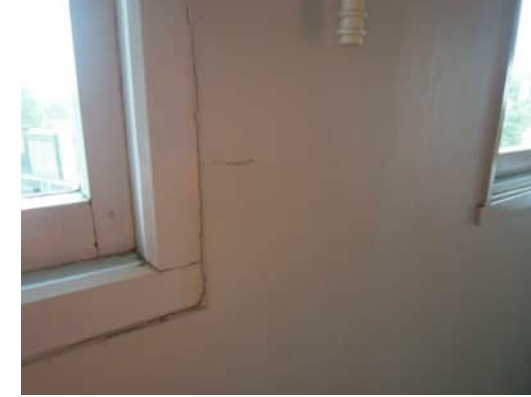
3.32 | SEPARATION OF GIB FROM WINDOW FRAME AND HORIZONTAL CRACK UP TO 0.8MM IN GRID 6 COLUMN
A-530

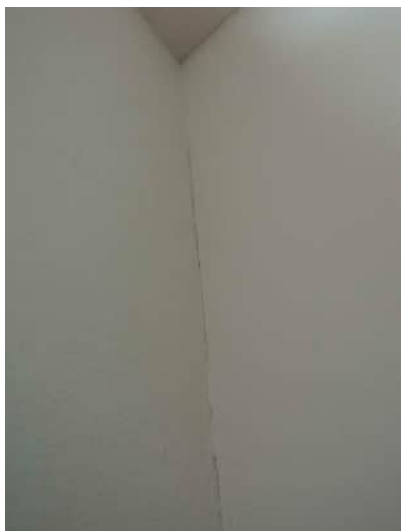
3.33 | SEPARATION BETWEEN COLUMN AND SERVICE SHAFT AT GRID 13
A-530

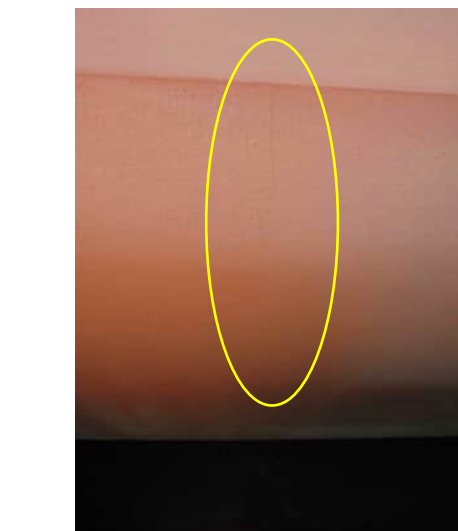
3.35 | VERTICAL HAIRLINE CRACK BELOW WINDOW BETWEEN GRID 17 AND 18
A-530

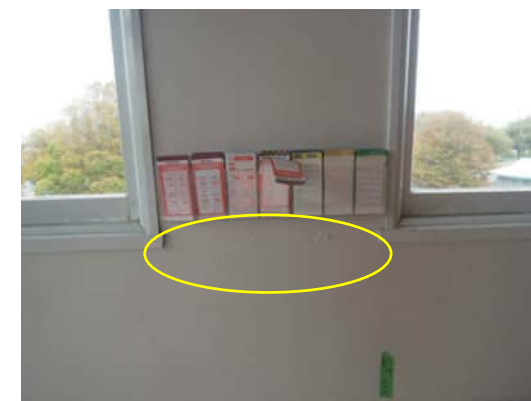
3.36 | EVIDENCE OF MOISTURE ON GRID 20 COLUMN. SIMILAR AT GRID 3 AND 5
A-530

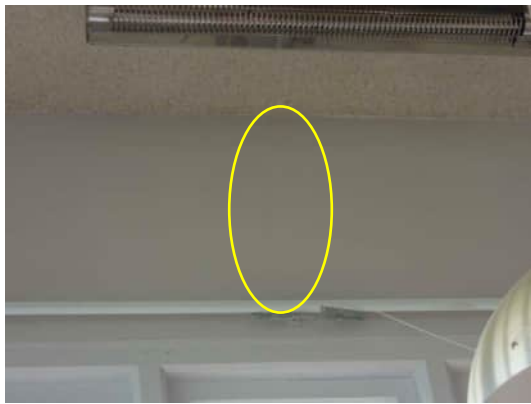
3.37 VERTICAL CRACK ABOVE WINDOW BETWEEN GRID 20 AND GRID 21
A-530

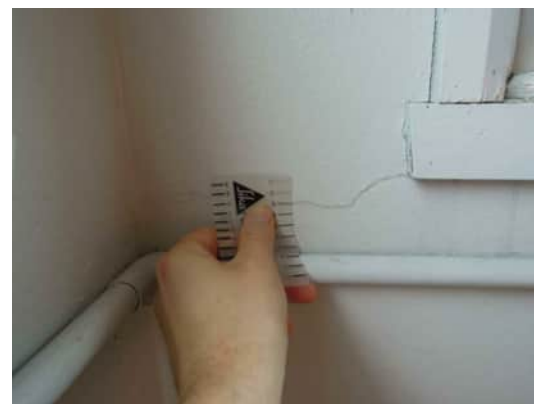
3.38 0.3MM HORIZONTAL CRACK IN GRID 21 COLUMN FROM CORNER OF WINDOW
A-530

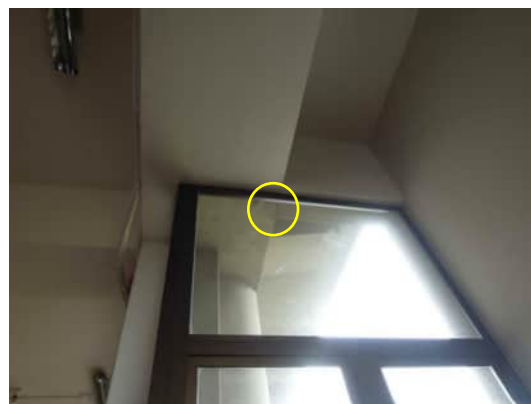
3.39 CRACK ON UNDERSIDE OF BEAMS BETWEEN GRID E BEAM AND BEAM FOR THE LIFT SHAFT EXTENSION, NEAR GRID 11
A-530

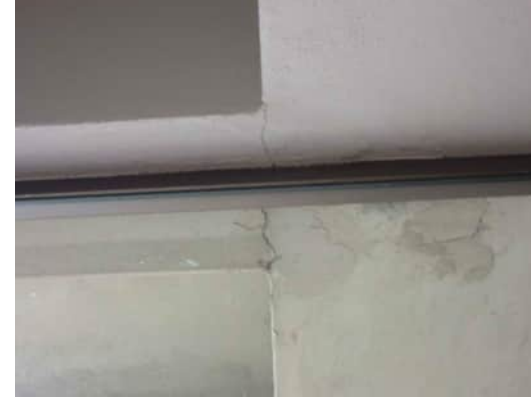
3.40 CRACK ON UNDERSIDE OF BEAMS BETWEEN GRID E BEAM AND BEAM FOR THE LIFT SHAFT EXTENSION, NEAR GRID 10
A-530

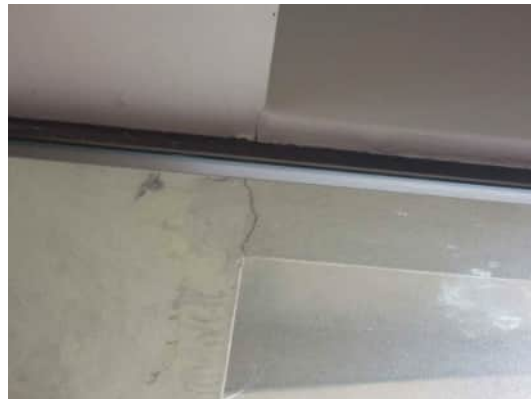
3.41 CRACK ON UNDERSIDE OF BEAMS BETWEEN GRID E BEAM AND BEAM FOR THE LIFT SHAFT EXTENSION, NEAR GRID 11
A-530

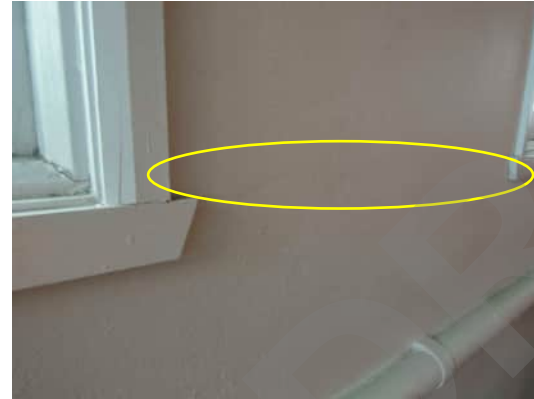
3.42 HORIZONTAL HAIRLINE CRACK ON GRID 12 COLUMN AT BOTTOM OF WINDOW
A-530

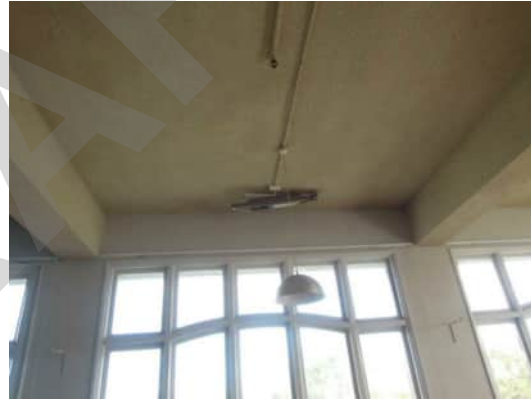
3.43 HEATER INADEQUATELY CONNECTED TO CEILING - HAZARD
A-530

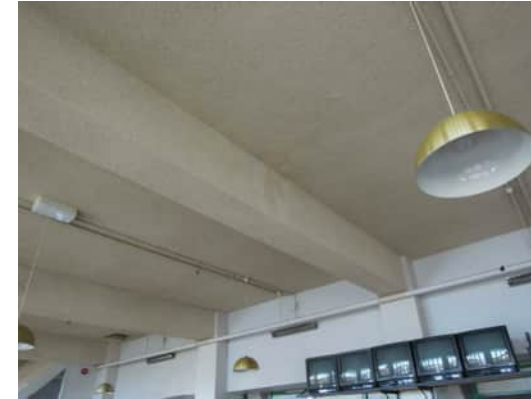
3.44 MOISTURE DAMAGE TO BEAM AND CEILING AT GRID 7
A-530

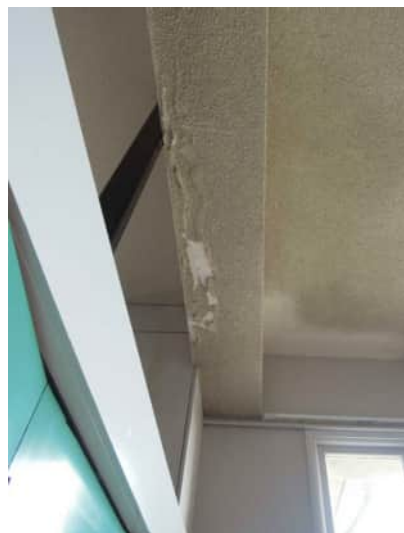
3.45 DAMAGE TO GRID 9 BEAM
A-530

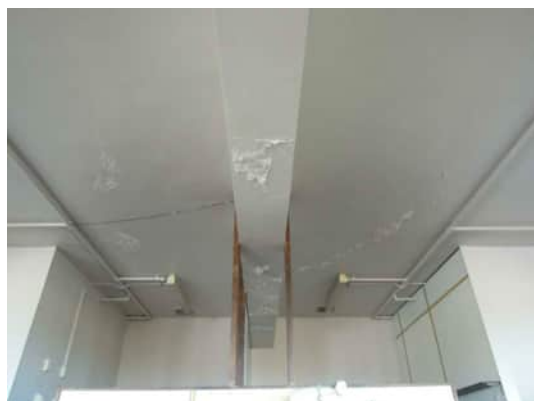
3.46 MOISTURE DAMAGE TO CEILING AND BEAM ON GRID 11
A-530

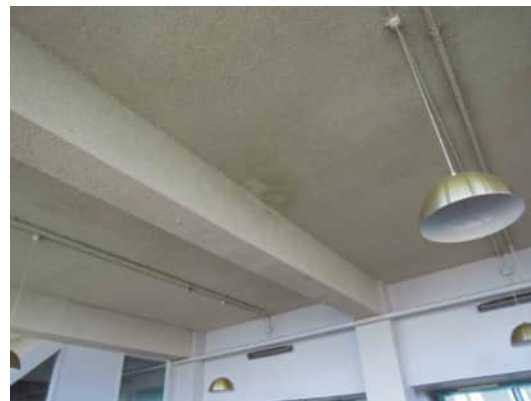
3.47 MOISTURE DAMAGE TO BEAM AND CEILING AT GRID 15
A-530

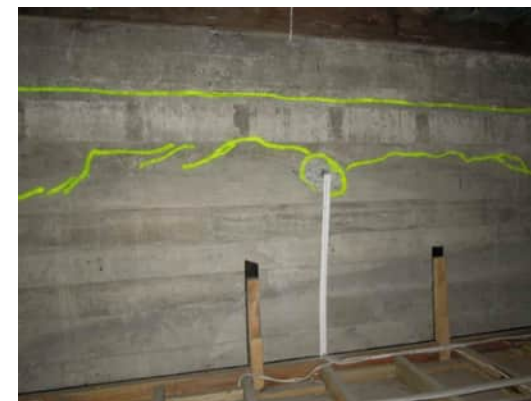
3.48 HORIZONTAL CRACKS TO SHEAR WALL. UPPER CRACK IS THROUGH POUR LINE. LOWER CRACK IS 0.2 TO 0.5MM WIDE
A-530

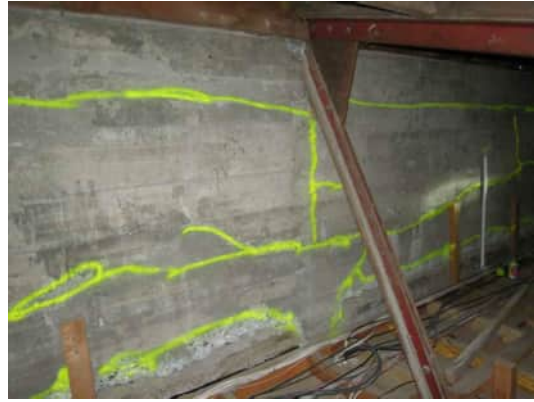
3.49 MULTIPLE CRACKS TO SHEAR WALL. UPPER CRACK IS THROUGH POUR LINE. VERTICAL CRACK UNDER TRUSS IS 1.2MM WIDE. POOR QUALITY CONCRETE IN BEAM AT BOTTOM. MIDDLE HORIZONTAL CRACK IS 1.8 TO 2MM WIDE
A-530

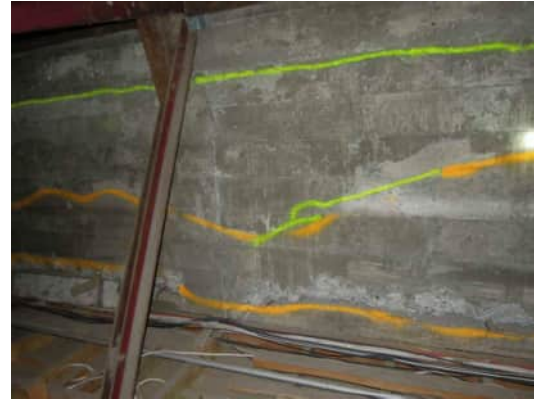
3.50 UPPER CRACK IS THROUGH POUR LINE. POOR QUALITY CONCRETE AT BOTTOM. MIDDLE HORIZONTAL CRACK 0.8 TO 1.6mm WIDE
A-530

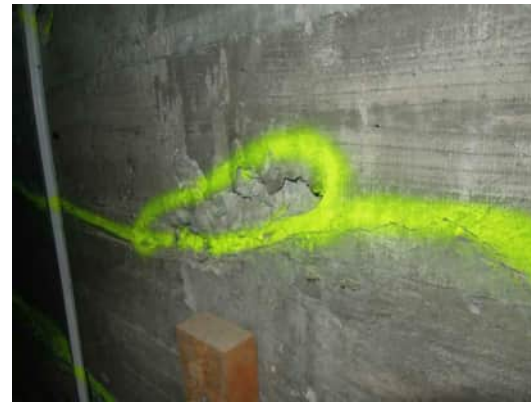
3.51 POOR QUALITY CONCRETE ON GRID 4 WITH 2MM WIDE HORIZONTAL CRACK
A-530

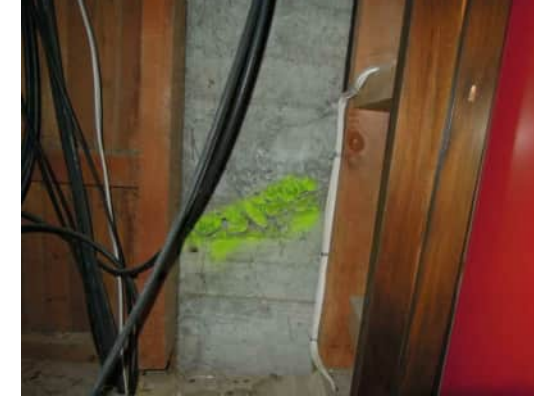
3.52 POOR QUALITY CONCRETE BETWEEN TWO VOIDS
A-530

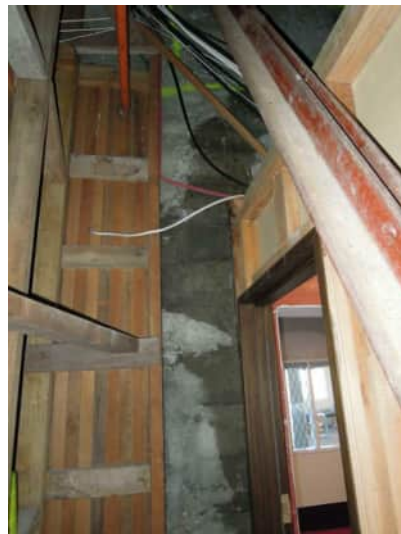
3.53 WATER INGRESS DAMAGE AT GRID 13 THROUGH CRACKING AT TOP
A-530

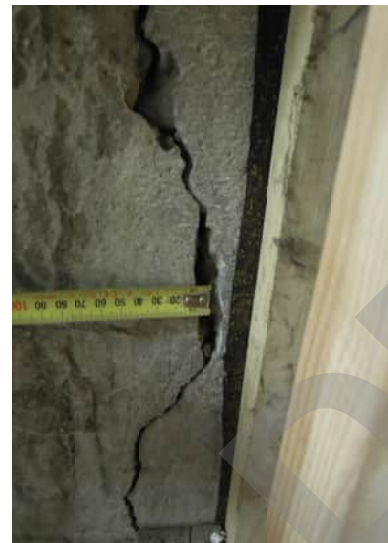
3.54 FULL HEIGHT VERTICAL CRACK UP TO 15MM WIDE
A-530

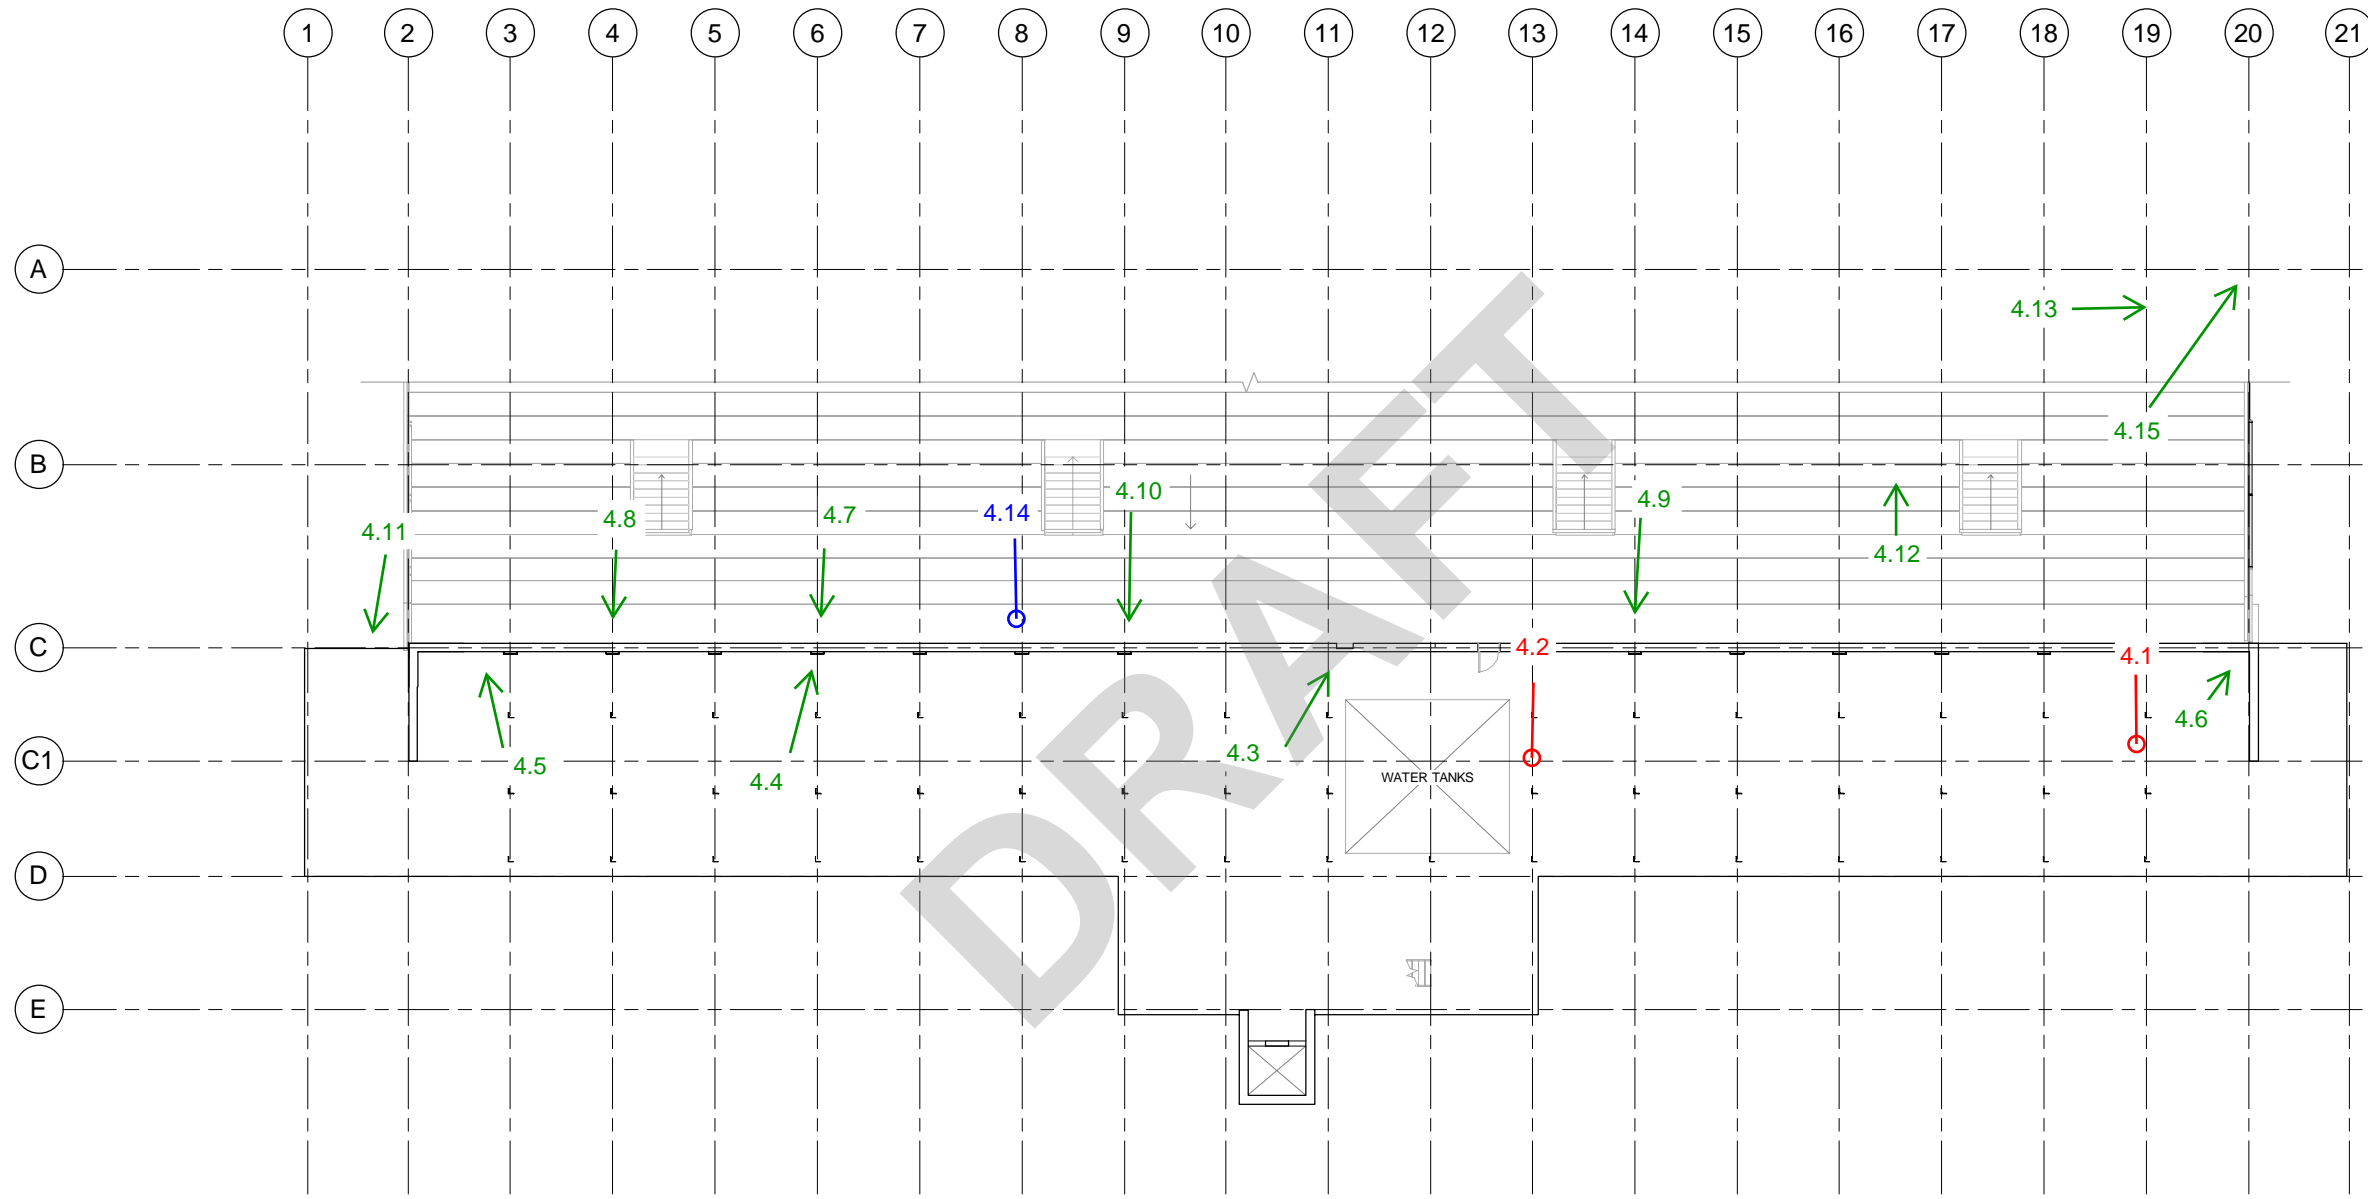
DAMAGE PHOTO KEYPLAN - FLOOR 4

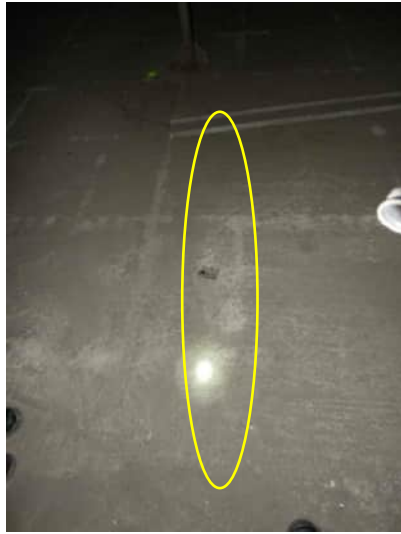
4.1
A-500 | TYPICAL CRACK NEAR GRIDLINE BETWEEN STEEL COLUMNS

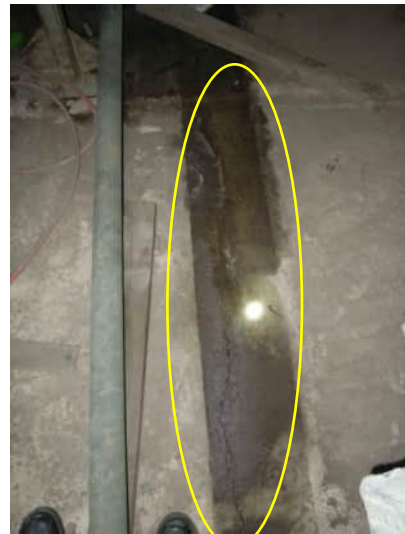
4.2
A-540 | CRACK THROUGH DRAINAGE CHANNEL, UP TO 1.4MM

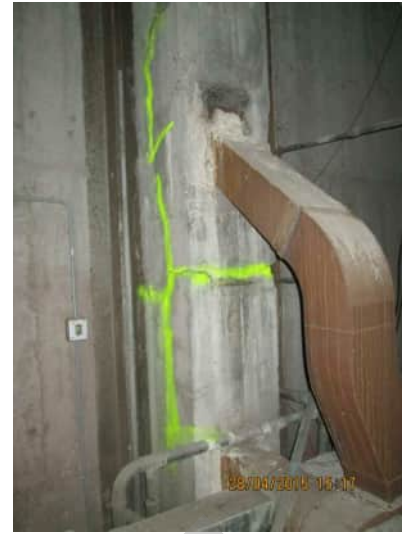
4.3
A-540 | CONCRETE COLUMN HAS SEPARATED FROM THE SHEAR WALL. THE COLUMN HAS MULTIPLE HORIZONTAL CRACKS SHOWING IT HAS BEEN BENT IN FLEXURE

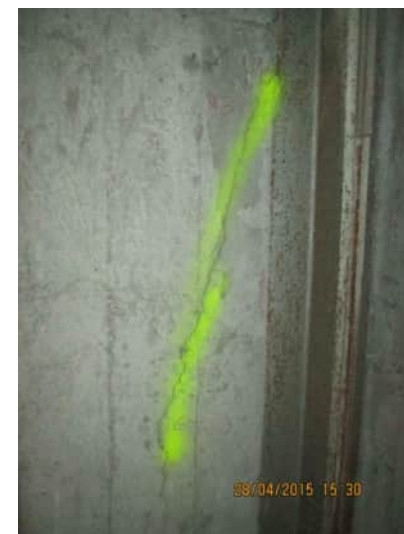
4.4
A-540 | CRACK RUNNING FROM THE STEEL COLUMN VERTICALLY

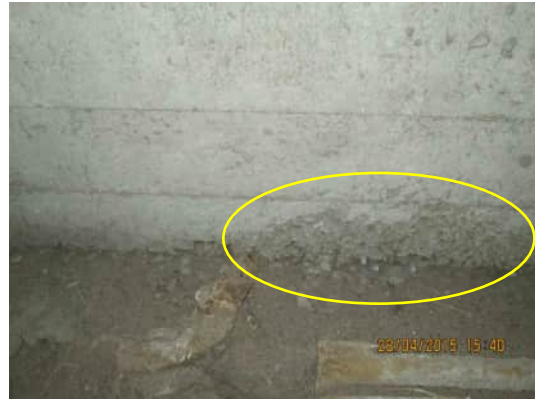
4.5
A-540 | POOR QUALITY CONCRETE OVER HANGING THE FLOOR SLAB

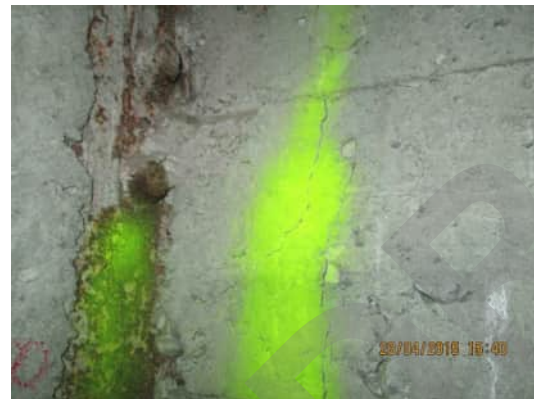
4.6
A-540 | VERTICAL CRACKS NEAR THE CONNECTION BETWEEN SHEAR WALL AND BUTTRESS. POOR CONCRETE AROUND THE CONNECTION

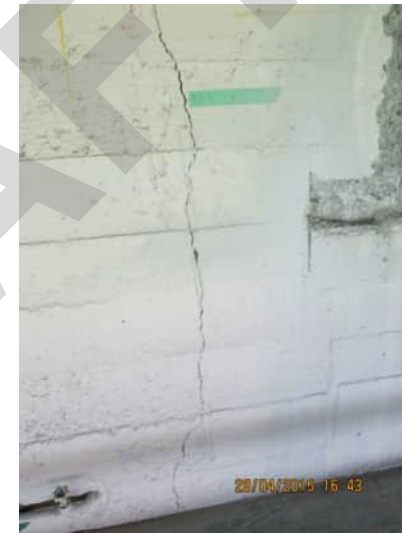
4.7
A-540 | VERTICAL CRACK ON THE EXTERNAL FACE OF THE SHEAR WALL AT GRID 6, RUNNING PARALLEL TO THE STEEL COLUMN ON INTERNAL FACE

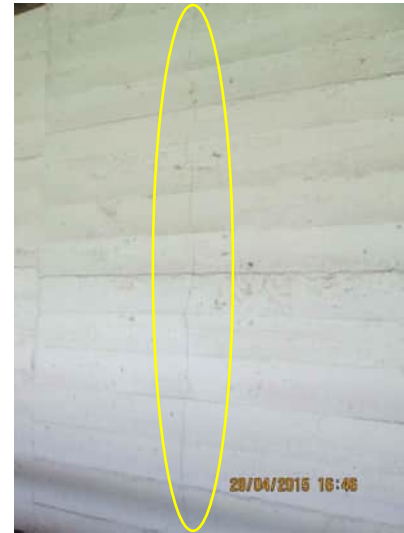
4.8
A-540 | VERTICAL CRACK ON THE EXTERNAL FACE OF THE SHEAR WALL RUNNING PARALLEL TO THE STEEL COLUMN ON INTERNAL FACE

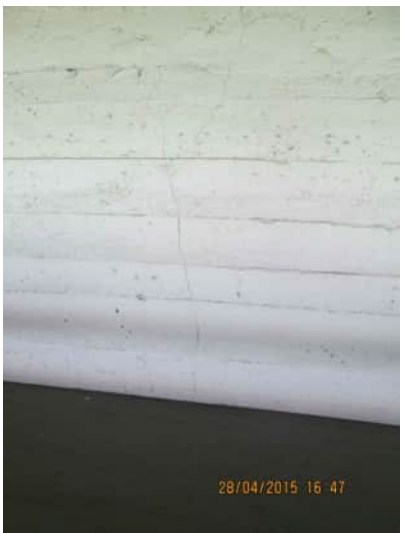
4.9
A-540 | VERTICAL CRACK ON THE EXTERNAL FACE OF THE SHEAR WALL RUNNING PARALLEL TO THE STEEL COLUMN ON INTERNAL FACE

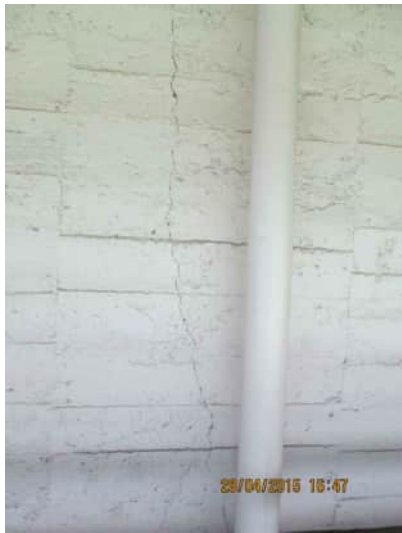
4.10
A-540 | VERTICAL CRACK ON THE EXTERNAL FACE OF THE SHEAR WALL RUNNING PARALLEL TO THE STEEL COLUMN ON INTERNAL FACE

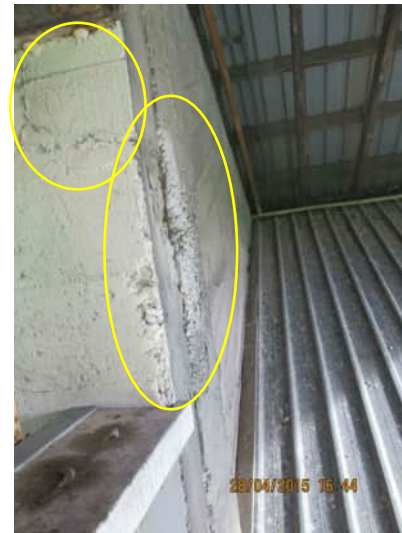
4.11
A-540 | VIEW OF THE WESTERN WING WALL FROM UPPER STAND SHOWING DAMAGE AROUND CONNECTION OF SHEAR WALL TO BUTTRESS WALL

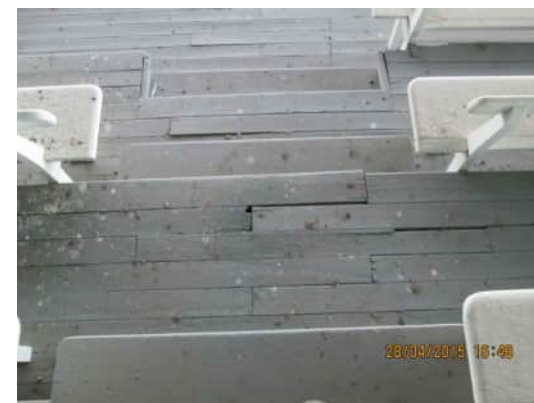
4.12
A-540 | CONDITION OF TIMBER DECKING ON THE UPPER STAND

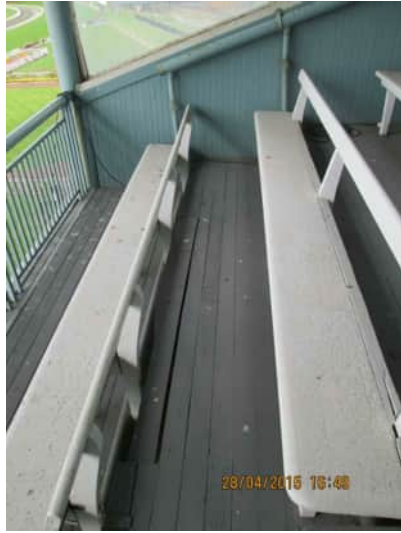
4.13
A-540 | CONDITION OF TIMBER DECKING ON THE UPPER STAND

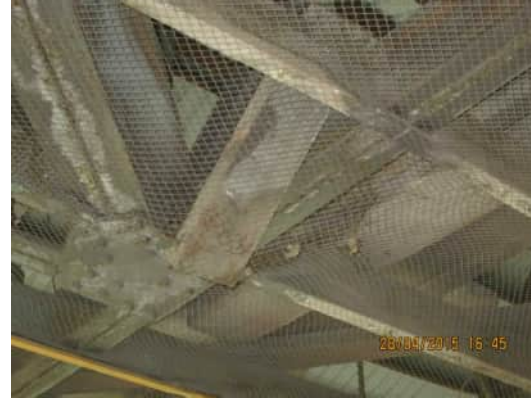
4.14
A-540 | LOOSE TIMBER PIECES CAUGHT IN THE PROTECTIVE MESH

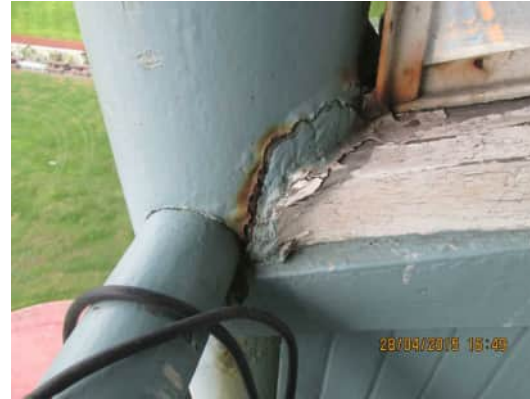
4.15
A-540 | DAMAGE TO INTERFACE BETWEEN COLUMN AND TIMBER INFILL

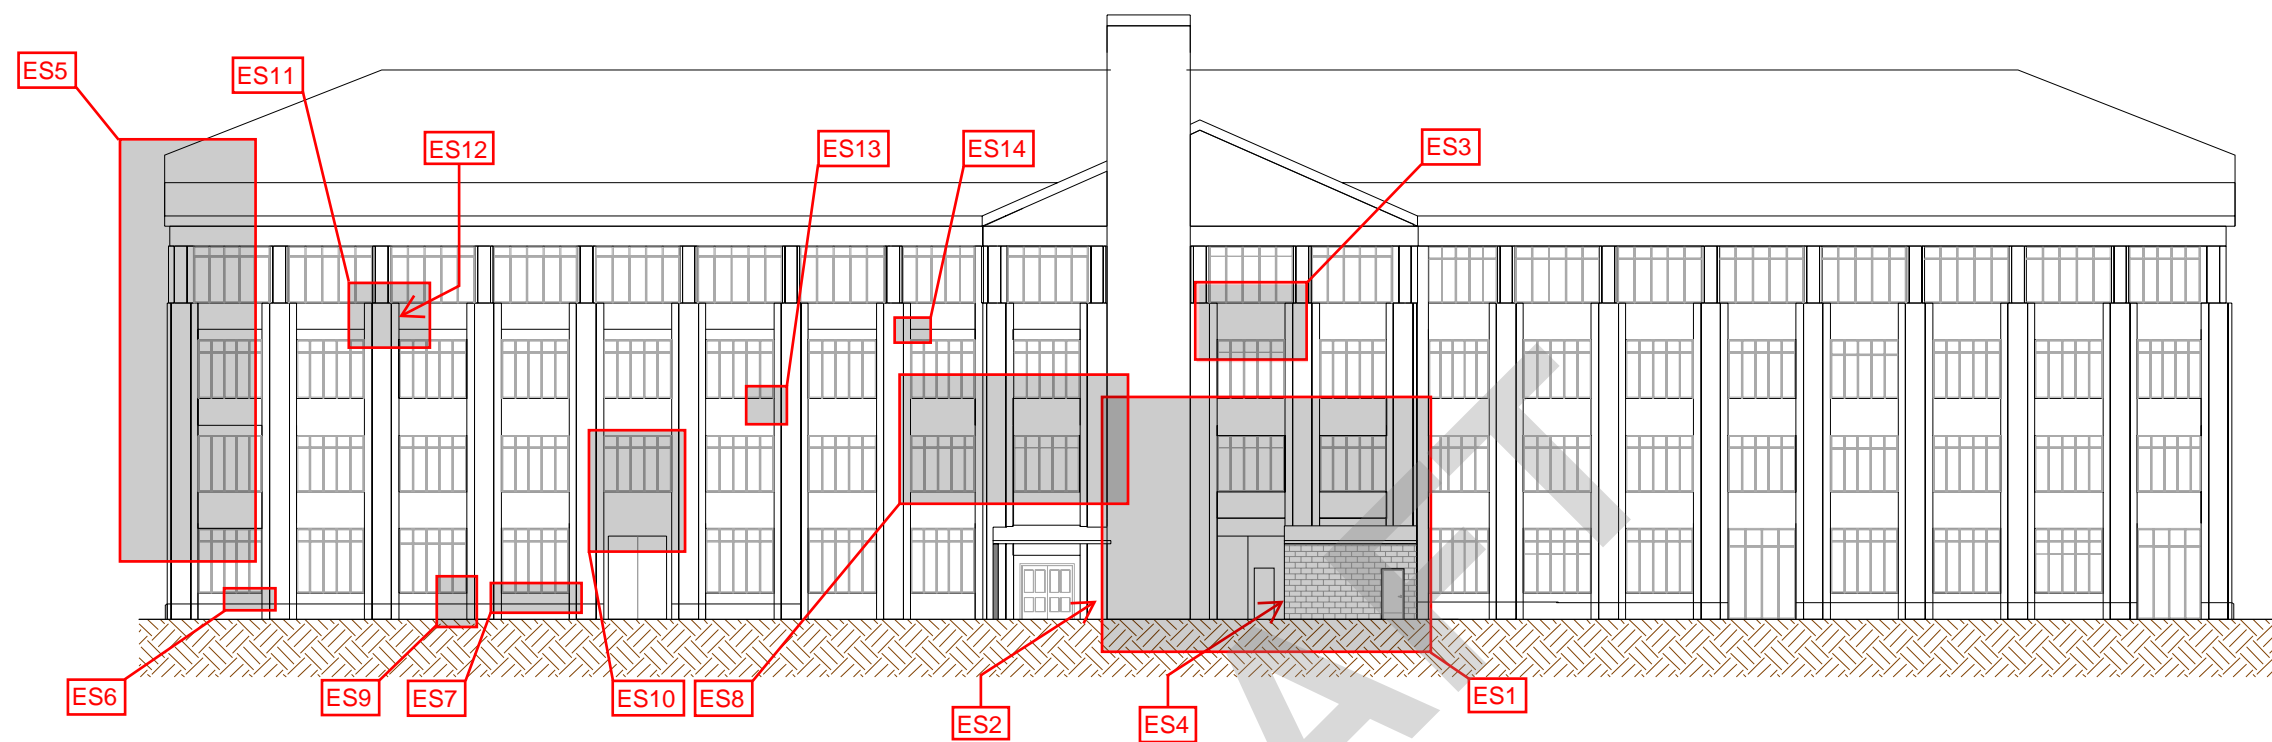
DAMAGE PHOTO KEYPLAN - SOUTH ELEVATION
 Scale: 1 : 150

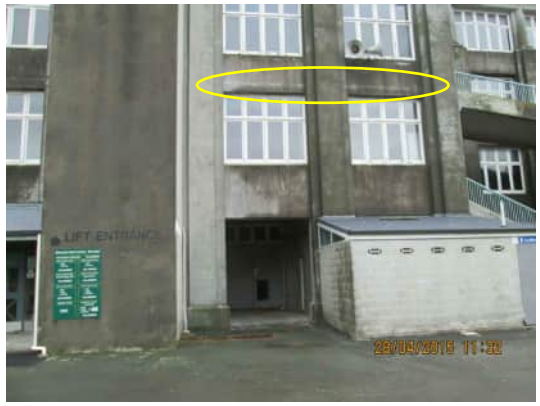
ES1
A-550 HORIZONTAL CRACK ABOVE FIRST FLOOR WINDOWS

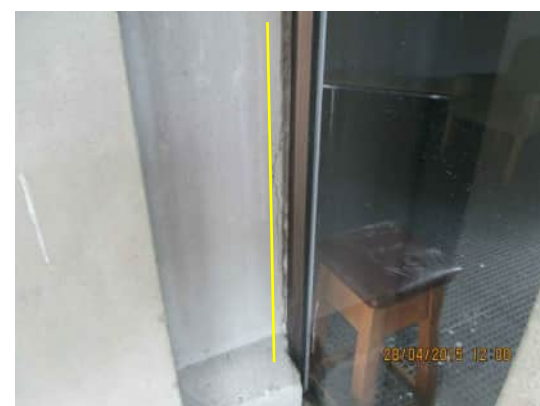
ES2
A-550 SEPARATION BETWEEN GRID 10 COLUMN AND LIFT SHAFT EXTENSION

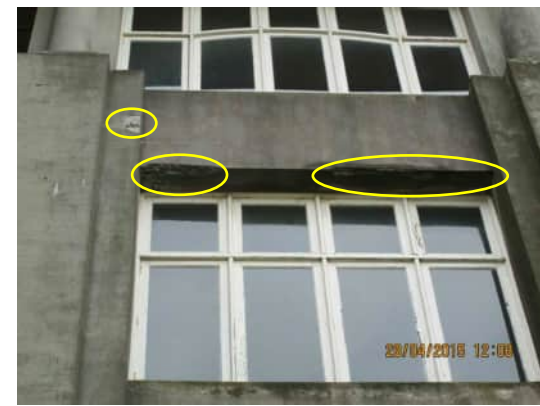
ES3
A-550 DAMAGED RENDER ABOVE SECOND FLOOR WINDOW EXPOSING REINFORCEMENT

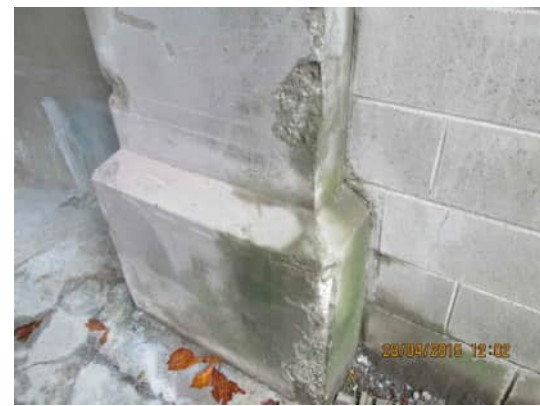
ES4
A-550 DAMAGE TO RENDER AT BASE OF GRID 12 COLUMN

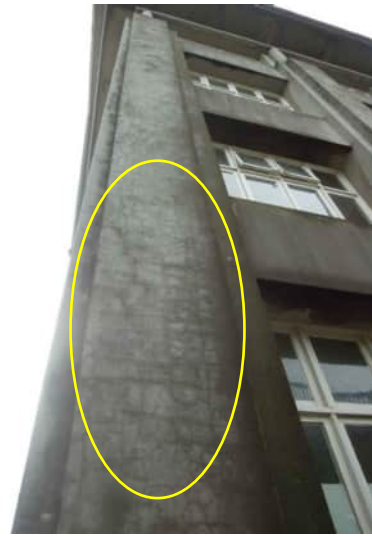
ES5
A-550 | TYPICAL CRAZED CRACKING TO RENDER

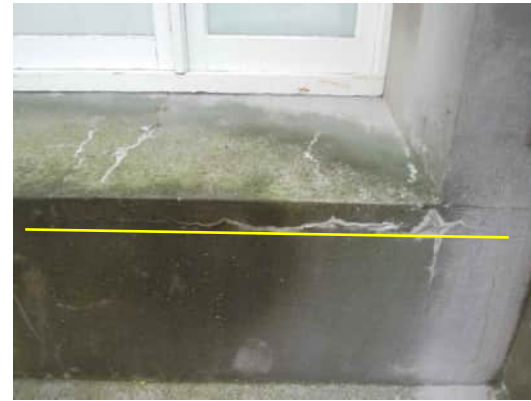
ES6
A-550 | TYPICAL HORIZONTAL CRACK BELOW WINDOW

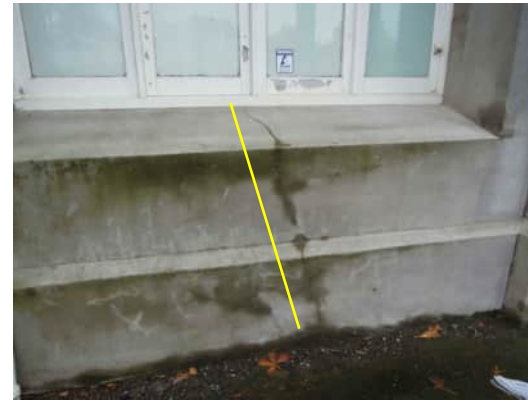
ES7
A-550 | TYPICAL VERTICAL CRACK BELOW WINDOW ON GROUND FLOOR

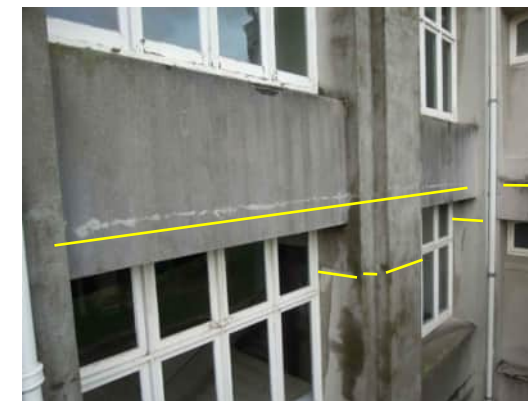
ES8
A-550 | TYPICAL HORIZONTAL CRACK ABOVE WINDOW AND HORIZONTAL CRACK AROUND COLUMN

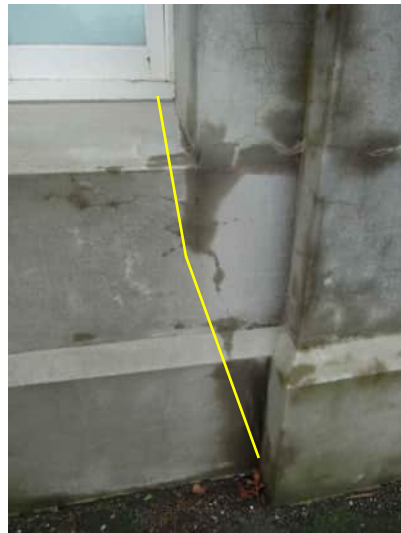
ES9
A-550 | VERTICAL CRACK UP TO 0.3MM FROM CORNER OF WINDOW ON GROUND FLOOR AT GRID 4 COLUMN

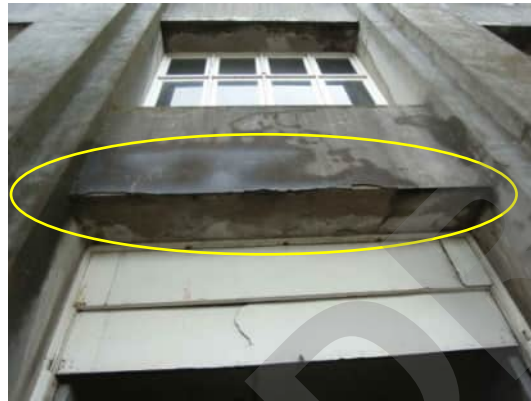
ES10
A-550 | RENDER HAS BROKEN OFF ABOVE DOOR OPENING BETWEEN GRID 5 AND 6

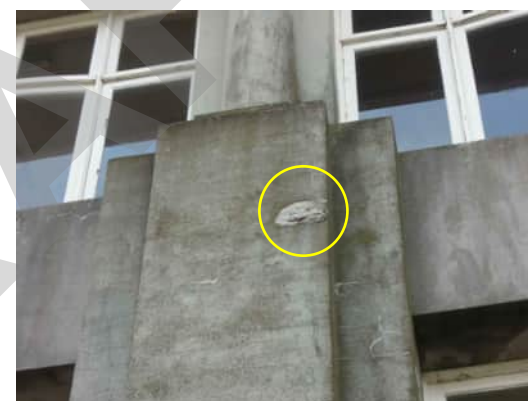
ES11
A-550 | SPALLING NEAR TOP OF GRID 3 COLUMN EXPOSING REINFORCING

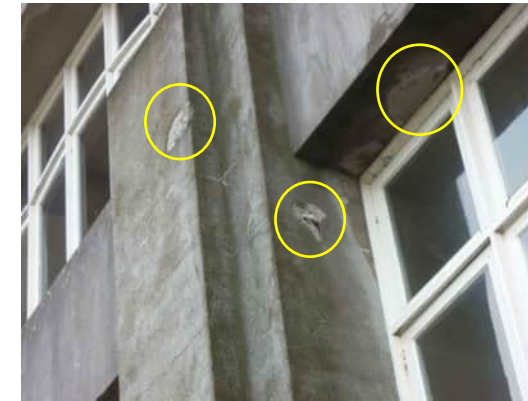
ES12
A-550 | SPALLING ON SIDE OF GRID 3 COLUMN EXPOSING REINFORCING

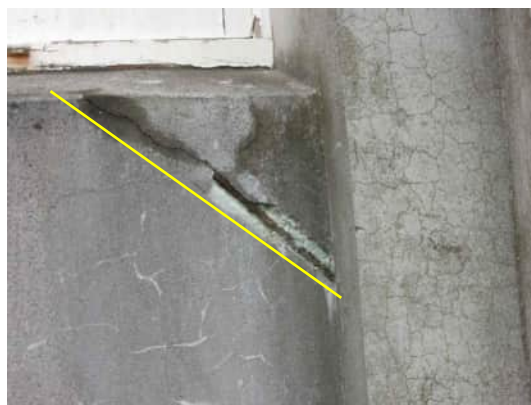
ES13
A-550 | CRACK EXPOSING REINFORCING BELOW SECOND FLOOR WINDOW AT GRID 7

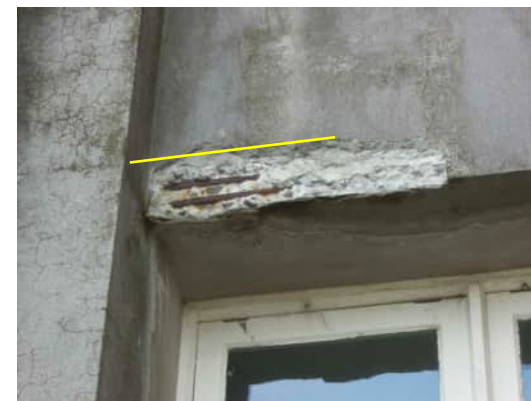
ES14
A-550 | EXPOSED REINFORCING ABOVE SECOND FLOOR WINDOW IN GRID 8

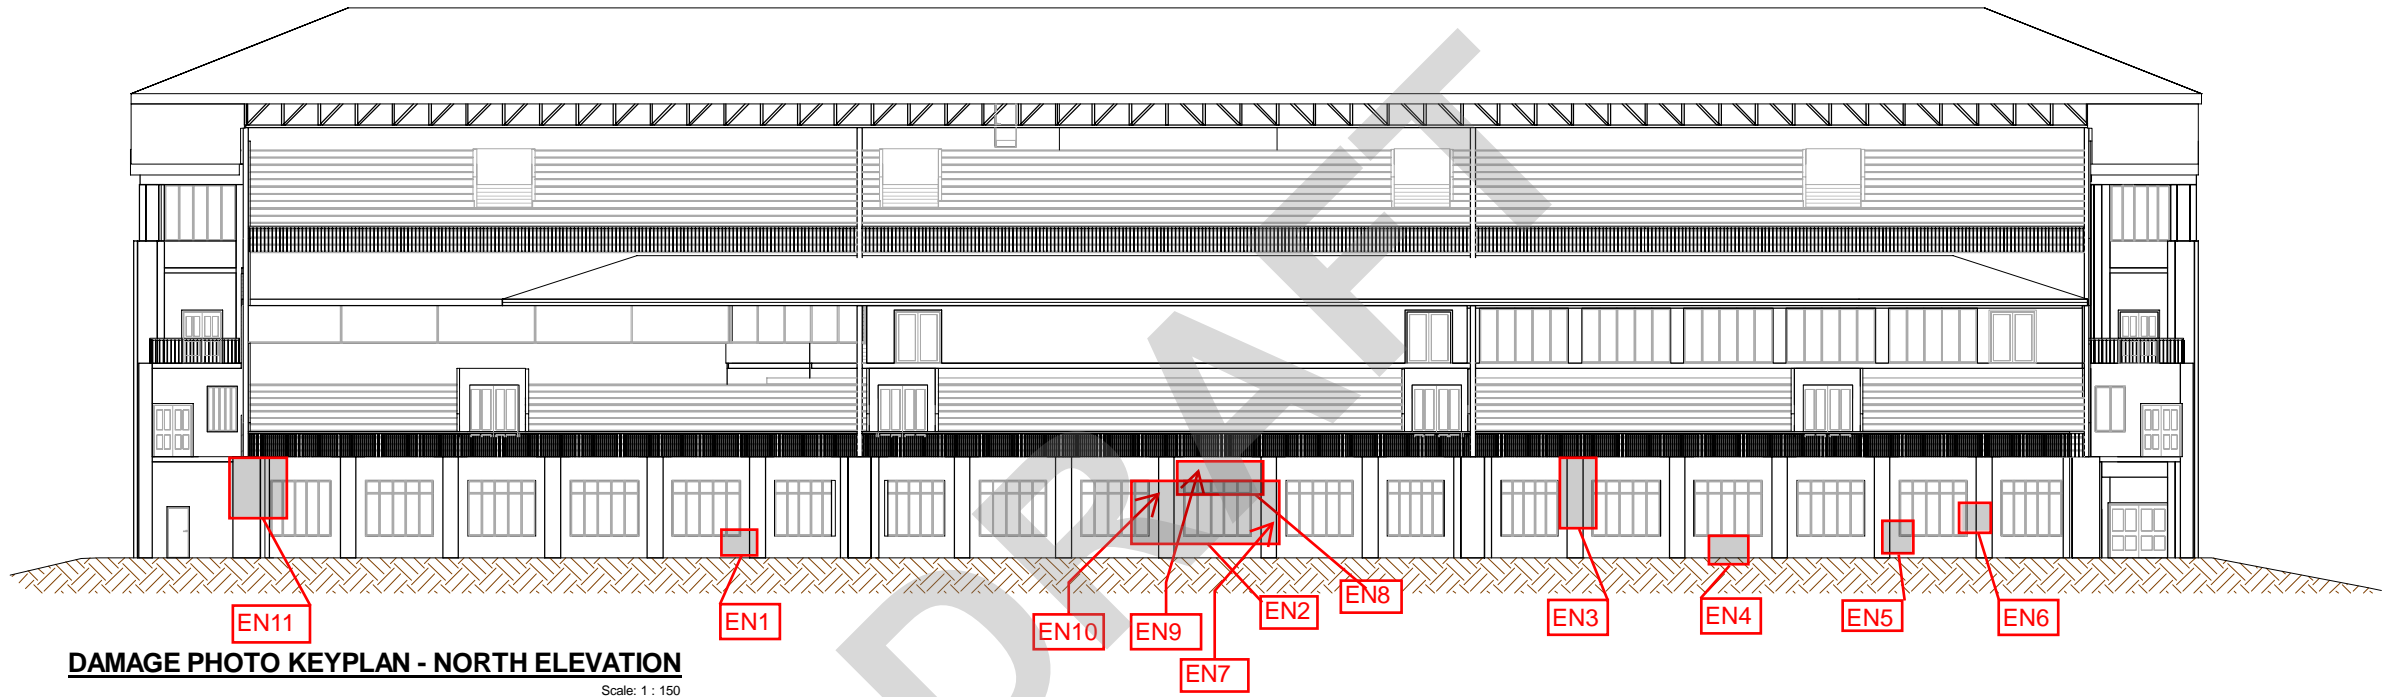
DAMAGE PHOTO KEYPLAN - NORTH ELEVATION
Scale: 1 : 150

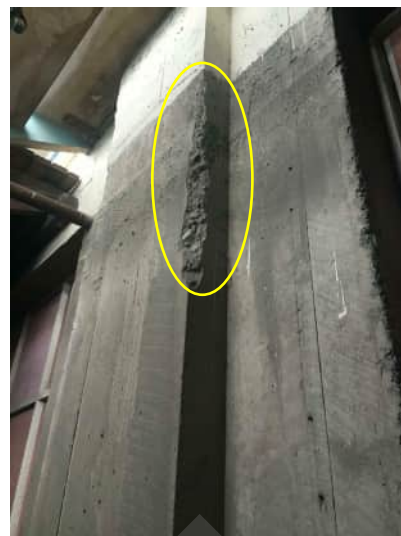
EN3
A-552 SPALLING TO CORNERS OF COLUMNS
