Detailed Damage Evaluation

Quantitative Seismic Analysis of Grand National (Public) Stand

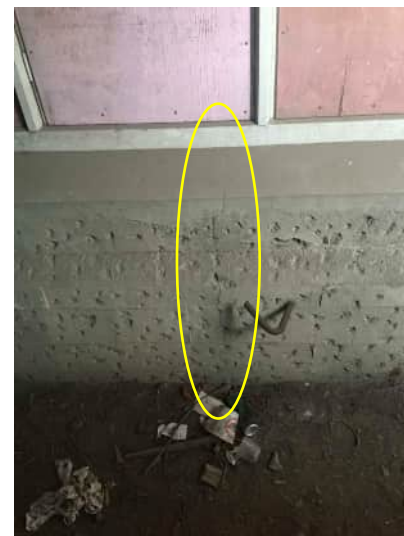
EN4
A-552 VERTICAL CRACK BELOW WINDOW

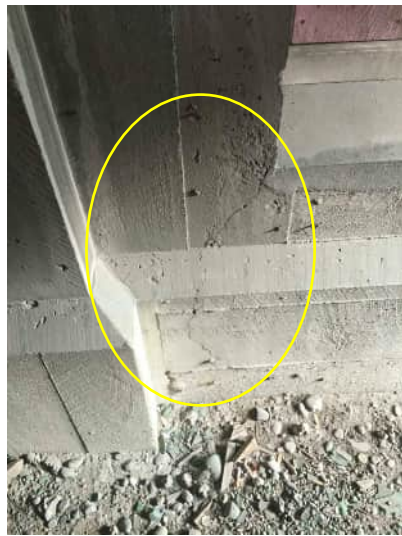
EN5
A-552 CRACK FROM CORNER OF WINDOW

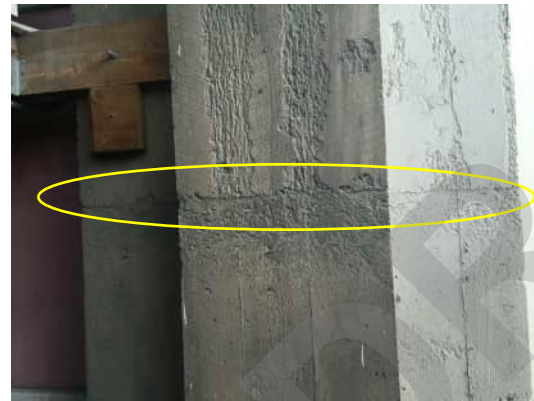
EN6
A-552 MINOR HORIZONTAL CRACK AT LOCATION OF CONSTRUCTION JOINT

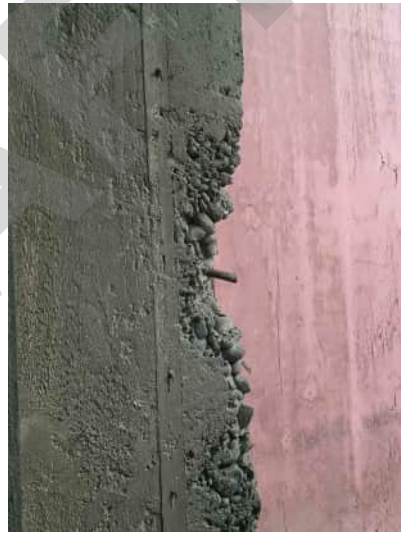
EN7
A-552 CONCRETE SPALLING WITH PROTRUDING STEEL BAR AT CORNER OF GRID 10 COLUMN

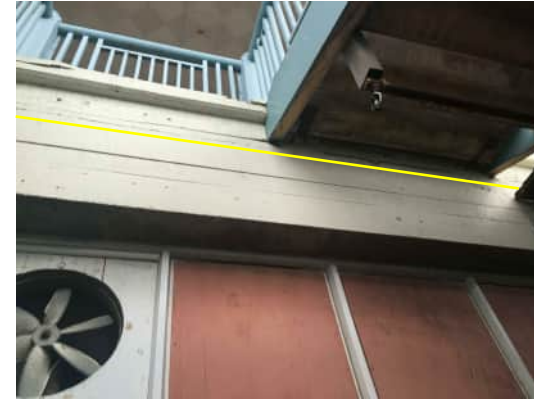
EN8
A-552 SIGNIFICANT HORIZONTAL CRACK ALONG TOP OF WALL AROUND 10MM WIDE, AT LOCATION WHERE STAIRS TO STANDS HAVE BEEN CAST INTO THE WALL

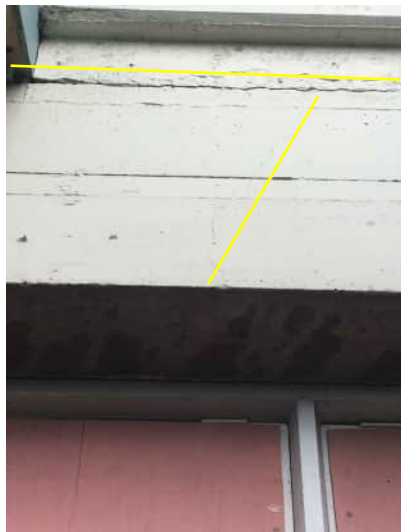
EN9
A-552 SIGNIFICANT HORIZONTAL CRACK AND MINOR VERTICAL CRACK ABOVE WINDOW BETWEEN GRID 10 AND 11, AT LOCATION WHERE STAIRS TO STANDS HAVE BEEN CAST INTO THE WALL

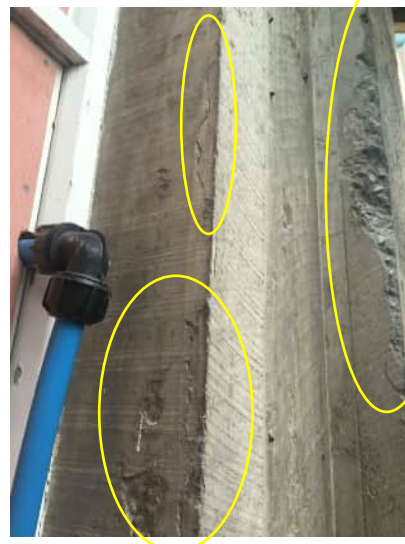
EN10
A-552 VERTICAL CRACK UP TO 0.4MM ON SIDE OF COLUMN AT GRID 11

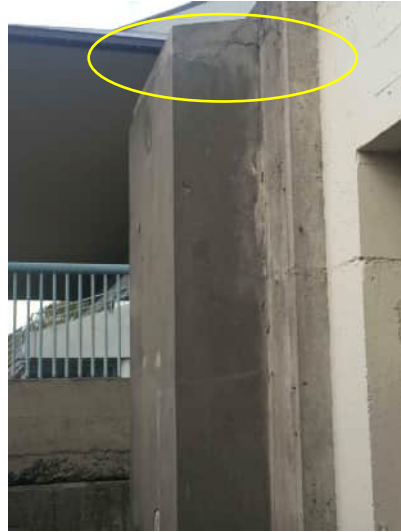
EN11
A-552 HORIZONTAL CRACK AT TOP OF GRID 20 COLUMN

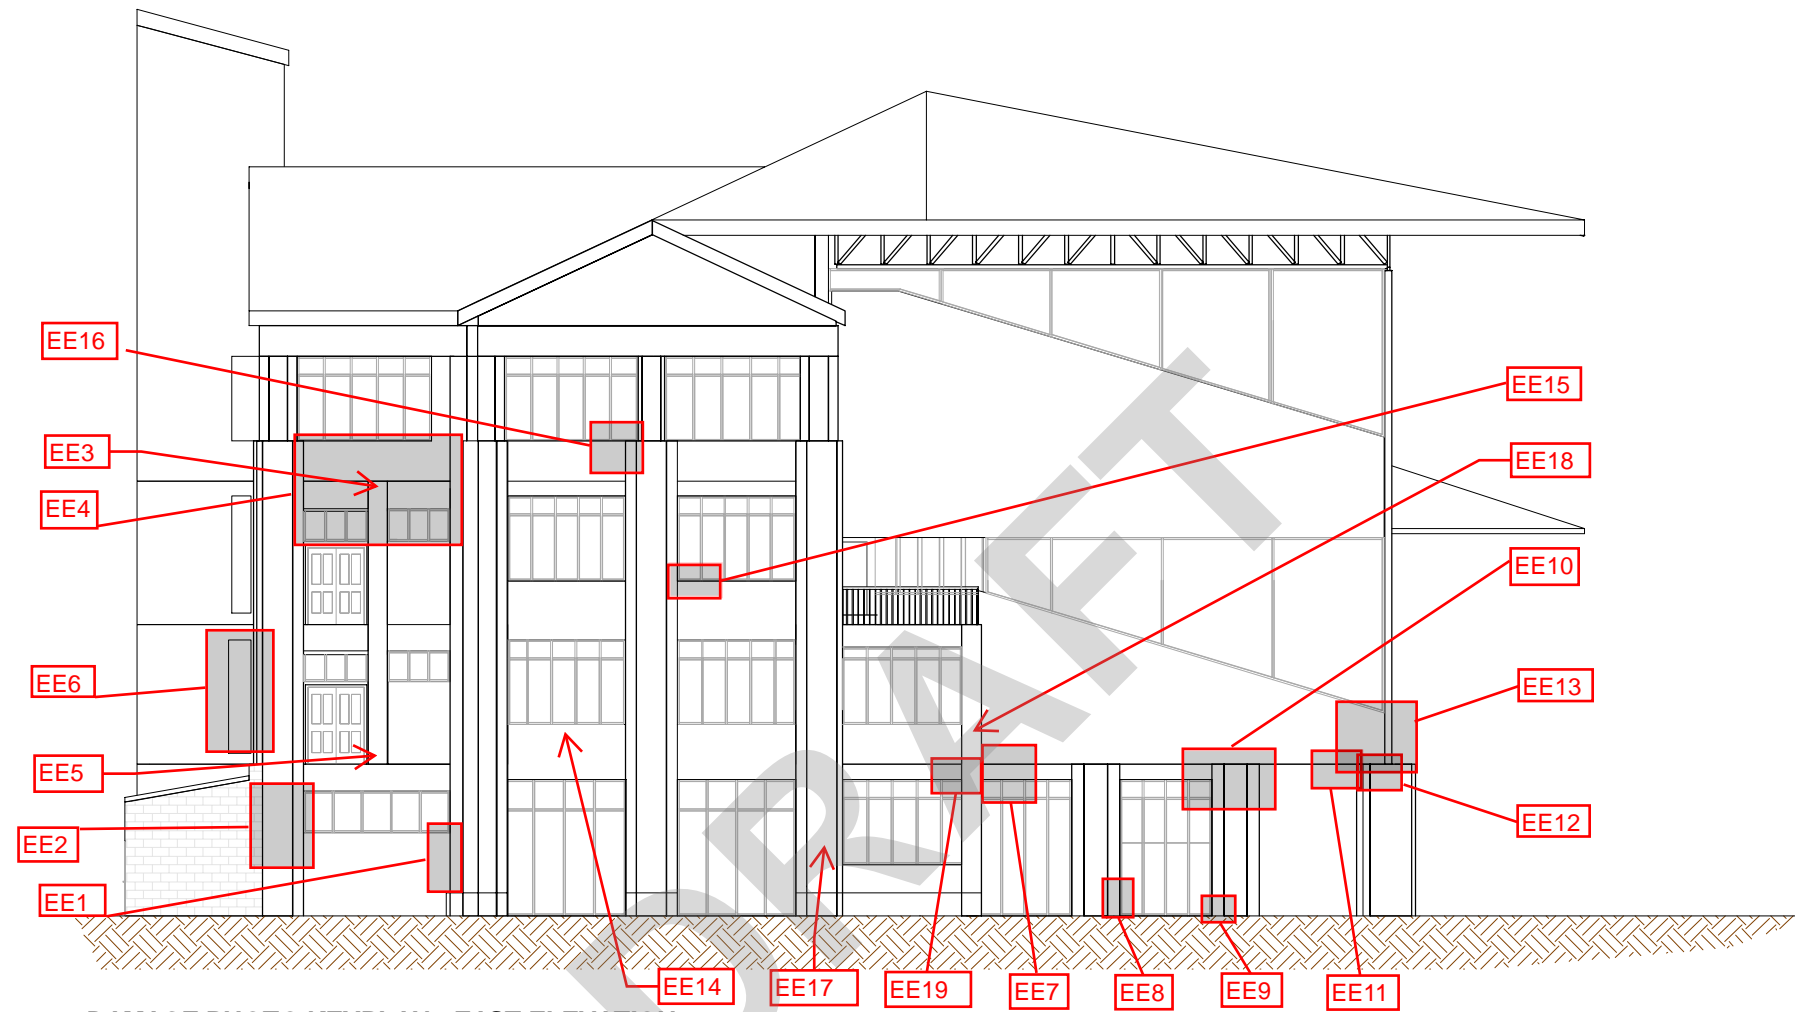
DAMAGE PHOTO KEYPLAN - EAST ELEVATION

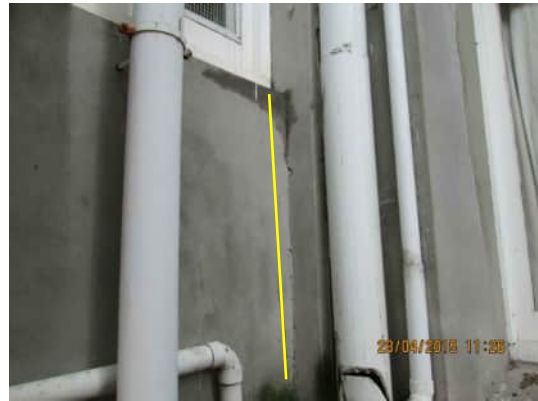
EE1
A-554 TYPICAL CRACK BETWEEN GRID D COLUMN AND CONCRETE INFILL WALL

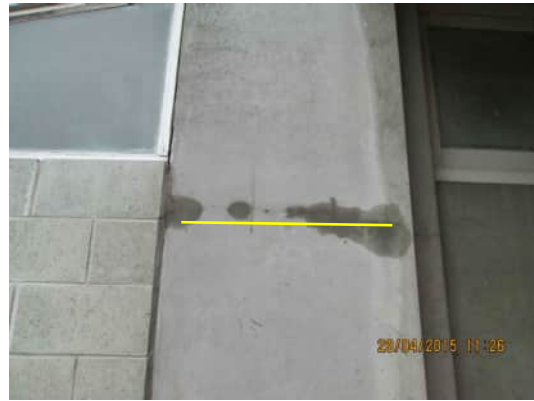
EE2
A-554 HAIRLINE CRACK TO GRID E COLUMN AT GROUND LEVEL

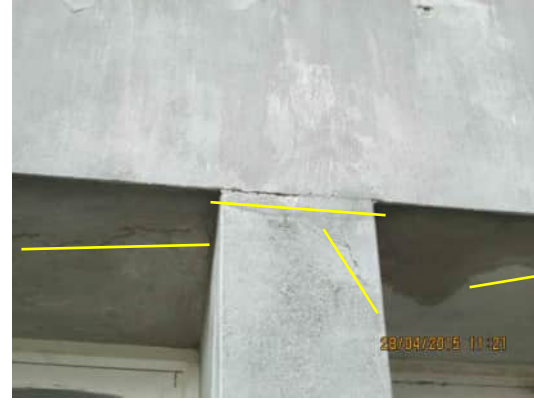
EE3
A-554 HORIZONTAL CRACK AND DIAGONAL CRACKS BETWEEN CENTRAL COLUMN AND THIRD FLOOR WALL

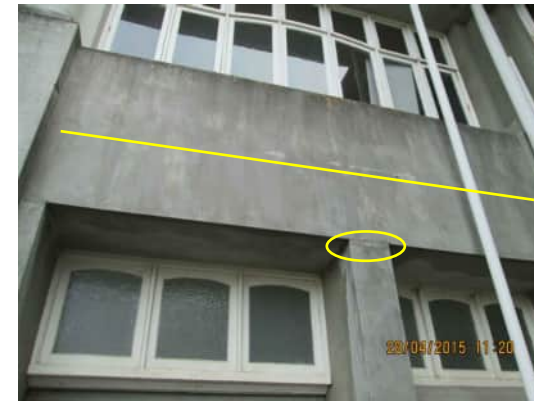
EE4
A-554 HORIZONTAL CRACK ALONG WALL ON THE THIRD FLOOR

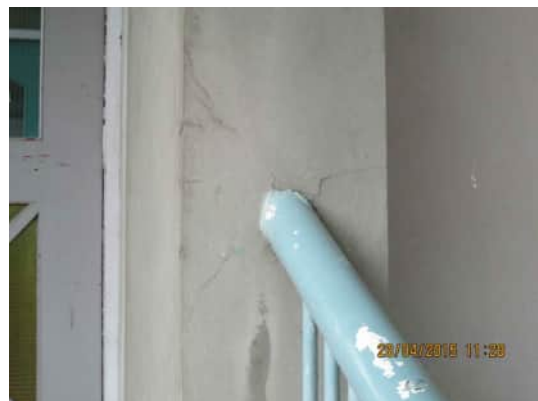
EE5
A-554 CRACKING AROUND CAST-IN HANDRAIL AT THE FIRST FLOOR

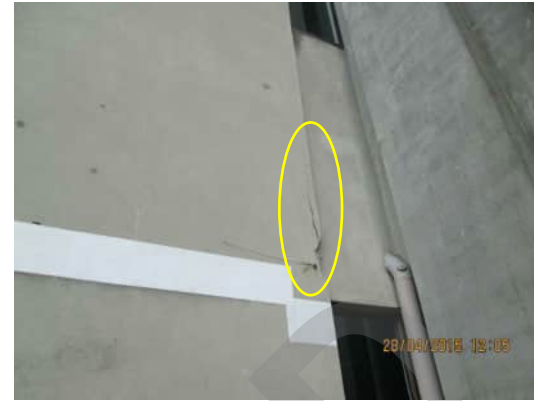
EE6
A-554 DAMAGE TO LIFT SHAFT AT CONNECTION TO MAIN BUILDING

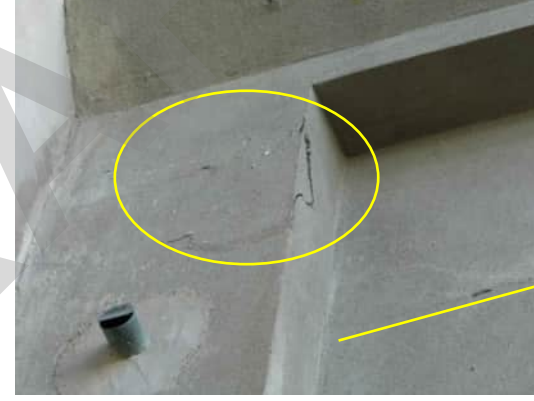
EE7
A-554 CRACKS AND DAMAGE TO RENDER ON THE GRID C COLUMN

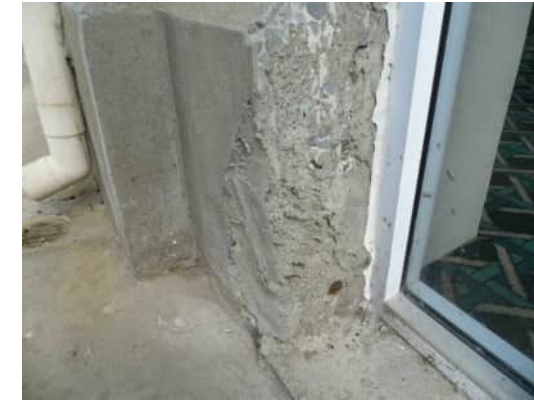
EE8
A-554 DAMAGED CONCRETE AROUND DOOR WITH REINFORCING EXPOSED (WALL APPEARS TO HAVE BEEN CUT TO FORM DOOR)

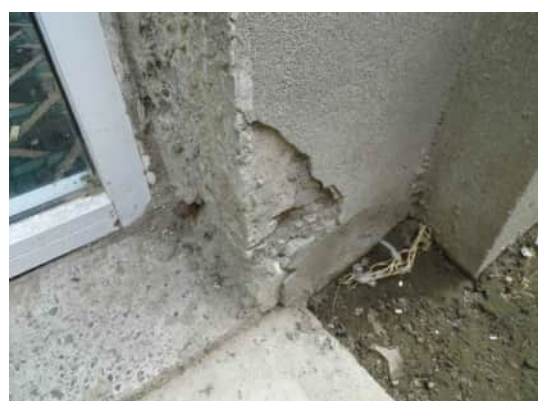
EE9
A-554 DAMAGED CONCRETE ON OTHER SIDE OF DOOR, REINFORCING IS ALSO EXPOSED (WALL APPEARS TO HAVE BEEN CUT TO FORM DOOR)

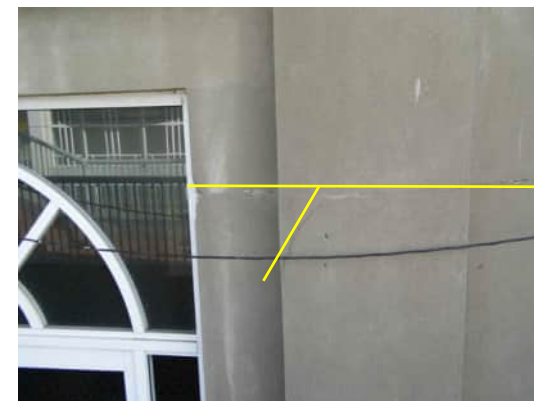
EE10
A-554 SIGNIFICANT HORIZONTAL CRACK ALONG WALL

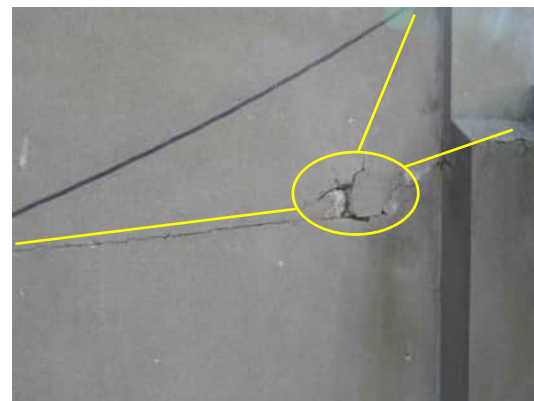
EE11
A-554 CONTINUATION OF CRACK SHOWN IN EE10 WITH SOME CONCRETE BREAKING OUT

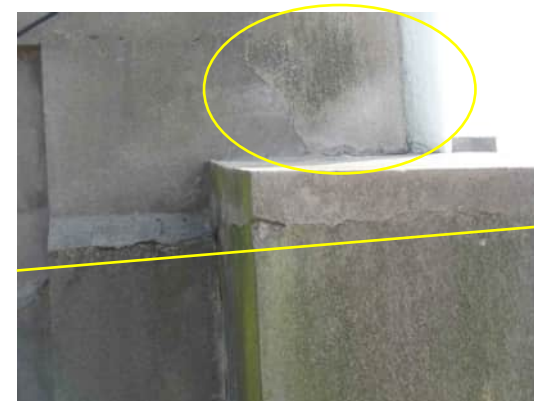
EE12
A-554 CONTINUATION OF CRACK SHOWN IN EE11 THROUGH GRID A COLUMN

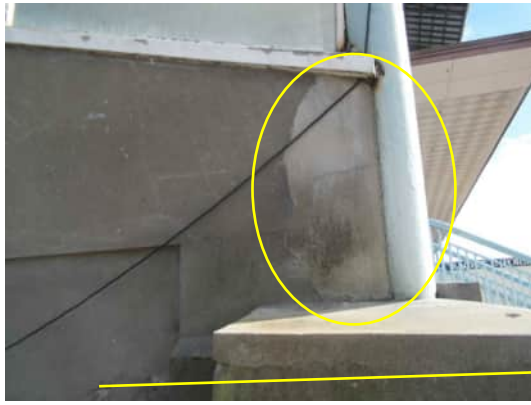
EE13
A-554 | CRACKING TO WALL ABOVE GRID A COLUMN

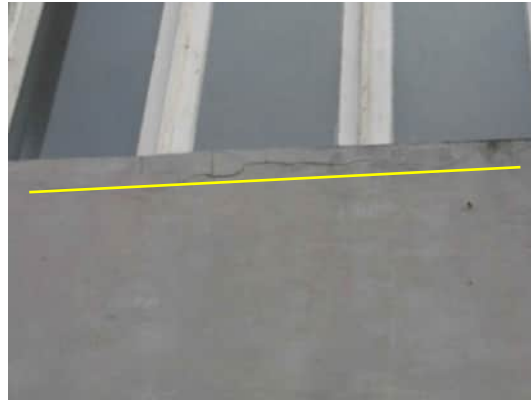
EE14
A-554 | CRACKS BELOW WINDOW BETWEEN GRID C AND GRID D

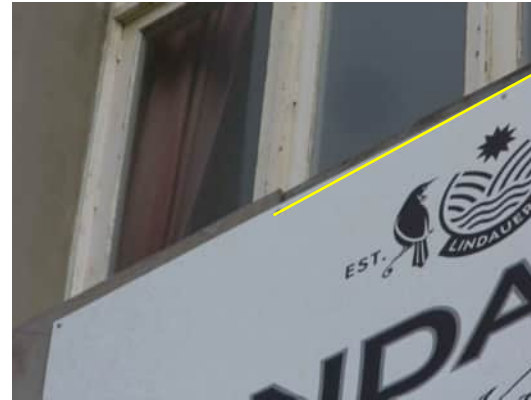
EE15
A-554 | RENDER HAS BROKEN OFF BEHIND SIGN

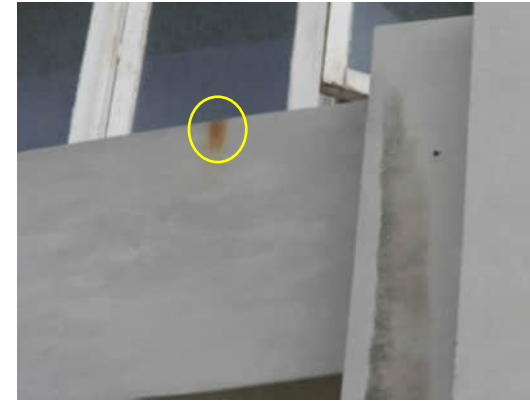
EE16
A-554 | EVIDENCE OF RUST BELOW THE THIRD FLOOR WINDOW

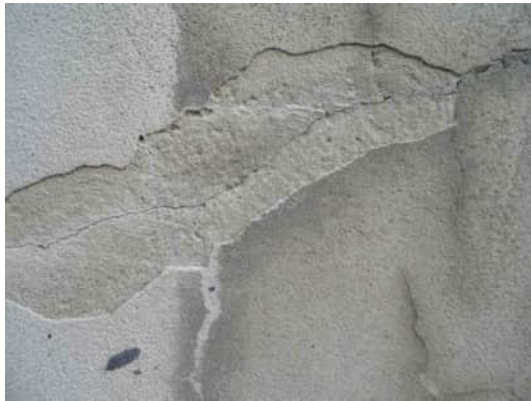
EE17
A-554 | 0.2MM CRACK IN GRID C COLUMN

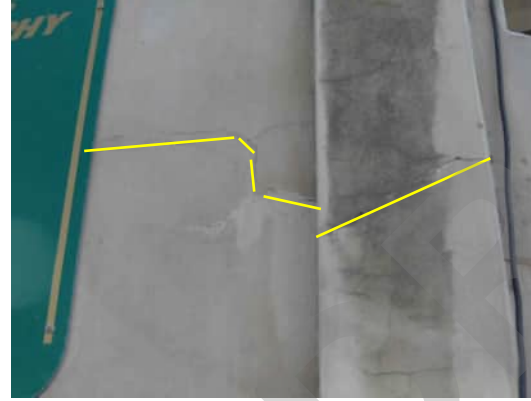
EE18
A-554 | HORIZONTAL CRACK IN WALL AND COLUMN BETWEEN GRID B AND C

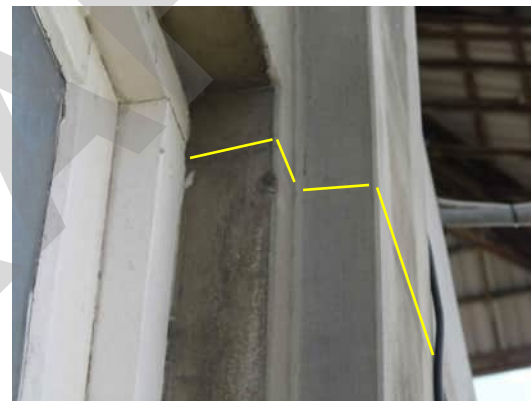
EE19
A-554 | HORIZONTAL CRACK IN COLUMN BETWEEN GRID B AND C

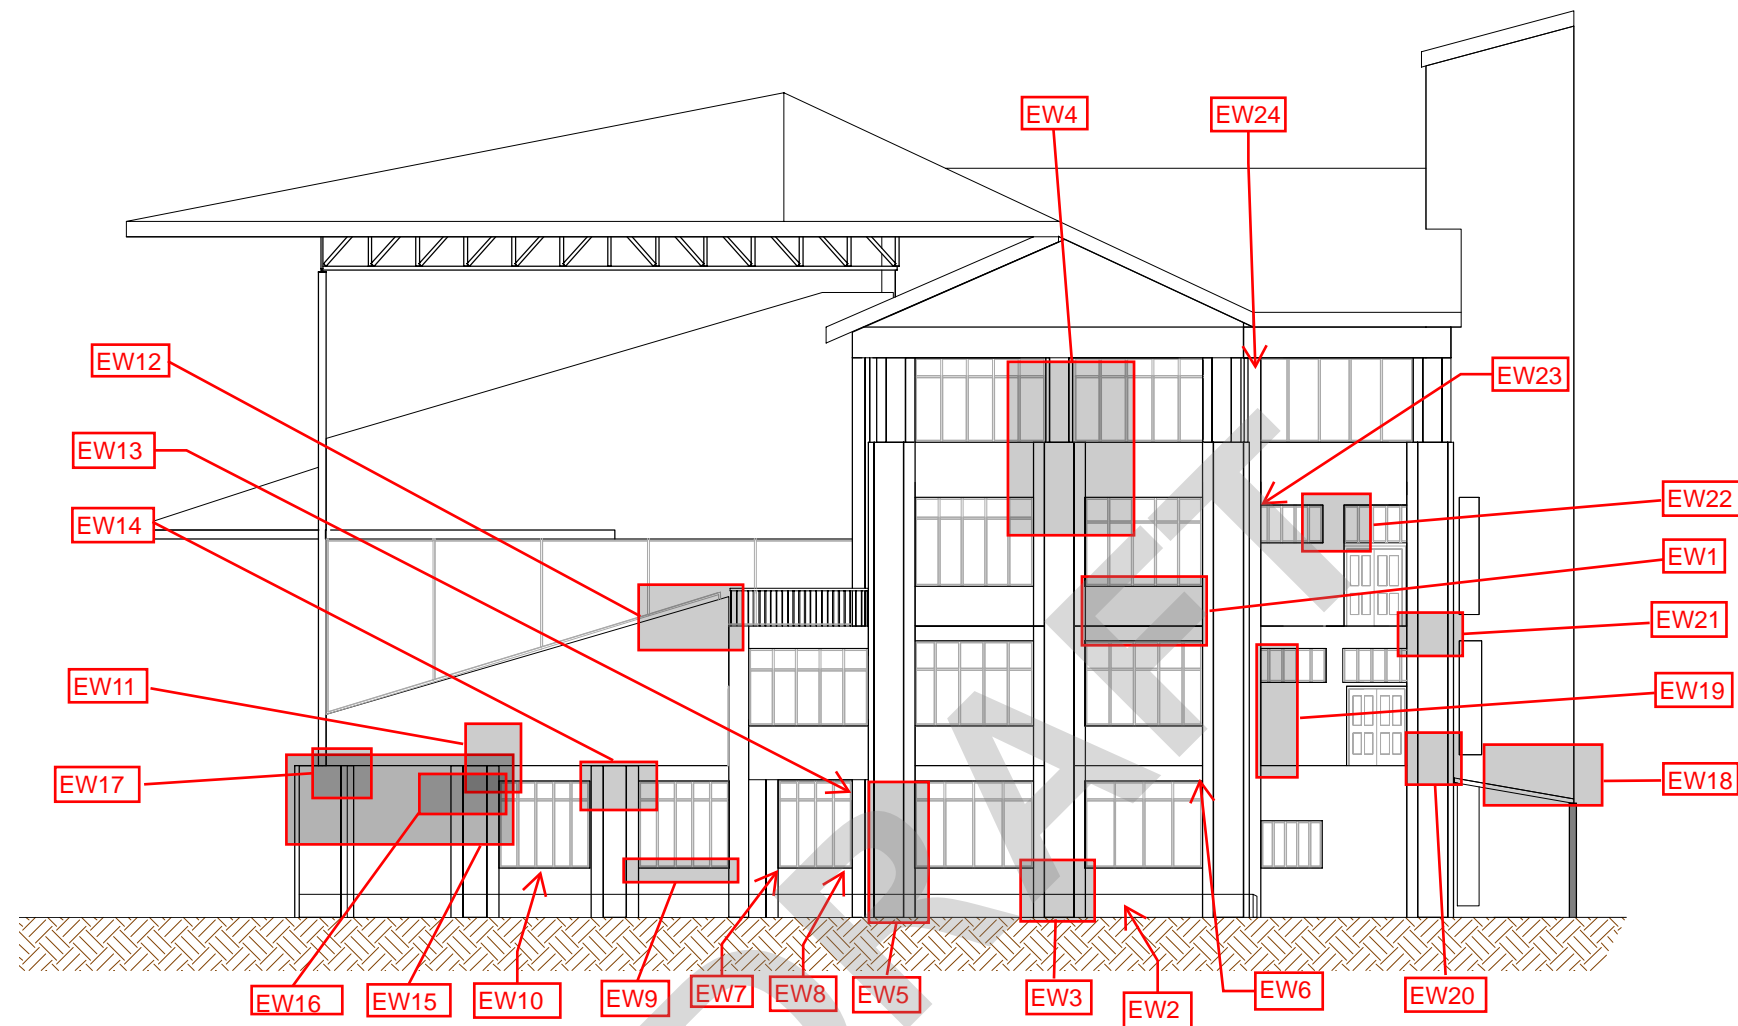
DAMAGE PHOTO KEYPLAN - WEST ELEVATION

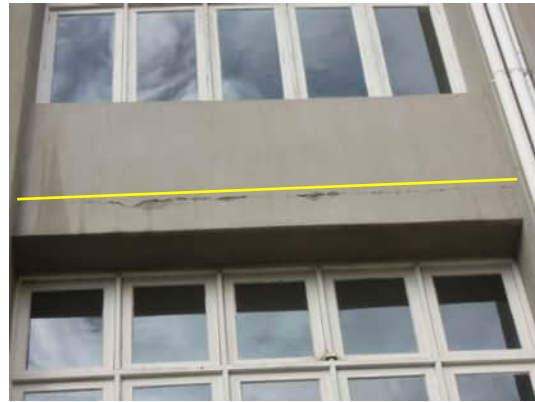
EW1 | SIGNIFICANT CRACK ABOVE FIRST FLOOR WINDOW BETWEEN GRID C AND GRID D
A-557

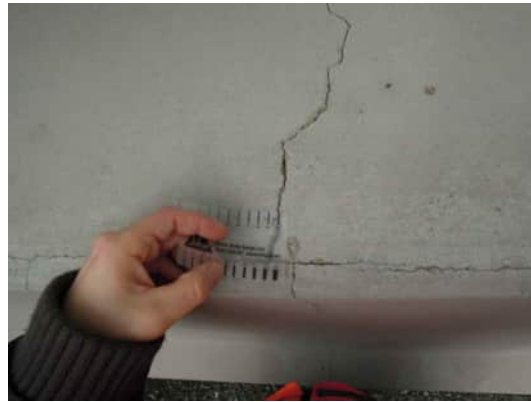
EW2 | 1.0MM VERTICAL CRACK BELOW GROUND FLOOR WINDOW
A-557

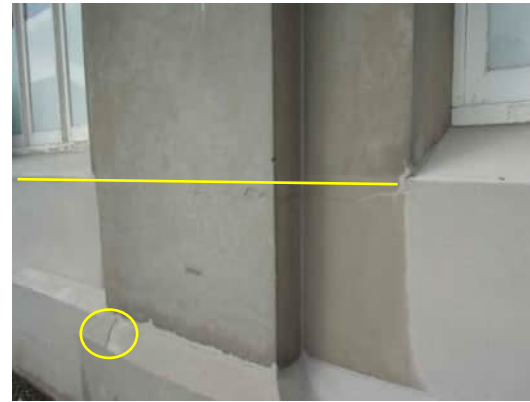
EW3 | 0.2MM HORIZONTAL CRACK NEAR BASE OF CENTRAL COLUMN
A-557

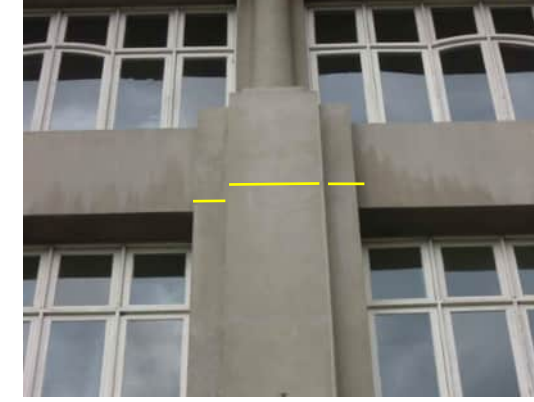
EW4 | HORIZONTAL CRACK ON CENTRAL COLUMN ABOVE SECOND FLOOR WINDOWS
A-557

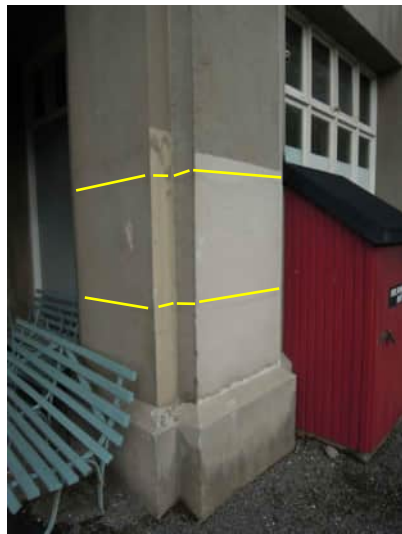
EW5 | 0.2MM HORIZONTAL CRACKS NEAR BASE OF GRID C COLUMN
A-557

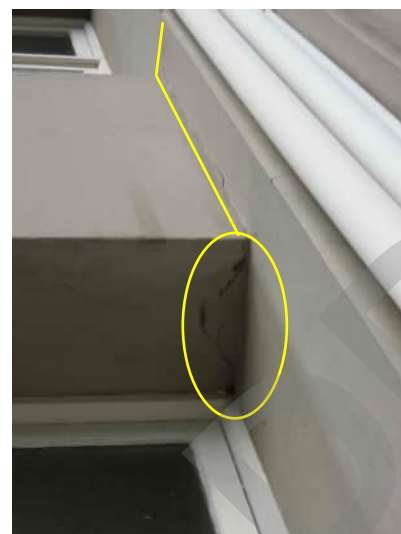
EW6 | TYPICAL SEPARATION BETWEEN WALLS AND COLUMNS
A-557

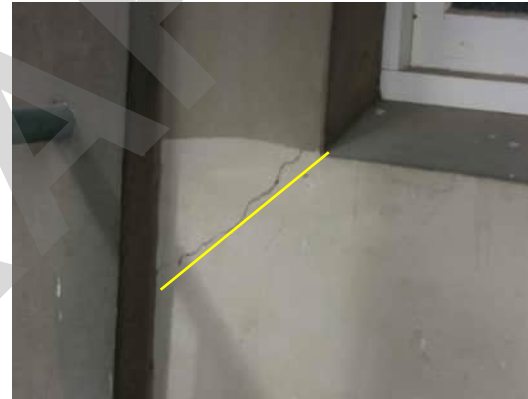
EW7 | DIAGONAL CRACK BELOW WINDOW ON COLUMN BETWEEN AND GRID C
A-557

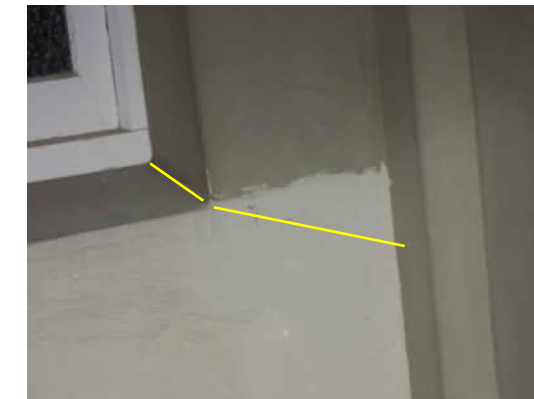
EW8 | DIAGONAL CRACK BELOW WINDOW ON COLUMN BETWEEN GRID B AND GRID C
A-557

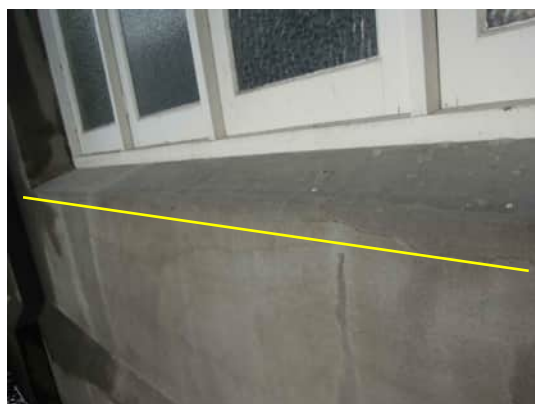
EW9 | HORIZONTAL CRACK BELOW WINDOW
A-557

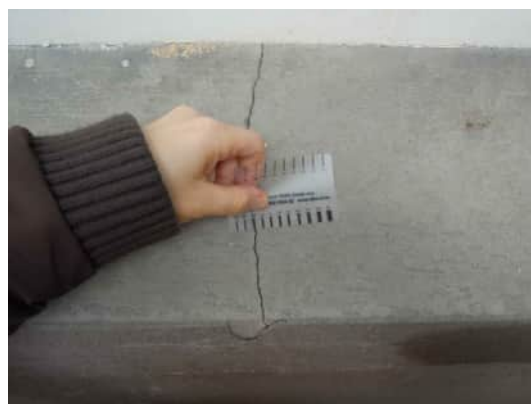
EW10 | 1.0MM VERTICAL CRACK BELOW WINDOW
A-557

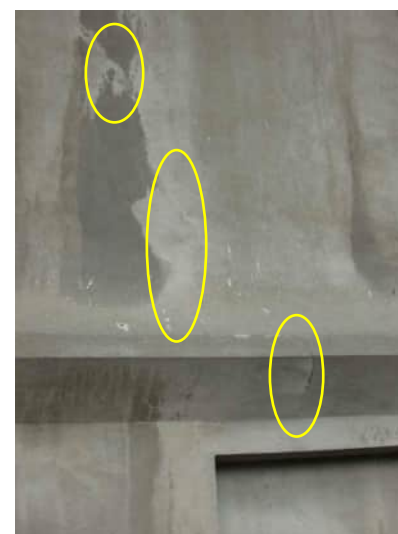
EW11 | VERTICAL CRACK ABOVE GROUND FLOOR WINDOW GRID A AND GRID B
A-557

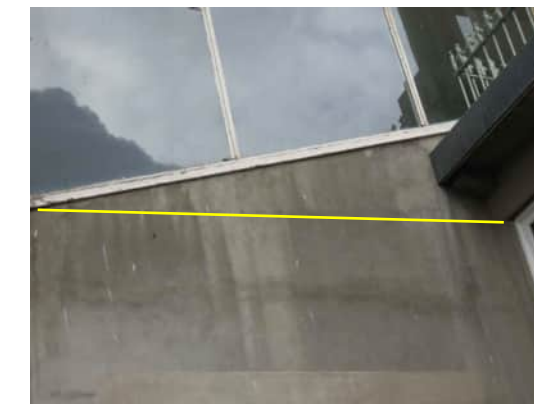
EW12 | HORIZONTAL CRACK IN CONCRETE WALL OF LOWER STAND
A-557

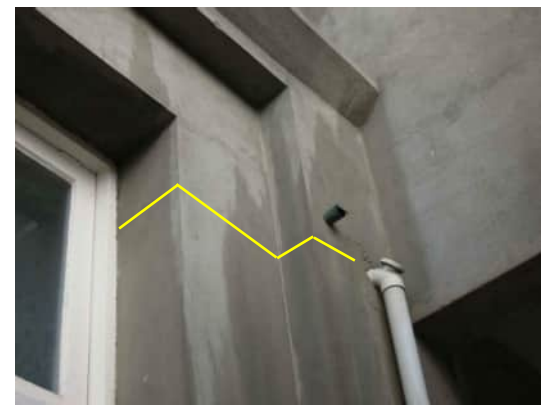
EW13
A-557 | HORIZONTAL CRACK NEAR CEILING LEVEL OF GROUND FLOOR, ON COLUMN BETWEEN GRID B AND GRID C

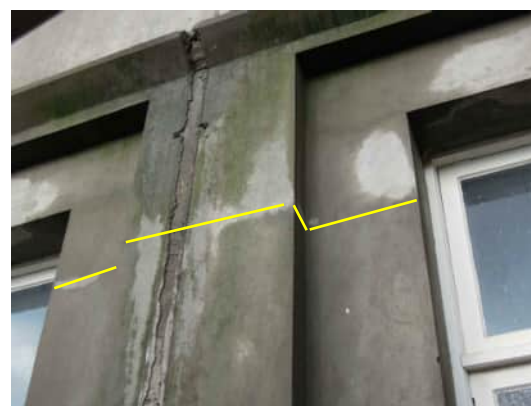
EW14
A-557 | HORIZONTAL CRACK NEAR CEILING LEVEL OF GROUND FLOOR ON COLUMN AT GRID B

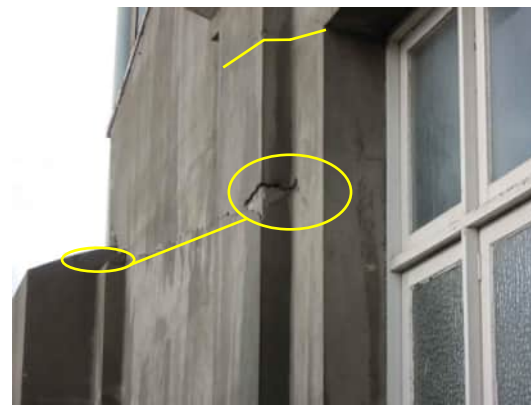
EW15
A-557 | HORIZONTAL CRACK BECOMES WIDER TOWARDS GRID A

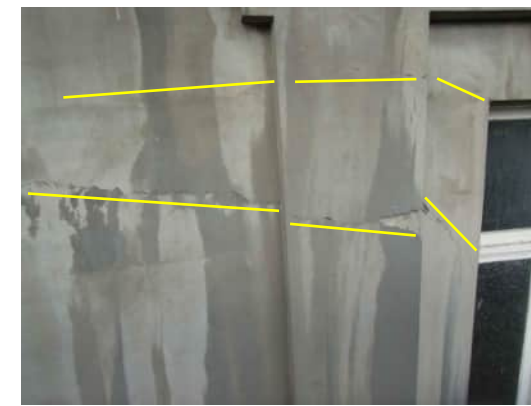
EW16
A-557 | HORIZONTAL CRACK AND DAMAGED COLUMN

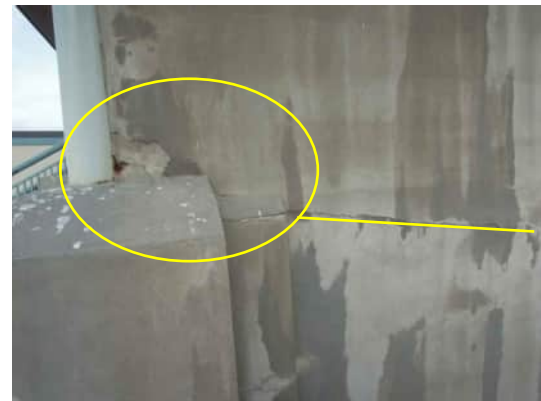
EW17
A-557 | HORIZONTAL CRACK AT GRID A COLUMN WITH SPALLING AND EVIDENCE OF RUST

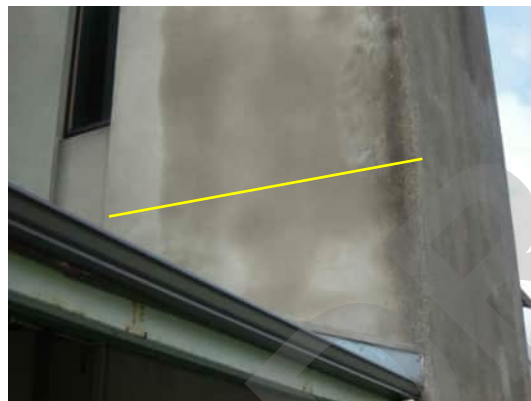
EW18
A-557 | CRACK IN LIFT SHAFT NEAR FLOOR LEVEL OF FIRST FLOOR

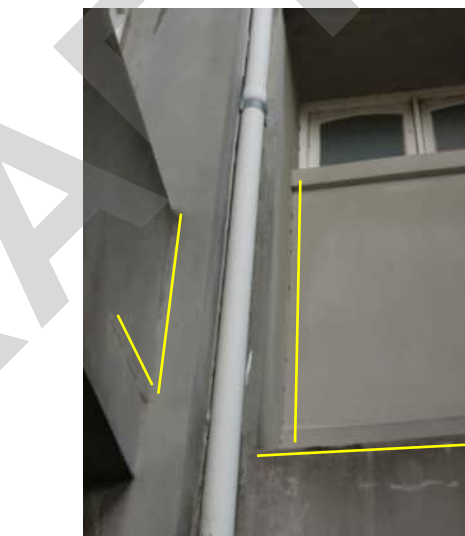
EW19
A-557 | SEPARATION BETWEEN GRID D COLUMN AND INFILL WALL

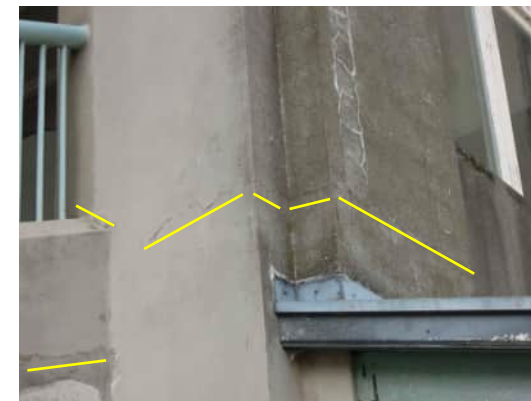
EW20
A-557 | HORIZONTAL CRACK AROUND GRID E COLUMN

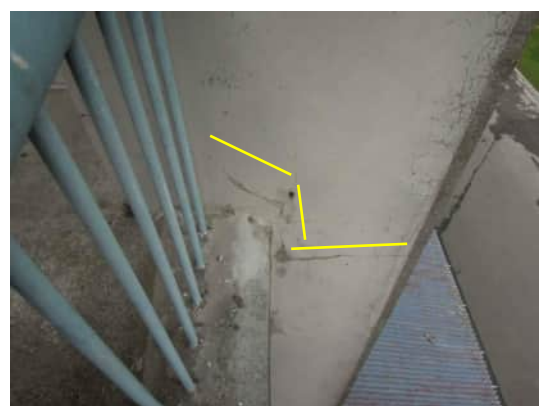
EW21
A-557 | CRACKING TO GRID E COLUMN NEAR WHERE STAIRS CONNECT AT SECOND FLOOR UP TO 0.5MM

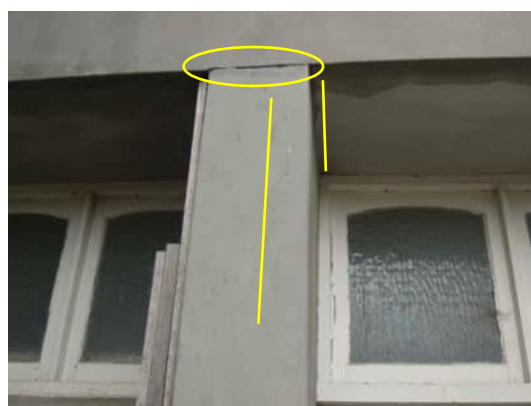
EW22
A-557 | VERTICAL CRACKING TO CENTRAL COLUMN AND SEPARATION BETWEEN THE COLUMN AND THE WALL BETWEEN THE SECOND AND THE THIRD FLOOR

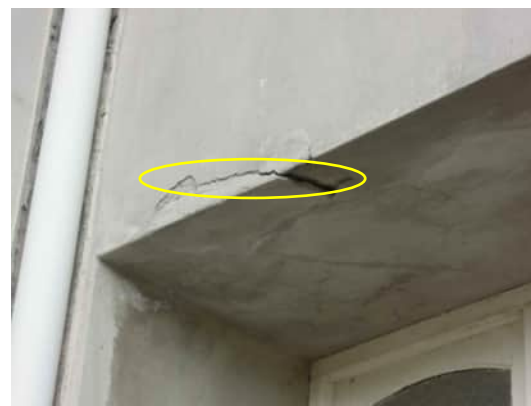
EW23
A-557 | RENDER BREAKING OFF ABOVE SECOND FLOOR WINDOW

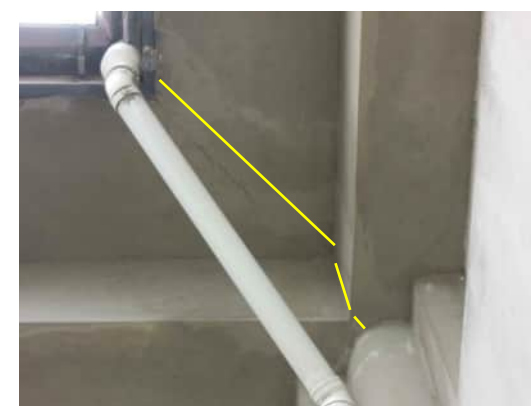
EW24
A-557 | CRACKING TO THE SOFFIT AT GRID D

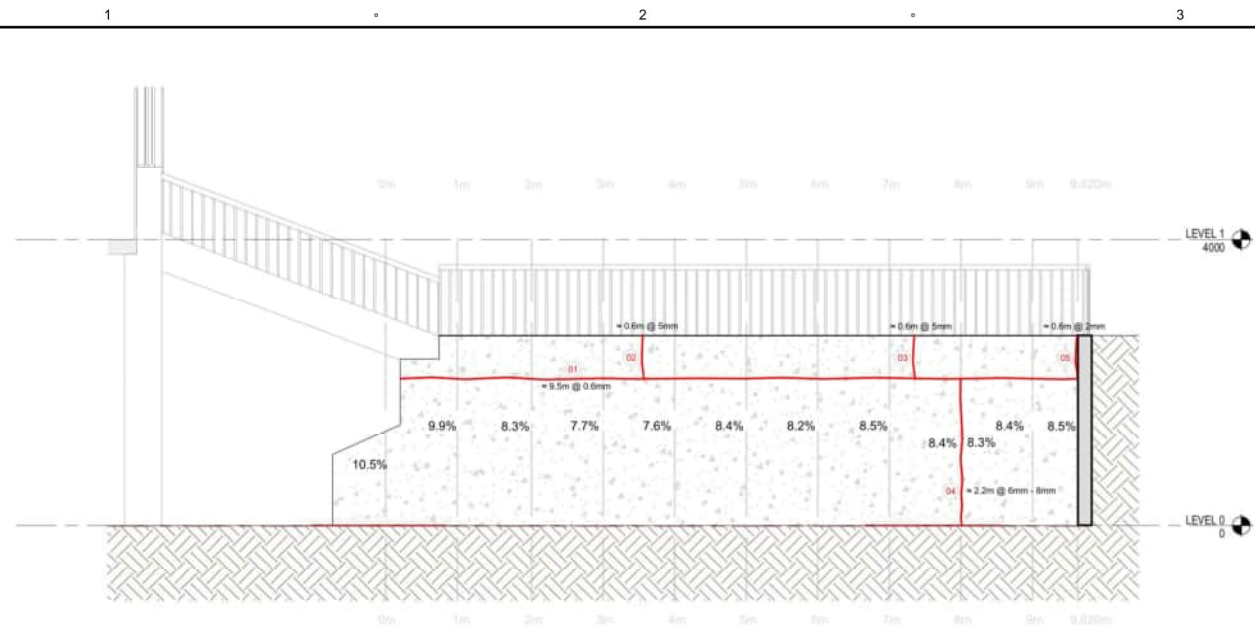
1 | RETAINING WALL DAMAGE SURVEY - WEST SIDE
A.700 REF: A.150 Scale: 1:50

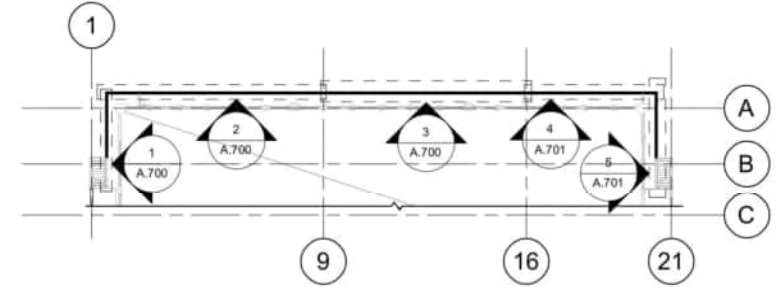
RETAINING WALL - DAMAGE ASSESSMENT
Scale: 1:500

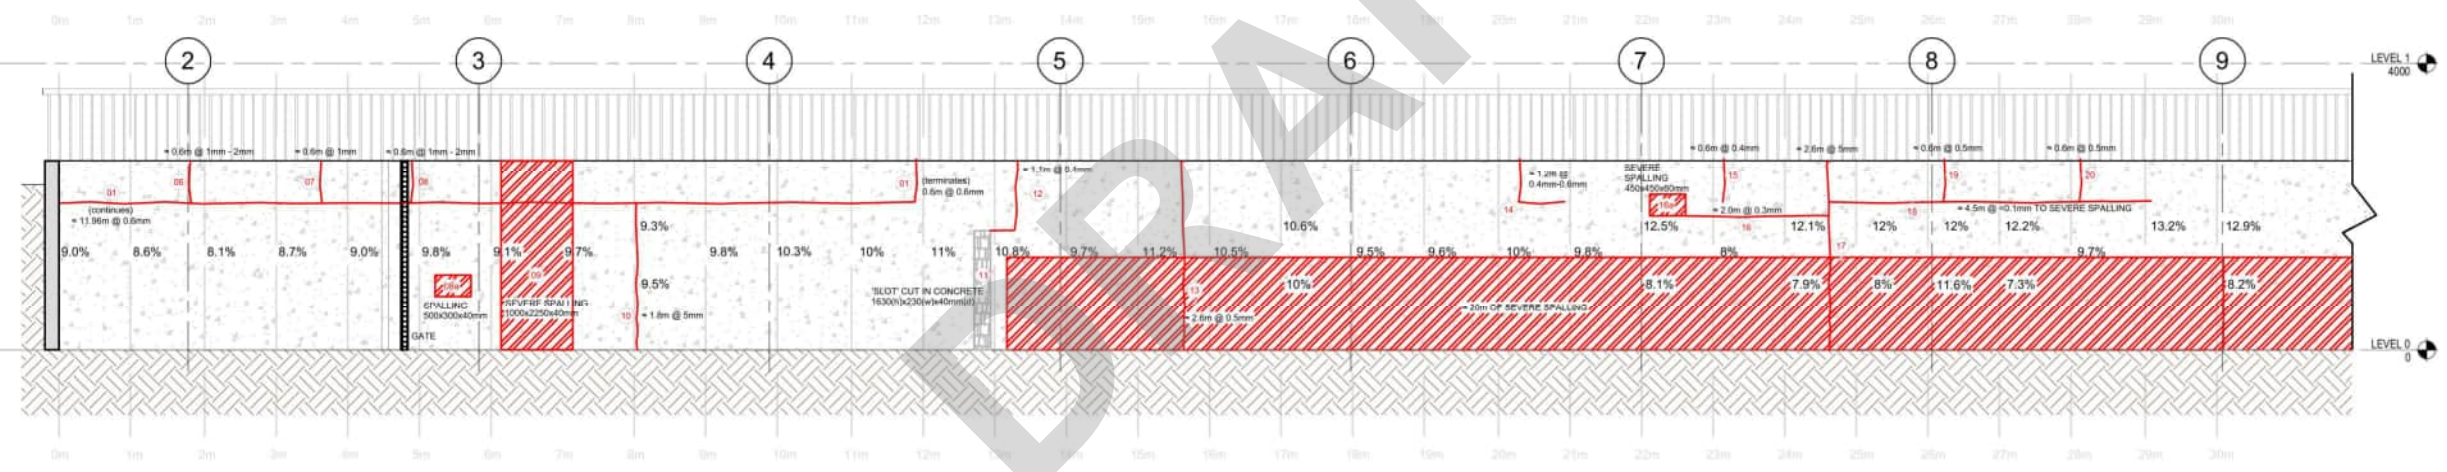
2 | RETAINING WALL DAMAGE SURVEY - NORTH SIDE UNTIL GRID 9
A.700 REF: A.153 Scale: 1:50

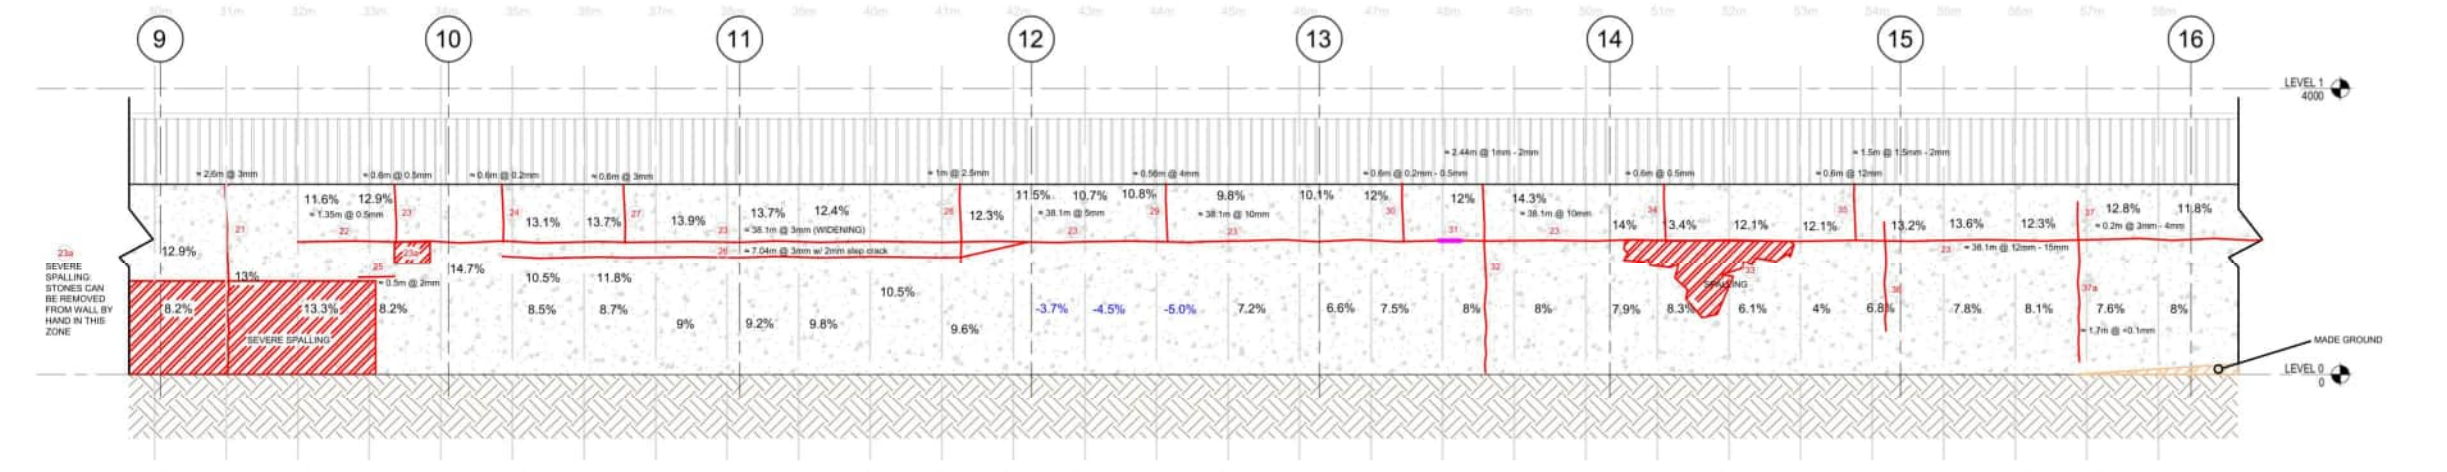
3 | RETAINING WALL DAMAGE SURVEY - NORTH SIDE FROM GRID 9 TO GRID 16
A.700 REF: A.153 Scale: 1:50

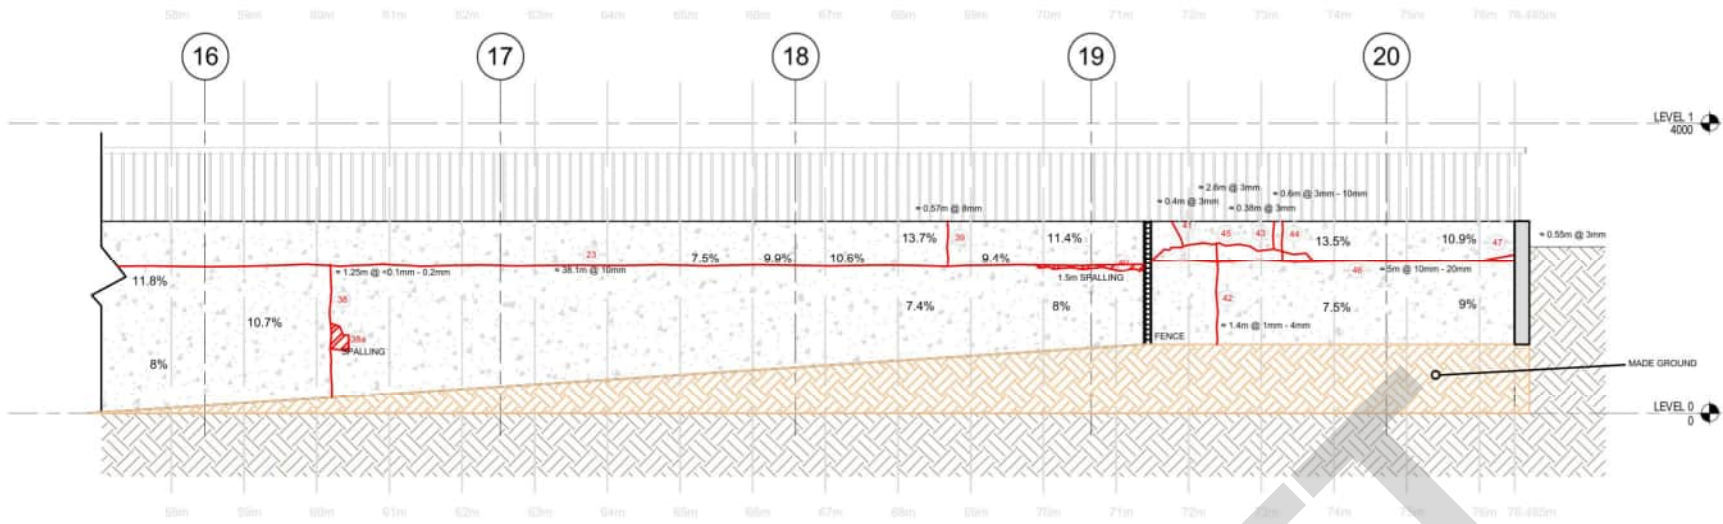
4 | RETAINING WALL DAMAGE SURVEY - NORTH SIDE - END PART FROM GRID 16

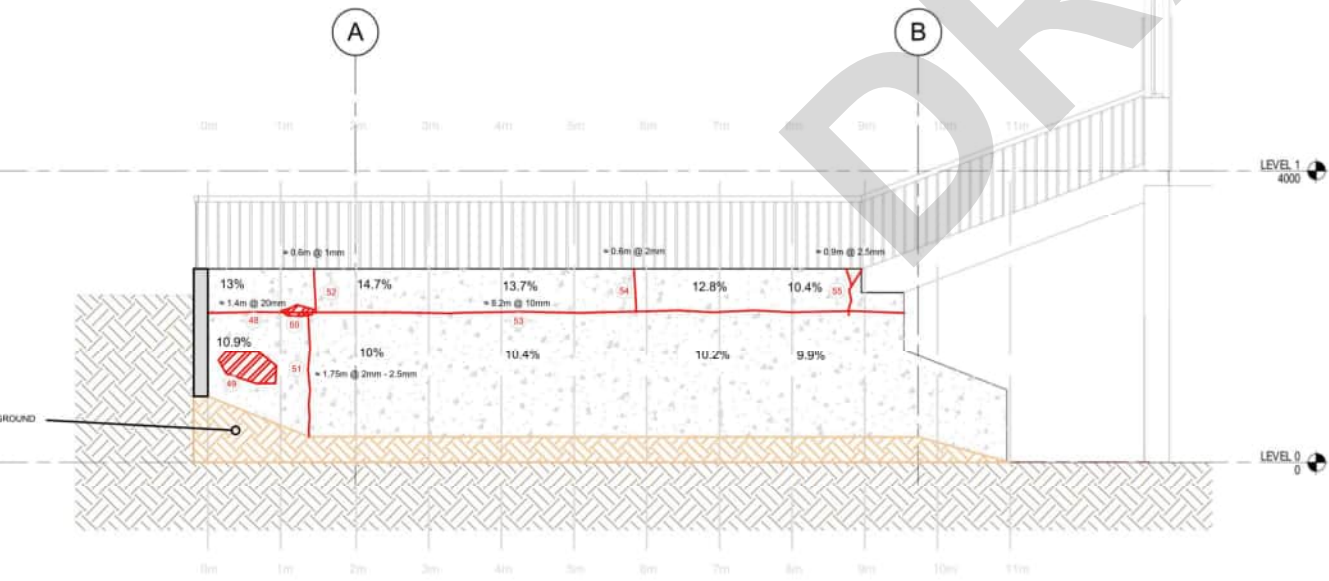
5 | RETAINING WALL DAMAGE SURVEY - EAST SIDE

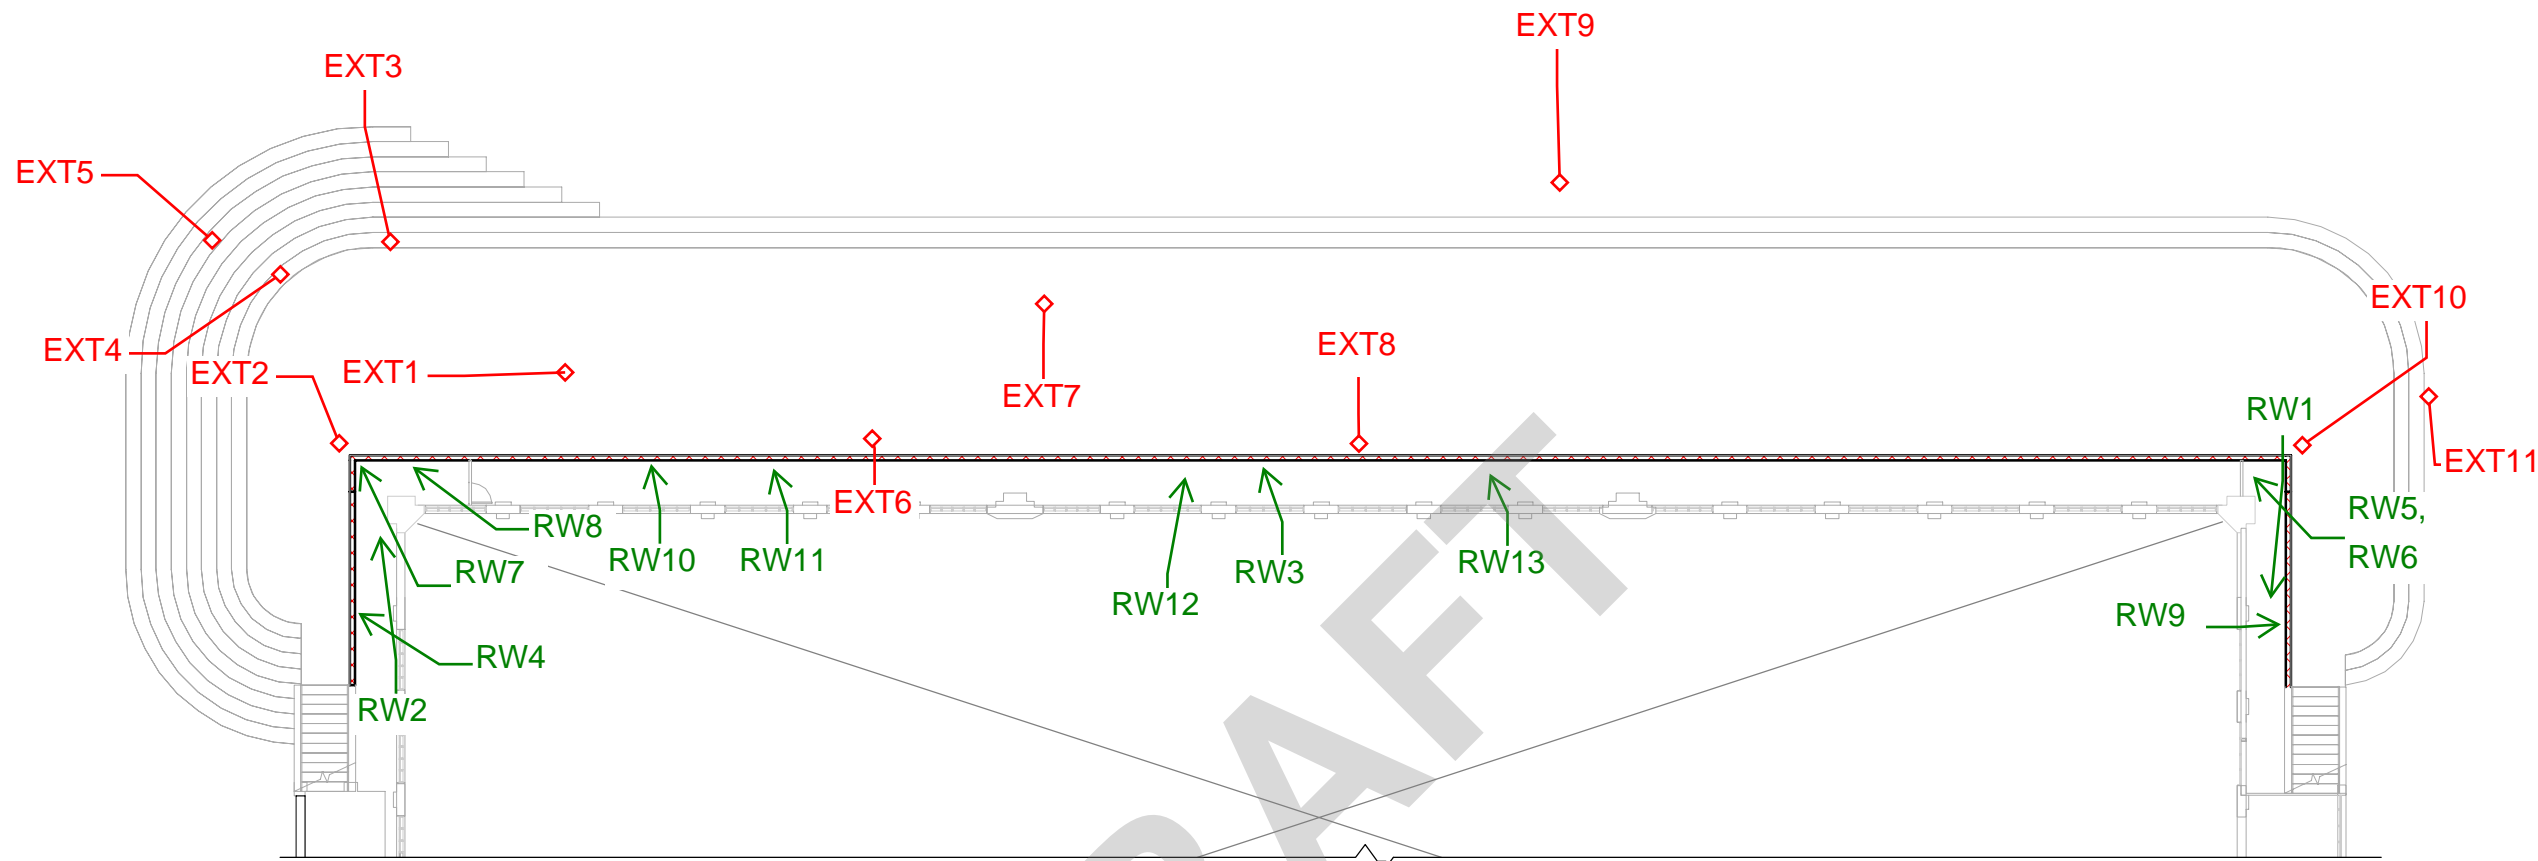
DAMAGE PHOTO KEYPLAN - RETAINING WALL AND CONCRETE STEPS

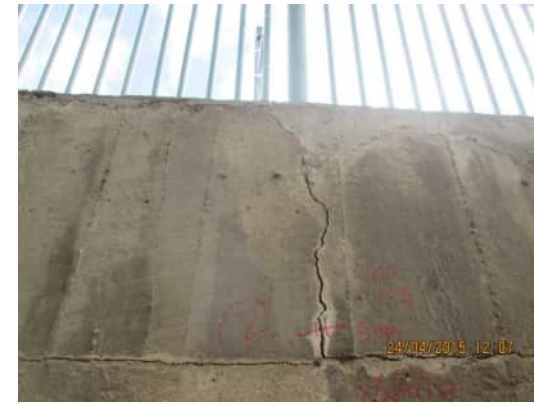
RW.4 TYPICAL CRACK FROM TOP OF WALL TO JOINT, CRACKS RANGE FROM 0.2MM TO 5MM
A.710
