Detailed Damage Evaluation

Quantitative Seismic Analysis of Grand National (Public) Stand

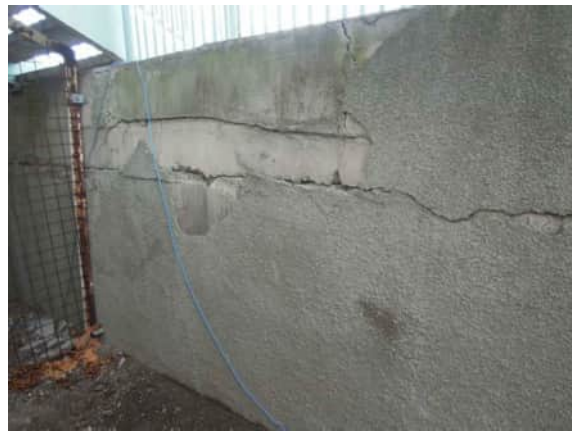
RW.5 SIGNIFICANT CRACKS UP TO 10MM AND DAMAGE TO RENDER
A.710

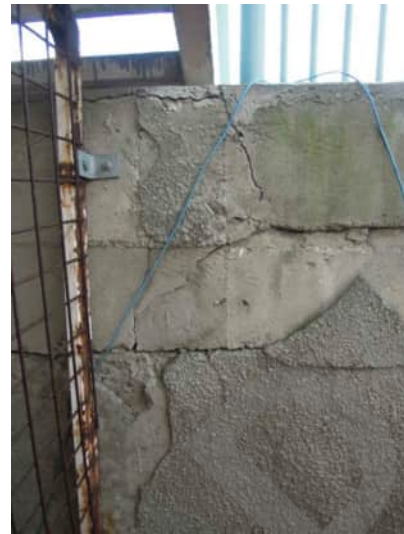
RW.6 SIGNIFICANT CRACKS BELOW STAIRS UP TO 3MM
A.710

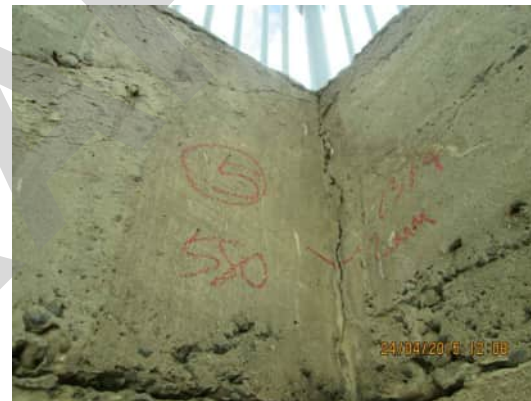
RW.7 CRACK IN CORNER OF RETAINING WALL, 2MM WIDE
A.710

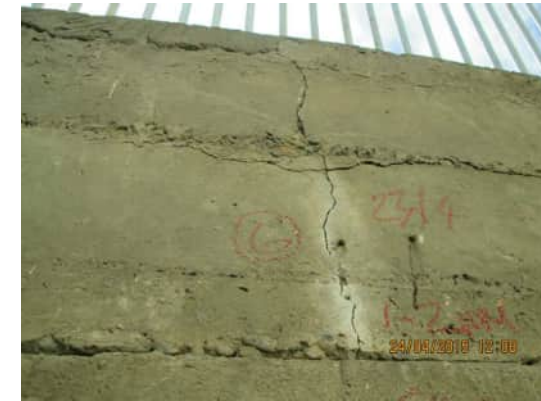
RW.8 VERTICAL CRACK FROM TOP OF WALL TO JOINT AND A HORIZONTAL CRACK RUNNING THROUGH
A.710

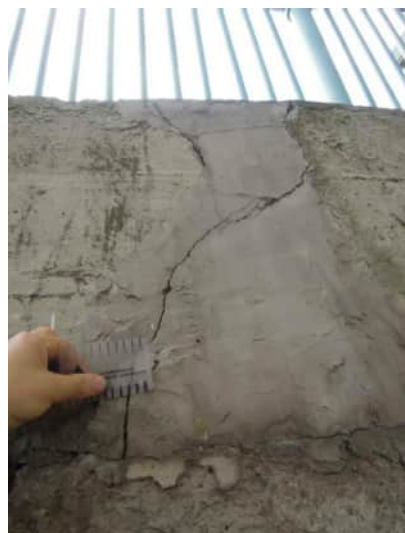
RW.9 CRACKS UP TO 2.5MM WHICH HAVE PREVIOUSLY BEEN REPAIRED BUT HAVE REAPPEARED
A.710

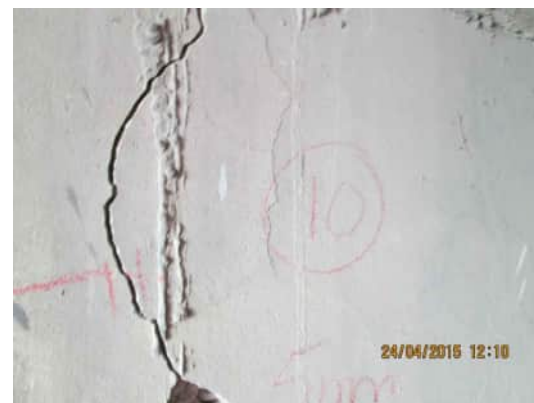
RW.10 1.8M LONG VERTICAL CRACK, UP TO 5MM WIDE, STARTING FROM THE BOTTOM OF THE WALL
A.710

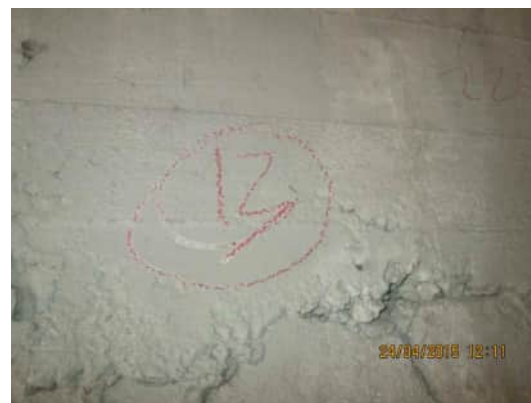
RW.11 SEVERE CONCRETE SPALLING
A.710

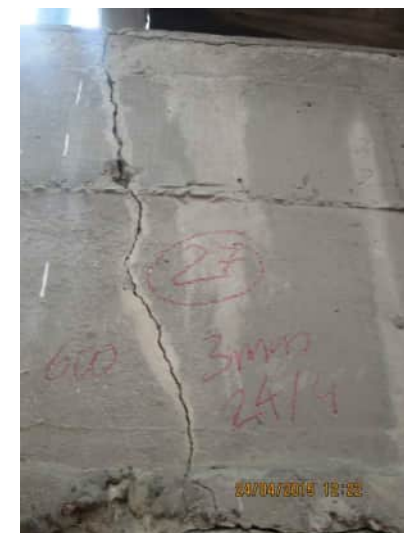
RW.12 APPROXIMATELY 600MM LONG VERTICAL CRACK, STARTING FROM THE TOP OF THE WALL, UP TO 3MM WIDE
A.710

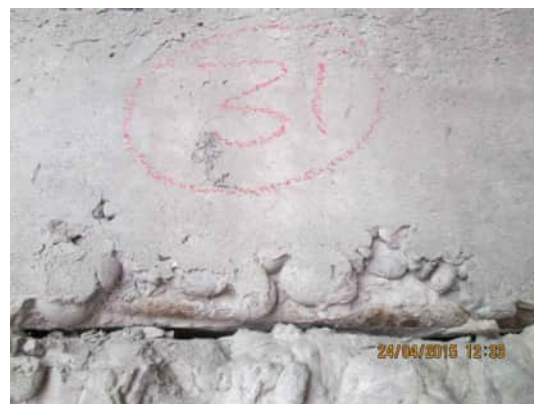
RW.13 | SIGNIFICANT HORIZONTAL CRACK AT JOINT AND EXPOSED REINFORCEMENT AT APPROXIMATELY 600MM FROM THE TOP OF THE WALL
A.710

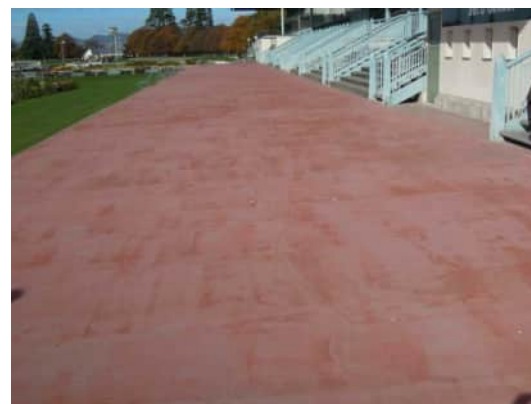
EXT.1 | CRACK ALONG ENTIRE LENGTH OF SLAB
A.710

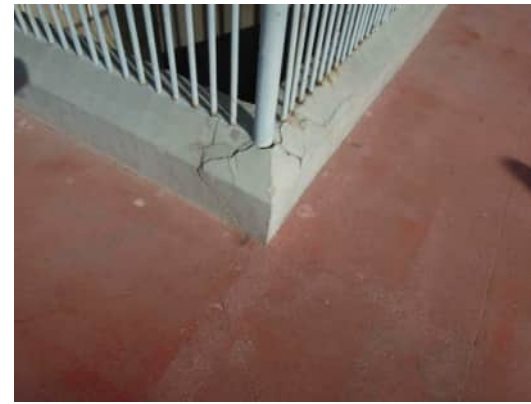
EXT.2 | DAMAGE TO TOP OF RETAINING WALL AROUND CAST-IN HANDRAIL
A.710

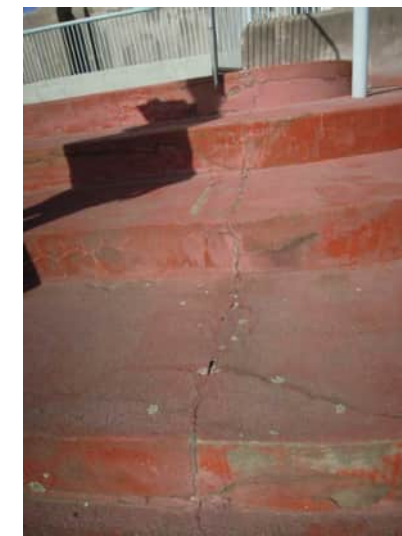
EXT.3 | CRACKS THROUGH STEPS, OCCURS THROUGHOUT
A.710

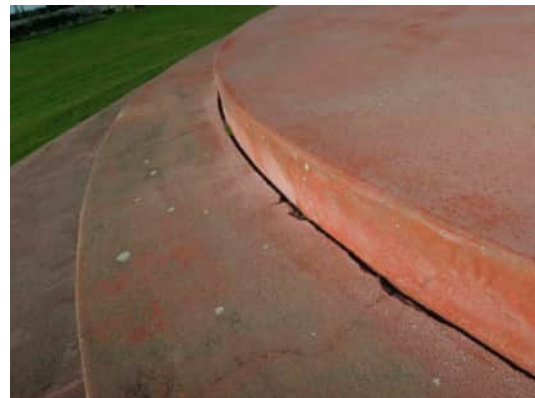
EXT.4 | SEPARATION BETWEEN SLAB AND FIRST STEP UP TO 25MM
A.710

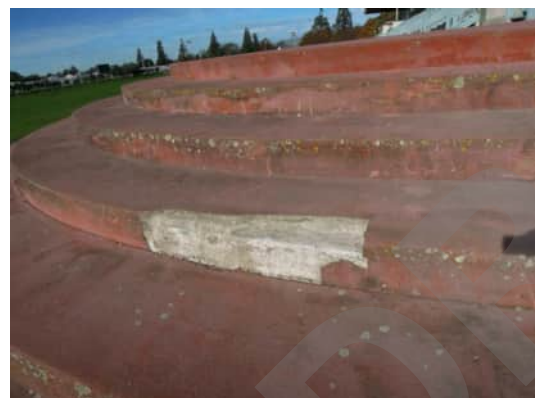
EXT.5 | SPALLING DAMAGE TO TOP OF STEP
A.710

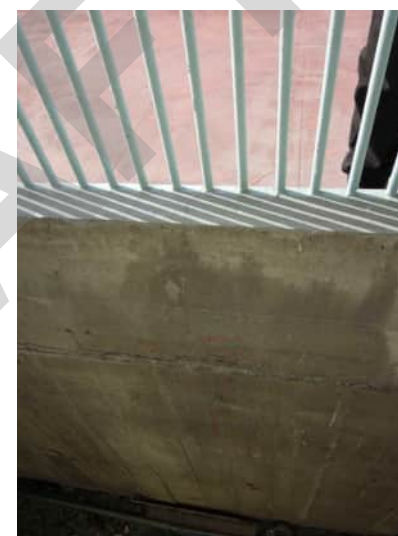
EXT.6 | CRACK IN SLAB WHICH CONTINUES THROUGH RETAINING WALL
A.710

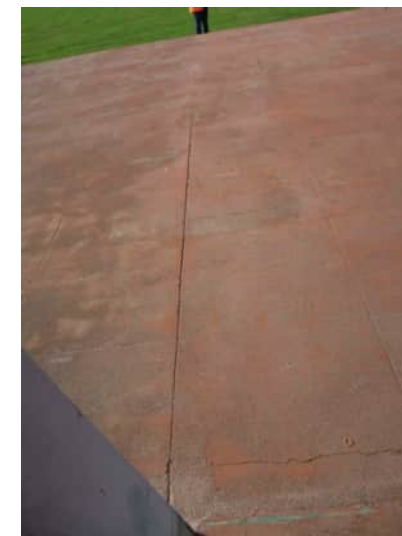
EXT.7 | TYPICAL CRACK IN JOINT
A.710

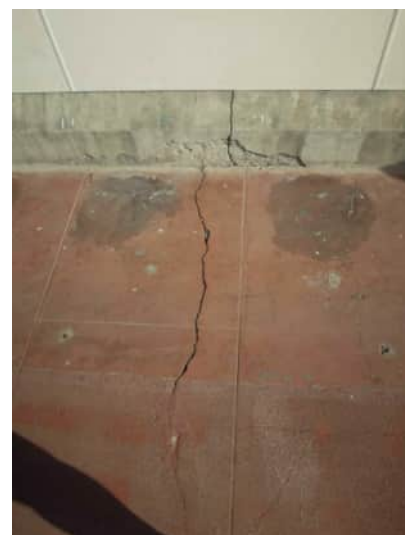
EXT.8 | CRACK IN SLAB AND RETAINING WALL
A.710

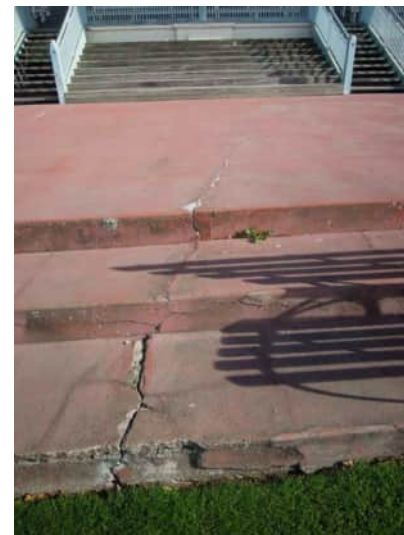
EXT.9 | CRACK THROUGH SLAB AND STEPS
A.710

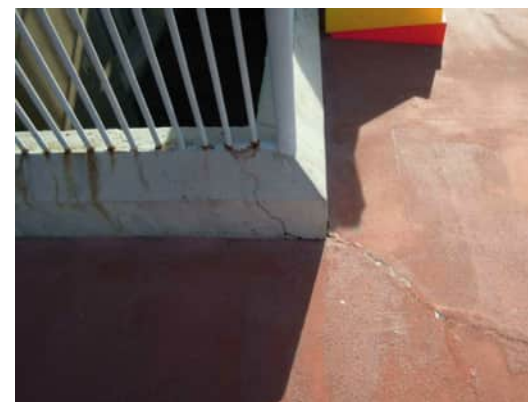
EXT.10 | CRACK IN SLAB FROM CORNER OF RETAINING WALL
A.710

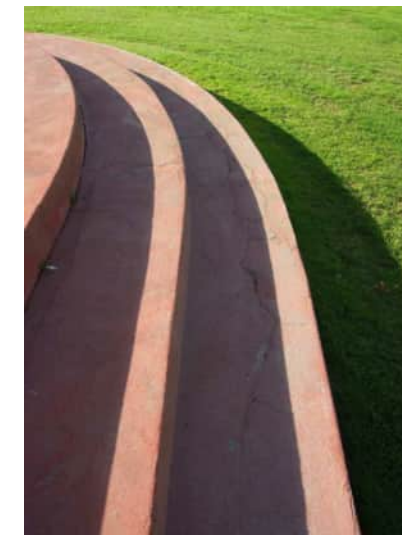
EXT.11 | CRACK ALONG LOWER STEP
A.710

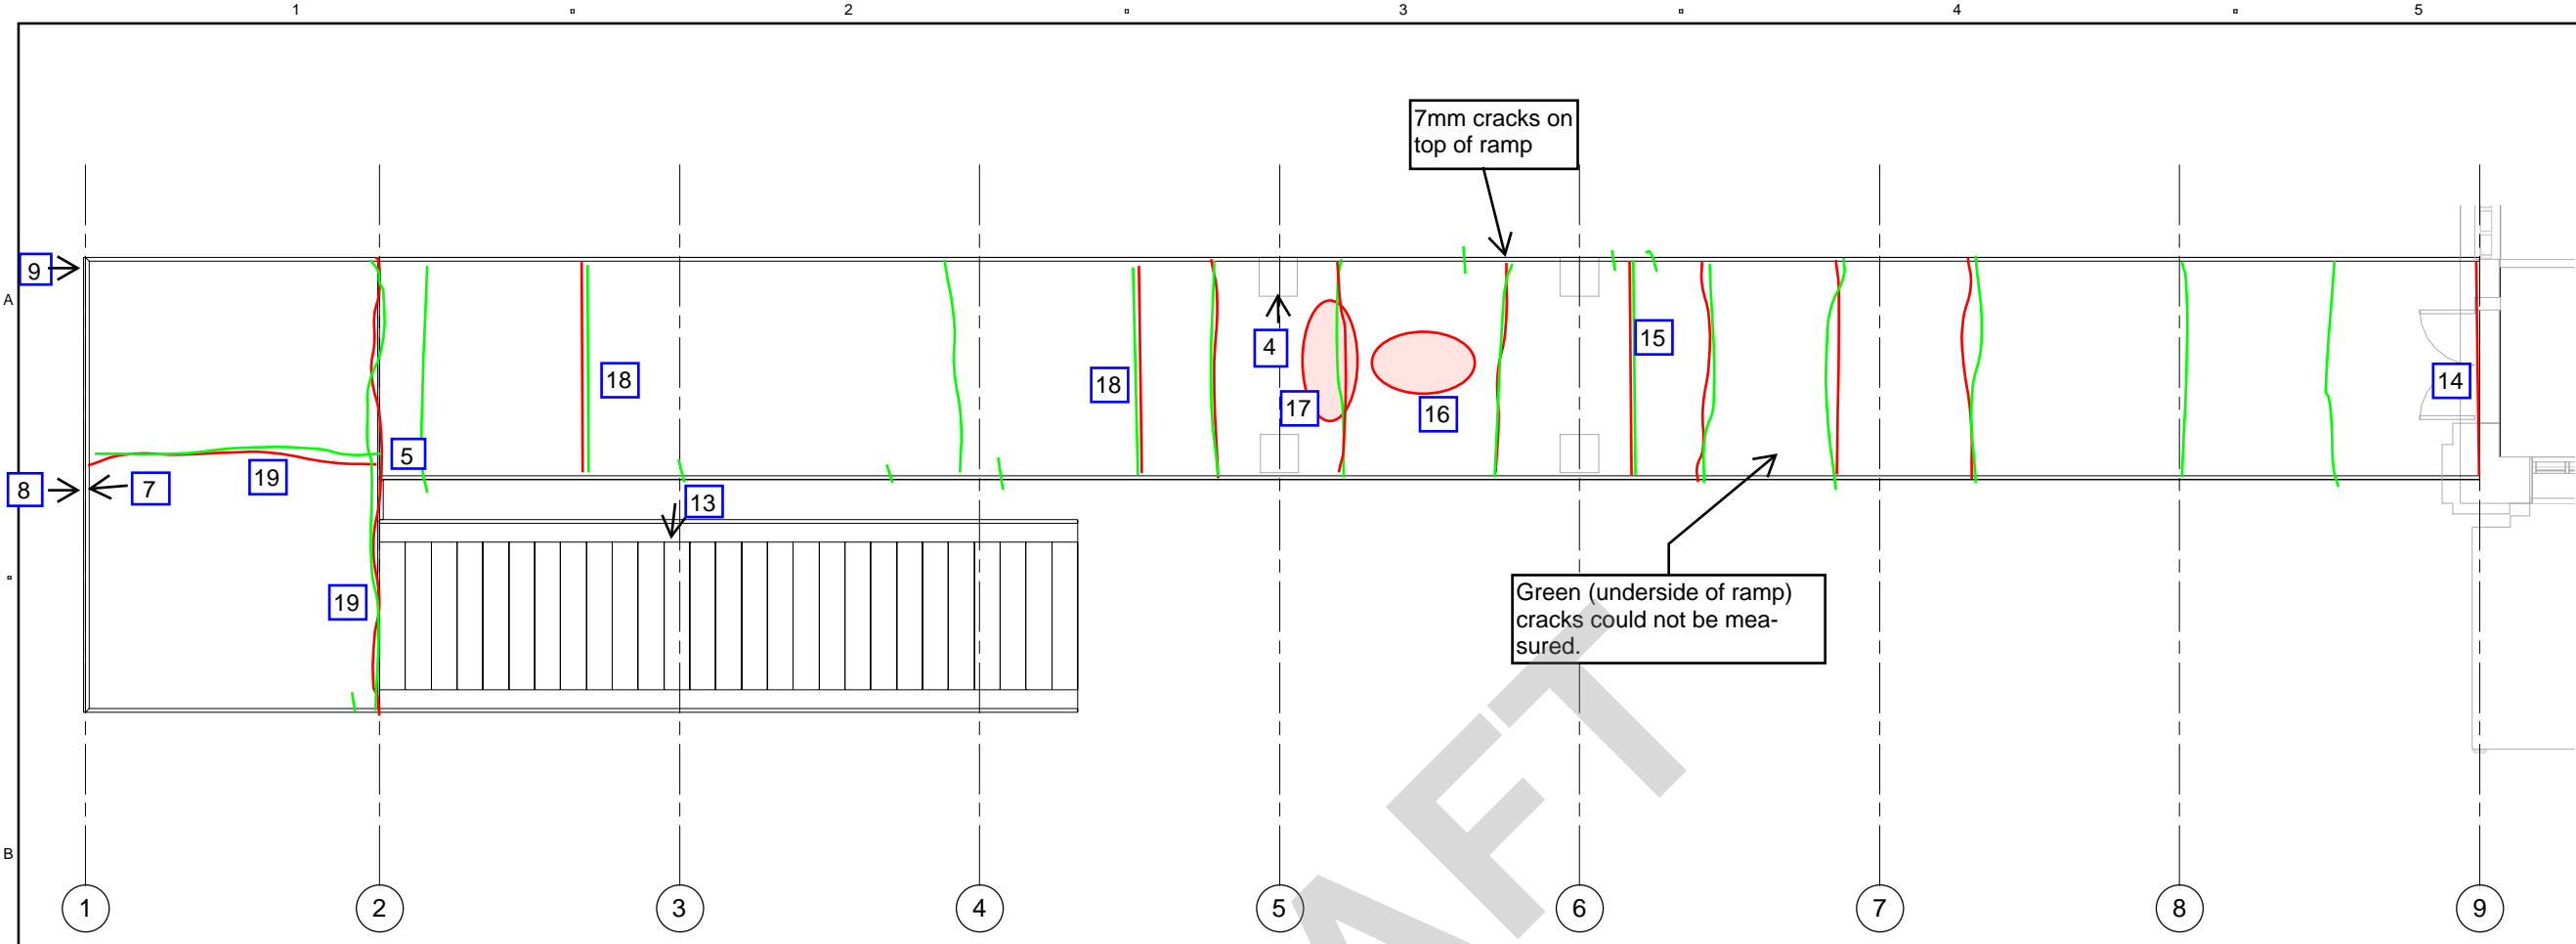
WEST RAMP DAMAGE ASSESSMENT - PLAN
 (See A.150 For Location) Scale: 1 : 50

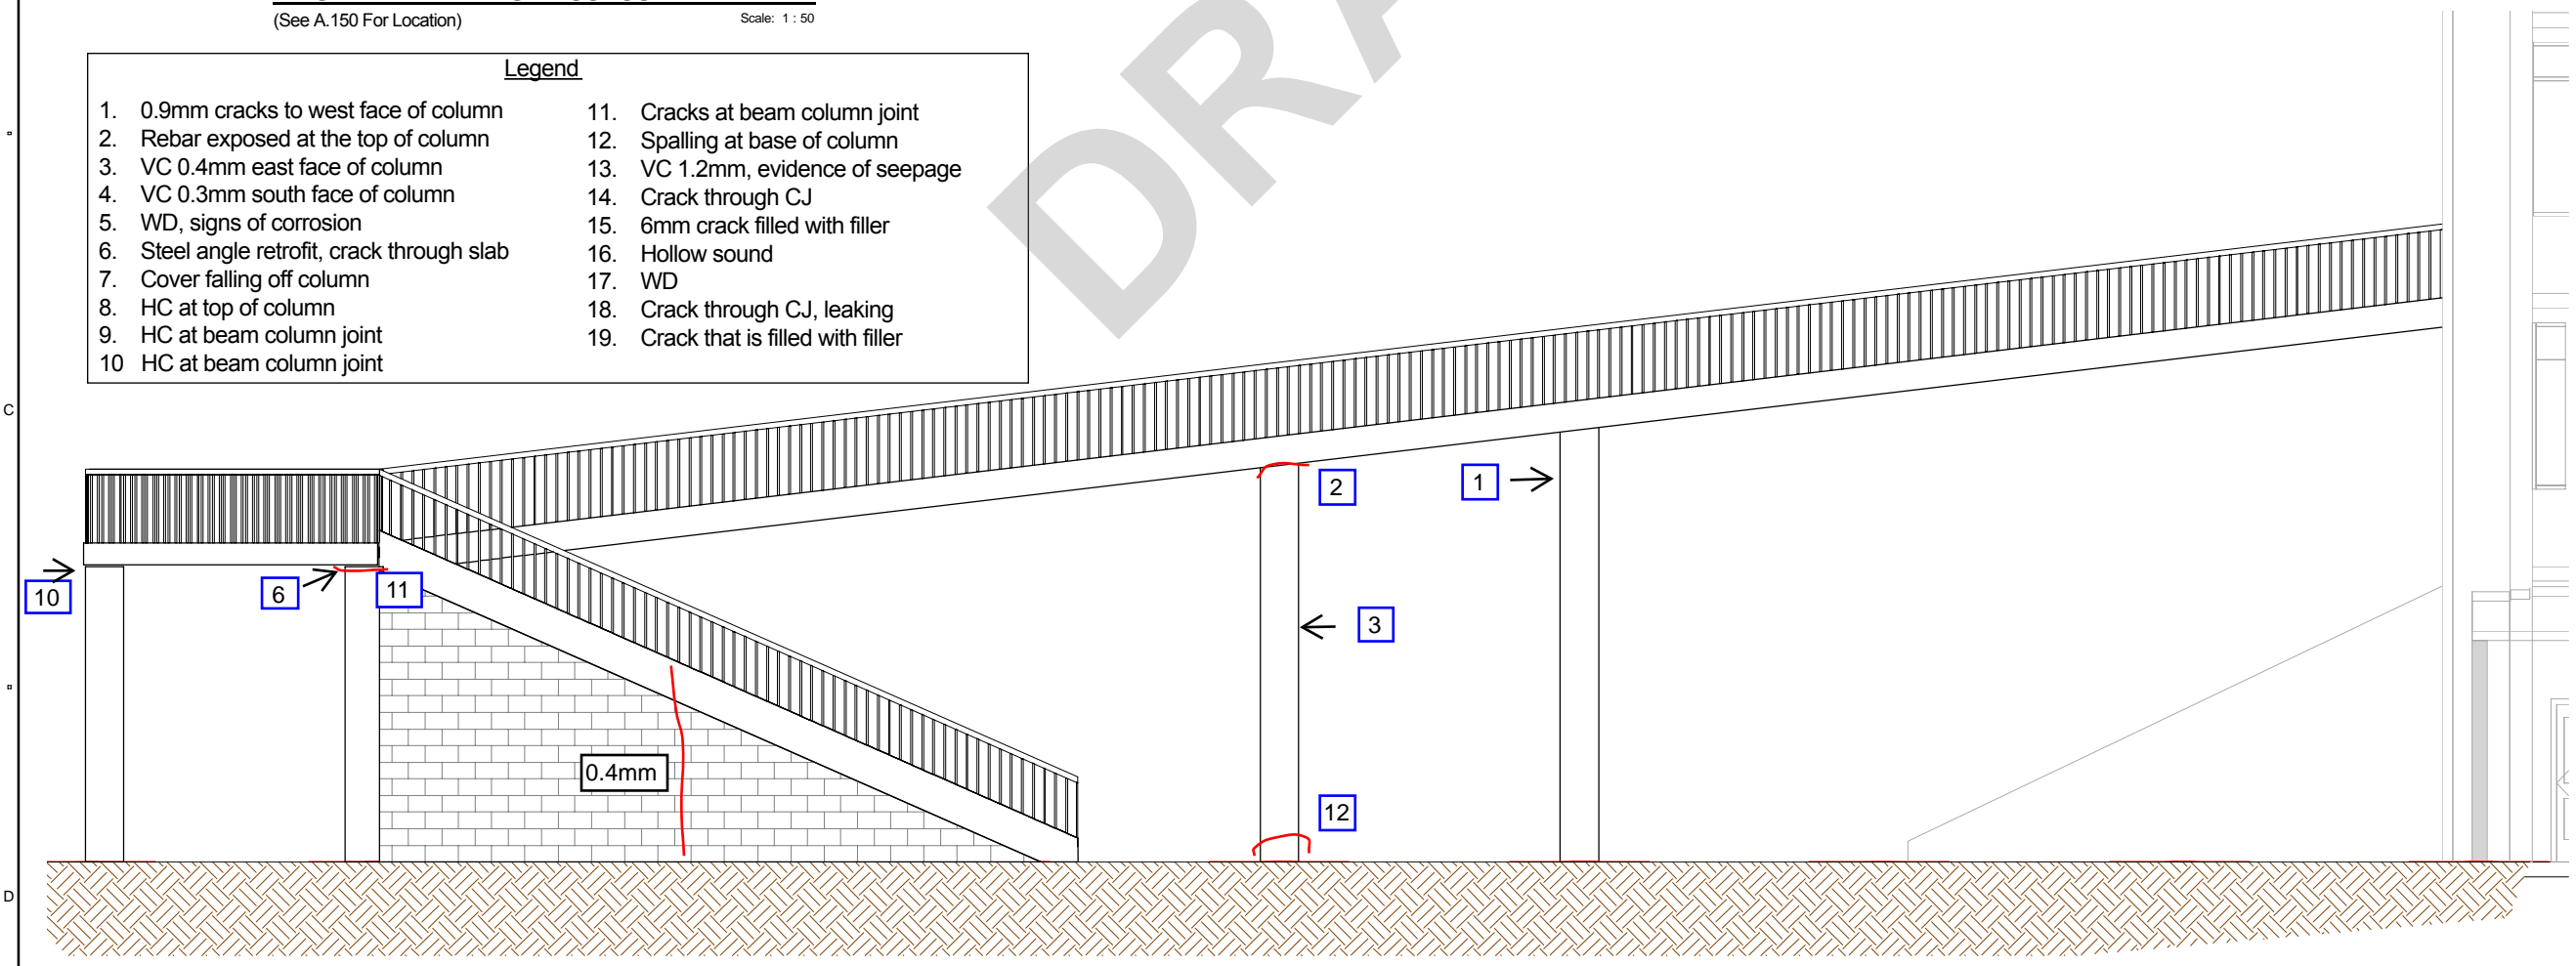
WEST RAMP DAMAGE ASSESSMENT - ELEVATION
 (See A.150 For Location) Scale: 1 : 50

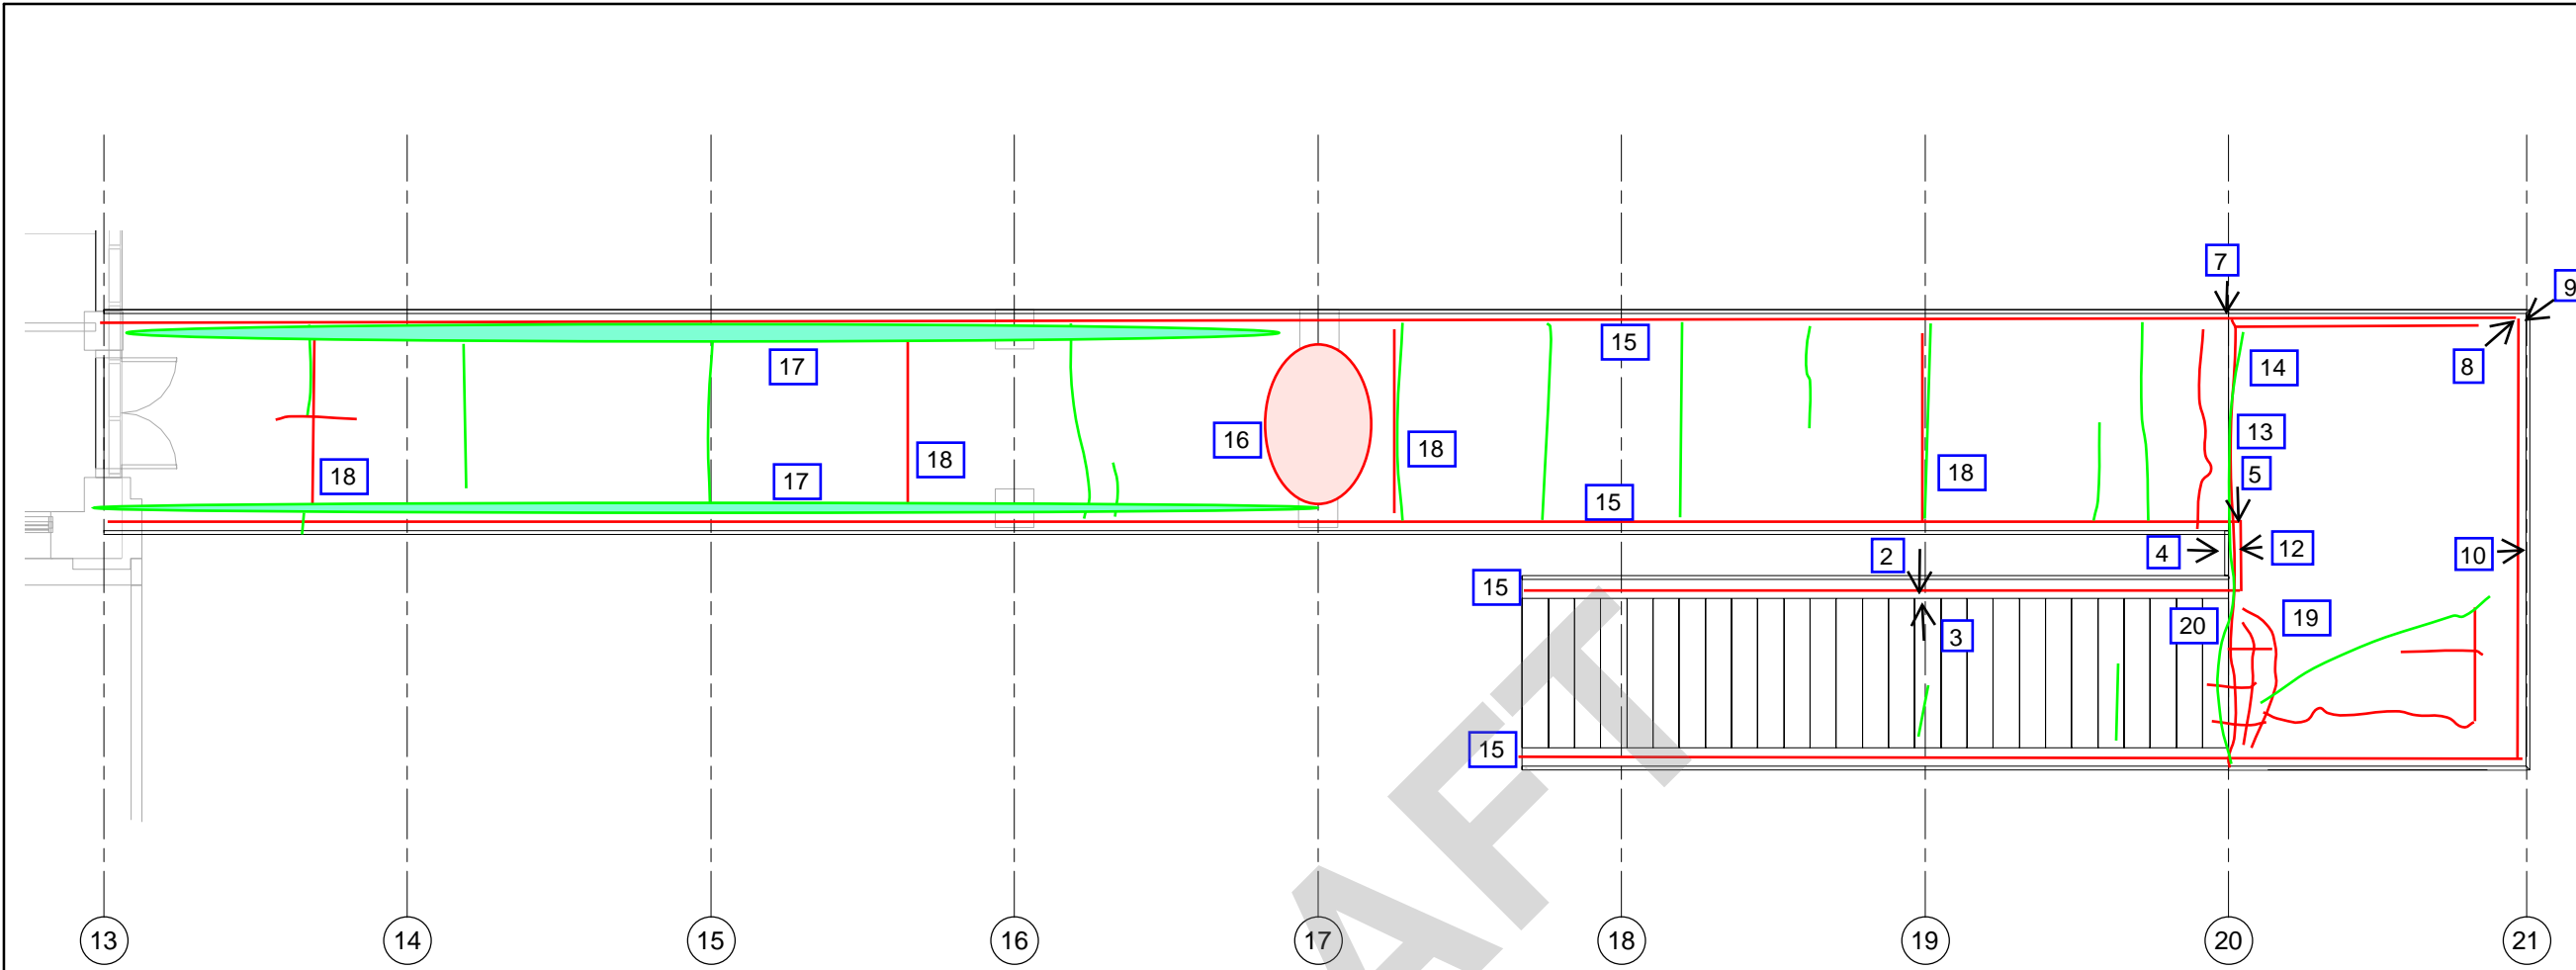
EAST RAMP DAMAGE ASSESSMENT - PLAN

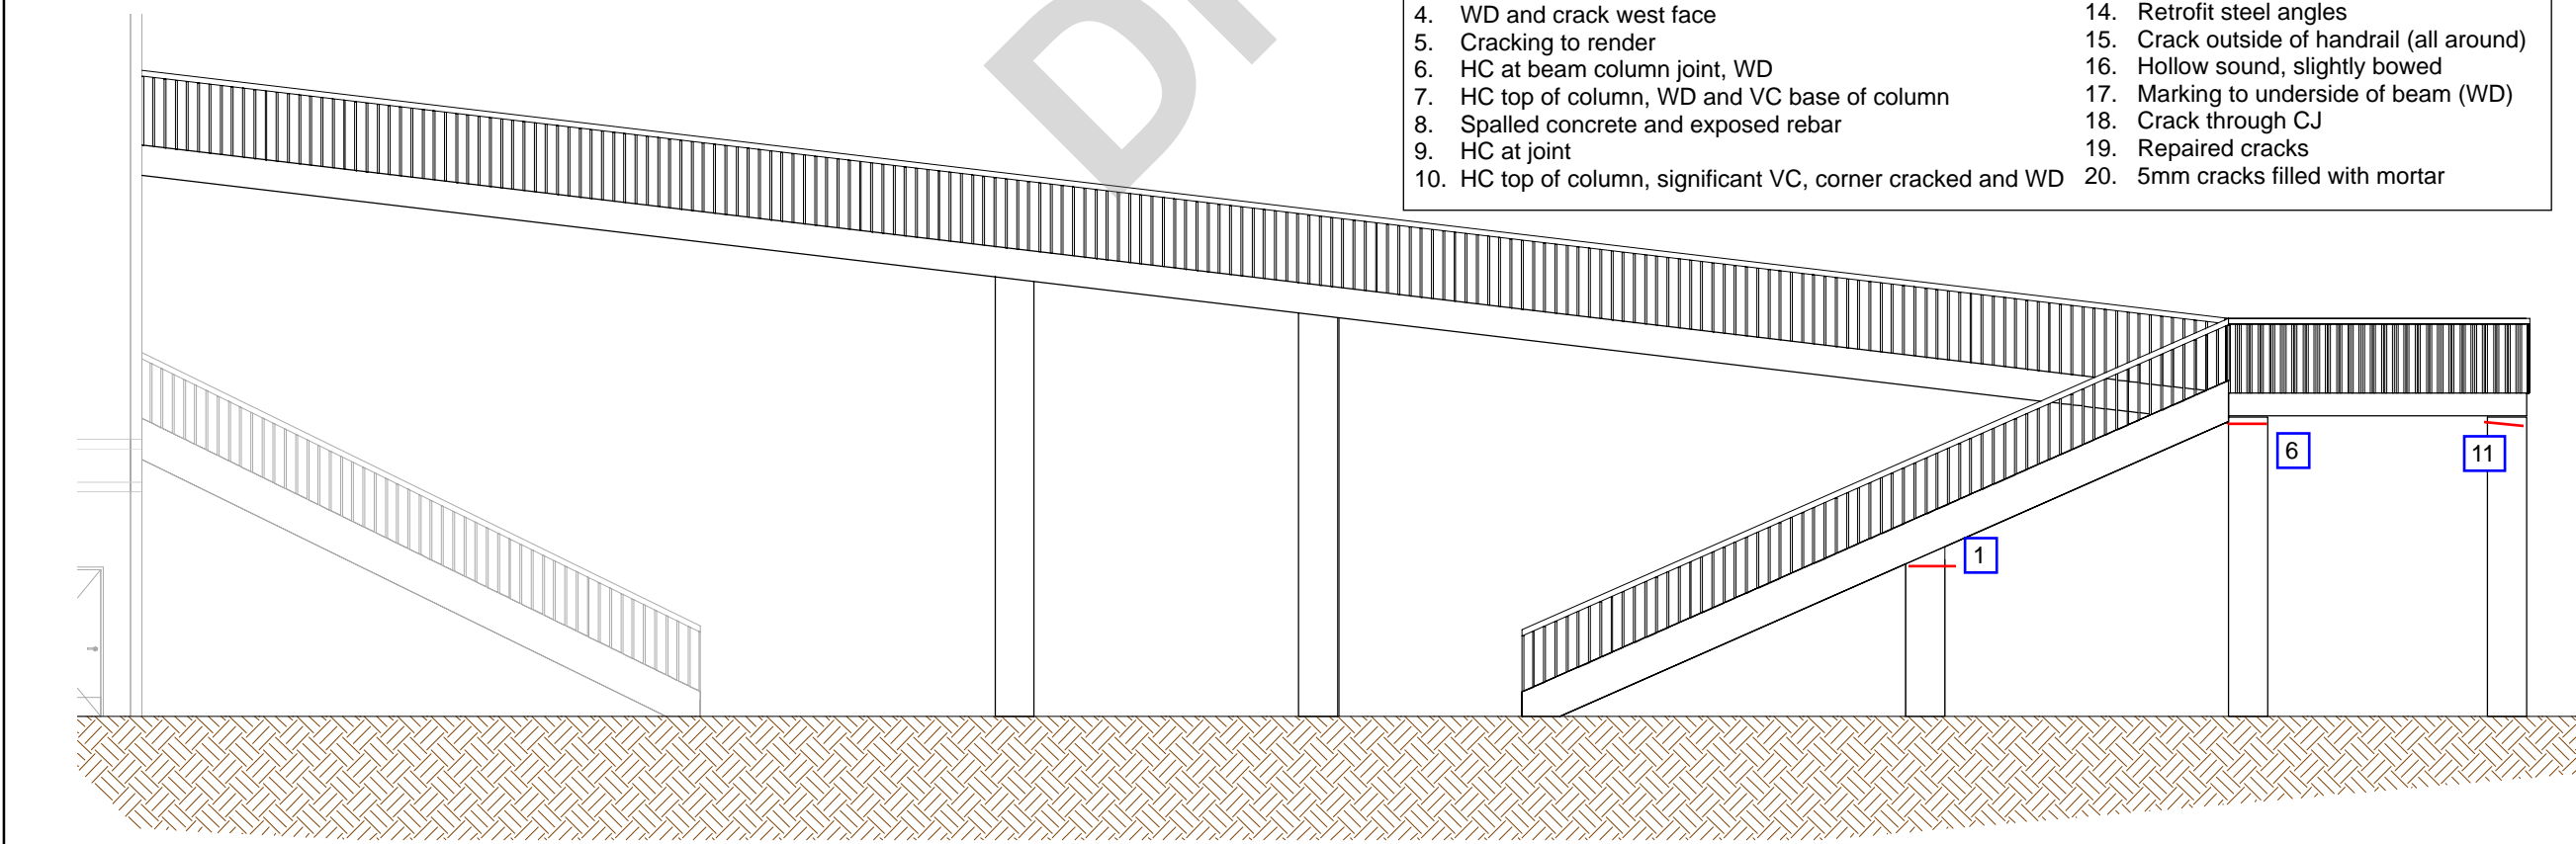
EAST RAMP DAMAGE ASSESSMENT - ELEVATION

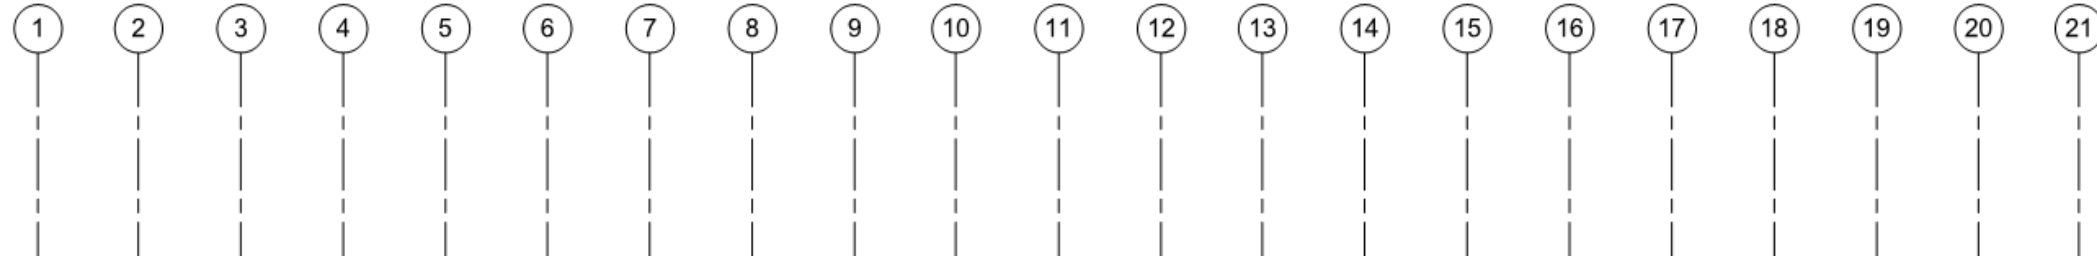
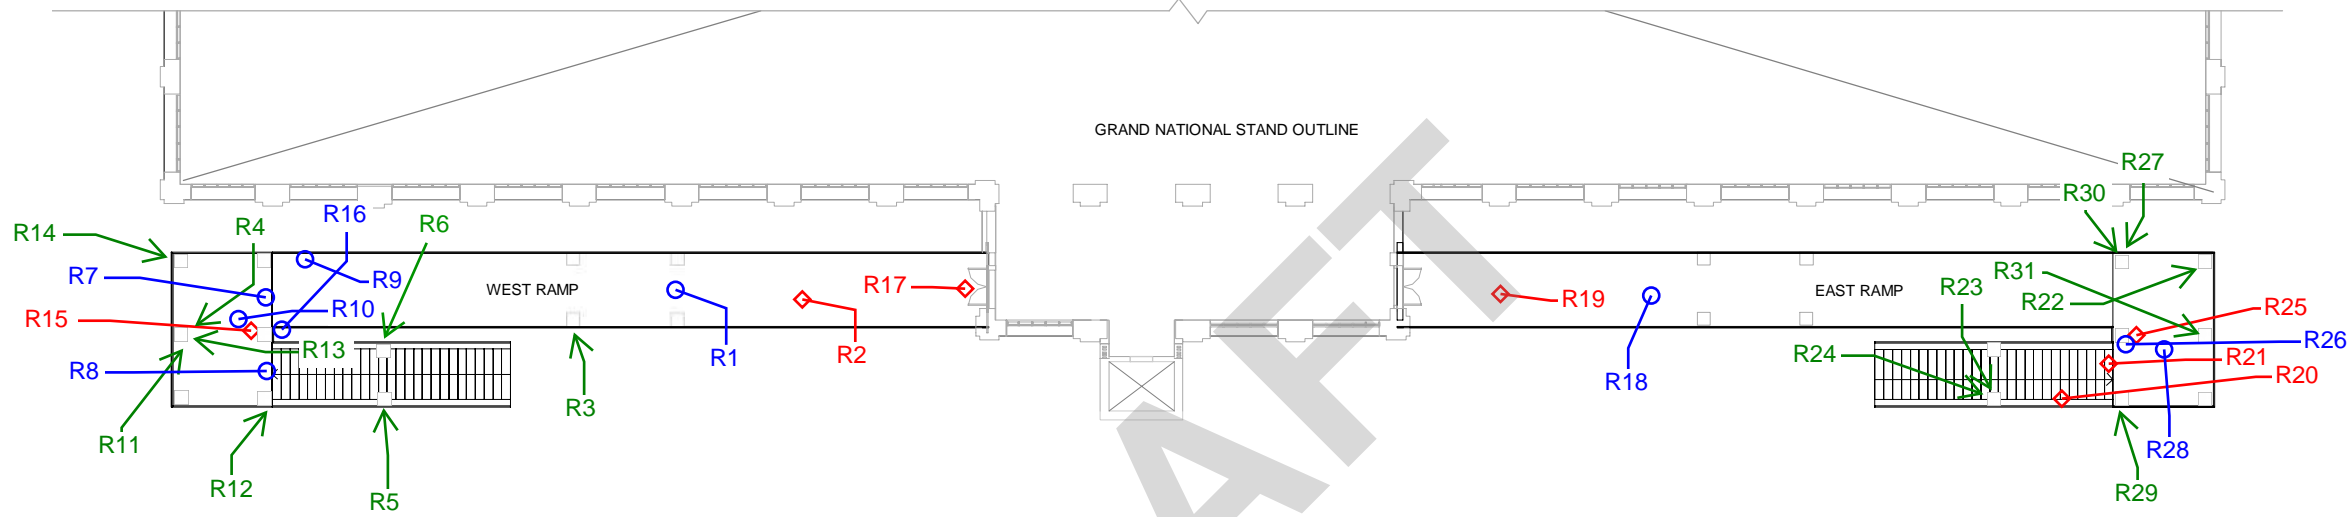
DAMAGE PHOTO KEYPLAN - RAMPS
 Scale: 1 : 150

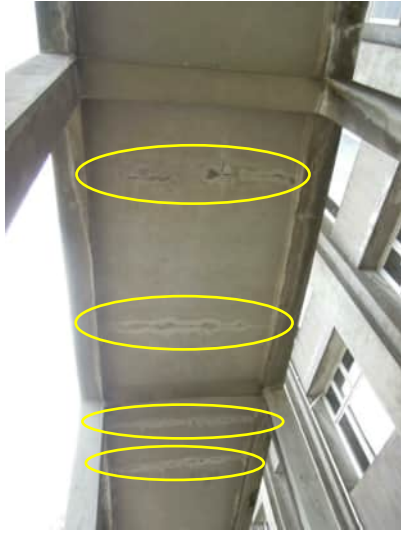
R1
A-810 TYPICAL CRACKS ON UNDERSIDE OF RAMP

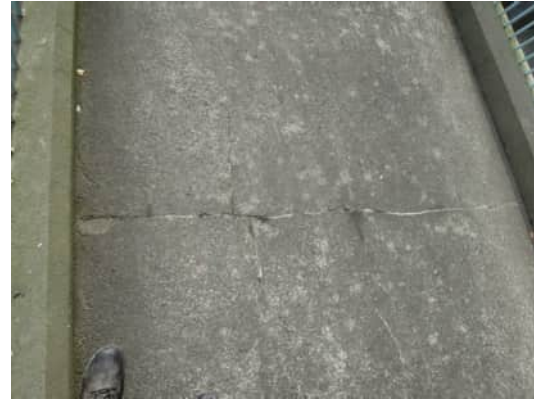
R2
A-810 TYPICAL CONSTRUCTION JOINT ON TOP SIDE OF RAMP

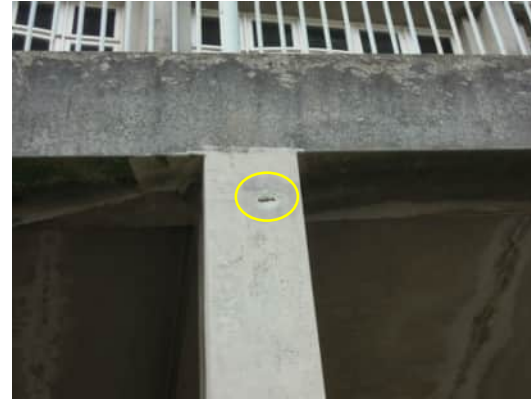
R3
A-810 SPALLING EXPOSING THE REINFORCING

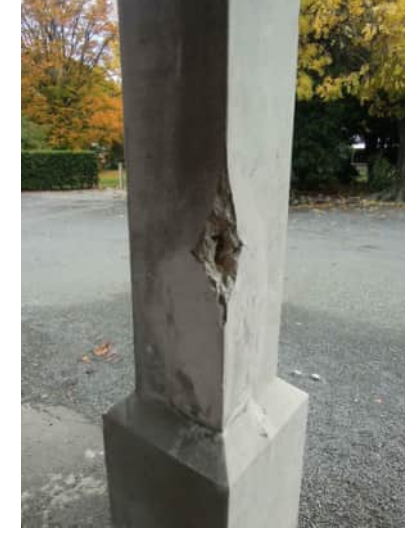
R4
A-810 SPALLING EXPOSING REINFORCING ON THE CORNER OF COLUMN

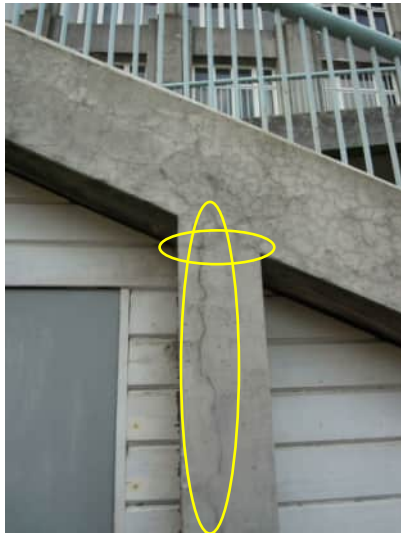
R5
A-810 VERTICAL CRACK DOWN COLUMN AND HORIZONTAL CRACK AT JOINT

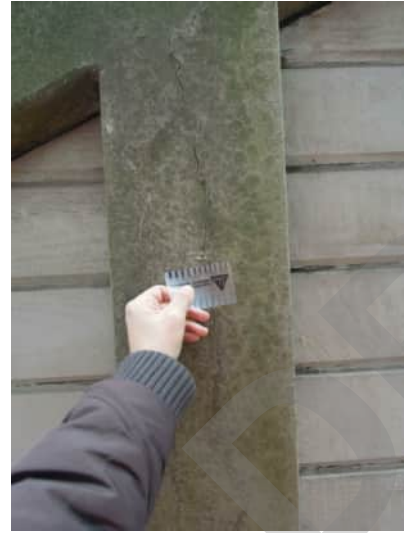
R6
A-810 VERTICAL CRACK DOWN COLUMN UP TO 1.2MM

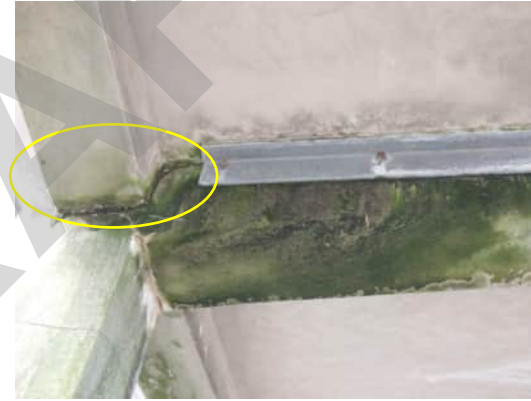
R7
A-810 SIGNIFICANT CRACK BETWEEN BEAM AND SLAB, BENEATH STEEL ANGLE

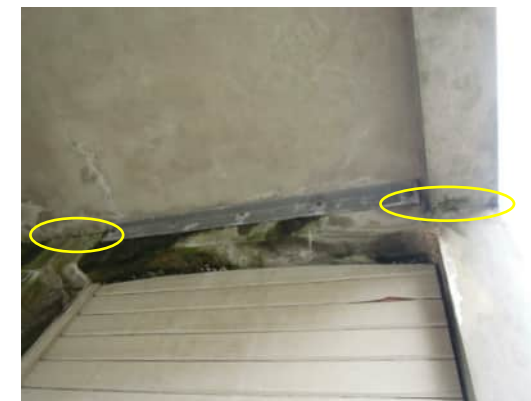
R8
A-810 CRACK CONTINUES TO OTHER SIDE OF PLATFORM

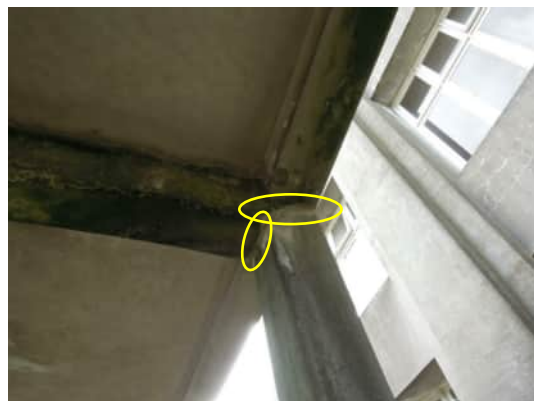
R9
A-810 HORIZONTAL CRACKS AROUND COLUMNS

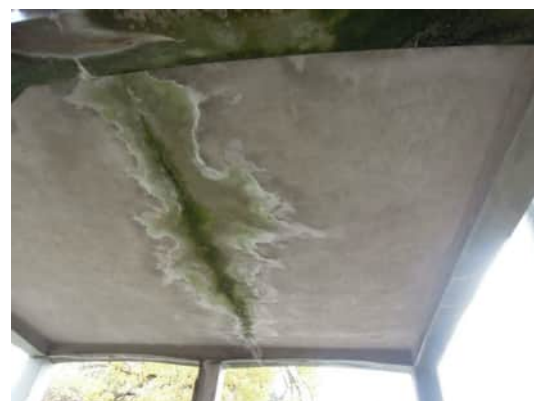
R10
A-810 SIGNIFICANT CRACK THROUGH PLATFORM

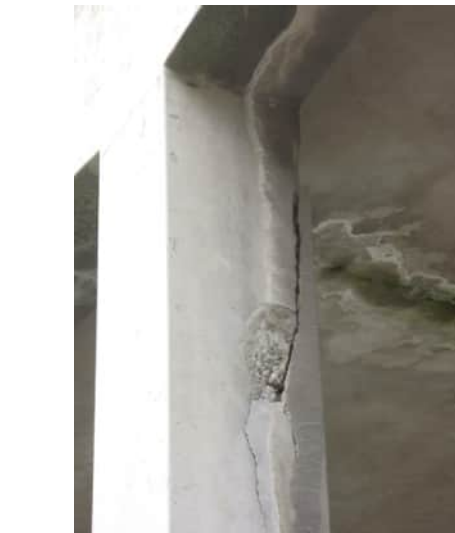
R11
A-810 CORNER BREAKING OFF COLUMN EXPOSING REINFORCING

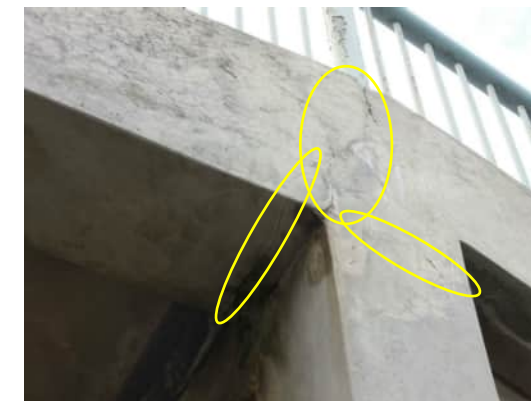
R12
A-810 CRACK THROUGH BEAM COLUMN JOINT WHERE STAIRS CONNECT TO PLATFORM

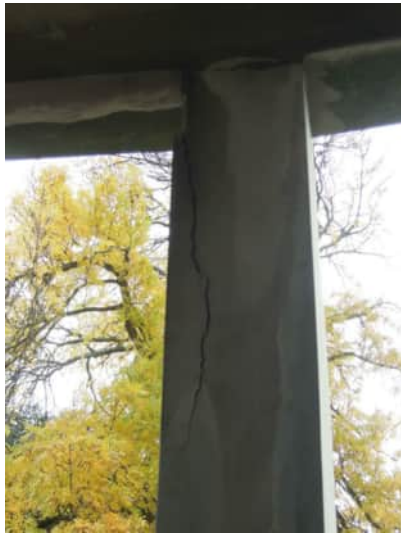
R13
A-810 | CORNER SPALLING OFF COLUMN

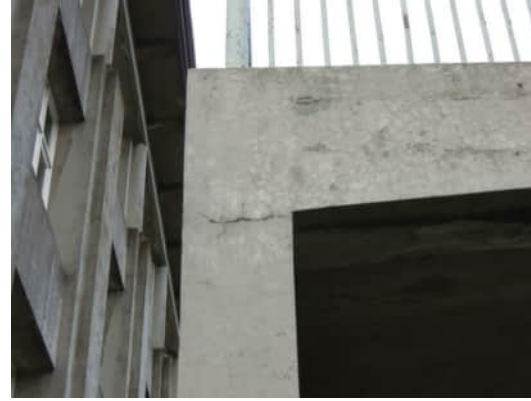
R14
A-810 | HORIZONTAL CRACK AT TOP OF COLUMN

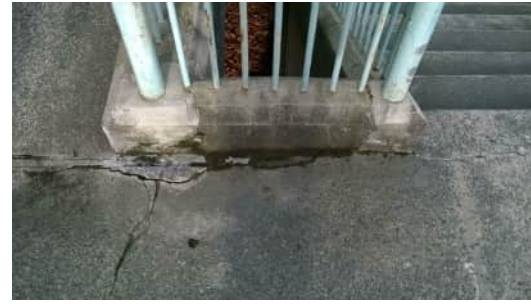
R15
A-810 | CRACKING THROUGH LANDING SLAB BETWEEN STAIRS AND RAMP

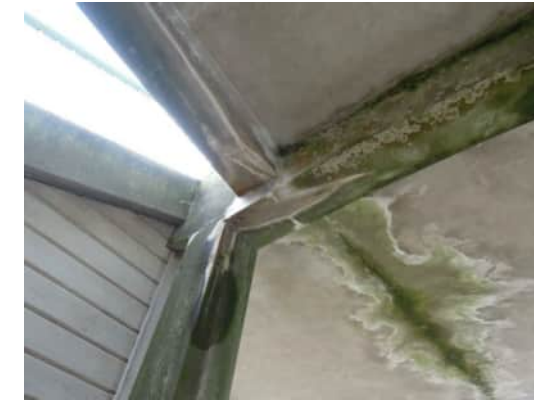
R16
A-810 | MULTIPLE CRACKS TO BEAMS AND COLUMNS WHERE RAMP'S CONNECTS TO LANDING

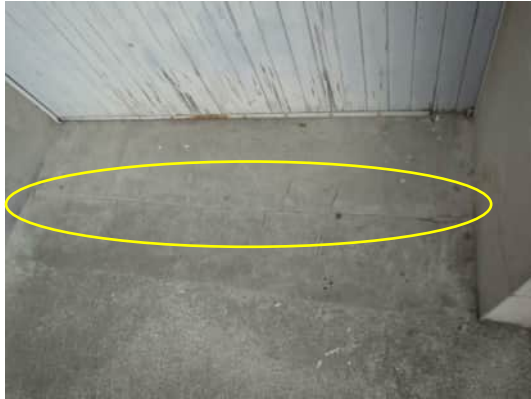
R17
A-810 | CRACK IN SLAB WHERE THE RAMP CONNECTS TO THE BUILDING

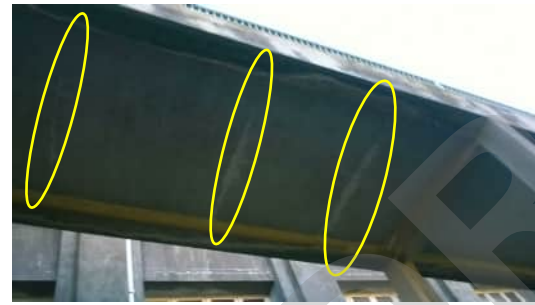
R18
A-810 | TYPICAL CRACKS TO UNDERSIDE OF RAMP

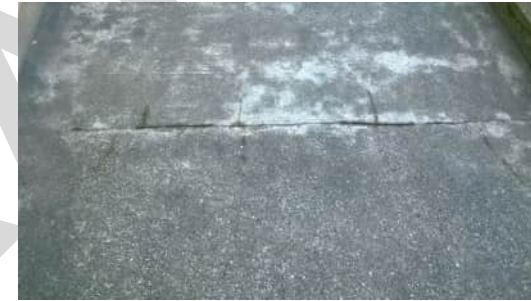
R19
A-810 | TYPICAL CONSTRUCTION JOINT ON TOP SIDE OF RAMP

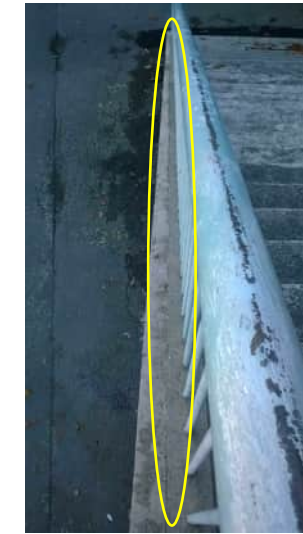
R20
A-810 | CRACK/JOINT ALONGSIDE THE HANDRAIL ON TOP OF STAIR STRINGER

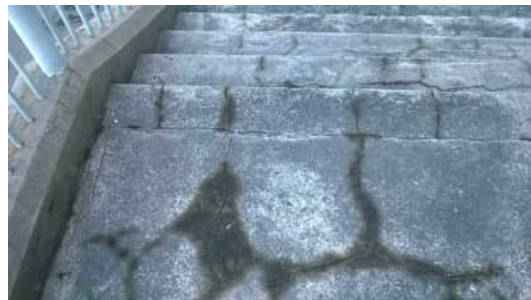
R21
A-810 | MULTIPLE CRACKS TO LANDING AND STAIRS

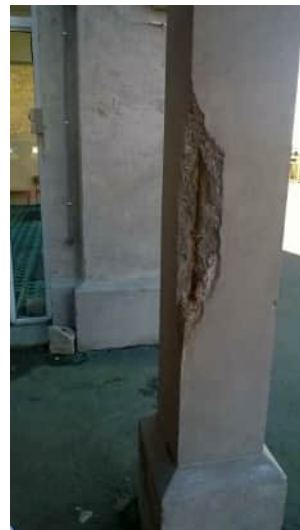
R22
A-810 | CORNER SPALLED OFF COLUMN EXPOSING REINFORCING

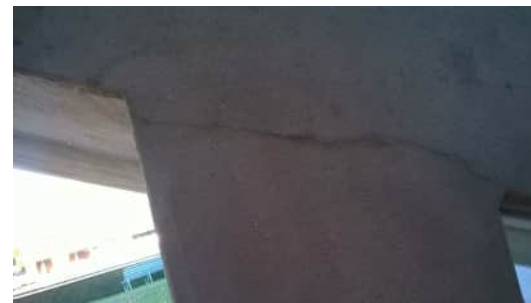
R23
A-810 | CRACK AT TOP OF COLUMN

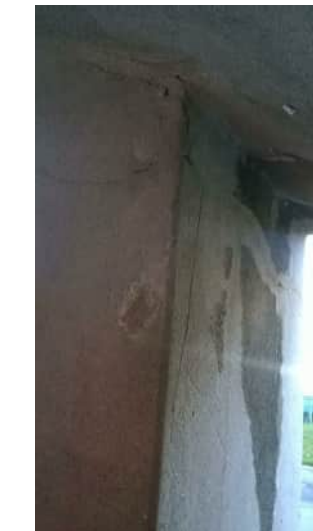
R24
A-810 | MULTIPLE CRACKS AT TOP OF COLUMN

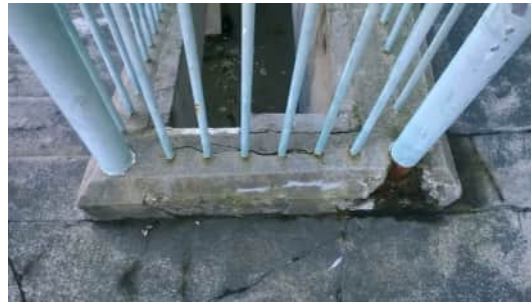
R25 | CRACKING TO THE BEAM AND LANDING SLAB BETWEEN THE STAIRS AND RAMP, CONCRETE BROKEN OUT AROUND HANDRAIL
A-810

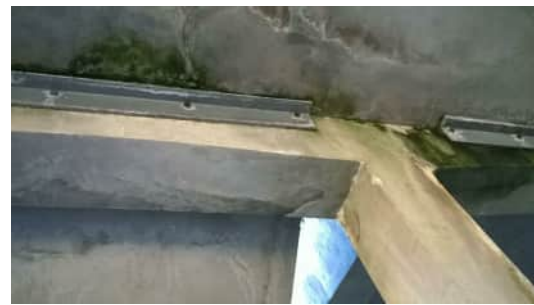
R26 | CRACK BETWEEN SLAB AND BEAM UNDER LANDING SLAB. STEEL ANGLES HAVE BEEN FITTED TO SUPPORT SLAB
A-810

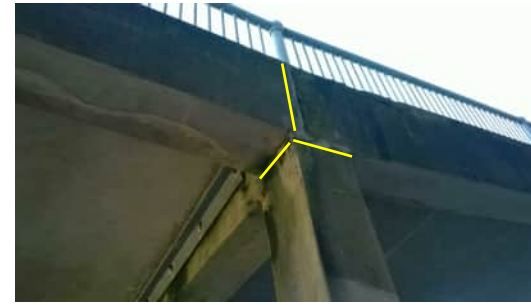
R27 | CRACK SHOWN IN PHOTO R26 CONTINUES THROUGH BEAM TO TOP OF COLUMN. VERTICAL CRACK THROUGH BEAM WHERE RAMP AND LANDING INTERSECT
A-810

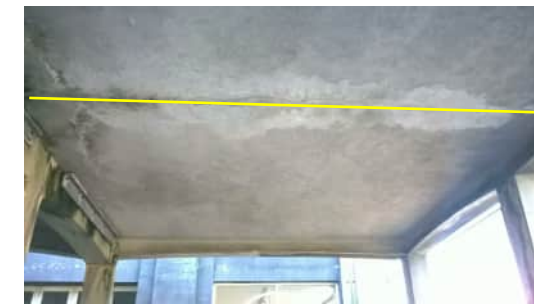
R28 | CRACK ON UNDERSIDE OF LANDING SLAB
A-810

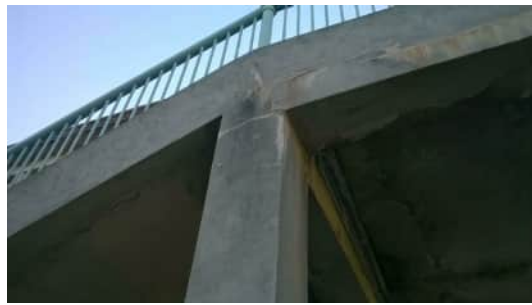
R29 | CRACKS TO BEAM AND COLUMN
A-810

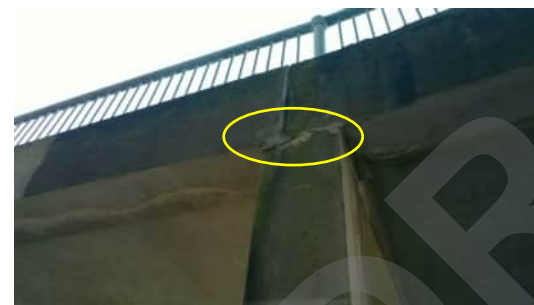
R30 | CRACK BETWEEN BEAM AND COLUMN
A-810

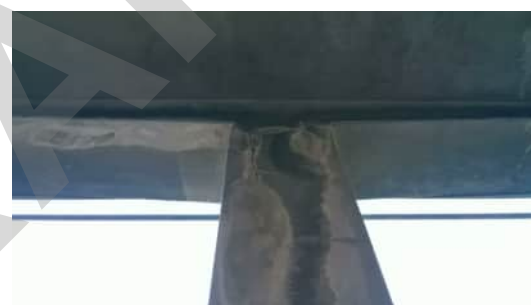
R31 | SIGNIFICANT VERTICAL CRACK NEAR TOP OF COLUMN
A-810
