Detailed Damage Evaluation

Quantitative Seismic Analysis of Grand National (Public) Stand

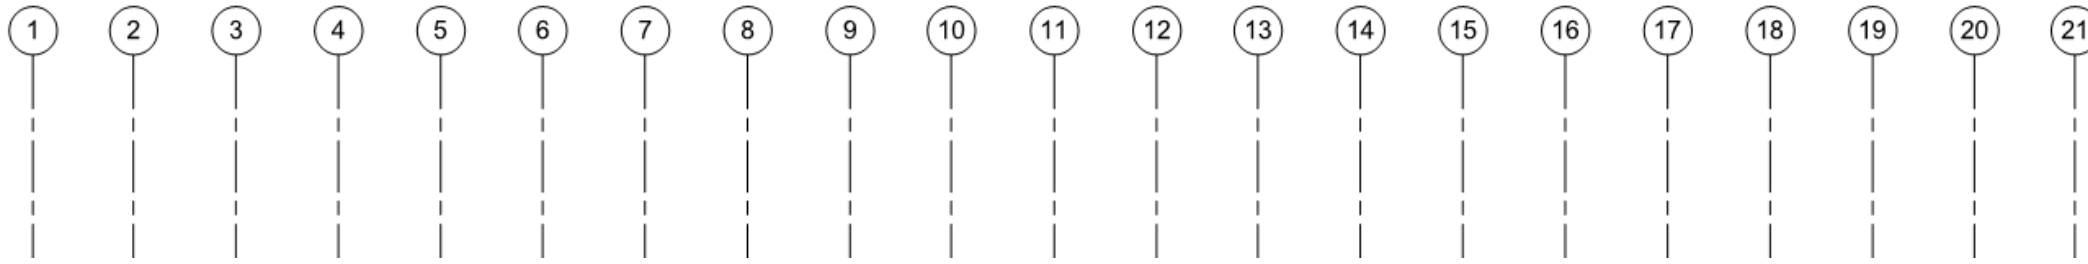
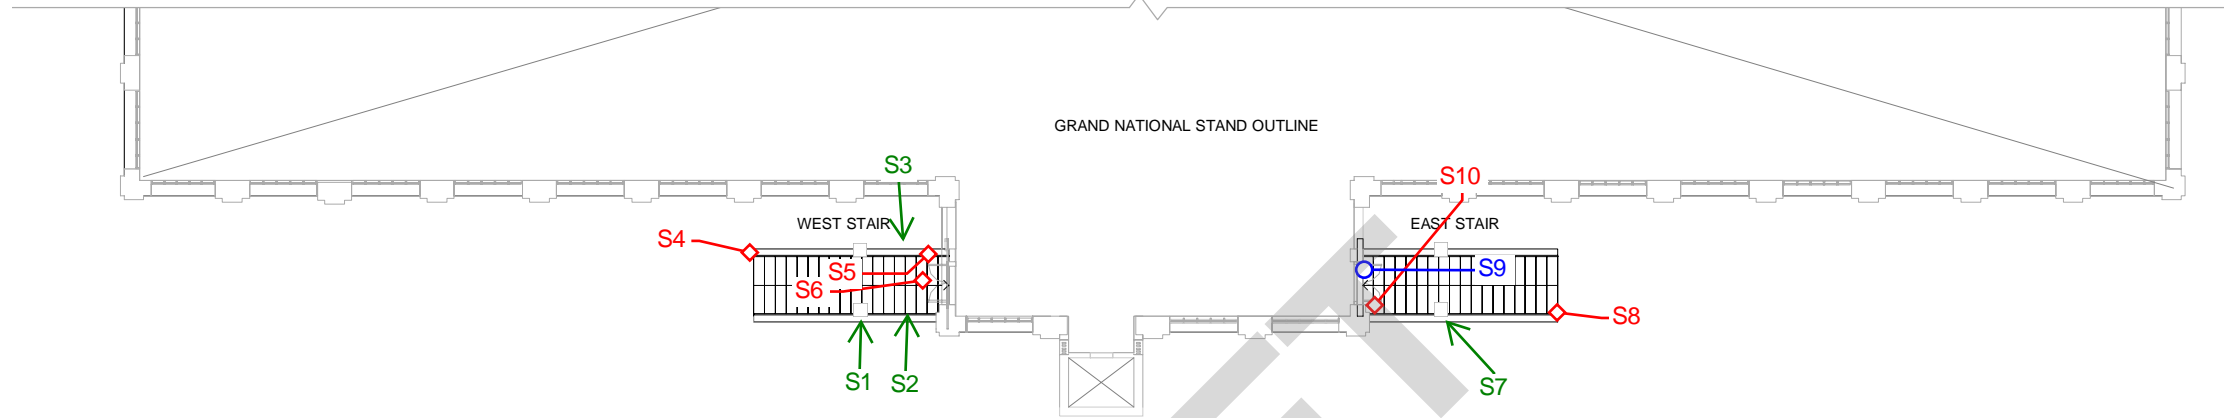
DAMAGE PHOTO KEYPLAN - STAIRS ON SOUTH ELAVATION

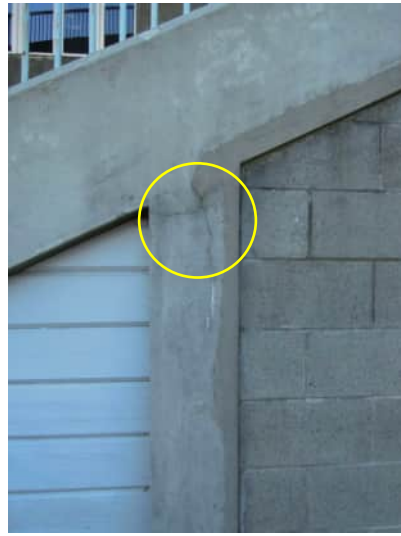
S1
A-814 | CRACKS AT THE TOP OF THE COLUMN UP TO 0.4MM

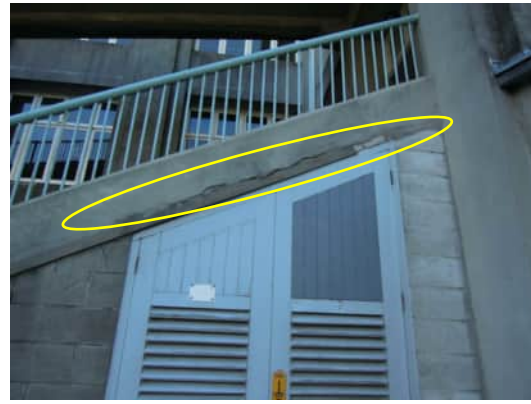
S2
A-814 | CRACK UP TO 20MM ALONG THE SIDE OF THE STRINGER

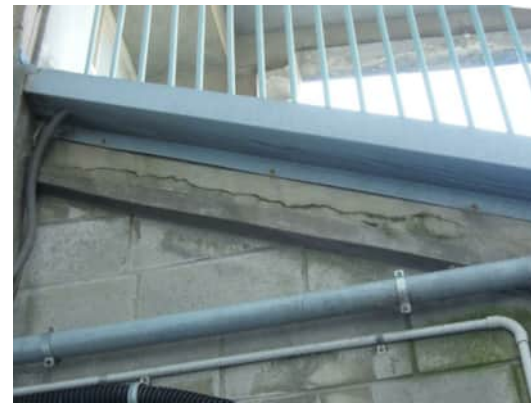
S3
A-814 | CRACK UP TO 5MM ALONG THE OTHER SIDE OF THE STRINGER

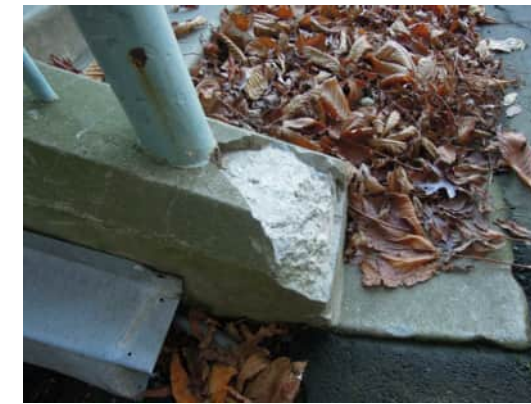
S4
A-814 | DAMAGE TO THE SURFACE OF THE CONCRETE AT BASE OF THE STRINGER

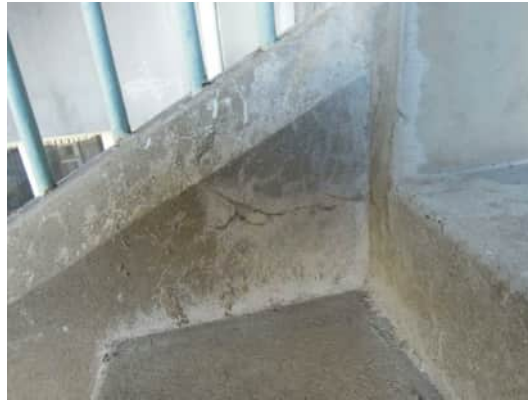
S5
A-814 | CRACK WHERE THE STAIRS CONNECT TO THE BUILDING

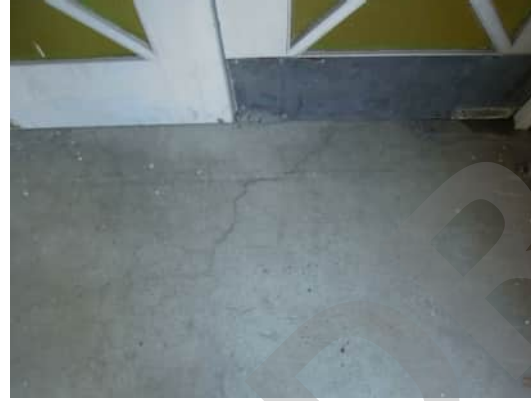
S6
A-814 | CRACK UP TO 1.6MM IN THE SLAB AT THE TOP OF THE STAIRS

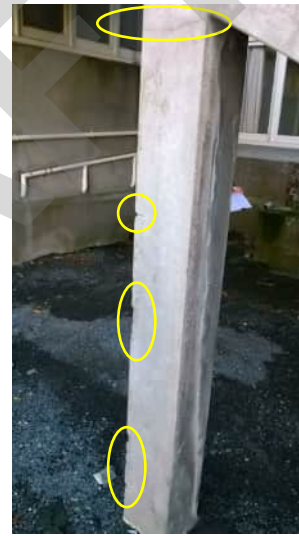
S7
A-814 | HAIRLINE HORIZONTAL CRACK AT TOP OF COLUMN AND SPALLING DAMAGE ALONG HEIGHT

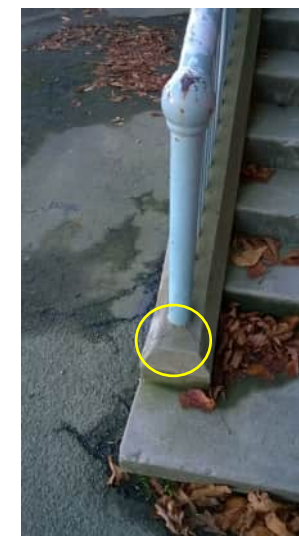
S8
A-814 | CRACKING AROUND WHERE HANDRAIL IS CAST INTO THE CONCRETE

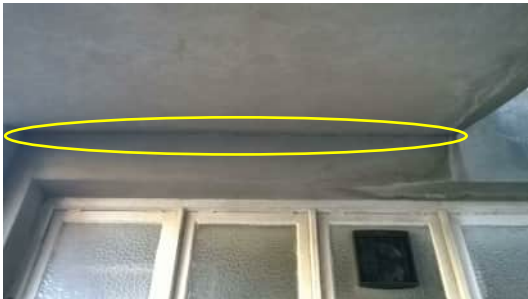
S9
A-814 | SEPARATION BETWEEN UNDERSIDE OF STAIRS AND THE MAIN BUILDING

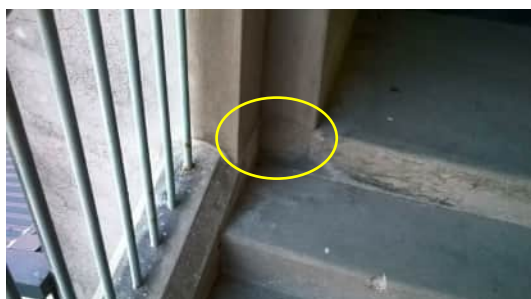
S10
A-814 | CRACKING IN THE CORNER WHERE THE STAIRS CONNECT TO THE MAIN BUILDING

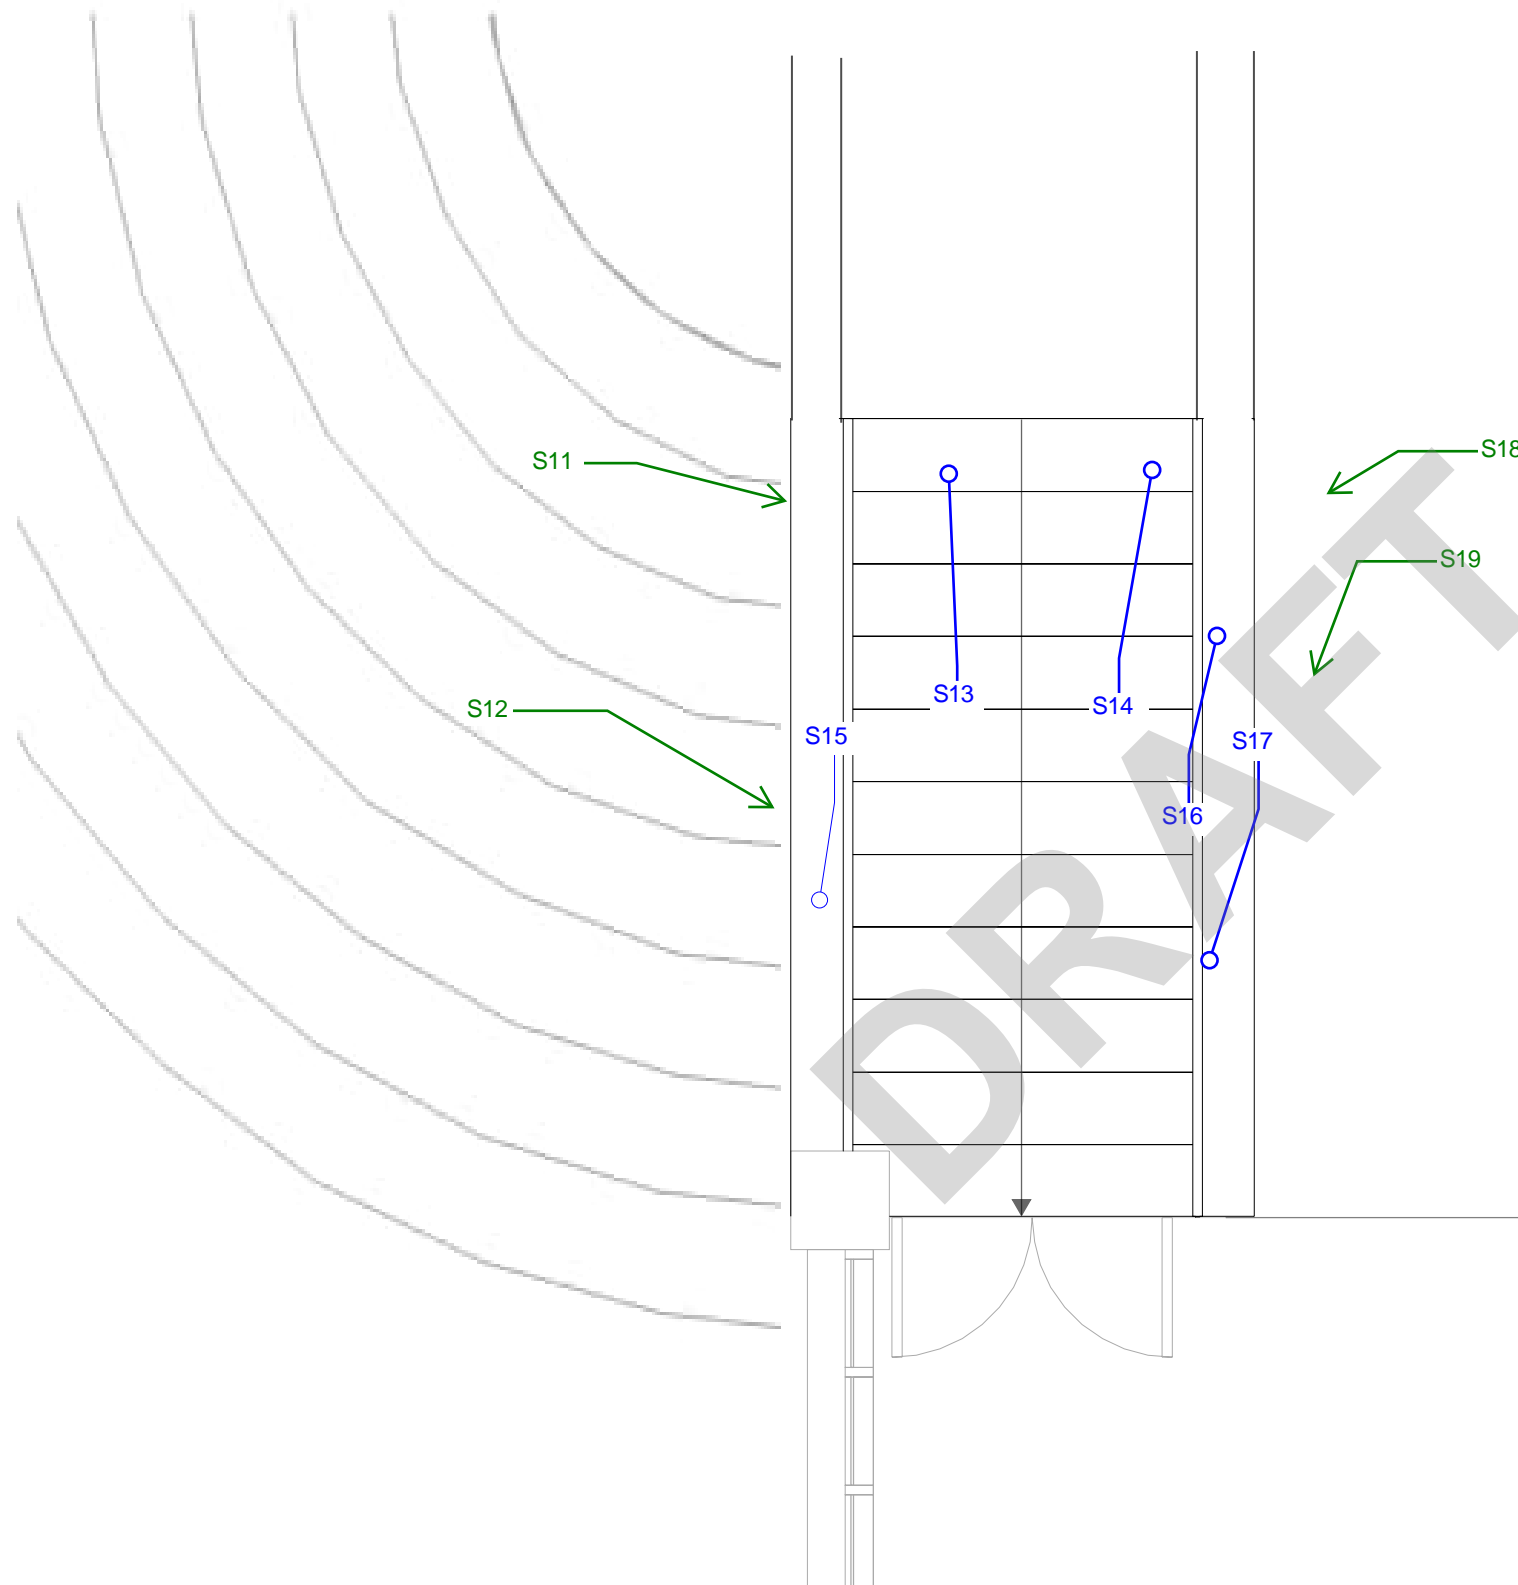
DAMAGE PHOTO KEYPLAN - STAIRS ON WEST ELEVATION

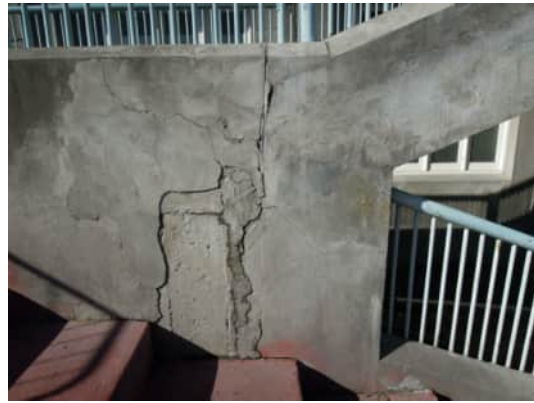
S11 | SIGNIFICANT CRACKS ON THE SIDE OF THE STAIRS UP TO 3.5MM WITH RENDER SPALLING OFF
A-816

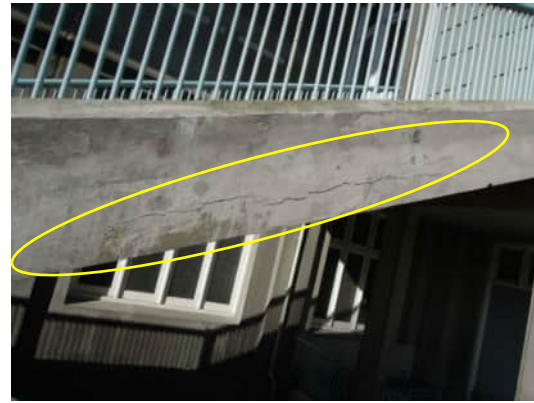
S12 | CRACK UP TO 4MM ALONG THE STRINGER
A-816

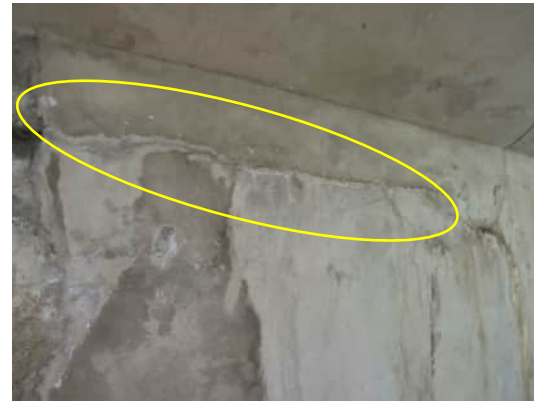
S13 | HORIZONTAL CRACK UP TO 0.5MM ON WALL BELOW STAIRS
A-816

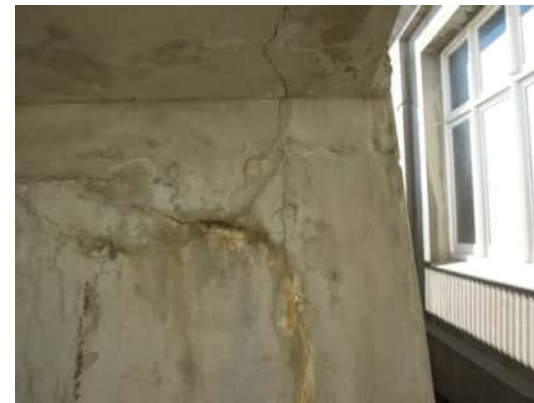
S14 | VERTICAL CRACKS UP TO 0.8MM WIDE ON THE UNDERSIDE OF THE STAIRS AND DOWN THE WALL BELOW THE STAIRS
A-816

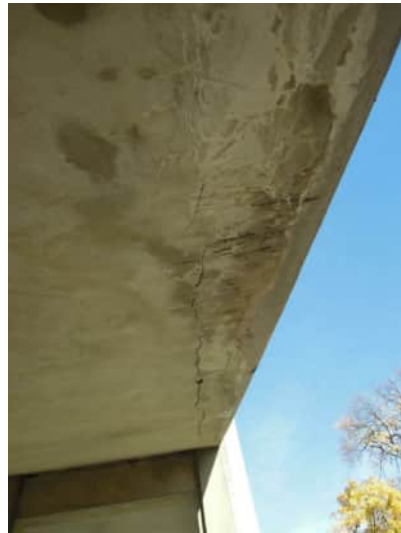
S15 | CRACK ON UNDERSIDE OF STAIRS UP TO 4MM WIDE
A-816

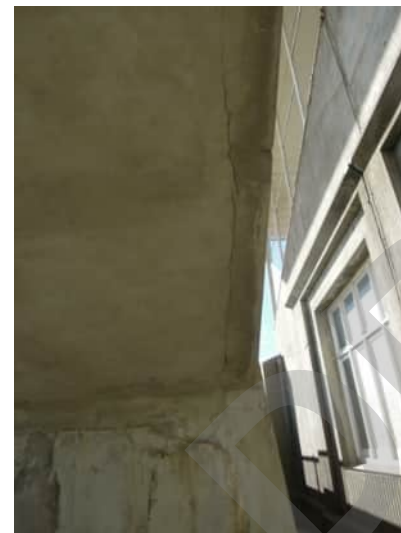
S16 | CRACK ON UNDERSIDE OF STAIRS UP TO 4MM WIDE
A-816

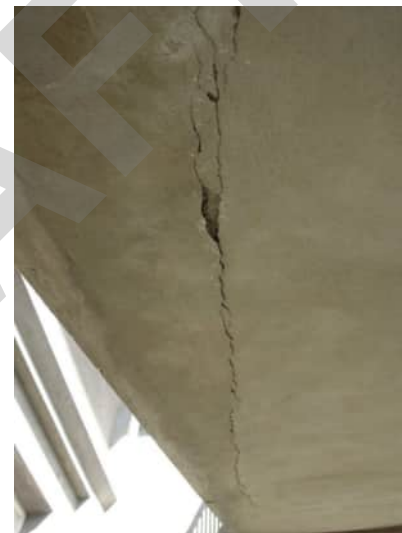
S17 | CRACK ON UNDERSIDE OF STAIRS UP TO 4MM WIDE WITH LOCALISED SPALLING TO RENDER
A-816

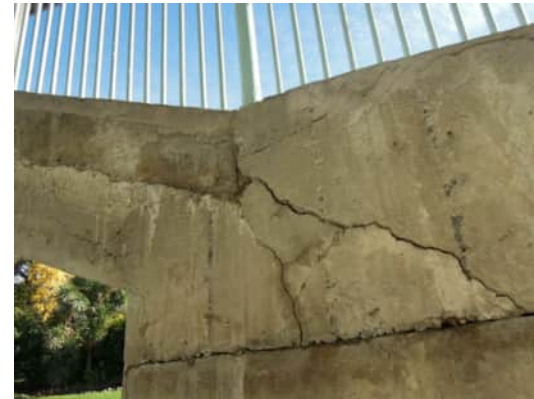
S18 | CRACKS UP TO 15MM AT TOP OF WALL WHERE STAIRS BEGIN
A-816

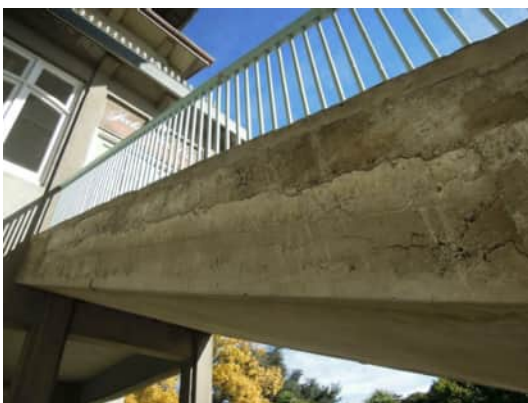
S19 | CRACKS ALONG STRINGER AS WELL AS POORLY COMPACTED CONCRETE
A-816

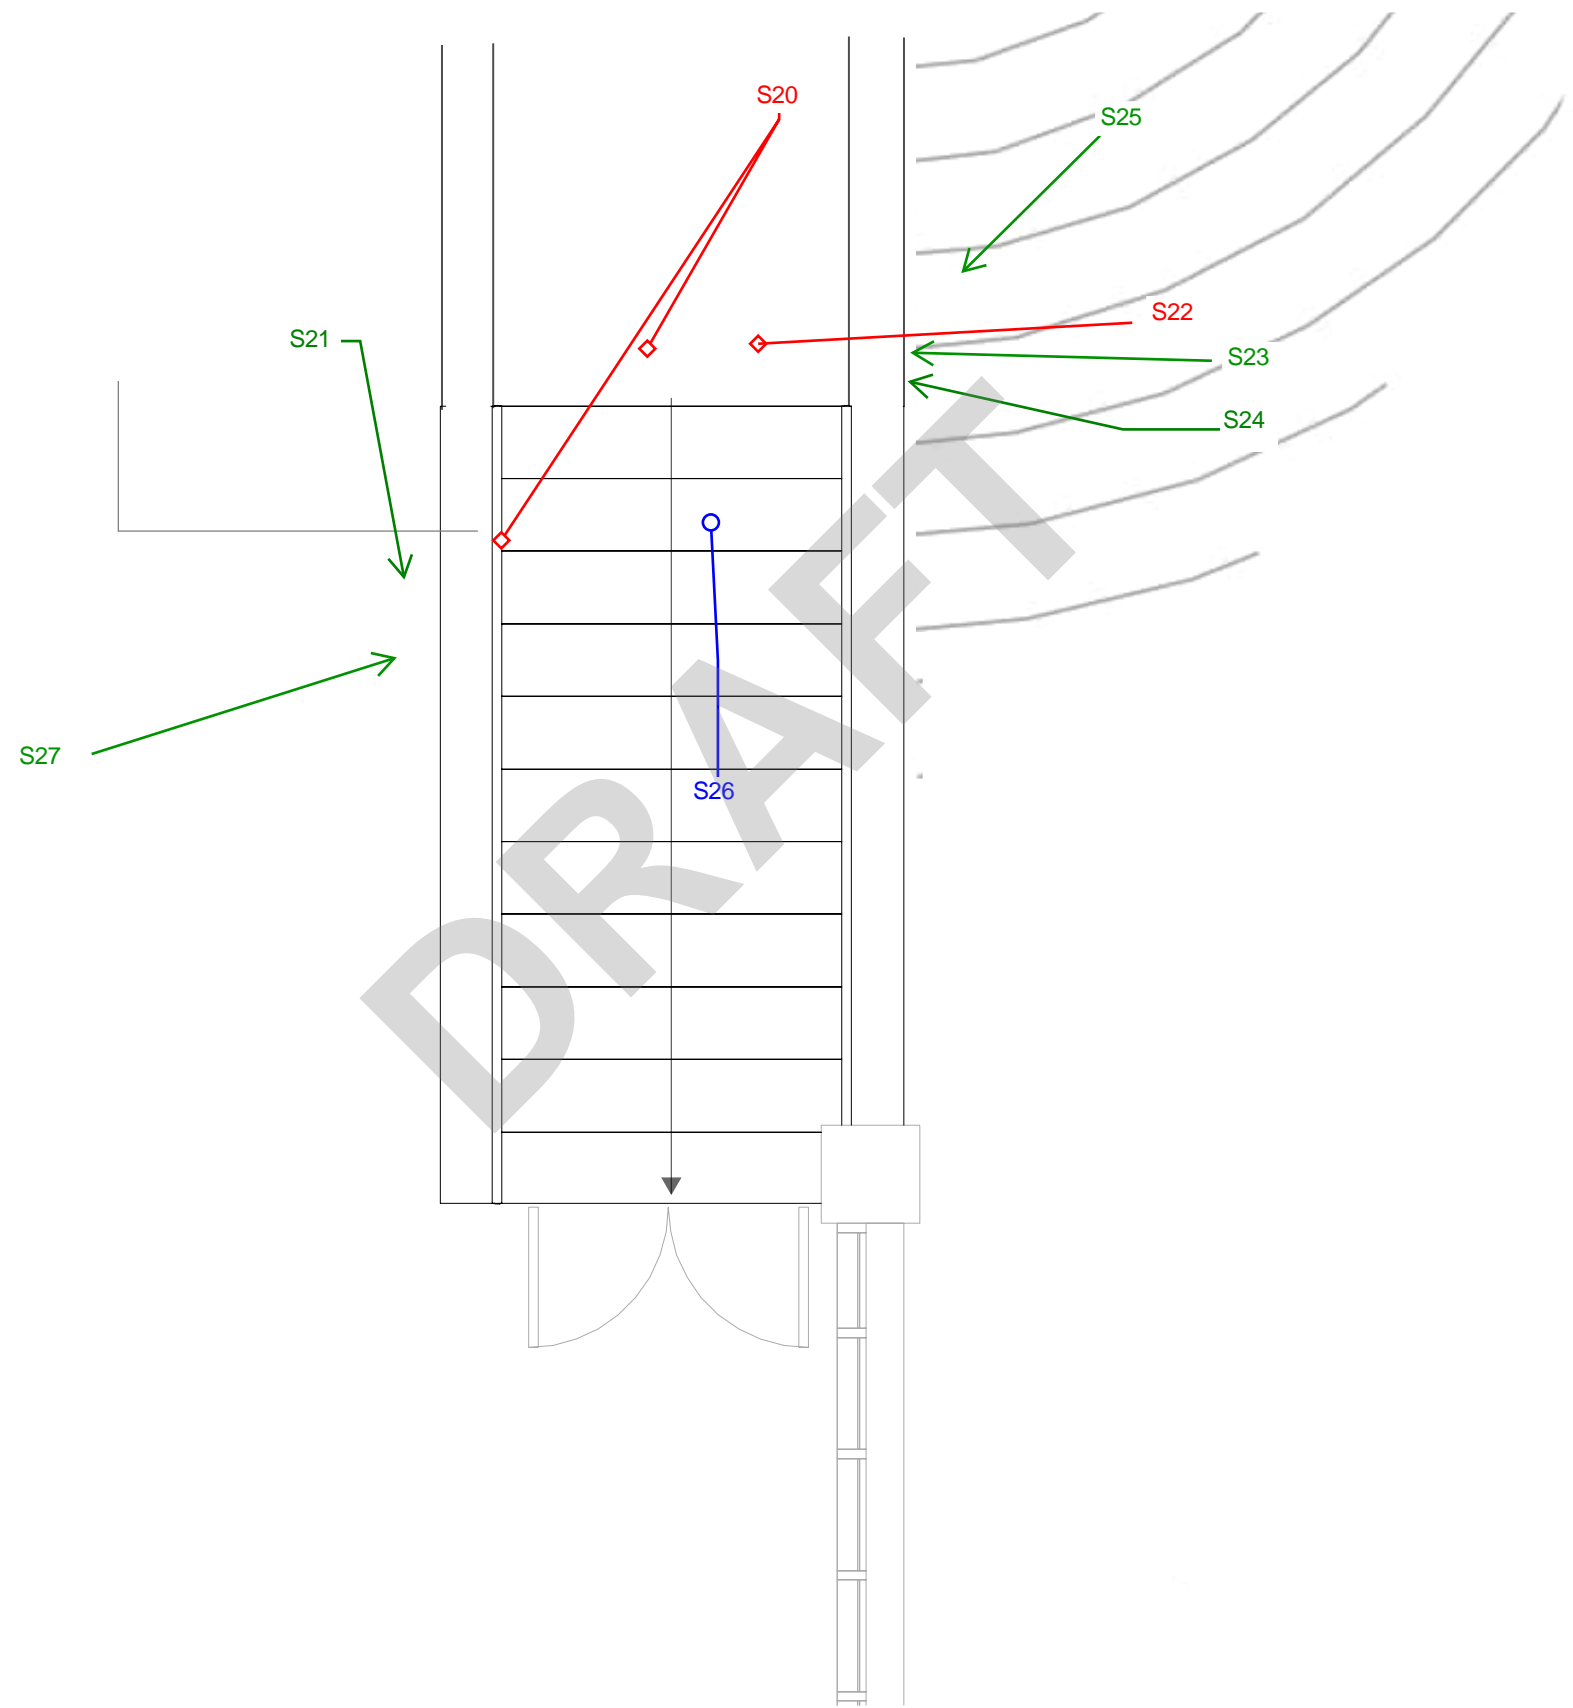
DAMAGE PHOTO KEYPLAN - STAIRS ON EAST ELEVATION

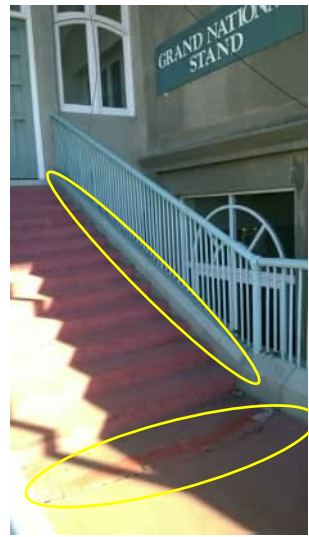
S20
A-818 | SIGNIFICANT CRACK ALONG STRINGER AND ANOTHER SIGNIFICANT CRACK ACROSS LANDING SLAB AT BOTTOM OF STAIRS

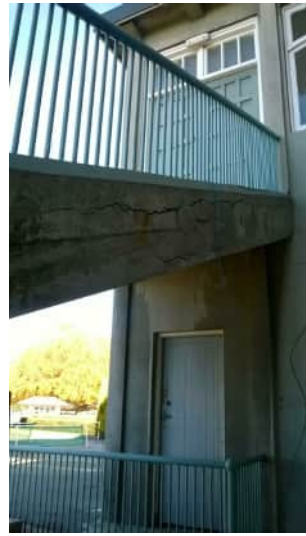
S21
A-818 | SIGNIFICANT CRACK ALONG STRINGER SHOWN IN PHOTO S20 IS ALSO VISIBLE ON OUTSIDE OF STAIRS

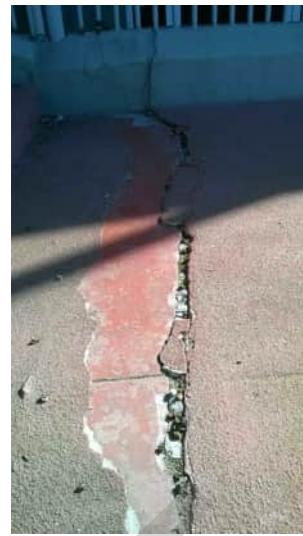
S22
A-818 | SIGNIFICANT CRACK IN LANDING SLAB AT BOTTOM OF STAIRS SHOWN IN PHOTO S20 HAS EVIDENCE OF SETTLEMENT TO THE STAIR SIDE

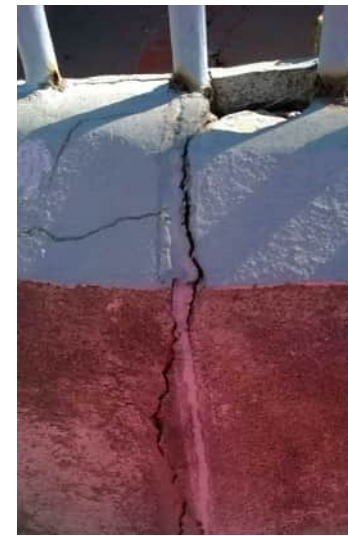
S23
A-818 | SIGNIFICANT CRACK IN LANDING SLAB AT BOTTOM OF STAIRS SHOWN IN PHOTO S22 CONTINUES INTO WALL

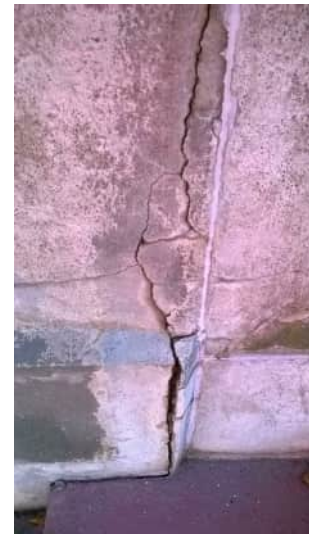
S24
A-818 | SIGNIFICANT CRACK IN WALL WITH SPALLING UP TO 10MM WIDE

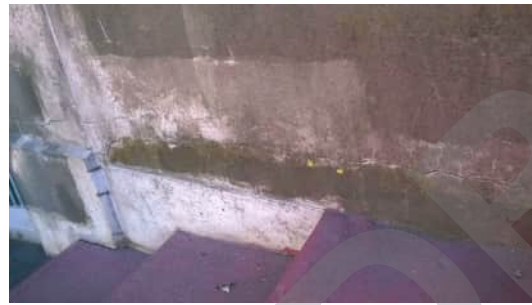
S25
A-818 | HORIZONTAL CRACK ALONG WALL AT THE BOTTOM OF THE STAIRS 3MM WIDE

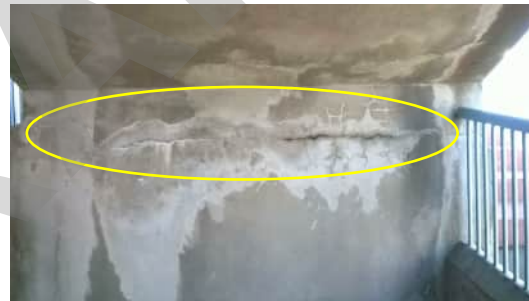
S26
A-818 | HORIZONTAL CRACK IN WALL CONTINUES TO THE WALL BENEATH THE STAIRS

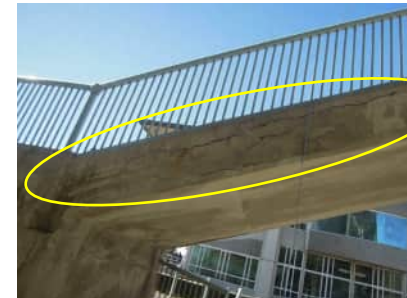
S27
A-818 | HORIZONTAL CRACK IN WALL CONTINUES TO THE WALL BENEATH THE STAIRS

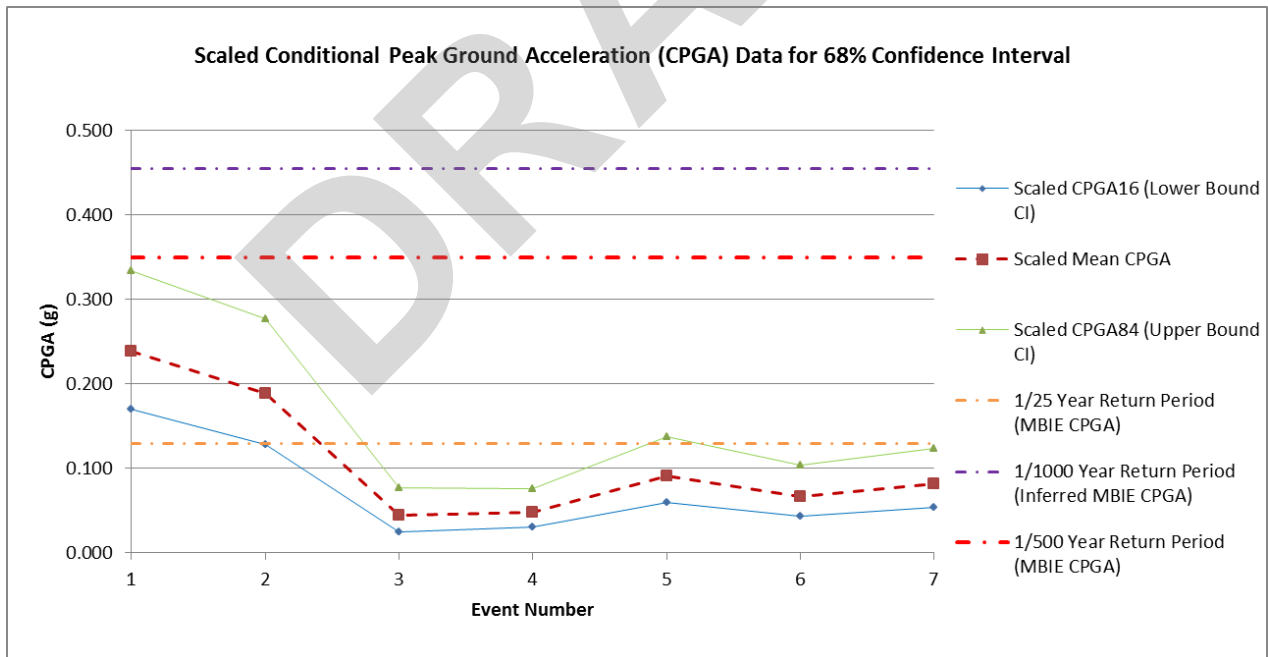
Figure E-1: Conditional Peak Ground Acceleration for Each Event

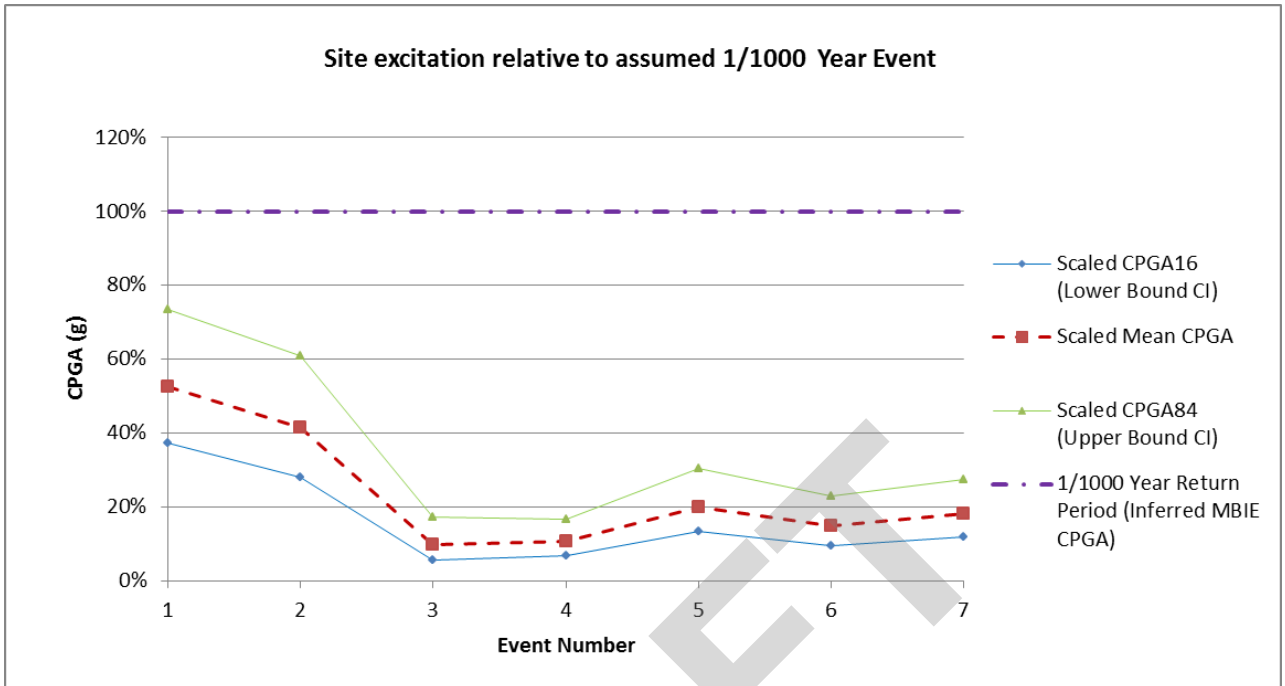
Figure E-2: Conditional Peak Ground Acceleration for Each Event Compared to 1/1000 Year Event

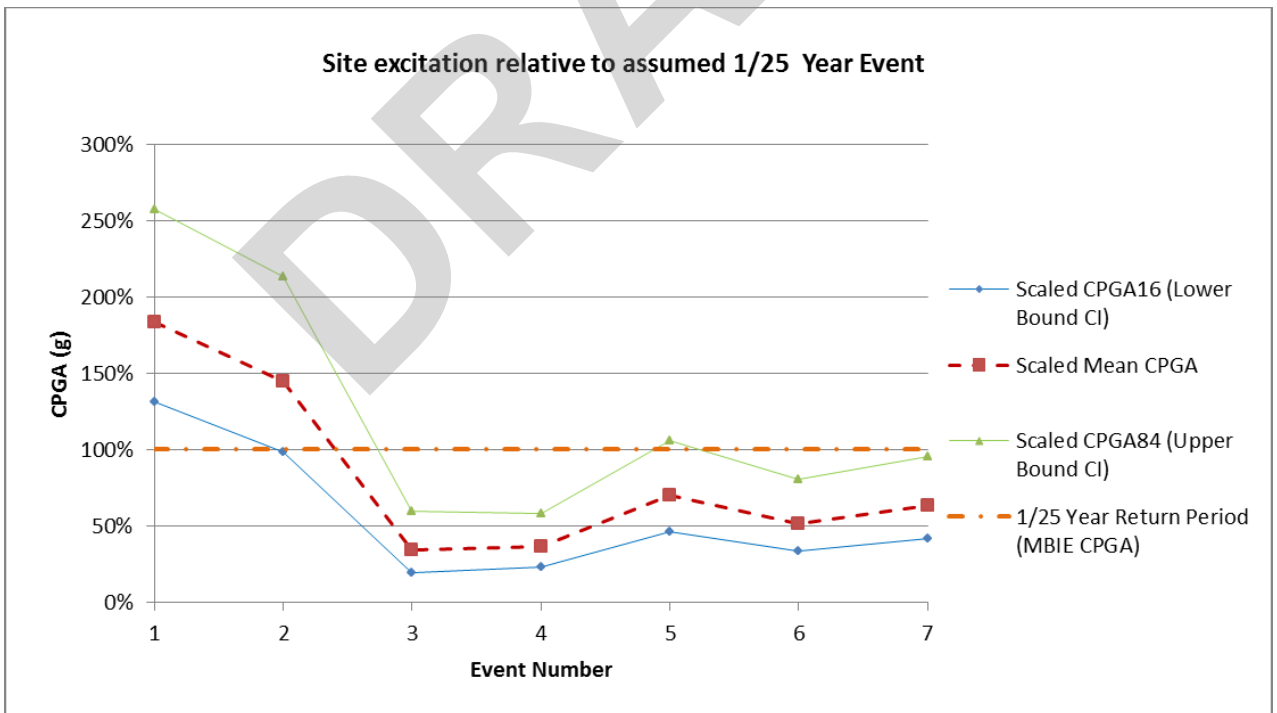
Figure E-3: Conditional Peak Ground Acceleration for Each Event Compared to 1/25 Year Event

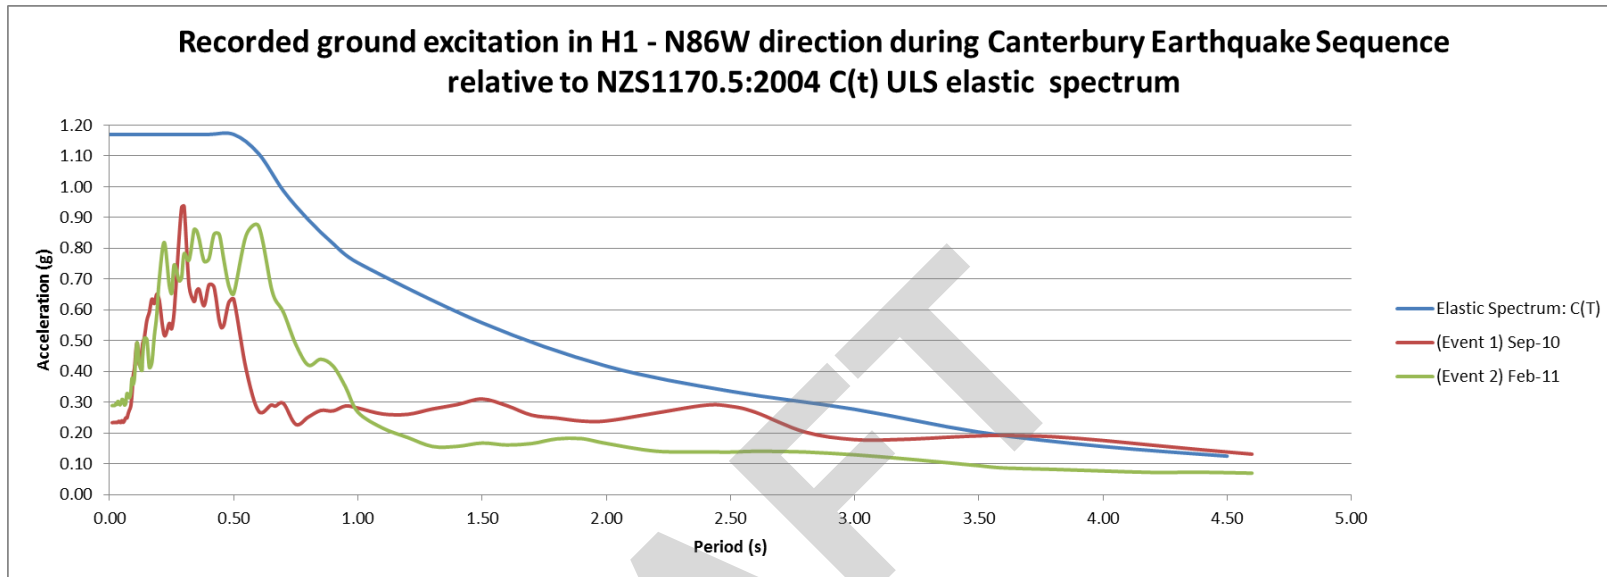
Figure E-4: Ground Motion H1 Direction Compared to Elastic Spectrum

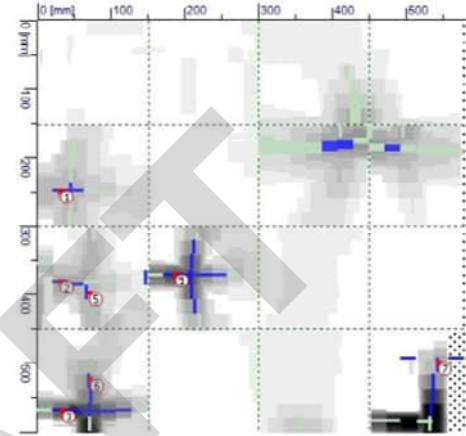
Customer: Canterbury Jockey Club
Location: L3-9 Vertical Column Scan 4
Operator: Mathew Le Comte
Comment:
6mm tags found within wall.
This is not indicative of continuous re enforcing

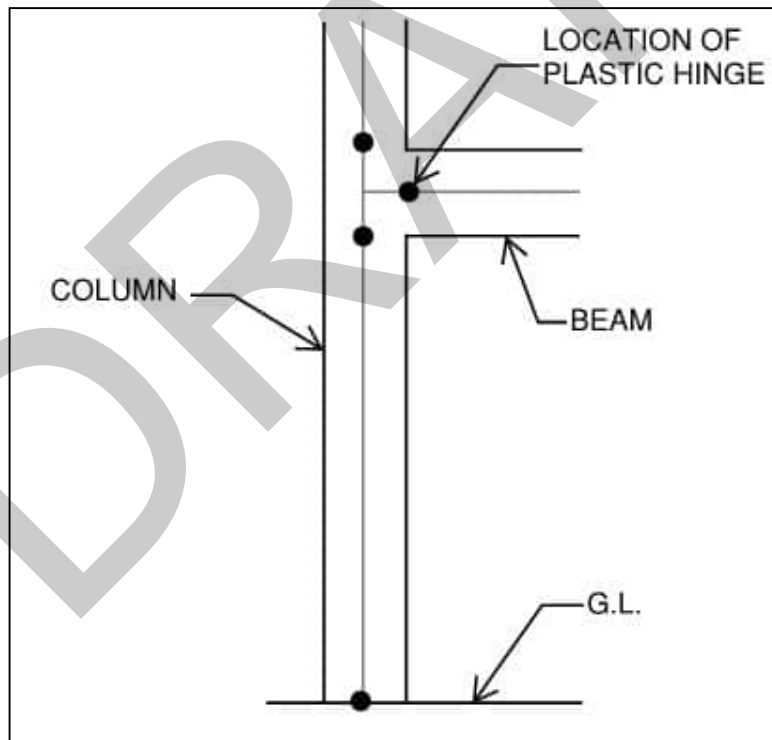
Figure 4-1: Representation of plastic hinge locations

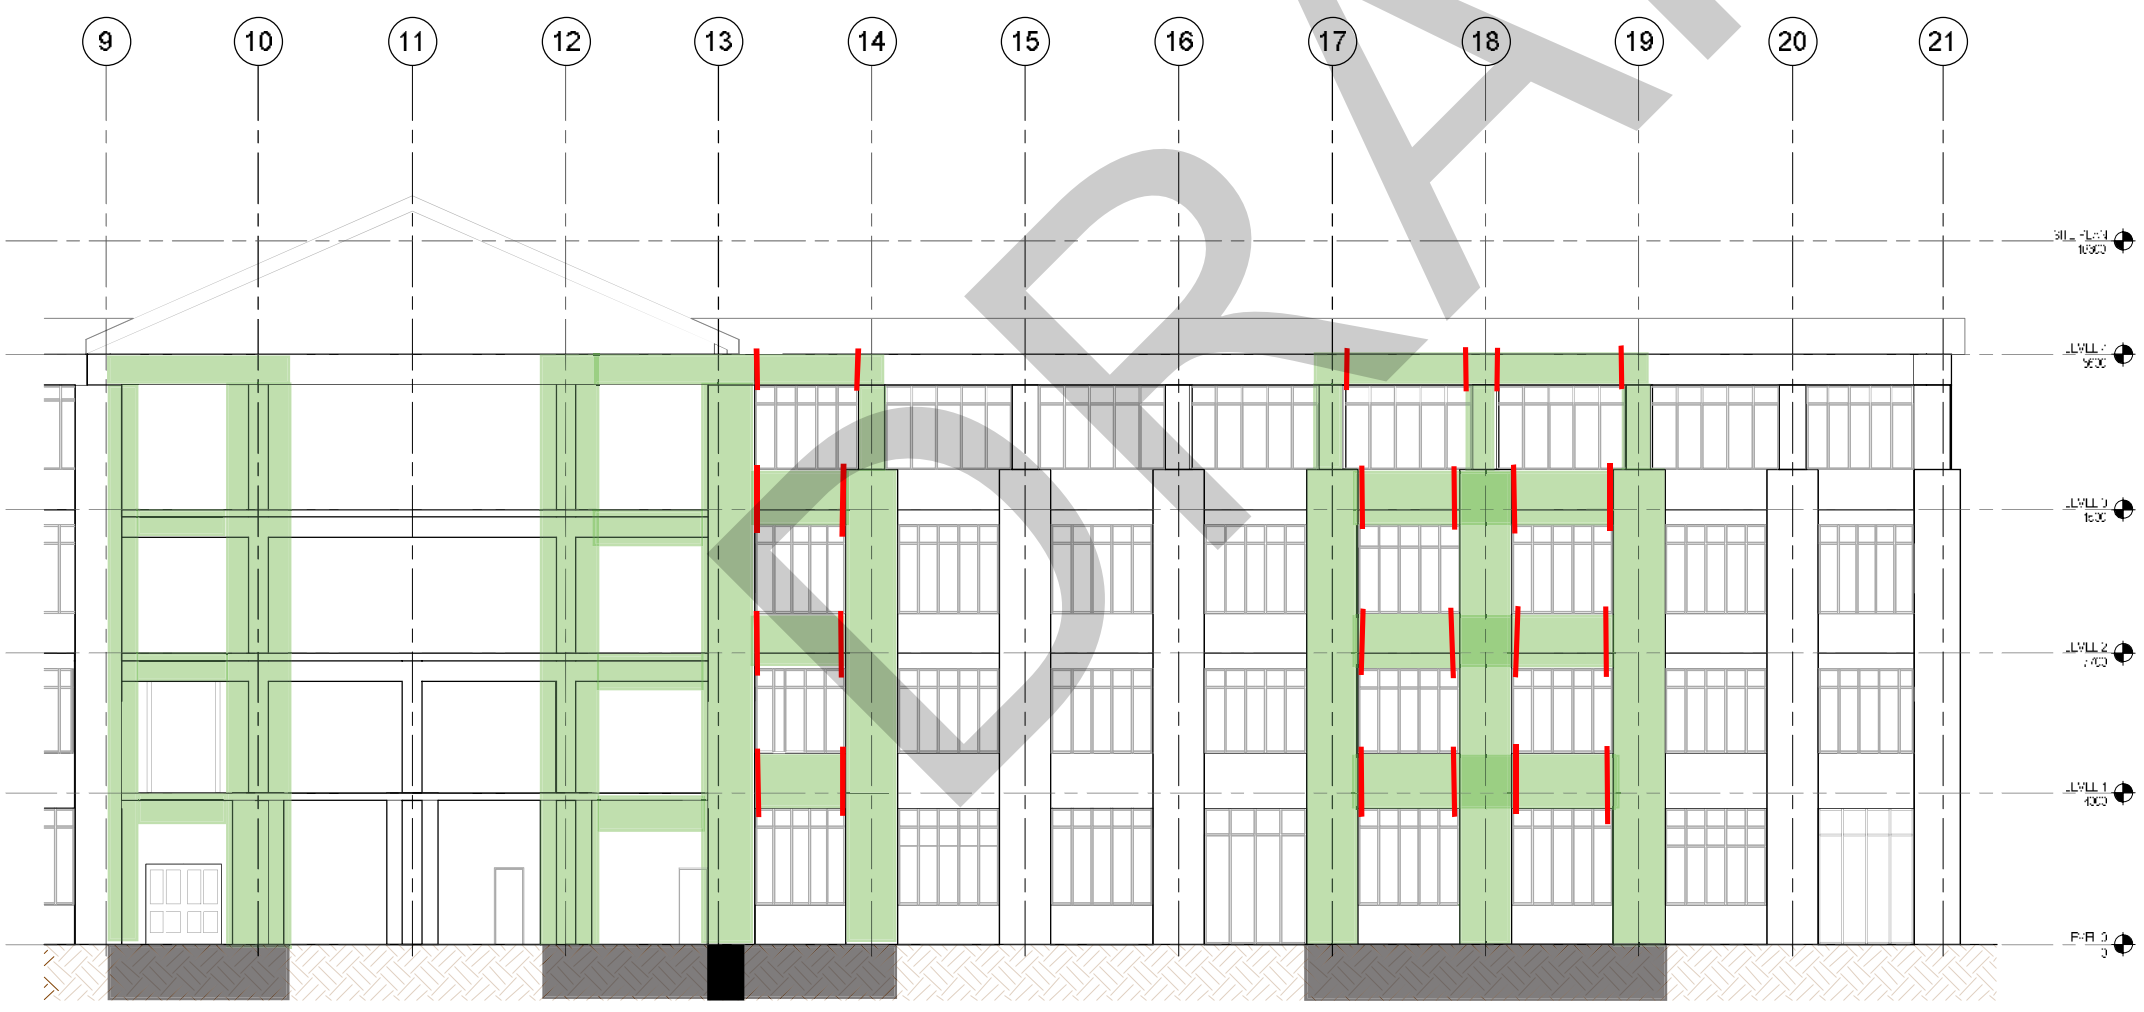
3 SECTION ON GRID D - GRID 9 TO GRID 21
A.131 REF: A.131 Scale: 1 : 100

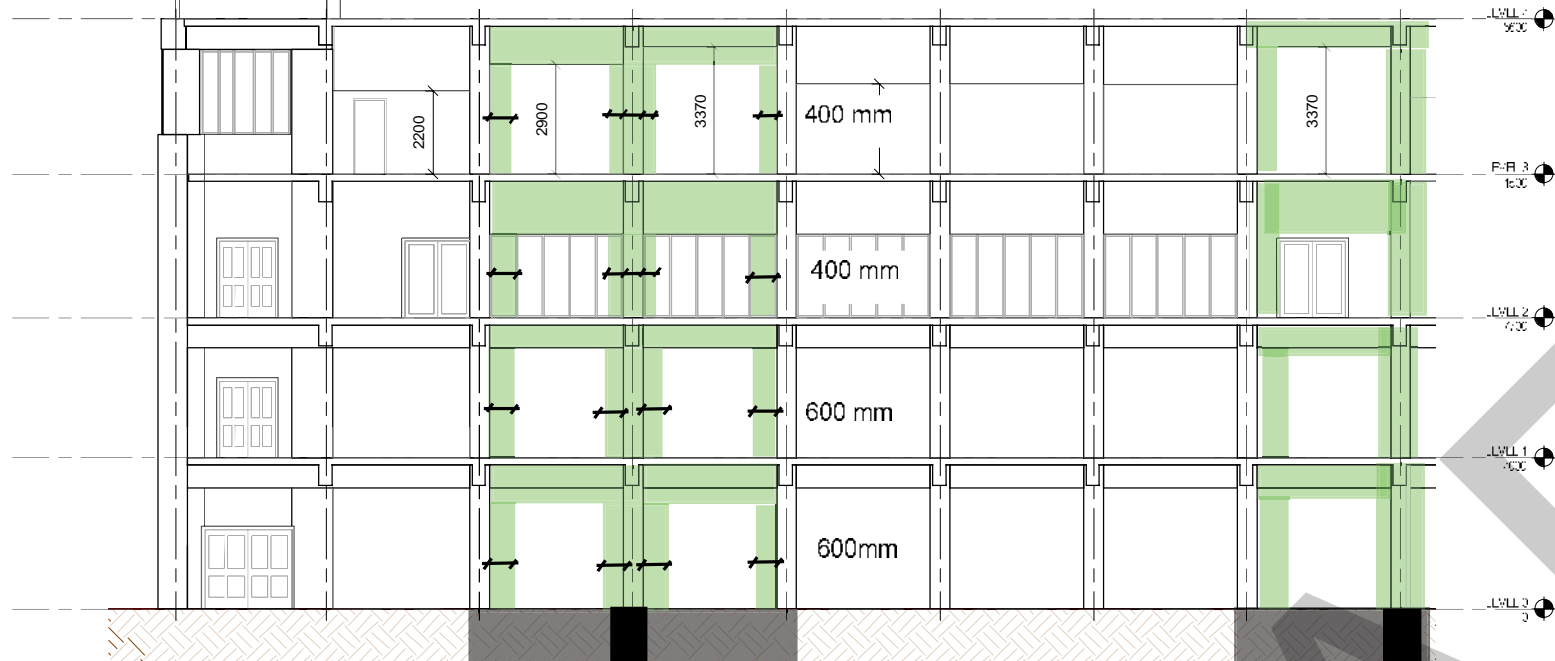
2 | SECTION ON GRID C - GRID 1 TO GRID 9
A.130 REF: A.130 Scale: 1 : 100

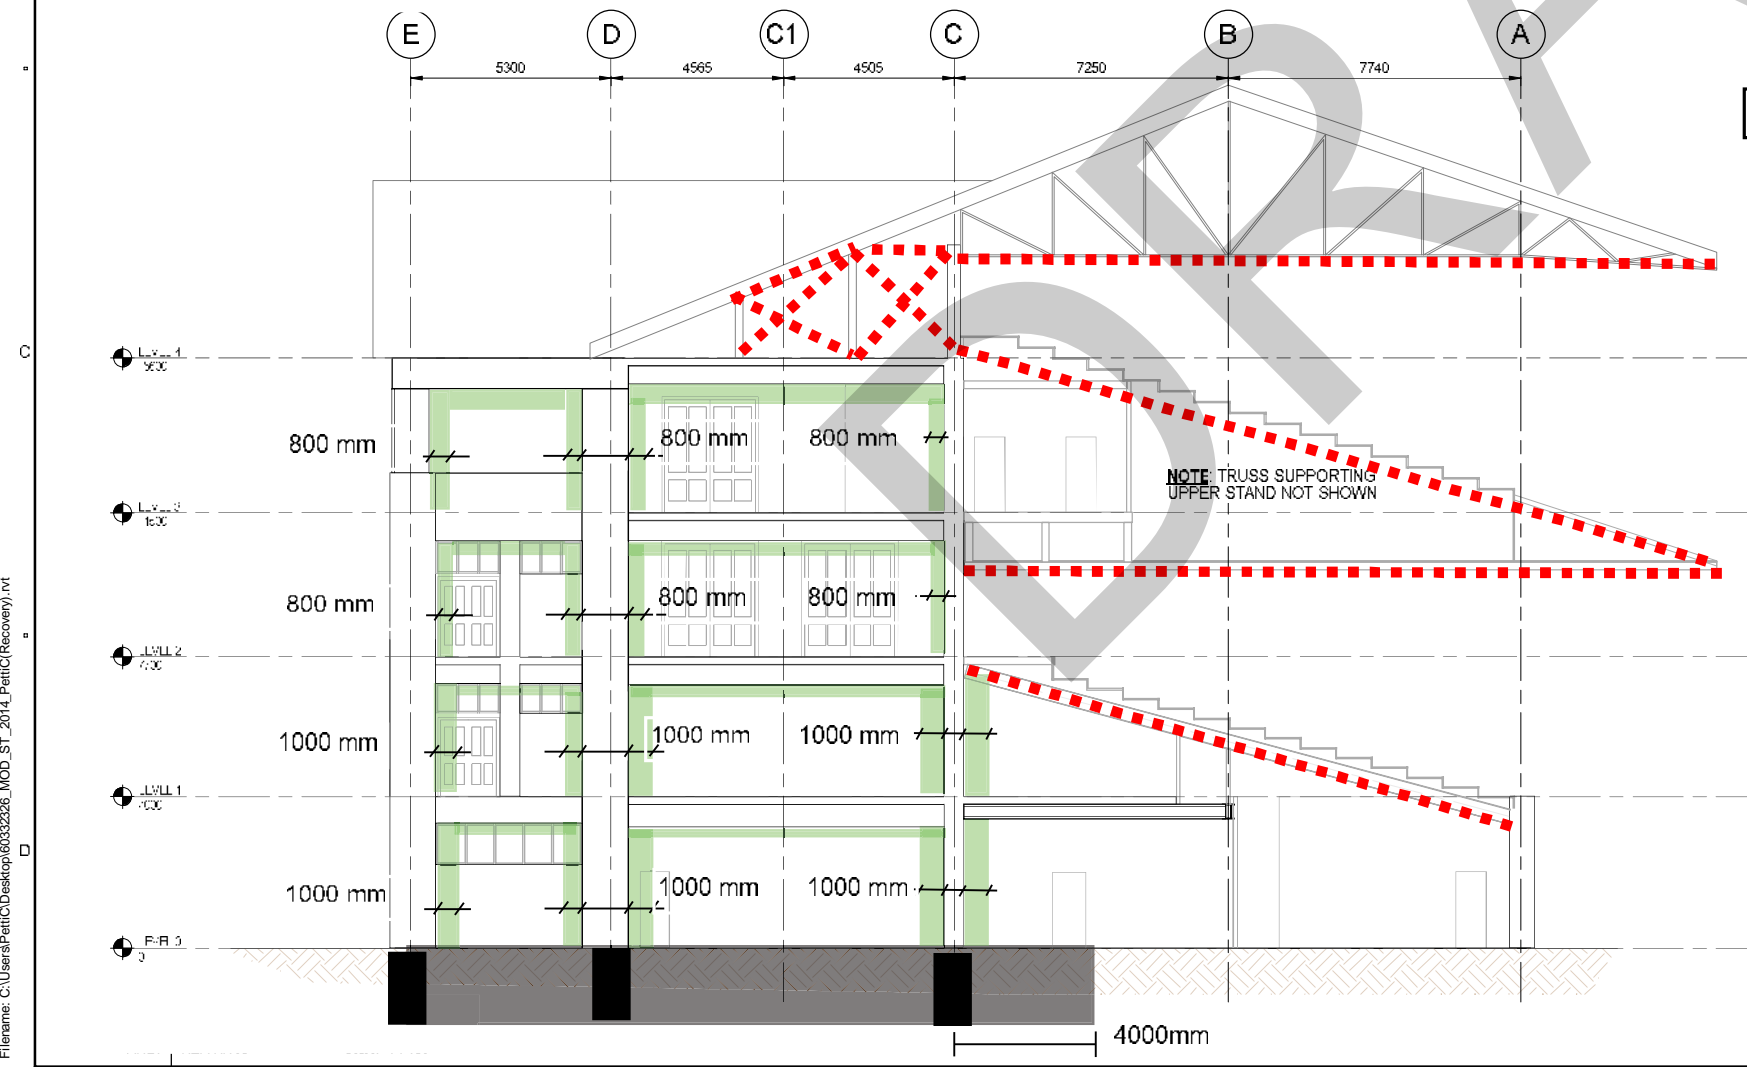
- New column and beams
- New bracing
- Foundation wall 1600 x 750mm
