Detailed Damage Evaluation

Quantitative Seismic Analysis of Grand National (Public) Stand

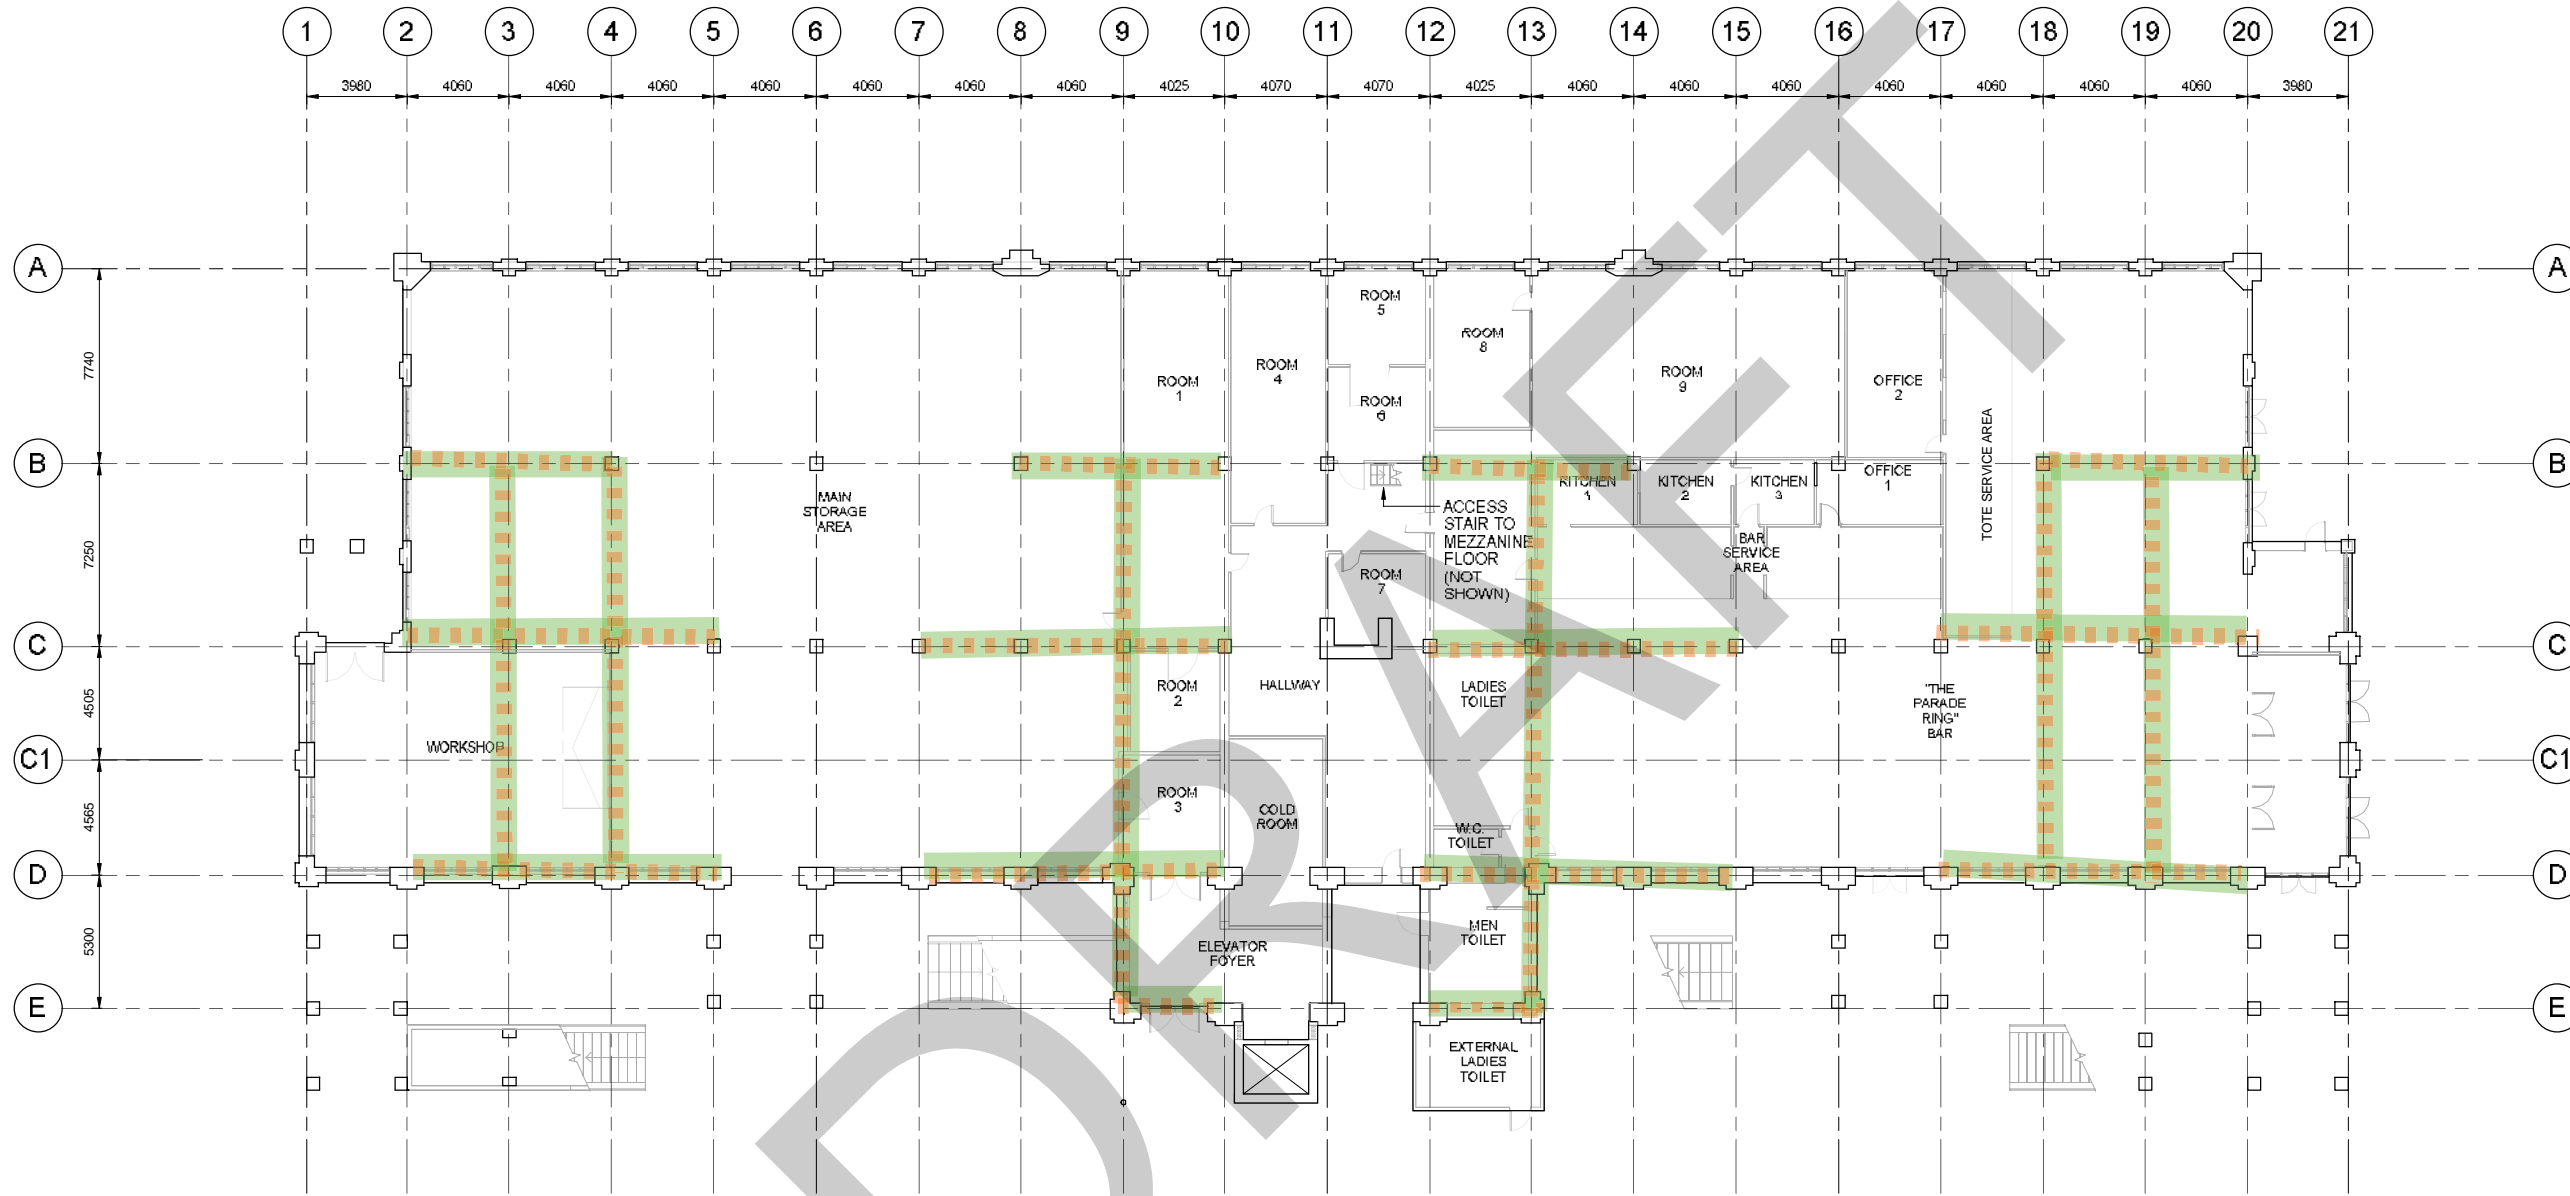
EXISTING GROUND FLOOR
Scale: 1 : 150

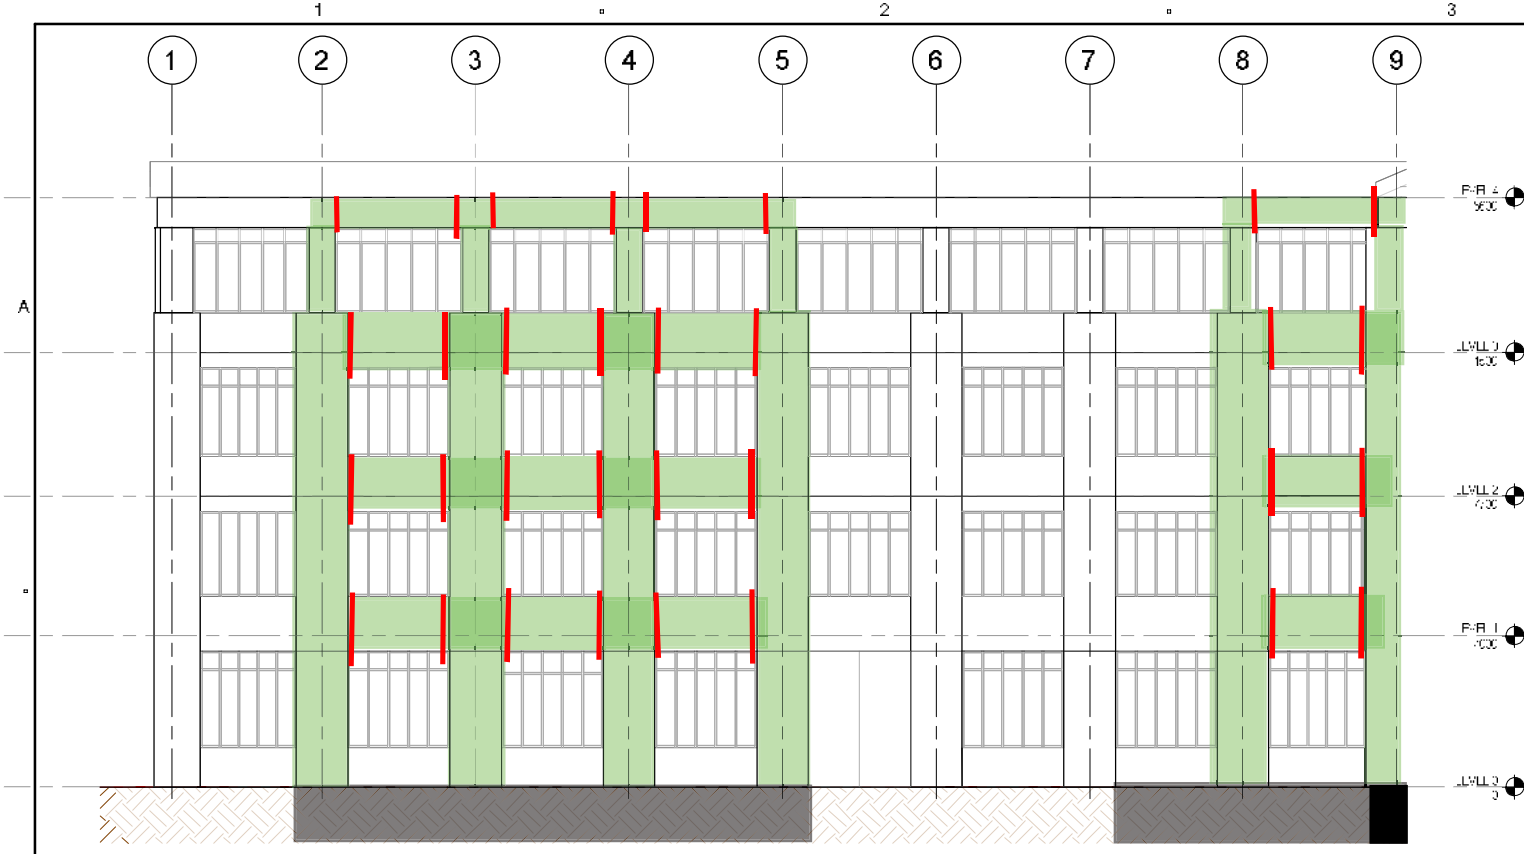
2 SECTION ON GRID D - GRID 1 TO GRID 9

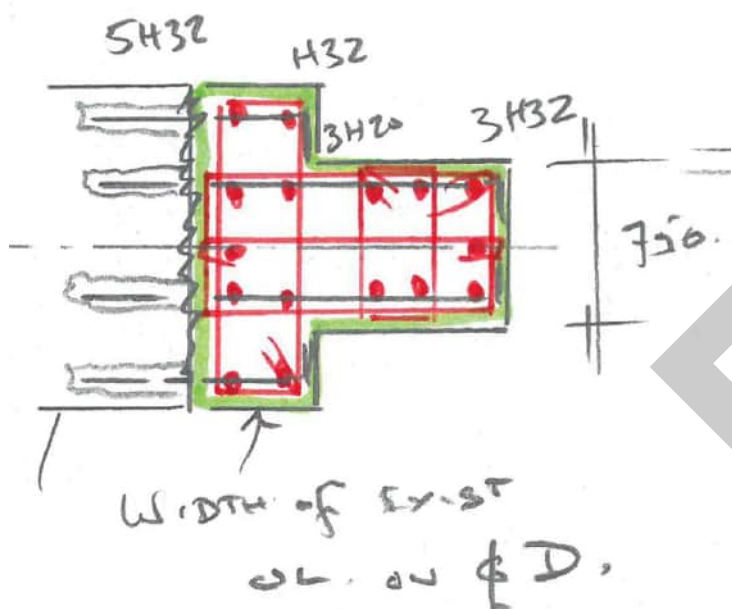
DETAIL 4
Section of concept foundation
wall and connection to existing
plinth
(N.T.S.)

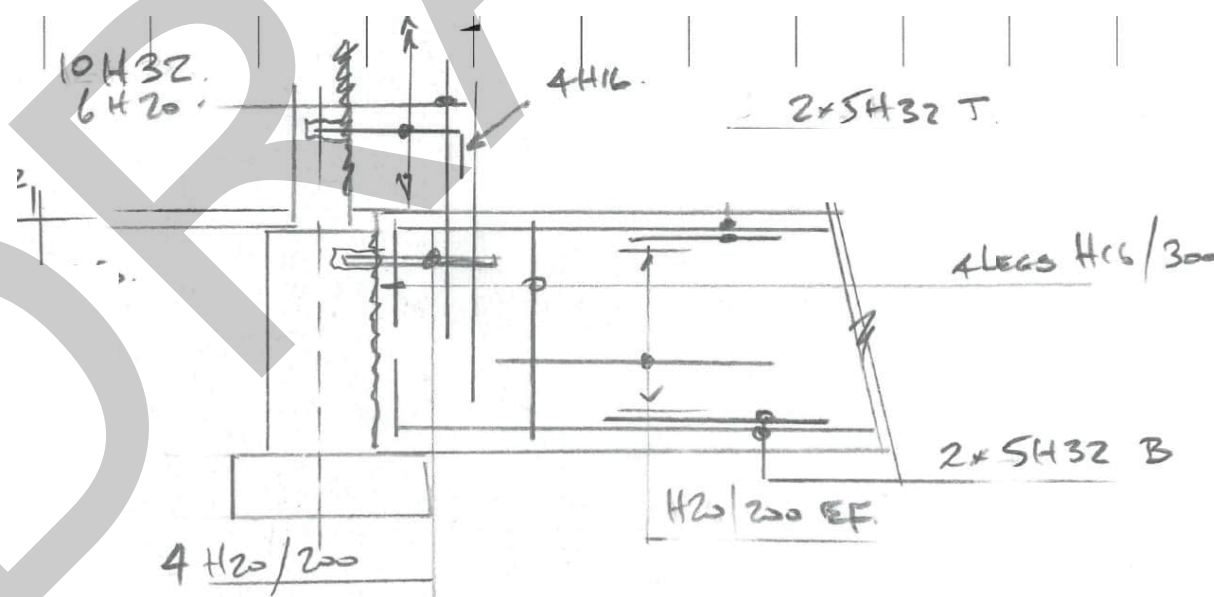
DETAIL 5
Elevation of concept foundation
wall and connection to existing
plinth
(N.T.S.)
