## National Grandstand Canterbury Jockey Club

165 Racecourse Road, Sockburn  
Christchurch

JOB No.: 1910036  
DATE: 18 November 2021  
ISSUE: 1

Seismic Upgrade – Impact Assessment on  
Existing Building Fabric

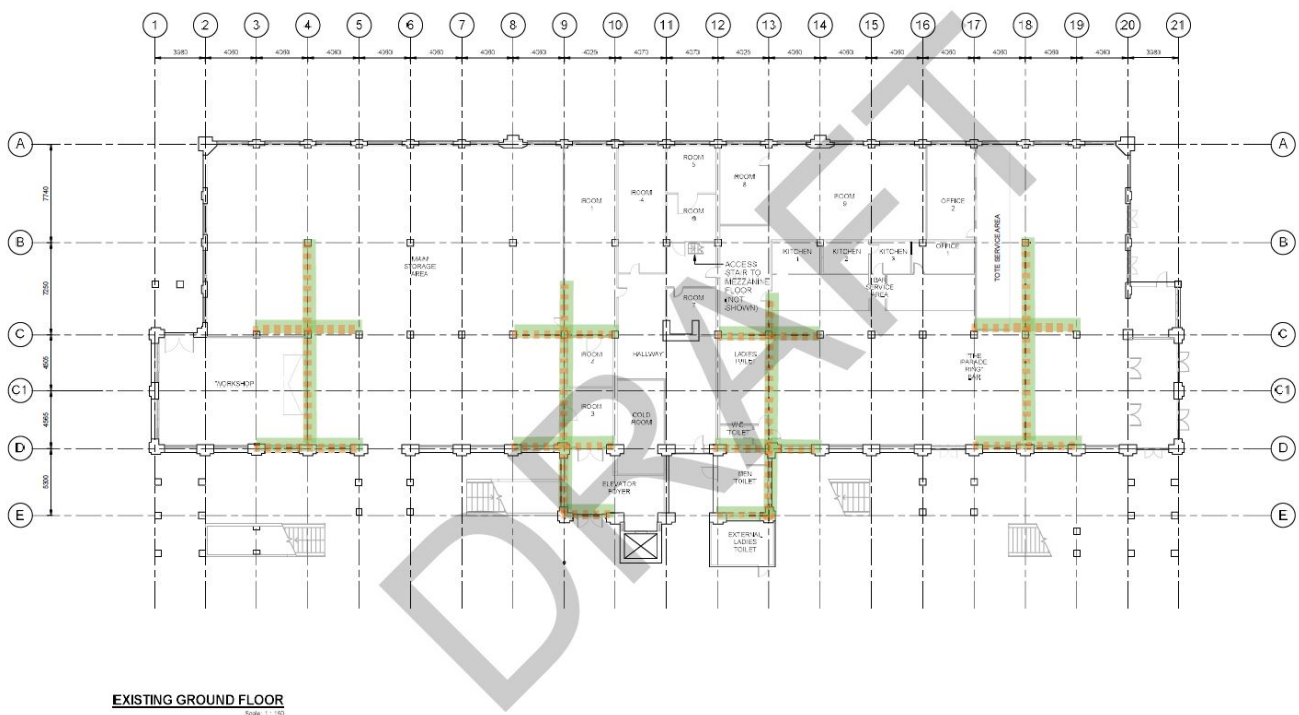
**Figure 2:** Extract from plan showing proposed new foundations (shaded in green) (AECOM 60332326-DRG-C1)

The existing foundations will require an upgrade to support the increase in forces imparted from the new frames. To install the new foundations large parts of the existing ground floor slab will need to be removed and replaced. Not only will this remove the original fabric but demolition around existing foundations carries inherent risk to the stability of the building that will need to be mitigated for works to proceed. This is likely to include extensive temporary propping of the primary structure to allow a safe working methodology. The new foundations required for this option are shown on the extract plan in **Figure 2**.

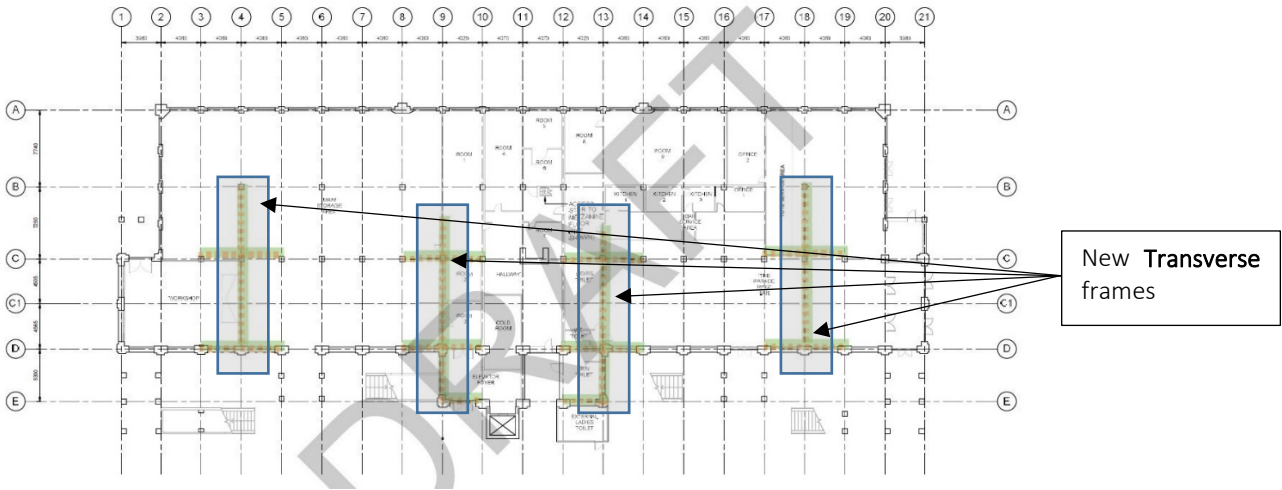
Figure 3: Extract from plan showing proposed new transverse frames (AECOM 60332326-DRG-C2)

In conjunction with the reinforced concrete frames within the building the seating and roof structure will need tying back to this new frame structure. It is envisaged 32mm diameter Reid brace (or similar) will be used as shown in **Figures 4 & 5**. It should also be noted that plan bracing of similar type will be provided to each of the levels shown for the full length of the building to transfer lateral loads back to the main concrete frames.

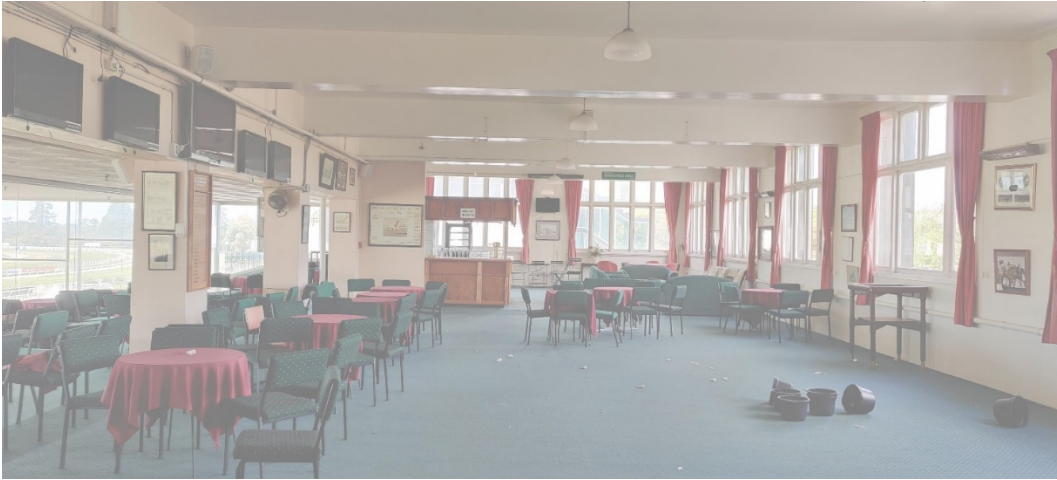
**Figure 6:** Members lounge as existing

The new transverse frames significantly impact the internal finishes and amenity value of the space. See **Figures 6 and 7** for a before and after representation. It should be noted that the pictures do not capture the loss of natural light that will occur in these areas with the introduction of new longitudinal frames.

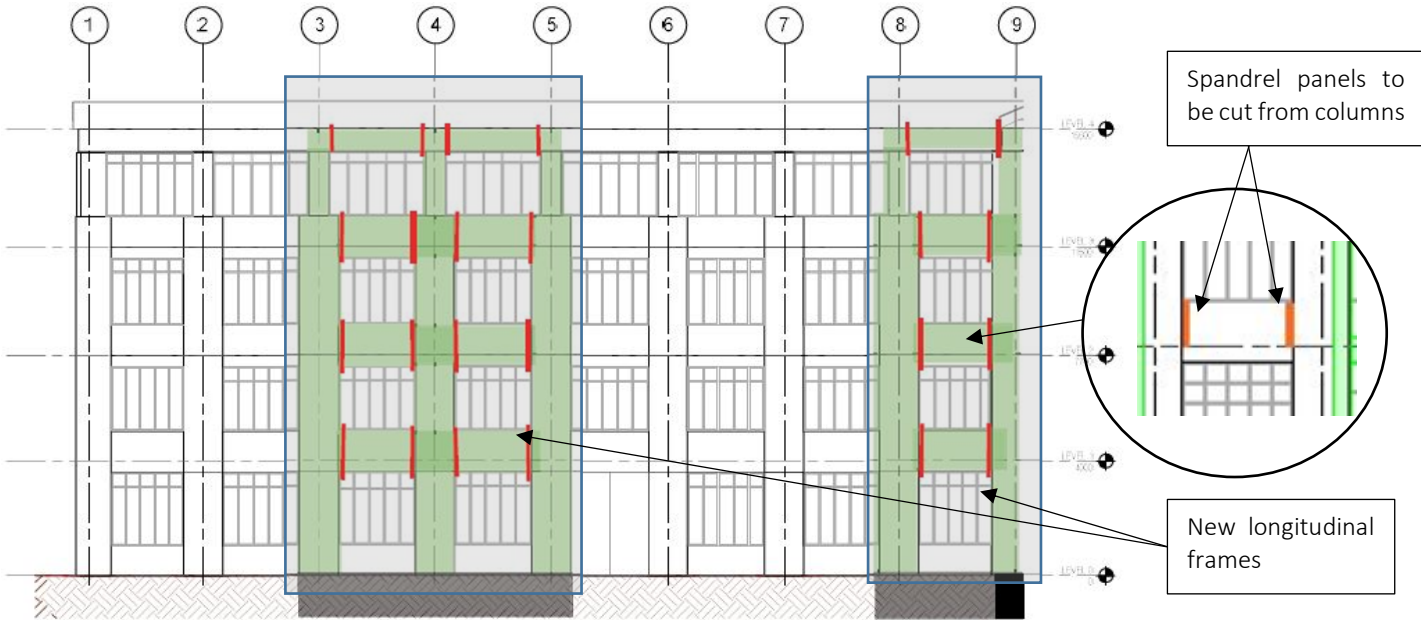
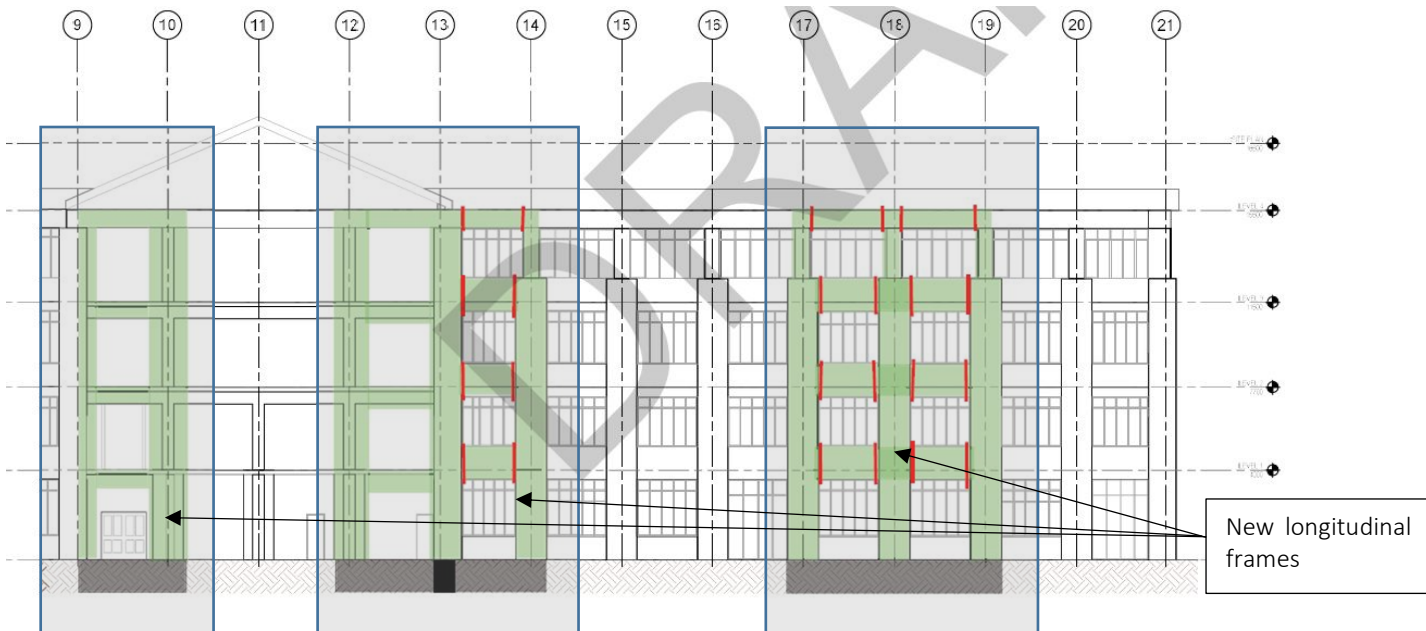
The new columns are to be positively fixed into the existing columns and so will require extensive demolition of the façade (on grid D) and the internal walls (on grid C). In addition to this, to avoid the detrimental transfer of moments and forces into the spandrel panels in future seismic events, they will need to be cut free from the new columns to prevent possible cracking. A mastic sealant will be applied in the new joint and with painting may have some minor effects on the aesthetics.

**Figure 8:** Elevation on Gridline D showing new longitudinal frames (shaded green) and disconnection of spandrel panels (marked in red) (AECOM 60332326-DRG-C3)

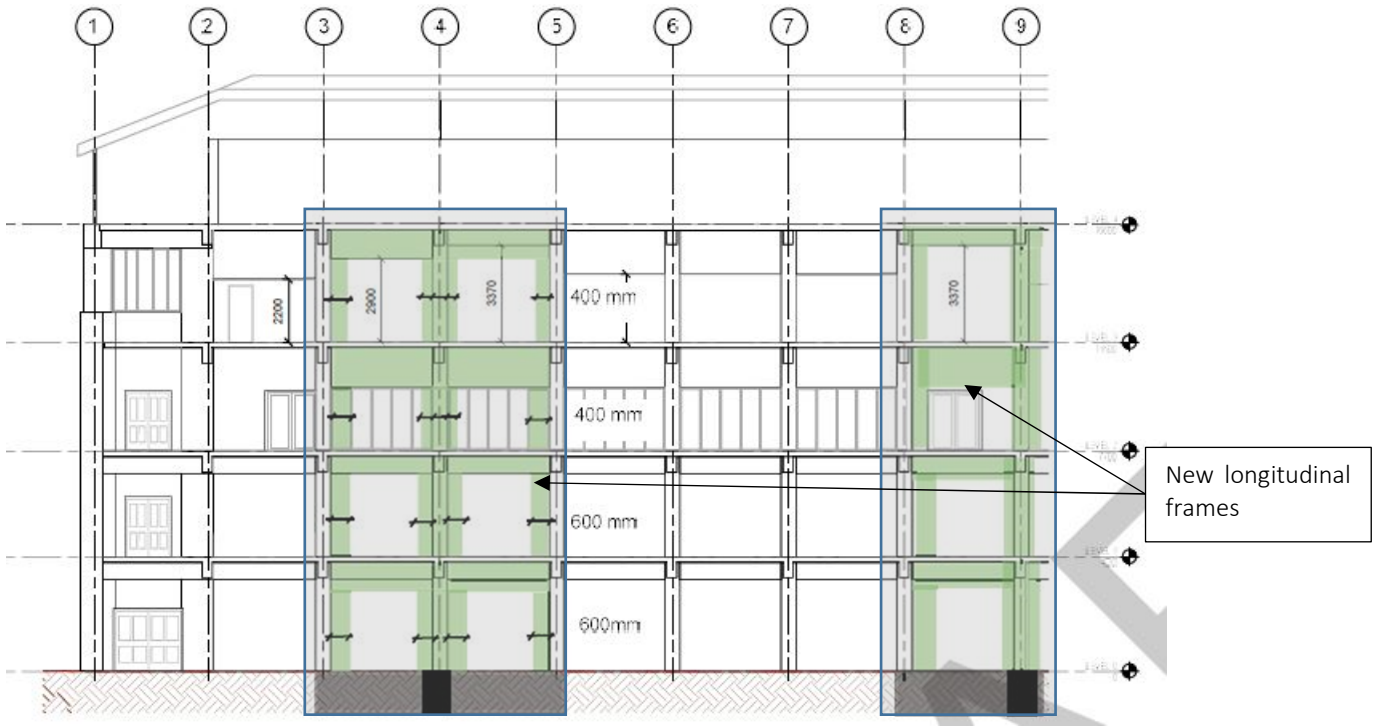
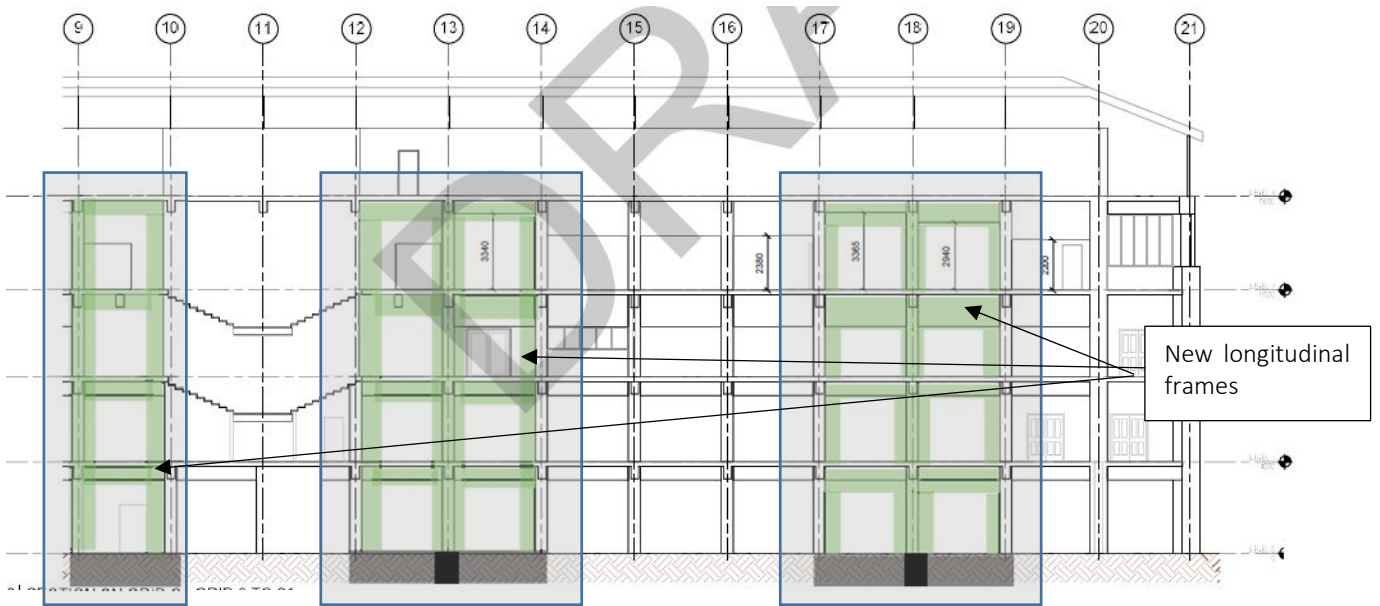
**Figure 10:** Elevation on Gridline C showing new longitudinal frames (shaded green) and disconnection of spandrel panels (marked in red) (AECOM 60332326-DRG-C4)

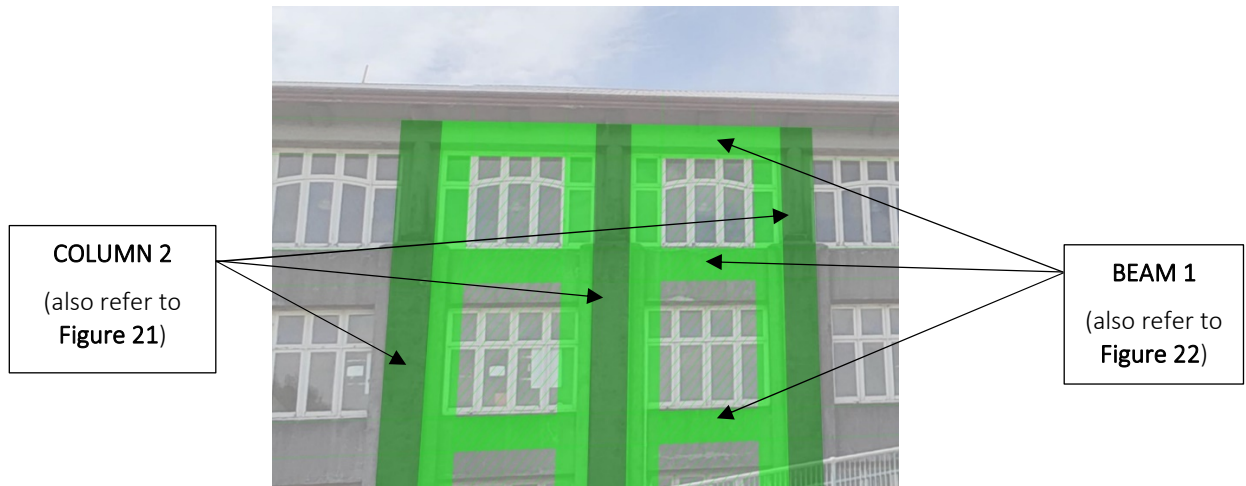
**Figure 12:** Close-up on impact new frame has on existing elevation (Grid D - Grids 3, 4 and 5)

The longitudinal frames are a significant size and will reduce the amenity of the building. **Figure 12** shows the outside face of the new frame, including columns and beams (discussed further below) on the external façade.

The new structure will also reduce the window openings, notwithstanding the potential Building Code issues of reinstalling the original (and non-compliant) windows, they will no longer physically fit into the opening so will need to be replaced. To maintain a similar appearance, it would be beneficial to maintain the window pane geometry and so reduce the size by a full pane module on each side. Whilst this may maintain some aesthetic continuity it is not only a loss of original heritage building fabric but will be significantly detrimental to the symmetrical geometric nature of the facade as a whole. The alternative is to replace all windows with a similar size to retain the symmetrical nature at the further cost of original heritage building fabric.

It should be noted that, for the 34%NBS solution, over 40% of the windows will be removed and replaced to allow installation of the seismic upgrade. It is further noted that the reduction in size of the windows will result in a further loss of natural light within the building.

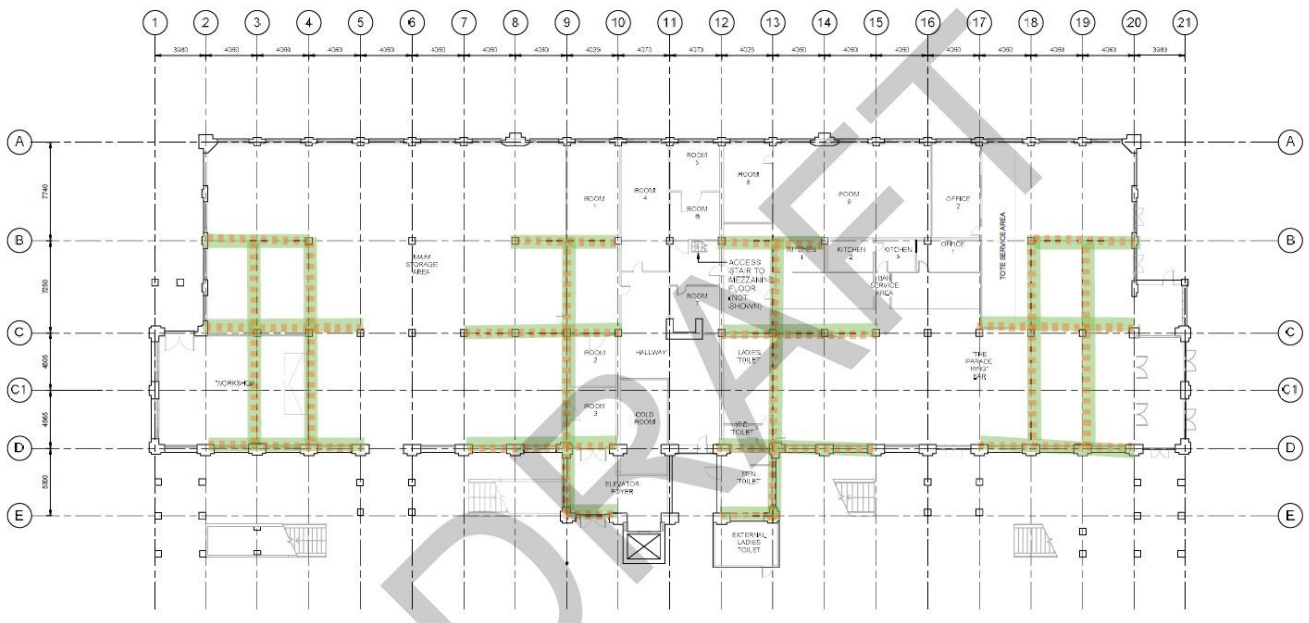
Figure 13: Extract from plan showing proposed new foundations (AECOM 60332326-DRG-C6)

The proposed solution for localised strengthening of foundations for 34%NBS is expected to remain valid. However, the number of foundations to which the detail relates will need to be increased to accommodate the new reinforced concrete frames required for this solution (as set out below). This is a much more extensive upgrade than the 34%NBS solution outlined above and will not only remove more of the original fabric, but will increase the risk/cost/time of demolition. This is likely to include extensive temporary propping of the primary structure to allow a safe working methodology.

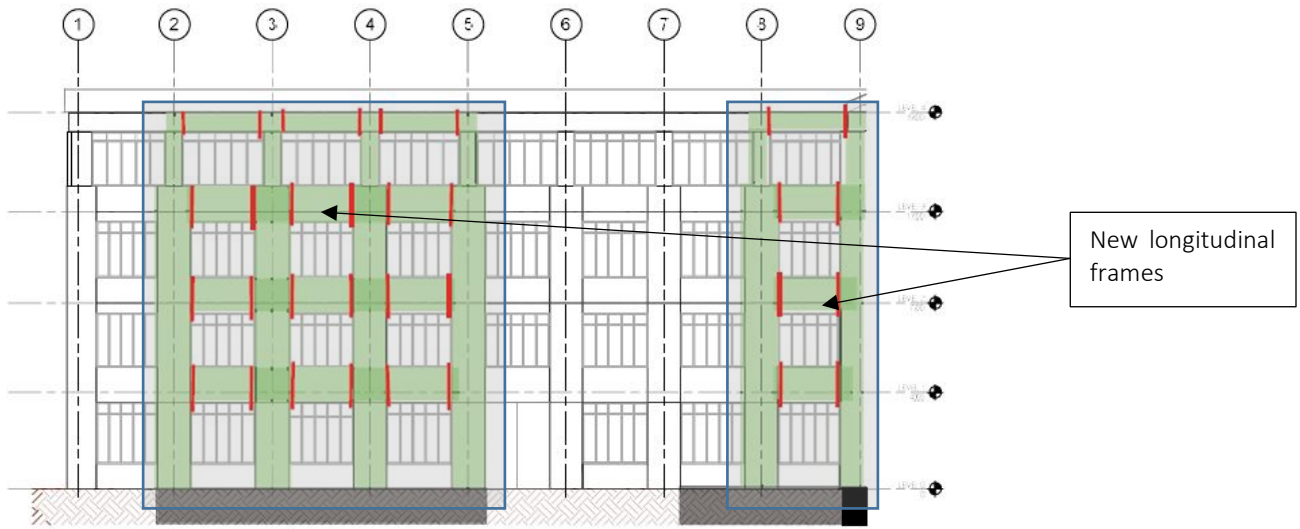
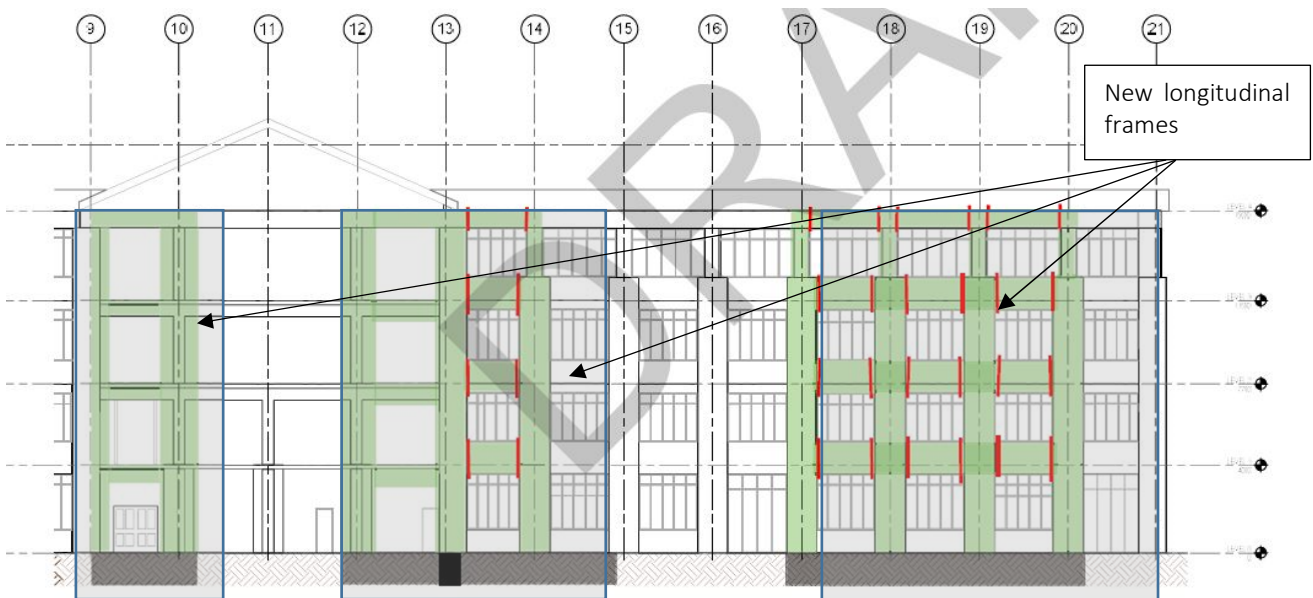
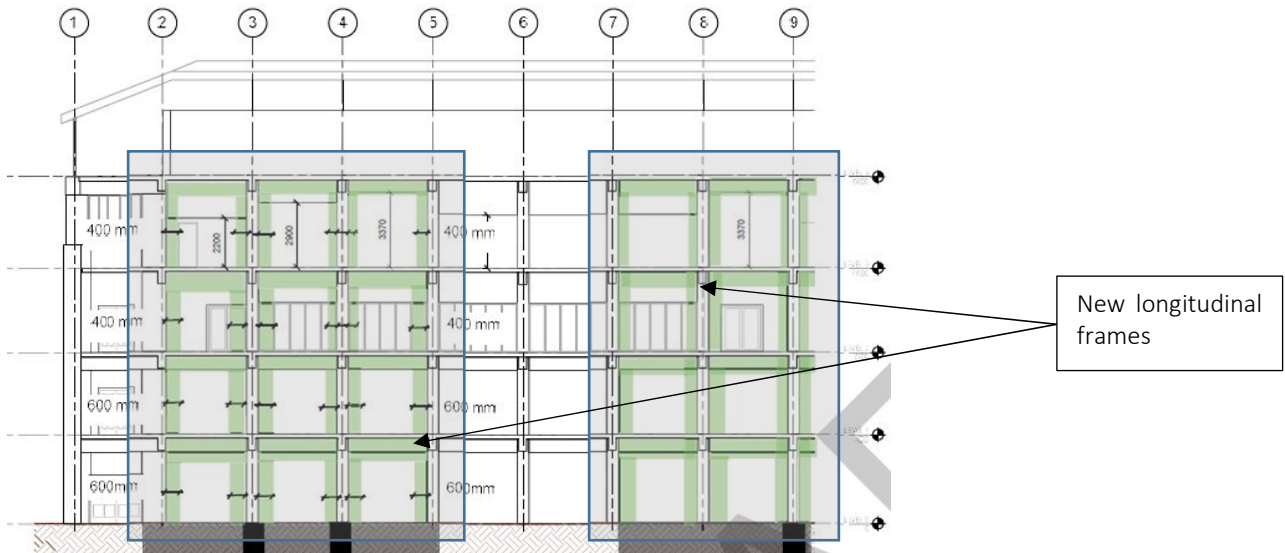
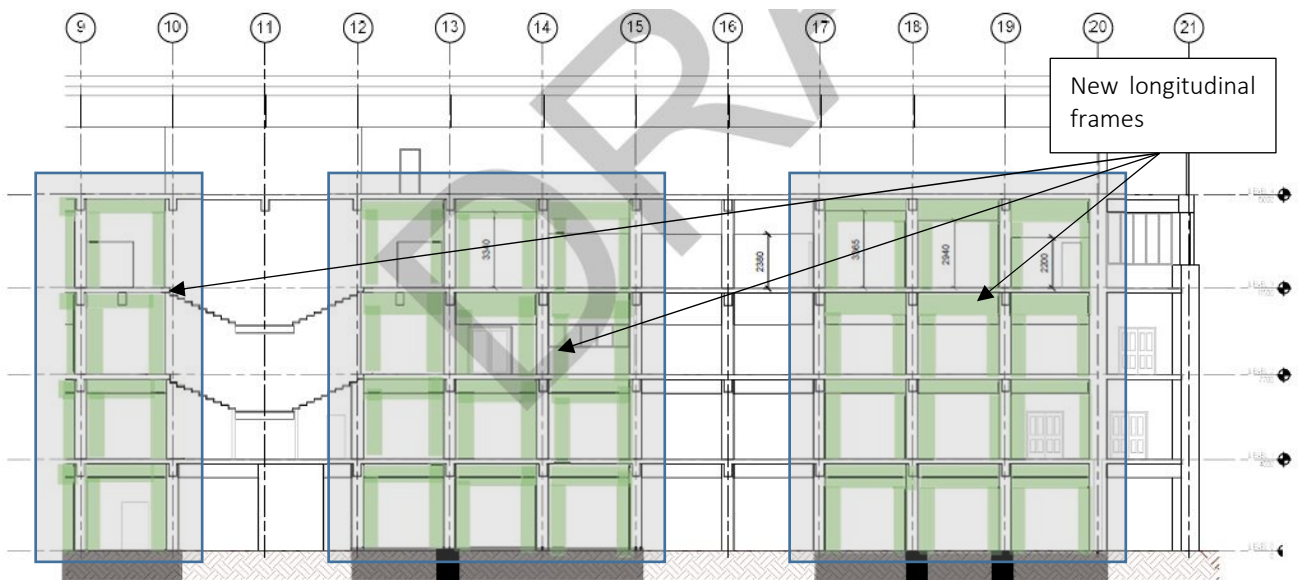
As shown the introduction of sufficient frames to provide 67%NBS capacity will require significant demolition and introduction of new structures that will severely impact the heritage fabric of the building. It is envisaged >50% of spandrel panels and windows will be affected by the installation of new longitudinal frames. The new columns and beams are installed in the same way as the 34%NBS solution.

**Figure 17:** Elevation on Gridline D showing new longitudinal frames (shaded in green) and disconnection of spandrel panels (marked in red) (AECOM 60332326-DRG-C8)

Again, the new structure will also reduce the window openings such that the original windows will need to be replaced, as is the case with 34%NBS option above but to a greater extent causing a loss of original heritage building fabric and natural light.

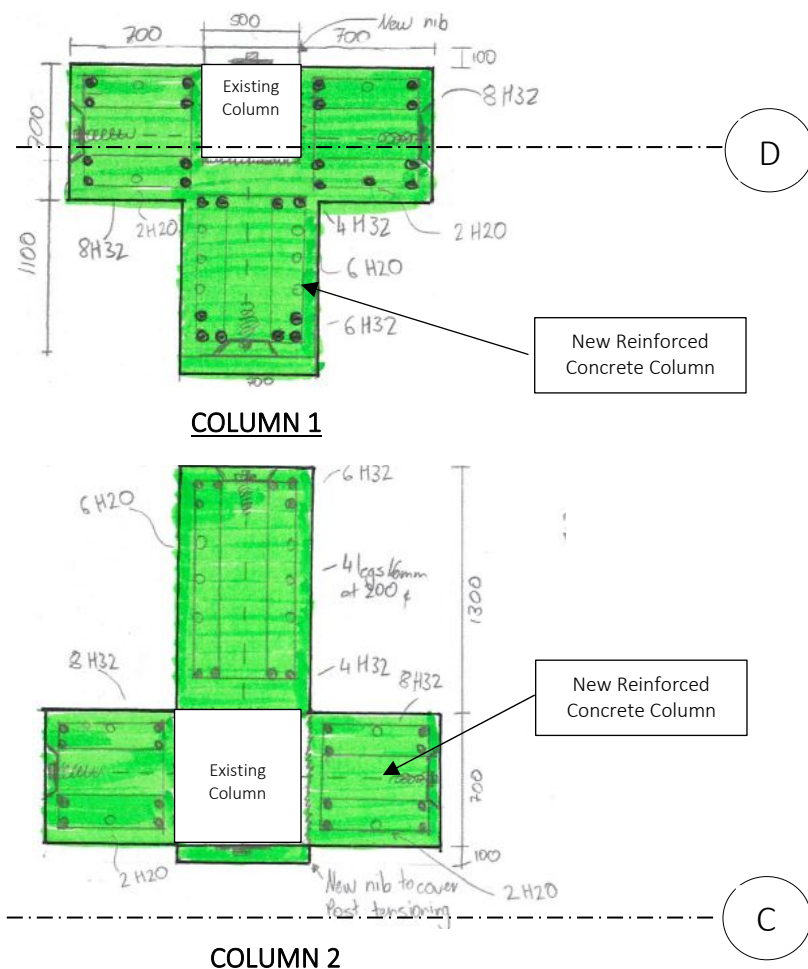
Figure 21: Proposed new column (shaded in green) showing attachment to existing column.

- The original columns are completely encapsulated by the new structure and no longer visible.
- The column size and form are significantly altered producing a different aesthetic from the original intent.
- The column sizes will be a mix of old and new which removes the current symmetrical nature of the building.
- The surrounding wall, floor, window frames, spandrel panels and ceilings will need to be demolished and replaced to make way for the new columns.

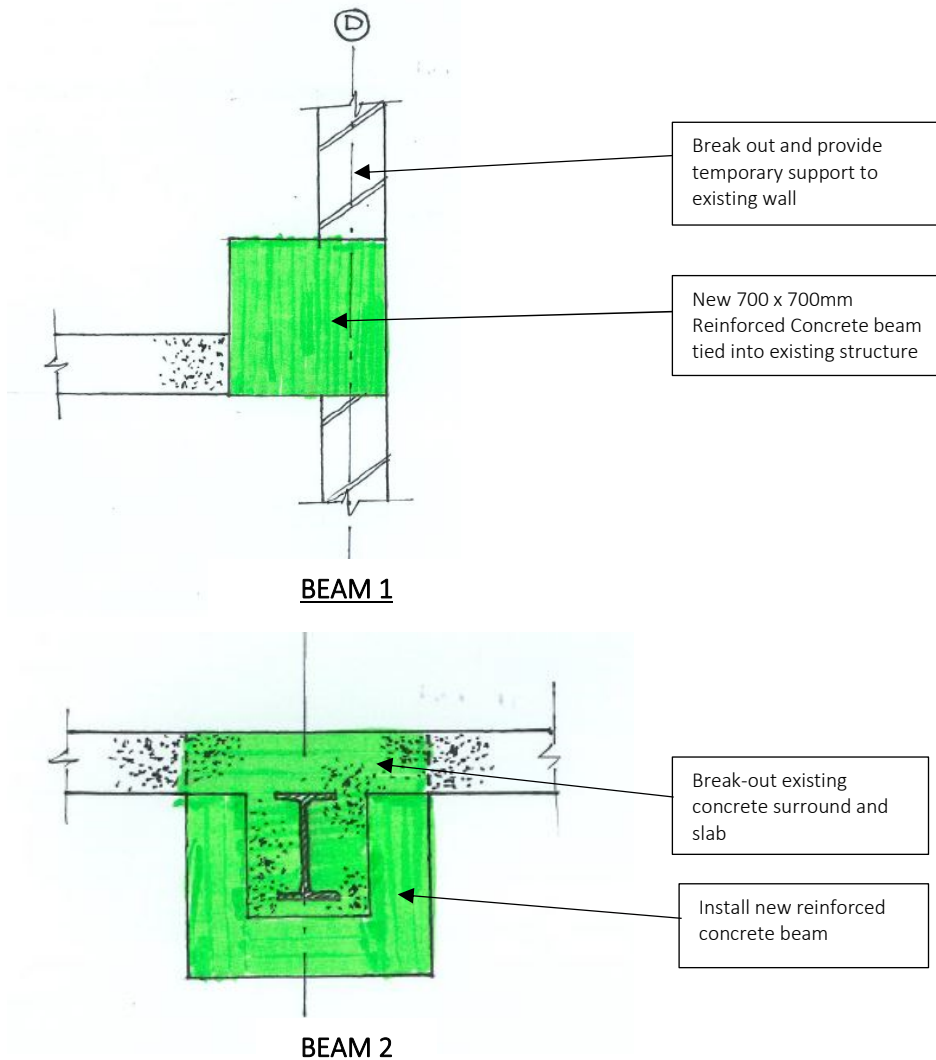
**Figure 22:** New Reinforced Concrete Beams (Beam 1- Longitudinal and Beam 2 - Transverse)

New transverse beams will be introduced for both the 34%NBS and 67%NMBS solution by removing the existing concrete encasement of the existing steel floor beams and local demolition of the existing reinforced concrete floor and replacing with a new reinforced concrete encasement. (Beam 2)

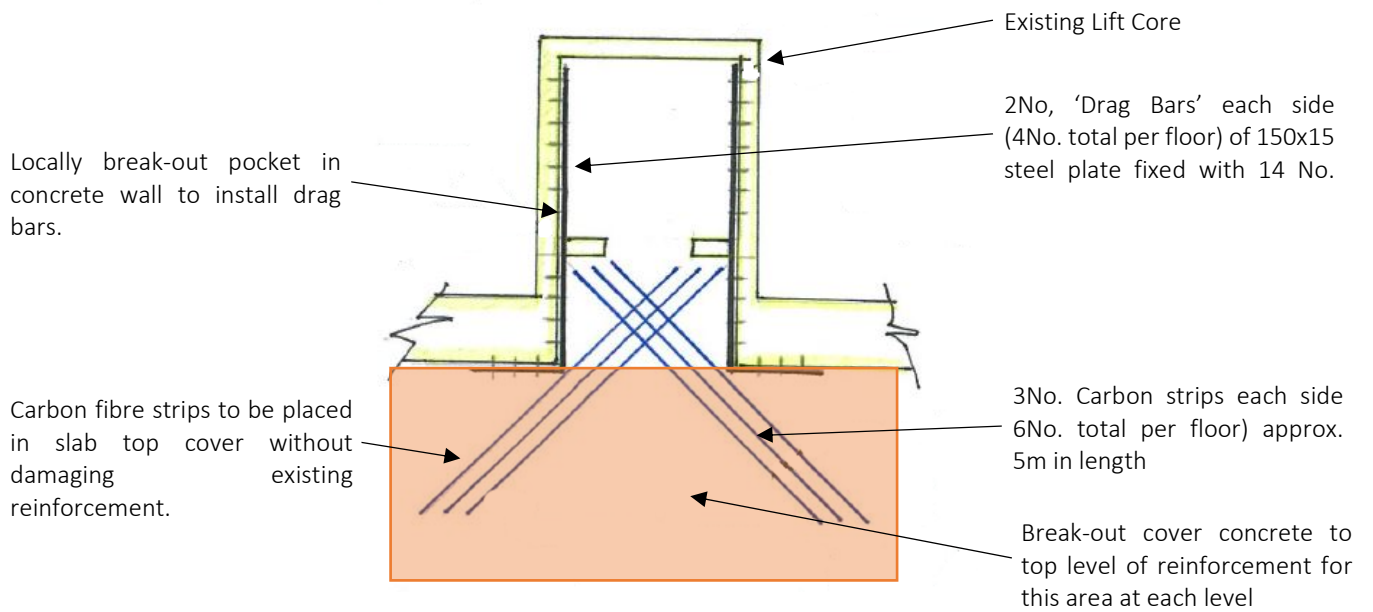
Figure 23: Lift Shaft Structural Tie Details – Typical level

The drag bars can be retrofitted directly to the concrete with minimal demolition but the carbon fibre strips will require removal of the top 50mm of concrete to allow placement of the strips into the cover zone. The slab in this area will therefore appear as new construction. This is required at 4 levels.

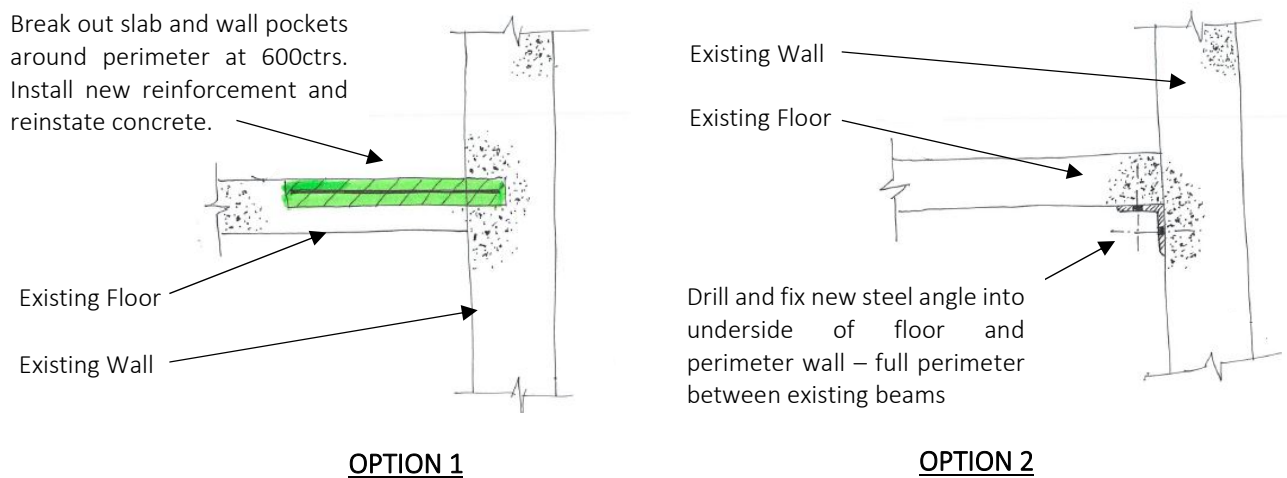
Figure 24: Edge connection details

At the time of writing the previous reports, we were utilising the reinforced concrete slabs as structural diaphragms to transfer lateral load into the new frames. Subsequent intrusive investigation of the floor reinforcement found that the reinforcing bars were not continuous over the supporting beams. The ability to act as a full diaphragm is therefore compromised. This would need rectifying for both the 34%NBS and 67%NBS solutions. To those areas we are not installing any transverse or longitudinal beams, we will need to tie the existing floor into the perimeter wall. This can be achieved by either breaking out the concrete over the floor beams and installing required reinforcement, or by providing an alternative solution utilising the edge beams. This would require either breaking out the slab and installing reinforcing bars into the edge beam (Option 1) or fixing a steel angle to the underside of the slab to attain full connection (Option 2). Both methodologies will be disruptive and compromise the existing fabric of the building.

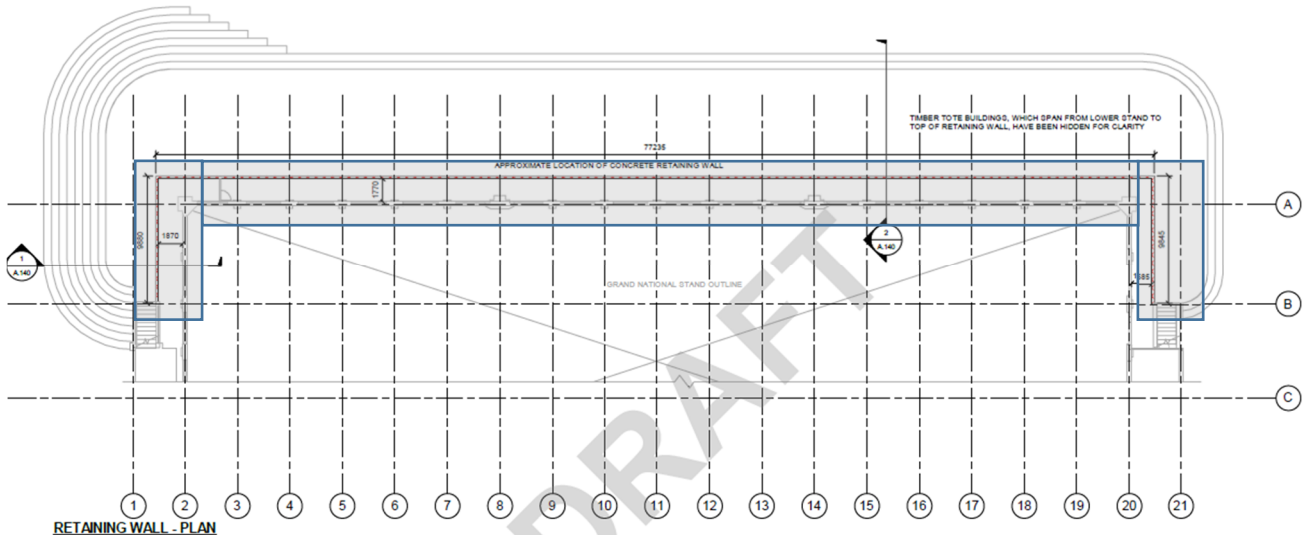
Figure 25: Retaining wall location plan

The retaining wall to the North of the building is damaged and will require demolition and replacement. It may be possible to remove ancillary buildings, such as Tote, betting kiosks and stairs with the intention to reinstate them once the works are complete, but it should be accepted that some damage will occur and at least partial replacement of some items will be required. The red concrete podium area will also require at least partial removal to allow installation of the new retaining wall. It is unlikely a new concrete podium will match the existing colour so it may all have to be replaced.

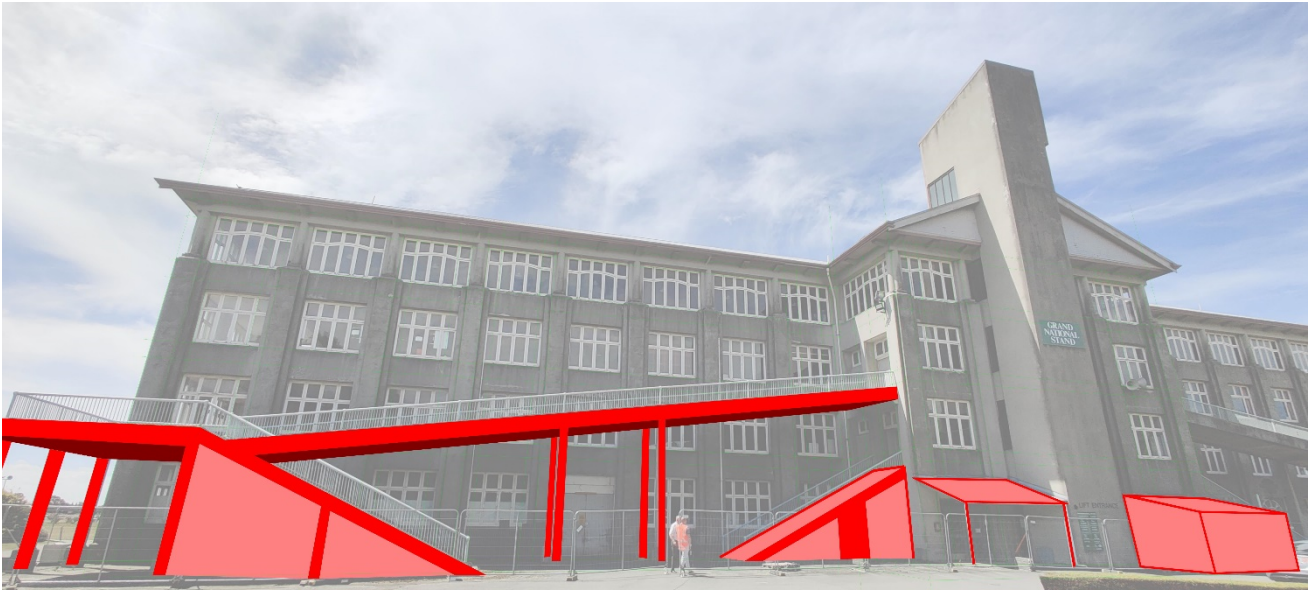
Further to this the seismic upgrade to the columns either side of the door openings are likely to reduce the opening width to not much greater than a single entry/exit door. This may have implications on fire egress over and above the compliance of the ramp geometry so a full fire assessment is likely to be required.

**Figure 26:** Access ramps (shown in red) to be demolished and replaced. Note – building is symmetrical – both ramps need to be replaced.

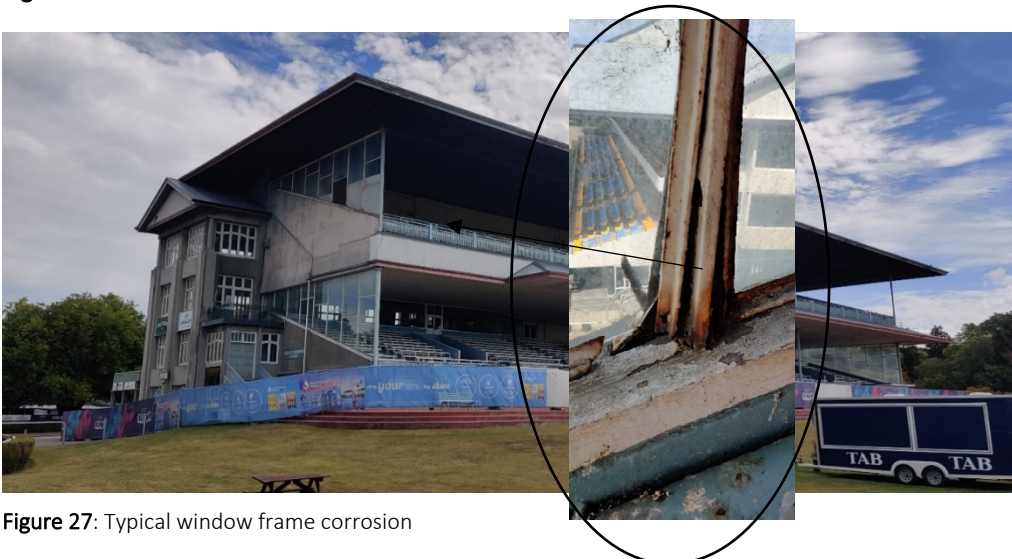
The window frames in the gable elevations are in an advanced dilapidated state and will require replacement as shown in Figure 27.

Figure 27: Typical window frame corrosion
