**Canterbury Earthquakes 2010/11 Port Hills Slope
Stability: Risk assessment for Cliff Street**

**GNS Science Consultancy Report 2014/73
August 2014 FINAL**

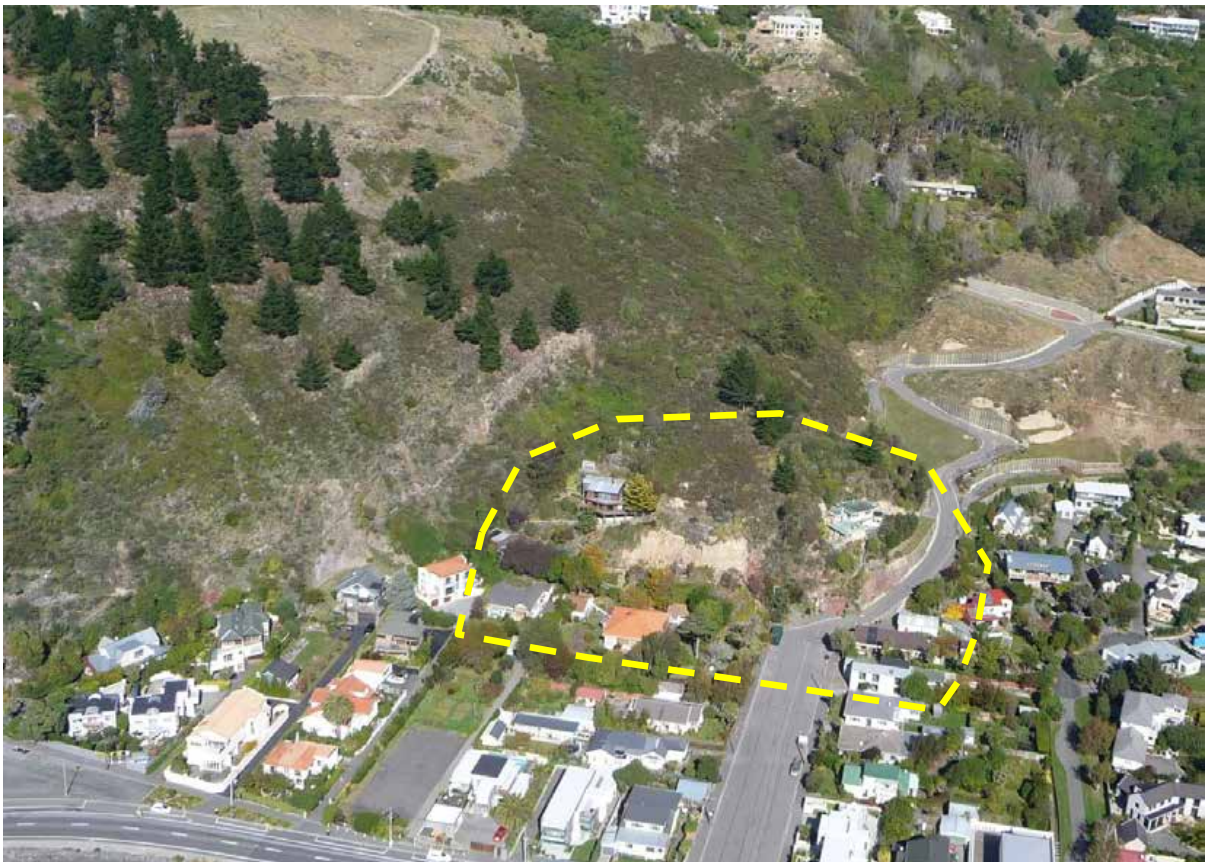
Figure 3 Aerial view of the Cliff Street mass movement study area number 6 (within the yellow dashed line), looking south.

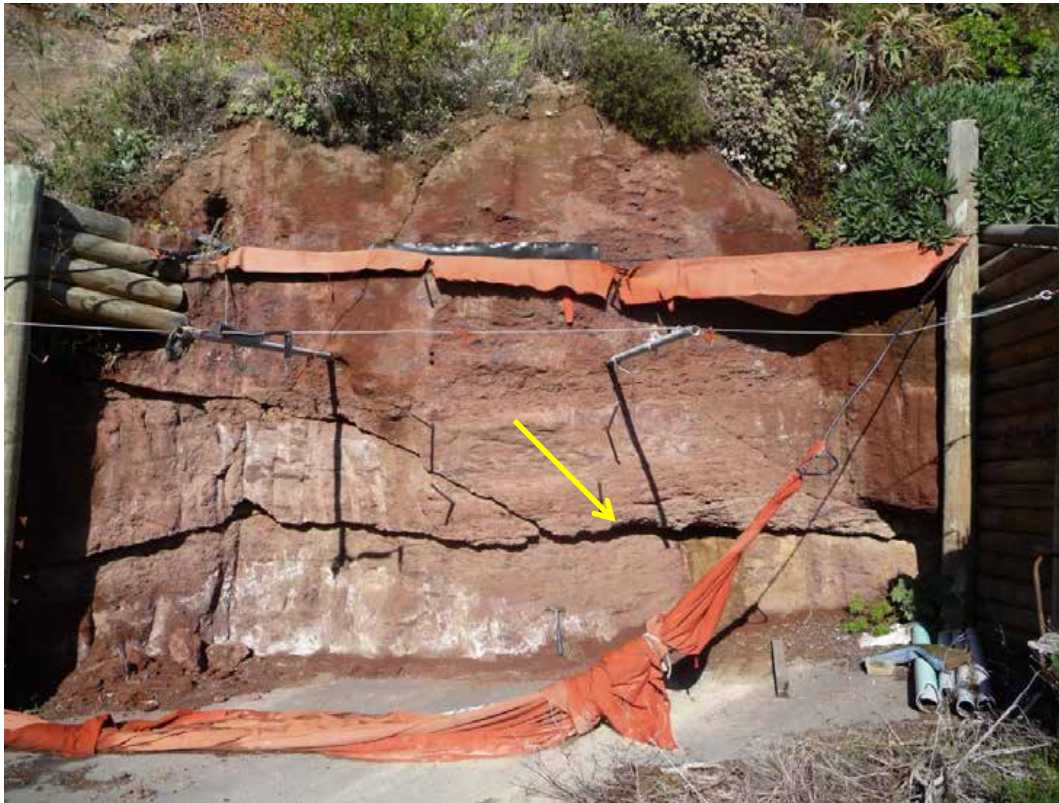
Figure 8 Earthquake-induced cracking in volcanic tuff with post-earthquake movement shown along a zone of discontinuous soft clay within a laterally persistent sub-horizontal discontinuity (yellow arrow). However, it is not known whether these displacements were only in response to the 22 February 2011 earthquakes, or include displacements in subsequent earthquakes.

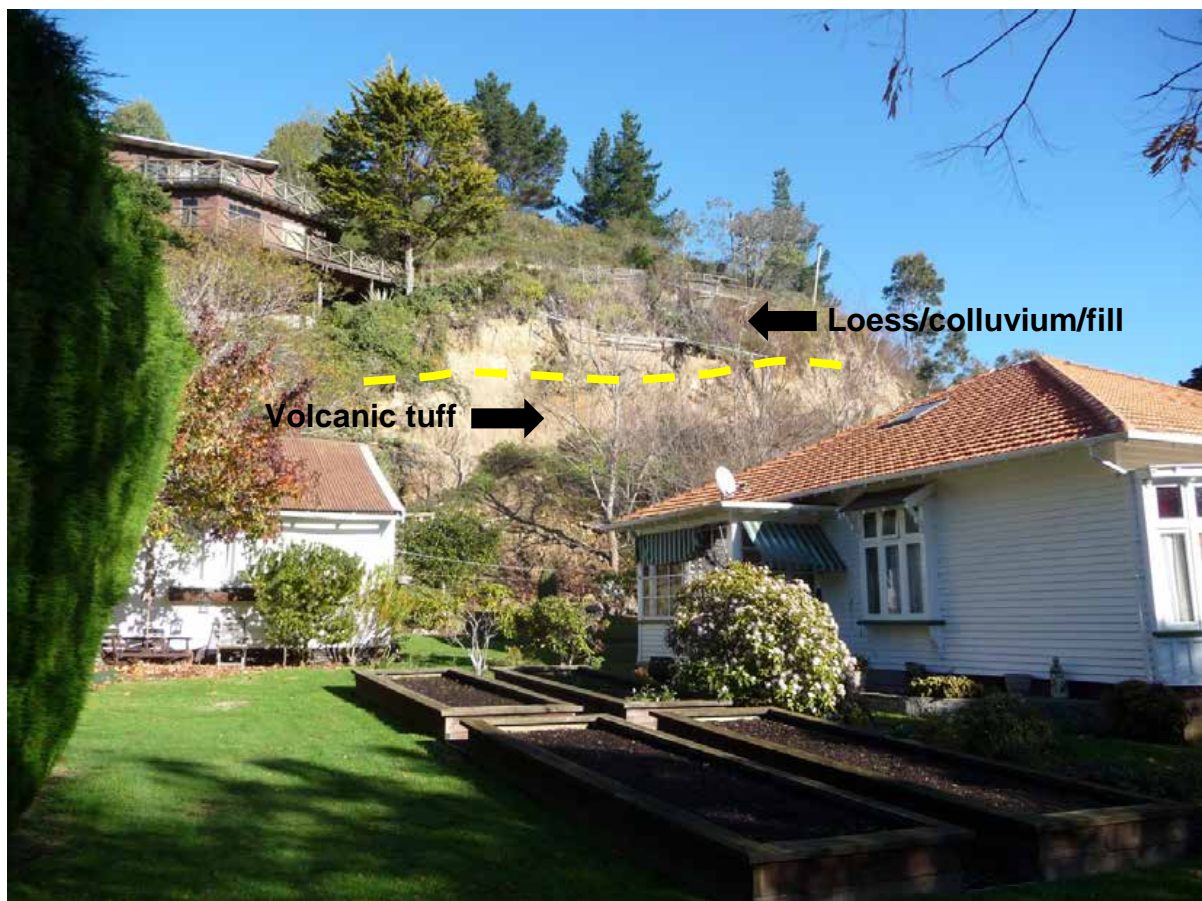
Figure 9 View to the south of the eastern end of the site. 11A Cliff Street is visible in top left of the photograph and 11 Cliff Street is in the foreground. Loess forms the upper part of the exposed (bare) slope and overlies volcanic tuff.

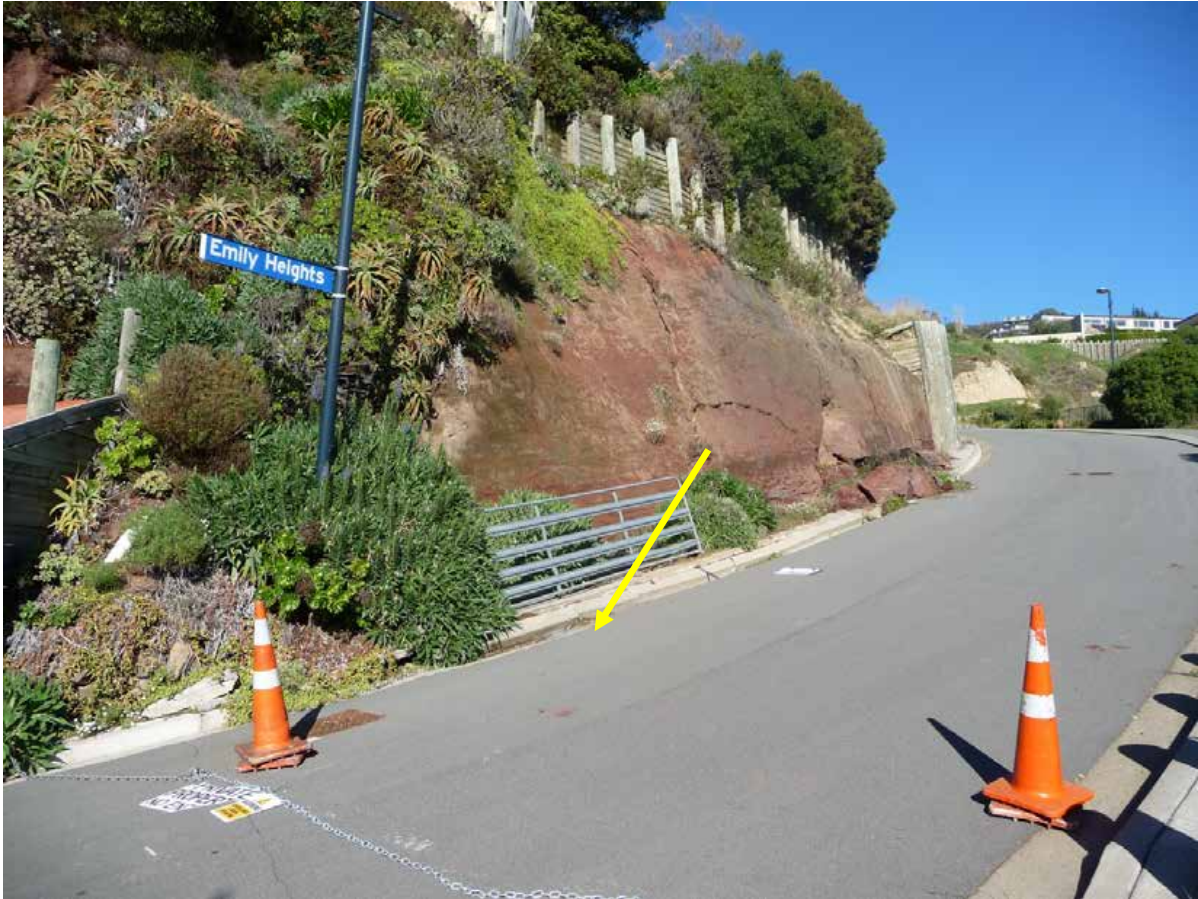
Figure 10 View southeast of the western end of the site. Emily Heights Road is in the foreground. Note the toe break out of the rock slope failure evident along the edge of Emily Heights Road (yellow arrow). This is an extension of the main discontinuities exposed in the car port for 12 Cliff Street (Figure 3).
