**Canterbury Earthquakes 2010/11 Port Hills Slope  
Stability: Risk assessment for Maffeys Road**

**GNS Science Consultancy Report 2014/79  
August 2014 FINAL**

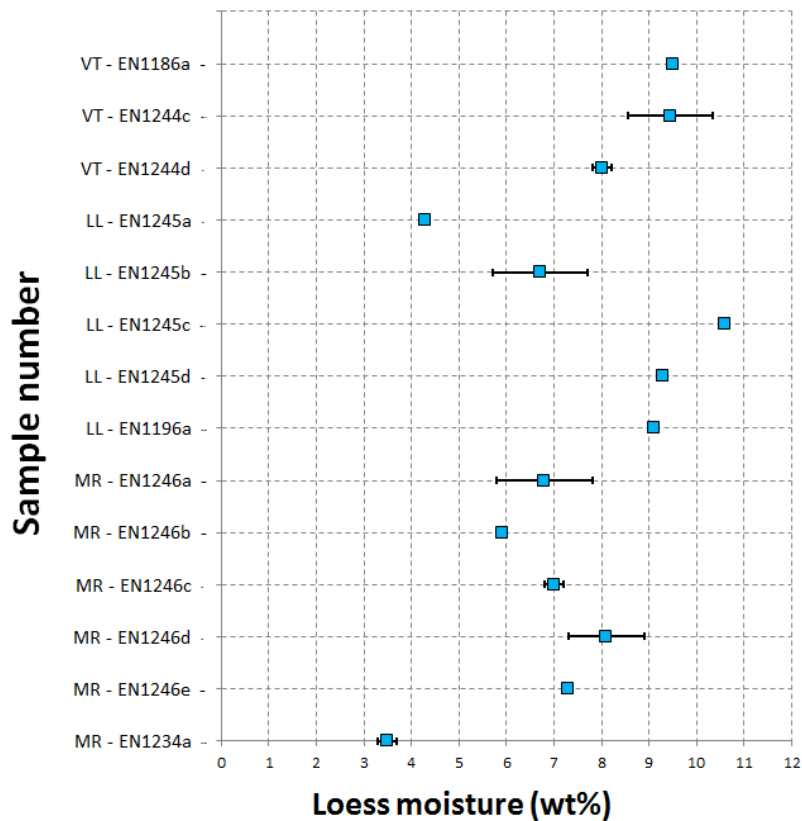
The water contents of the loess in drillcore samples were all substantially higher than those for the block samples. The difference may reflect the sampling method, where drilling includes using water as a flush, and block sampling does not, or that slope faces in loess tend to be free-draining and relatively dry (Table 7).

**Figure 8** In-ground moisture (water, wt%) content of collected loess samples.

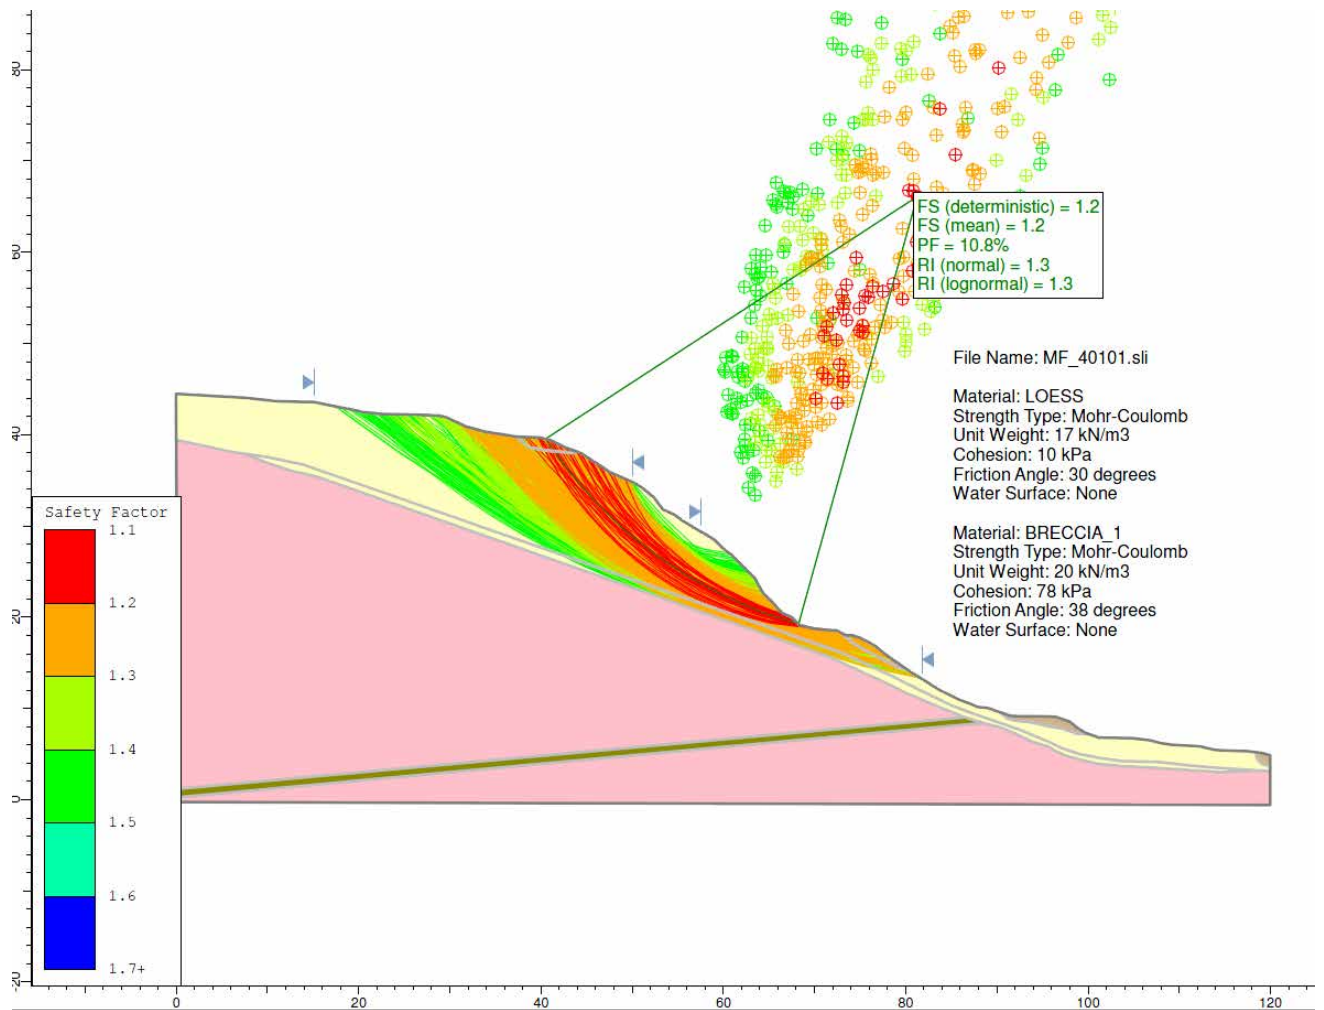
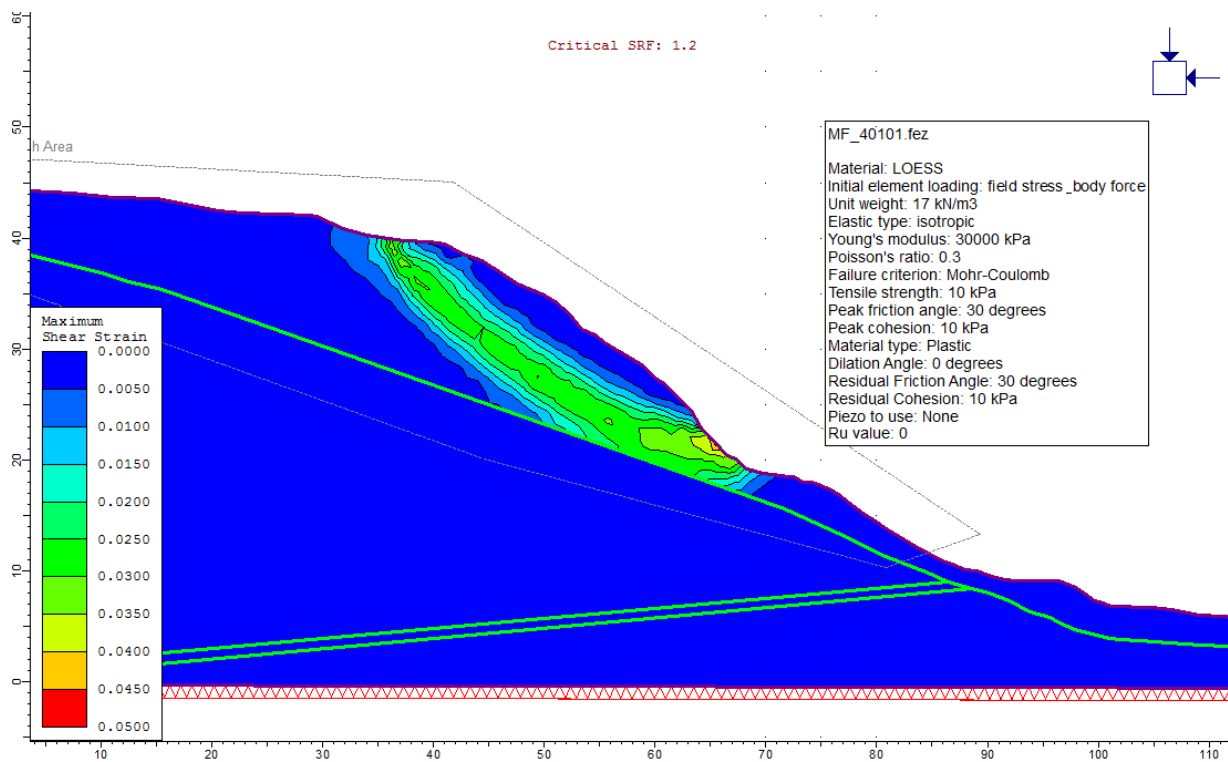
**Figure 19** Example of limit equilibrium and finite element modelling results for cross-section 4, mechanism 1 assessment through loess (circular failure model).

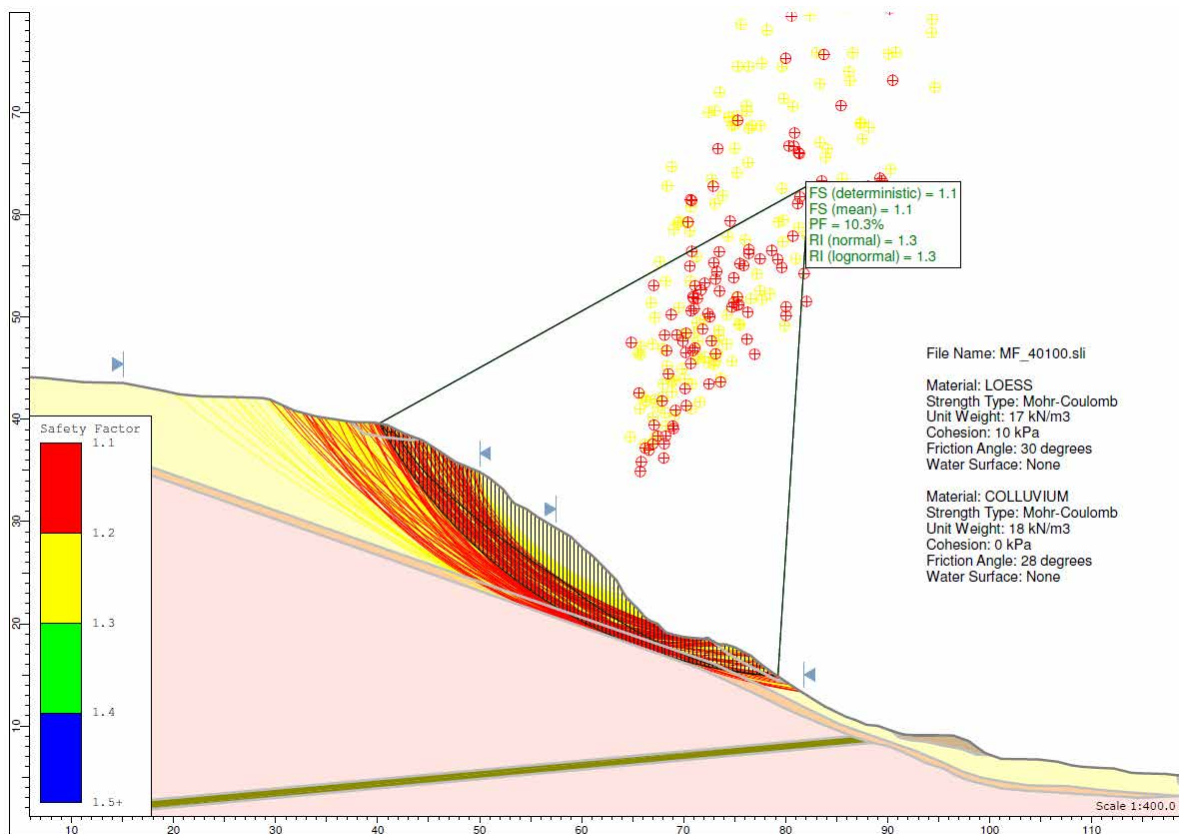
**Figure 20** Example of limit equilibrium modelling results for cross-section 4, mechanism 2, with weak colluvium layer (circular failure model).

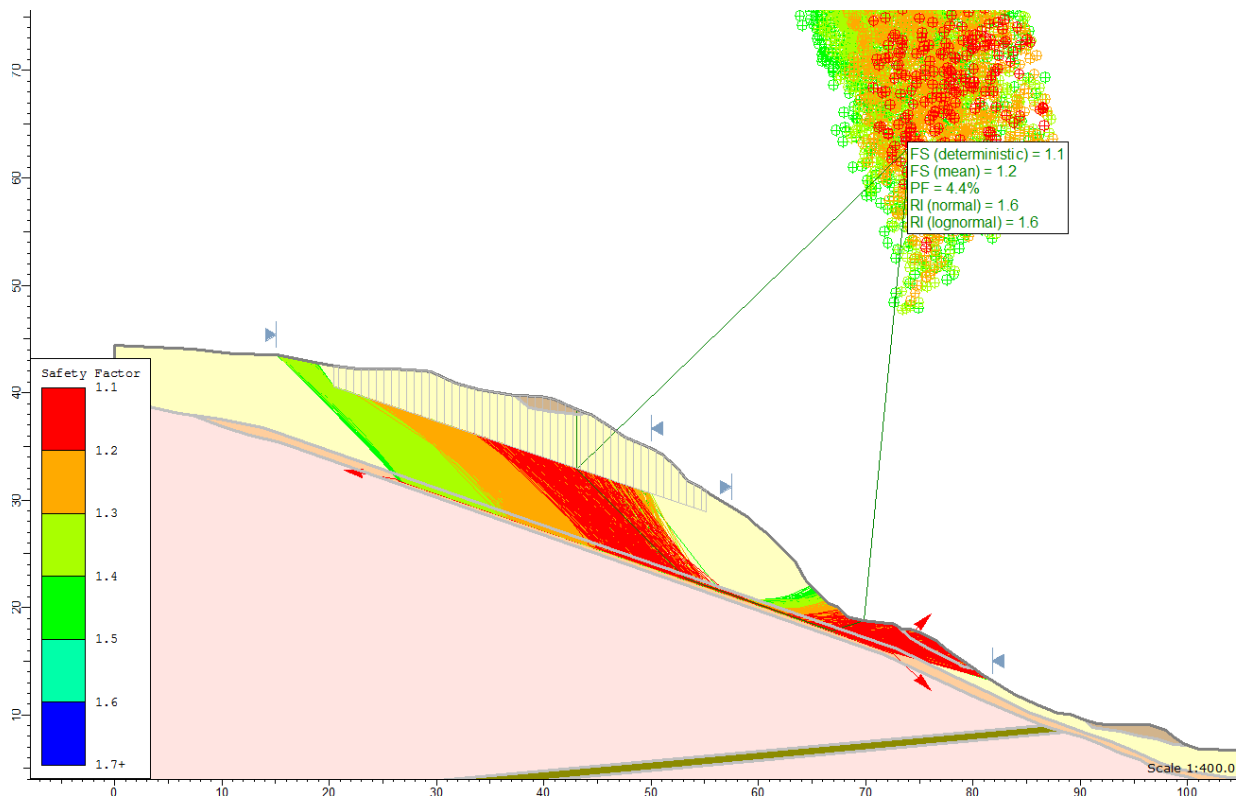
**Figure 21** Example of limit equilibrium and finite element modelling results for cross-section 4, mechanism 2, with weak colluvium layer, assuming a block slide failure model for the limit equilibrium model.

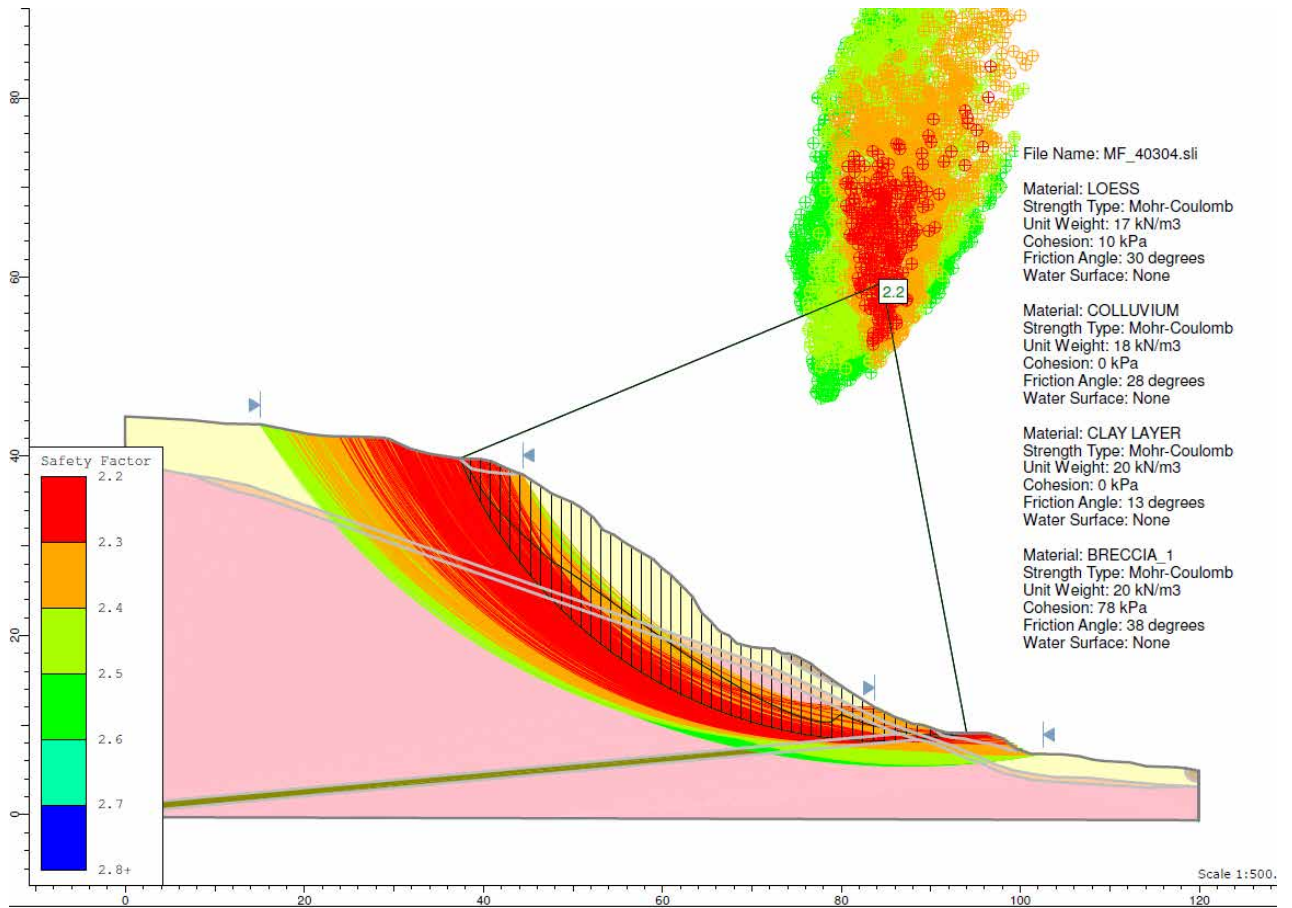
**Figure 22** Example of limit equilibrium modelling results for cross-section 4, mechanism 3 (circular failure model).

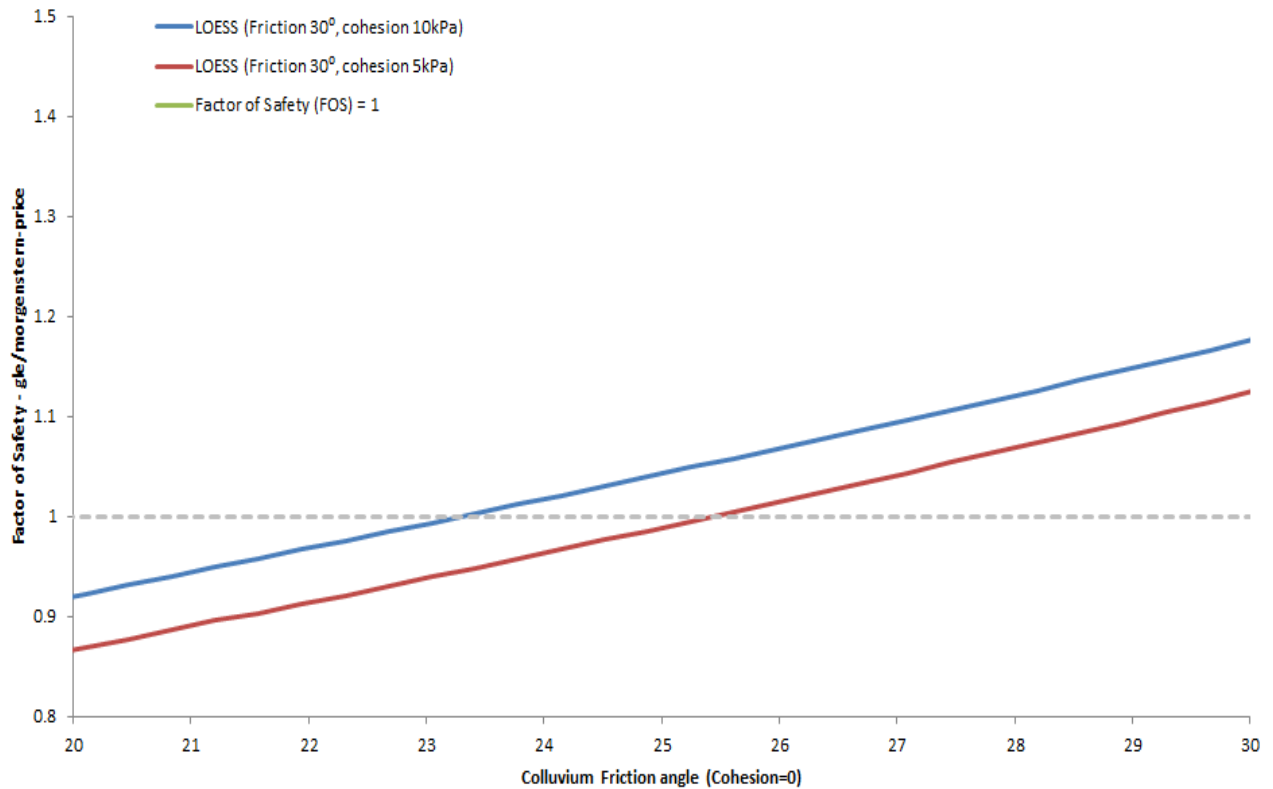
**Figure 25** Mechanism 2, sensitivity of the slope factor of safety to changes in the friction angle of the volcanic colluvium, for cross-section 4. The cohesion (c) of the volcanic colluvium is fixed at 0 kPa and a variable friction angle ( $\phi$ ) was adopted. The assessment adopted two different shear strength conditions for the overlying loess. The blue line represents loess shear strength of friction ( $\phi$ ) 30° and cohesion (c) of 10 kPa. The red line represents loess shear strength of friction ( $\phi$ ) 30° and cohesion (c) of 5 kPa.

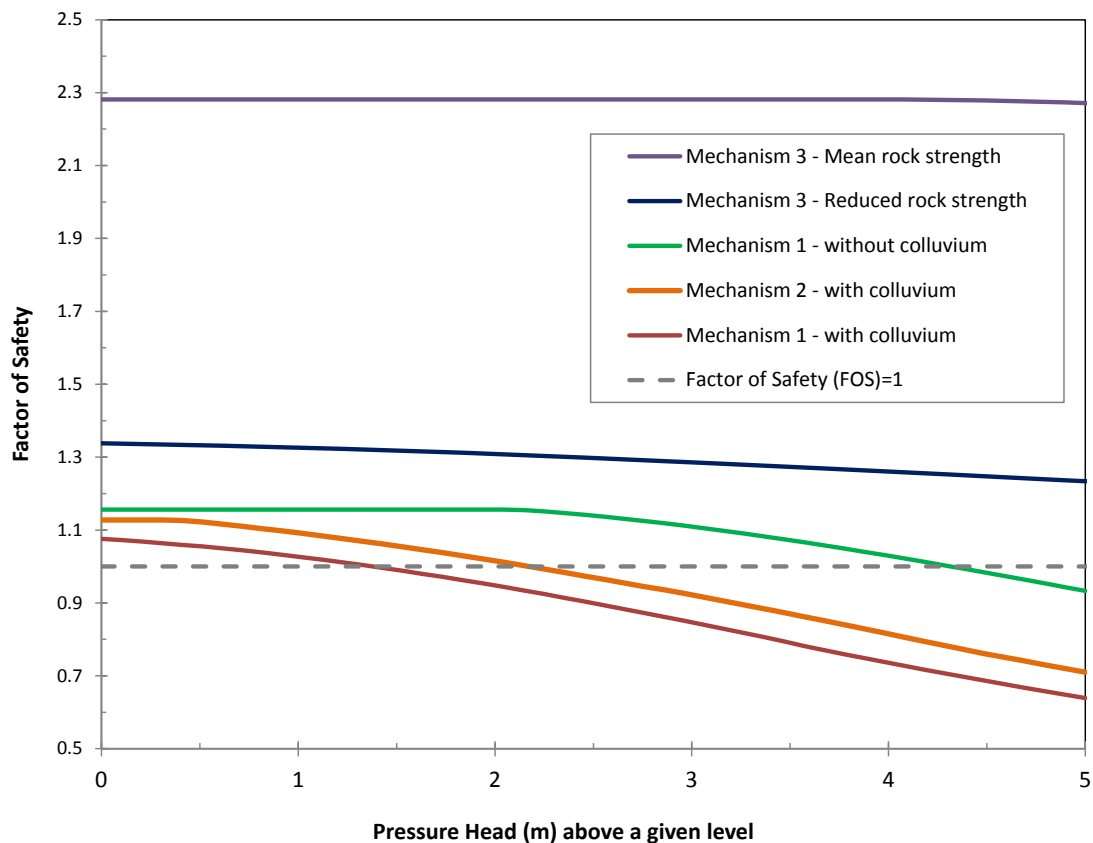
- Adopting the low bulk strength parameters for the mixed volcanic breccia and lava (of friction ( $\phi$ ) of  $27^\circ$  and cohesion ( $c$ ) of 44 kPa), a piezometric head level of approximately 13 m above the weak clay layer is needed to reduce the factor of safety to less than one (adopting parameters of friction ( $\phi$ ) of  $12^\circ$  and cohesion of 0 kPa for the clay).
- Using the mid rock bulk strength parameters (of friction ( $\phi$ ) of  $38^\circ$  and cohesion ( $c$ ) of 78 kPa), a piezometric head level of approximately 20 m above the weak clay layer is needed to reduce the factor of safety to less than one.

**Figure 26** Sensitivity of the slope factor of safety (cross-section 4) in response to changing piezometric head levels, and the effects on the assessed failure mechanisms 1–3.

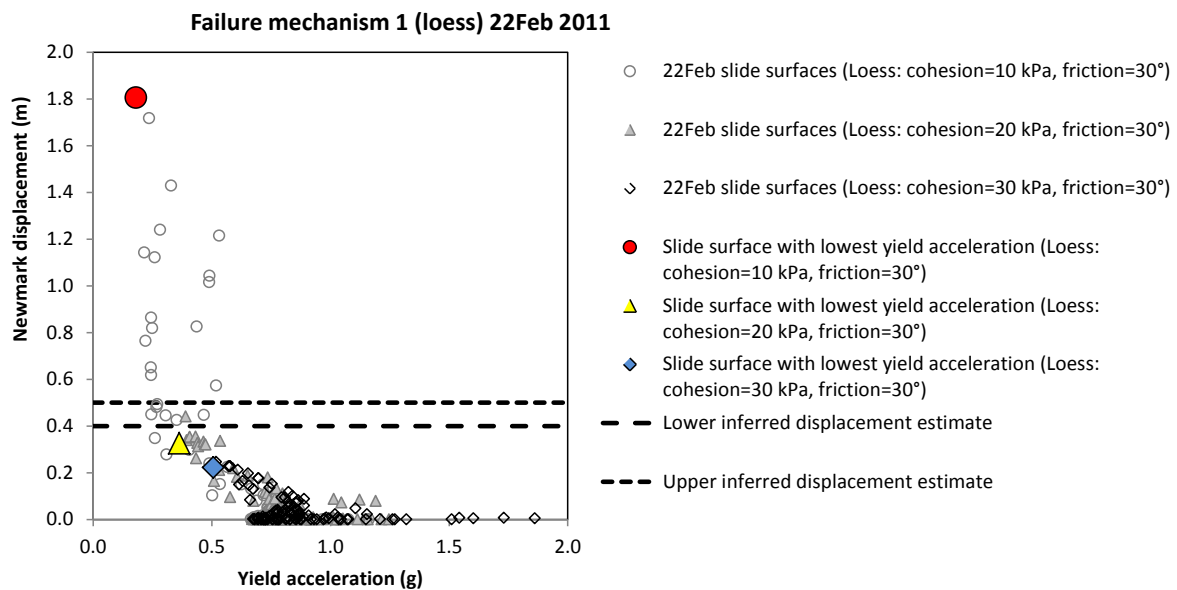
**Figure 27** Modelled Slope/W decoupled displacements of cross-section 4 for the 22 February 2011 earthquake and adopting variable estimates of the material strength of the loess. Each datapoint represents a modelled circular slide surface and the corresponding estimate of its displacement as a result of the 22 February 2011 earthquake – adopting the synthetic free-field rock outcrop earthquake acceleration time histories. The dashed lines represent the total inferred coseismic permanent displacement for the cross-section during the given earthquake.

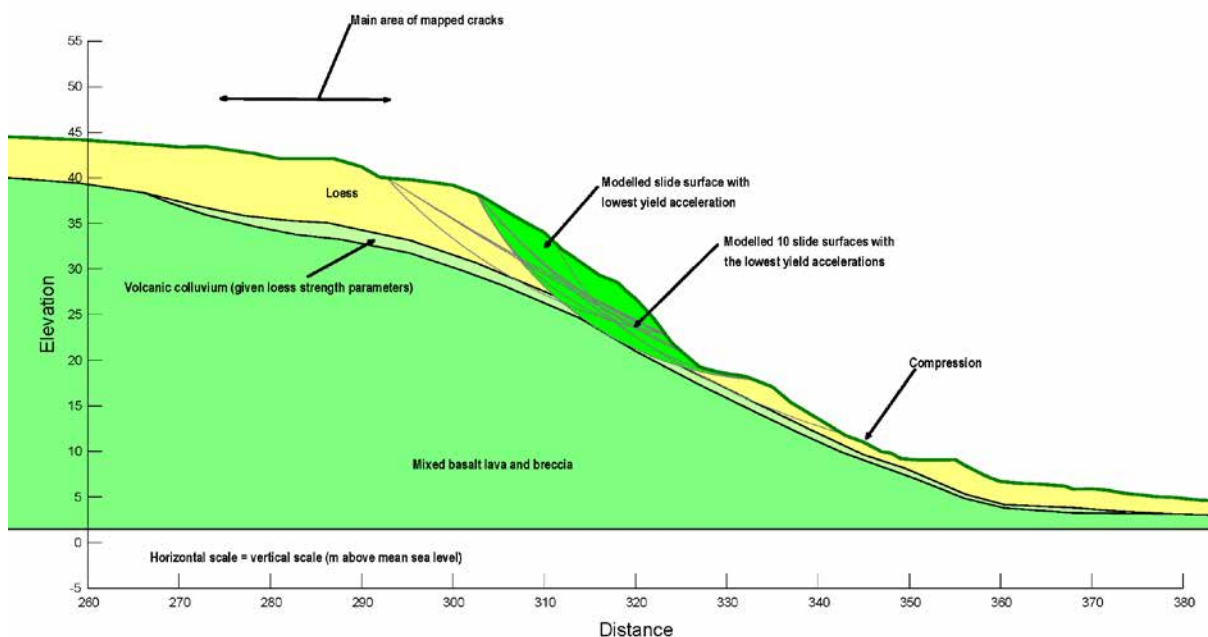
**Figure 29** Results from the seismic slope stability assessment for failure mechanism 1, cross-section 4, for the 22 February 2011 earthquake.

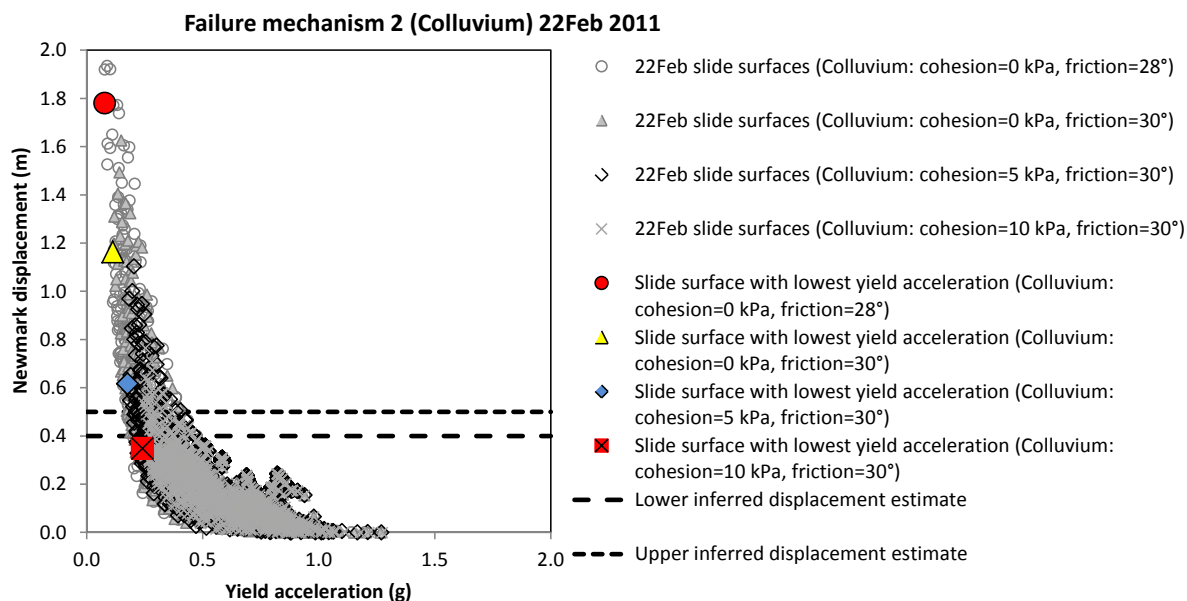
**Figure 30** 22 February 2011 earthquake, modelled Slope/W decoupled displacements for cross-section 4, and adopting variable estimates of the material strength of the volcanic colluvium. Each datapoint represents a modelled block slide surface and the corresponding estimate of its displacement as a result of the 22 February 2011 earthquake – adopting the synthetic free-field rock outcrop earthquake acceleration time histories. The dashed lines represent the total inferred coseismic permanent displacement for the cross-section during the given earthquake.

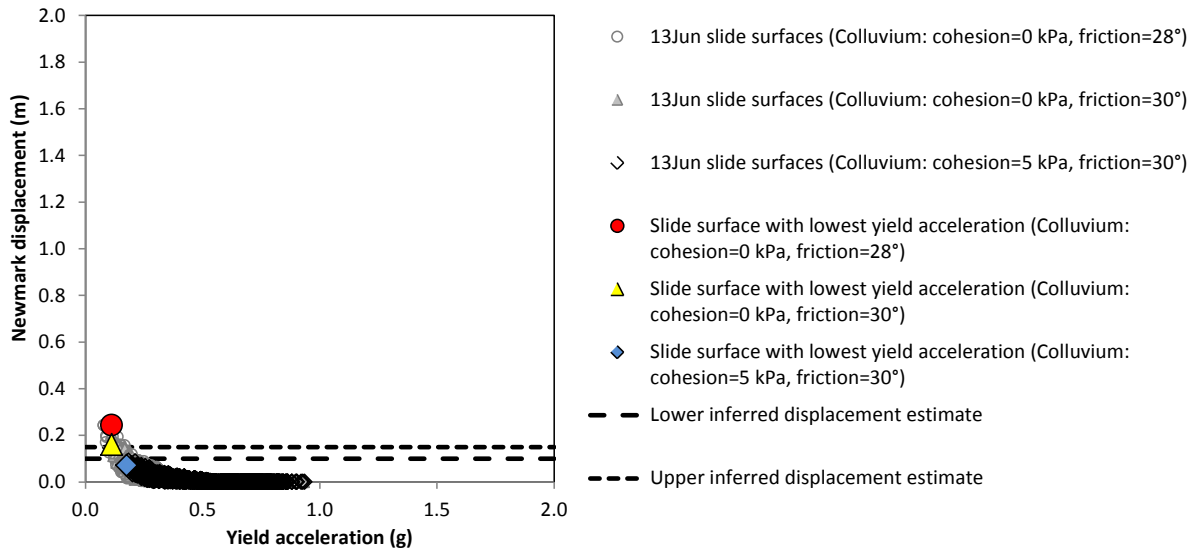
**Figure 31** 13 June 2011 earthquake, modelled Slope/W decoupled displacements for cross-section 4, and adopting variable estimates of the material strength of the volcanic colluvium. Each datapoint represents a modelled block slide surface and the corresponding estimate of its displacement as a result of the 13 June 2011 earthquake – adopting the synthetic free-field rock outcrop earthquake acceleration time histories. The dashed lines represent the total inferred coseismic permanent displacement for the cross-section during the given earthquake.

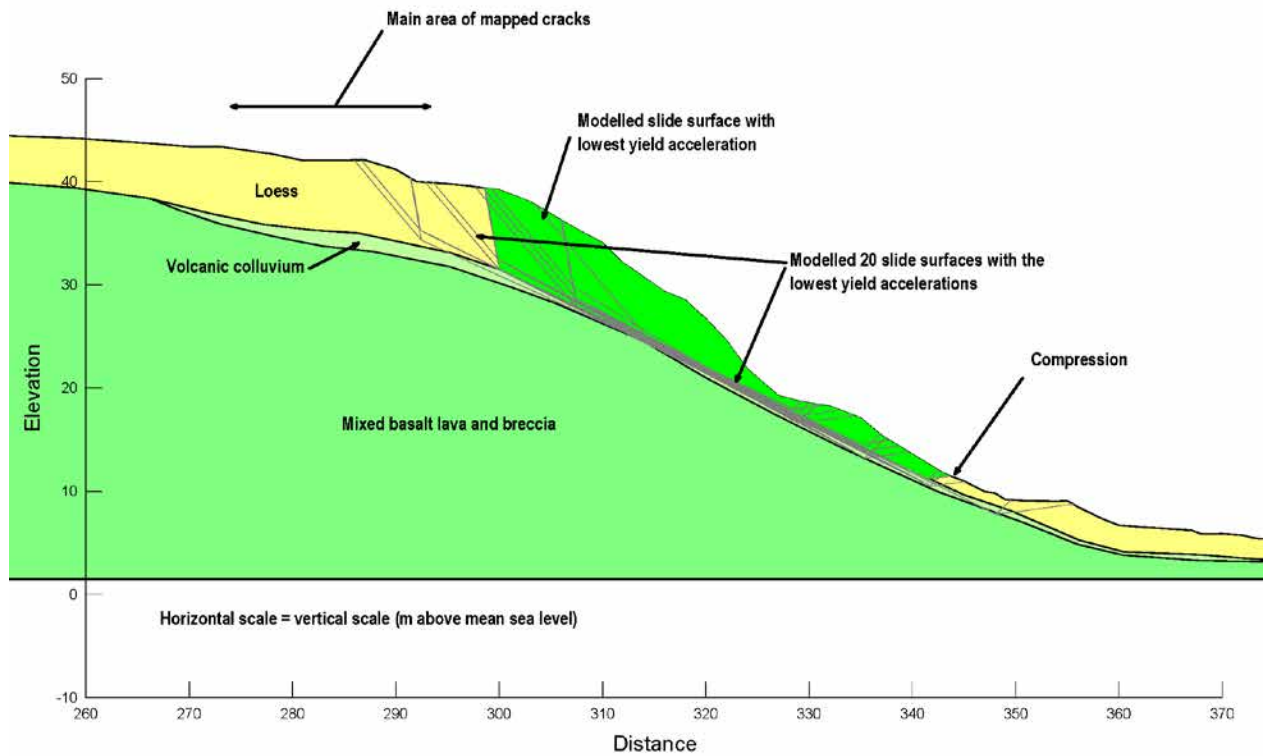
**Figure 32** Results from the seismic slope stability assessment for failure mechanism 2, cross-section 4, for the 22 February 2011 earthquake.

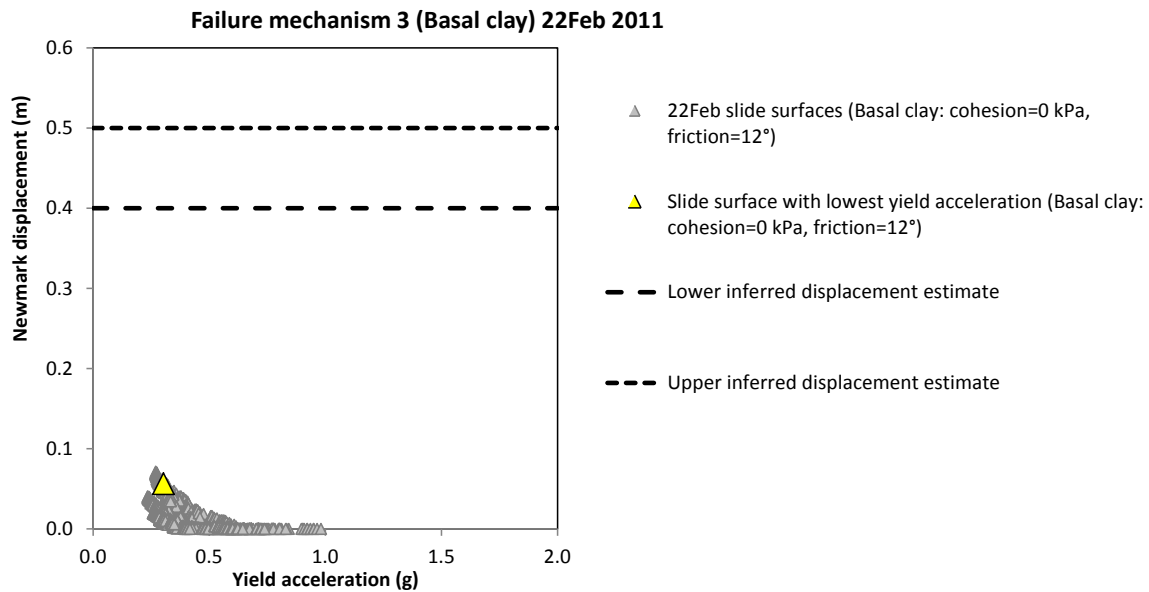
**Figure 33** 22 February 2011 earthquake, modelled Slope/W decoupled displacements for cross-section 4, and adopting variable estimates of the material strength of the volcanic colluvium. Each datapoint represents a modelled block slide surface and the corresponding estimate of its displacement as a result of the 22 February 2011 earthquake – adopting the synthetic free-field rock outcrop earthquake acceleration time histories. The dashed lines represent the total inferred coseismic permanent displacement for the cross-section during the given earthquake.

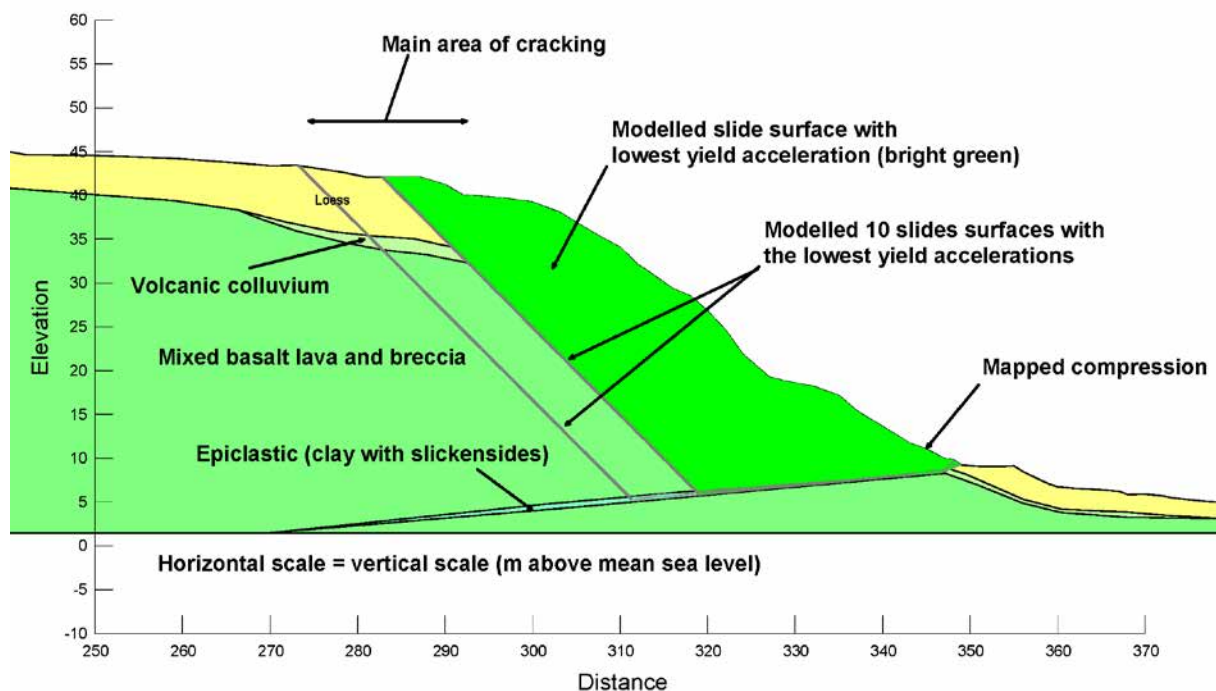
**Figure 34** Results from the seismic slope stability assessment for failure mechanism 3, cross-section 4, for the 22 February 2011 earthquake.

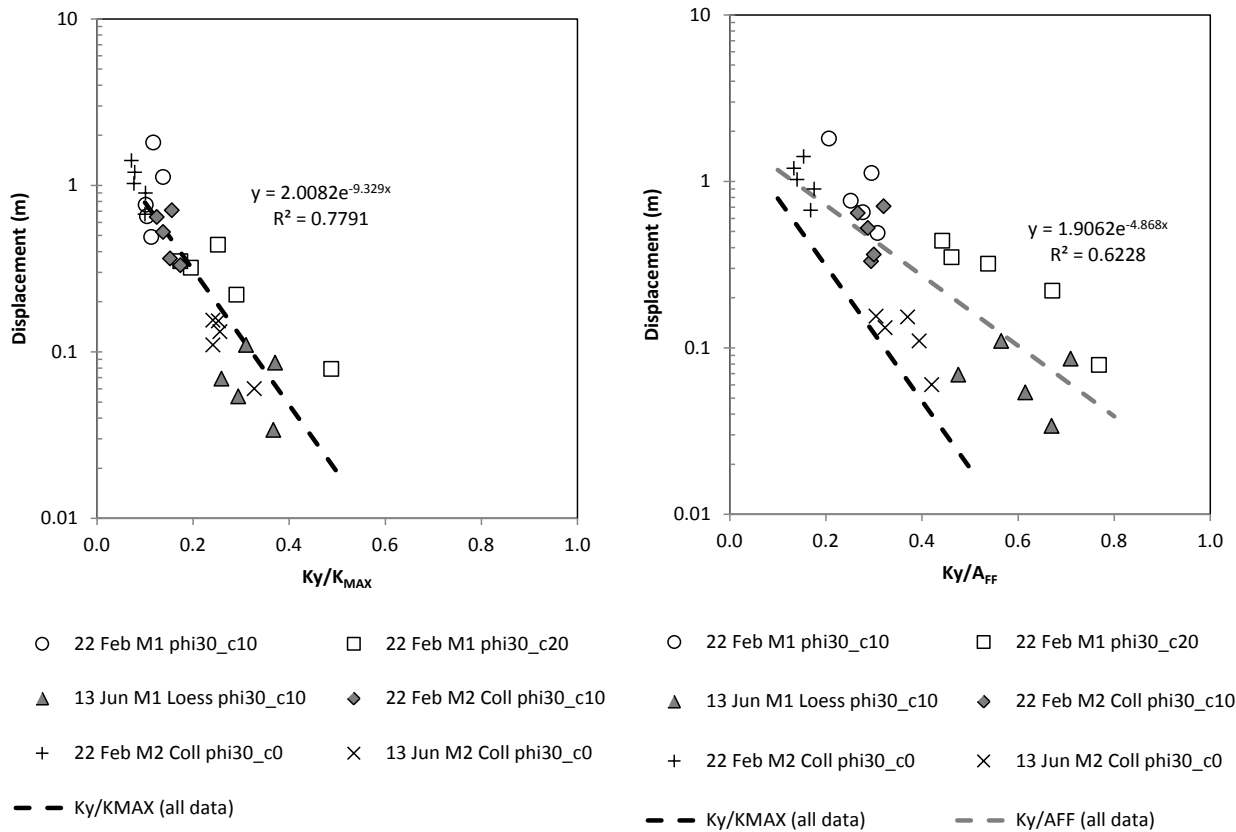
For ratios of  $K_y/A_{FF}$  in Figure 35, the estimated magnitudes of displacement are consistent with those reported by Jibson (2007), where these data plot between the ranges for earthquakes of M6.5–7.5 as reported by Makdisi and Seed (1978) and plotted by Jibson (2007).

**Figure 35** Cross-section 4, failure mechanisms 1 and 2 (M1 and M2). Decoupled Slope/W displacements calculated for different ratios of yield acceleration to maximum average acceleration of the mass ( $Ky/K_{MAX}$ ), and maximum acceleration of the mass ( $Ky/A_{FF}$ ), for selected slide-surface geometries, and given material shear strength parameters.  $A_{FF}$  is the peak acceleration of the input earthquake time acceleration history. Synthetic rock outcrop time acceleration histories for the 22 February and 13 June 2011 earthquakes were used as inputs for the assessment.  $N = 30$ . The dashed lines are exponential trend lines fitted to the semi-log data. The formula and the coefficient of determination ( $R^2$ ) for the trend lines are shown.
