Christchurch Fish Barriers Update: 2023

October 2023

Prepared for:
Christchurch City Council

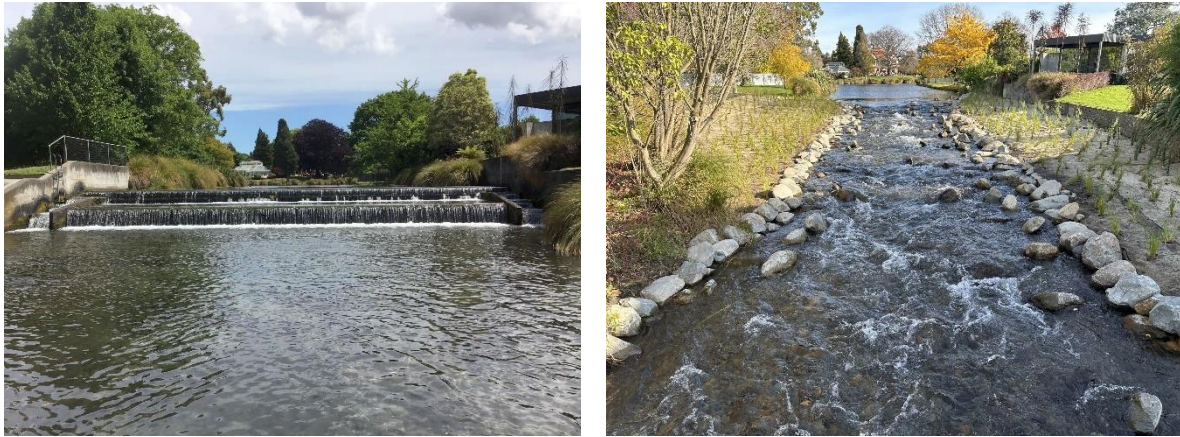
This model update was recommended during the previous prioritisation study, which identified several substantial barriers outside of the priority catchments, most notably, the Mona Vale weir (Instream Consulting 2022). In recognition of the significance of the Mona Vale weir as a fish barrier, the Council completed a remediation project to enhance fish passage in 2023. This involved the installation of a rock riffle over the existing step weir (Figure 9). The design of the remediation was intended to enhance passage for all native fish, including weakly swimming species. To achieve this, the design specifications included a gradient of 1:30, as recommended by Franklin *et al.* (2018), with rest areas along the margins. A monitoring programme has been established by the Council to assess the success of the remediation, which included a pre-remediation baseline fish survey. The structure will require a follow-up fish passage assessment, to ensure that the desired hydraulic conditions have been achieved, as well as follow-up fish monitoring, to confirm the ecological benefits are being realised. The update to the prioritisation model described in the current study draws attention to other such structures beyond the priority catchments, that have previously been precluded from receiving high remediation priorities.

Figure 9: Mona Vale weir, in 2020 prior to remediation (left) and in 2023, after remediation to enhance fish passage (right).

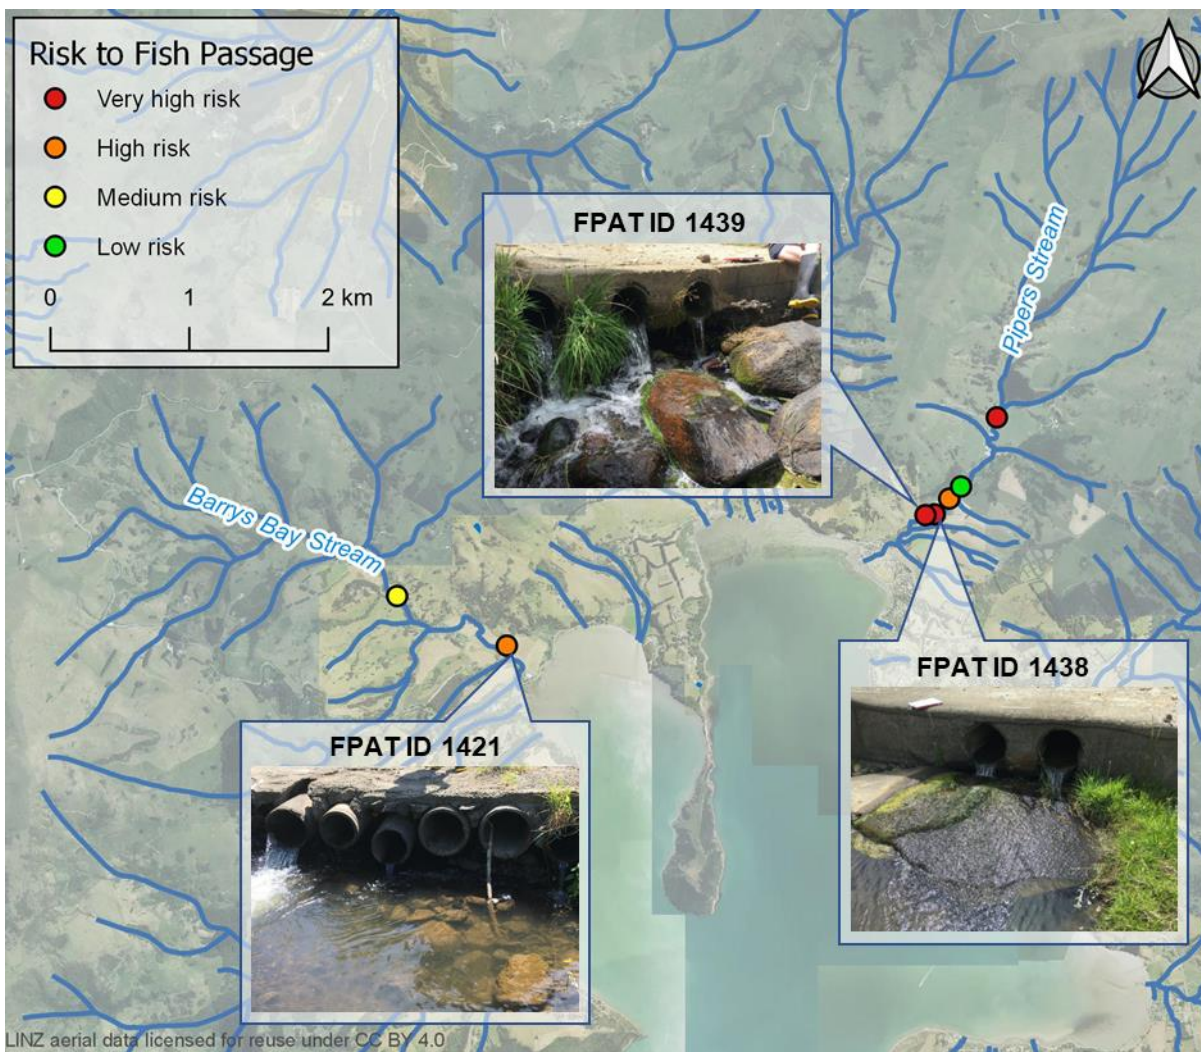
Figure 10: Examples of high and very high risk private structures, near the coast in Akaroa Harbour.

Of the 2,554 structures prioritised in the current study, 161 were owned by organisations or individuals other than the Council, while ownership was not certain for an additional 1,061 (Table 2). Of the structures not recognised as Council assets, 13 were structures with a high priority for remediation and a further nine were structures with a high priority for fish surveys (Appendix 4). Most of these high priority structures appear to be privately owned, with many located on farms in the Bank Peninsula area. Of particular concern are the private structures that present a high risk to fish passage near the coast, with large catchments upstream. Two catchments worthy of particular mention are Barrys Bay Stream and Pipers Stream in Akaroa Harbour (Figure 10). The structures in Pipers Stream are especially relevant to the Council, as there is currently a project underway to improve fish passage upstream at the Council's Pipers Stream water intake. The benefits of enhancing fish passage at the Pipers Stream intake will not be fully realised, while there are at least three high-risk private structures present downstream. Environment Canterbury should be engaged to discuss the remediation of such structures.

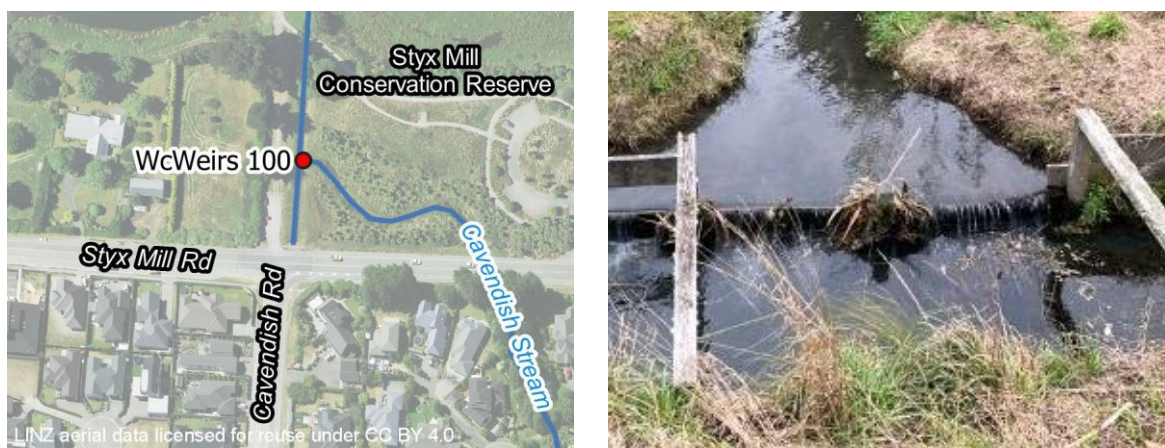
Figure 11: The weir in Cavendish Stream in Styx Mill Conservation Reserve that is suspected to be a Council Asset.

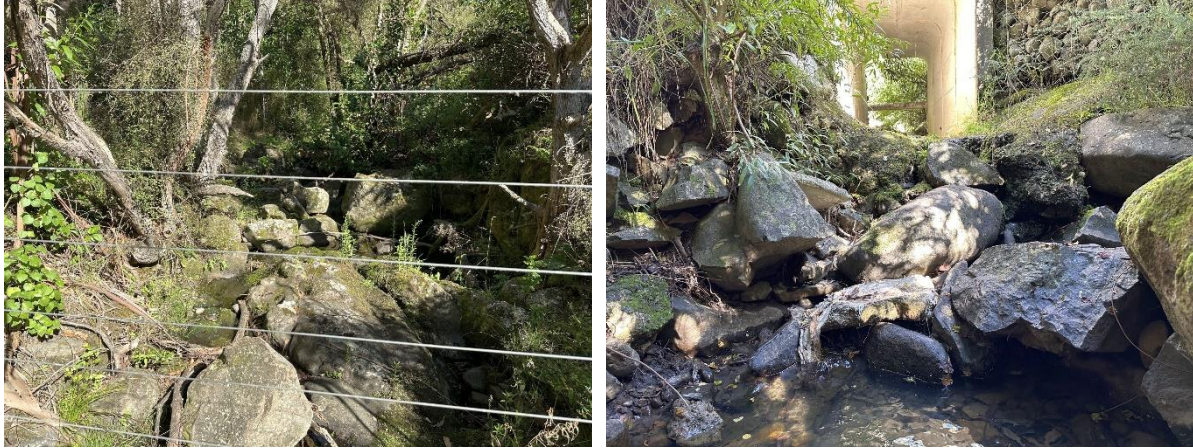
Church Gully Stream is a small hill-fed waterway on Banks Peninsula (Figure 1). It has a steep gradient and a bed that has a mixture of large boulders and bedrock slabs. Immediately downstream of the road culvert, surface flow is lost to the bed, resulting in discontinuous surface flow (see Appendix 2 for site photographs). Approximately 70 m downstream of the culvert is a 6–8 m tall waterfall that is a significant natural fish barrier. The perched road culvert (FPAT ID 152008) presents a very low risk to fish passage compared with the waterfall (FPAT ID 152009). We therefore did not undertake fishing in relation to the culvert, as any fish that could pass the waterfall would easily navigate the comparatively low risk culvert.

Figure 1: Church Gully Stream upstream of the road culvert (left) and immediately downstream of the culvert (right), showing the perched apron.

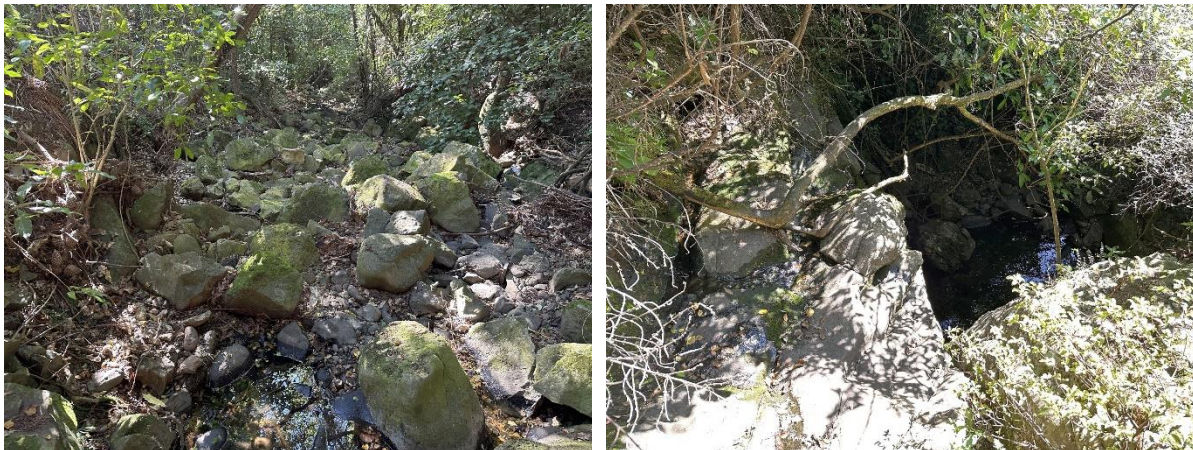
Notes: ¹ The fish survey at this location was abandoned due to the presence of substantial natural barriers downstream, including a 6 m waterfall.

Figure 2: Church Gully Stream downstream of the road culvert, showing natural barriers in the form of lacking surface flow (left) and a waterfall (right).

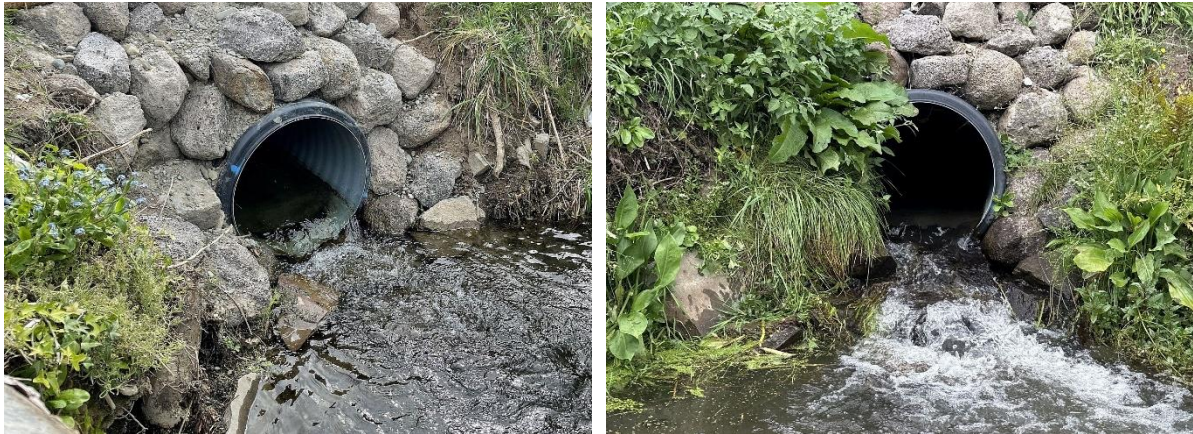
Cashmere Stream is a small, spring-fed tributary of the Ōpāwaho – Heathcote River in Christchurch city (Figure 1). Well-established native plantings border the waterway upstream of the Sutherlands Road culvert, while new native plantings occur downstream (see Appendix 2). The new culvert under Sutherlands Road has a lower gradient than the previous one, plus it has the addition of weir-style baffles and a short rock ramp at the outlet to enhance fish passage. During the March 2023 FPAT assessment, the rock ramp had a mean water velocity of 0.7 m/s, a height of 0.27 m, and a length of 1.2 m (FPAT ID 174784). This presented a greater potential barrier compared to a site visit in October 2022, when water levels were higher, resulting in a lower effective ramp height and velocities (see photographs in Appendix 2). This suggests that the ramp may present a partial barrier when water levels are lower.

Figure 3: Downstream end of Cashmere Stream culvert at Sutherlands Road, in October 2022 (left) and March 2023 (right), when water levels were lower and the FPAT assessment was made.

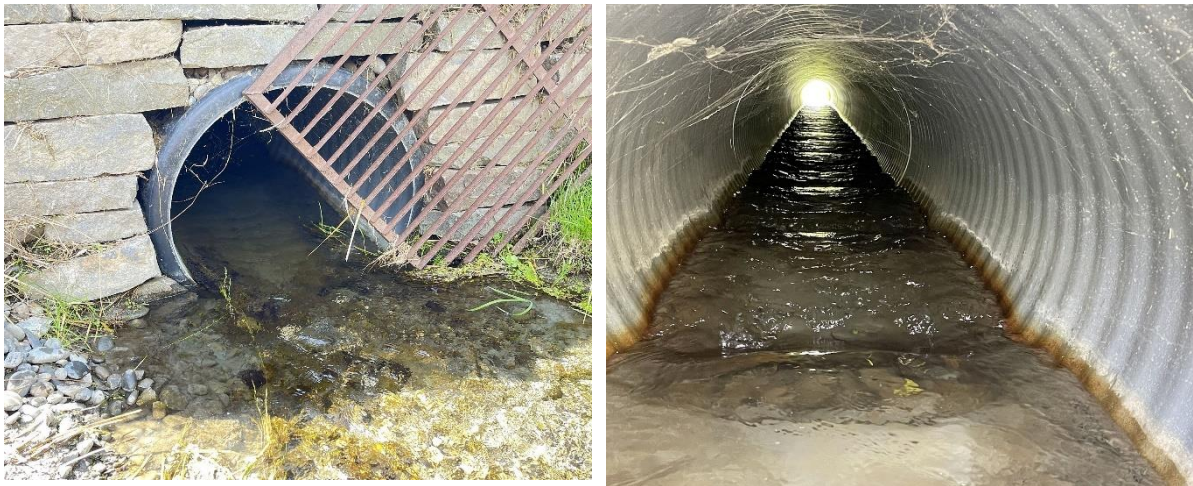
Figure 4: Upstream end of Sutherlands Road culvert in March 2023, showing the inlet (left) and weir baffles (right).

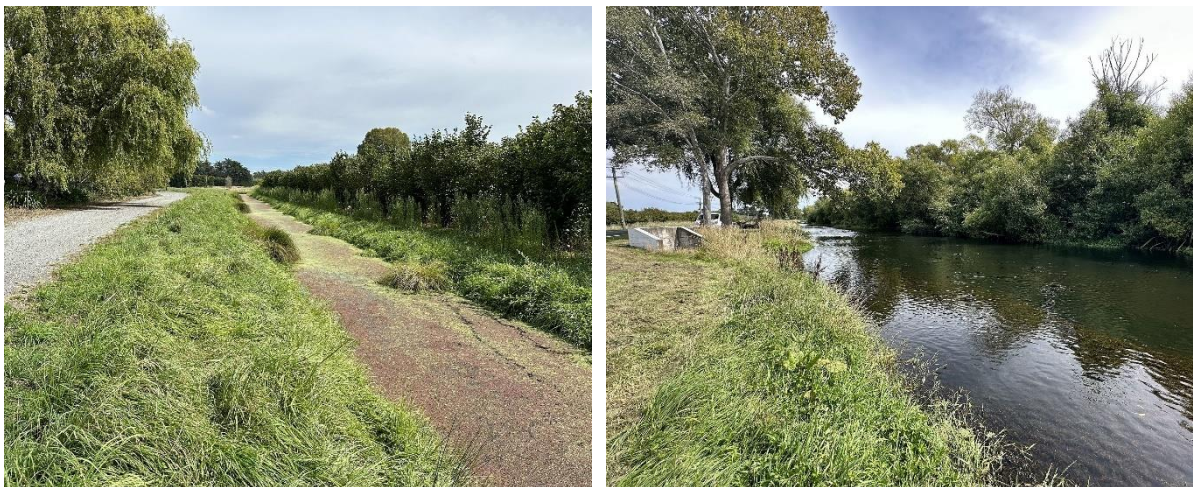
Sheppards Drain is a sluggish, spring-fed waterway that discharges into the Pūharakekenui – Styx River. Upstream of the culvert at 234 Lower Styx Road, Sheppards Drain is artificially straight, has minimal shading, and has minimal flow. The water had a dark, tannin-stained appearance, reflecting the extensive wetland source in its headwaters. Dissolved oxygen levels were very low, with a concentration of 2.93 mg/L and 30.2% saturation measured upstream of the culvert on 7 March 2023. The culvert flap gate was closed during the site visit, which resulted in a lack of flow in Sheppards Drain and may have contributed to the observed low oxygen levels. Downstream, the culvert discharges into the Pūharakekenui River, which is comparatively broad and has moderate flow, but is also relatively straight and unshaded.

A total of 242 fish were caught downstream and 88 fish were caught upstream of the culvert (Figure 5). The fish catch in the Pūharakekenui River downstream of the culvert comprised six native species, including shortfin eel, longfin eel, inanga, upland bully, common bully (*Gobiomorphus cotidianus*), and giant bully (*G. gobioides*). Upstream of the culvert, only two species were caught, shortfin eel and longfin eel. The catch downstream was dominated by inanga, with 148 caught, followed by shortfin eels, with 34 caught. By comparison, the catch upstream of the culvert was almost entirely dominated by shortfin eels, with 79 caught. During

Figure 7: Sheppards Drain upstream of the culvert with flapgate (left); Styx River downstream of the Sheppards Drain culvert (right).

Overall, there is a clear impact of the flap gate on the fish community and likely also water quality upstream. Therefore, we recommend investigating options for enhancing fish passage at this location. One solution would be to replace the existing flap gate with a fish-friendly tide gate that delays gate closure on an incoming tide.
