Fish Passage Barriers in Christchurch City Waterways

April 2020

Prepared for:
Christchurch City Council

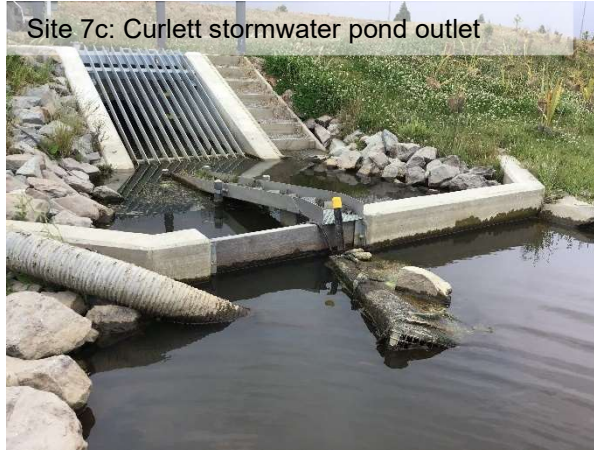
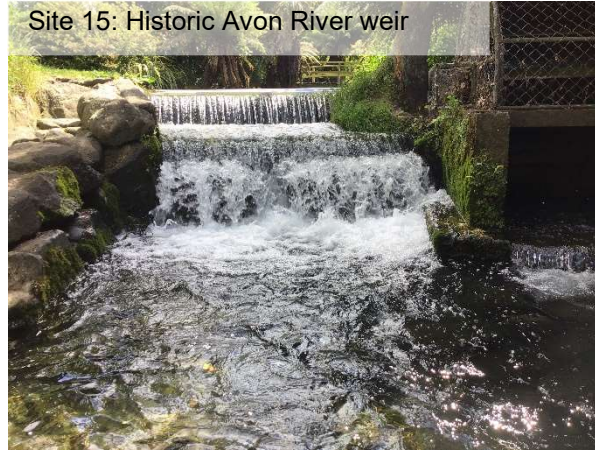
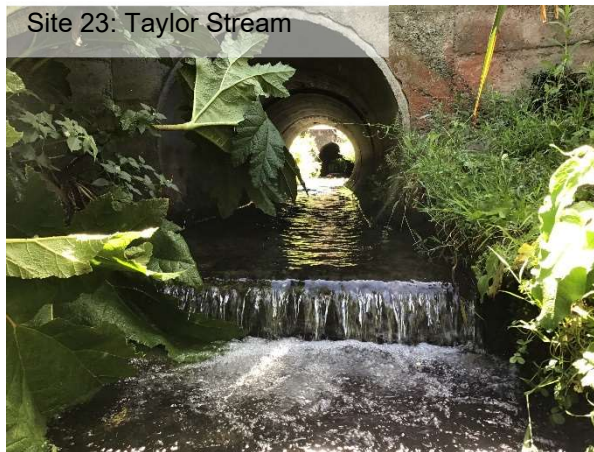
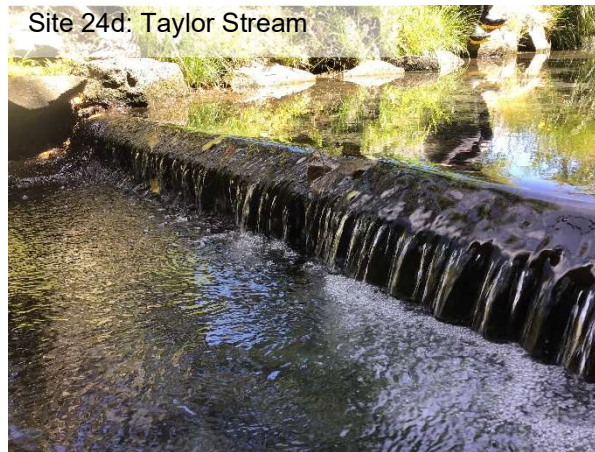
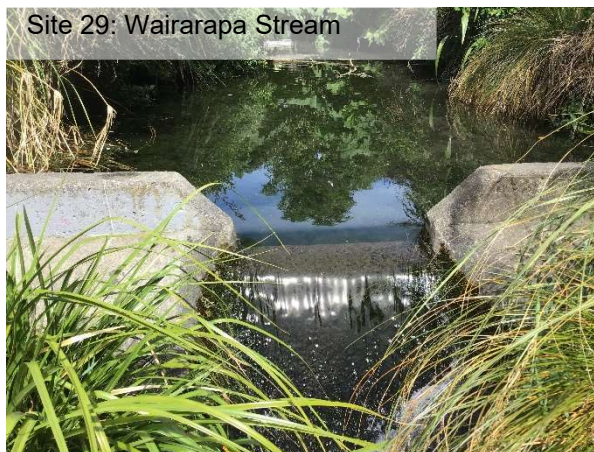
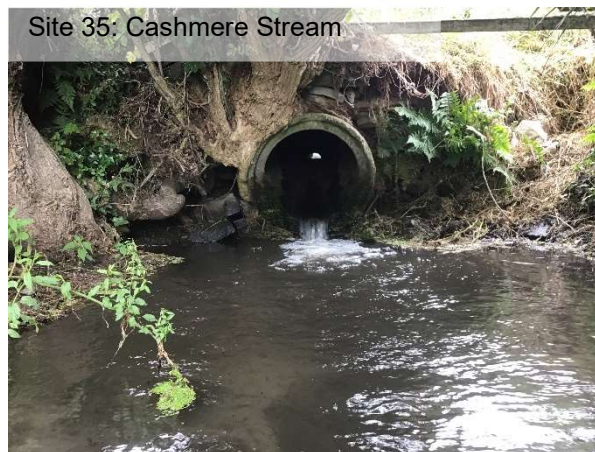
Figure 2: Examples of the range of structures assessed.

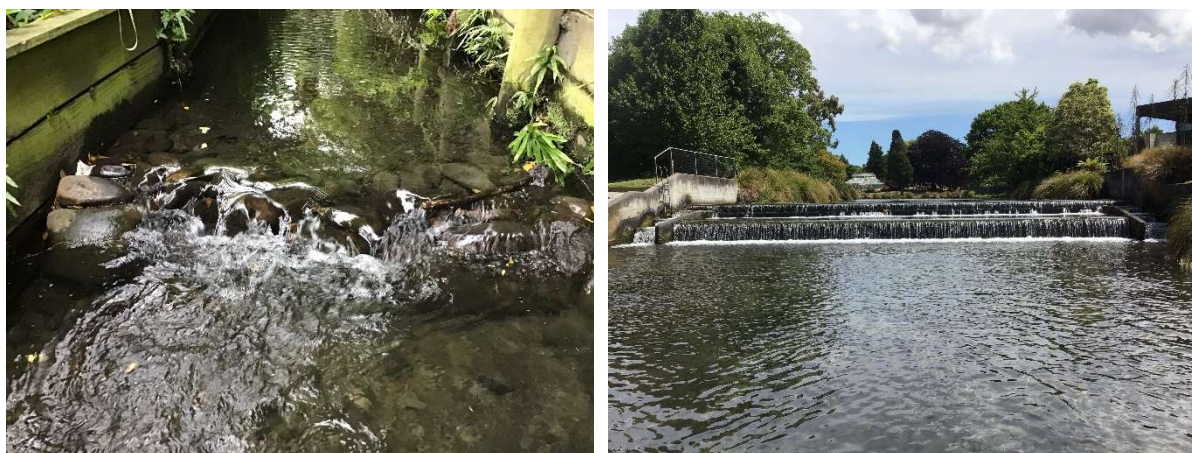
The qualitative risk to fish passage (estimated in the field by the assessor) was often lower than the calculated FPAT risk assessment (Figure 3). This was mainly the case for structures in tributary waterways, where the structures were often small weirs made of material such as wood and stacked rocks. These structures were considered by the assessor to present less of a fish passage risk, as the structures had often degraded over time, creating better fish passage. For example, a low weir made of rocks at Site 20 was judged by the assessor to present only a medium risk to fish passage, when compared to a taller weir such as Site 12 (Figure 4). Similarly, a low wooden weir at Site 19 was constructed with logs that had slumped in places along its length, providing opportunities for fish to swim past, and so the structure was judged by the assessor to present a medium risk to fish passage (Figure 5).

Figure 4: A low-level weir made of rocks (left, Site 20) was qualitatively assessed as a medium risk to fish passage, but had an FPAT assessment of very high risk. A large weir on the Avon River (Site 12, right) was considered a high risk by both methods.

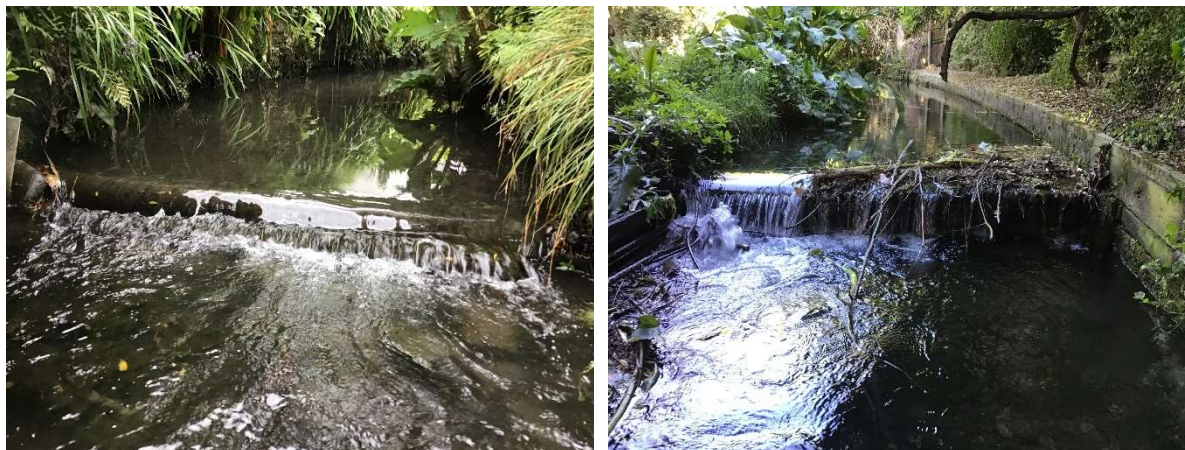
Figure 5: A low wooden weir (Site 19, left) presents less of a barrier to fish than a taller weir (Site 17, right), but both were assigned a very high risk to fish passage by the FPAT website. In the assessor's opinion, the low weir represented a medium risk, while they agreed that the taller weir presented a very high risk to fish passage.

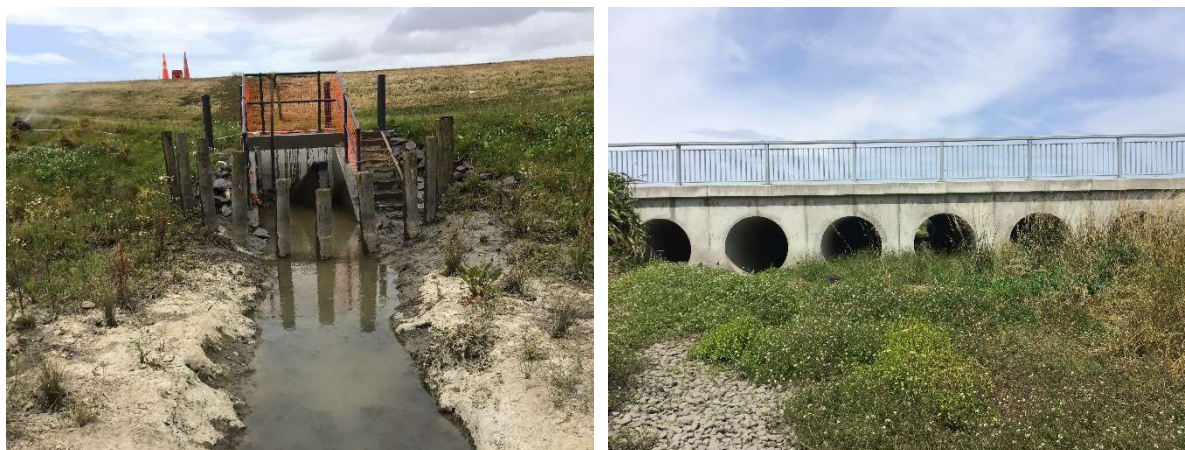
Sites 7b and 34 were qualitatively assessed as low risk but calculated by the FPAT website to be high risk (Figure 6). Both sites were culverts with no flow through them, but based on the level of water ponding through the culverts, the assessor considered that the culverts would present a low risk to fish passage during normal flow conditions. It appears that the considerable length of the culverts (both were > 22 m long) substantially affected the FPAT score, as culvert length is a factor affecting the overall “passability” of a culvert in the FPAT risk calculation.

Figure 6: Site 7b (left) and Site 34 (right) were deemed low risk by the assessor but classified as high risk by the FPAT website. The outlet of Site 7b was temporarily sealed to retain water for watering new plants in the stormwater wetlands, but was assessed as if the seal was absent.

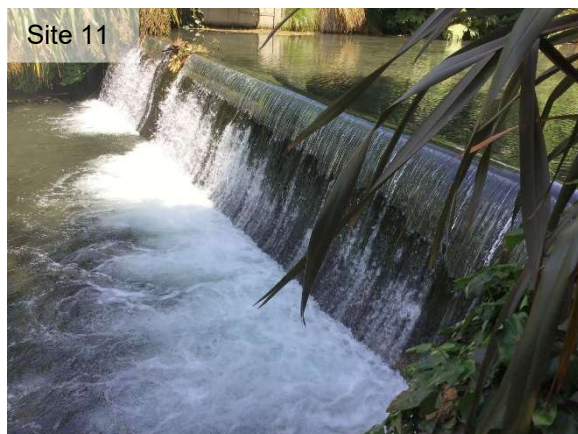
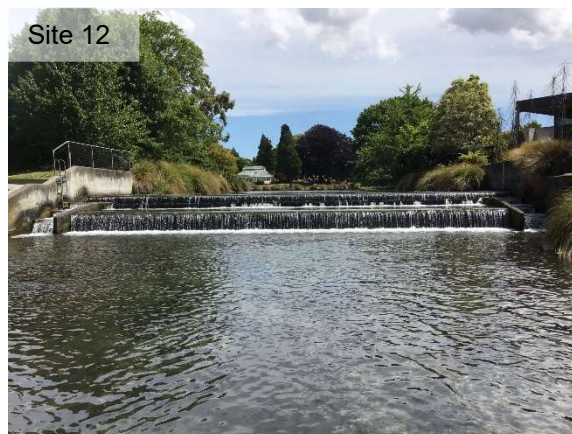
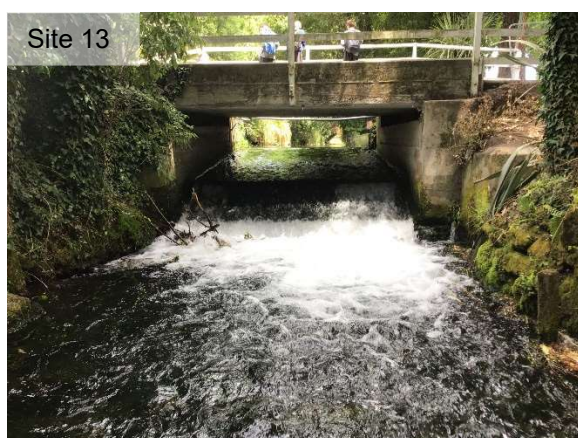
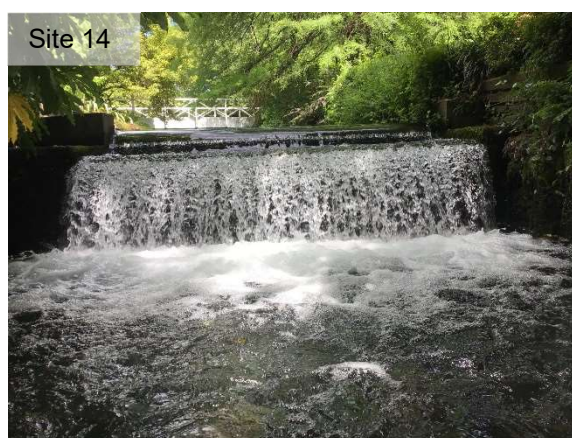
Of the structures surveyed, greatest priority should be given to remediating fish barriers in the Avon River catchment, starting with the large weirs on the Avon River near Mona Vale (Sites 12 and 13, Figure 8). That is because these structures have the largest upstream catchment of all those assessed, they are clearly significant barriers, and there is plenty of fish habitat upstream. The next highest priority should be given to the weir on the Avon River at Christchurch Boys High School (Site 13), followed by a weir on the Avon River downstream of Clyde Road (Site 14). Improving fish passage past these four weirs would provide by far the greatest opportunity for increasing native fish diversity and abundance upstream.

Figure 8: Four weirs on the Avon River that are the highest priority for improving fish passage of the structures assessed. The structures are located near Mona Vale (Sites 11 and 12), Christchurch Boys High School (Site 13), and downstream of Clyde Road (Site 14).

- Prioritise improving fish passage past the major weirs on the Avon River, starting with the Mona Vale weirs and moving upstream.
- CCC engineers and ecologists visit new stormwater facilities on Curlett and Paparoa Streams to look at fish passage issues and options for enhancing fish passage.
- Assess fish passage associated with the following structures across the city:
 - Stormwater treatment facilities with significant baseflow.
 - Road culverts.
 - Pump stations.
 - Tide gates.
- As additional structures are assessed for fish passage, prioritise remediation for fish passage enhancement based on a combination of:
 - The FPAT app risk assessment.
 - Consideration of constructability and how practical remediation is.
 - Fish communities present in the catchment.
 - Priorities of iwi and local community groups.
