MAYORAL FLOOD TASKFORCE

Final Report Part C - Appendix B: Detailed Area Reports

Document title: Mayoral Flood Taskforce Temporary Flood Defence Measures
Final Report – Part C: Appendix B, Detailed Area Reports

Date: 8 August 2014

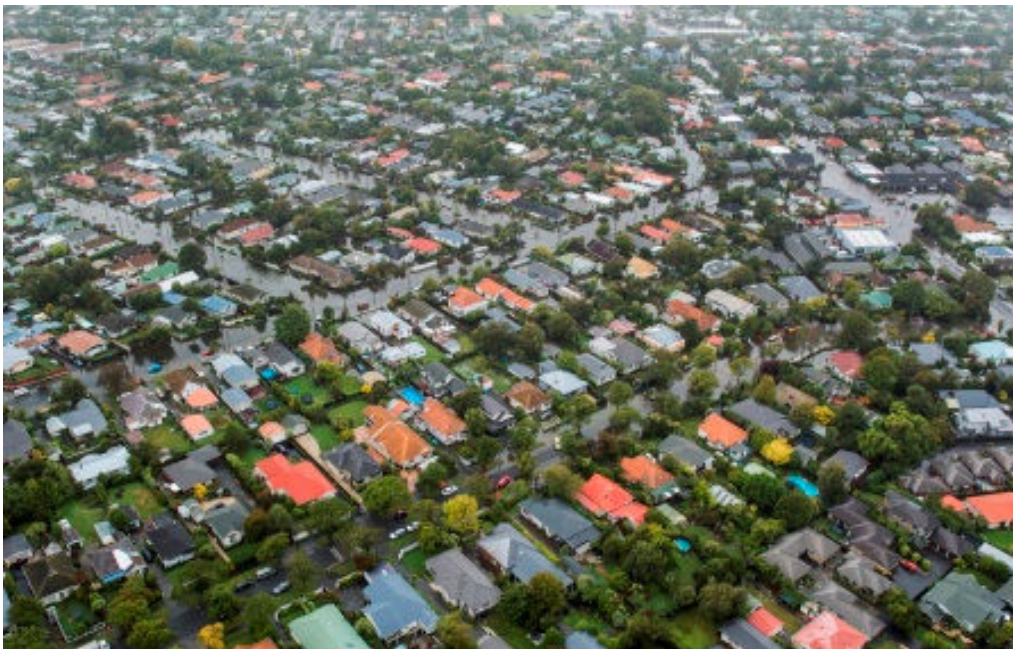
During flooding to the Flockton area, many houses were flooded above floor level. For the wider area, many properties experienced flooding across the section or under foundations.

Figure 2 Flockton area flooding in March 2014 event

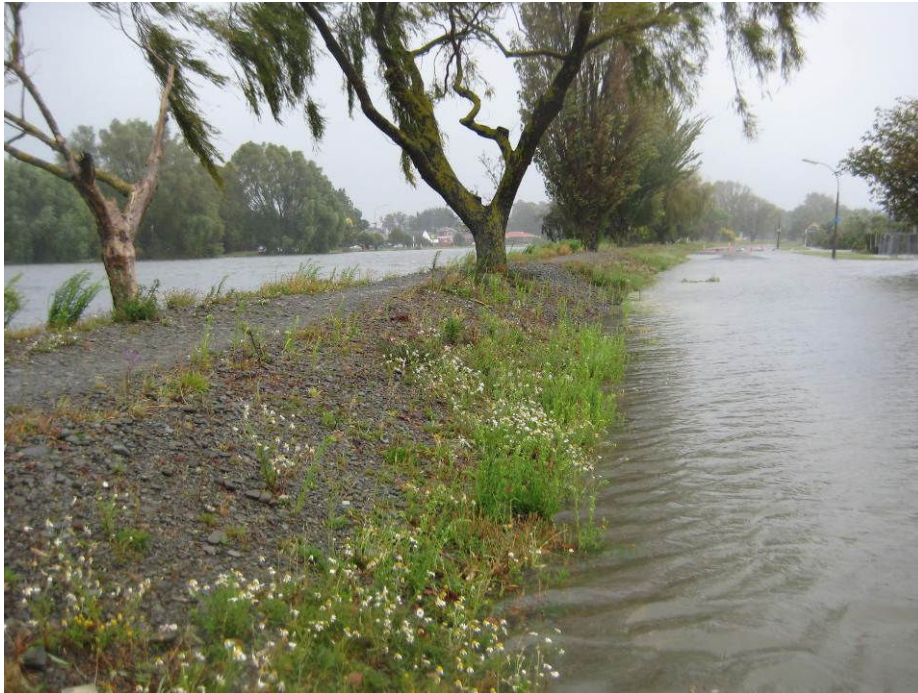
Flooding at the stopbanks is illustrated in Figure 6; a further photo in Figure 7 provides an example of a low point in the stopbanks is at the Owles Tce boat ramp.

Figure 6 Lower Avon flooding behind stopbanks

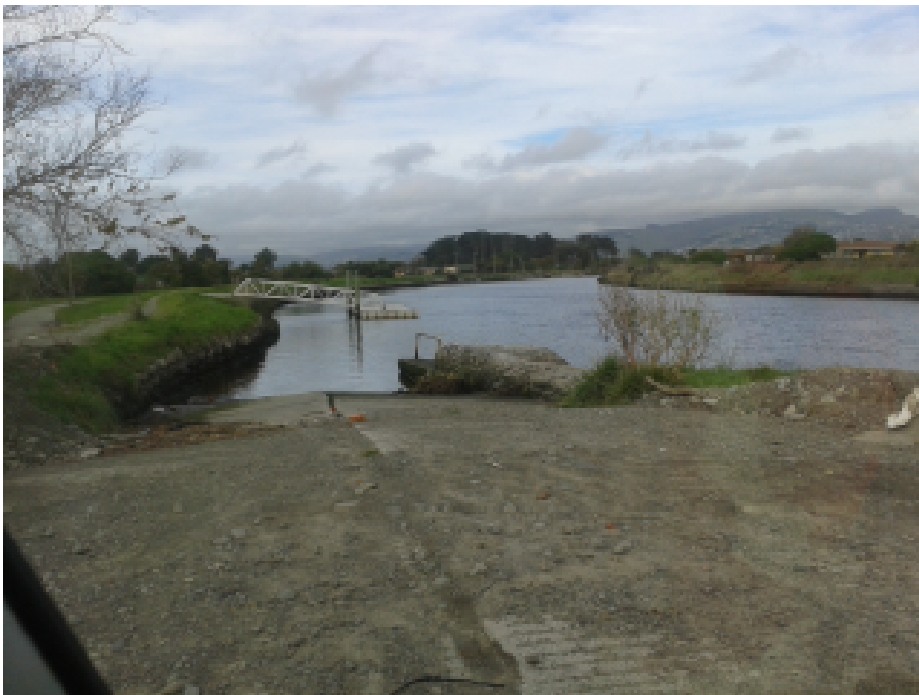
An investigation completed in March 2014 identified that topping up of the stopbanks is required in some locations, particularly Hulverstone Drive and the Owles Terrace boat ramp. It was also identified that multiple flapgates in the lower Avon are either missing or blocked open.

Figure 7 Lower Avon stopbanks at Owles Terrace

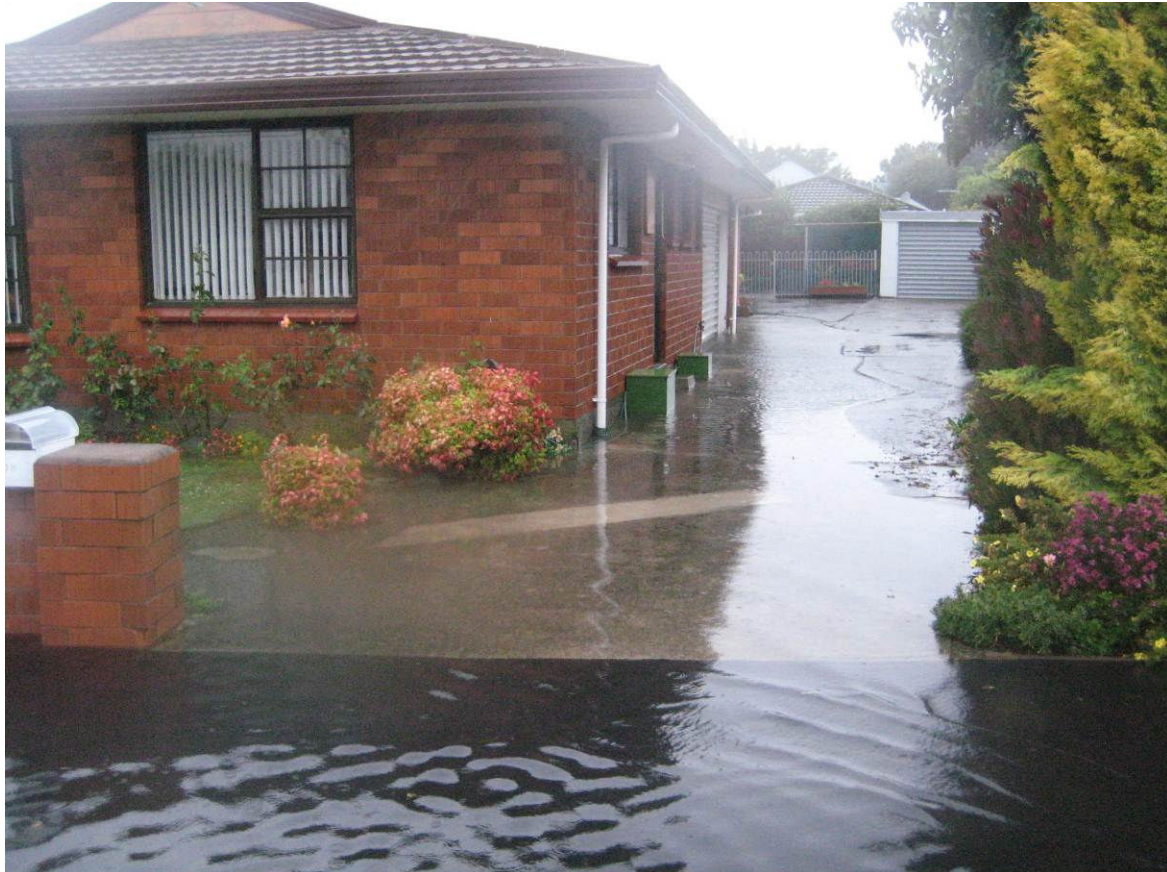
House floor level flooding has not been identified, however four garages were flooded. It can be concluded that as the garages were flooded to a depth of 100mm, water would have also have been present under the floor of the houses. Some degree of flooding has been observed at 20-30 properties across seven streets and further flooding occurred in the Residential Red Zone.

The photograph in Figure 8 is indicative of flood levels in Avondale.

Figure 8 Lower Avon Avondale example of flooding up to house foundations and in garage

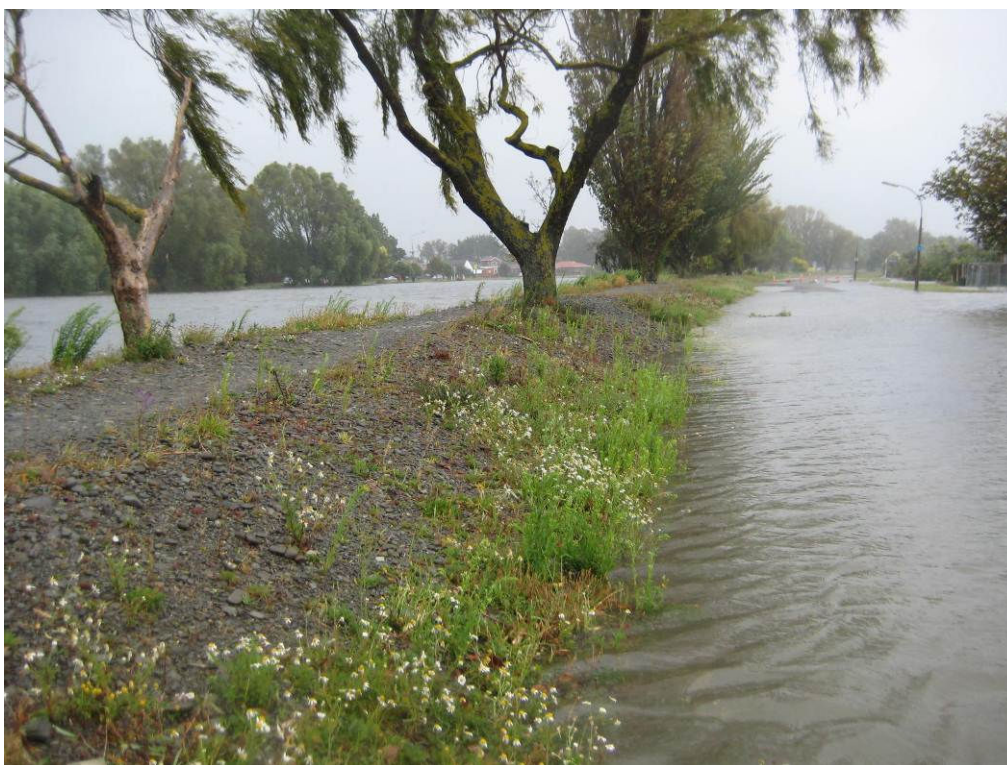
Figure 9 Lower Avon RRZ – flooding within stopbank

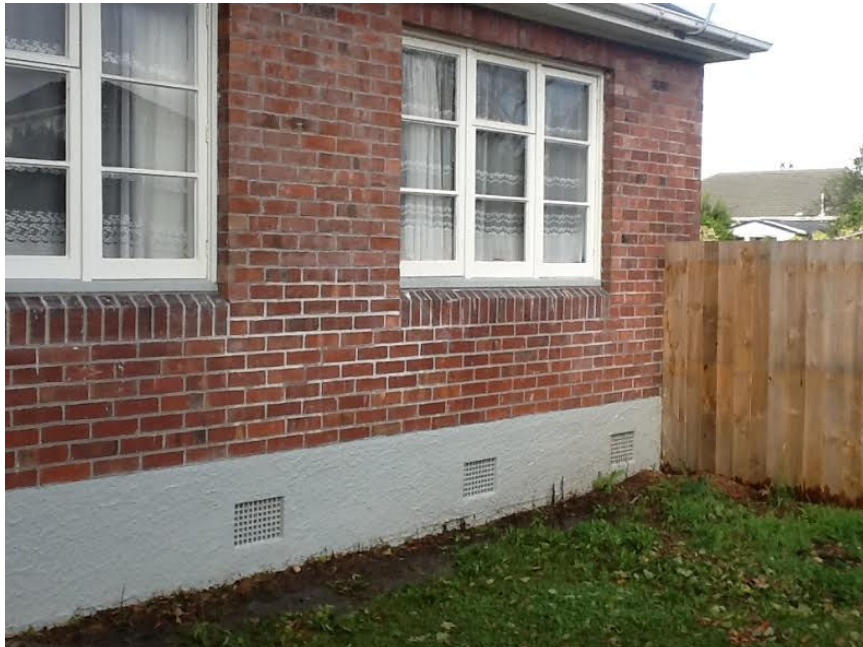
The worst affected house in March experienced flooding to a depth of 50 mm up the foundations. Brittans Drain was reported as 2 m deep at Kerrs and Wainoni Roads intersection.

Figure 10 Debris mark showing water level on foundation of Kerrs Road property after March 5th event

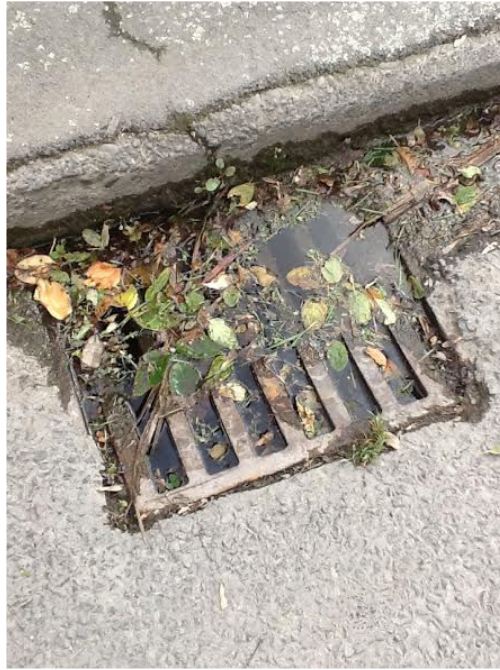
Figure 11 Brittans Drain sump two days after March 5th event

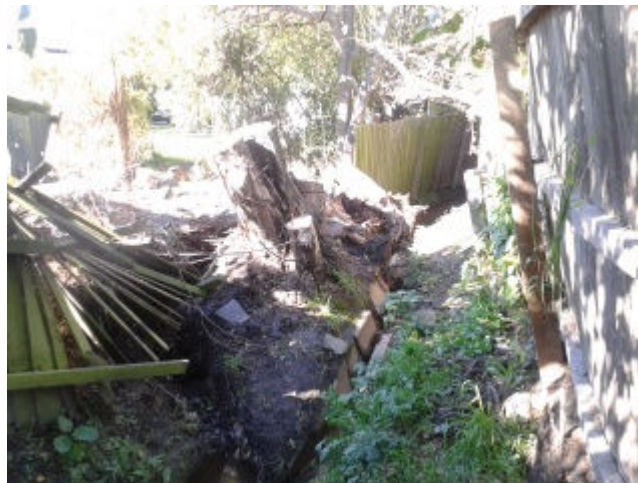
Figure 12 Large constriction in Brittans Drain (since removed)

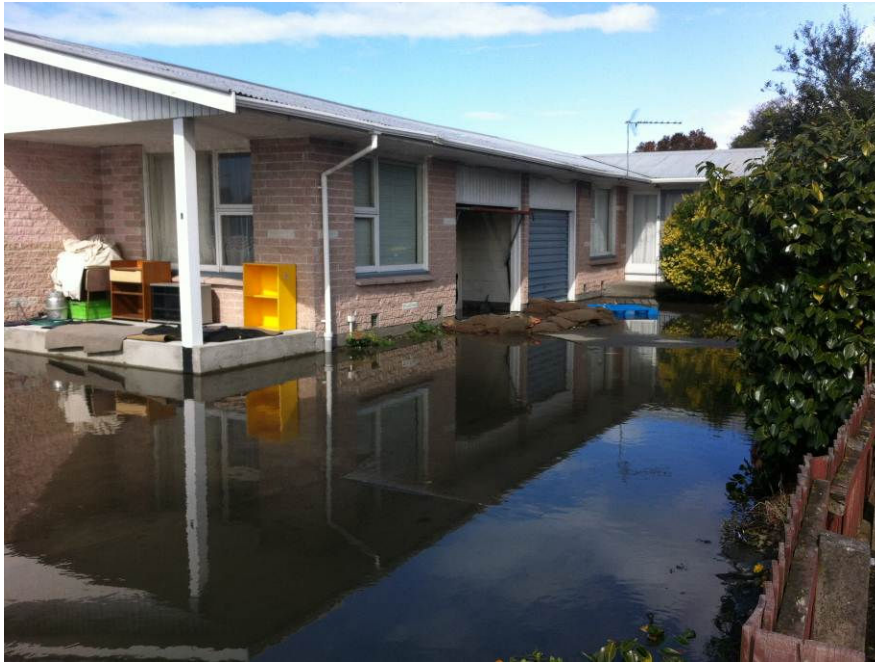
Figure 13 Ponding remaining around property three days after the March event

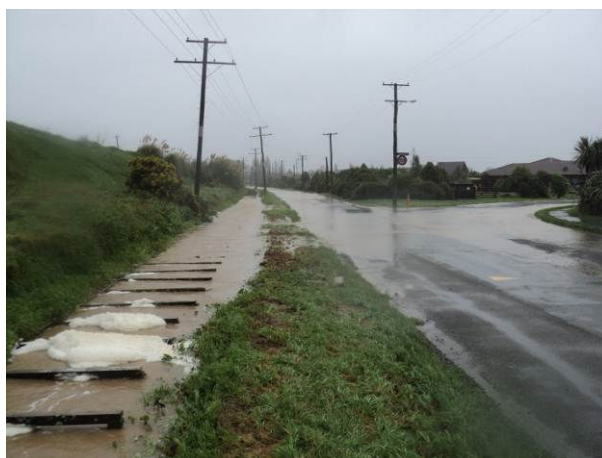
Sinking of Truscotts Stream Branch was observed.

Figure 15 Truscotts Road showing subsidence of timbered drain

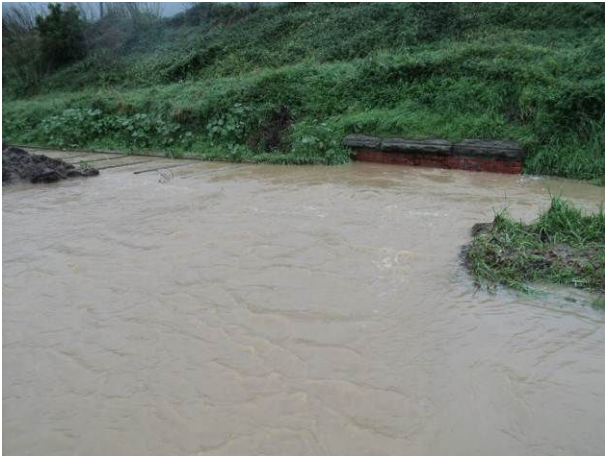
Figure 19 Truscotts Road outlet of 1200 mm brick barrel after trimming sections of berm

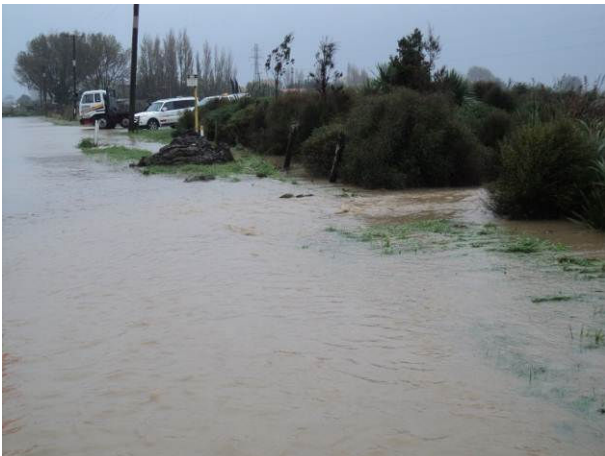
Figure 20 Truscotts Road berm cut down to allow flow into Matuku Waterway

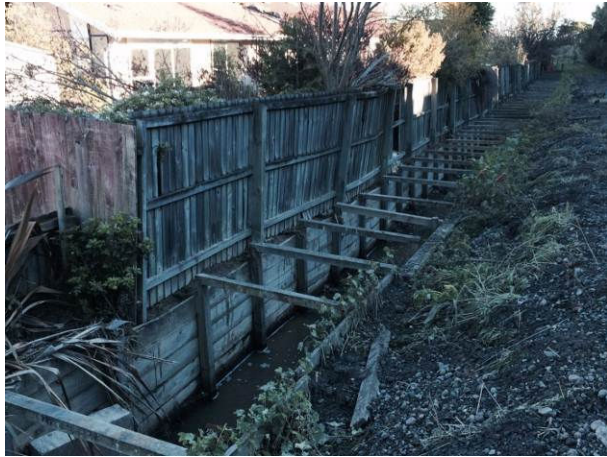
Figure 22 Bridle Path drain west of rail embankment property side timbering to the raised

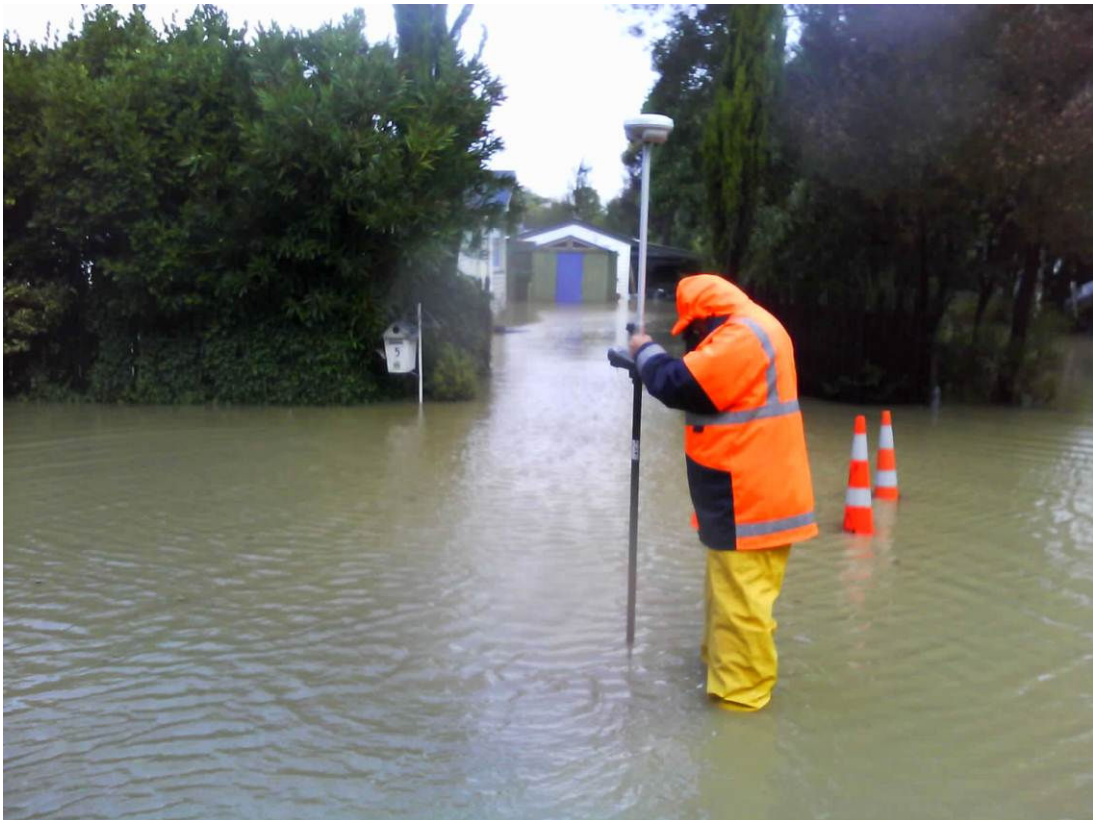
Figure 28 Lower Heathcote riverside properties - floor level flooding at Clarendon Terrace

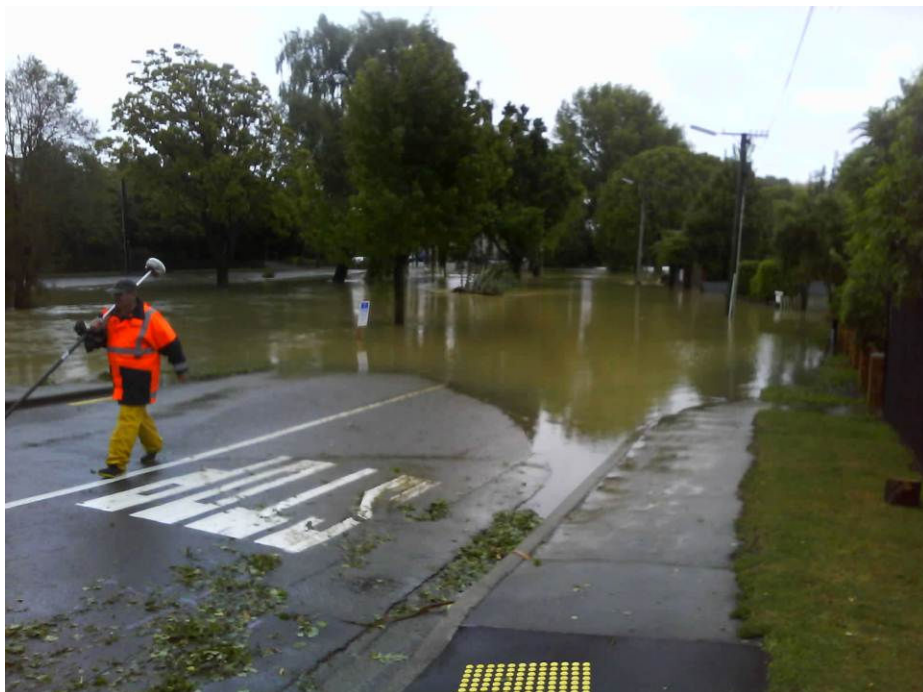
Figure 29 Flooding on Riverlaw Terrace

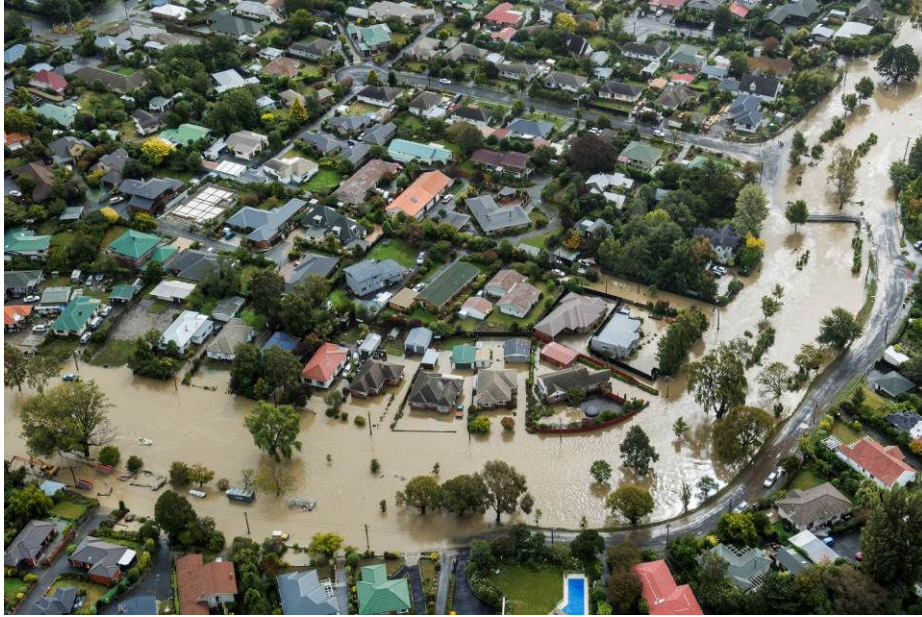
Figure 30 Extensive floor level flooding on Riverlaw Terrace

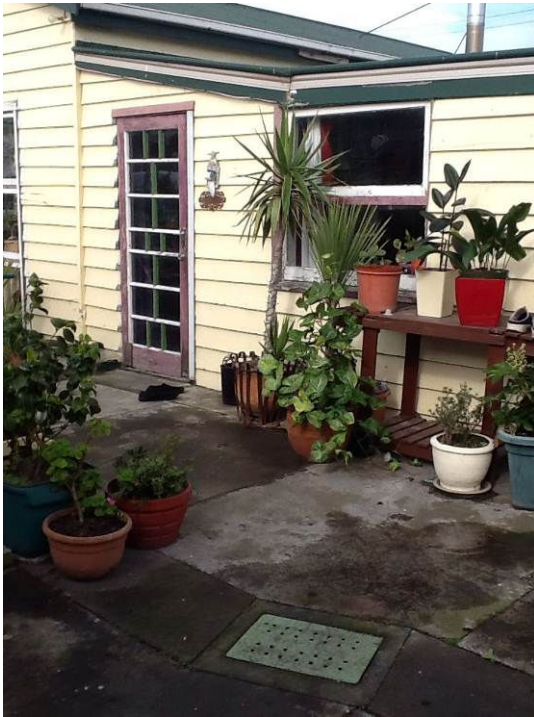
Figure 31 Photo of private grate that surcharges and enters nearby doorway due to lack of flow path away from building and freeboard above the adjacent paving

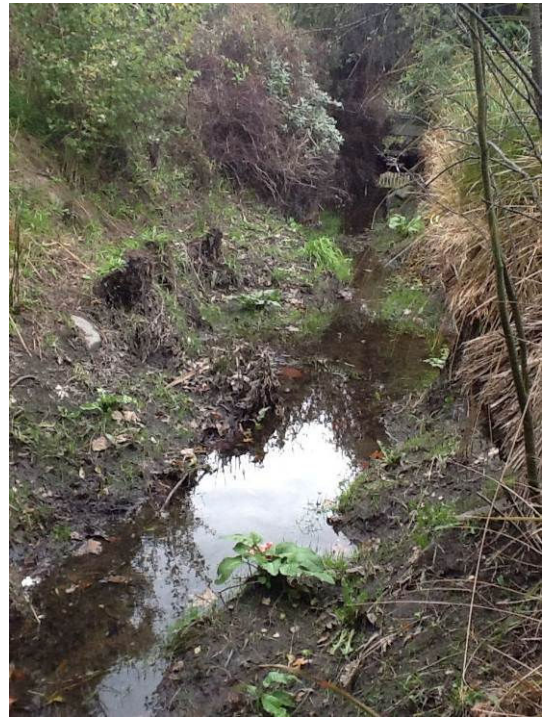
Figure 32 Upper Bells Creek: scope to increase channel capacity

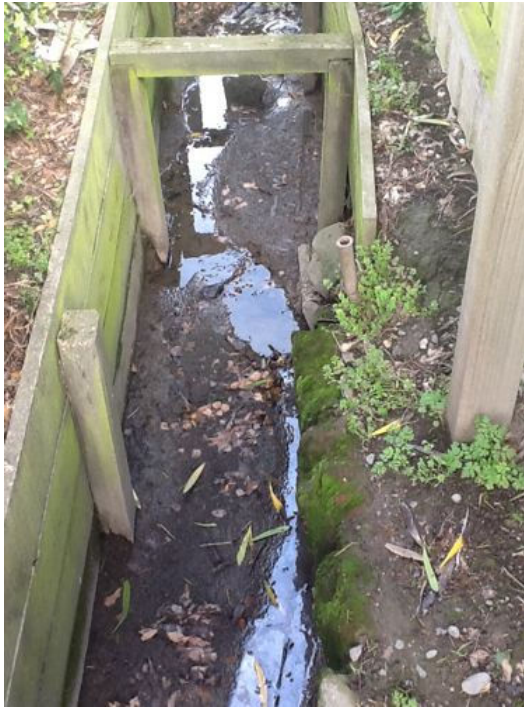
Figure 33 Silt in invert of drain at Okeover Street

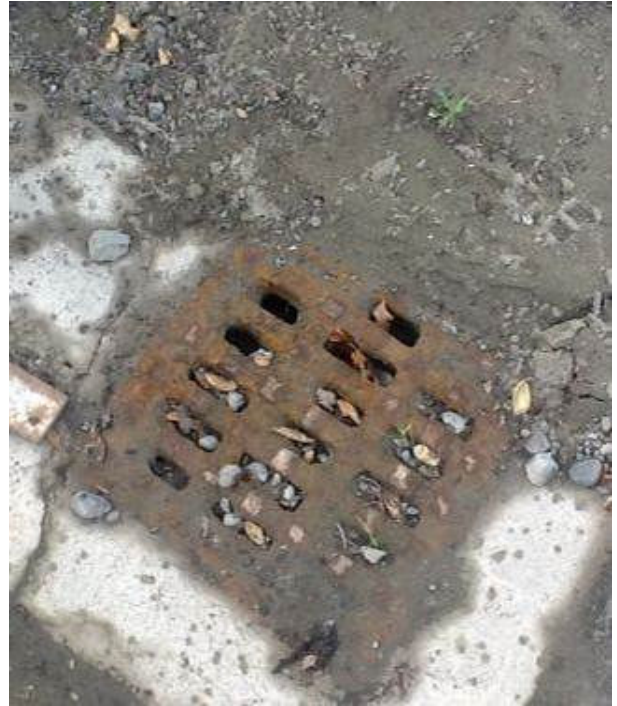
Figure 34 Blocked sump at PS11, possibly due to recent construction activity

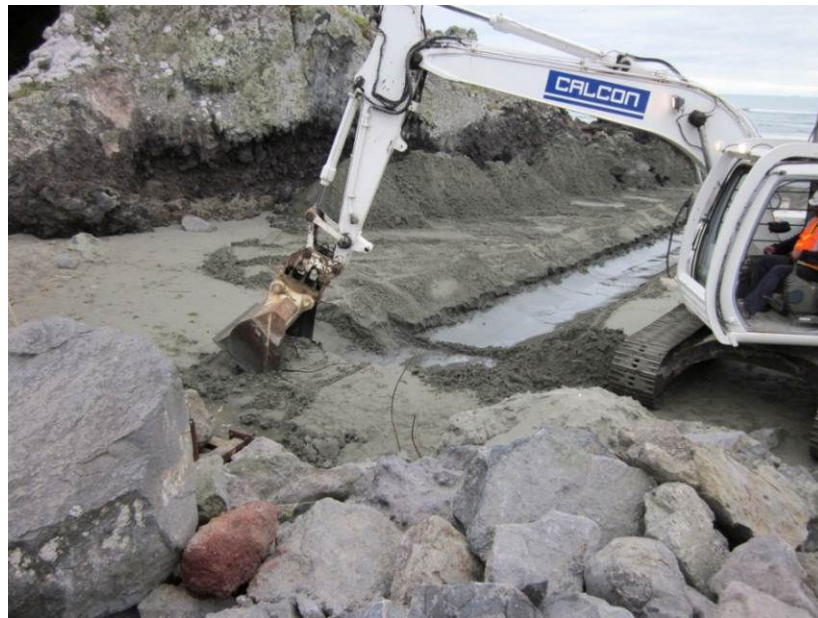
During site inspections local Sumner residents suggested that the majority of surface flooding which occurs along Marriner Street and the Esplanade can be attributed to operation and maintenance issues associated with the stormwater outfalls at Cave Rock and Burgess Street. During the March flooding event the Cave Rock outfall was operational however the Burgess Street DN650 outfalls were potentially blocked which resulted in surcharging of the stormwater network upstream in Marriner Street. During previous flood events the Cave Rock outfall has been completely restricted by sand deposits which were removed in 2011 through an excavator in order to prevent further flooding on Marriner Street (Figure 37).

Figure 37 Cave Rock sand removal

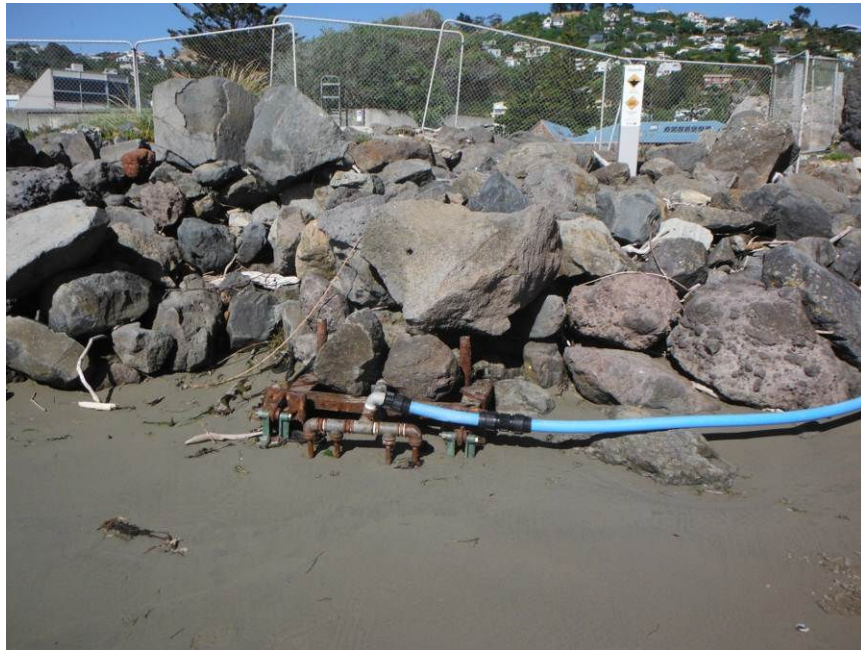
Figure 39 Cave Rock outfall with sand restrictions

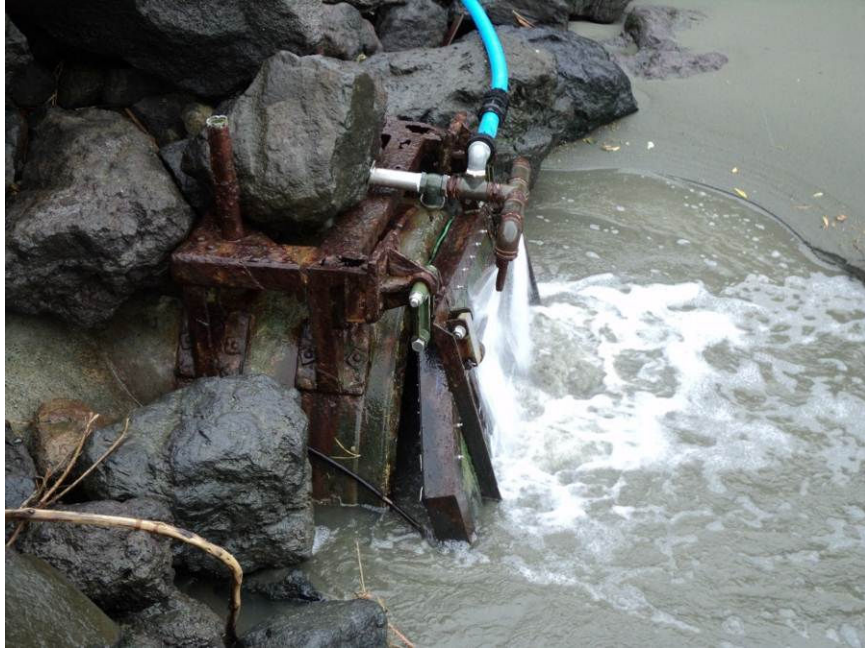
Figure 40 Cave Rock outfall during March event (flap gate partially open)

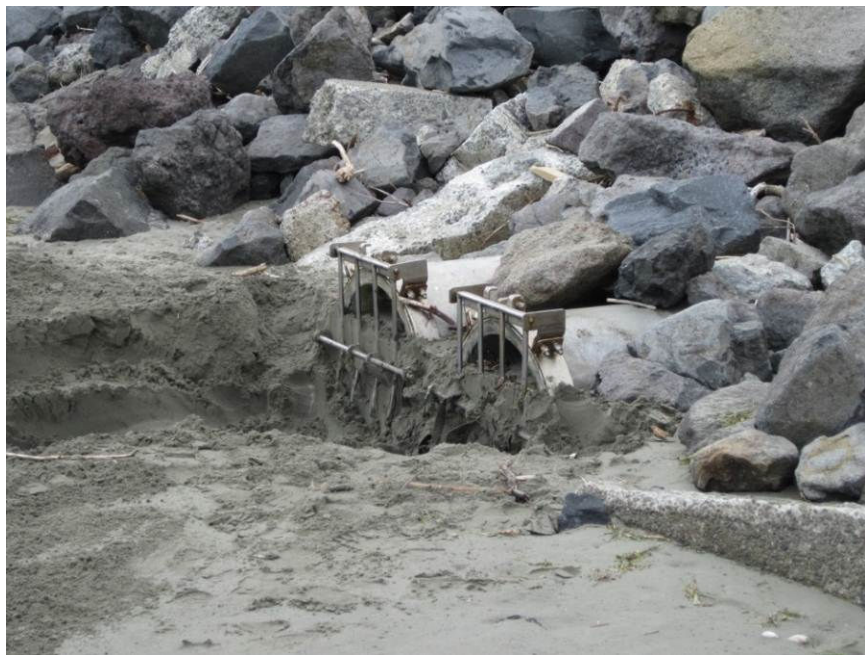
Figure 41 Burgess Street outfalls with sand build-up

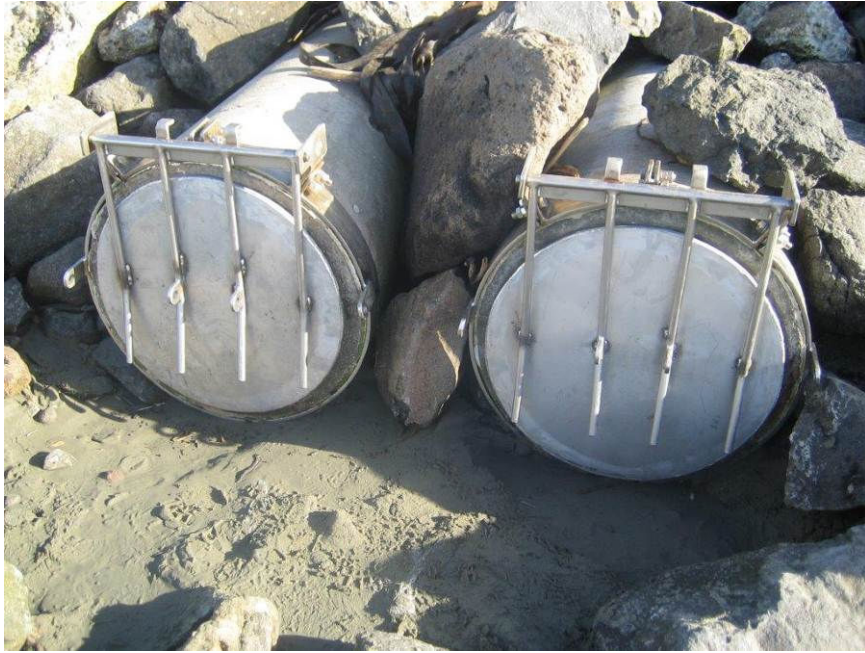
Figure 42 Burgess Street outfall with new flap gates

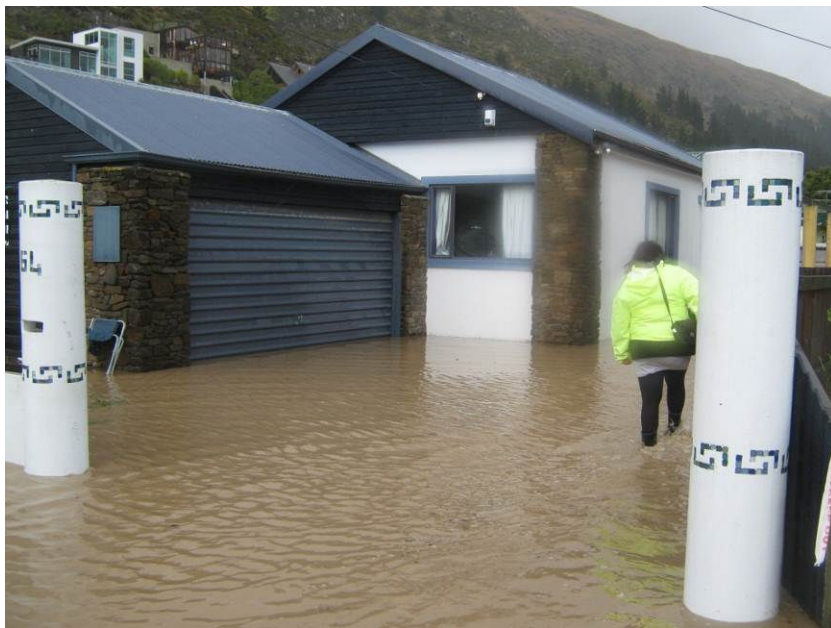
Figure 43 March flooding up to foundations

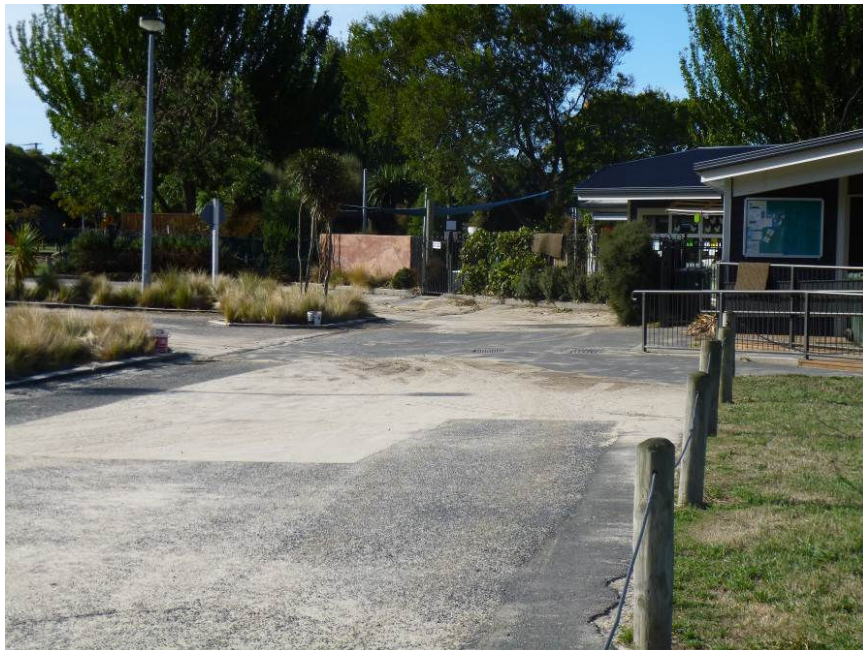
Figure 44 Moa Community Kids Early Learning Centre day after March 2014 flooding event

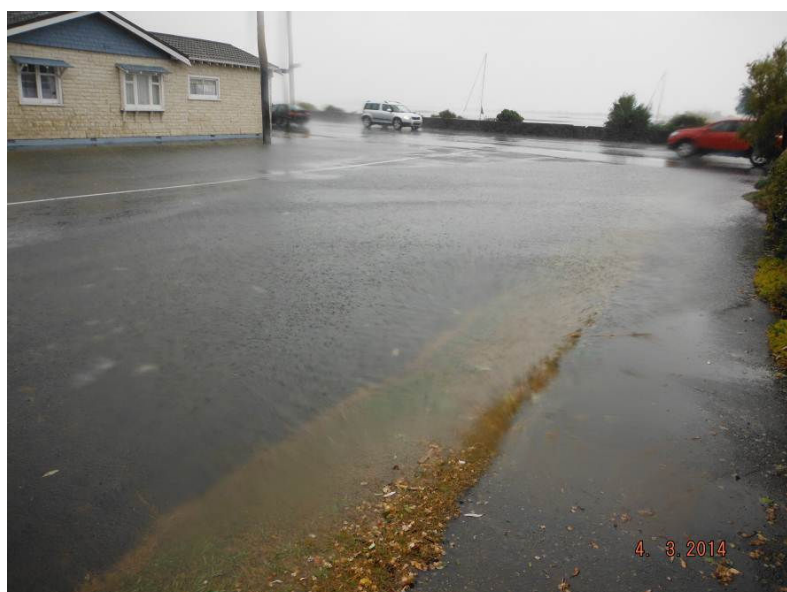
Figure 45 Surface flooding Bayview Road March 2014

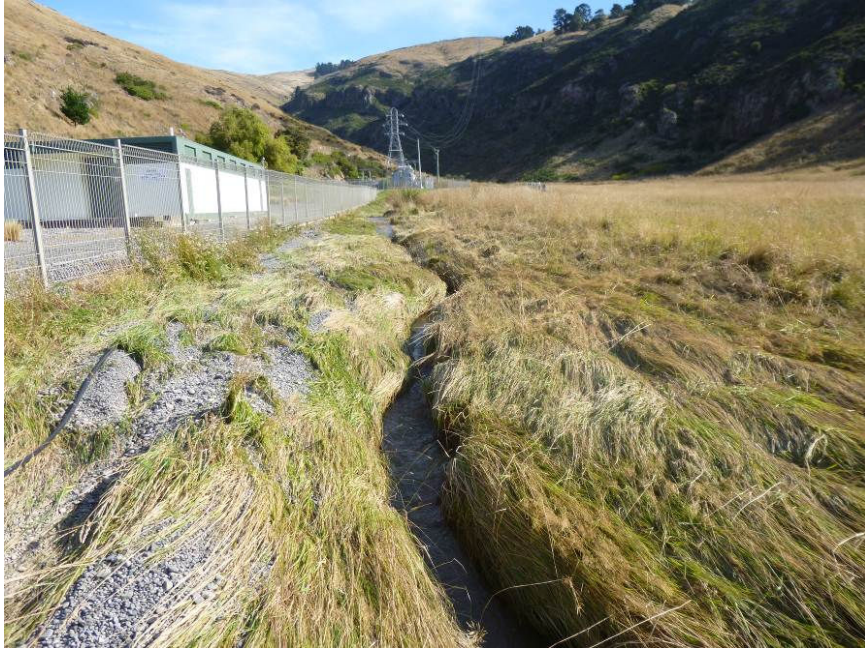
Figure 46 Rifle Range Drain in Barnett Park. High flood level indicated by flattened vegetation and gravel deposits

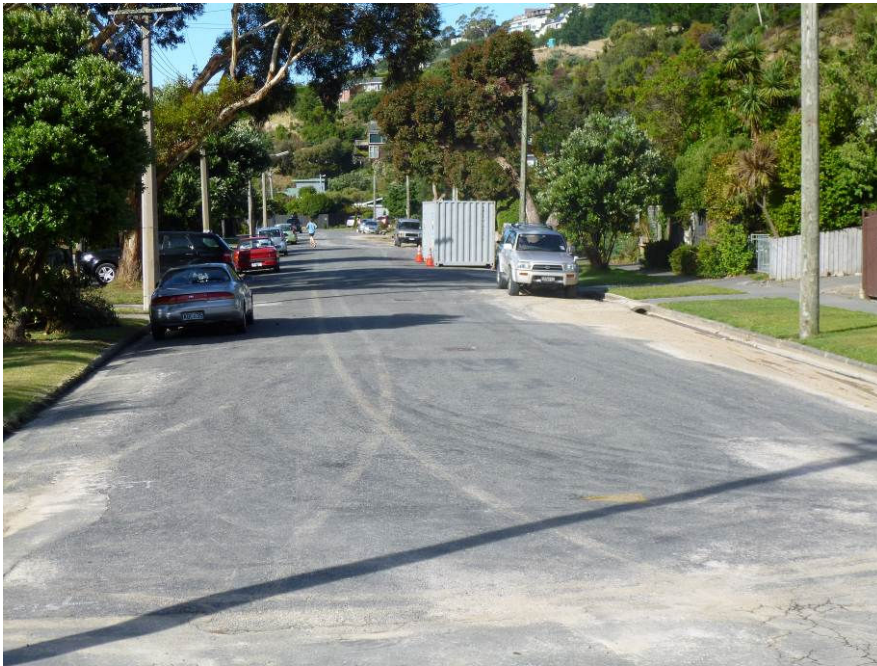
Figure 47: Top of Bayview Road with silt deposits day after March 2014 flooding event

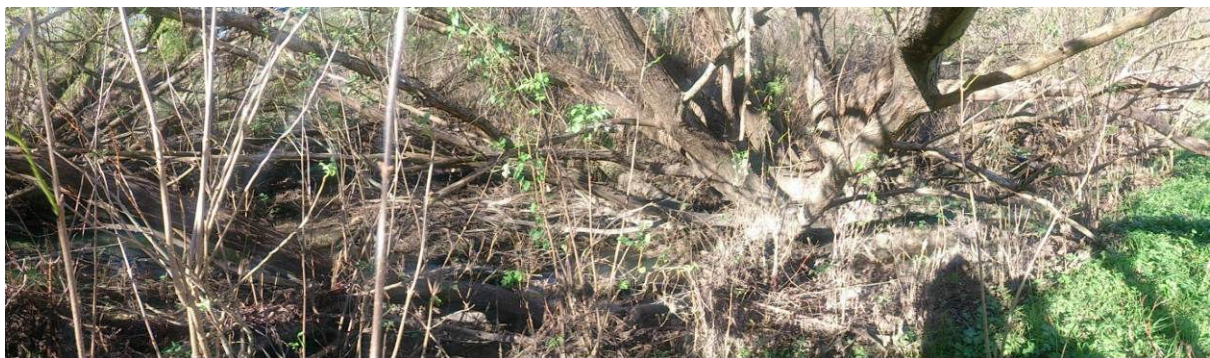
Figure 49 Little River – An indication of the level of vegetation in Okana River Branch 3

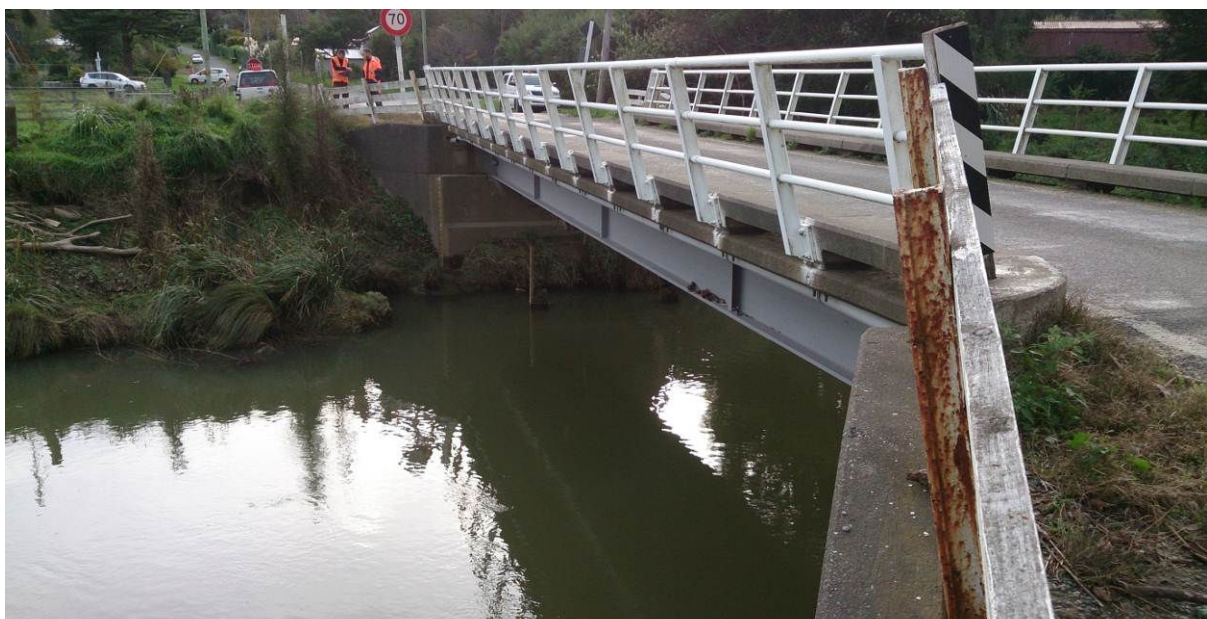
Figure 50 Little River – Wairewa Pa Road Bridge; a key constraint on the network
