Annual Report

Akaroa Wastewater Treatment Plant

1 July 2023 to 30 June 2024

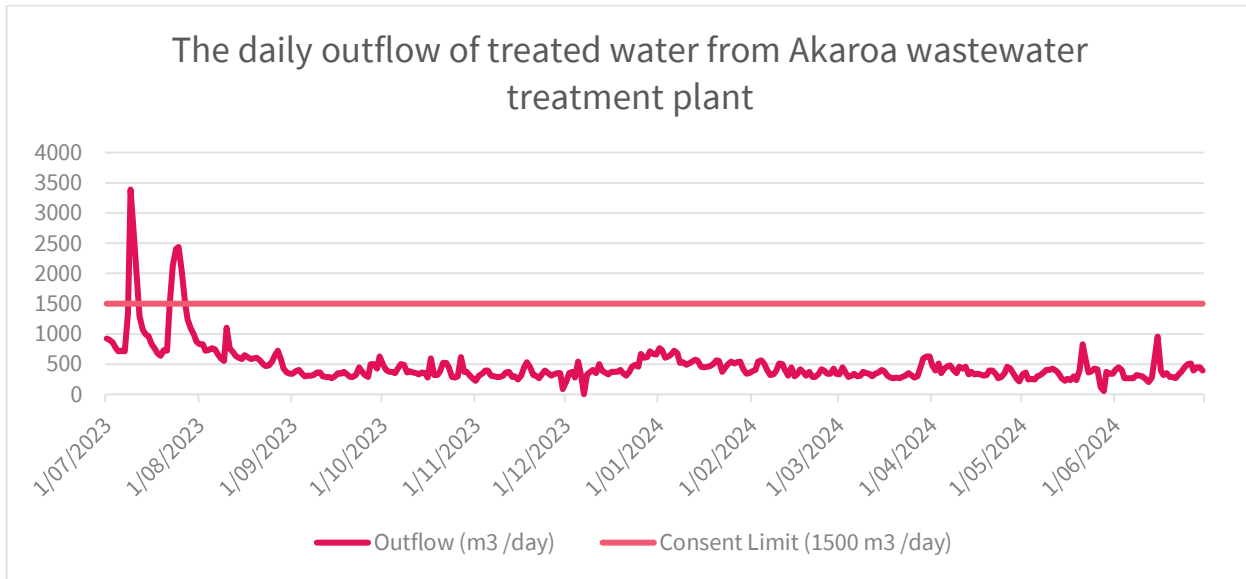
Flow Data

Date	Outflow (m3/day)	Consent limit (m3/day)	Rainfall (mm/day)
9/07/2023	3388	1500	65.8
10/07/2023	2656	1500	43.6
11/07/2023	1897	1500	13.2
23/07/2023	2130	1500	198.8
24/07/2023	2402	1500	47.6
25/07/2023	2438	1500	1.2
26/07/2023	2031	1500	9.8
27/07/2023	1530	1500	2.2

The consent limit for flow was exceeded 8 times in FY24, all of these could be correlated with high rainfall, where there were events of a total of 30 millimetres or more over three consecutive days
