FIRE INVESTIGATION REPORT

Shuttle Drive, Bromley, Christchurch City

F3350186
High Value Loss
3:07 p.m. 1 November 2021

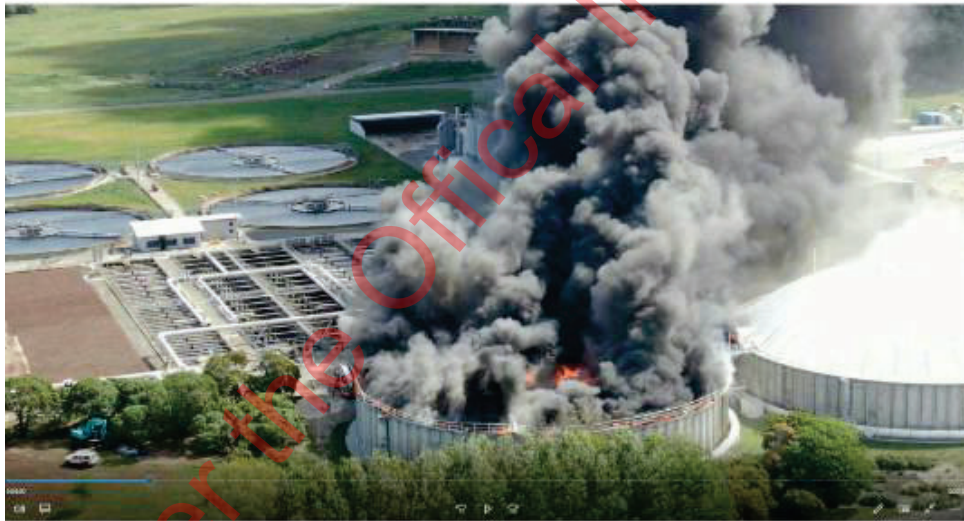
Image 1: Drone image taken from the east side of the tanks showing Trickling Tank #2 as the area of origin. (From video supplied by yt5s.com)

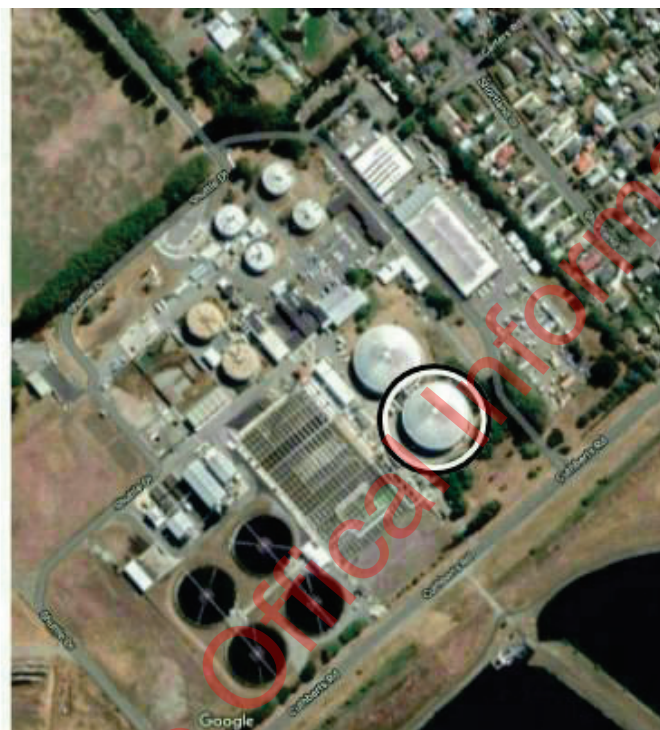
Image 2: Google aerial image of the CCC Waste Treatment Plant Shuttle Drive. The circle indicating the Tank of origin being "Trickling Tank # 2"

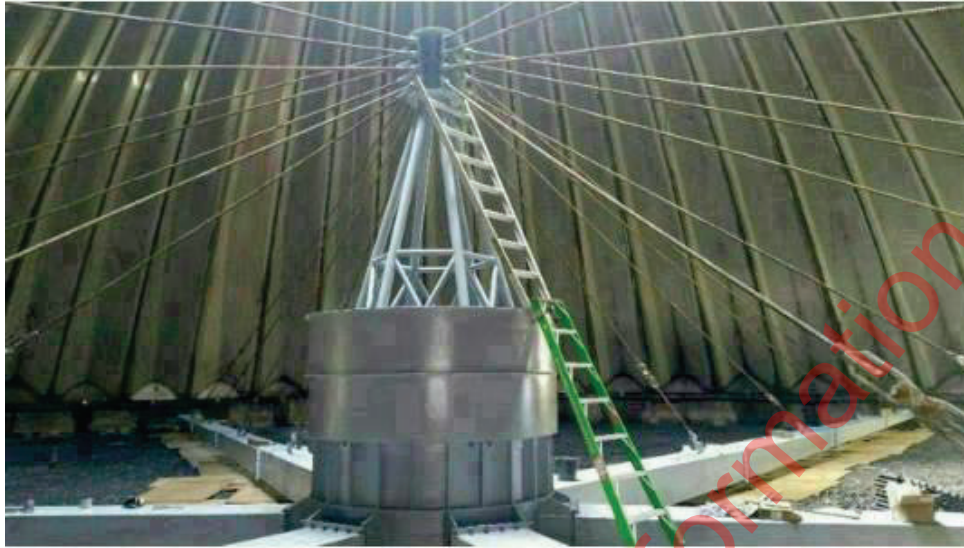
Image 3: The internal structure during a maintenance project several years prior to the fire. Circa 2016. Detail showing the central pivot and supports. (Photo supplied by CCC).

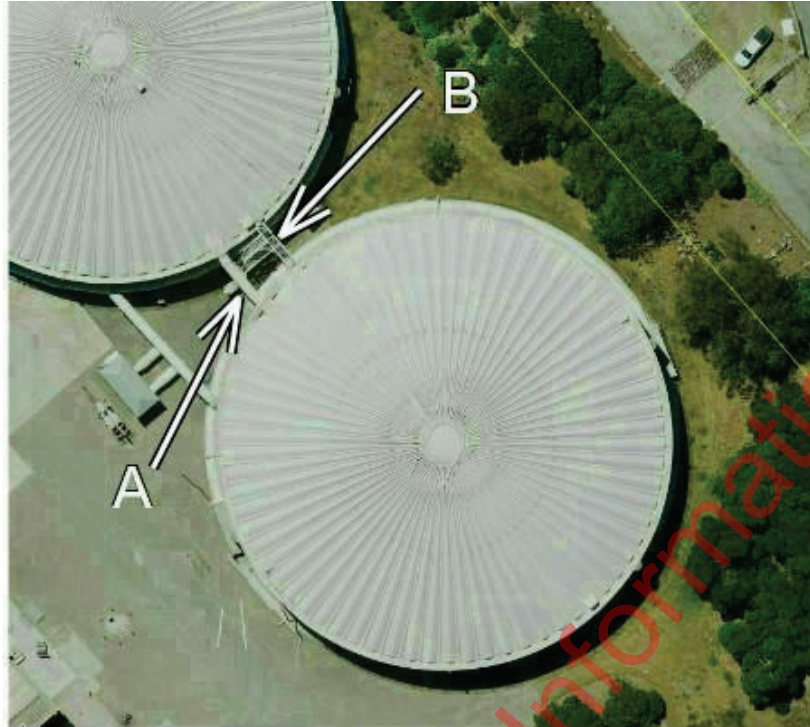
Image 4: Detail of roof and connection between the two trickling tanks. "A" is an inflow ducting air vent between the tanks. "B" is the shared maintenance staircase use for accessing the tank rim. Image supplied from FENZ Smart Map.

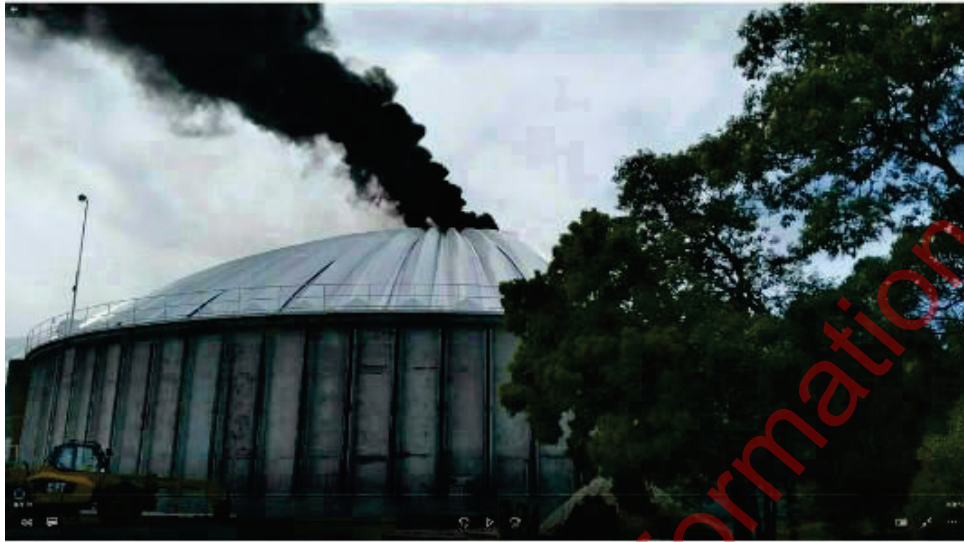
Image 5: A snip image from the video footage taken by Witness 3 identified at 15:11 hours by time stamp. Location is identified as South west corner of Trickle tank #2. (Image supplied by Witness 3 Video 20211101_51003.mp4)

The fire appeared to be at a location near the apex of the roof structure, near where the Goleman Group Staff had been working.

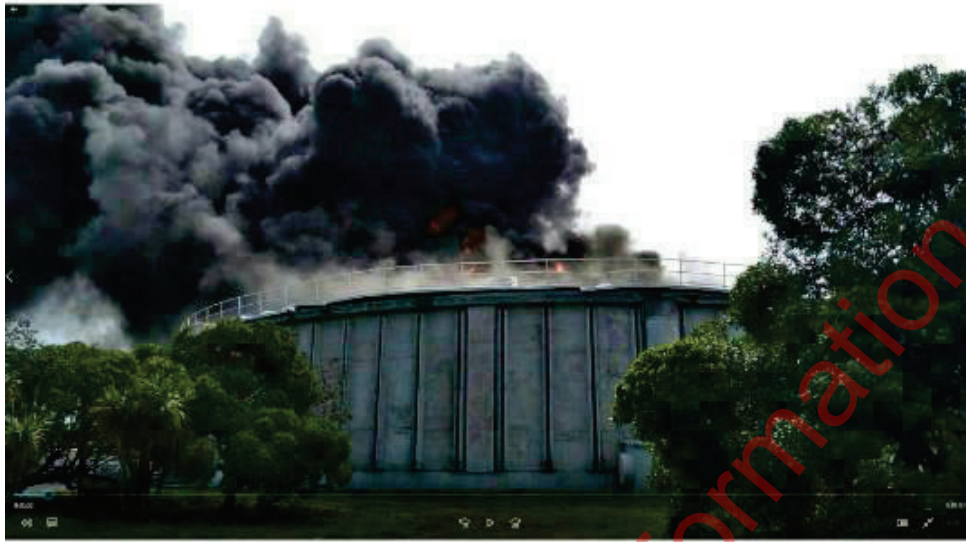
Image 6: The roof of the Tank #2 has collapsed at this point due to the design of the interlocking roof panels and the failure of the supporting ring at the apex of the dome. (Image supplied by Witness 3 Video 20211101_51407.mp4)

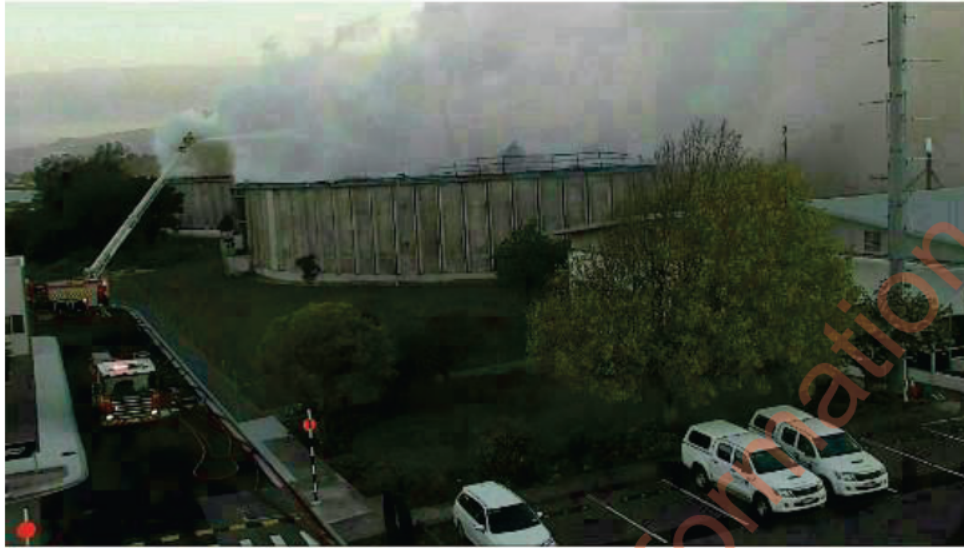
Photo 1: Firefighting operations later in the incident showing the use of aerial monitors to extinguish the fire. (Photo from FENZ Command Unit)

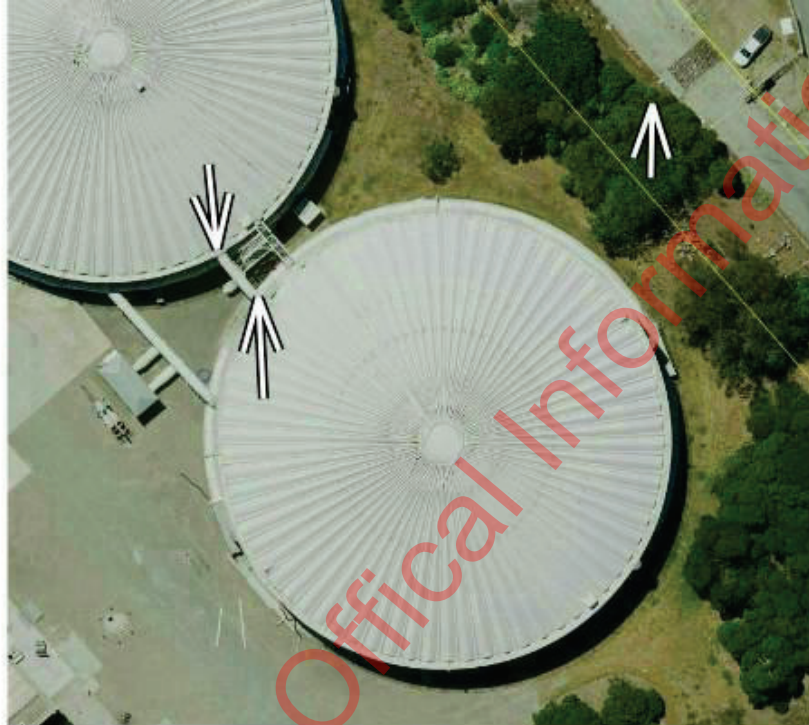
Image 7: FENZ Smart Map clip image of the two tanks. Arrow indicating North. The southern of the two tanks was the area of origin. The two arrows identify a connecting air duct between the two tanks.

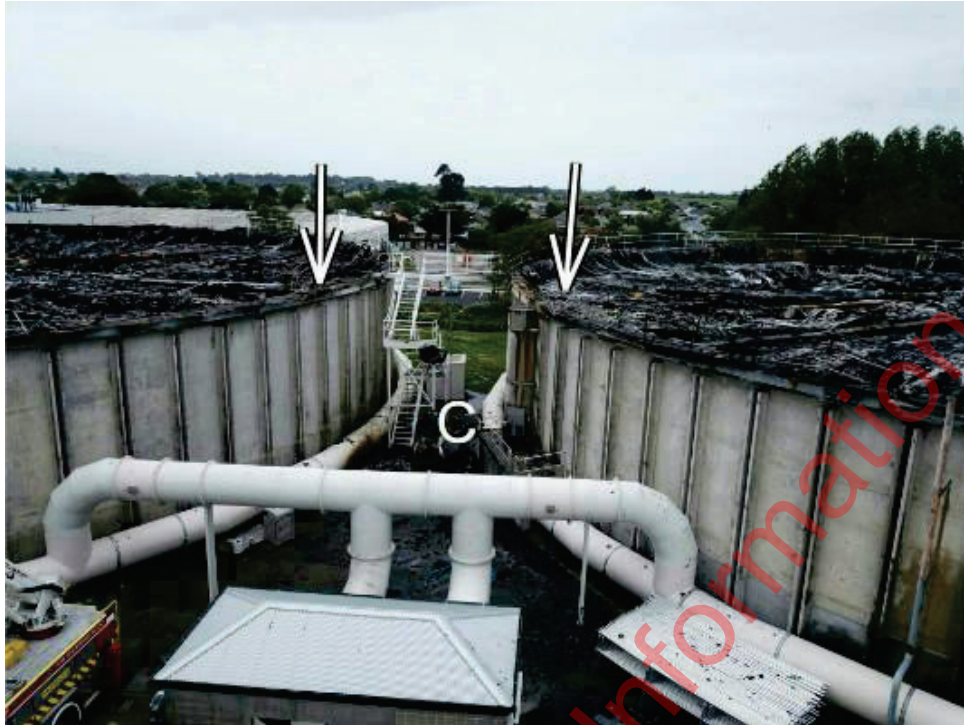
I completed a photographic review of the tanks including the roof top and central air duct connection between the two tanks. I identified burnt roof and piping strictures in the fire debris both within the tank and outside the tank. I believe that the fire that originated in the southern tank (Trickling Tank #2) progressed to the northern tank (Trickling Tank #1) via this air duct connection pipe. I have excluded the motor and fan as an ignition source as this area was intact and not on fire during the early stages of the fire.

Photo 2: In foreground is the ventilation pipework for the Tanks. The service stairway connecting the two tanks. A ventilation pipe connected the tanks at rim level, identified by the arrows. "C" indicates a ventilation fan at ground level.

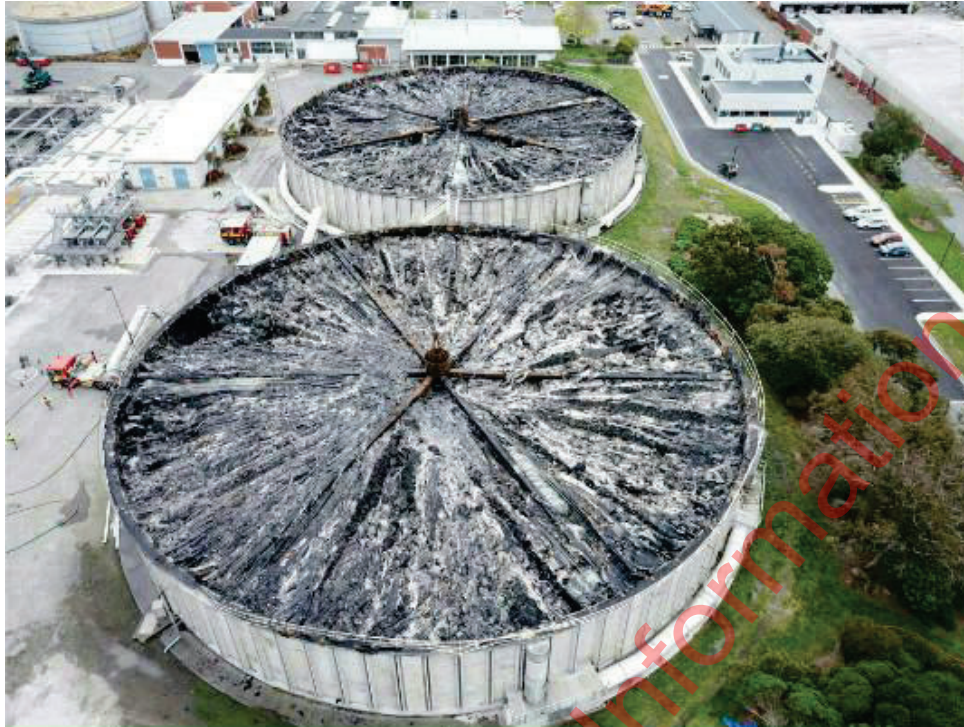
Photo 3: Aerial image of Tank #2 in the foreground. (Photo supplied by FIS from drone footage).

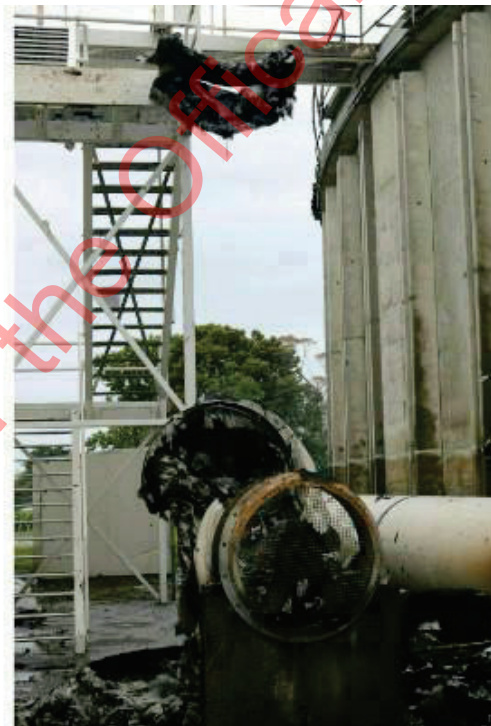
Photo 4: Ventilation fan area at the base of the access stair between the tanks identified as "C" in Photo 2. This area was consumed by fire after the fire was discovered on the roof of Tank #2.

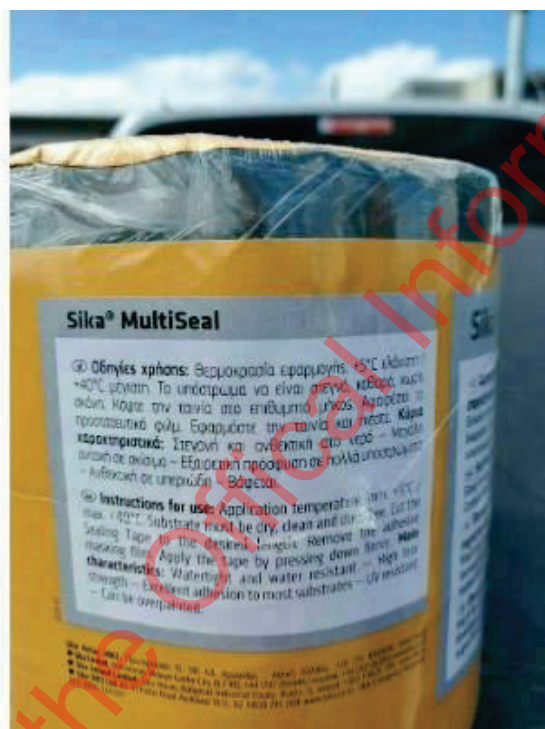
A box of "Sika MultiSeal" tape was identified by one of the investigation team on the east side of the stairway connection between the tanks. This was identified as the product being used under the permit to work system for providing a weather seal on the roofing structure. The operating instructions for the product identified ambient temperature of application to be between +5° Celsius to +40° Celsius. On the day of the fire the ambient air temperature was within this range within Christchurch City. (I estimated the temperature was between 15° and 20° Celsius at the time of fire.) The Temperature at Christchurch International Airport weather station at 3:00pm the day of the fire was recorded as between 14.4° - 15.5° Celsius, for the time period leading up to the first 111 call. The temperature on the surface of the tank was not recorded as a microclimate consideration. Wind was predominantly from the east nor east direction, being a cooling sea breeze.

Photo 5: Operating instructions for the Sika MultiSeal product being used.

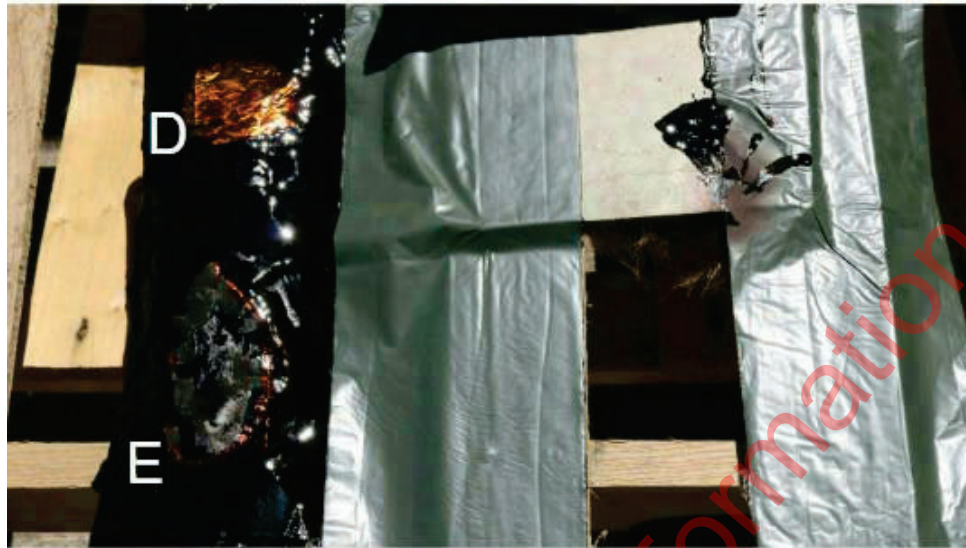
Photo 6: Test result of the tape as applied to an element of the roof structure with sustained open flame exposure. Tests self-extinguished due to wind present removing heat from the products/tape when ignited. "D" indicates an Electric Heat Gun application to the tape resulting in melting. "E" Indicates an open flame application to the tape resulting in burnt product.

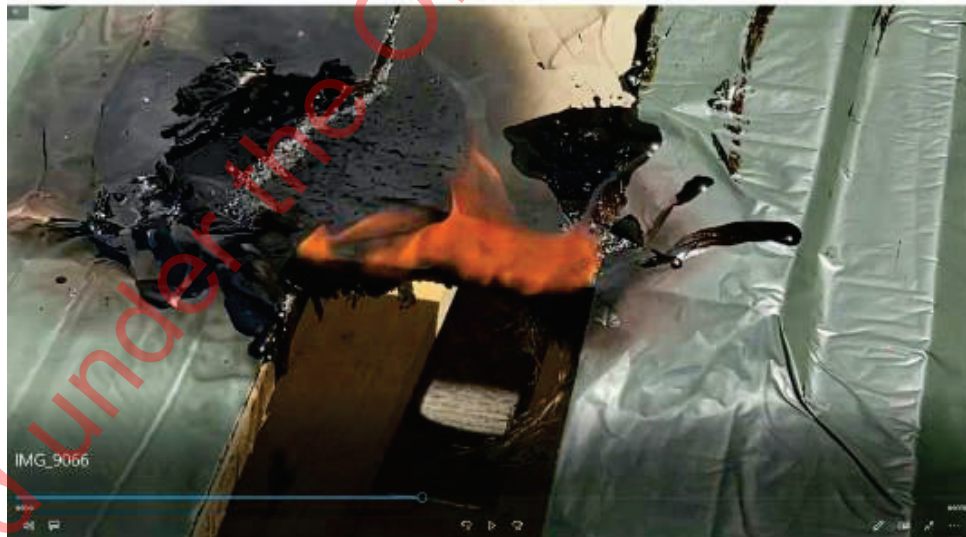
Image 8: After the removal of an open flame heat torch the structure of the roof continued to burn for a minute. This indicates and confirms the roof structure could be ignited and sustain combustion. (Image taken from video-clip IMG_9066.MP4 from FIS Testing)

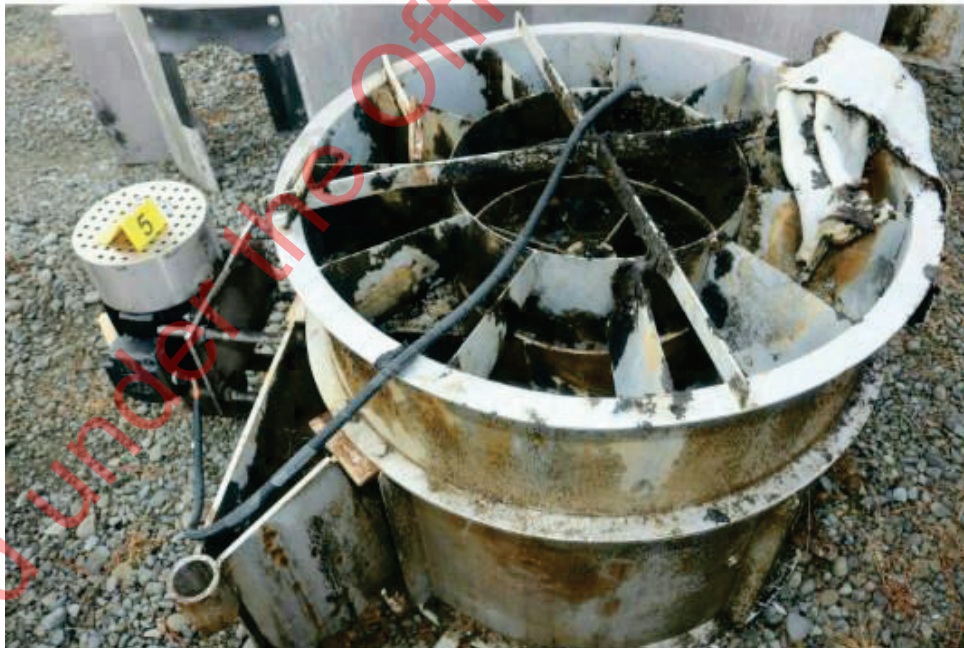
Photo 7: Motor and fan #5 showing burnt product within the cowling of the fan unit. Motor was unaffected by fire when electrically tested. Drive belt intact and unaffected by fire. Fan #5 was located Trickling Tank#2 North West corner.

No chafing of the cowlings was observed eliminating friction or sparks as a potential cause. The motors turned freely indicating that no internal winding damage had caused an overload in the motor windings.

Conclusions: From my observations and basic electrical testing I would be confident in documenting that a point of fire origin was not connected to the failure of the 8 motors investigated."

My observation of the burn indicators to the cowlings and fans, concur with this statement also being that the burning observed was as a result of the fire and not the cause of the fire.

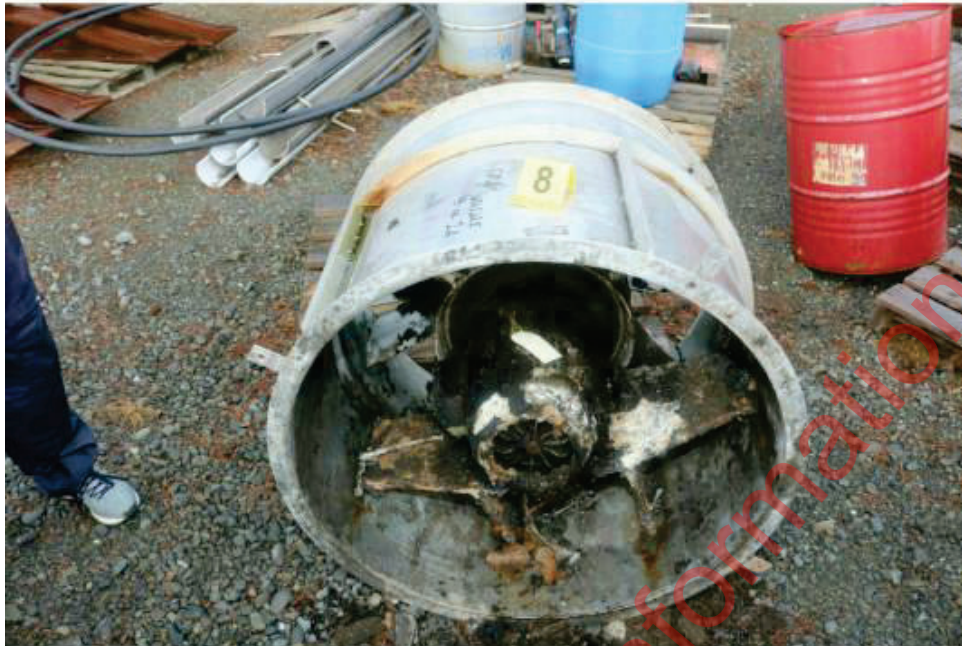
Photo 8: Motor and Fan #8 showing burnt fibrous product on the outside of the motor below the fan. This is a direct drive system from motor to fan blade. It is believed that this fan was from Trickle Tank #2 West side.

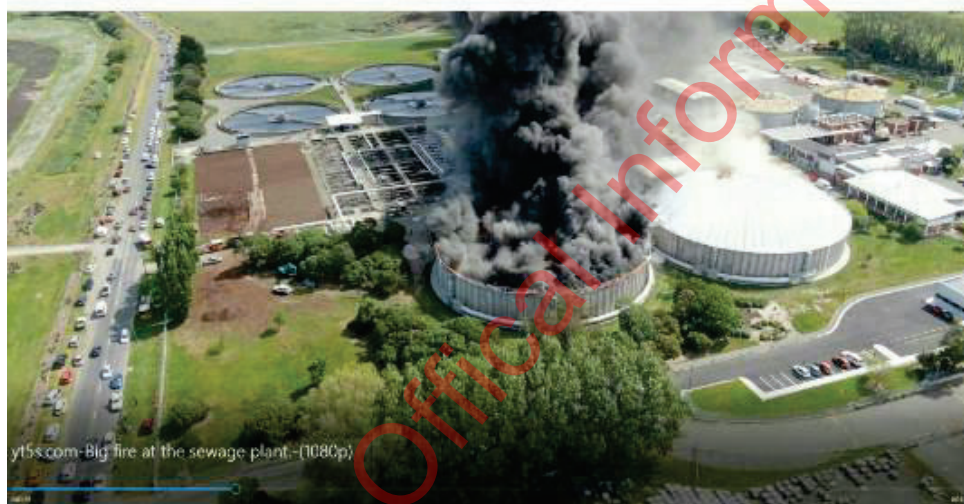
*Image 9: This drone image at the time of the fire shows the fully involved southern tank on fire with fire progressing to the northern tank via a ventilation pipe connecting the tanks at the roof rim level.
(Supplied by independent source yt5s.com)*

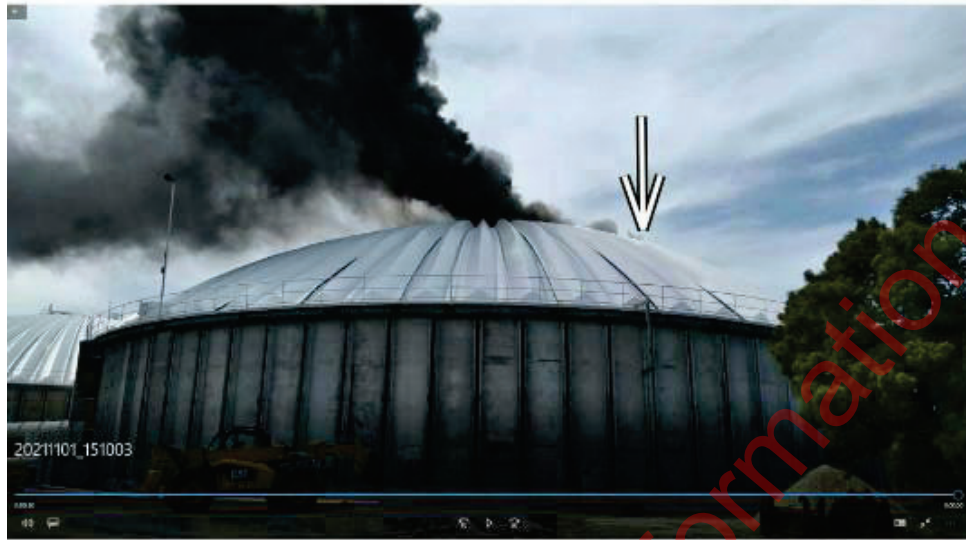
Image 10: Image taken from a video footage, taken at 3 12pm by witness 3 standing in the south west corner of the tank looking north. Smoke rising from the central cap with a leading edge to the east as indicated by the arrow. (Image from 20211101-151003.mp4)

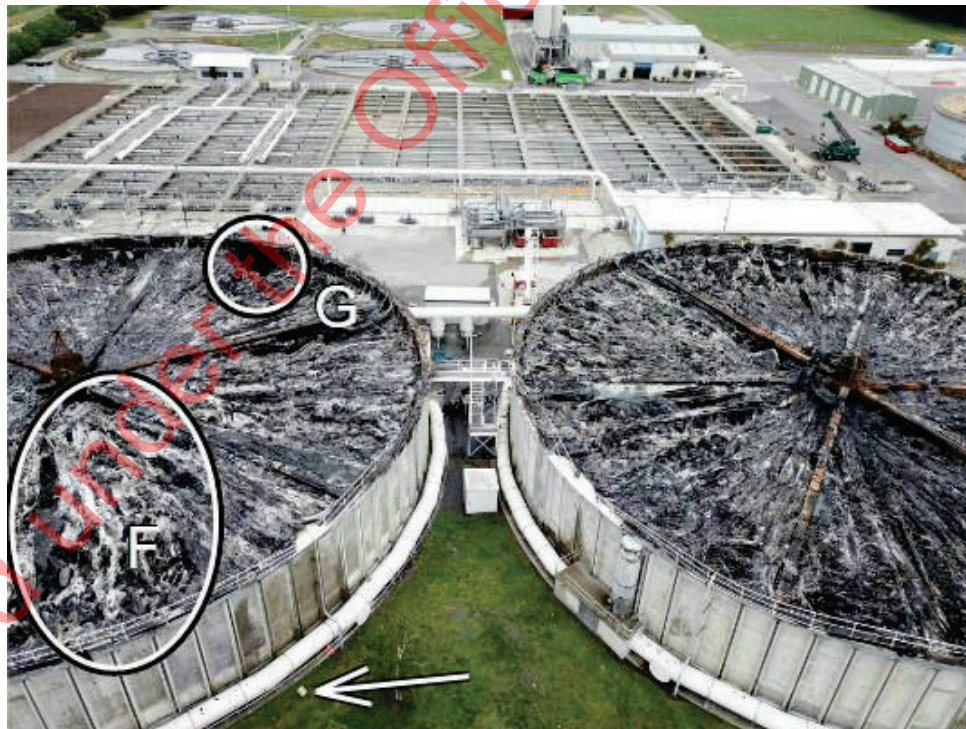
Photo 9: Two areas of significant damage in the Trickling Tank #2 were identified. Circle "F" is believed to be where the first collapse of the roof occurred. Circle "G" is downwind from this location at an intensified area of burning. (Photo supplied by FIS DJI_0226.jpg)

In the above photo I identified an area on the north eastern side of the trickling tank #2 "F" that has sustained more damage than most of the rest of the tank surface. I believe that the workers were somewhere in this area of the roof above this location, based on this being an area of most damage. Witnesses have yet to confirm where they were working on the tank at the time, but I have excluded the western side of the tank. The arrow indicates a box of Sika MultiSeal tape found at the site as per Photo 6 below this location where the workers vehicle had been parked during work operations.

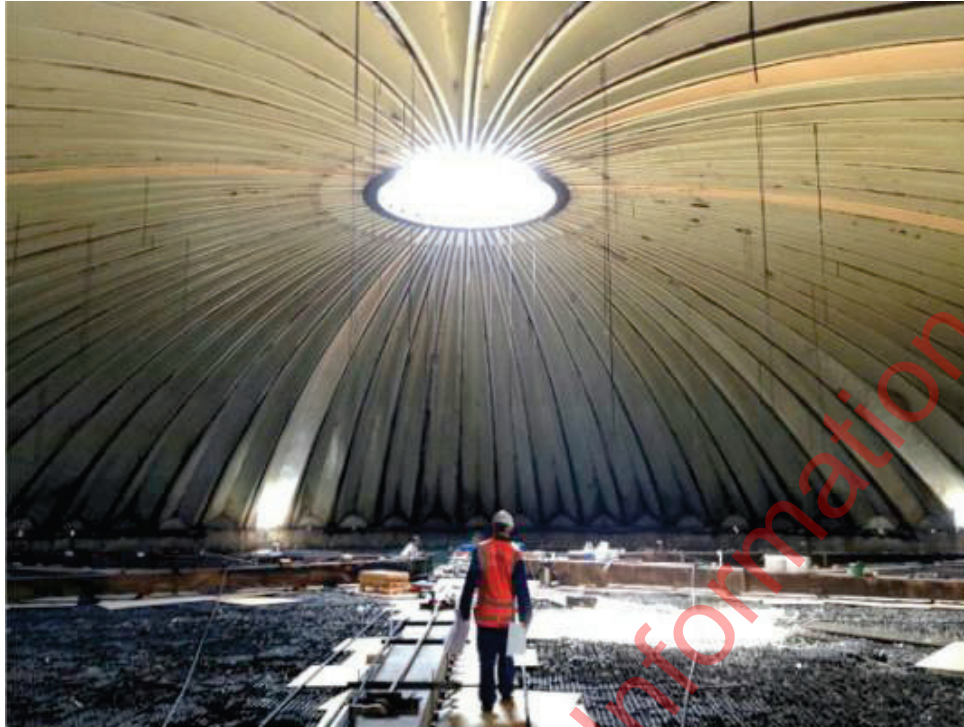
Image 11: The internal structure of the roof dome. No forms of electrical hazards were present within this area of the processing plant.
