Arboricultural Report

23 October 2018

**Christchurch City Council
Naval Point Development
(Lyttelton Recreation Ground & Marina)
54-56 Godley Quay & 16-25 Marina Access
Lyttelton**

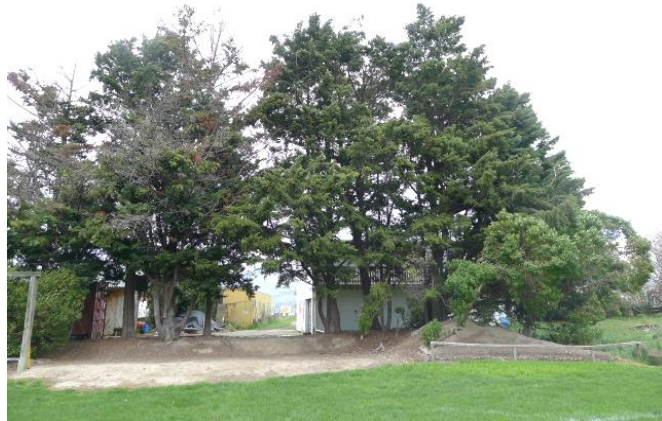
Although there were no significant structural failures observed, some of the Leyland cypress and Monterey Cypress were found to be affected by canker disease and are expected to have a limited useful life.

Figure 2: Trees near the Lyttelton Sea Scouts building.

The trees that were assessed as being in fair condition had reasonably good foliage density and no significant structural defects. However, six of the Leyland Cypress Monterey Cypress had obvious signs of canker disease (affecting less than 30% of the tree canopies at the time of the survey).

The trees that were assessed as being in poor condition had decline resulting in more than 30% foliage density loss, poor structure and/or significant crown suppression.

The trees that were assessed as being in very poor condition had advanced decline resulting in more than 70% foliage density loss, or significant crown suppression.

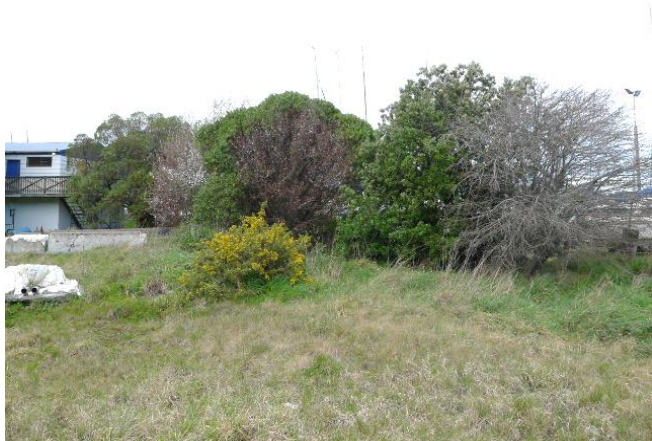
Figure 3: Trees and shrubs near Lyttelton Sea Scouts.

The overall condition of the trees/shrubs within the group was assessed as fair (average).

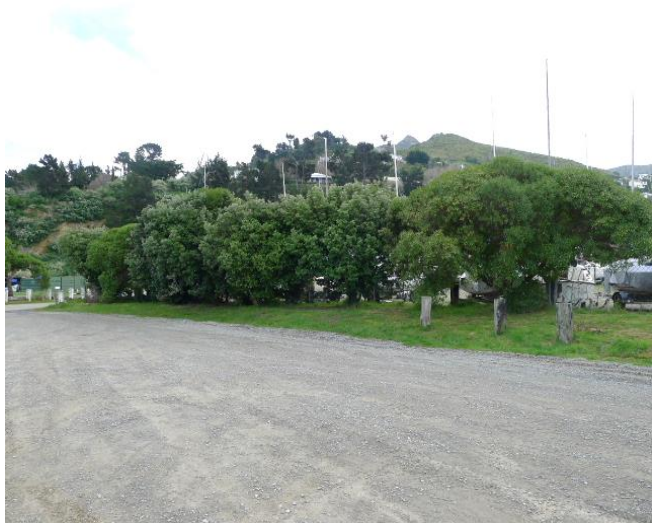
Figure 4: Trees and shrubs within Marina Access area.

The condition of the majority of trees/shrubs within the groups was assessed as fair (average), but some were assessed as poor due to poor health or poor structural integrity.

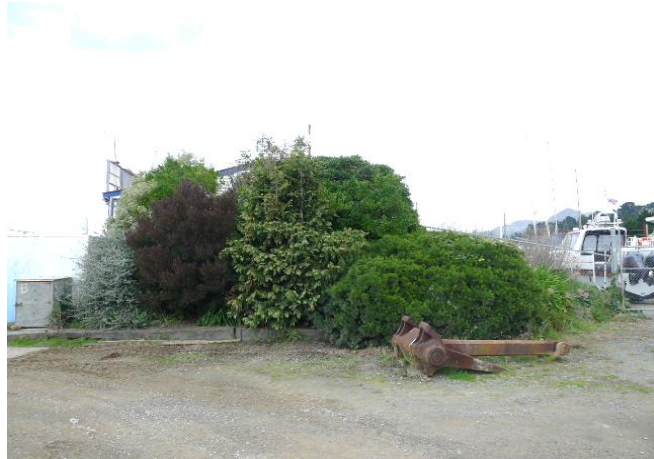
The overall condition of the trees/shrubs within the groups was assessed as fair (average), but a Lacebark was in decline and in poor condition.

Figure 5: Trees near the Coastguard Canterbury building.

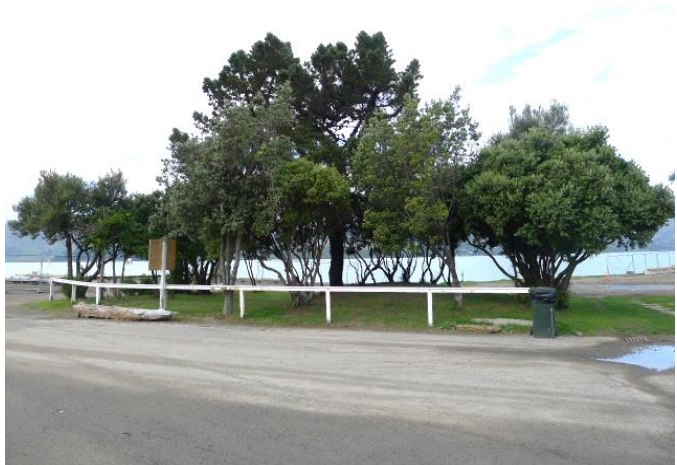
The condition of the majority of trees/shrubs within the groups was assessed as fair (average), but some were assessed as poor due to poor health or structural integrity.

Figure 6: Example of trees and shrubs near the Boat Ramp.
