HORNBY LIBRARY, SERVICE CENTRE AND SW LEISURE CENTRE KYLE PARK

Landscape and Visual Assessment

Kyle Park Tree Survey

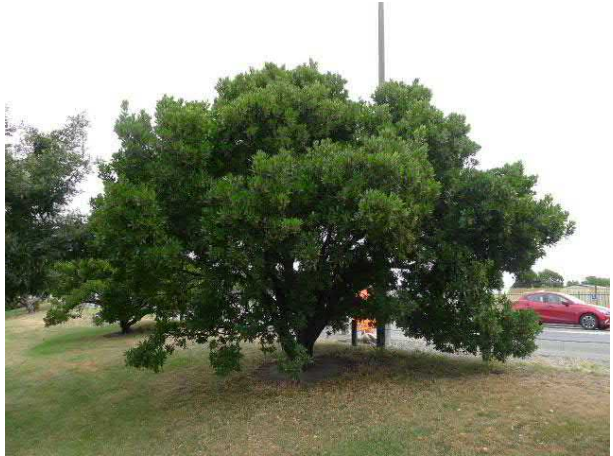
01 - 93361

Survey Number	Tree ID	Species	Common Name	Height	Canopy Spread	DBH	Tree Health	Tree Form	Overall Condition	Comments
1	93361	Arbutus unedo	Irish Strawberry Tree	3.0	5.0	0.30	2	3	3	Reasonably good foliage density, broken branch stub on southern side. Multiple stems near base, and canopy to near ground level.
2	93356	Arbutus unedo	Irish Strawberry Tree	5.0	7.0	0.35	2	3	3	Reasonably good foliage density, previous branch failures on western side. Multiple stems near base, and canopy to near ground level.
3	93360	Quercus cerris	Turkey Oak	6.0	7.0	0.2	2	3	3	Previous branch failures, and extensive decay.
4	93354	Arbutus unedo	Irish Strawberry Tree	4.0	5.0	0.3	2	3	3	Reasonably good foliage density, previous branch failures on the south-western side. Multiple stems near base, and canopy to near ground level.
5	93355	Arbutus unedo	Irish Strawberry Tree	5.0	6.0	0.45	2	3	3	Reasonably good foliage density. Multiple stems near base, and canopy to near ground level.

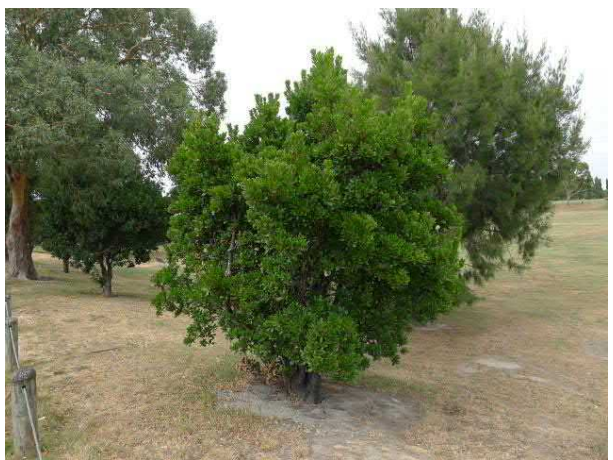
06 - 93359

6	93359	Arbutus unedo	Irish Strawberry Tree	4.0	3.0	0.3	3	3	3	Areas of isolated dieback, with less than 30% foliage density loss overall. Previous branch failures on the south-western side.
7	93365	Casuarina cunninghamiana	She Oak	9.0	9.0	0.35	3	3	3	Slightly sparse crown density, and previous branch failures.
8	93368	Casuarina cunninghamiana	She Oak	8.0	9.0	0.3	3	3	3	Slightly sparse crown density, and previous branch failures.
9	93364	Arbutus unedo	Irish Strawberry Tree	4.0	4.0	0.18	3	4	4	Slightly sparse foliage density, less than 30% foliage density loss overall. Included unions and previous structural failures. Further structural failures likely.

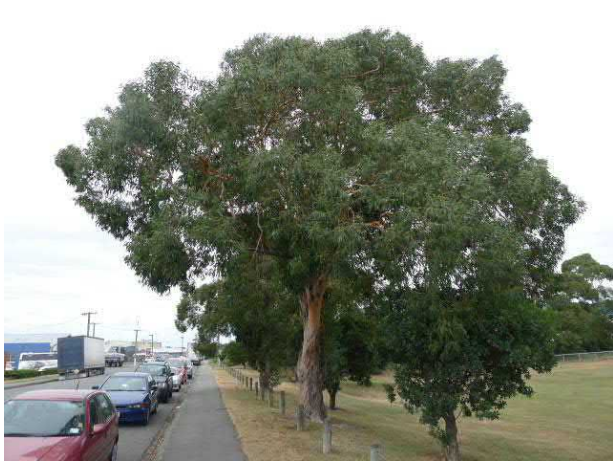
10 - 93367

Survey Number	Tree ID	Species	Common Name	Height	Canopy Spread	DBH	Tree Health	Tree Form	Overall Condition	Comments
10	93367	Eucalyptus gunnii	Cider Gum	10.0	14.0	0.8	2	3	3	Reasonably good foliage density, no significant structural defects. One dead branch over footpath.
11	93369	Arbutus unedo	Irish Strawberry Tree	3.5	4.0	0.2	3	3	3	Slightly sparse crown density, and previous branch failures.
12	93371	Eucalyptus gunnii	Cider Gum	7.0	8.0	0.4	2	3	3	Reasonably good foliage density, and minor deadwood. No significant structural defects.
13	93375	Arbutus unedo	Irish Strawberry Tree	3.0	4.0	0.2	2	3	3	Reasonably good foliage density. Previous branch failures on the south-western side.
14	93376	Quercus cerris	Turkey Oak	5.0	5.0	0.18	2	3	3	Reasonably good foliage density. Previous branch failures on the eastern side. Squat form due to crown suppression.
15	93377	Eucalyptus delegatensis	Alpine Ash	12.0	12.0	0.9	2	4	4	Three stems originating from the tree base with included unions. Decay present within the main stems. Multiple previous branch failures, further structural failures likely.

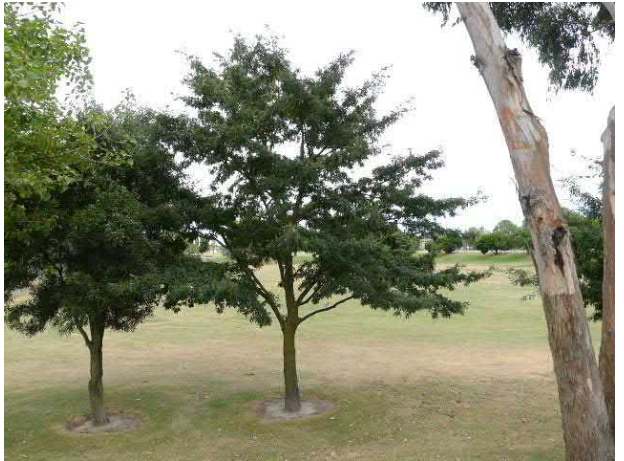
16 - 93380

16	93380	Quercus cerris	Turkey Oak	8.0	8.0	0.28	2	3	3	Reasonably good foliage density. No significant structural defects. Minor mower damage to base.
17	93381	Acacia melanoxylon	Tasmanian Blackwood	7.0	6.0	0.2	2	3	3	Reasonably good foliage density. Included unions, and partial suppression.
18	93382	Populus nigra	Black Poplar	12.0	12.0	0.38	4	4	4	Sparse crown, more than 30% decline.
19	93385	Arbutus unedo	Irish Strawberry Tree	3.5	3.5	0.2	2	3	3	Reasonably good foliage density. Multiple stems near base, canopy to near ground level.
20	93384	Cedrus atlantica	Atlas Cedar	6.0	6.0	0.2	2	3	3	Reasonably good foliage density. Asymmetrical form. Minor bark wound, but no significant structural defects.

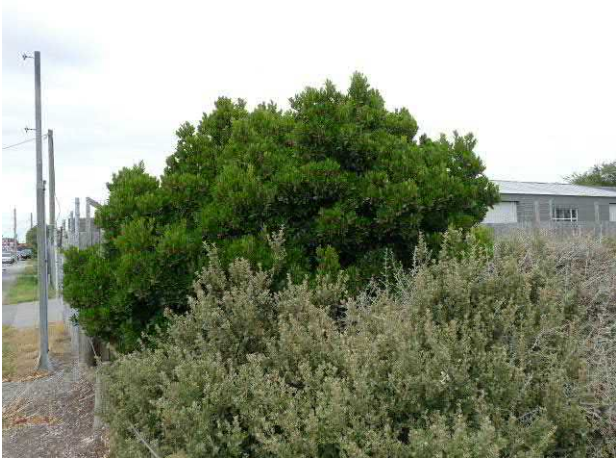
21 - 93391

Survey Number	Tree ID	Species	Common Name	Height	Canopy Spread	DBH	Tree Health	Tree Form	Overall Condition	Comments
21	93391	Arbutus unedo	Irish Strawberry Tree	4.0	6.5	0.25	2	3	3	Reasonably good foliage density. Multiple stems near base, and canopy to near ground level.
22	93387	Cedrus atlantica	Atlas Cedar	9.5	6.0	0.3	2	2	2	Reasonably good condition.
23	93390	Cedrus atlantica Glauca	Blue Atlas Cedar	5.5	6.0	0.18	2	3	3	Reasonably good foliage density. Asymmetrical form. No significant structural defects.
24	93389	Cedrus atlantica Glauca	Blue Atlas Cedar	5.5	5.0	0.18	2	4	4	Reasonably good foliage density. Asymmetrical form. A large bark wound at the tree base on the eastern side, but no significant structural defects.
25	93393	Populus nigra Italica	Lombardy Poplar	9.5	2.0	0.18	2	2	2	Reasonably good foliage density. No significant structural defects.
26	93392	Quercus robur	English Oak	9.5	8.0	0.2	2	2	2	Reasonably good foliage density. No significant structural defects.

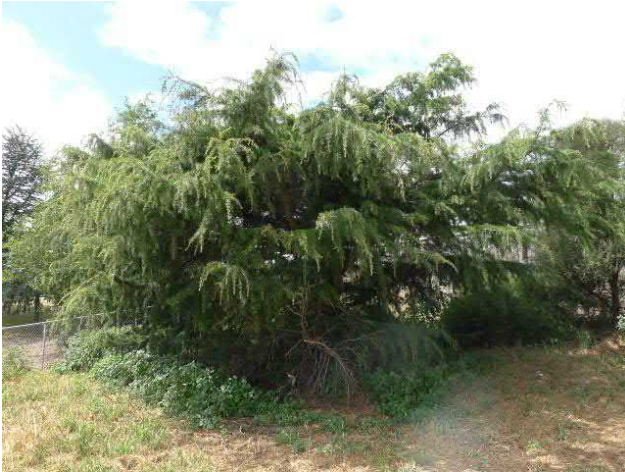
27 - 93395

93394	Quercus cerris	Turkey Oak							No tree.
27	93395	Cedrus deodara	Deodar Cedar	5.0	11.0	0.35	2	3	3	Reasonably good foliage density. Multiple stems from near ground level, and canopy to ground. No apical dominance. No significant structural defects.
28	93402	Casuarina cunninghamiana	She Oak	7.5	7.0	0.2	2	3	3	Reasonably good foliage density. Asymmetrical from. No significant structural defects.
29	93399	Casuarina cunninghamiana	She Oak	8.5	7.5	0.3	2	3	3	Reasonably good foliage density. Asymmetrical from. No significant structural defects.
30	93404	Casuarina cunninghamiana	She Oak	7.0	7.0	0.3	2	3	3	Reasonably good foliage density. Crown suppression, and asymmetrical from. No significant structural defects.

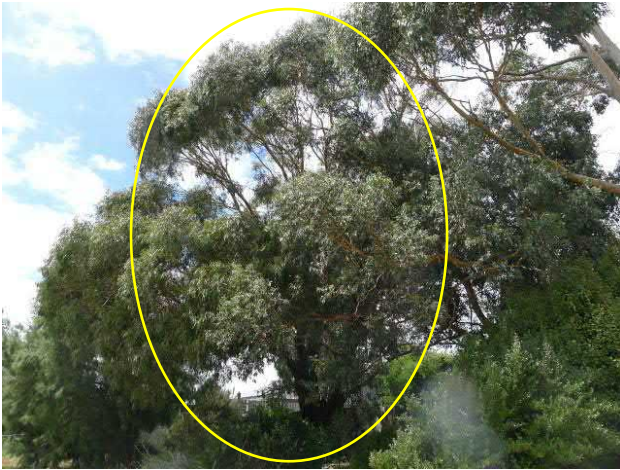
31 - 93412

Survey Number	Tree ID	Species	Common Name	Height	Canopy Spread	DBH	Tree Health	Tree Form	Overall Condition	Comments
31	93412	Eucalyptus nicholii	Narrow-leaved Black Peppermint Gum	15.0	13.0	1.3	4	4	4	More than 30% decline. Potential for structural failures.
32	93416	Eucalyptus	Gum	13.0	12.0	0.4	4	4	4	Dieback in central leader, more than 30% decline.
33	93418	Eucalyptus saligna	Sydney Blue Gum	18.0	12.0	0.6	3	4	4	A large trunk wound from 1.5-3.5m above ground level, possible decay present. Canopy imbalance.
	93419	Eucalyptus nicholii	Narrow-leaved Black Peppermint Gum							Stump regrowth.
34	93423	Eucalyptus	Gum	16.0	8.0	0.7	4	4	4	Decline in central leader, more than 30% decline. Significant suppression on the southern side.
35	93425	Eucalyptus nicholii	Narrow-leaved Black Peppermint Gum	22.0	25.0	2.3	3	4	4	Five main stems originating from near ground level. Included stem and branch unions. Previous large stem failures and the potential for further significant structural failures.

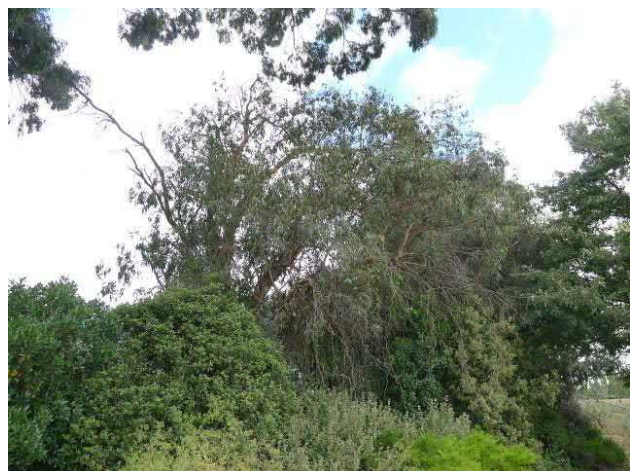
36 - 93427

36	93427	Eucalyptus	Gum	9.0	8.0	0.6	4	4	4	More than 30% decline. Multiple stems from 1m.
37	93428	Eucalyptus	Gum	10.0	11.0	0.7	4	3	4	Canopy becoming sparse, with possibly more than 30% foliage density loss. No significant structural defects.
38	93429	Quercus cerris	Turkey Oak	10.0	11.0	0.45	2	3	3	Reasonably good foliage density, included branch unions.
39	93430	Fraxinus americana	White Ash	6.5	9.0	0.2	2	3	3	Reasonably good foliage density. Multiple stems from 1.0m. Minor bark wound at the base and on one stem. No significant structural defects.

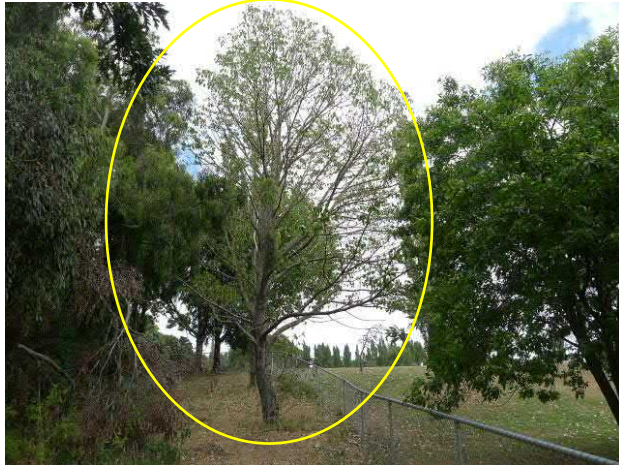
40 - 93432

Survey Number	Tree ID	Species	Common Name	Height	Canopy Spread	DBH	Tree Health	Tree Form	Overall Condition	Comments
40	93432	Populus yunnanensis	Chinese Poplar	10.5	14.0	0.35	5	4	5	More than 70% decline.
41	93434	Eucalyptus	Gum	10.5	16.0	0.1	3	4	4	Isolated dieback, currently less than 30% of the canopy affected. Co-dominant near base. Previous and recent structural failures and further failures likely.
42	93437	Populus Italica nigra	Lombardy Poplar	11.5	2.5	0.25	4	3	4	More than 30% decline, but no significant structural defects.
43	93435	Eucalyptus	Gum	10.0	14.0	0.6	3	4	4	Foliage density becoming sparse on the southern side, currently less than 30% of the canopy affected. Co-dominant near base, with included unions. Previous structural failures, and further failures likely.
44	93436	Populus Italica nigra	Lombardy Poplar	4.5	0.5	0.1	5	5	5	Dead tree.
45	93442	Cedrus libani	Cedar of Lebanon	10.0	7.5	0.3	2	3	3	Reasonably good foliage density. Co-dominant from 4.0m with included unions.

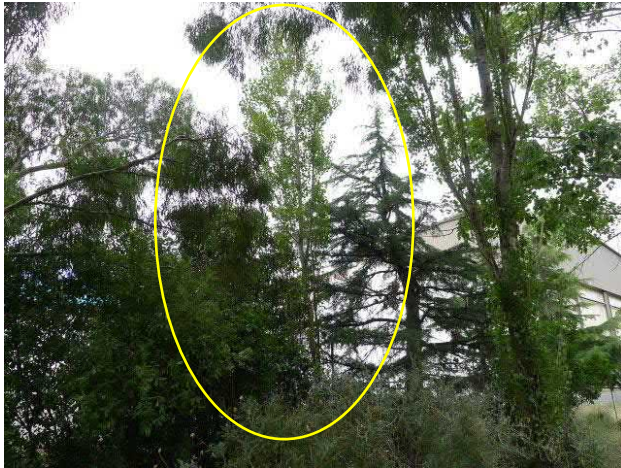
46 - 46

46	46	Populus Italica nigra	Lombardy Poplar	8.0	2.0	0.1	3	3	3	Partial suppression, but fair condition overall.
47	93445	Populus Italica nigra	Lombardy Poplar	12.0	4.0	0.3	3	3	3	Sparse mid canopy. Basal wound on the western side, with possible decay. No significant structural defects.
48	93446	Cedrus deodara	Deodar Cedar	8.0	8.0	0.35	3	3	3	Slightly sparse lower canopy. Asymmetrical form due to suppression. No significant structural defects.
49	93447	Cedrus deodara	Deodar Cedar	5.5	4.0	0.18	3	3	3	Slightly sparse lower canopy. Asymmetrical form due to suppression. No significant structural defects.

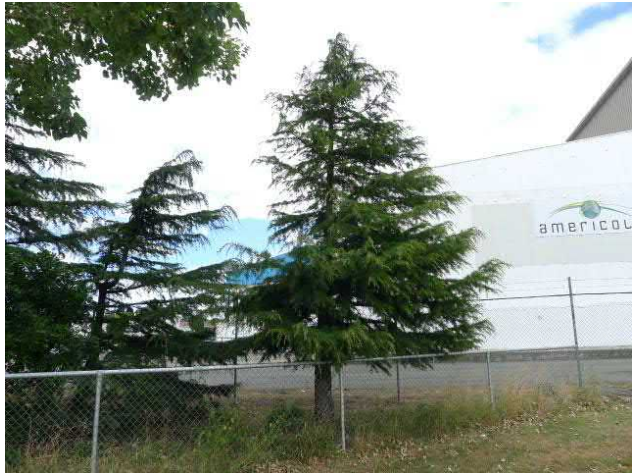
50 - 93448

Survey Number	Tree ID	Species	Common Name	Height	Canopy Spread	DBH	Tree Health	Tree Form	Overall Condition	Comments
50	93448	Cedrus deodara	Deodar Cedar	8.0	5.0	0.25	2	3	3	Some suppression on the north-western side of the canopy. No significant structural defects.
51	93444	Populus nigra	Black Poplar	14.5	11.0	0.45	3	3	3	Slightly sparse foliage density, currently less than 30% foliage density loss. Minor deadwood. Previous branch failures.
52	93443	Populus yunnanensis	Chinese Poplar	14.5	9.0	0.4	2	3	3	Reasonably good foliage density. Co-dominant from 2.0m with included unions.
53	93441	Cedrus Glauca atlantica	Blue Atlas Cedar	2.0	2.5	0.08	5	4	5	Small, stunted tree in very poor condition due to lack of live growth, a large bark wound at the trunk base, and multiple previous branch failures.
54	93439	Populus Italica nigra	Lombardy Poplar	13.0	2.0	0.18	3	3	3	Reasonably good foliage density, slight yellowing of leaves. No significant structural defects.

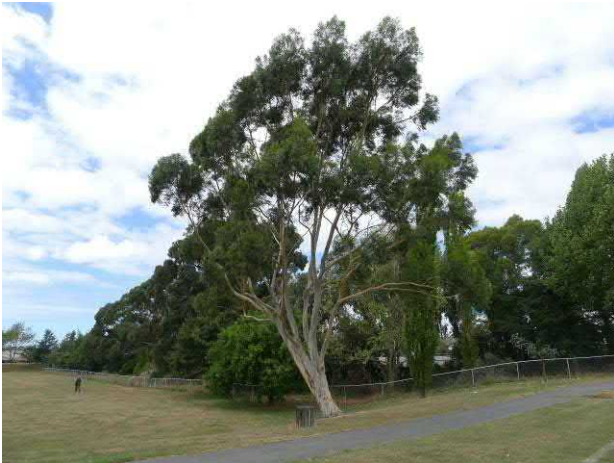
55 - 93440

55	93440	Eucalyptus pulchella	White Peppermint Gum	11.0	10.0	0.55	3	4	4	Slightly sparse foliage density, but less than 30% decline. Multiple stems at 1.5m, and multiple included unions in main trunk and scaffold branches.
56	93426	Populus Italica nigra	Lombardy Poplar	11.0	2.5	0.3	2	3	3	Reasonably good foliage density. One-sided crown due to lateral suppression from an adjacent tree, but no significant structural defects.
57	93421	Cedrus Glauca atlantica	Blue Atlas Cedar	5.0	8.0	0.25	3	3	3	Slightly sparse foliage density, but less than 30% decline. A minor bark wound on lower trunk, but no significant structural defects.
58	93424	Populus Italica nigra	Lombardy Poplar	11.0	3.0	0.3	2	3	3	Reasonably good foliage density. One-sided crown due to lateral suppression from an adjacent tree, but no significant structural defects.

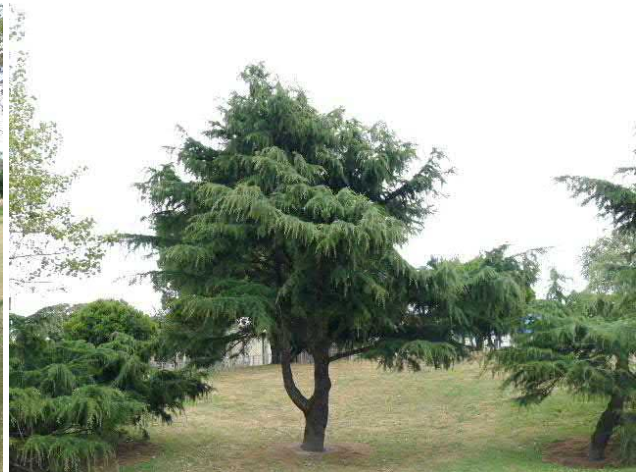
64 - 93406

64	93406	Cedrus atlantica	Atlas Cedar	7.0	10.0	0.35	2	3	3	Reasonably good foliage density. Multiple recent branch failures on the western side of the canopy.
65	93403	Cedrus atlantica	Atlas Cedar	3.5	5.0	0.2	3	4	4	Reasonably good foliage density. Central leader lost some time ago, and heavily suppressed by adjacent trees. Multiple previous branch failures.
66	93401	Cedrus atlantica	Atlas Cedar	6.0	8.0	0.4	2	3	3	Reasonably good foliage density. Asymmetrical form. No significant structural defects, but multiple branch failures in the lower crown.
67	67	Arbutus unedo	Irish Strawberry Tree	3.5	6.0	0.5	2	3	3	Reasonably good foliage density. Multiple stems from base, and canopy to near ground level. Broken branch stub on western side.
