Kyle Park
Geotechnical Assessment Report

Prepared for
Christchurch City Council

Prepared by
Tonkin & Taylor Ltd

Date
November 2018

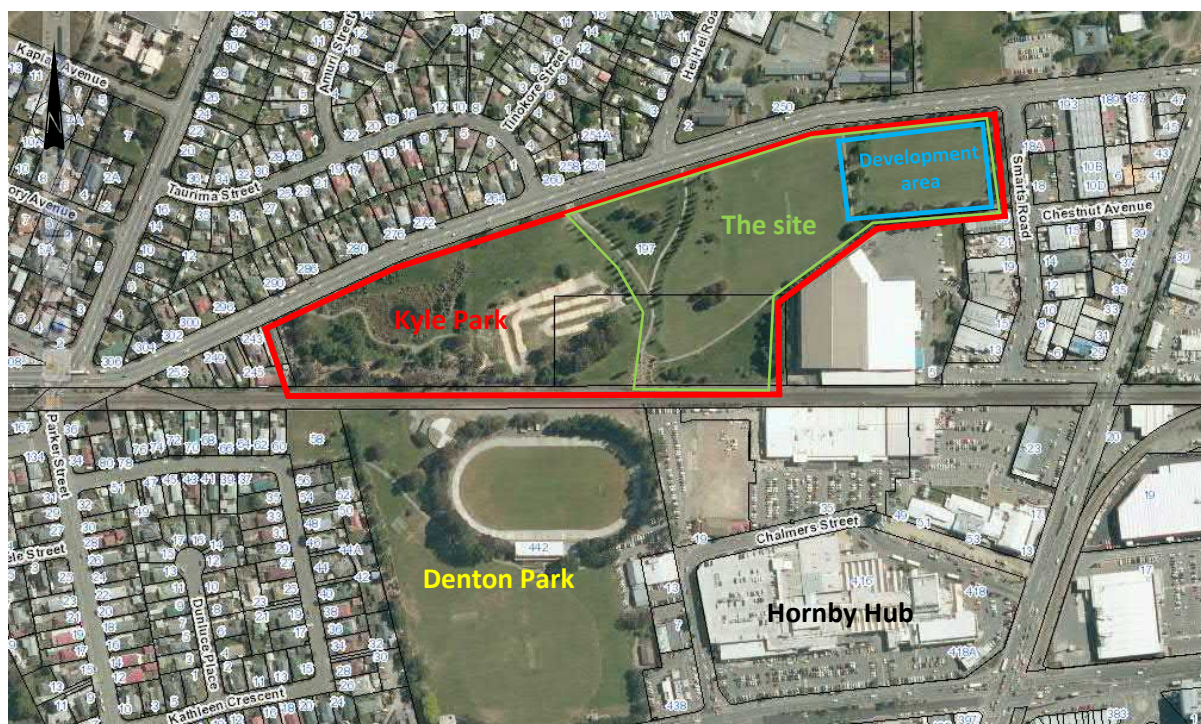
Figure 1 – Kyle Park location (source - <https://apps.canterburymaps.govt.nz/CanterburyHistoricAerialImagery/>).

CCC is considering developing the Centre on the eastern part of Kyle Park, with a preferred option being the eastern corner of the site, within the development area identified on Figure 1 (below), which identifies the following areas referred to in this report:

- Kyle Park – red polygon below.
- The *site* (i.e. subject of this investigation and assessment) – green polygon below.
- The *development area* (i.e. preferred location for the centre) – blue polygon below.

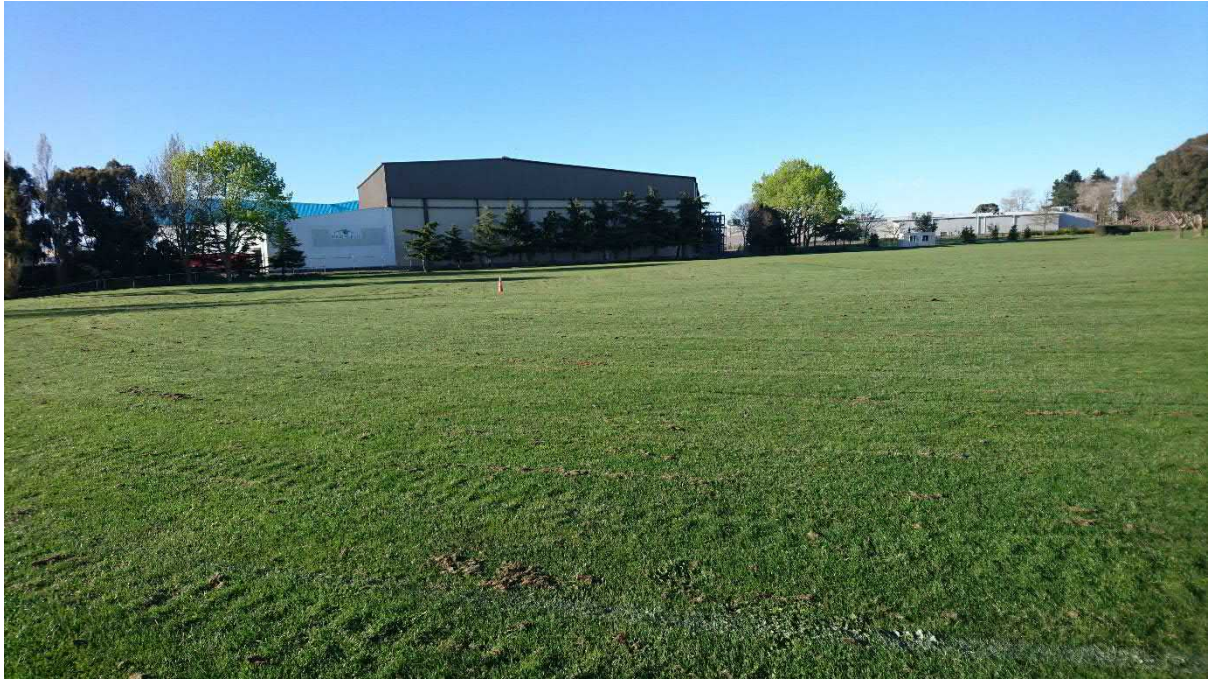
Photograph 1 –centre of the site looking south-west.

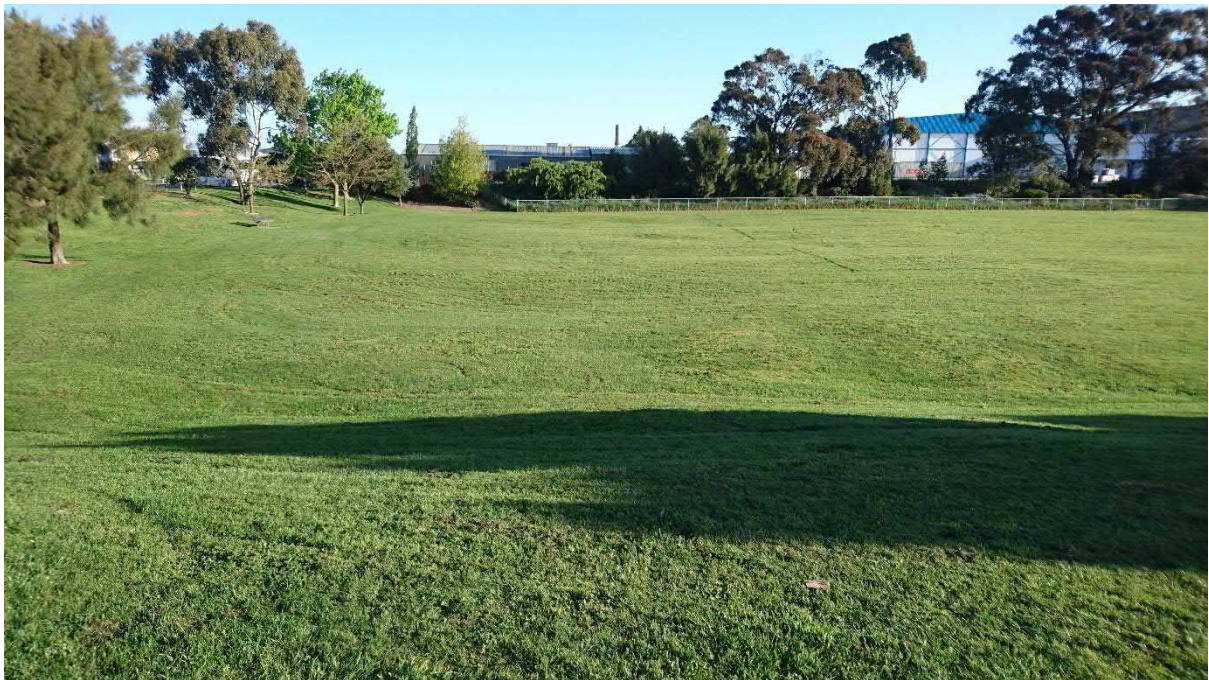
Photograph 2 – development area looking easterly (Waterloo Road left of frame).

The central area of the site is relatively flat and lies at an elevation of approximately 30 mLVD. The stormwater retention pond lies at approximately 27 mLVD, while the eastern end of the site lies at approximately 28 mLVD. The stormwater retention pond is bounded to the west and south by a raised embankment walkway, and to the north and east by grassed embankments (refer Photograph 1 in Appendix A). Generally, the site boundaries along Waterloo Road, Smarts Road and the rail lines comprise grassed embankments (Photograph 2, Appendix A).

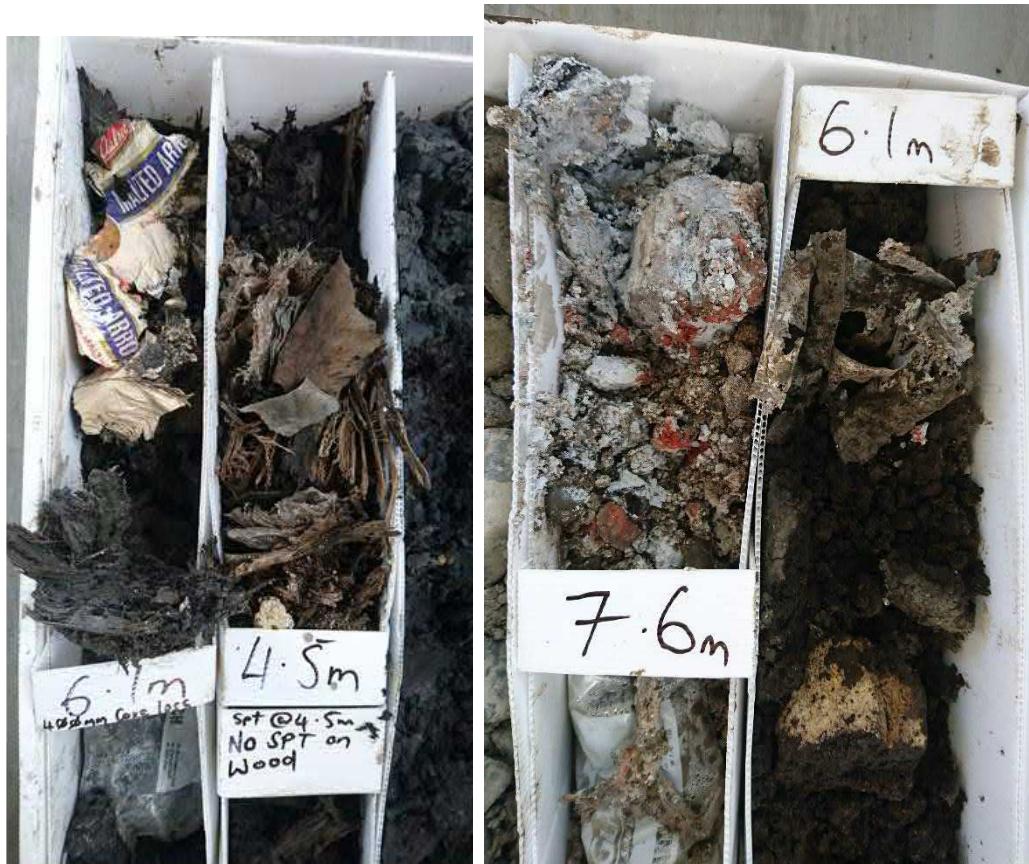
Photograph 4 – examples of landfill materials.

Photographs 3 to 6 inclusive (Appendix B) illustrate some of the landfill materials observed and sampled across the site. In some instances it was noted that the vegetative/organic content of the landfill materials was high, in the approximate order of 50% by volume of material sampled.

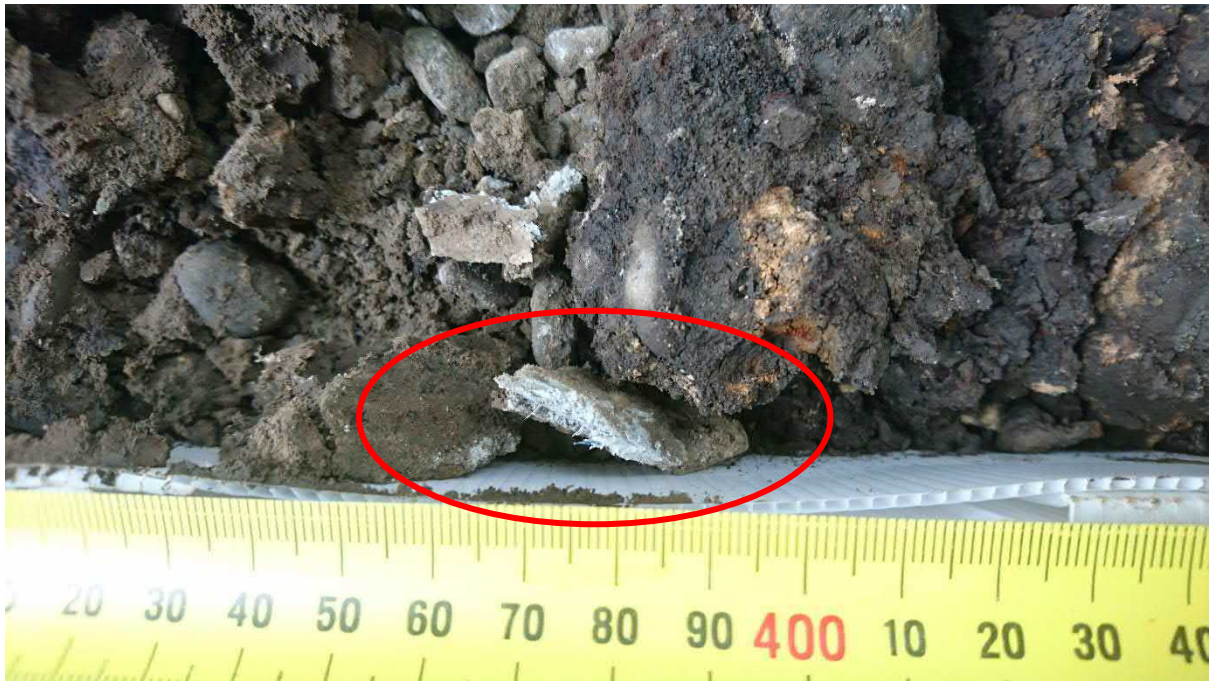
Photograph 5 – example of asbestos containing material (cement board materials) (Borehole 111 at 0.7 m bgl).
