**Ground Contamination
Assessment - Kyle Park,
Hornby**

Prepared for
Christchurch City Council

Prepared by
Tonkin & Taylor Ltd

Date
November 2018

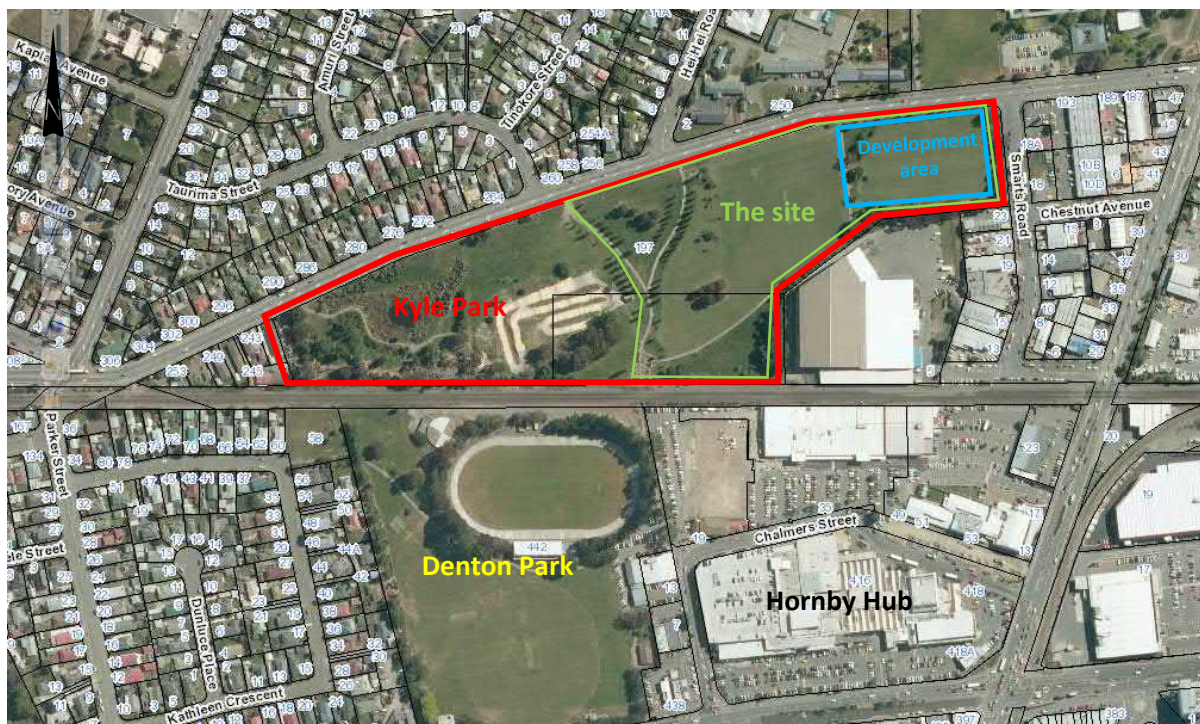
Figure 1 – Kyle Park location (source Canterbury maps - <https://apps.canterburymaps.govt.nz/CanterburyHistoricAerialImagery/>)

- Kyle Park – red polygon below.
- The *site* (i.e. subject of this investigation and assessment) – green polygon below.
- The *development area* (i.e. preferred location for the centre) – blue polygon below.

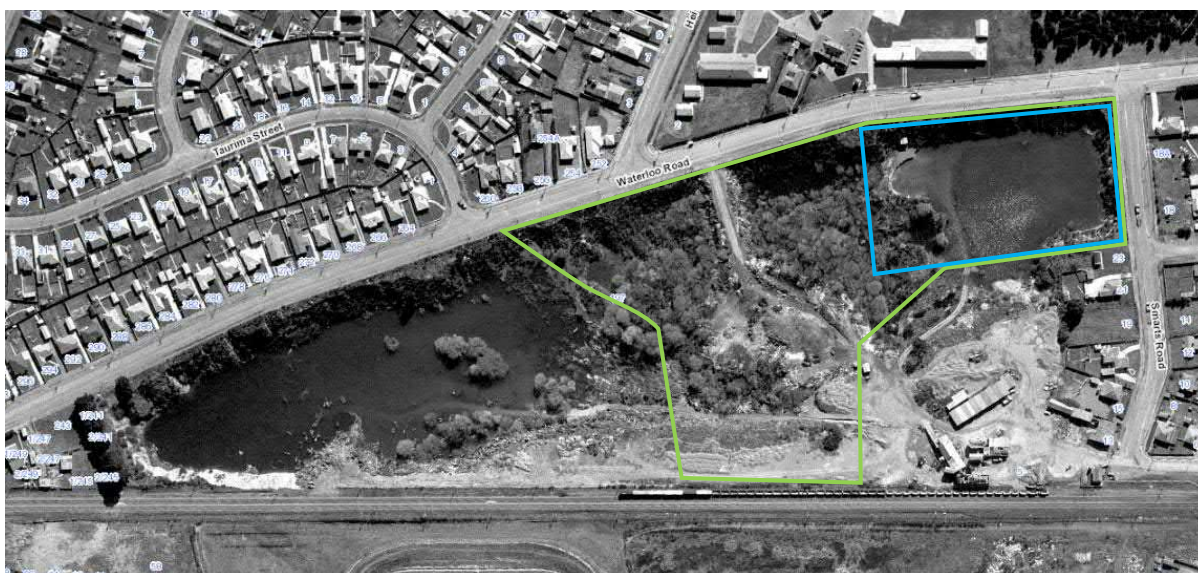
Photograph 1 – early 1960s aerial photograph of Kyle Park– approximate site and development areas shown in green and blue polygons, respectively (source <https://apps.canterburymaps.govt.nz/CanterburyHistoricAerialImagery/>).

Historical aerial photographs⁶ of the site show the quarry workings expanding in area from the first available photograph from the early 1940s until the early 1960s when it was then progressively infilled into the mid-1970s (i.e. corroborating the ownership and land use information discussed above). Observation of the 1950s and early 1960s aerial photographs (see Photograph 1 below) identifies areas of water within the base of the pit, which suggests that excavation ceased at around the depth when groundwater was encountered. After infilling ceased some regrading/capping of the site occurred and photographs from the early 1980s onwards show much of Kyle Park as at the present day.

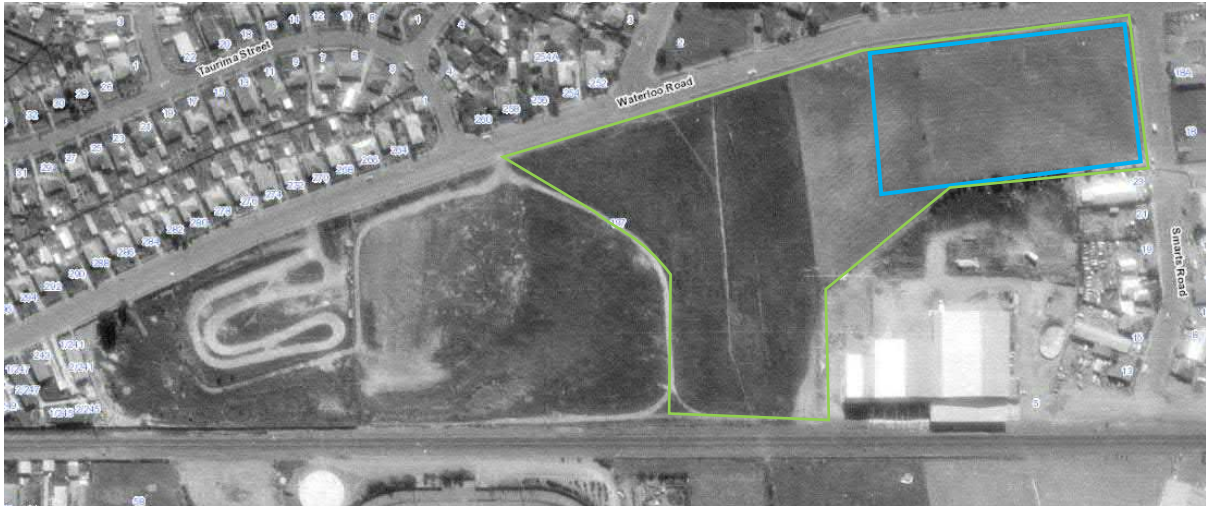
Photograph 2 – early 1980s aerial photograph of Kyle Park – approximate site and development areas shown in green and blue polygons respectively (source <https://apps.canterburymaps.govt.nz/CanterburyHistoricAerialImagery/>).

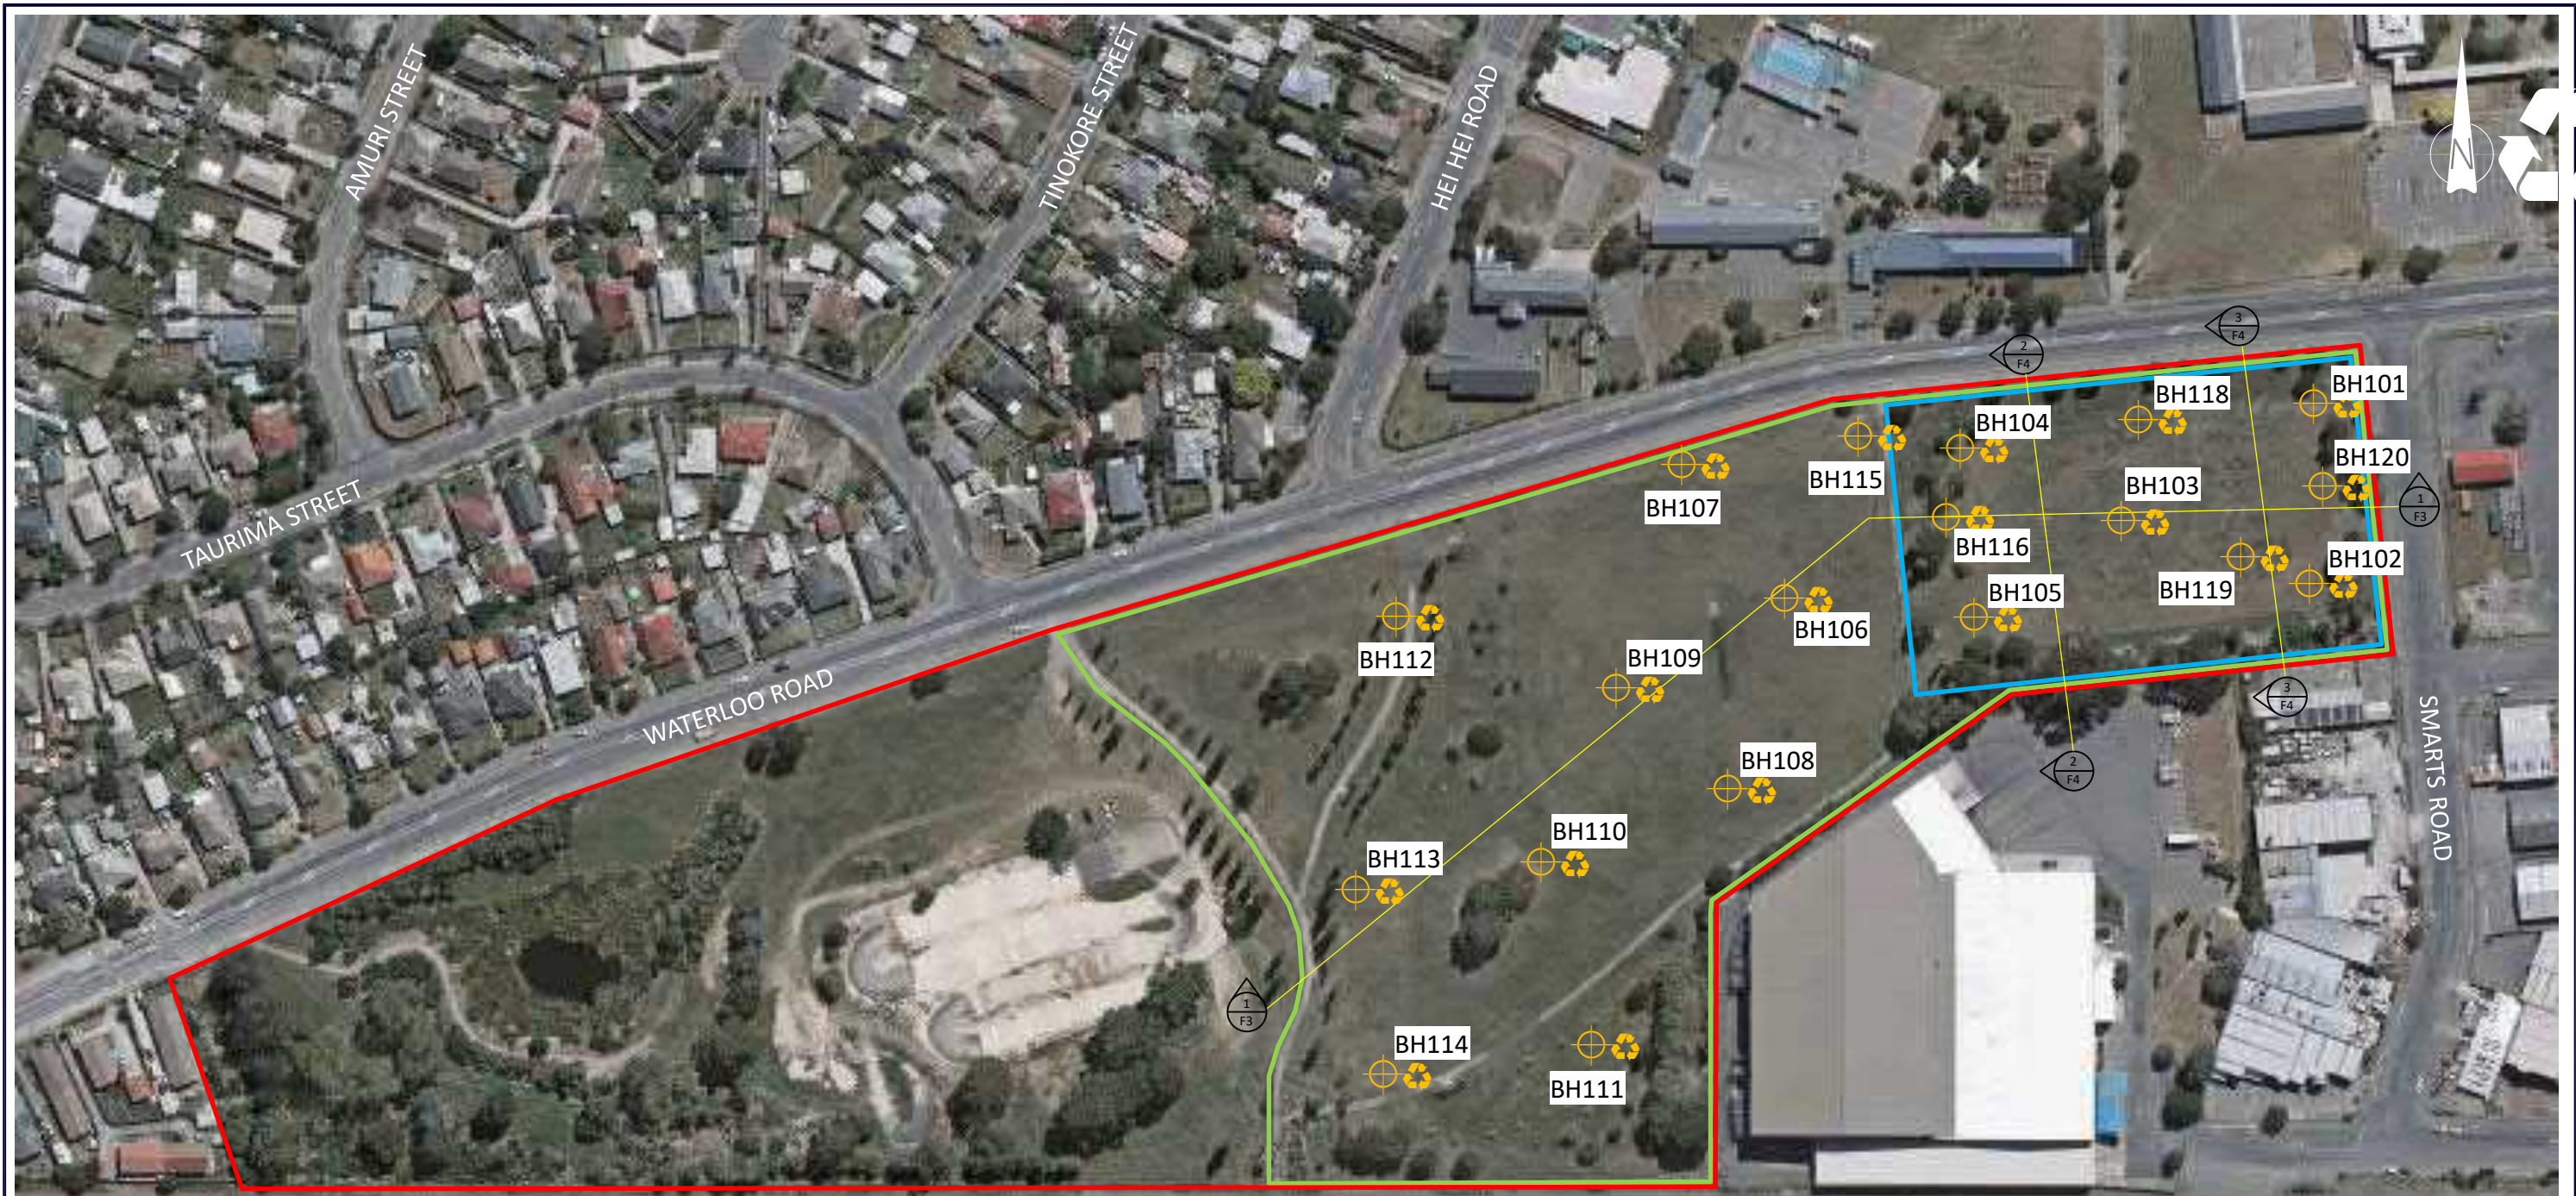
CHRISTCHURCH CITY COUNCIL
KYLE PARK
WATERLOO ROAD, HORNBY
INVESTIGATION LOCATION PLAN

- BH101 Borehole investigation location
- Development area
- Site boundary
- Kyle Park property boundary
- Cross section transects
