Christchurch City Council

New Brighton Road Bus Stop Improvements

Scheme Safety Audit

December 2020

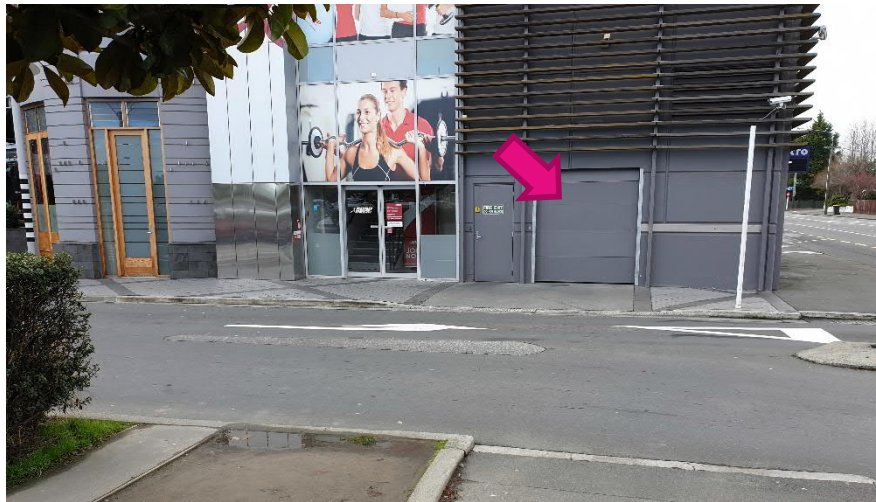
2.1.2 Storage access at pedestrian crossing – Moderate

While on site the SAT noted the eastern crossing point of the appears to be used as a driveway or access for a garage or storage unit. It is unclear how often this is used, but there is an increased risk for conflict due to the higher volume of pedestrians around the shopping centre access and pedestrian crossing.

Recommendations	Confirm garage access is in the appropriate location. Consider treatments such as tactile pavers to warn pedestrians of the hazard
Designers Response	Noted. The access and pedestrian crossing point is located within The Palms. The Palms centre management advised that the access is used for wheelie bins pick up only for nearby businesses. The bins are usually picked up outside the mall operating hours. No tactile pavers to be added to warn pedestrians of the access.
Auditors Comment	No further comment.
Safety Engineer	Designer response noted and accepted
Clients Response	Responses noted and accepted
Action Completed	Yes, no further action required.

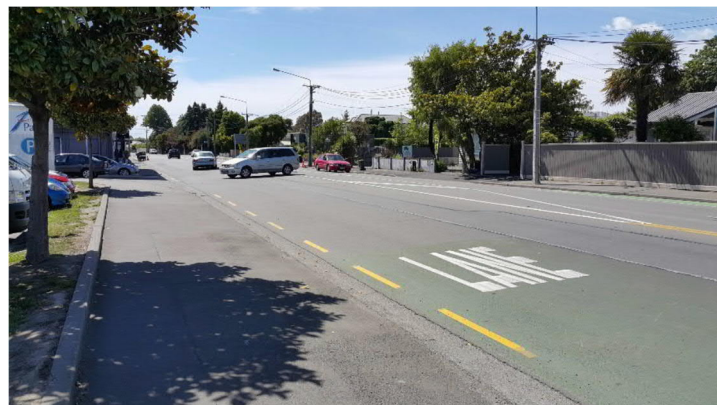
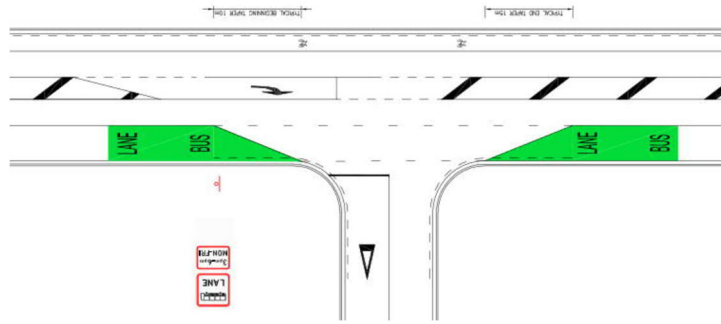
2.1.3 Bus lane – Minor

While on site the SAT noted the bus lane being used for the majority of its length from Marshland Road as a left turn lane by vehicles travelling east on New Brighton Road turning into The Palms shopping centre. This can result in conflict at the entranceway as the bus line marking is unclear.

Recommendations	Consider installing intersection markings to delineate start and end of bus lane around access way to shopping centre
Designers Response	Agreed. The Palm access is not a legal road but the intersection markings for bus lane could be added to highlight the access to approaching motorists.
Auditors Comment	No further comment.
Safety Engineer	Designer response noted and accepted
Clients Response	Responses noted and accepted
Action Completed	Yes

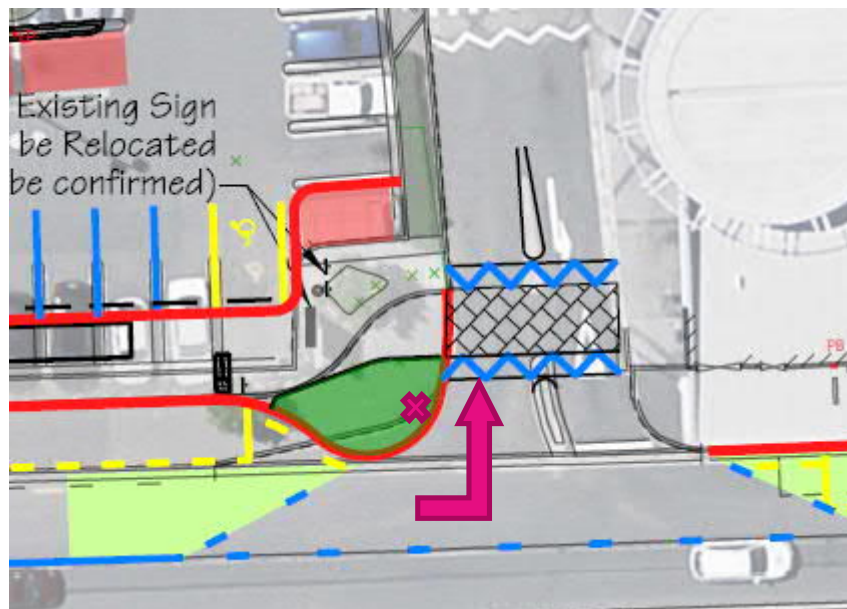
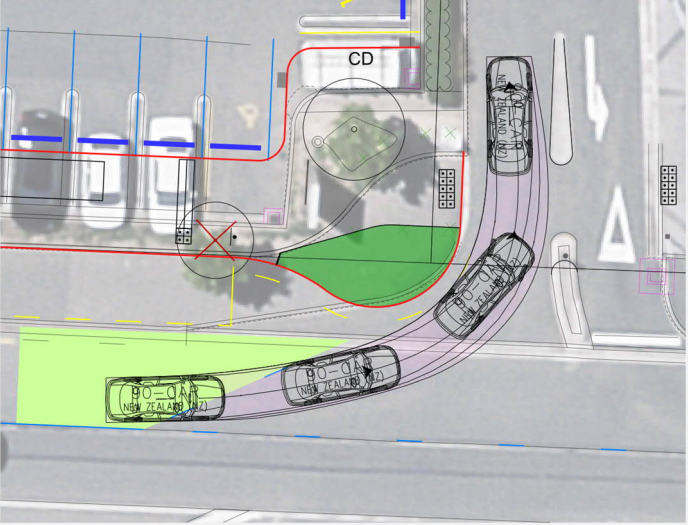
2.1.4 Vehicle tracking at entrance - Minor

While on site the SAT noticed that vehicles often clip the kerb when entering The Palms. With the new buildout extending further out towards the road the likelihood of a vehicle clipping the kerb could increase.

It is acknowledge however that tracking has not been provided.

Recommendations	Confirm vehicle tracking is appropriate
Designers Response	<p>Noted. Vehicle tracking has been undertaken with 90 percentile NZ car turning into The Palms. The turning path shows that car is able to enter The Palms without mounting the kerb. The proposed kerb will be kerb only (CSS SD602) to deter motorists from mounting it and encourage motorists to slow down when entering The Palms access.</p>

Auditors Comment	No further comment.
Safety Engineer	Designer response noted and accepted. New kerb alignment has more consistent radius, and requires drivers to take a higher entry angle, therefore less likely to clip kerb.
Clients Response	Responses noted and accepted
Action Completed	Yes, no further action required.

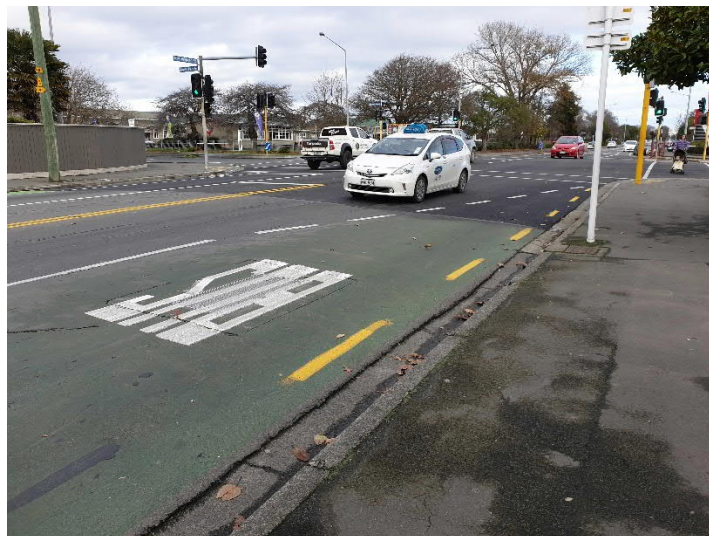
2.1.5 Pavement surfacing – Minor

While on site the SAT noted that the bus lane pavement markings are faded and have not been remarked after a recent reseal.

Recommendations	Remark bus lane pavement with green paint to help delineated the bus lane
Designers Response	Agreed. The bus lane markings are to be remarked. The pavement along the bus lane is proposed to be reshaped as part of the project.
Auditors Comment	No further comment.
Safety Engineer	Designer response noted and accepted
Clients Response	Responses noted and accepted
Action Completed	Yes, the remarking of the bus lane is to be included in detailed design

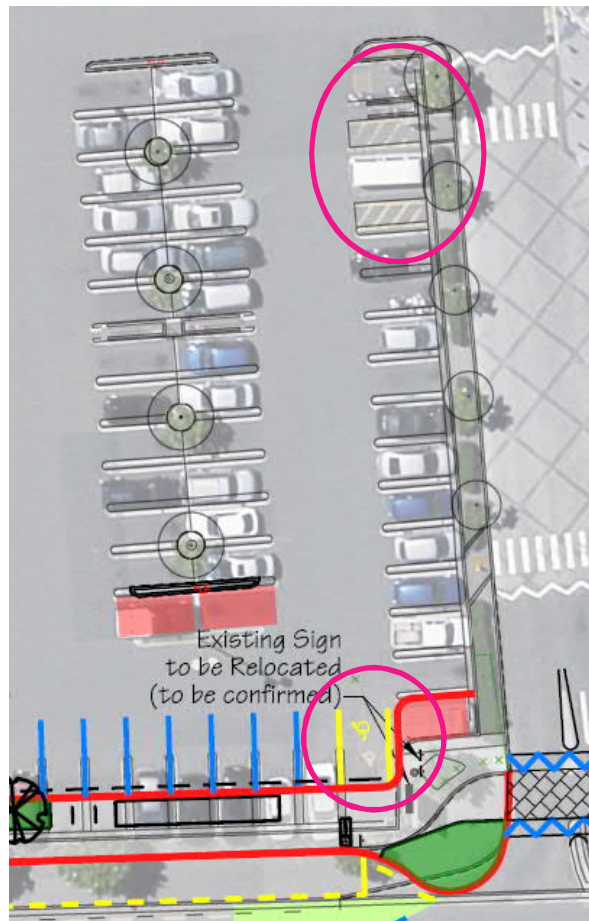
2.1.6 Parking dimensions – Comment

The SAT note that dimensions for the parking spaces have not been provided so cannot assess whether they are appropriate width and length. It is noted however that the mobility parking space provided does not match the existing mobility parks located within the car park

Recommendations	Consider providing extra width for safe entry and exit out of vehicle by matching the line marking of existing mobility parking.
Designers Response	Noted. The width of the proposed mobility parking is 3.6m wide (to the new kerb) and 5m long. This width meets the requirements for NZ Standards for mobility parking. The existing mobility parking space is 3.5m wide with 1.4m shared space more than the current requirements. We are unable to provide additional width to the proposed mobility parking to match existing without further loss of parking. We had a loss of six parking spaces with the current proposal. We proposed to mark the mobility parking with 2.5m stall width and 1.1 shared space to match the line marking of the existing mobility parking.
Auditors Comment	No further comment.
Safety Engineer	Designer response noted and accepted
Clients Response	Responses noted and accepted

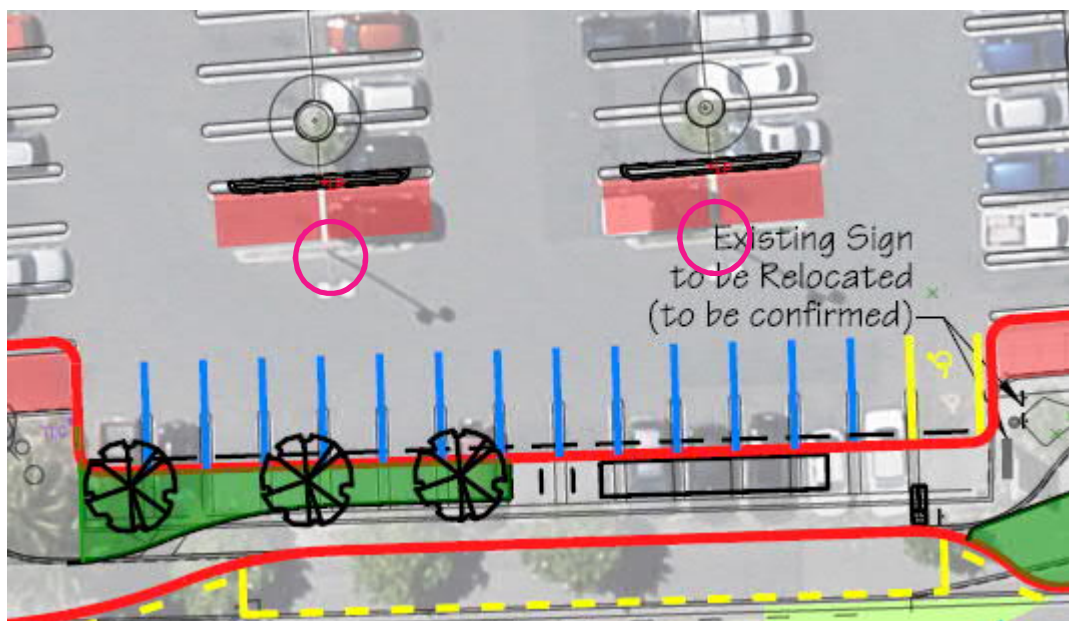
2.1.7 Light pole – Comment

The SAT note that the existing light poles will have to be removed/relocated. It is assumed this will be picked up in detailed design / lighting plans.

Recommendations	Confirm relocation/removal of existing light poles
Designers Response	The two existing light poles are to be relocated. The lighting designer recommended to relocate them to maintain the lighting level in the carpark.
Auditors Comment	No further comment.
Safety Engineer	Designer response noted and accepted
Clients Response	Responses noted and accepted.
Action Completed	Yes, the relocation of lighting poles is to be included in detailed design
