IN THE MATTER Of Resource Consent Application RMA/2020/2852 for the Canterbury Museum Trust Board for a comprehensive redevelopment of the Canterbury Museum complex including the Robert McDougall Art Gallery

EVIDENCE OF MR JAMES (JIM) GARD'NER ON BEHALF OF THE CANTERBURY MUSEUM TRUST BOARD

Dated 25 MAY 2021

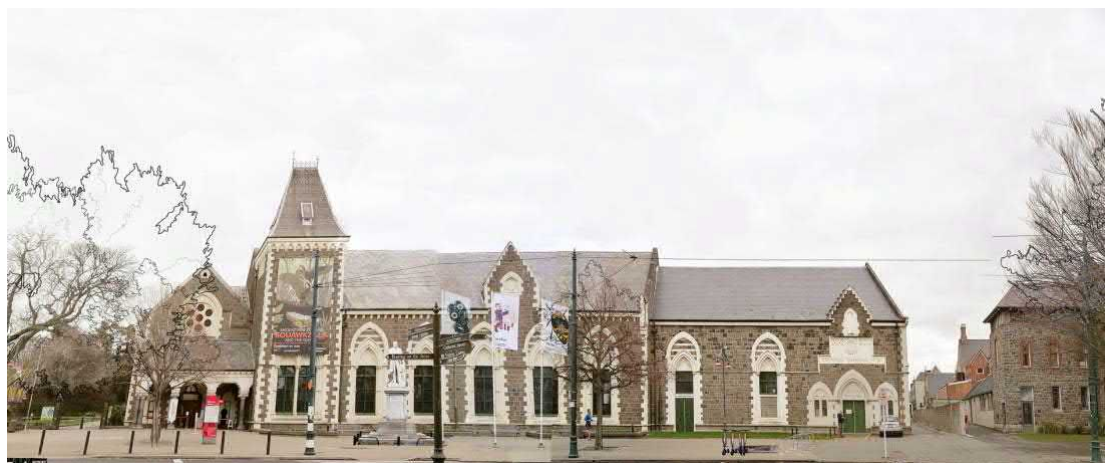
Figure 10. Composite image of the Rolleston Avenue (east) elevation of the Canterbury Museum showing the 1878 porch and the facades of the 1877 building and 1958 Centennial Wing (Source: Athfield Architects)

- 30 The entry portico to Canterbury Museum was constructed between the two wings of the 1877 building in 1878. It remains the principal entrance to the Museum. It has a slate roof, along with a pediment, column capitals and facings of Oamaru limestone. Hoon Hay basalt has been used for the supporting columns and their bases.

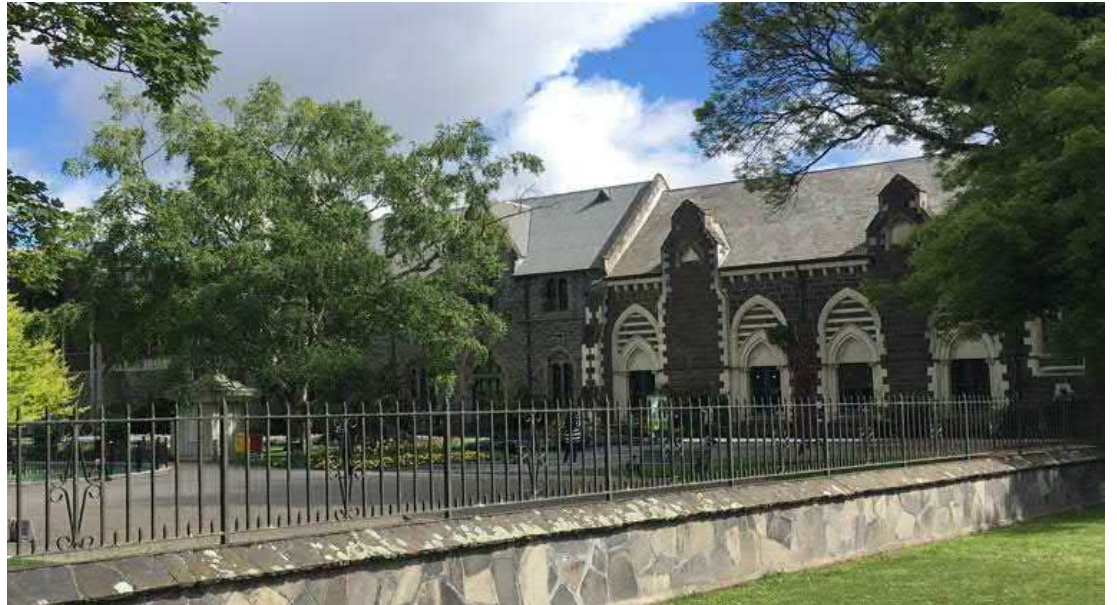
Figure 11. South elevation of the Canterbury Museum (Source: GJM Heritage)

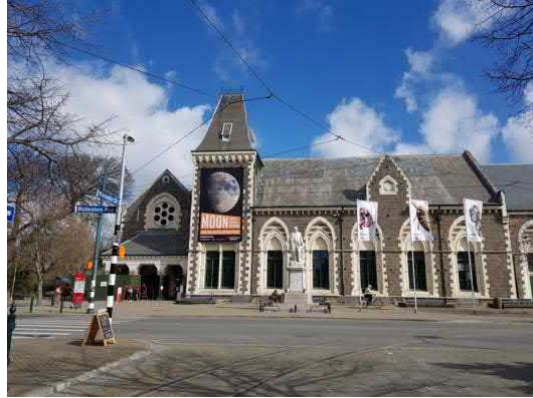
Figure 14. Rolleston Avenue (east) elevation of the 1877 building and 1878 porch (Source: Athfield Architects)

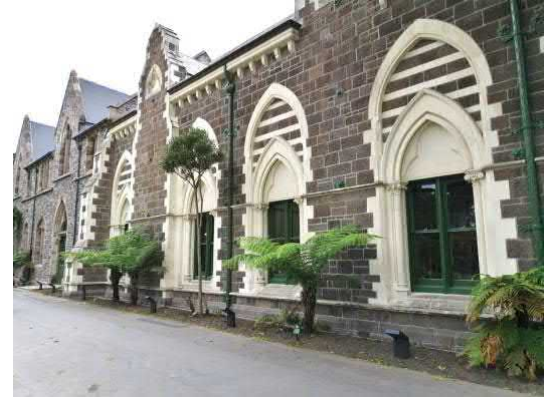
Figure 15. South elevation of the 1872 (left) and 1878 (right) buildings (Source: Athfield Architects)

- 28 The 1872 building is also designed in a Gothic Revival style. Its southern façade is visible from the Botanic Gardens, while the remainder of the building is concealed by other museum buildings. This building features small blocks of random rubble Halswell basalt brought to course, with Port Hills trachyte dressed facings, stringcourses, quoins and mullions. The steeply pitched roof runs east-west with secondary gables to the south. Clad in short-sheet corrugated steel, much of the original roof structure and cladding materials appear to have been replaced. A buttress in matching stone was added in 1977 as part of the construction of the Roger Duff Wing to terminate the western end of the building.

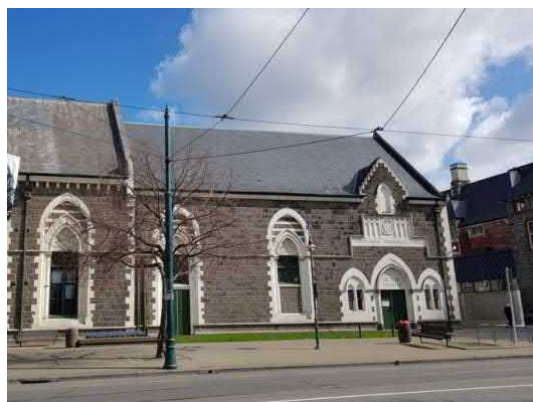
Figure 16. Rolleston Avenue (east) elevation of the Centennial Wing (Source: Athfield Architects)

32 Constructed in 1958 to a design by Dunedin architects Miller, White and Dunn, the Centennial Wing occupies the majority of the northern part of the Canterbury Museum site. A longitudinal gable roof with a similar form to the 1877 building extends over the front section of the Centennial Wing and runs parallel to Rolleston Avenue. Beyond this, two lower-pitched gable roofs clad in corrugated asbestos cement and steel run at right angles to Rolleston Avenue, one over the offices and the other over the large exhibition hall. The east and north elevations of the Centennial Wing closely emulated Mountfort's 1877 wing in a contextual or historicist interpretation of nineteenth century Gothic Revival architecture. The final design of the building differs substantially from the 1949 competition-winning design, probably due to budget constraints. The east or Rolleston Avenue façade is clad with a veneer of Port Hills basalt laid as random squared coursed rubble with dressed Oamaru stone facings, stringcourses, modillions, mouldings, quoins and mullions to match the 1877 building. To the west of this façade the majority of the fabric of the Centennial Wing comprises a more utilitarian rendered (plastered) concrete structure with regular square openings to its northern elevation.

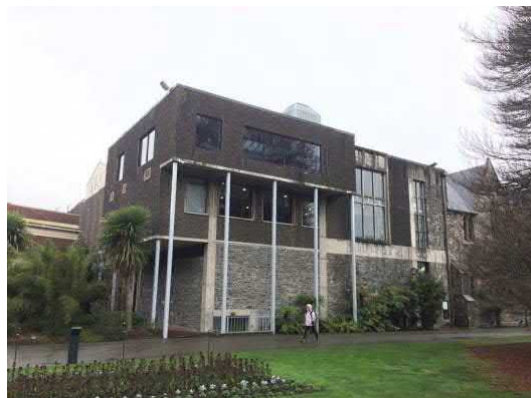
Figure 20. Roger Duff Wing from the southeast (Source: Athfield Architects)

33 The John Hendry-designed Roger Duff Wing was constructed in 1977 to link the 1872 building and the 1958 Centennial Wing. The Hendry design is a Late Modern design that combines the formality of modular exposed basalt aggregate pre-cast panels and slender steel piloti (columns) with parts of the walls clad in Halswell basalt to match the 1872 Mountfort building. While Henry's design envisaged the potential for a five-storey pitched roof addition, the resulting building comprised two floors of exhibition areas and had a planetarium installed on the roof as an external feature on the southwest corner of the building. Some aggregate panels are no longer intact due to the insertion of later openings which were introduced when the planetarium was removed and a cafeteria established in its place. A flat, membrane-clad roof extends over most of the building.

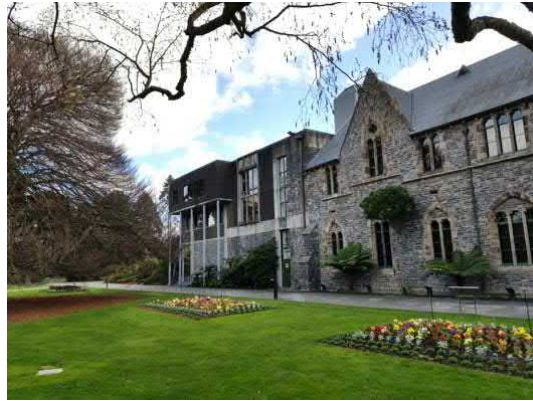
Figure 22. South elevation of the Roger Duff Wing (left) and the 1872 building (right) (Source: Athfield Architects)

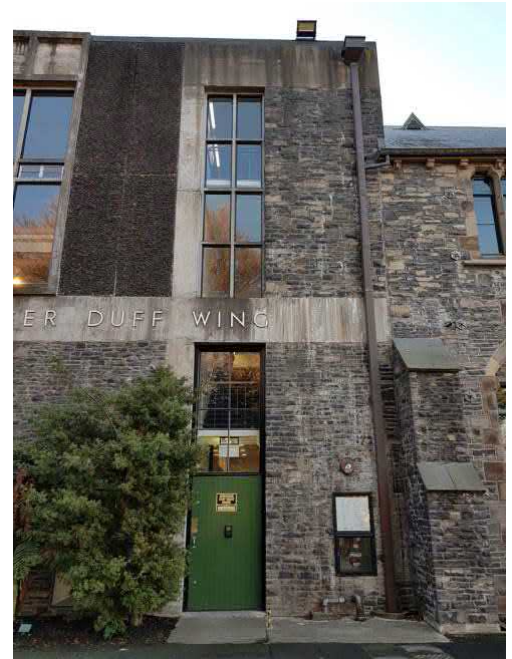
Figure 23. Junction of the Roger Duff Wing (left) and the 1872 building (right) (Source: Athfield Architects)

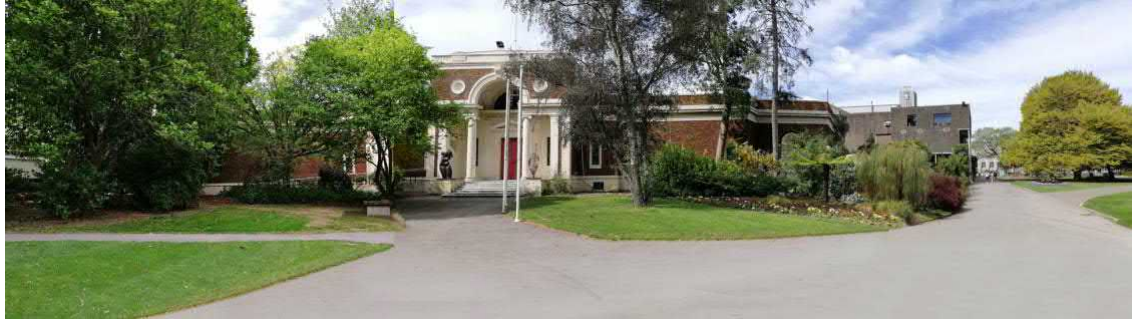
Figure 25. Composite image of the west elevation of the Robert McDougall Art Gallery, with the Roger Duff Wing of Canterbury Museum in the background (Source: Athfield Architects)

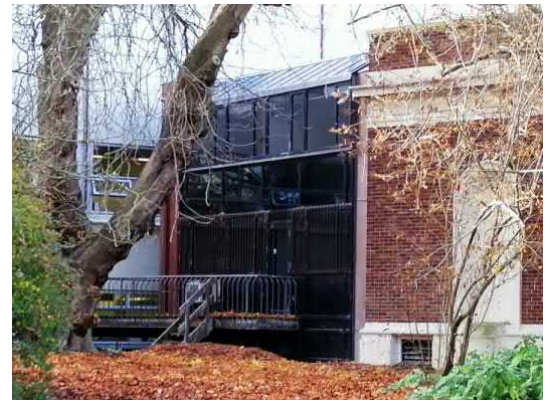
Figure 29. West elevation of the Canaday Wing (Source: Athfield Architects)

- 38 The Canaday Wing is a restrained Modernist single storey addition to the north of the Robert McDougall Art Gallery. It occupies a triangular area of land between the 1932 gallery building and the southern boundary of Christ's College. The principal (west) elevation of the Canaday Wing is aluminium curtain glazed with a small triangular shaped cantilever balcony projecting from it.

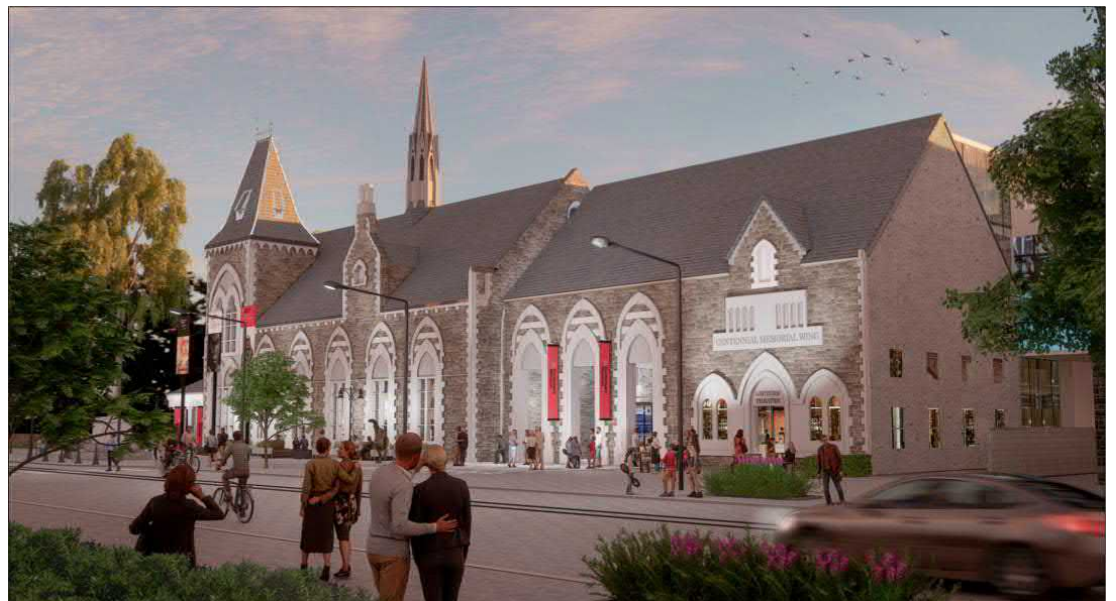
Figure 36. Render of the Rolleston Avenue (east) elevation showing the proposed slot and new opening within the Centennial Wing. (Source: Athfield Architects)

- 86 The proposed solution of a third Gothic-arch headed window draws directly on the competition-winning scheme for the Centennial Wing prepared by Miller, White and Dunn in 1949, 10 years before the eventual construction of the addition. The location of the proposed new window continues the rhythm established by the fenestration on the eastern façade of the 1877 building. I do not consider this a conjectural 'fixing' of a past mistake (refer Ohs evidence, para. 63) but rather a solution that reveals the original design intent of the architects. Noting the comments from the NZHPT submission, it is my view that any architectural device to differentiate the new opening from the existing two openings should be subtle and I concur with Ms Ohs' proposal that a condition be applied requiring detailed

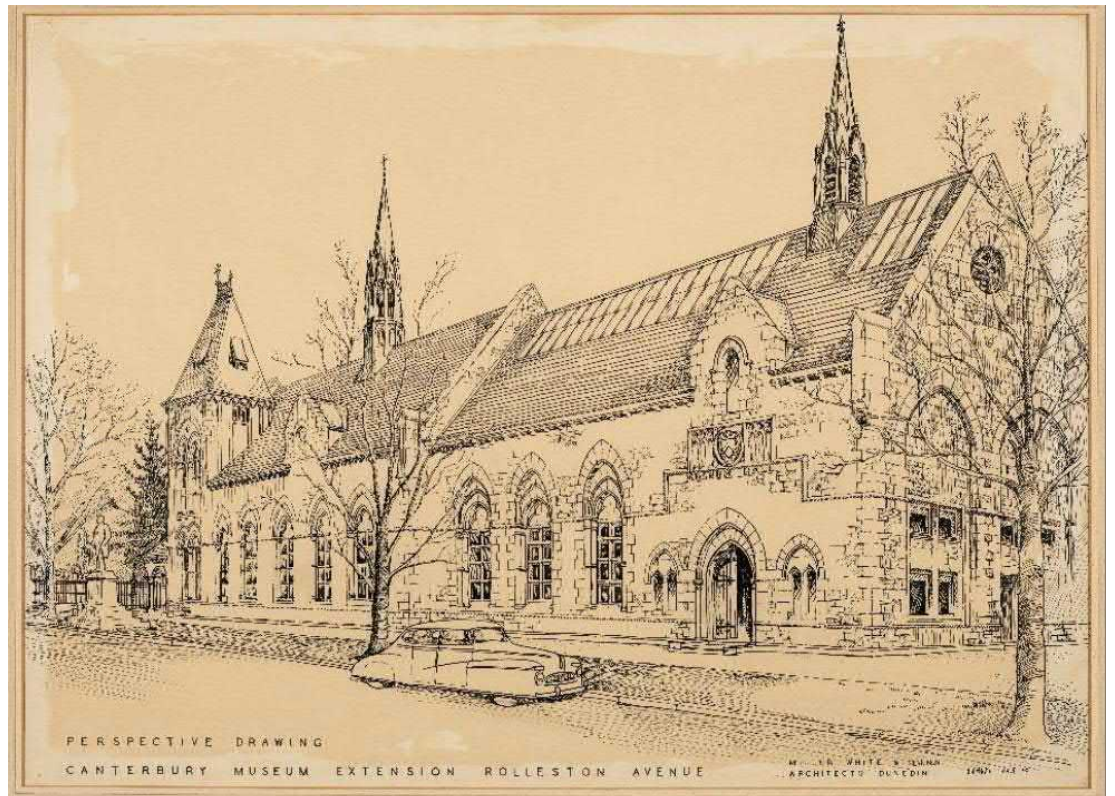
Figure 37. Perspective drawing of the proposed Centennial Wing prepared by Miller, White and Dunn and dated 1949. (Source: Canterbury Museum)

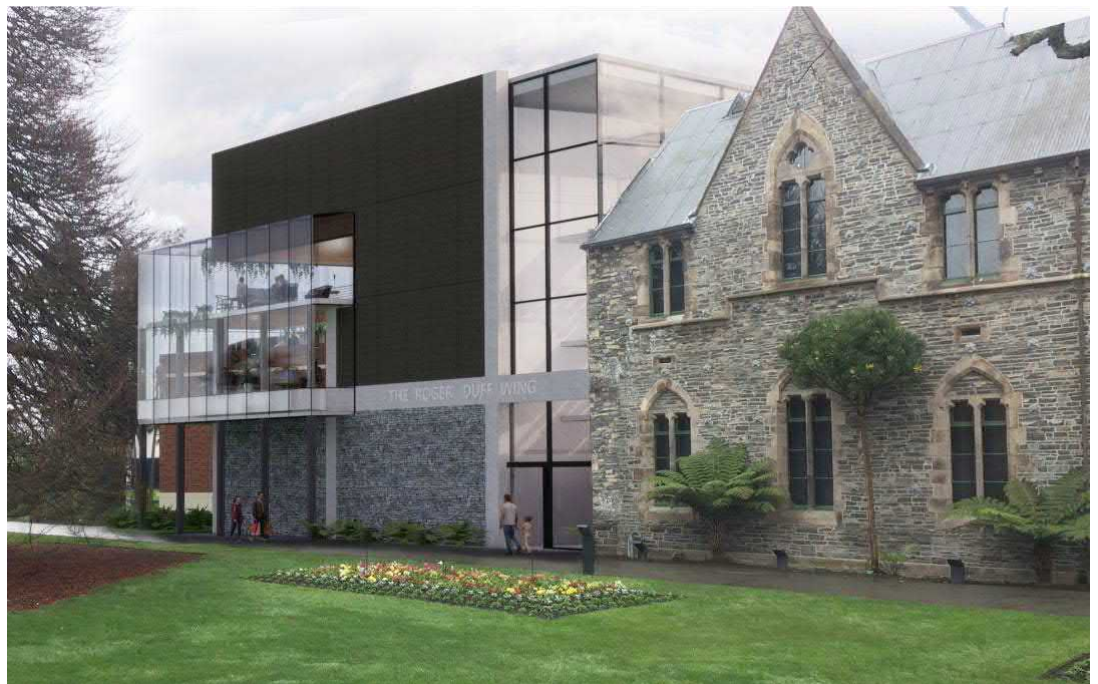
Figure 40. Render showing the south elevation of the proposed alterations to the Roger Duff Wing and the western part of the 1872 building. (Source: Athfield Architects)

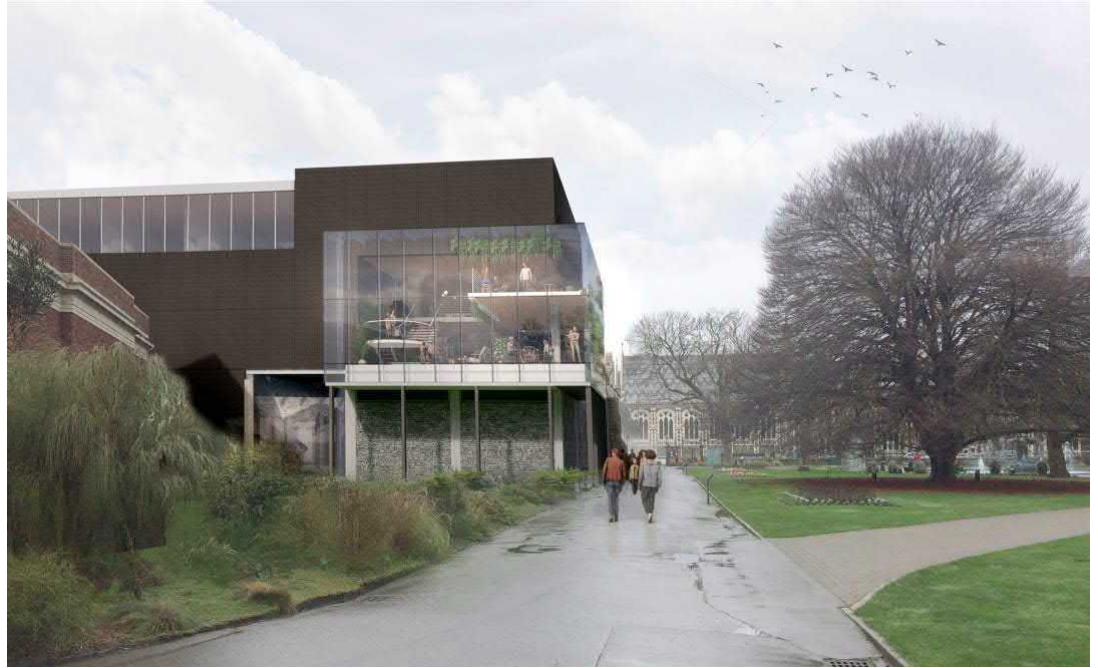
Figure 41. Render showing the west elevation of the proposed alterations to the Roger Duff Wing. (Source: Athfield Architects)

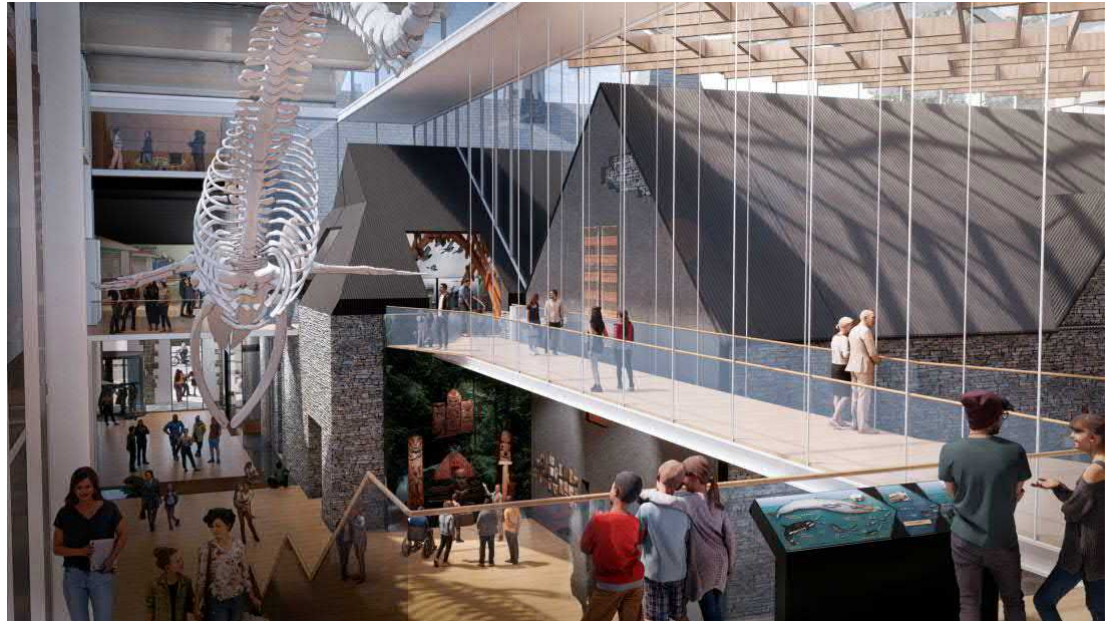
Figure 42. Artist's impression of the blue whale skeleton in the atrium with the 1870 and 1882 buildings in the background (Source: Athfield Architects)

- 114 In my view the proposed new structures appropriately balance the programme and brief requirements of Canterbury Museum while providing a sensitive connection to the newly revealed heritage fabric. The use of atria will enable the three-dimensional forms of the Mountford-designed buildings to be readily understood for the first time in more than 60 years, as well as allowing for the display of collection items and taonga, such as the Whare Whakairo Hau-Te-Ananui-O-Tangaroa and the blue whale skeleton.

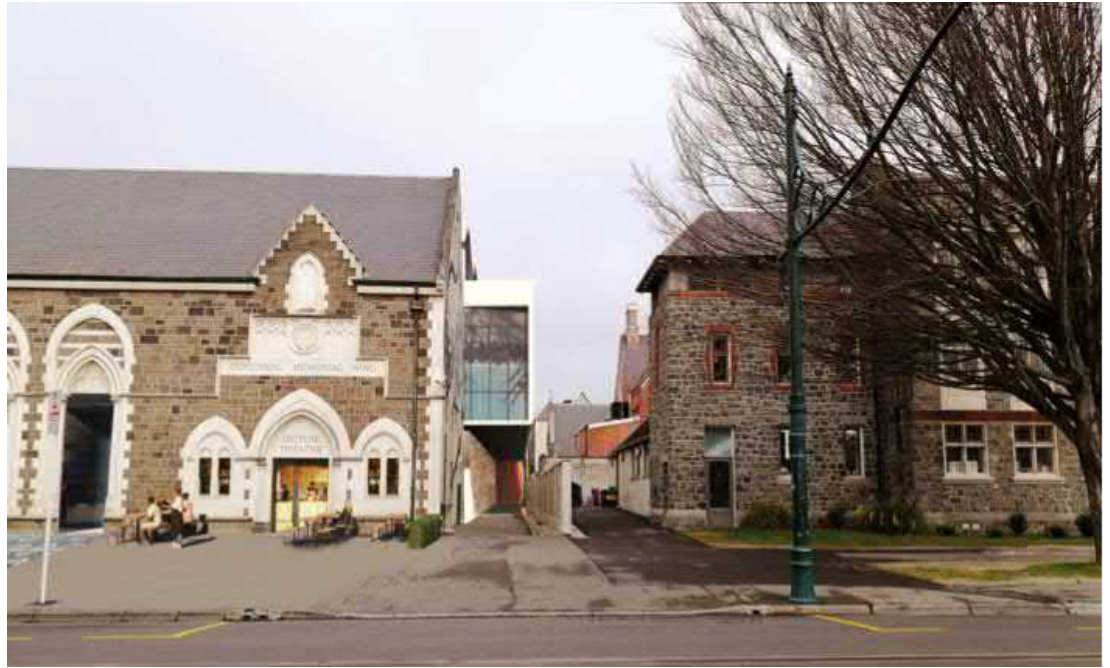
Figure 43. Render showing the cantilevered element over the northern service land viewed from Rolleston Avenue (Source: Athfield Architects)

- 115 The new structures have been designed to minimise their visual impact on the setting of the Canterbury Museum, Robert McDougall Art Gallery and neighbouring heritage places including Christ's College, the Rolleston Statue and the Arts Centre. The simple form of the new building to its northern elevation comprises a two-storey mass cantilevering part way over the service lane. The ground floor is clad in mid-grey precast panels with faceted lighter-coloured panels to the two-storey form that visually 'floats' above the darker base. The module of the panels responds to the rhythm of the Gothic Revival architecture and the restrained material choices and muted colours reflect the natural stone of the Rolleston Avenue façades and retained rendered concrete of the north gable end of the Centennial Wing.

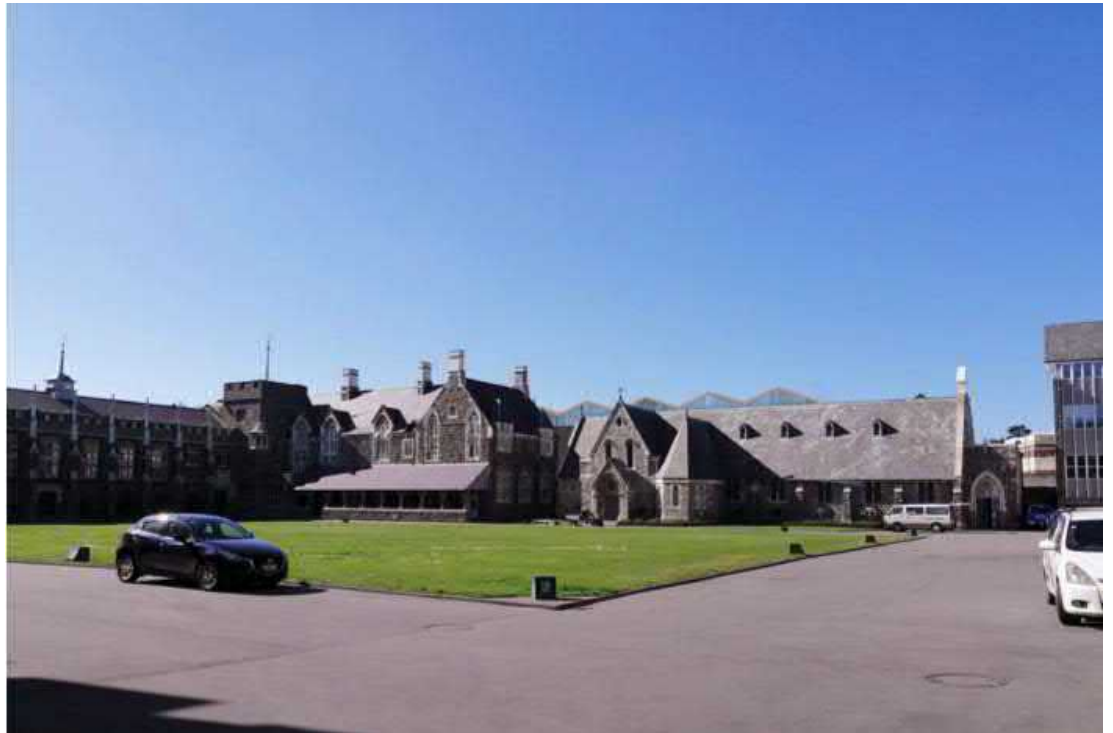
Figure 45. Render of the folded roof from the northwest corner of the Christ’s College Quadrangle (Source: Athfield Architects)

- 118 The proposed roof form of new structures has been designed to achieve the internal space requirements for Canterbury Museum’s back-of-house, conservation and staff requirements while minimising any intrusion above the 15m height plane. The height plane falls at the midpoint of the folded roof form and aligns with the flat roof of the boardroom located within the volume of the Centennial Wing. Approximately half of the folded roof and atrium forms exceed the 15m height limit by up to 1m at the ridge lines with half of the new roof form falling below height plane. The folded roof form helps reduce the apparent bulk of the new building and subtly references the pitch roof forms of Canterbury Museum and its context and I note Ms Ohs’ support for this design response (refer Ohs evidence para. 114).

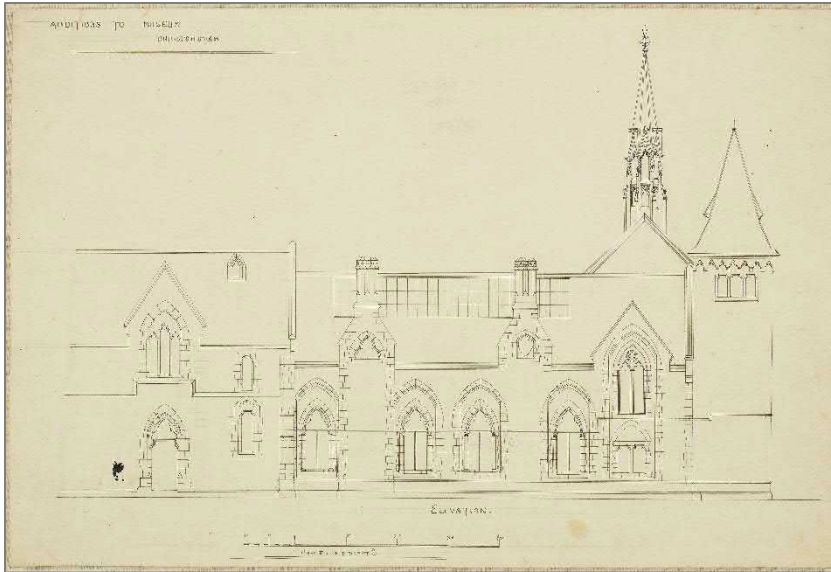
Mountfort plans for Canterbury Museum south façade 1872 and 1877. The additions to Canterbury Museum from the south elevation. Canterbury Museum, Plan 681.

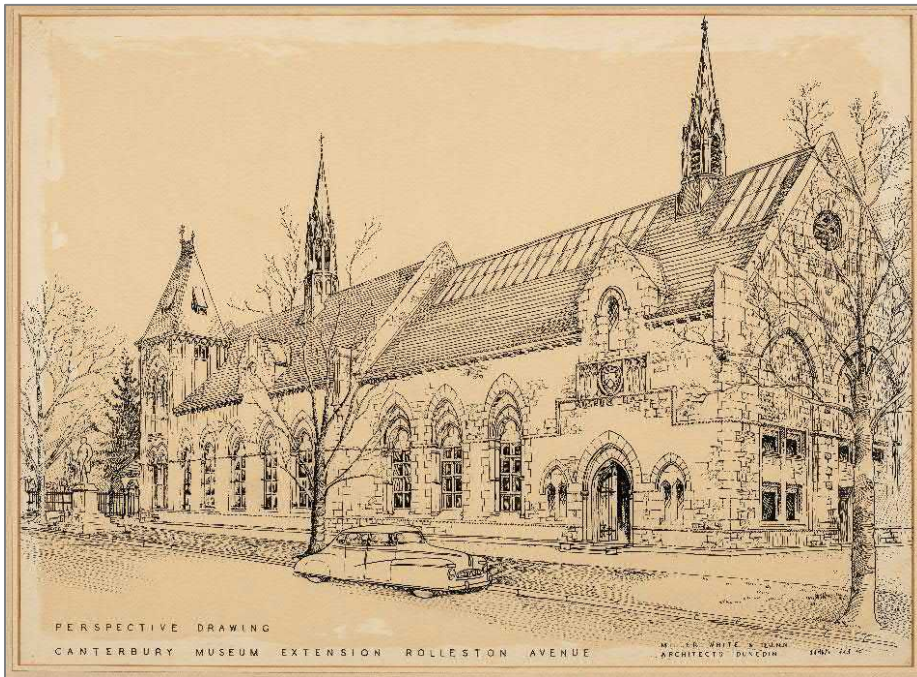
The stonedetailing to the north façade was never realised.
 Perspective Drawing Canterbury Museum Extension Rolleston Avenue 1949,
 Miller, White and Dunn drawing, Canterbury Museum, Mu 30a.

However, due to financial constraints, what was ultimately built was a Gothic Revival stone 'skin' adhered to the Rolleston Avenue façade with the remainder of the building following a utilitarian design consisting of a concrete structure with steel windows.

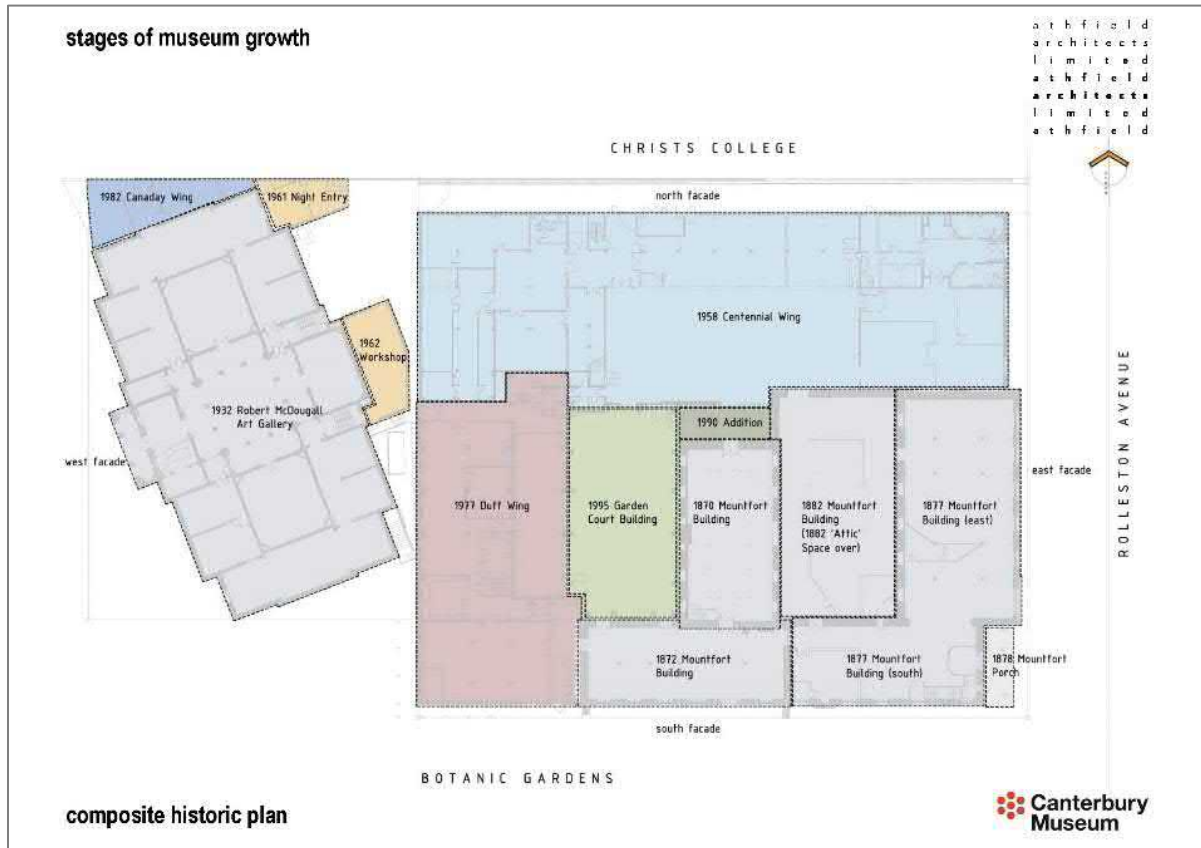
Stages of buildings that make up Canterbury Museum.
Plan from Athfield Architects.

The final building that made up the Benjamin Mountfort group of buildings was the 1882 building that was inserted between, while also connecting, the 1877 and the earlier 1870 buildings. The building originally comprised a single volume but was subsequently divided into two levels by an intermediate floor.

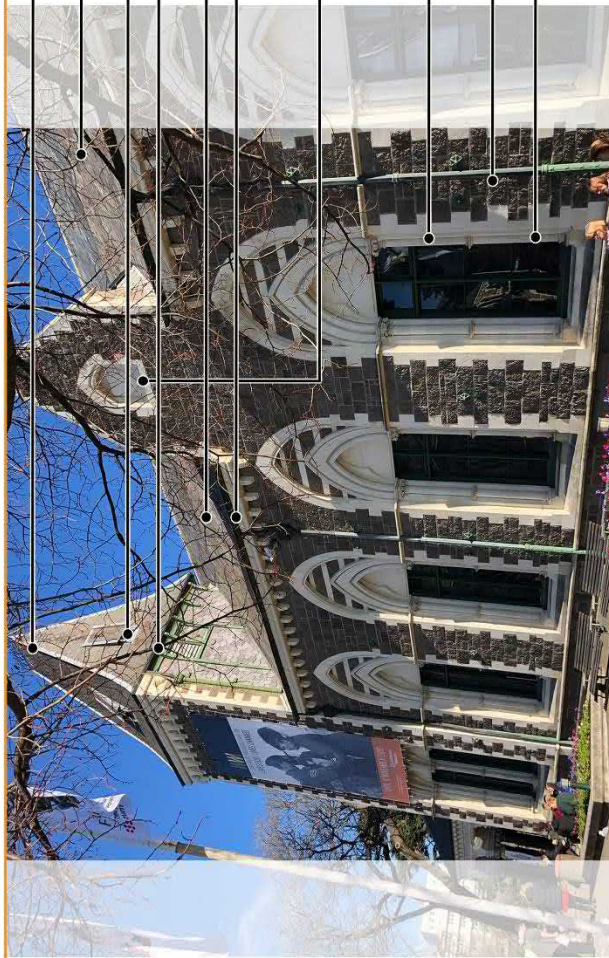
- Tower roof including wrought iron cresting and finials. (OHF)
- Slate roof, lead gutters and flashings. (OHF) / (LHF)
- Roof lights. (OHF)
- Copper gutters and downpipes on tower. (LHF)
- Gable roof forms (OHF)
- Slate roof. (OHF/LHF)
- Gablet on the east facade: (OHF) the chimneys have been removed and the gablet reduced in size. heritage value could be revealed by reinstating of chimneys.
- Oamaru stone fascias, corbels/brackets. (OHF)
- Original window openings and timber joinery. (OHF)
- Oamaru stone window details including reveals, sills, gothic arched heads and quoins. (OHF)

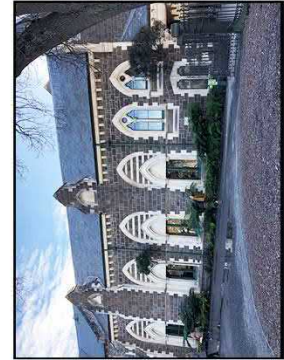
Entrance Porch:

- Rose window above entrance porch. (OHF)
- Oamaru lime stone cornice, column capitals and facings; Hoon Hay basalt columns and bases. (OHF)

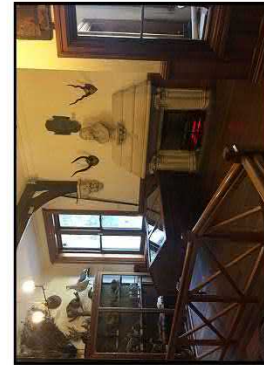
(3)

Original beams and corbels. (OHF)

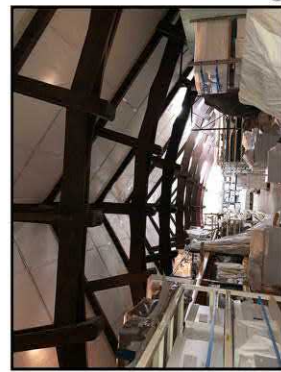
Original timber "double" trusses in space used for mammal storage. (OHF) (2)

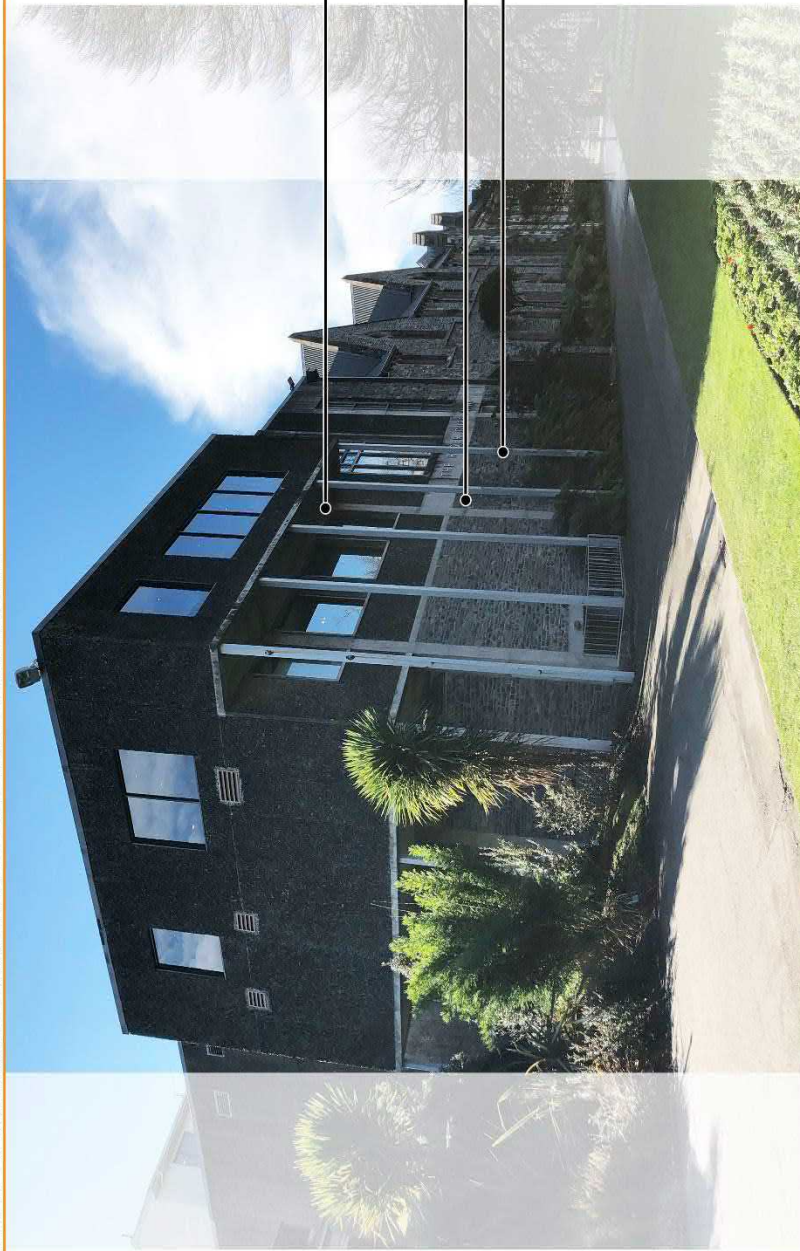
This building features walls, which are a combination of raw concrete and pre-cast panels with exposed, basalt aggregate. However, some of these are not intact due to the openings which have been formed for the café windows. (LHF)

This Halswell Basalt Veneer. (LHF)

Walls and Structure - Windows have been added to the area that became the café when the planetarium was removed.

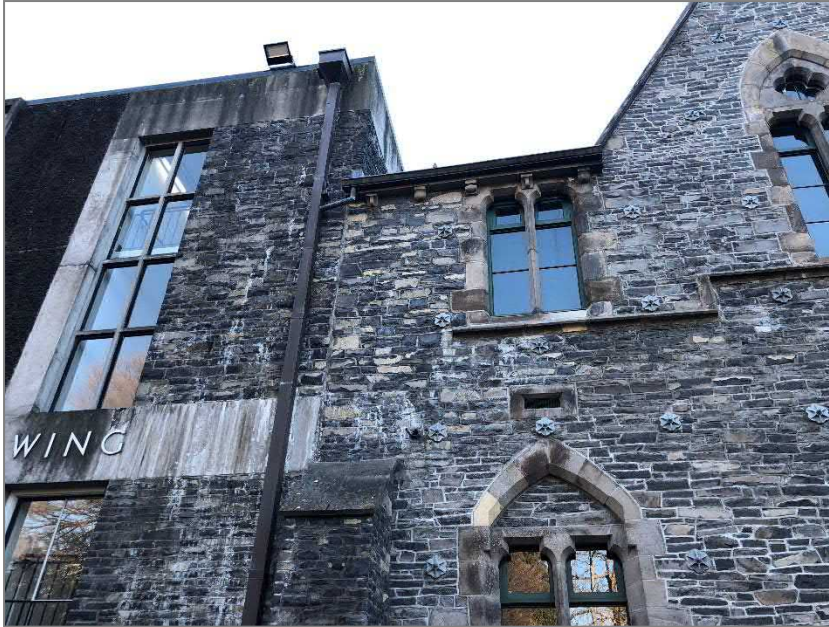
The existing junction between the Roger Duff Wing and the 1872 Mountfort building is unresolved and does not provide adequate seismic or appropriate visual separation. Improved seismic separation is likely to be required in this location and should be designed to only impact on the later Duff Wing. (2018, DPA Architects).

The limited extent of secondary heritage fabric and the later changes provide an opportunity for the Roger Duff wing to be further modified as required or returned to an earlier form. It is also likely that a vertical seismic joint will be required between it and the 1872 building.

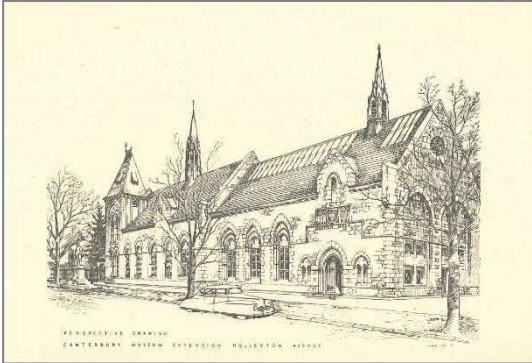
Extension
Canterbury Museum Annual Report 1949-50.

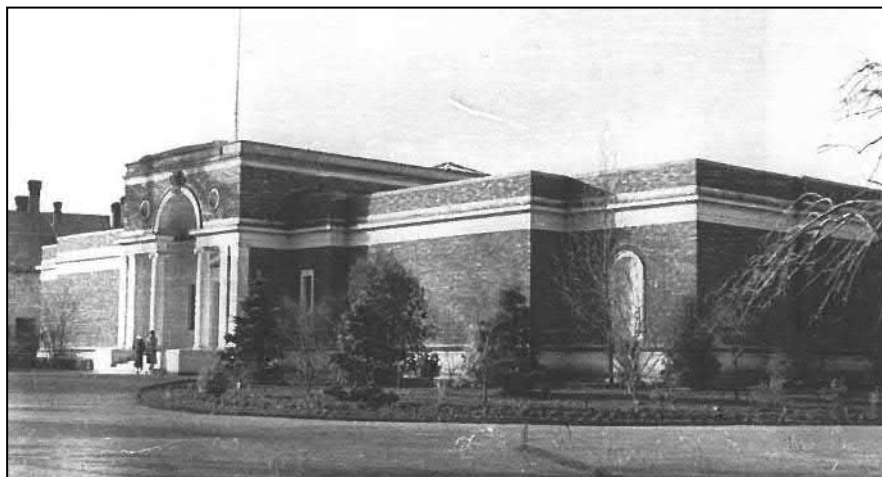
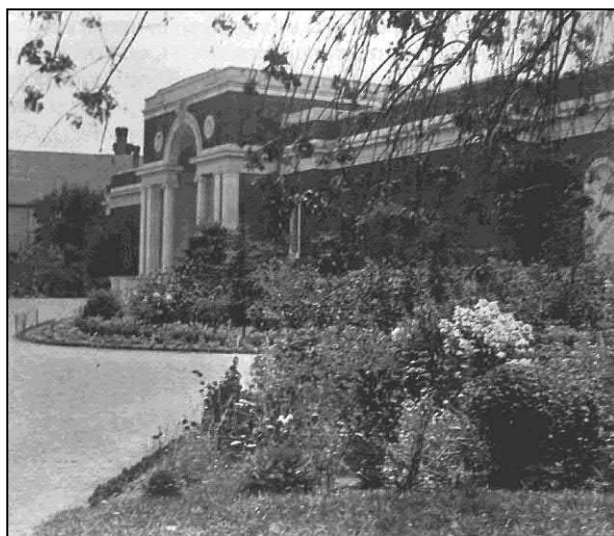
Newly completed gallery landscape, 1932. Note plant labels in the south-western garden bed. (*Pearson Collection 1986.341.4 CDRL*)

Gallery forecourt and garden beds were formed to sweep into the space, foregrounding the building setbacks on either side of the portico. Areas between the portico and the garden beds appear to have been formed for seating.

Photographs of these garden beds a few years later show that Young's scheme had become a herbaceous border-style setting for the building with an emphasis on massed floral effect rather than refined ornamentation. Whether this was his intention or the work of the new curator James McPherson remains unclear. Nevertheless, by the mid 1930s, the two front beds had become highly decorative features in their own right.

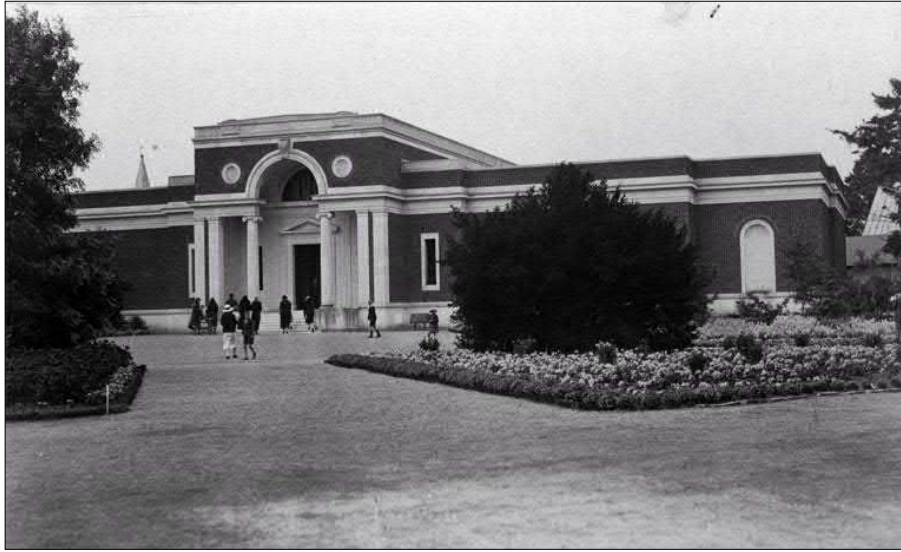
Mid 1940s view showing the path system pre Eveleyn Couzins memorial. Note the absence of plant material around the base of the Gallery and seating areas either side of the portico. (*Heritage files, CCC*)

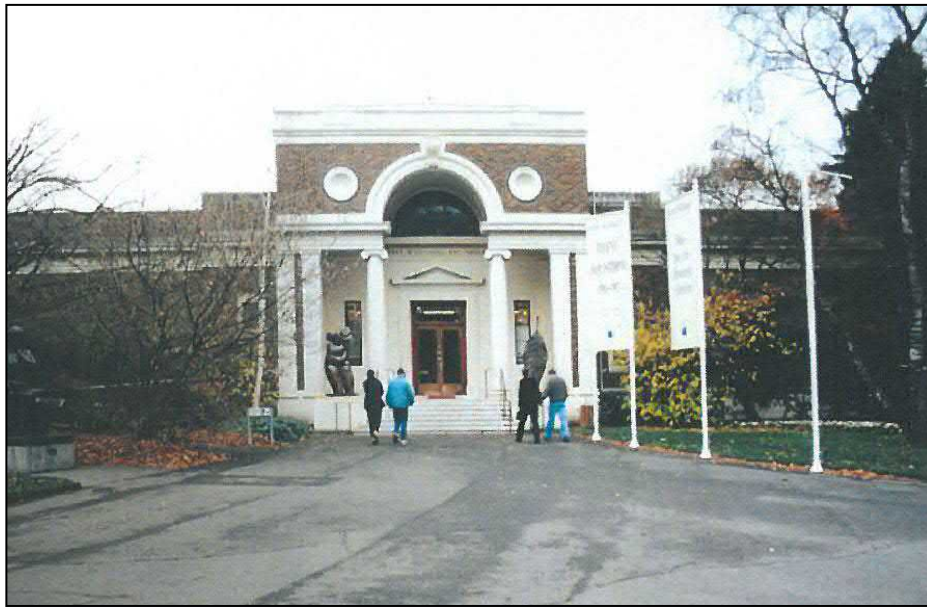
The gallery in the late 1998. '*Ex Tenebris Lux*' is on the left of the image and *E Noho Ra De Chirico* are either side of the portico. The wheelchair ramp can be seen to the rear of the sculpture (*Historic Places Trust*)

In 1980, as an attempt to address the problem of the gallery being overlooked by members of the public, the sculpture '*Ex Tenebris Lux*' was relocated from inside the gallery to an outdoor setting on the left of entrance in 1980. Positioned so it could be seen from the junction of the pathways at the end of the Armstrong Lawn it was used as a focal point to draw members of the public into the gallery forecourt. Another similar strategy to 'signpost' the gallery to the public was used in 1996 when Paul Dibble's work *E Noho Ra De Chirico* was placed on either side of the portico.¹²⁶ Banner poles were added between 1992 and 1998.

Following the relocation of works to the new gallery site in 2002, including *Ex Tenebris Lux* and *E Noho Ra De Chirico*, no significant changes have been made to the planting in the garden beds aproning the front of the gallery. The gallery's forecourt is now used as a shuttle stop on the Caterpillar Garden shuttle route.

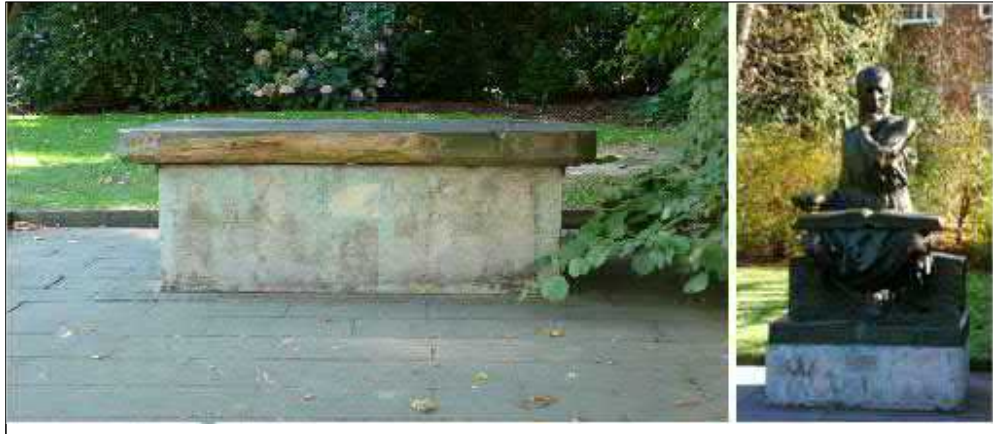
In order for to integrate with its architectural setting, Edward Armstrong was engaged to design a complimentary plinth. The sculpture was positioned in the sculpture court

from 1938 until it was moved to a nondescript corner in 1972. In 1980 the sculpture was relocated outside to a position on the north side of the Gallery forecourt.¹⁴¹ In 2002 when the Robert McDougall collection moved to the new gallery, the sculpture was removed leaving Edward Armstrong's purpose designed plinth. At some point after 2002 the plinth was capped with a timber slab for use as a seat associated with the shuttle stop.

Left – Plinth in 2010. The position of the commemorative plaque is still visible on the plinth's front face. (L.Beaumont). Right - *Ex Tenebris Lux* in the 1980s on the Armstrong designed plinth. (CAGL)

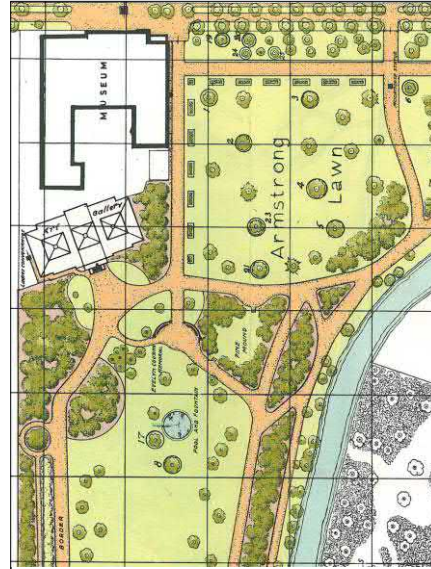
1958 plan showing the reconfigured pathway system after Eveleyn Couzins (CCC)

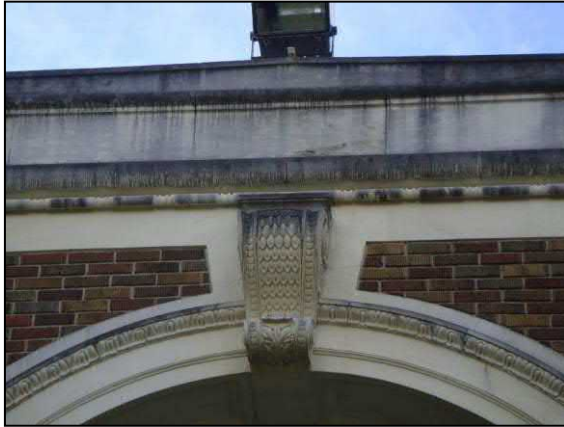
At a high level on either side of the arch and above the cornice is an area of brickwork with concave roundels of Oamaru stone symmetrically placed on either side. The wall culminates in a parapet which conceals the roof behind.

Keystone in centre of arch and detailing of arch. (DPAL)

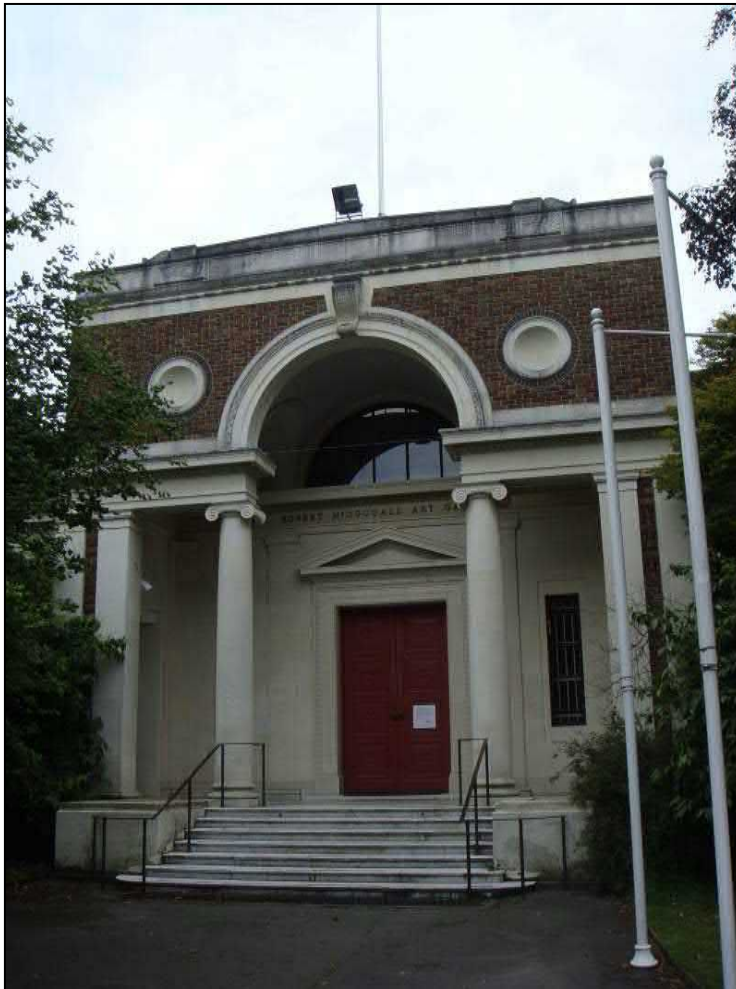
The double entrance doors have moulded facings and a moulded triangular pediment with egg and dart detailing above. Each door has four square panels which, according to the newspaper accounts of the time originally featured with relief motifs such as fleur de lis. Narrow windows are situated at either side of the entrance doors. Above the doors is an arched window that provides light to the boardroom at first floor level.

Central front entrance to Robert McDougall Gallery with floor above. (DPAL)

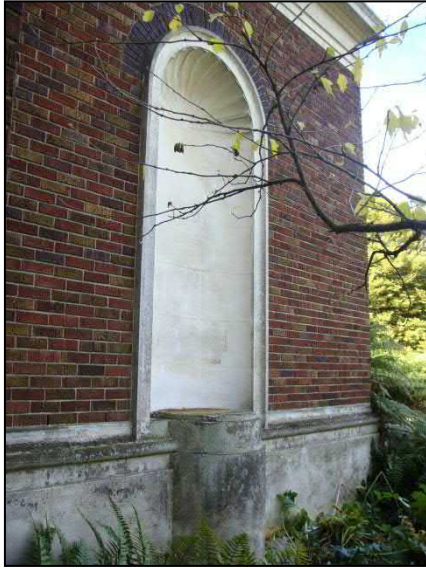
The remainder of the west elevation has equally proportioned wings at either side of the entrance portico. The wings are finished with façades of red brick which rest on a stone plinth. Towards the outer corners, concave niches finished with ashlar patterned plaster and with rounded plinths feature on the walls.

Niche on west elevation. (DPAL)

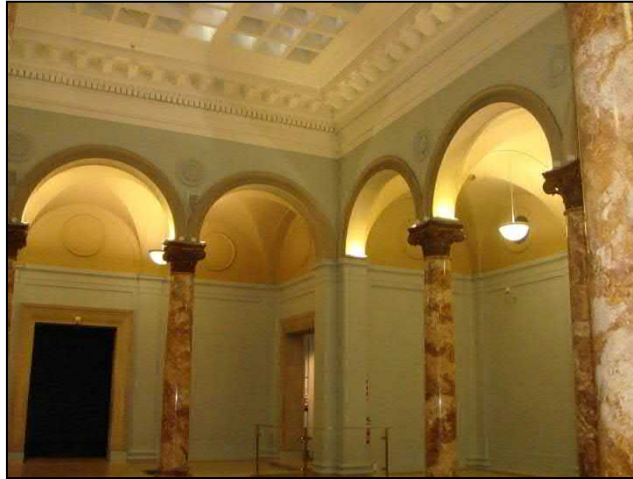
The internal walls are finished in plaster, some being solid plaster while other consist of plaster wallboard fixed to timber framing. Within the sculpture court, the walls were originally finished with plaster comprising white cement and yellow sand in an ashlar pattern. The fabric seen over some of the walls may be the original “Burlap” fabric. In recent times, the plastered walls in the sculpture court have been painted and a number of the walls in the original gallery areas have been overlaid with plaster wallboard.

Sculpture Court (DPAL).

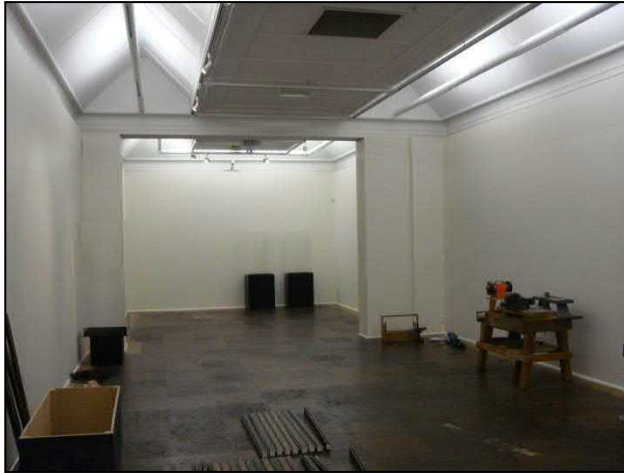
Each gallery has an intricate ceiling structure. In the centre of each space is a suspended ceiling panel backed with insulation board. From the suspended ceiling areas, redwood sashes glazed with ‘small glistre’ rolled glass rise at an angle to meet the outer inclined ceiling planes. This was Hurst Seager’s famed “top-side” natural lighting system incorporating the “lanterns” referred to in the newspaper accounts of the time.

Gallery room showing top-side lighting system. (DPAL)

In 1977 the entire top-side lighting system was masked by glass being covered or painted over and spotlights were added. The fluorescent lighting was replaced by more ambient track lighting. Emergency lighting was installed in 1995 and an upgrade began on the existing light fittings which continued through to 1996. Most of the interior doors were replaced in 1996 as part of a fire stop upgrade. In 1996 a goods lift was installed in the northern stairwell.

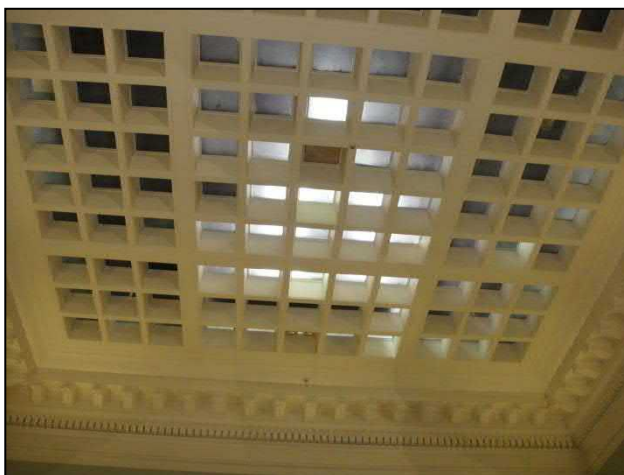
The sculpture court of the Robert McDougall Gallery has a different ceiling structure comprising a series of deep coffers or cells which are glazed on the top to admit light to the internal space. The coffered form is constructed of concrete and has a plaster finish.

Coffered ceiling to sculpture Court (DPAL).
