IN THE MATTER Of Resource Consent Application RMA/2020/2852 for the Canterbury Museum Trust Board for a comprehensive redevelopment of the Canterbury Museum complex including the Robert McDougall Art Gallery

EVIDENCE OF MR JAMES (JIM) GARD'NER ON BEHALF OF THE CANTERBURY MUSEUM TRUST BOARD

Dated 25 MAY 2021

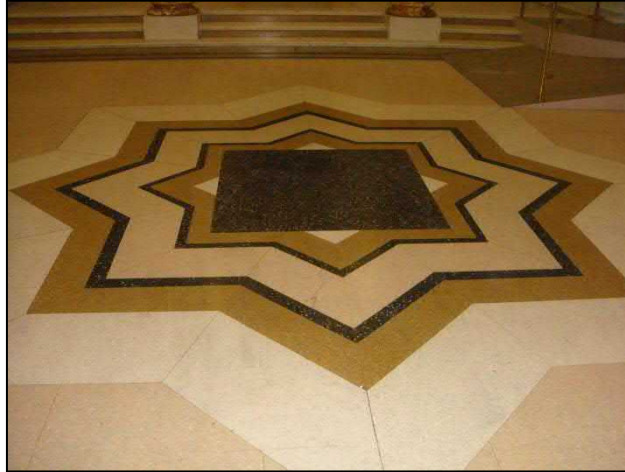
The floors to the galleries are covered in cork tiling. The sculpture court and the entrance hall have floors of marble terrazzo with black, cream, yellow and white colours being used in a bold star pattern with brass edgings.

Terrazzo floor in sculpture court (DPAL).

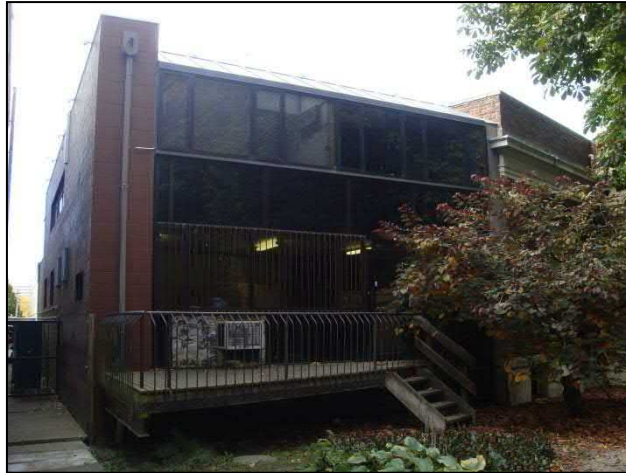
Canaday Wing (DPAL).

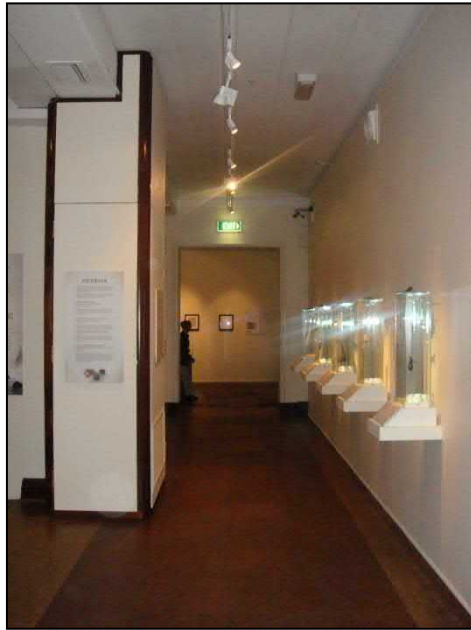
Air-conditioning plant was placed on the roof or within the space between the external skylights and the suspended ceilings with grilles being located in place of the glazed sashes. Within the galleries horizontal and vertical ducts have been provided.

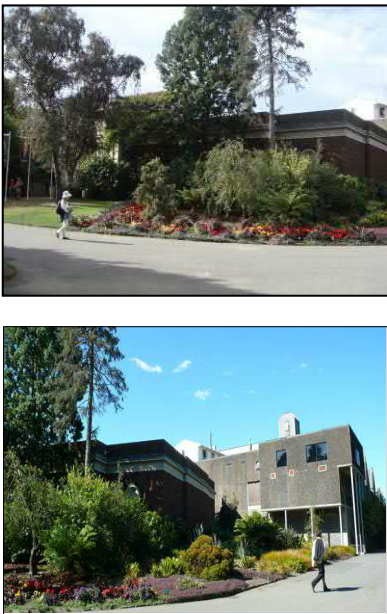
<p>Setting : The gallery was deliberately placed within the Botanic Gardens for the experiential, aesthetic, and to a lesser degree the educational qualities it provided. It is also significant that it was placed next to the museum in terms of its cultural value. Engagement with the natural beauties of the Botanic Gardens prior to entering the Robert McDougall Gallery was considered to elevate the experience of the visit and enhance the appreciation of the works on display. This was described by Samuel Hurst Seagar and endorsed by the architect Edward Armstrong.</p> <p>Present Rating: High significance</p>	
<p>High significance Forecourt (OF) Plinth (LF) Garden beds (OF) Plant labelling practice (OF) Trees – 1890-1900 (OF) Some trees and shrubs- 1950-1960 (LF) Views from gallery to archery lawn (OF) Views of west elevation of gallery in setting from archery lawn(OF) Views of south elevation in setting (OF)</p> <p>Moderate significance Some trees and shrubs (Hibiscus, Betula) 1950-1960 (LF)</p> <p>Some significance Some shrubs and perennials 1990s(LF)</p> <p>Non-contributory Adjacent toilet building (LF)</p> <p>Intrusive Pole Banners (RF) Disabled access ramp (RF) Some trees and shrubs-Picea, Laurelia, Acer, Chimonanthus 1950-1960 (LF) Some trees and shrubs – Corylus, Lonicera (RF)</p>

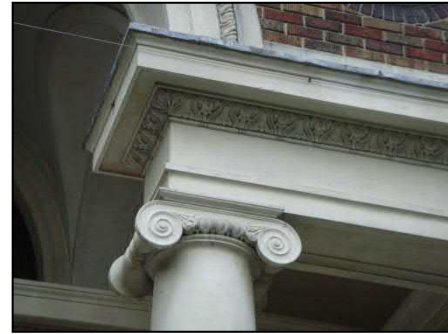
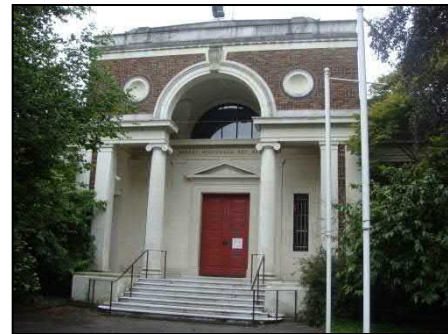
Side (South) Elevation: The southern façade of the building is the original elevation apart from the addition of grilles to the basement windows.
Present Rating: High significance

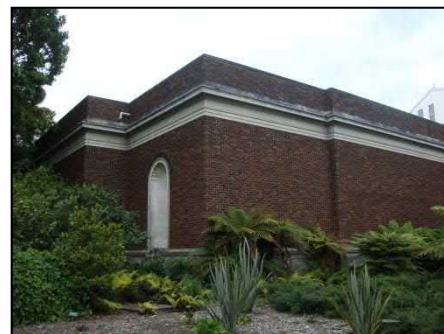
Rear (East) Elevation: At the rear of the gallery this elevation has been altered since it was first built. On the northern side the addition of the night entrance and the loading dock have altered the symmetry of the building. The rear elevation has also been modified by the construction of the workshop. However the rear façade of the gallery still retains a considerable amount of original fabric.

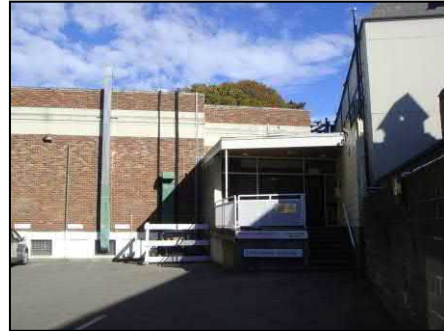
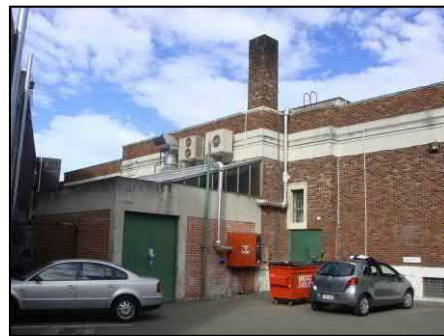
Night entry extension (LF)

Concrete block wall to night entry extension (LF)

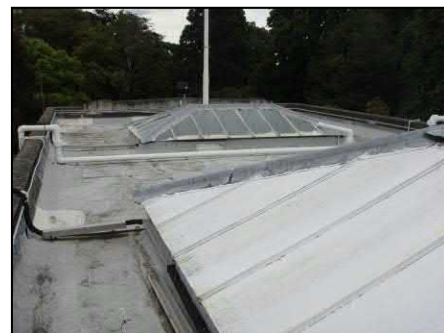
Air-conditioning plant (RF)

Later timber access ladders (RF)

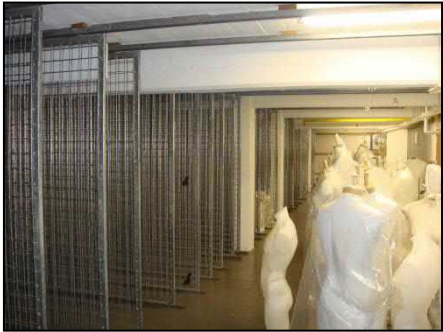
<p>Basement – B1 The eastern side of the basement was part of the original building. Further excavations were undertaken over an extended period of time ranging from 1974 to the mid 1980s. This area is part of those additions. Present Rating: Non-contributory</p>	
<p>Some significance Concrete columns Concrete floors (RF) Concrete Walls (RF) Non-contributory Sprinkler pipes (RF)</p>

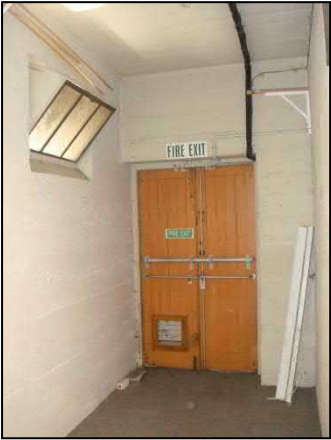
<p>Basement – B2 The eastern side of the basement was part of the original building. Present Rating: Some significance</p>	
<p>Some significance Brick wall (OF) Concrete slab ceiling (OF) Non-contributory Concrete floors (RF) Concrete rib wall (RF) Sprinkler pipes (RF) Timber partition (RF) Extract duct hook (RF)</p>

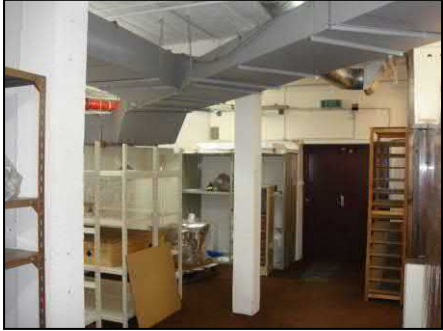
<p>Basement – B4 Further excavations were undertaken over an extended period of time ranging from 1974 to the mid 1980s. This area is part of those additions. Present Rating: Non-contributory</p>	
<p>Some significance Concrete slab ceiling (OF) Foundation walls (OF) Concrete columns(OF)</p> <p>Non-contributory Concrete floors (RF) Concrete rib wall (RF) Sprinkler pipes (RF) Fluorescent lighting (RF)</p>

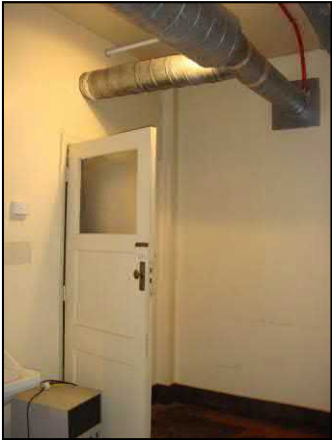
<p>Basement – B5 Excavations were made under the northern galleries in 1983 to create this space in the basement. Present Rating: Non-contributory</p>	
<p>Some significance Plastered concrete walls (OF) Plastered concrete ceiling (OF) Concrete floor (OF)</p> <p>Non-contributory Duct work (RF)</p>

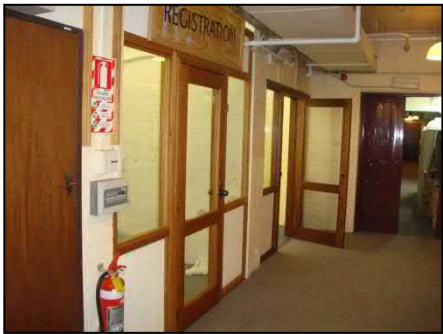
<p>Basement – B6 The area on the eastern side of the basement was part of the original building. Once a storage room, it is now a circulation area. Present Rating: Some significance</p>	
<p>Some significance Glazed screens and doors added (RF) Brick walls (OF) Concrete ceiling</p> <p>Non-contributory Duct work and cabling (RF) Carpet flooring (RF)</p>

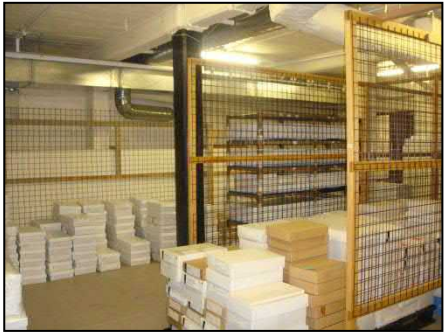
<p>Basement – B7 Excavations were made under the northern galleries in 1983 to create this space in the basement. Present Rating: Non-contributory</p>	
<p>Some significance Concrete floor (OF) Concrete walls (OF) Concrete ceiling (OF) Non-contributory Duct work and cabling (RF) Concrete columns (RF)</p>

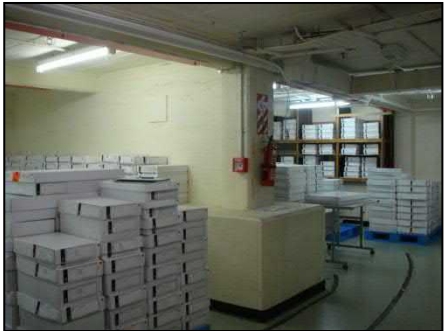
<p>Basement – B8 Excavations were made under the northern galleries in 1983 to create this space in the basement. Present Rating: Non-contributory</p>	
<p>Some significance Concrete floor (OF) Concrete walls (OF) Concrete ceiling (OF) Non-contributory Duct work and cabling (RF) Concrete columns (RF)</p>

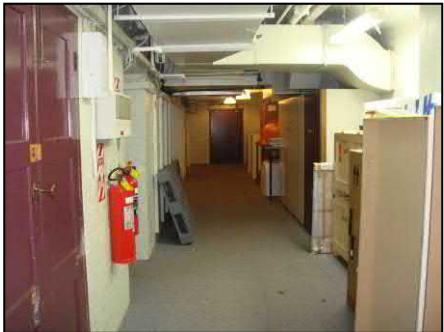
<p>Basement – Main corridor This area on the eastern side of the basement was part of the original building. Present Rating: Some significance</p>	
<p>Some significance Glazed screens and doors added (RF) Brick partition walls (OF) Concrete structural wall and columns (OF) Concrete ceiling (OF) Non-contributory Duct work and cabling (RF) Carpet flooring (RF) Cupboards added (RF) Fire extinguisher (RF)</p>

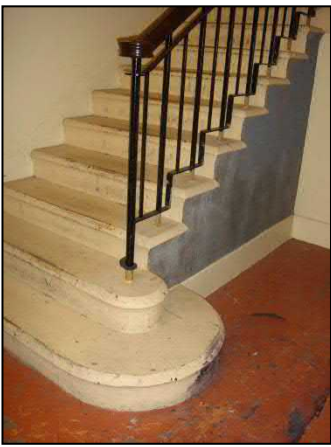
<p>Stairs to Basement – G12 The stairs to the basement are part of the original building. Present Rating: Moderate significance</p>	
<p>High significance Concrete staircase (OF) Steel balustrade (OF) Timber handrail (OF) Moderate significance Plastered concrete walls (OF) Concrete floor (OF) Non-contributory Sprinkler pipes (RF) Intrusive Fire doors(RF) Cable ducting (RF) Exit signs (RF) Fire extinguishers (RF)</p>

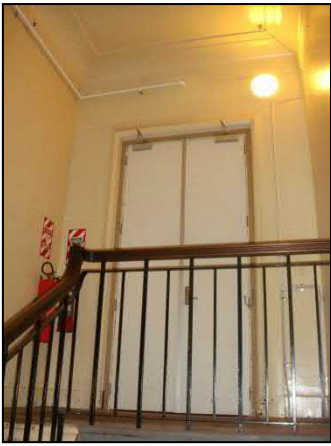
<p>North East Stairs – G9 The lift well was installed in 1996 in the north eastern stairwell. A flight of stairs remains. Present Rating: Some significance</p>	
<p>Moderate significance Remnant of staircase (OF) Steel balustrade (OF) Timber handrail (OF) Plastered concrete walls (OF) Concrete floor (OF) Non-contributory Door to car park (LF) Intrusive Lift car (RF) Sprinkler pipes (RF)</p>

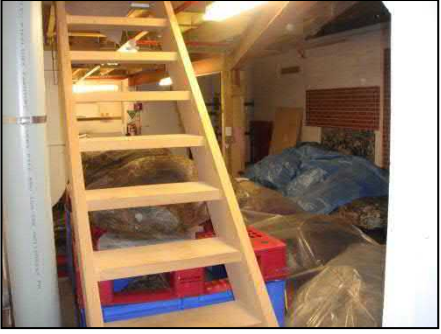
<p>Workshop – G32 The workshop is located at the mid landing level of the basement stairs and was added in 1961. The mezzanine level was added in 1979. Present Rating: Non-contributory</p>

<p>High Significance Tapestry brick wall to original building (OF) Non-contributory Mezzanine added (LF) Tongue and groove sarking (LF) Steel frame and timber roof (LF) Sprinkler pipes (RF) Fluorescent lighting (LF)</p>

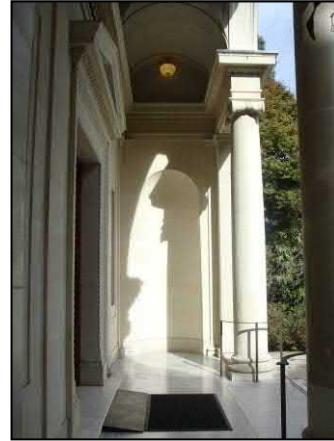
Ground Floor- (G1) This is the portico entrance to the gallery. Most of the portico is original fabric apart from the addition of the ramp on the northern side in 1985 which necessitated to removal of the apse from the northern side.
Present Rating: High significance

High Significance
Plaster walls with ashlar pattern (OF)
Ionic Columns (OF)
Plaster vaulted ceiling (OF)
Triangular pediment above doors (OF)
Timber double entry doors (OF)
Timber framed fanlight (OF)
Timber framed double hung sash windows (OF)
Marble Floor (OF)
Non-contributory
Balustrade (RF?)
Intrusive
Ramp(RF)
Security cameras (RF)
Security grilles on windows (RF)

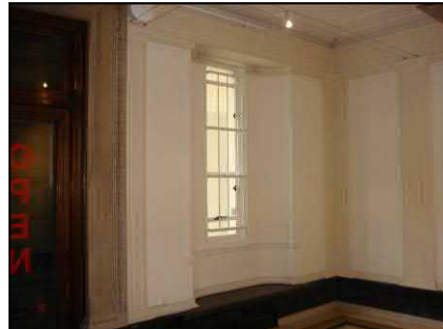
Ground Floor - (G2) The entrance hall has retained many original features. The former attendants' room is now a storage area.
Present Rating: High Significance

High Significance
Terrazzo floor and skirting (OF)
Timber panelled doors with glazing (OF)
Fibrous Plaster ceiling (OF)
Moderate Significance
Plaster walls (OF)
Non-contributory
Lighting tracks (RF)
Carpet in reception area (RF)
Intrusive
Reception cupboards and desk (RF)
Glass partition (RF)
Service conduits (LF)
Fire extinguisher (RF)
Phone and intercom (RF)

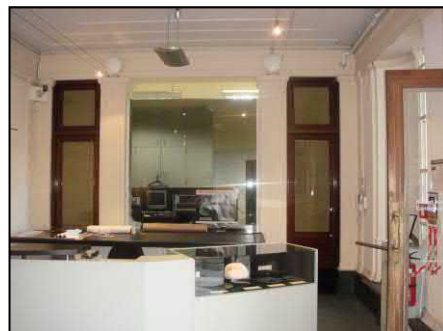
<p>Ground Floor (G3) One of the galleries originally used for large oil paintings, this room has had some modifications including the original skylights being painted over. Present Rating: Moderate significance</p>	
<p>High Significance Cork tile floor (OF) Skylights (OF)</p> <p>Moderate Significance Solid plaster ceilings (OF)</p> <p>Non-contributory Lighting tracks (RF)</p> <p>Intrusive Service conduits (RF) Wallboards overlaid on walls (RF) Air conditioning ducts in ceiling (RF)</p>

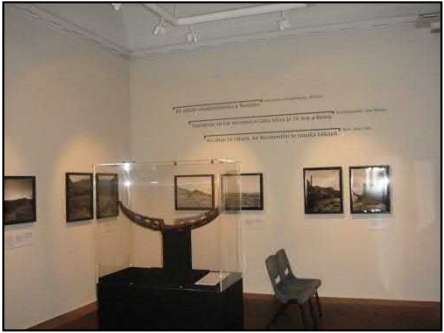
<p>Ground Floor (G4): Another small original gallery used for large oil paintings and it has had some modifications including the original skylights being painted over. Present Rating: Moderate significance</p>	
<p>High Significance Cork tile floor (OF) Skylights (OF)</p> <p>Moderate Significance Solid plaster ceilings (OF)</p> <p>Non-contributory Lighting tracks (RF)</p> <p>Intrusive Service conduits (RF) Wallboards overlaid on walls (RF) Air conditioning ducts in ceiling (RF)</p>

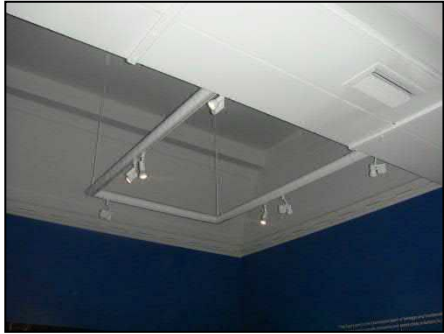
<p>Ground Floor (G5): This gallery was once used for watercolours. Although still a gallery it has been modified to provide access to the Canaday Wing and the night entrance. Present Rating: Moderate significance</p>	
<p>High Significance Cork tile floor (OF) Skylights (OF)</p> <p>Moderate Significance Solid plaster ceilings (OF)</p> <p>Non-contributory Glazed timber door with brass hardware (RF) Lighting tracks (RF)</p> <p>Intrusive Service conduits (RF) Wallboards overlaid on walls (RF) Hollow core doors to night entrance (LF) Air conditioning ducts in ceiling (RF)</p>

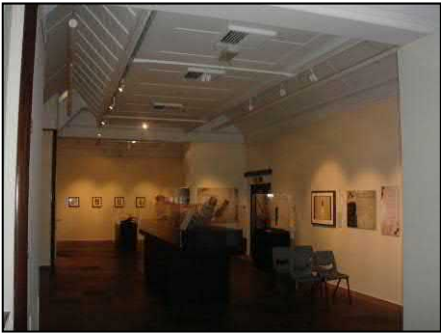
<p>Ground Floor (G6): Another small original gallery used for large oil paintings. It has had some modifications including the original skylights being painted over. Present Rating: Moderate significance</p>	
<p>High Significance Cork tile floor (OF) Skylights (OF) Moderate Significance Solid plaster ceilings (OF) Non-contributory Lighting tracks (RF) Intrusive Service conduits (RF) Wallboards overlaid on walls (RF) Air conditioning ducts in ceiling (RF)</p>

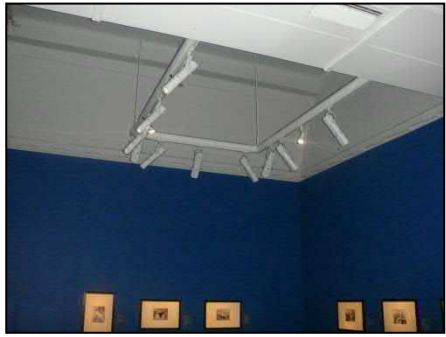
<p>Ground Floor (G7): Another small original gallery used for large oil paintings. It has had some modifications including the original skylights being painted over. Present Rating: Moderate significance</p>	
<p>High Significance Cork tile floor (OF) Skylights (OF) Moderate Significance Solid plaster ceilings (OF) Non-contributory Lighting tracks (RF) Intrusive Service conduits (RF) Wallboards overlaid on walls (RF) Air conditioning ducts in ceiling (RF)</p>

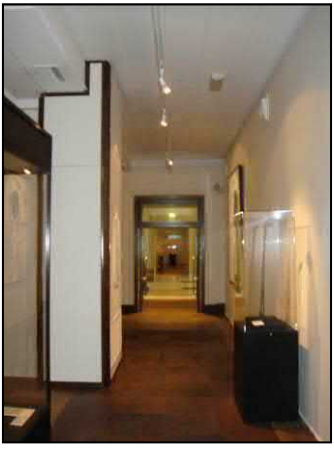
<p>Ground Floor (G10): This area comprises a small lobby area outside the stairwell and linking circulation areas. Present Rating: Moderate significance</p>	
<p>High Significance Cork tile floor (OF) Original plaster moulded door surrounds (OF)</p> <p>Moderate Significance Solid plaster ceilings (OF)</p> <p>Some Significance Double mahogany doors to G8 with brass hardware(LF)</p> <p>Non-contributory Lighting tracks (RF) Security cameras (RF) Exit sign (RF)</p> <p>Intrusive Service conduits (RF) Wallboards overlaid on walls (RF) Air conditioning ducts in ceiling (RF) Flush doors accessing G9 (RF)</p>

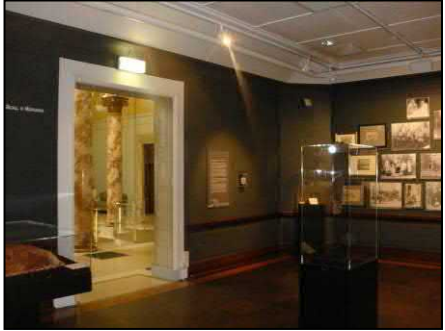
<p>Ground Floor (G11): Originally the engravings gallery this room is on the central eastern side of the building. It is the most intact of the gallery spaces with original trim having been preserved. Present Rating: High significance</p>	
<p>High Significance Cork tile floor (OF) Original plaster moulded door surrounds (OF) Original timber skirtings and dado mould (OF) Skylights (OF)</p> <p>Moderate Significance Plaster walls below dado (OF) Solid plaster ceilings (OF)</p> <p>Non-contributory Lighting tracks (RF) Security cameras (RF) Exit sign (RF)</p> <p>Intrusive Service conduits (RF) Wallboards overlaid on walls above dado(RF) Air conditioning ducts in ceiling (RF)</p>

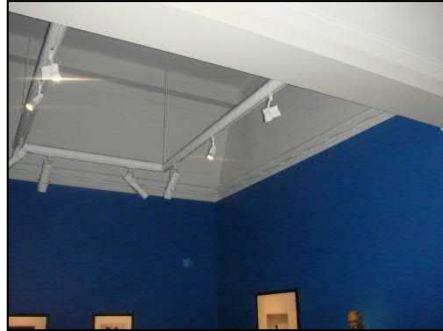
Ground Floor (G13): Another small original gallery used for large oil paintings. It has had some alterations including the original skylights being painted over.
Present Rating: Moderate significance

High Significance
Cork tile floor (OF)
Skylights (OF)
Moderate Significance
Solid plaster ceilings (OF)
Non-contributory
Lighting tracks (RF)
Intrusive
Service conduits (RF)
Wallboards overlaid on walls (RF)
Air conditioning ducts in ceiling (RF)

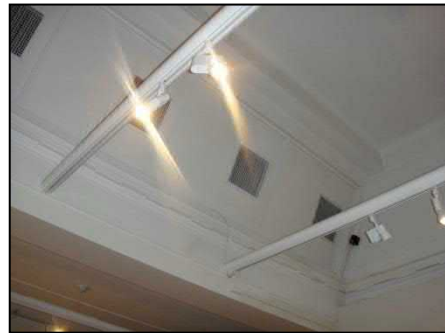
Ground Floor (G14): Another small original gallery used for large oil paintings. It has had some alterations including the original skylights being painted over.
Present Rating: Moderate significance

High Significance
Cork tile floor (OF)
Skylights (OF)
Moderate Significance
Solid plaster ceilings (OF)
Non-contributory
Lighting tracks (RF)
Intrusive
Service conduits (RF)
Wallboards overlaid on walls (RF)
Air conditioning ducts in ceiling (RF)

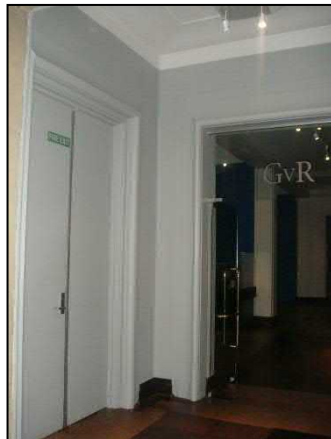
Ground Floor (G15): A small lobby area outside the stairwell and linking circulation areas.
Present Rating: Moderate significance

High Significance
Cork tiles (OF)
Original plaster moulded door surrounds (OF)
Moderate Significance
Solid plaster ceilings (OF)
Non-contributory
Glass doors to G16 with brass hardware (RF)
Lighting tracks (RF)
Intrusive
Service conduits (LF)
Wallboards overlaid on walls (RF)
Air conditioning ducts in ceiling (RF)
Flush doors accessing G12 (RF)
Security cameras (RF)
Exit sign (RF)

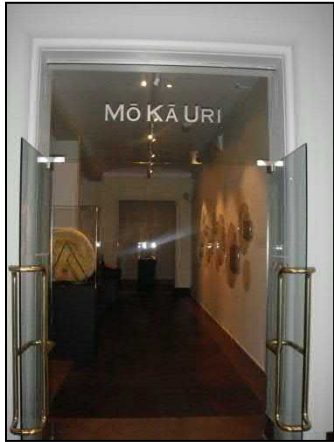
<p>Ground Floor (G16): This area in the south eastern wing has always been a corridor. Present Rating: Moderate significance</p>	
<p>High Significance Cork tile floor (OF) Original plaster moulded door surrounds (OF)</p> <p>Moderate Significance Solid plaster ceilings (OF)</p> <p>Non-contributory Lighting tracks (RF) Glass doors (RF)</p> <p>Intrusive Service conduits (RF) Wallboards overlaid on walls (RF) Air conditioning ducts in ceiling (RF) Exit sign (RF) Security cameras (RF)</p>

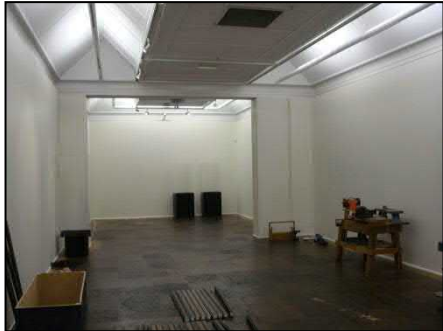
<p>Ground Floor (G17 – G19): These areas run to almost the width of the gallery on the southern side and were once used for watercolours. Again the skylights have been painted over. Present Rating: Moderate significance</p>	
<p>High Significance Cork tile floor (OF) Skylights (OF)</p> <p>Moderate Significance Solid plaster ceilings (OF)</p> <p>Non-contributory Lighting tracks (RF)</p> <p>Intrusive Service conduits (LF) Wallboards overlaid on walls (RF) Air conditioning ducts in ceiling (RF) Exit sign (RF) Security cameras (RF)</p>

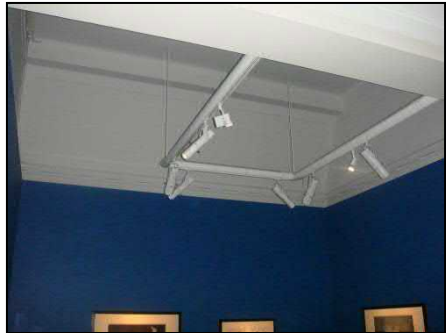
<p>Ground Floor (G20): Another small original gallery used for large oil paintings. It has had some alterations including the original skylights being painted over. Present Rating: Moderate significance</p>	
<p>High Significance Cork tile floor (OF) Skylights (OF)</p> <p>Moderate Significance Solid plaster ceilings (OF)</p> <p>Non-contributory Lighting tracks (RF)</p> <p>Intrusive Service conduits (RF) Wallboards overlaid on walls (RF) Air conditioning ducts in ceiling (RF)</p>

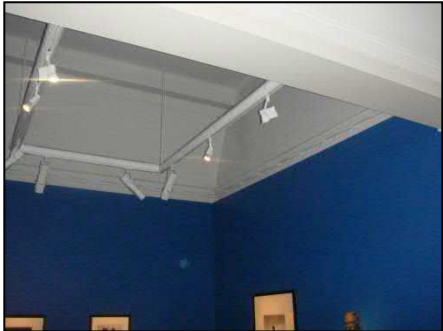
<p>Ground Floor (G21): Another small original gallery used for large oil paintings. It has had some alterations including the original skylights being painted over. Present Rating: Moderate significance</p>	
<p>High Significance Cork tile floor (OF) Skylights (OF)</p> <p>Moderate Significance Solid plaster ceilings (OF)</p> <p>Non-contributory Lighting tracks (RF) Glass doors to G23</p> <p>Intrusive Service conduits Wallboards overlaid on walls (RF) Air conditioning ducts in ceiling (RF)</p>

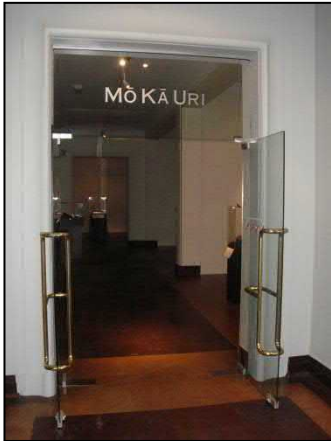
<p>Ground Floor (G22): Another circulation area that runs alongside the rooms G20 and G21 and leads into the G23 lobby area. Present Rating: Moderate significance</p>	
<p>High Significance Cork tile floor (OF) Moulded plaster surrounds to doorways</p> <p>Moderate Significance Solid plaster ceilings (OF)</p> <p>Non-contributory Lighting tracks (RF) Wall plasterboard on timber frame (LF)</p> <p>Intrusive Service conduits (RF) Wallboards overlaid on walls (RF) Air conditioning ducts in ceiling (RF) Cameras (RF) Exit sign (RF)</p>

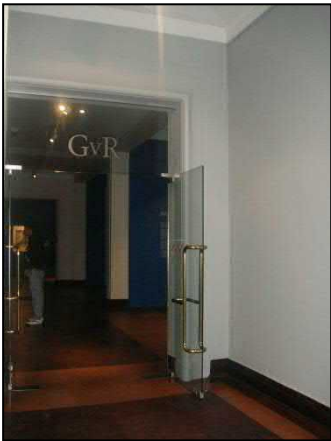
<p>Ground Floor (G23): A small lobby area near the entrance hall on the western side of the building linking circulation areas. Present Rating: Moderate significance</p>	
<p>High Significance Cork tile floor (OF) Original plaster moulded door surrounds (OF) Stained timber skirting (OF)</p> <p>Moderate Significance Solid plaster ceilings (OF) Plastered walls (OF)</p> <p>Non-contributory Glass doors with brass hardware (RF)</p> <p>Intrusive Security cameras (RF) Exit sign (RF)</p>

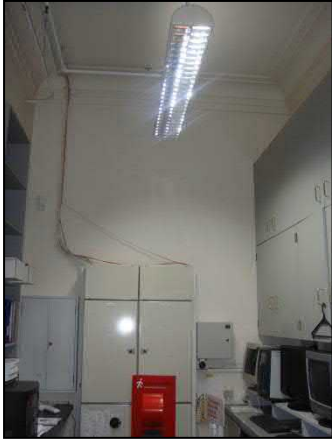
<p>Ground Floor (G24): A small storage room that was once the gallery attendant's office. Present Rating: Some significance</p>	
<p>High Significance Stained timber skirting (OF)</p> <p>Moderate Significance Fibrous plaster ceilings (OF)</p> <p>Non-contributory Carpeted floors (RF) Terrazzo counter top (RF)</p>

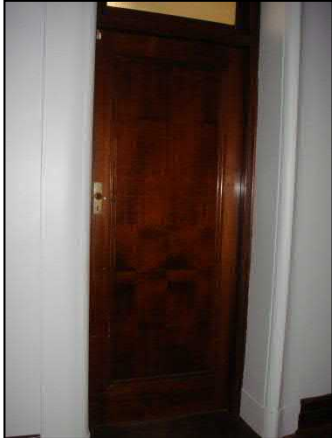
<p>Ground Floor (G27): Another circulation area that runs alongside the rooms G3 and G4 and leads into the G5 gallery. Present Rating: Moderate significance</p>

<p>High Significance Cork tile floor (OF) Original plaster moulded door surrounds (OF)</p> <p>Moderate Significance Solid plaster ceilings (OF) Plastered walls (OF)</p> <p>Non-contributory Glass doors with brass hardware (RF)</p> <p>Intrusive Vent and air conditioning ducts (RF) Security cameras (RF) Exit sign (RF)</p>

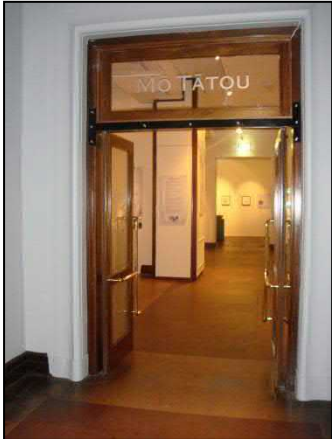
<p>Ground Floor (G28): A separate gallery area adjacent to the sculpture court. Present Rating: Moderate significance</p>	
<p>High Significance Cork tiles (OF) Original fanlight (OF) Skylight (OF) Original plaster moulded door surrounds (OF) Stained timber skirting (OF)</p> <p>Moderate Significance Solid plaster ceilings (OF) Plastered walls</p> <p>Non-contributory Glass doors with brass hardware (RF) Plasterboard walls over framing (LF) Timber framed glazed door (LF)</p> <p>Intrusive Air conditioning vents (RF) Security cameras (RF) Exit sign (RF)</p>

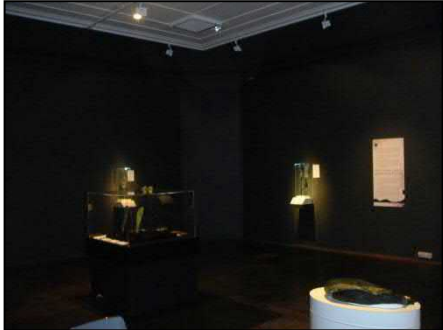
<p>Ground Floor (G29) The central sculpture court has a large amount of original fabric. Present Rating: High Significance</p>	
<p>High Significance Coffered ceiling in centre (OF) Vaulted ceiling in arcades (OF) Elaborate plaster cornice (OF) Plastered arches with capitals (OF) Plastered walls in ashlar pattern (OF) Original plaster moulded opening surrounds with lime pointing (OF) Terrazzo floor and steps (OF) Stained timber skirting (OF) Marbled columns in arcade (OF) Ventilation grilles (OF)</p> <p>Some significance Light fittings in coffered ceiling (LF)</p> <p>Non-contributory Glass doors with brass hardware (RF) Suspended light fittings (RF)</p> <p>Intrusive: Skylights in arcades blocked off (OF) Security cameras (RF) Disabled ramp added (RF)</p>

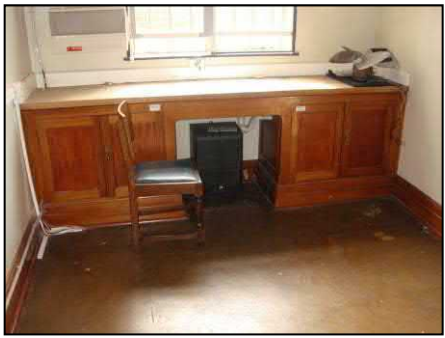
<p>Canaday Wing – Staff Room This wing was added in 1973 on the north western side. Present Rating: Some significance</p>	
<p>Some significance Plasterboard ceiling (LF) Plasterboard walls (LF) Tapestry brick walls (LF) Timber skirting and architraves (LF) Varnished flush door (LF)</p> <p>Not significant Carpeted floor</p>

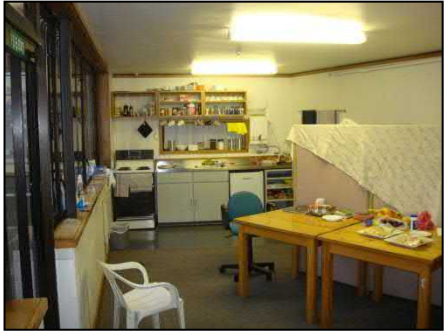
<p>Canaday Wing – Other areas This wing was added in 1973 on the north western side. Present Rating: Some significance</p>	
<p>High Significance Tapestry brick walls (OF)</p> <p>Some significance Plasterboard ceiling (LF) Plasterboard walls (LF) Timber skirting and architraves (LF) Varnished flush door (LF)</p> <p>Not significant Carpeted floor</p>

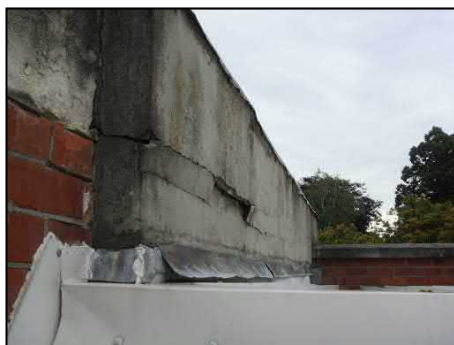
Damage to parapet with erosion evident (DPAL) membrane (DPAL)

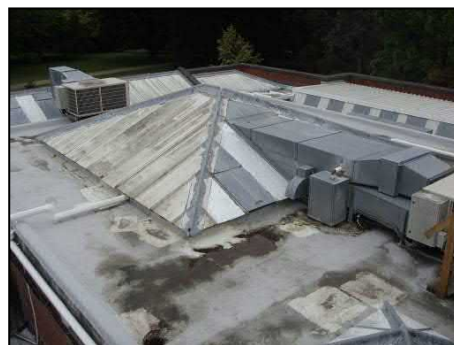
Evidence of water pooling and patched surface

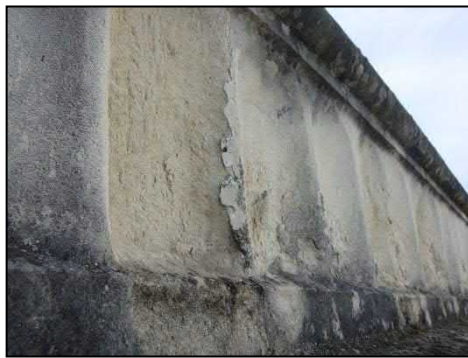
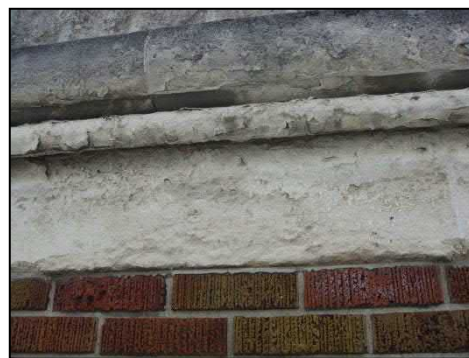
Erosion of stonework. Dirt in the pores reduces the ability of the stone to breathe while the deterioration continues below the outer surface (DPAL).

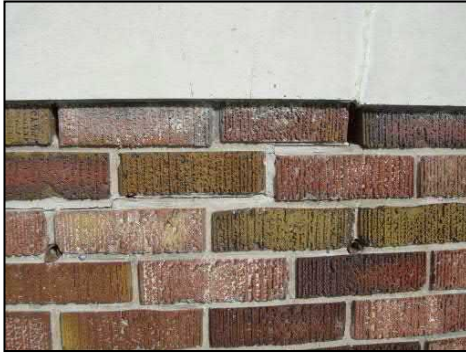
Crack in stringcourse with evidence of loss of mortar in brickwork. (DPAL)

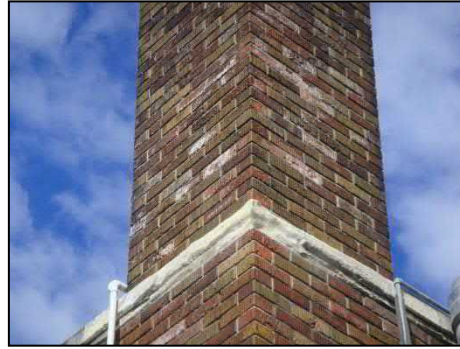
Efflorescence in chimney. Note also erosion of limestone string course (DPAL).

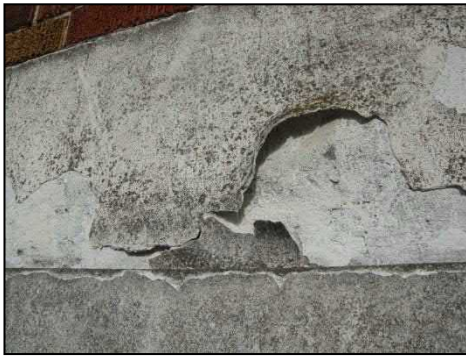
Plaster failure, east elevation (above left) and the movement between capping stones (above right) (DPAL).

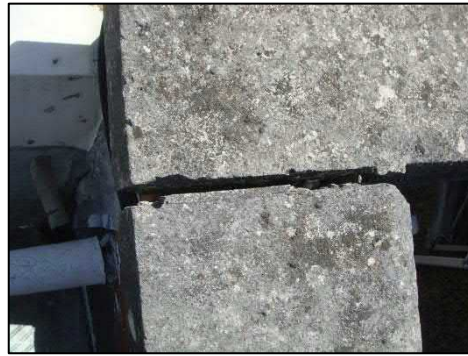
Damage as a result of the Canterbury earthquakes includes the opening up of the joints between the parapet stones and the loosening of some stones.

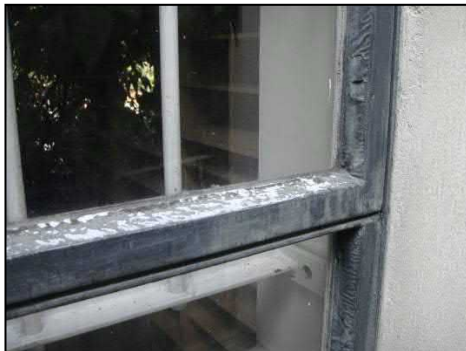
There does not appear to be any damage to the window joinery as a result of the earthquakes. The window joinery is generally in good condition. Prior to the earthquakes it was noted that paint was blistering on some of the sash frames and muntins. The putty is also sagging.

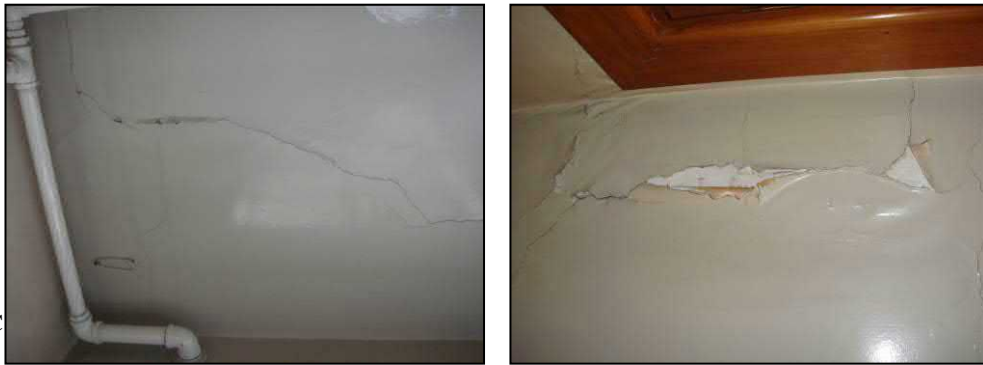
Crack and paint lifting in the wall of the upstairs servery.
