BEFORE THE CHRISTCHURCH CITY COUNCIL

IN THE MATTER of the Resource Management Act 1991 ('the Act')
AND
IN THE MATTER Of Resource Consent Application RMA/2020/2852 for the
Canterbury Museum Trust Board for a comprehensive
redevelopment of the Canterbury Museum complex including the
Robert McDougall Gallery

**EVIDENCE OF TREVOR WATT OF ATHFIELD ARCHITECTS LIMITED ON BEHALF OF THE
CANTERBURY MUSEUM TRUST BOARD**

Dated 25th May 2021

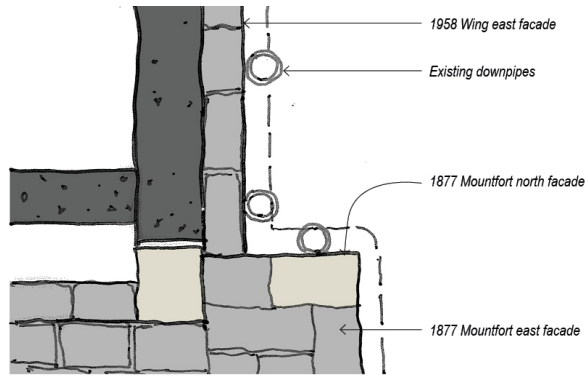
Image 3: Current 1877 / 1958 Wall Junction

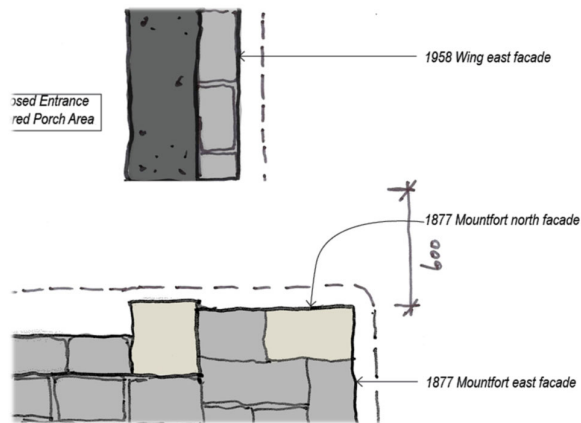
Image 5: Proposed 1958 / 1877 Wall Junction

92 **The proposed separation detail with no infill is absolutely the least intrusion and impact on the heritage fabric of the highly significant 1877 façade and allows the total highly significant façade to be revealed in full.** This is achieved with the minimal removal of heritage fabric of secondary significance.

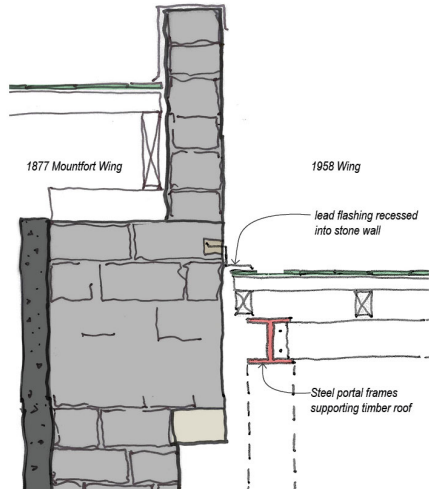
Image 6: Current 1877 / 1958 Roof Junction

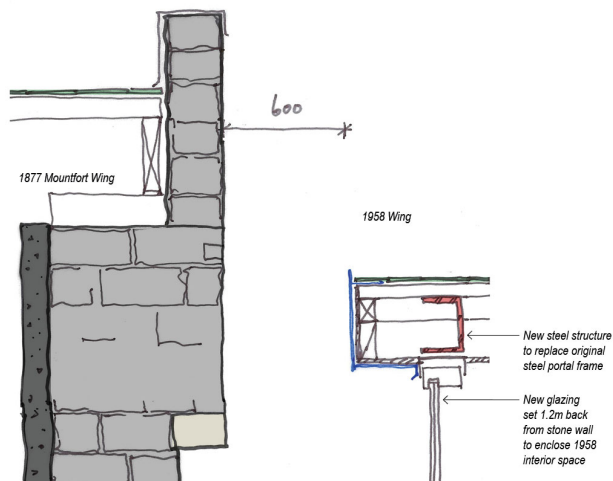
Image 8: Proposed 1877 Wall / 1958 Roof Junction

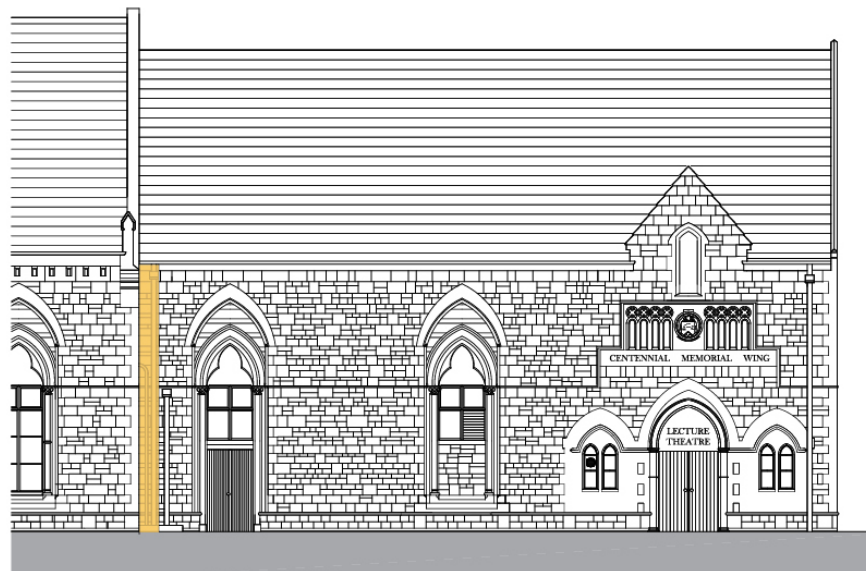
Plan view: 1958 Wing east facade

Image 9: Existing 1958 Wing Façade Plan & Elevation. Area in orange indicates extent of the listed façade fabric removal for the separation in relation to the whole 1958 listed façade.

- 94 As there is acceptance of a seismic joint in the order of 200mm, the only area of difference in agreement is to the additional loss of 400mm of 1958 concrete and stone wall material fabric as the 1958 roof element is outside of the item of listed significance in the CDP (although it is acknowledged the eastern roof fabric is recommended to be retained in Policy 8.10.5 of the Building Conservation Plan).

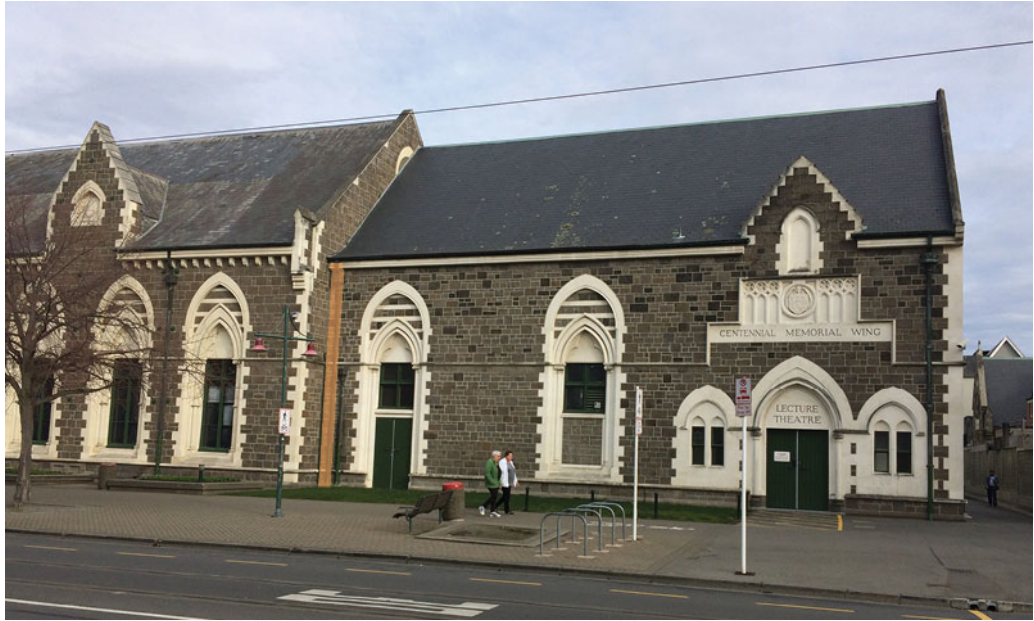
Image 10: Existing 1958 Wing Façade Plan. Area in orange indicates extent of listed façade fabric removal for the separation in relation to the whole 1958 listed façade. (source: Athfield Architects Ltd, 2020)

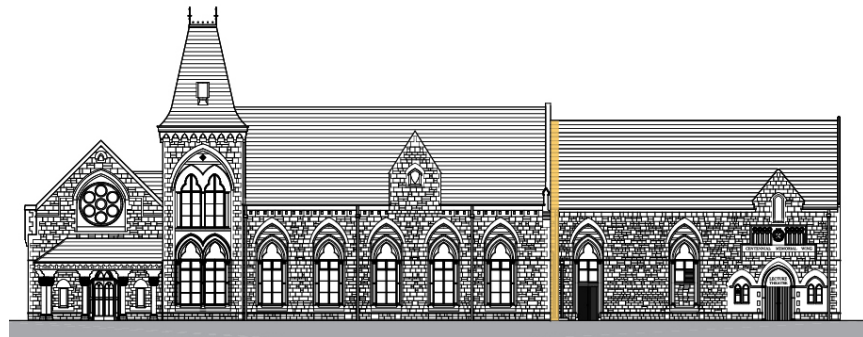
Image 11: Existing Rolleston Avenue Museum Plan & Elevation. Area in orange indicates the extent of 1958 façade & roof fabric removal for the separation in context with the whole Rolleston Avenue façade.

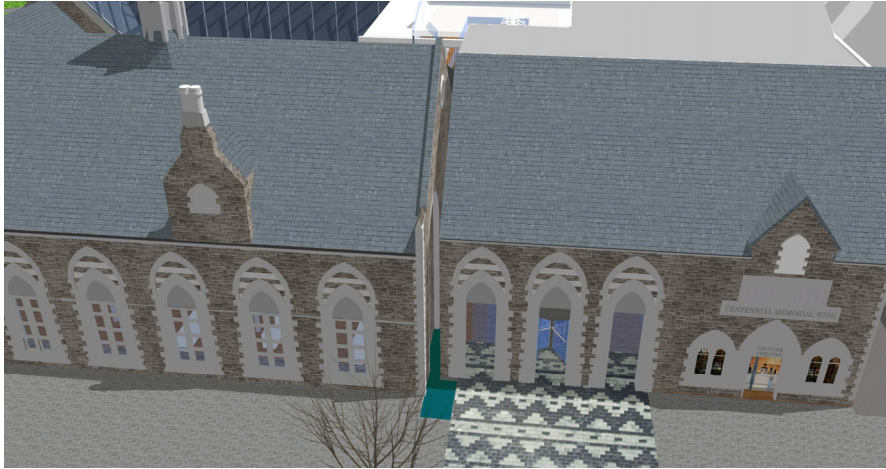
Image 12: Additional sketch view of the proposed subtle separation between the 1877 and 1958 buildings

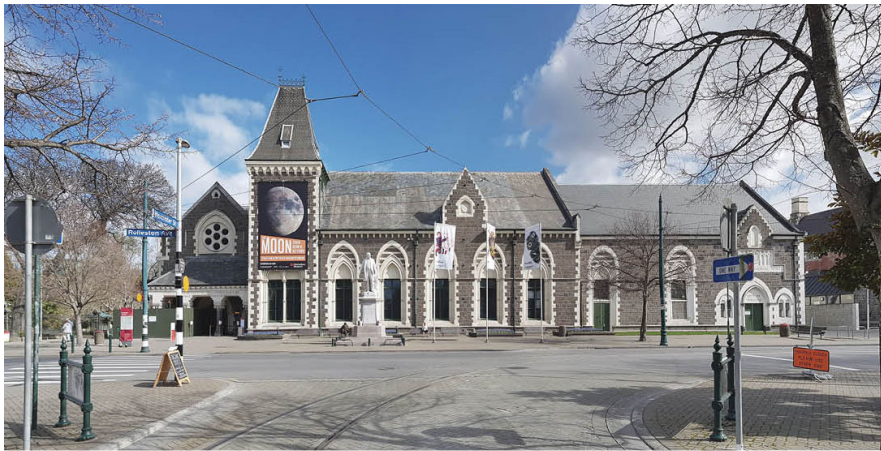
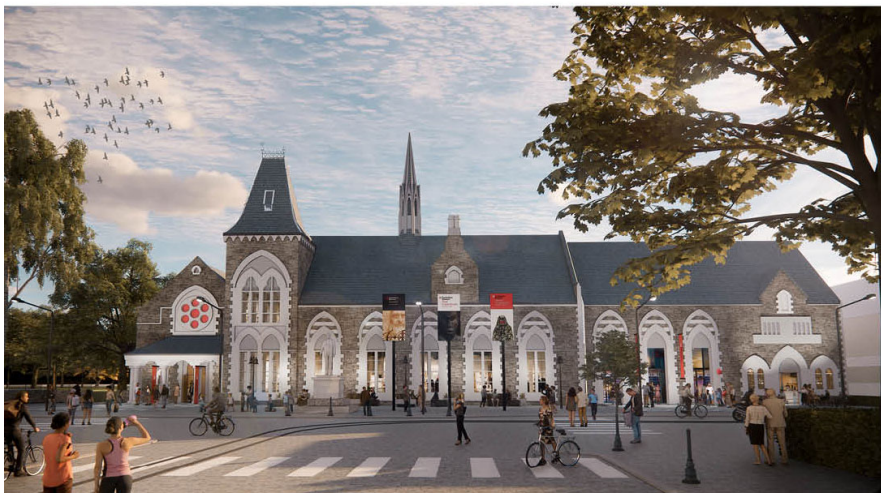
Image 13: Comparison of the existing and proposed Rolleston Avenue (Eastern) façade of Canterbury Museum taken from centre of Worcester Boulevard. Note that the separation is not visible from this perspective.

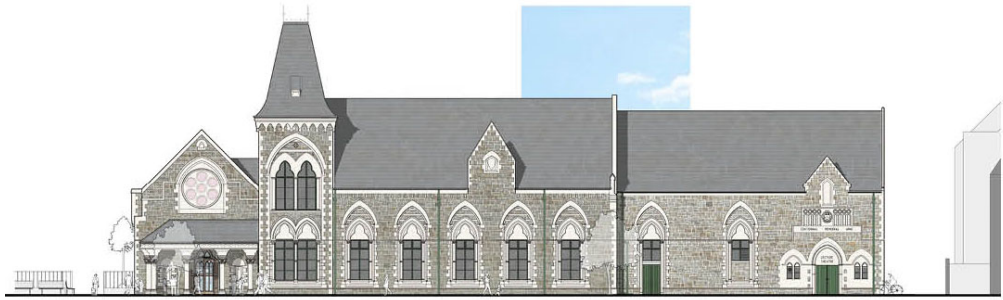
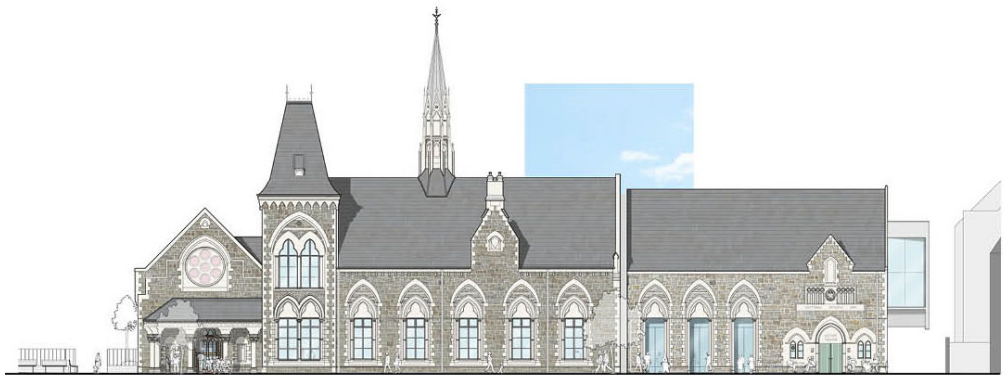
Image 14: Comparison of the Existing and Proposed Rolleston Avenue (Eastern) Façade of Canterbury Museum

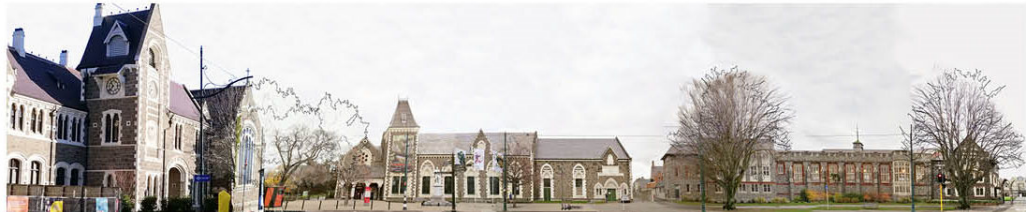
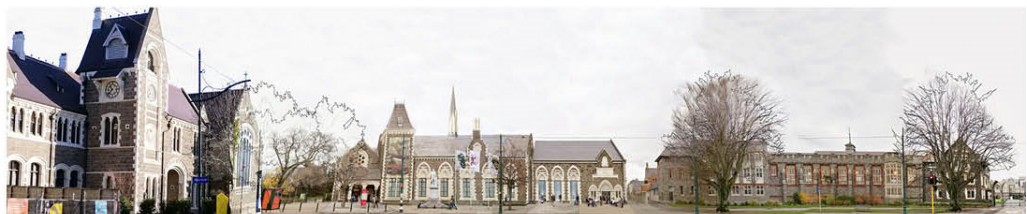
Image 15: Comparison of photo montage of combined Arts Centre (partial), Canterbury Museum, Christs College neo-gothic precinct facades. Note that this image has been created by removal of all other context and is not a perspective that is possible to view. The intent of the image is to convey the sense of continuity of the neo-gothic precinct, experienced when walking Worcester Boulevard & Rolleston Avenue. As can be seen in this image the separation between the 1877 & 1958 buildings is barely discernible.

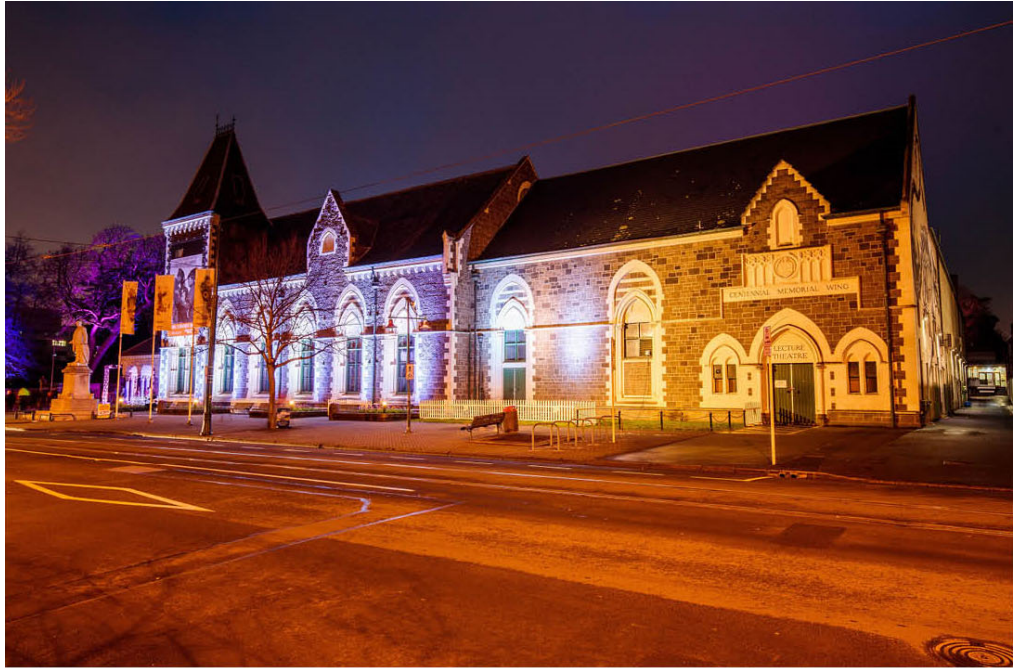
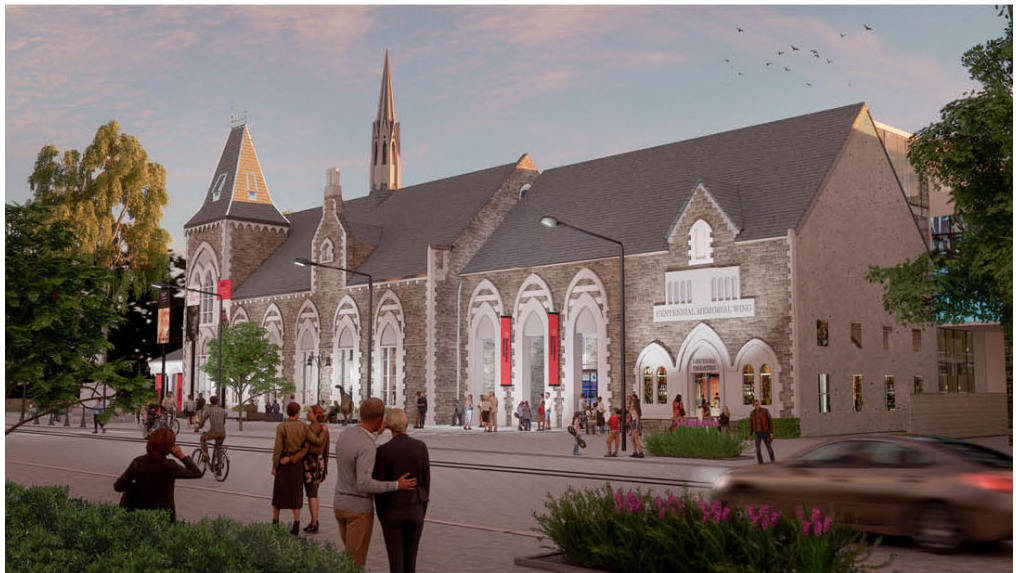
Image 16: Comparison of the Existing and Proposed Rolleston Avenue (Eastern) Façade of Canterbury Museum taken from centre of Rolleston Avenue, opposite Christs College. Note that the separation is not readily discernible from this perspective.

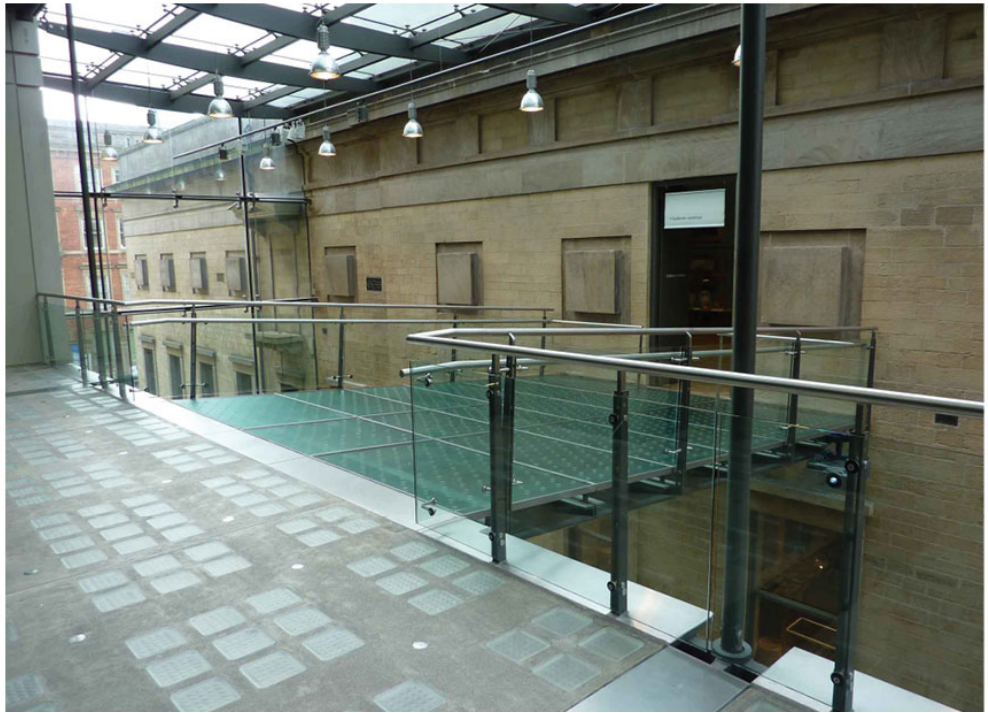
Image 18: Example of double height stone heritage wall being able to be legible from inside to outside. (note that in this case there is a glazed wall and roof connection). Manchester Art Gallery. Hopkins Architects (source: Anglezarke, 2009)

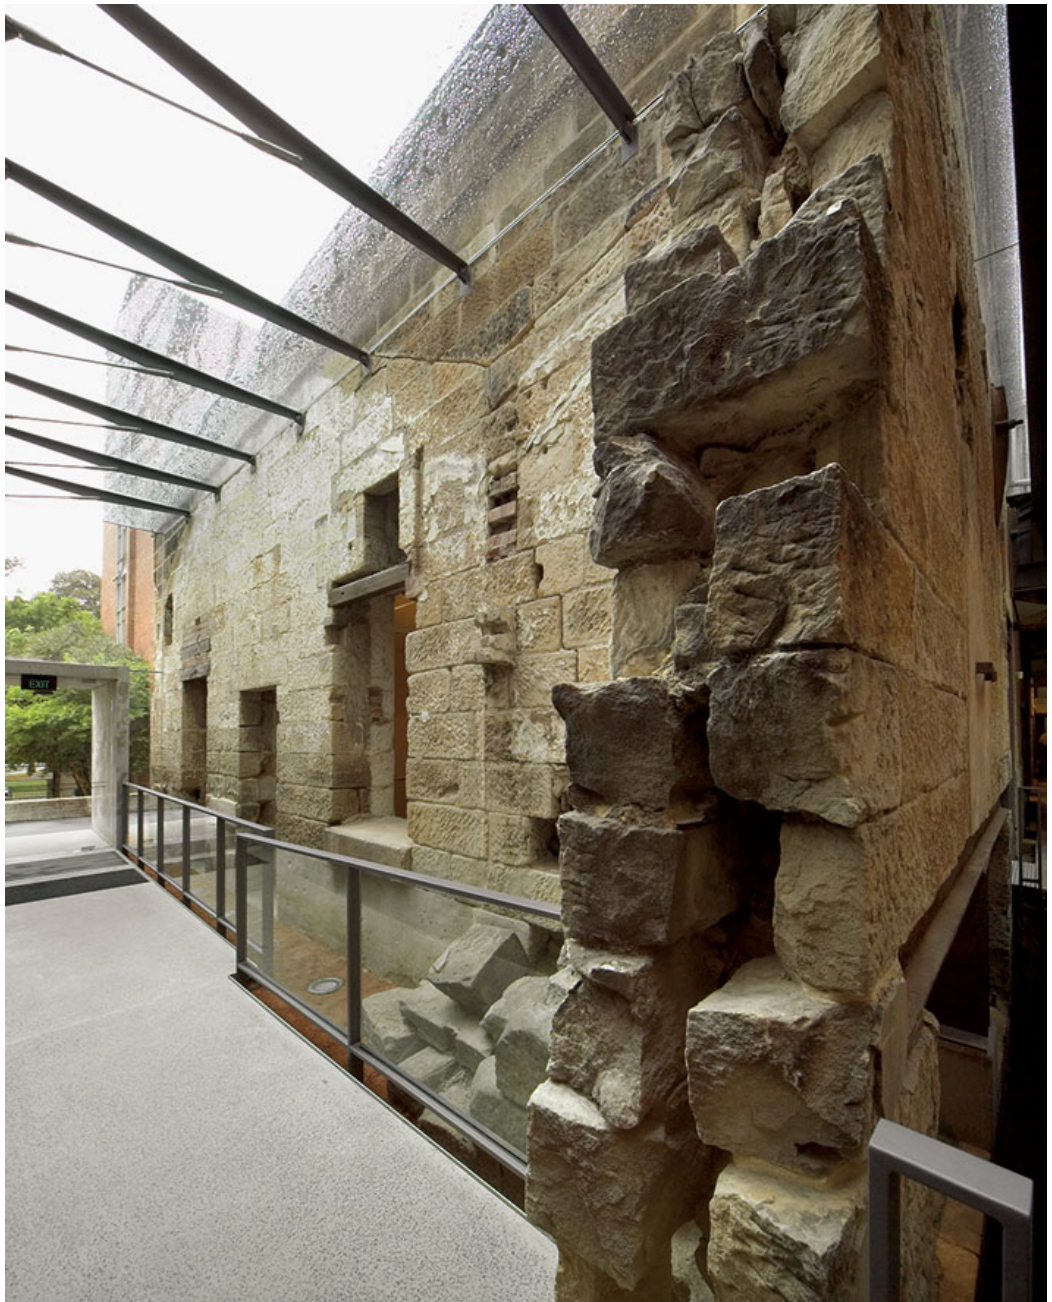
Image 20: Example of heritage stone wall with glazed separation to wall and roof allowing full appreciation of heritage wall inside and out. This image also highlights one benefit of the proposed open (non-glazed) separation in that even with glazing providing a high level of openness, you still get structure, reflections and rain which reduce visibility. The Mint, Sydney, FJMT Architects, 2002 (source: John Gollings)

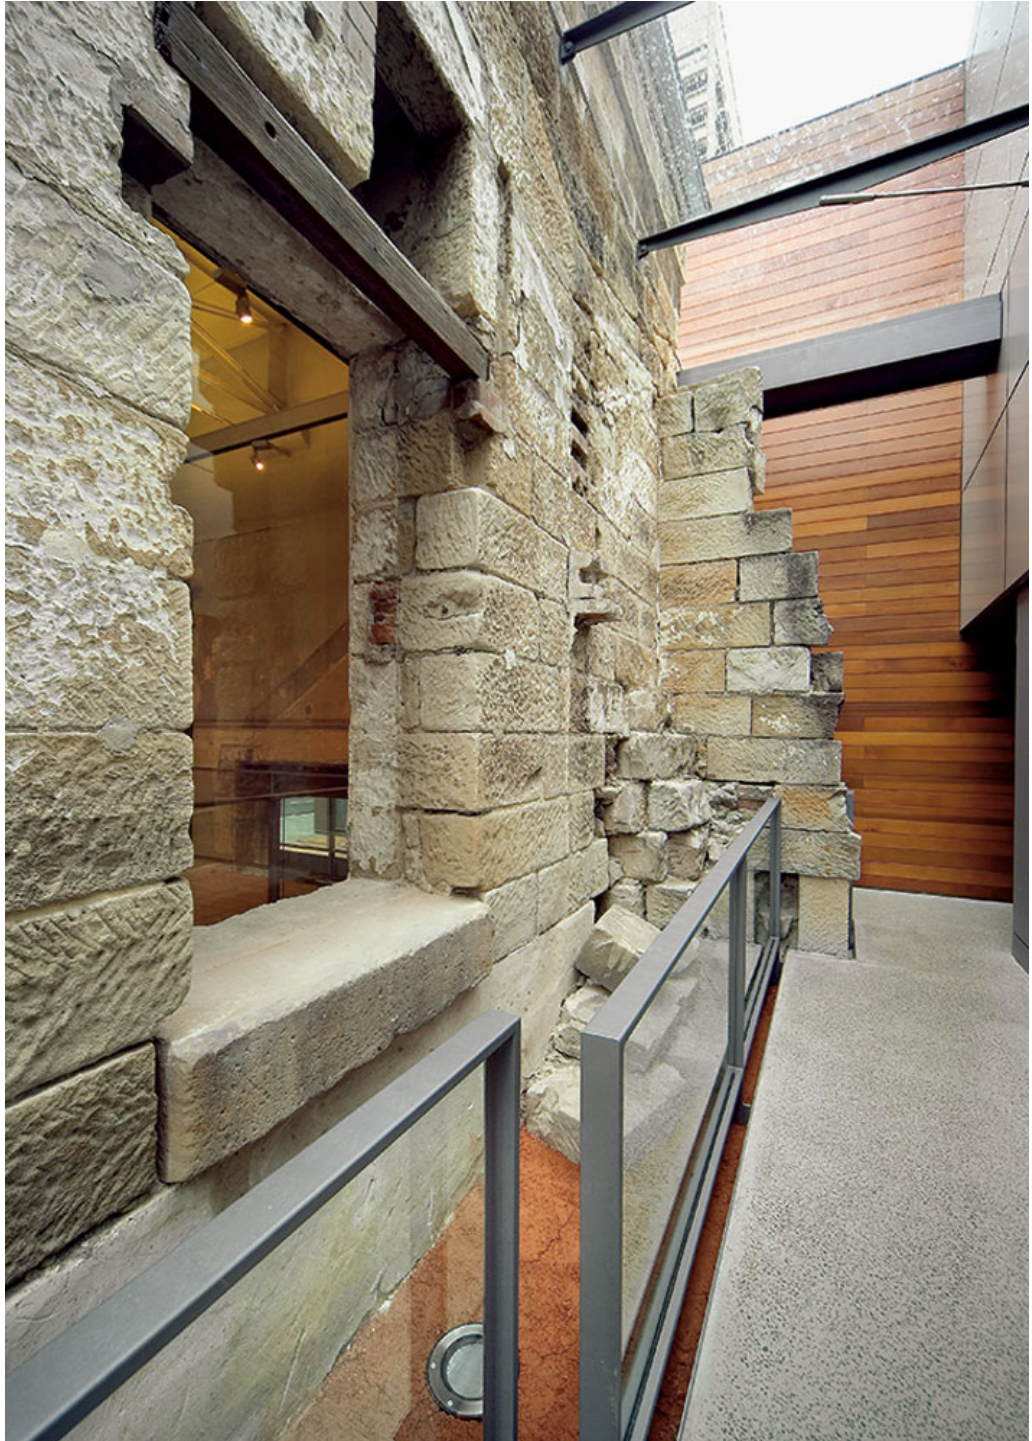
Image 21: Example of heritage stone wall with glazed separation to roof allowing greater appreciation of heritage wall inside and out. This image also highlights similar aspects to the separation between the 1877 & 1958 wings; the clear separation of new structure from primary significance even at floor level, the natural light grazing down the uneven stonework, the appreciation of the heritage wall even within a narrow space in this case a narrow corridor space) The Mint, Sydney, FJMT Architects, 2002 (source: John Gollings)

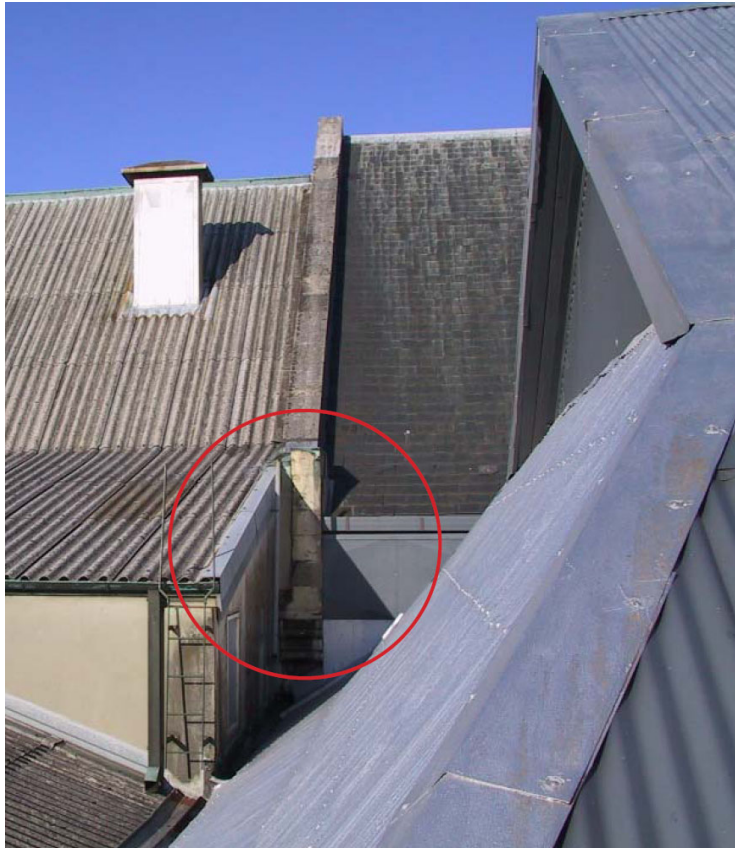
Image 22: Existing 1877, 1882, 1958 roof junction. This highlights the complexity of flashing (both for seismic and waterproofing) where multiple buildings come together. This indicates the physical impact to heritage fabric and legibility of heritage form (source Athfield Architects Ltd, 2000).

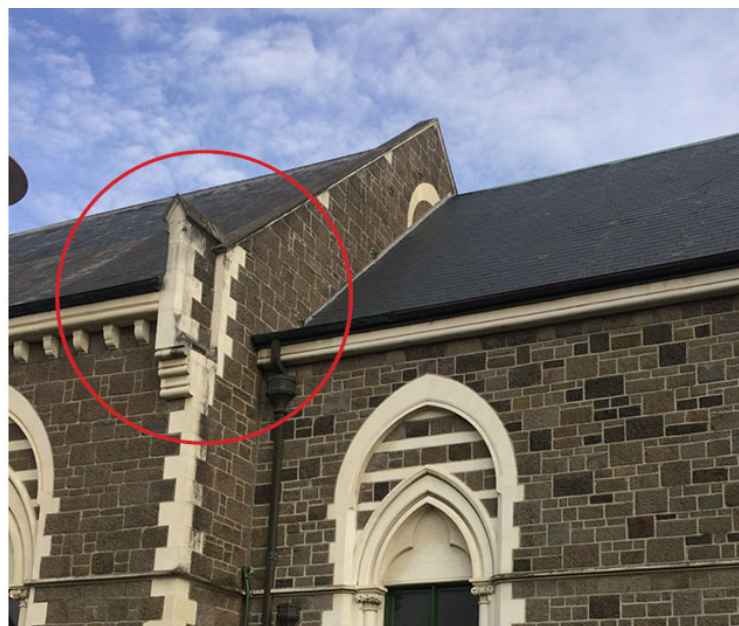
Image 23: Eastern corbel detail of the 1877 Wing. The redevelopment will unveil the western corbel to public view. If a physical connection were to be required, due to the detailed nature of the corbel it is

very complex and difficult to achieve a robust seismic and waterproofing detail, without a high degree of intervention to the original heritage fabric. (source Athfield Architects Ltd, 2020).

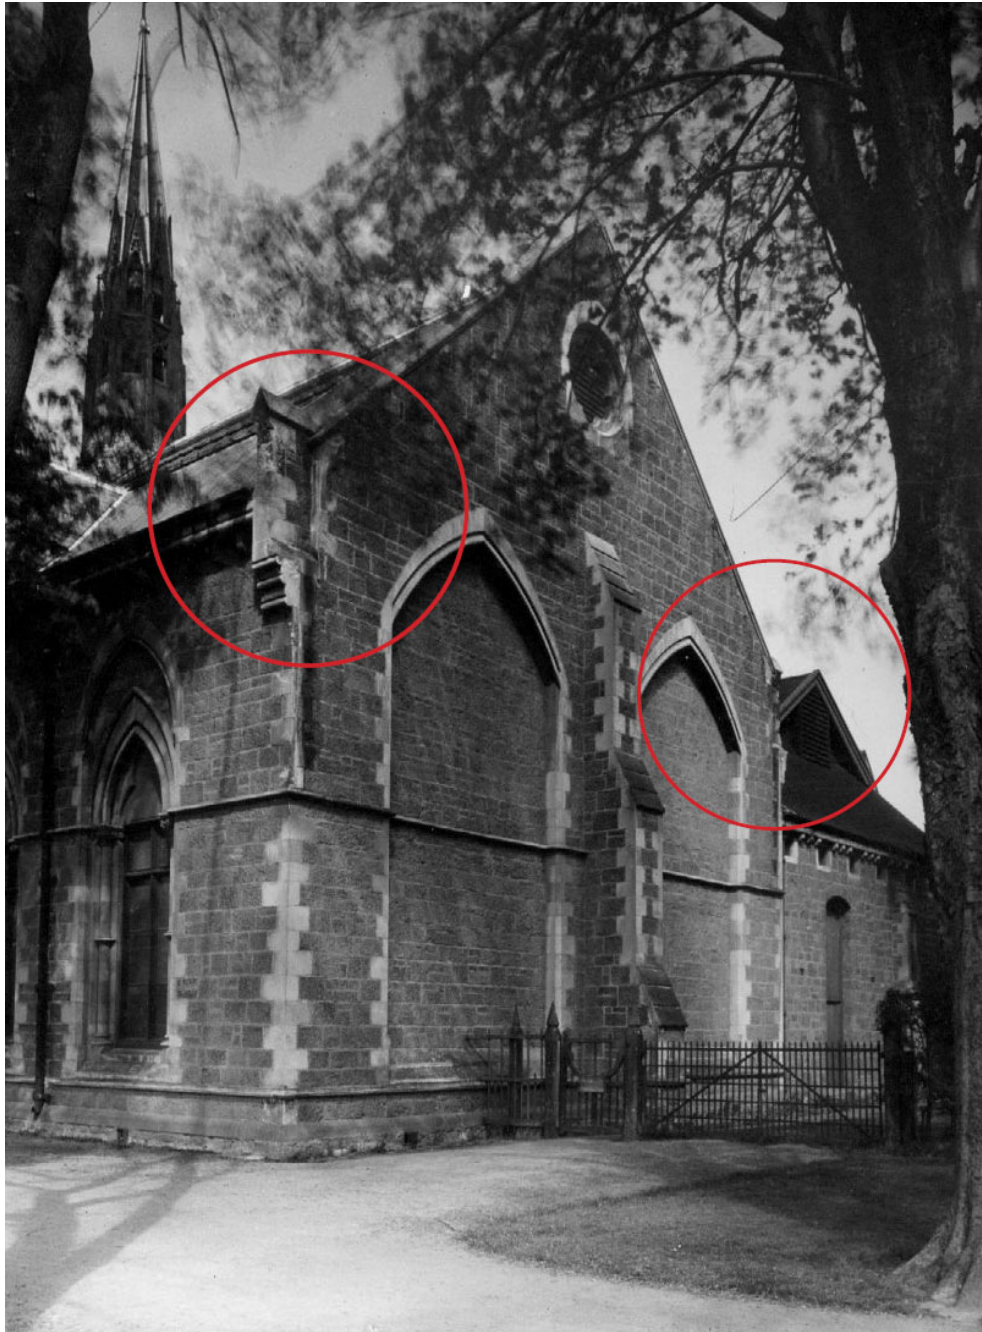
Image 24: 1877 Mountfort Building, north wall pre-1958. The central buttress has been demolished with the construction of the 1958 building, however all evidence suggests that all of the remainder of this façade will be able to be revealed to the public as part of the redevelopment, including the corbel detail (within right-hand circle) (original image source: Canterbury Museum archives)

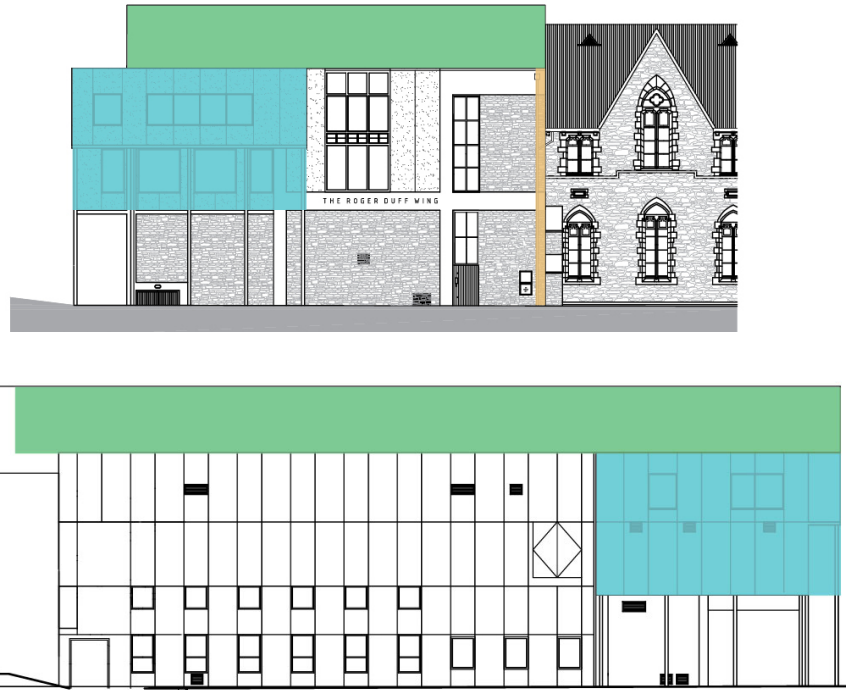
Image 29: Current 1977 facades, with highlighted areas requiring design considerations with the redevelopment. It should be noted that the reason there are numerous design consideration to this public face of the Museum is that the majority of the other public faces are the more highly significant Mountfort buildings.

Green is the upper floor addition (considerations included cladding materials & window articulation)

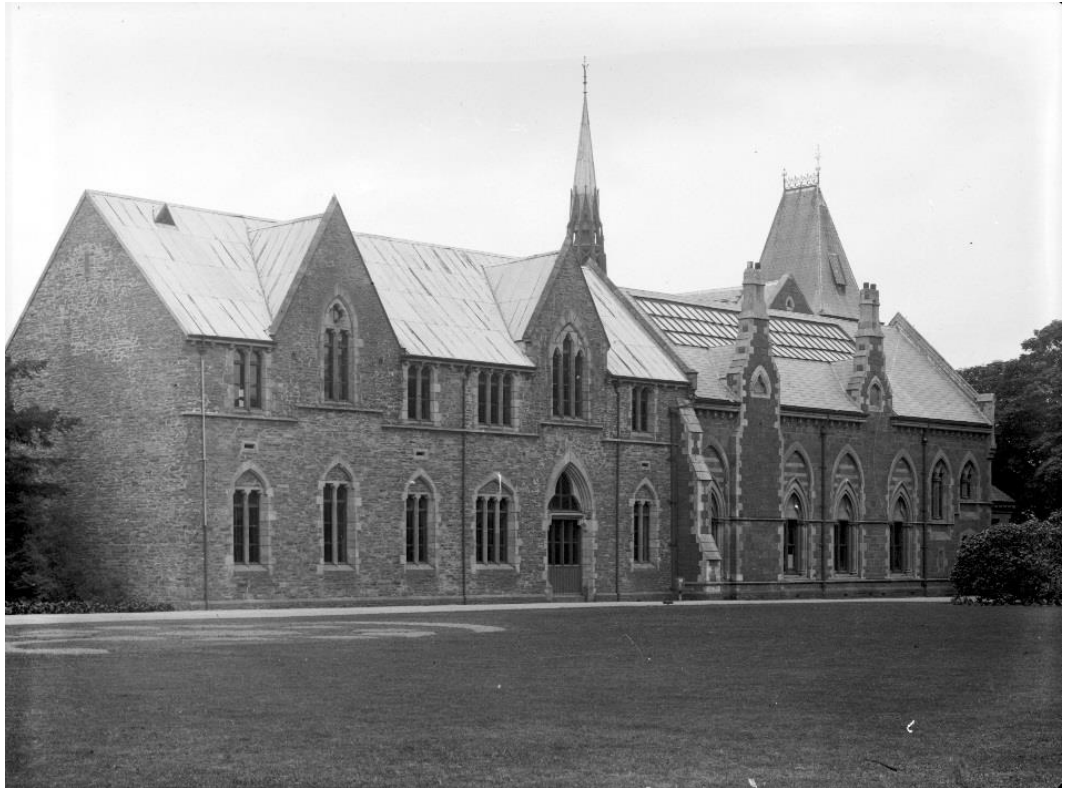
Image 31: View from Botanic Gardens showing 1872 & 1877 Wings. The benefit of the wider glazing proposed to the existing 1977 façade adjacent to the 1872 Mountfort building is that it will provide greater legibility of the Mountfort era and the gabled form of the west 1872 facade will be unveiled (albeit without the stone) (source WA Taylor photograph, Canterbury Museum archives)

- 129 The Canterbury Museum Building Conservation Plan Policy 8.10.6 strategy 3 was particularly relevant when reviewing the design options in relation to the junction with the 1872 Wing. As well as the seismic joint integration, the additional glazing to the stairwell allows the opportunity for greater legibility of the form of the 1872

Wing (refer image 31). This additional glazing is also important in completion of the legibility of the Mountfort era edge – refer image 27.
