CONCEPT DESIGN - ELEVATIONS & SECTIONS

20.02
 Canterbury Museum Redevelopment Project
Concept Design Report
 Final for Resource Consent
 25th November 2020

CONCEPT DESIGN 3D AXONOMETRIC VIEWS

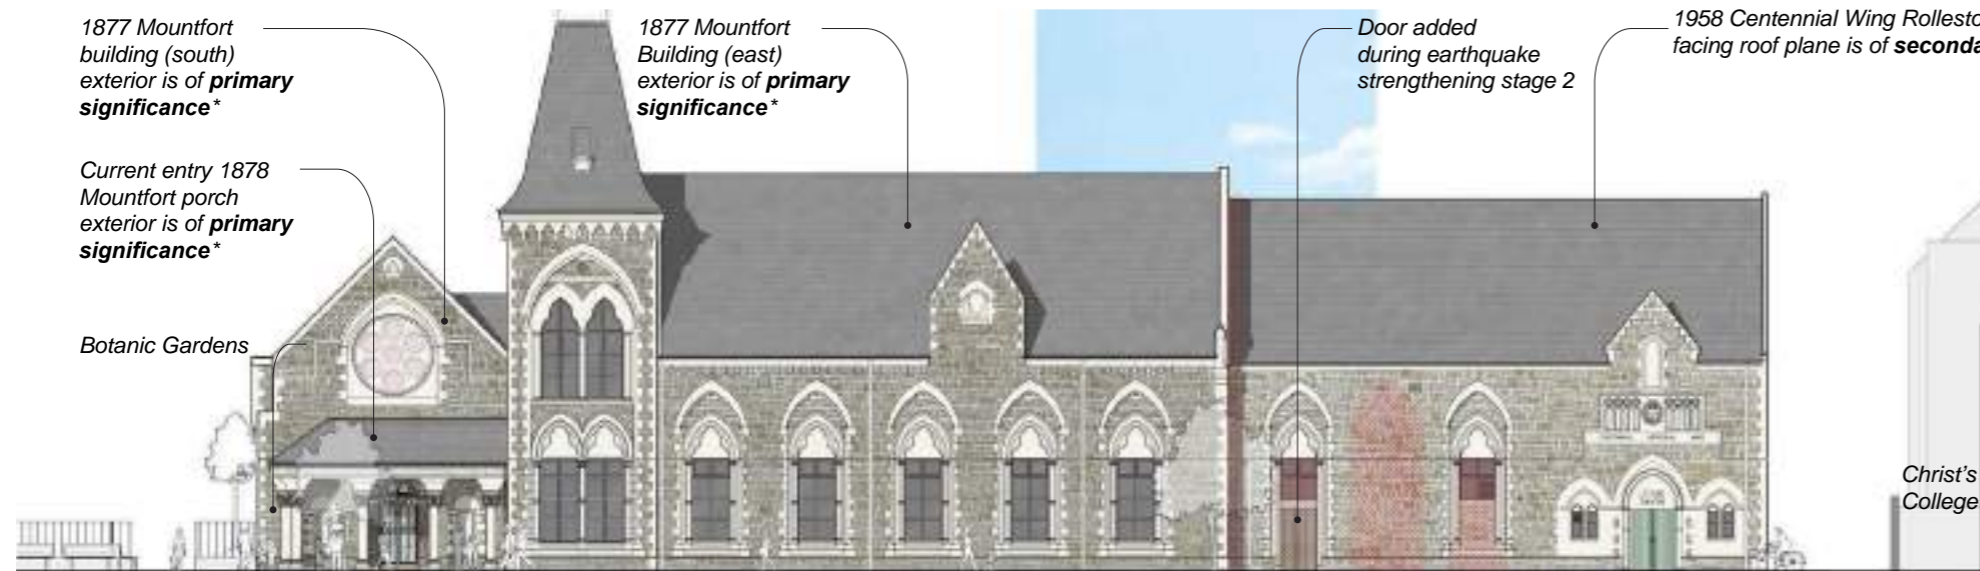
MUSEUM EAST ELEVATION - LOOKING FROM ROLLESTON AVENUE

Current condition

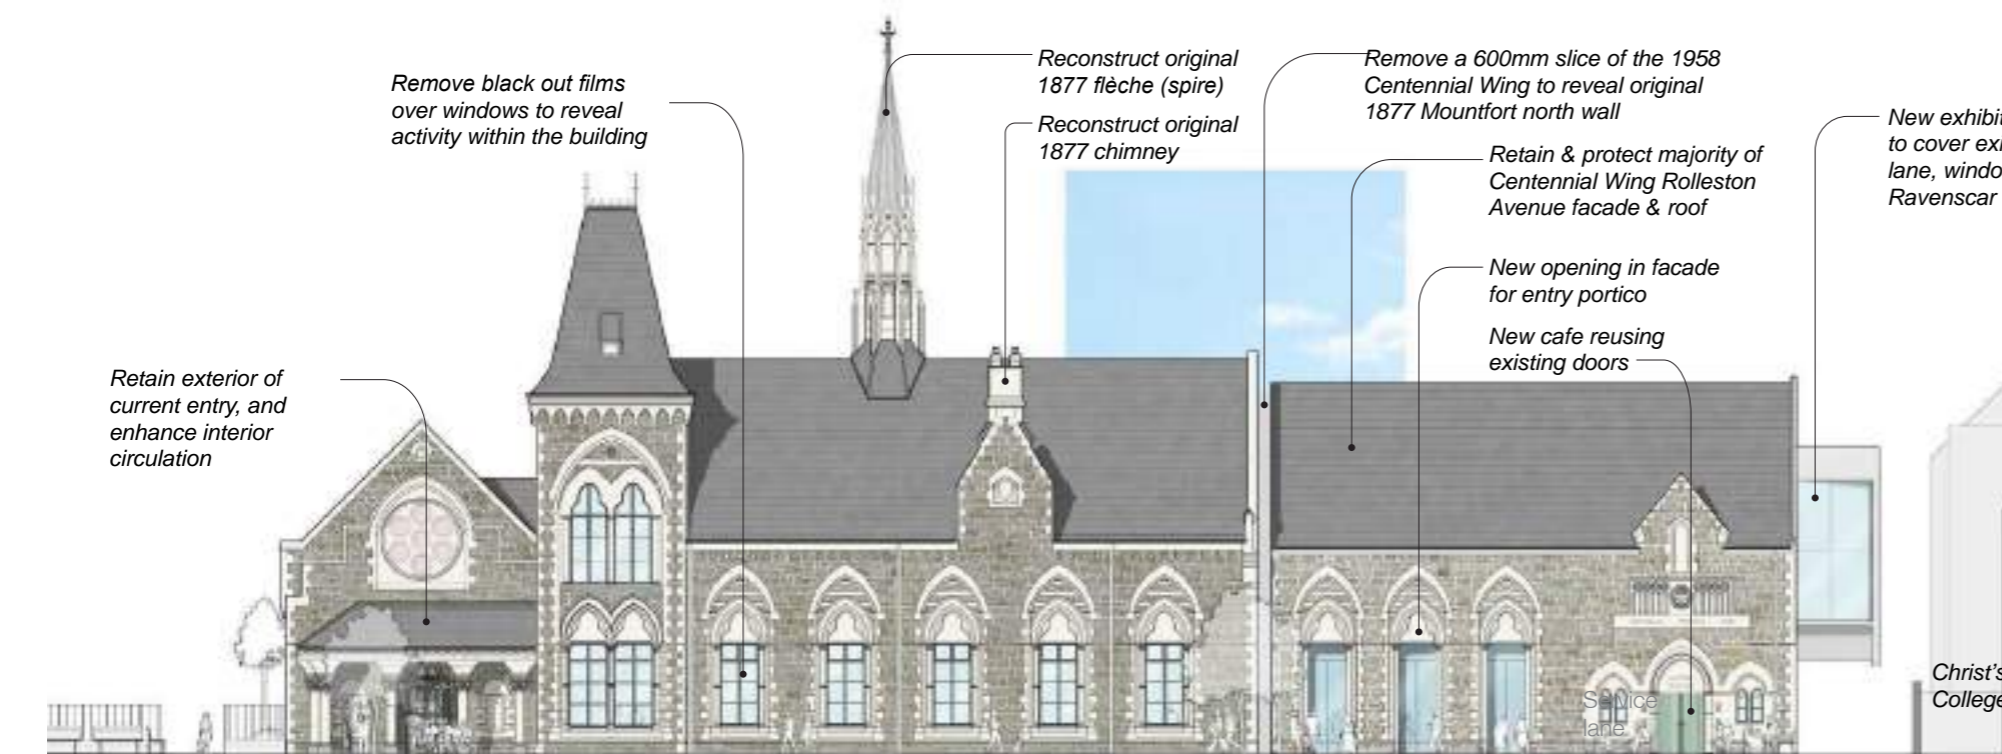
Proposed

Original entry

Additional entry

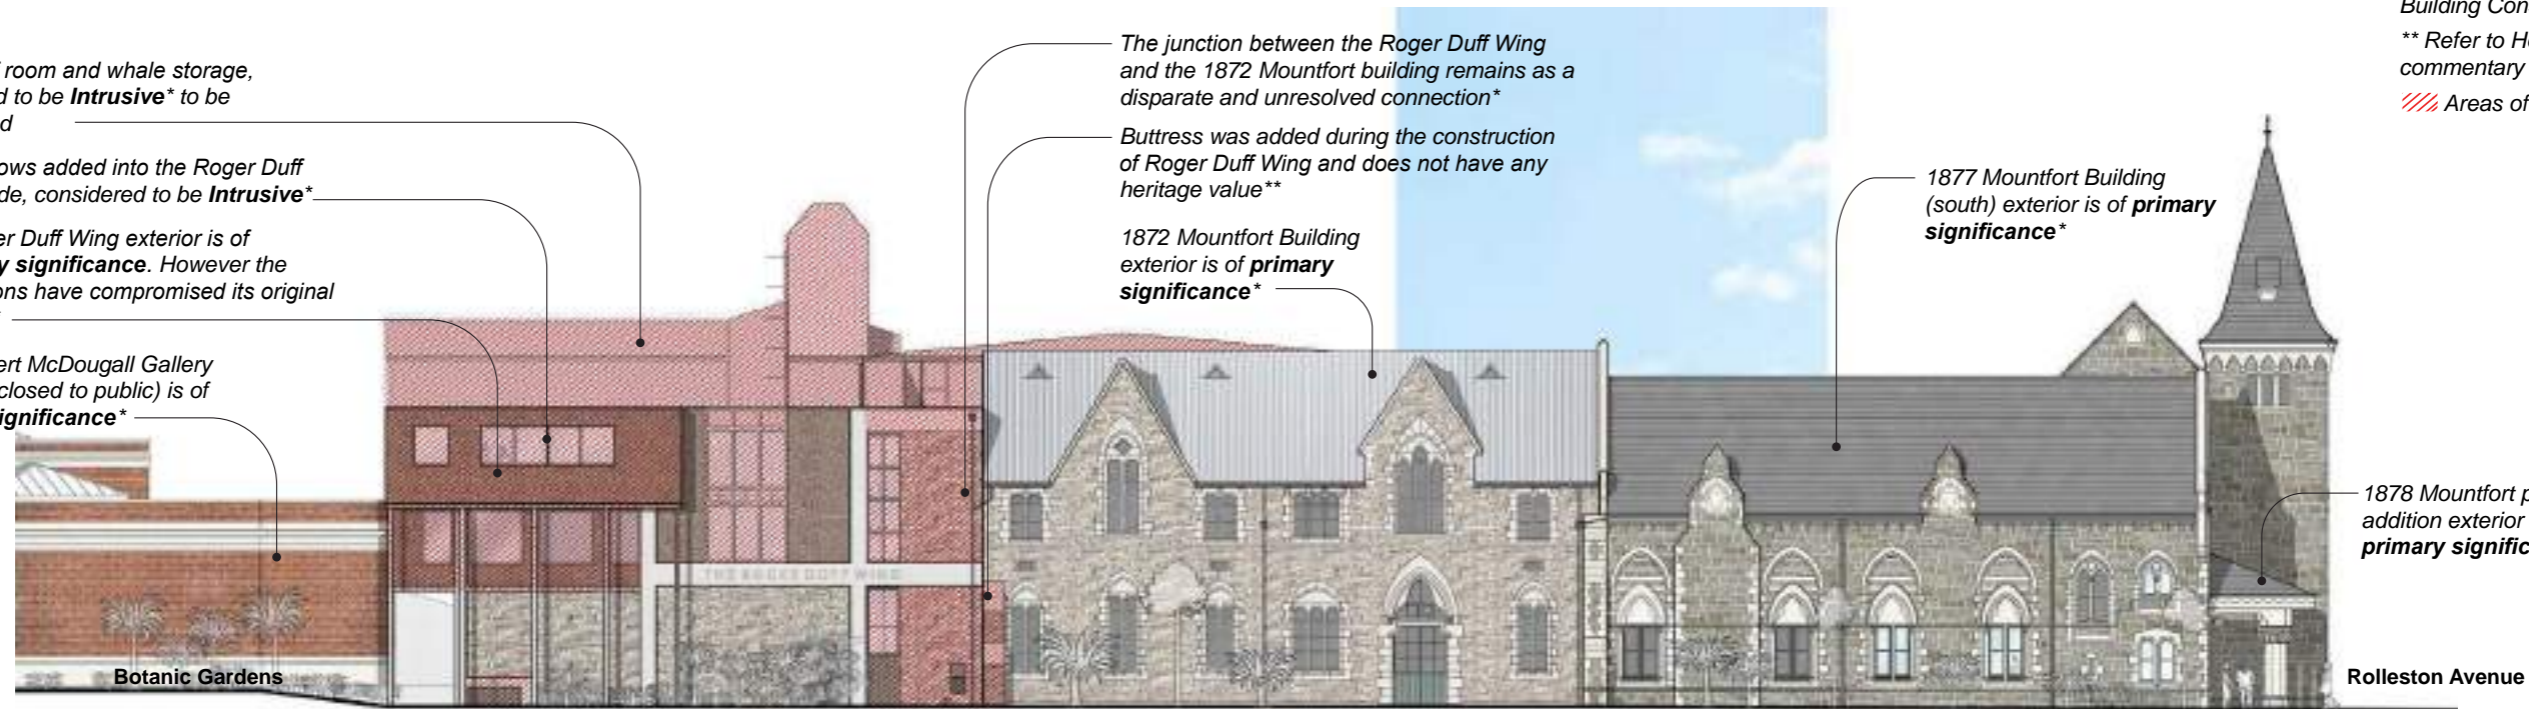
MUSEUM SOUTH ELEVATION - LOOKING FROM BOTANIC GARDENS

1995 Staff room and whale storage, considered to be **Intrusive*** to be demolished

Cafe windows added into the Roger Duff Wing facade, considered to be **Intrusive***

1977 Roger Duff Wing exterior is of **secondary significance**. However the modifications have compromised its original character*

1932 Robert McDougall Gallery (currently closed to public) is of **primary significance***

The junction between the Roger Duff Wing and the 1872 Mountfort building remains as a disparate and unresolved connection*

Buttress was added during the construction of Roger Duff Wing and does not have any heritage value**

1872 Mountfort Building exterior is of **primary significance***

1877 Mountfort Building (south) exterior is of **primary significance***

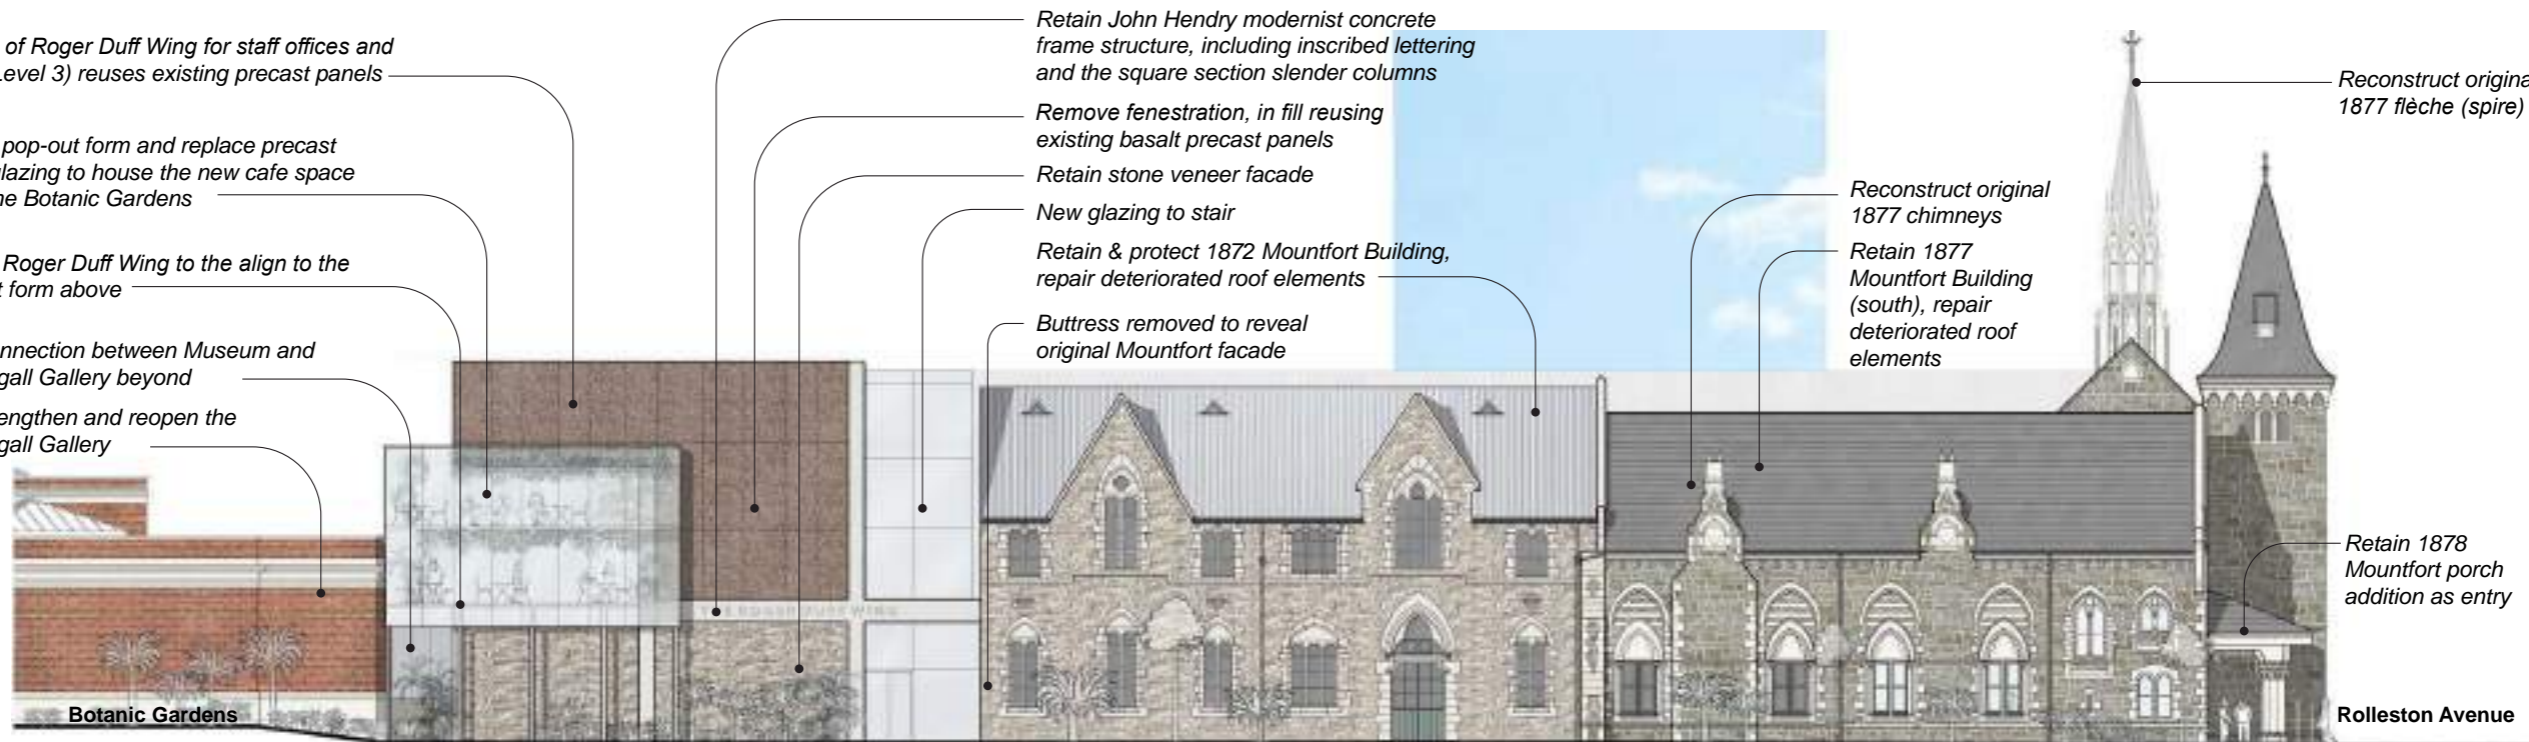
New extension of Roger Duff Wing for staff offices and work spaces (Level 3) reuses existing precast panels

Retain original pop-out form and replace precast cladding with glazing to house the new cafe space with views of the Botanic Gardens

Extend floor of Roger Duff Wing to the align to the face of pop-out form above

New glazed connection between Museum and Robert McDougall Gallery beyond

Structurally strengthen and reopen the Robert McDougall Gallery

Retain John Hendry modernist concrete frame structure, including inscribed lettering and the square section slender columns

Remove fenestration, in fill reusing existing basalt precast panels

Retain stone veneer facade

New glazing to stair

Retain & protect 1872 Mountfort Building, repair deteriorated roof elements

Buttress removed to reveal original Mountfort facade

Reconstruct original 1877 flèche (spire)

Reconstruct original 1877 chimneys

Retain 1877 Mountfort Building (south), repair deteriorated roof elements

Retain 1878 Mountfort porch addition as entry

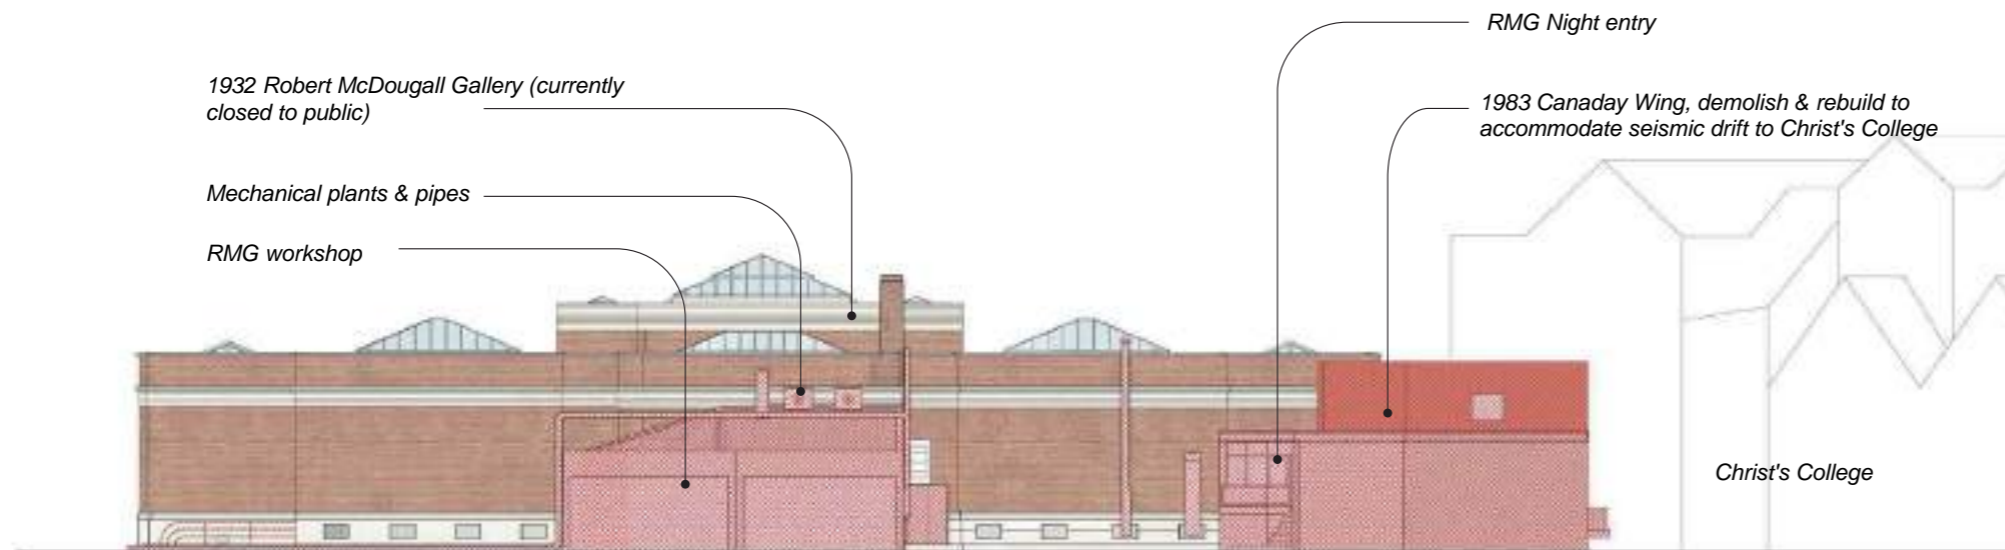
RMG EAST ELEVATION - TRUE ELEVATION

Current condition

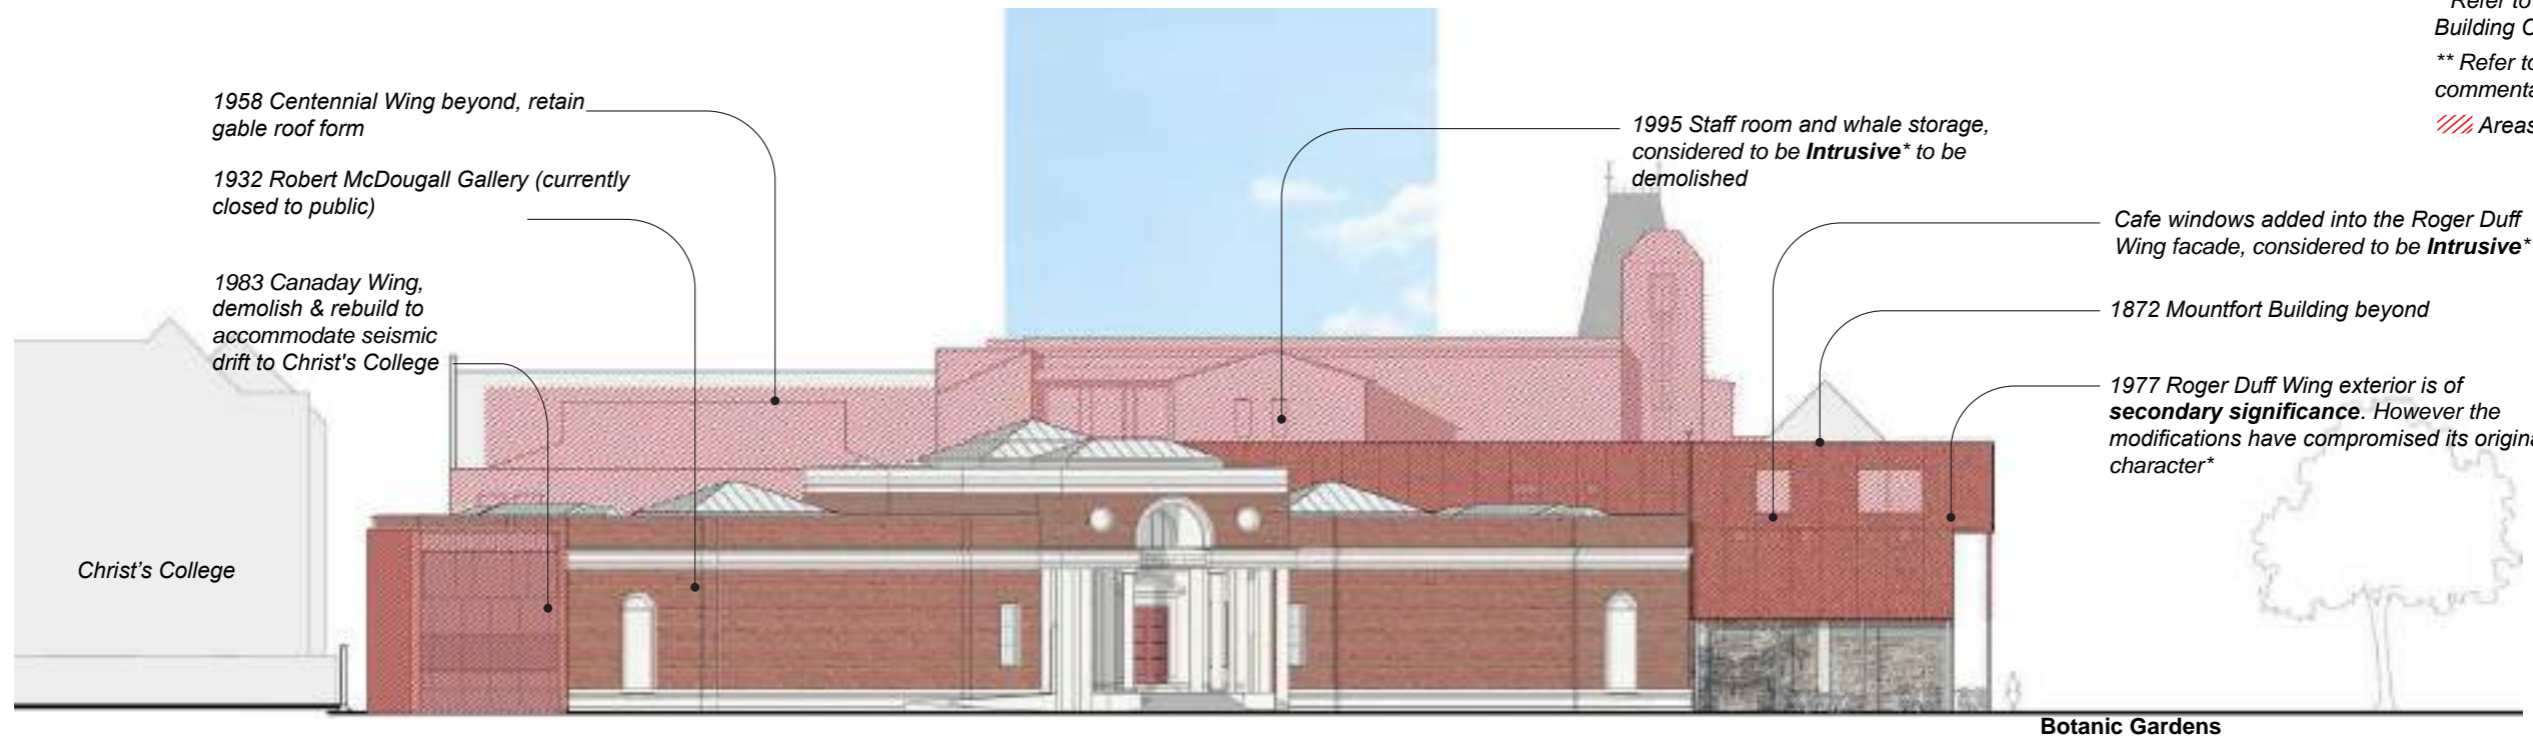
MUSEUM WEST ELEVATION 1 - LOOKING FROM ROBERT MCDUGALL

Current condition

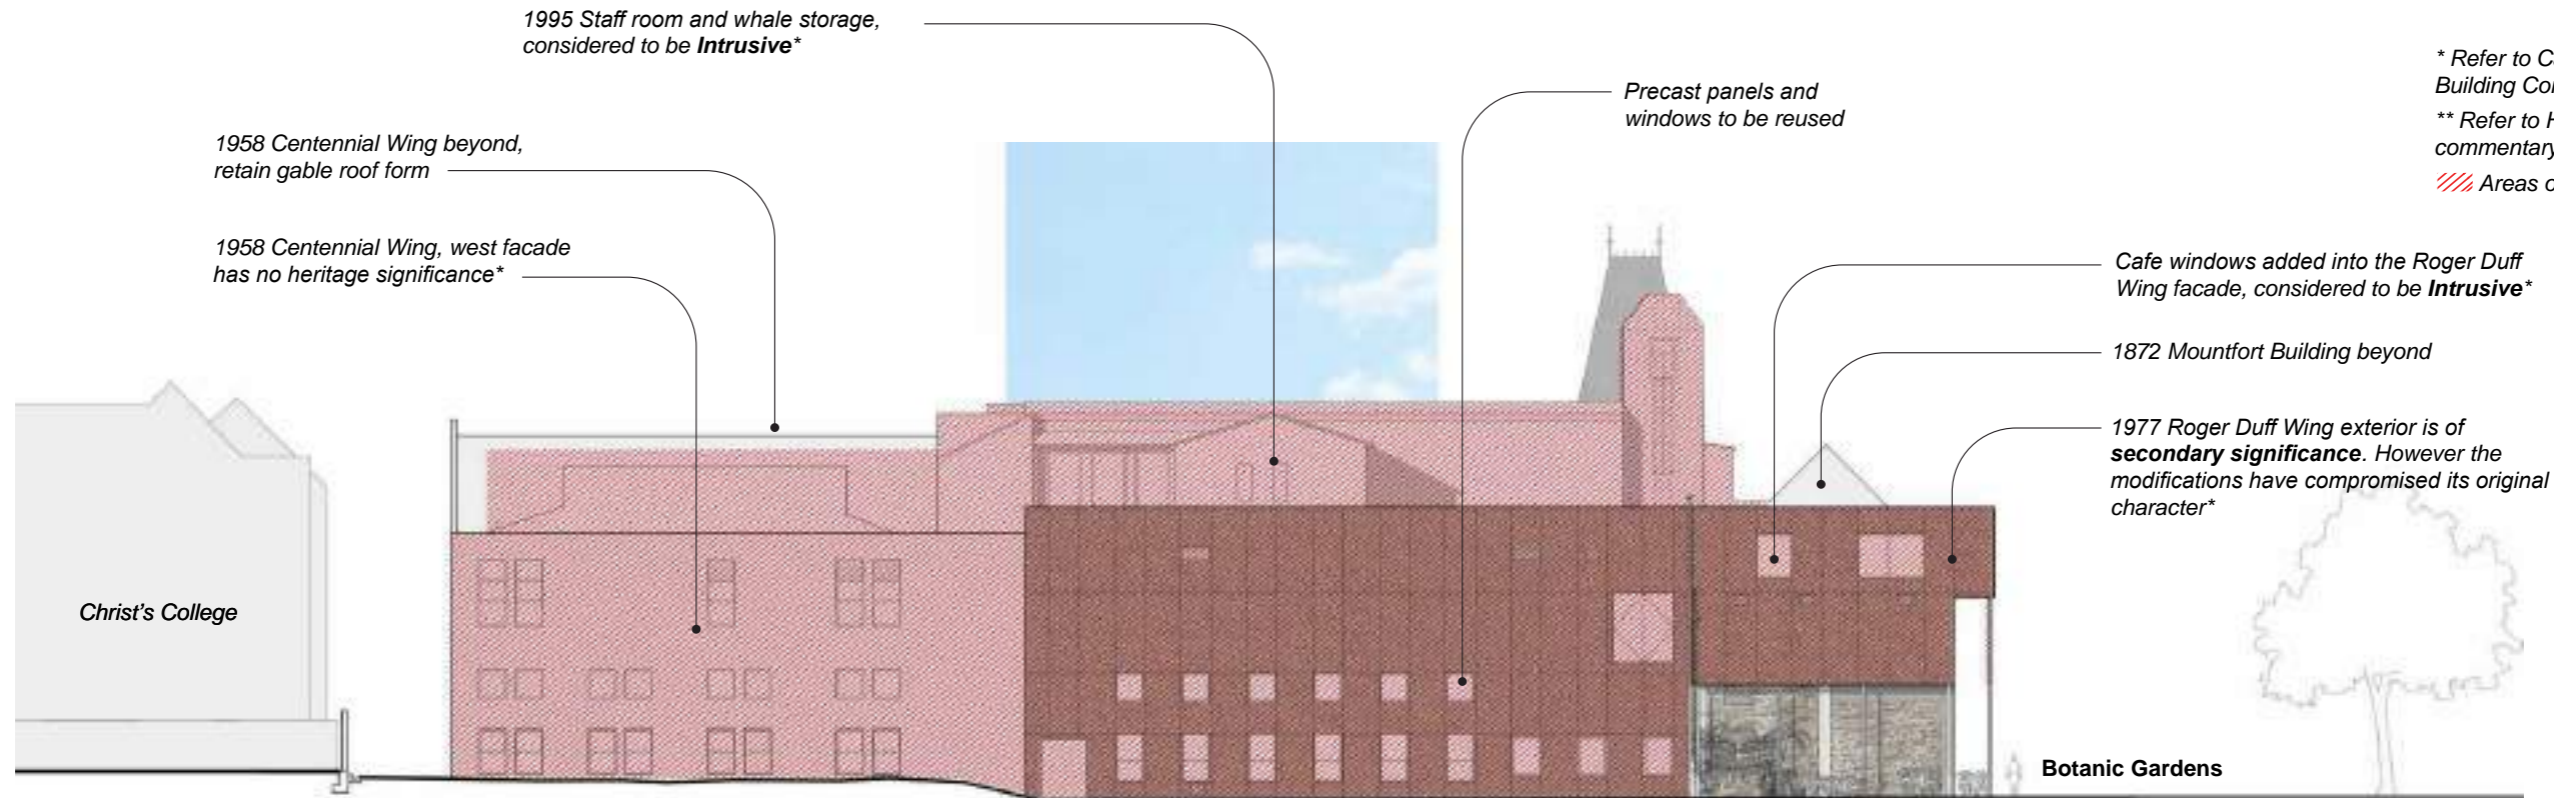
MUSEUM WEST ELEVATION 2 -TRUE ELEVATION

Current condition

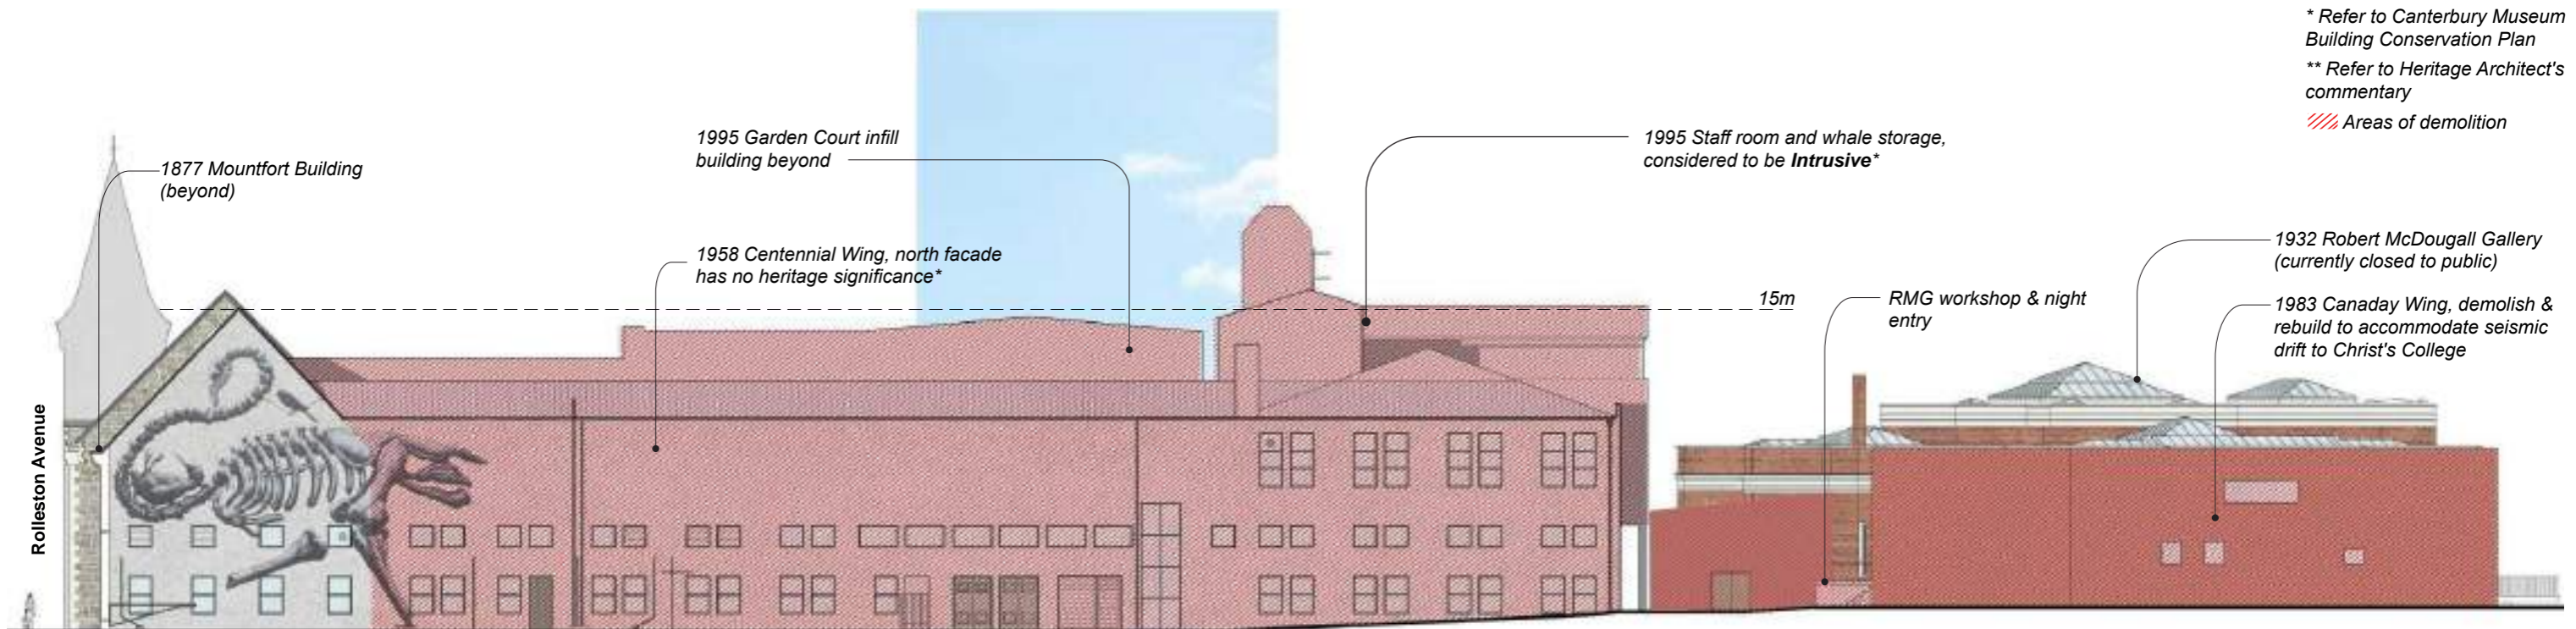
MUSEUM & RMG NORTH ELEVATION

Current condition

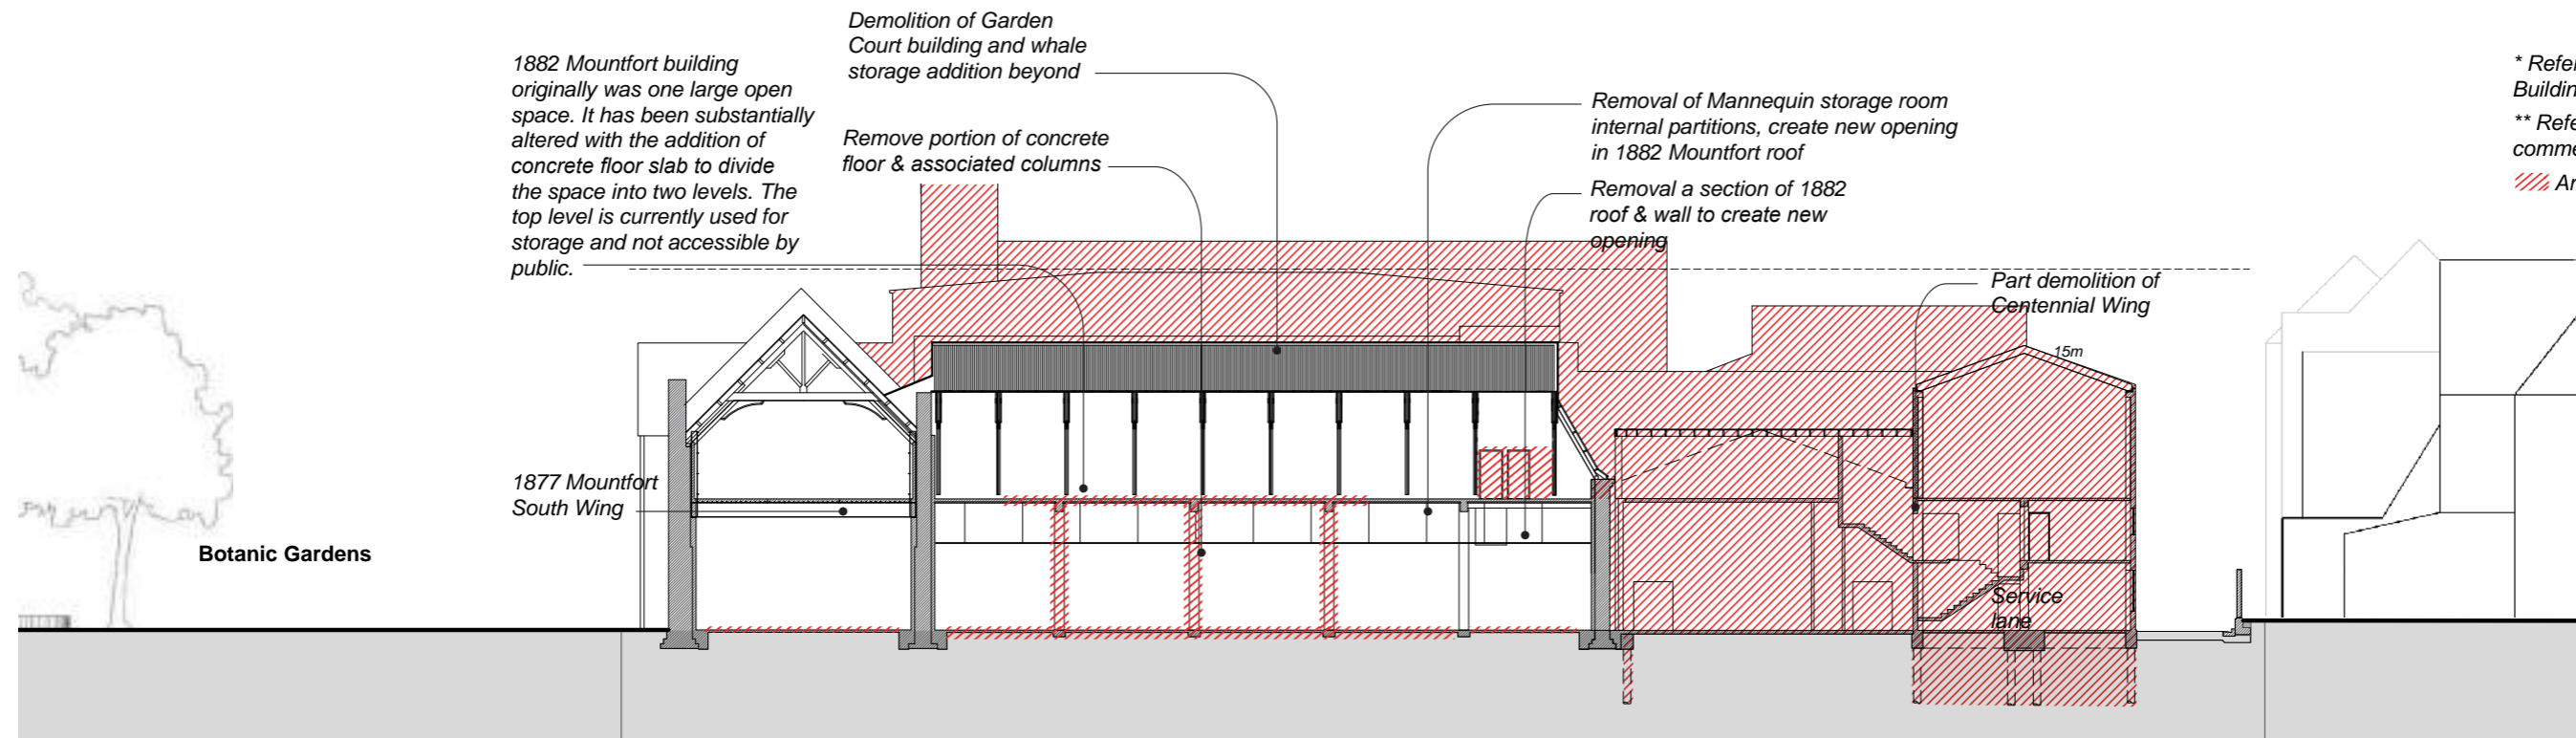
SECTION A - THROUGH 1882 MOUNTFORT BUILDING

Current Condition

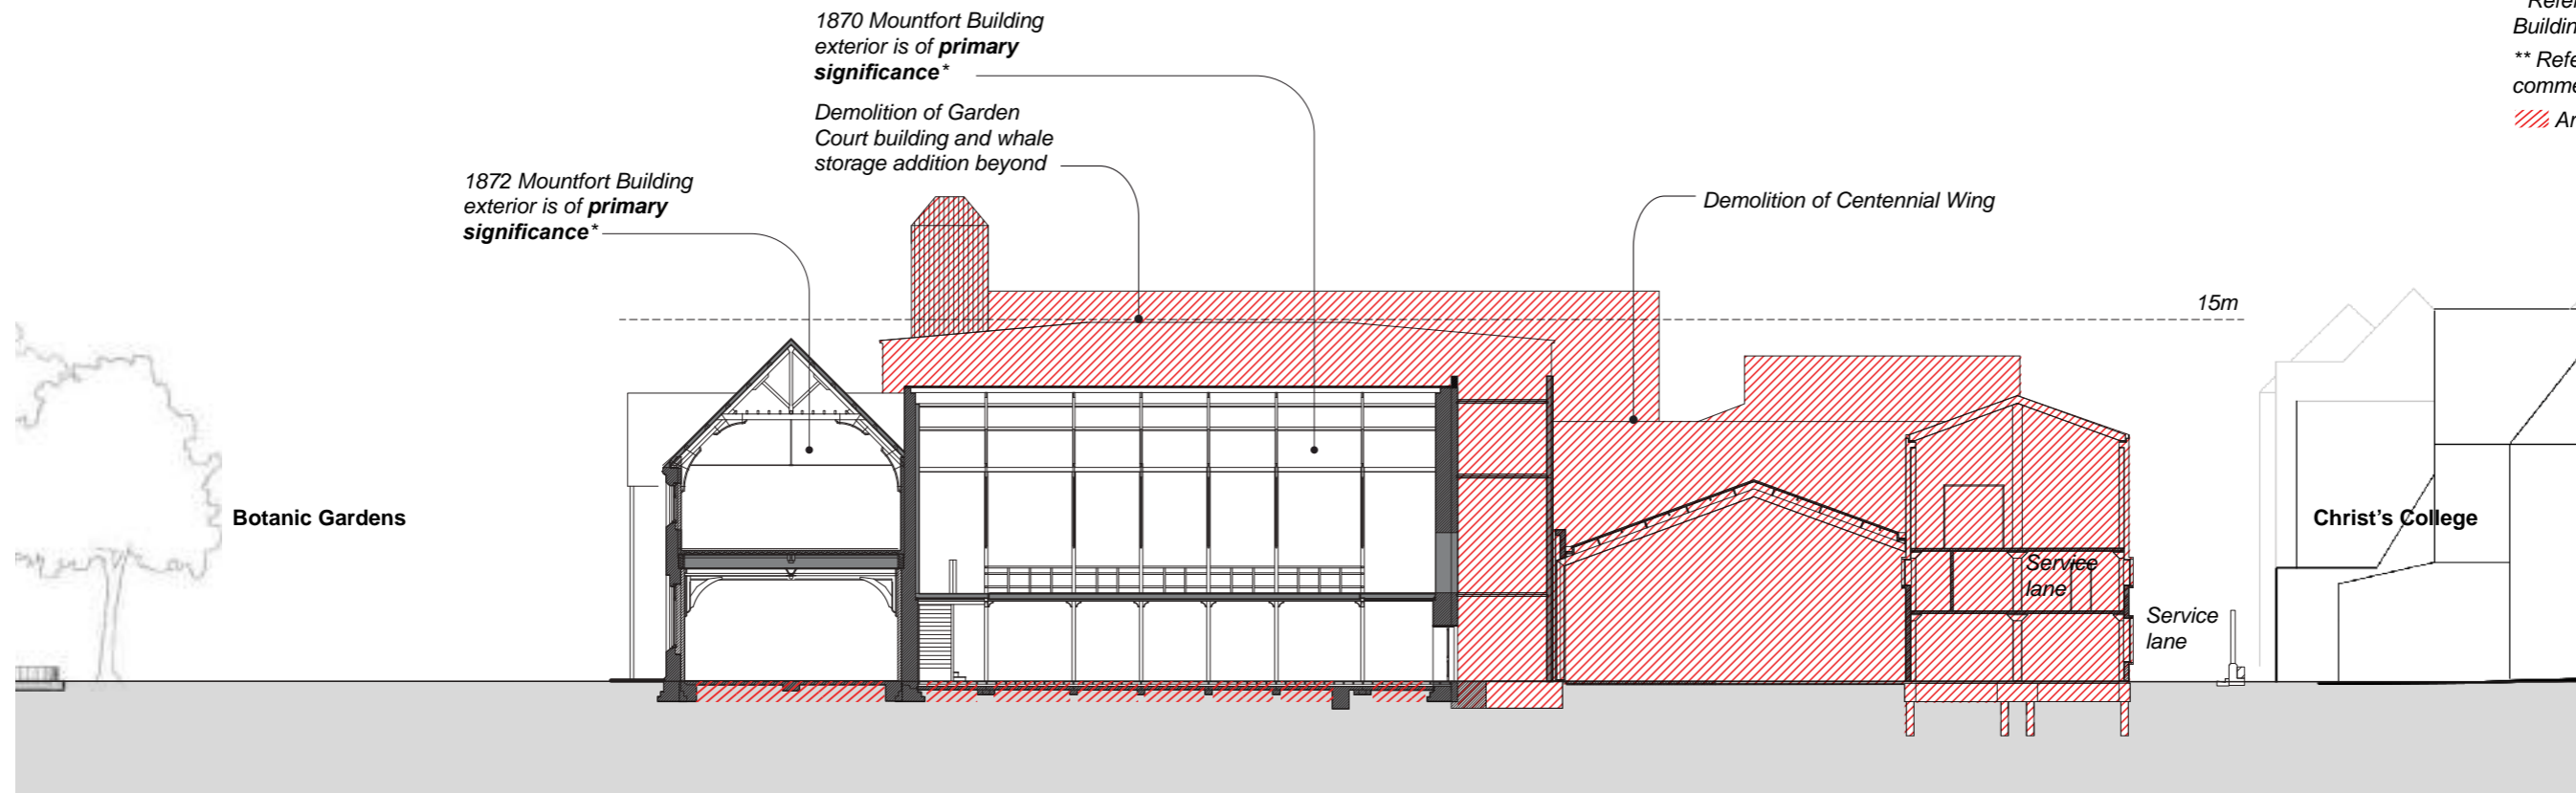
SECTION B - THROUGH 1870 & 1872 MOUNTFORT BUILDINGS

Current Condition

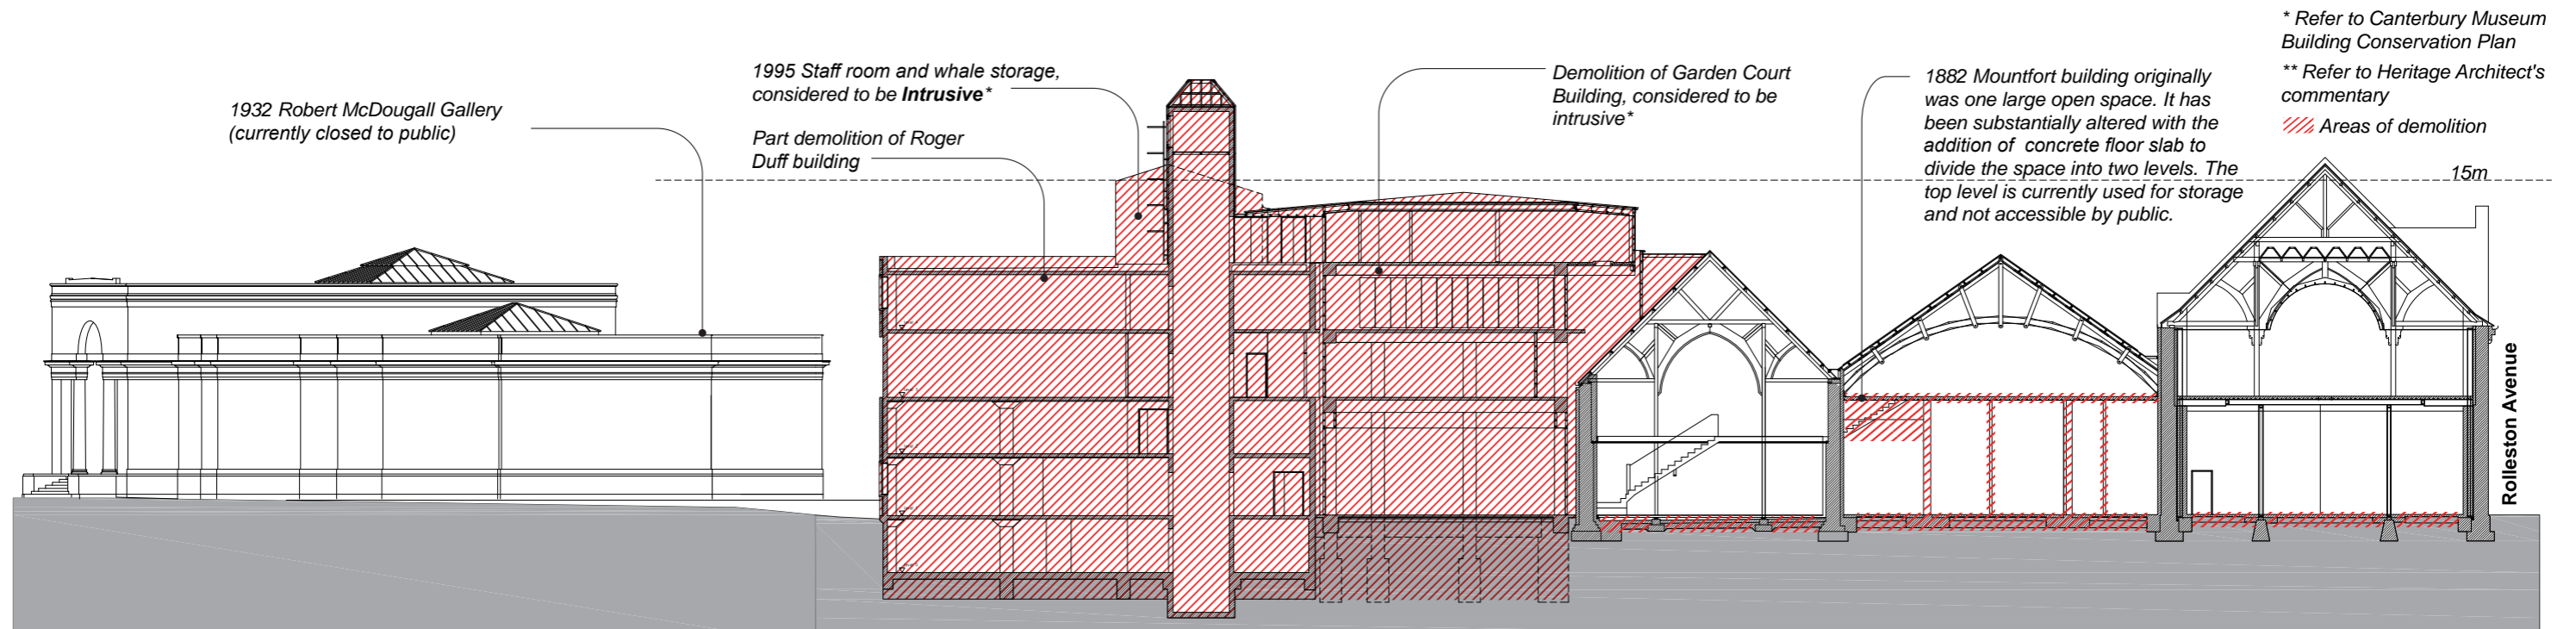
SECTION 1 - THROUGH 1870, 1877 & 1882 MOUNTFORT BUILDINGS

Current Condition

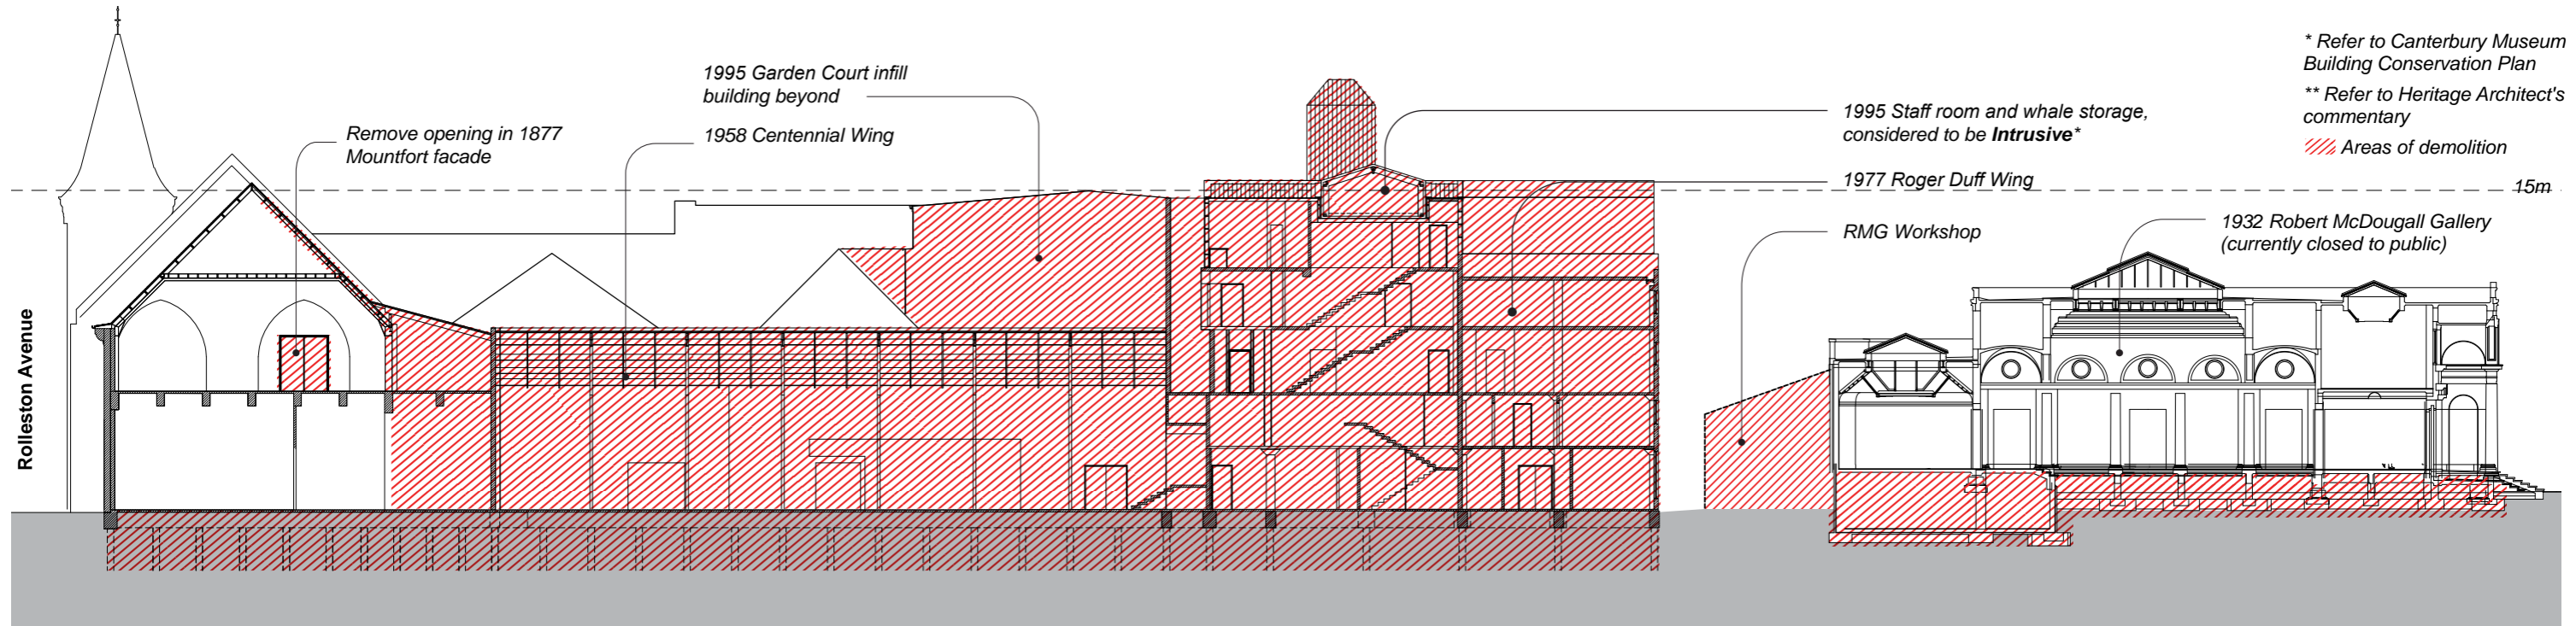
SECTION 2 - THROUGH CENTENNIAL WING

Current Condition
