CONCEPT DESIGN - ELEVATIONS & SECTIONS

20.02
 Canterbury Museum Redevelopment Project
Concept Design Report
 Final for Resource Consent
 25th November 2020

CONCEPT DESIGN 3D AXONOMETRIC VIEWS

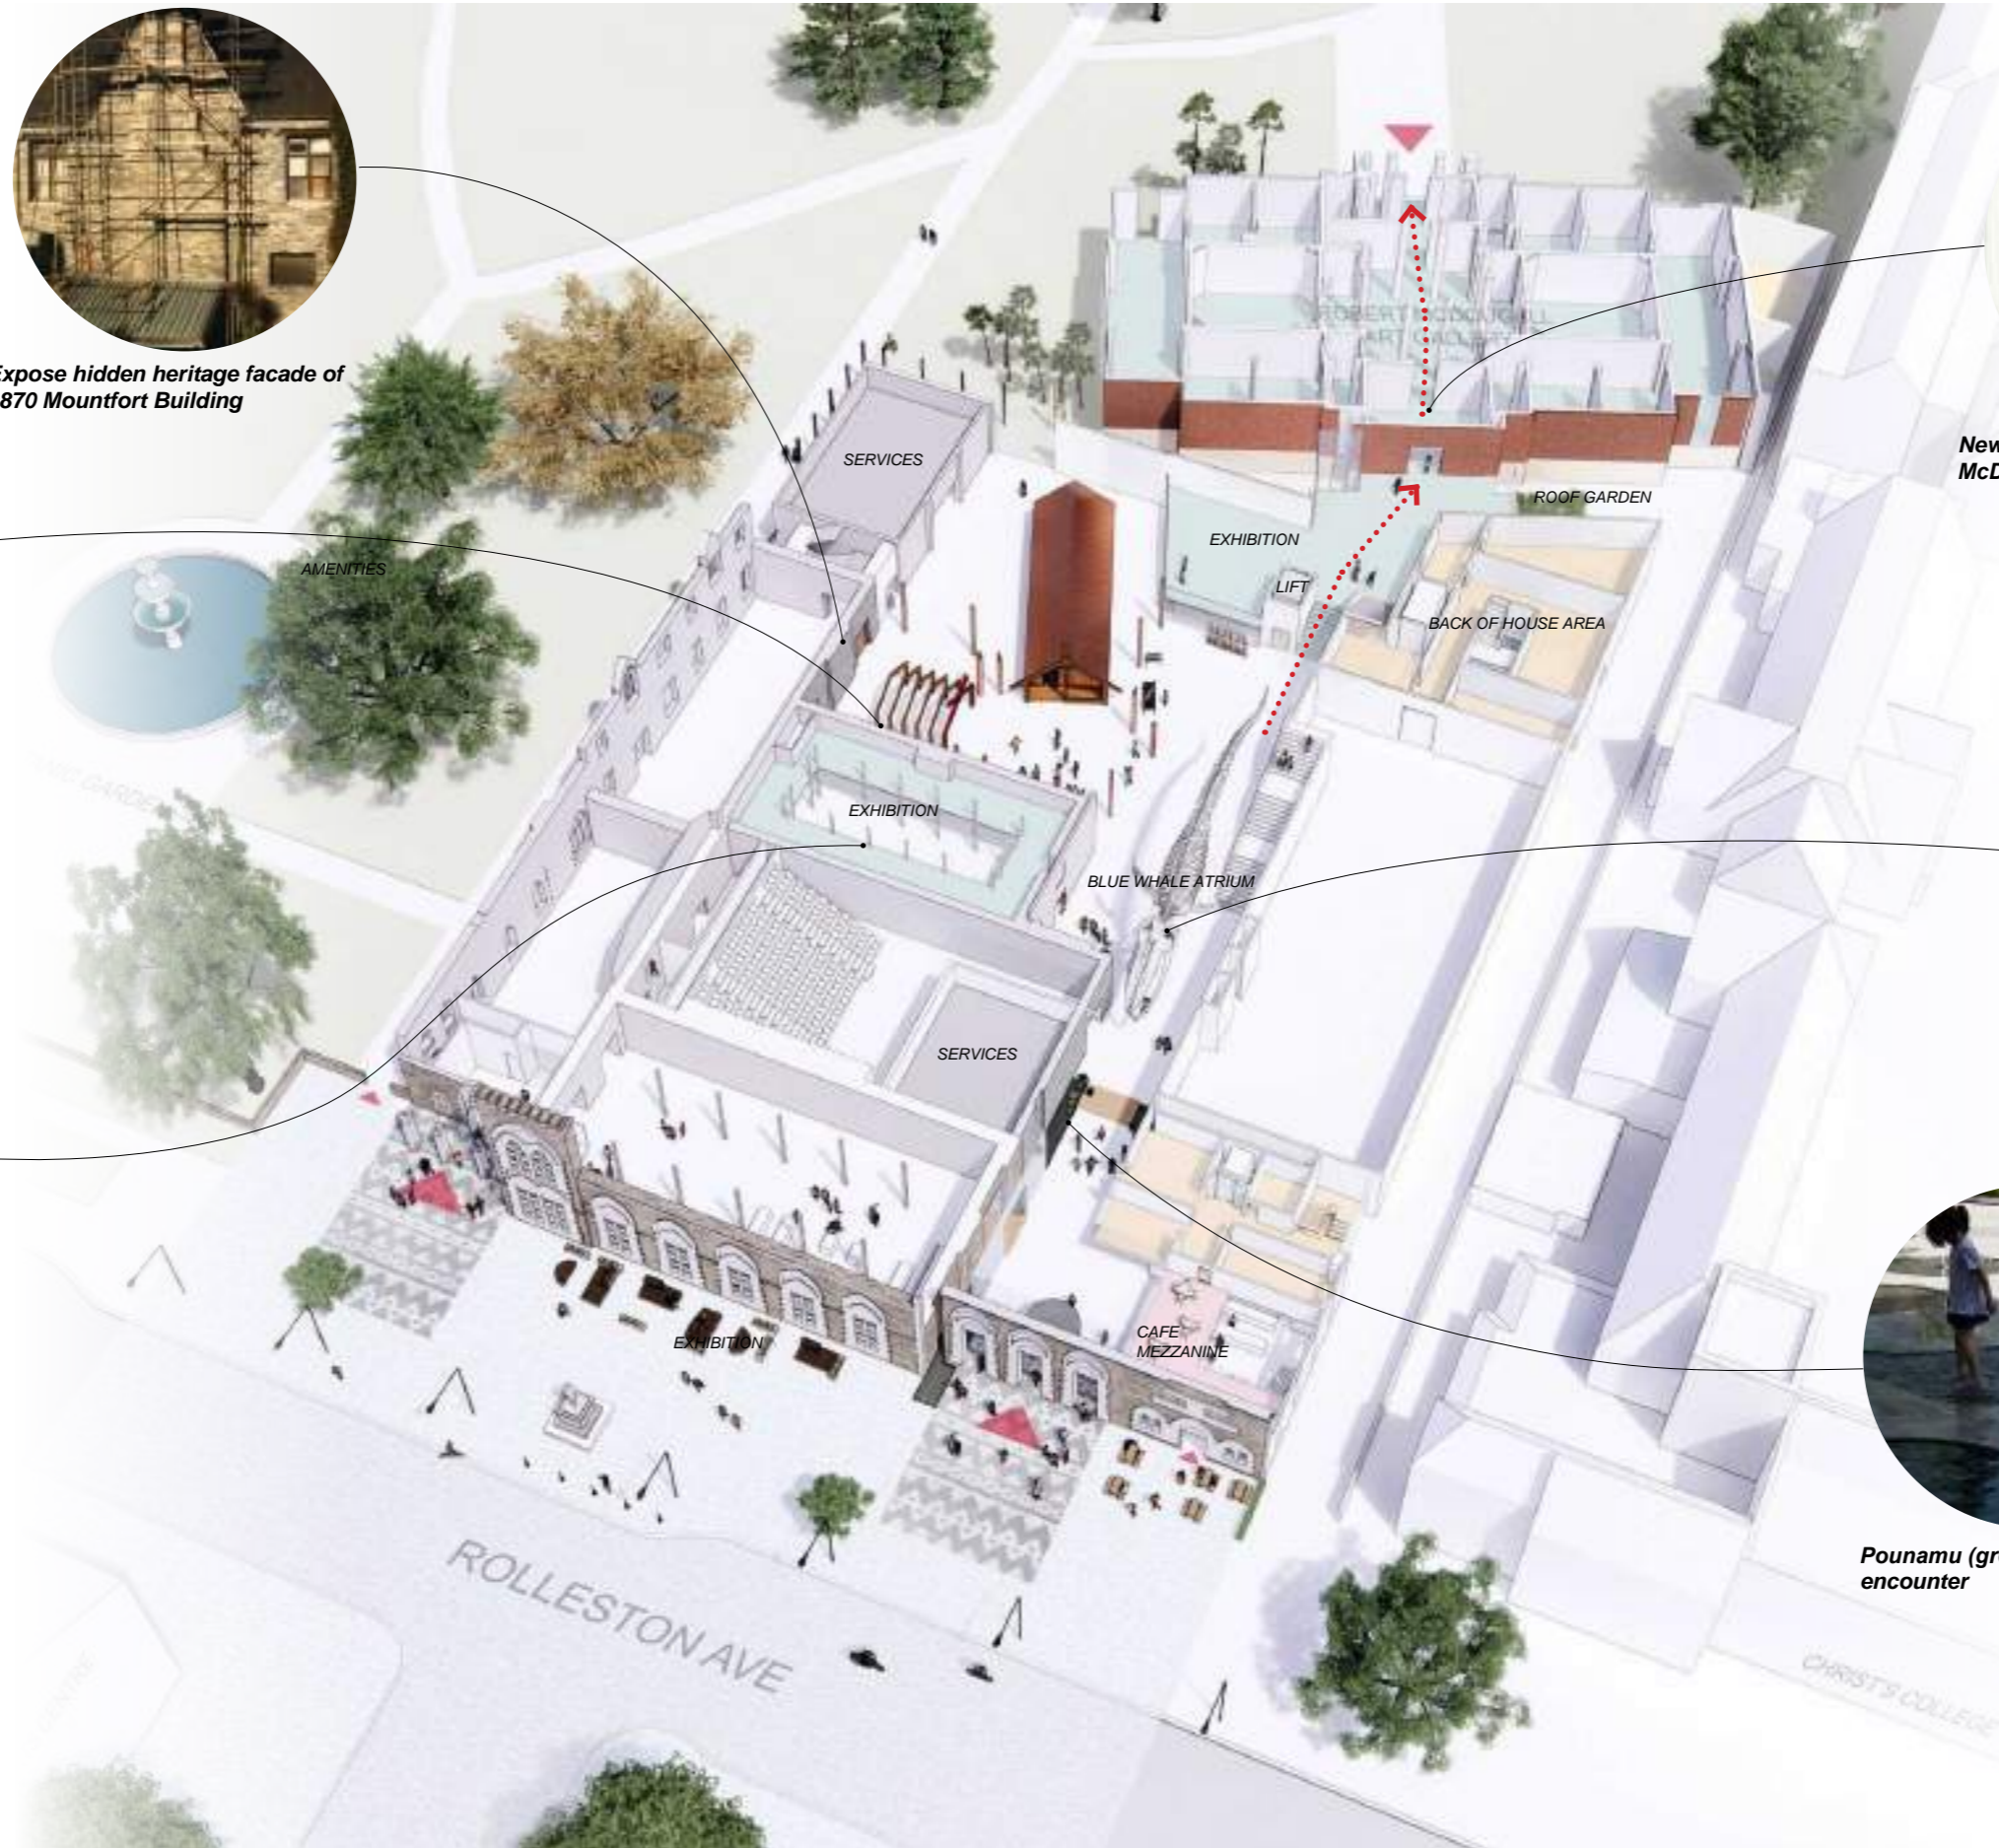
AXONOMETRIC VIEW LEVEL 1.5 MEZZANINE

Expose hidden heritage facade of 1870 Mountfort Building

Preserve heritage 1870 Mountfort building interior

New connection to Robert McDougall Gallery

New atrium with blue whale display (pictured: Canterbury Museum 1995)

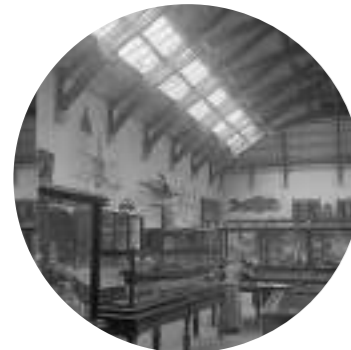
Restore Mountfort 1882 building to expose original roof truss

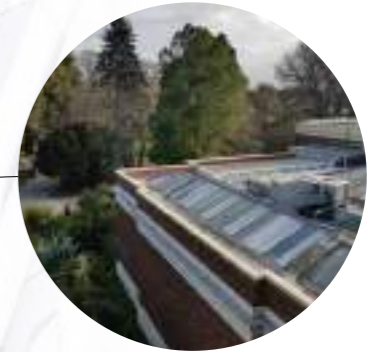
Repair & restore Robert McDougall Gallery roof

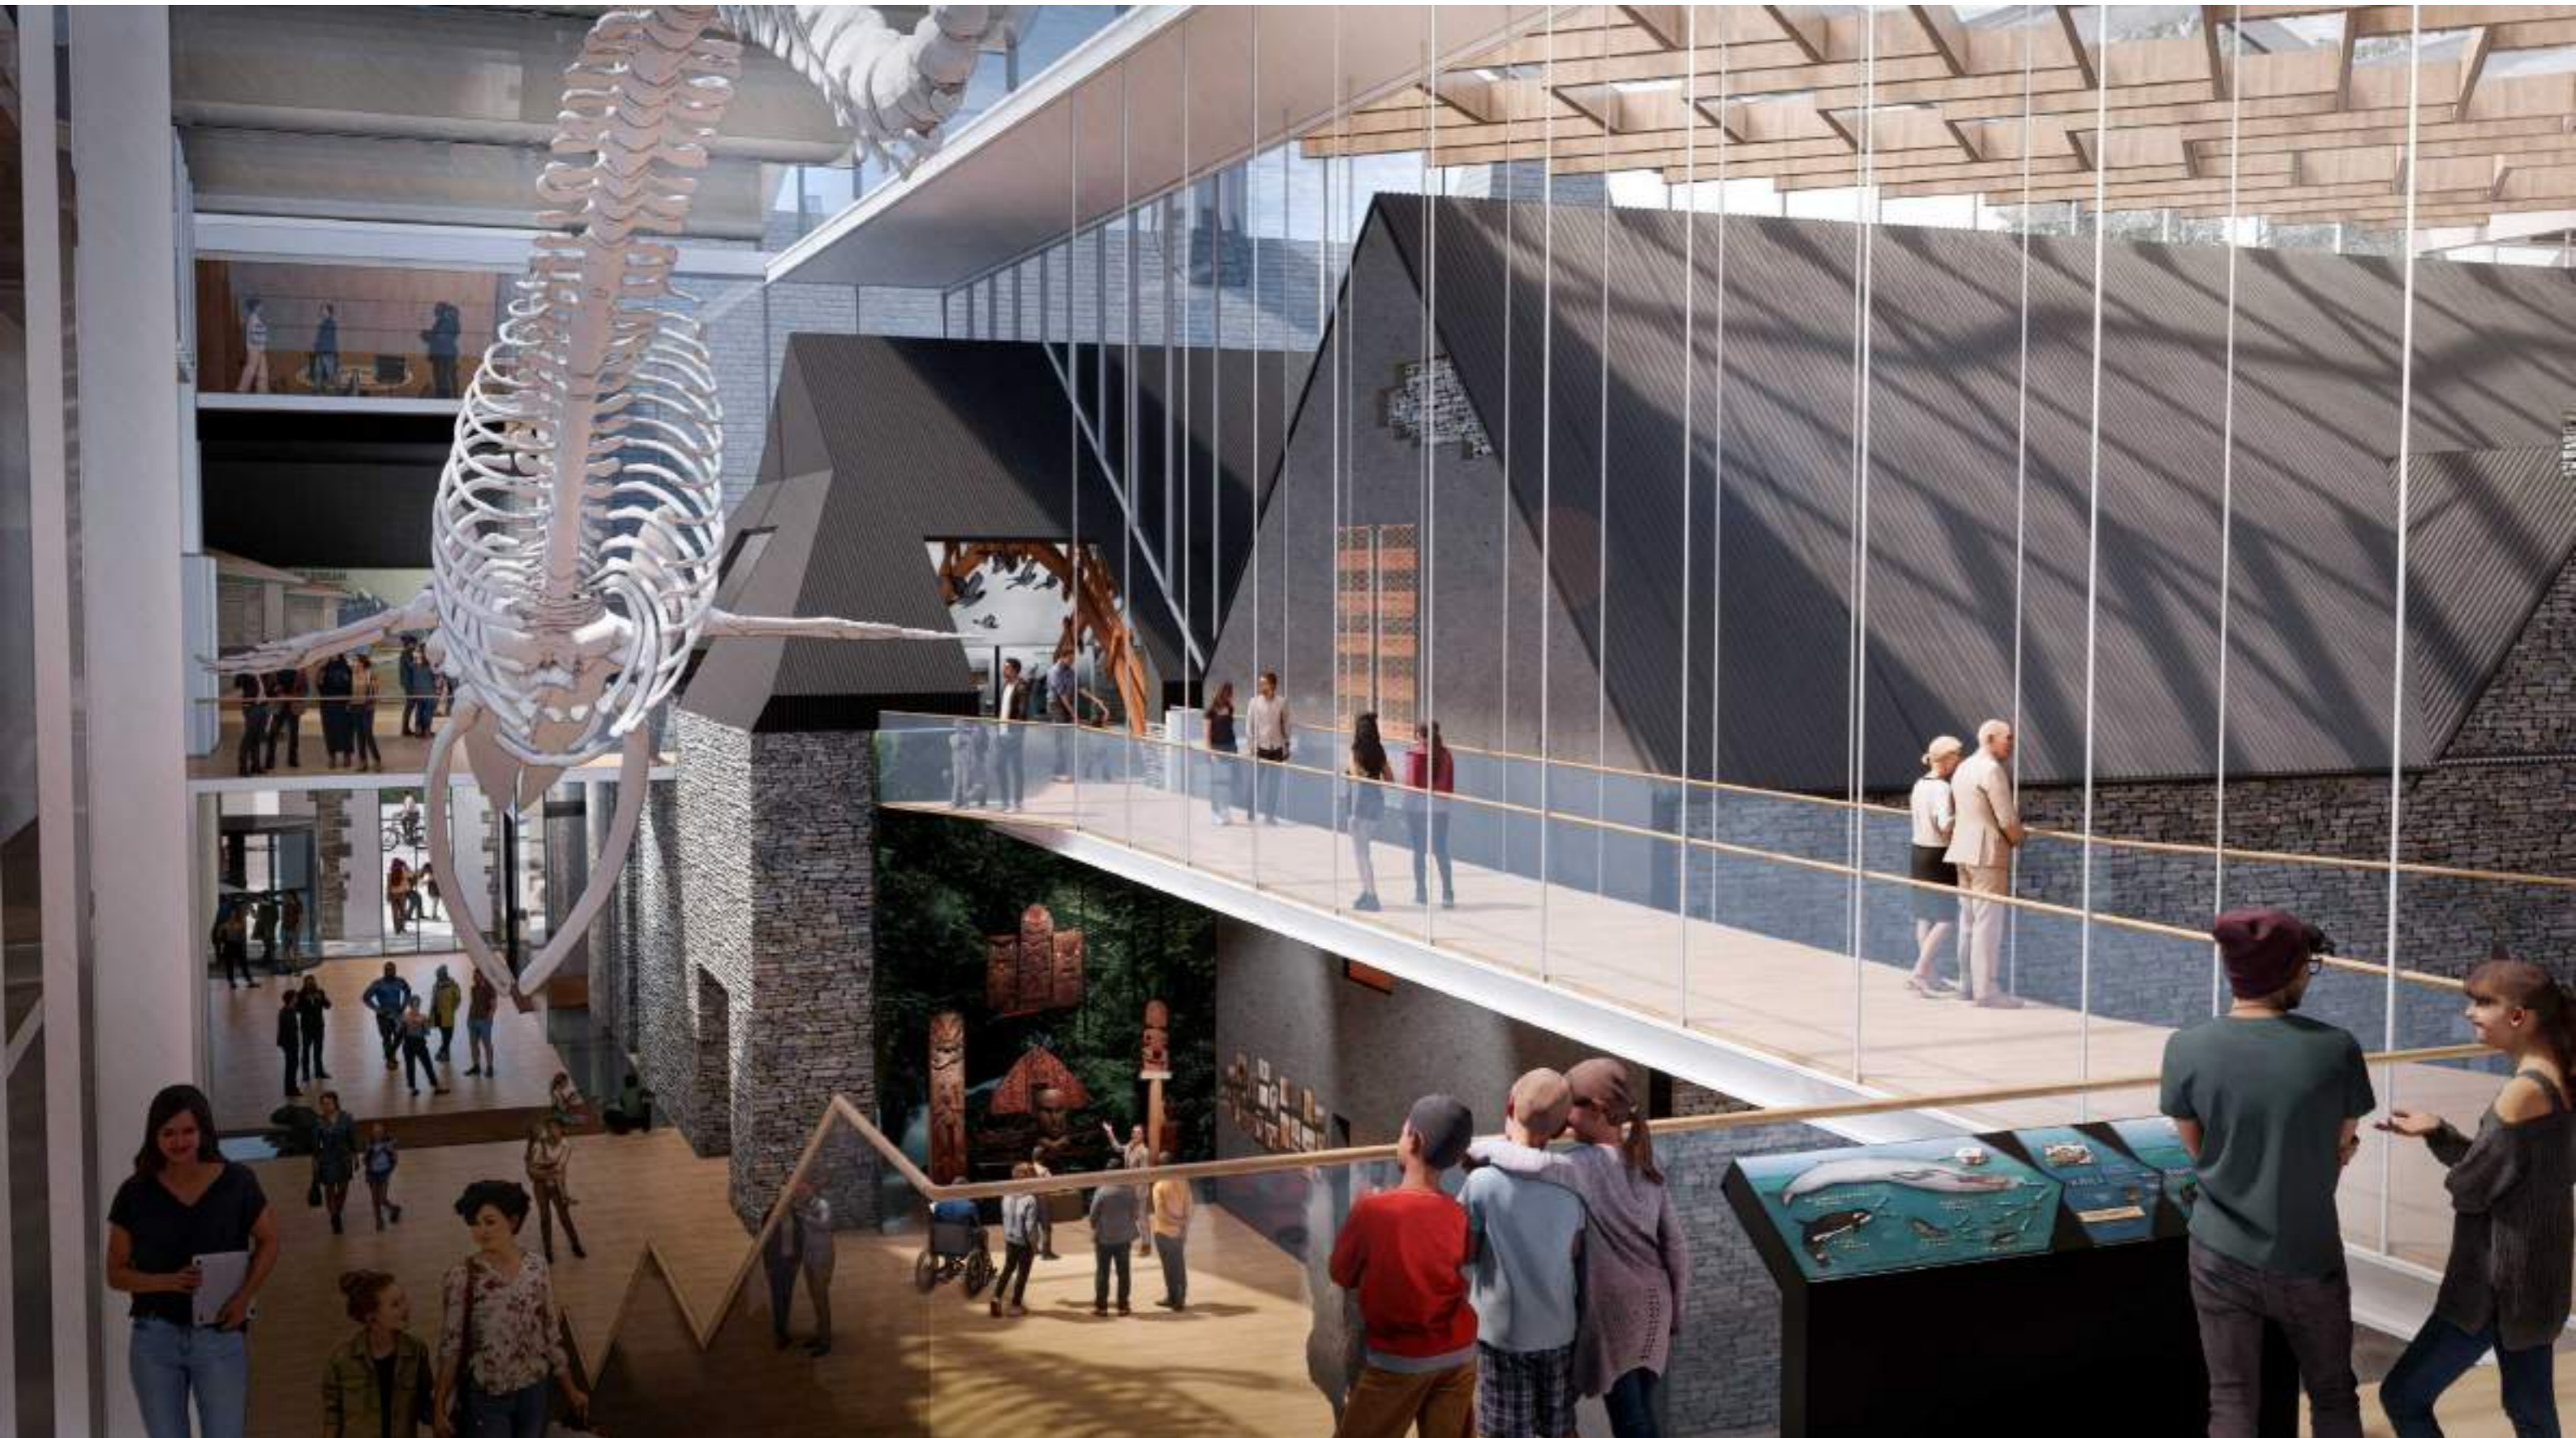
INTERIOR PERSPECTIVE VIEW ARTIST'S IMPRESSION OF THE BLUE WHALE IN ATRIUM

Interior perspective looking from top of main stair towards additional entrance, Mountfort building facades recovered as a part of exhibition space.
