ROGER DUFF WING ALTERATION VIEWS TO THE BOTANIC GARDEN

20.02
Canterbury Museum Redevelopment Project
Concept Design Report
Final for Resource Consent
25th November 2020

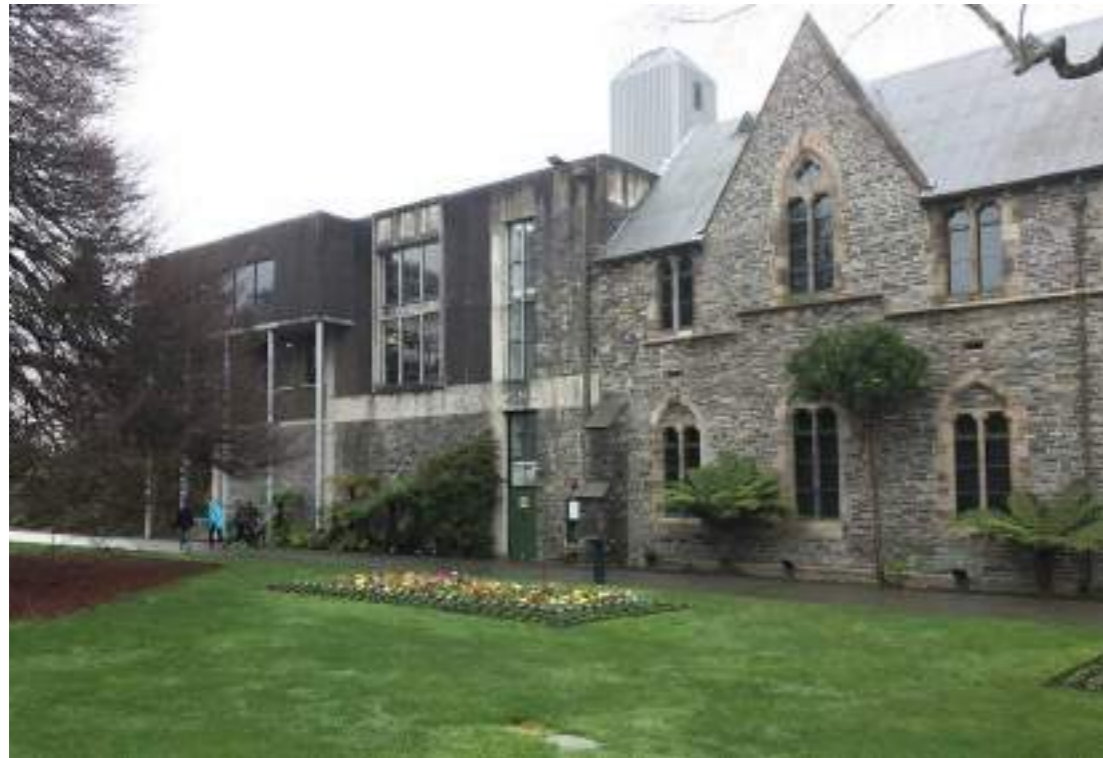
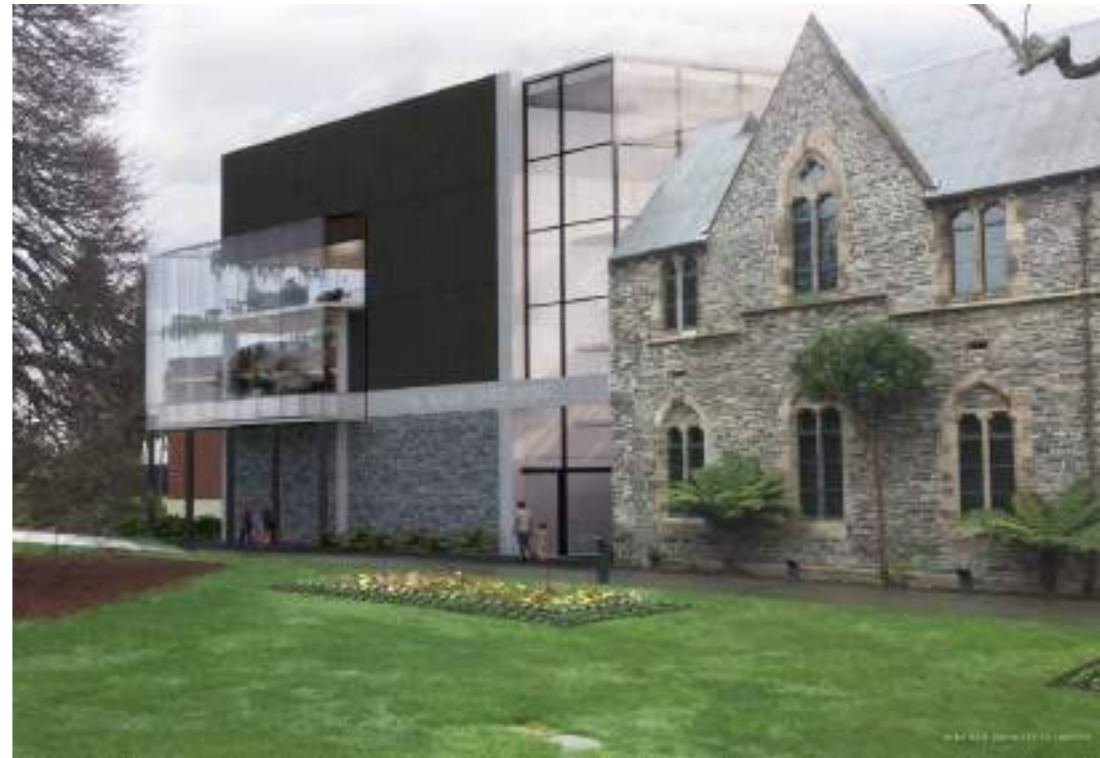
Current conditions - South Elevation

Views of existing and proposed south elevation shows

- The facade glazing over existing stairwell between Roger Duff Wing and 1872 Mountfort building. This address the issue of facade treatment and roof termination identified in the Building Conservation Plan.
- Removal of the buttress added to the end of 1872 Mountfort building during the construction of Roger Duff Wing.
- Vertical extension above existing building.
- Floor area extended to the line of existing columns on level 2.

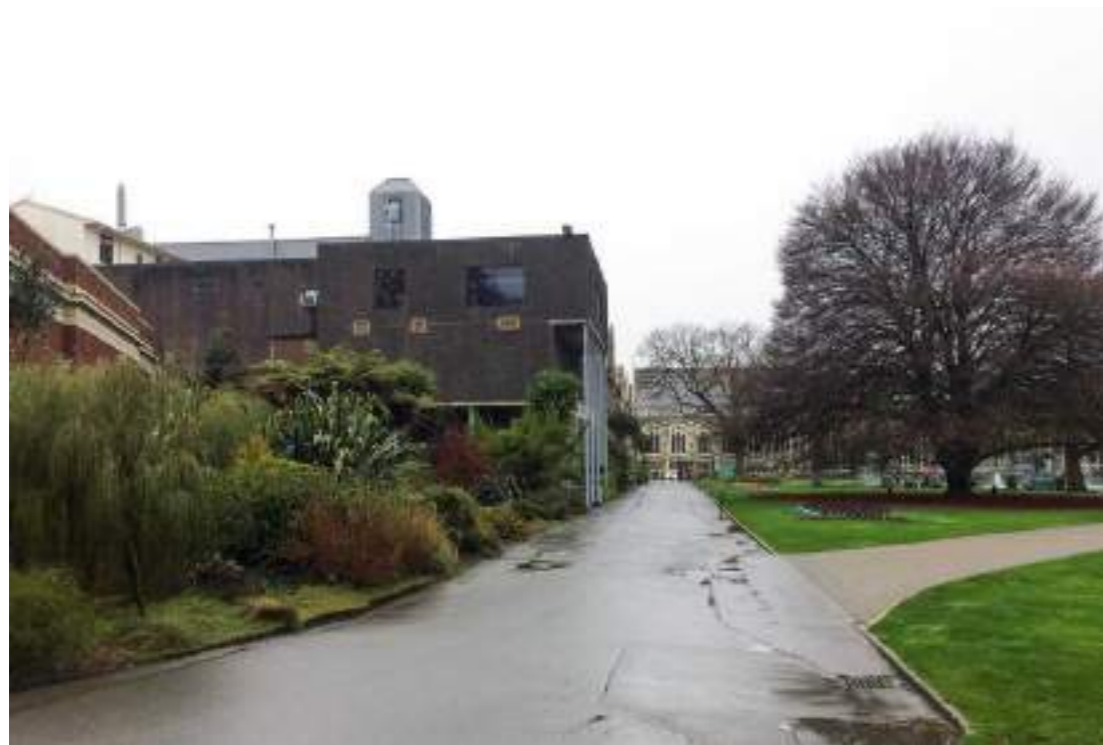
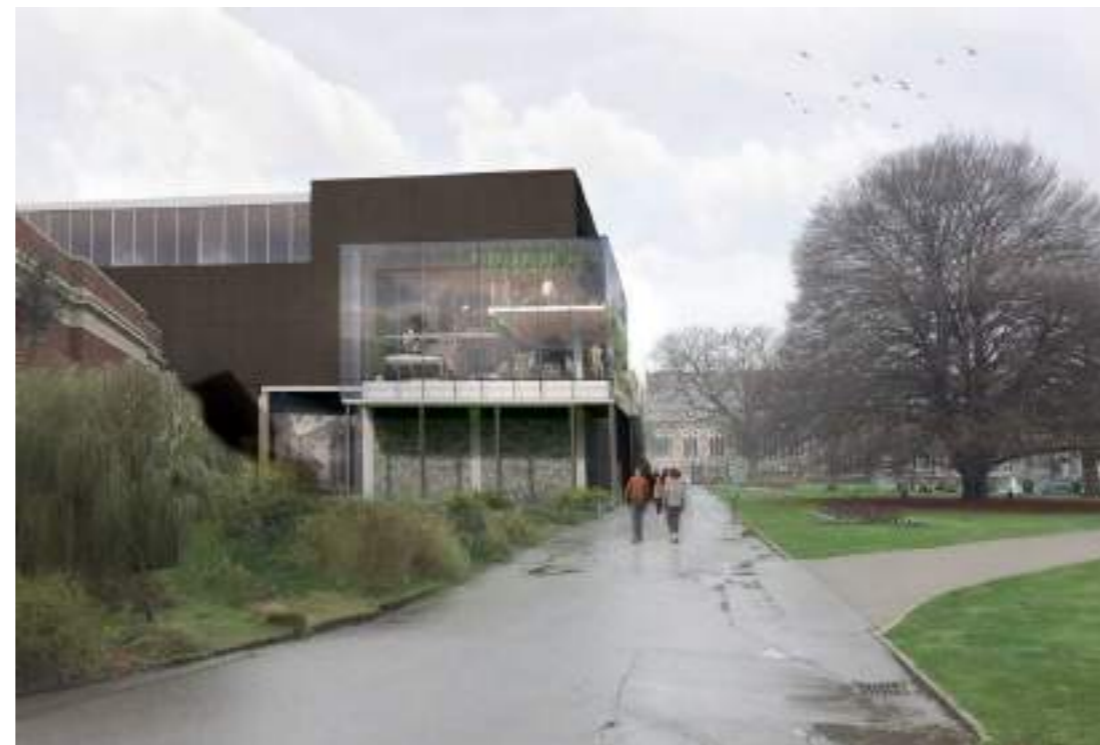
Current conditions - West Elevation

Views of existing and proposed west elevation shows

- Vertical extension of the Roger Duff Wing
- Glazing to the existing 'pop-out' on levels 2-3.
- Floor area extended to the line of existing columns on level 2.
- Glazing at ground floor, allowing pedestrians to 'peek' into the Museum exhibitions.

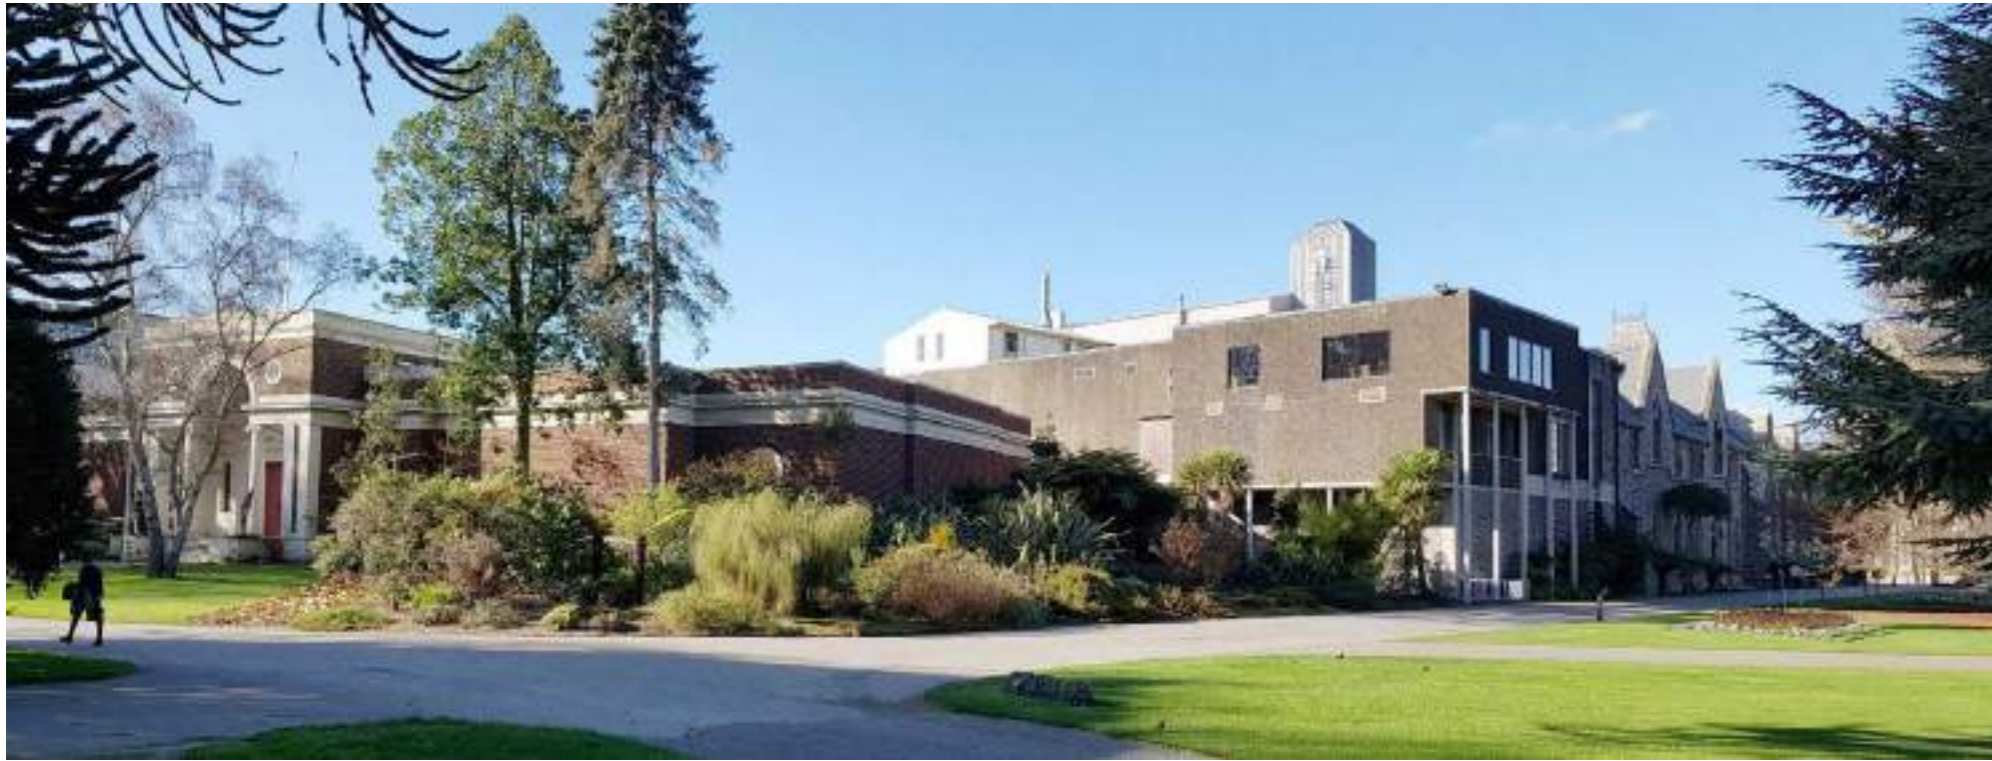
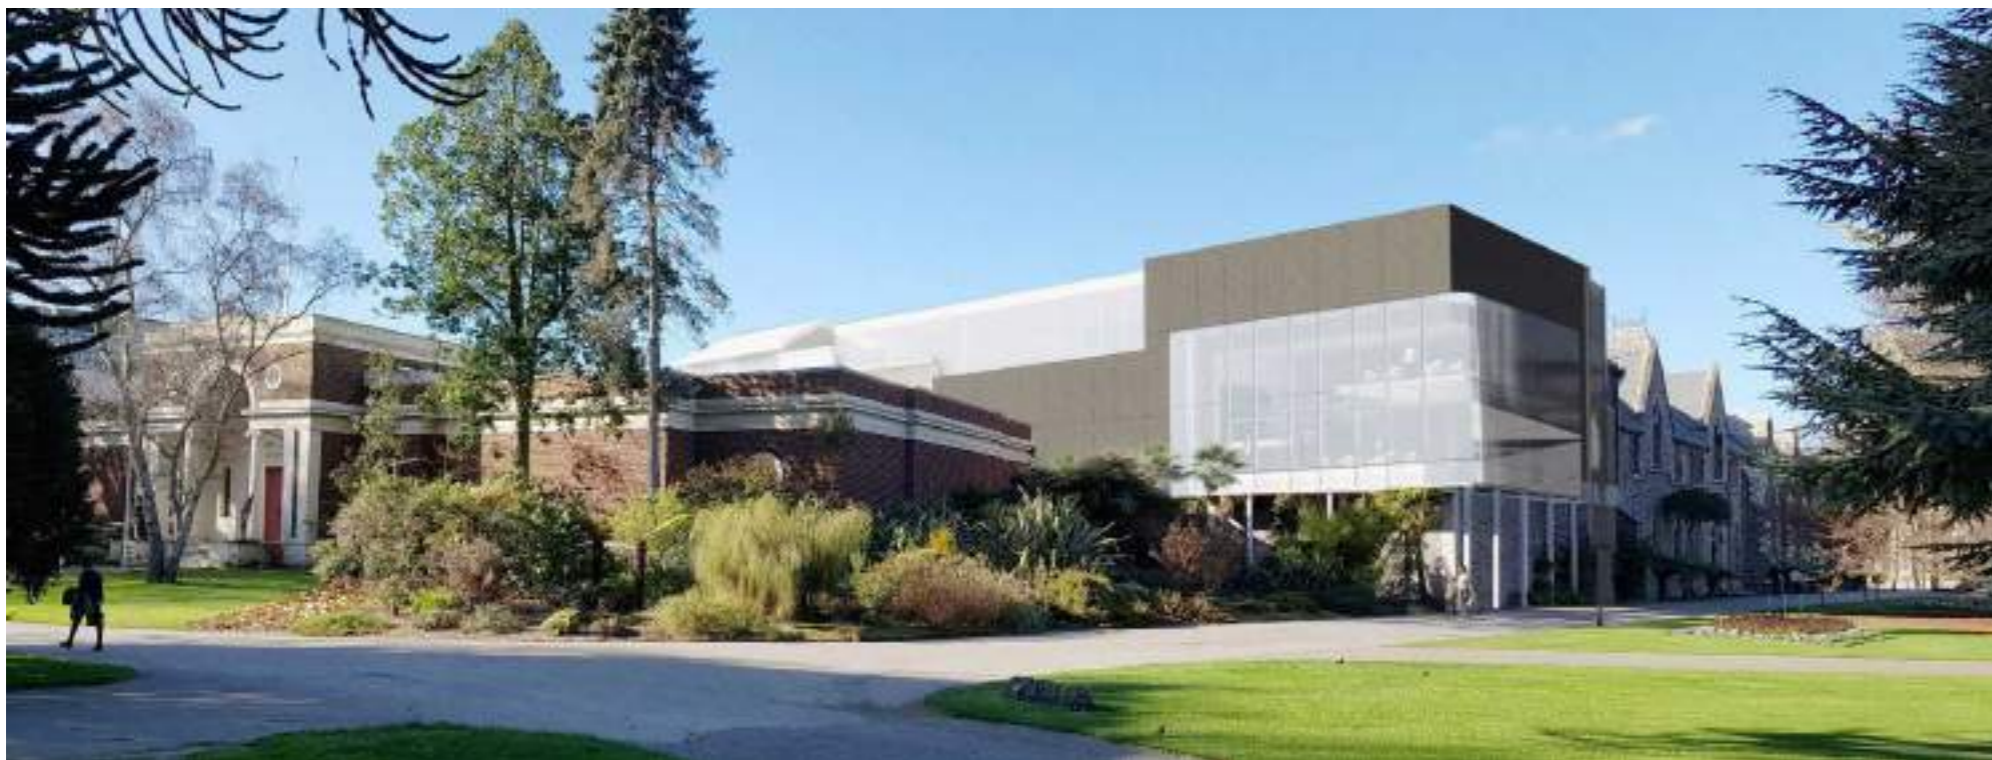
Views of RMG and Roger Duff Wing viewed from "pine mount" in the Botanic Garden

- The flat roof of new additional Level 3 can be seen from the Botanic Gardens. It compliments the existing language of the RMG roof forms while recedes into the background.
- The staff room, whale store room and the lift machine can be seen here, which will be replaced the new addition, which provides the much needed staff work areas.
- Glazing opens up Roger Duff Wing up to the Botanic Gardens. Views of the active cafe interior can be seen from the footpath, which may entice more public visits.

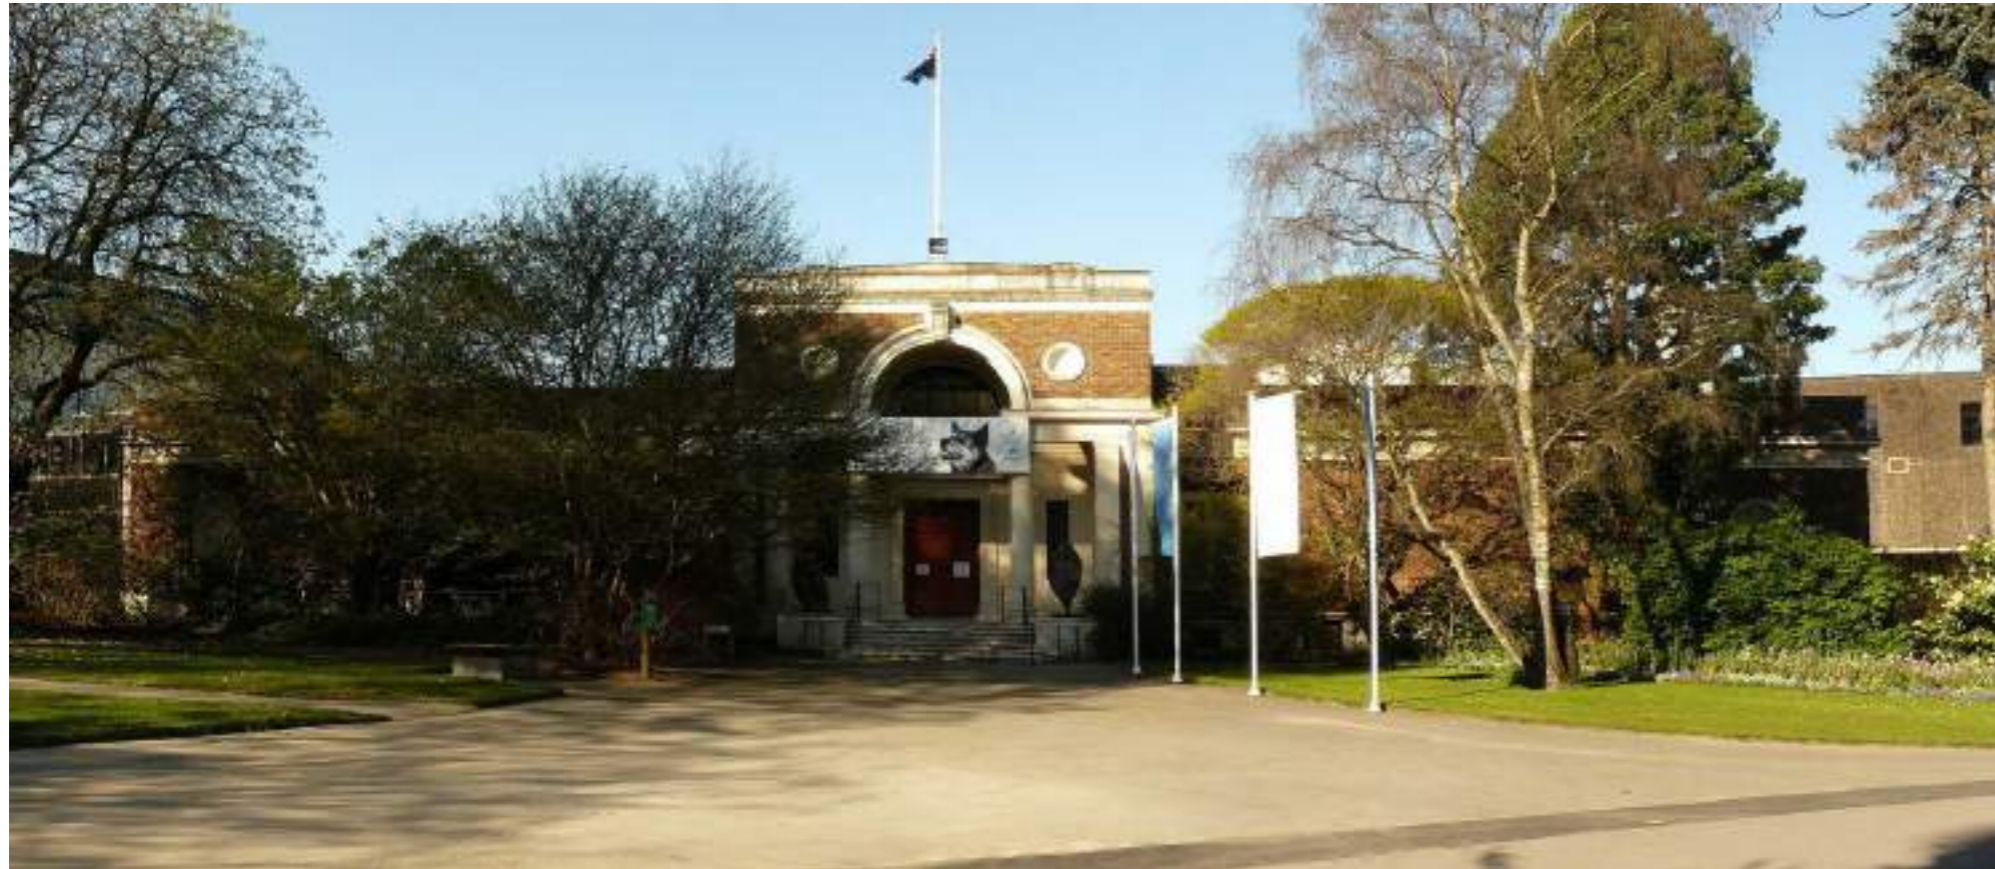
RMG forecourt & entrance looking from Botanic Gardens

As a part of the Museum Redevelopment project, RMG will be upgraded with much needed earthquake strengthening, base isolation and heritage restoration. A new walkway is proposed to connect the RMG to the current Museum, via a glazed link. The RMG building will be returned, as far as practical, to its original form and design; this includes the removal of the 1960's Night Entry and Workshop to uncover heritage fabric, as these programs can now be shared with the extended Museum back-of-house areas. New climate control upgrades will see the removal of external roof plants, which will also be shared with the Museum.

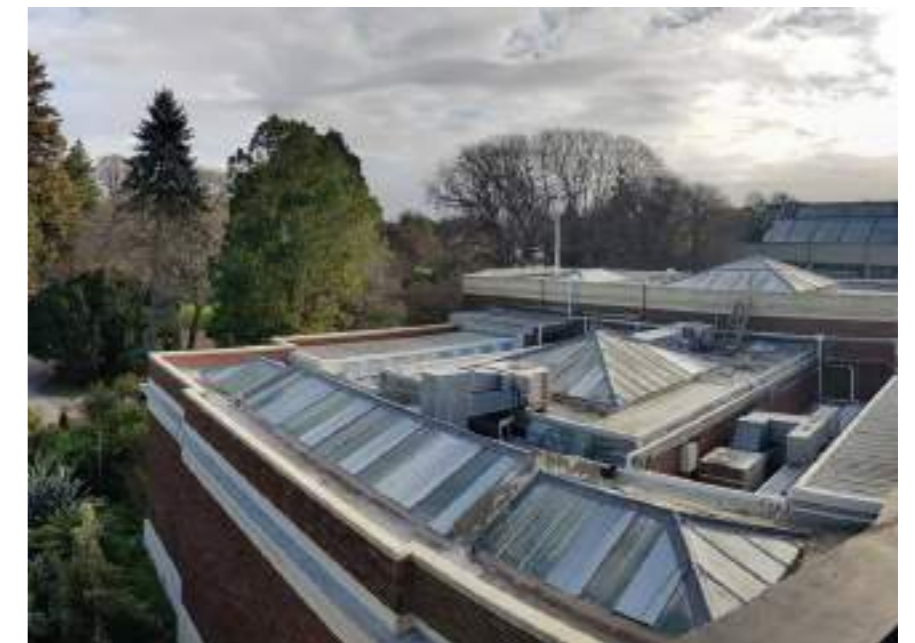
RMG roof

The roof lights is of High Significance heritage value, known as 'top side' lighting which was the brain-child of another architect, Samuel Hurst Seager. They have generally survived, although some have been overlaid with corrugated steel. Proposed work includes restoration of these skylights, and removal of air-conditioning plant which was deemed Intrusive (RMG Conversation Plan 2013)

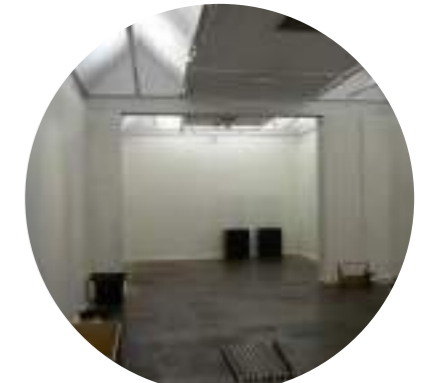
Gallery room current condition (image: DPAL, refer to RMG Conservation Plan for more information)

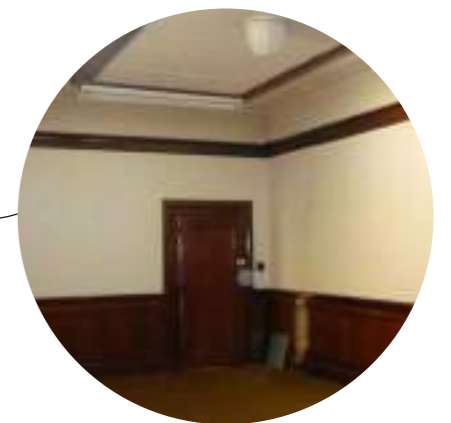
Restore Boardroom with Tasmanian Blackwood panelling and picture rail, architraves and door (image: DPAL, refer to RMG Conservation Plan for more information)

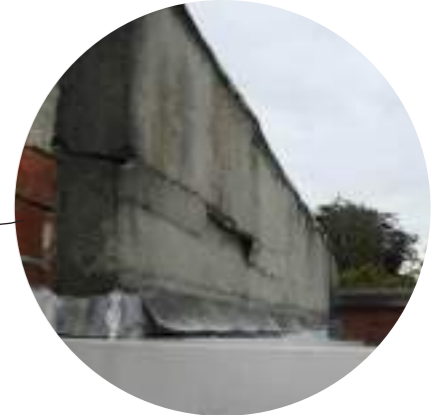
Restore RMG heritage fabric such as damage to parapet with erosion evident (RMG Conversation Plan 2013)

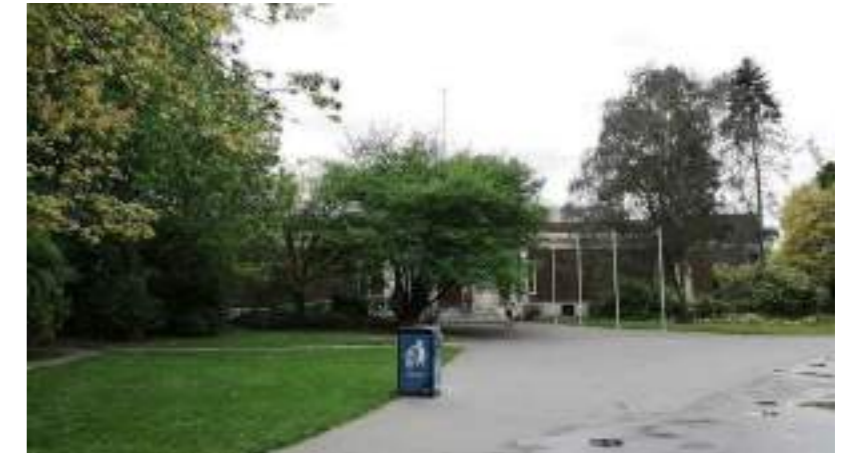
Current condition

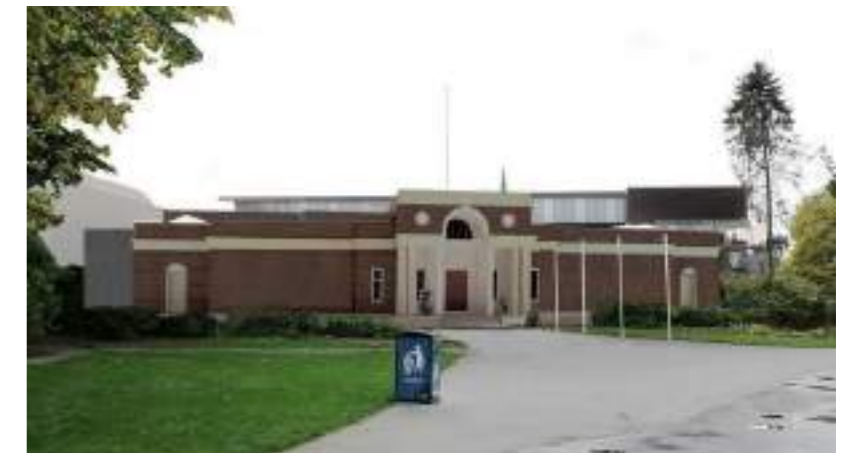
Post vegetation removal will bring the RMG back to its original appearance

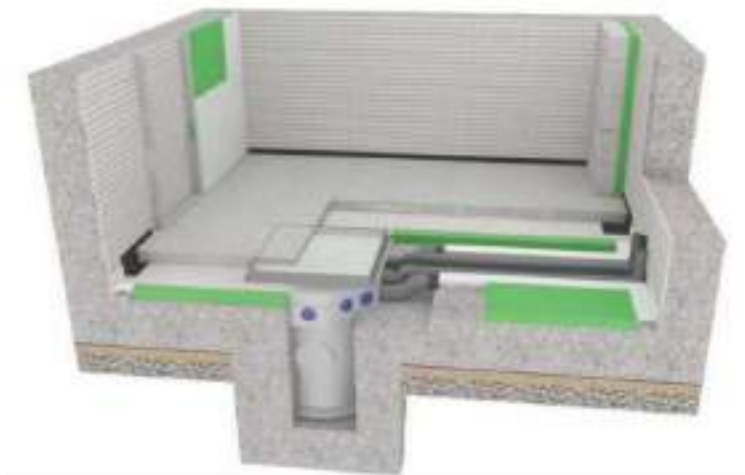
Type C drainage system, Newtown Basedraing detail

- Basement waterproofing design: Newton Basedrain system
- 1. Structure/design & **Type B** structural integral system
- 2. Trench voids - are to provide an unimpeded area/void for the Isolator bearings to move in the event of an earthquake.
- 3. **Type C** Cavity drain membrane, sumps and drainage. Contingency planning for dealing with any localised defects or system failure that arise should be included as part of the overall water resisting design of the structure.
- 4. Lift pit with existing draining and new internal membrane tanking.

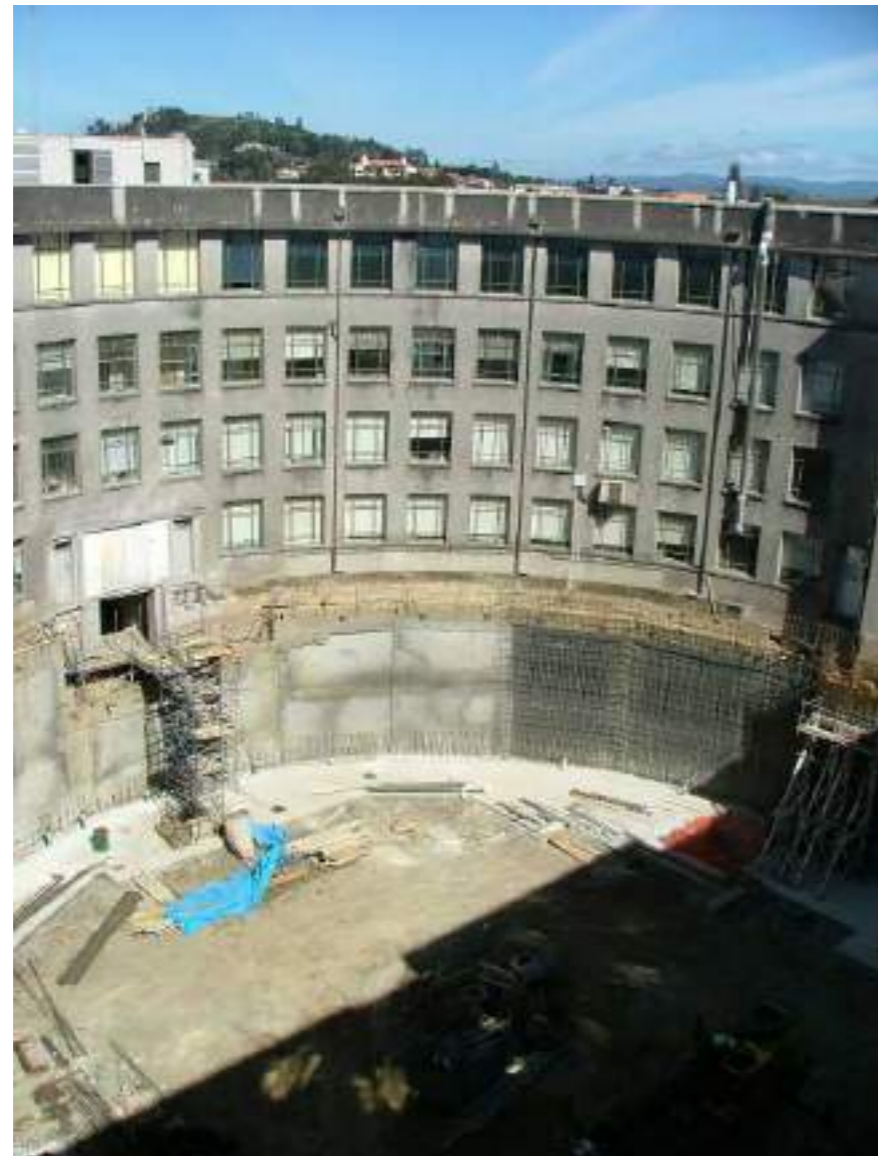
Auckland War Memorial Museum basement construction. (image: Allco)

The 2006 restoration and expansion of the 1960 Rear Southern Courtyard of the Auckland War Memorial Museum included six new floors, two of those below ground. With the basement providing collection storage for valuable items. The environment designed to be controlled and moisture free.

- 1. Structure/design & combination **Type A** a barrier system and **Type C** a drained protection system.
- An Allco swelling, self healing membrane (Volclay Voltex DS Bentonite Membrane) is pinned to the shotcrete retention structure.
- Volclay RX101T Waterstop was installed in all joints.
- Pipe penetrations around the perimeter of the slab through the membrane allow drainage into wall drains around the perimeter.

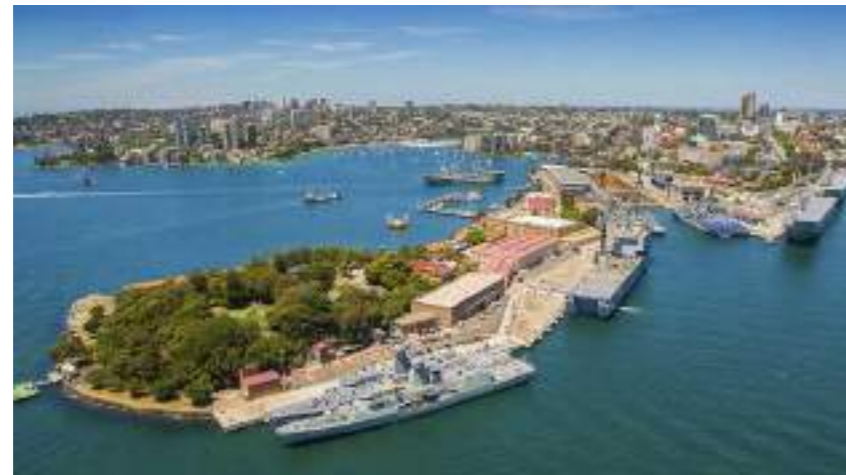
New Zealand made, ARDEX WPM 1500 is normally used as a single layer membrane in horizontal or vertical applications for waterproofing in below ground applications. It is primarily applied to the outside of a sub-structure of a building, such as a foundation or basement, to prevent water ingress or as a gas barrier to prevent the ingress of toxic gases. ARDEX WPM 1500 can also be used in other applications including under floor slabs, behind masonry walls, the lining of substrates of in-situ or precast concrete; retaining walls, lift shafts and tunnels. ARDEX WPM 1500 can also be used in combination with other ARDEX WeldTec products. ARDEX WPM 1500 may be used in various combinations to produce a variety of specifications tailored to suit the individual waterproofing needs.

Ardex WPM 1500 and hydro stop were used in the Green Island Naval Base 1500mm below the Sydney Harbour waterline. (image: Ardex)

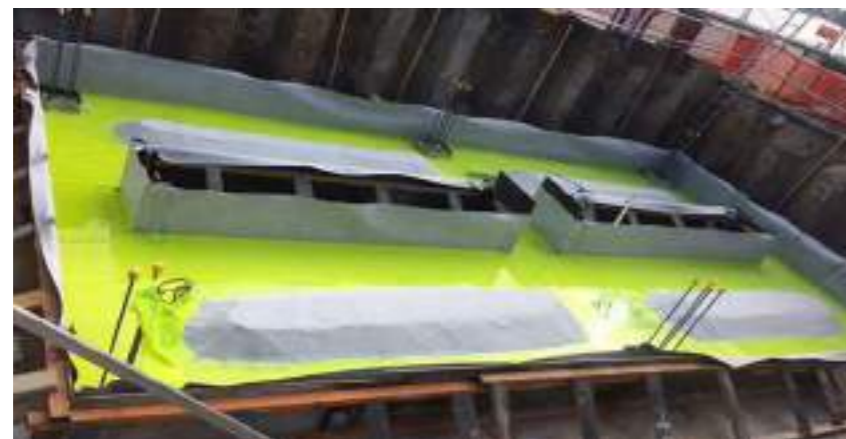
Green Island Naval Base Weldtec membrane application. (image: Ardex)

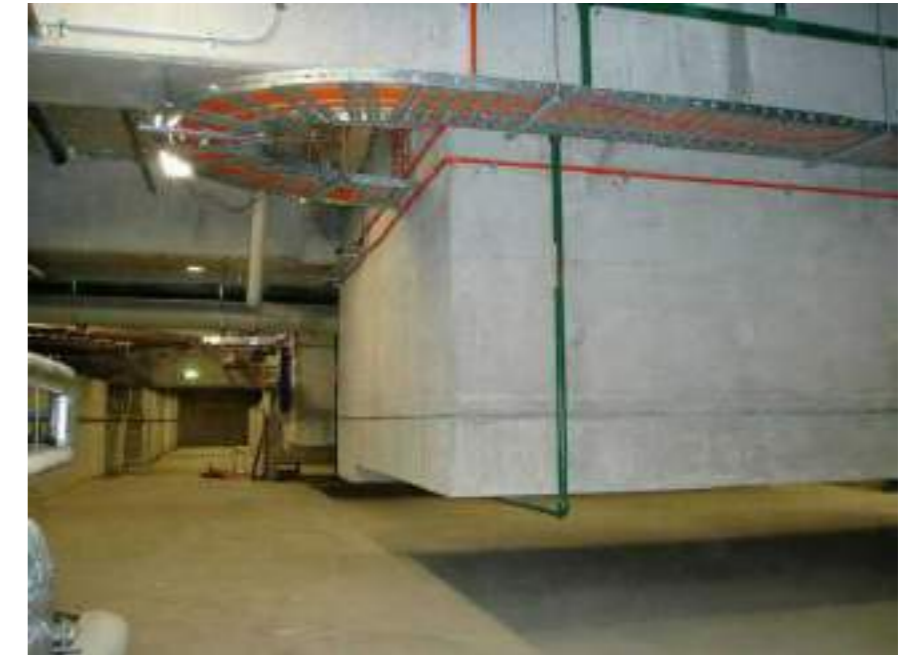
- The lift pits are suspended from the lower ground floor superstructure floor. So they can move independently from the foundation slab with the superstructure.

Christchurch Women's Hospital lift pits suspended into the basement from the superstructure.

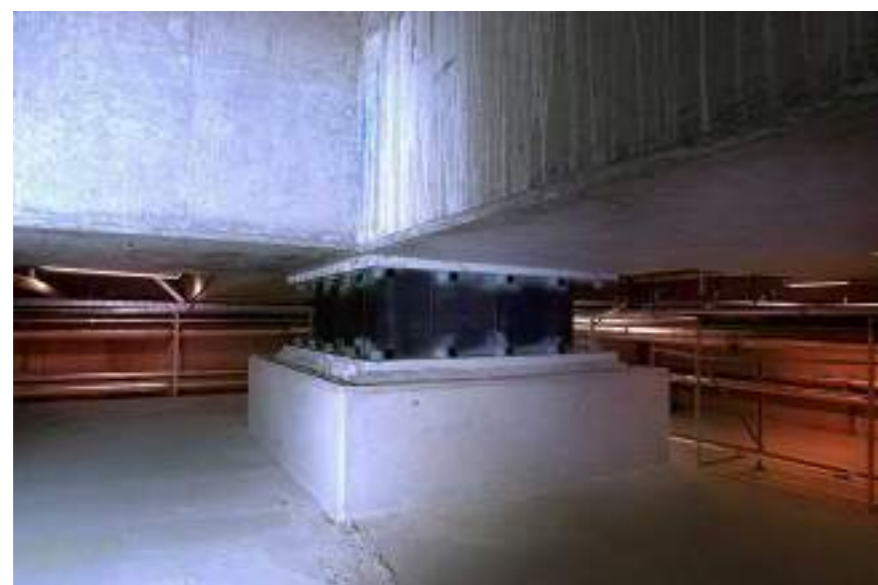
- The base isolators are between the concrete raft foundation slab (anchored by four 6.5m deep caisson piles) and the superstructure. The lower ground floor (underground) is not base isolated from the above ground superstructure.

Christchurch Women's Hospital base isolator between foundation slab and basement (Image: Holmes).

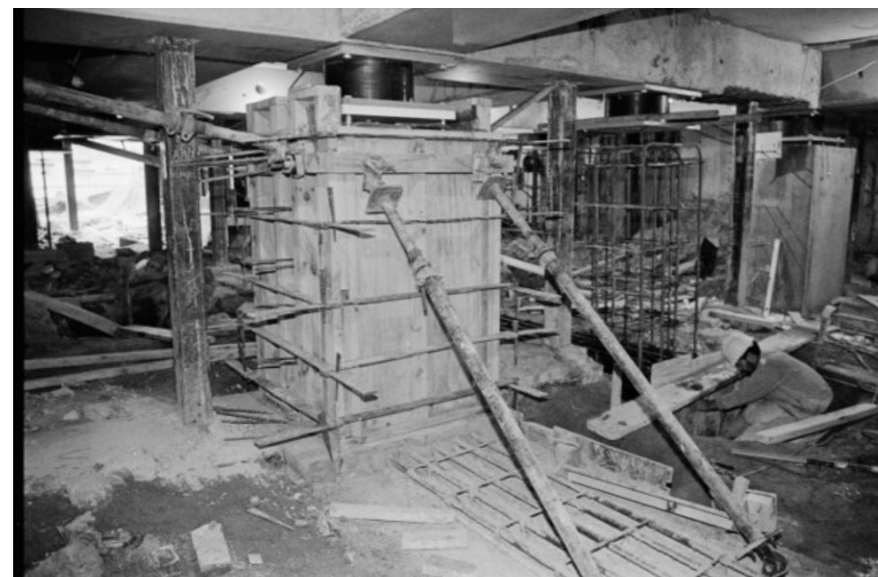
New Zealand Parliament building base isolators being retrofitted. Section swer cut from the existing foundation columns. (image: 1993 Dominion Post)

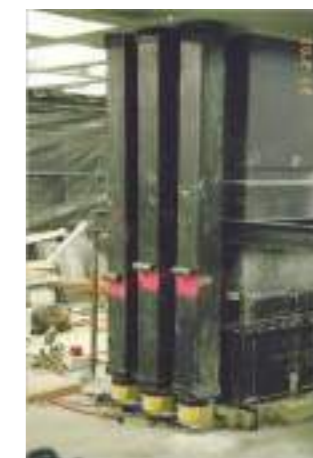
Level 0 props and jacks used while cutting the columns (image: 2004 NZSEE conference)
