# Application for Land Use Consent

## 187 Fitzgerald Avenue, Central City, Christchurch

# Heritage Impact Assessment - Commercial Building and Setting

187 Fitzgerald Avenue, Central City, Christchurch

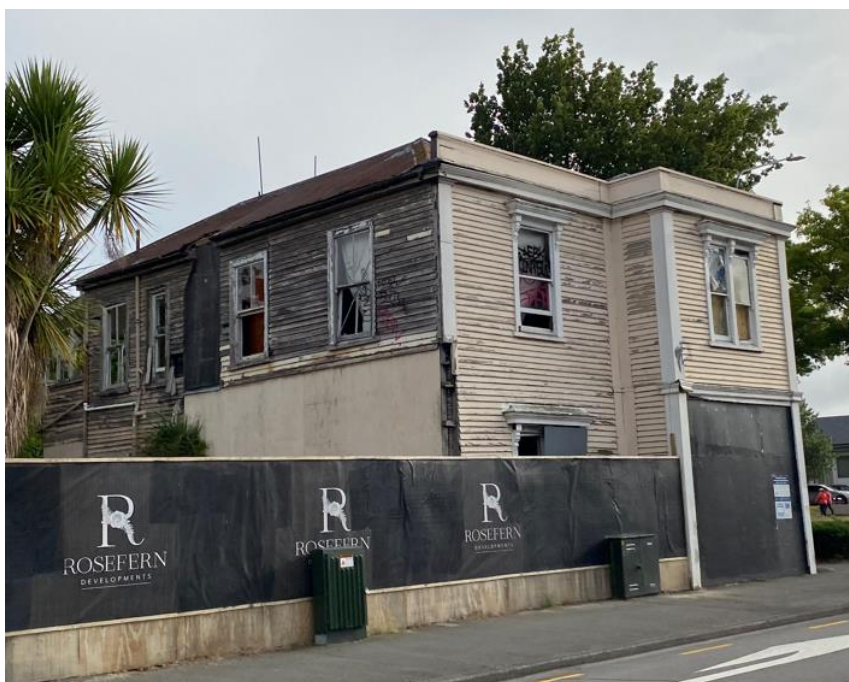
Figure 2: Street photo of the existing building at 187 Fitzgerald Ave

*"It has architectural significance as a distinctive colonial building type with residual restrained detailing. 187 Fitzgerald Ave has technological and craftsmanship significance for what it may reveal of late Victorian timber construction methodologies, materials, fixtures and fittings. It has contextual significance as a building type now rare in Christchurch and as a landmark on Fitzgerald Avenue"*

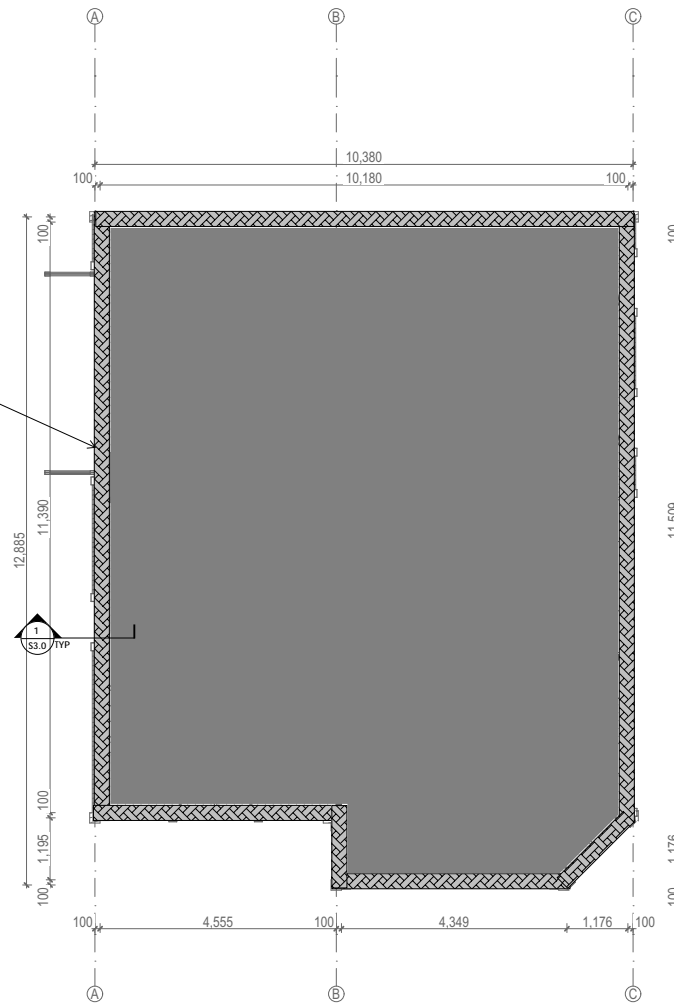
1 NEW FOUNDATION PLAN  
SCALE: 1: 50

EXISTING FOUNDATION TO BE DEMOLISHED AS REPLACED WITH NEW SLAB ON GRADE FOUNDATION

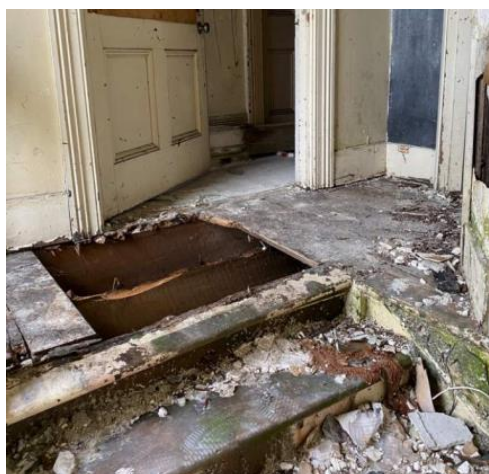
Experience in similar situations indicate a large quantity of new framing will be installed to reintroduce integrity to the existing suspended floor joist system. Either due to historic damage or consequential to the new works it is envisaged a certain portion of the existing structure will be removed to make way for new. An allowance for this demolition is included in the general demolition sum which is based on overall resource hours required. A similar requirement may apply to the roof rafters, and it is expected the extent will be similar to the floor system.

**Image 4: Existing Floor Condition**

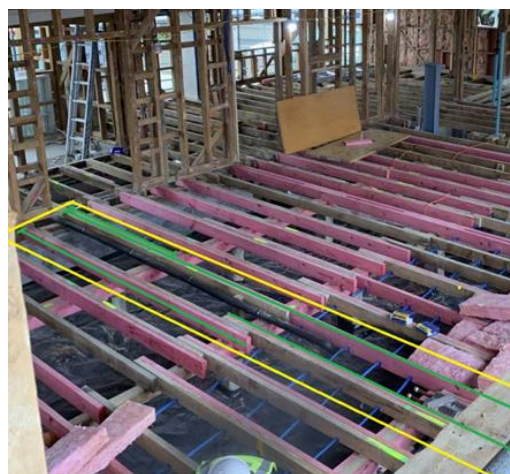
**Image 5: - Example recent project showing extend of new framing to floors that may be required.**

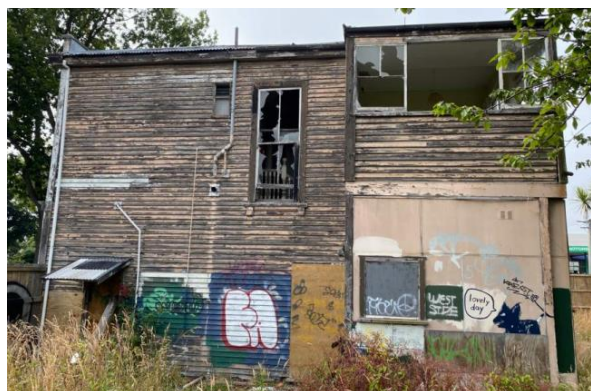
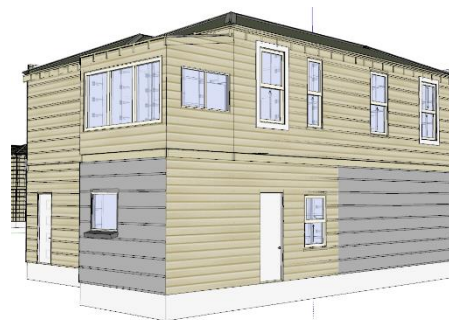
**Image 8 & 9 Cladding views**

This repairs strategy assumes that the current cladding system is not compliant and new cavity system must be incorporated into the reinstatement.

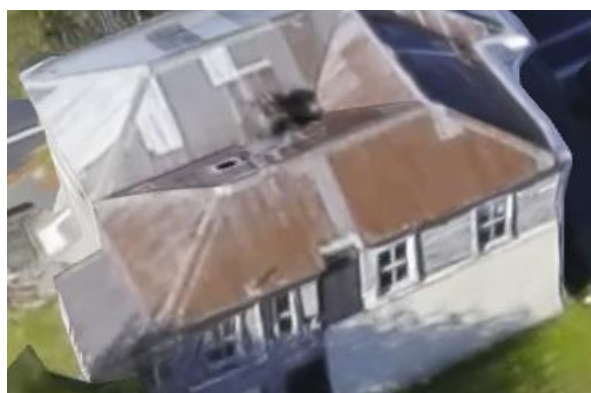
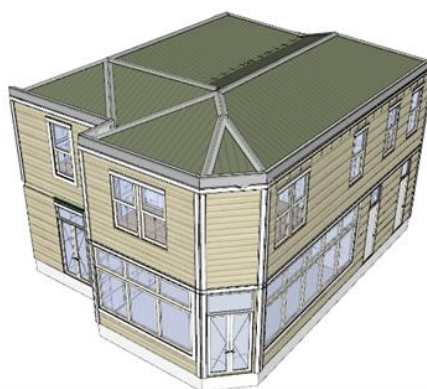
**Image 10 & 11 Roof Views**

Taking into consideration the access required for framing repairs and also due to the extent of damage to the coverings as mentioned in the report we have developed our repair costs based on full replacement of the roof claddings.
