**Canterbury Earthquakes 2010/11 Port Hills Slope
Stability: Debris avalanche risk assessment for
Richmond Hill**

**GNS Science Consultancy Report 2014/34
August 2014 FINAL**

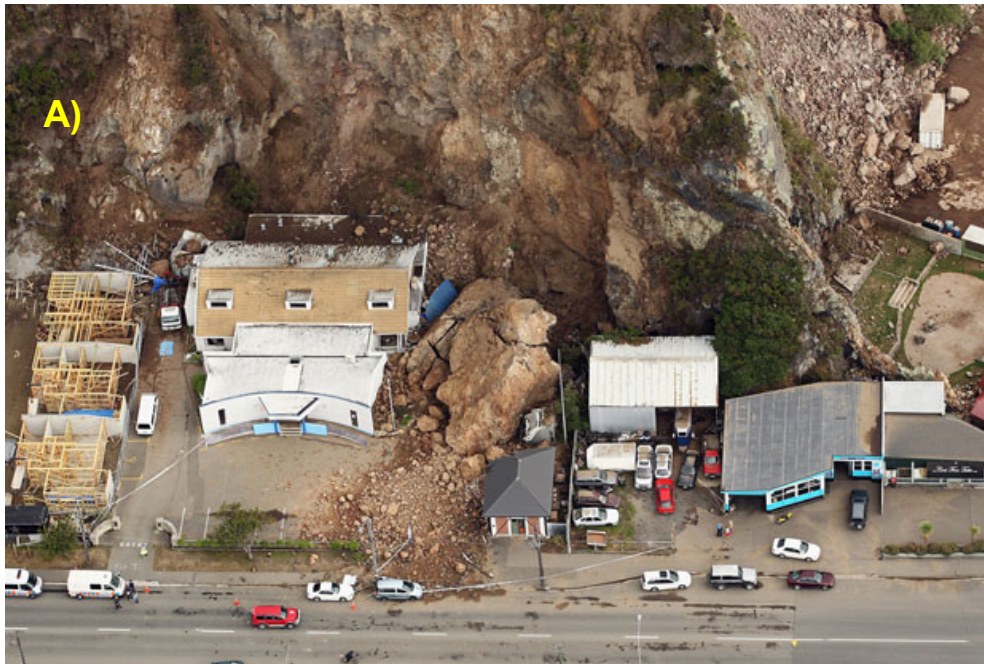
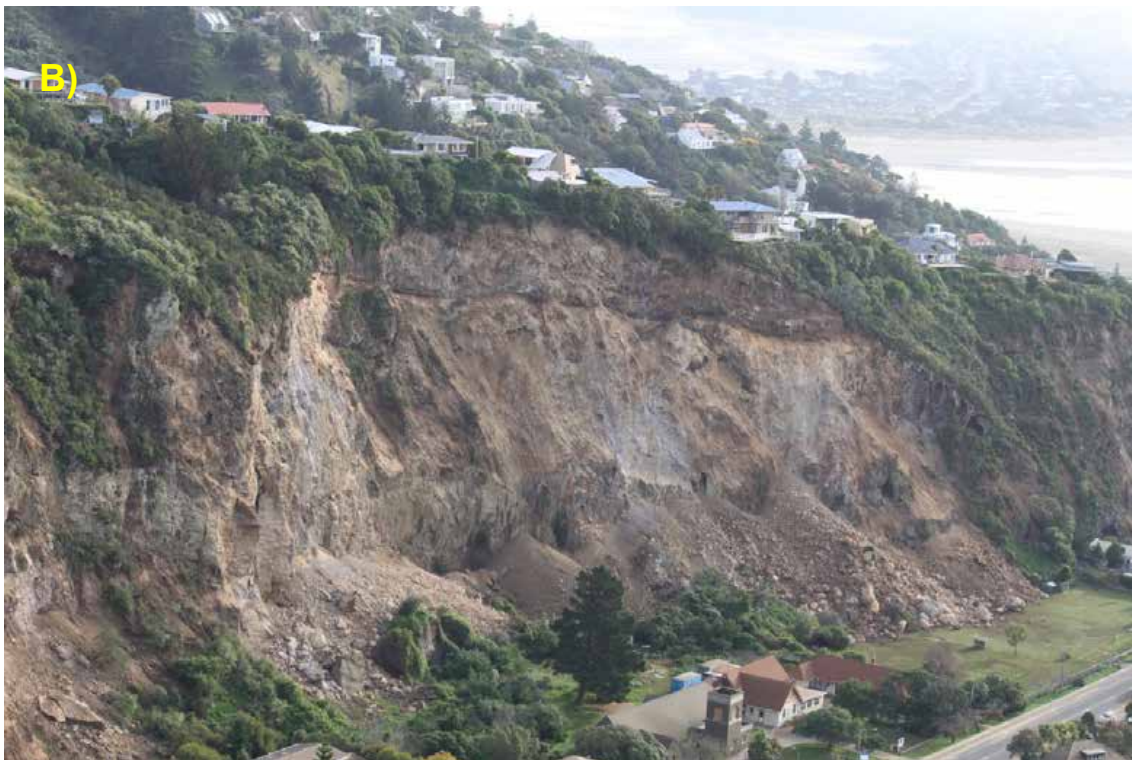
Figure 3 A) Debris avalanche triggered by the 2010/11 Canterbury earthquakes (location of one fatality) at the northern end of the site. Wakefield Avenue is in the foreground. Photograph by G. Hancox GNS Science. B) Debris avalanches triggered by the 2010/11 Canterbury earthquakes have fallen onto properties at the foot of the former sea cliff along the western side of Wakefield Avenue (right foreground). Photograph by G. Hancox, GNS Science.

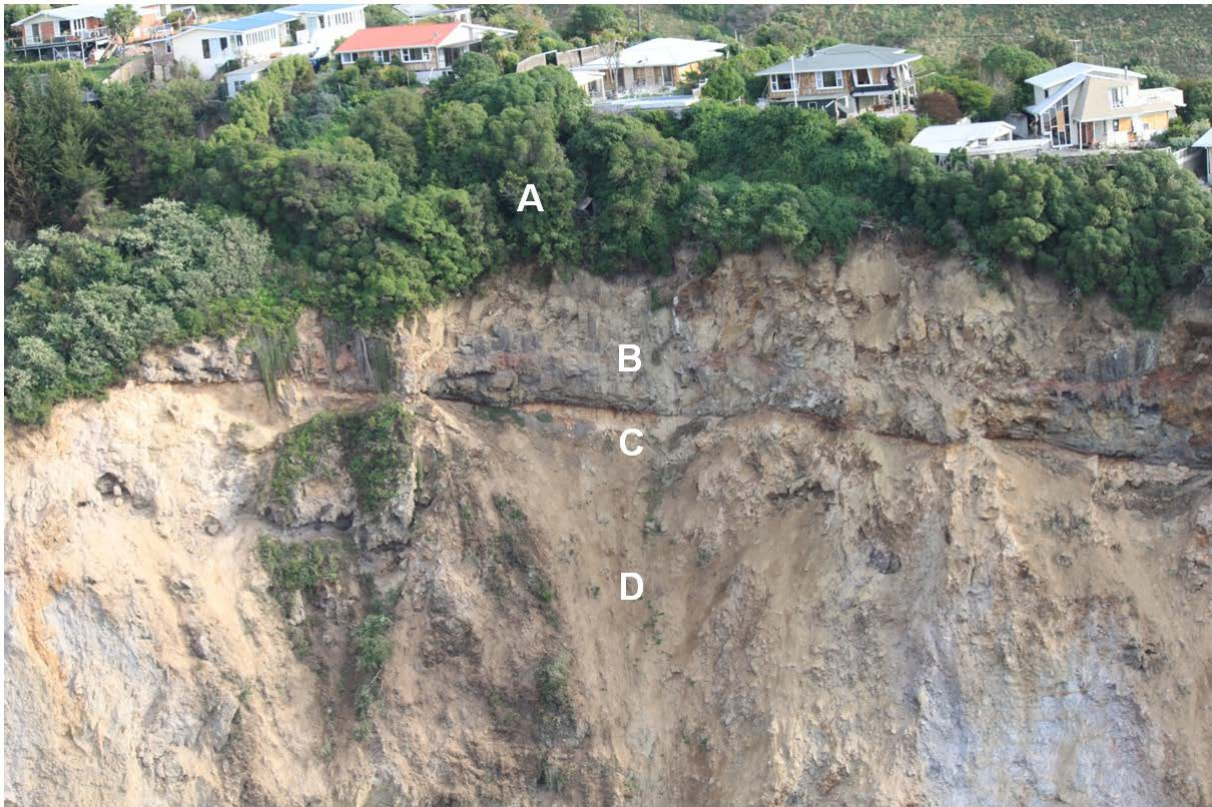
Figure 9 View to the west onto the northern cliff at Wakefield Avenue. The homes are accessed from Richmond Hill Road. The loess/fill, which is thickly covered by tall shrubs, overlies rock at the slope crest (**A**). The rock exposed in the upper part of the cliff (**B**) is columnar jointed basalt lava and breccia. The persistently recessed layer beneath this is the epiclastic deposit (**C**), and the material below this is massive trachy basalt lava breccia (**D**). Photograph C. Massey GNS Science (July 2011).

The cliff face comprises gently dipping (and locally steeply dipping) interlayered variations of four main rock types – in order from the cliff edge to cliff bottom: 1) Blocky columnar-jointed basalt lava interlayered with more massive basalt lava breccia; 2) epiclastic layers within the basalt-breccia/lava sequence ranging from coarse poorly sorted conglomerates and sandstones to tuffaceous clays and silts and rare but prominent palaeosols (Figure 9). The materials within the layers are highly variable both laterally and vertically but the layers are laterally persistent along most of the cliff); 3) trachy-basalt breccia; and 4) trachy-basalt lava. Descriptions of the main units are given in Table 10.

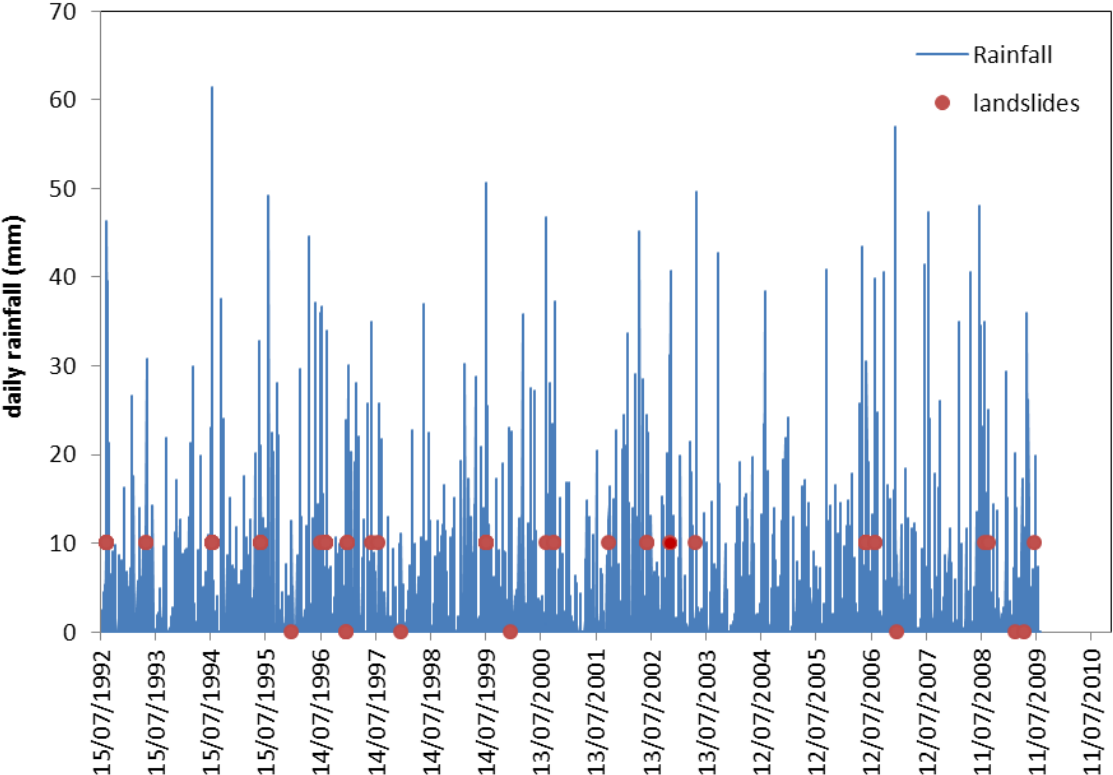
Figure 11 Daily rainfalls at Christchurch Gardens and landslides in the Port Hills. Daily rainfalls at Christchurch Gardens and landslides in the Port Hills investigated by Geotechnical Consulting Ltd, or listed by the Earthquake Commission as causing damage to homes. Landslides without rain are plotted at 0 mm, all others are plotted at 10 mm of rain (the minimum rainfall for triggered landslides).

A list of Earthquake Commission claims for landslide (rockfall) damage was examined for the interval 1997–2010, and a Geotechnical Consulting Ltd. landslide investigations list covers the interval 1992–2009. Any duplicate records for the period 1997–2009 contained in the data sets were removed. These records, though incomplete with respect to all of the landslides that occurred over those intervals, may be approximately complete with respect to the episodes of rain associated with landslide occurrences that damaged homes and urban properties (Figure 11).

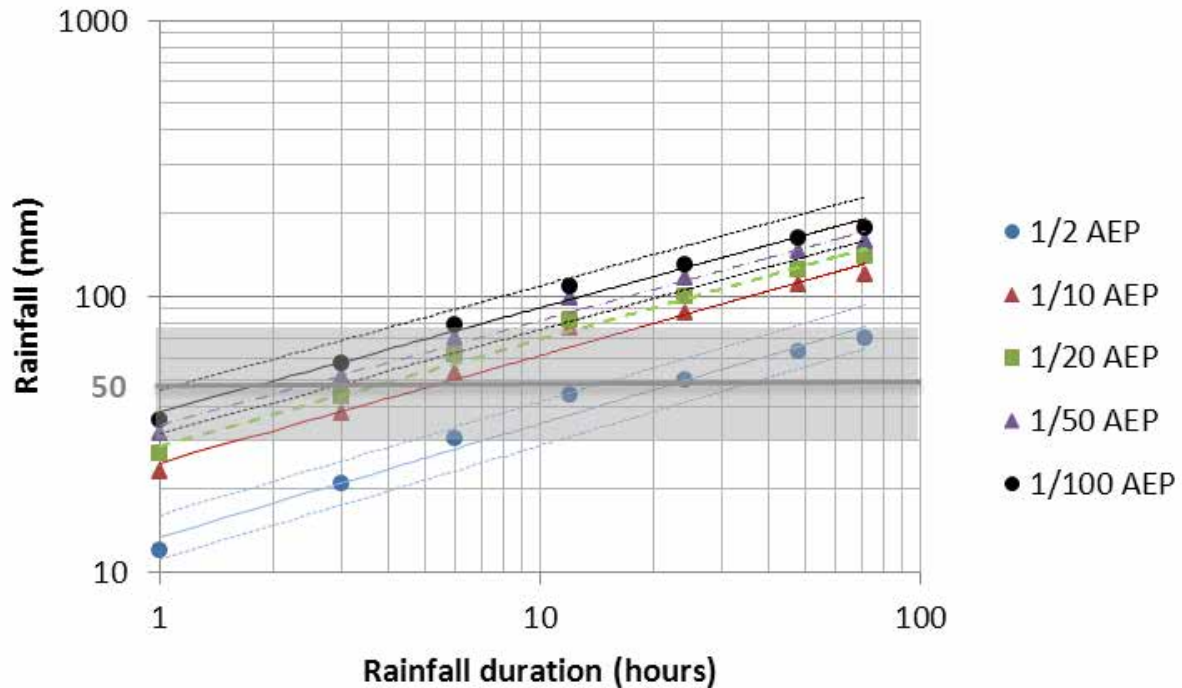
Figure 12 Rainfall depth-duration-return period relations estimated for Christchurch Gardens by Griffiths et al. (2009) using recorded rainfall data. Error limits of 20% are shown by dotted lines for the 1/2 and 1/100 AEP curves. Shaded area covers the range of 30–75 mm of rainfall over which the expected number of soil landslides in the Port Hills rises from very few to many. Rockfalls can occur without rain, but the probability of rockfalls occurring increases with increasing intensity of rainfall.

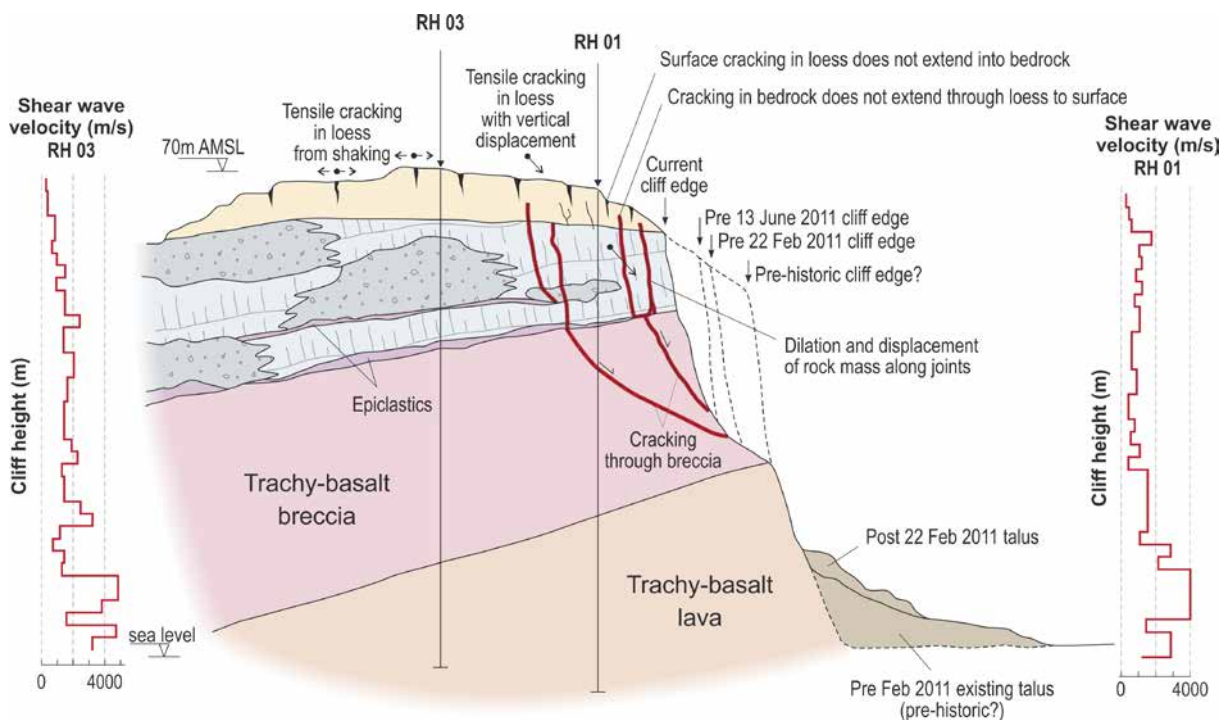
Figure 14 Schematic cross-section (cross-section 2, Figure 7) of the cliff showing the inferred failure mechanisms and differences in rock mass strength derived from the downhole shear wave surveys.

The static strength of the rock slope and its loess mantle at the slope crest is considered to have been weakened from its pre-earthquake state by earthquake-induced cracking and deformation of the rock-mass and loess. The newly exposed slope is considered to be more prone to failure than was the former slope which had had many hundreds of years to shed its less stable material after the penultimate earthquake sequence. Significant rock-mass degradation is supported by post-earthquake down-hole geophysical surveys, laboratory strength tests of drill core samples and boulders, and identification of significant cracks and areas of deformation on the cliff face that were visible after the 13 June 2011 earthquake (Figure 14).

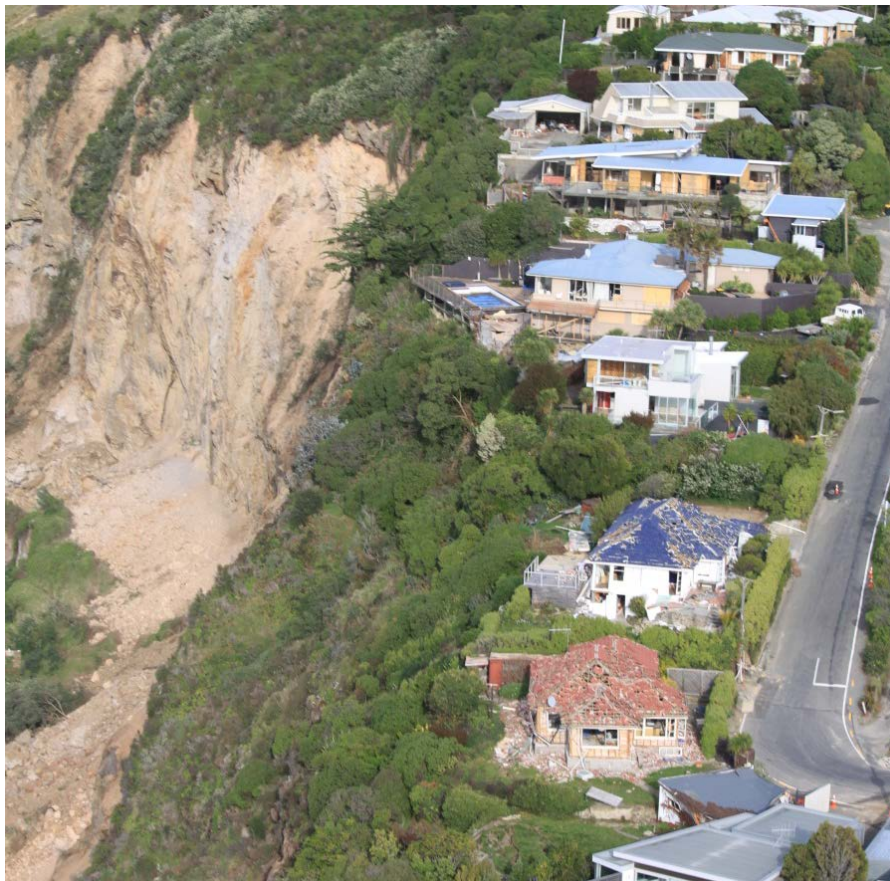
Figure 15 View to the south along Richmond Hill after the 13 June 2011 earthquake. Photograph taken by C. Gibbons, Aurecon New Zealand Ltd.

Buildings at the cliff top towards the northern end of the spur – where the width of the spur is thinnest – showed major shaking damage, indicating that significant amplification of ground shaking occurred in these areas (Figure 15).

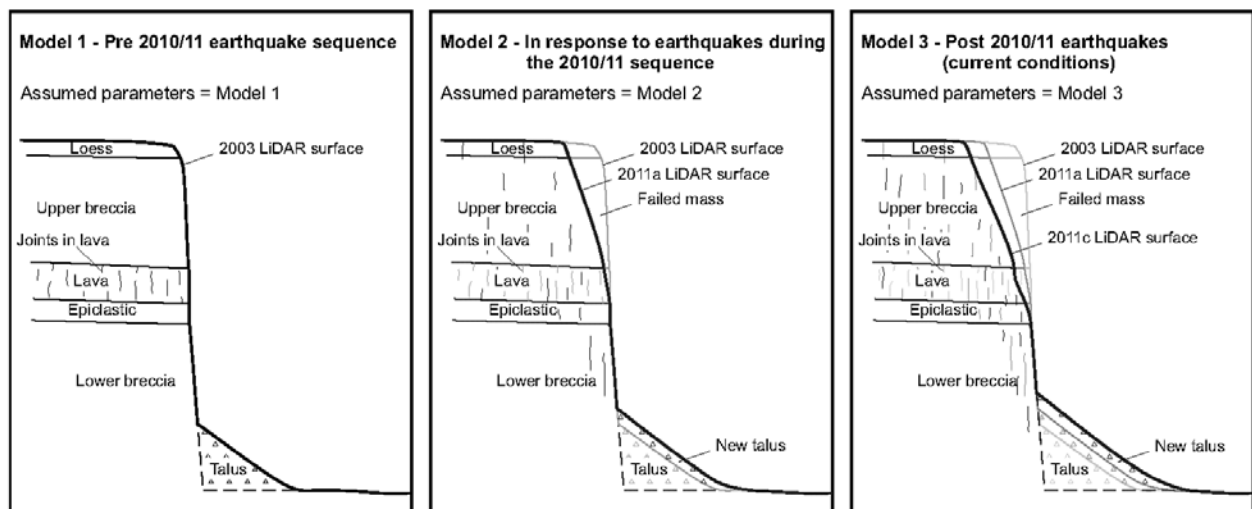
Figure 16 Schematic diagram showing the increasing frequency of defects in the slope in response to the successive 2010/11 Canterbury earthquakes.

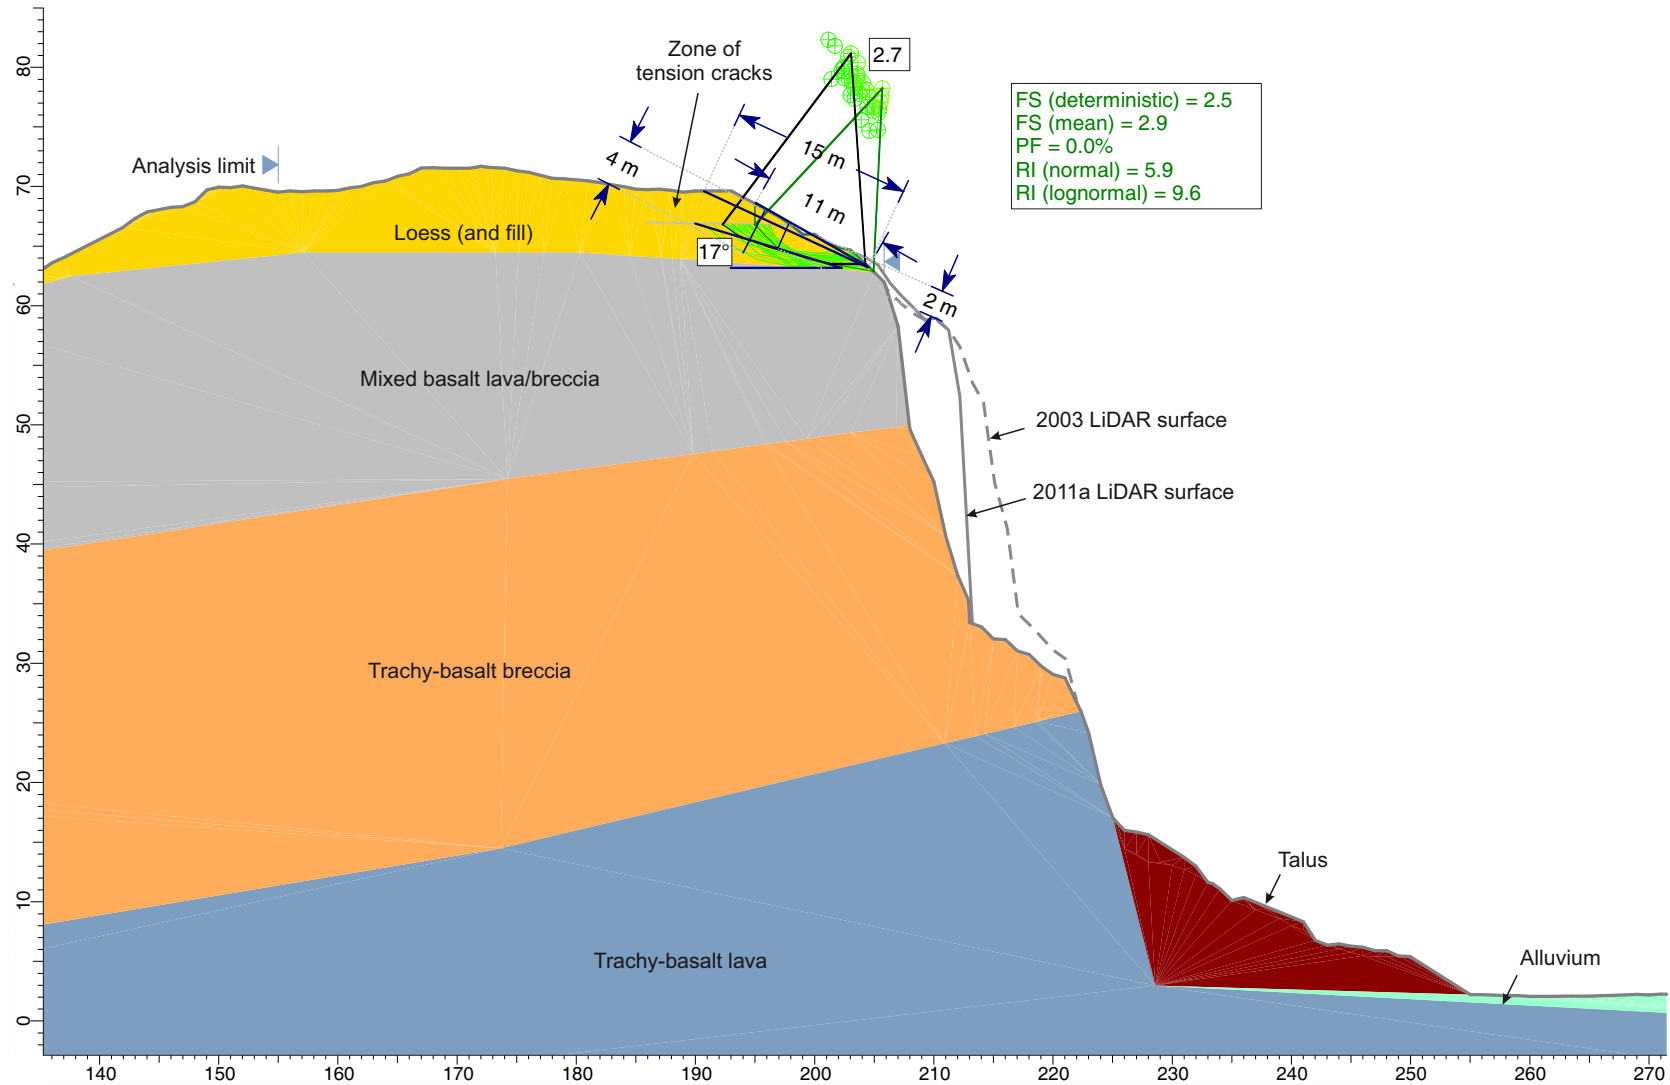
Slip surfaces shown with factor of safety < 3
 Factor of safety calculated adopting the GLE Morgenstern and Price (1965) method

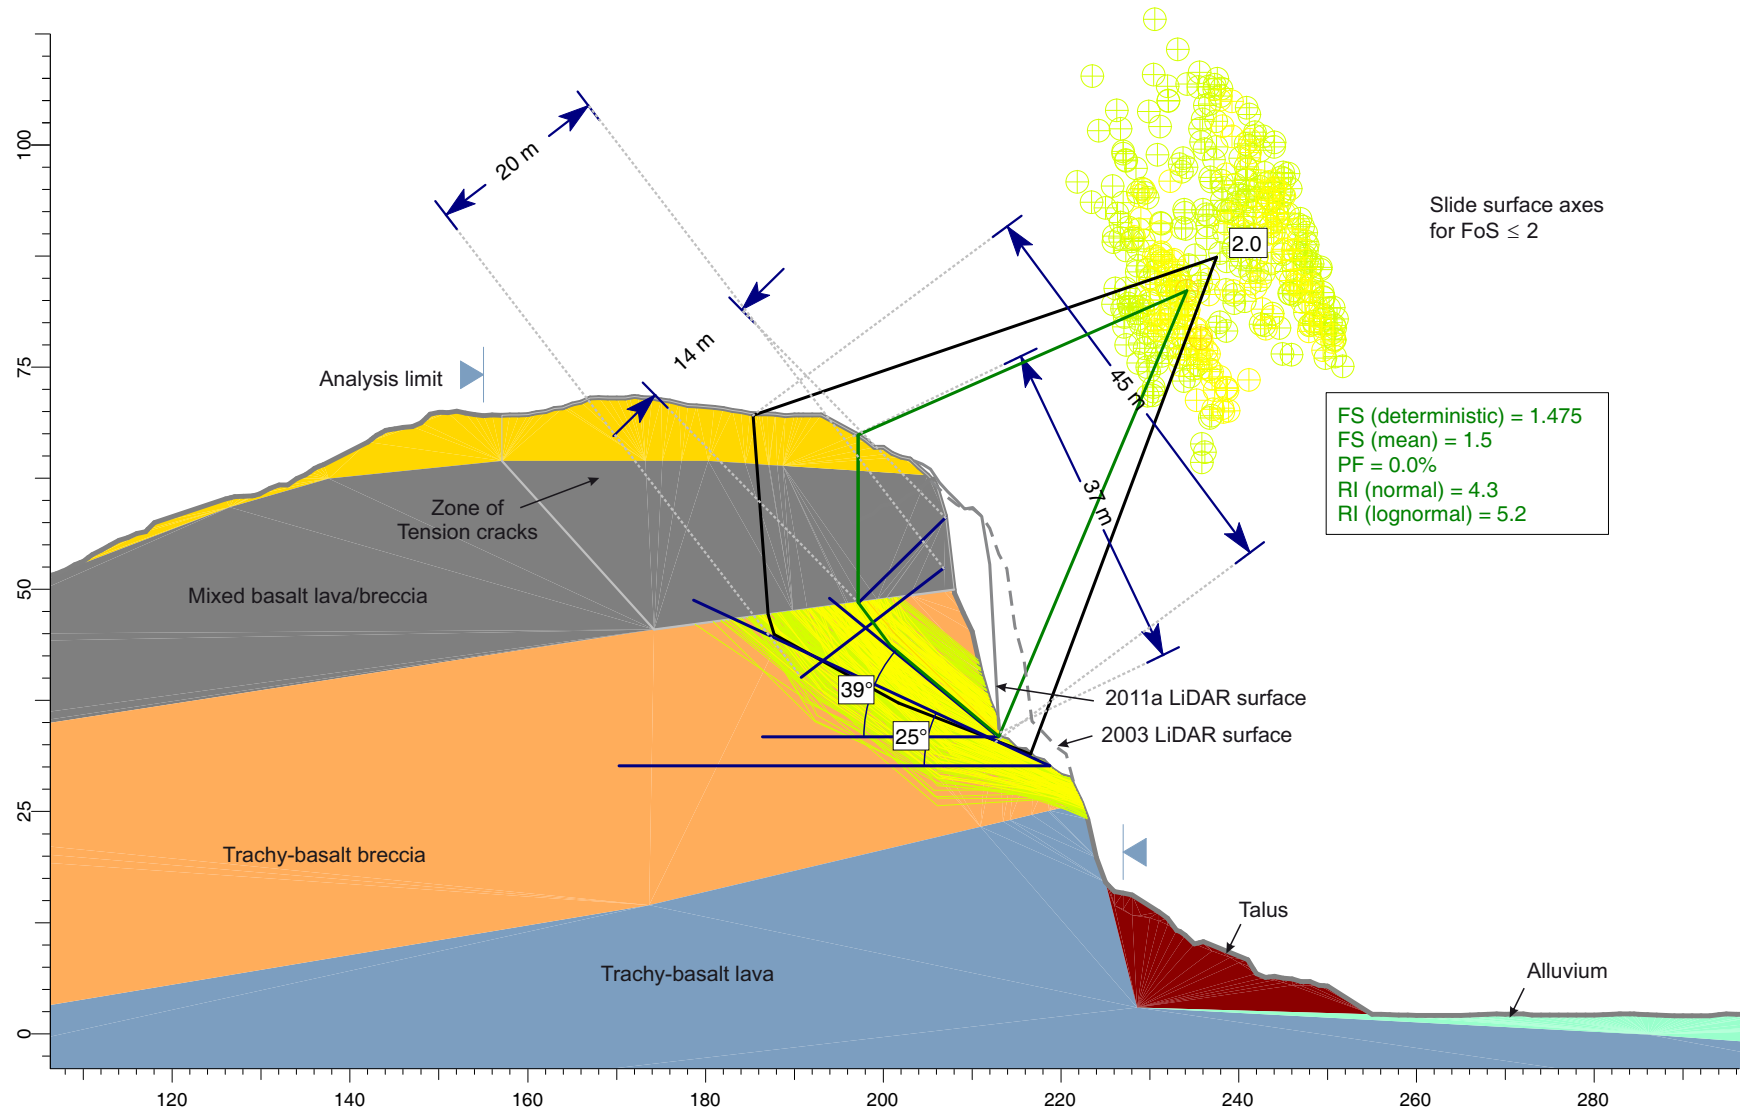
Slip surfaces shown with factor of safety < 2
 Factor of safety calculated adopting the GLE Morgenstern and Price (1965) method

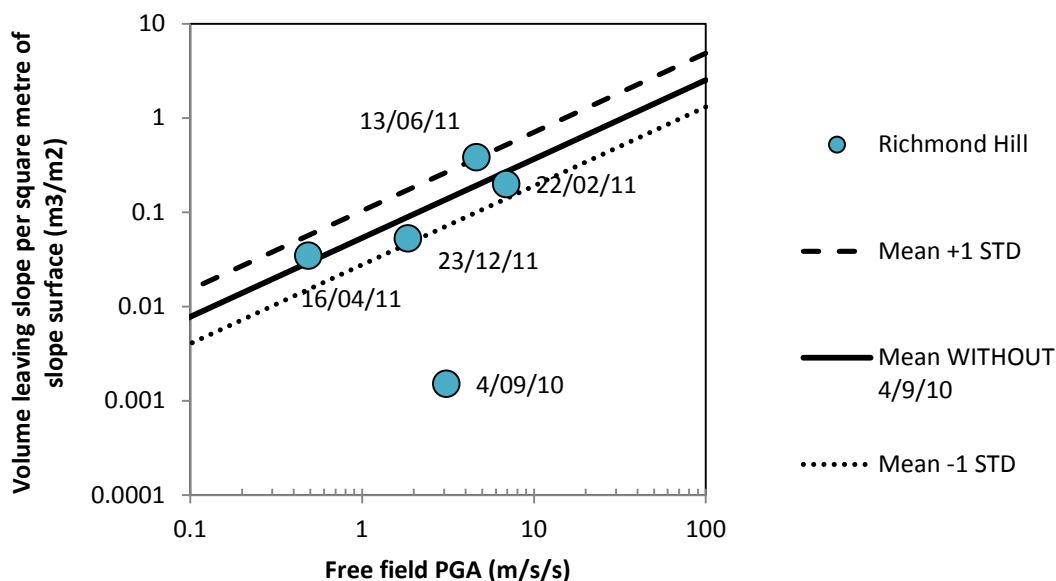
Figure 27 Relationship between free field peak ground accelerations at Richmond Hill and the volume of debris leaving the Richmond Hill slope.

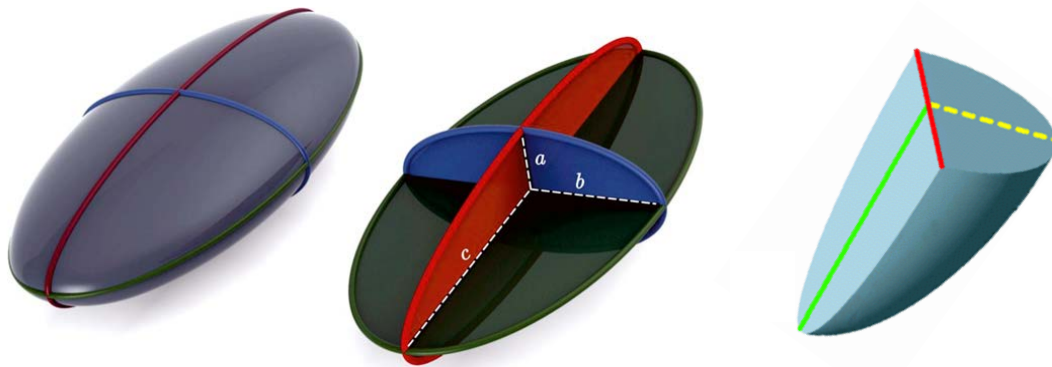
Figure 29 Estimation of landslide volume assuming a quarter-ellipsoid shape.

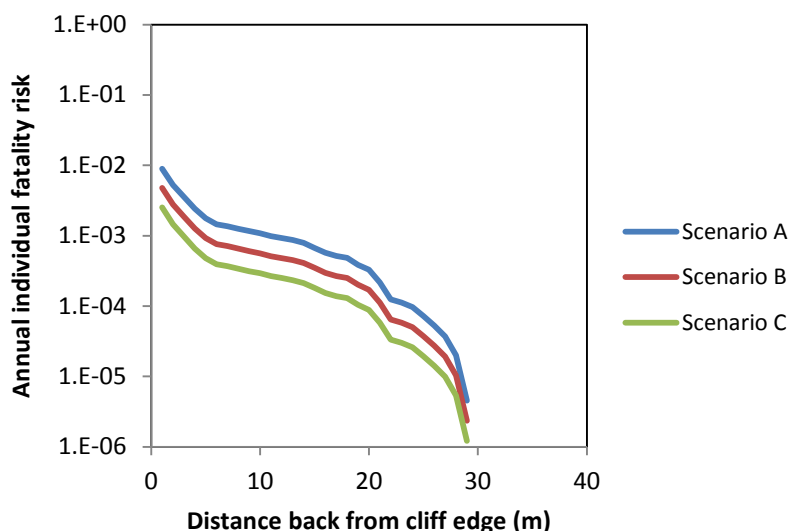
Figure 40 Results from the cliff top recession risk assessment, per scenarios A, B and C (dwelling occupant). Refer to Table 25 for details of the each scenario.

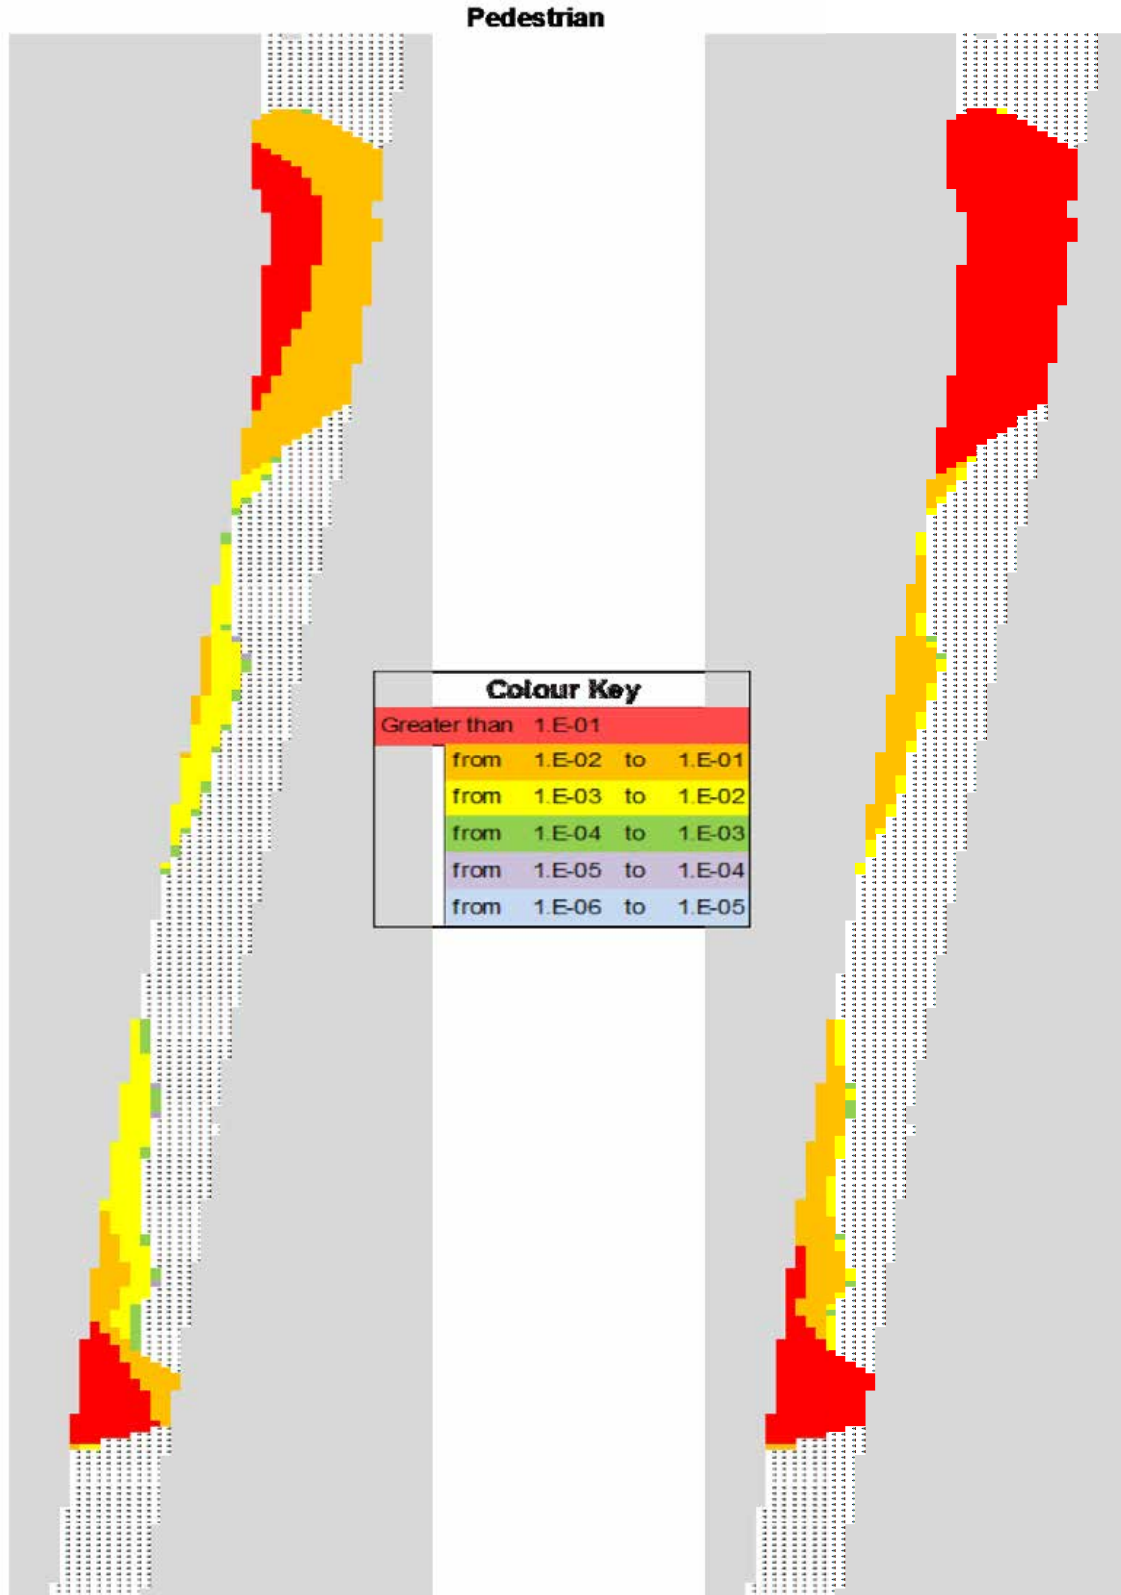
Figure 42a Road user risk contributions (per 100 million journeys) from individual cells – Scenario A.

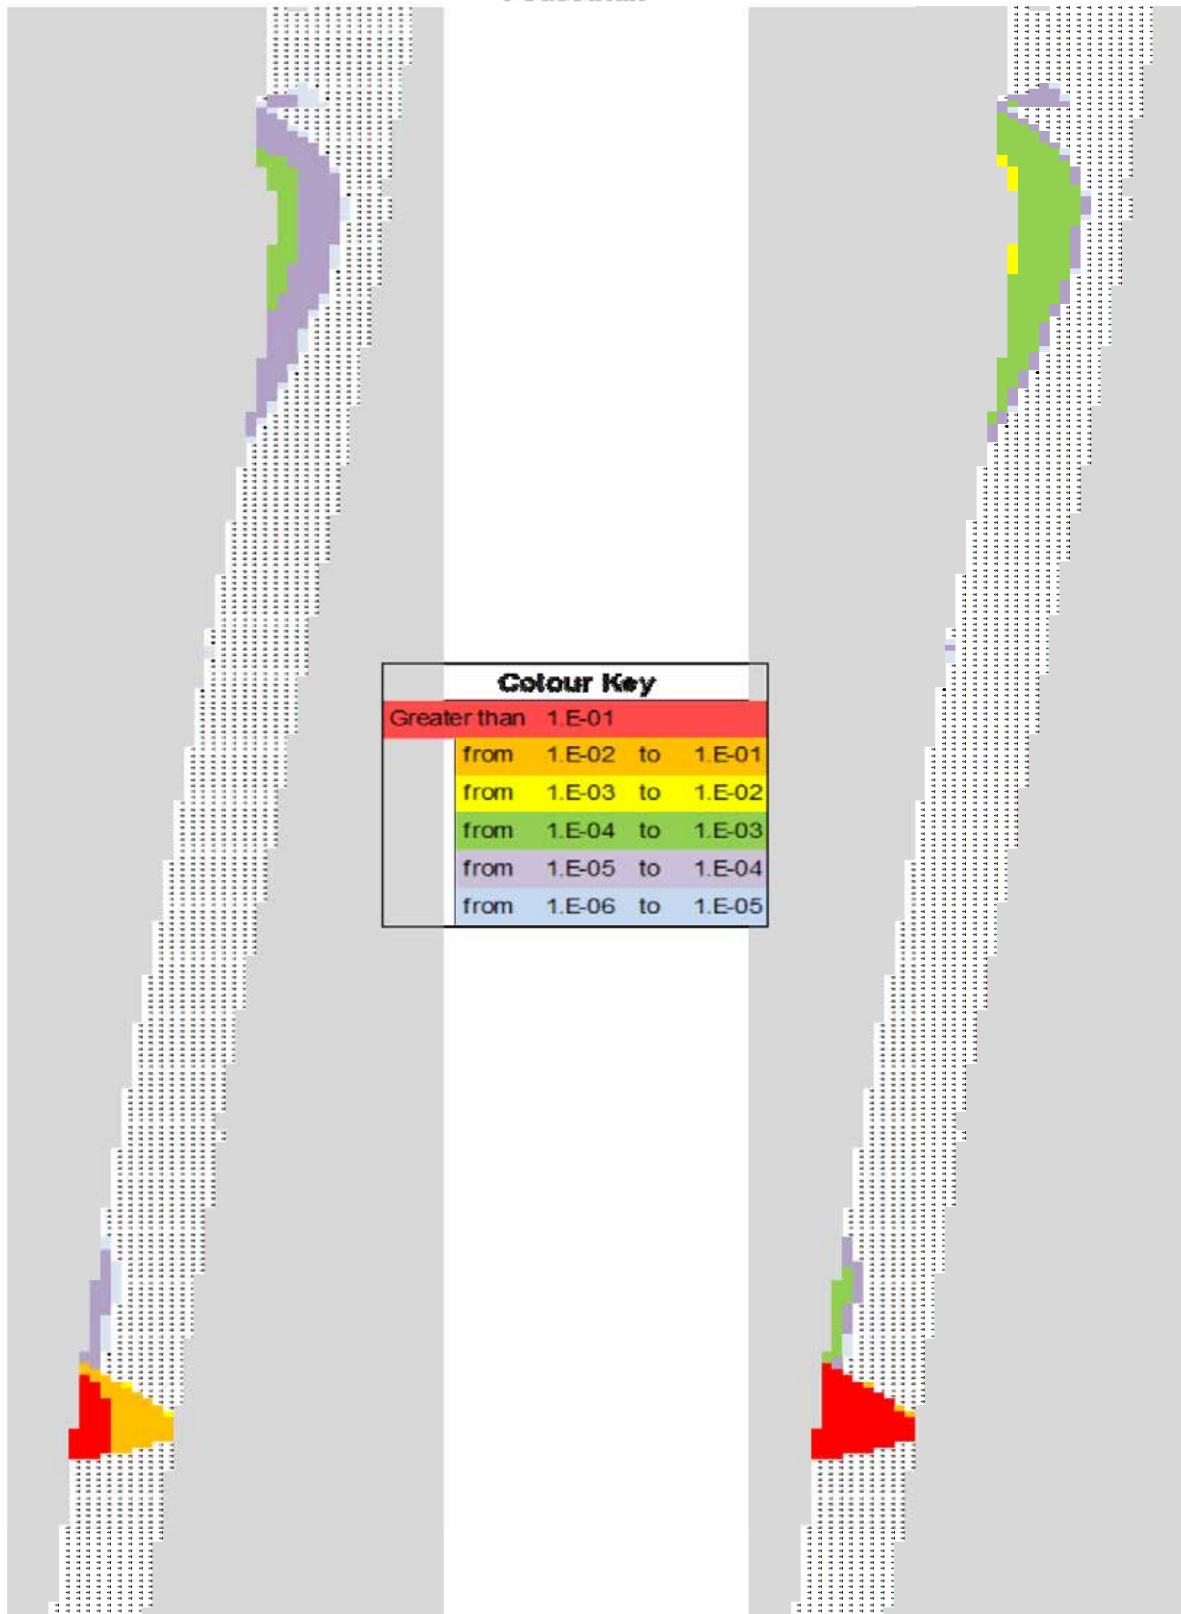
Figure 42c Road user risk contributions (per 100 million journeys) from individual cells – Scenario C.

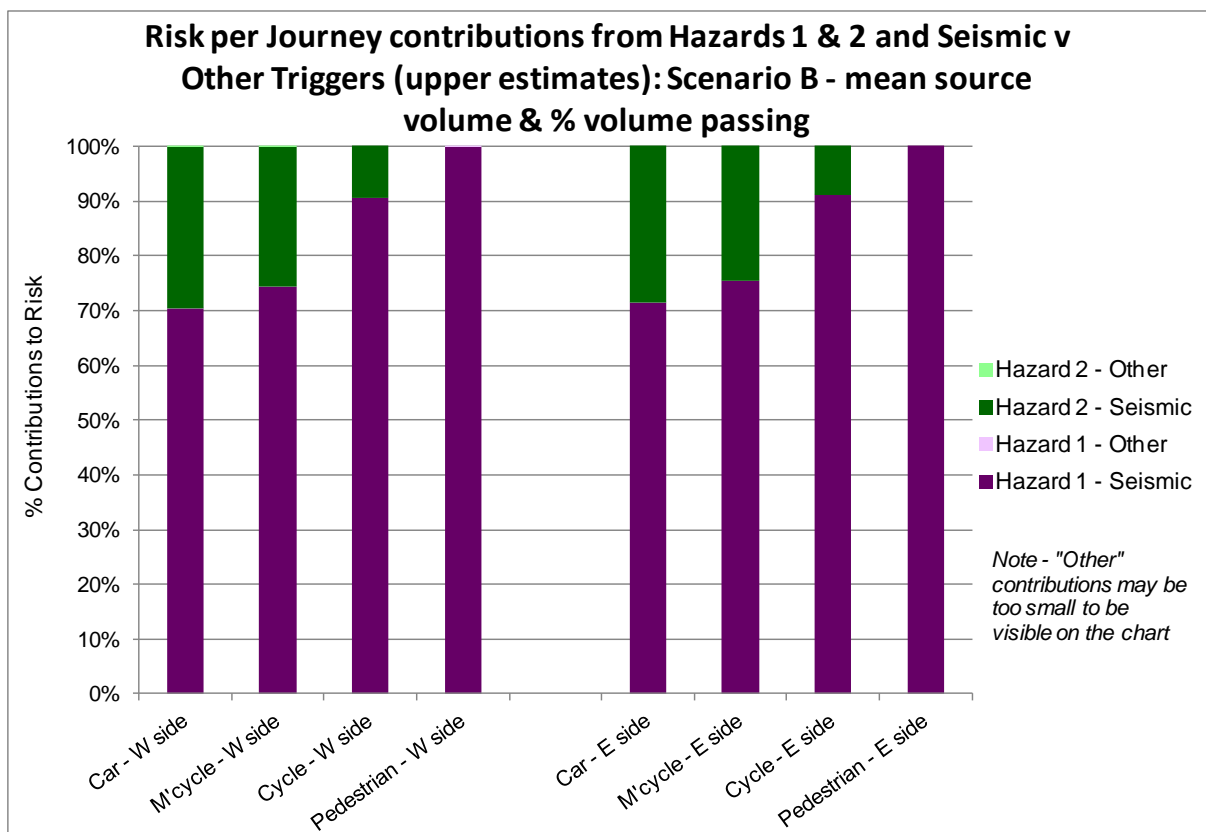
Figure 43 Risk contributions from hazards 1 and 2 and seismic versus other triggers.

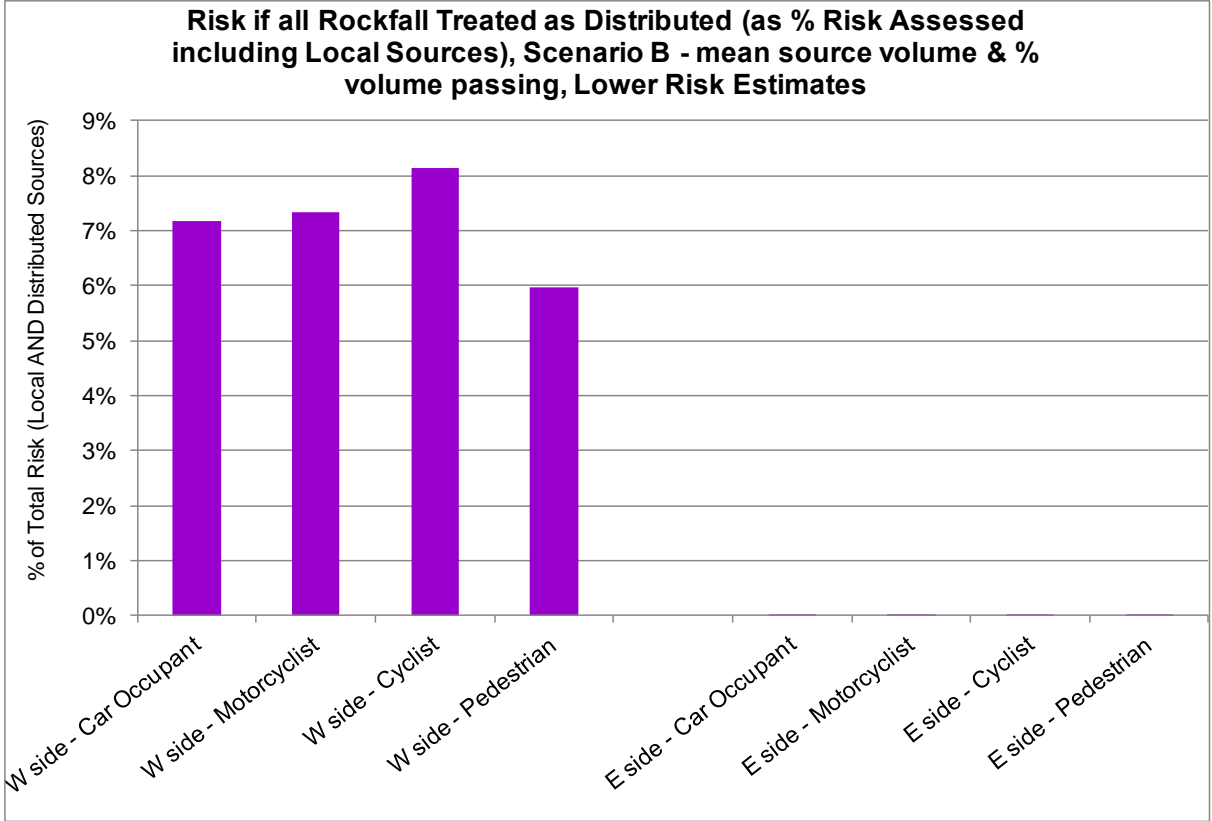
Figure 44 Effect of treating all rockfall as uniformly distributed along the cliff – Scenario B.

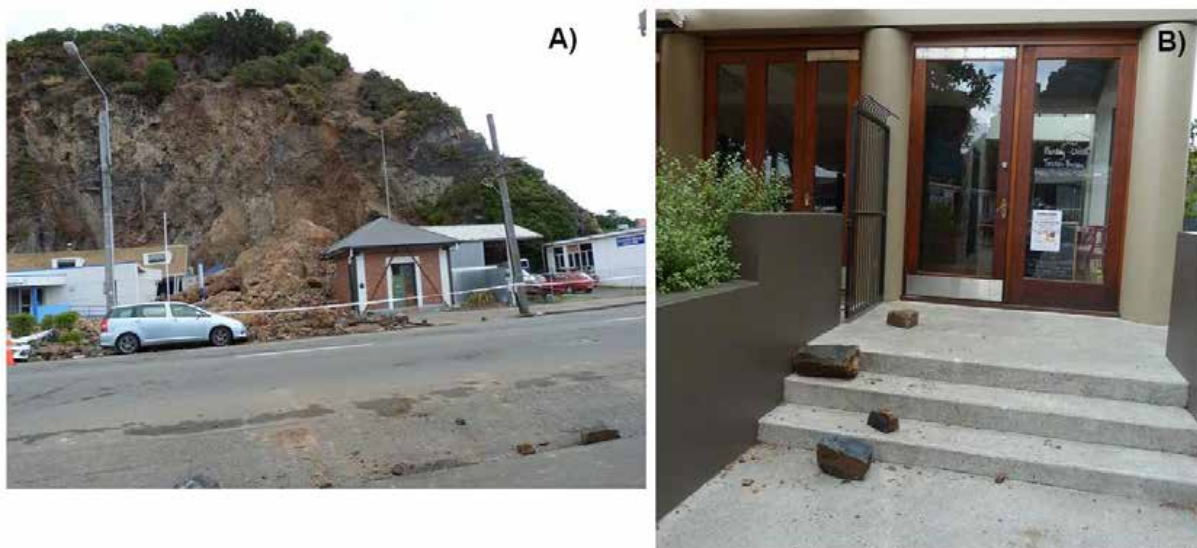
Figure A1.2 Debris avalanche at the northern end of Richmond Hill site triggered by the 22 February 2011 earthquakes. **A)** Photograph looking west across Wakefield Avenue – note debris in the foreground and some debris has been cleared from the road. **B)** Photograph looking east from Wakefield Avenue, opposite photograph A) showing fly-rock debris. Photographs taken by M. Yetton.

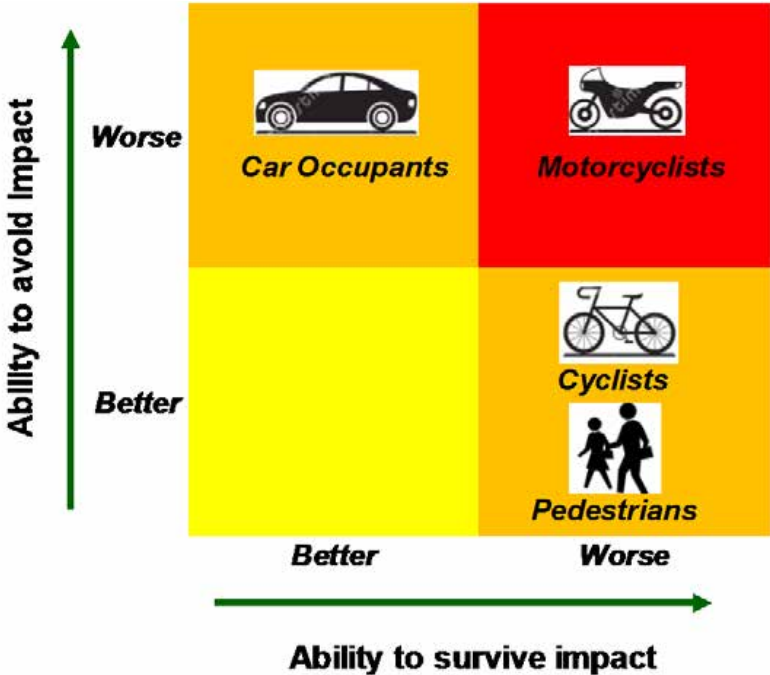
Figure A1.4 Overview of vulnerability factors for road users in path of rockfall.

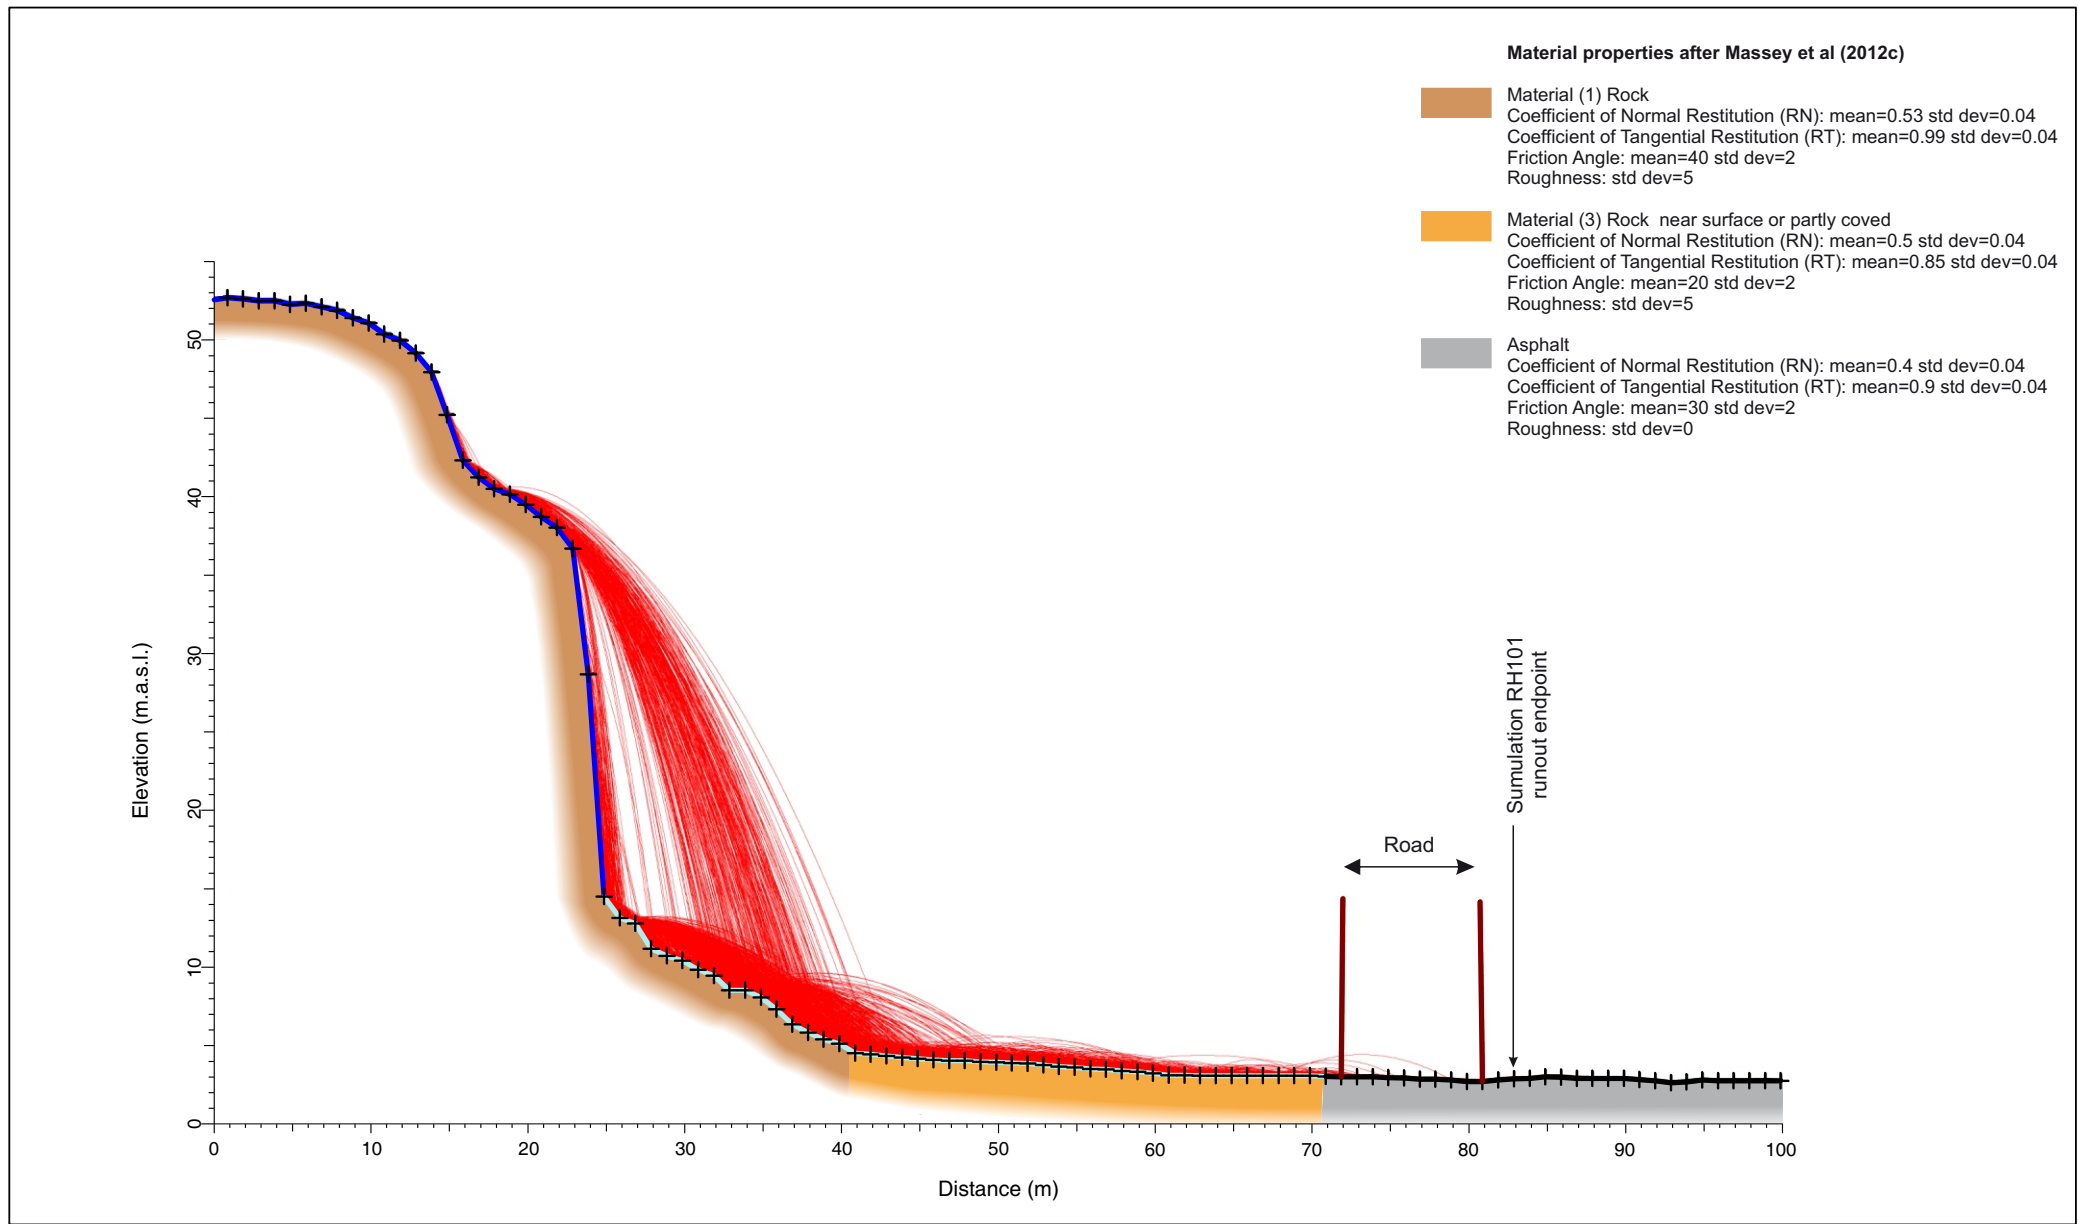
Input material parameters from Massey et al 2012c
 Number of rocks = 2000
 Unit weight 27 KN/m³
 Cut of velocity 0.1m/sec
 Simulated rock mass 1,000kg (~0.3m³)
