**Canterbury Earthquakes 2010/11 Port Hills Slope
Stability: Debris avalanche risk assessment for
Richmond Hill**

**GNS Science Consultancy Report 2014/34
August 2014 FINAL**

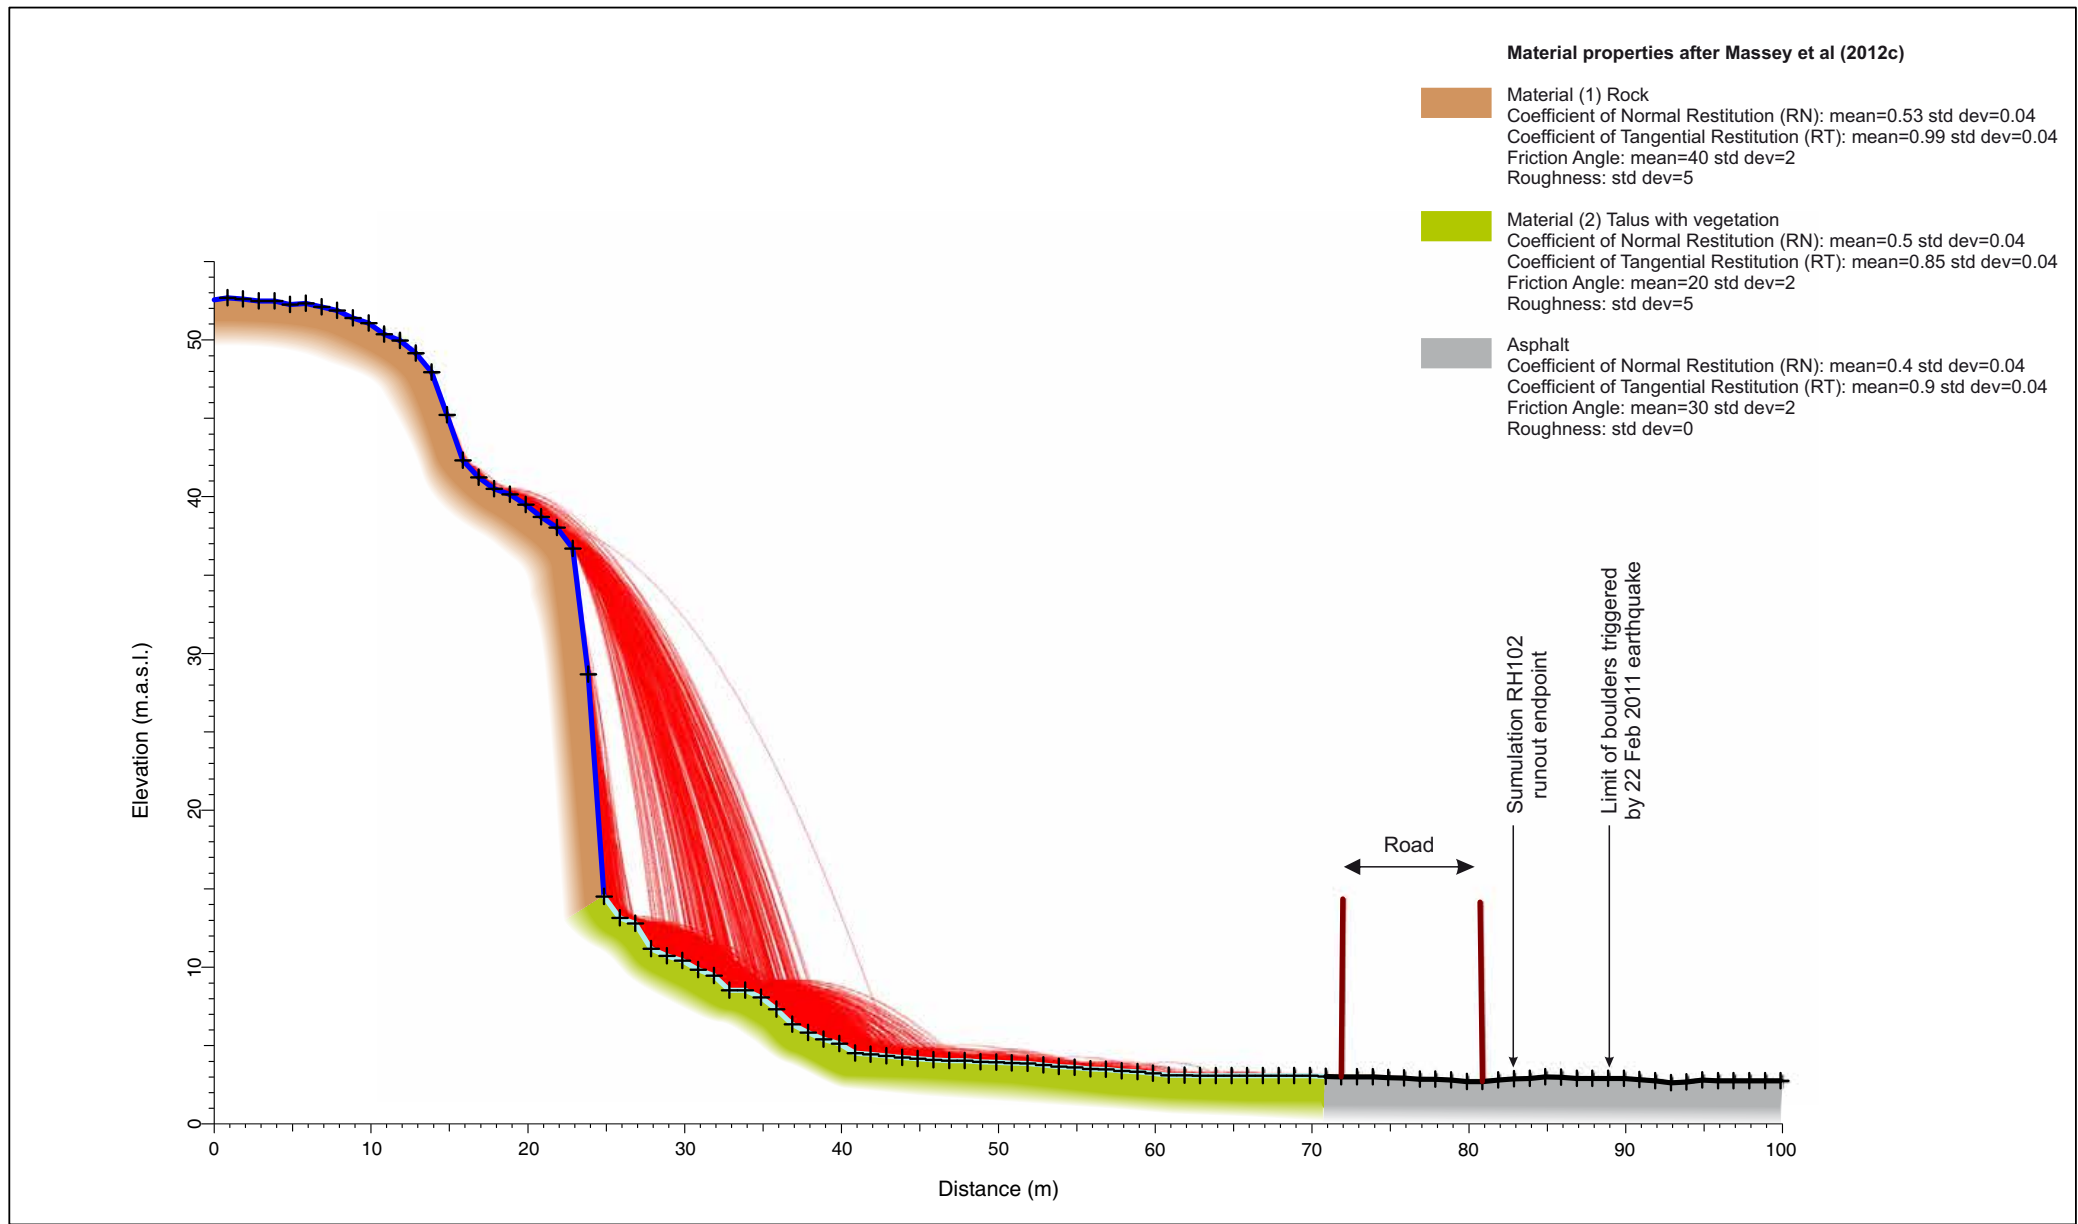
Input material parameters from Massey et al 2012c Number of rocks = 2000 Unit weight 27 KN/m ³ Cut of velocity 0.1m/sec Simulated rock mass 1,000kg (~0.3m ³)	DRW: PC

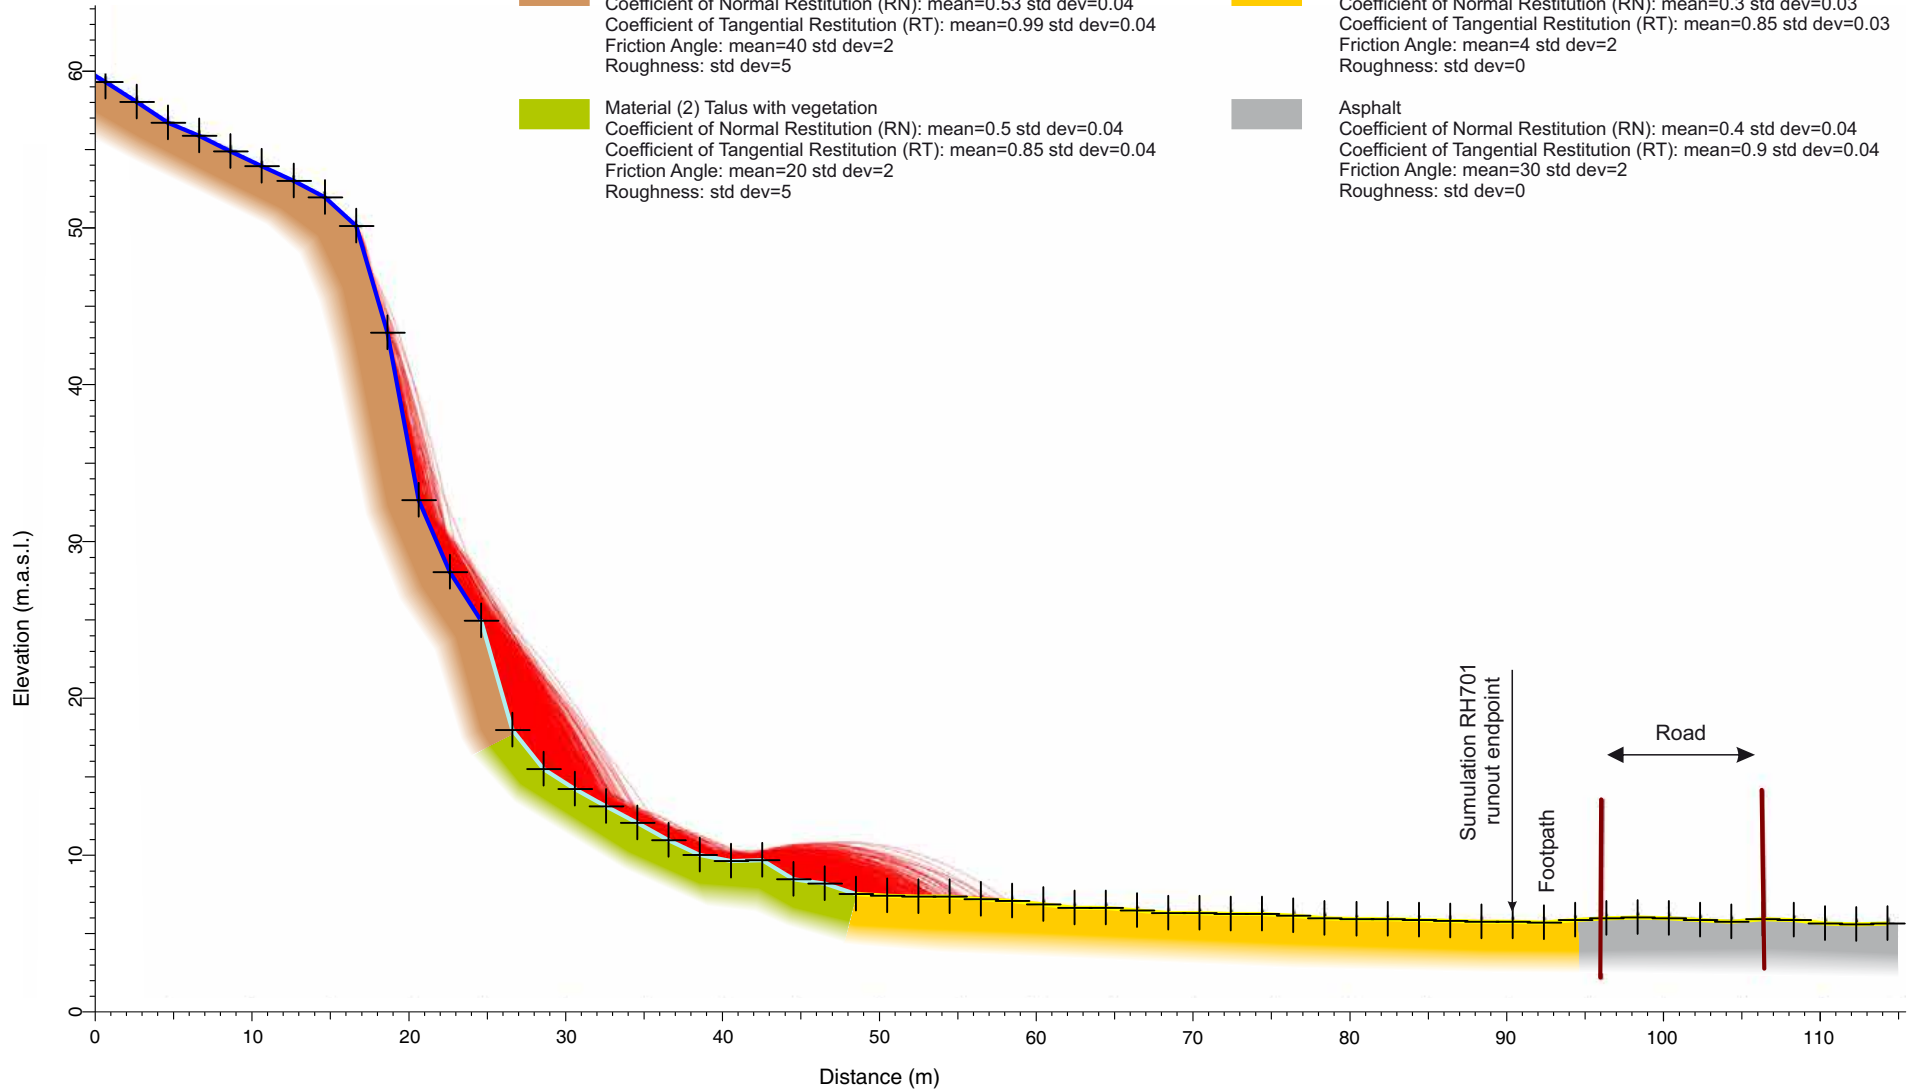
Input material parameters from Massey et al 2012c
 Number of rocks = 2000
 Unit weight 27 KN/m³
 Cut of velocity 0.1m/sec
 Simulated rock mass 1,000kg (~0.3m³)
