Geotechnical Assessment Report (Addendum)

Review of the District Plan for R6 - East Belfast,
Christchurch

20 August 2014

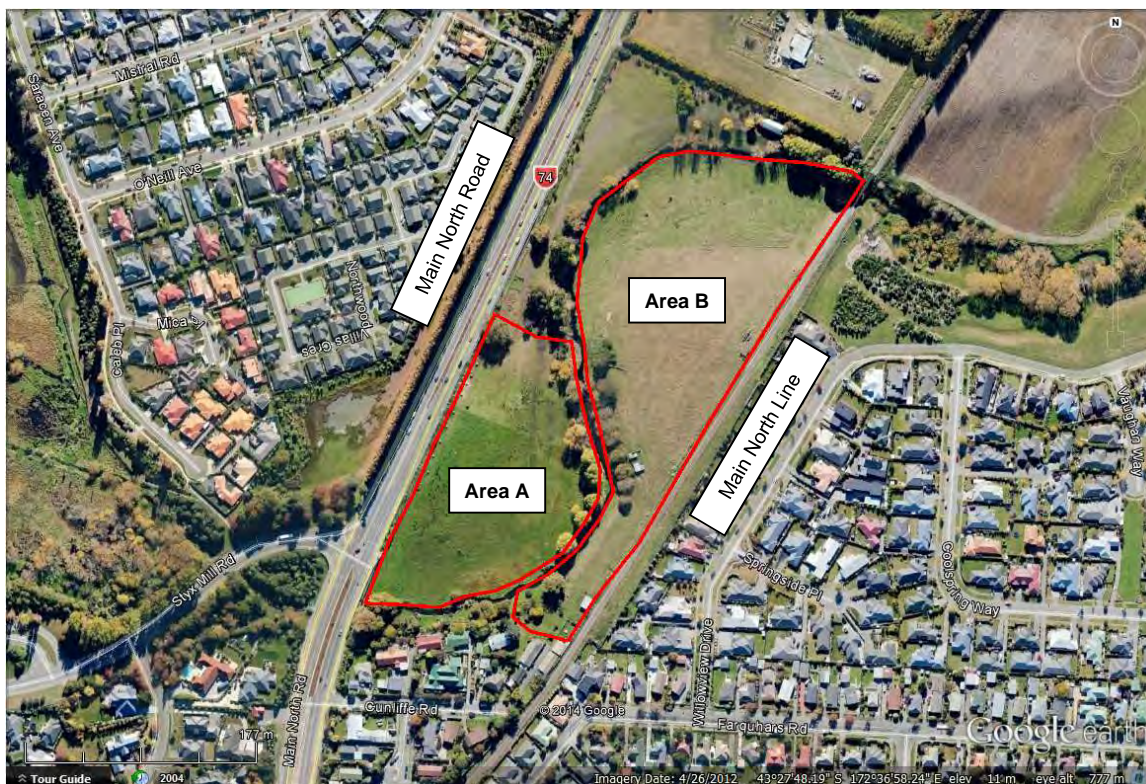
Figure 1 Addendum report site areas (north at top; scale as shown)

The location of the area addressed by this addendum report is shown in Figure 1.

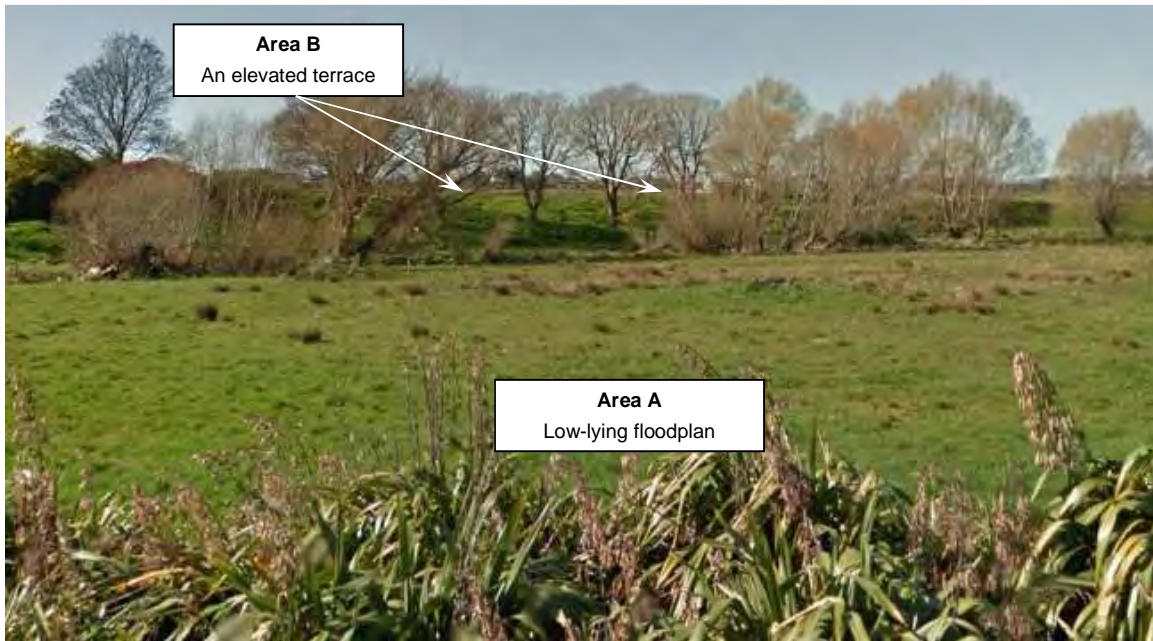
Figure 2 Viewing east across Area A from Main North Road.

Area A is low-lying pastoral flood-plain with areas of reeds that give a swampy appearance. The reeds are indicative of the low-lying nature of the land adjacent to the Styx River (Figures 2 & 3).

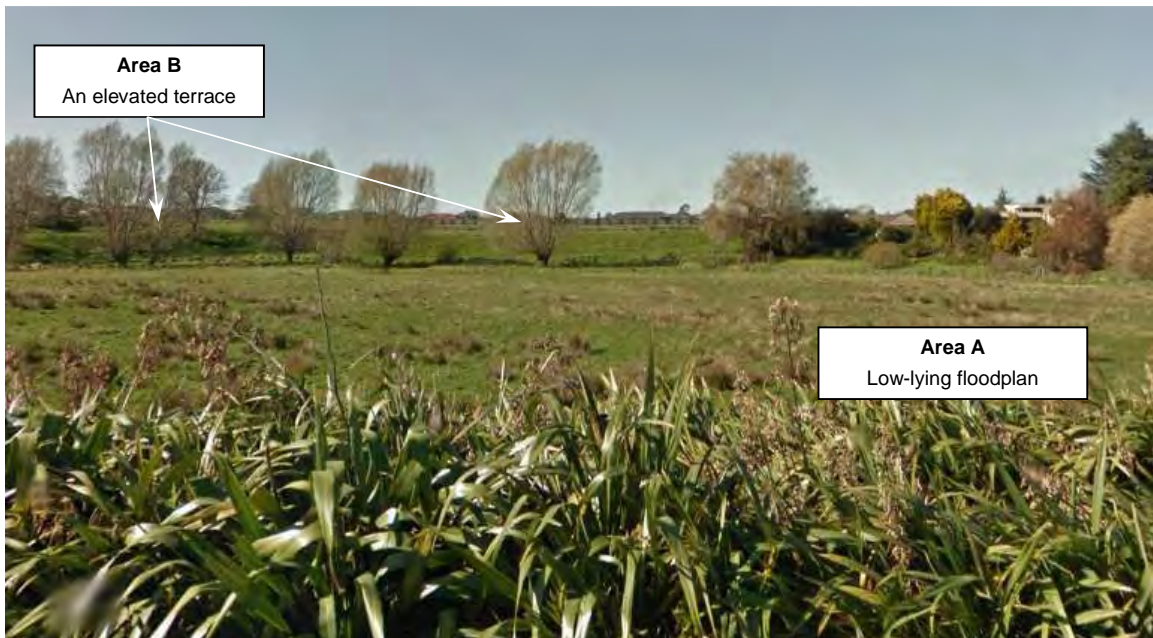
Figure 3 Viewing east across Area A from Main North Road

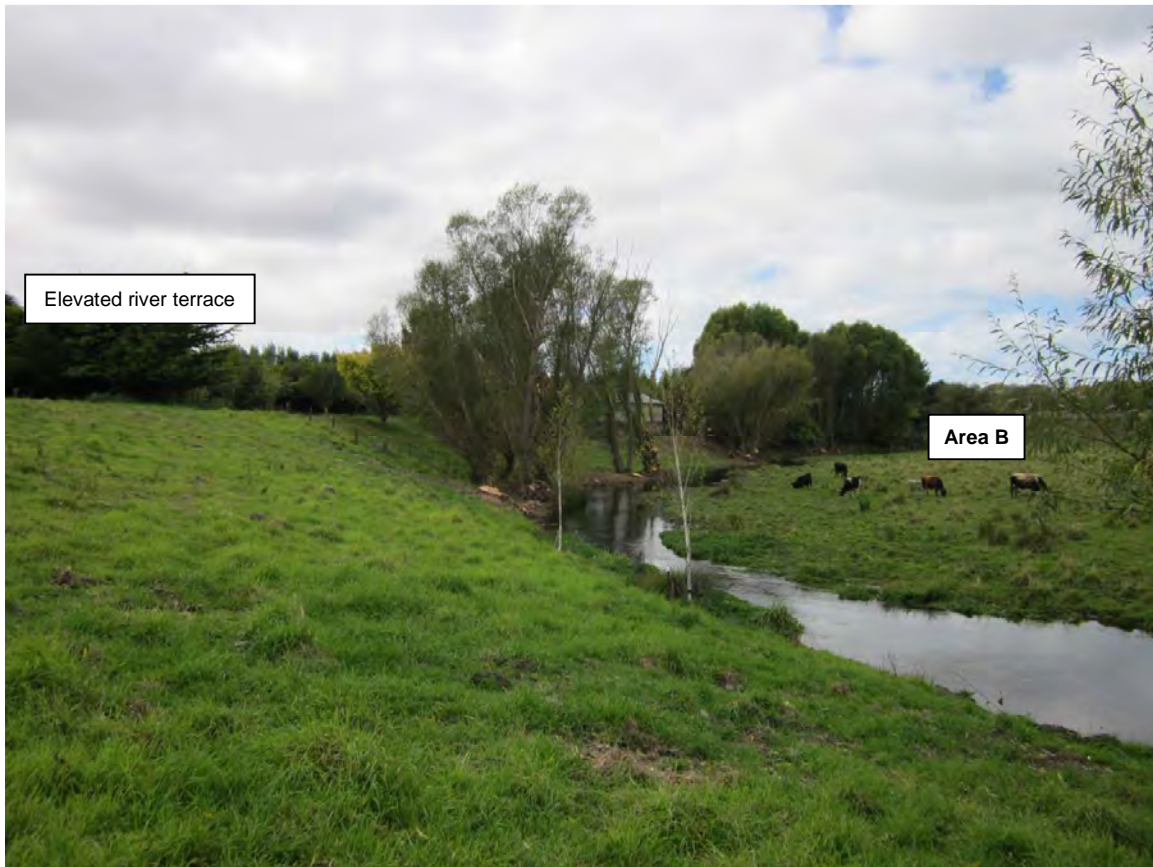
Figure 4 Viewing east across northern part of Area B. The river terrace to the left is the land to the north of the site (site of proposed Styx Town Centre).

Area B is mostly an elevated river terrace with a land elevation >2 metres above Area A. The land elevation falls to the north down to the level of the Styx River where the land is swampy floodplain (Figure 4).

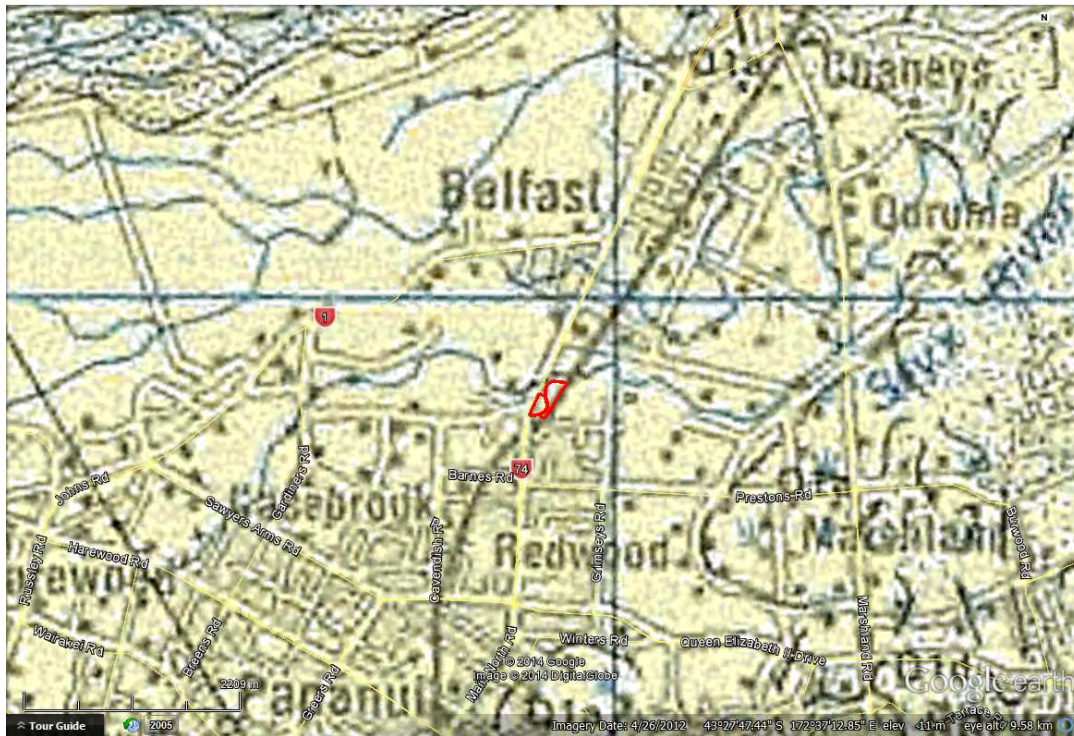
1.1 Geological Maps

Brown, L.J. & Weeber, J.H. (1992), Geology of the Christchurch urban area. Scale 1:25000. Institute of Geological and Nuclear Sciences geological map 1. One sheet. Institute of Geological and Nuclear Sciences Limited, Lower Hutt, New Zealand. Canterbury Geotechnical Database Map CGD5122 - 27 Sept 2012

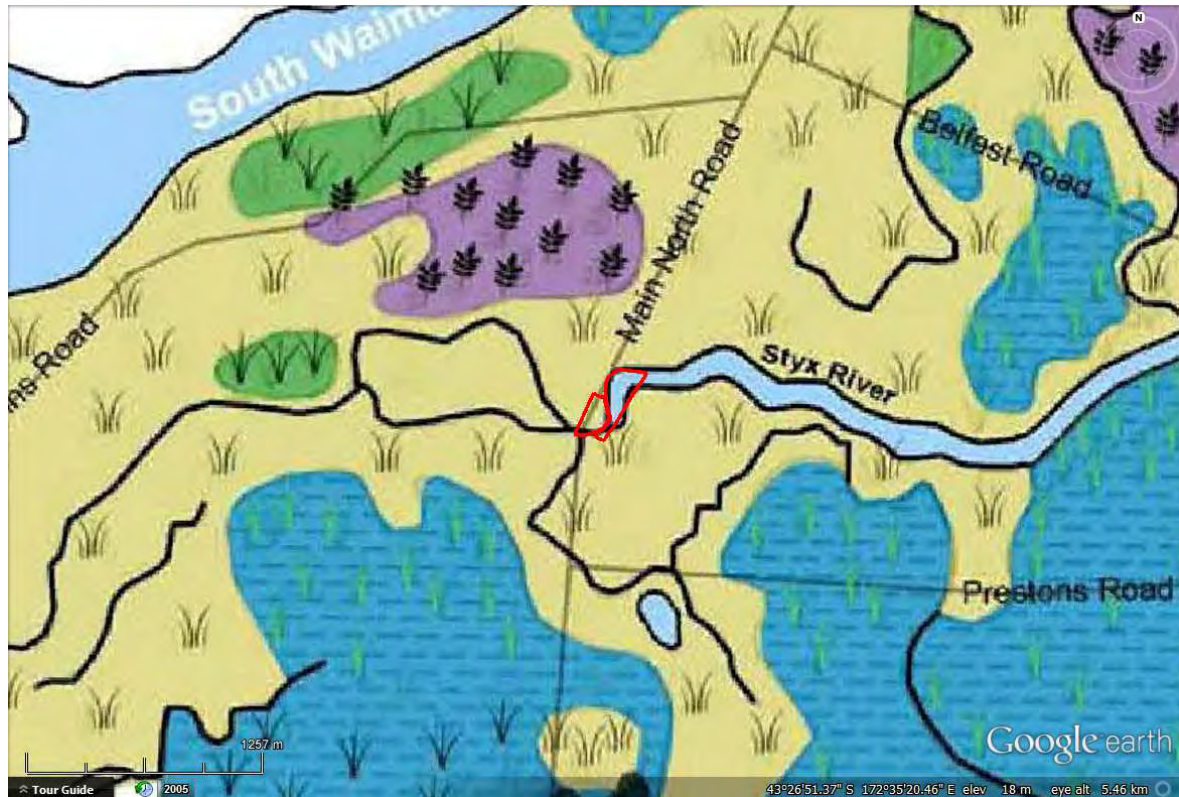
1.2 Black Maps

Waterways, Swamps and Vegetation Cover in 1856 Compiled from "Black Maps" approved by J Thomas and Thomas Cass, Chief Surveyors, 1856 – Christchurch City Council Information Services digitised Map Ap001725 compiled by Ken Sibley Jul 1989 and revised by G Tibble Apr 1996. Source: Christchurch City Council Retrieved 31 May 2011 <http://resources.ccc.govt.nz/files/blackmap-environmentecology.pdf>

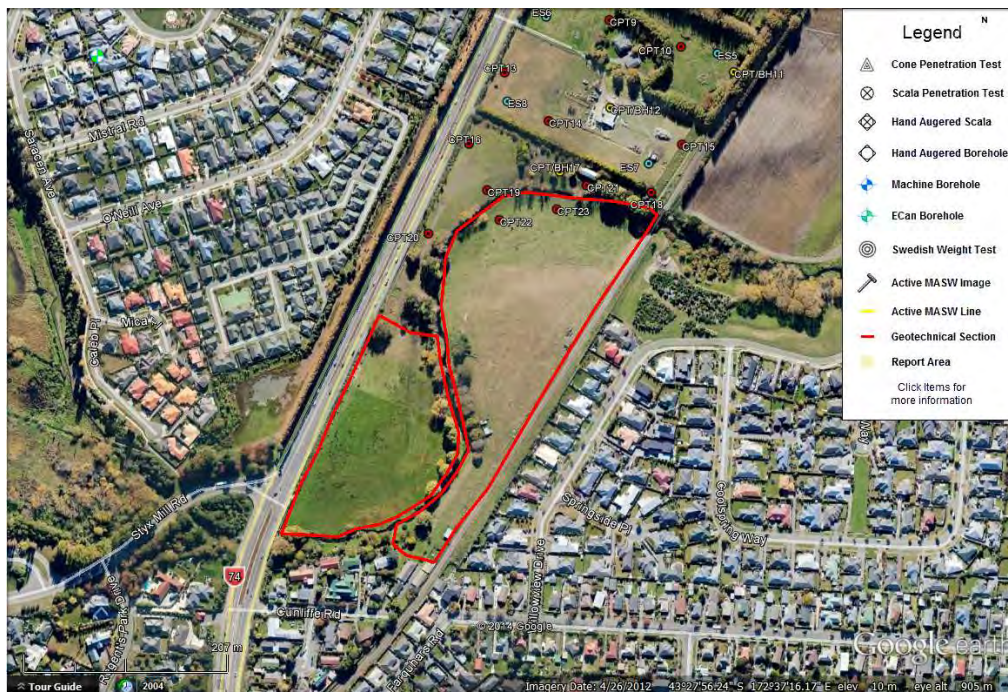
Coffey - Styx Super Centre Data (15084AB)

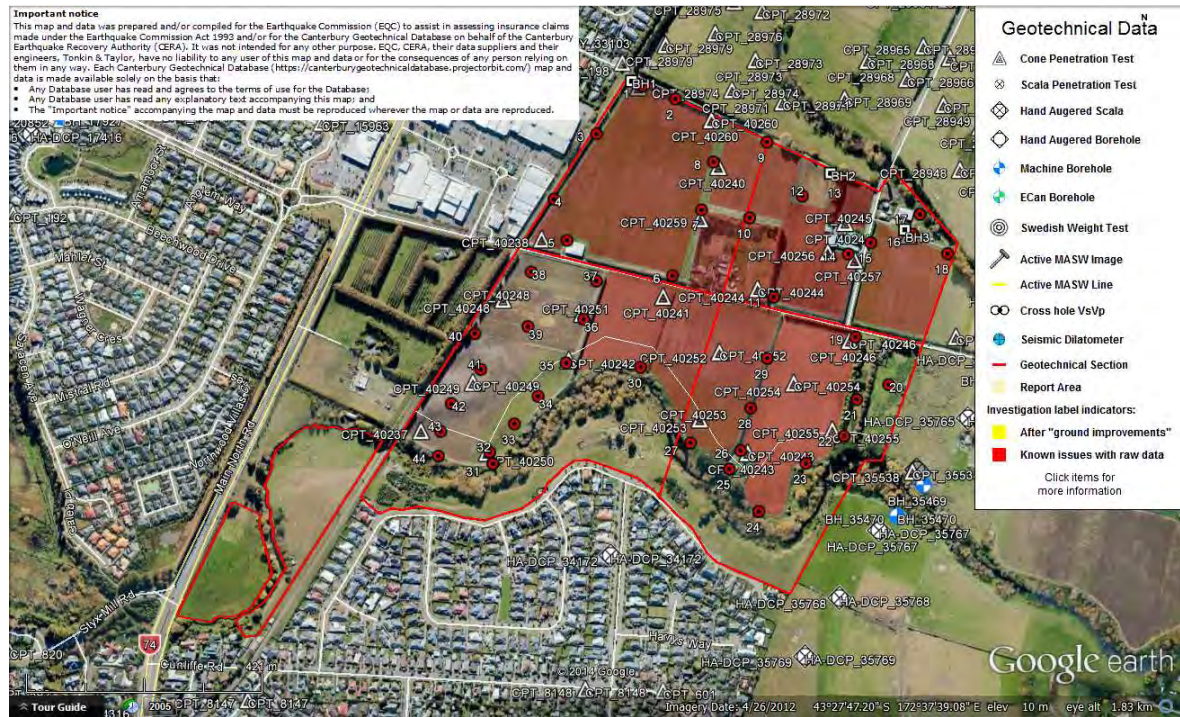
Database data and GENZCHRI15602AB:

Note: For the data closest to the site, refer to the folder GENZCHRI15084AB (Styx Super Centre)
