Christchurch City Council

Geotechnical Assessment Report

Review of the District Plan for R6 - East Belfast,
Christchurch

12 June 2014

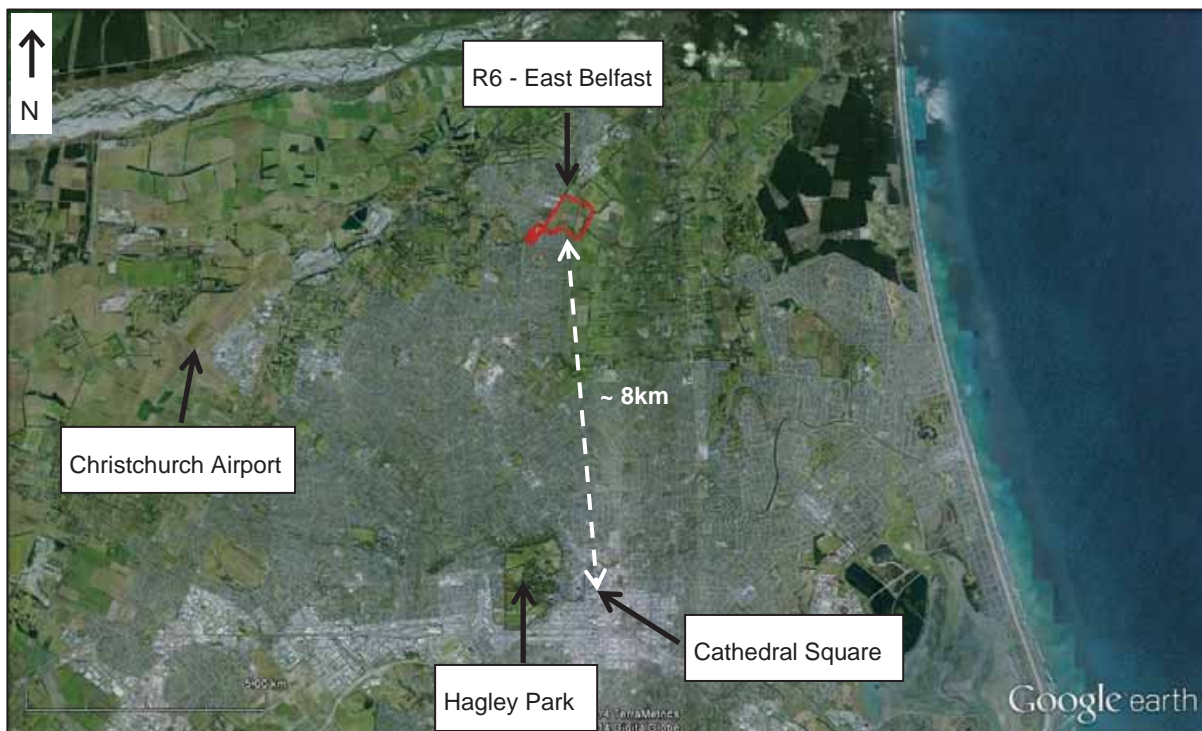
Figure 1: Site location plan (scale as shown)

Coffey Geotechnics (NZ) Limited (Coffey) was commissioned by Christchurch City Council (CCC) to provide geotechnical reporting pertinent to a proposed rezoning of land known as R6 – East Belfast for future urban development. The R6 - East Belfast project is being led by CCC and covers a land area of 60 hectares (approx.) in the northern Christchurch suburb of East Belfast (Figure 1).

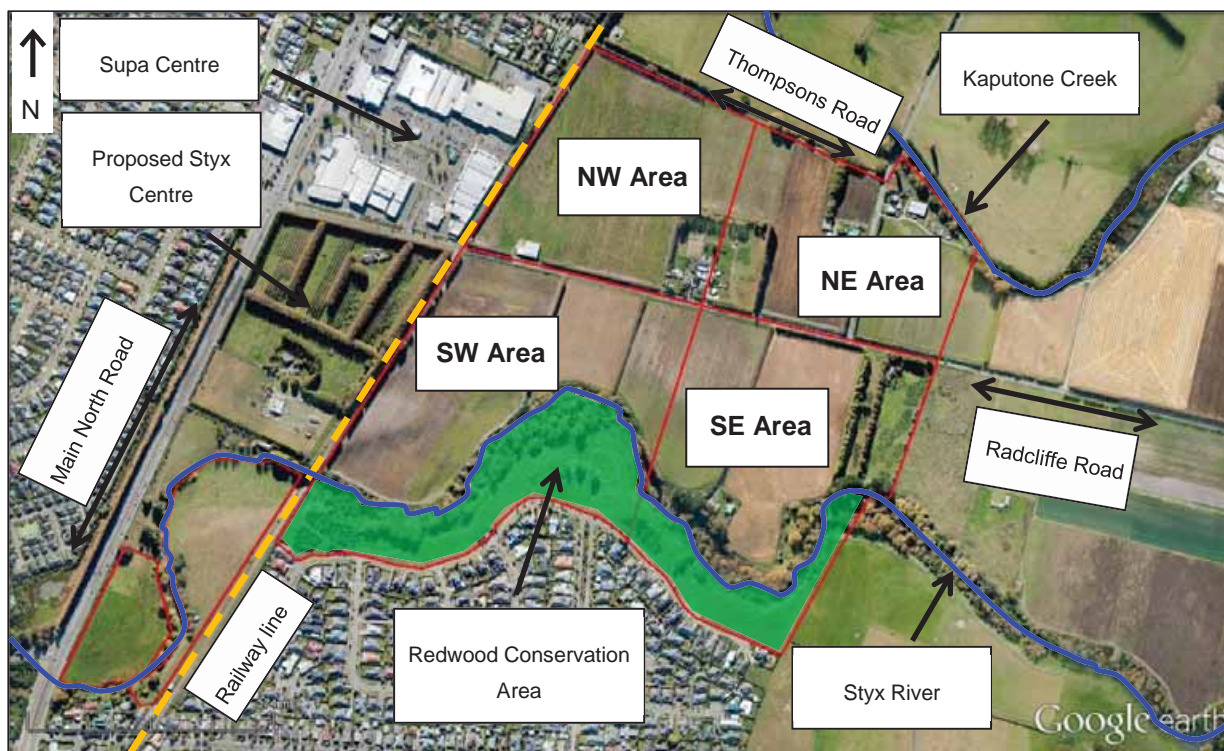
Figure 2: Site investigation areas (scale as shown)

For the purposes of reporting the site has been divided into four areas to aid in the description of the site, ground conditions and engineering matters. Figure 2 provides a plan of the site with the report areas marked.

The 60ha of land known as R6 - East Belfast, Christchurch is located approximately 8km north of Christchurch City Centre. As shown on Figure 2 below, the site is bordered on its western side by the railway line heading north out of Christchurch. The Styx River flows through the southern portion of the site towards the east. The site consists of eighteen legal lots, which are associated with eleven physical addresses.

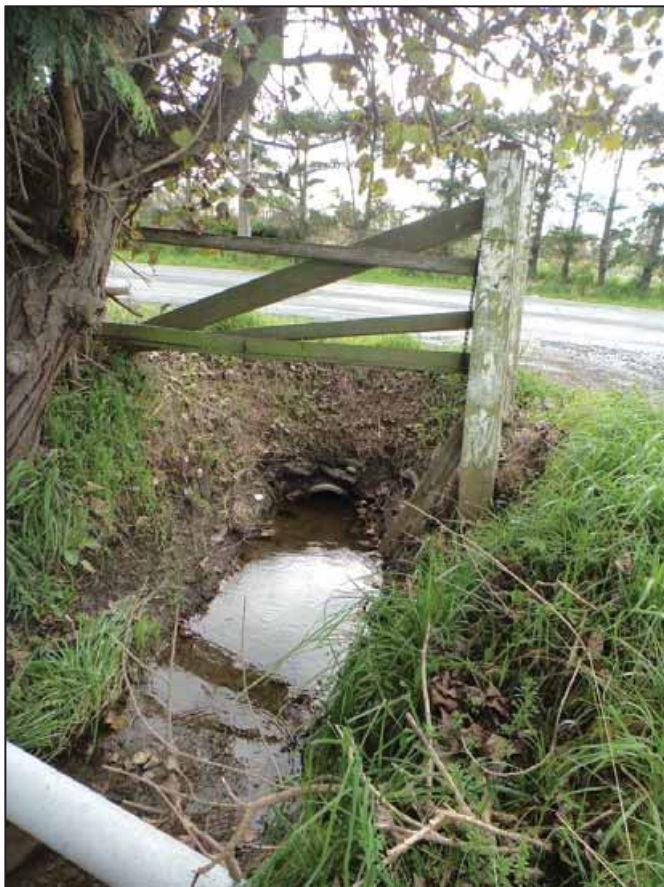
Figure 3: Viewing north along drain where it flows underneath Radcliffe Road at the entrance to 120 Radcliffe Road property. The drain invert is approximately 1 metre deep below existing ground level.

The only noticeable surface drainage across the site was that of shallow ditch drains (Figures 3 to 5), on the western side of the gravel access road to the property at 120 Radcliffe Road, which pipes under Radcliffe Road and joins the shallow drains capturing run-off from the properties and Blakes and Thompsons Roads. These ditch drains are typically in the order of 0.5m to 1.0m deep and are timber-lined and strutted only where access to properties in this area is required (refer to Figure 4).

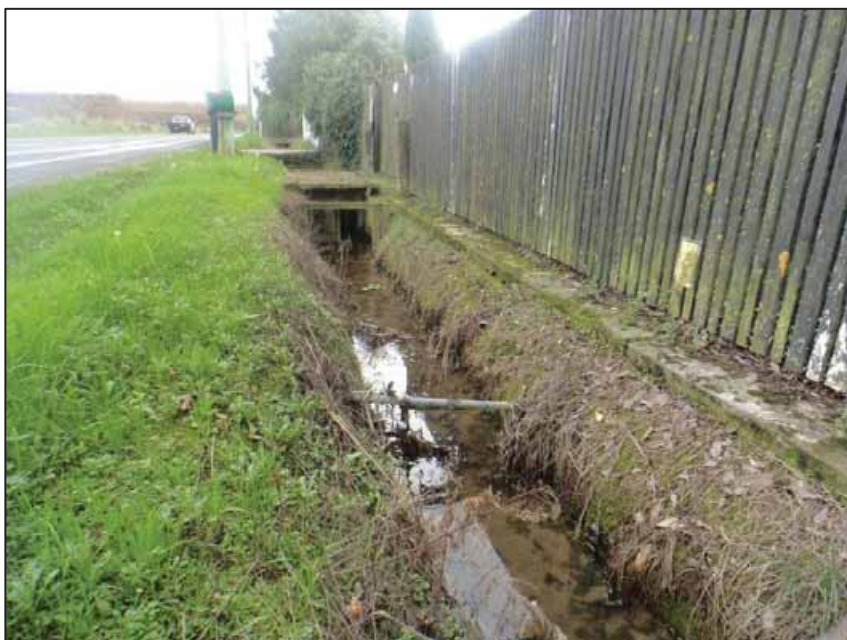
Figure 4: Viewing northwest along the north side of Radcliffe Road. The drain in on a slightly raised embankment, invert is approximately 0.5 metre deep below existing ground level, and is timber-lined and strutted to provide access to properties.

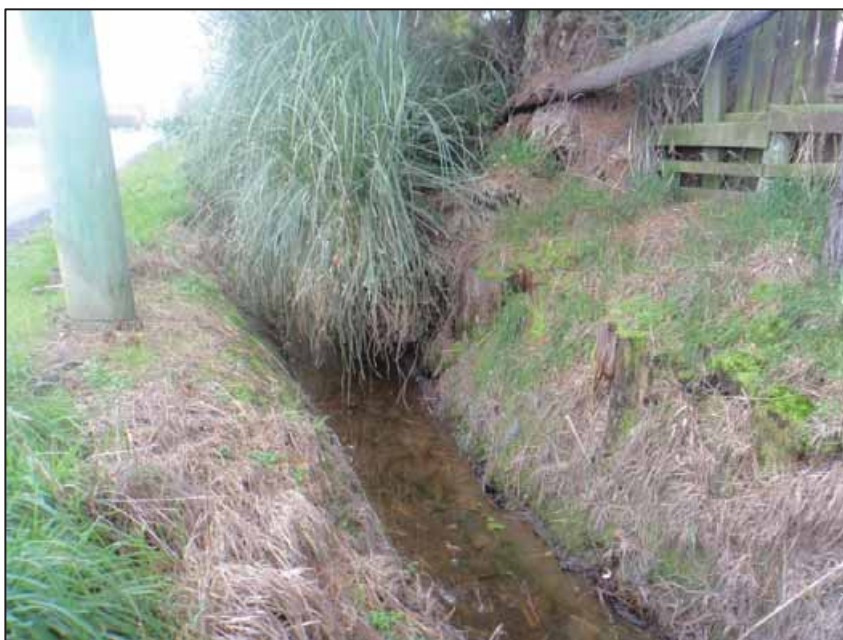
Figure 5: Viewing northwest along north side of Radcliffe Road. The drain invert is approximately 1 metre deep below existing ground level.

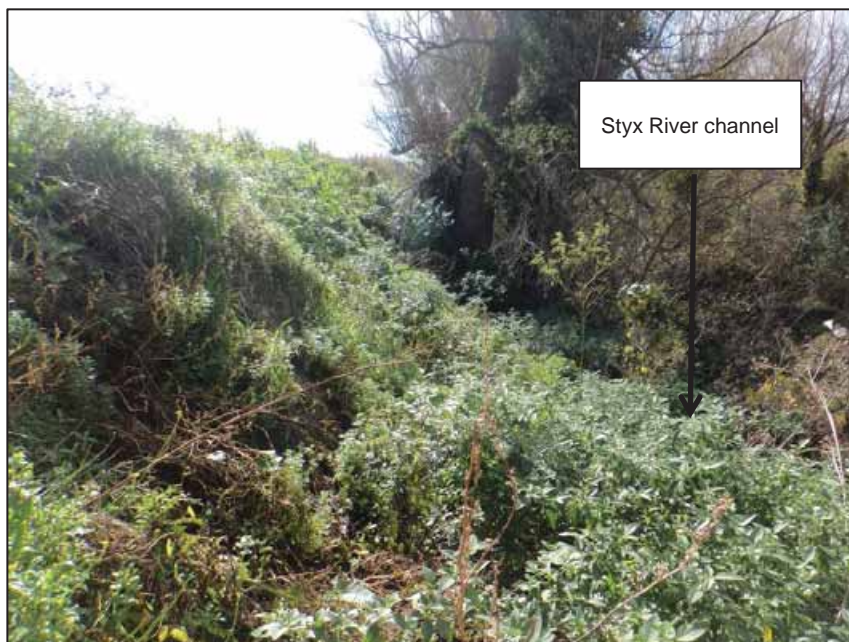
Figure 7: The steep Styx riverbank geometry at Point 3. Similar steep geometries were observed at Points 2, 4, 5 and 8.

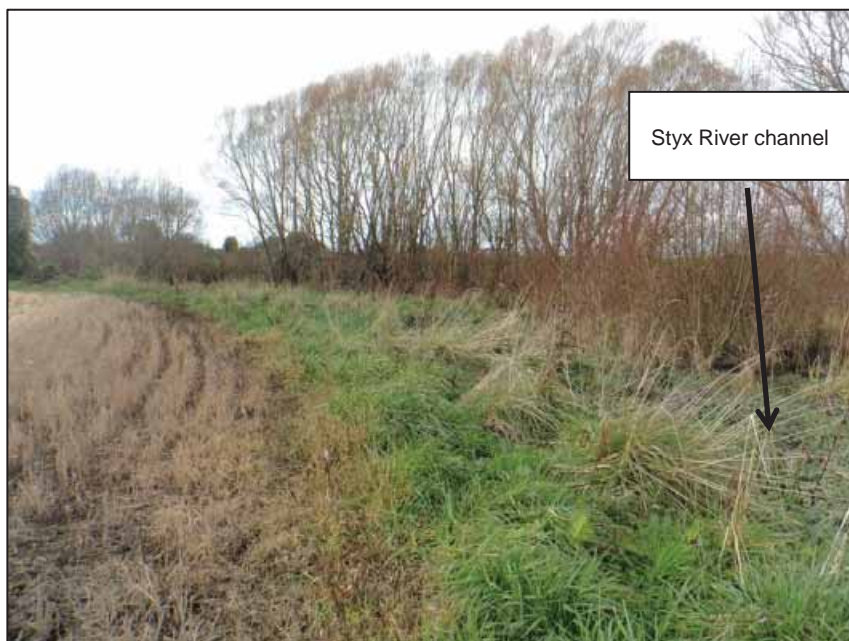
Figure 8: The shallow Styx riverbank geometry at Point 7. Similar shallow geometries were observed at Points 2 and 9.

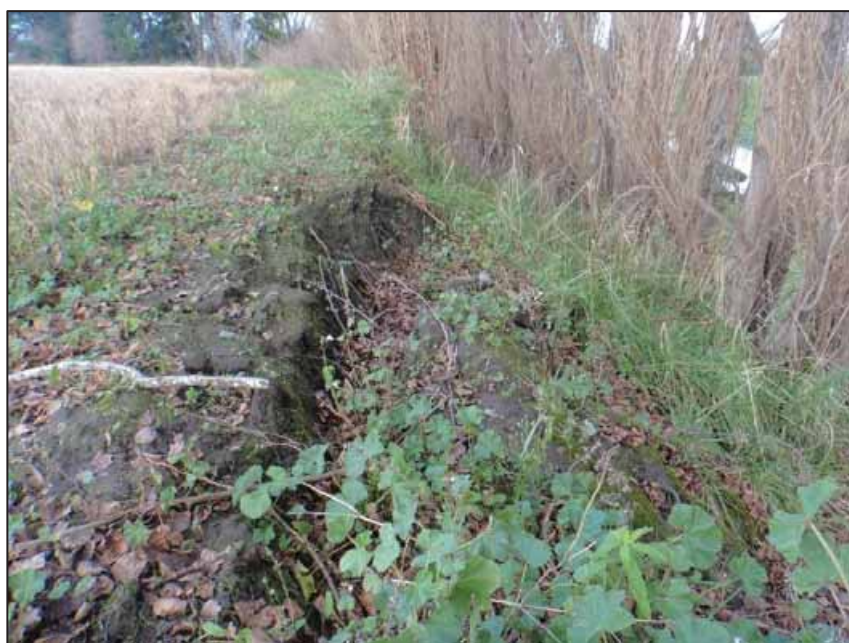
Figure 10: Slope instability along the Styx River channel at the boundary of the SE and SW Areas

Generally, there is a strong impression of a mature slope and river terrace area along the Styx River. There is however evidence of minor slope instability at the riverbank at the approximate position indicated in Figure 6. The bank affected is approximately 1.2m high with a slope batter of 30° and is located 7.0m from the active river channel. The slip face created is approximately 3.7m in length and 0.6m deep with a crack in the order of 200mm to 400mm wide (refer to Figure 10).

The instability does not appear to be of significance to the land development.

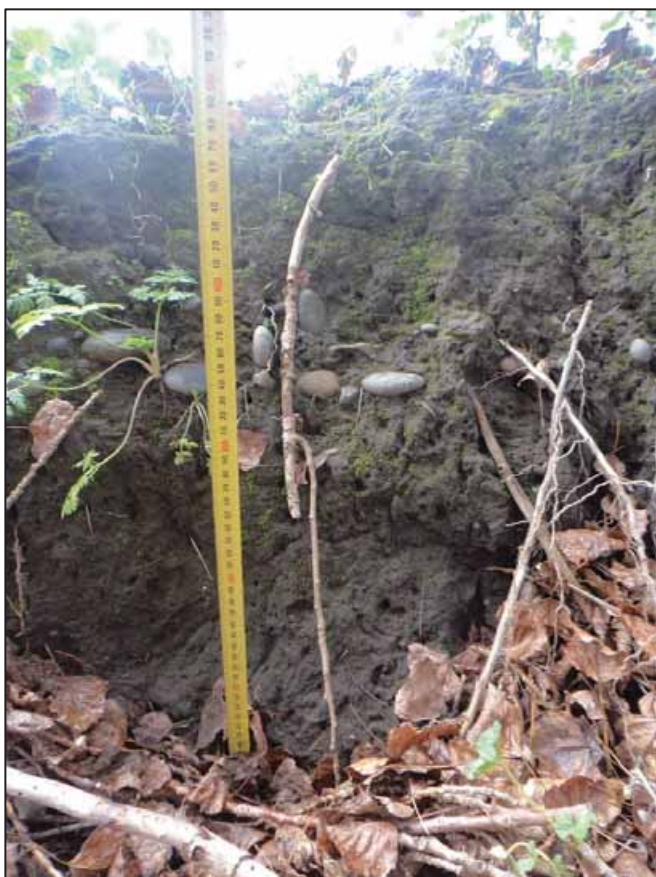
Figure 11: Scattered sub-rounded to rounded gravel in a grey silty profile at the Styx riverbank where slope instability was noted.

Gravel is visible in the river bank of the Styx River at the above mentioned slip which is consistent with the watercourse's location in the bed of a former flood channel of the Waimakariri River.

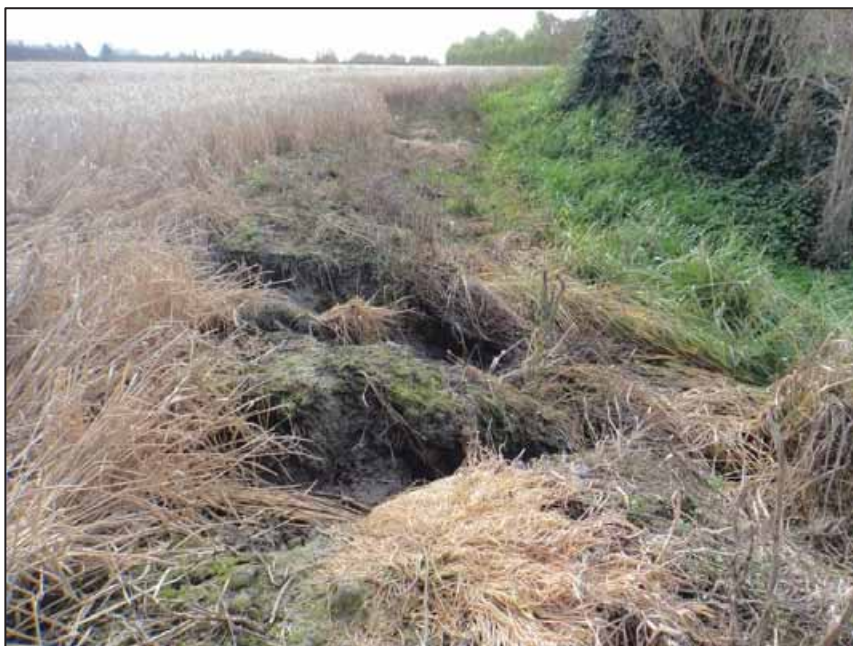
Figure 12: Erosion feature in the SE Area (refer to Figure 6 for the approximate location of this feature).

The erosion does not appear to be of significance to the land development.

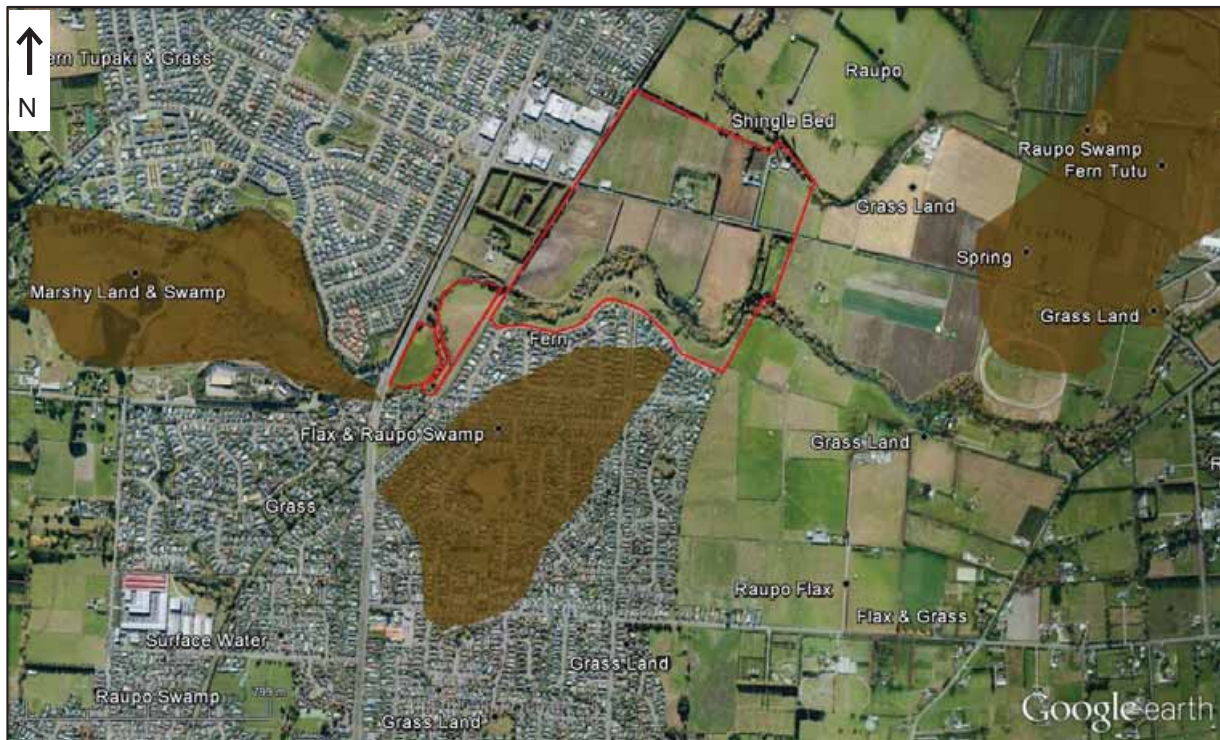
Figure 13: The Christchurch Black Maps for R6 – East Belfast site and surroundings (scale as shown)

The Christchurch Black Maps⁹ indicate that the site was covered by "Grass Land" and "Fern Tupaki and Grass", Swamp areas were mapped immediately to the south and south east, and approximately 600m to the east of the site (refer to Figure 13).

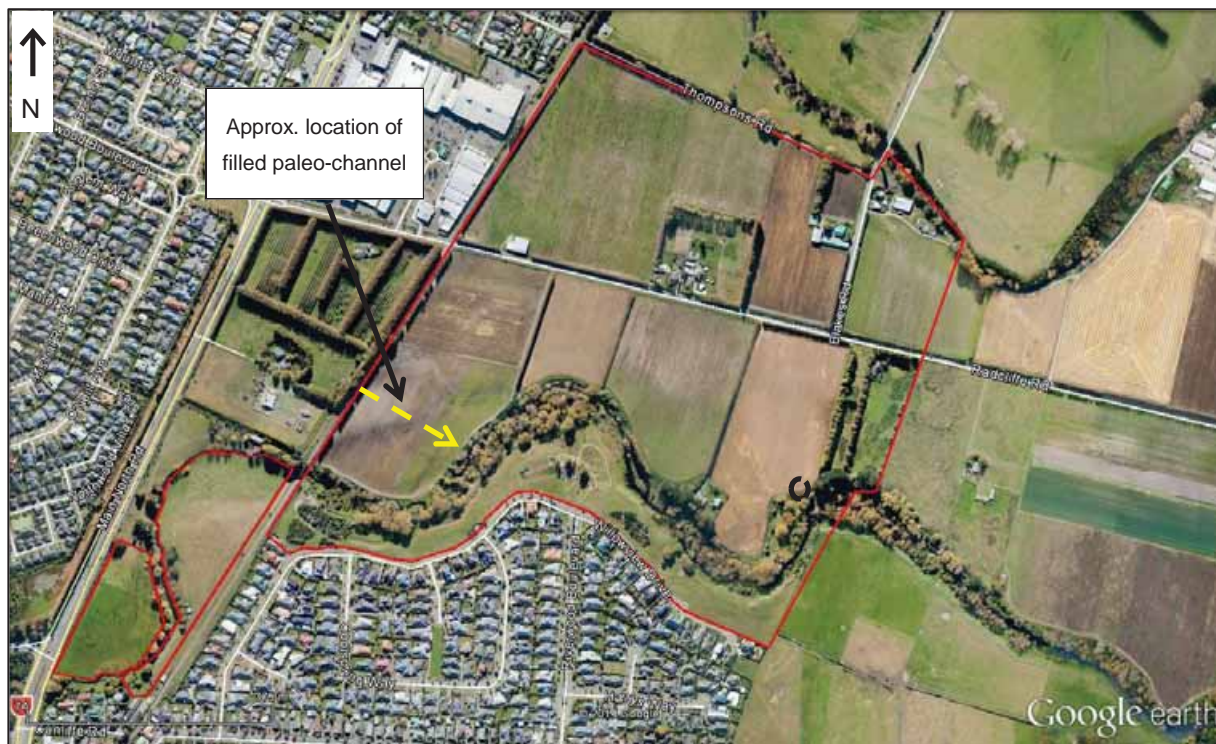
Figure 14: Approximate location of in-filled paleo-channel (according to majority landowner interview during the Phase 1 PSE).

landowner, Mr Mundy, confirmed that a paleo-channel once bisected the South West Area and drained land from the railway line into the Styx River. The Mundy's filled this channel using materials excavated to the south west during the 1970s. CPT records in the area of the in-filled channel did not confirm or refute the presence of the material. This could be because (i) the fill has similar properties to the natural soil or (ii) the CPTs were located outside the area of the fill. Refer to the yellow dashed line in Figure 14 for the approximate location of the historical paleo-channel.

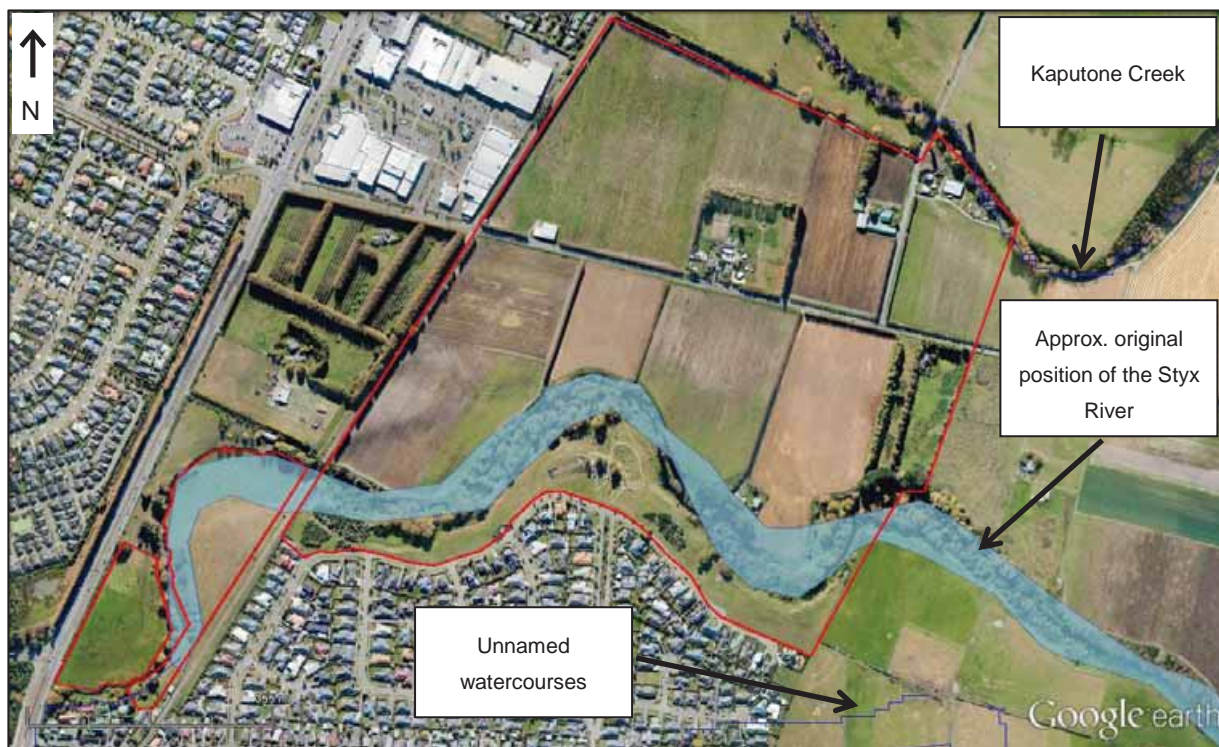
Figure 16: Site plan showing an overlay of historic watercourses extracted from the 1856 Black Map⁹ and indicative alignments of smaller watercourses.

The majority landowner, Mr Mundy, indicated that immediately to the south of the area, work by the government during the 1920s straightened the current stream alignment of the Styx River. The river occasionally floods to its original position, resulting in boggy areas as shown in Figure 16 (highlighted in blue). An appropriate setback will mitigate this.

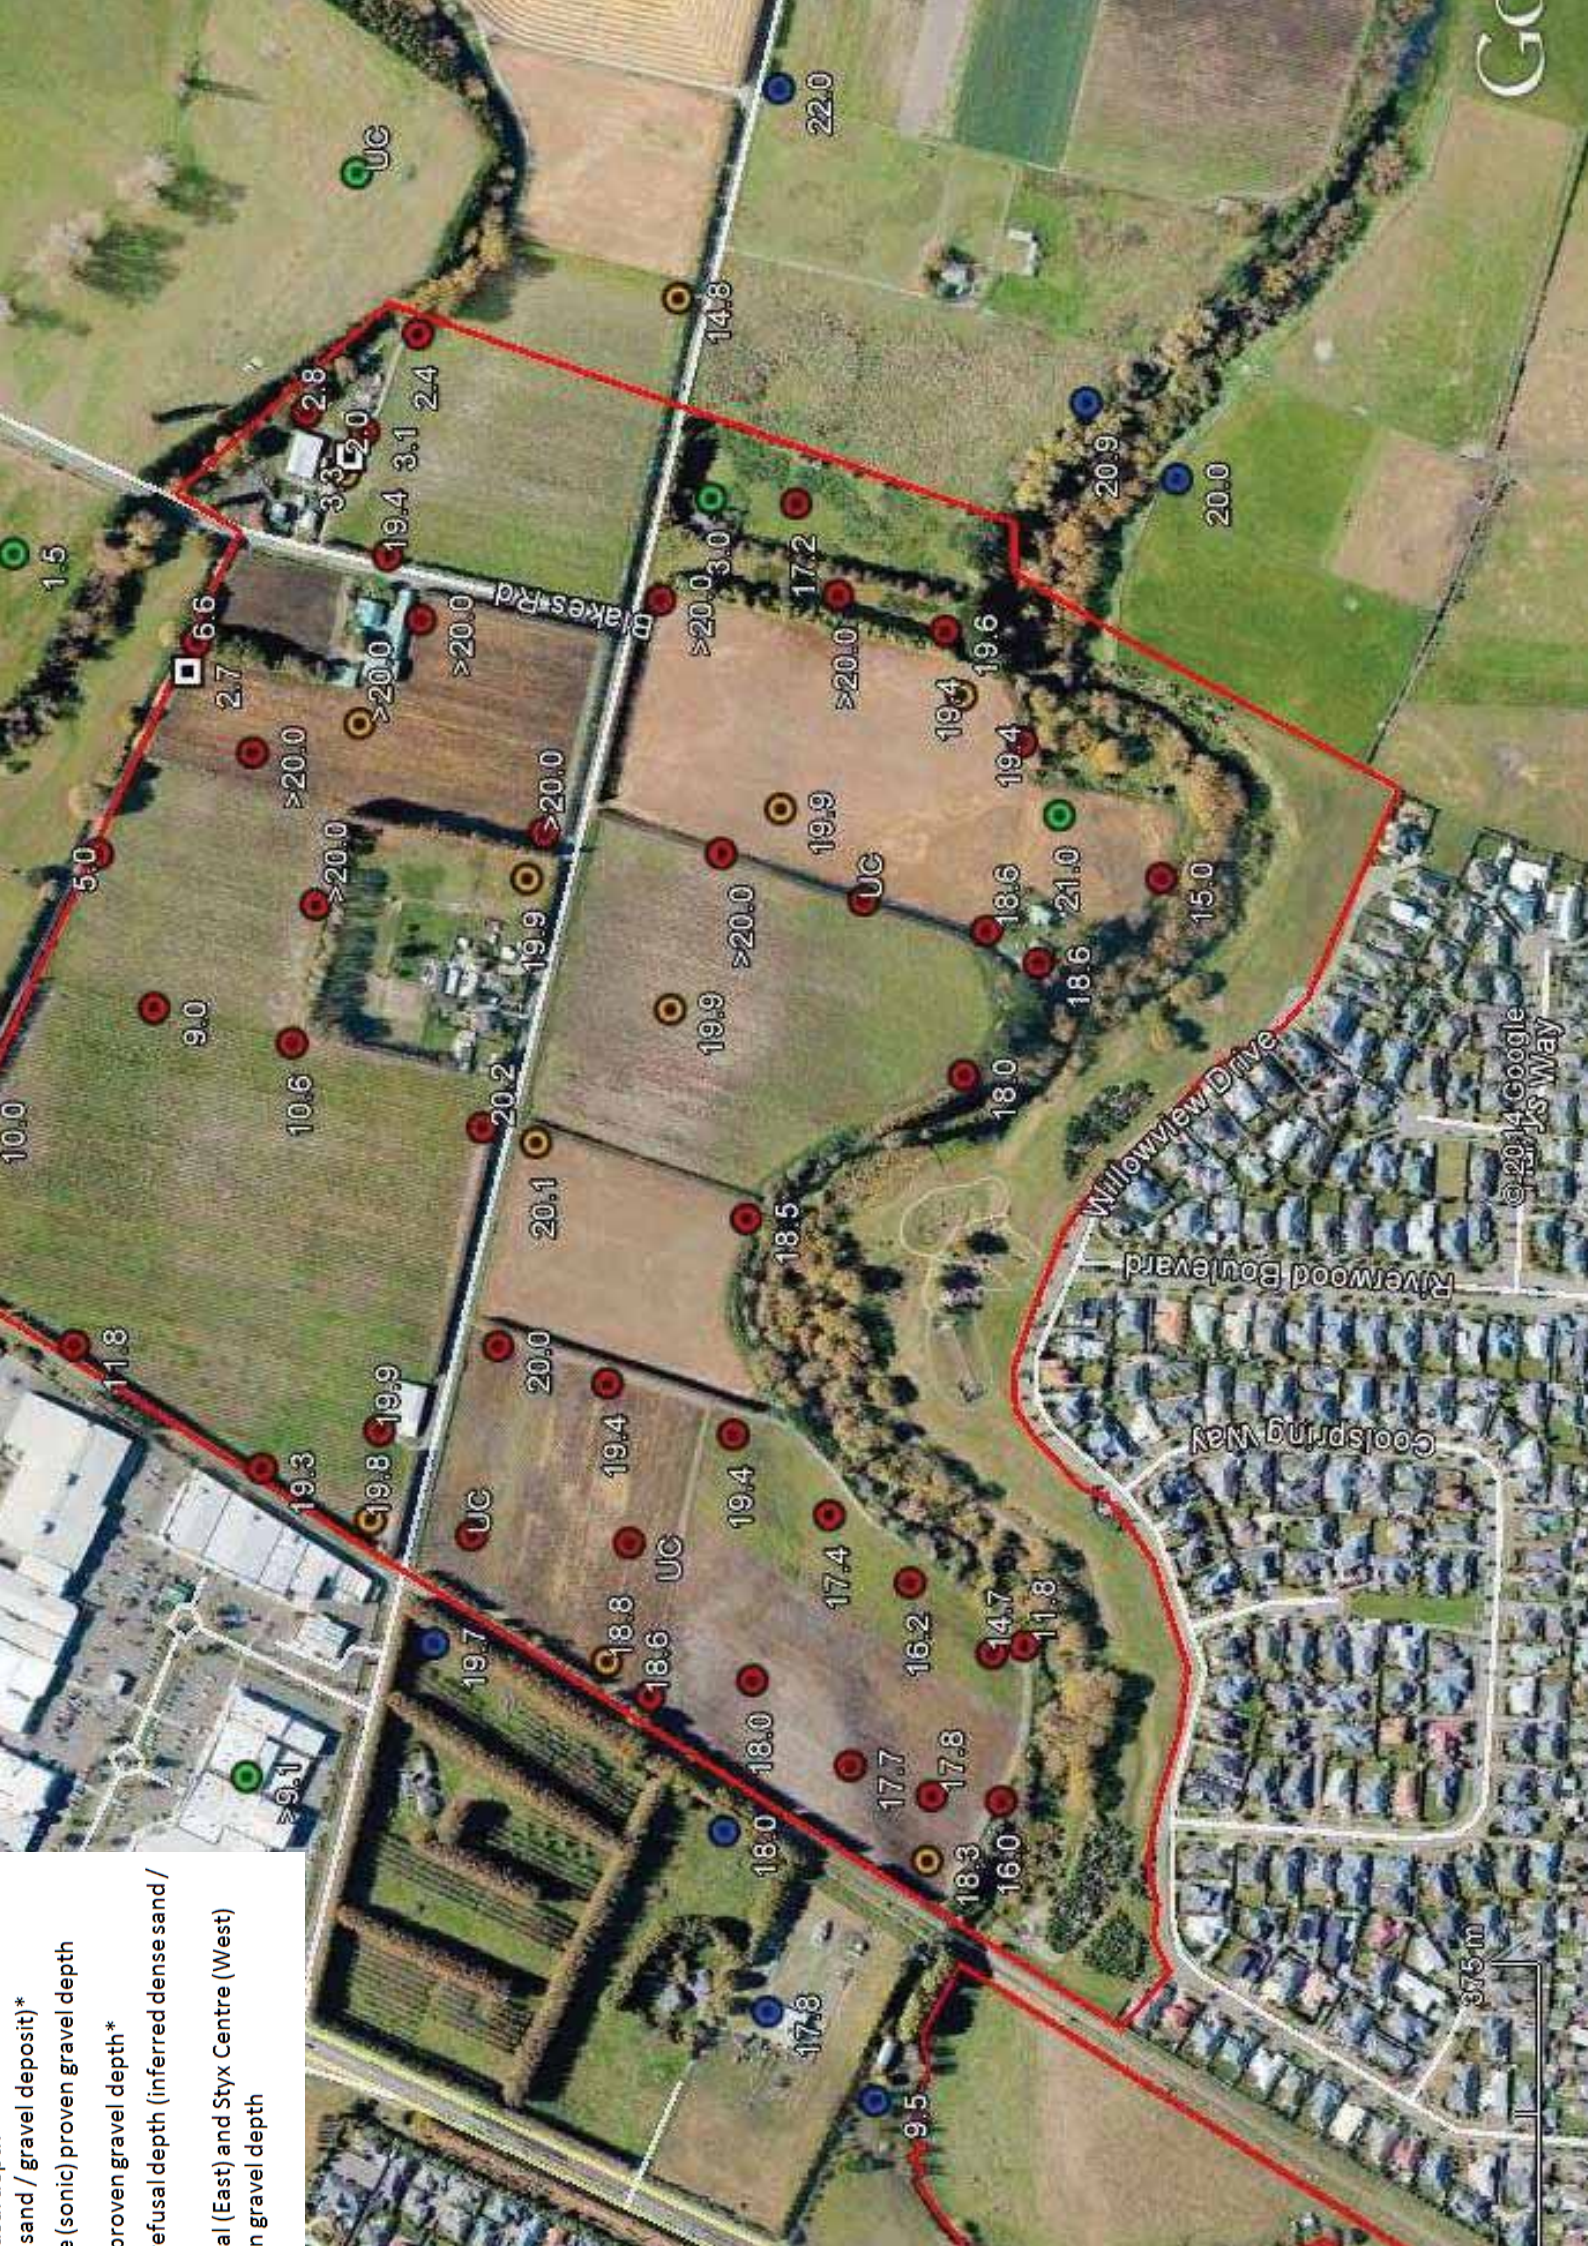
Plan of indicative depth to inferred dense sand/gravel soil

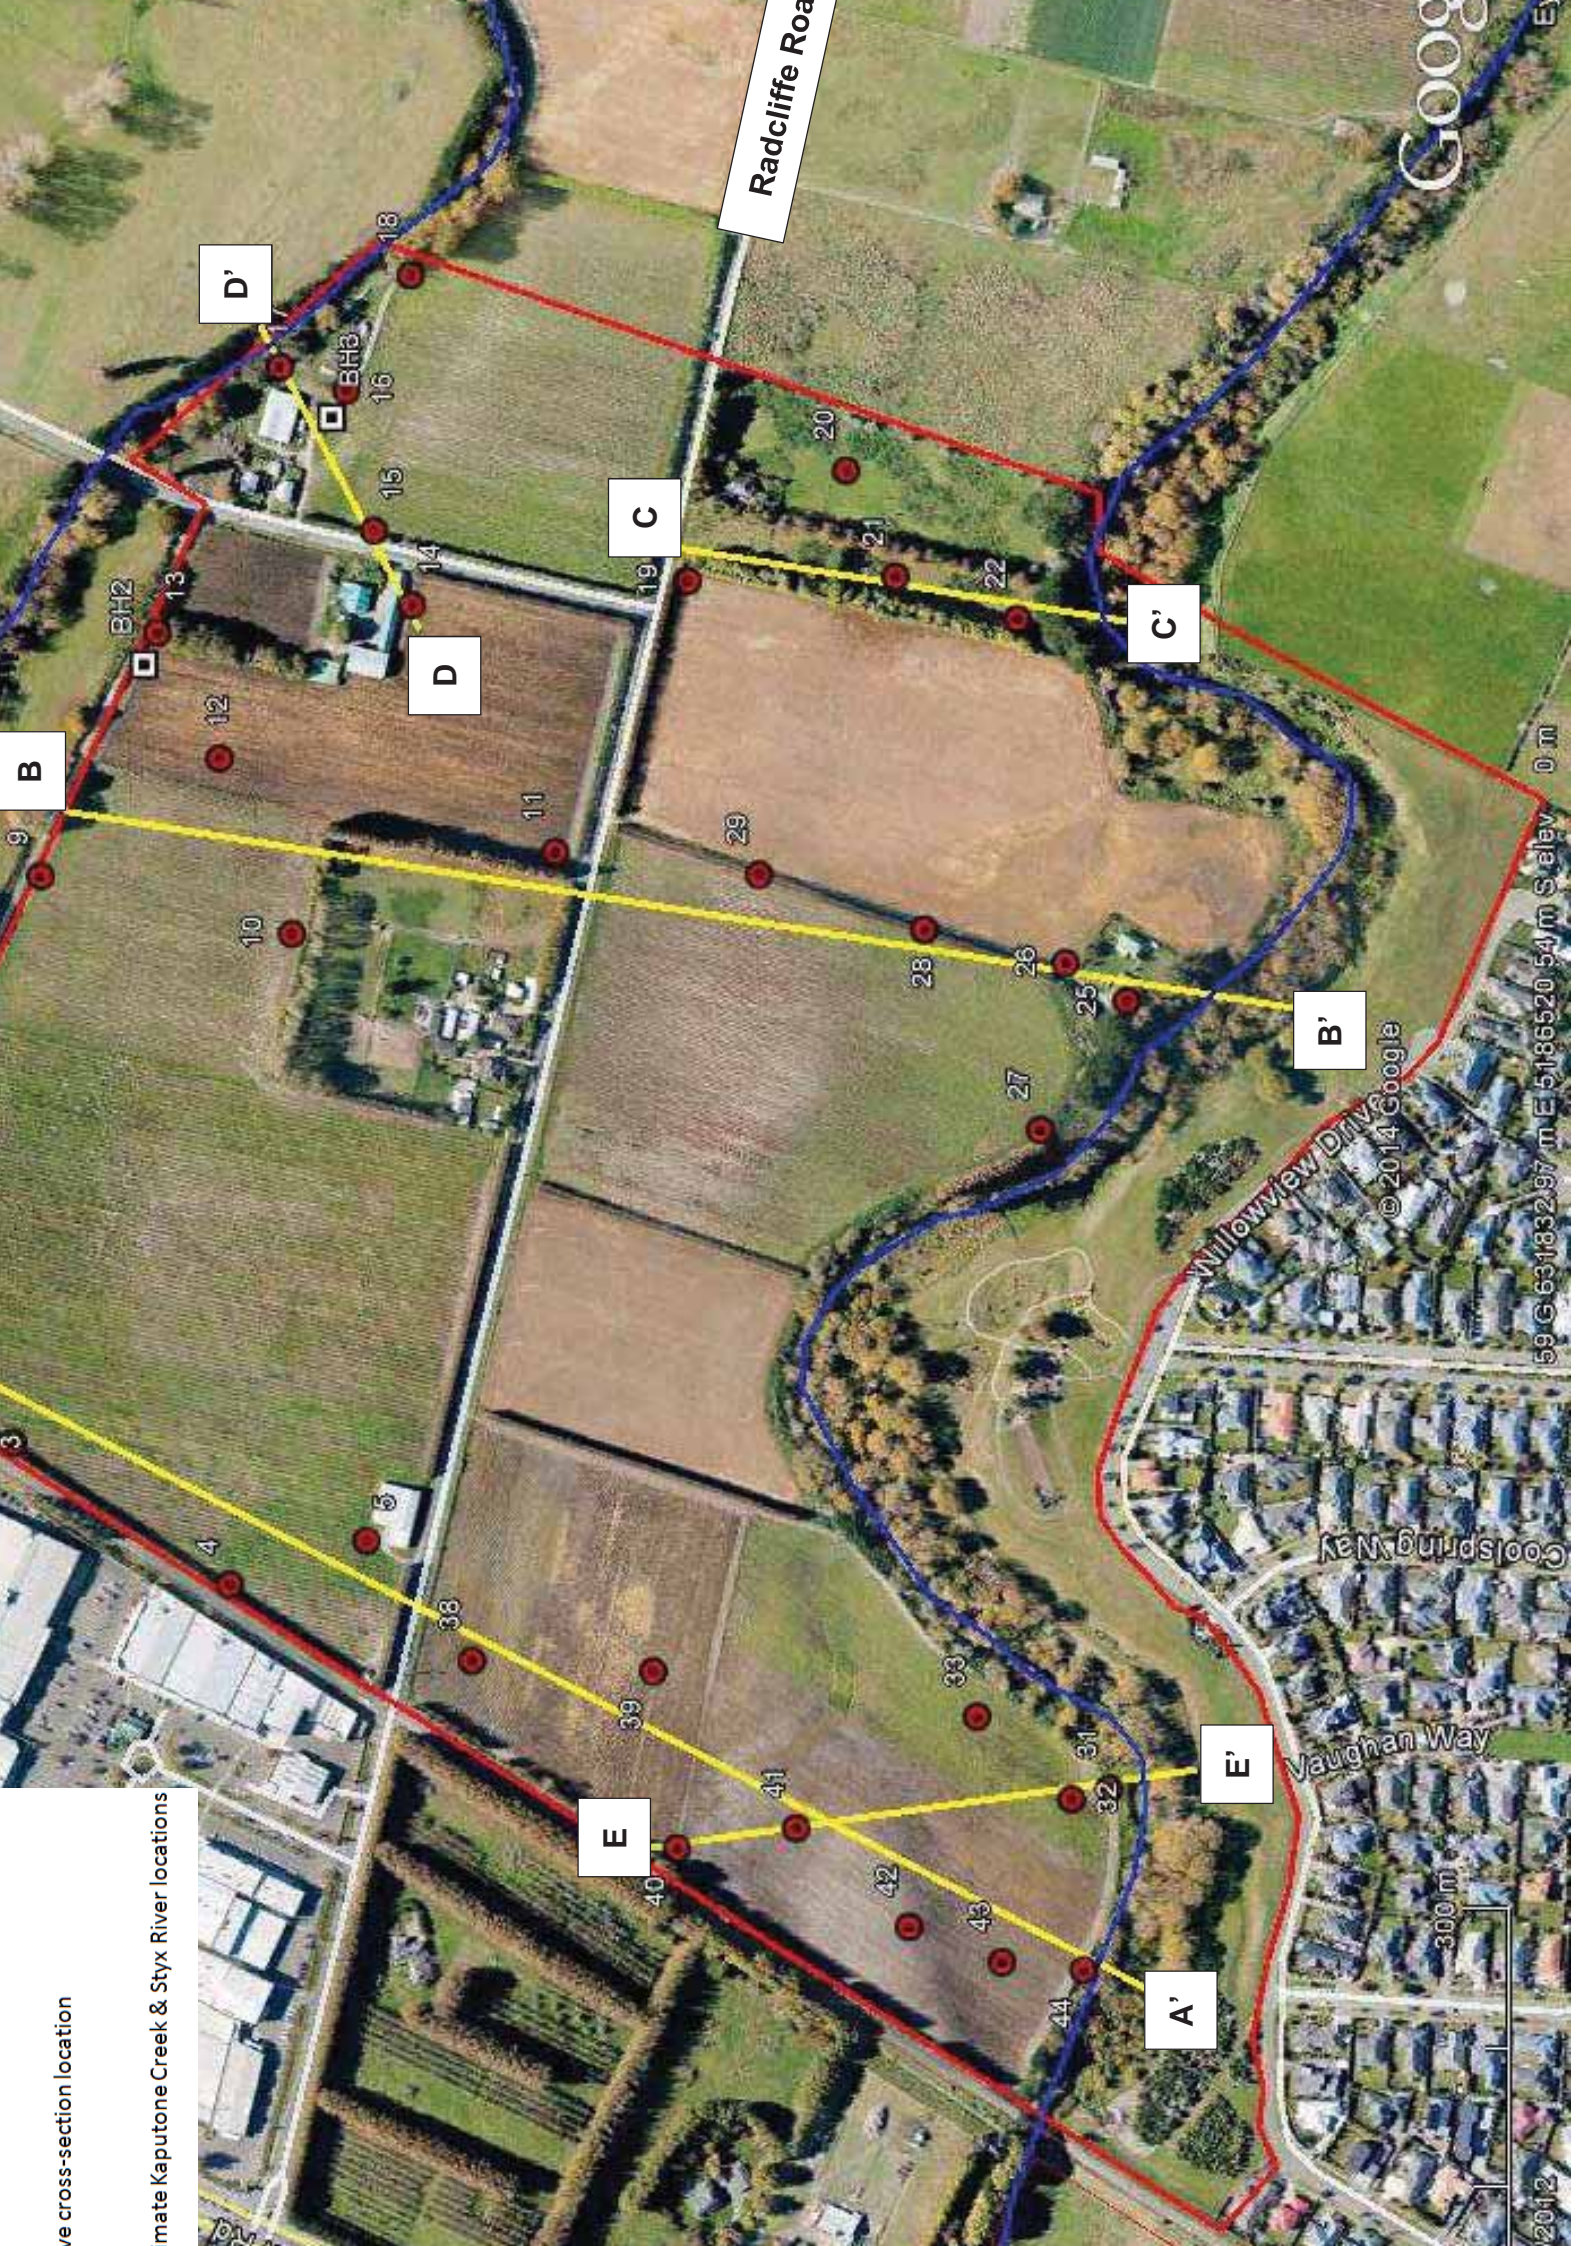
Indicative Cross Section Location Plan

Geological cross sections (A-A' to E-E')

Appendix D contains the indication cross section location plan as well as Sections A-A’ to E-E’ which are cross-sections compiled using CPT records to give an overview of the soil conditions across the site area (A-A’ and B-B’) and also near the main watercourses i.e. Styx River and Kaputone Creek to assist with the lateral spread assessment (C-C’ to E-E’). The cross sections pull together pairings of CPTs and boreholes to show how the cone resistance profiles correlate with the logged soil units. All of the pairings are for holes located at essentially the same location i.e. effectively zero distance between CPT and borehole.

The cross-sections are particularly useful in presenting a lot of relevant and useful information about the ground profile across the site. Understanding the structure of the ground and the relationship of the various soil units tells us a great deal about the liquefaction susceptibility and foundation engineering properties across the site. Reference should be made to these drawings as the following sections of the

report relate specifically to information assembled from them. It should be noted that the vertical scale of the cross-sections are in elevation and not metres below ground level. In addition, there would appear to be an over-exaggeration of topography on Section A-A' and B-B' as we had to evenly space the test positions to incorporate all of the available information.
