**APPENDIX 4: GEOMORPHOLOGY MAPS**

**GEOMORPHOLOGY MAPPING FOR  
ROCKFALL RISK ASSESSMENT**

**Port Hills  
Christchurch**

REPORT: CR2012/15 DATE: Sept 2012

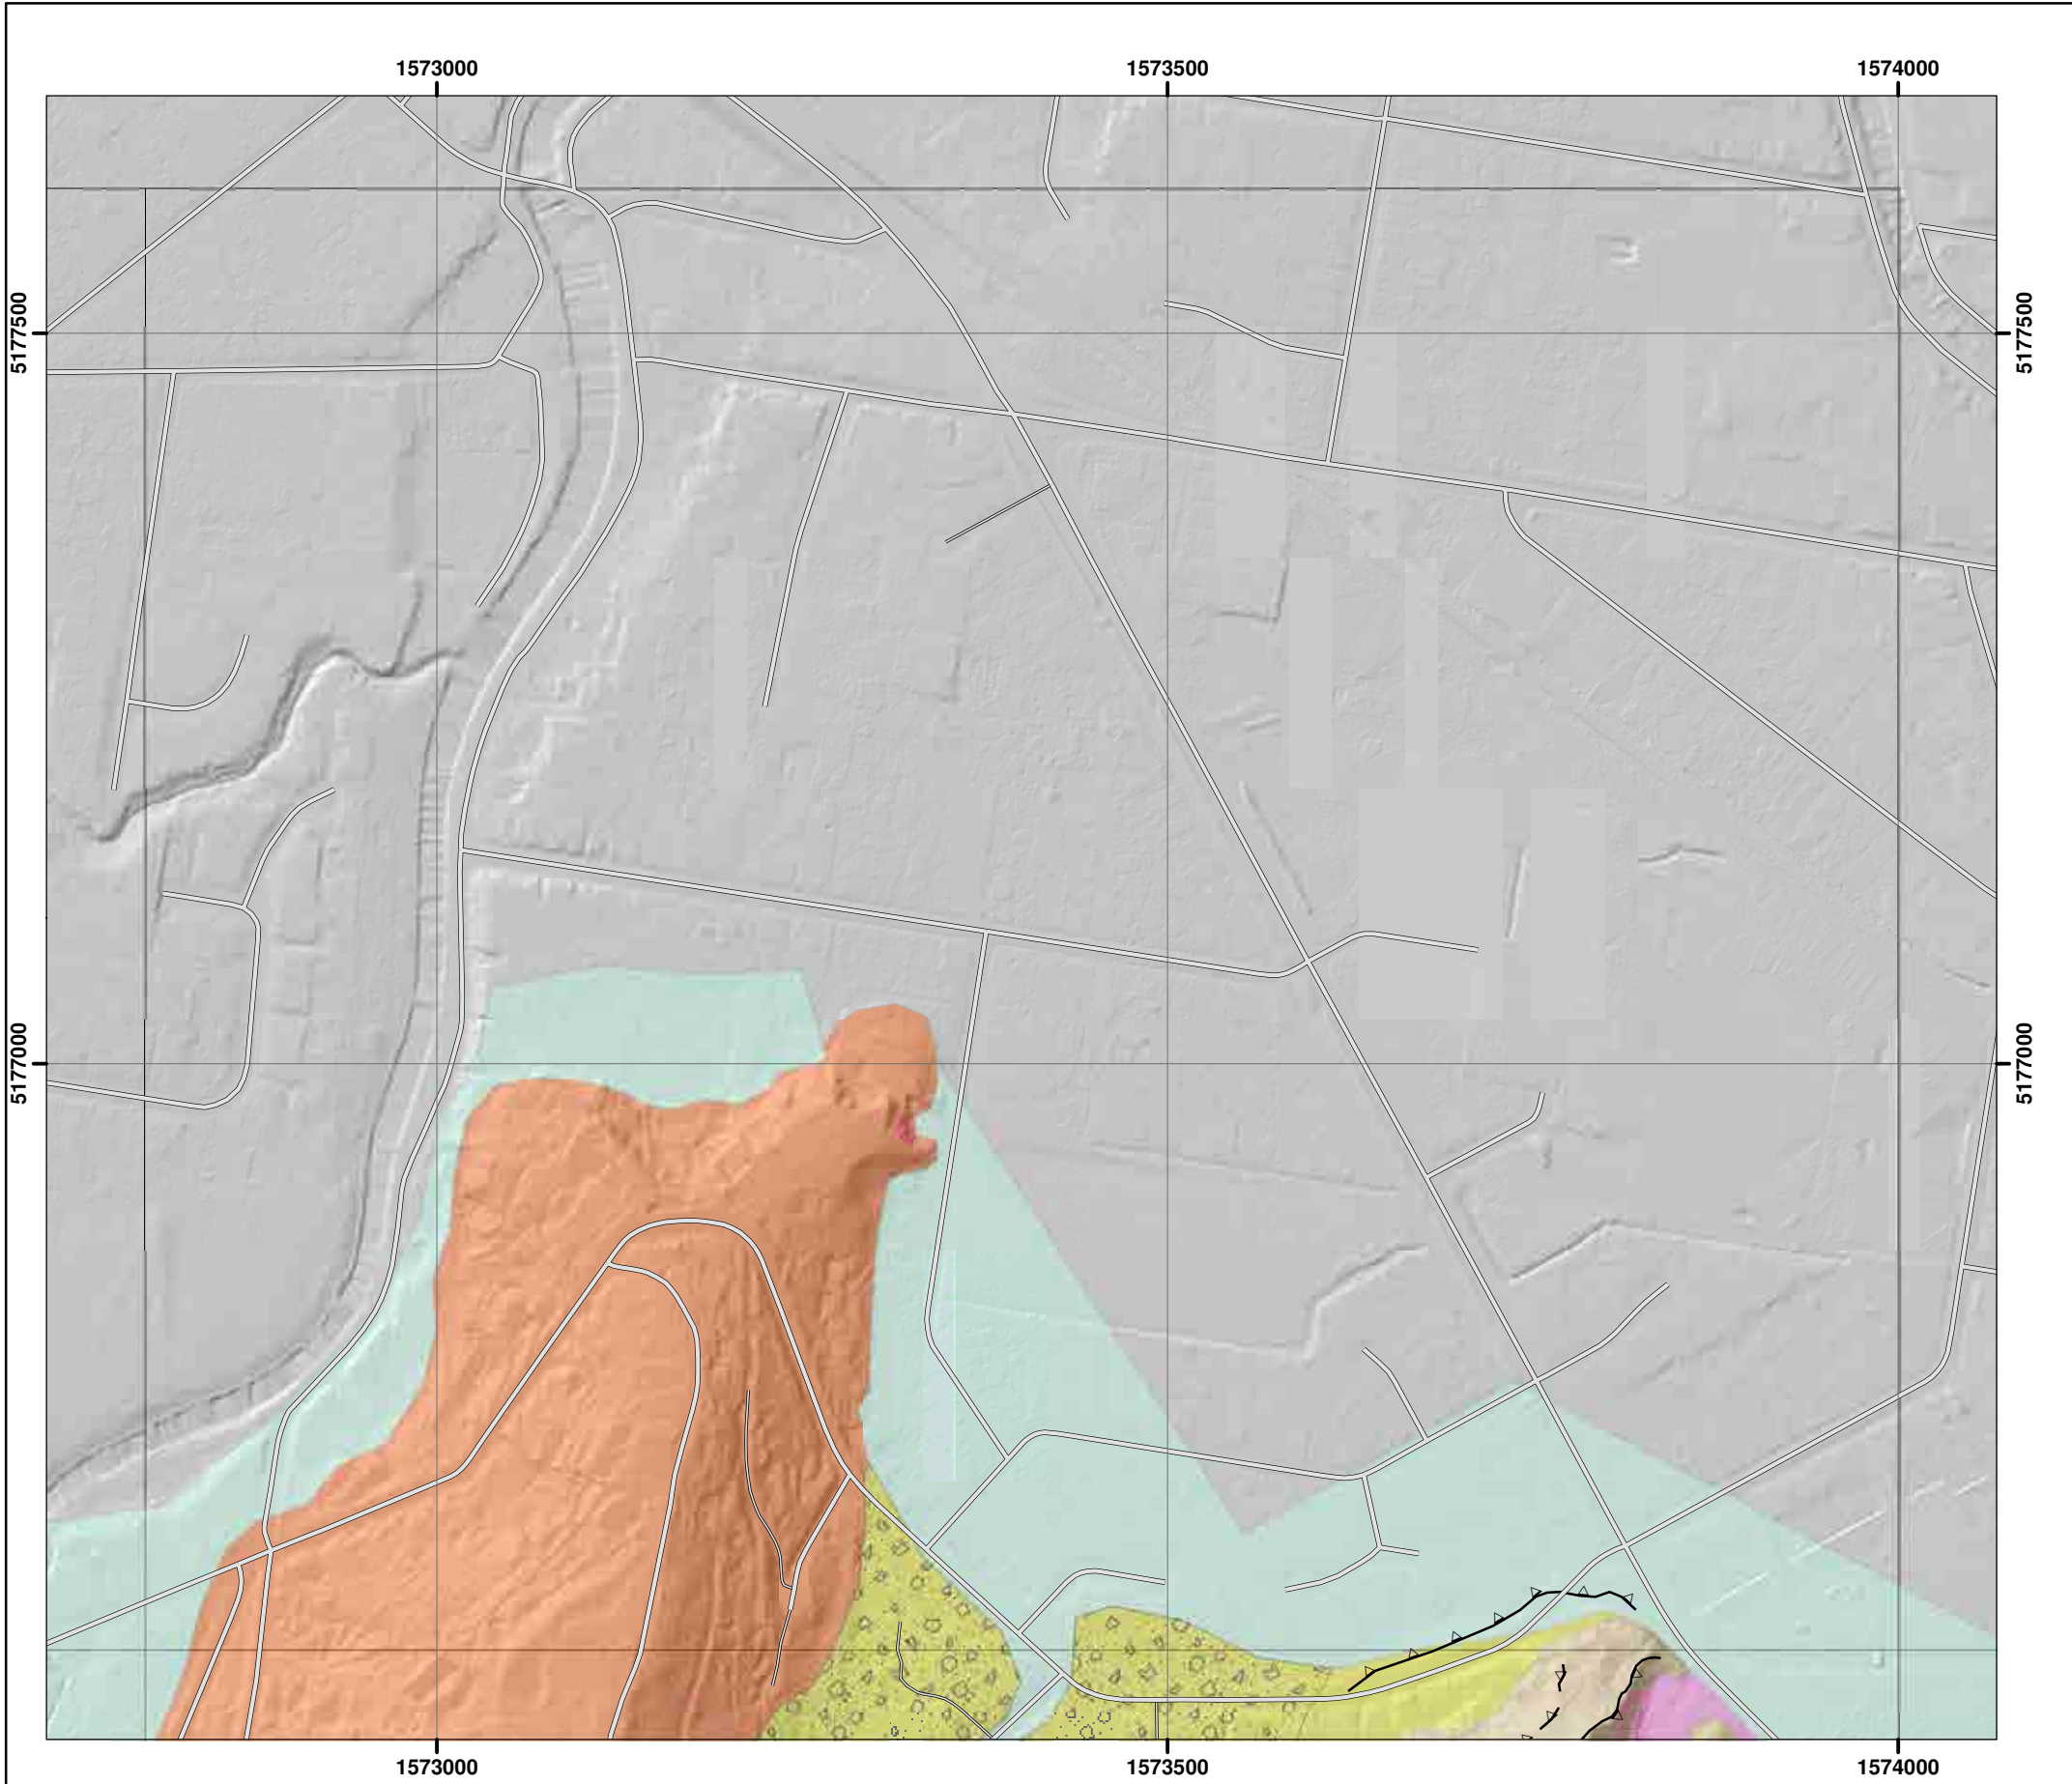
APPENDIX 4  
 Map A7

Morphology description	Interpreted Materials type	Genesis type
Boulder trail	Rock at/near surface	Rockfall (recent)
Dike	Talus	Rockfall (many scattered boulders)
Bund	Colluvium	Rockfall (few scattered boulders)
Ephemeral drainage line (well defined)	Loess	Dune
Ephemeral drainage line (poorly defined)	Alluvium	Beach
Lineation	Sand and gravel	Rills
Sharp lineation (crack)	Boulders	Terracettes
Rounded concave break in slope	Fill	Fan
Rounded convex break in slope	Unknown	Landslide scar (recent)
Rounded ridge line		Landslide scar (relict)
Sharp concave break in slope		Swamp/wetland
Sharp convex break in slope		
Cliff		
Shelter belt/trees

EXPLANATION:  
 Background shade model derived from NZAM post-earthquake 2011c (July 2011) LiDAR survey resampled to a 1m ground resolution.  
 Roads provided by Christchurch City Council (20/02/2012).  
 PROJECTION: New Zealand Transverse Mercator 2000.

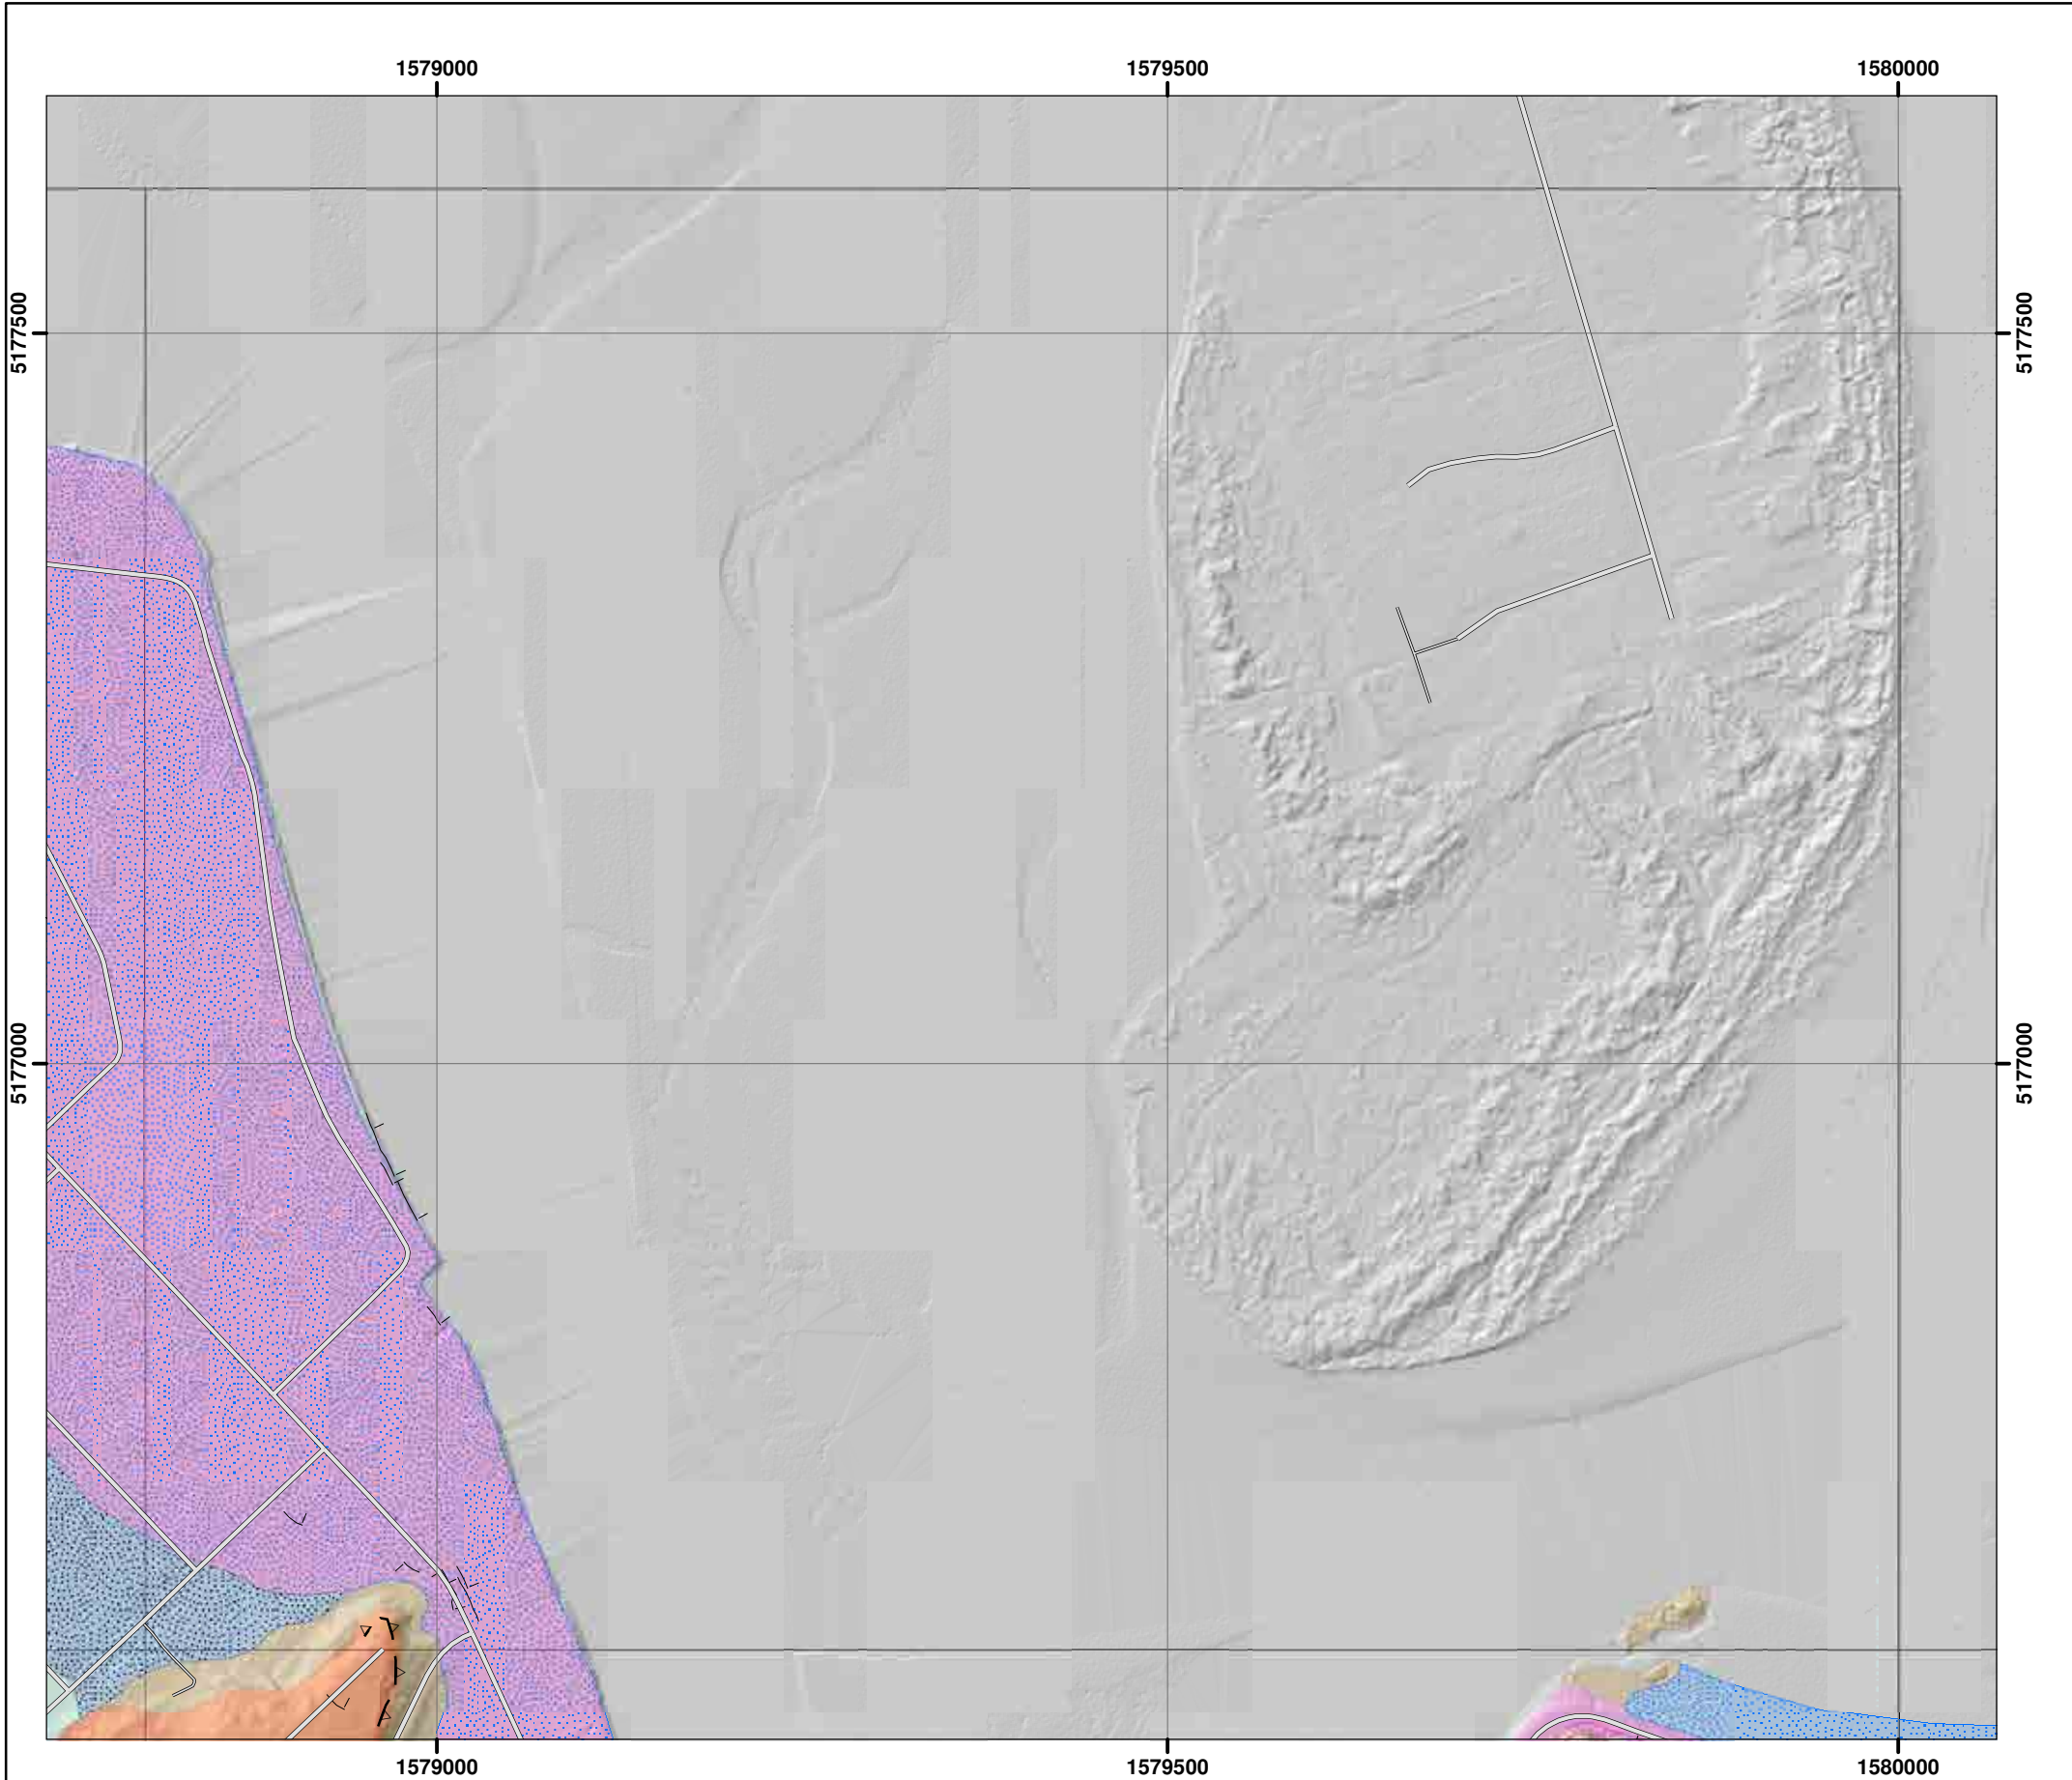
APPENDIX 4  
Map A12

Morphology description	Interpreted Materials type	Genesis type
Boulder trail	Rock at/near surface	Rockfall (recent)
Dike	Talus	Rockfall (many scattered boulders)
Bund	Colluvium	Rockfall (few scattered boulders)
Ephemeral drainage line (well defined)	Loess	Dune
Ephemeral drainage line (poorly defined)	Alluvium	Beach
Lineation	Sand and gravel	Rills
Sharp lineation (crack)	Boulders	Terracettes
Rounded concave break in slope	Fill	Fan
Rounded convex break in slope	Unknown	Landslide scar (recent)
Rounded ridge line		Landslide scar (relict)
Sharp concave break in slope		Swamp/wetland
Sharp convex break in slope		
Cliff		
Shelter belt/trees

EXPLANATION:  
 Background shade model derived from NZAM post-earthquake 2011c (July 2011) LiDAR survey resampled to a 1m ground resolution.  
 Roads provided by Christchurch City Council (20/02/2012).  
 PROJECTION: New Zealand Transverse Mercator 2000.

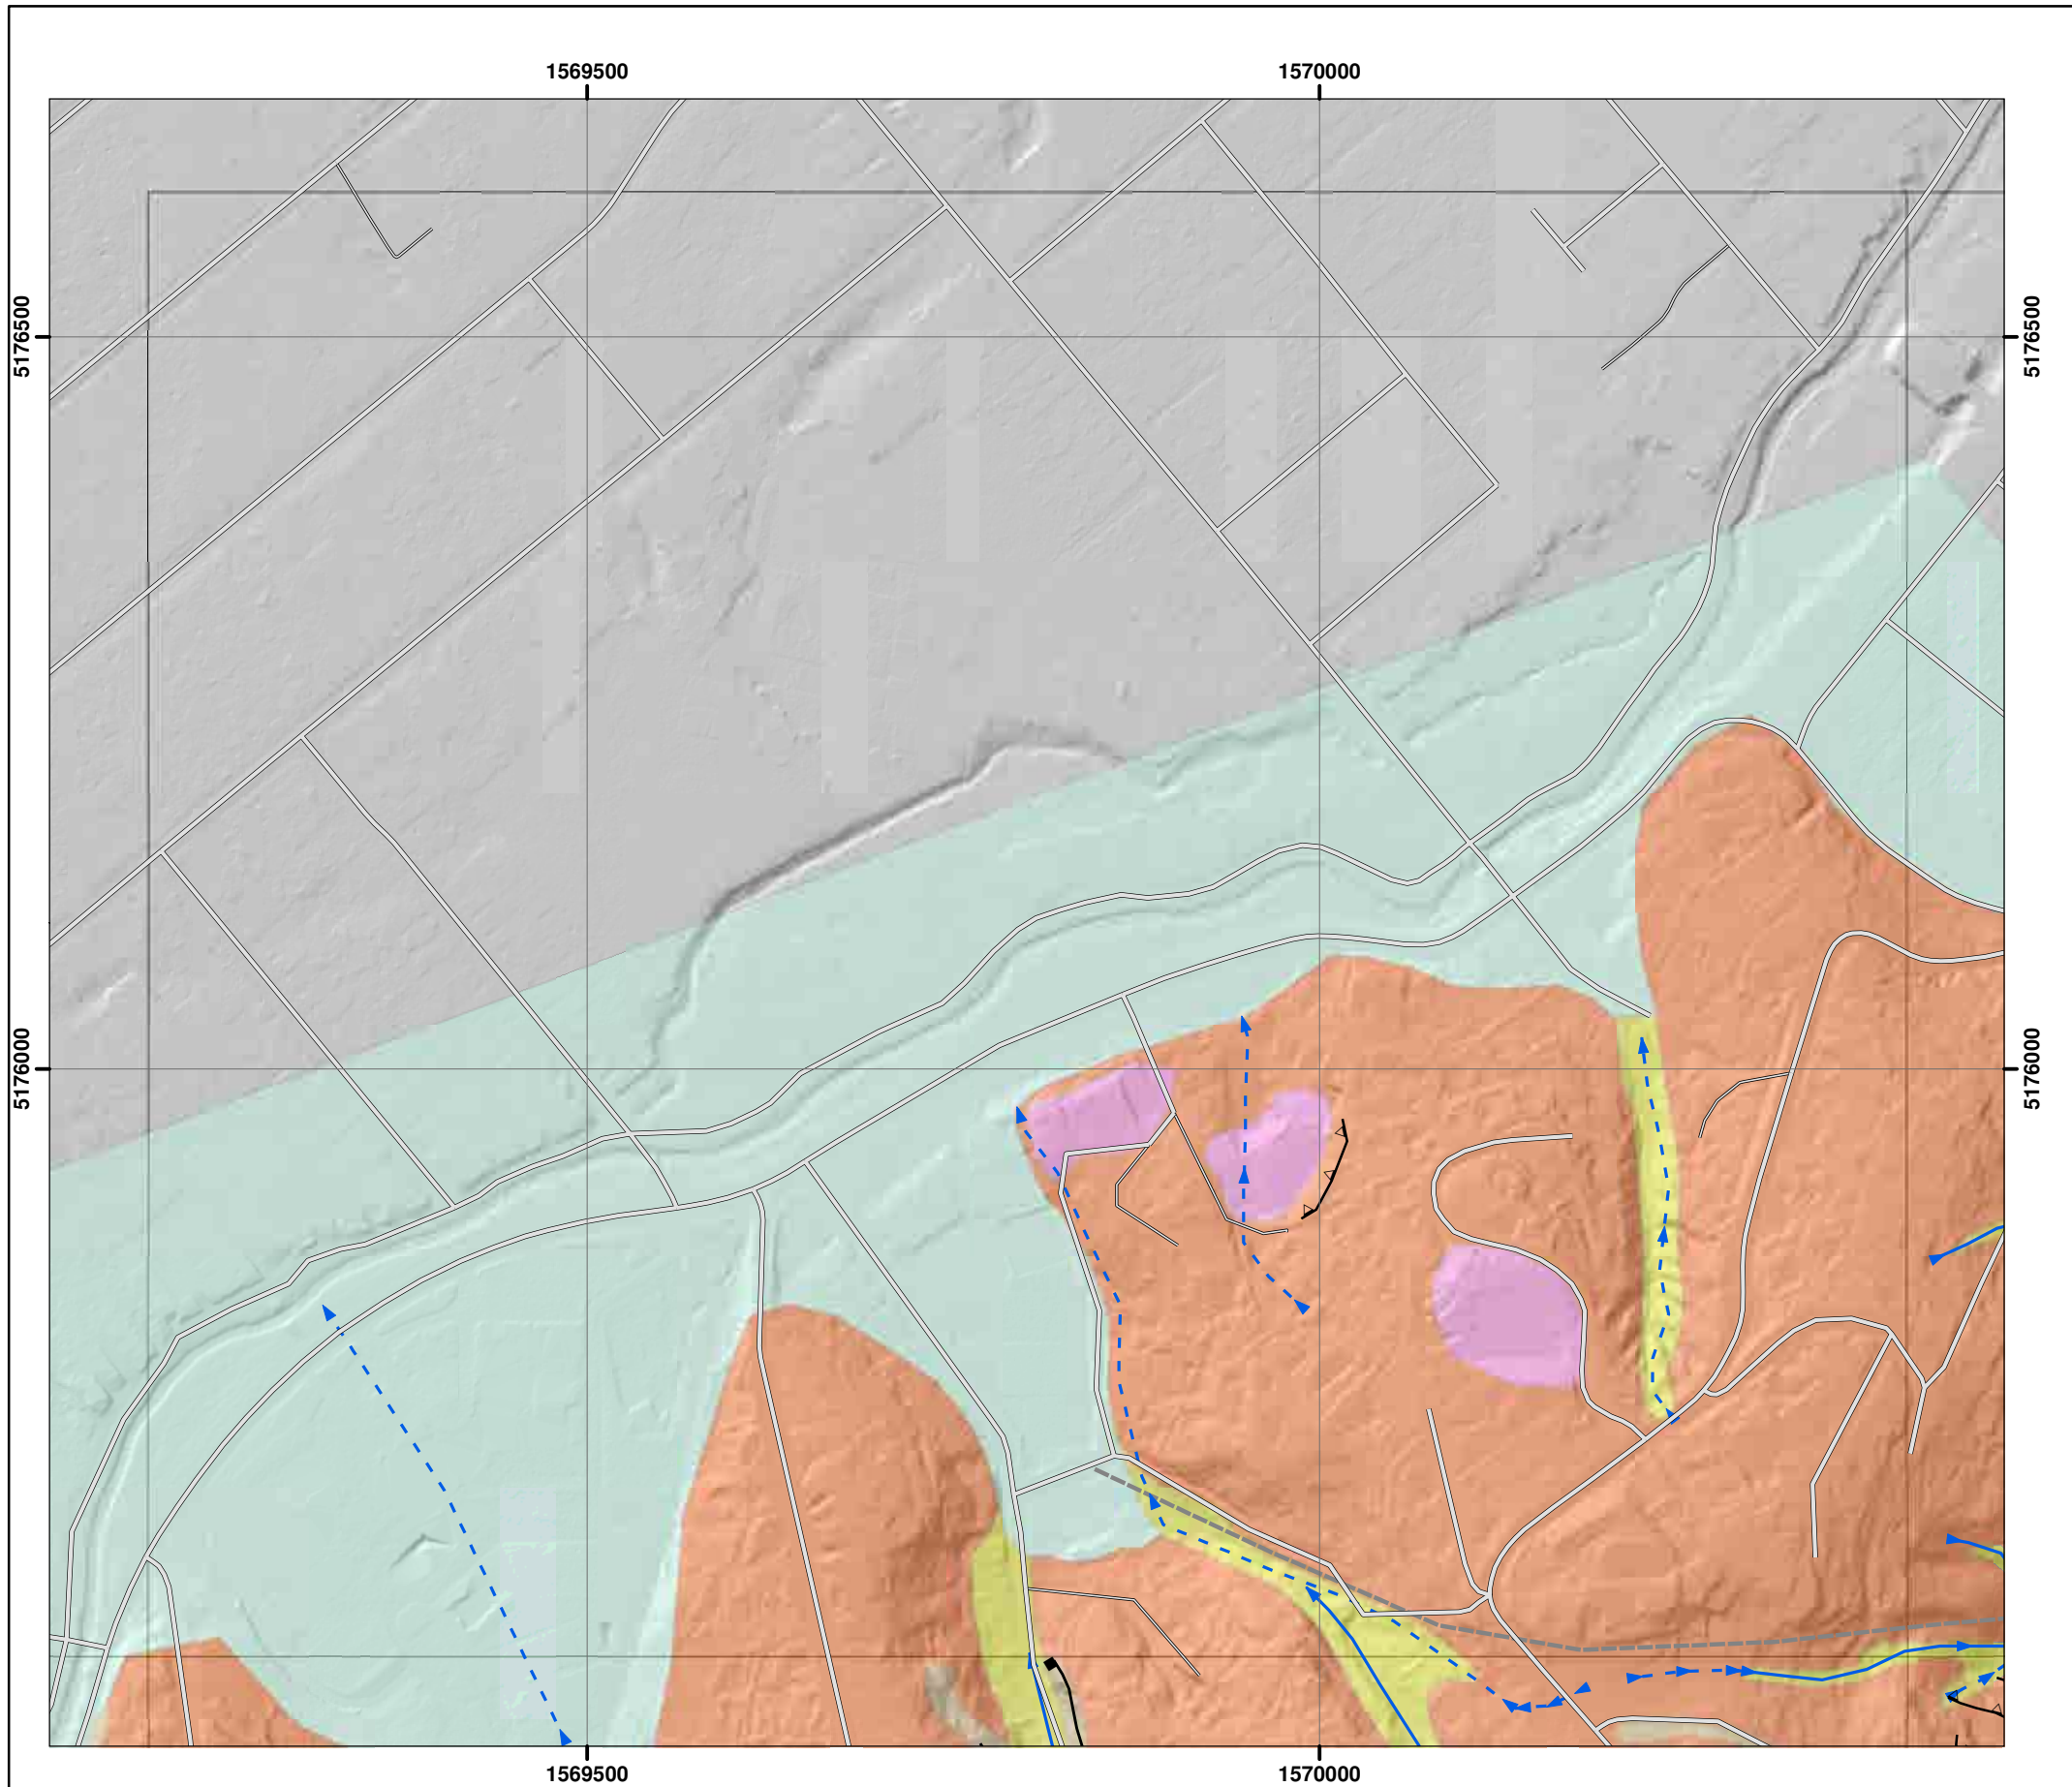
APPENDIX 4  
Map B4

Morphology description	Interpreted Materials type	Genesis type
Boulder trail	Rock at/near surface	Rockfall (recent)
Dike	Talus	Rockfall (many scattered boulders)
Bund	Colluvium	Rockfall (few scattered boulders)
Ephemeral drainage line (well defined)	Loess	Dune
Ephemeral drainage line (poorly defined)	Alluvium	Beach
Lineation	Sand and gravel	Rills
Sharp lineation (crack)	Boulders	Terracettes
Rounded concave break in slope	Fill	Fan
Rounded convex break in slope	Unknown	Landslide scar (recent)
Rounded ridge line		Landslide scar (relict)
Sharp concave break in slope		Swamp/wetland
Sharp convex break in slope		
Cliff		
Shelter belt/trees

EXPLANATION:  
 Background shade model derived from NZAM post-earthquake 2011c (July 2011) LiDAR survey resampled to a 1m ground resolution.  
 Roads provided by Christchurch City Council (20/02/2012).  
 PROJECTION: New Zealand Transverse Mercator 2000.

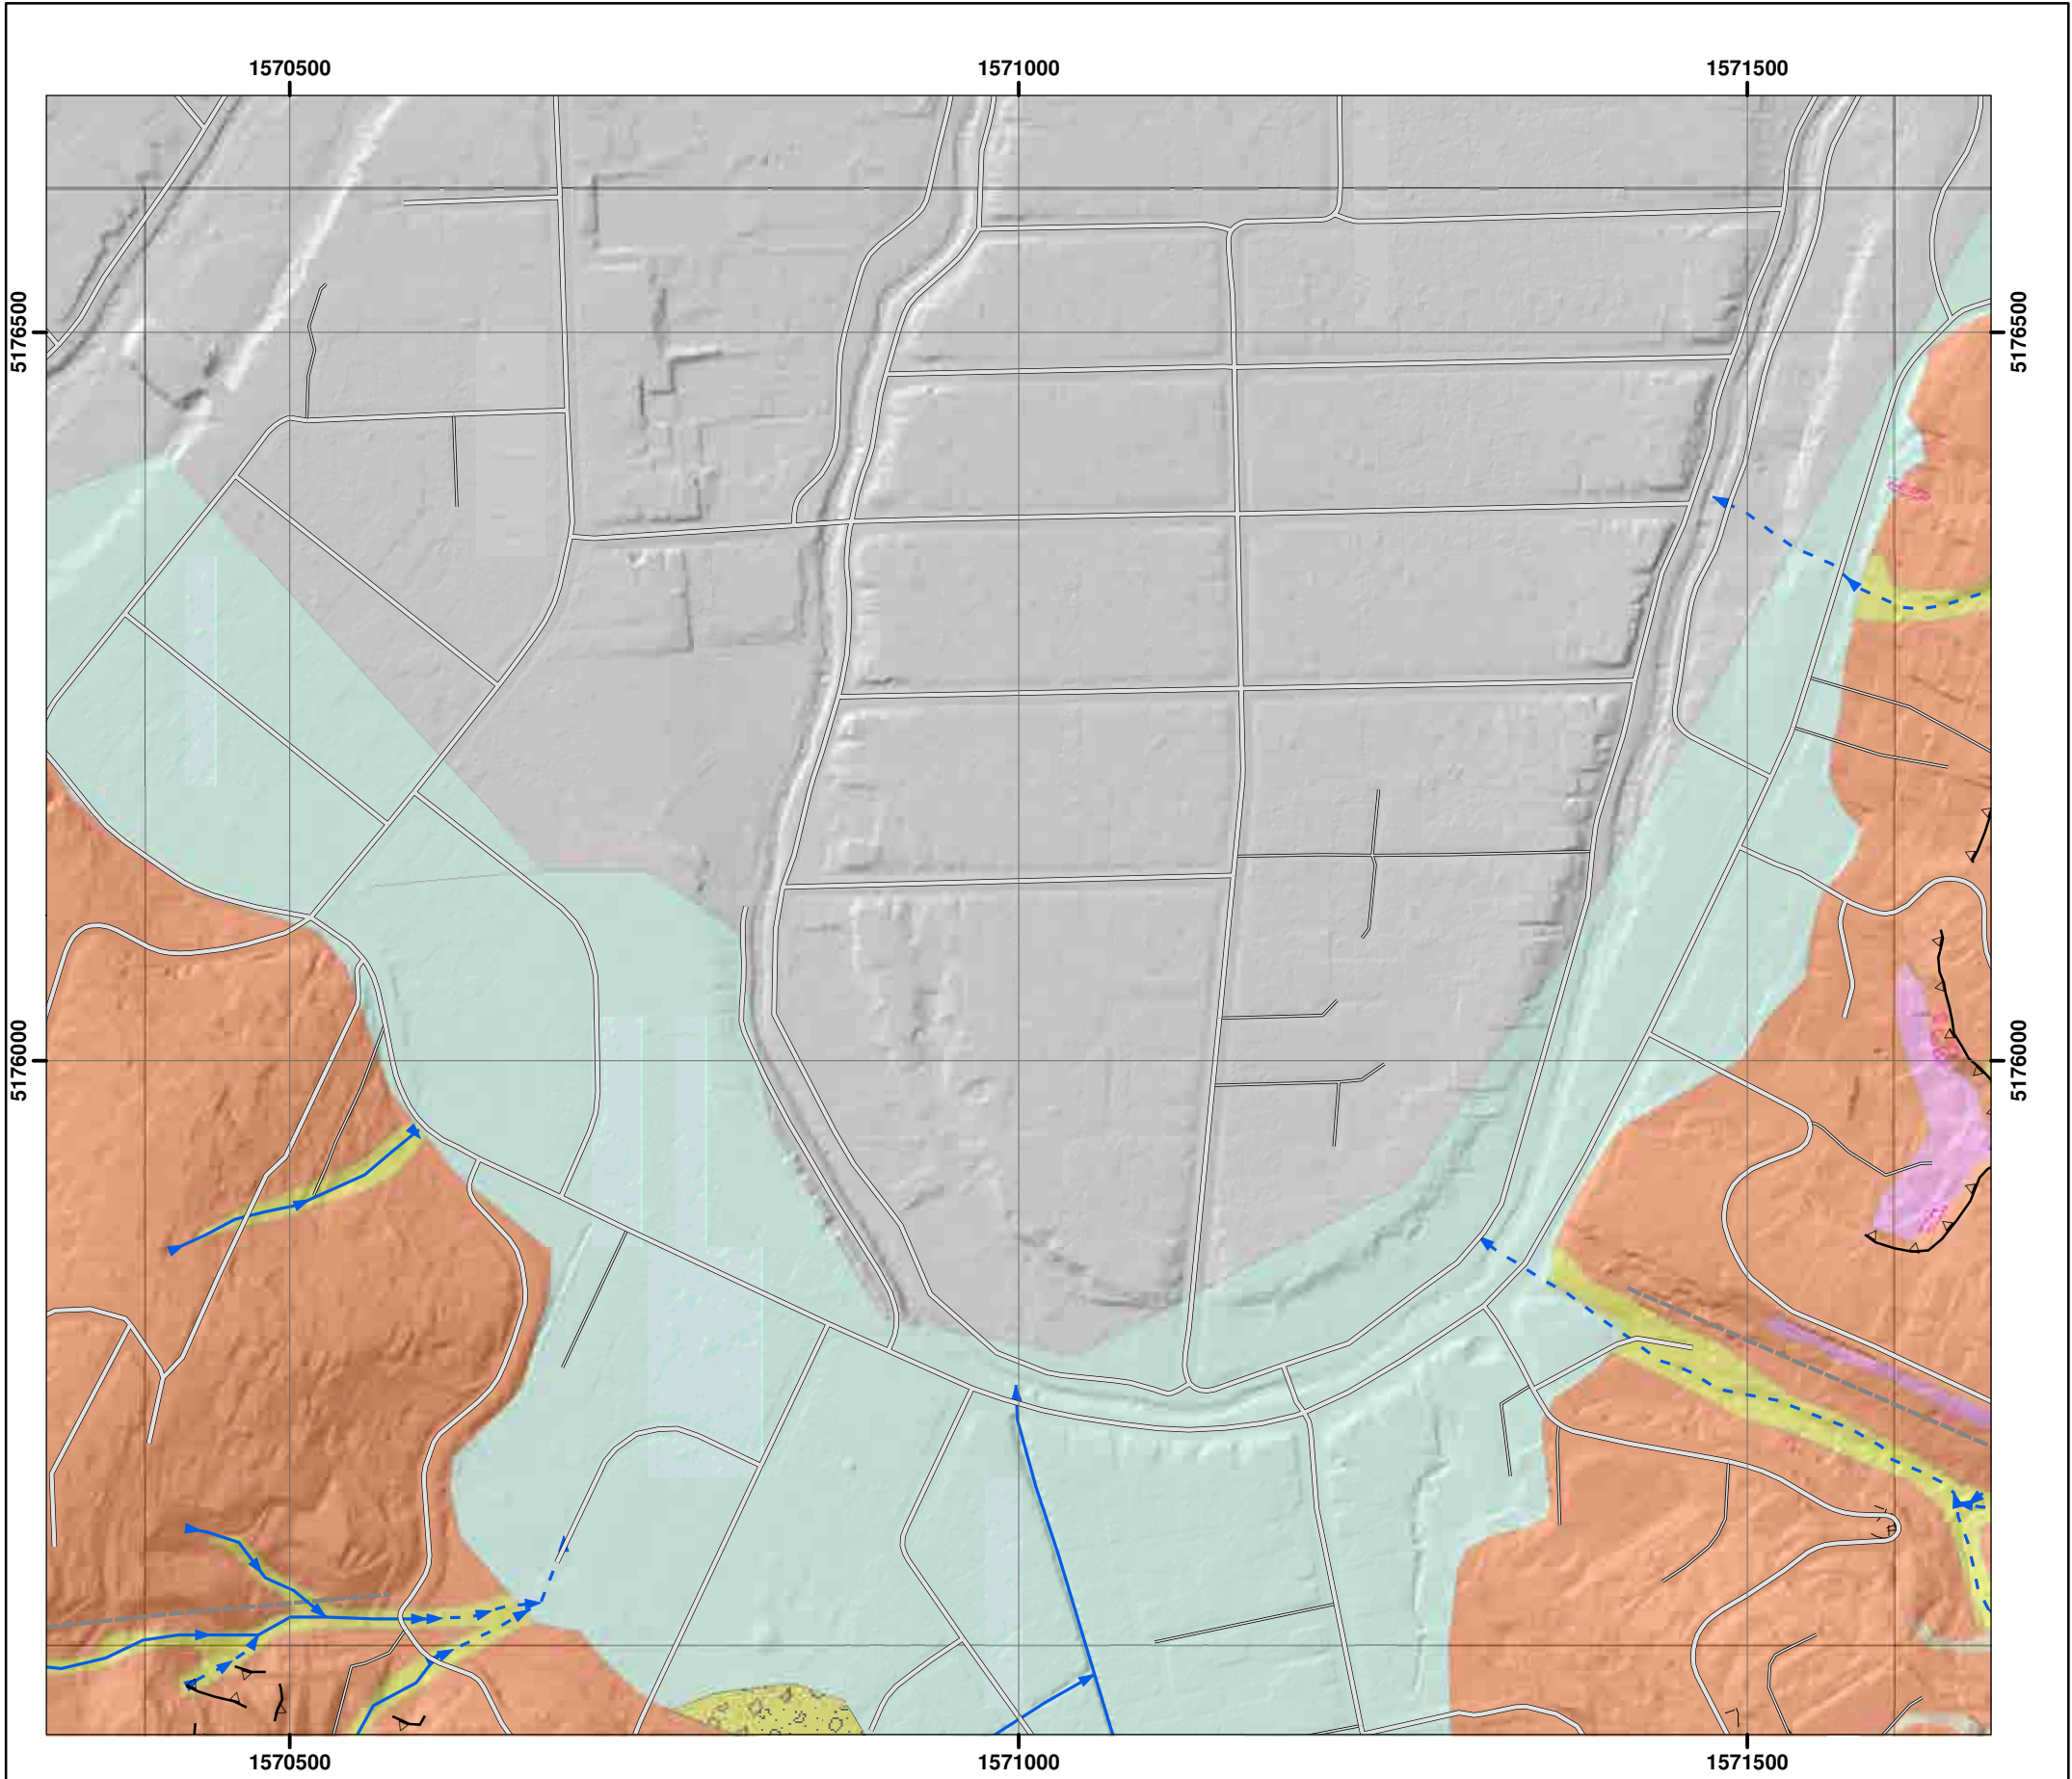
APPENDIX 4  
Map B5

Morphology description	Interpreted Materials type	Genesis type
Boulder trail	Rock at/near surface	Rockfall (recent)
Dike	Talus	Rockfall (many scattered boulders)
Bund	Colluvium	Rockfall (few scattered boulders)
Ephemeral drainage line (well defined)	Loess	Dune
Ephemeral drainage line (poorly defined)	Alluvium	Beach
Lineation	Sand and gravel	Rills
Sharp lineation (crack)	Boulders	Terracettes
Rounded concave break in slope	Fill	Fan
Rounded convex break in slope	Unknown	Landslide scar (recent)
Rounded ridge line		Landslide scar (relict)
Sharp concave break in slope		Swamp/wetland
Sharp convex break in slope		
Cliff		
Shelter belt/trees

EXPLANATION:  
 Background shade model derived from NZAM post-earthquake 2011c (July 2011) LiDAR survey resampled to a 1m ground resolution.  
 Roads provided by Christchurch City Council (20/02/2012).  
 PROJECTION: New Zealand Transverse Mercator 2000.

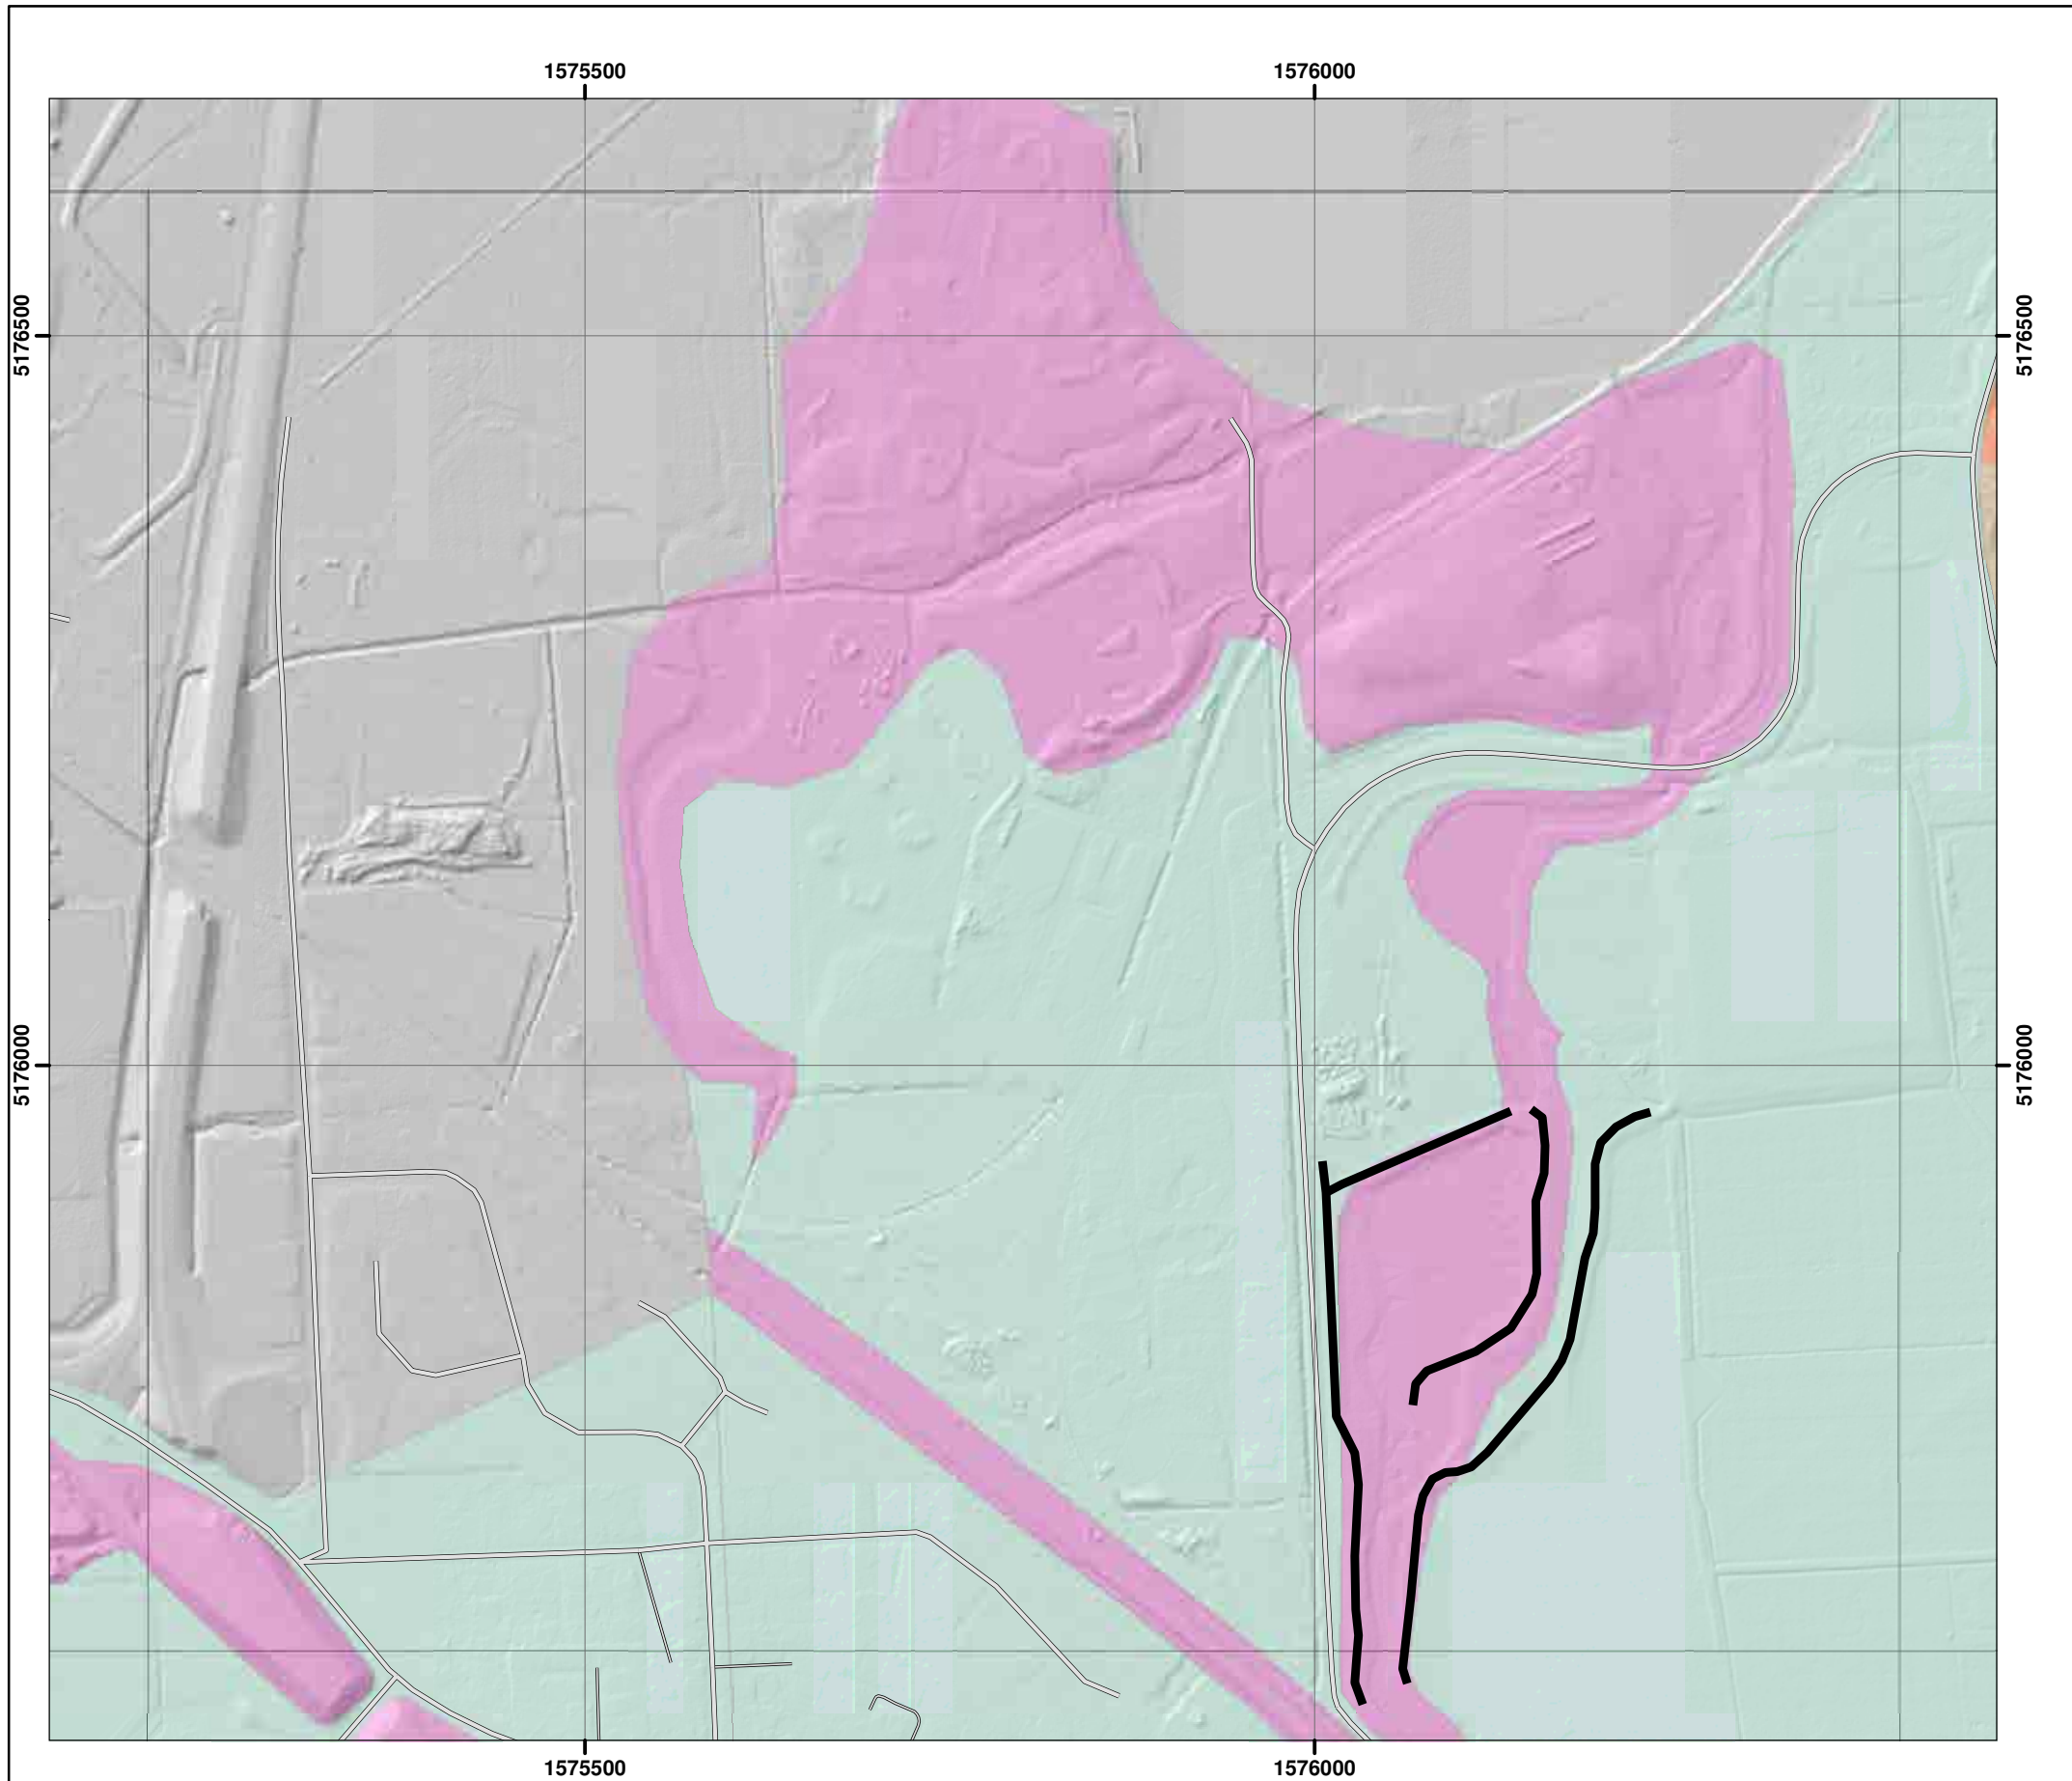
APPENDIX 4  
Map B9

Morphology description	Interpreted Materials type	Genesis type
Boulder trail	Rock at/near surface	Rockfall (recent)
Dike	Talus	Rockfall (many scattered boulders)
Bund	Colluvium	Rockfall (few scattered boulders)
Ephemeral drainage line (well defined)	Loess	Dune
Ephemeral drainage line (poorly defined)	Alluvium	Beach
Lineation	Sand and gravel	Rills
Sharp lineation (crack)	Boulders	Terracettes
Rounded concave break in slope	Fill	Fan
Rounded convex break in slope	Unknown	Landslide scar (recent)
Rounded ridge line		Landslide scar (relict)
Sharp concave break in slope		Swamp/wetland
Sharp convex break in slope		
Cliff		
Shelter belt/trees

EXPLANATION:  
 Background shade model derived from NZAM post-earthquake 2011c (July 2011) LiDAR survey resampled to a 1m ground resolution.  
 Roads provided by Christchurch City Council (20/02/2012).  
 PROJECTION: New Zealand Transverse Mercator 2000.
