**APPENDIX 4: GEOMORPHOLOGY MAPS**

**GEOMORPHOLOGY MAPPING FOR  
ROCKFALL RISK ASSESSMENT**

**Port Hills  
Christchurch**

REPORT: CR2012/15 DATE: Sept 2012

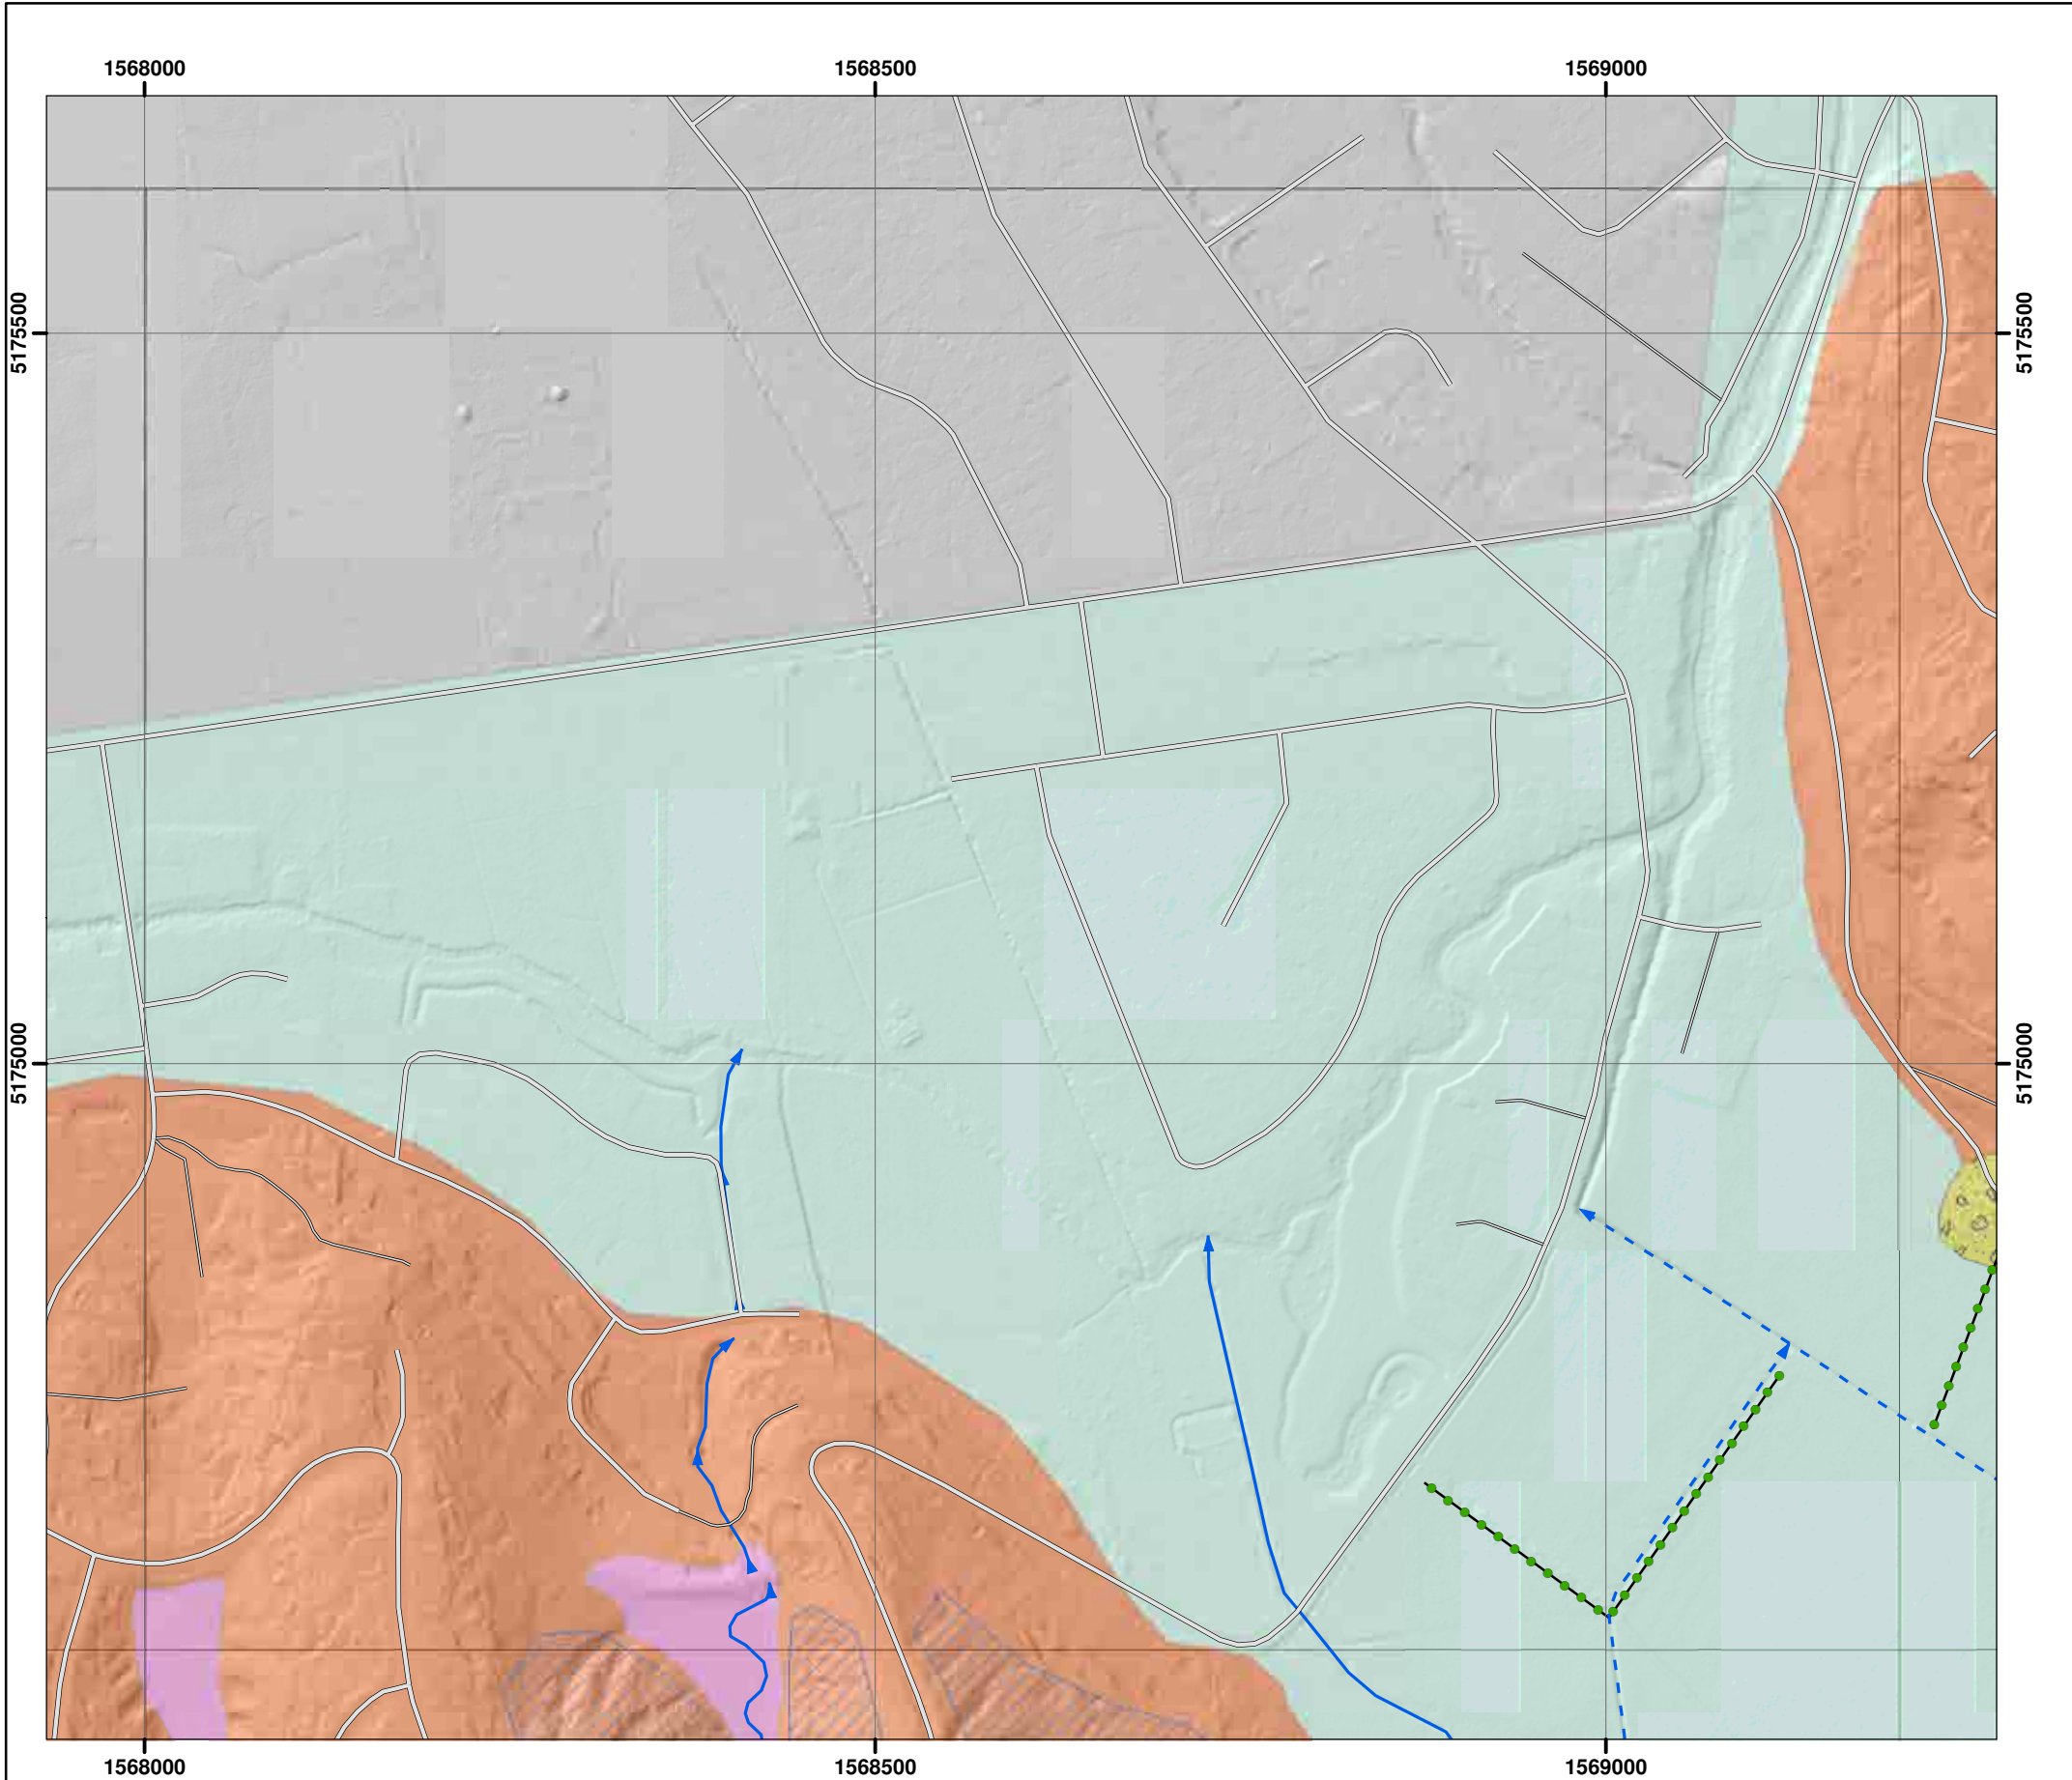
APPENDIX 4  
Map C3

Morphology description	Interpreted Materials type	Genesis type
Boulder trail	Rock at/near surface	Rockfall (recent)
Dike	Talus	Rockfall (many scattered boulders)
Bund	Colluvium	Rockfall (few scattered boulders)
Ephemeral drainage line (well defined)	Loess	Dune
Ephemeral drainage line (poorly defined)	Alluvium	Beach
Lineation	Sand and gravel	Rills
Sharp lineation (crack)	Boulders	Terracettes
Rounded concave break in slope	Fill	Fan
Rounded convex break in slope	Unknown	Landslide scar (recent)
Rounded ridge line		Landslide scar (relict)
Sharp concave break in slope		Swamp/wetland
Sharp convex break in slope		
Cliff		
Shelter belt/trees

EXPLANATION:  
 Background shade model derived from NZAM post-earthquake 2011c (July 2011) LiDAR survey resampled to a 1m ground resolution.  
 Roads provided by Christchurch City Council (20/02/2012).  
 PROJECTION: New Zealand Transverse Mercator 2000.

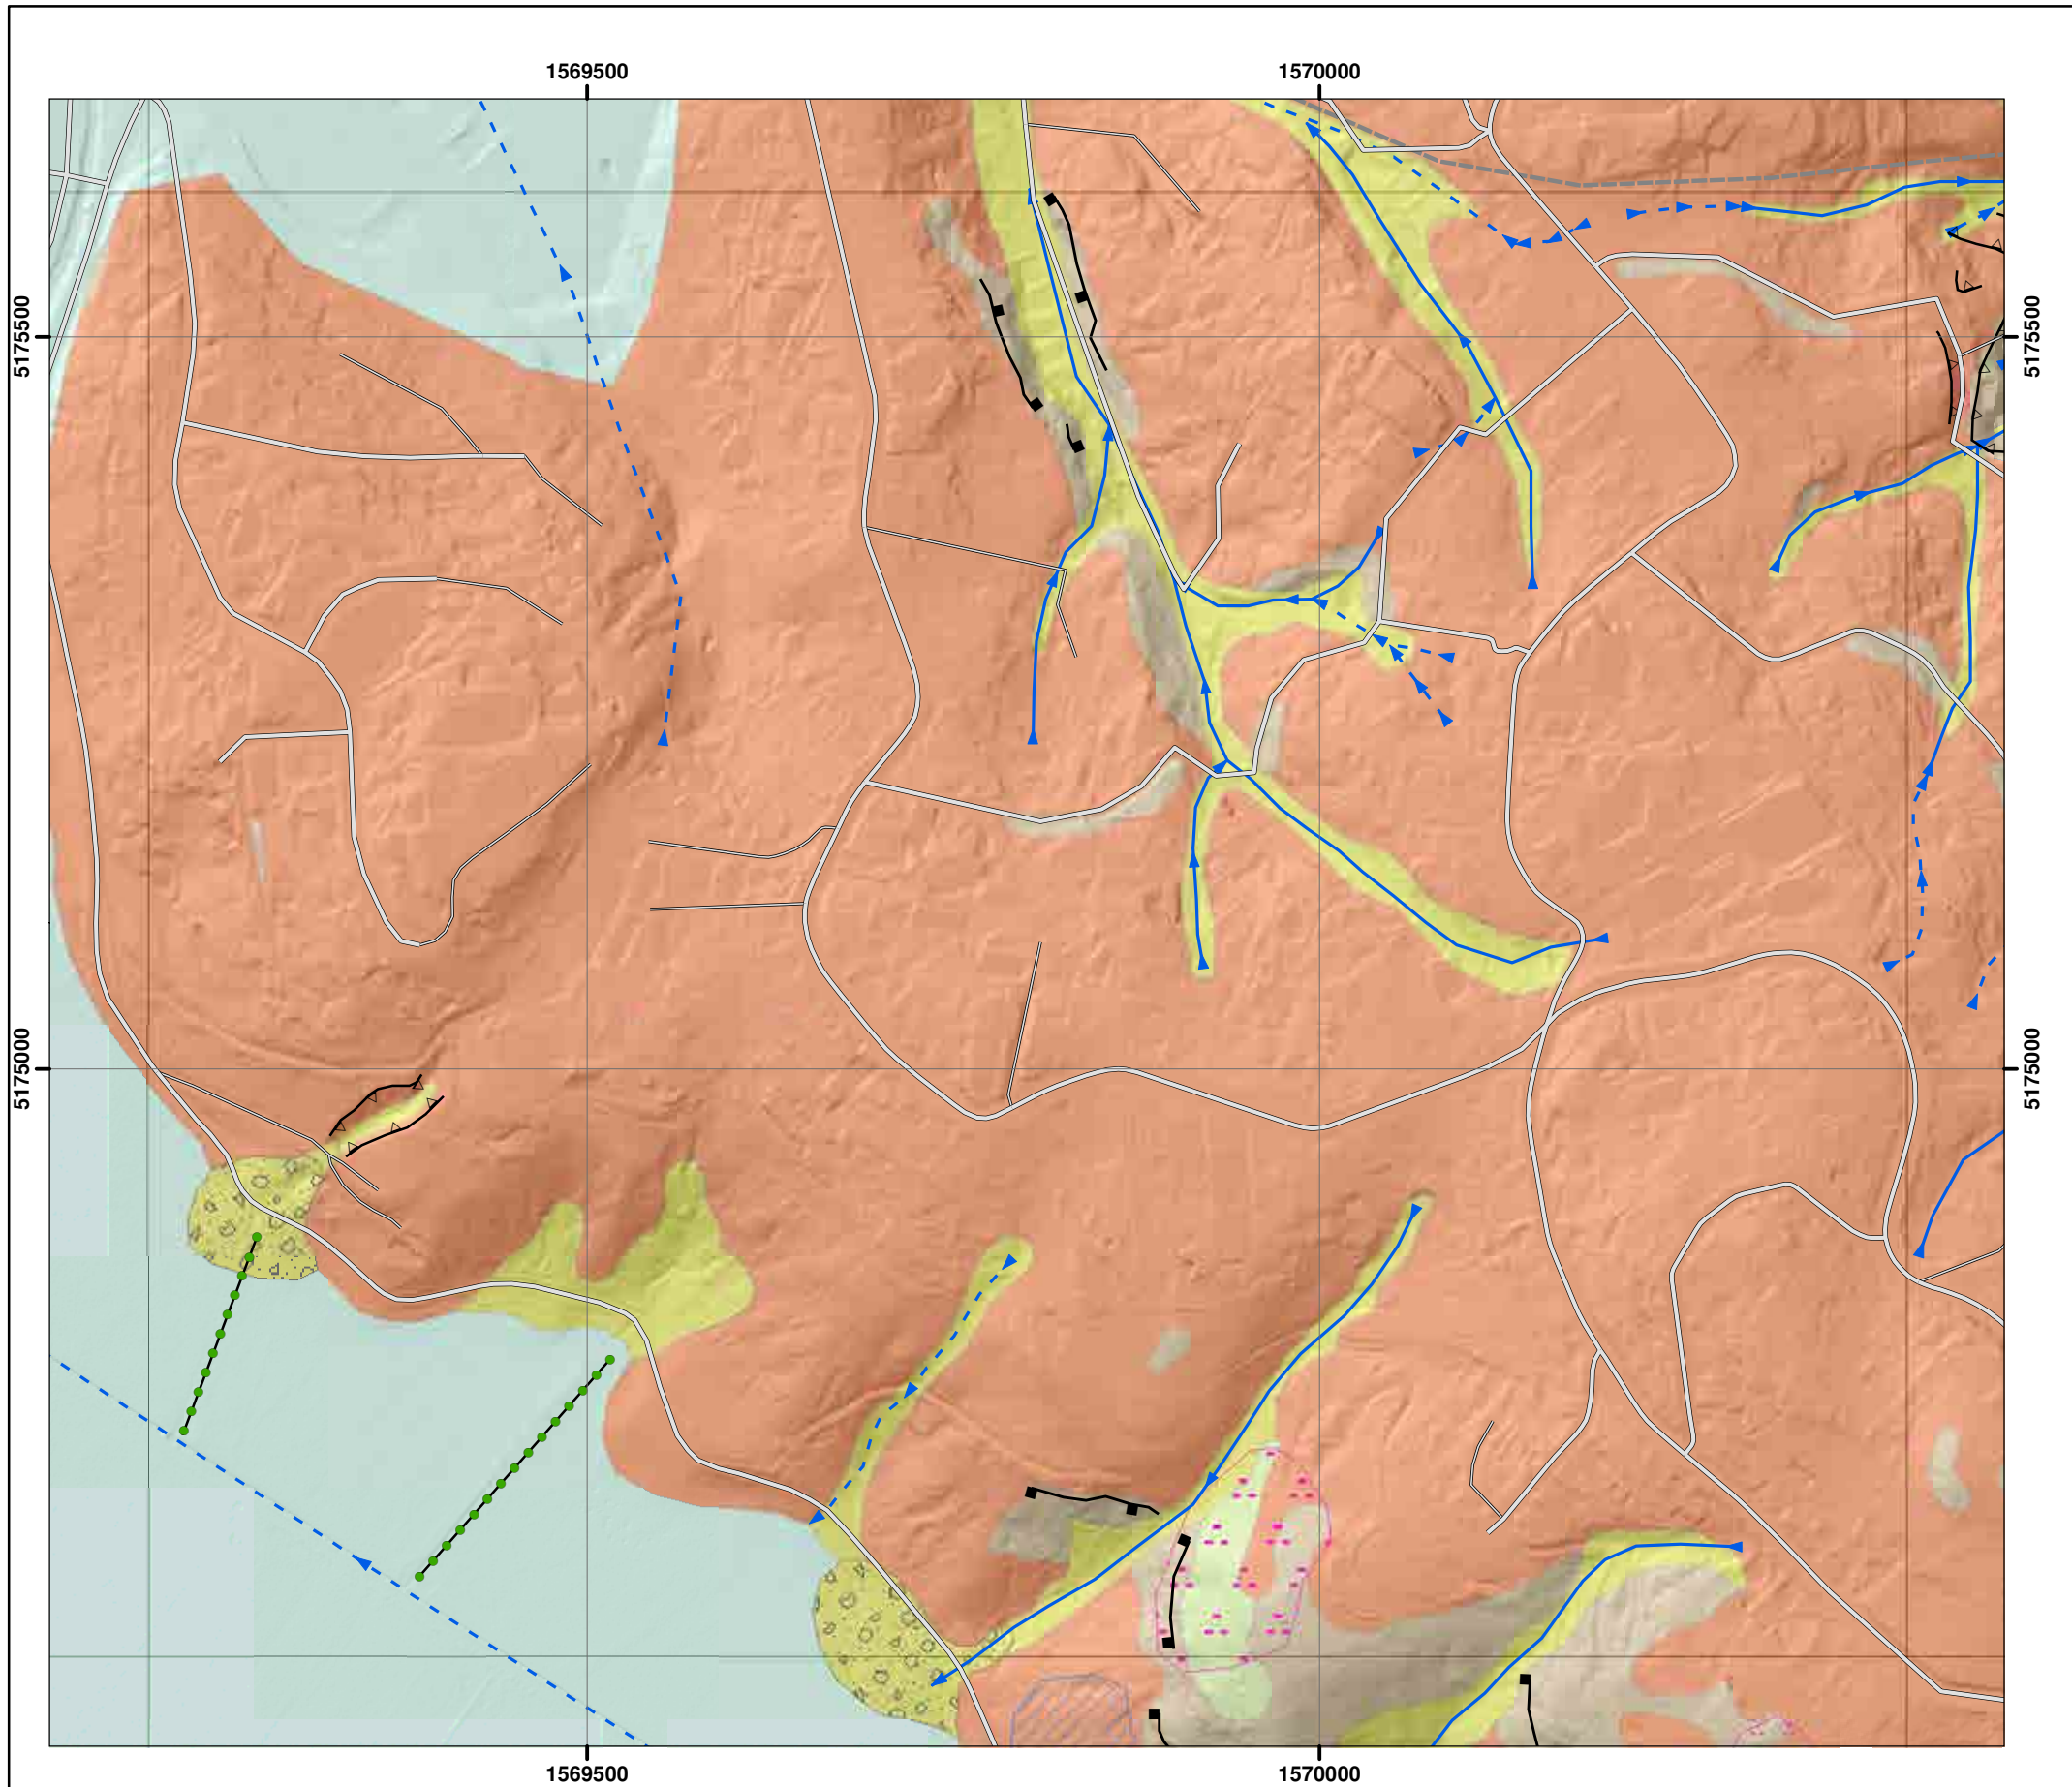
APPENDIX 4  
Map C4

Morphology description	Interpreted Materials type	Genesis type
Boulder trail	Rock at/near surface	Rockfall (recent)
Dike	Talus	Rockfall (many scattered boulders)
Bund	Colluvium	Rockfall (few scattered boulders)
Ephemeral drainage line (well defined)	Loess	Dune
Ephemeral drainage line (poorly defined)	Alluvium	Beach
Lineation	Sand and gravel	Rills
Sharp lineation (crack)	Boulders	Terracettes
Rounded concave break in slope	Fill	Fan
Rounded convex break in slope	Unknown	Landslide scar (recent)
Rounded ridge line		Landslide scar (relict)
Sharp concave break in slope		Swamp/wetland
Sharp convex break in slope		
Cliff		
Shelter belt/trees

EXPLANATION:  
 Background shade model derived from NZAM post-earthquake 2011c (July 2011) LiDAR survey resampled to a 1m ground resolution.  
 Roads provided by Christchurch City Council (20/02/2012).  
 PROJECTION: New Zealand Transverse Mercator 2000.

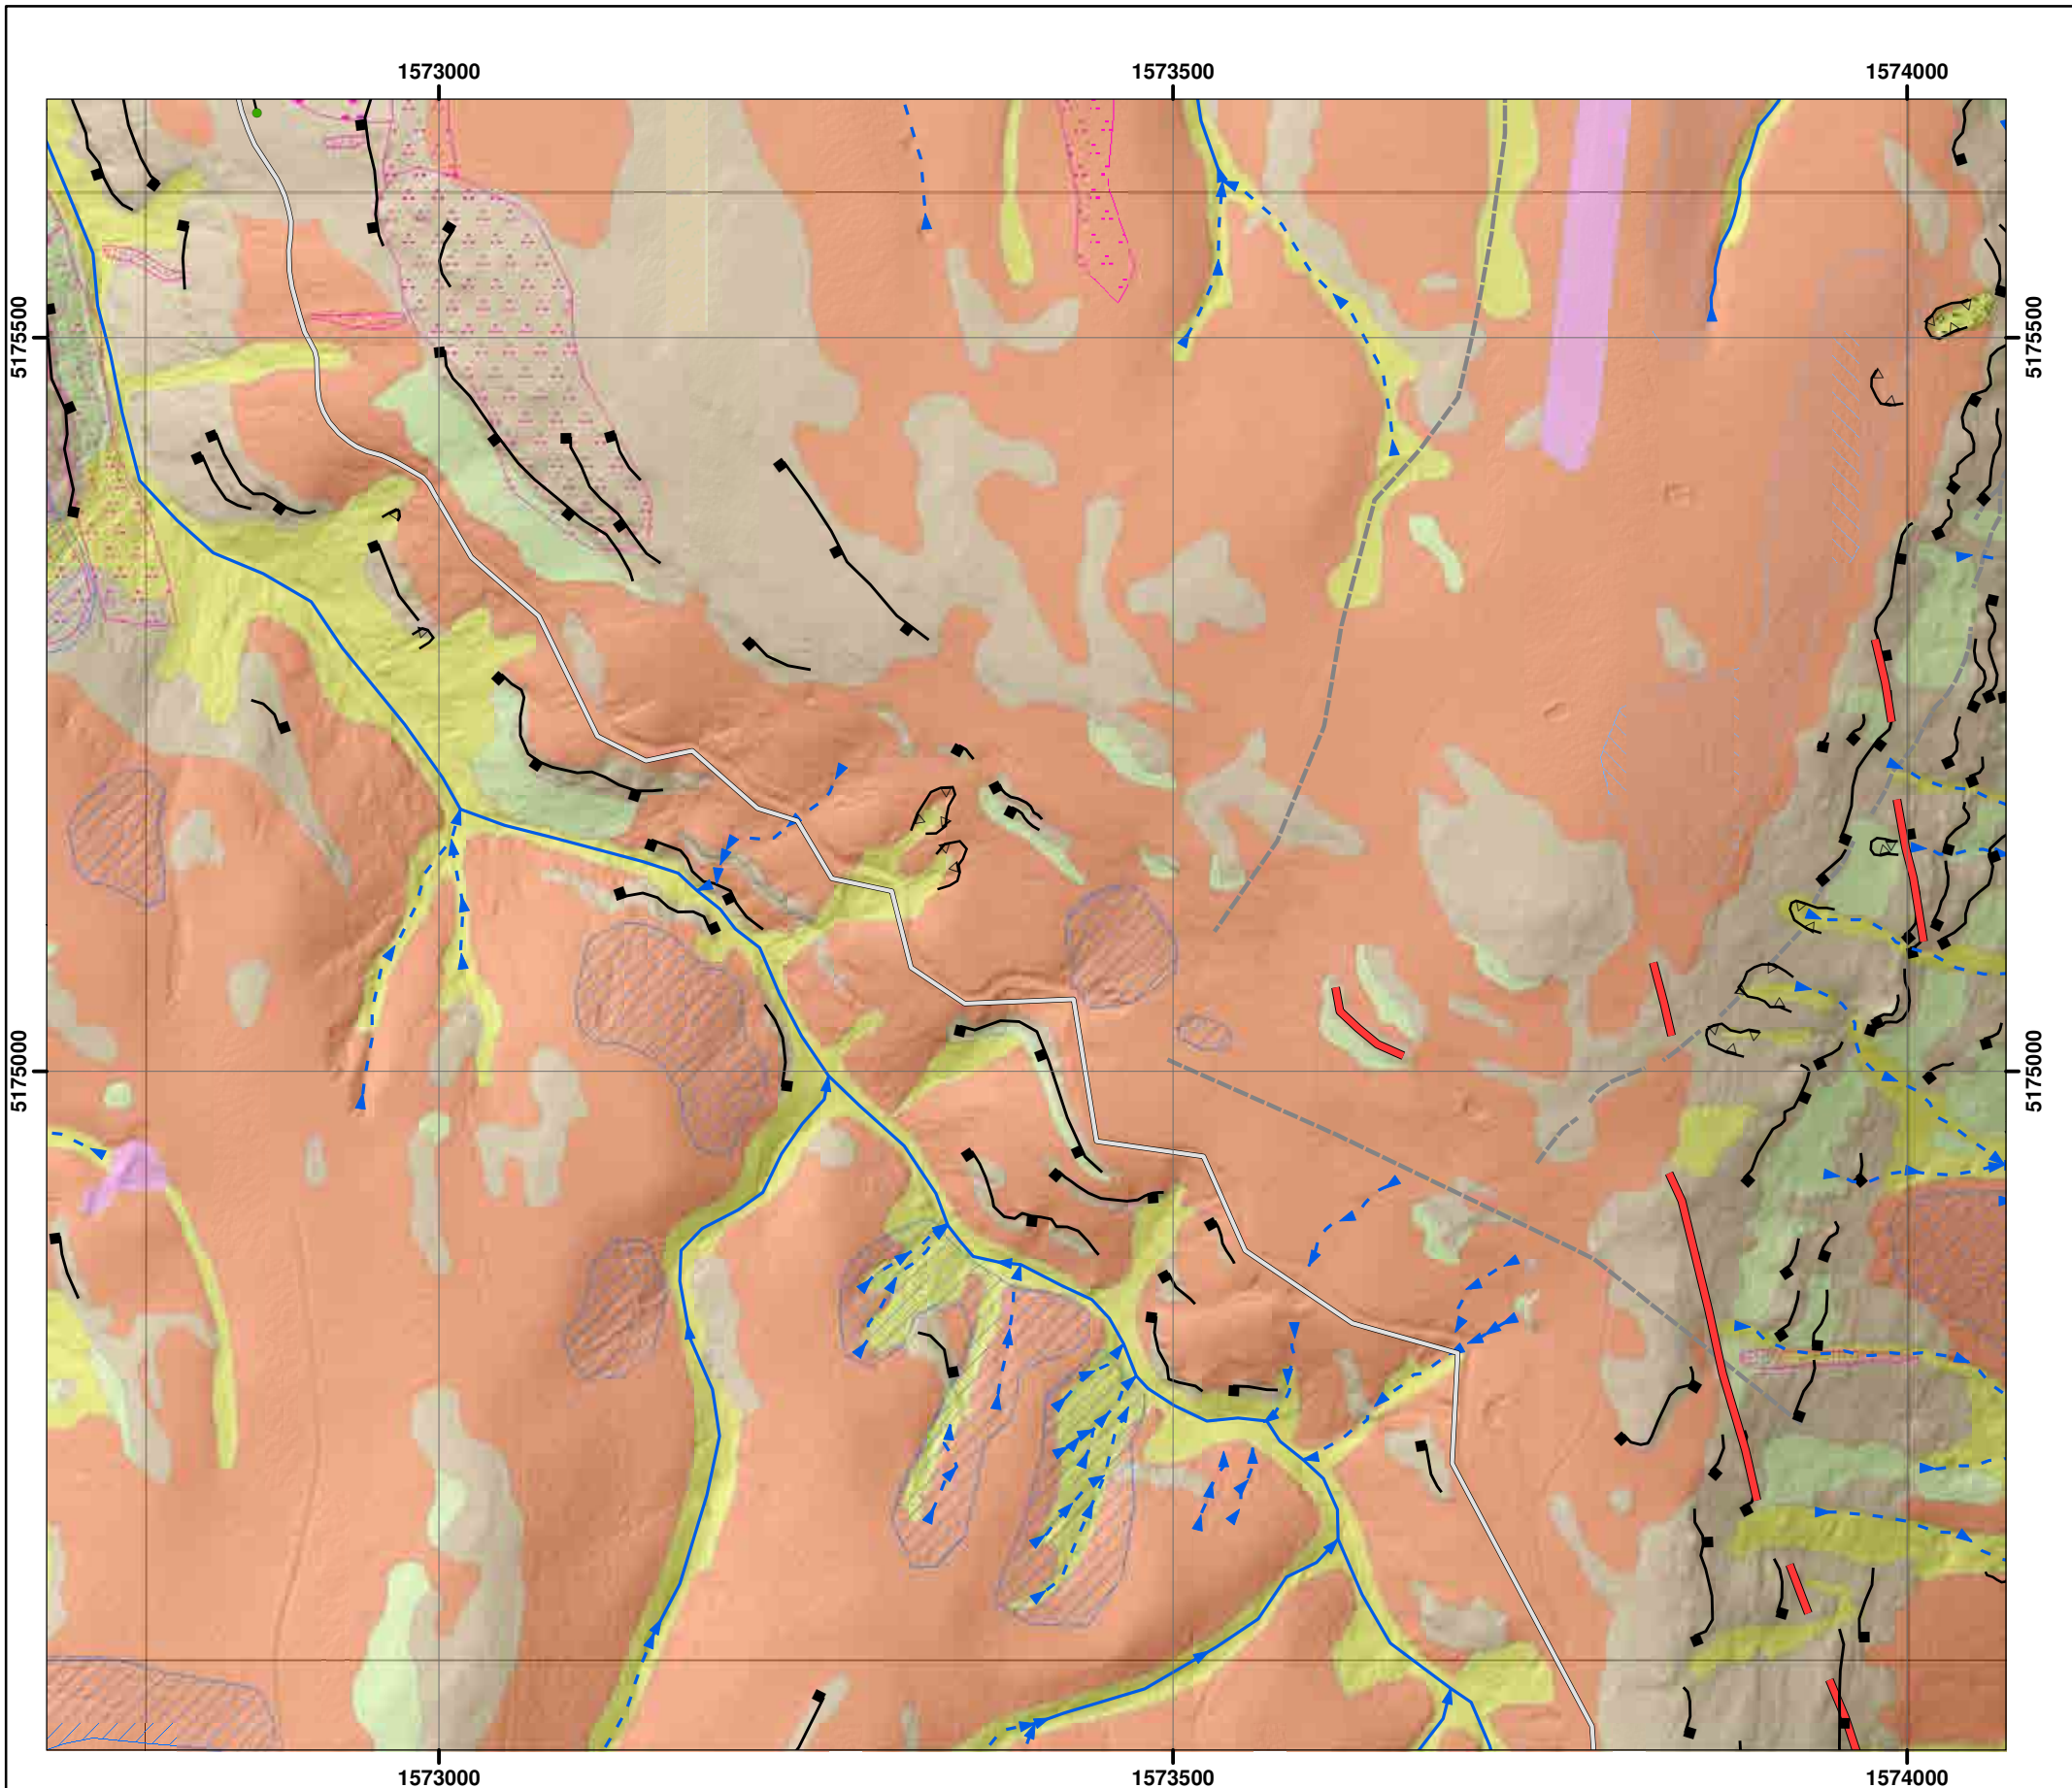
APPENDIX 4  
Map C7

Morphology description	Interpreted Materials type	Genesis type
Boulder trail	Rock at/near surface	Rockfall (recent)
Dike	Talus	Rockfall (many scattered boulders)
Bund	Colluvium	Rockfall (few scattered boulders)
Ephemeral drainage line (well defined)	Loess	Dune
Ephemeral drainage line (poorly defined)	Alluvium	Beach
Lineation	Sand and gravel	Rills
Sharp lineation (crack)	Boulders	Terracettes
Rounded concave break in slope	Fill	Fan
Rounded convex break in slope	Unknown	Landslide scar (recent)
Rounded ridge line		Landslide scar (relict)
Sharp concave break in slope		Swamp/wetland
Sharp convex break in slope		
Cliff		
Shelter belt/trees

EXPLANATION:  
 Background shade model derived from NZAM post-earthquake 2011c (July 2011) LiDAR survey resampled to a 1m ground resolution.  
 Roads provided by Christchurch City Council (20/02/2012).  
 PROJECTION: New Zealand Transverse Mercator 2000.

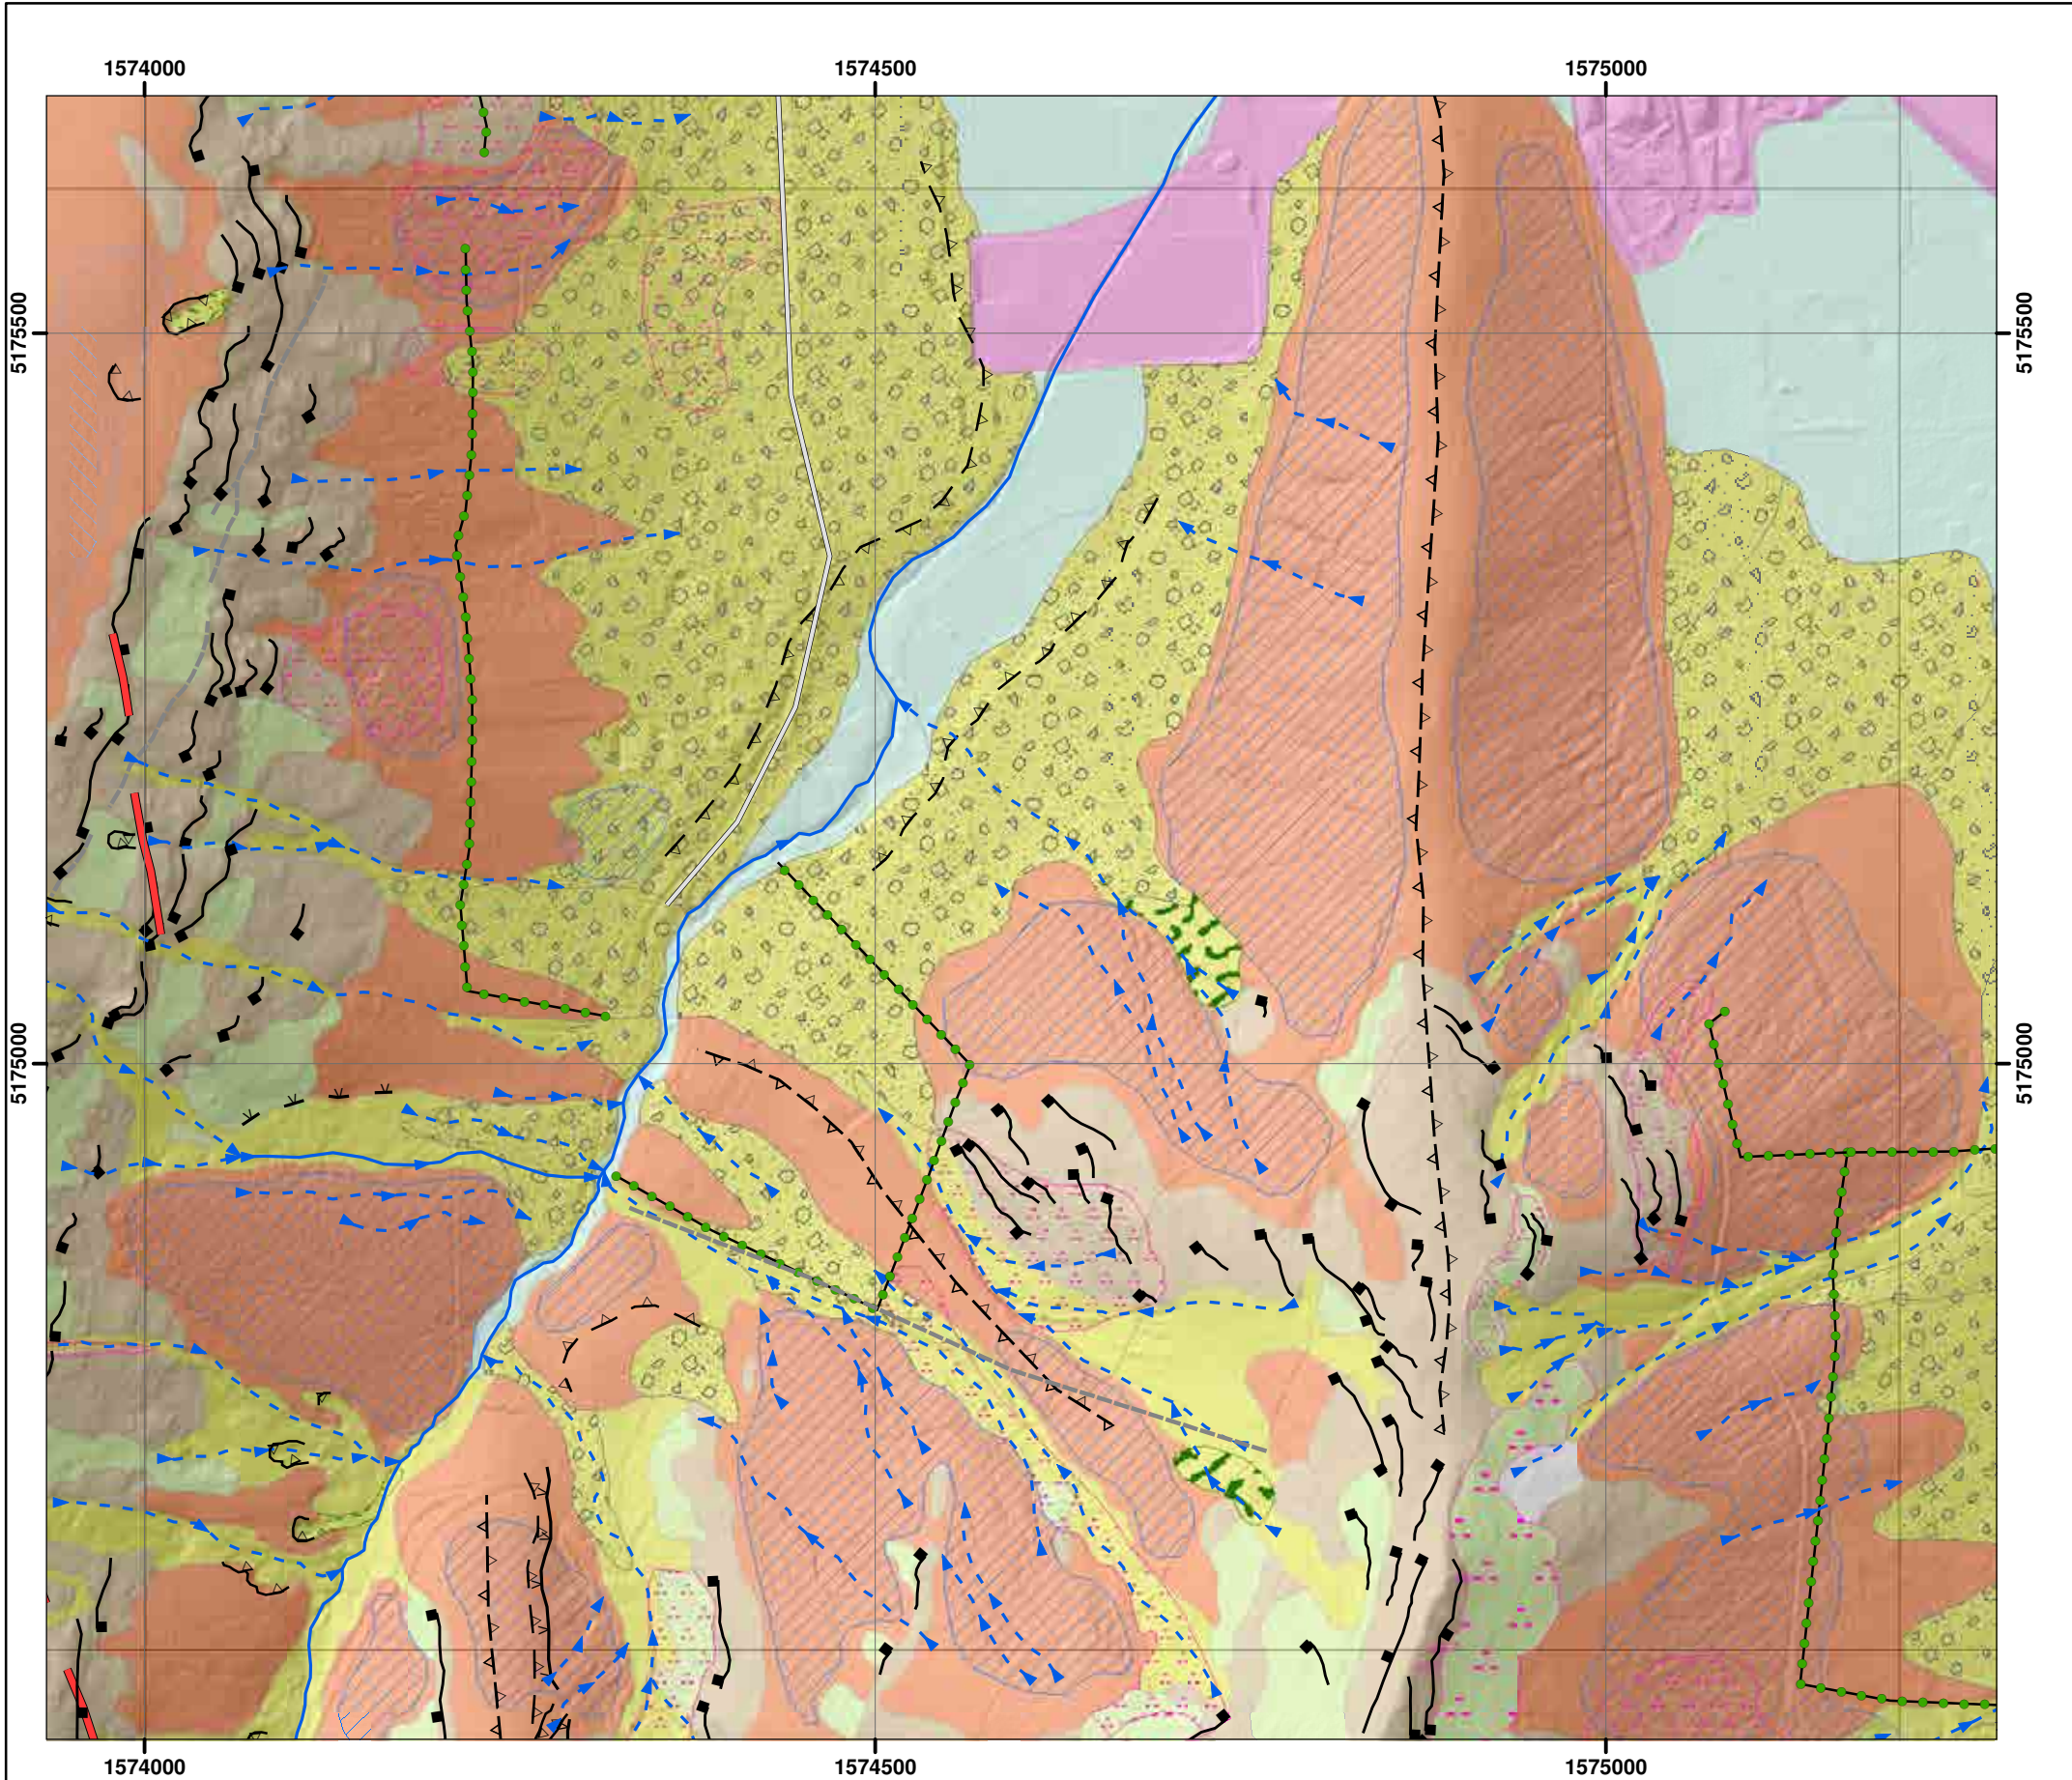
APPENDIX 4  
 Map C8

Morphology description	Interpreted Materials type	Genesis type
Boulder trail	Rock at/near surface	Rockfall (recent)
Dike	Talus	Rockfall (many scattered boulders)
Bund	Colluvium	Rockfall (few scattered boulders)
Ephemeral drainage line (well defined)	Loess	Dune
Ephemeral drainage line (poorly defined)	Alluvium	Beach
Lination	Sand and gravel	Rills
Sharp lination (crack)	Boulders	Terracettes
Rounded concave break in slope	Fill	Fan
Rounded convex break in slope	Unknown	Landslide scar (recent)
Rounded ridge line		Landslide scar (relict)
Sharp concave break in slope		Swamp/wetland
Sharp convex break in slope		
Cliff		
Shelter belt/trees

EXPLANATION:  
 Background shade model derived from NZAM post-earthquake 2011c (July 2011) LiDAR survey resampled to a 1m ground resolution.  
 Roads provided by Christchurch City Council (20/02/2012).  
 PROJECTION: New Zealand Transverse Mercator 2000.
