**GEOMORPHOLOGY MAPPING FOR  
ROCKFALL RISK ASSESSMENT**

**Port Hills  
Christchurch**

REPORT: CR2012/15 DATE: Sept 2012

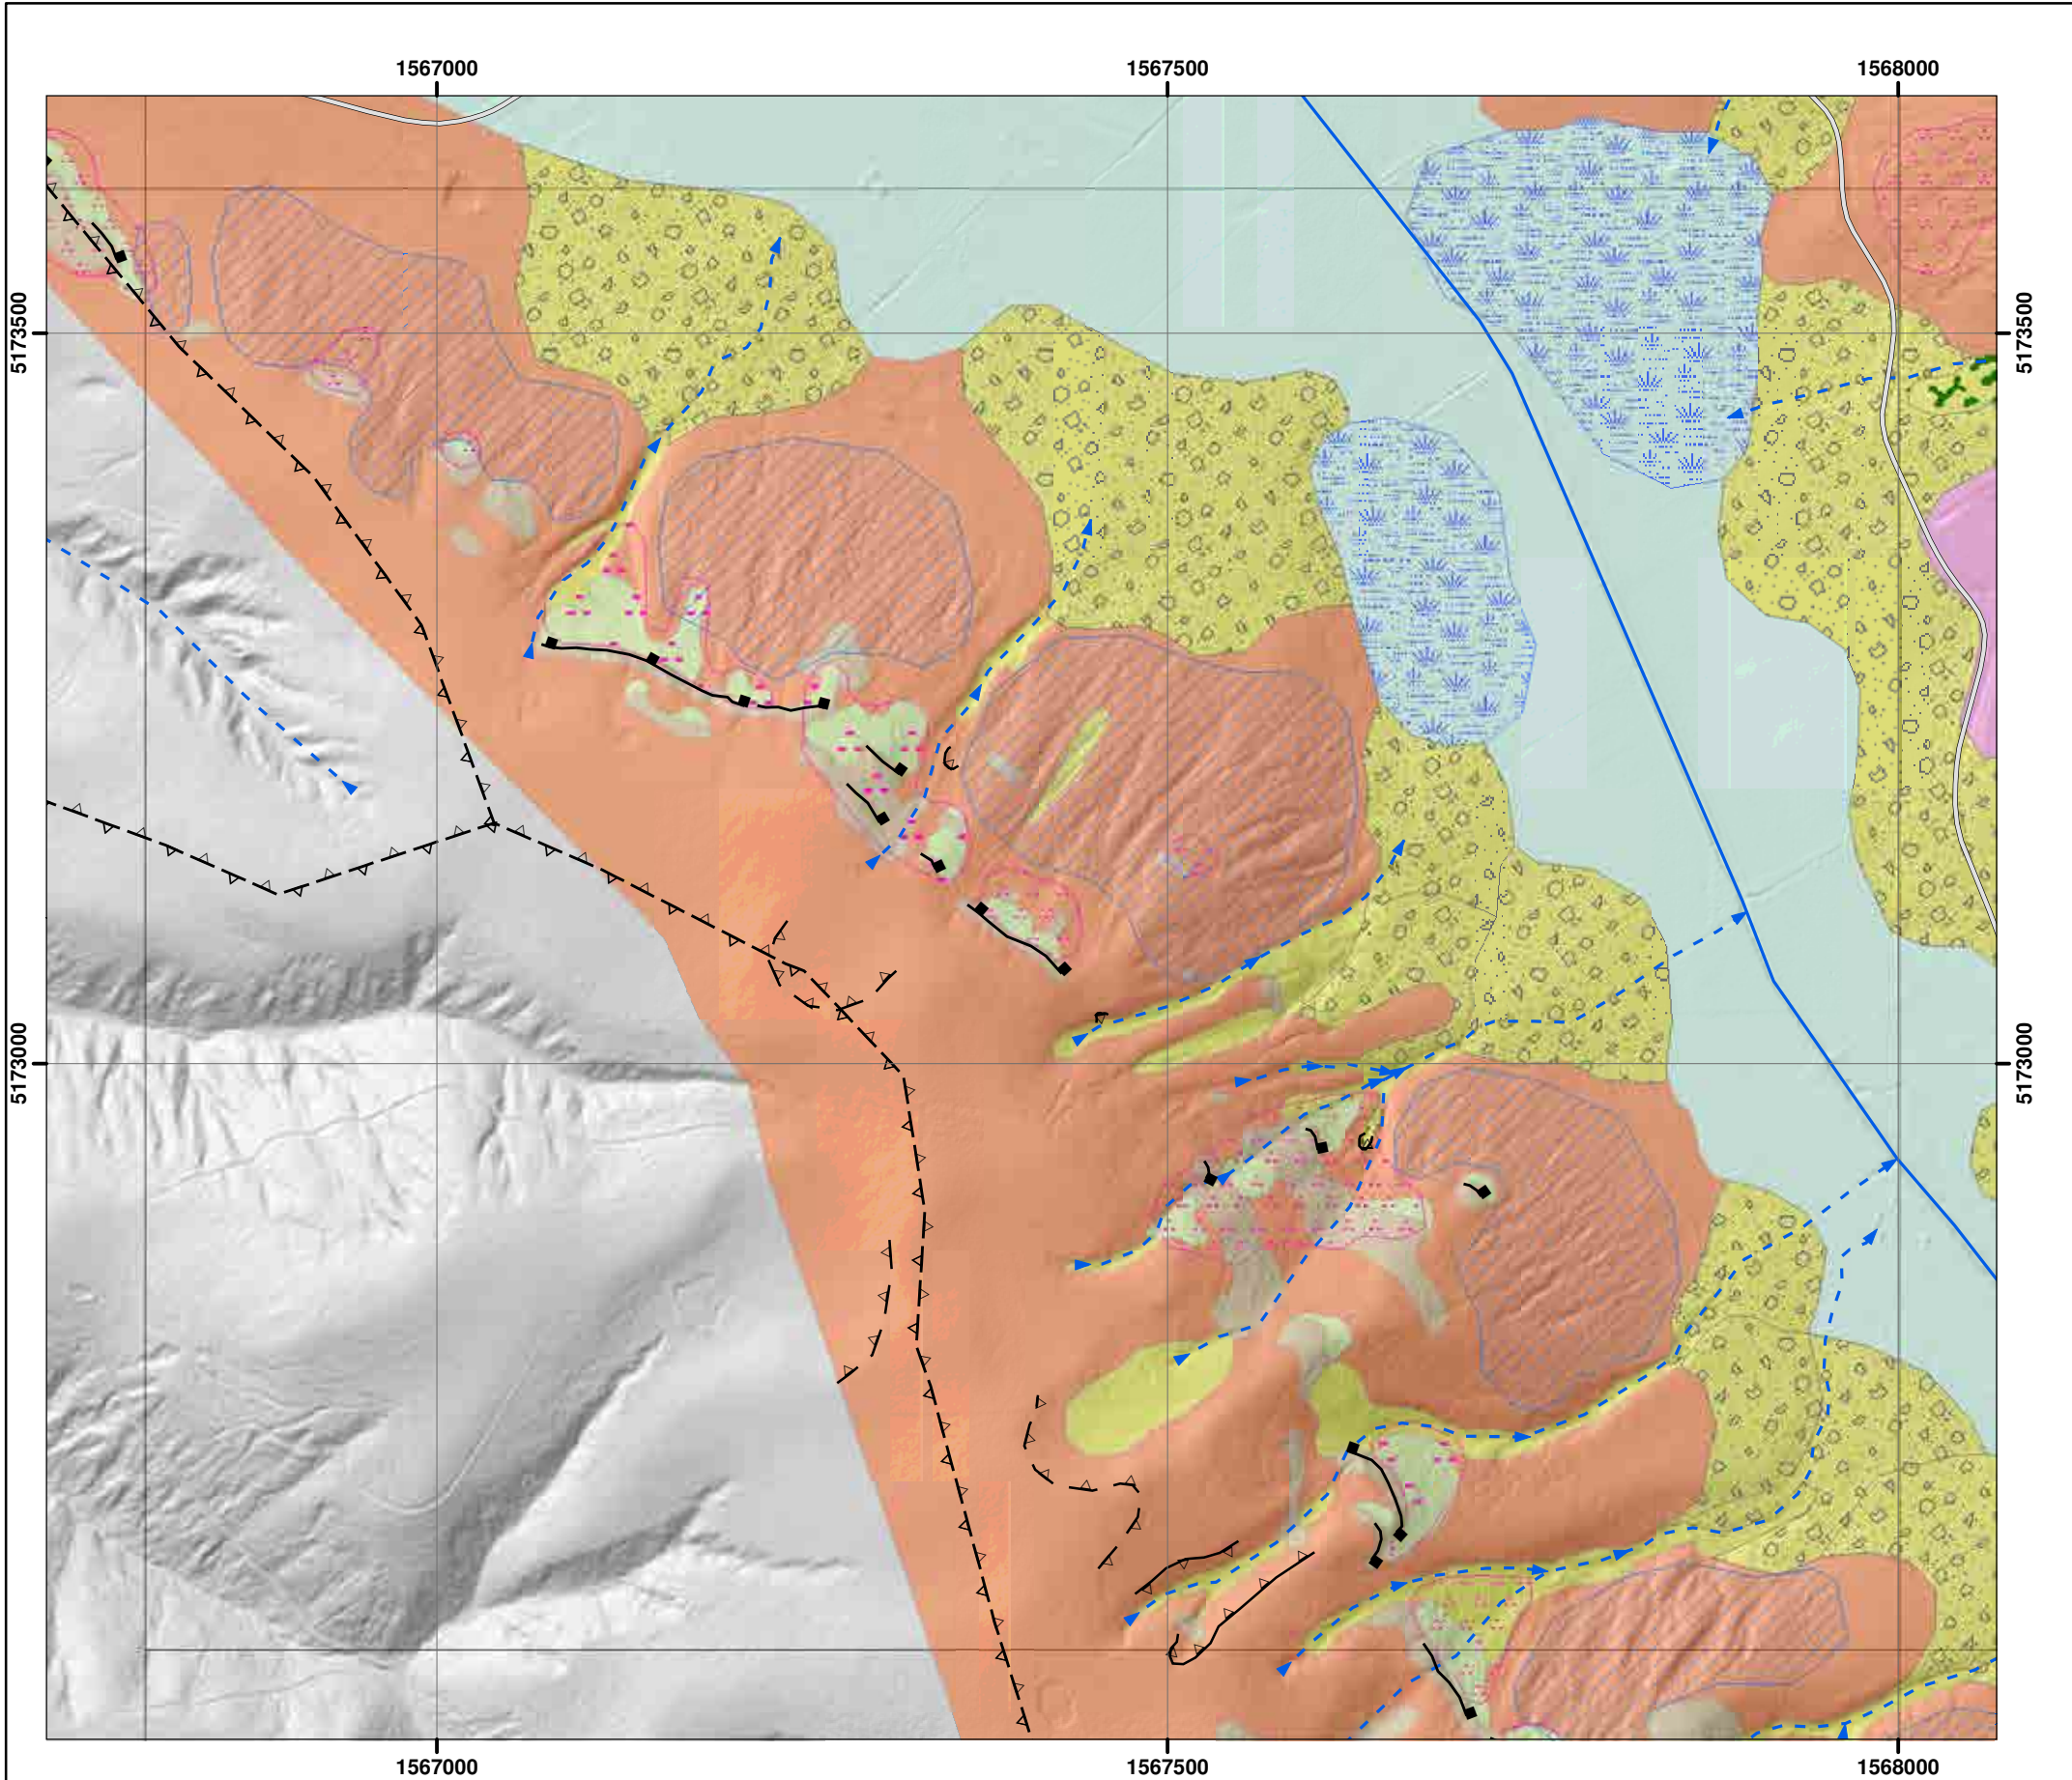
APPENDIX 4  
Map E2

Morphology description	Interpreted Materials type	Genesis type
Boulder trail	Rock at/near surface	Rockfall (recent)
Dike	Talus	Rockfall (many scattered boulders)
Bund	Colluvium	Rockfall (few scattered boulders)
Ephemeral drainage line (well defined)	Loess	Dune
Ephemeral drainage line (poorly defined)	Alluvium	Beach
Lineation	Sand and gravel	Rills
Sharp lineation (crack)	Boulders	Terracettes
Rounded concave break in slope	Fill	Fan
Rounded convex break in slope	Unknown	Landslide scar (recent)
Rounded ridge line		Landslide scar (relict)
Sharp concave break in slope		Swamp/wetland
Sharp convex break in slope		
Cliff		
Shelter belt/trees

EXPLANATION:  
 Background shade model derived from NZAM post-earthquake 2011c (July 2011) LiDAR survey resampled to a 1m ground resolution.  
 Roads provided by Christchurch City Council (20/02/2012).  
 PROJECTION: New Zealand Transverse Mercator 2000.

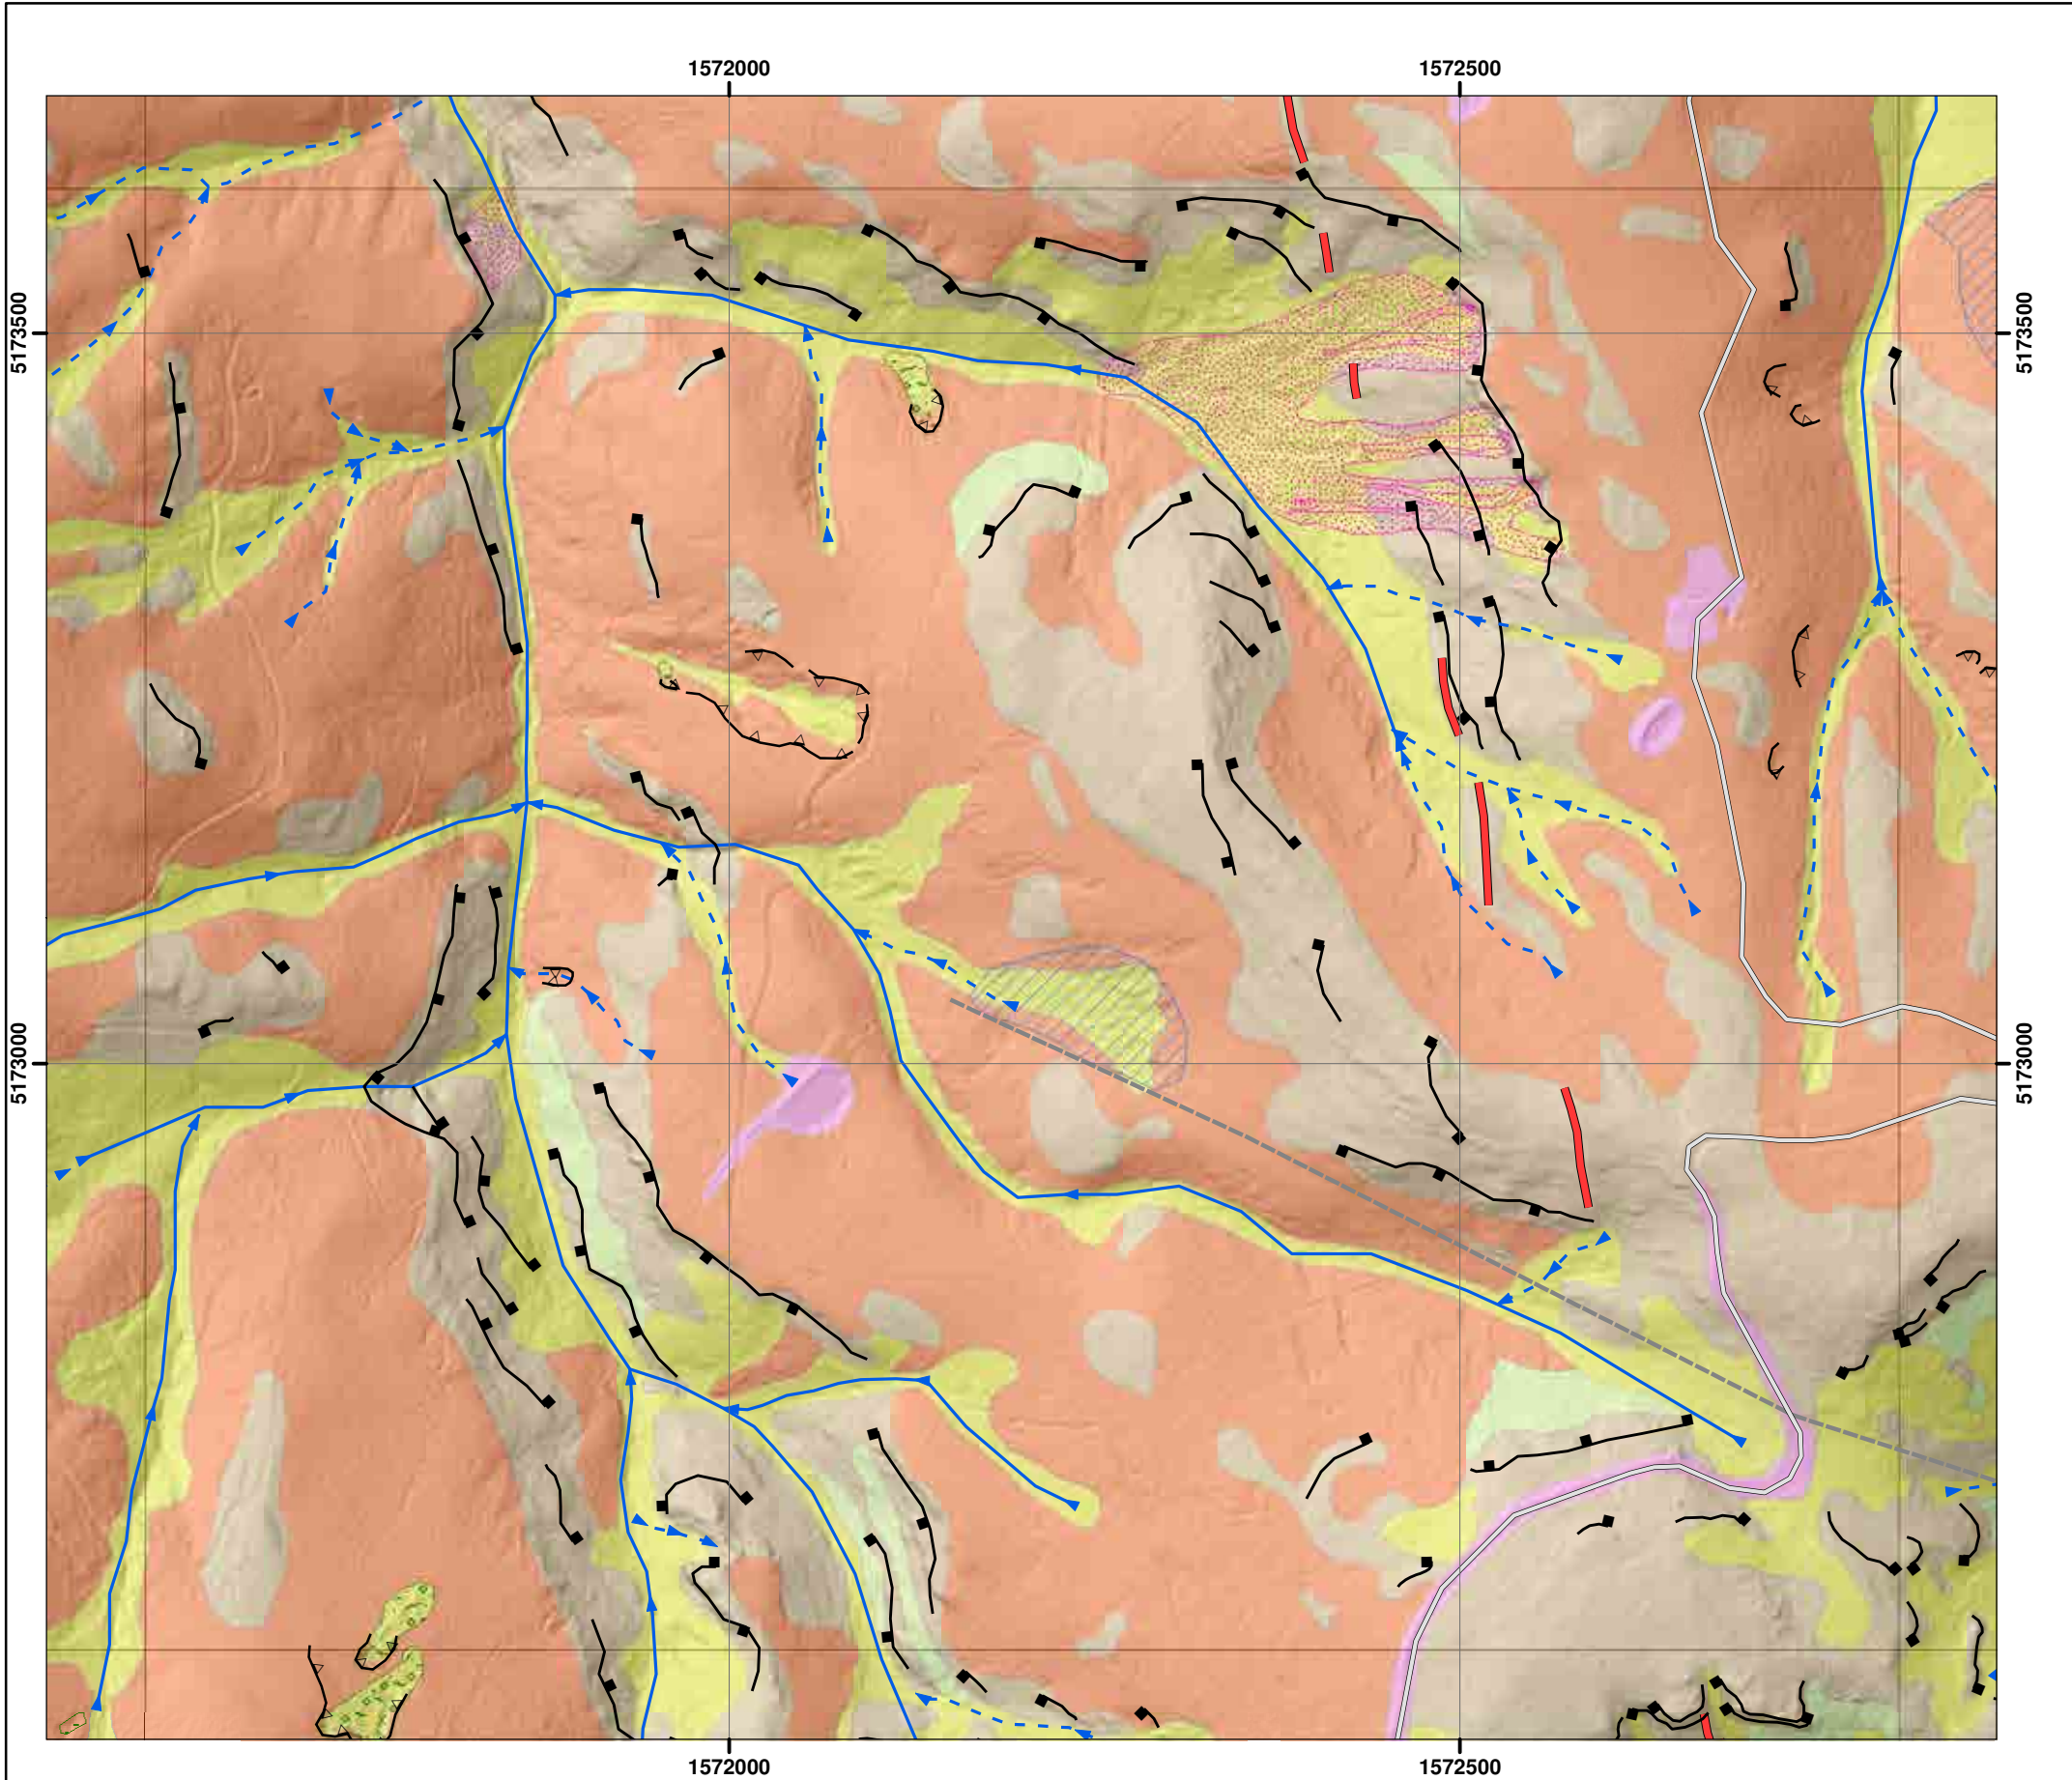
APPENDIX 4  
Map E6

Morphology description	Interpreted Materials type	Genesis type
Boulder trail	Rock at/near surface	Rockfall (recent)
Dike	Talus	Rockfall (many scattered boulders)
Bund	Colluvium	Rockfall (few scattered boulders)
Ephemeral drainage line (well defined)	Loess	Dune
Ephemeral drainage line (poorly defined)	Alluvium	Beach
Lineation	Sand and gravel	Rills
Sharp lineation (crack)	Boulders	Terracettes
Rounded concave break in slope	Fill	Fan
Rounded convex break in slope	Unknown	Landslide scar (recent)
Rounded ridge line		Landslide scar (relict)
Sharp concave break in slope		Swamp/wetland
Sharp convex break in slope		
Cliff		
Shelter belt/trees

EXPLANATION:  
 Background shade model derived from NZAM post-earthquake 2011c (July 2011) LiDAR survey resampled to a 1m ground resolution.  
 Roads provided by Christchurch City Council (20/02/2012).  
 PROJECTION: New Zealand Transverse Mercator 2000.

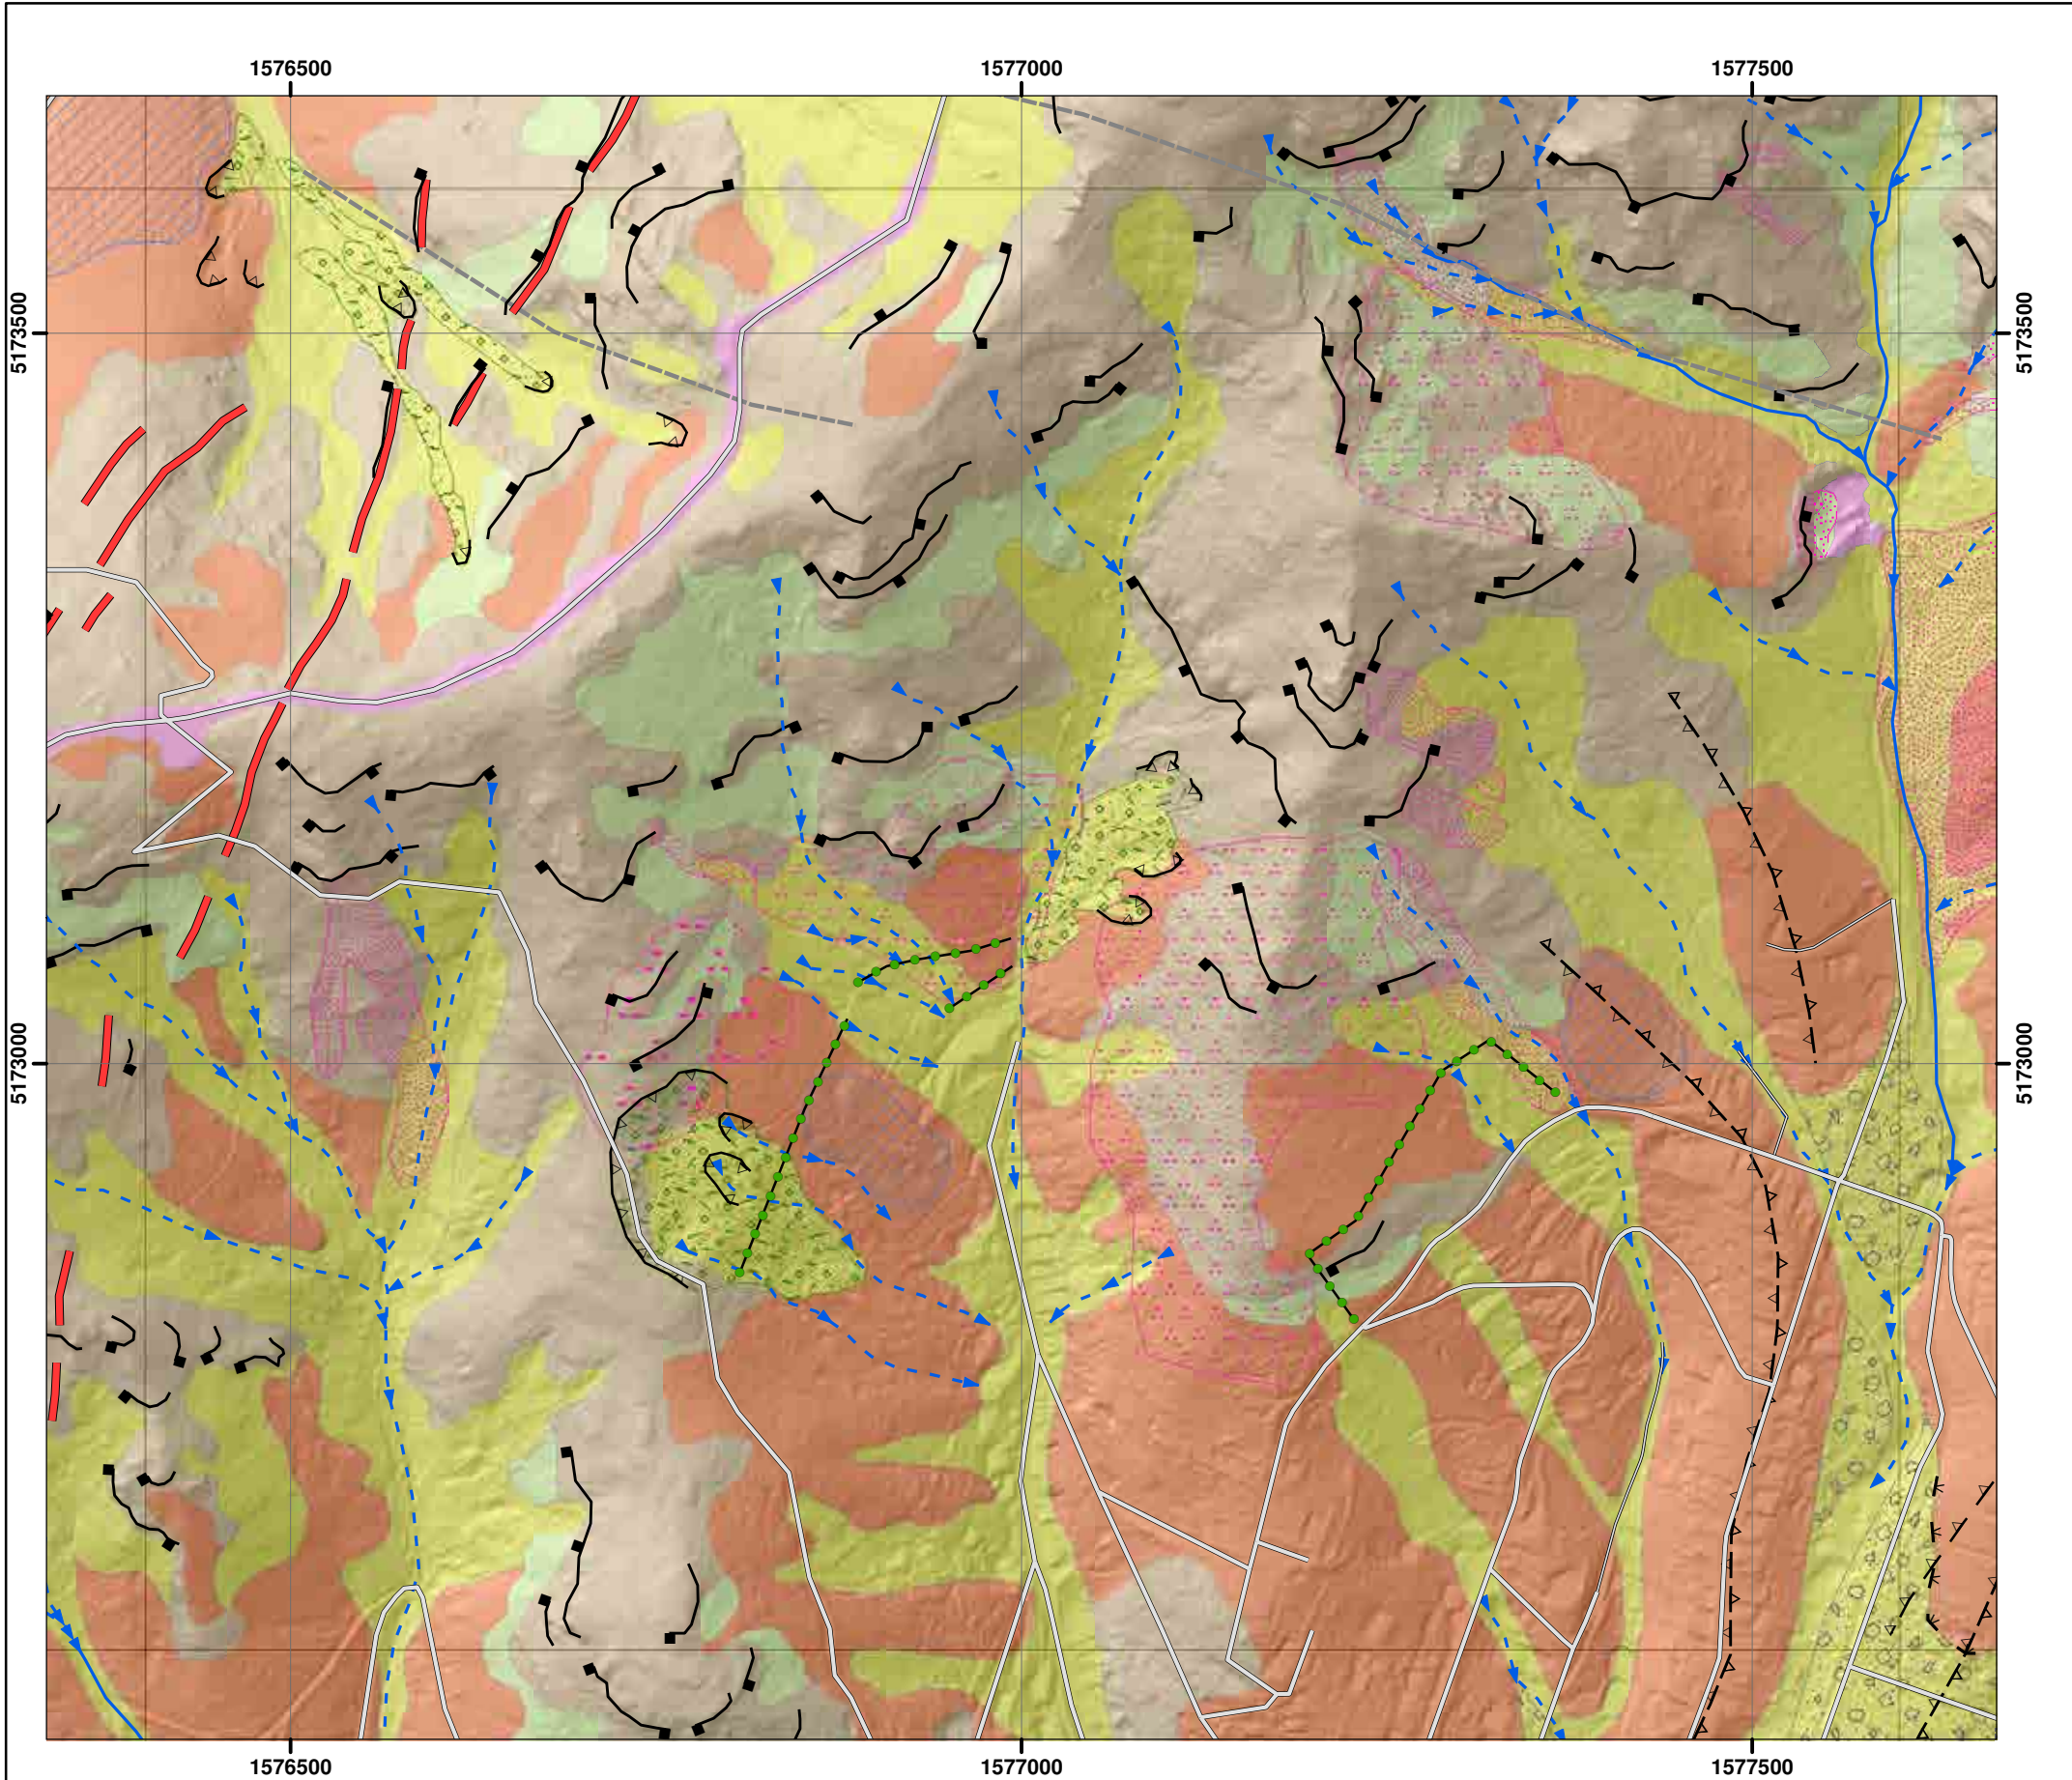
APPENDIX 4  
Map E10

Morphology description	Interpreted Materials type	Genesis type
Boulder trail	Rock at/near surface	Rockfall (recent)
Dike	Talus	Rockfall (many scattered boulders)
Bund	Colluvium	Rockfall (few scattered boulders)
Ephemeral drainage line (well defined)	Loess	Dune
Ephemeral drainage line (poorly defined)	Alluvium	Beach
Lination	Sand and gravel	Rills
Sharp lination (crack)	Boulders	Terracettes
Rounded concave break in slope	Fill	Fan
Rounded convex break in slope	Unknown	Landslide scar (recent)
Rounded ridge line		Landslide scar (relict)
Sharp concave break in slope		Swamp/wetland
Sharp convex break in slope		
Cliff		
Shelter belt/trees

EXPLANATION:  
 Background shade model derived from NZAM post-earthquake 2011c (July 2011) LiDAR survey resampled to a 1m ground resolution.  
 Roads provided by Christchurch City Council (20/02/2012).  
 PROJECTION: New Zealand Transverse Mercator 2000.

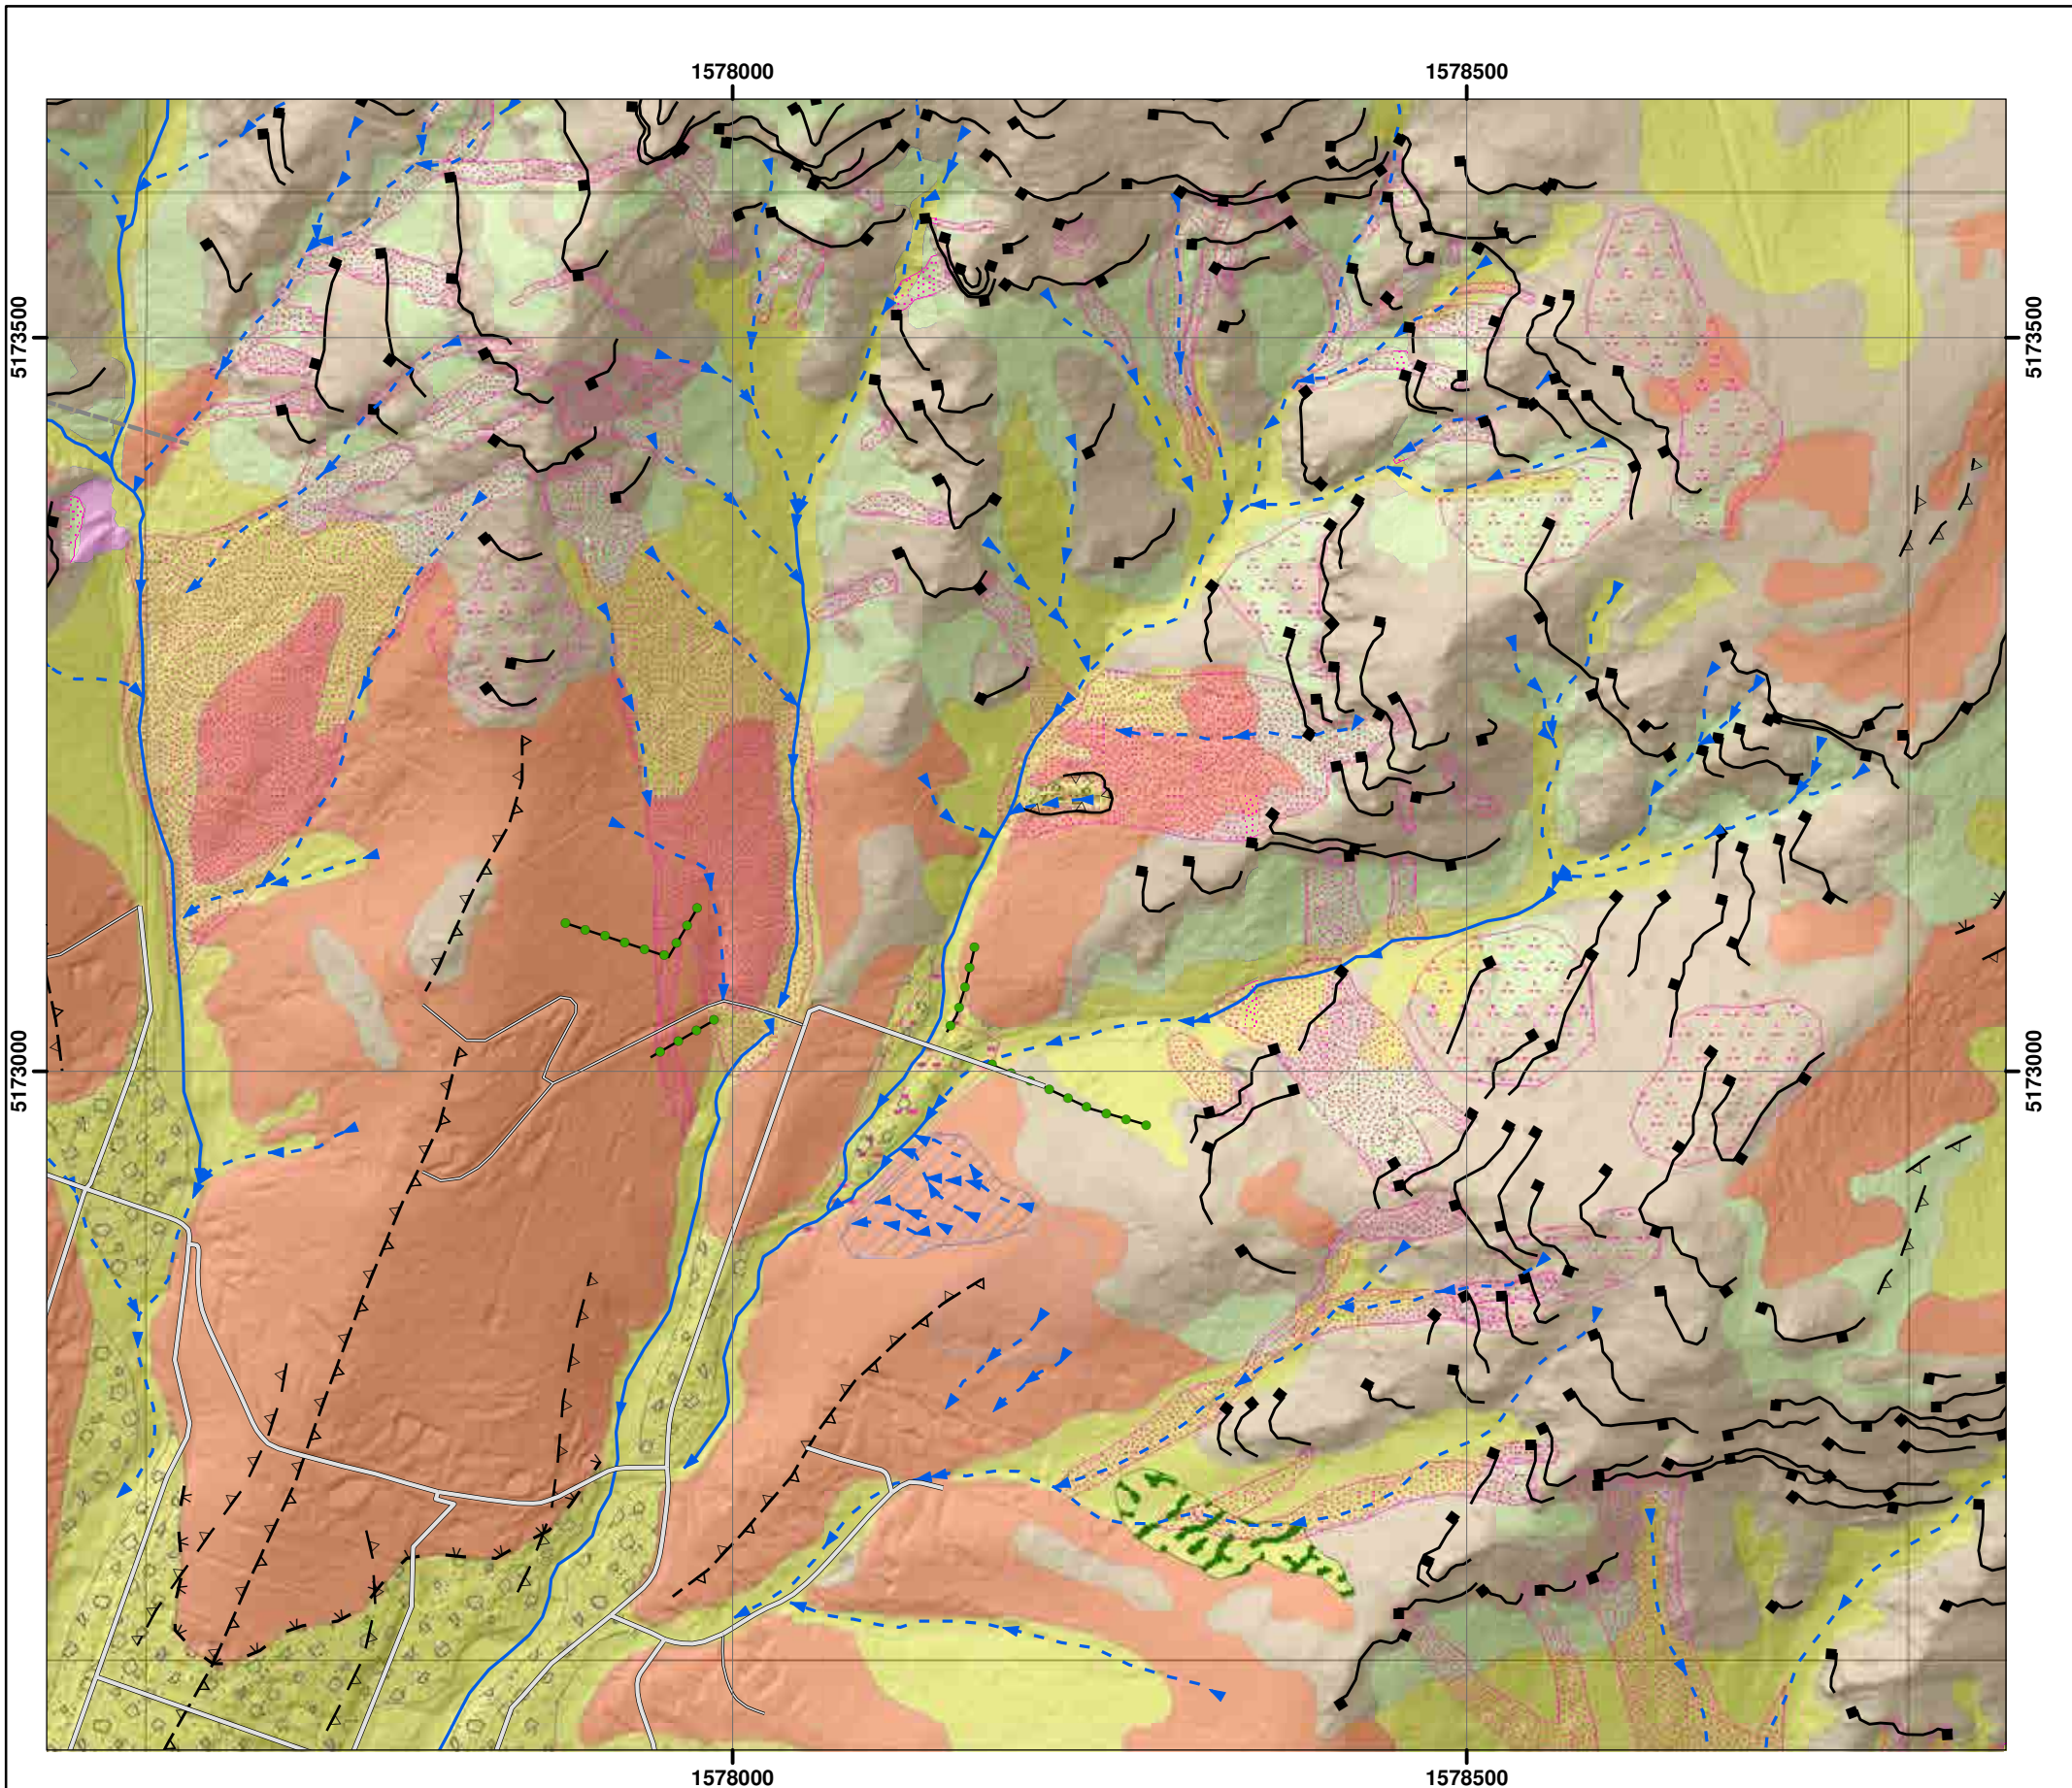
APPENDIX 4  
Map E11

Morphology description	Interpreted Materials type	Genesis type
Boulder trail	Rock at/near surface	Rockfall (recent)
Dike	Talus	Rockfall (many scattered boulders)
Bund	Colluvium	Rockfall (few scattered boulders)
Ephemeral drainage line (well defined)	Loess	Dune
Ephemeral drainage line (poorly defined)	Alluvium	Beach
Lineation	Sand and gravel	Rills
Sharp lineation (crack)	Boulders	Terracettes
Rounded concave break in slope	Fill	Fan
Rounded convex break in slope	Unknown	Landslide scar (recent)
Rounded ridge line		Landslide scar (relict)
Sharp concave break in slope		Swamp/wetland
Sharp convex break in slope		
Cliff		
Shelter belt/trees

EXPLANATION:  
 Background shade model derived from NZAM post-earthquake 2011c (July 2011) LiDAR survey resampled to a 1m ground resolution.  
 Roads provided by Christchurch City Council (20/02/2012).  
 PROJECTION: New Zealand Transverse Mercator 2000.

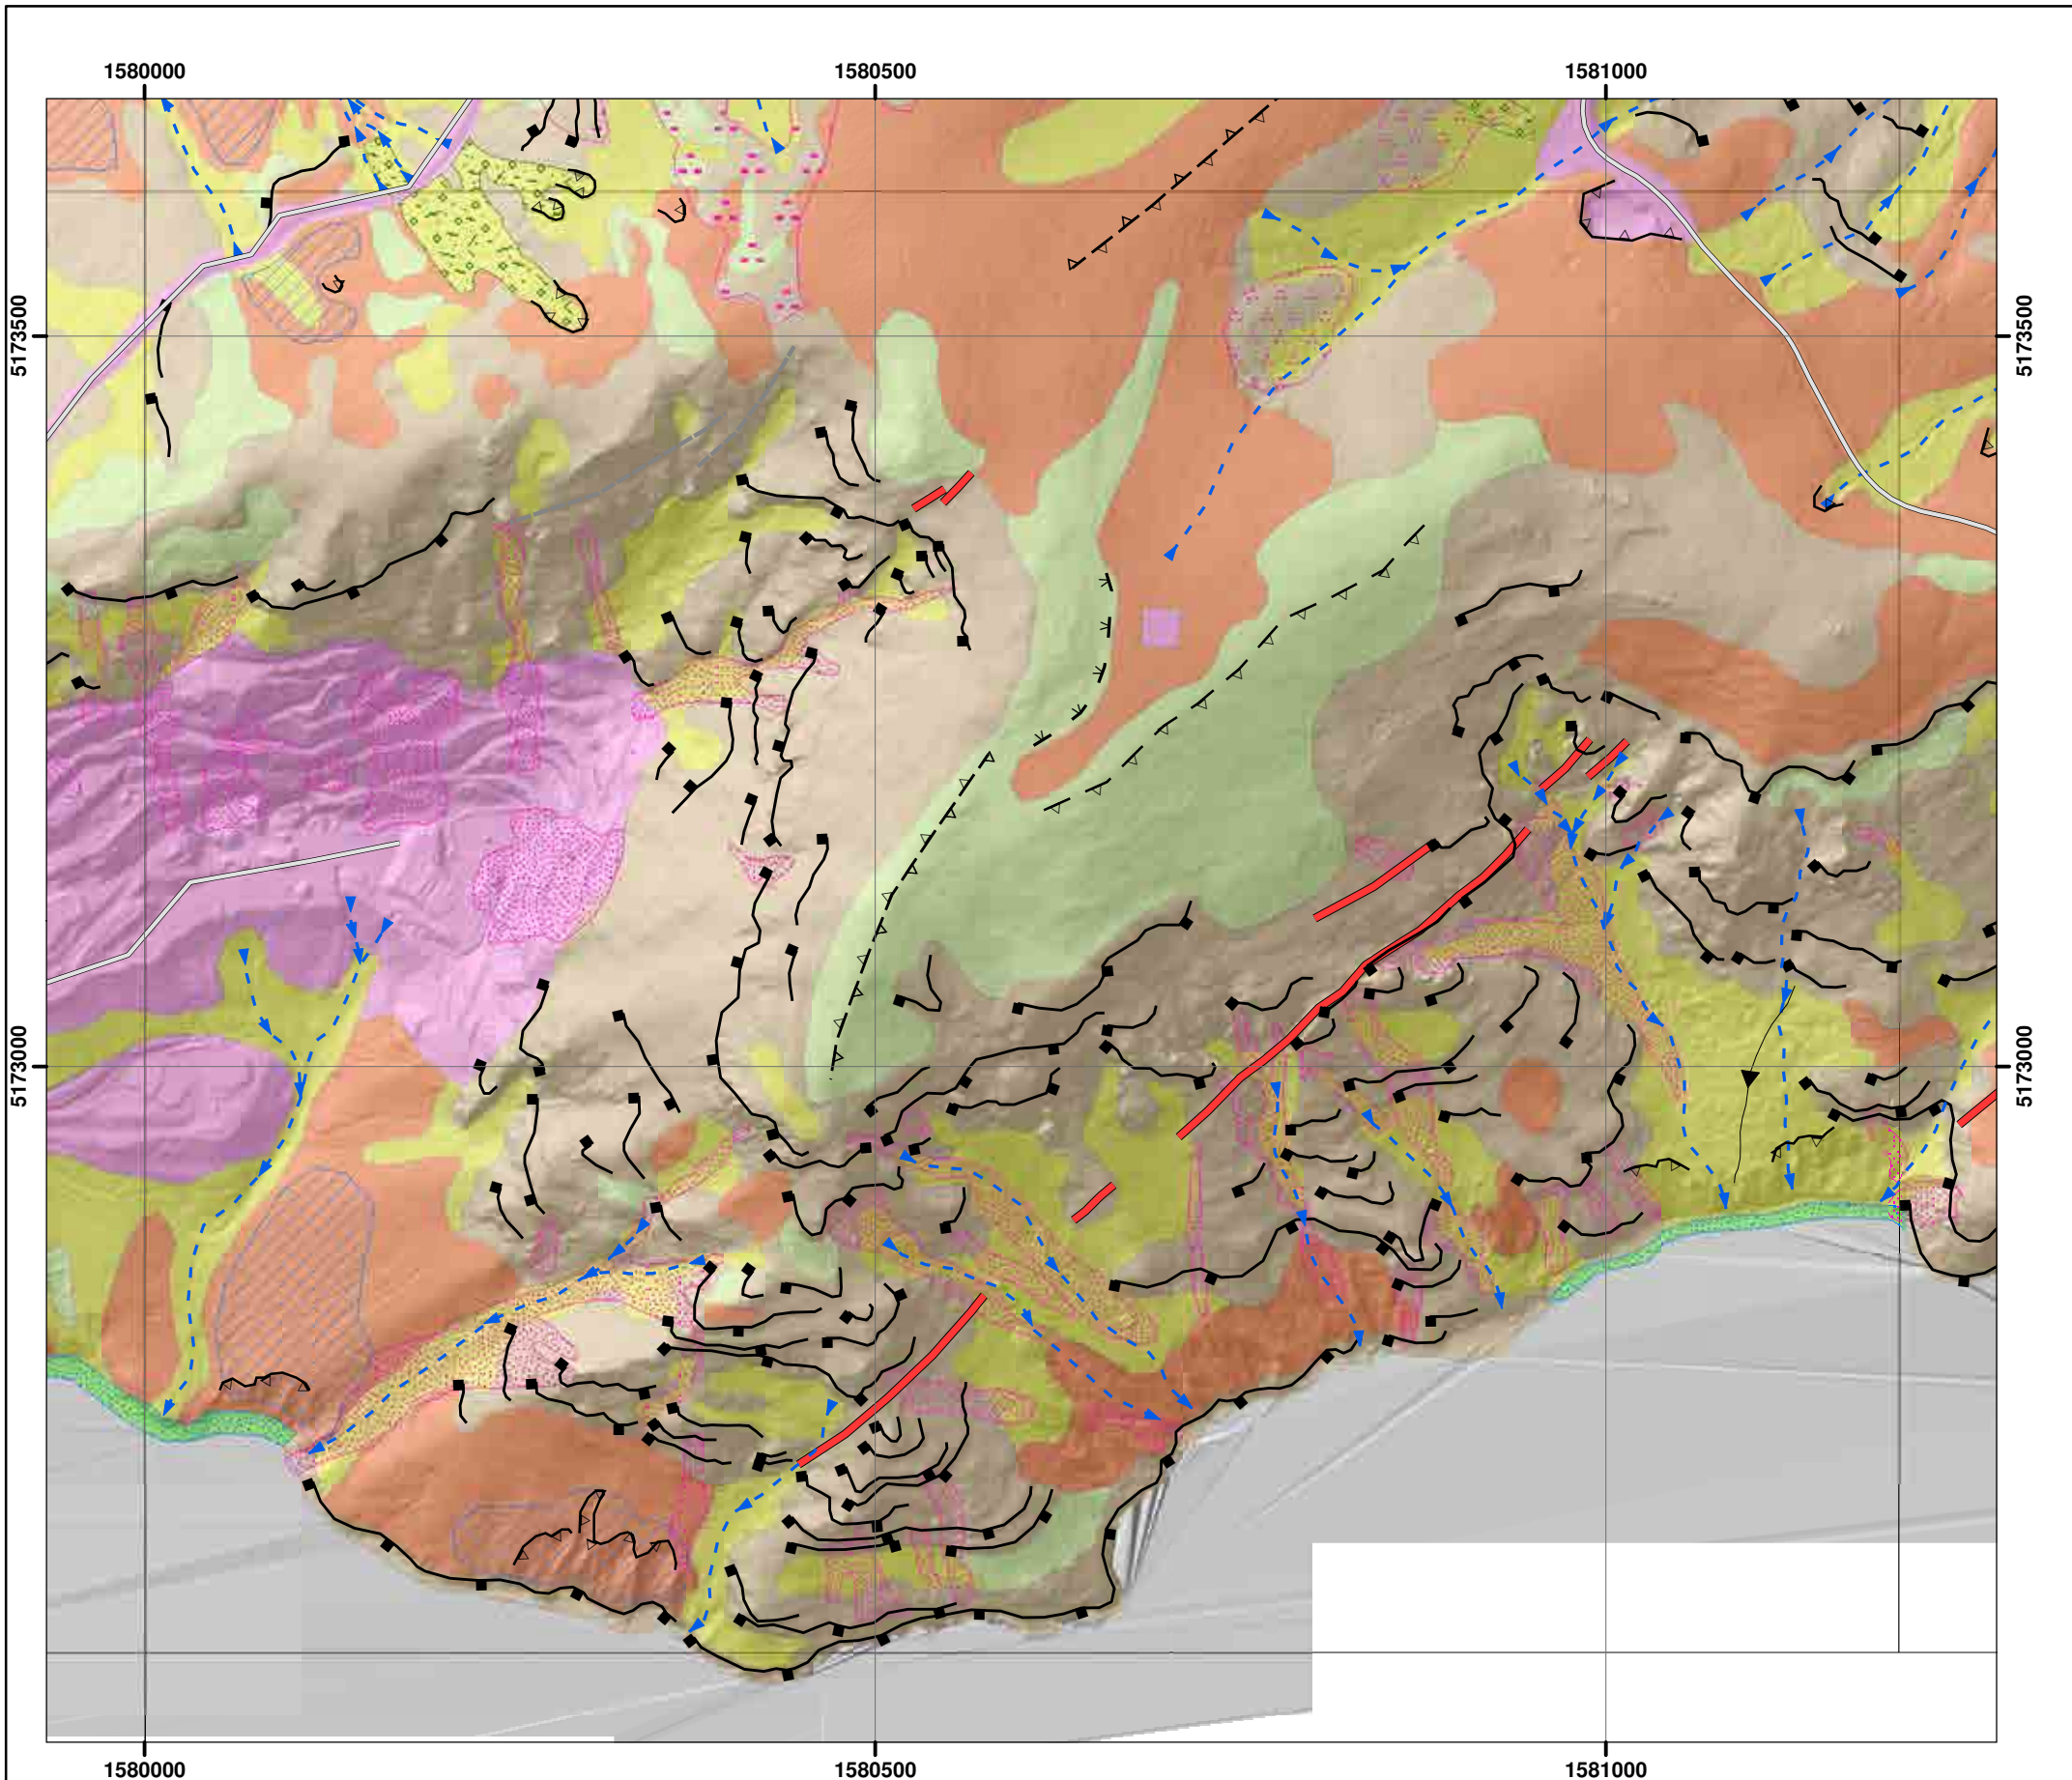
APPENDIX 4  
Map E13

Morphology description	Interpreted Materials type	Genesis type
Boulder trail	Rock at/near surface	Rockfall (recent)
Dike	Talus	Rockfall (many scattered boulders)
Bund	Colluvium	Rockfall (few scattered boulders)
Ephemeral drainage line (well defined)	Loess	Dune
Ephemeral drainage line (poorly defined)	Alluvium	Beach
Lineation	Sand and gravel	Rills
Sharp lineation (crack)	Boulders	Terracettes
Rounded concave break in slope	Fill	Fan
Rounded convex break in slope	Unknown	Landslide scar (recent)
Rounded ridge line		Landslide scar (relict)
Sharp concave break in slope		Swamp/wetland
Sharp convex break in slope		
Cliff		
Shelter belt/trees

EXPLANATION:  
 Background shade model derived from NZAM post-earthquake 2011c (July 2011) LiDAR survey resampled to a 1m ground resolution.  
 Roads provided by Christchurch City Council (20/02/2012).  
 PROJECTION: New Zealand Transverse Mercator 2000.
