**GEOMORPHOLOGY MAPPING FOR  
ROCKFALL RISK ASSESSMENT**

**Port Hills  
Christchurch**

REPORT: CR2012/15 DATE: Sept 2012

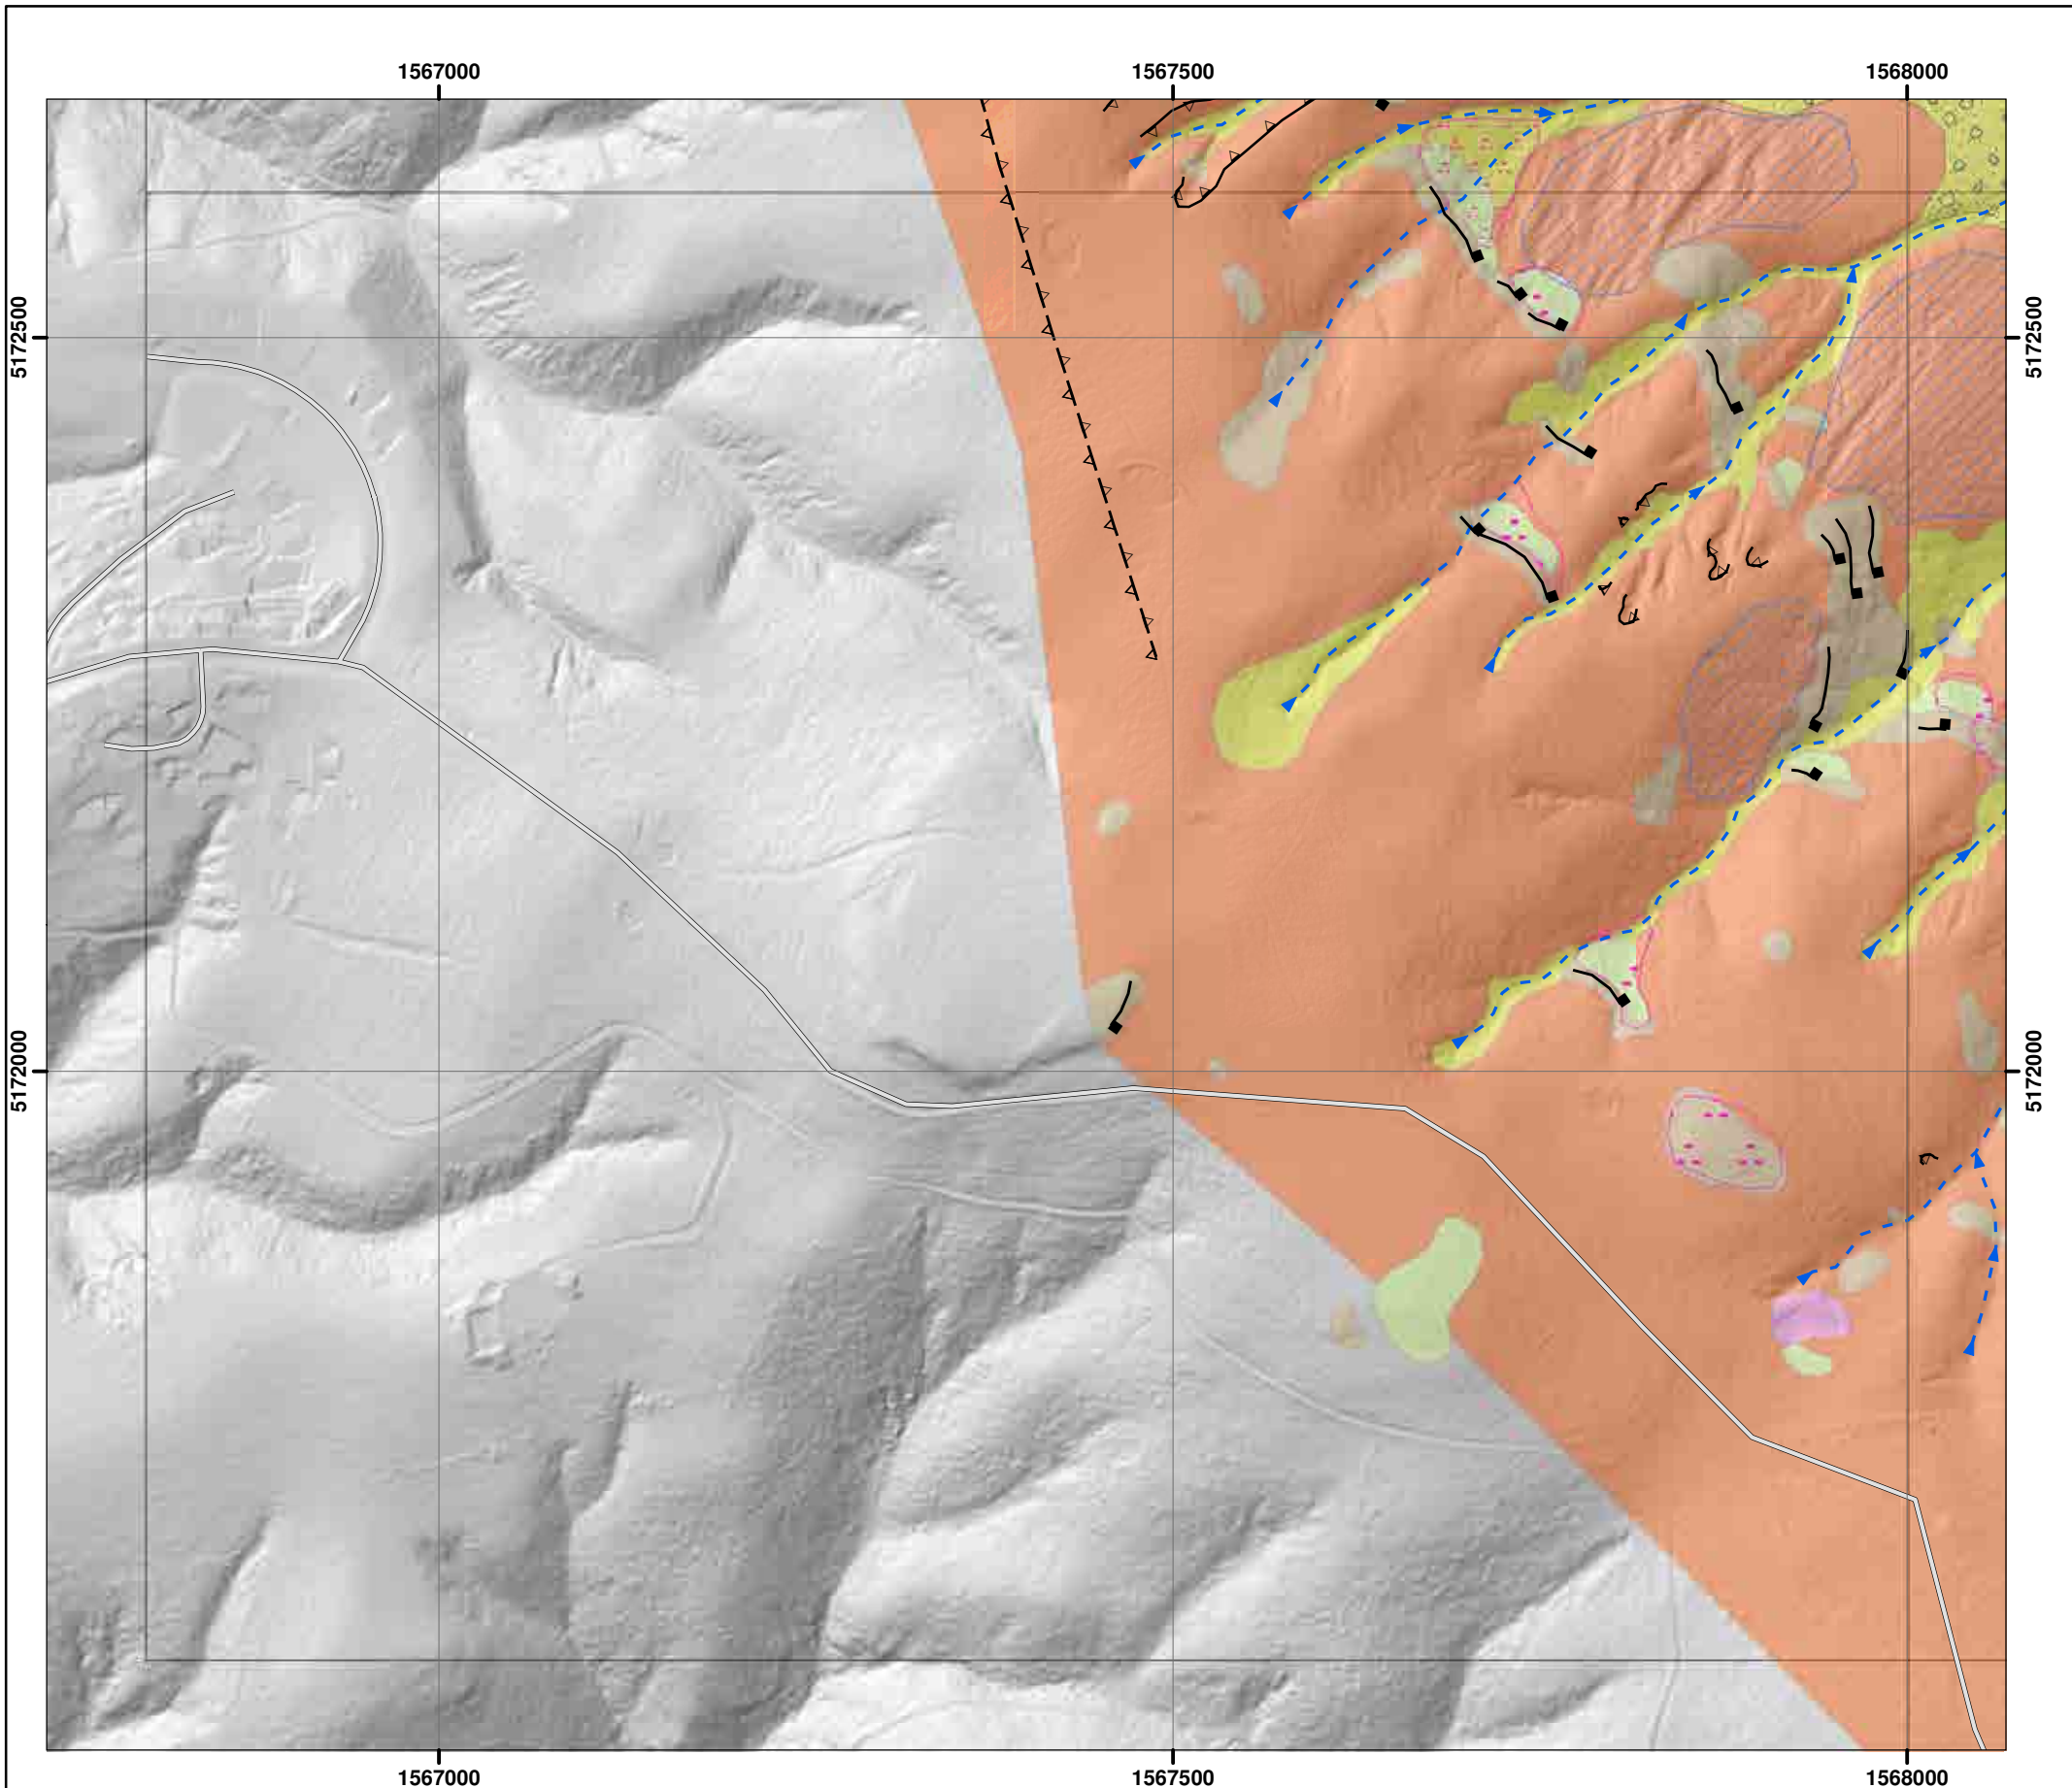
APPENDIX 4  
 Map F2

Morphology description	Interpreted Materials type	Genesis type
Boulder trail	Rock at/near surface	Rockfall (recent)
Dike	Talus	Rockfall (many scattered boulders)
Bund	Colluvium	Rockfall (few scattered boulders)
Ephemeral drainage line (well defined)	Loess	Dune
Ephemeral drainage line (poorly defined)	Alluvium	Beach
Lineation	Sand and gravel	Rills
Sharp lineation (crack)	Boulders	Terracettes
Rounded concave break in slope	Fill	Fan
Rounded convex break in slope	Unknown	Landslide scar (recent)
Rounded ridge line		Landslide scar (relict)
Sharp concave break in slope		Swamp/wetland
Sharp convex break in slope		
Cliff		
Shelter belt/trees

EXPLANATION:  
 Background shade model derived from NZAM post-earthquake 2011c (July 2011) LiDAR survey resampled to a 1m ground resolution.  
 Roads provided by Christchurch City Council (20/02/2012).  
 PROJECTION: New Zealand Transverse Mercator 2000.

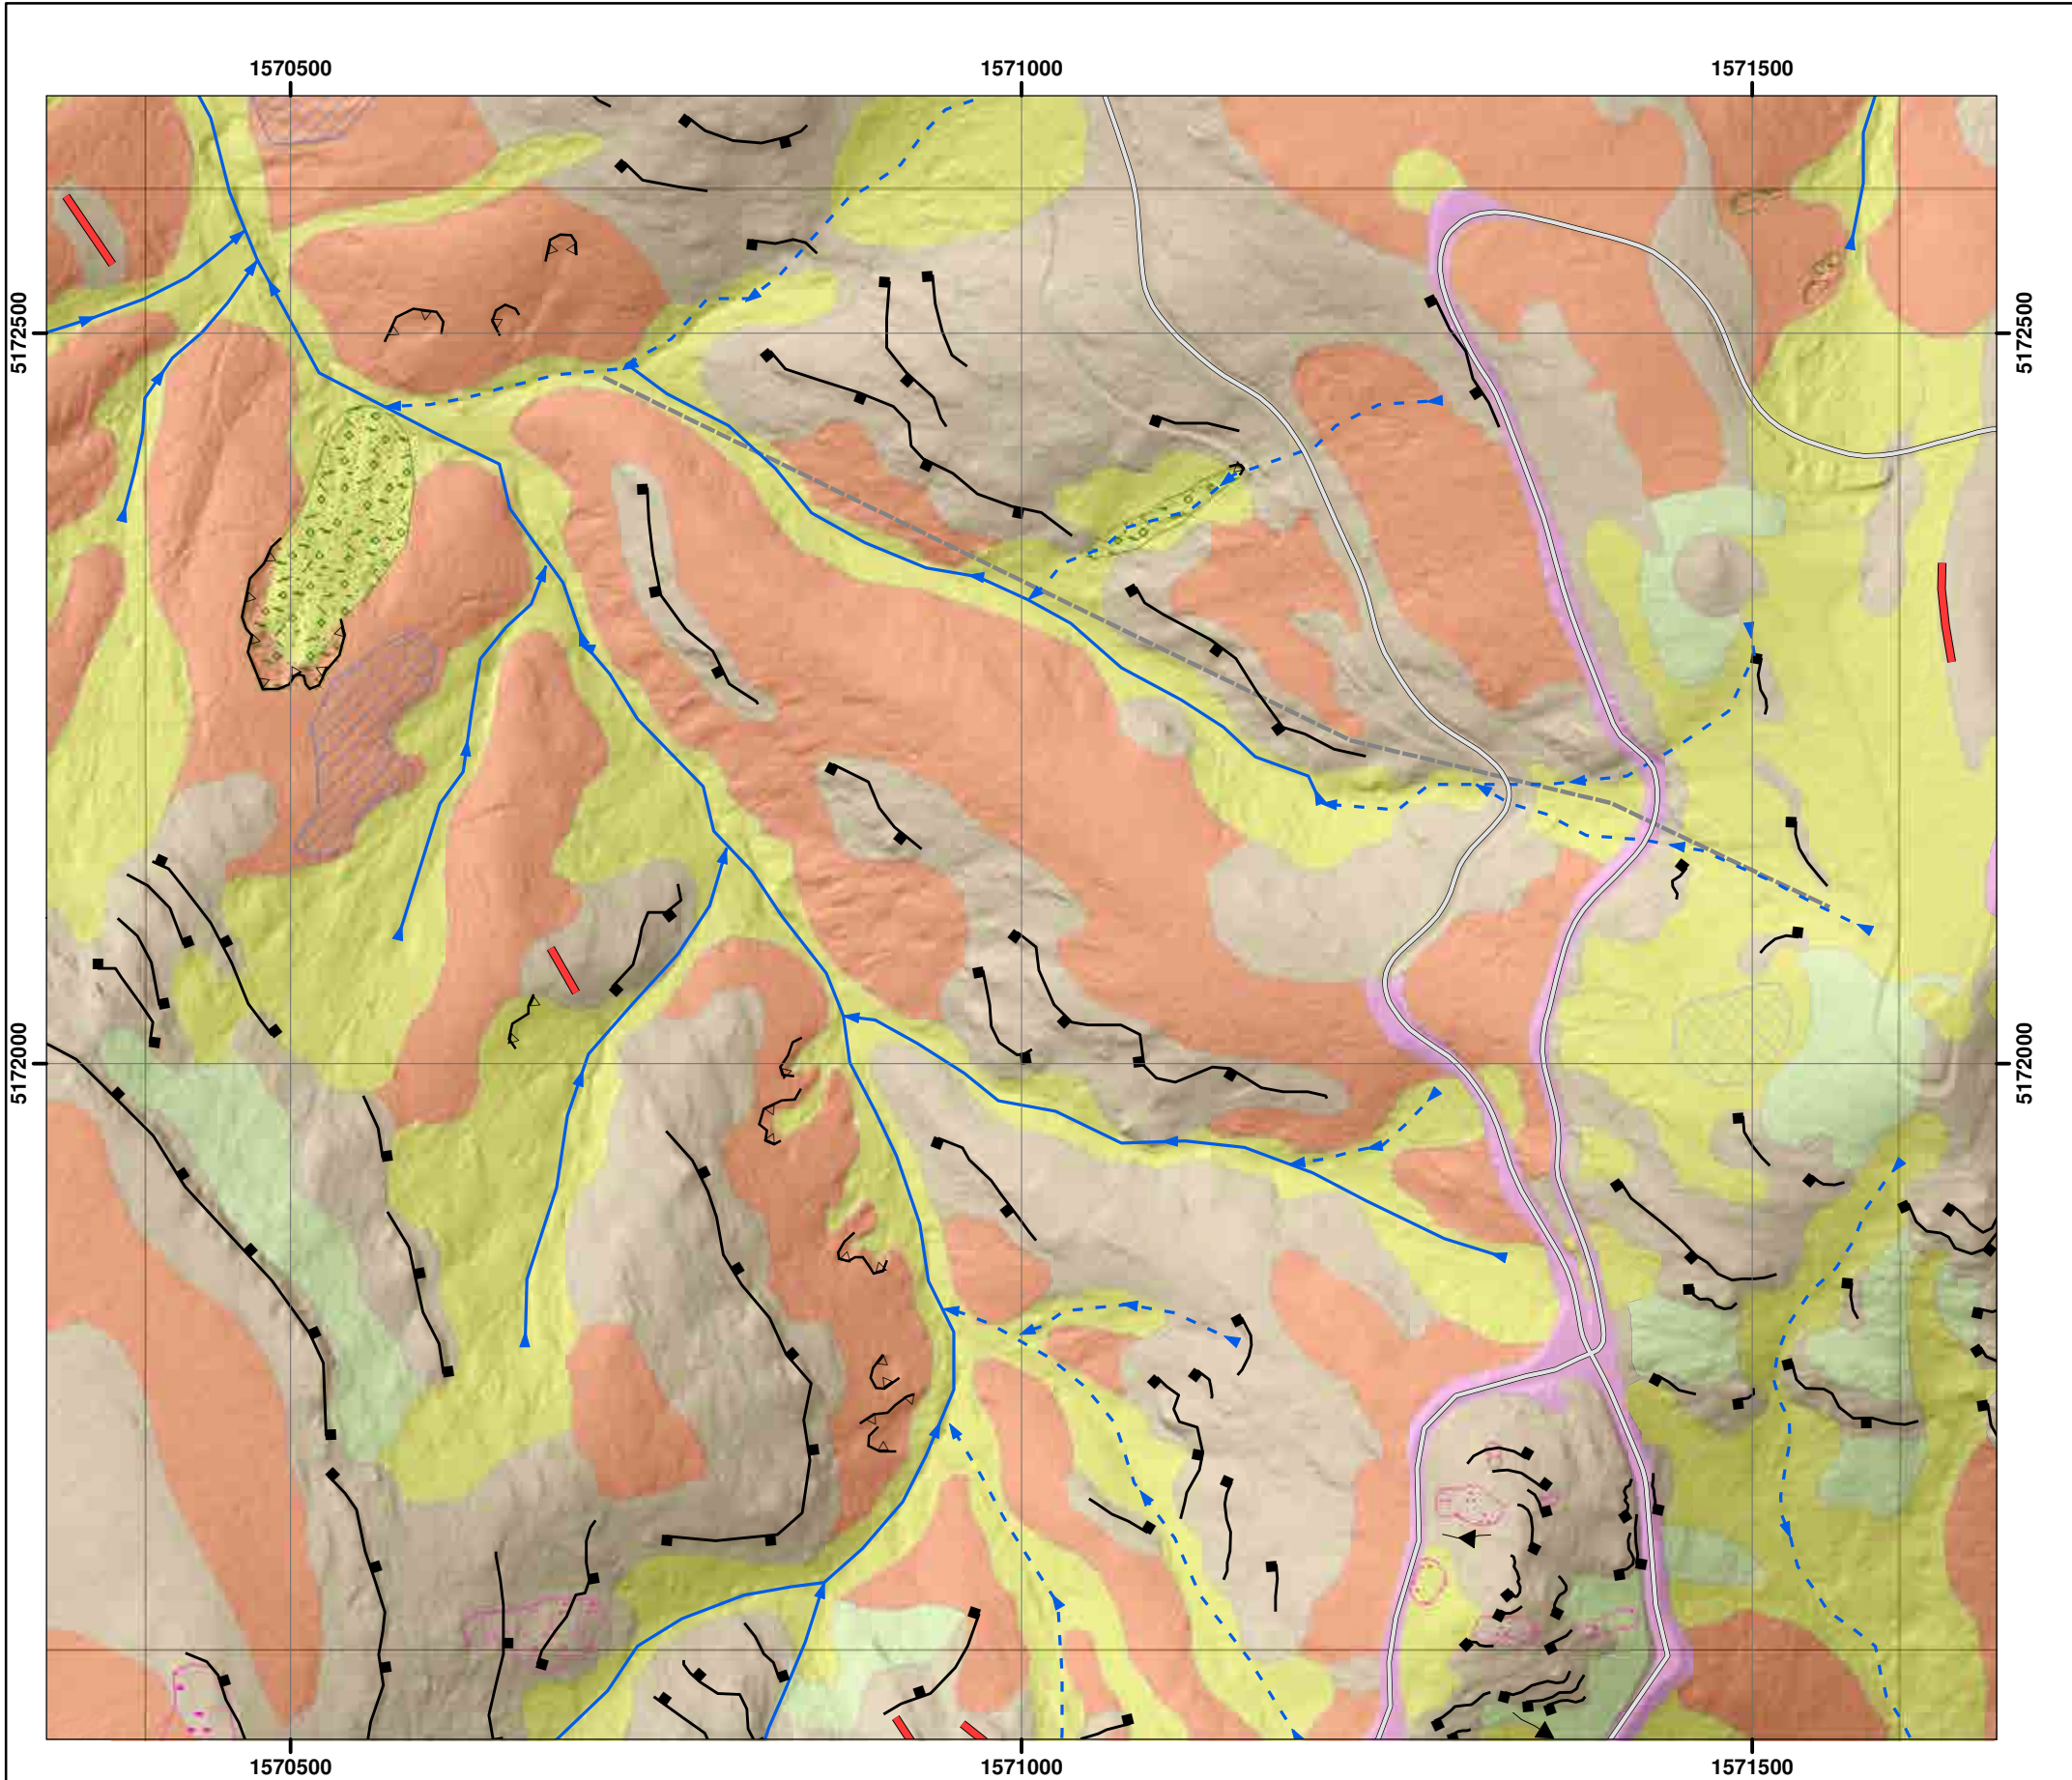
APPENDIX 4  
Map F5

Morphology description	Interpreted Materials type	Genesis type
Boulder trail	Rock at/near surface	Rockfall (recent)
Dike	Talus	Rockfall (many scattered boulders)
Bund	Colluvium	Rockfall (few scattered boulders)
Ephemeral drainage line (well defined)	Loess	Dune
Ephemeral drainage line (poorly defined)	Alluvium	Beach
Lineation	Sand and gravel	Rills
Sharp lineation (crack)	Boulders	Terracettes
Rounded concave break in slope	Fill	Fan
Rounded convex break in slope	Unknown	Landslide scar (recent)
Rounded ridge line		Landslide scar (relict)
Sharp concave break in slope		Swamp/wetland
Sharp convex break in slope		
Cliff		
Shelter belt/trees

EXPLANATION:  
 Background shade model derived from NZAM post-earthquake 2011c (July 2011) LiDAR survey resampled to a 1m ground resolution.  
 Roads provided by Christchurch City Council (20/02/2012).  
 PROJECTION: New Zealand Transverse Mercator 2000.

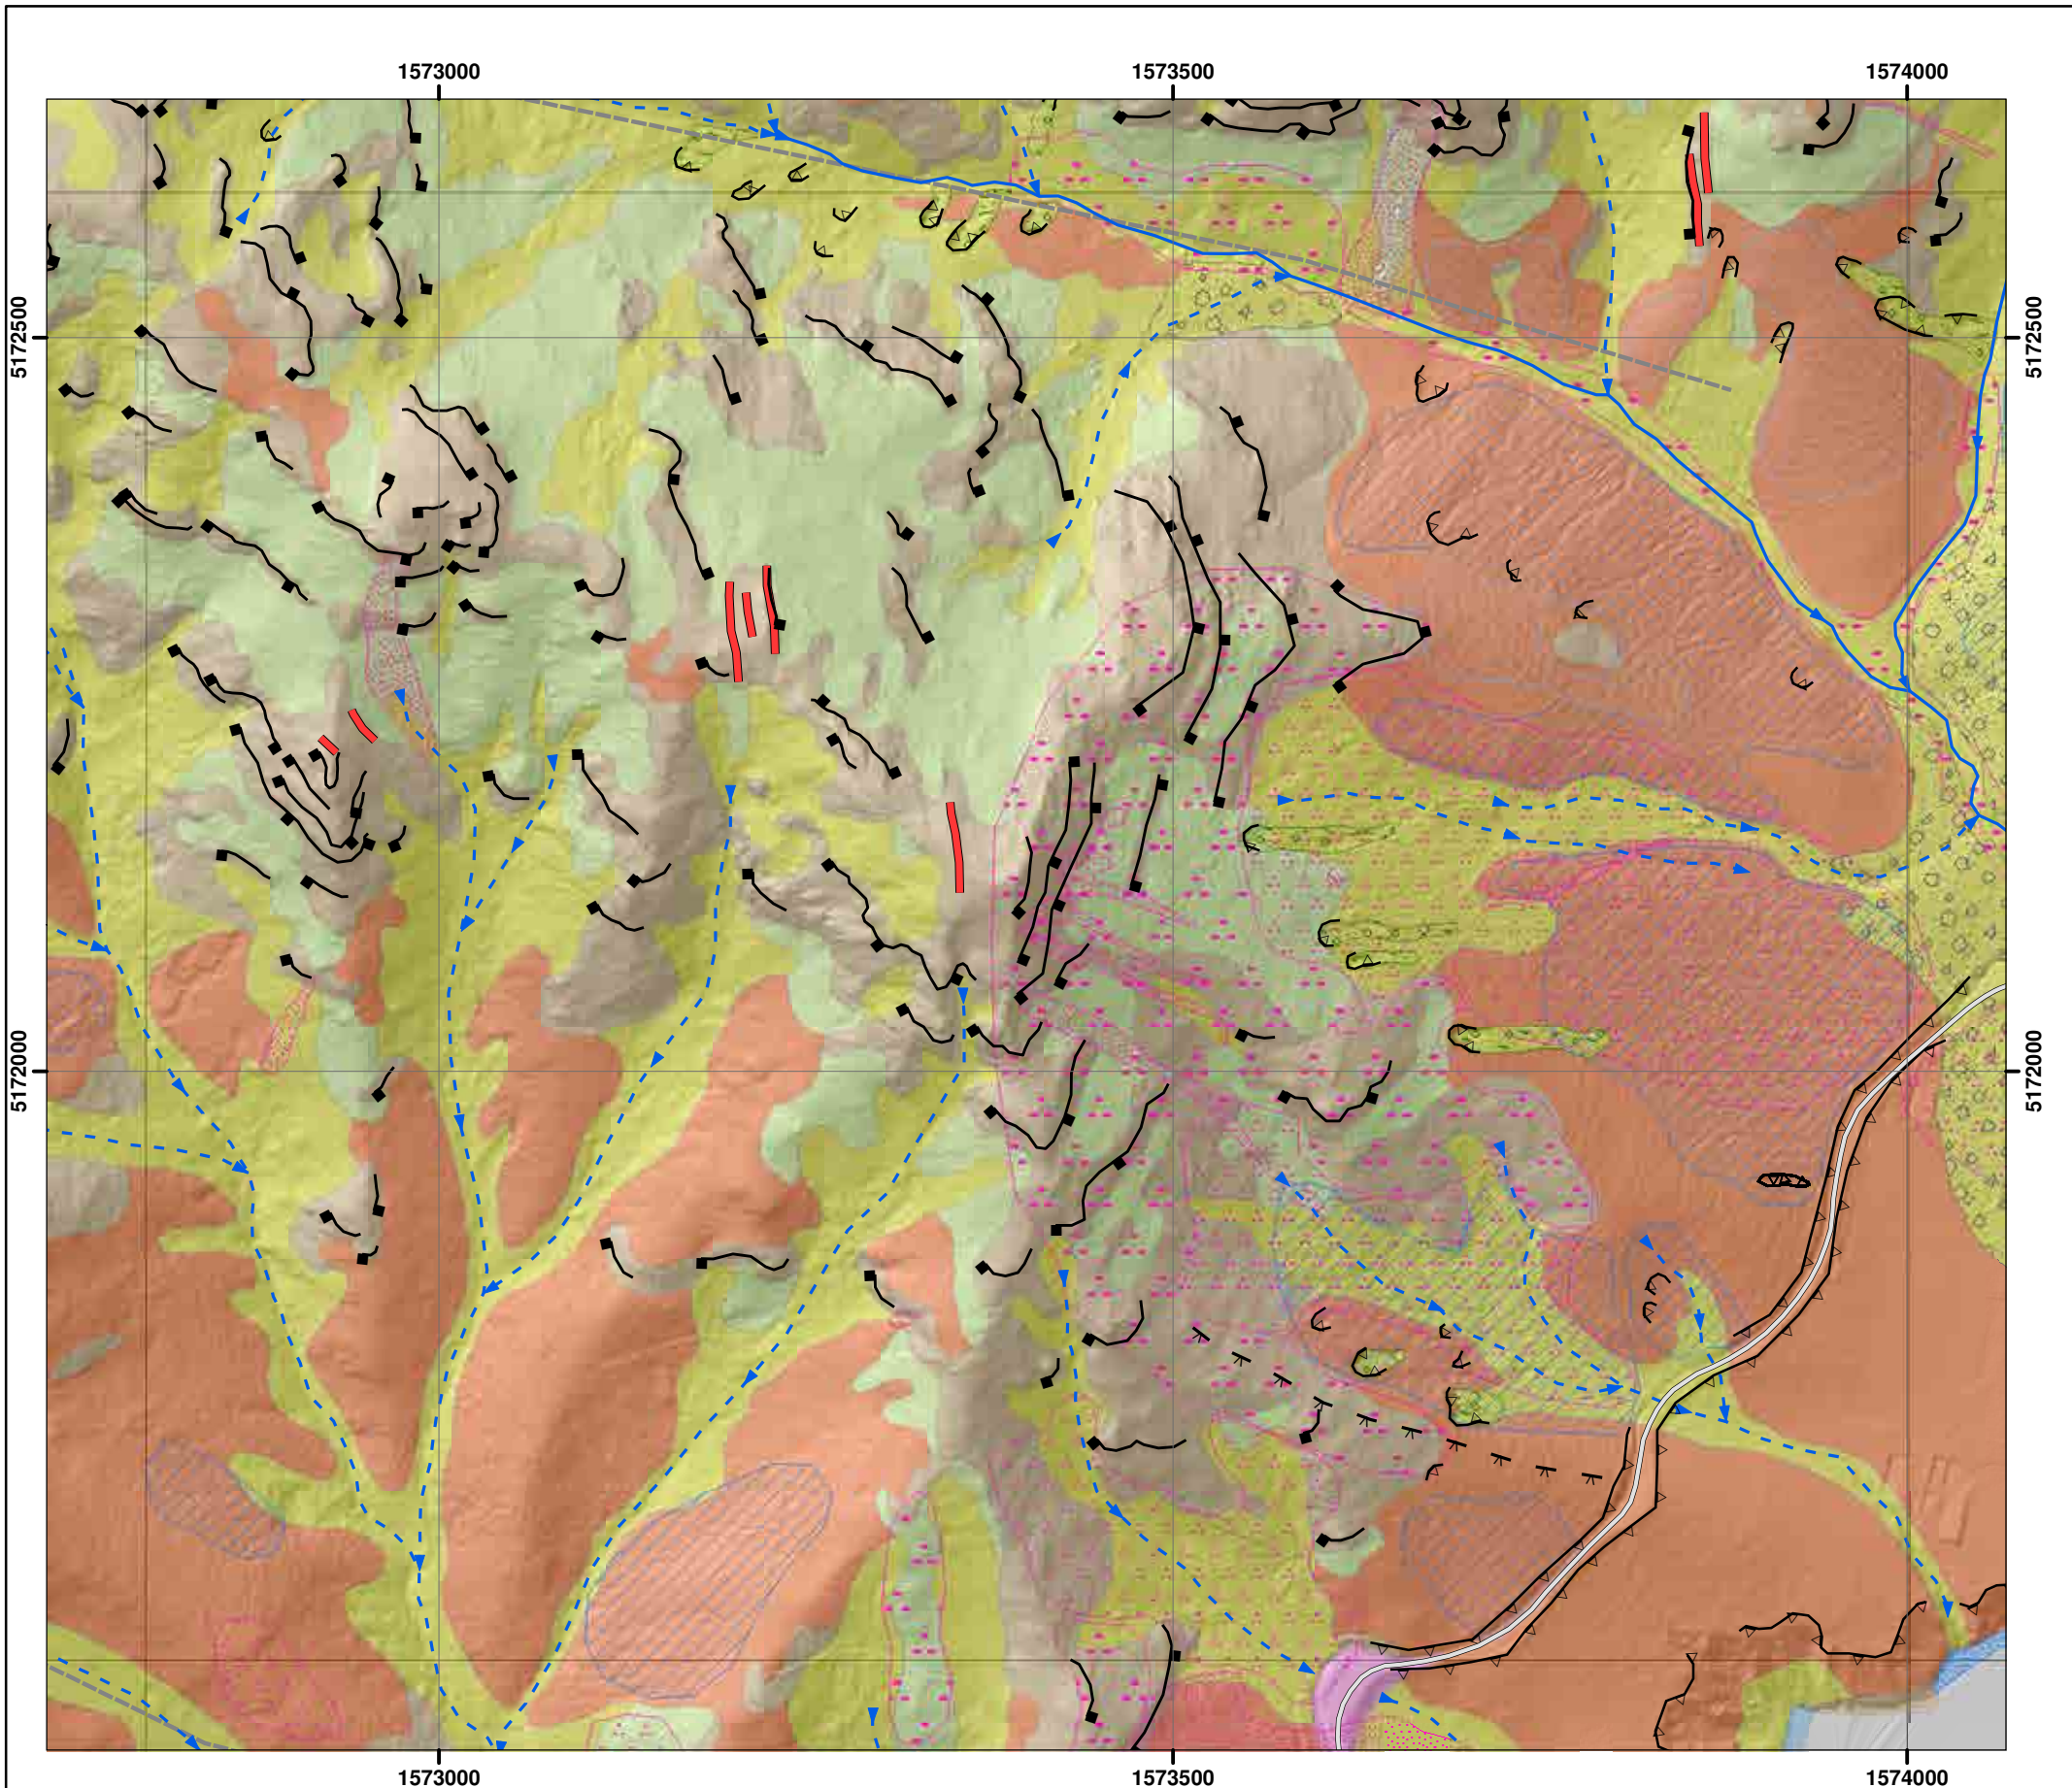
APPENDIX 4  
Map F7

Morphology description	Interpreted Materials type	Genesis type
Boulder trail	Rock at/near surface	Rockfall (recent)
Dike	Talus	Rockfall (many scattered boulders)
Bund	Colluvium	Rockfall (few scattered boulders)
Ephemeral drainage line (well defined)	Loess	Dune
Ephemeral drainage line (poorly defined)	Alluvium	Beach
Lineation	Sand and gravel	Rills
Sharp lineation (crack)	Boulders	Terracettes
Rounded concave break in slope	Fill	Fan
Rounded convex break in slope	Unknown	Landslide scar (recent)
Rounded ridge line		Landslide scar (relict)
Sharp concave break in slope		Swamp/wetland
Sharp convex break in slope		
Cliff		
Shelter belt/trees

EXPLANATION:  
 Background shade model derived from NZAM post-earthquake 2011c (July 2011) LiDAR survey resampled to a 1m ground resolution.  
 Roads provided by Christchurch City Council (20/02/2012).  
 PROJECTION: New Zealand Transverse Mercator 2000.

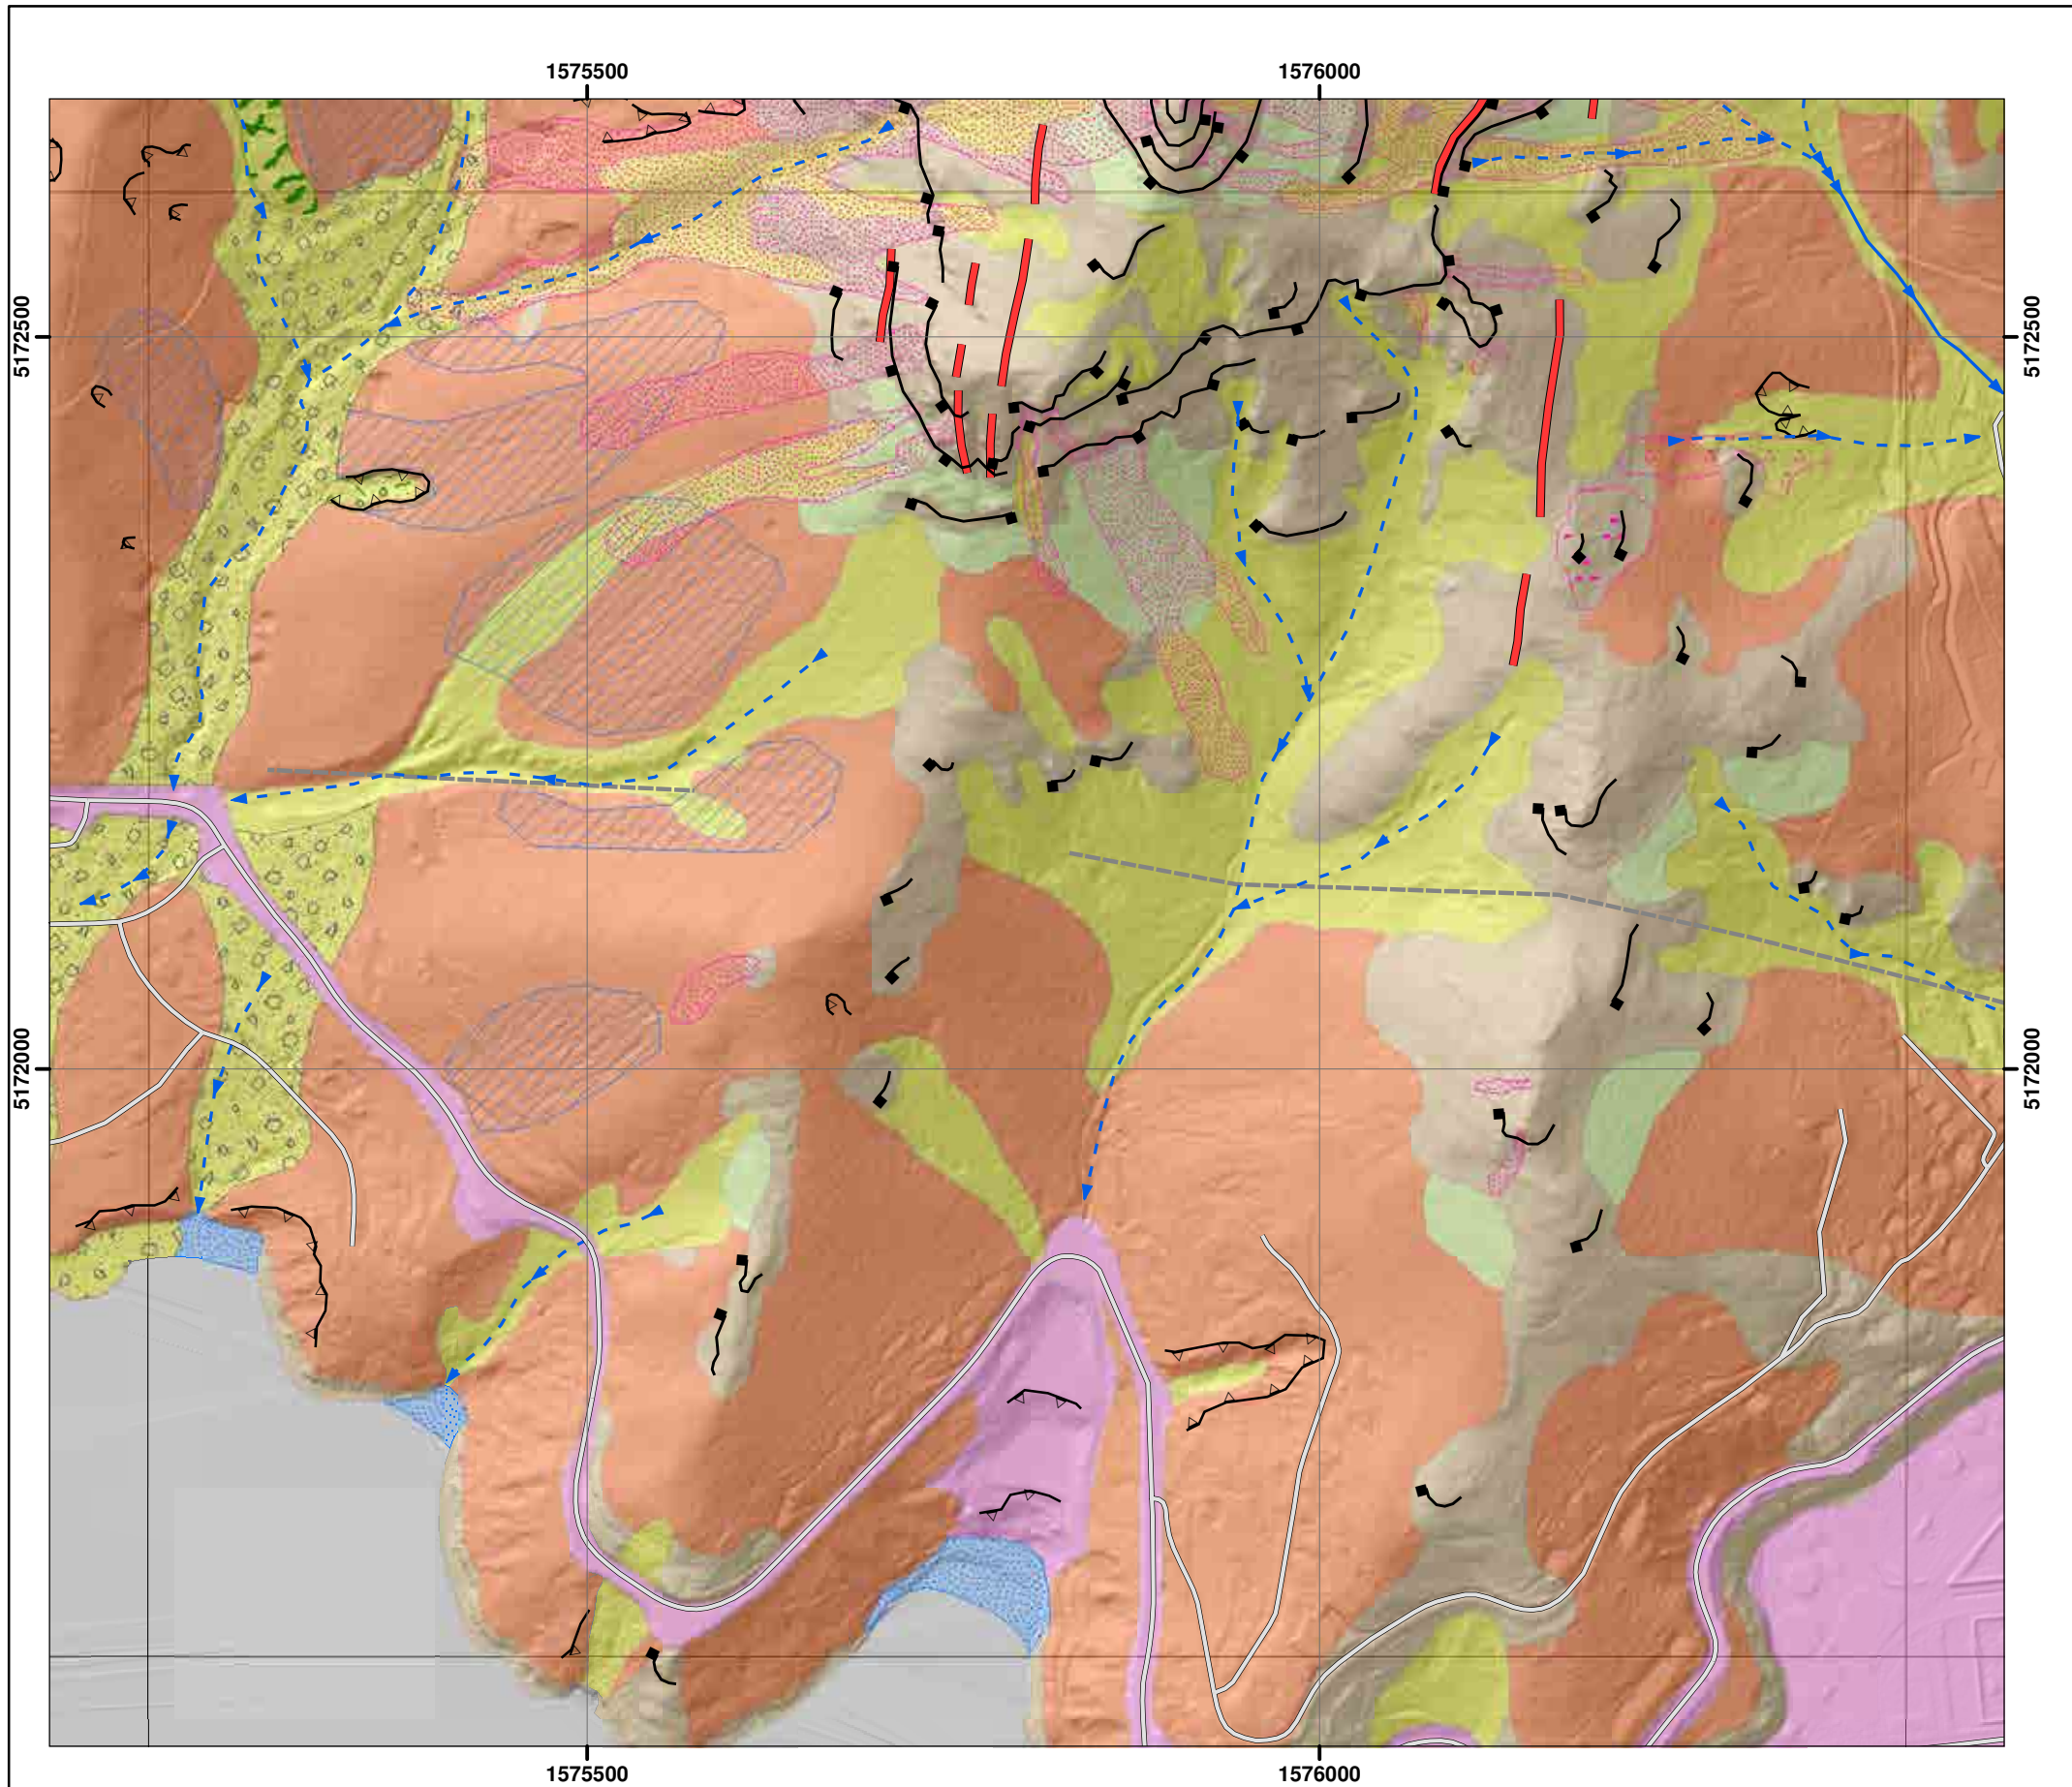
APPENDIX 4  
Map F9

Morphology description	Interpreted Materials type	Genesis type
Boulder trail	Rock at/near surface	Rockfall (recent)
Dike	Talus	Rockfall (many scattered boulders)
Bund	Colluvium	Rockfall (few scattered boulders)
Ephemeral drainage line (well defined)	Loess	Dune
Ephemeral drainage line (poorly defined)	Alluvium	Beach
Lineation	Sand and gravel	Rills
Sharp lineation (crack)	Boulders	Terracettes
Rounded concave break in slope	Fill	Fan
Rounded convex break in slope	Unknown	Landslide scar (recent)
Rounded ridge line		Landslide scar (relict)
Sharp concave break in slope		Swamp/wetland
Sharp convex break in slope		
Cliff		
Shelter belt/trees

EXPLANATION:  
 Background shade model derived from NZAM post-earthquake 2011c (July 2011) LiDAR survey resampled to a 1m ground resolution.  
 Roads provided by Christchurch City Council (20/02/2012).  
 PROJECTION: New Zealand Transverse Mercator 2000.

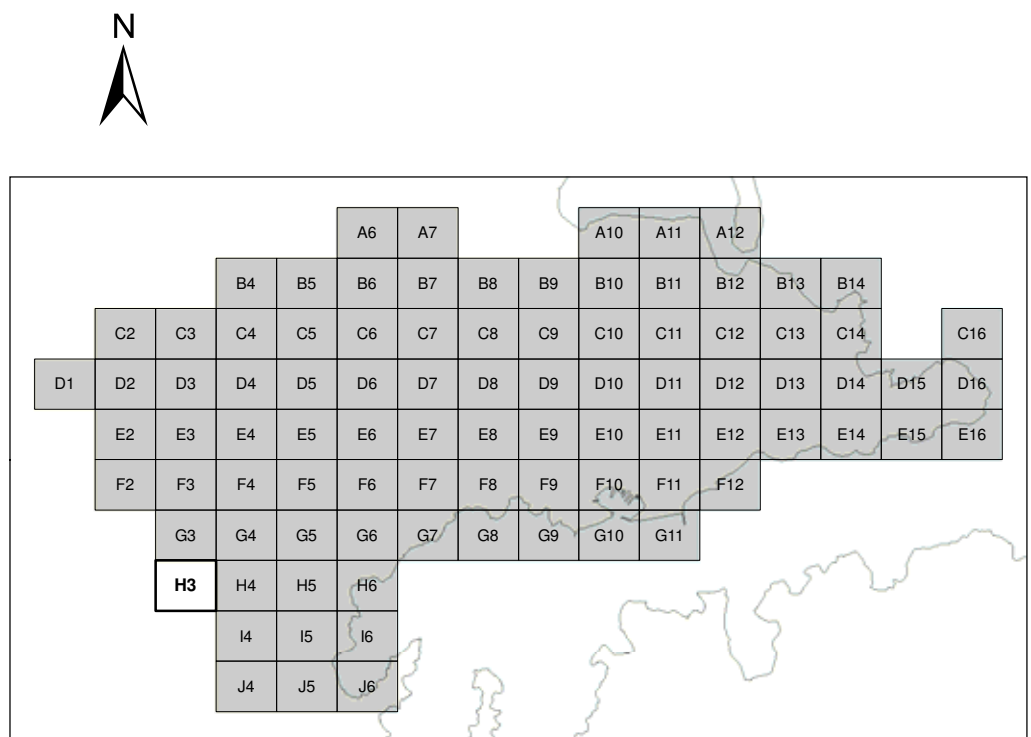
EXPLANATION:  
 Background shade model derived from NZAM post-earthquake 2011c (July 2011) LiDAR survey resampled to a 1m ground resolution.  
 Roads provided by Christchurch City Council (20/02/2012).  
 PROJECTION: New Zealand Transverse Mercator 2000.

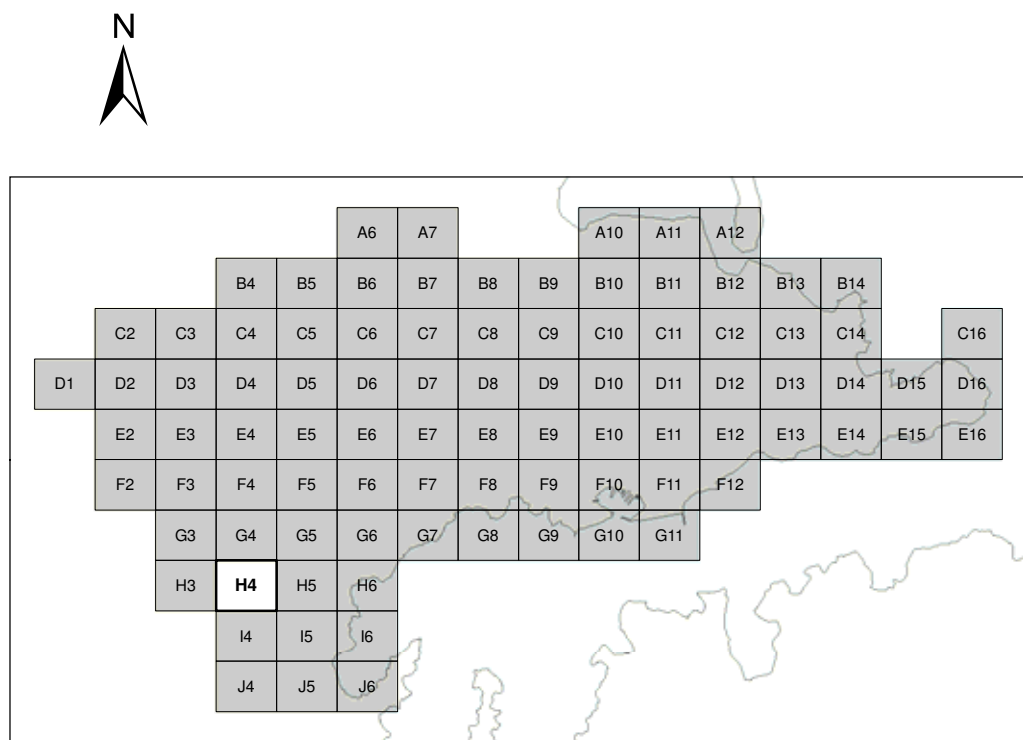
EXPLANATION:  
 Background shade model derived from NZAM post-earthquake 2011c (July 2011) LiDAR survey resampled to a 1m ground resolution.  
 Roads provided by Christchurch City Council (20/02/2012).  
 PROJECTION: New Zealand Transverse Mercator 2000.

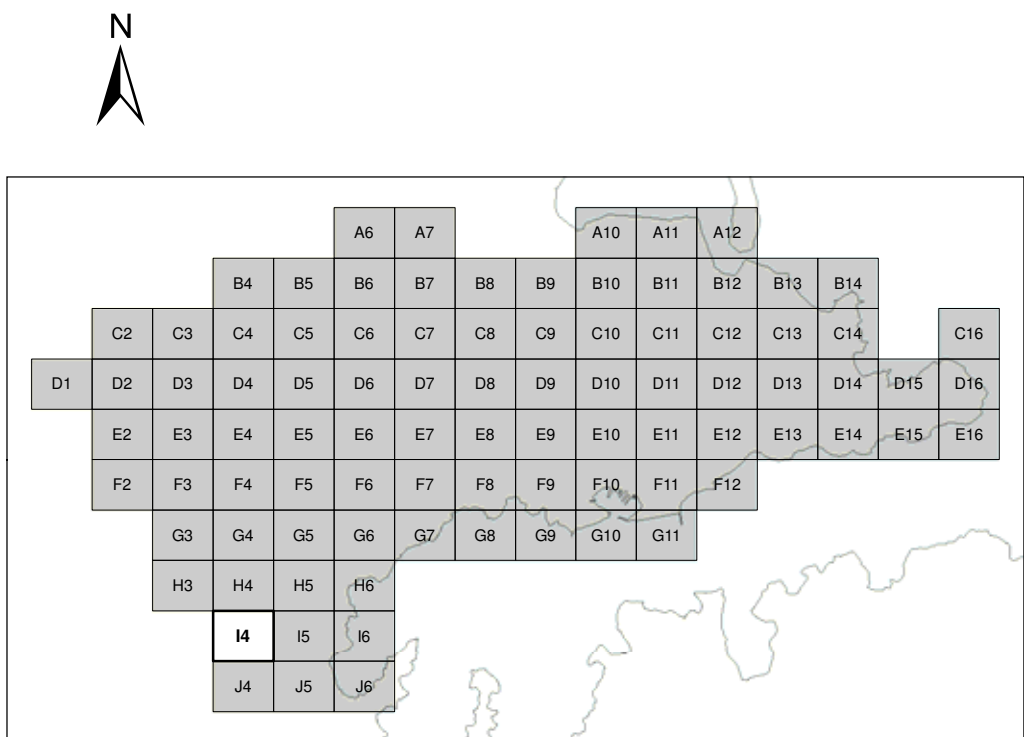
EXPLANATION:  
 Background shade model derived from NZAM post-earthquake 2011c (July 2011) LiDAR survey resampled to a 1m ground resolution.  
 Roads provided by Christchurch City Council (20/02/2012).  
 PROJECTION: New Zealand Transverse Mercator 2000.
