**Canterbury Earthquakes
2010/11 Port Hills Slope Stability:
Pilot study for assessing life-safety risk from
cliff collapse**

**GNS Science Consultancy Report 2012/57
March 2012 FINAL**

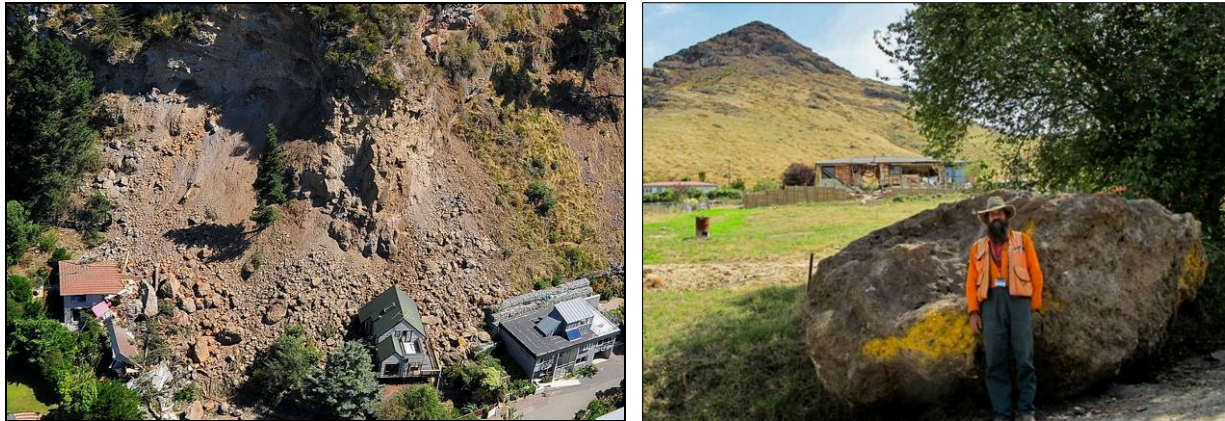
Figure 2 Illustration of the difference between *cliff collapse* with countless boulders (left, Raekura Place, Redcliffs) and *rockfall* where the location of each boulder can be precisely located (right, Rapaki Bay). Differences in what data can be collected about the two types lead to differences in how they are analysed to determine life-safety risk. The illustrated rockfalls occurred in the 22nd February 2011 earthquakes. Photographs by G. Hancox (left); D. Barrell (right), GNS Science.

Cliff collapses are here considered separately from the failure and runout of individual boulders, referred to as “boulder rolls” (addressed by Massey et al., 2012). Although both cliff collapses and boulder rolls are classified as rockfalls (Cruden and Varnes, 1996), the risk analysis for boulder rolls utilises information on the location of each fallen boulder. Mapping individual boulder locations in a cliff collapse is impractical due to the large number of boulders involved (Figure 2).

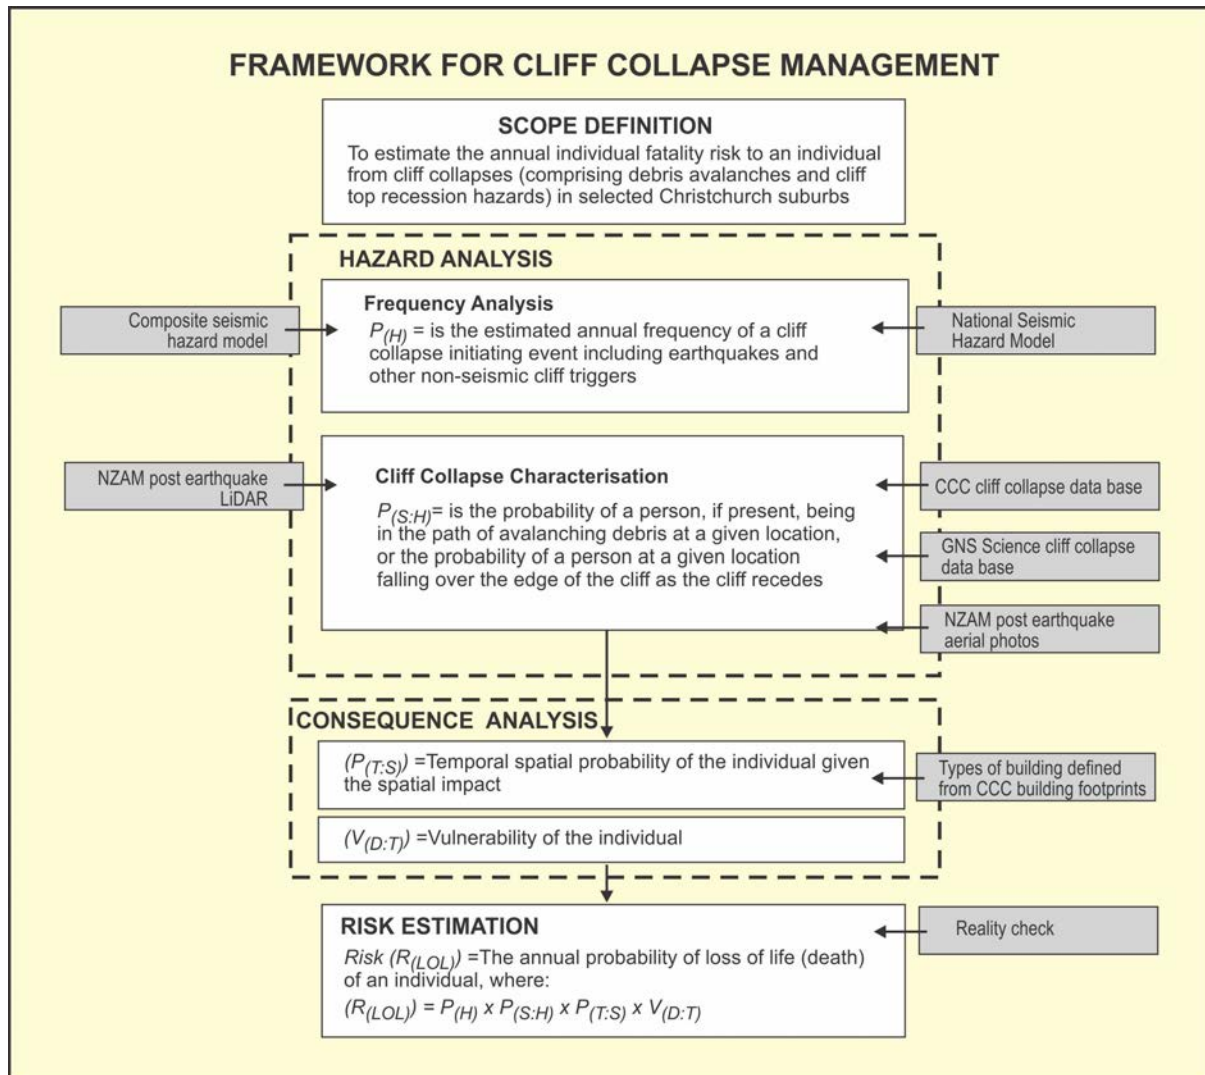
Figure 9 Framework used to assess the annual probability of loss of life (death) of an individual from cliff collapses in the Port Hills. Modified after the Australian Geomechanics Society Guidelines for landslide risk management (Australian Geomechanics Society, 2007).

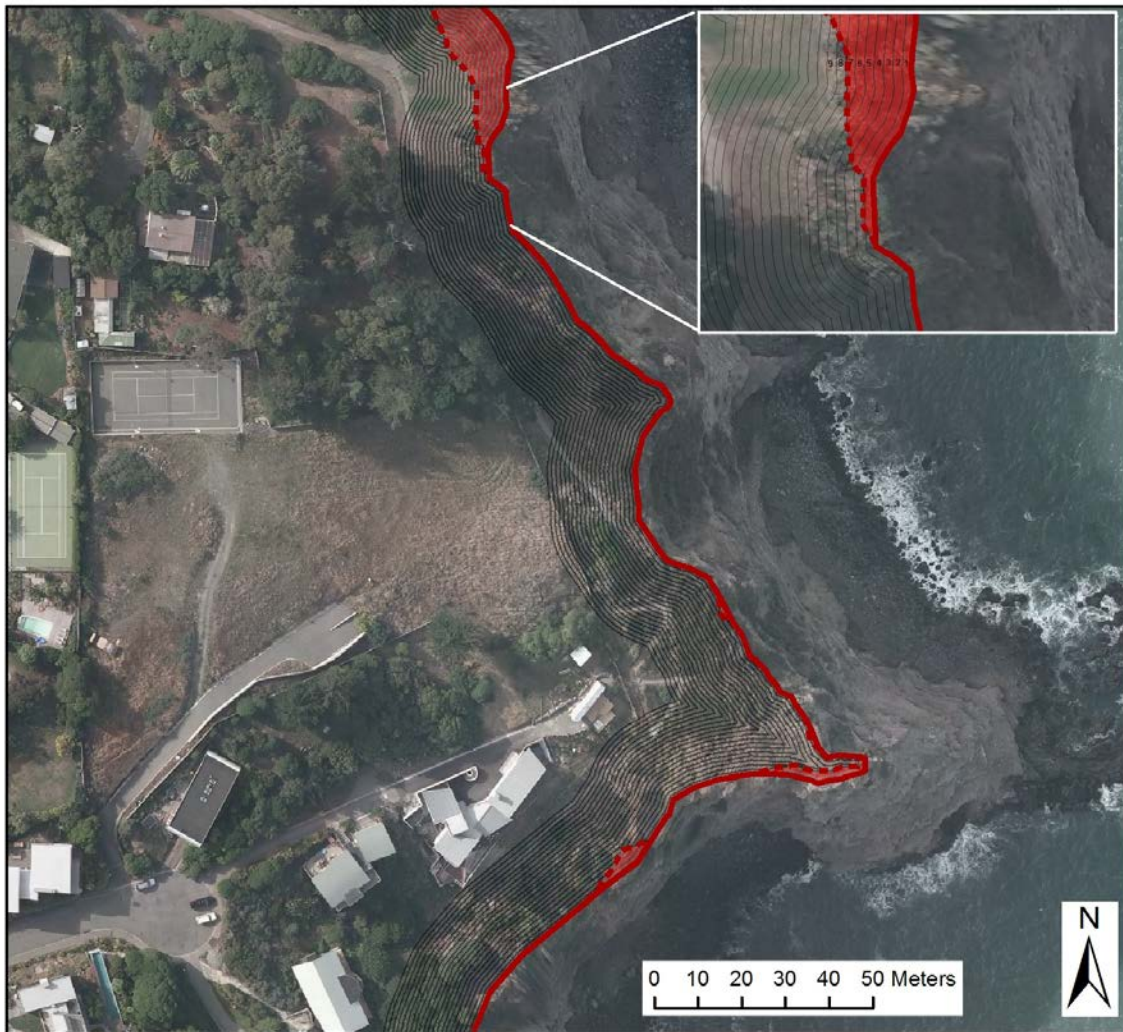
Figure 18 Example of how the area lost at the top of the cliff between the LiDAR surveys has been estimated. The solid red line represents the 2003 cliff edge and the dashed red line represents the 2011a cliff edge. The black lines with numbers (see inset) represent 1 metre zones (back from the 2003 cliff edge) that run parallel to the 2003 cliff edge. Area shown is on Whitewash Head.

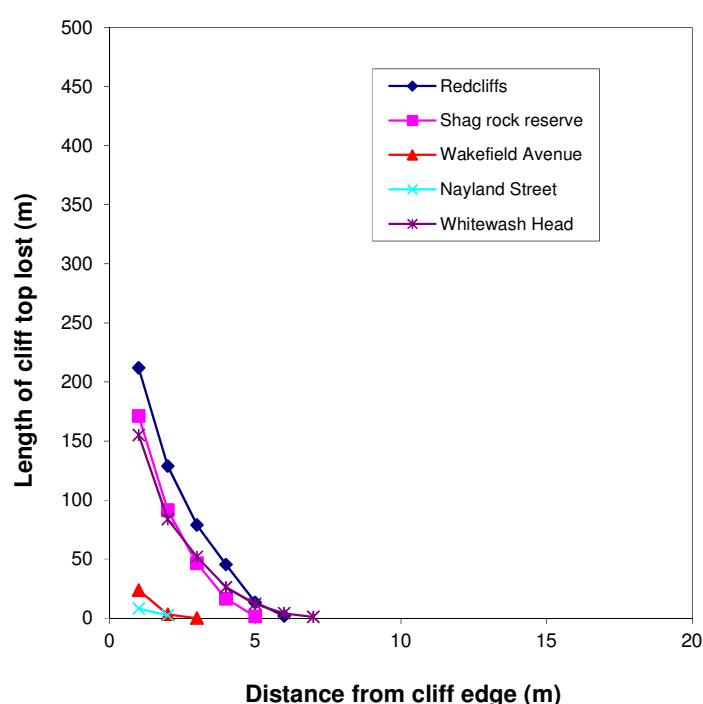
Figure 19 Length of cliff top lost per metre distance back from the cliff edge. Length lost is calculated as the change between cliff edges identified using the LiDAR surveys 2003 and 2011a (assumed to be caused by the 22nd February 2011 earthquakes).

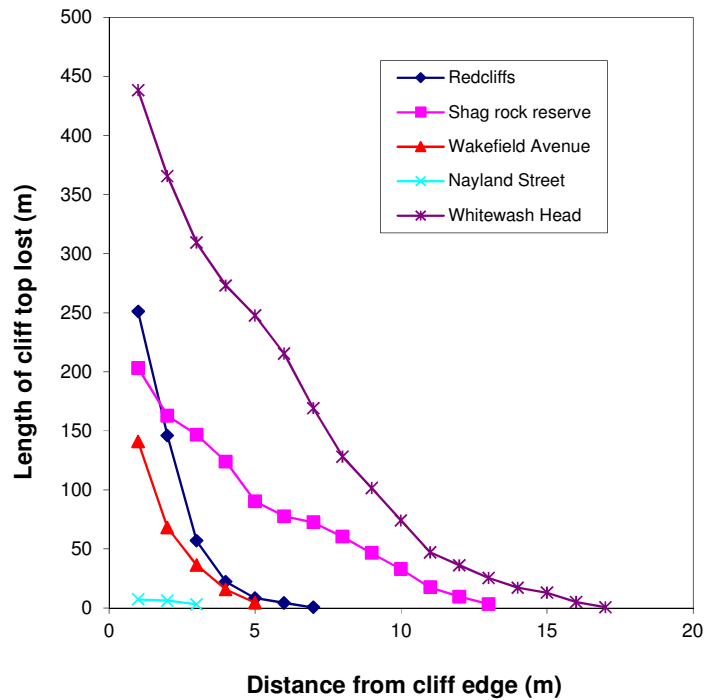
Figure 20 Length of cliff top lost per metre distance back from the cliff edge. Length lost is calculated as the change between cliff edges identified using the LiDAR surveys 2011a and 2011b (reasoned to be caused by the 13th June 2011 earthquakes).

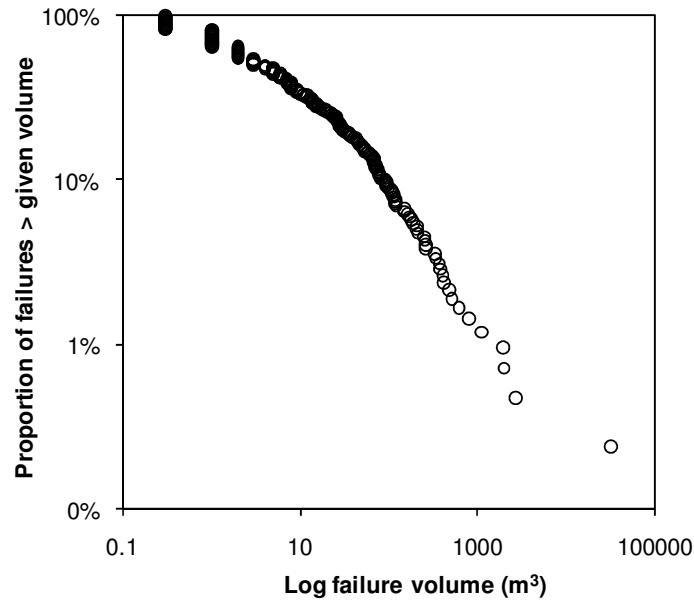
Figure 23 Volume magnitude frequency distribution of material leaving the cliffs between terrestrial laser scan (TLS) surveys. Plot is generated from change models between TLS surveys TLSb to TLSc and TLSc to TLSd, assuming the change to be caused by the 13th June 2011 earthquake.

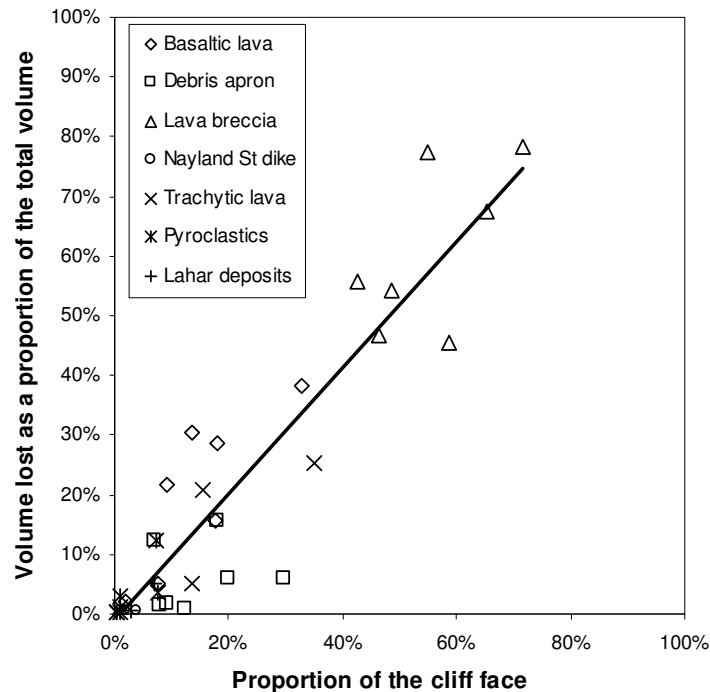
Figure 24 Volume lost, per material type, as a proportion of the total volume (of that material leaving the cliffs) plotted against the proportion of the cliff face formed in that material. Data are for the TLSb to TLSc and TLSc to TLSd change models. Changes are assumed to be due to the 13th June 2011 earthquake. The linear trend line is fitted to all data.

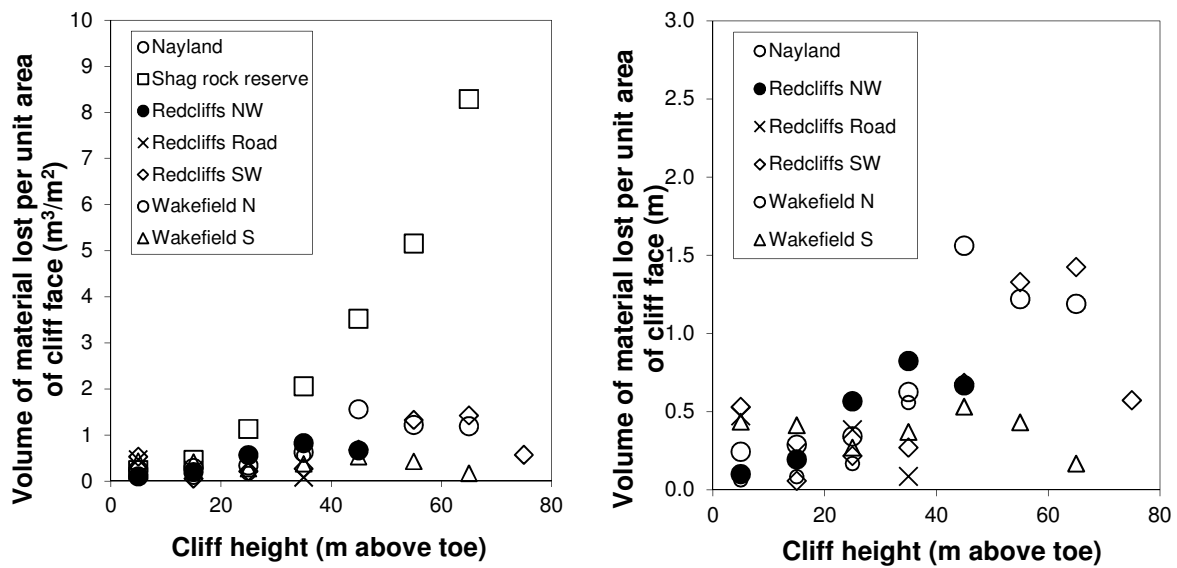
Figure 25 The volume of material leaving each cliff per unit area of cliff face plotted against the source height on the cliff face within 10 m elevation zones. Data are for the TLSb to TLSc and TLSc to TLSd change models. The changes are assumed to be due to the 13th June 2011 earthquakes.

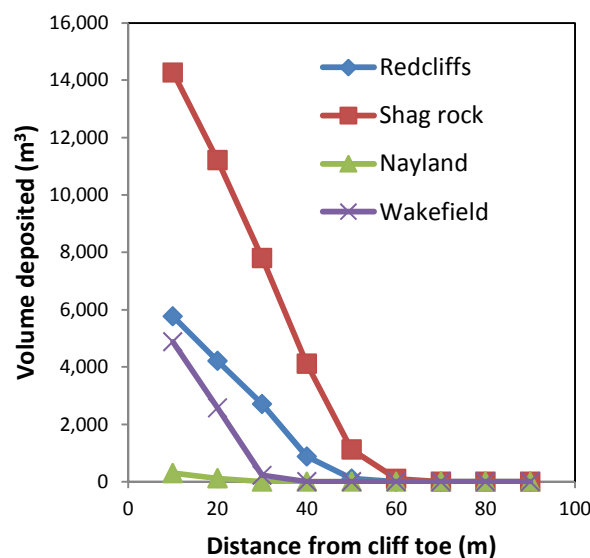
Figure 26 Distribution of deposited debris volume with distance from the toe of the rock slope portion of the cliff. Volumes were calculated from the 2011a to 2011c LiDAR survey change model.

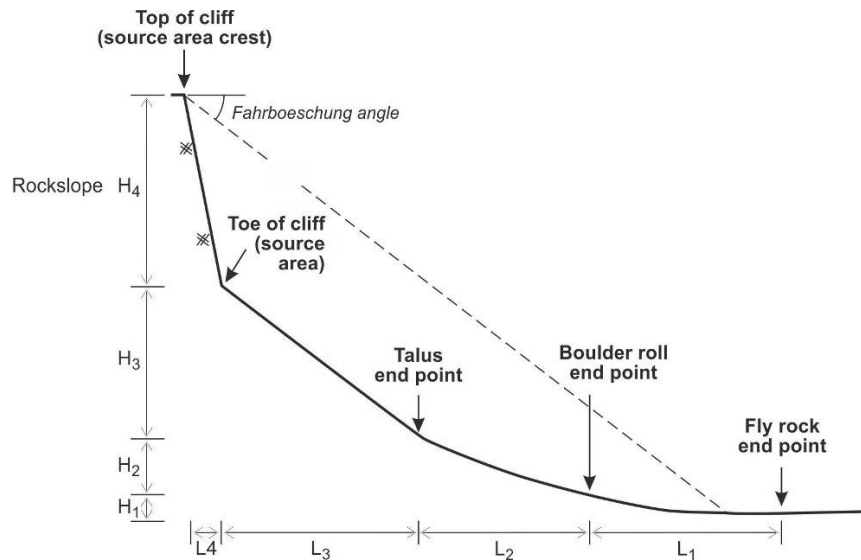
Figure 27 Schematic diagram illustrating the terrain parameters used in this study to assess the runout of debris avalanches. The section is shown in map view in Figure 28.

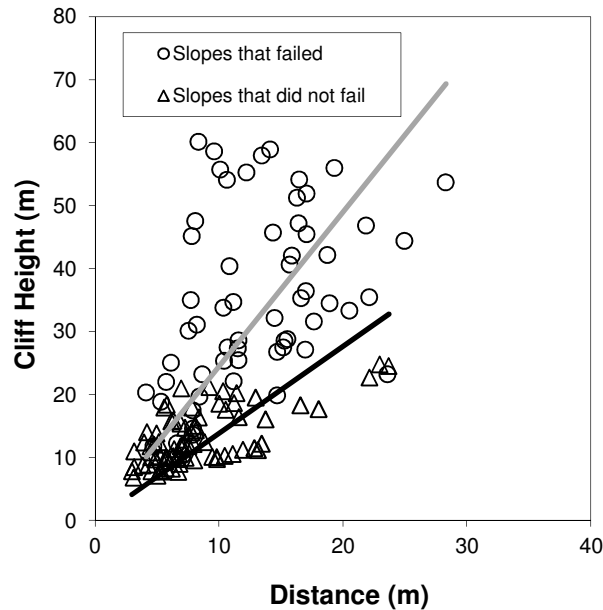
Figure 31 Geometrical relationships between those slopes that did fail and those that did not fail during the 2011 earthquakes. Slopes that did fail are from the slope sections discussed in Section 4.3.5 (n = 48) and the slopes that did not fail are from measurements of slopes in the same area of the Port Hills (n = 72). Linear trend lines are fitted to the data, the grey line represents slopes that failed and the black line slopes that did not fail.

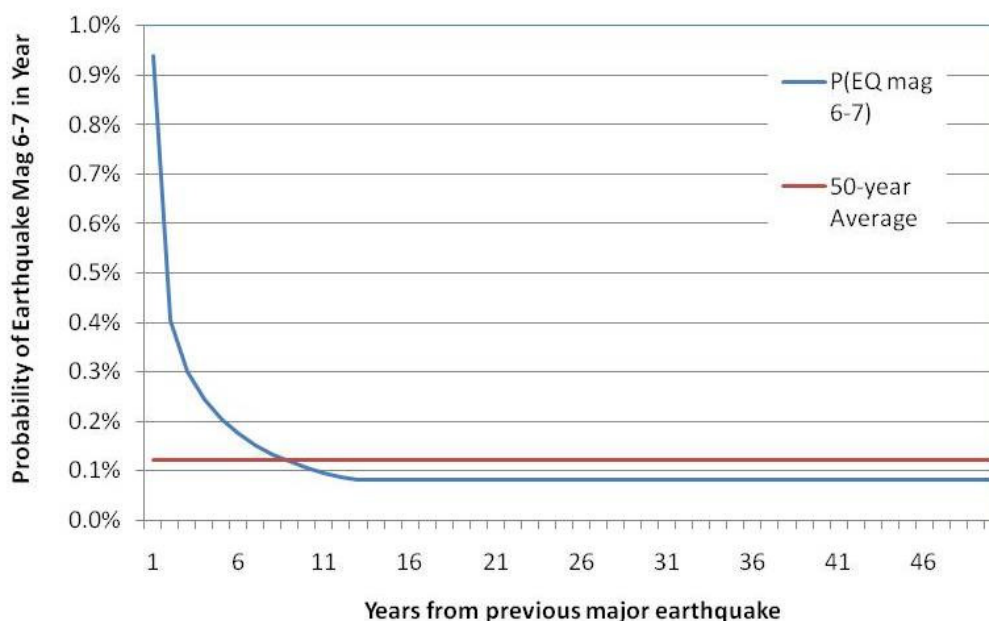
Figure 35 Estimated probability of an earthquake of M_w 6-7 occurring in the next 50-year period. Data contained in Webb et al. (2011) (which predates the 13th June 2011 earthquake model).

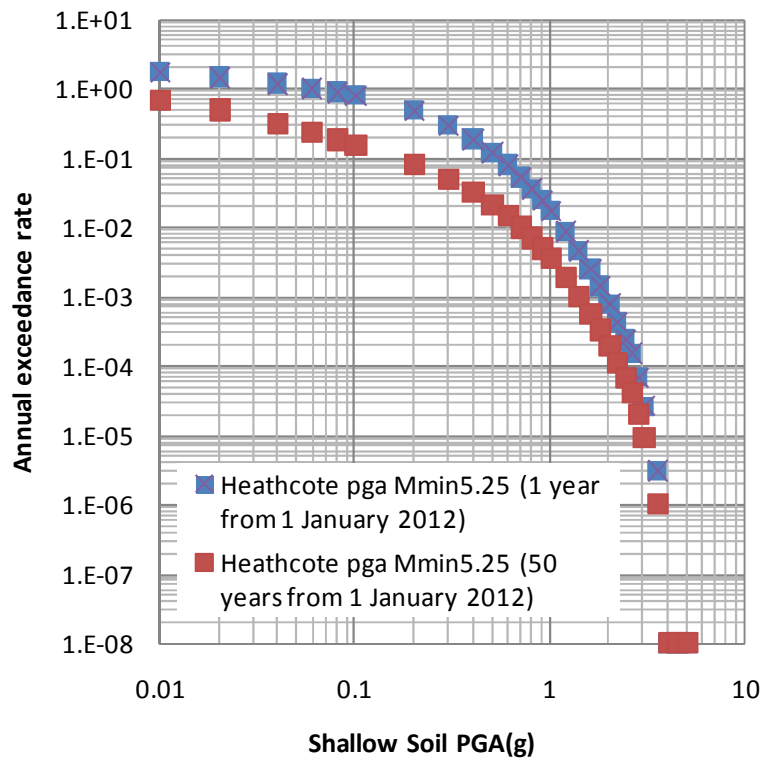
Figure 36 Peak ground acceleration (PGA) hazard curves for the Heathcote Valley Primary School site in the Port Hills, using the composite seismic hazard model results for the next 1-year and 50-year periods, using a minimum earthquake magnitude (M_{min}) of $M_w 5.25$. The Heathcote Valley Primary School site is classed as a shallow soil site (NZS 1170 site class C). These values do not include amplification effects induced in the source areas, or any magnitude weighting.

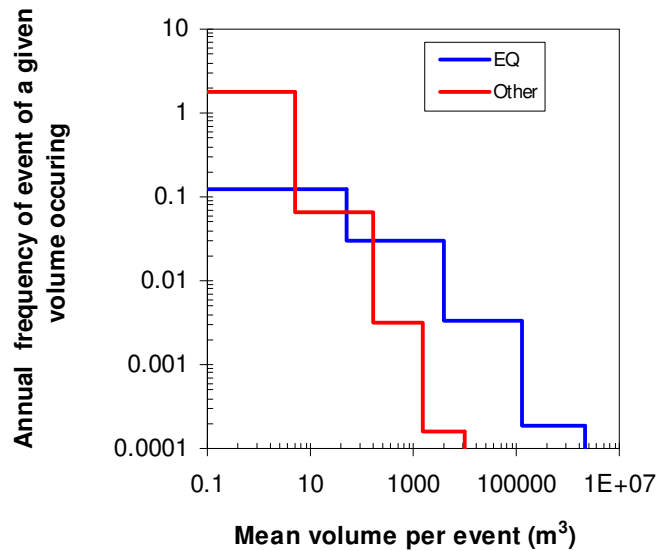
Figure 38 The cliff collapse frequency magnitude model developed for this study incorporating earthquake and non-seismic triggers. The frequency and magnitude of earthquake-triggered cliff collapses are shown using the next 1-year median composite seismic hazard model results. Plot is for all sites.

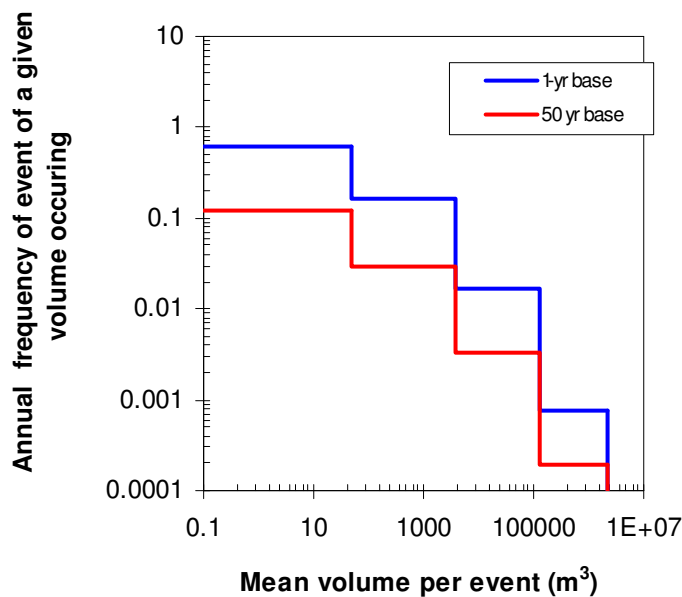
Figure 39 The cliff collapse frequency magnitude model developed for this study comparing results using the next 1-year with the next 50-year composite seismic hazard models. Plot is for all sites.

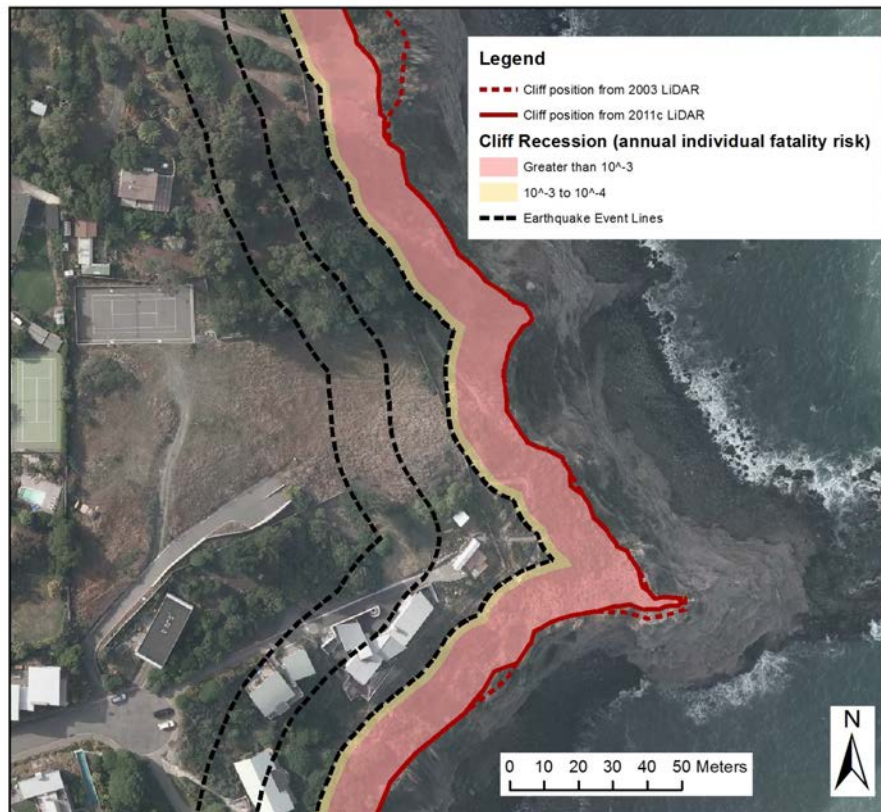
Figure 41 Illustrative example of the estimated annual individual fatality risk (considering all events) zones calculated for cliff top recession.

Step 6: The annual individual fatality risk considering all events was calculated for each zone back from the cliff edge for each site, following the steps outlined in the example. These values were then modelled using ArcGIS®. ArcGIS is used to interpolate between the risks calculated at given zones back from the cliff edge so as to produce contours of equal risk

(Figure 41). The annual individual fatality risk zones were projected back from the current cliff edge location, as derived from the 2011c LiDAR survey. Contours were developed for logarithmic classes, e.g., 10^{-2} to 10^{-3} , 10^{-3} to 10^{-4} of individual risk values. The Christchurch City Council building footprints were then overlain on the risk model and each dwelling was assigned a risk value, based on the highest risk value that the building intersected.

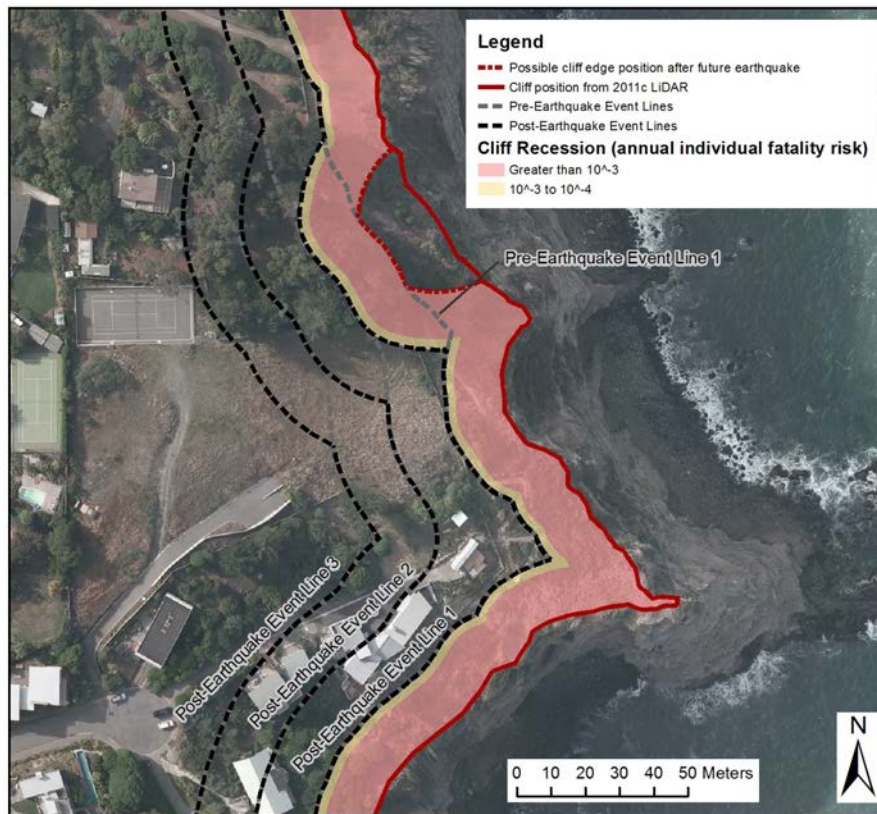
Figure 42 An example of the how the annual individual fatality risk zone may migrate after a future earthquake causes a partial cliff collapse.

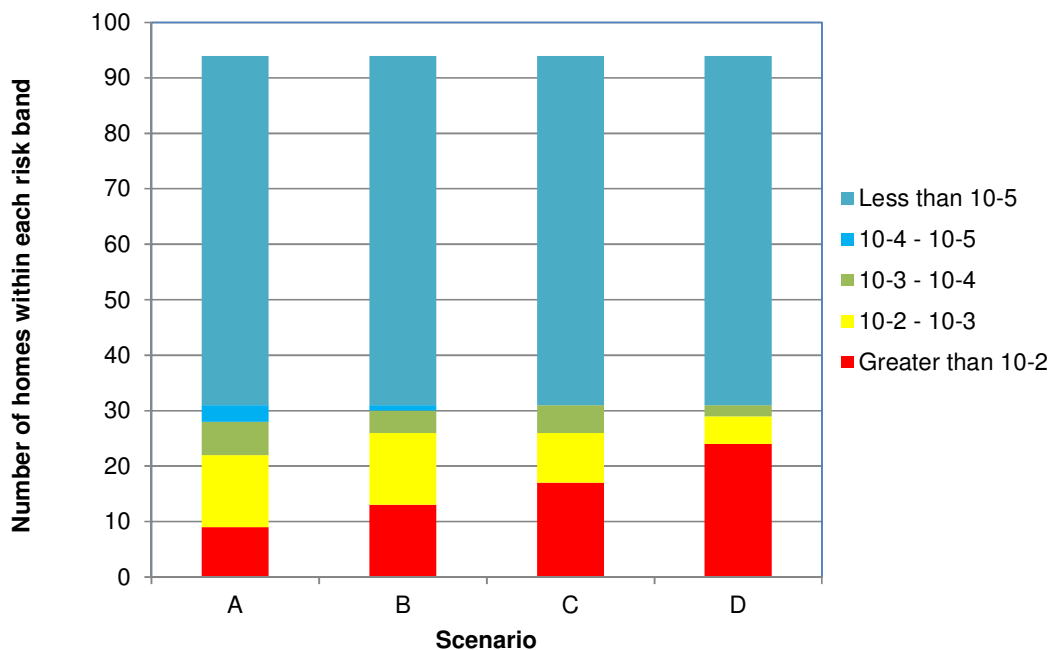
Figure 43 Numbers of dwellings estimated by band of annual individual fatality risk (AIFR) for each assessment scenario – debris avalanches only. The total number of homes in the areas analysed is 91 (between the toe of the cliff and the 20° Fahrboeschung angle).
