ŌTĀKARO / AVON RIVER CATCHMENT

TAUĀKĪ WAI PĀTAUA / VISION AND VALUES

Part Two of this document summarises a number of key technical documents that have been used to inform the development of stormwater management approaches, they detail the necessary infrastructure required for improving water quality and quantity discharges into the river.

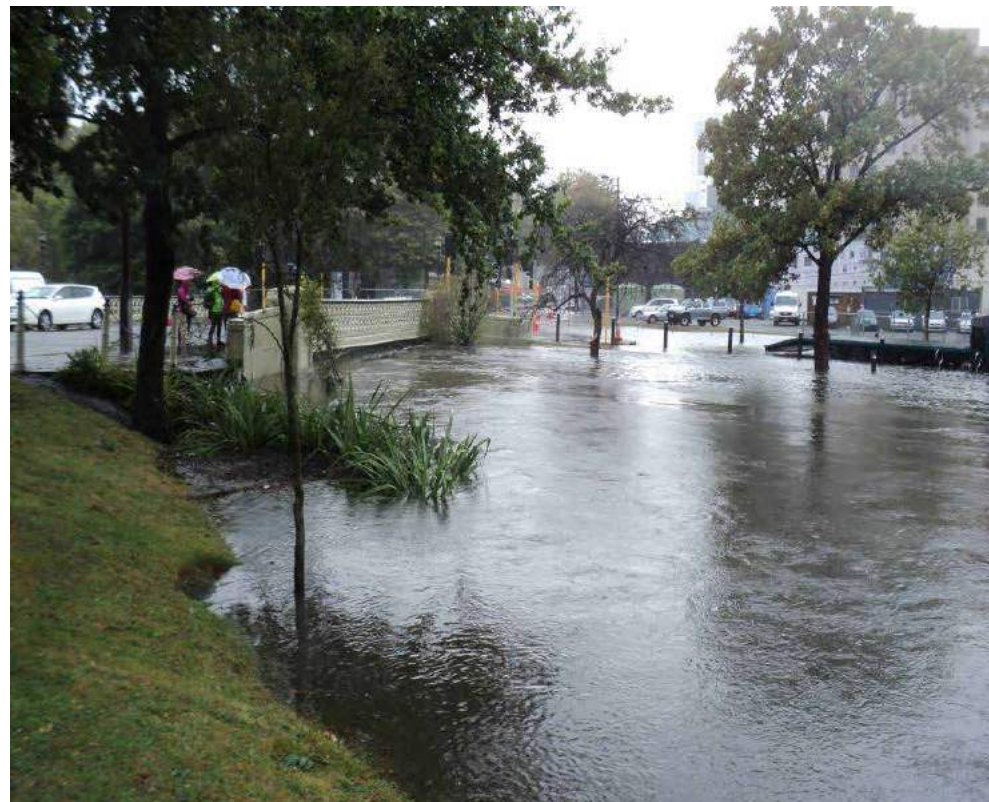
Ōtākaro / Avon River Flooding at Gloucester Bridge 5th March 2014

Below Fitzgerald Avenue flooding is influenced by the tide and the volume of flood water. Flooding downstream of Kerrs Reach is dominated by extreme tide levels rather than channel capacity. There are temporary stopbanks along the top of both banks of the river for much of this length of the river. These temporary stopbanks constructed at a crest level ranging between RL 11.0 m and RL 11.2 m prevent extreme tides inundating the adjacent land.

The local stormwater network draining to this reach of the river typically has backflow prevention devices, such as flap gates, to prevent the tide from flowing beneath the stopbank and flooding properties behind the stopbank. The gates close when flood levels in the main channel exceed the local stormwater network levels. Regular inspection and maintenance is undertaken to ensure the network is operating effectively during tidal events.

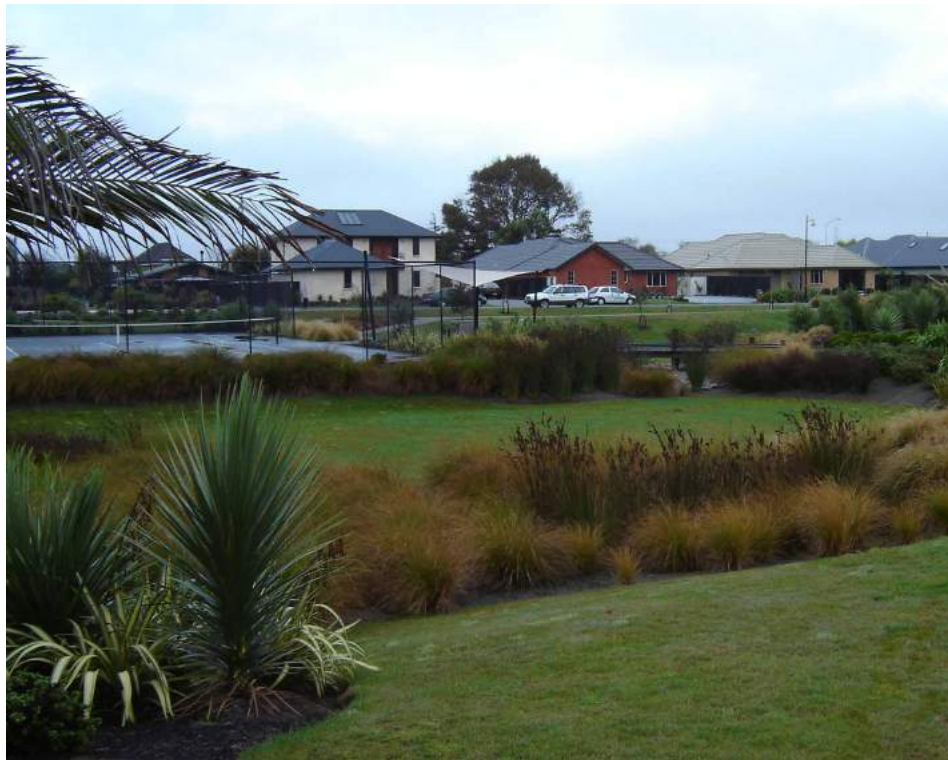
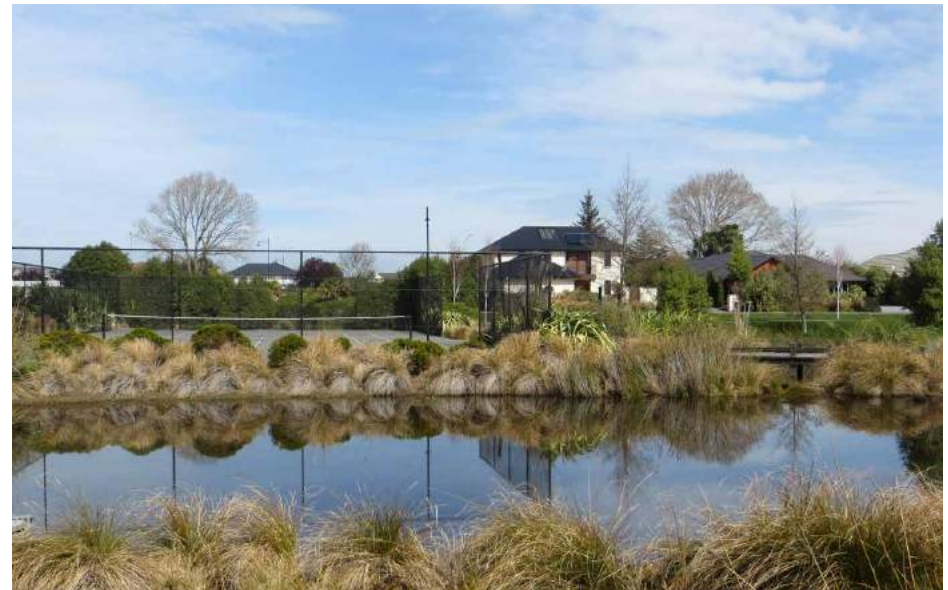
Toolbox Treatment Hierarchy Based on Values Supported

Stormwater treatment methods and devices have been arranged from multi-value at the top to single value at the bottom of the Toolbox Treatment Hierarchy (opposite). For any particular site, appropriate methods near the top of the table (multi-value) are preferred to single value methods lower down the table. The toolbox table lists only the 'structural' or engineering methods considered in this SMP. Other engineering methods such as green roofs, for example, have been used elsewhere. However, 'green roofs' have not been included in the Toolbox because they have not been assessed in the SMP technical studies for potential coverage and subsequent benefit.
