Response of īnanga spawning habitat to riparian vegetation management in the Avon & Heathcote catchments

Shane Orchard

Christchurch City Council
June 2017

Waterlink Ltd

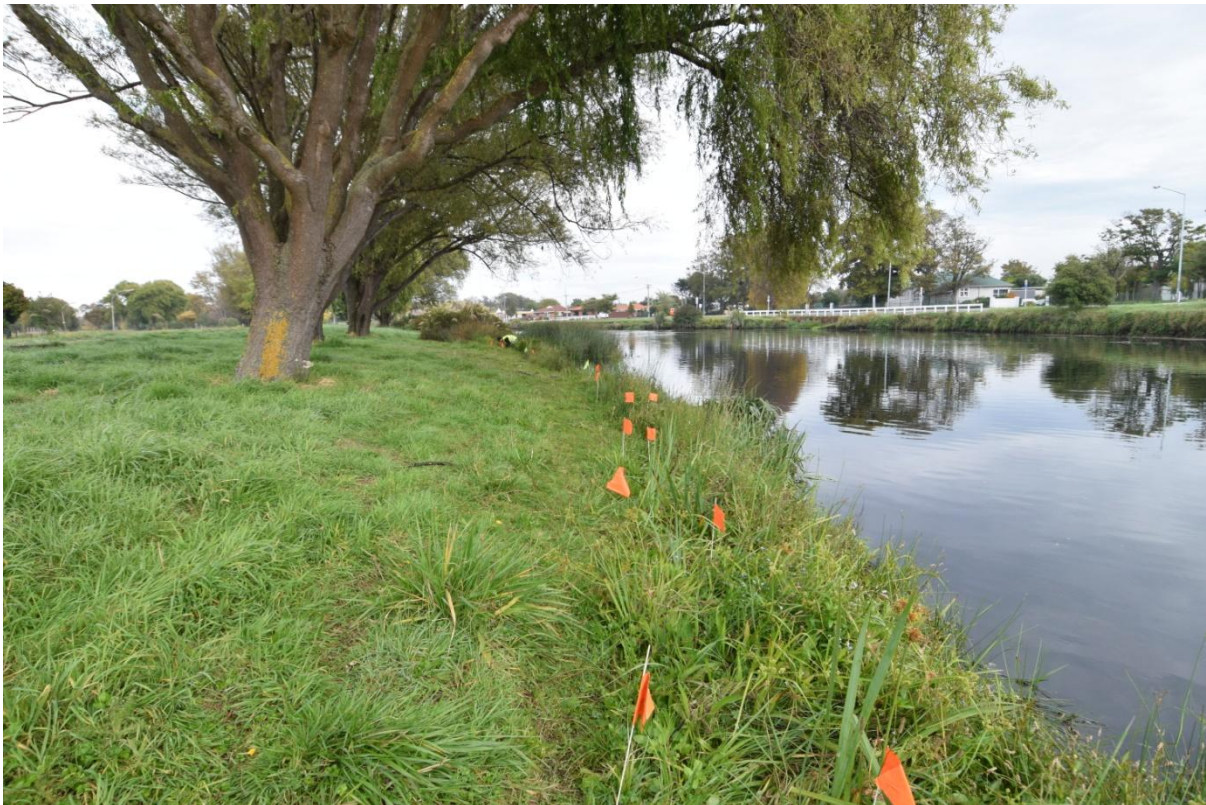
Figure 4. Īnanga spawning at a site that was regularly mown prior to the CCC trial.

In the Avon/Ōtākaro four sites were found in Corsers Stream, all above the tide gate. This is the first time spawning has been recorded here. These sites were found outside of the original survey area for this study and there may be other sites upstream in this tributary. The area searched in this study only covered the lower part of the stream on the true left. Many of the other new sites occurred in previous gaps in the known post-quake distribution, in some cases showing an obvious response to improved riparian vegetation. An example from upstream of Avondale Road bridge on the true right is shown in Figure 4. This site occurred in an area that was previously mown to the water's edge. Although the mowing line was relaxed only a short distance it was sufficient to accommodate the position of the high water mark on the spawning tide.

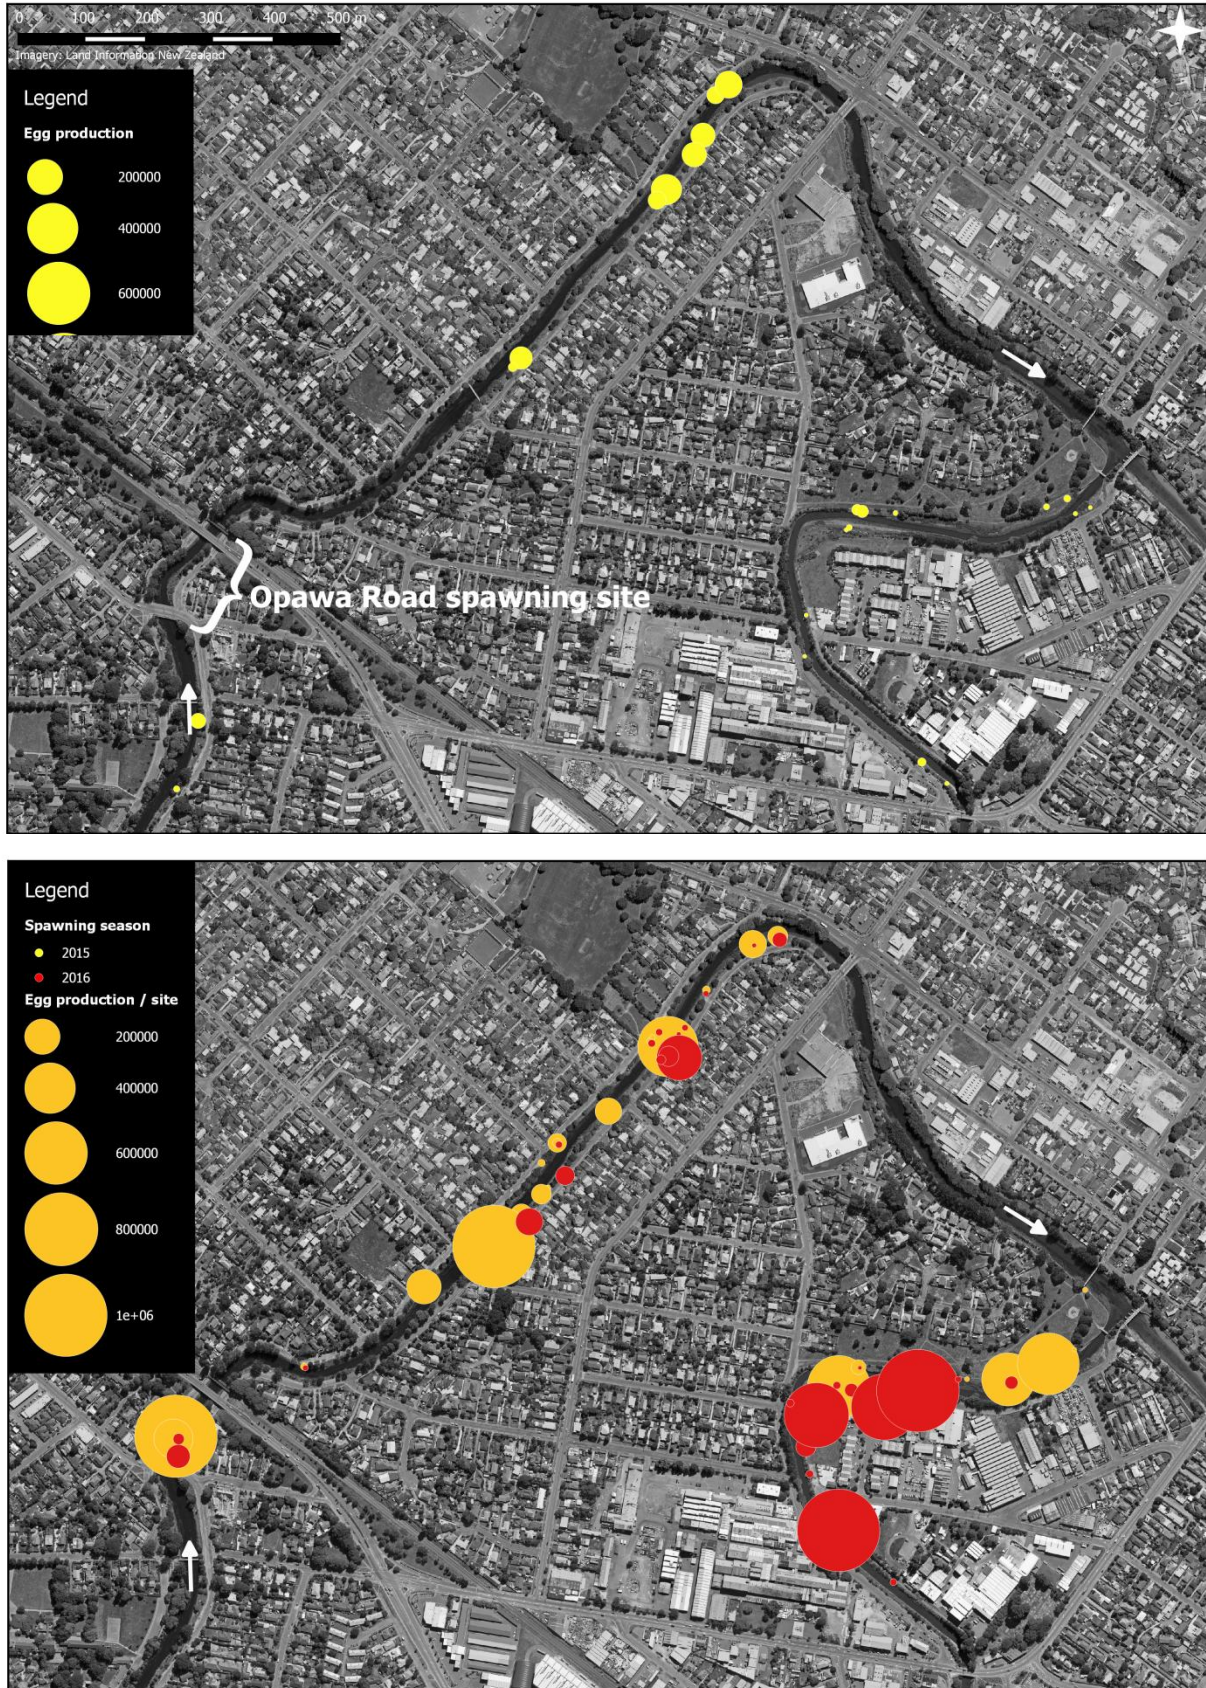
Figure 8. Egg production in the Heathcote/Ōpāwaho. (a) Egg production recorded at each site in this study. (b) Total egg production at spawning sites recorded in 2015 and 2016.

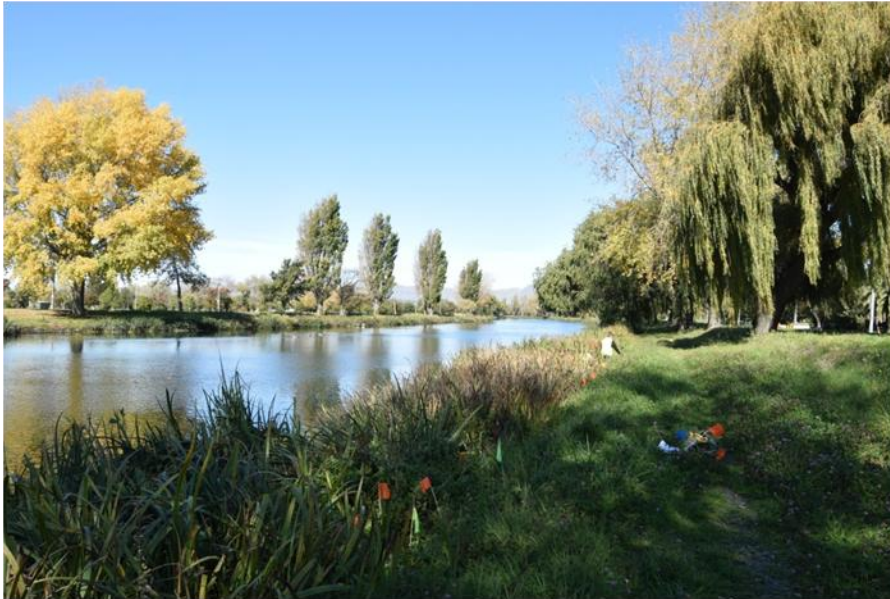
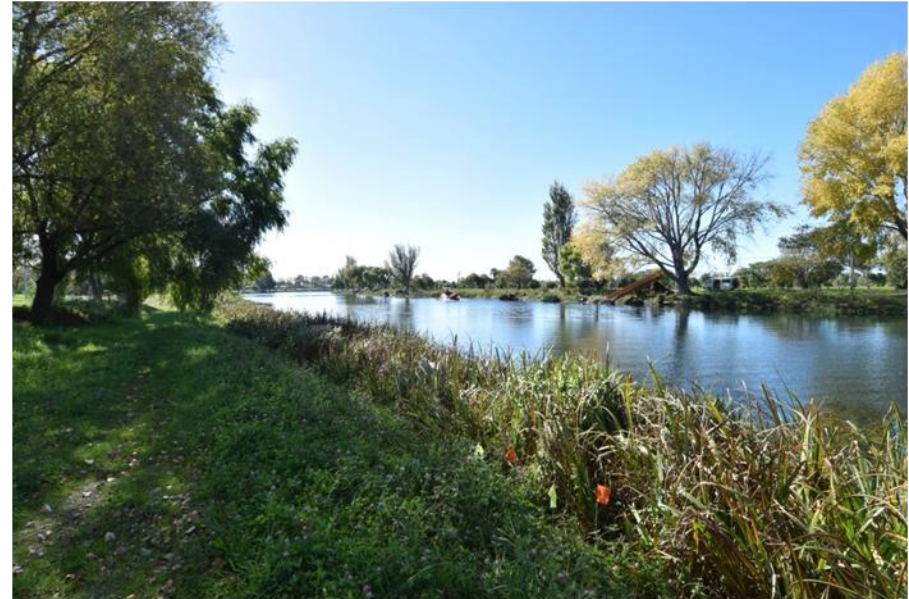
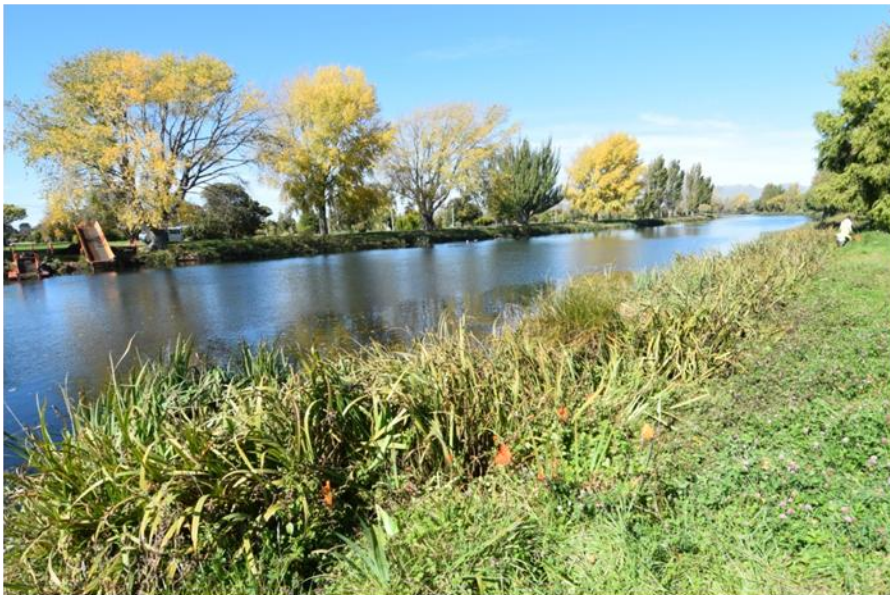
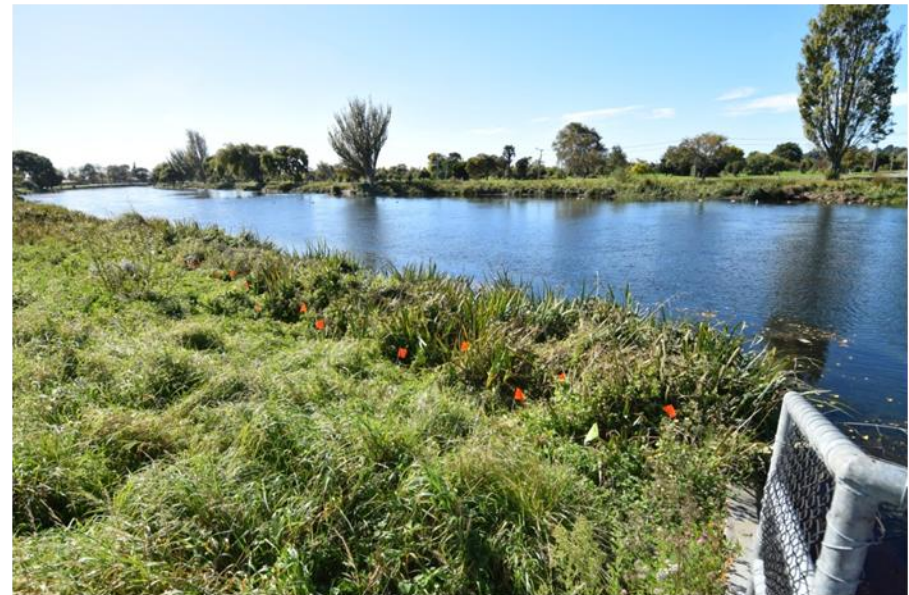
Appendix 1. Examples of spawning sites in the Avon / Ōtākaro catchment. (a) sites along Locksley Terrace on the true left bank.
Note: yellow flags are used to mark the upstream and downstream limits of the spawning site in all photos.

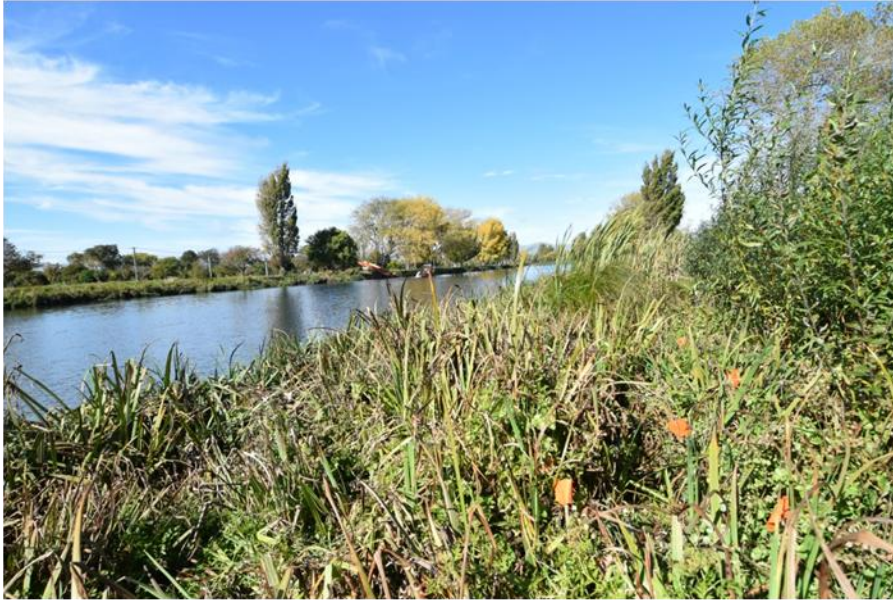
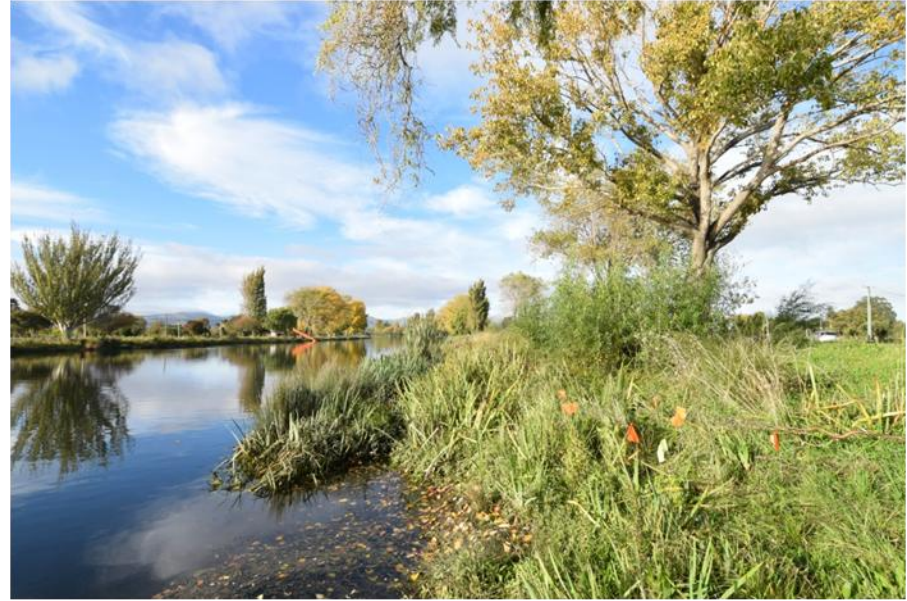
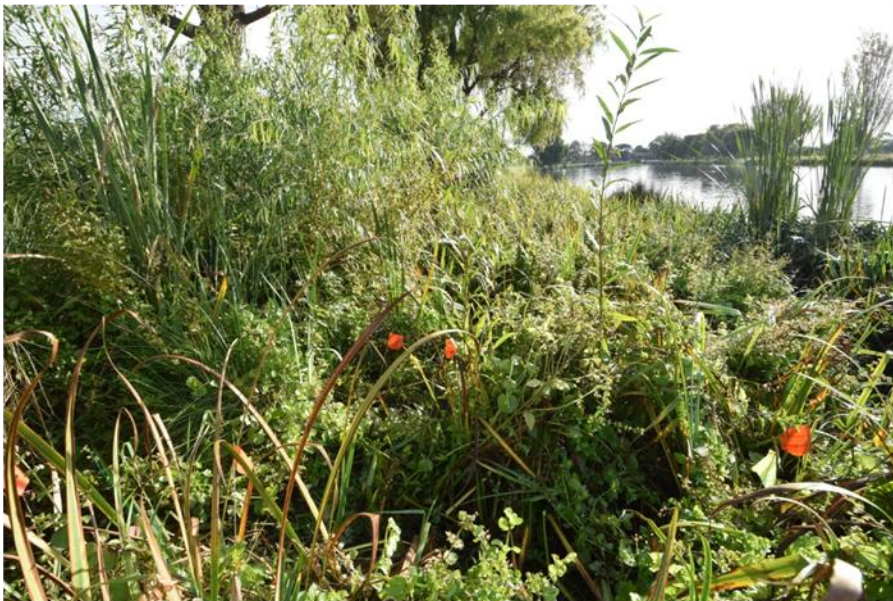
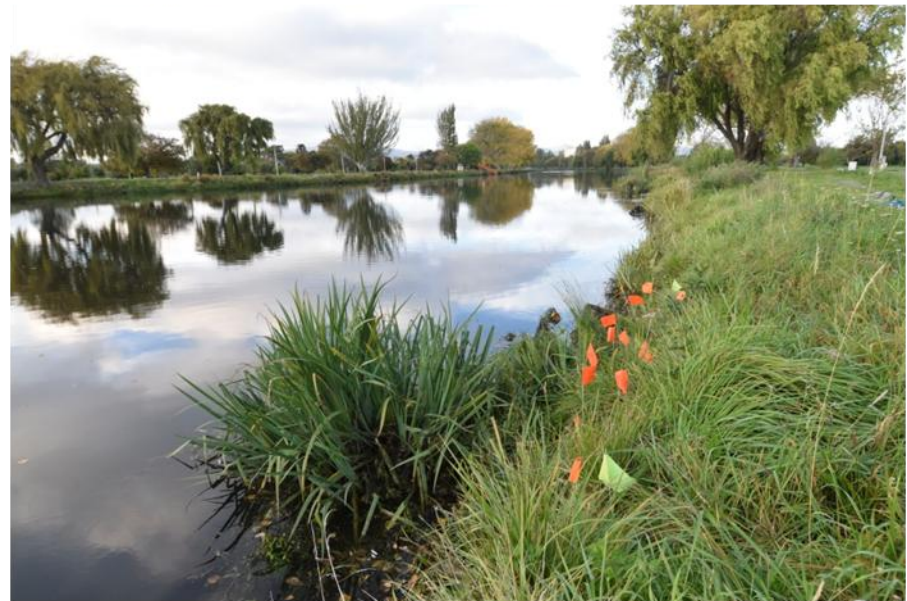
Appendix 1. Examples of spawning sites in the Avon / Ōtākaro catchment. (b) sites above the Horseshoe Lake/Waikākāriki confluence along New Brighton Road on the true left bank.

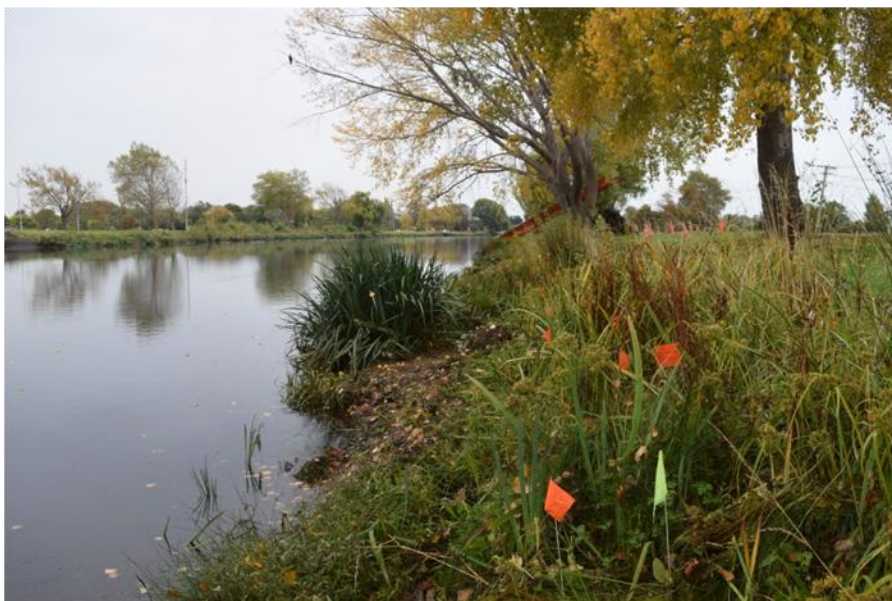
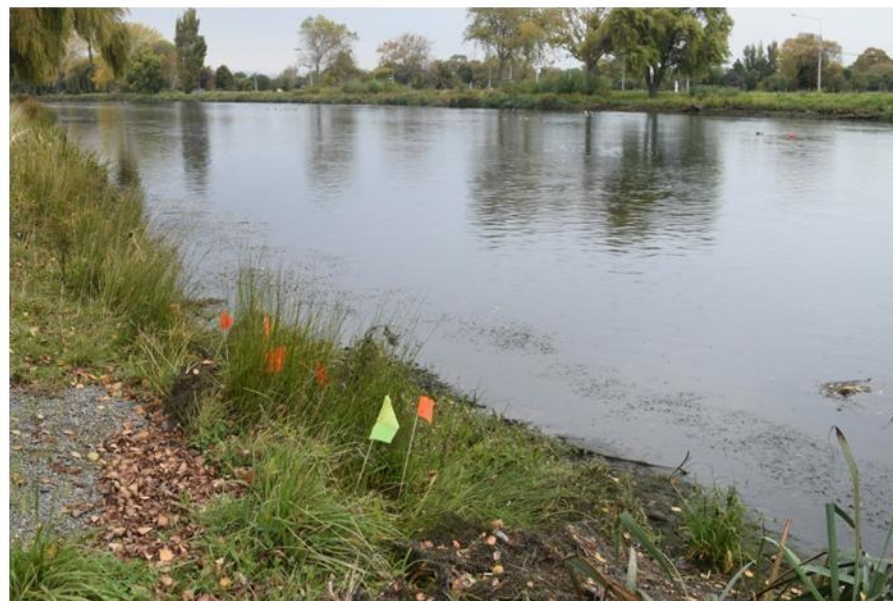
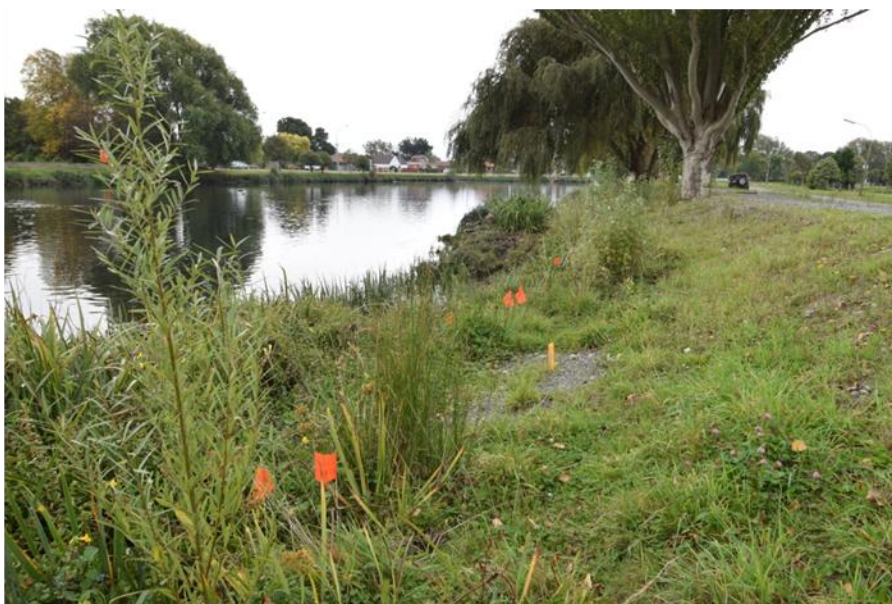
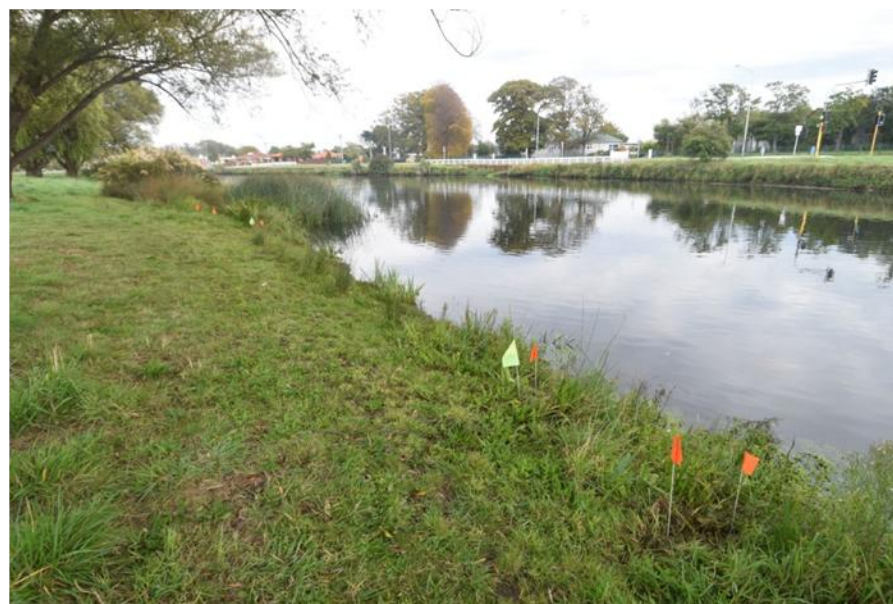
Appendix 1. Examples of spawning sites in the Avon / Ōtākaro catchment. (c) sites upstream of the Avondale Road bridge on the true right bank.

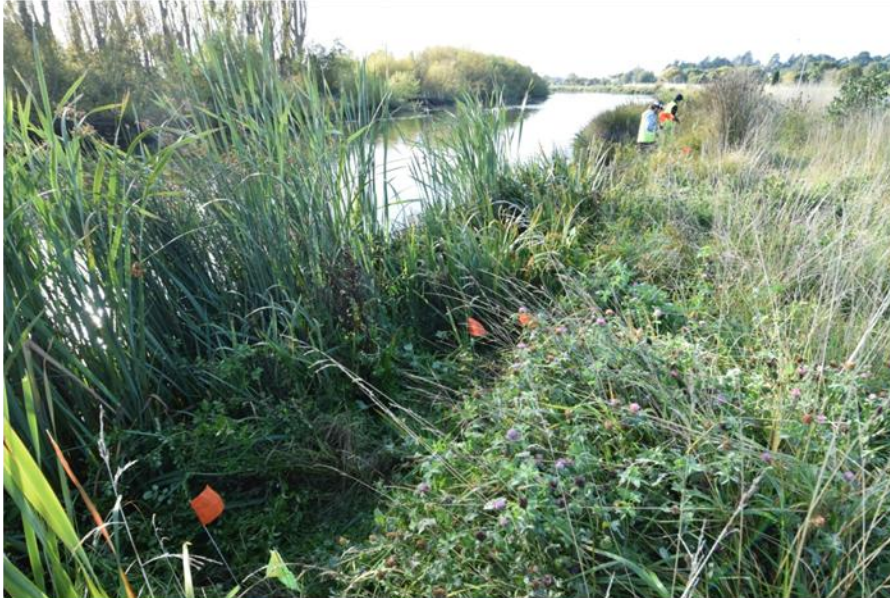
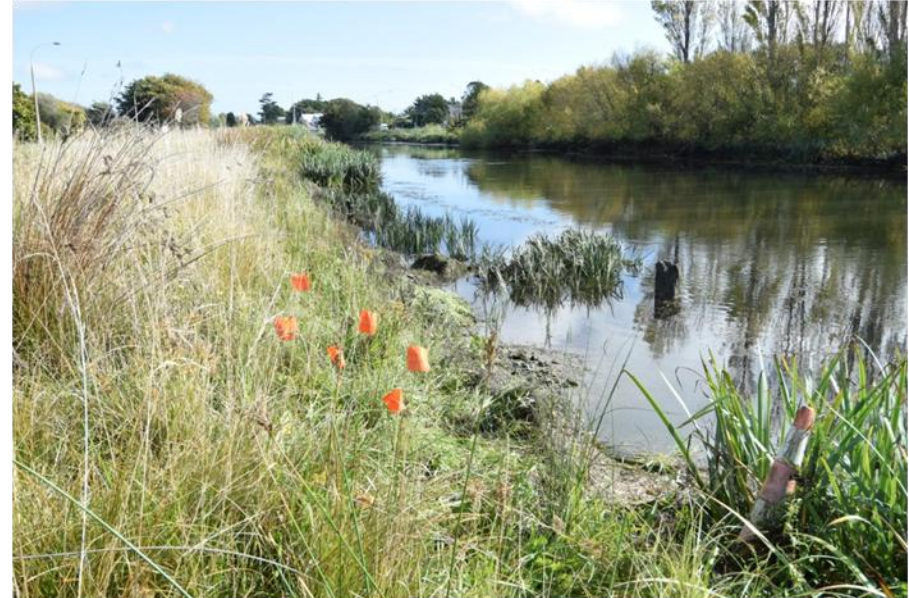
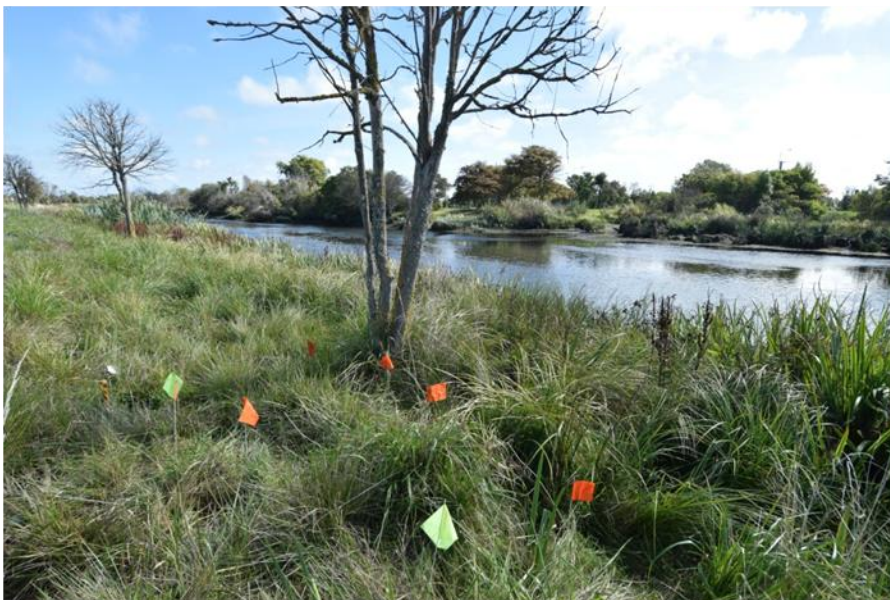
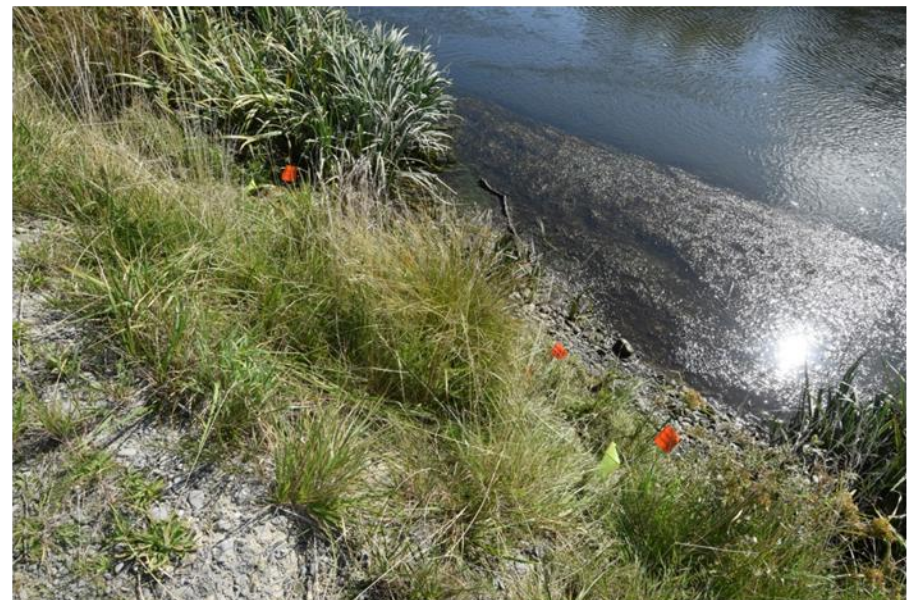
Appendix 1. Examples of spawning sites in the Avon / Ōtākaro catchment. (d) sites upstream of the Avondale Road bridge on the true right bank along Hulverstone Drive.

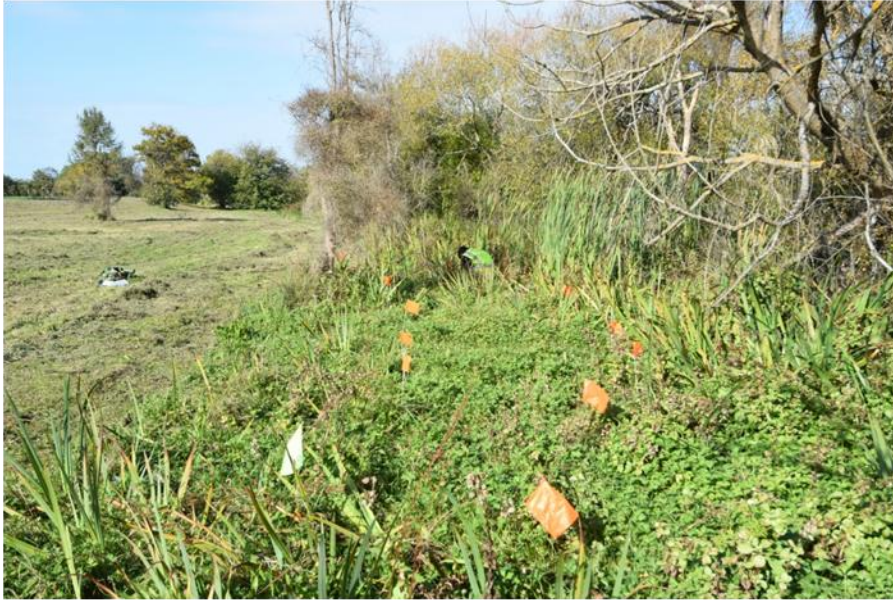
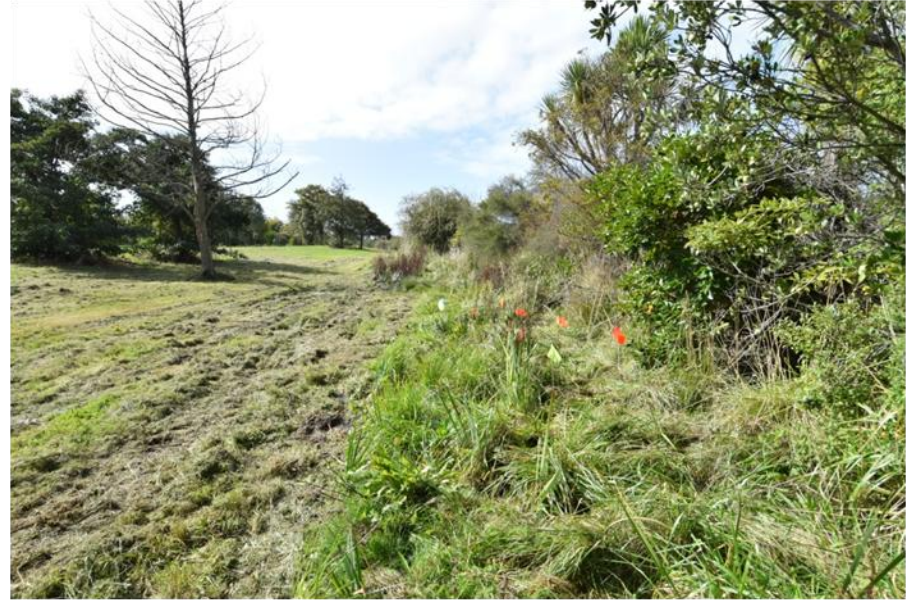
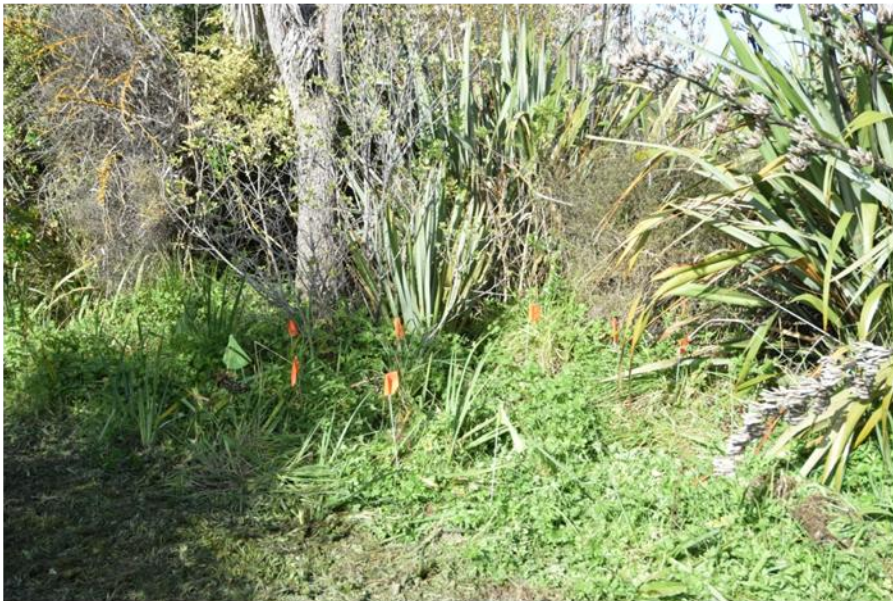
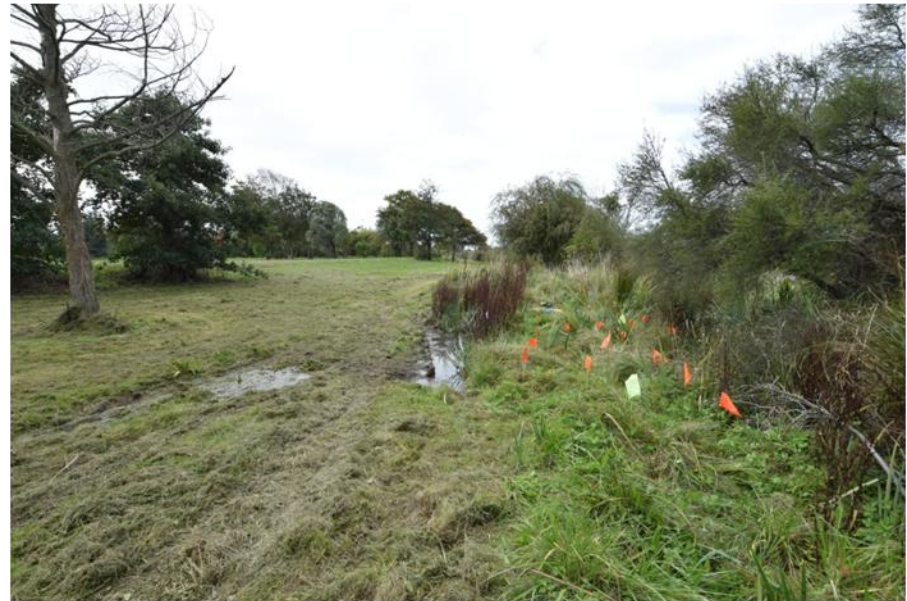
Appendix 1. Examples of spawning sites in the Avon / Ōtākaro catchment. (e) sites downstream of the Avondale Road bridge on the true left bank in Amelia Rogers Reserve.

Another area where new or expanded sites were found is downstream of Avondale Road bridge on the true right where the vegetation has recovered well in response to the trial. Eight new sites were also recorded upstream of the Horseshoe Lake/Waikākāriki confluence. These are in locations that were not typically mown in maintenance work previously though are close to the edge of the mown area. There was also a considerable area of high quality habitat in both rivers that was not utilised for spawning. This included previously used sites located at a similar elevation on the bank face in comparison to the sites that were used.

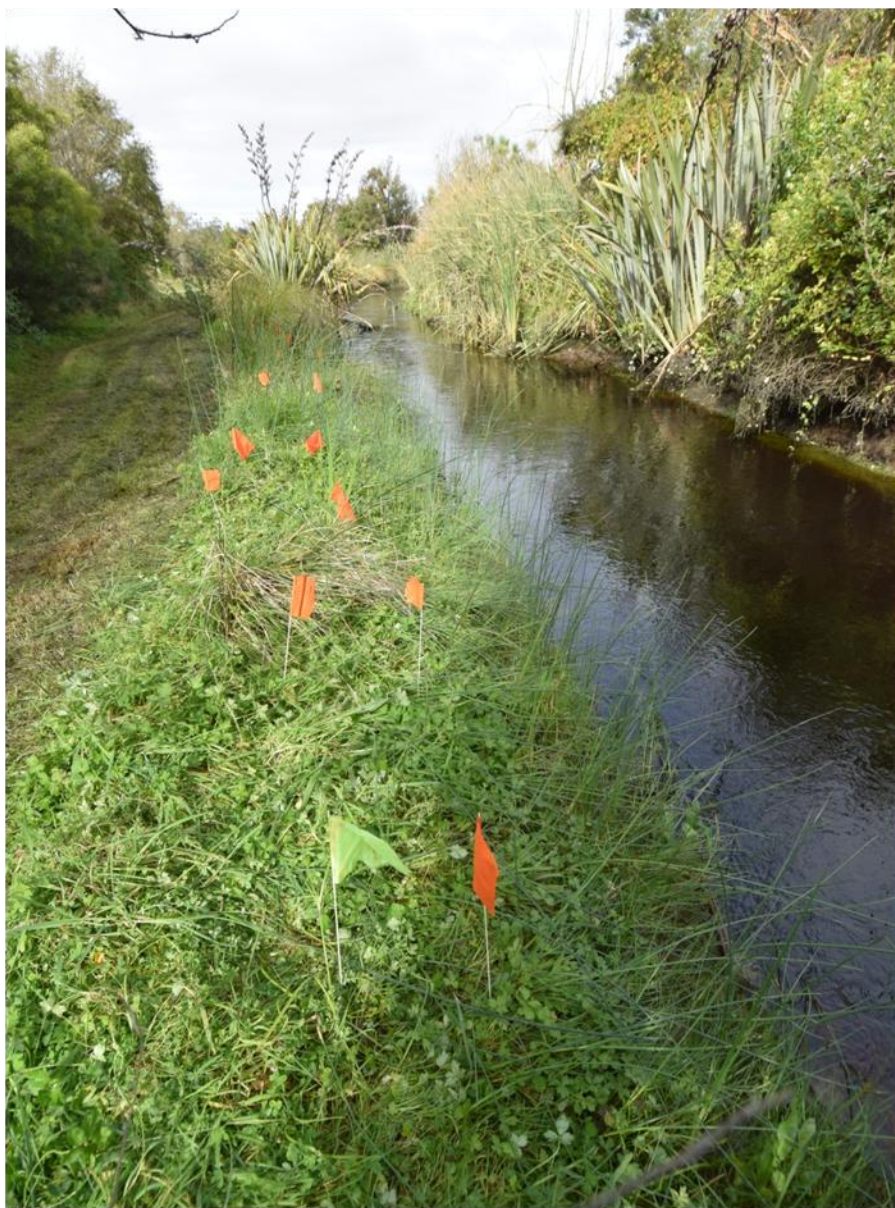
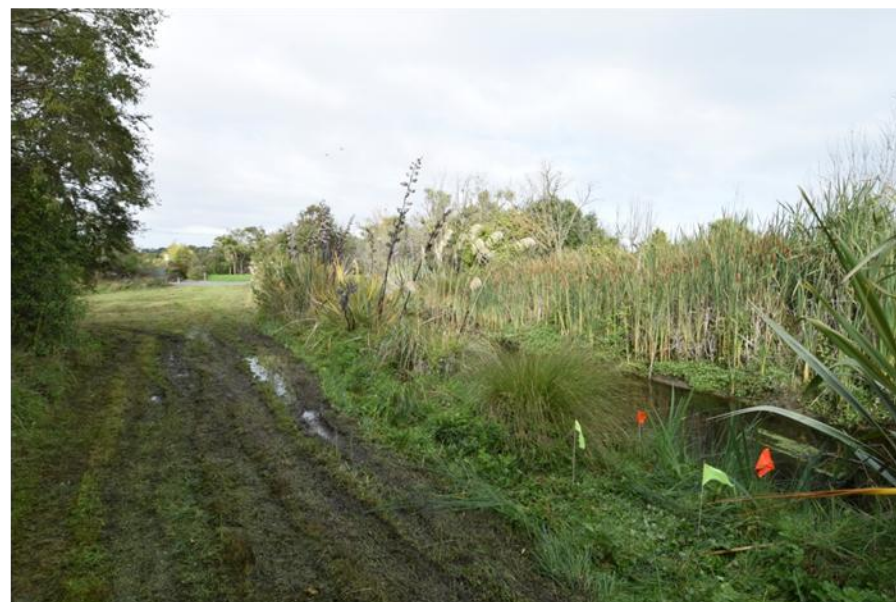
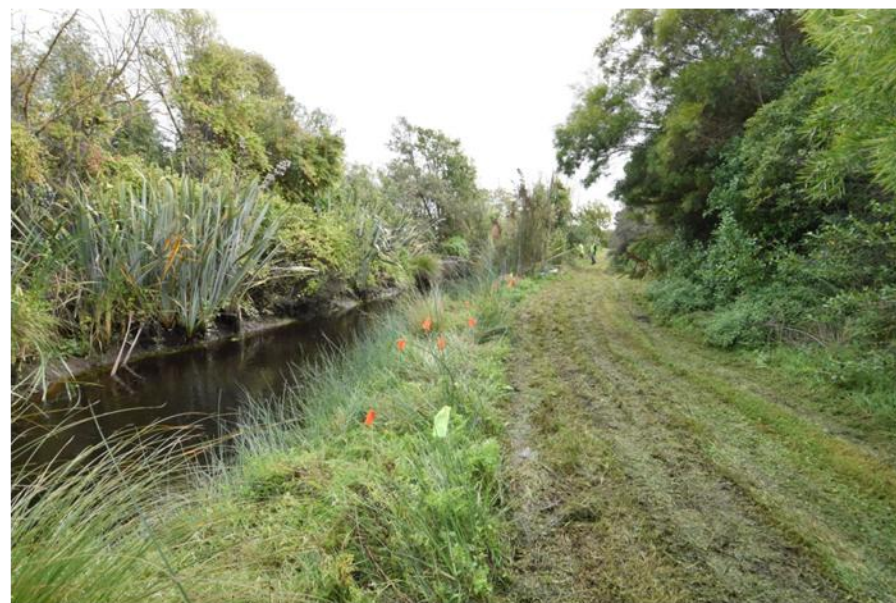
Appendix 1. Examples of spawning sites in the Avon / Ōtākaro catchment. (f) sites on the true left bank of Corsers Stream above the tide gate.

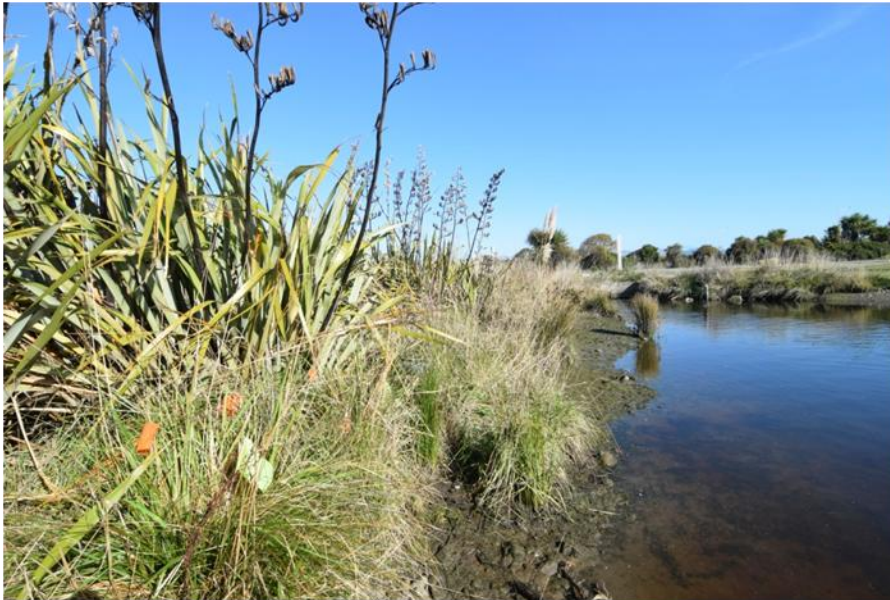
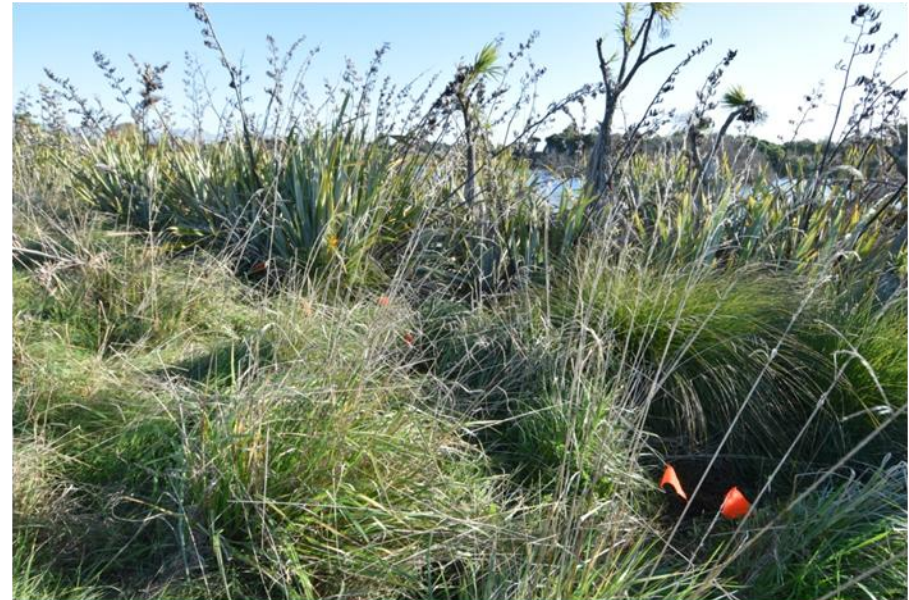
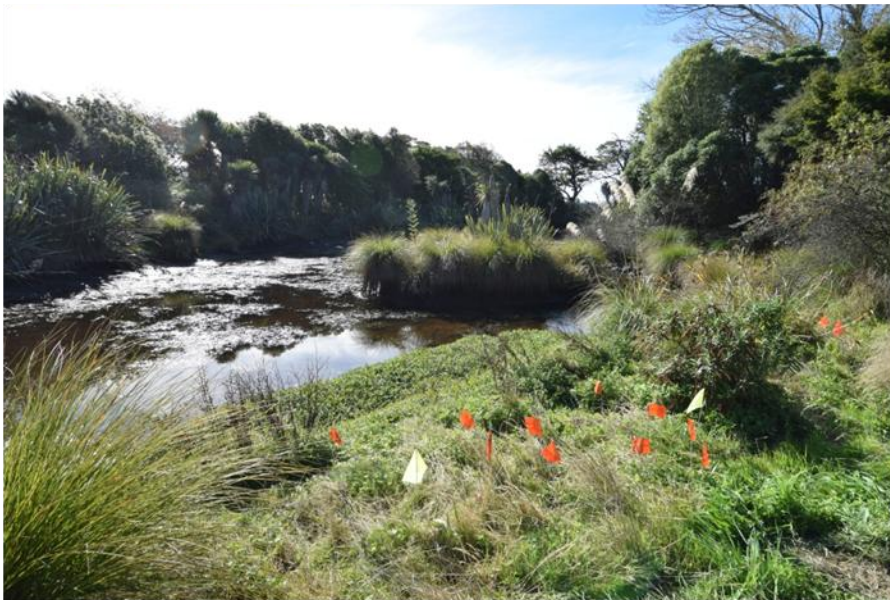
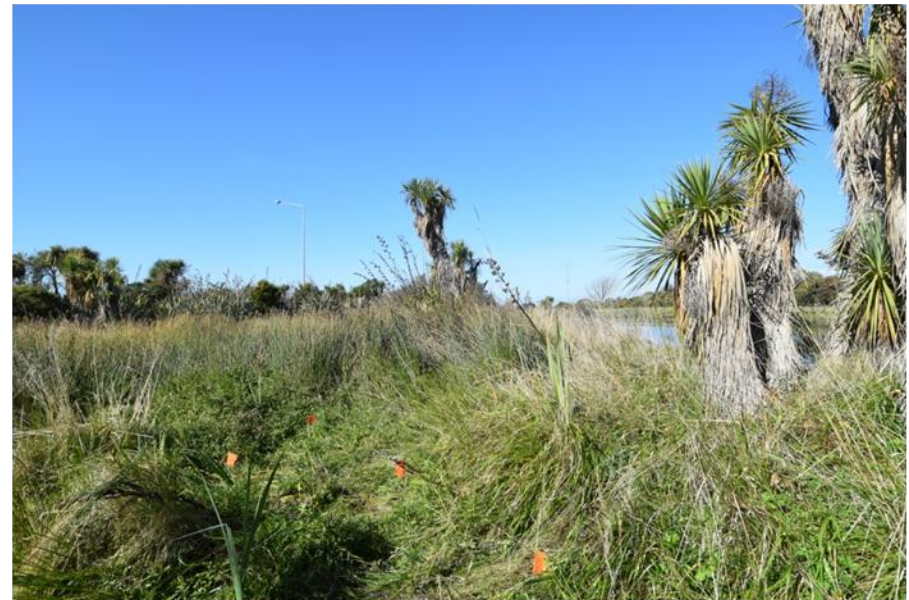
Appendix 1. Examples of spawning sites in the Avon / Ōtākaro catchment. (g) sites in Lake Kate Sheppard (top), in the wetland near the Anzac Road bridge (bottom right), and in Anzac Creek near the New Brighton Road culvert (bottom left).

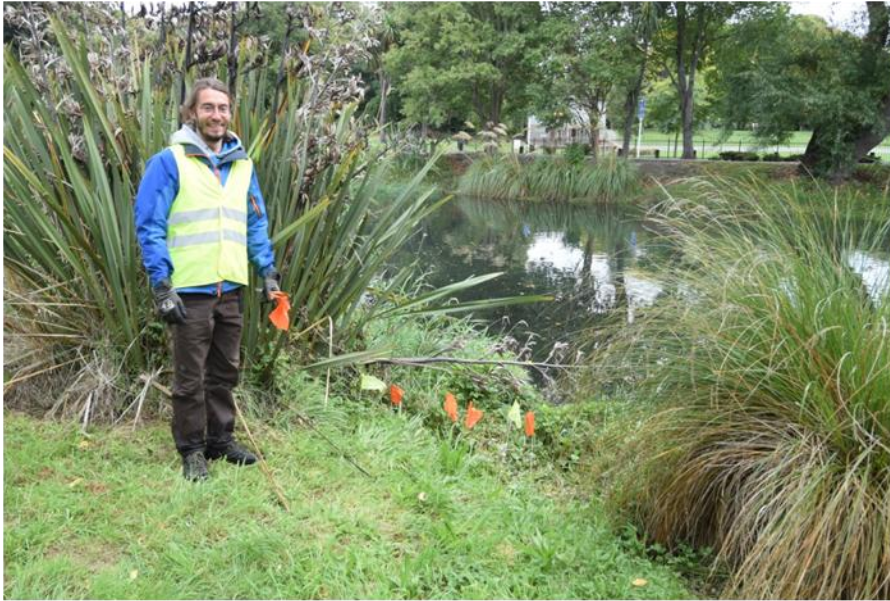
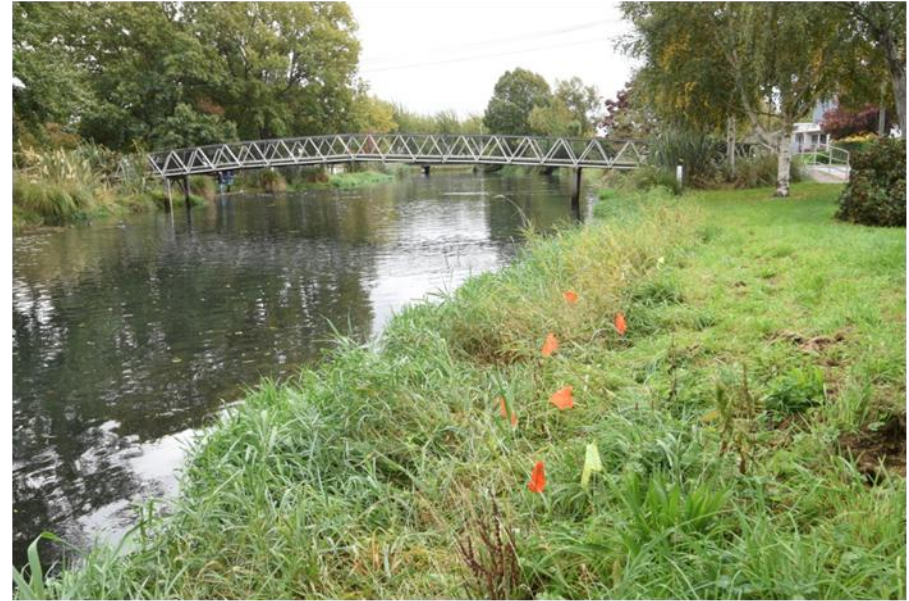
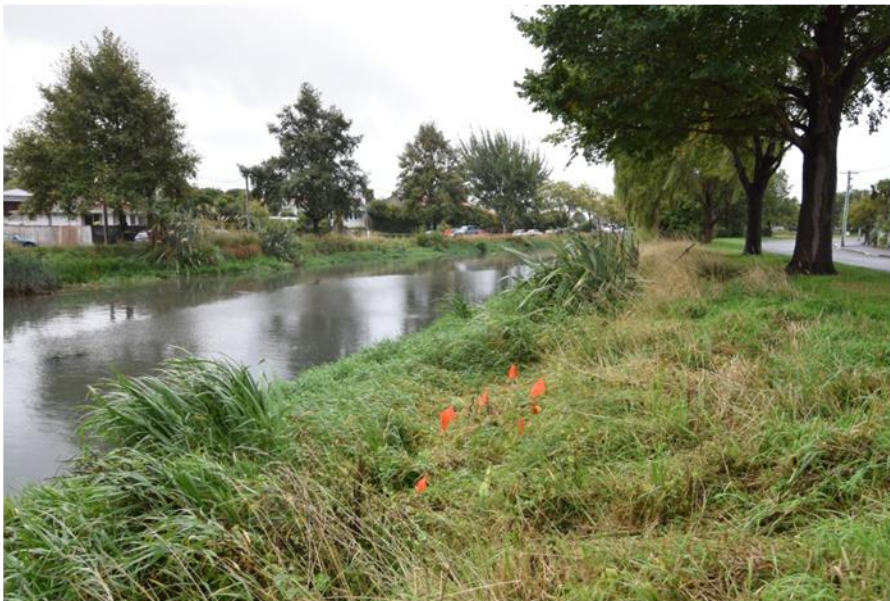
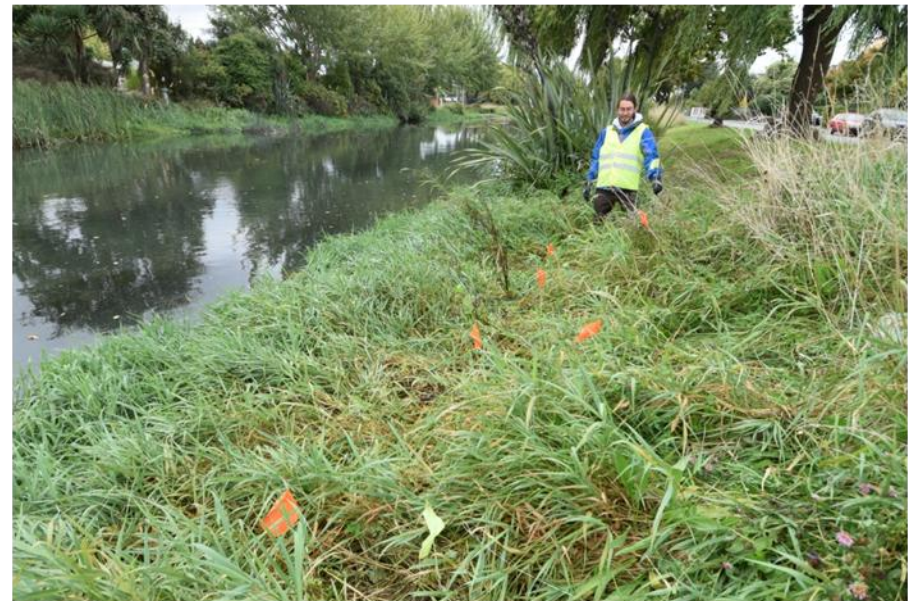
Appendix 2. Examples of spawning sites in the Heathcote / Ōpāwaho catchment. (a) clockwise from top left; furthest upstream site on Aynsley Terrace, spawning along the edge of the reserve near the Aynsley Terrace footbridge, two views of a site on Clarendon Terrace, on the true right bank.
