Response of īnanga spawning habitat to riparian vegetation management in the Avon & Heathcote catchments

Shane Orchard

Christchurch City Council
June 2017

Waterlink Ltd

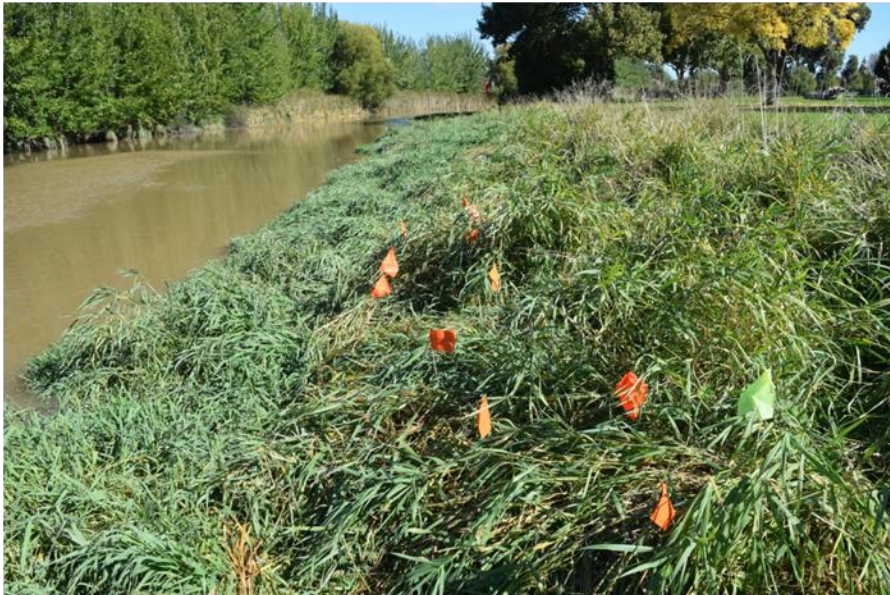
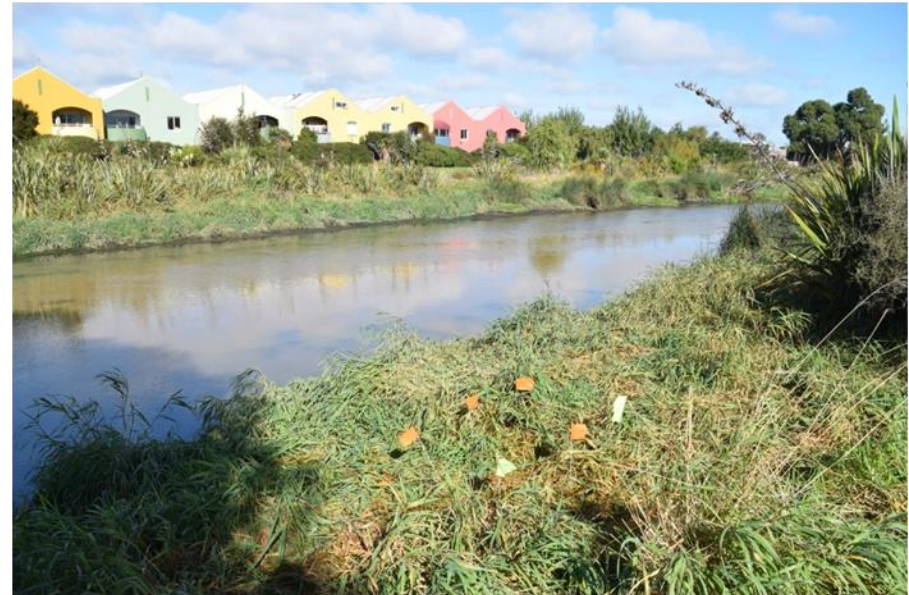
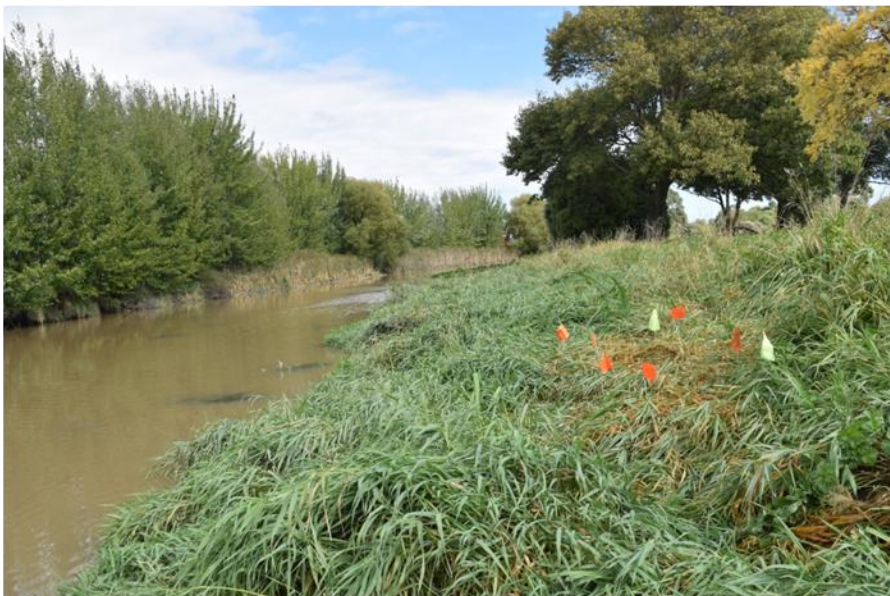
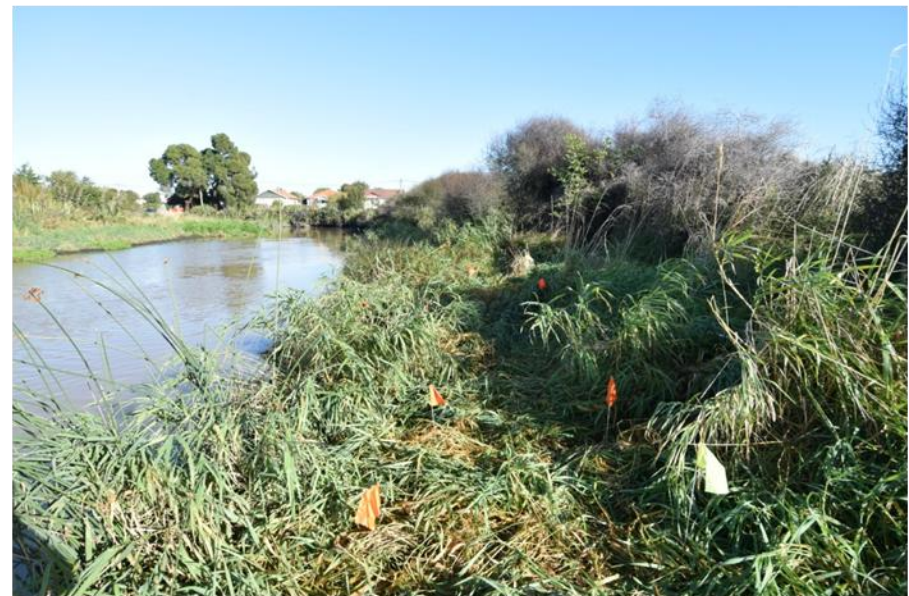
Appendix 2. Examples of spawning sites in the Heathcote / Ōpāwaho catchment. (b) spawning sites in the Radley Park area, on the true right bank.

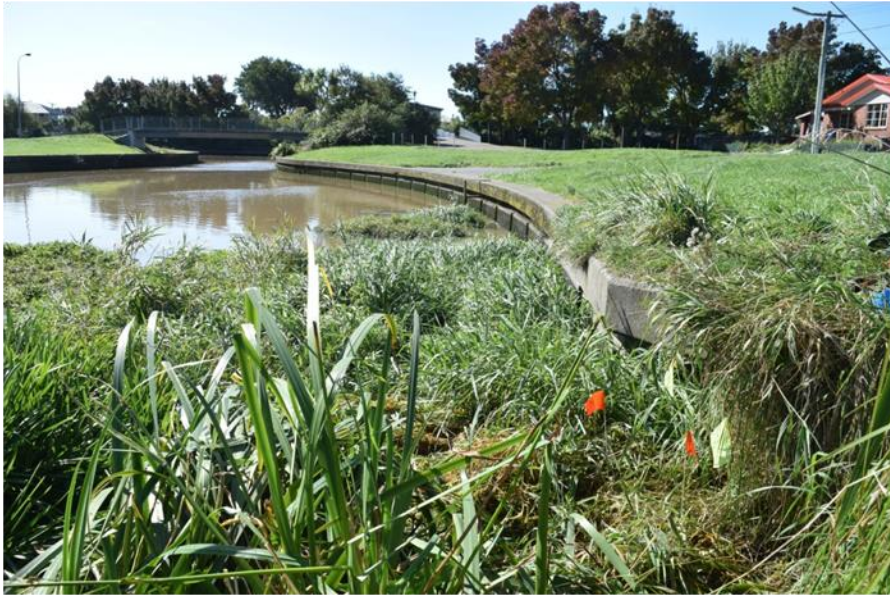
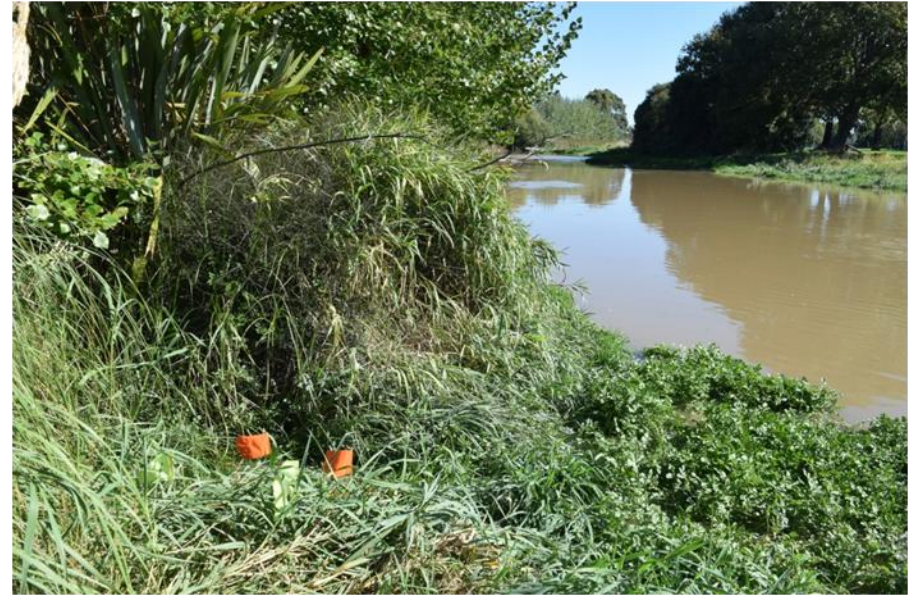
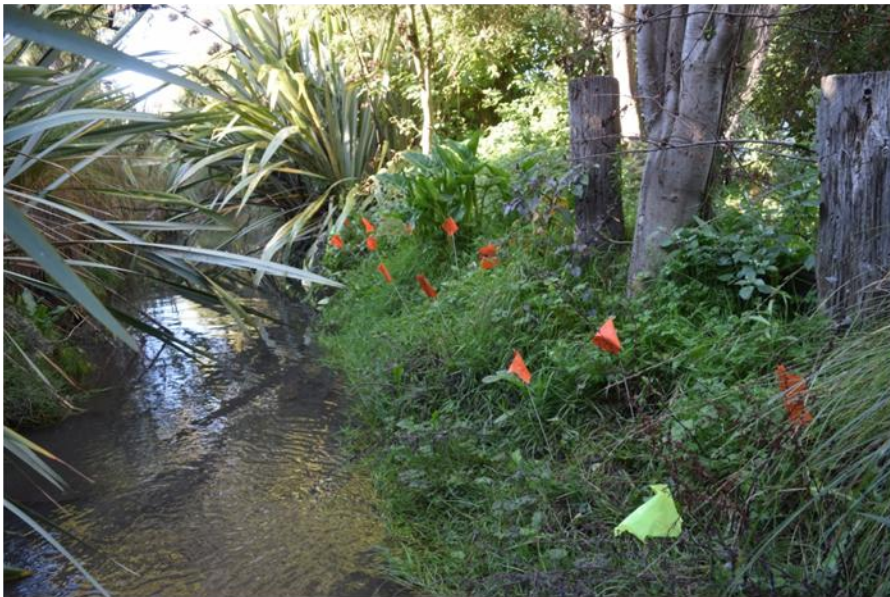
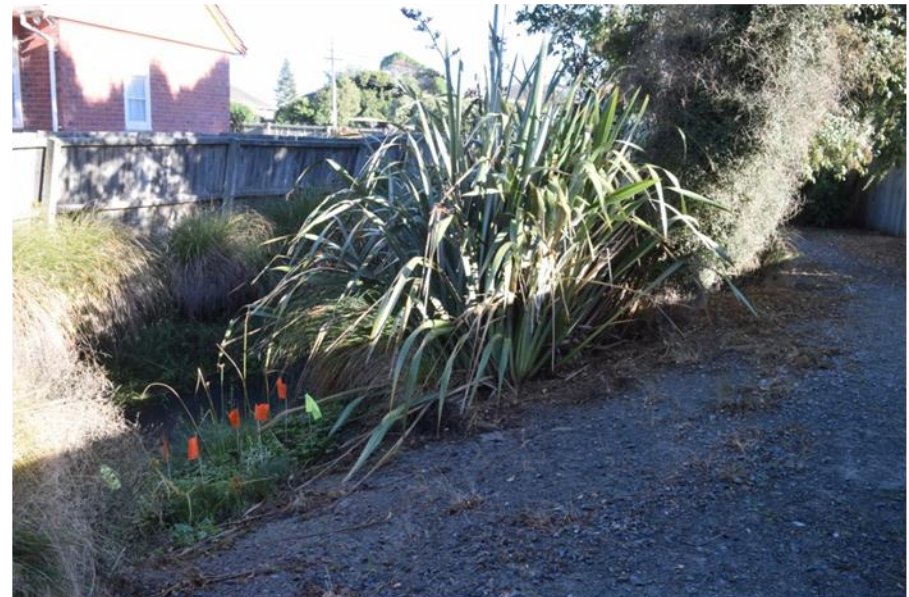
Appendix 2. Examples of spawning sites in the Heathcote / Ōpāwaho catchment. (c) Spawning sites in the Connal Street area, on the true left bank (top), two sites in Steamwharf stream (bottom).

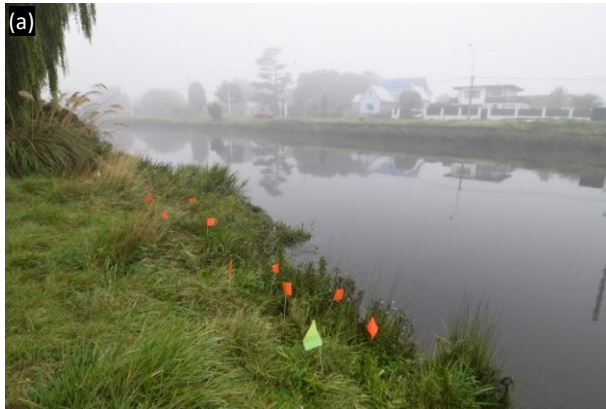
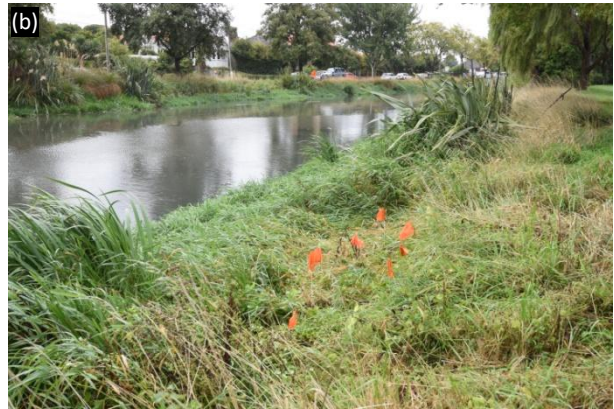
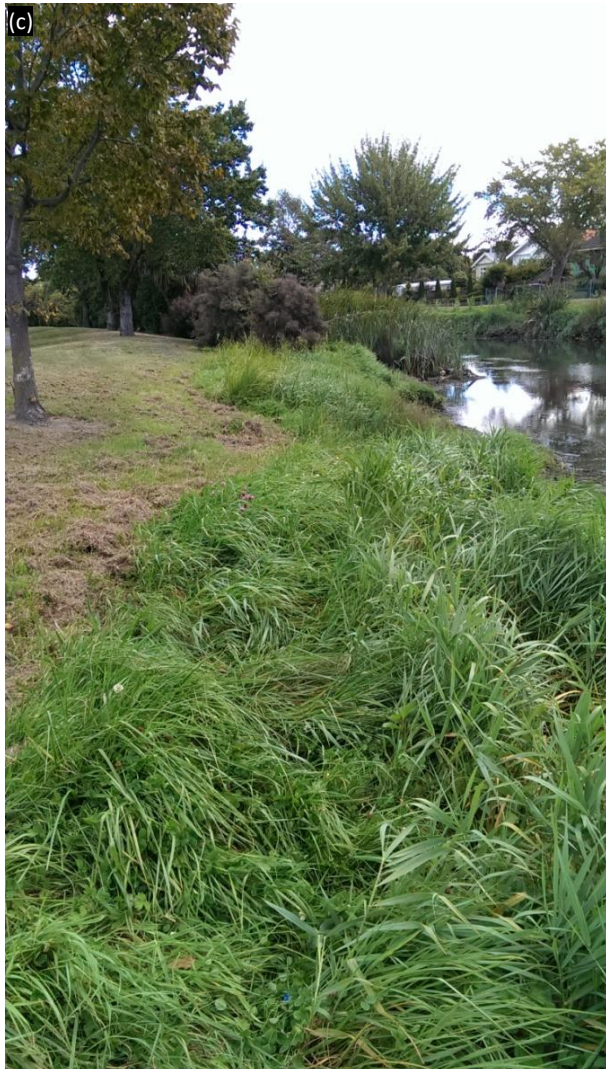
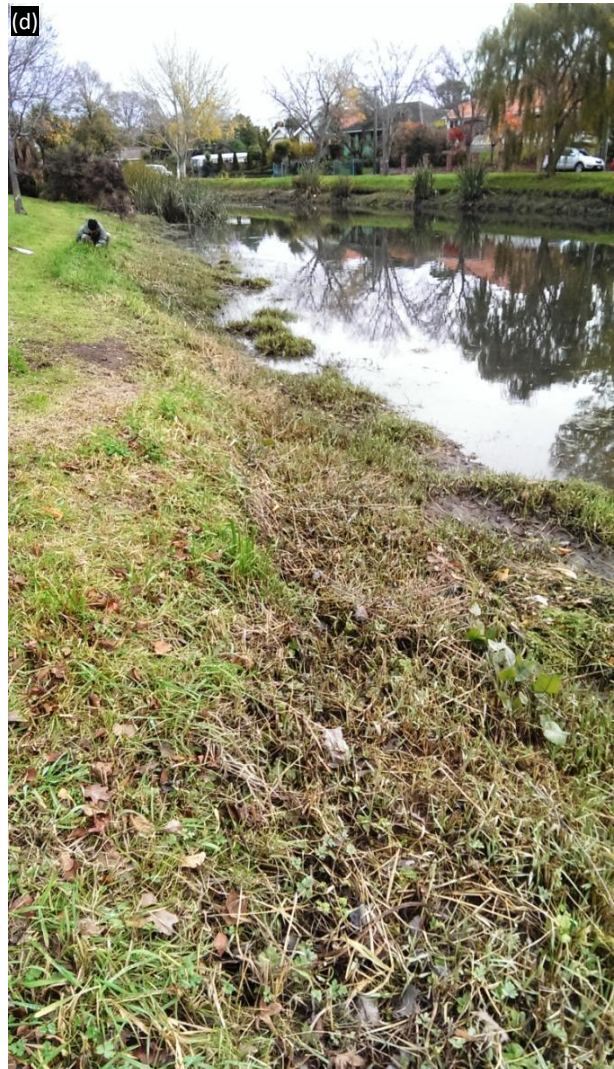
Appendix 3. Sites re-measured to obtain egg survival rates. (a) Clarendon Terrace (Heathcote/Ōpāwaho, 88178 eggs). (b) Avondale Road (Avon/Ōtākaro, 26080 eggs). (c) & (d) 2015 site on Clarendon Terrace with 118000 eggs for which the mortality was 98.4% following the clearance of vegetation on the banks (right).

Two sites not affected by vegetation clearance were selected for comparison to data available from a site on Clarendon Terrace site in 2015 that had been cleared using line trimmers subsequent to spawning. The re-measurement was scheduled 14 days after the first measurement as used in 2015. Unfortunately the 2017 survey found no eggs at the same site. A different site was chosen in the Heathcote/Ōpāwaho further along Clarendon Terrace, and another in the Avon/Ōtākaro just upstream of Avondale Road on the true right. See Appendix 3 for site photos.

The vegetation remained in good condition over the study period at both of two sites selected for re-measurement. At the Avondale Road site (26080 eggs) the survival rate was $84.2\% \pm 7.2(\text{SE})$. This was a patchy site with high densities in clumps of favourable vegetation. At the Clarendon Terrace site (88178 eggs) the survival rate was $67.3\% \pm 0.02(\text{SE})$. This was a less patchy site with relatively high densities throughout. For comparison, a survival rate of 1.6% was recorded at a site re-measured in 2016 following the clearance of vegetation on the bank face using line trimmers (Orchard & Hickford, 2016). See Appendix 3 for site photos. These results are also comparable with survival rates reported in previous studies (e.g. Hickford & Schiel, 2011b).
