# Īnanga spawning in Takamatua Stream, Banks Peninsula

Shane Orchard

Christchurch City Council  
May 2018

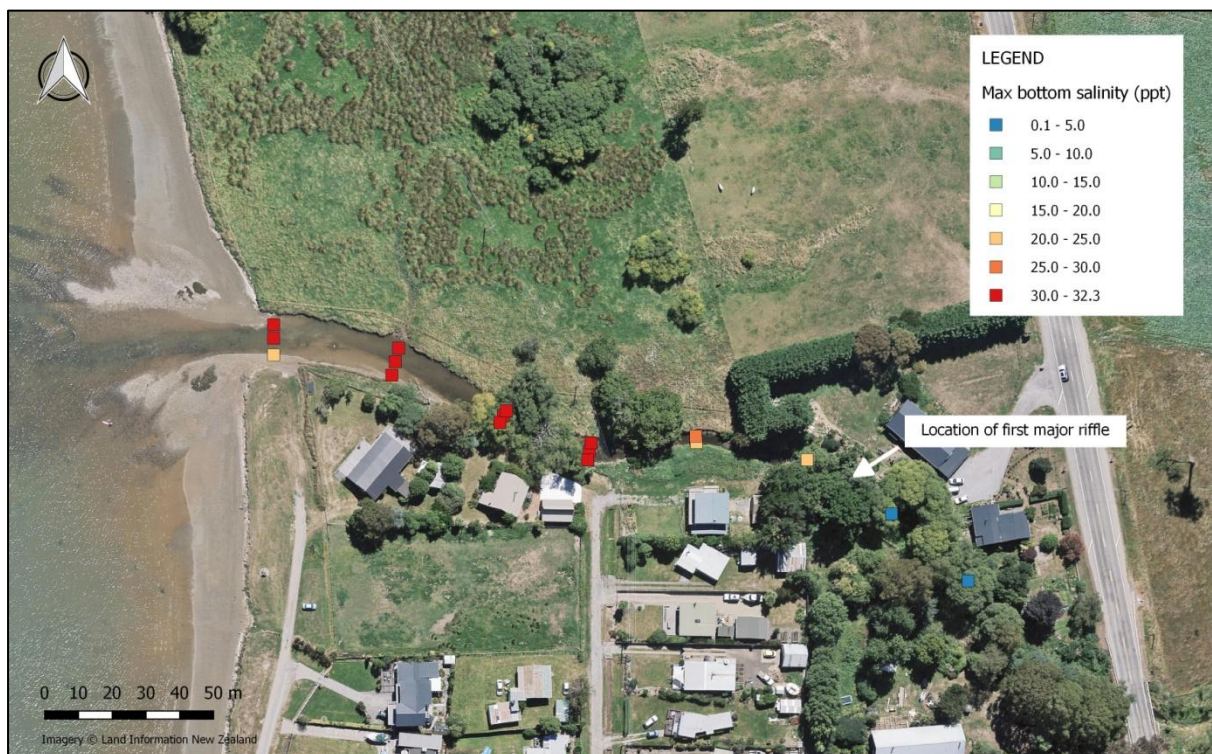
**Figure 4.** Typical spring high tide salinity ranges at Takamatua Stream. Data shown are the maximum bottom salinity recorded at each monitoring site on the spring high tide of 1 March 2018.

Salinity measurements taken on the two spring high tides sampled showed a consistent pattern in this stream. A defined salt water ‘wedge’ (Richardson & Taylor 2002) forms on incoming tides terminating in a relatively sharp salinity front at a major riffle where the stream gradient increases markedly (Figure 4). On the largest predicted tide that was sampled (2.8 m) the tidal flow did not reach the top of this riffle. The furthest upstream position of salt water intrusion was approximately midway ‘up’ this riffle at the same location of the furthest upstream spawning site found later that month (see below). Downstream of this riffle the salinity regime is relatively stratified on the incoming tide (Figure 5). A deeper stretch of the stream (the ‘pool below willow’) appears to influence the stratification characteristics, possibly due to the slower flow in this stretch allowing greater mixing of the bottom layer with water closer to the surface (Figure 5). Alternatively this may reflect the influence of localised upwelling at the positions where measurements were taken. The influence of a small freshwater input from a side drain on the true left can also be seen in Figure 4 near the stream mouth.

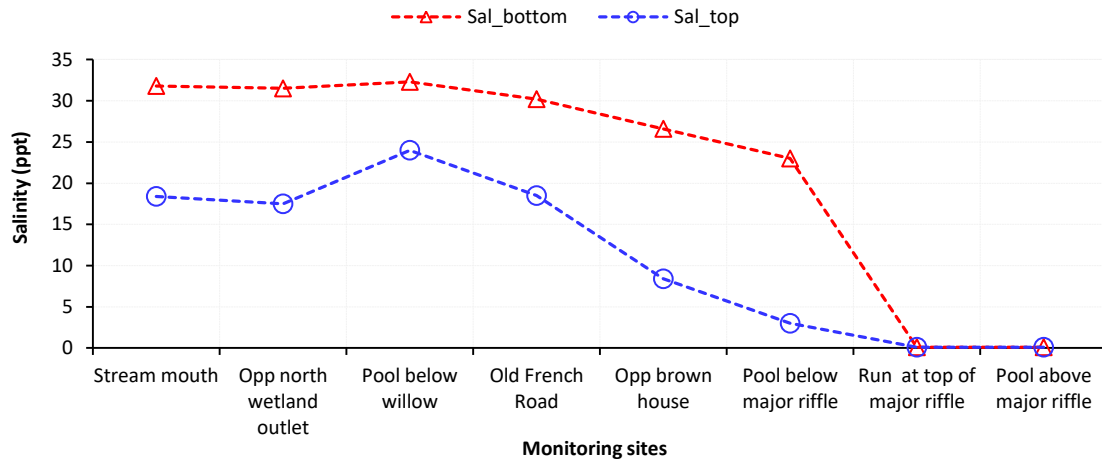
**Figure 5.** Plot of maximum salinity at the bottom, and 10 cm from the top of the water column, as recorded at monitoring sites in Takamatua Stream on the spring high tide of 1 March 2018.

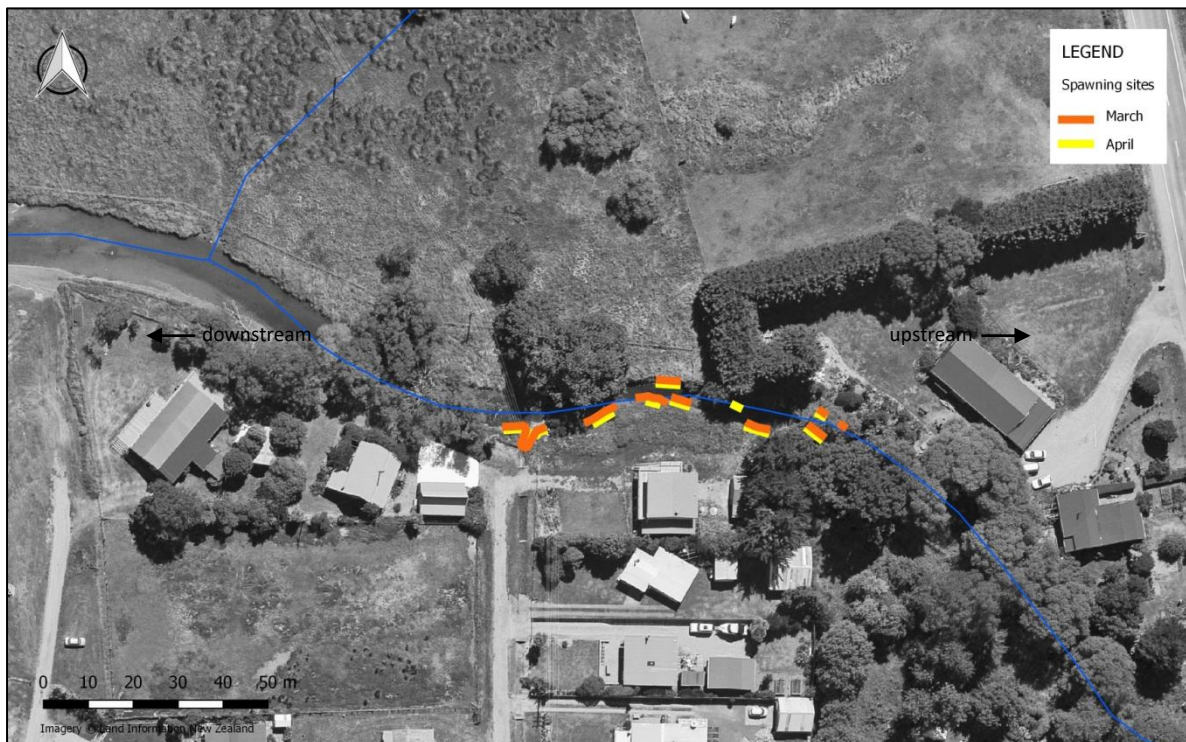
**Figure 6.** Location and extent of Īnanga spawning sites identified in Takamatua Stream in March and April 2018.

Nine spawning sites were found in the vegetation searches in March, three on the true right and six on the true left (Figure 6). All of the sites were located between Old French Road and the first major riffle upstream, and included spawning at same location as the previous record in 2012. The total length of the spawning reach was around 100 m. Repeat use of most of the March sites was observed in April. The egg band occupied a similar elevation range between months at most sites with some slightly lower (by 5–10 cm) in April. The downstream limit of spawning was the same in both months, and the upstream limit was similar (Figure 6).

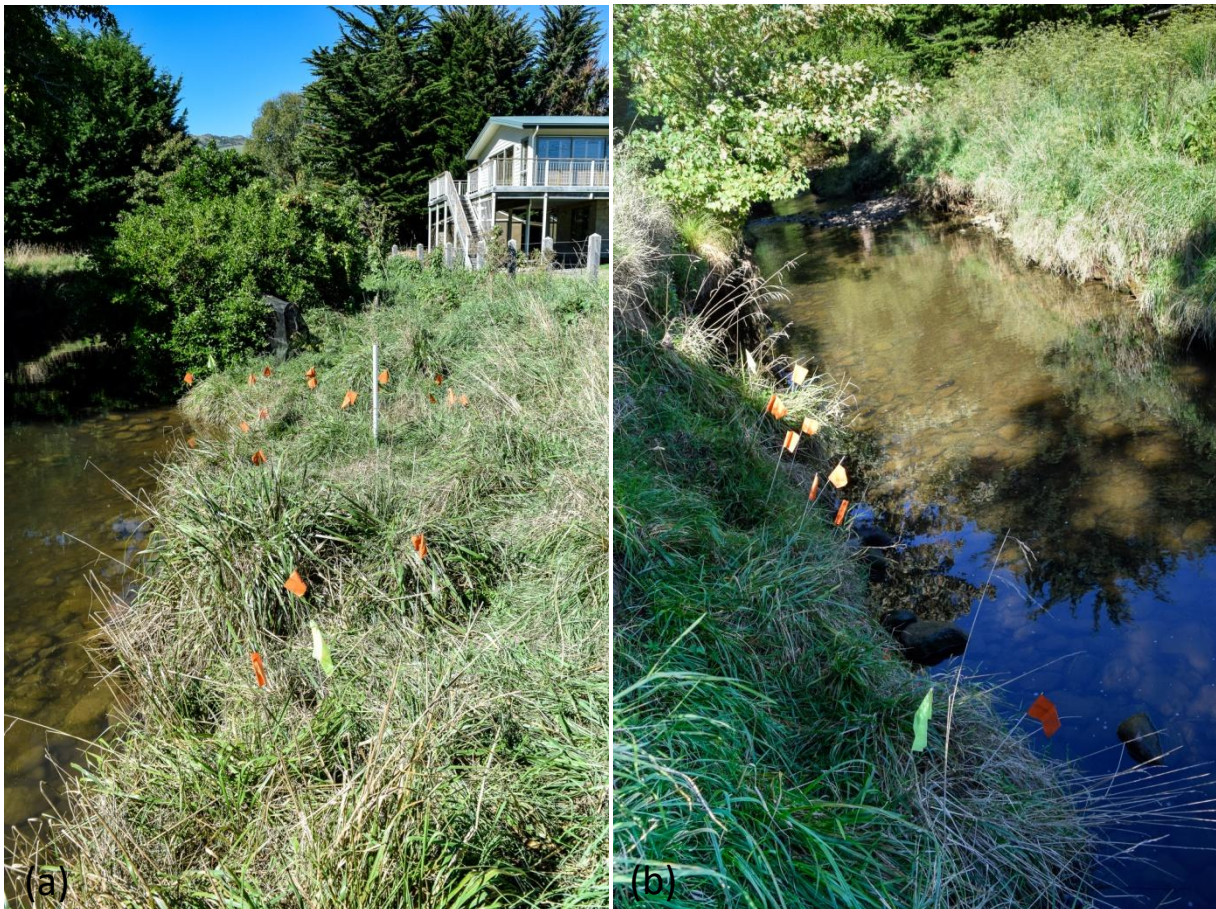
**Figure 7.** Two examples of inanga spawning sites found at Takamatua Stream in March 2018. (a) the largest site found located at the end of Old French Road on the true left. (b) a site on a section of slumped bank on the true right.

The largest spawning site in both months was located on the true left at the end of Old French Road (Figure 7a). The site extended along the main riverbank and around the outlet of a small side drain and was the furthest downstream of all sites found. The stretch of high quality habitat extends downstream to where bank reinforcement with concrete and rubble has affected the waterway margin. Other spawning sites on the true left were located on steep banks and small ledges upstream of Old French Road (see photos in Appendix 1). Vegetation in contact with the eggs was mainly tall fescue (*Schedonorus arundinaceus*) and creeping bent (*Agrostis stolonifera*).

On the true right only small stretches of high quality habitat were found with the largest spawning site being on a section of slumped bank (Figure 7b). On this bank the vegetation is mostly sparse at the level of the high tide waterline with relatively recent bank erosion in some places.

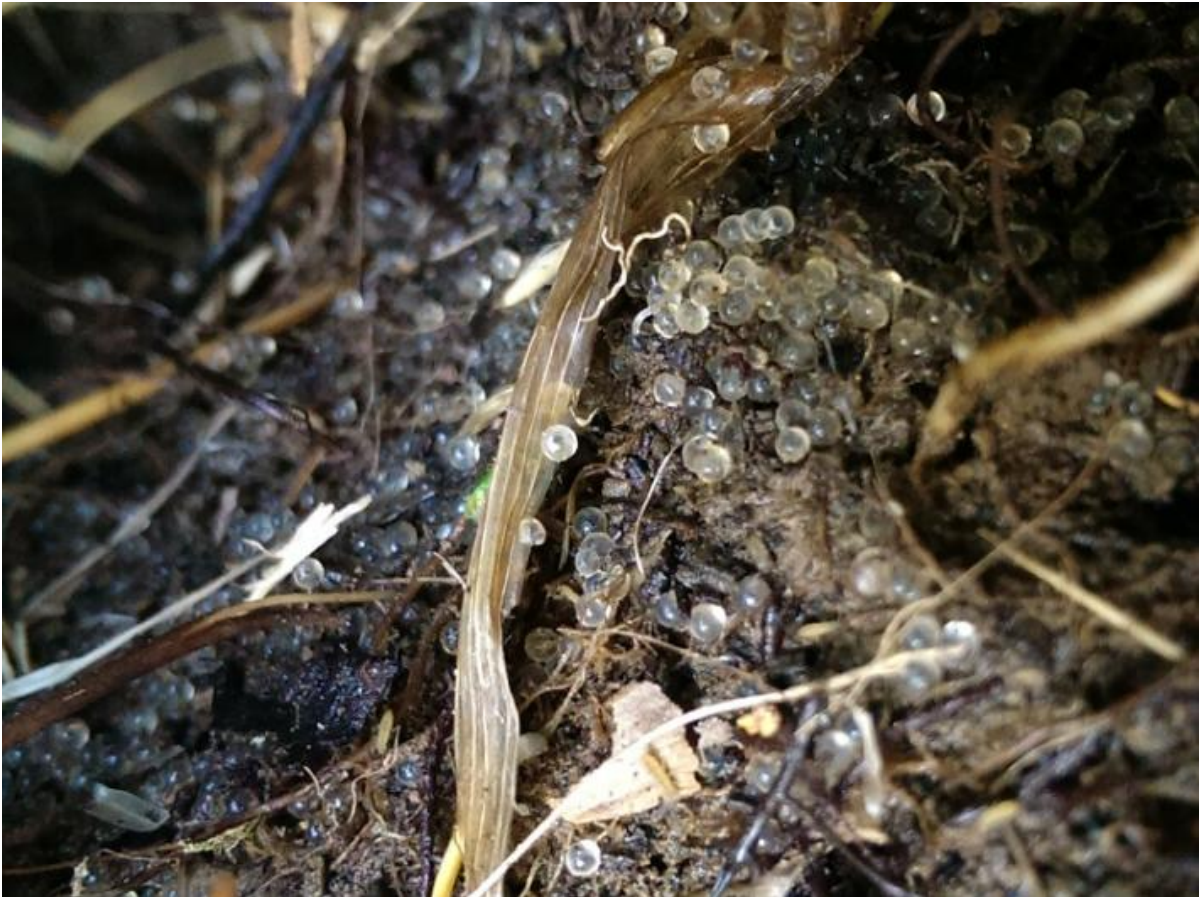
**Figure 9.** High egg densities at a spawning site in April 2018. This site (TR2) was located on the true right in a clump of tall fescue.

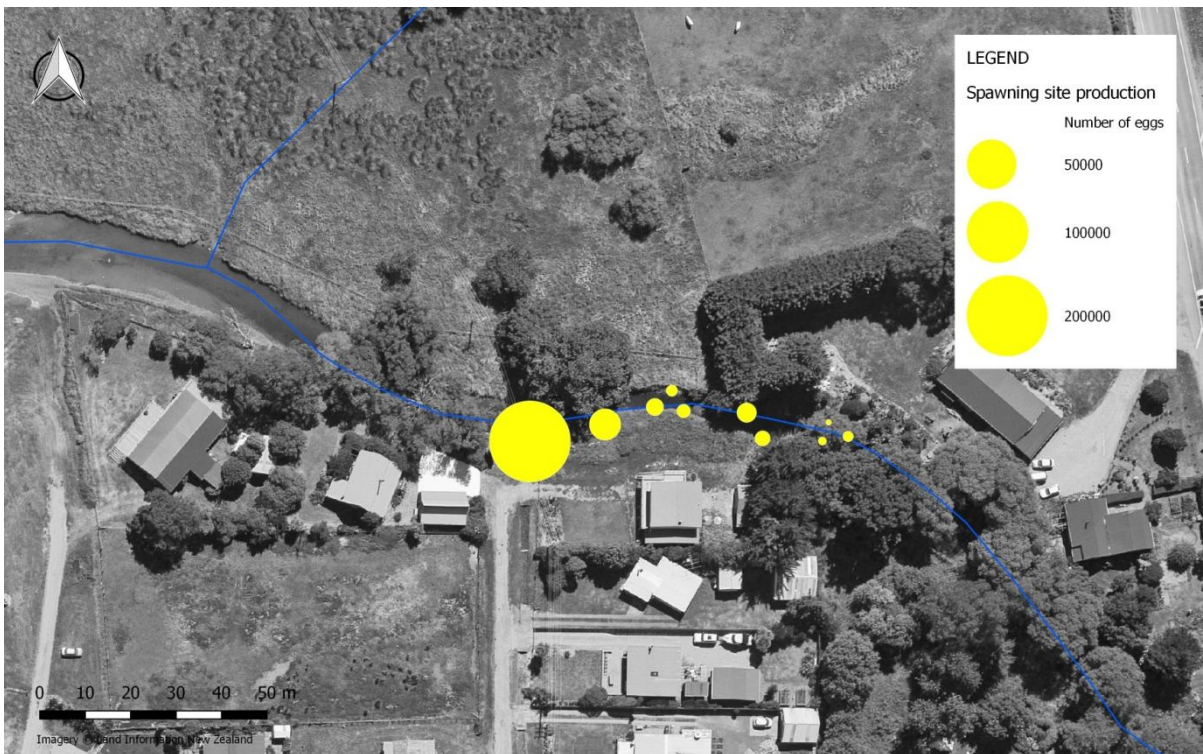
**Figure 10.** Spatial distribution of inanga egg production in Takamatua Stream in 2018 showing combined totals for each of ten spawning sites recorded in field surveys conducted in March and April.

patches with very high egg densities (see Appendix 1B). Most of these were in the base of tall fescue plants. In April the egg production was 146,600 eggs, being slightly more than in March despite the lower AOO. On the true right, a new site (TR2) was found with relatively high egg numbers despite its small size (Figure 9). Spawning sites on the true left contributed 84% of the total. Site TL1 again contributed the most eggs (71%). The spatial distribution of egg production based on combined data is shown in Figure 10.

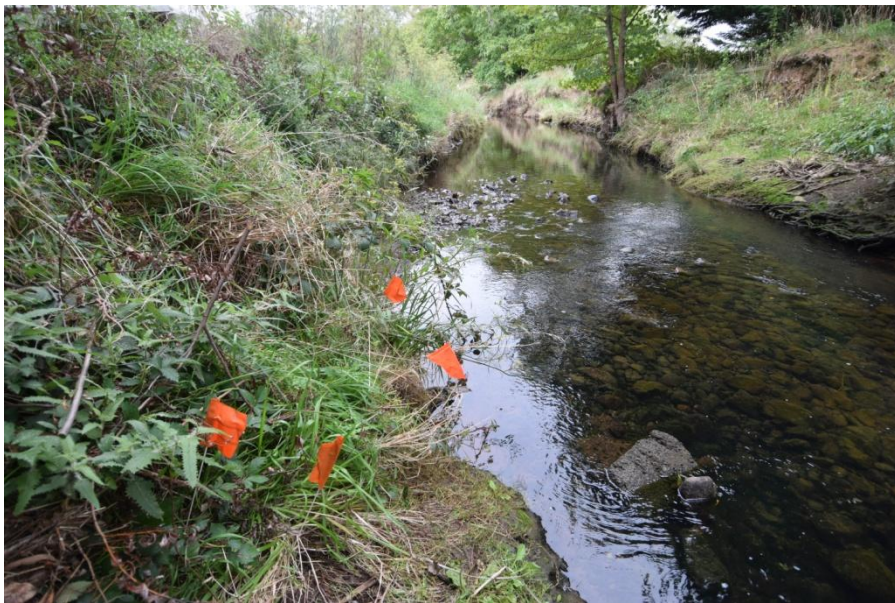
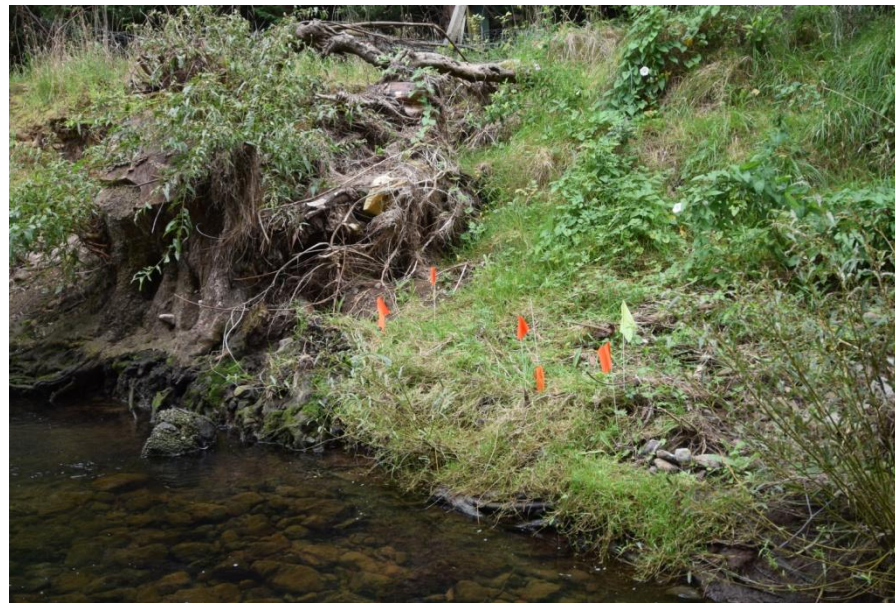
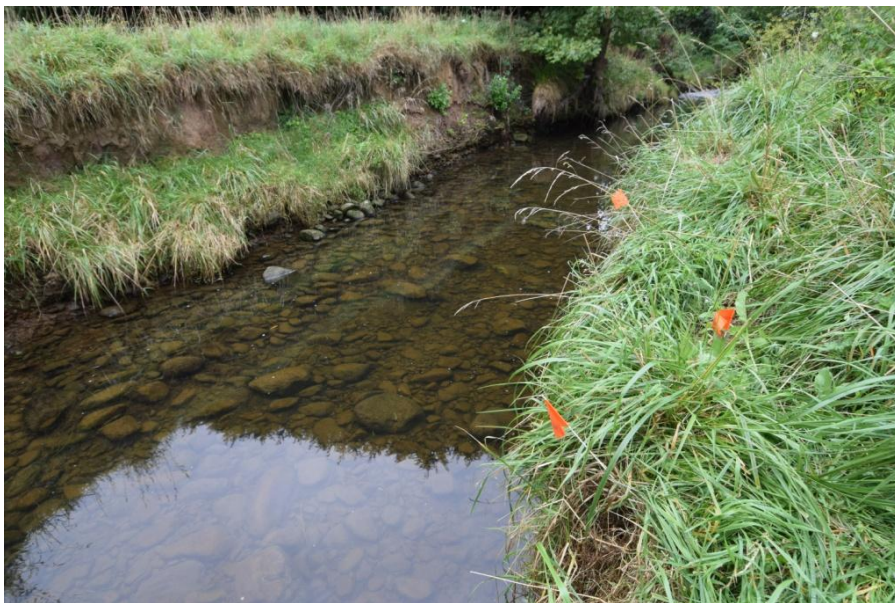
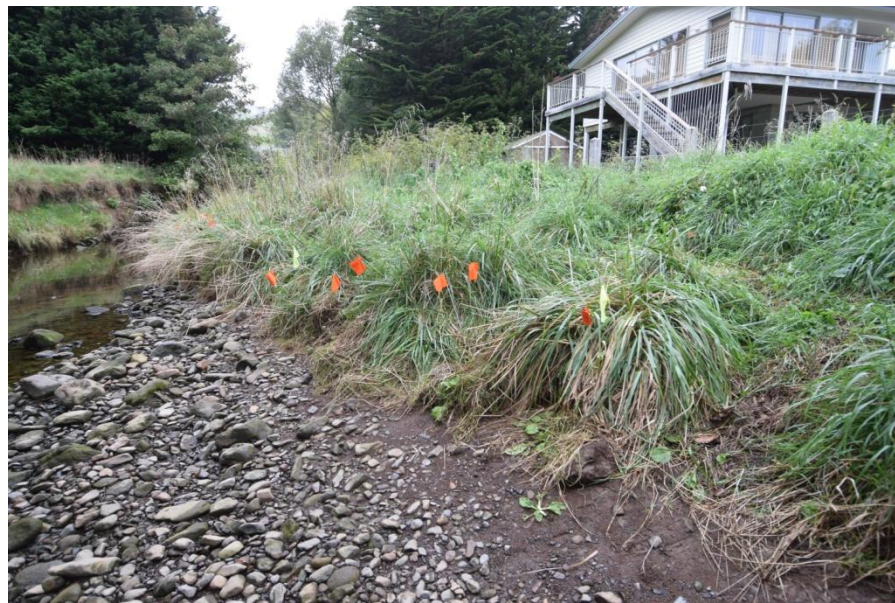
A. March 2018 spawning sites above Old French Road. These sites are located on steep banks and small ledges near the stream channel.

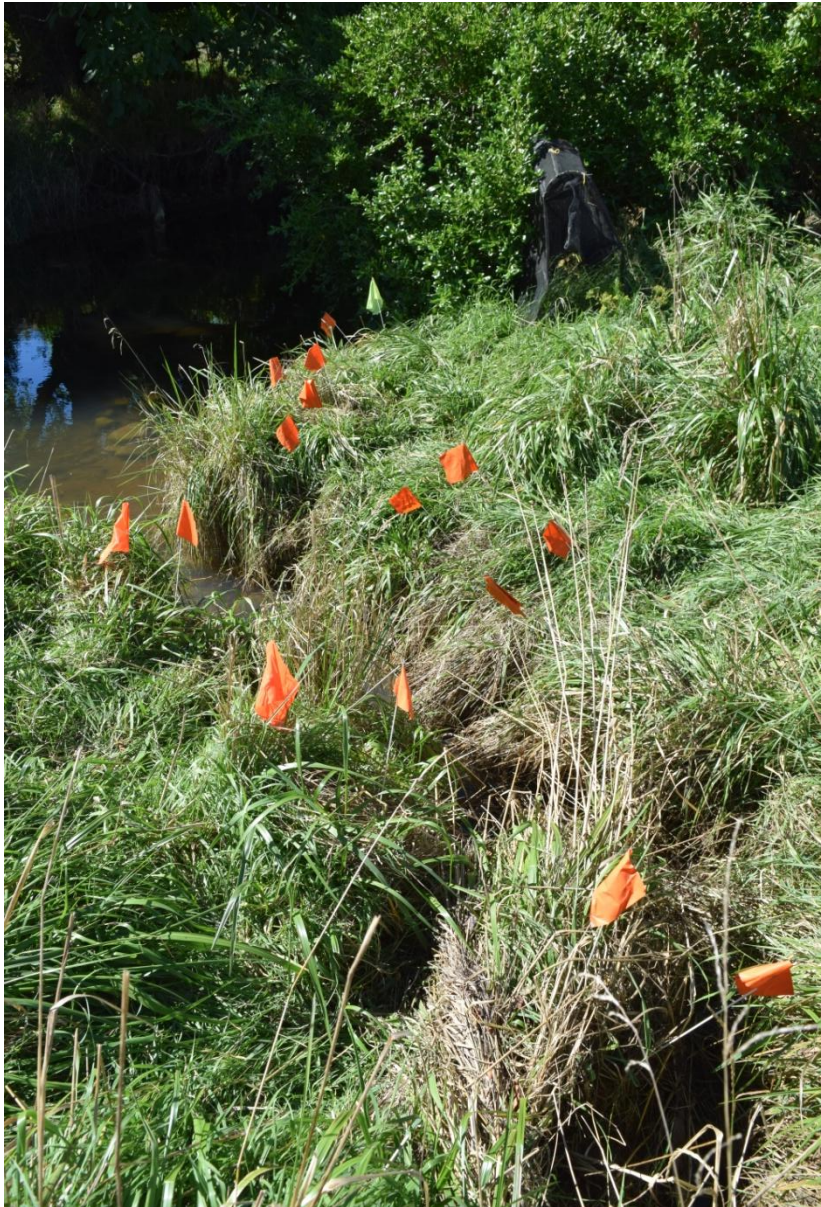
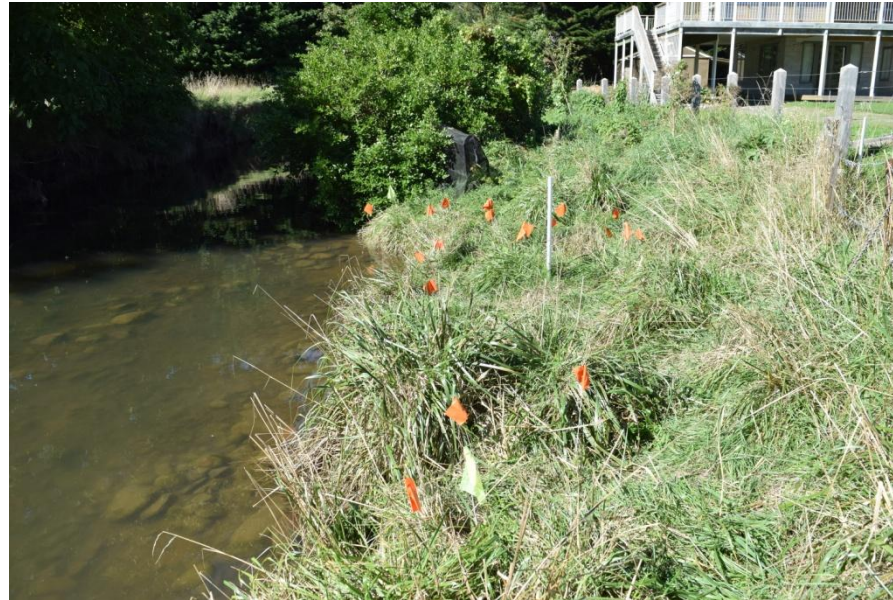
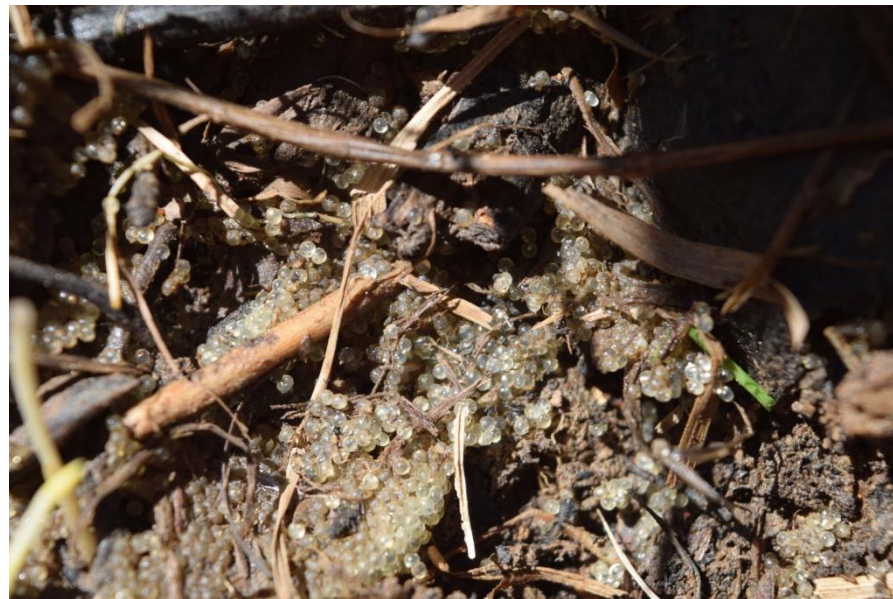
B. Three views of the March 2018 spawning site at the end of Old French Road on the true left (the same location as the spawning site recorded in 2012). Eggs were found in clumps along a 12 m stretch of river bank with very high egg densities in some places as shown bottom right.

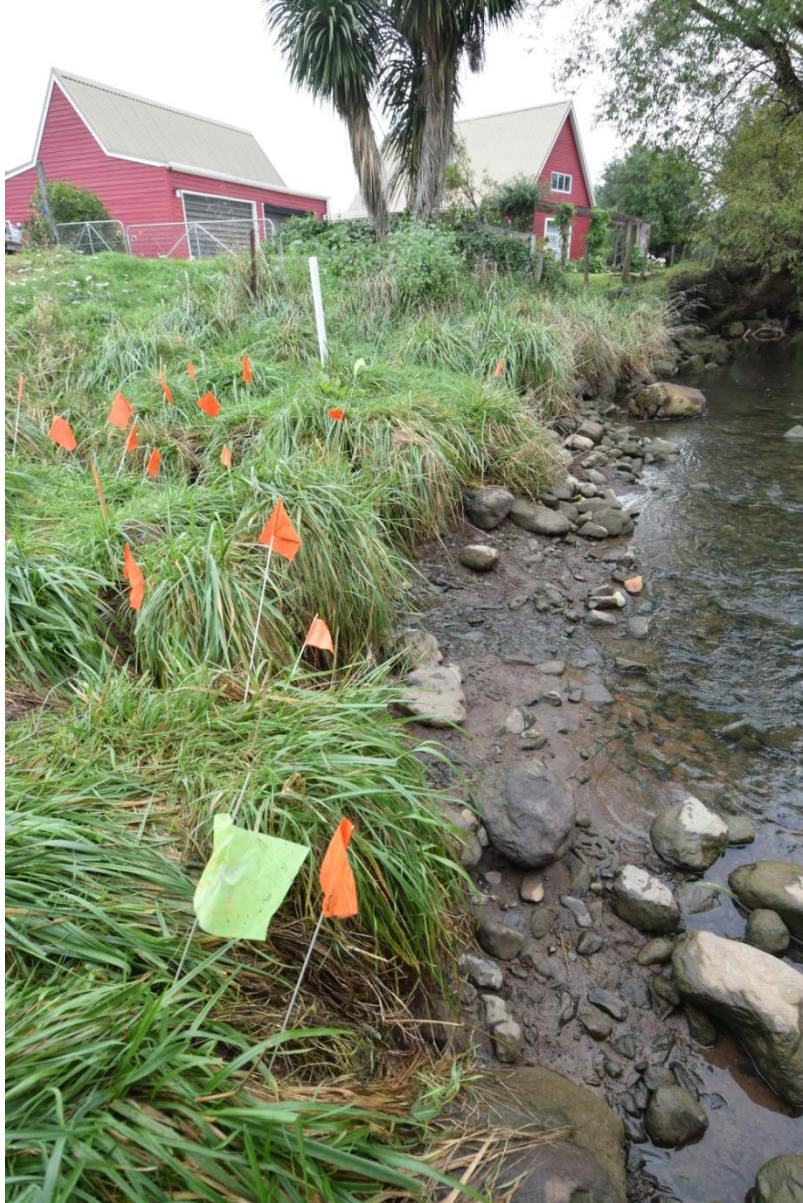
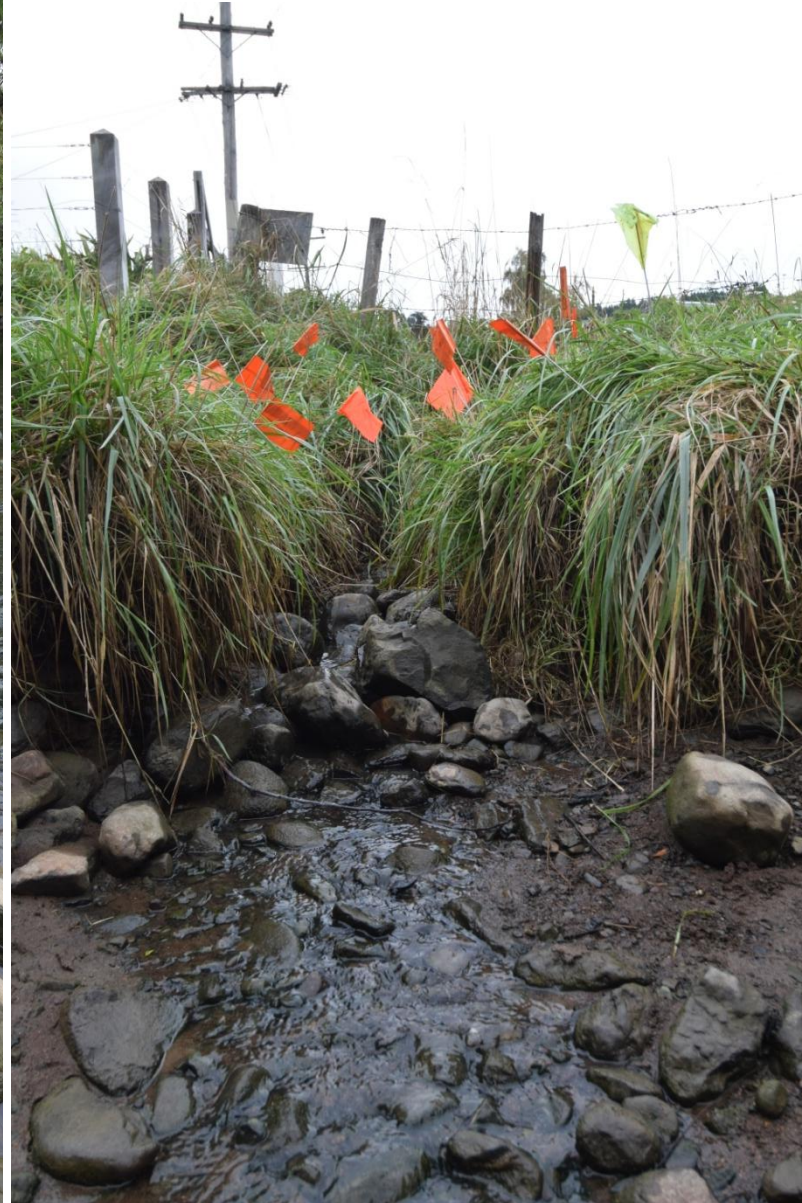
C. Two views of the spawning site at the end of Old French Road in April 2018. The position of the egg band was similar to the March spawning event at this site, with many of the same clumps of vegetation being used.

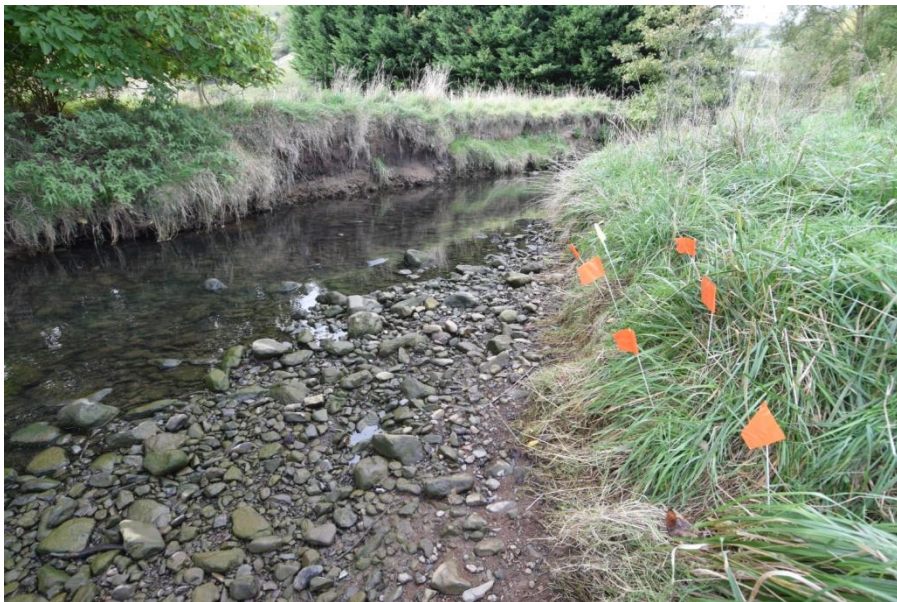
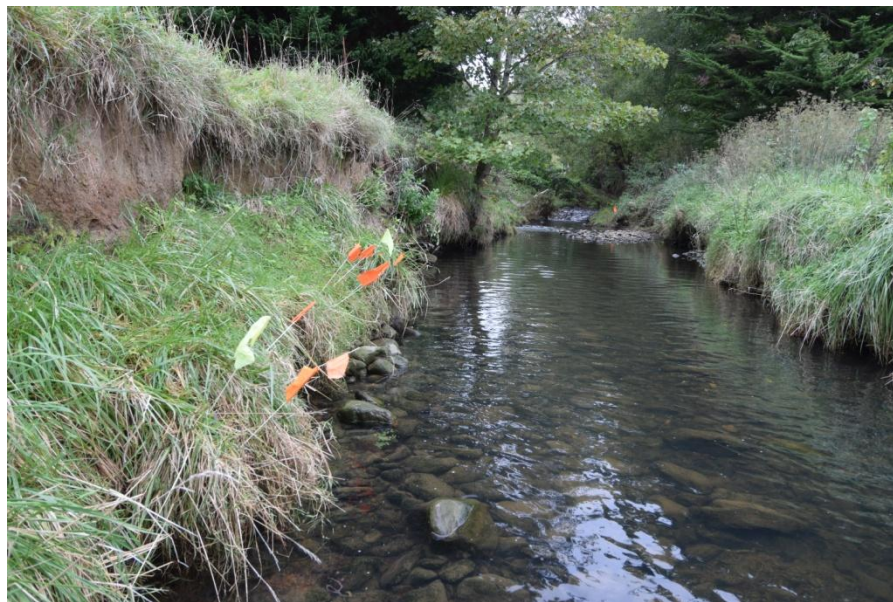
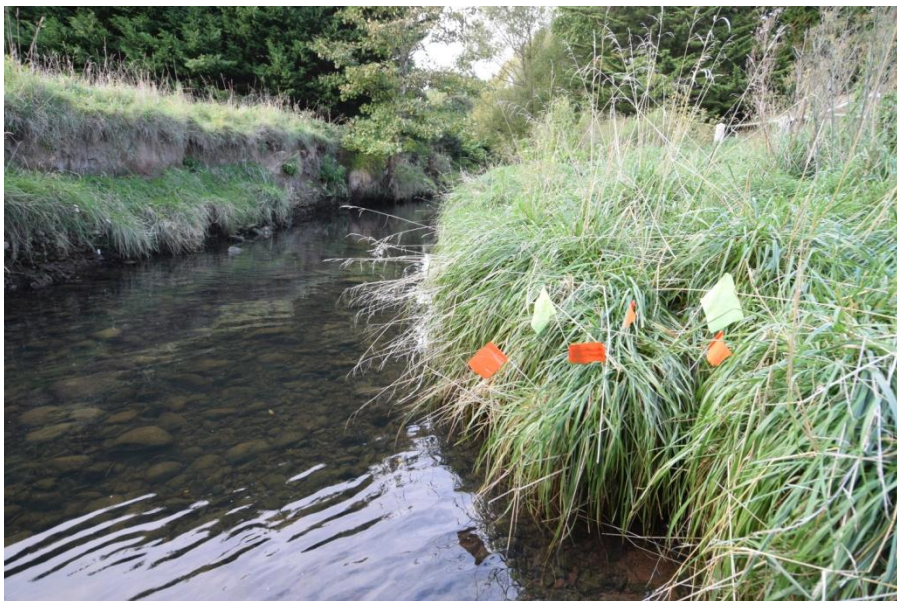
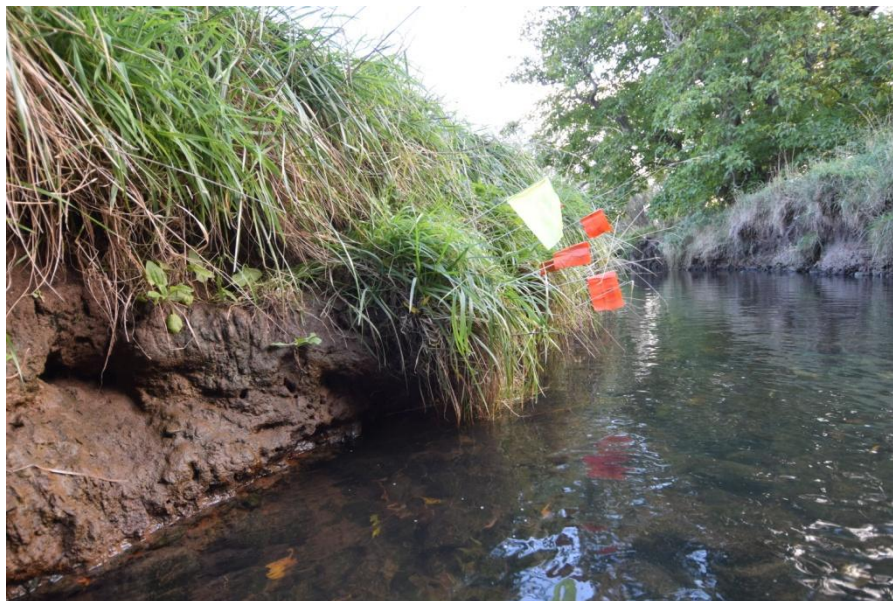
**Appendix 1. Examples of Īnanga spawning sites in the Takamatua Stream catchment.**  
D. April 2018 spawning sites above Old French Road

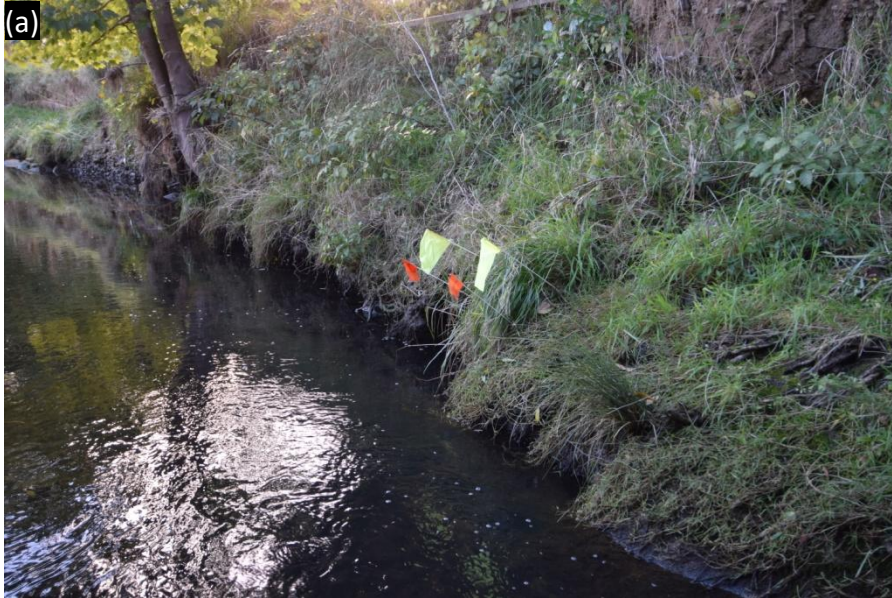
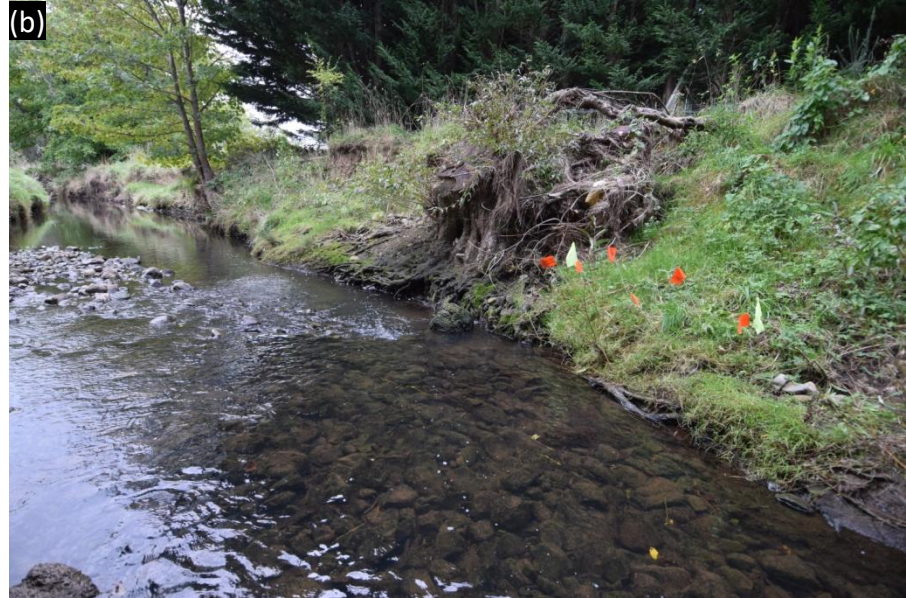
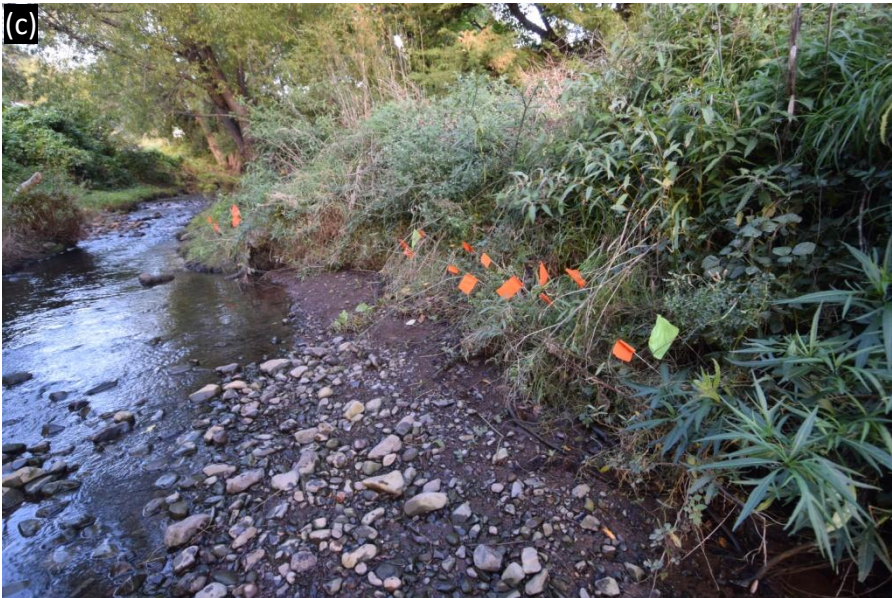
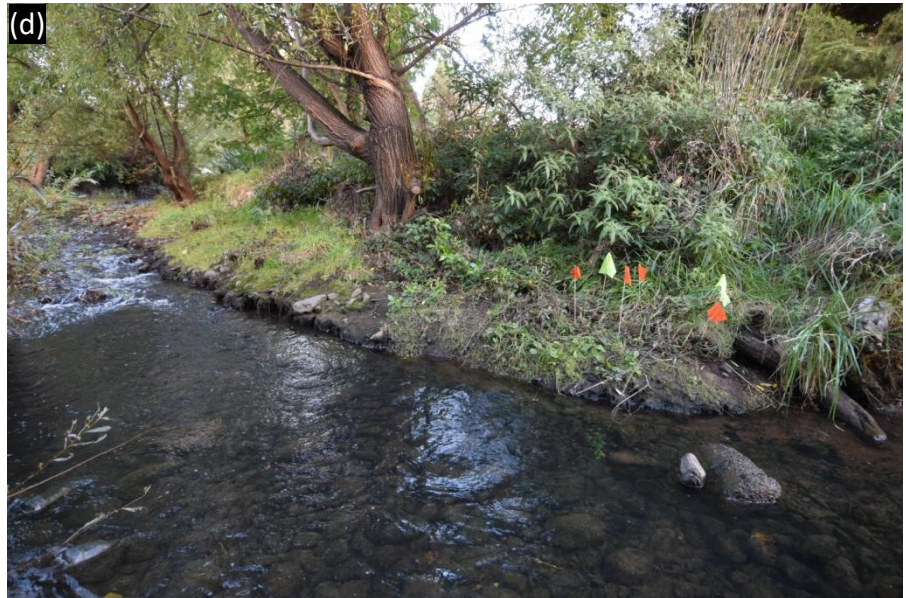
E. April 2018 spawning sites near the upstream limit of salt water. (a) & (b) sites on the true right. (c) & (d) sites on the true left.
