Īnanga spawning survey of Linwood Canal and Steamwharf Stream

Shane Orchard

Christchurch City Council
June 2018

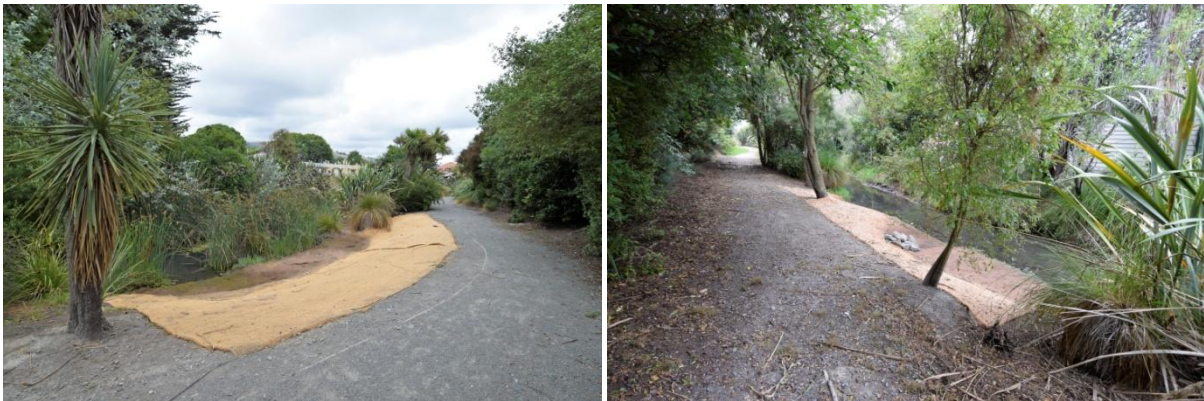
Figure 1. Two views of the Steamwharf Stream restoration area showing initial stabilisation work on the riparian margins between the recreational track and the waterway, January 2018. Photos: S. Orchard.

Christchurch City Council (CCC) is undertaking riparian restoration work at Steamwharf Stream involving the stabilisation and revegetation of stream banks that were affected by the Canterbury earthquakes, and have been slow to recover. Most of these areas are in close proximity to a gravel walking track that contributes to potential disturbance of the stream banks for vegetation recovery, as well as being source of sediment in rainfall events. These areas have been targeted for long term restoration in the current CCC project (Figure 1). The project will involve re-establishing riparian vegetation cover, preferably using native plant species that are suited to the area and can provide Īnanga spawning habitat (B. Margetts, pers. comm.). The restoration planting design will be finalised and implemented after the 2018 Īnanga spawning season. As an aspect of this project, straw bale installations are being used to provide temporary support for spawning in advance of the restoration work being completed.

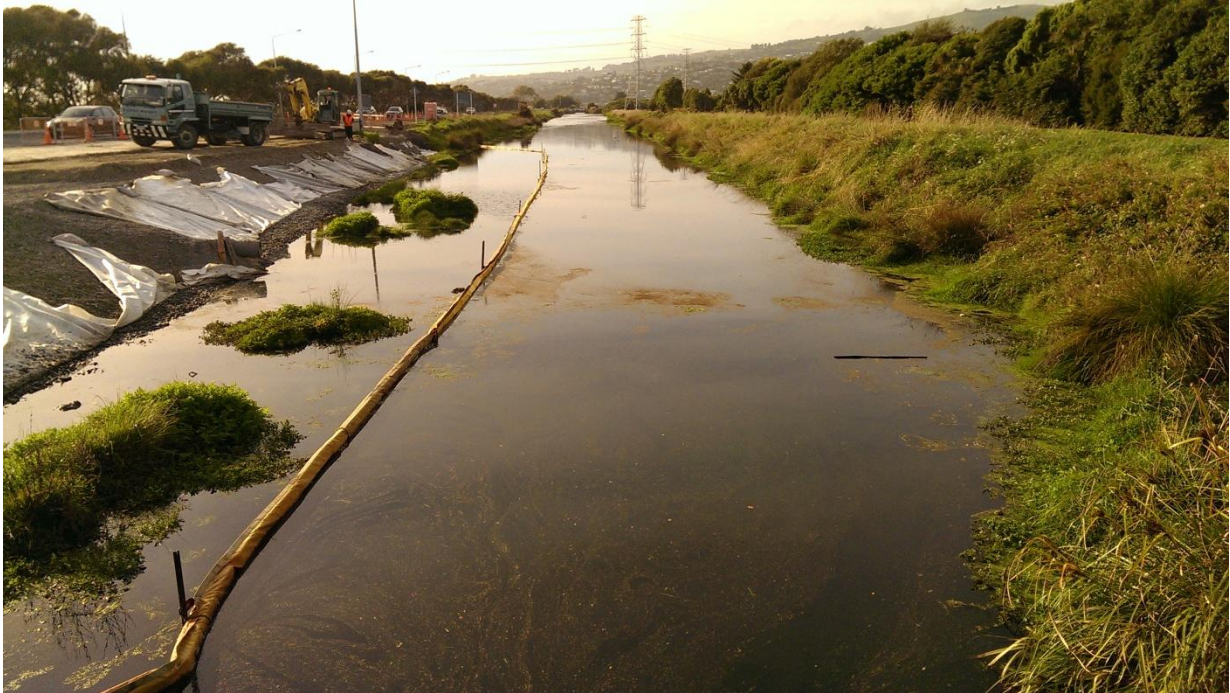
Figure 2. Linwood Canal looking downstream from Dyers Road showing current road works in the riparian zone. A silt curtain can be seen protecting the waterway from construction site run-off.

At Linwood Canal, there is no current riparian restoration project that targets Īnanga spawning habitat. However, works are underway to improve the road network in the area, and these include ground stabilisation measures close to the waterway (Figure 2). These and other sites provide opportunities for ecological restoration activities in the near future. Previously, there has been only one record of Īnanga spawning in this waterway. This was a small spawning site found in 1999 close to Dyers Road (Taylor 1999). In other respects, very little is known about the potential extent of spawning activity in the catchment or details of the fish population, especially in the post-earthquake context. However, adult

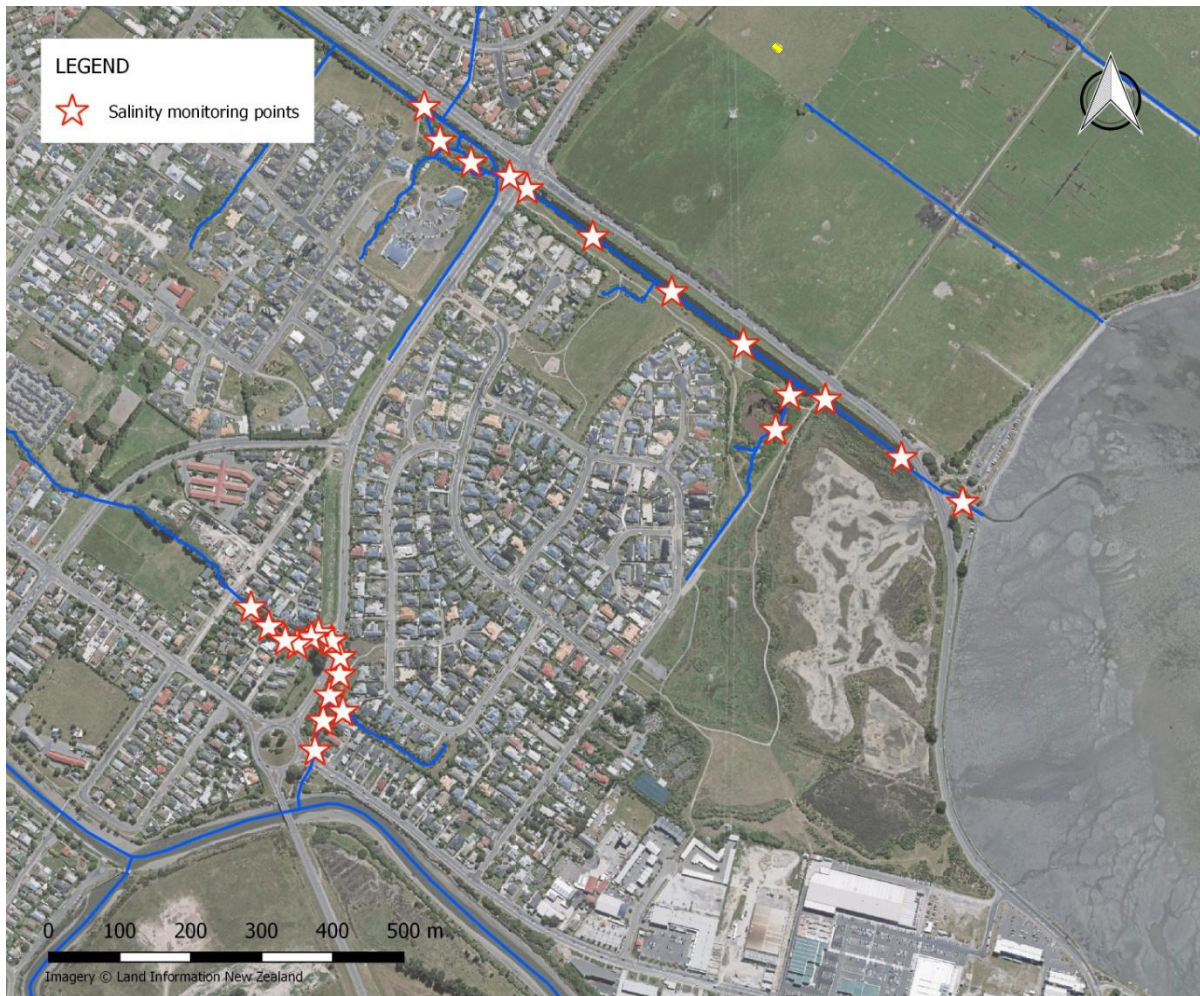
Figure 4. Location of salinity monitoring points in Linwood Canal and Steamwharf Stream.

Salinity monitoring sites were established at regular intervals across the study area in both waterways (Figure 4). At each site, salinity was measured on spring high tides using a YSI Model 30 salinity meter following Orchard & Hickford (2018). Two measurements were taken at each monitoring site; the first at the bottom, and the second 10 cm from the top of the water column. Each survey was timed to follow the incoming tide upstream with the objective of taking the furthest upstream measurement at time of peak high water in that location. In both waterways this is associated with a turn-around point in flow direction under most conditions (i.e. typical discharge rates). Because of its proximity to the main estuary, the time of peak high water at Linwood Canal occurs 1-2 hours earlier than at Steamwharf Stream.

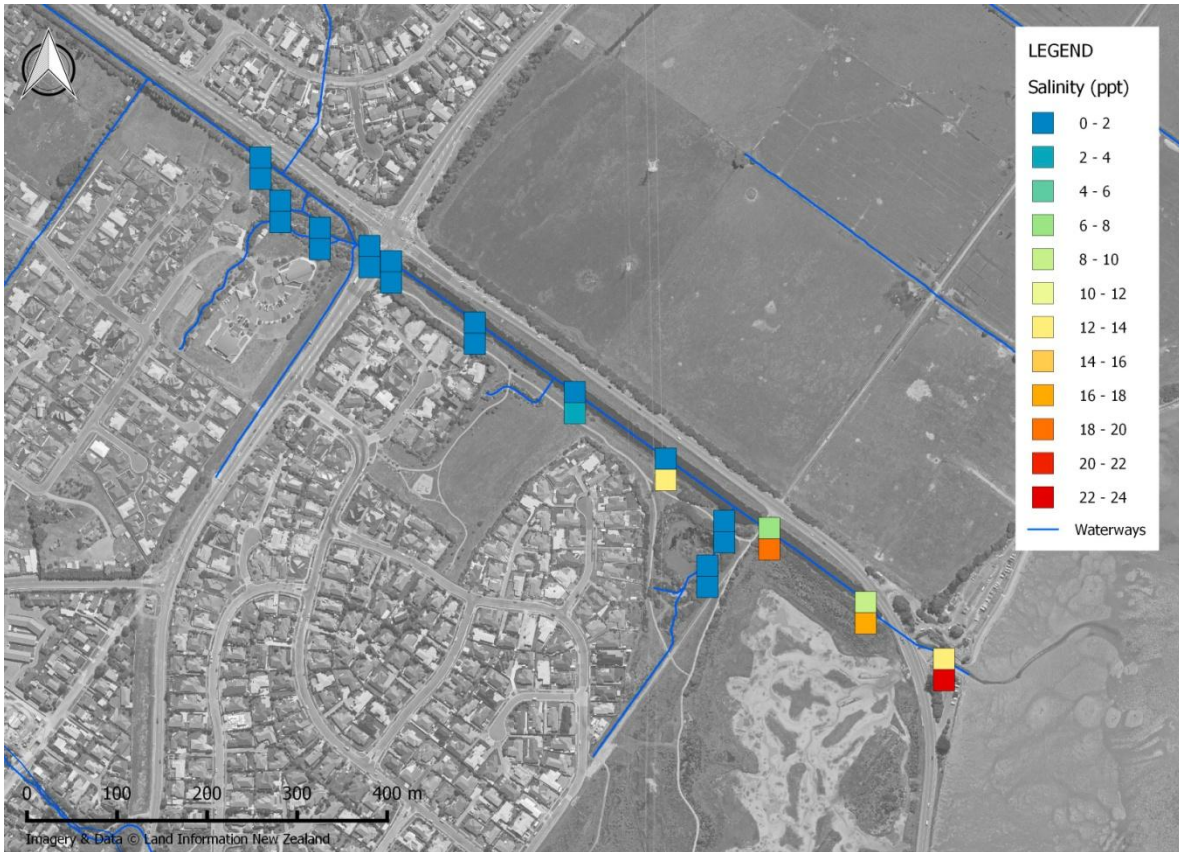
Figure 5. Typical spring high tide salinity ranges in Linwood Canal, as recorded on 2 March 2018. Two measurements are shown at each monitoring site; at the bottom of the water column (bottom marker), and 10 cm below the water surface (top marker). All measurements are the maximum salinity value recorded during the field survey at different times on the incoming tide.

Despite being a shallow waterway, field measurements showed that the salinity regime is highly stratified in Linwood Canal (Figure 5). This is associated with a relatively high salinity layer at the bottom of the water column with lower salinity water near the surface (Figure 6). Repeat measurements at different times showed that the tidal waters move slowly upstream on incoming tides and may also sit in locally deeper areas between tides creating a complex salinity environment.

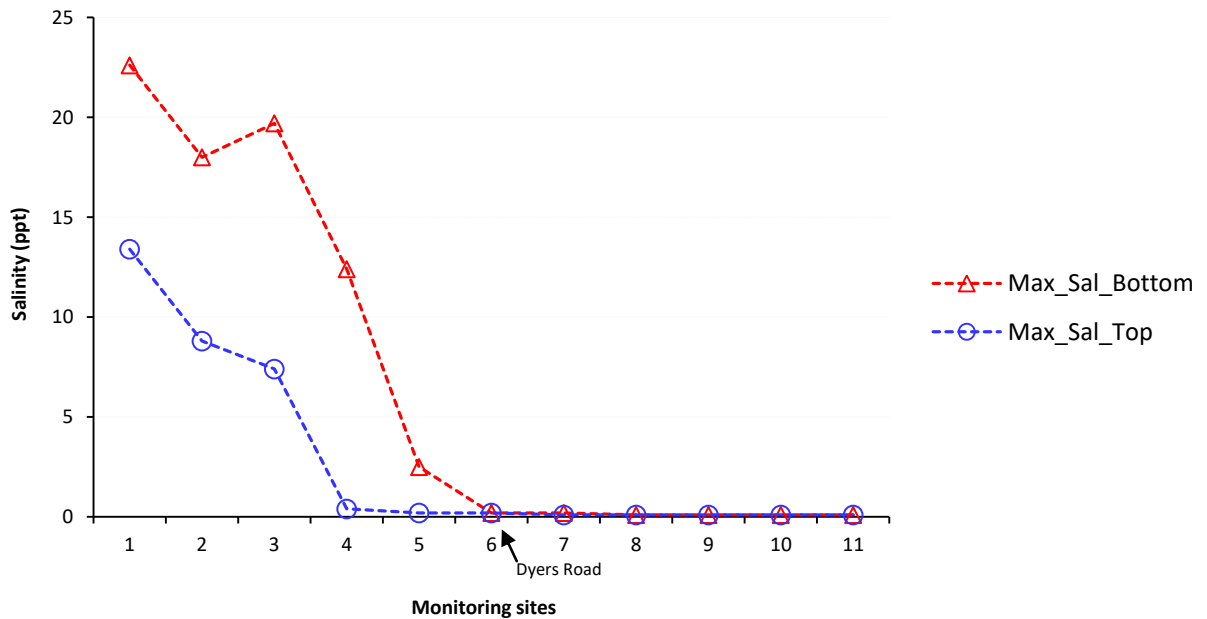
Figure 6. Plot of maximum salinities at the bottom and 10 cm from the top of the water column, as recorded on the spring high tide of 2 March 2018 in Linwood Canal. Upstream is to the right of the plot.

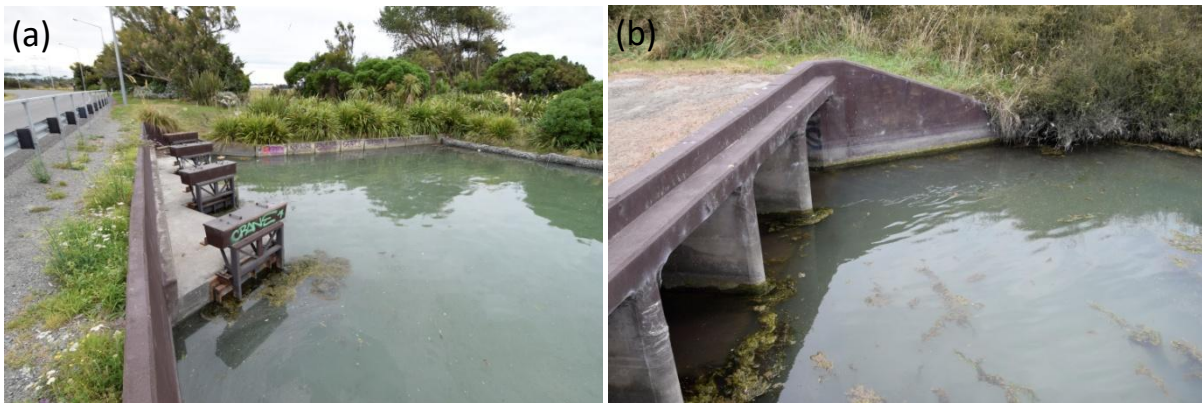
Inspection of the outlet structure at Humphrey's Drive showing that salt water ingress occurs through the flap-gate on the southern pipe with the other three pipes apparently well sealed (Figure 7). A weir prevents ingress of tidal water to the small freshwater lake near the Charlesworth footbridge on small tides, but retains saline waters following larger tides. Salinity recorded in this lake was as high as 7.4 ppt (on February 2nd). In the main channel of Linwood Canal, a sill created by the floor of the large box culvert at Dyers Road appears to prevent the intrusion of salt water further upstream on all but the largest tides. Salinity above 0.1 ppt (which is the background value in the waterway) was recorded only once in the survey period upstream of Dyers Road (0.2 ppt on February 2nd).

Figure 7. Linwood Canal outlet structure at the Avon Heathcote Estuary Ihutai on Humphrey’s Drive. (a) View of the four flap-gates in operation on a high tide. (b) Tidal ingress into Linwood Canal through the southern culvert on an incoming tide.

- Take steps to protect the spawning sites identified in this study.
- Restore the area of potential spawning habitat on the true left bank.
- Complete further monitoring to investigate temporal aspects of spawning activity and habitat use, and to provide additional information on whether the true left bank may support a greater area of spawning habitat than was recorded in this study.
- Monitor the effectiveness of habitat protection measures over time.
- Give careful attention to the ecological impacts of any proposed alteration to the flood gate structures on Humphrey's Drive.

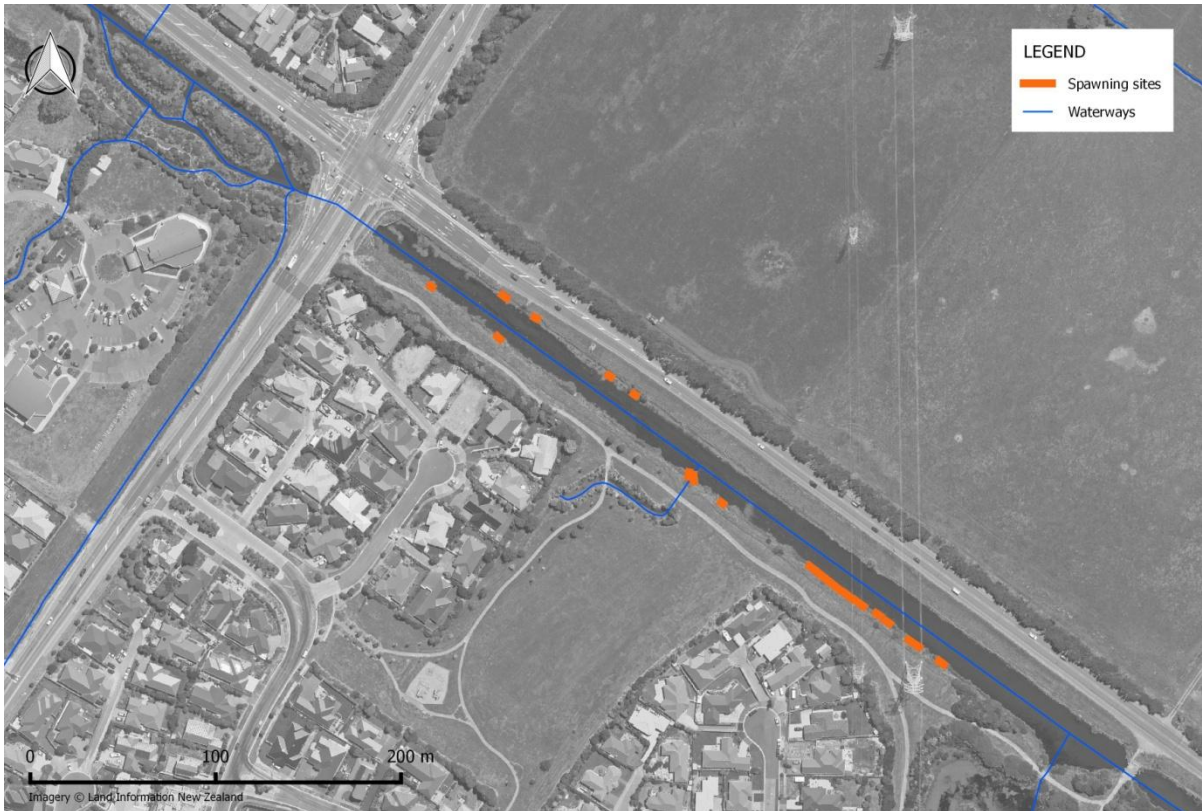
A total of 16 spawning sites were found in the Linwood Canal survey completed in April (Figure 8). These were distributed over a 340 m reach downstream of Dyers Road with the majority (12 sites) being located on the true right bank. Most sites on the true right were located on a bench that is a characteristic of the river bank in this reach (Figure 9a). The vegetation species supported spawning on the true right were mainly clumps of tall fescue (*Schedonorus arundinaceus*) and dense swards of creeping bent (*Agrostis stolonifera*). However another species present is Caldwell’s sedge (*Bolboschoenus caldwelli*). It appears to provide an important scaffolding function, especially in association with creeping bent. The four spawning sites on the true left were all relatively small and located at the toe of the main bank. The vegetation here consisted of a mixed grass and herb community that is relatively short in stature compared to the true right (Figure 9b). This difference results from regular weed-eating down to the waterline that does not occur on true right (J. Carlton, pers. comm.).

Figure 8. Location and extent of Īnanga spawning sites identified in Linwood Canal, April 2018.

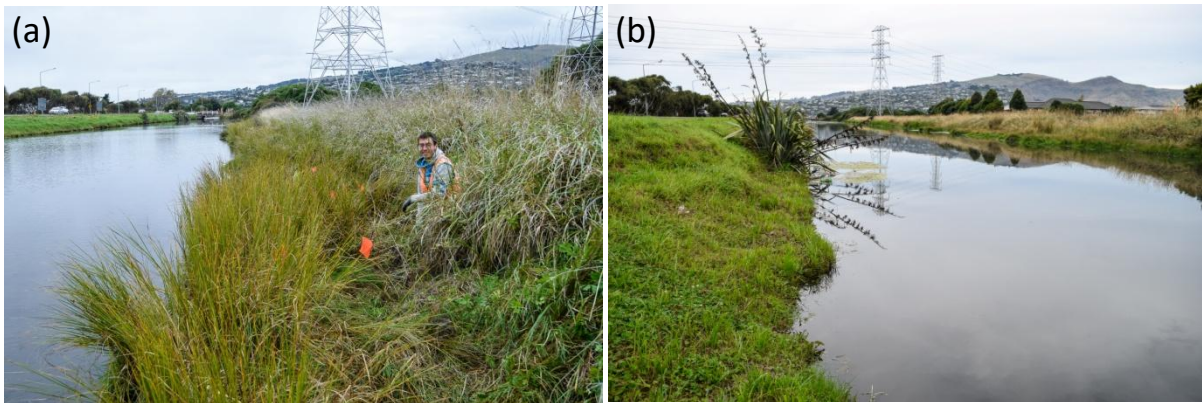
Figure 9. Examples of Īnanga spawning habitat in Linwood Canal. (a) A bench at the toe of a steeper slope on the true right bank was found to support several spawning sites. (b) Typical spawning habitat at the high tide waterline on the true left where regular weed-eating occurs. Although spawning sites were identified on this bank egg mortality rates are likely to be high.

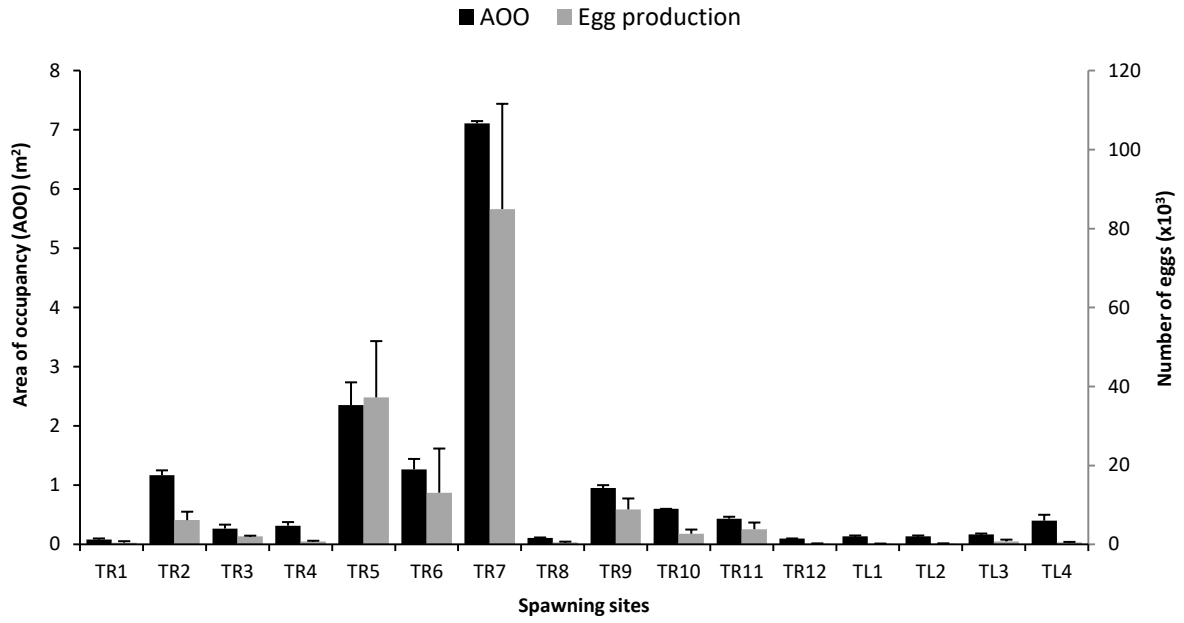
The total area of occupancy (AOO) of spawning sites was 15.6 m². Spawning sites on the true right bank accounted for 95% of the AOO (Figure 10). The largest site was 20 m in length with an AOO of 7.1 m². Total egg production across all sites was 162,000 eggs with spawning sites on the true right contributing 99% of the total. The largest site (TR7) contributed 52%. Figure 11 shows the spatial distribution of egg production across the different sites.

Figure 10. Area of occupancy (AOO) and egg production of inanga spawning sites in Linwood Canal on 9 April 2018. Error bars are standard error of the mean

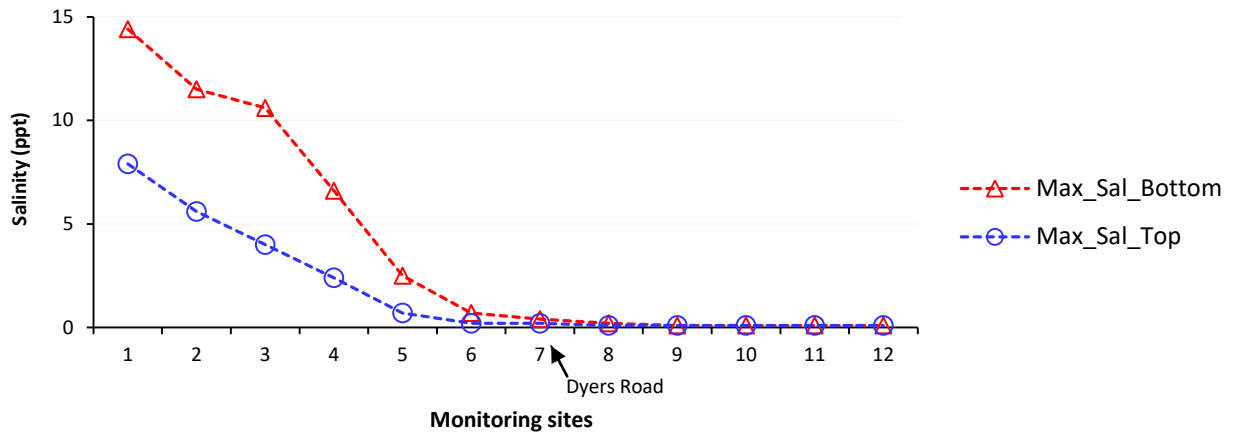
Figure 13. Plot of maximum salinities at the bottom and 10 cm from the top of the water column, as recorded on the spring high tide of 2 March 2018 in Steamwharf Stream. Upstream is to the right of the plot.

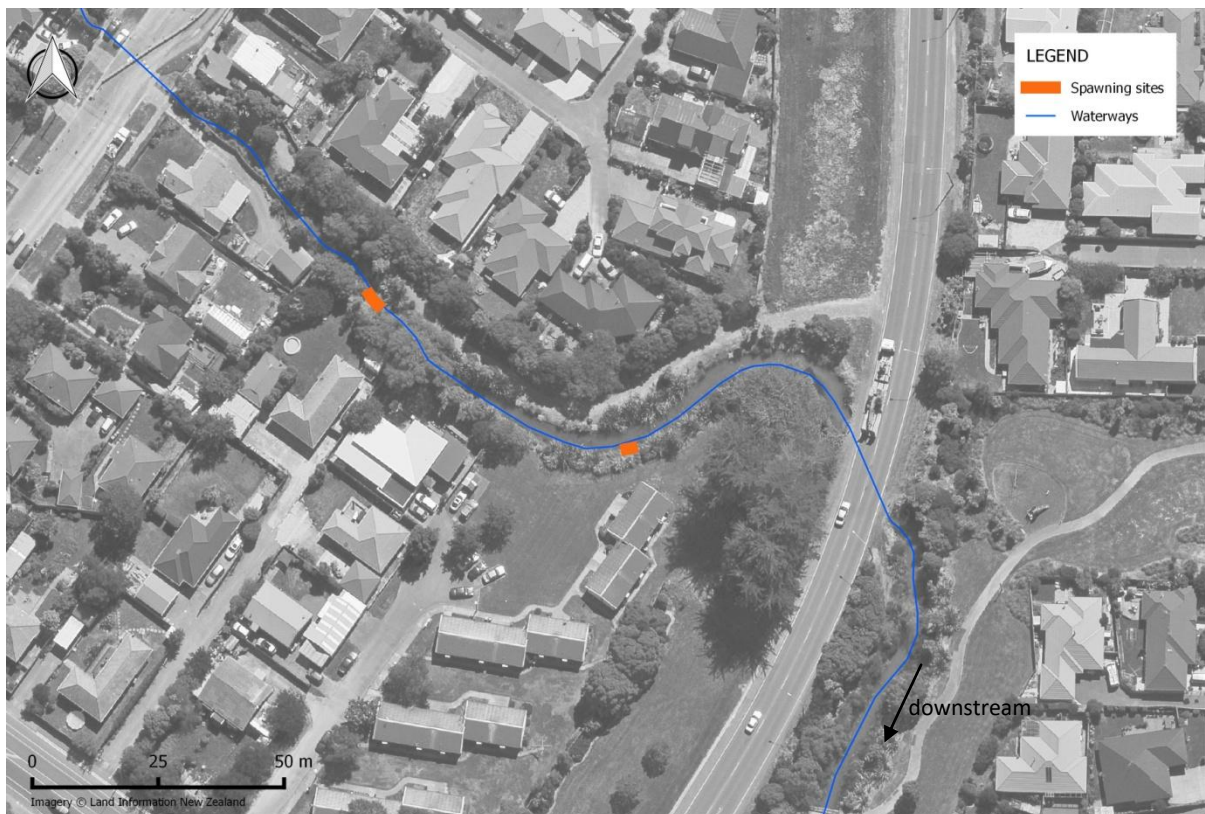
No eggs were found on the straw bales in any of the four months of monitoring. However, spawning sites were discovered in the riparian vegetation surveys on three of the four months. One spawning site was found in March, two in April, and one in May. There was no spawning found anywhere in the catchment in February. One of the two sites found in April has been used repeatedly in other years (as reported in other studies), and the other was a location not previously recorded as a spawning site [see Orchard (2017)]. Figure 14 shows the location of these sites with the previously used site being the further upstream site of the two. This same site was also the location of the eggs found in March and May.

Figure 14. Location and extent of Ōnanga spawning sites identified in Steamwharf Stream over four months (February–May) in 2018. Downstream is to the right.

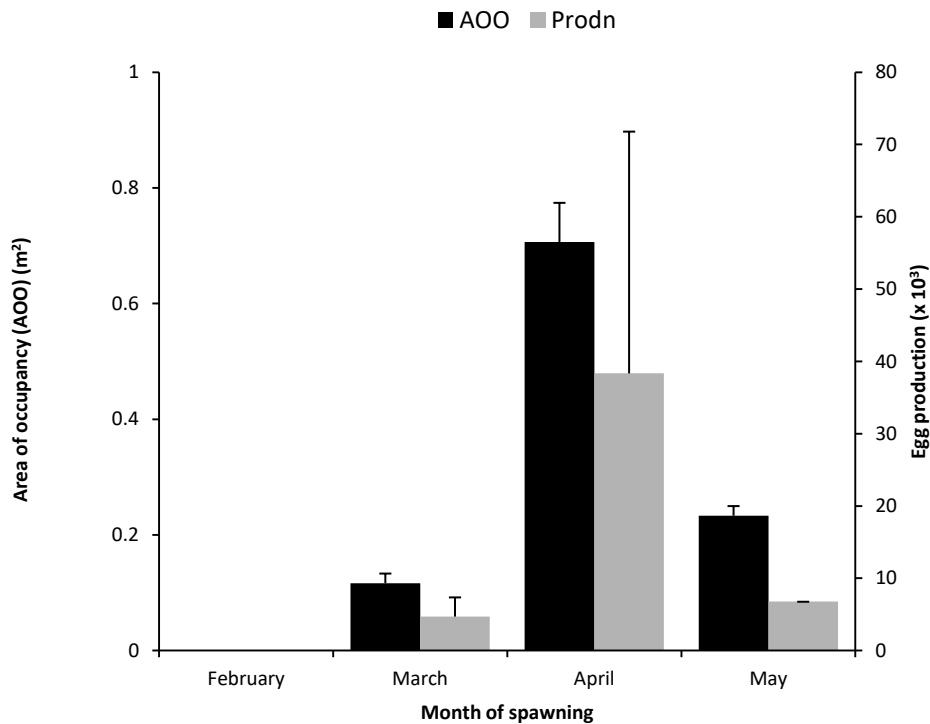
Figure 15 summarises the AOO and egg production trends as recorded over the four month survey period.

Figure 15. Area of occupancy (AOO) and egg production of inanga spawning sites in Steamwharf Stream over four months (February– May) in 2018. Error bars are standard error of the mean.

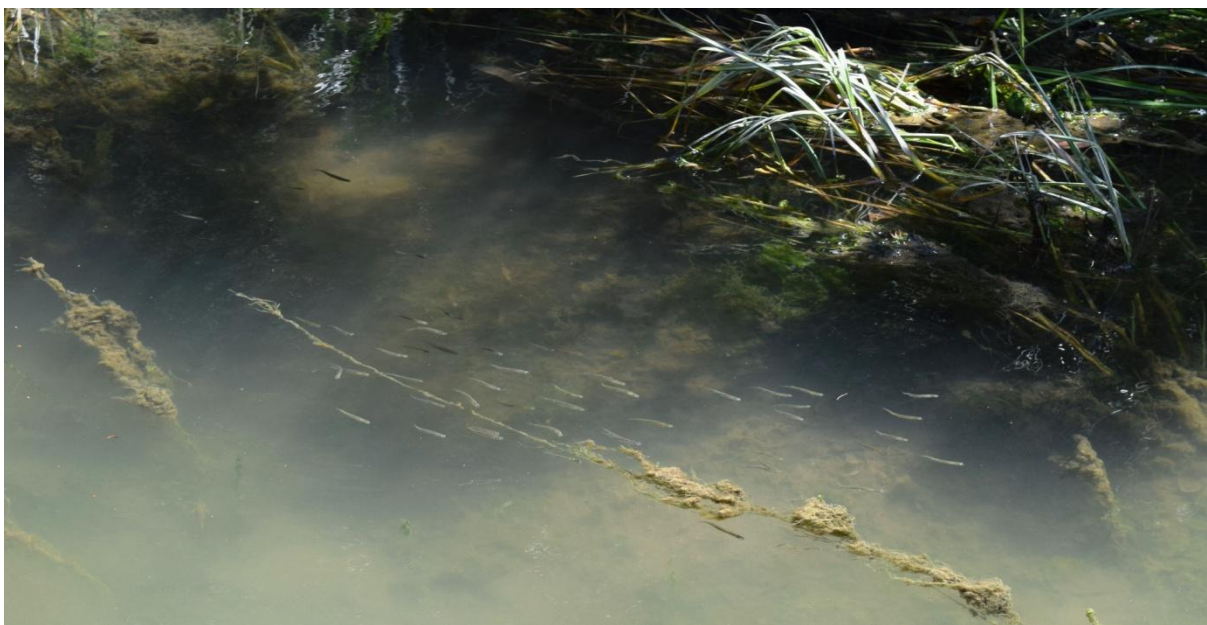
Figure 16. Juvenile Īnanga in Steamwharf Stream in December 2015 in the reach between Ferry Road and Dyers Road. Photo: S. Orchard.

These results suggest that attention to the quality of rearing habitat for juvenile Īnanga may be beneficial in Steamwharf Stream. In general, habitat quality can be improved by ensuring that adequate cover is provided, for example by overhanging vegetation, in-stream debris, or macrophyte beds (Richardson & Taylor 2002). During the 2018 survey period, large scale clearance of emergent vegetation in the channel was observed between Ferry Road and Dyers Road (Figure 17). Reducing these activities when fish are present is one potential strategy for ecological restoration. Another possibility might involve forms of ecological engineering such as the introduction of large in-stream debris, which is rarely found at present. Investigating the opportunities to integrate these potential enhancements with flood management work is recommended.

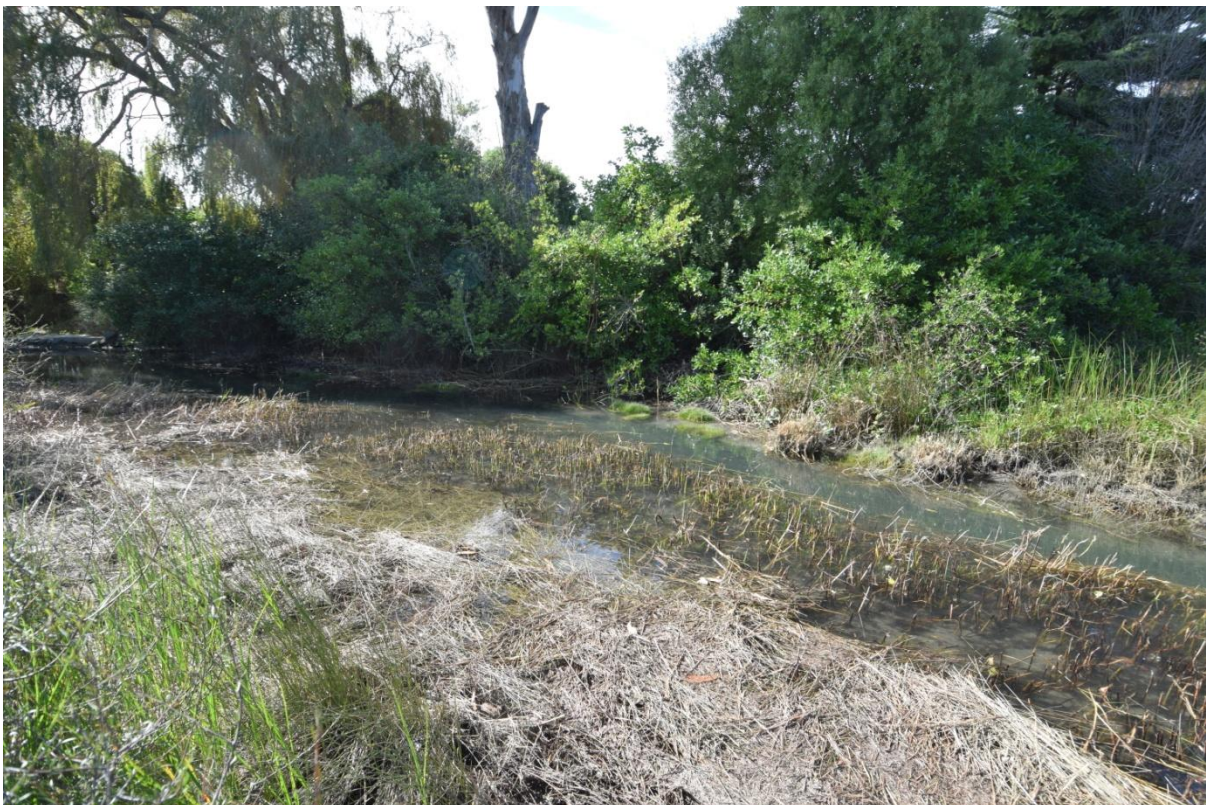
Figure 17. Clearance of emergent vegetation in the channel observed on 7 April 2018 in Steamwharf Stream. Photo: S. Orchard.

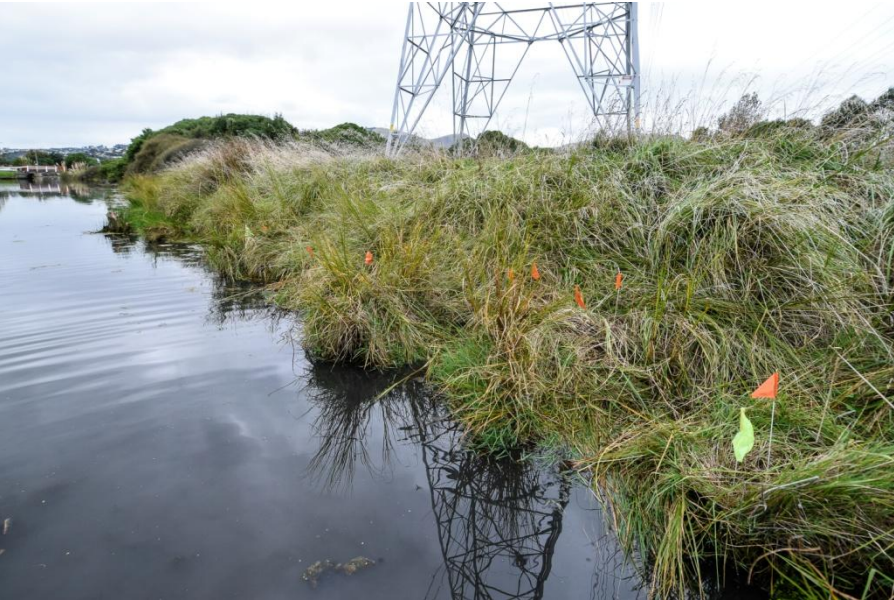
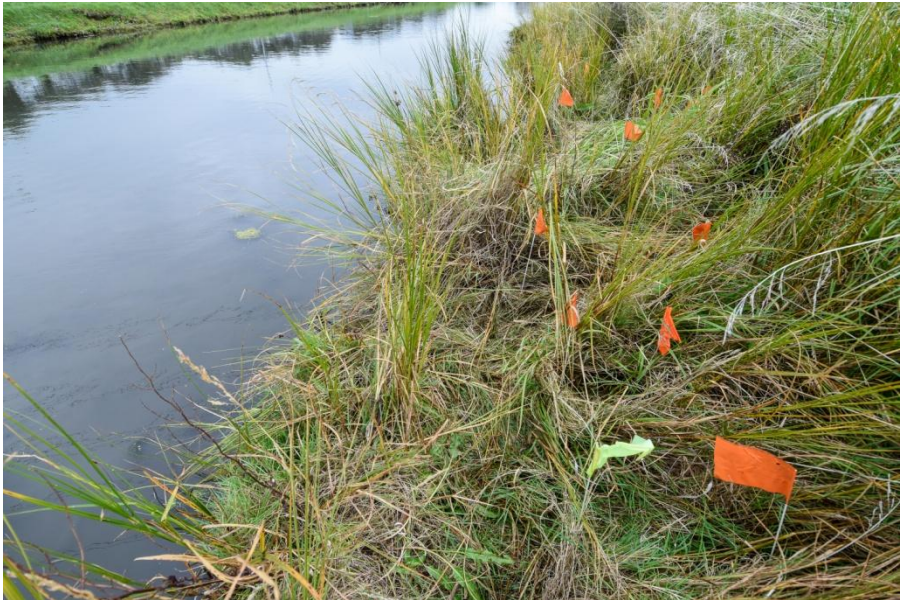
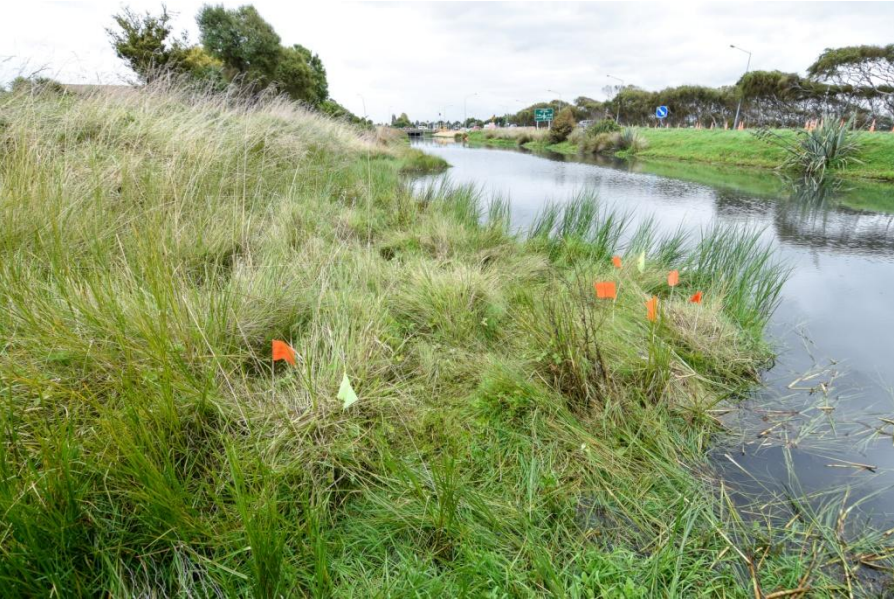
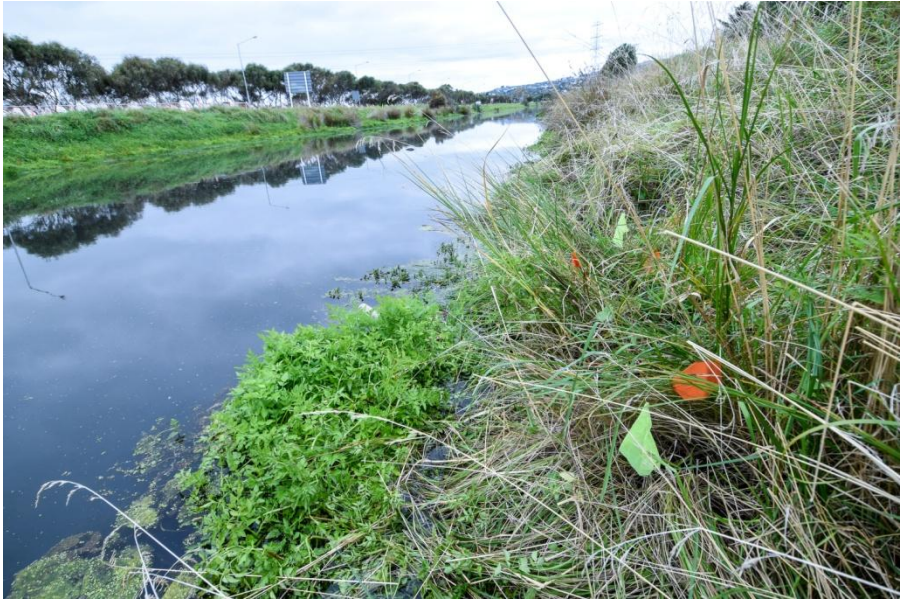
Appendix 1. Examples of Īnanga spawning sites in Linwood Canal.

A. Sites on the true right bank. Clockwise from top left - TR2, TR5, TR10, TR11.

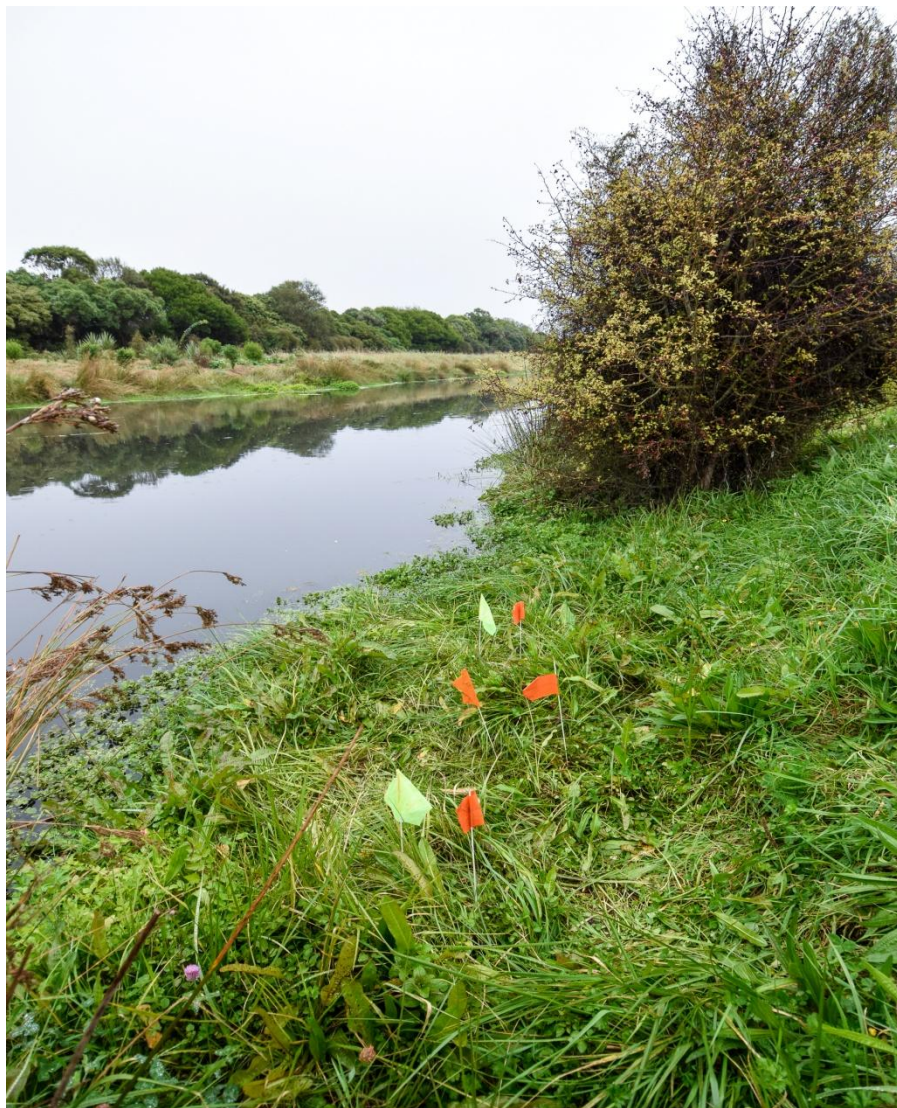
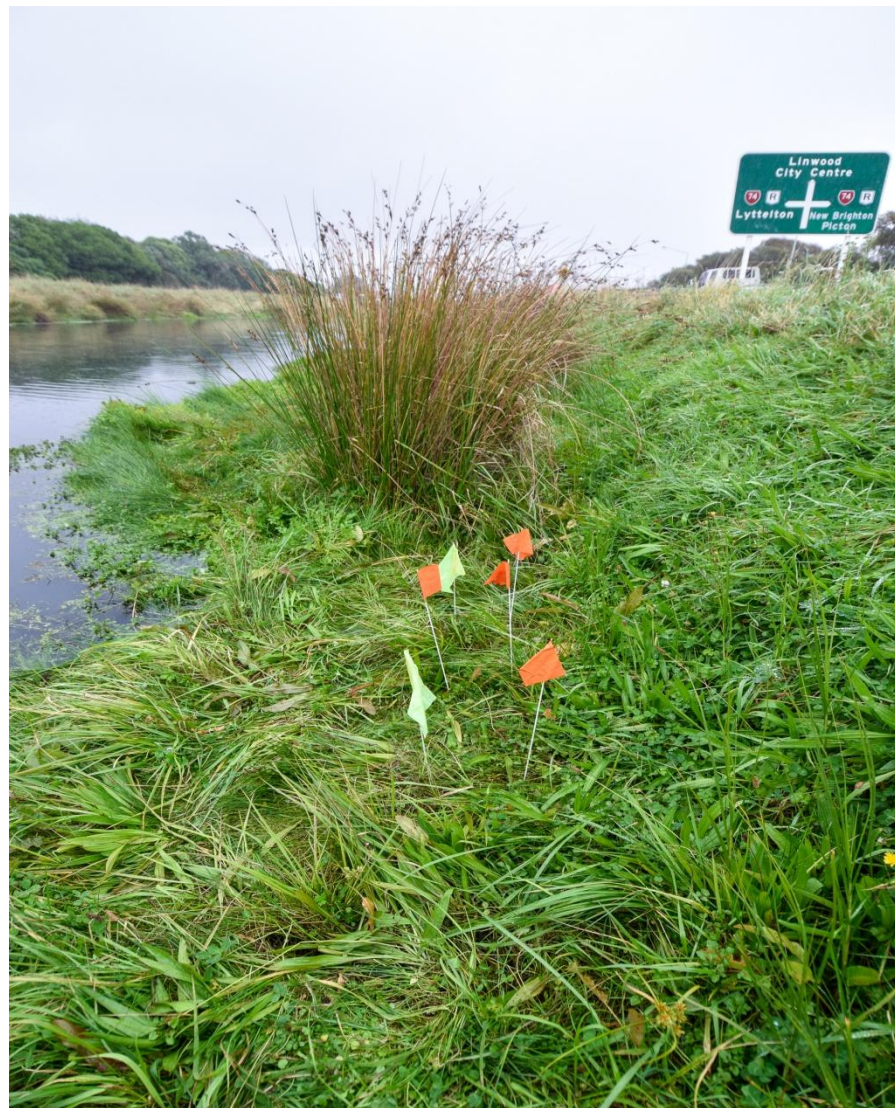
Appendix 1. Examples of Īnanga spawning sites in Linwood Canal.

B. Sites on the true left bank. Left – TL1, right - TL2.

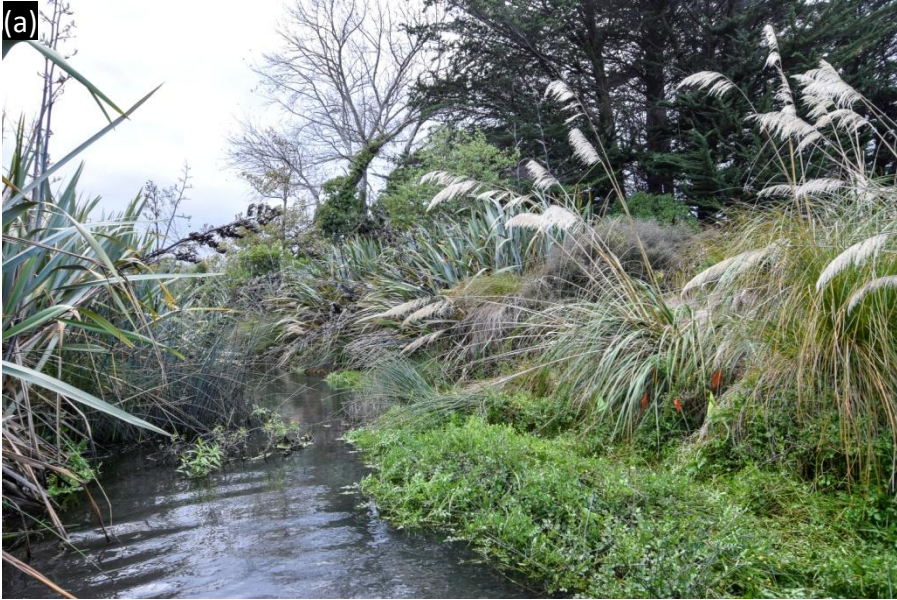
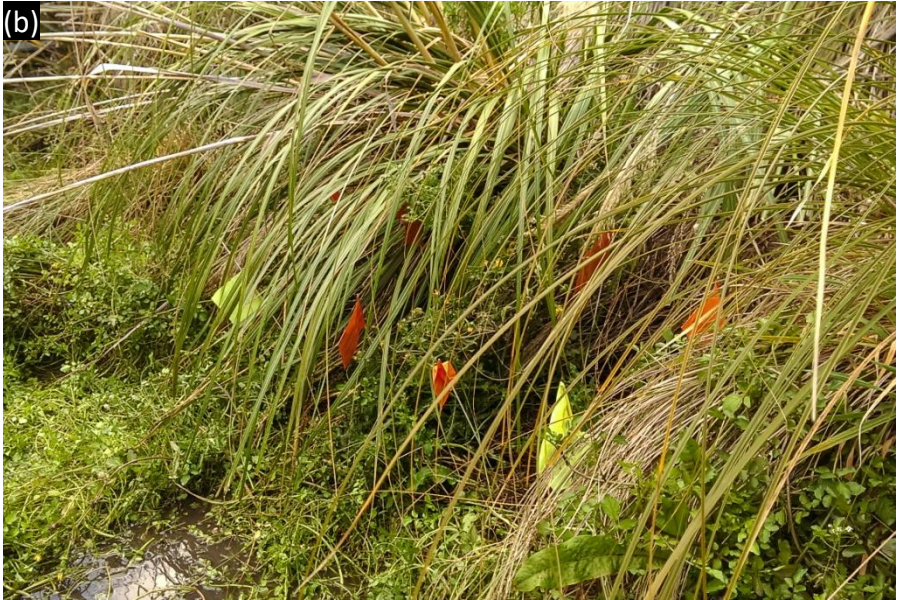
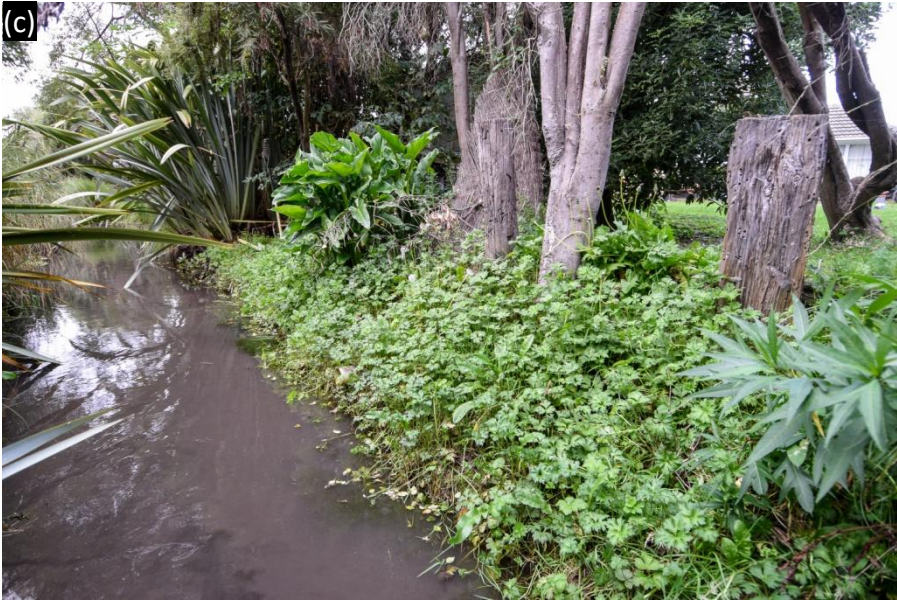
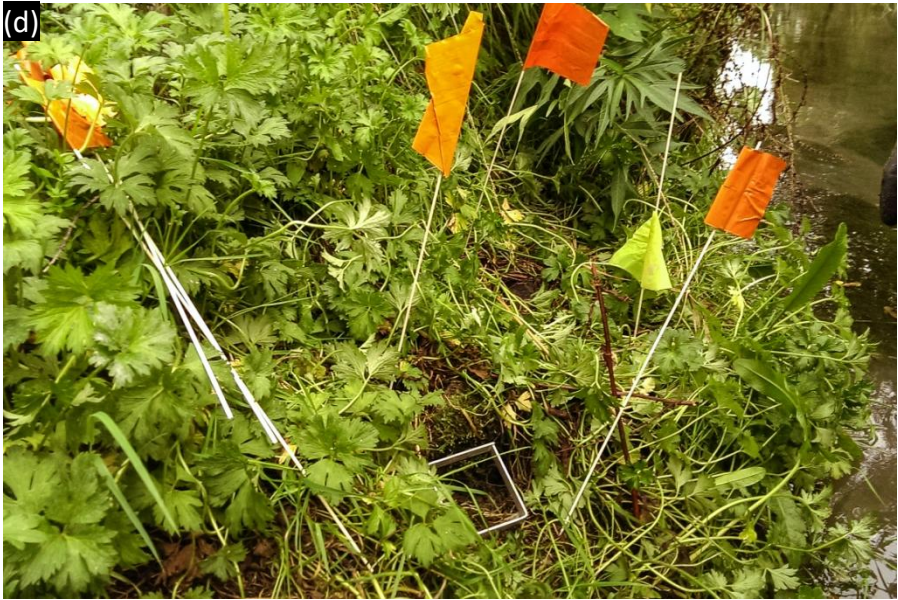
Appendix 2. Examples of Īnanga spawning sites in Steamwharf Stream.

A. April 2018 spawning sites. (a) & (b) two views of the furthest downstream of the two spawning sites identified in the 2018 surveys. (c) & (d) two views of the furthest upstream site. This site accounted for most of the spawning recorded in 2018 and has been used in previous years (Orchard 2017).

April was the month of peak spawning activity in terms of the number of spawning sites (two), total AOO (0.71m²) and total number of eggs (~38, 300). The upstream site was the major contributor with an AOO of 0.44m² and 36, 700 eggs in this month. This site was dominated by buttercup (*Ranunculus* spp.) and had changed little from previous years. The downstream site was smaller (AOO of 0.27m²) and contributed 1, 600 eggs. This site was partly shaded by toetoe (*Cortaderia richardii*) with most of the eggs laid in creeping bent (*Agrostis stolonifera*). See Appendix 2 for site photographs.
