Fish in Stormwater Wetlands: A Pilot Study

October 2022

Prepared for:
Christchurch City Council

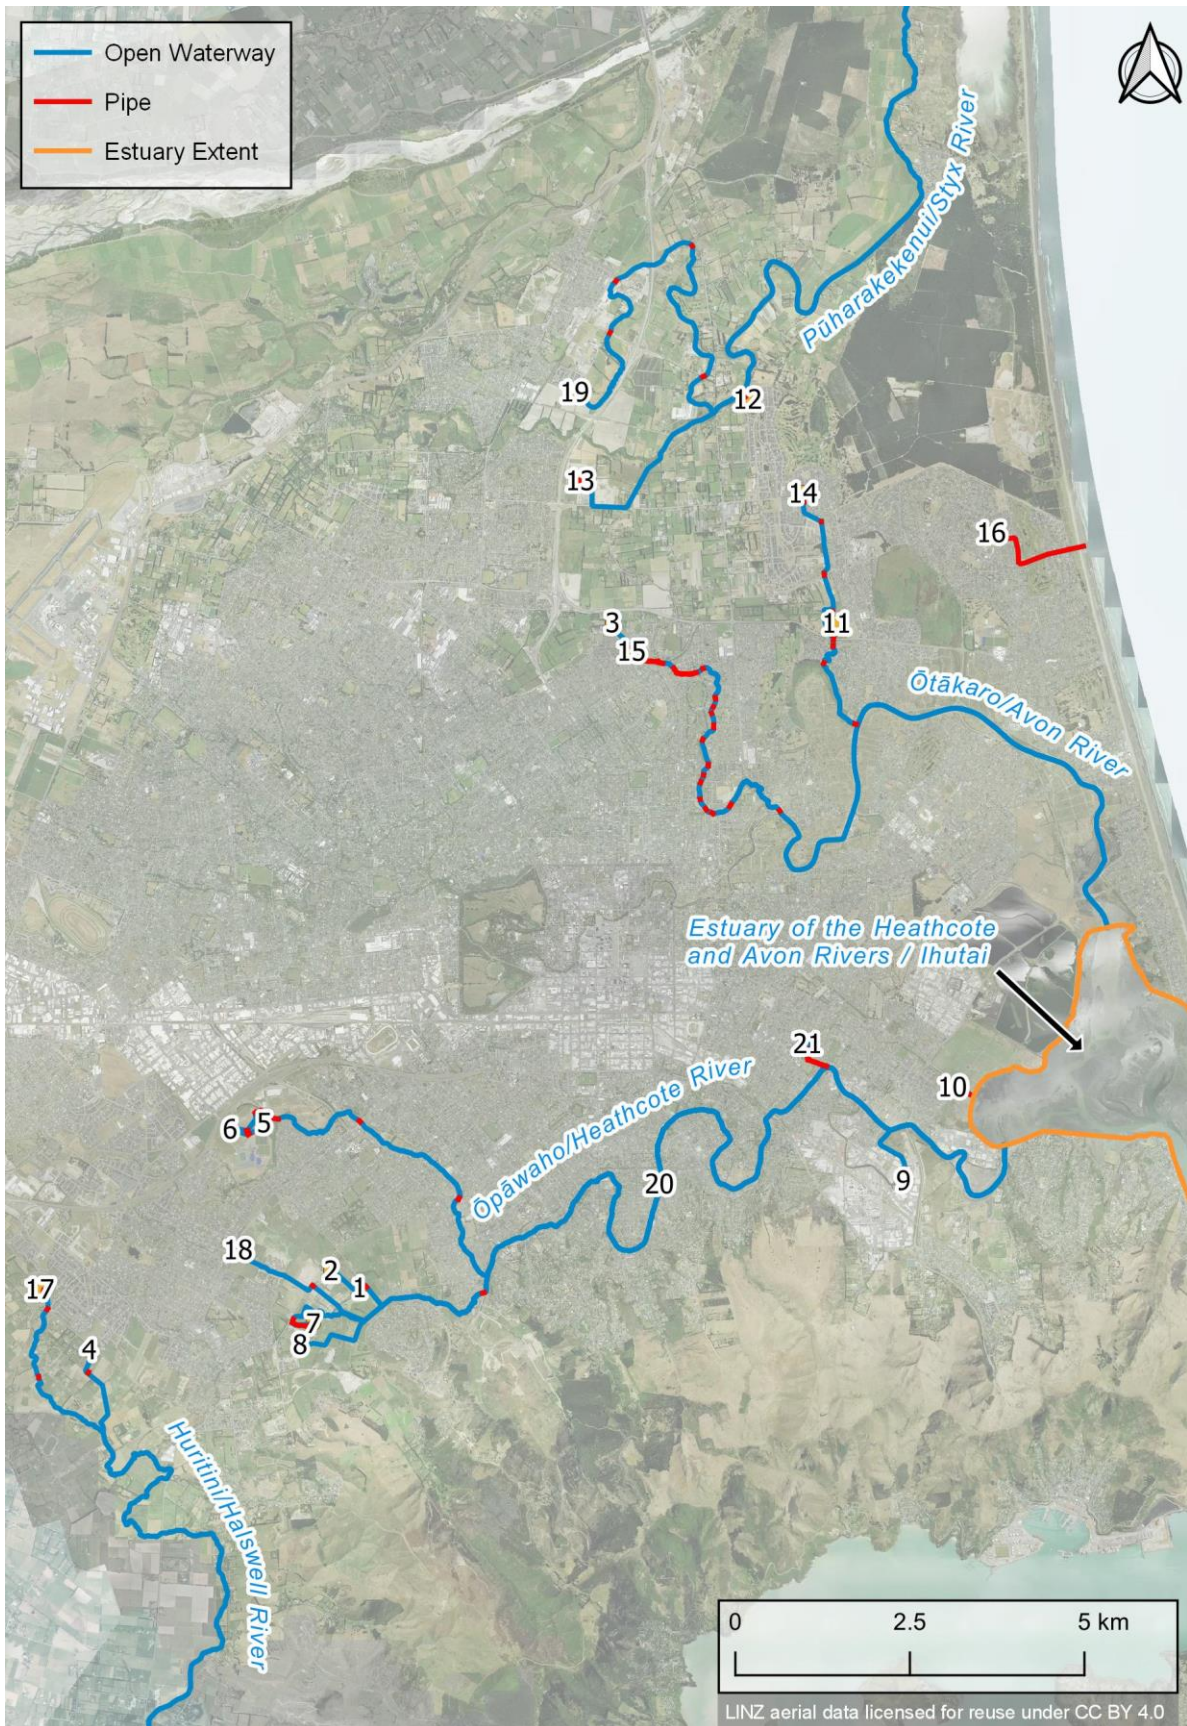
Figure 1: Stormwater wetland sampling sites and downstream waterways.

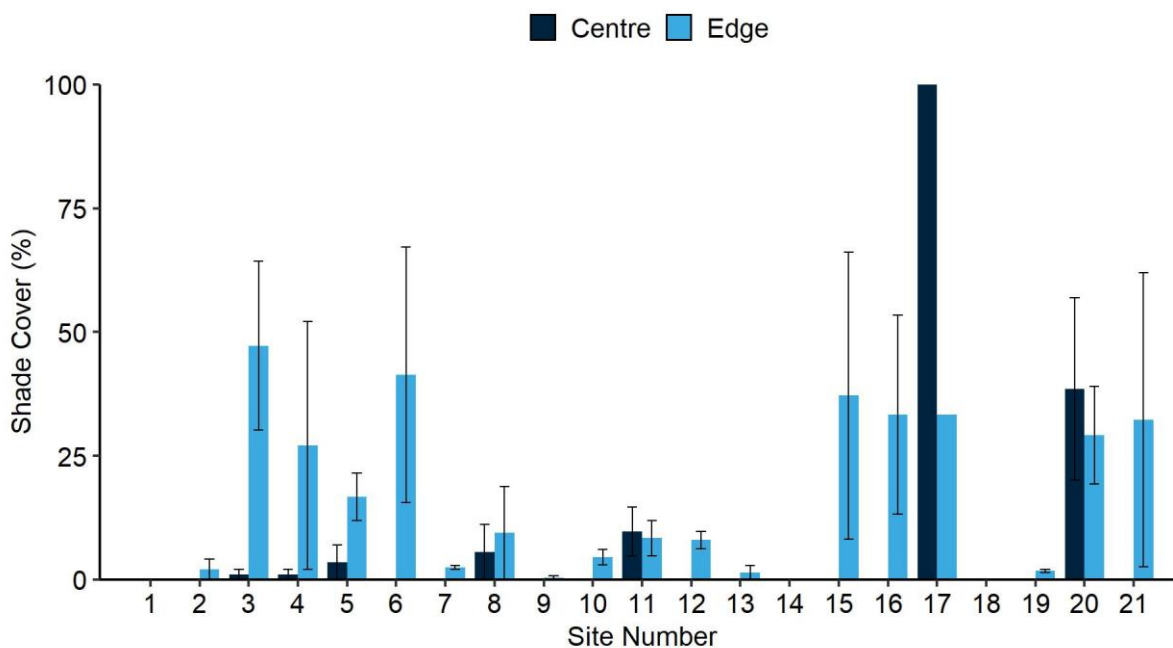
Figure 3: Mean ($1\pm SE$) shade percent for edge and centre measurements at all sites. No error bars are shown for Site 17 because only a single transect was measured at that site.

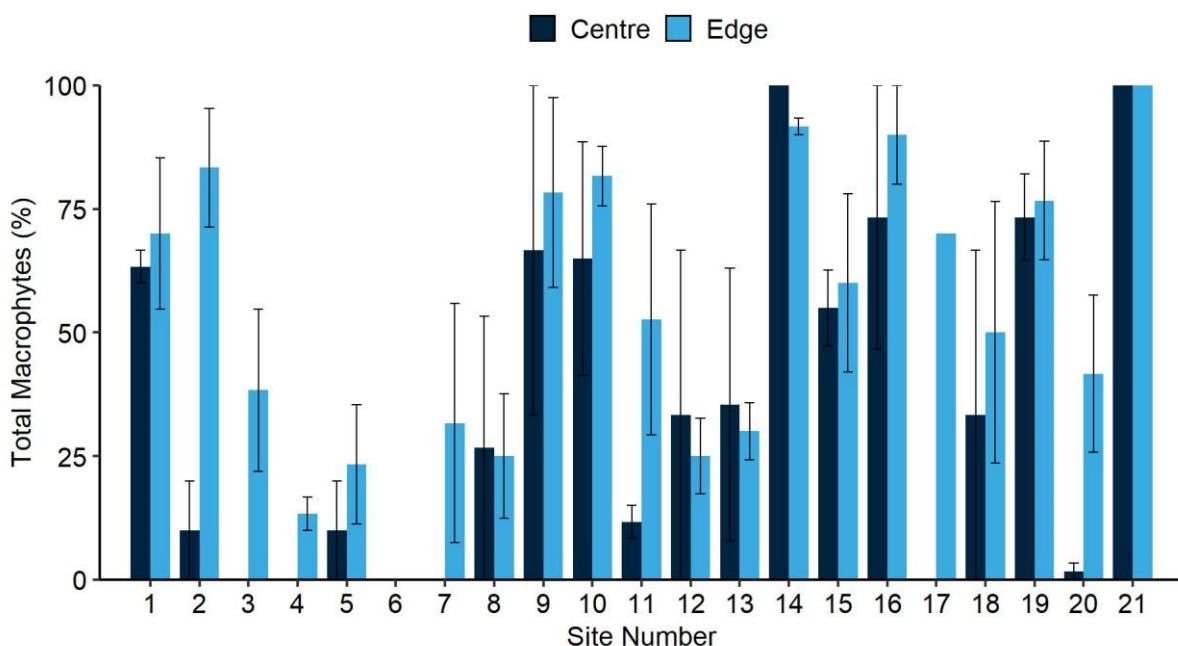
Figure 4: Mean ($1\pm SE$) total macrophyte cover for edge and centre measurements at all sites. No error bars are shown for Site 17 because only a single transect was measured at that site.

Total macrophyte cover was often high, but it varied considerably amongst sites (Figure 4). Macrophyte cover was typically greatest towards the edge of wetlands, where emergent macrophytes were found (Figure 5). Site 6 (Ngā Puna Wai) was the only site where no macrophytes were recorded, possibly due to high turbidity observed at the site. Common duckweed (*Lemna disperma*) is a floating native species that was common at many sites and covered the entire wetland surface at Sites 14 (Alpine View) and 21 (Te Oranga Waikura). Another native floating species, Pacific azolla (*Azolla rubra*) was also common. Other regularly encountered macrophytes included the exotic macrophyte watercress (*Nasturtium officinale*), an emergent species found mostly around the water's edge, and the exotic curly pondweed (*Potamogeton crispus*), a submerged species.

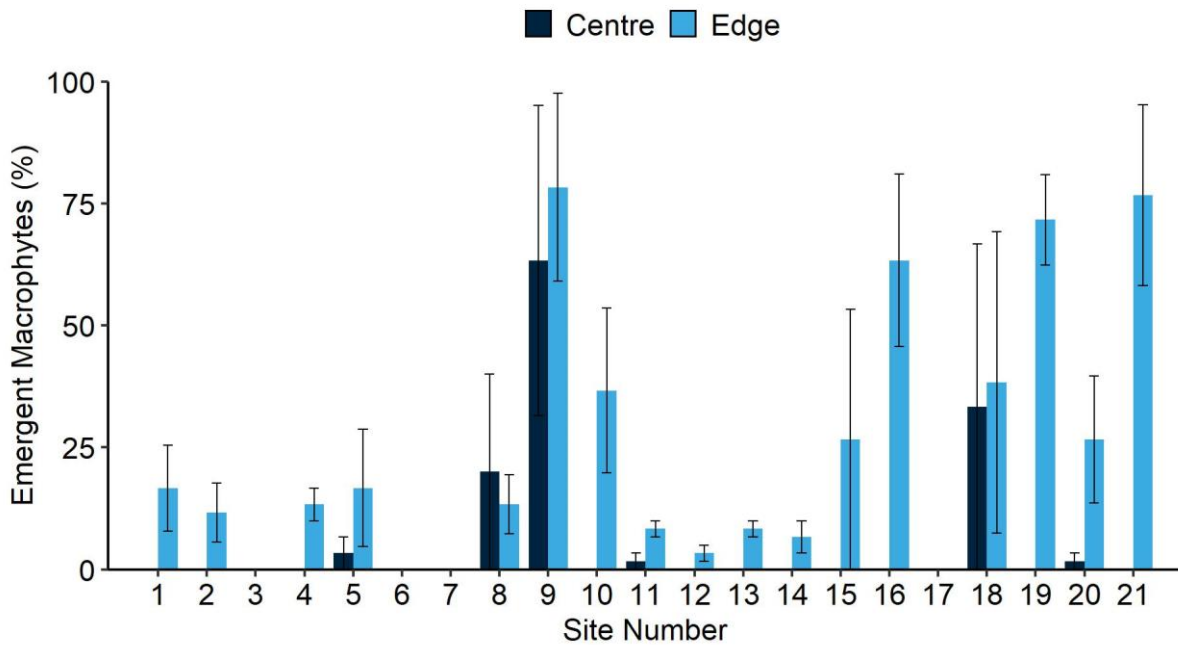
Figure 5: Mean (1±SE) emergent macrophytes cover for edge and centre measurements at all sites

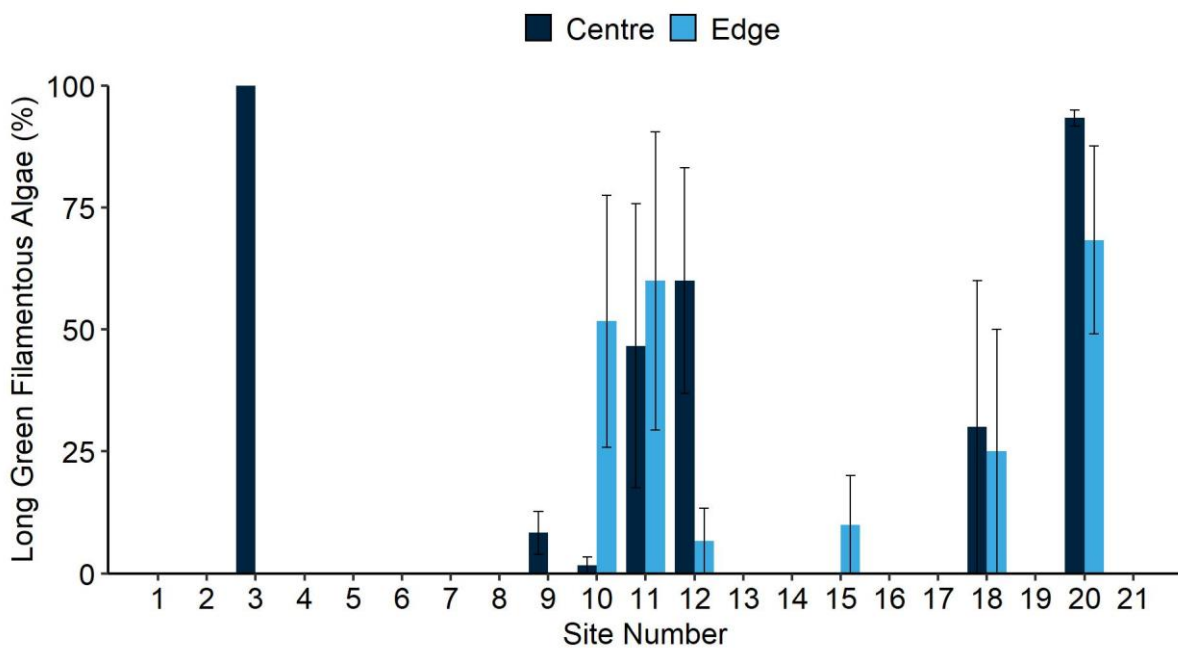
Figure 6: Mean (1±SE) long green filamentous algae cover for edge and centre measurements at all sites.

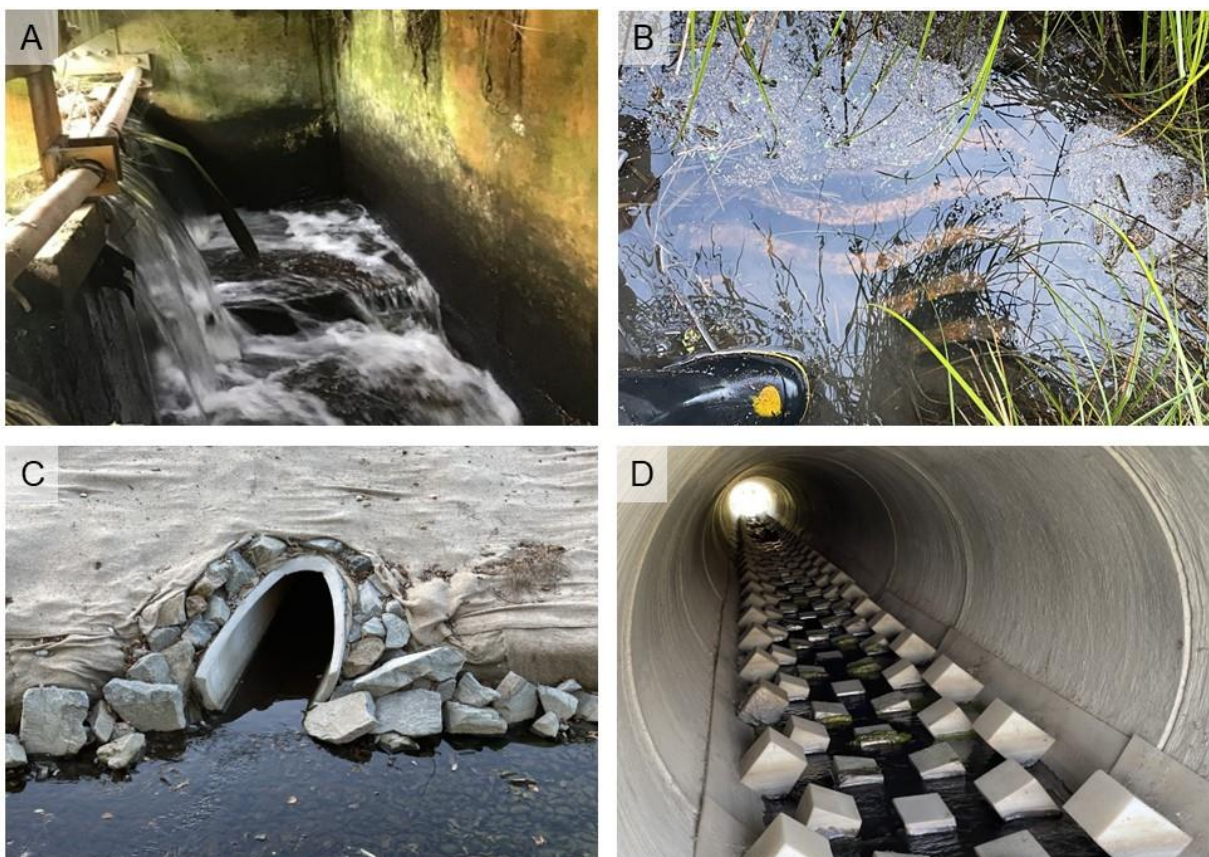
Figure 7: Examples of structures assessed for fish passage risk at the wetlands sampled. These include a very high-risk structure at A) Site 16 (Arthur Adcock), a medium-risk structure at B) Site 18 (Douglas Clifford), and low risk structures at C) Site 21 (Te Oranga Waikura) and D) Site 13 (Burlington).

Of the 21 wetlands sampled, downstream structures presented a low risk to fish passage at five sites, medium risk at five sites, high risk at four sites, and very high risk at seven sites (Table 3). Pipe culverts were the most common structures, while other structures included gates, valves, weirs, and narrow flow constrictions. Examples of low-risk structures include the outlet of Site 21 (Te Oranga Waikura), where there is adequate depth and low velocities to provide fish passage, and a culvert joining wetland cells at Site 13 (Burlington), where baffles have been placed to enhance fish passage (Figure 7). An example of a very high-risk structure is the outlet of Site 16 (Arthur Adcock), which comprises a weir with multiple steps (Figure 7). Other very high-risk structures were the combination of grates and piped network draining the retention pond outlets at Site 7 (Eastman) and Site 18 (Spring Grove). The outlet grates had 35 mm spacings between the bars at both wetlands (Figure 7). See Appendix 2 for details of all 51 structures assessed for fish passage across the wetland sites.

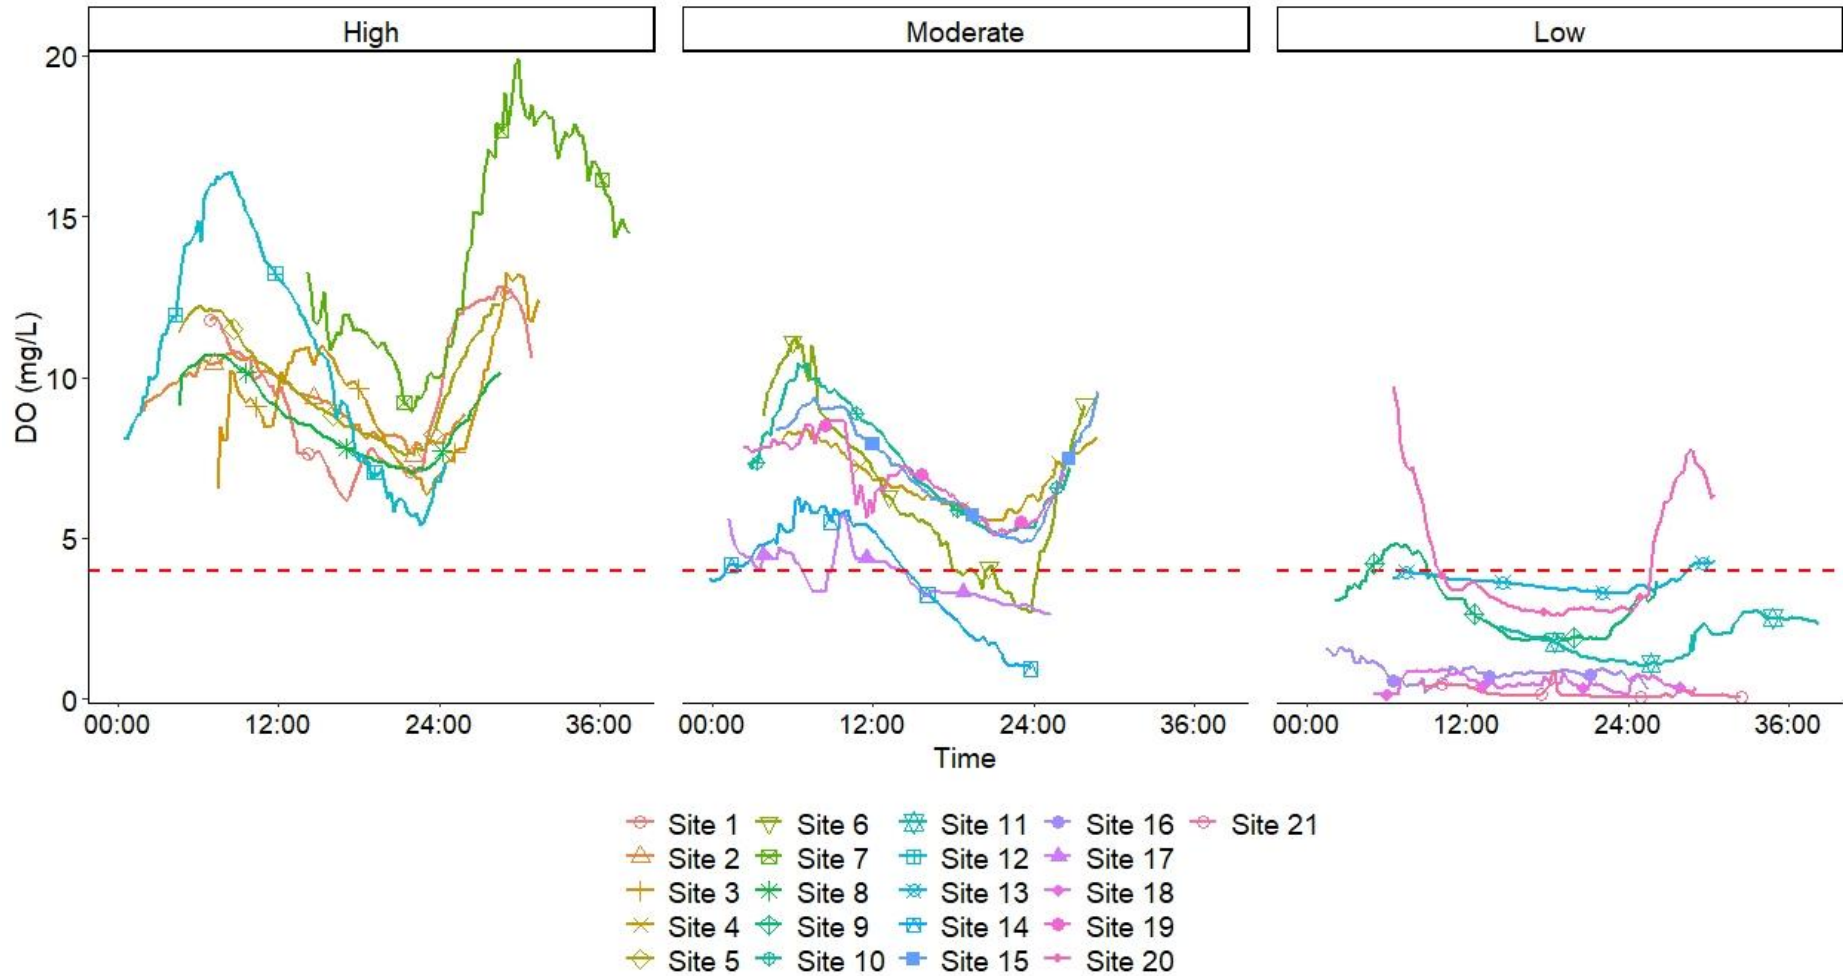
Figure 8: Dissolved oxygen (DO) concentrations recorded over a 24 hour period at each sampling site. Sites are even split into those with relatively high, moderate, and low median DO concentrations over the 24 hour period. Red dashed line indicates NPSFM national bottom line of 4 mg/L.

Mean DO concentrations recorded over a 24-hour period ranged from a low of 0.2 mg/L at Site 21 (Te Oranga Waikura) in mid-April to a high of 14.0 mg/L at Site 7 (Eastman) in early May (Table 4). Minimum DO concentrations were also lowest at Site 21, with a low of

0.06 mg/L, while the highest daily minimum DO concentration was 14 mg/L at Site 7. The National Policy Statement for Freshwater Management 2020 (NPSFM, Ministry for the Environment 2020) has a national bottom line of 4 mg/L for protection of aquatic biota in lakes and rivers. While some sites were characterised by high DO concentrations that were consistently well above 4 mg/L, others had moderate to low concentrations that dropped below 4 mg/L for at least part of the day (Figure 8). Ten of the 21 sites recorded minimum DO concentrations below 4 mg/L, with some sites sitting well below 4 mg/L for the entire 24-hr period.

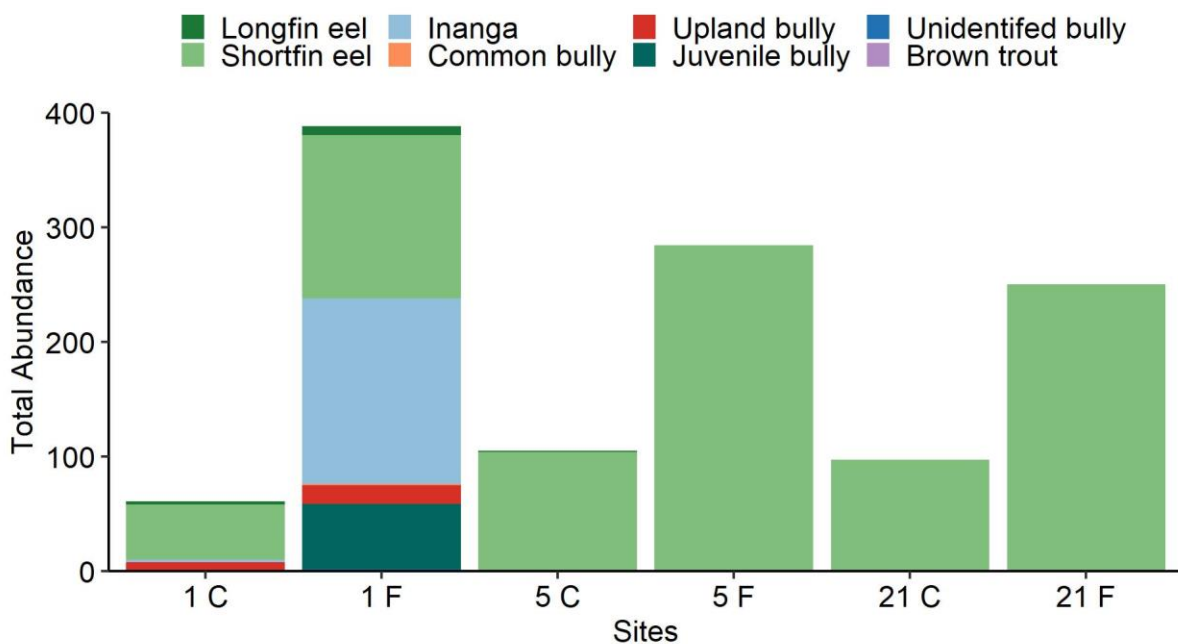
Figure 9: Comparison of the fish catch between coarse mesh fyke nets and minnow traps (C) and fine mesh fyke nets (F), at sites where both fishing methods were used.

Fine mesh fyke nets caught more fish and a greater range of fish species and life stages than coarse mesh fykes and minnow traps combined (Figure 9). For example, common bully (*Gobiomorphus cotidianus*) and juvenile bullies (*Gobiomorphus sp.*) were caught by fine mesh fykes, but not by coarse mesh fykes and minnow traps at Site 1 (Sparks Wetland). Similarly, longfin eel (*Anguilla dieffenbachii*) were caught using fine mesh fykes, but were not caught using coarse mesh fykes and minnow traps at Site 5 (Wigram). In addition, coarse mesh fykes caught fewer smaller-sized eels (Figure 10). Both fine mesh fyke nets and minnow traps were used to sampled fish at five sites (Table 2). No additional species were caught using minnow traps than were caught by fine mesh fyke nets at each of the five sites. Overall, these data indicate that fish diversity was likely underestimated at those sites where coarse mesh fykes and/or minnow traps were used to sample the fish community, when compared with sites sampled using fine mesh fyke nets.

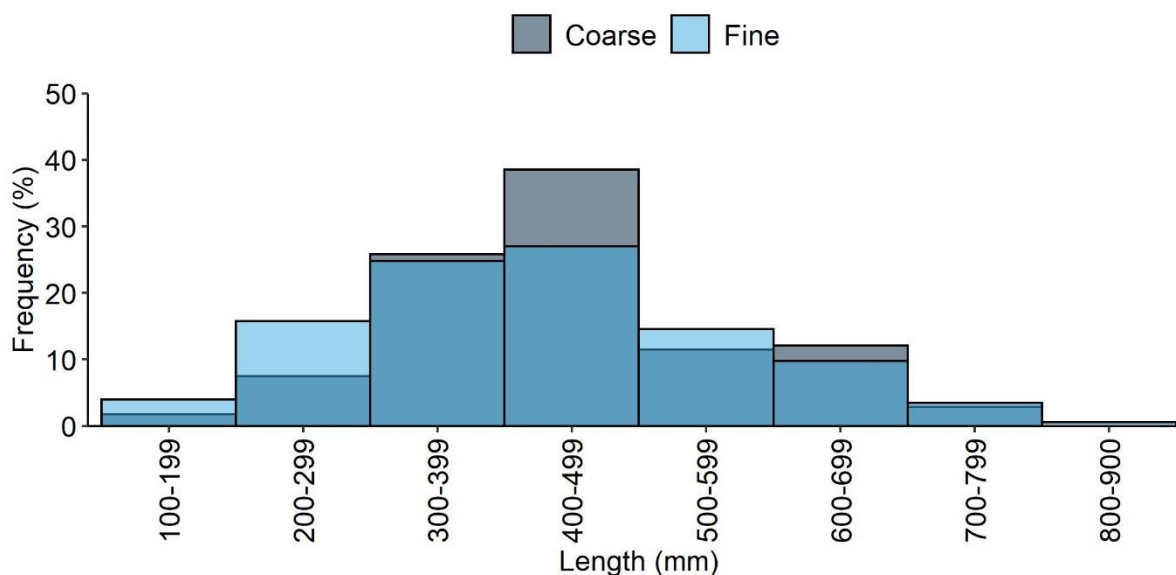
Figure 10: Comparison of the size distribution of shortfin eels caught in fine mesh and coarse mesh fyke nets.

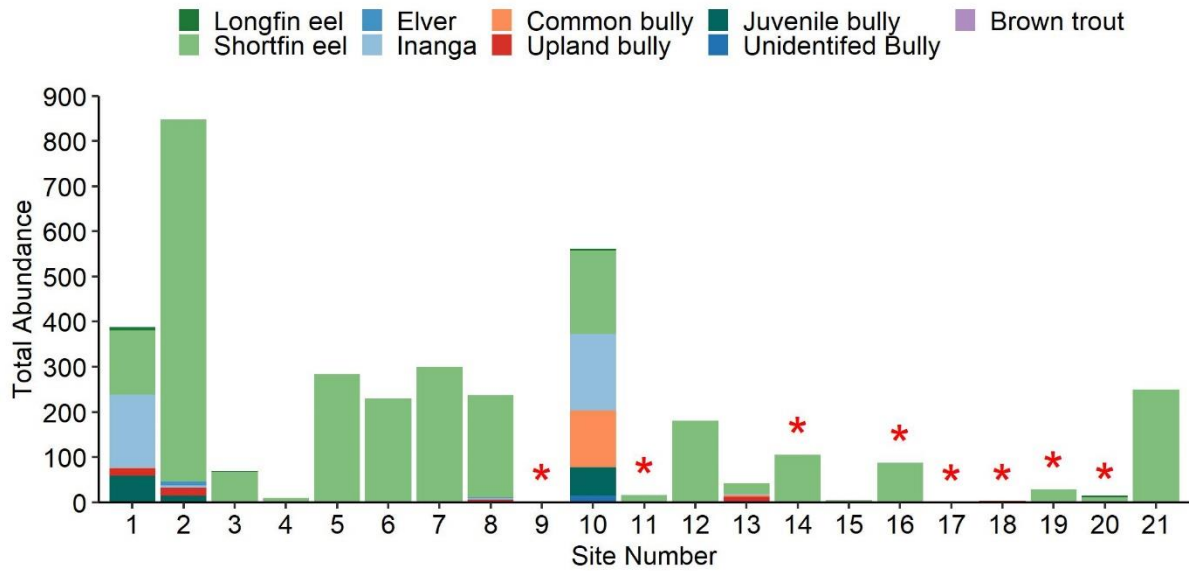
Figure 11: Abundance of fish species caught at each wetland site. Data are from fine mesh fyke nets, except those marked with asterisks, which were sampled using a combination of coarse mesh fyke nets and minnow traps.

Fish were caught at all sites except for Site 17 (Knights), which had minimal surface water (Table 3). A total of six species were caught across the wetland sites, including native shortfin eel, longfin eel, inanga, common bully, and upland bully, and introduced brown trout (*Salmo trutta*). Shortfin eels were caught at all 20 of the sites where fish were found and they were the most abundant species overall, with a total of 2,945 caught across the wetlands. Site 2 (Sparks First Flush) had the largest catch of shortfin eels, with 802 caught in five fine mesh fyke nets (Figure 11). Inanga were the second-most abundant species, with a total of 344 caught across five sites, although they were most abundant at Site 10 (Charlesworth) and Site 1 (Sparks Wetland). Common bully was the third most abundant species, with a total of 131 caught across three sites, with the greatest catch at Site 10 (Charlesworth). Upland bully were found at six sites, but only 56 were caught across the sites. Longfin eel were caught at five sites and they were also uncommon, with a total of 19 caught. The largest fish caught overall was a longfin eel measuring 1,218 mm, from Site 1 (Sparks Wetland). A single brown trout was caught at Site 5 (Wigram). See Appendix 3 for a summary of fishing results for all sites and fishing methods.

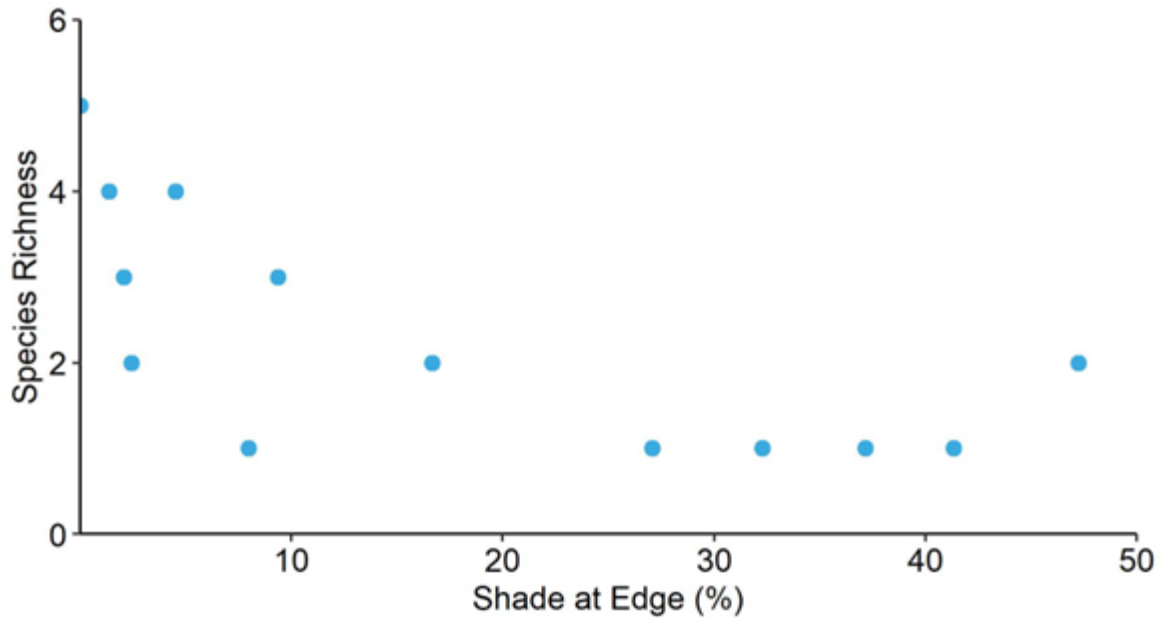
Figure 14: Relationship between shade and fish species richness for 13 sites with fine mesh fyke data.

There were several statistically significant spearman rank correlations between environmental variables and the response variables of total fish abundance, fish taxa richness, shortfin eel abundance, and median shortfin eel length. Total abundance was positively correlated ($p < 0.01$) with mean depth (Figure 13); taxa richness was correlated positively with mean depth ($p < 0.05$) and negatively with percent edge shade ($p < 0.01$, Figure 14); and shortfin eel abundance was positively correlated with mean depth ($p < 0.05$). In addition, shortfin eel length and abundance were negatively correlated to each other ($p < 0.05$, Figure 15). Fish abundance and taxa richness showed a weak, positive correlation ($p = 0.054$). Plots of the fish data categorised by barrier score suggest that ponds with the highest richness and abundance had low barrier risk, but high abundance and richness did not occur at all sites with low barrier risk scores (Figure 16). Kruskal-Wallis tests revealed no significant effect of barrier risk score on any of the response variables ($p > 0.05$).

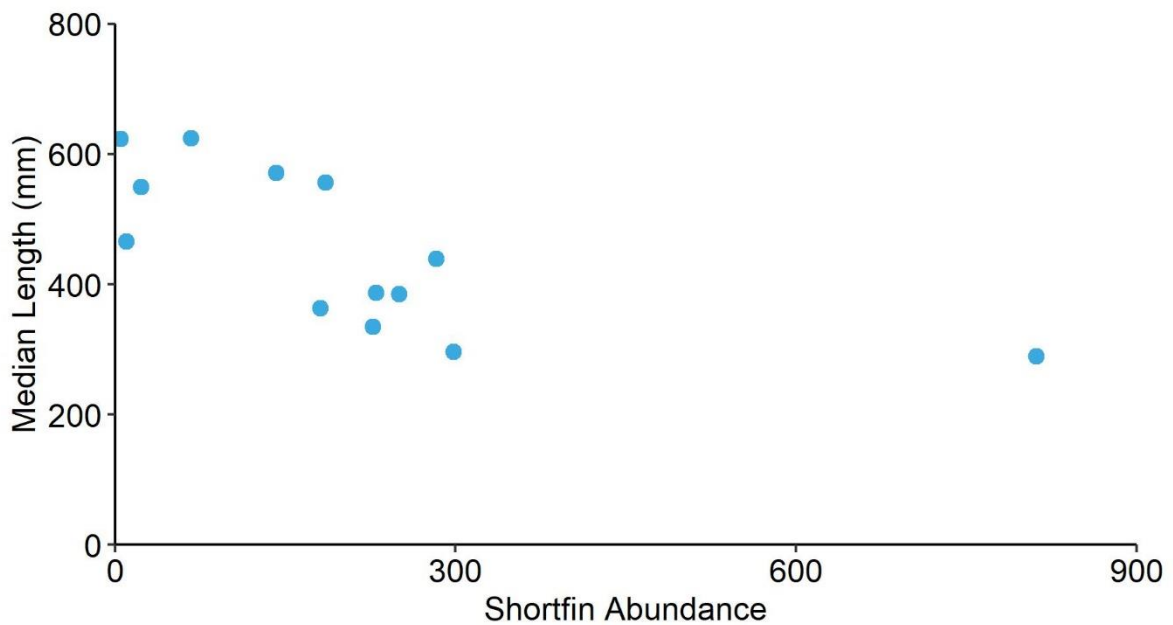
Figure 15: Relationship between shortfin eel abundance and length for 13 sites with fine mesh fyke data.

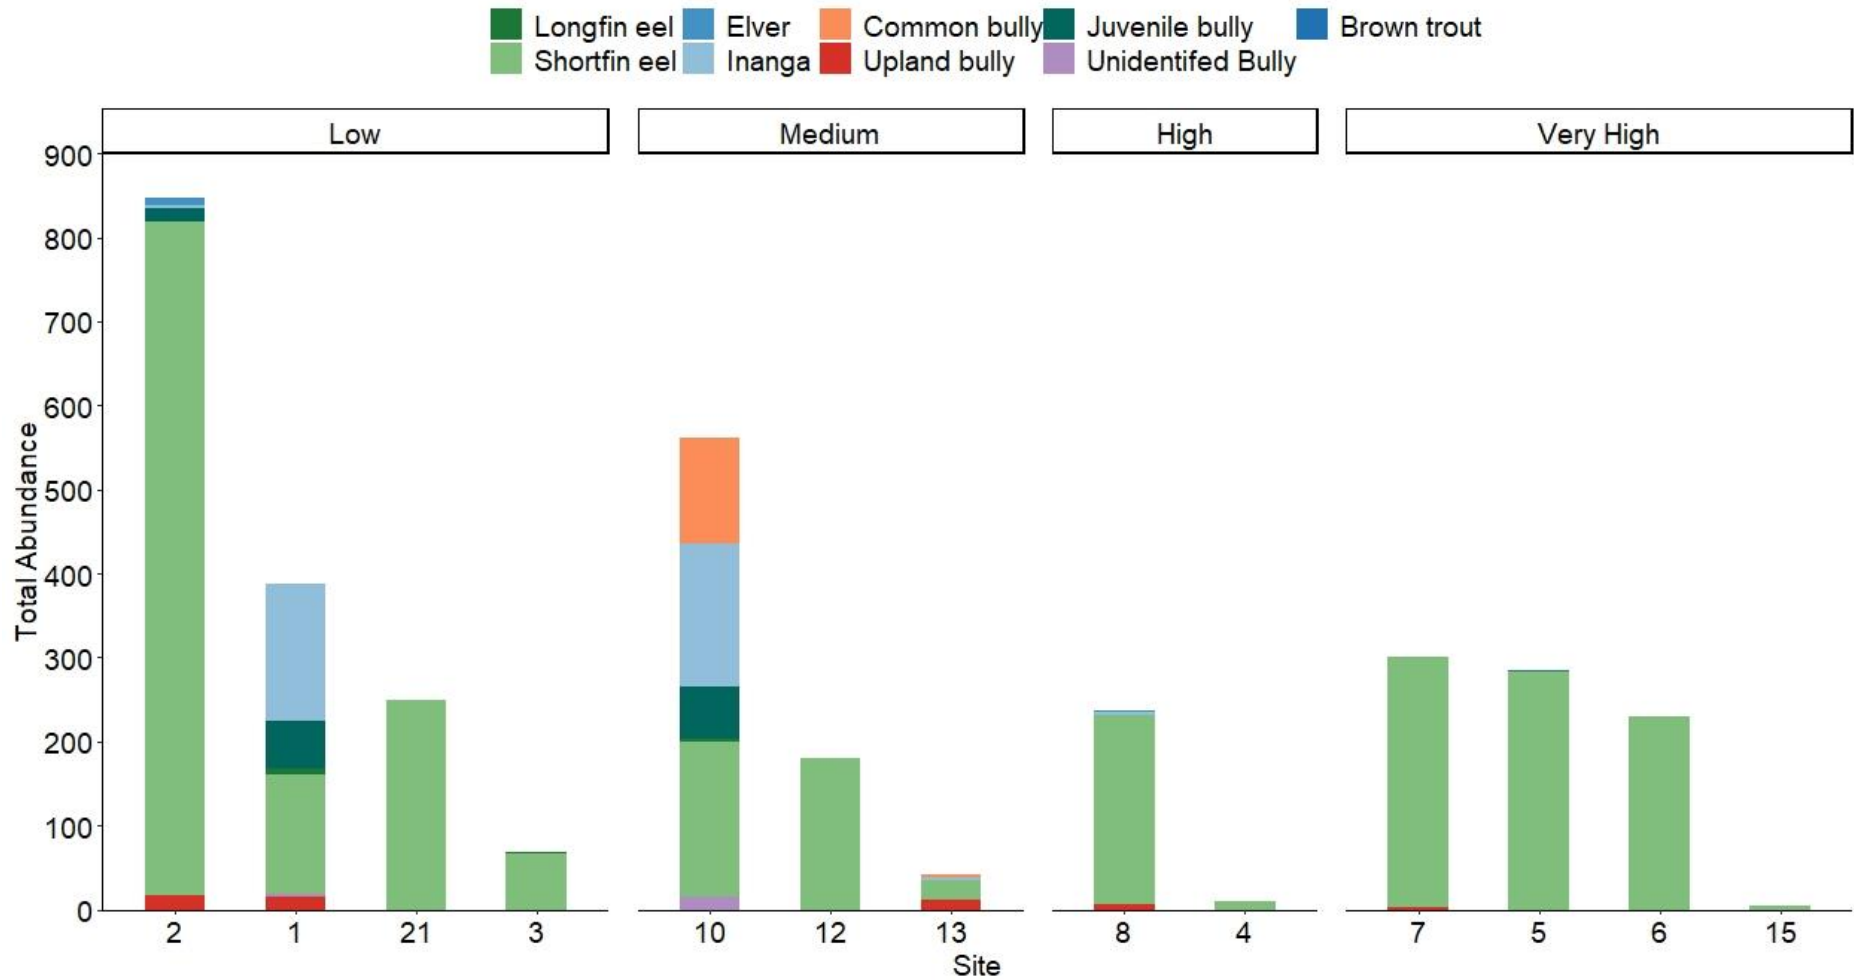
Figure 16: Fish community composition for sites sampled with fine mesh fyke nets. Sites are ordered by fish passage risk for each wetland.

Ordination on the fish community at the 13 sites with fine mesh fyke netting data yielded a stress value of 0.06, indicating a good representation of the dissimilarity matrix in two dimensional space (Clarke 1993). There were no statistically significant ($p < 0.05$) or ecologically meaningful envfit correlations between axis scores and environmental variables. However, pond area, downstream pipe length, and shade at edge were nearly significant ($p = 0.053 - 0.077$).
