Mahaanui Kurataiao Ltd

# Pūharakekenui Cultural Monitoring Report

October 2023

This report details monitoring undertaken to assess mana whenua values in the Pūharakekenui catchment as required under the conditions of the Comprehensive Stormwater Network Discharge Consent (CSNDC; CRC231955) held by Christchurch City Council (CCC). Mahaanui Kurataiao Ltd undertook cultural monitoring in March and April of 2023 at eight sites within the Pūharakekenui catchment using the State of Takiwā and Cultural Health Assessment methods. Overall, this monitoring indicated that the catchment has slightly below or at moderate cultural health values. The Attribute Target Level for Mana Whenua Values of 5 (i.e., very good) was not met by the 2023 survey results. A previous State of Takiwā monitoring was undertaken by mana whenua in 2012. The results of the 2023 survey showed a slight improvement in the overall health scores recorded in comparison to the 2012 survey, but this improvement is not significant. High *E. coli* levels (above the limit value of 550 MPN/100 mL in the Canterbury Land and Water Plan) at two sites (STYX09 / Ōuruhia Reserve, Kā Pūtahi and STYX19 / Redwood Springs, Pūharakekenui

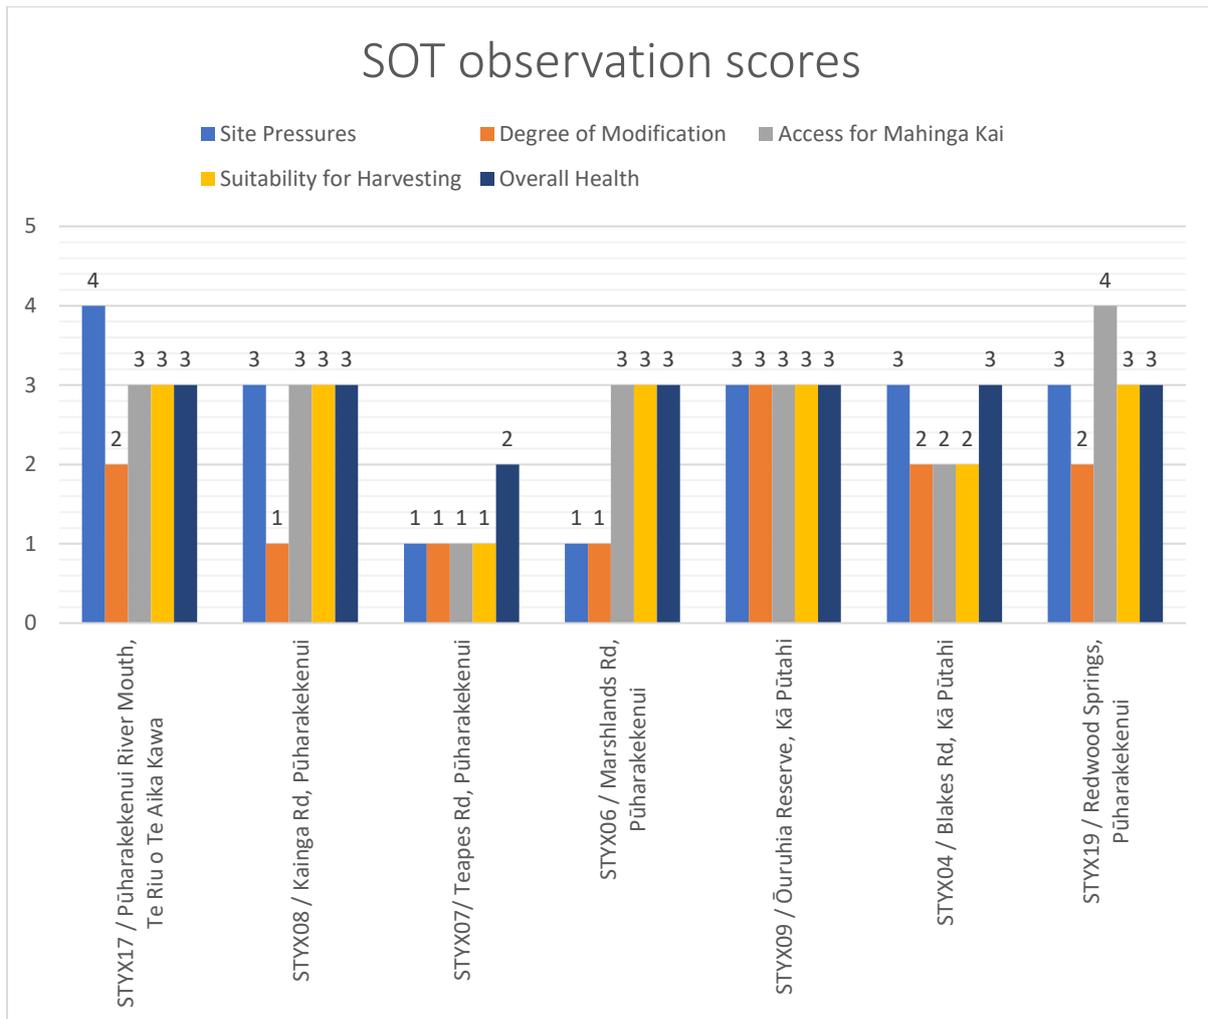
**Figure 3. The scores for each category in the SOT for each surveyed site.**

Most of the scores ranged from 1 (poor values) to 3 (moderate values) for each category and site. The lowest scores were recorded at STYX08 / Kainga Road, Pūharakekenui, STYX07 / Teapes Road, Pūharakekenui and STYX06 / Marshland Road, Pūharakekenui, particularly for degree of modification and site pressures. At STYX08 / Kainga Road, Pūharakekenui, recorded observations for degree of modification included the drainage of the wetlands, the flood/tidal gates and the bridge/road. At STYX07 / Teapes Road, Pūharakekenui, every category except overall health scored a 1. Reasons for the scoring include: the surrounding farms creating site pressure, modification of the site through drainage of the wetlands, the bridge, straightening of the channel and earthquake repairs, and limited access for harvesting mahinga kai due to the river being fully fenced off and surrounded by farms. At STYX06 / Marshland Road, Pūharakekenui, recorded site pressures included the main road and bridge, heavy traffic and the urban area. Recorded observations for the degree of modification at this site included the bridge, rebattering of banks, and straightening for the river channel.

Scores of 4 (high value) were recorded for site pressure at STYX17 / Pūharakekenui River Mouth, Te Riu o Te Aika Kawa and for access for mahinga kai at STYX19 / Redwoods Springs, Pūharakekenui. Boating was the main site pressure noted at STYX17 / Pūharakekenui River Mouth, Te Riu o Te Aika Kawa. Access for mahinga kai at STYX19 / Redwoods Springs, Pūharakekenui was considered good due to the public reserve at the site. Further recorded observations are detailed in Section 4.2 as part of the CHA.

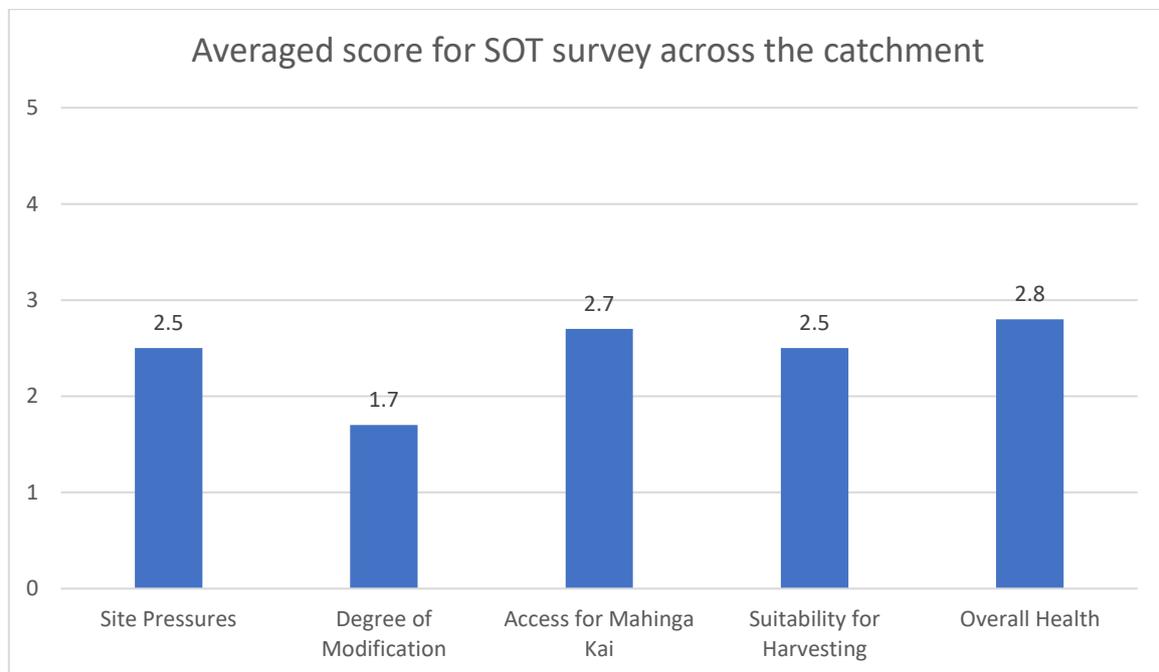
Figure 4 below shows the average score from all sites for each category. These numbers illustrate the score at the catchment level, including the overall health score. The average scores for the catchment are all under 3 (moderate values), with the lowest score for degree of modification (1.7 – low value).

Figure 4. The averaged scores for the SOT survey for each category across the catchment.

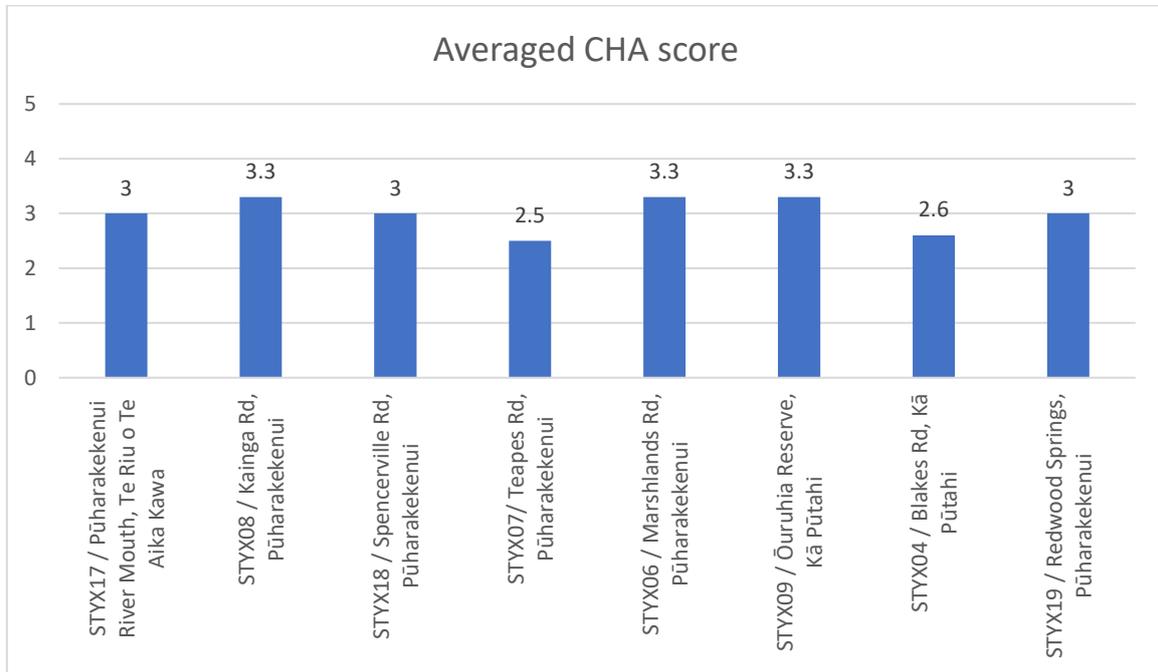
(Figure 5). The overall results show a trend of scores around 2 (poor values) and 3 (moderate values).

**Figure 5. The averaged CHA score for overall health across the catchment.**

The lowest averaged scores were recorded for catchment land use, riverbank use and development, riverbed condition, water quality, changes in the river channel and overall health. These scores ranged from 1 to 3.6, placing the sites from poor values to above moderate values. Higher averaged scores (above 4) were recorded for riverbank vegetation, range of habitat, minimal to no barriers to water flow and fish passage, and access. Despite the higher scores, for most of these categories there was only one site out of the eight surveyed which scored an average of four or higher for these categories. Questions on whether there is suitable fish passage and accessibility were the only categories with more than one score of 4 (high values). Only one score of 5 (high values) was recorded for STYX17 / Pūharakekenui River Mouth, Te Riu o Te Aika Kawa for accessibility.

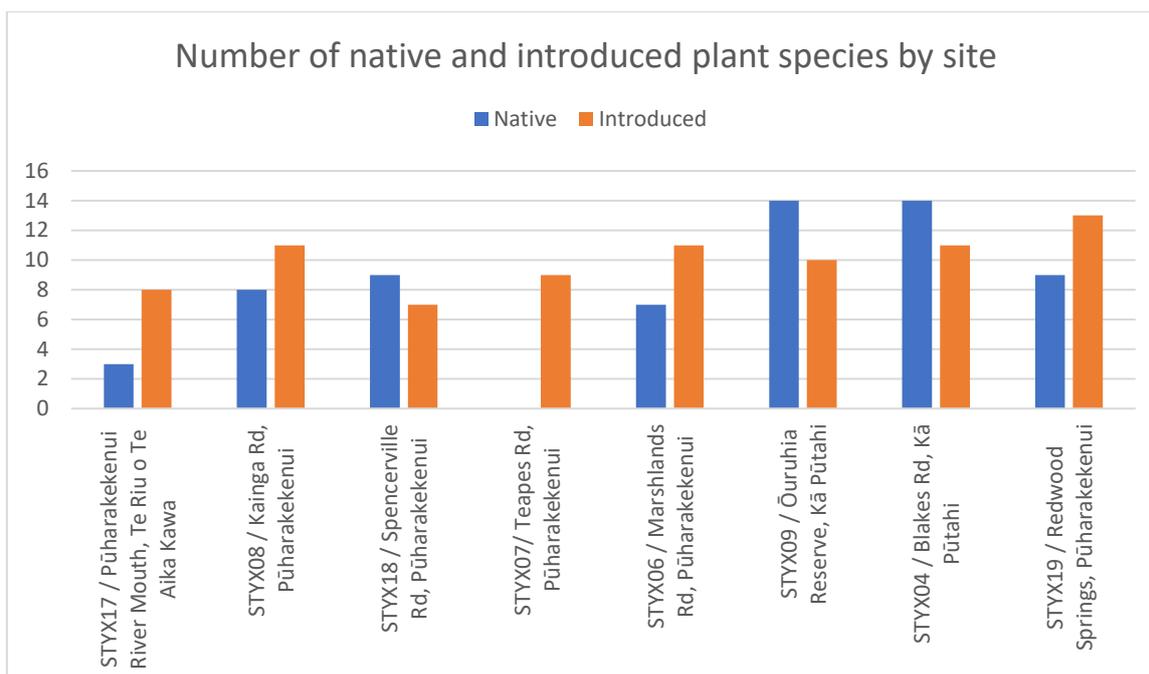
The full list of observed species can be found in Appendix B. Figure 6 below shows the numbers of native and introduced plant species observed and identified during the survey by site. Across the catchment, 45% of the recorded vegetation is native and 55% is introduced.

**Figure 6. The numbers of identified native and introduced plants species by site recorded in the vegetation survey.**

The number of introduced plant species recorded was high across the catchment with percentage cover ranging from 40% to 70%. At site STYX07 / Teapes Road, Pūharakekenui the percentage was 100% introduced species. Recorded species included willow (including dead trees), gorse, oxygen weed, pine, macrocarpa, poplar, old mans beard, monkey musk, blackberry, grasses and weeds. Comments recorded by the monitors included a specific mention of the old mans beard overgrowth at STYX08 / Kainga Road, Pūharakekenui; blackberry at STYX09 / Ōuruhia Reserve, Kā Pūtahi; and swamp willow and celery at STYX04 / Blakes Road, Kā Pūtahi.

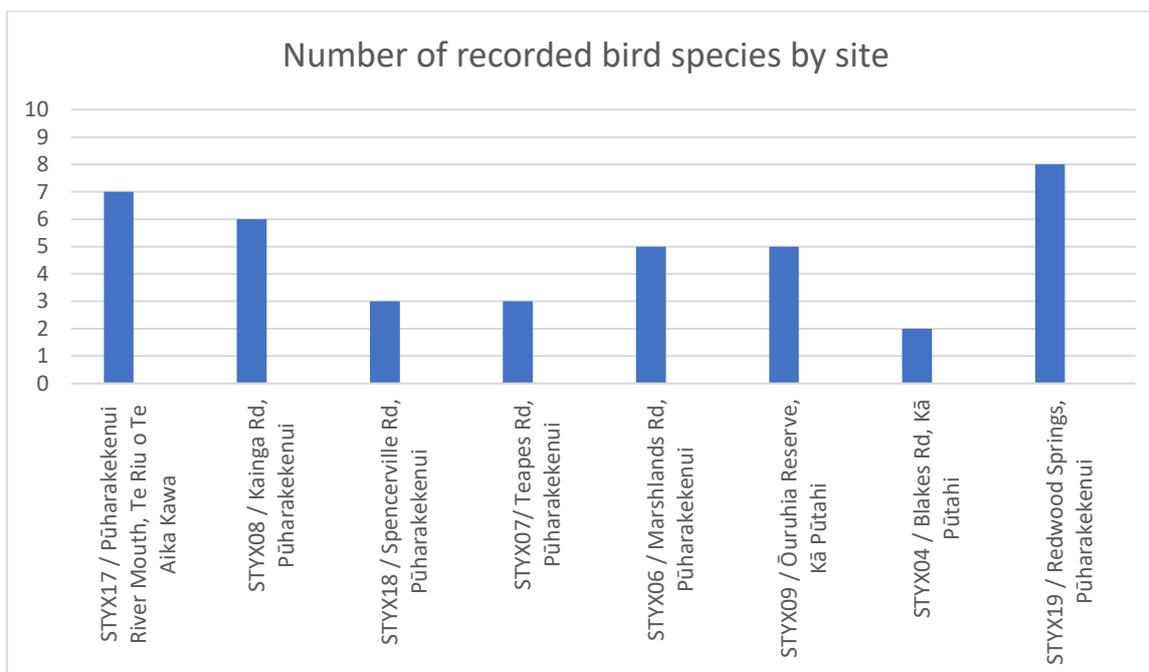
Figure 7 below shows the number of observed species of bird by site. The highest number of bird species was recorded at STYX19 / Redwood Springs, Pūharakekenui with a total of eight. Species recorded here included pūtangitangi, pūkeko, pīwaiwaka, kakīānau (black swan), unidentified geese, unidentified ducks, manu pango (blackbird) and swallow. These species were some of the most common species recorded across the catchment, with the only common species not recorded at STYX19 being sparrow. The next highest was at STYX17 / Pūharakekenui River Mouth, Te Riu o Te Aika Kawa with a total of seven recorded species. The coastal location of this site meant that there were records of different, more coastal dwelling species such as unidentified seagulls, tōrea (oystercatcher) and shag. Low numbers of bird species were recorded at STYX18 / Spencerville Road, Pūharakekenui, STYX07 / Teapes Rd, and Pūharakekenui and STYX04 / Blakes Road, Kā Pūtahi.

Figure 7. Numbers of bird species recorded at each site.

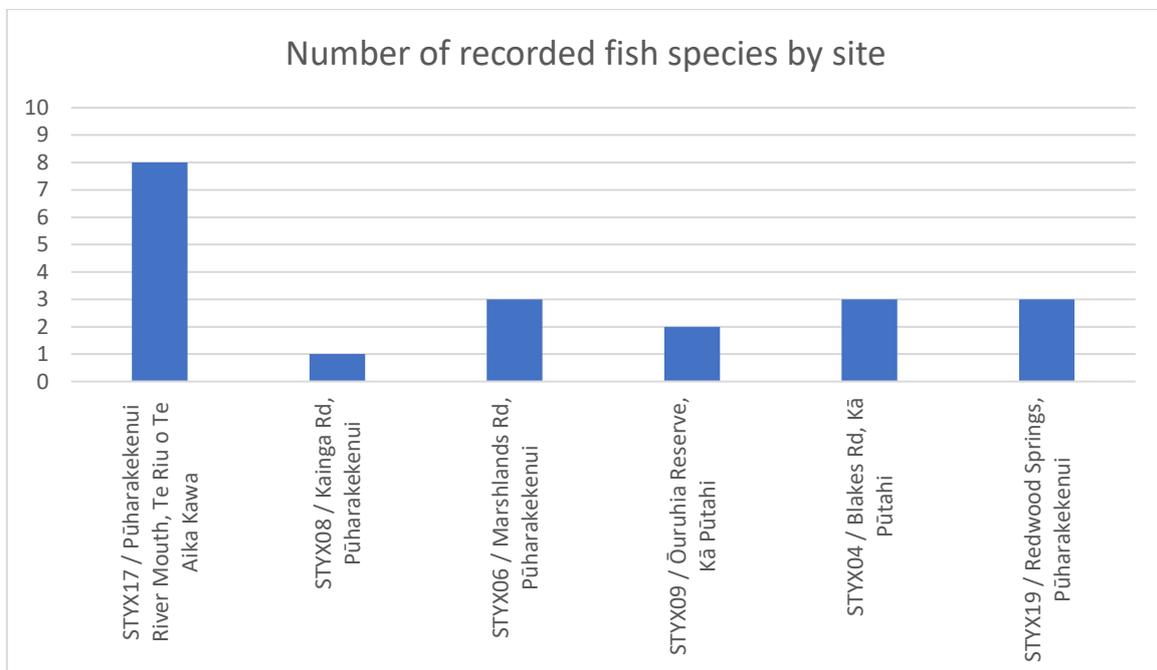
No species were recorded at STYX18 due to the destruction of the nets in place, although unidentified trout species were observed during the CHA monitoring. No species were recorded at STYX07 as the depth of the river was unsafe to enter and set nets, but an unidentified trout was observed during the monitoring for the CHA. Monitors also noted observations of kākahi at the same location (abundance was not recorded). These have not been included in the results below as they did not constitute part of the fish survey (Figure 8).

**Figure 8. Numbers of fish species recorded at each site.**

The site at Pūharakekenui River Mouth, Te Riu o Te Aika Kawa (STYX17) recorded the highest number of fish species (eight). The location of this site on the coast and at the mouth of the river is a factor in the range of species found here, as species such as tunnelling mud

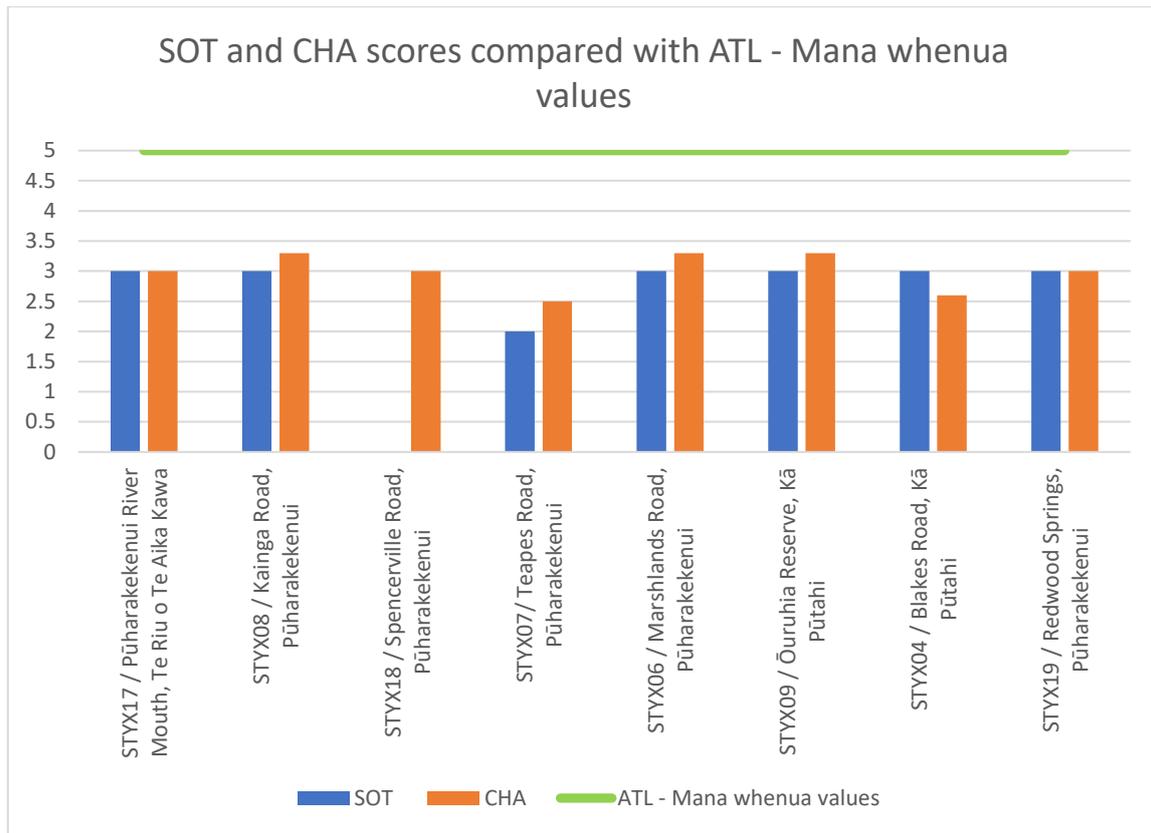
For the Pūharakekenui catchment, the average score of overall health from the SOT survey of the monitored sites (excluding STYX18 / Spencerville Road, Pūharakekenui) was 2.8. The average score from the Cultural Health Assessment survey (based on the score for overall health) for all sites was 3. These scores do not meet the set target level of 5 (Figure 9). This score demonstrates that there is still significant work to be done to improve the cultural health of sites in the catchment, as well as the catchment overall.

Figure 9. The SOT and CHA scores for overall health by site in comparison to the attribute target level for mana whenua monitoring as per Condition 54 of the CSNDC.

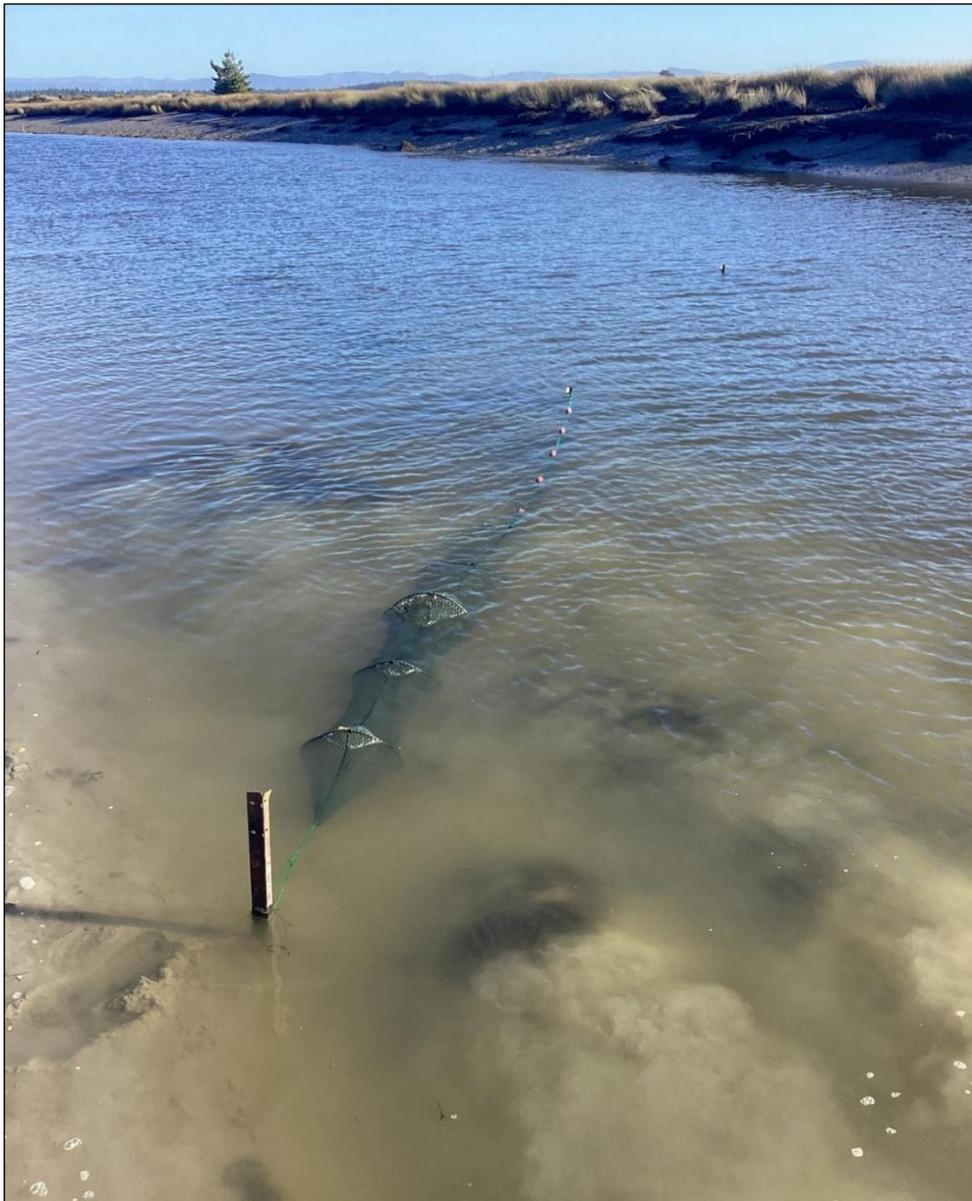
The SOT scores for STYX17 / Pūharakekenui River Mouth, Te Riu o Te Aika Kawa were 4 (high values) for site pressures, 2 (poor values) for degree of modification and 3 (moderate values) for all other categories. The overall health for the site as recorded in the CHA monitoring was 3 (moderate values). Scores across the CHA categories were largely under at or below this score, with a higher score of 4.6 (high values) for no barriers and fish passage, and a score of 5 for safe access. Many of the results for STYX17 / Pūharakekenui River Mouth,

Te Riu o Te Aika Kawa reflect the different coastal environment of the site (Figure 10). This includes high levels for electrical conductivity, thicker deposits and lower recorded clarity in the SHMAK records. There were high numbers and abundance of fish and bird species with many coastal-dwelling types recorded. However, there were low numbers of native vegetation, with higher numbers of introduced plant species indicating further work for restoration of indigenous biodiversity at this site. Monitors commented on the presence of boats and jet skis as concerns specific to the site. Identified issues of concern shared with other sites included: discharge from industries (specifically Belfast Freezing Works) and rubbish. Actions to restore mahinga kai include: riparian planting/restoration of native plant species, controlling discharge, improve water quality, rubbish bins.

Figure 10. Looking northwest at the hīnaki placed during monitoring at STYX17 / Pūharakekenui River Mouth, Te Riu o Te Aika Kawa.

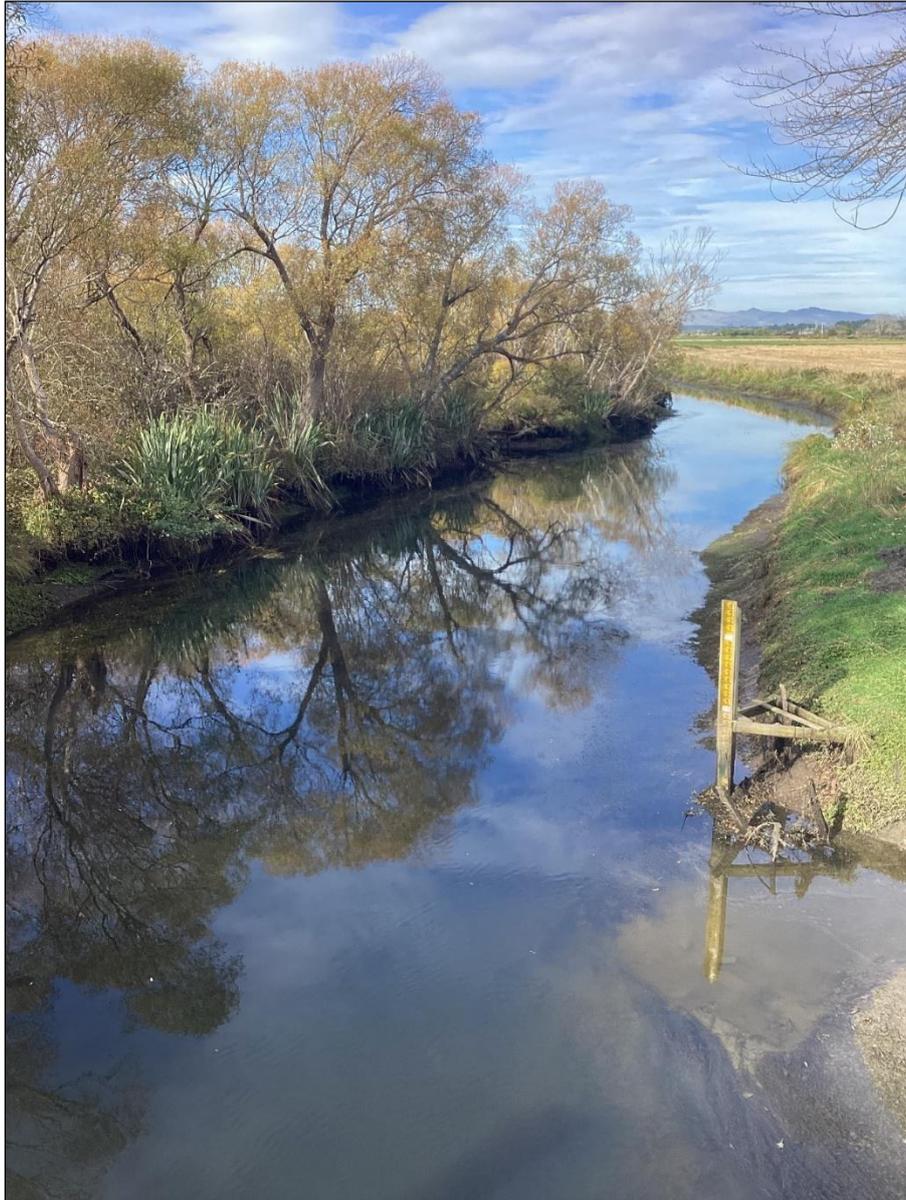
The SOT scores for STYX08 / Kainga Road, Pūharakekenui were consistent at 3 (moderate values) for most categories. A low score of 1 for degree of modification is due to the drainage of the wetlands, the flood/tidal gates and the bridge/road. The overall health for the site as recorded in the CHA monitoring was 3.3 (moderate values). Scores across the CHA categories were largely under at or below this score, with a higher score of 4 (high values) for riverbank vegetation and a score of 4.3 (high values) for in-stream habitats. *E. coli* levels were elevated but not above the guideline limit level. The number of native plant species was mid-range but there was a higher number of introduced species (Figure 11). Only one fish species was

observed at the site. The site had the third highest number of bird species recorded. Identified concerns specific to the site include a lack of flow when the floodgates are closed and dead willows. Identified issues of concern shared with other sites included: cows close to the river/effluent runoff from stock, rubbish, no or minimal birds, and direct stormwater discharge to river. Actions to restore mahinga kai include: riparian planting/restoration of native plant species, rubbish bins, controlling discharge and improving water quality.

Figure 11. Looking upstream at STYX08 / Kainga Road, Pūharakekenui.

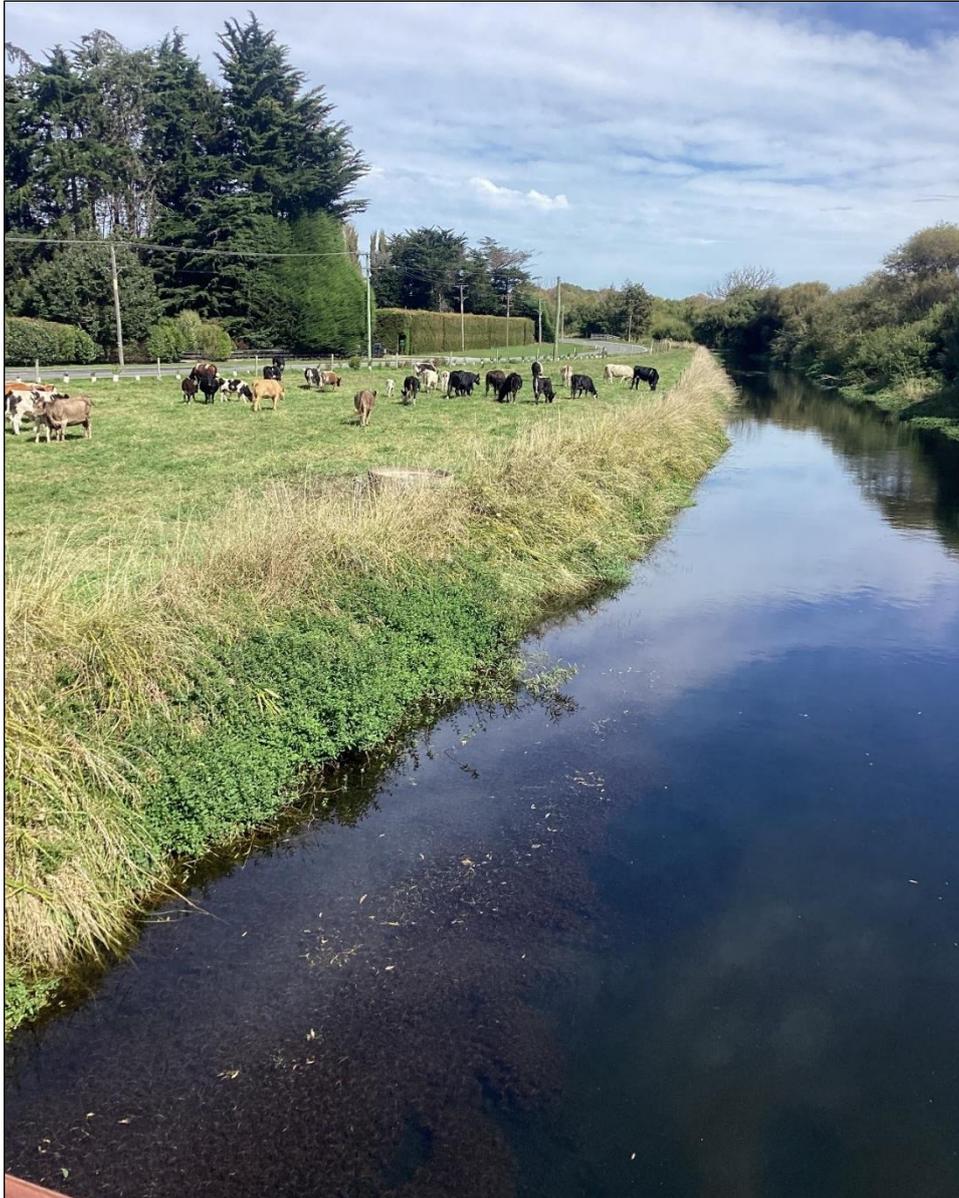
The SOT scores for STYX07/ Teapes Road, Pūharakekenui were very low across all categories, with ratings of 1 and 2 (poor values). The average overall health score of 2.5 (poor to moderate values) was recorded for the CHA monitoring. Scores across other CHA categories were at or under this rating, apart from the slightly higher score of 2.6 (poor to moderate values) for in-stream habitats, a score of 3.3 (moderate values) for barriers and 4 (high values) for fish passage. The depth of the river at this site prevented some recording methods being undertaken. No native plant species were recorded, and there was a low number of bird species. The greatest issue of concern noted by monitors is that the site was heavily farmed on all sides with cows next to the water and that there was no native riparian planting to act as a filter for the effluent runoff from the livestock (Figure 12). There were also concerns about runoff of fertilisers from crops planted close to the river (Figure 13). Other identified issues of concern shared with other sites included: fencing for stock too close to the river, land use related runoff (e.g., fertilisers), minimal access, weeds and plant overgrowth, sediment and silt (including as result of earthquakes) and generally insufficient riparian and/or native planting. It was noted that monitors had heard that the land use, runoff and nitrates going into the water was “killing off the ecosystem of the river here”. At the time of recording one of the monitors noted that the water looked “polluted”. These issues were significant enough that the monitors recorded that they would not use this site. The monitors noted that

trout and kākahi were observed in the river. No native plants were recorded from this site and minimal birds were recorded. Actions to restore mahinga kai include: riparian planting with native plant species, ensuring stock fencing and farming activities are further away from the river (i.e., increasing the buffer) and improving access.

**Figure 12.** Looking upstream at the river and riverbank, showing the lack of buffer between livestock and the river.

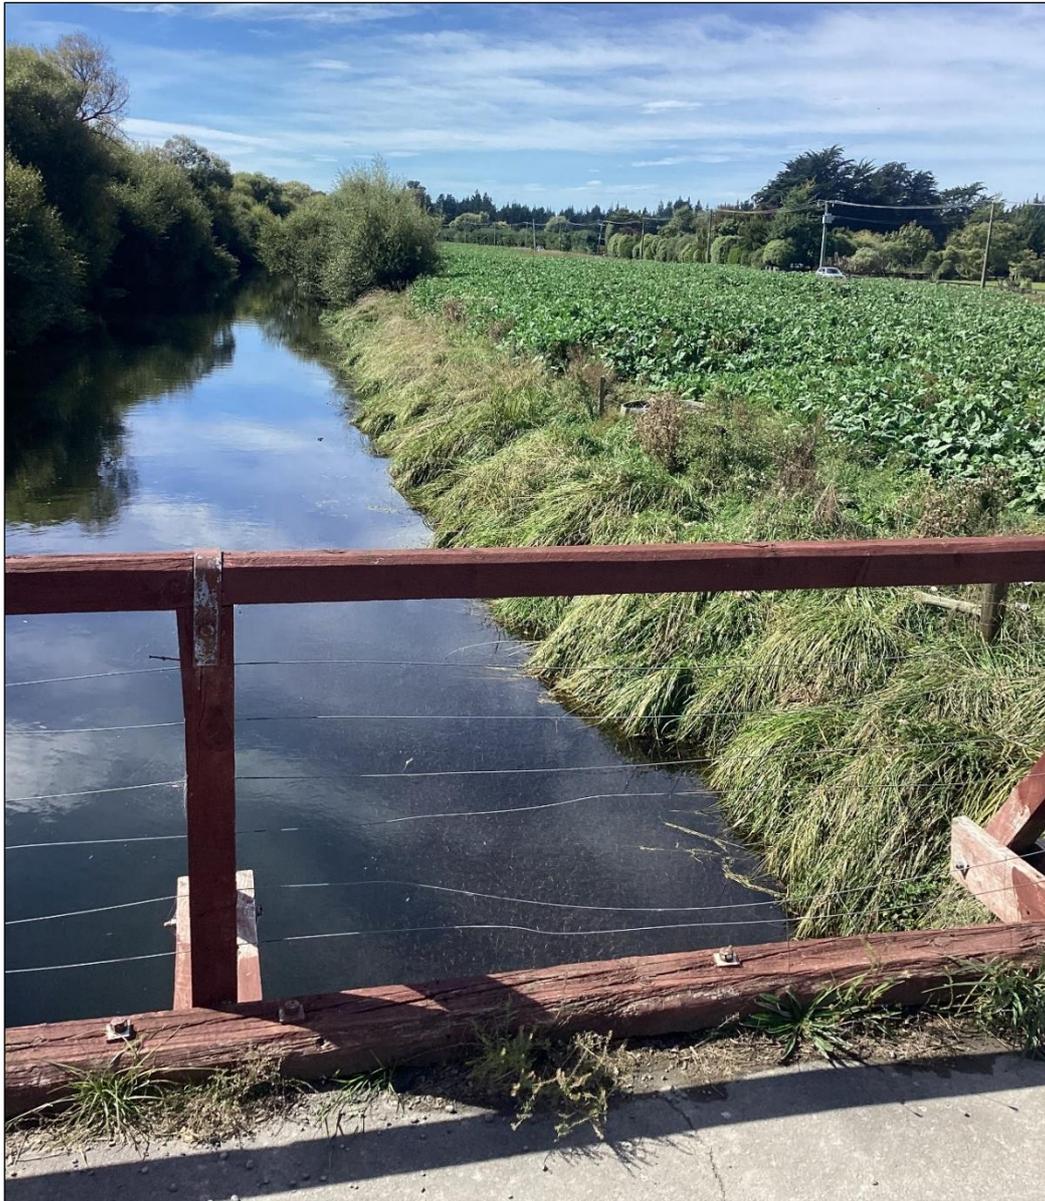
**Figure 13. Looking downstream at the river and riverbank, showing the lack of buffer between crops and the river.**

- Mahinga kai sites should be developed throughout the catchment in conjunction with mana whenua.
- The location of stock fencing, buffers and riparian margins should be consistent with recommended waterway setbacks in the Mahaanui Iwi Management Plan 2013 (refer **WM12.5**).

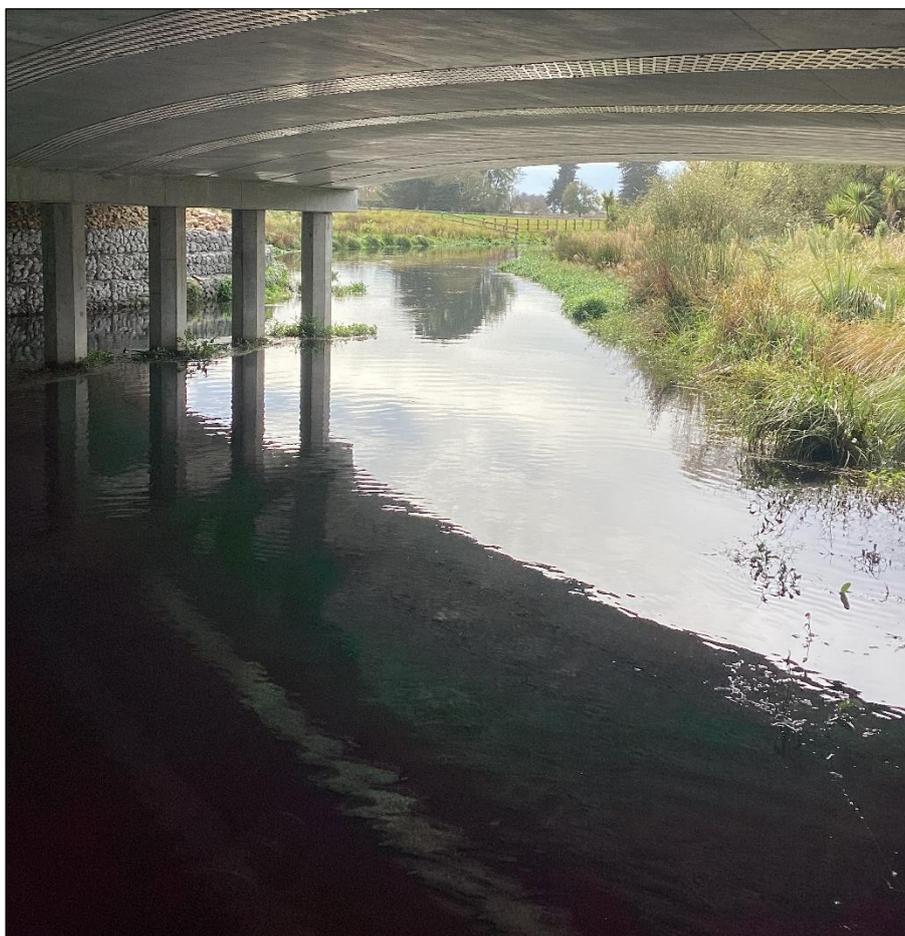
The SOT scores for STYX06 / Marshlands Road, Pūharakekenui ranged from 1 (poor values) for site pressures and degree of modification, to 3 (moderate values) for the remaining categories. The overall health for the site as recorded in the CHA monitoring was 3.3 (moderate values). Scores across the CHA categories were largely at or under this score, with a higher score of 3.6 (moderate to high values) for water quality and safe access, and 4.6 (high values) for fish passage. *E. coli* rates were above safe guidelines for swimming, but not over the limit value under the Canterbury LWRP. Recorded vegetation comprised native and introduced plant species, but there was a higher number of introduced plant species. Number

of fish species recorded was low but on par with two other sites. Bird numbers were roughly mid-range. Identified issues of concern shared with other sites included: discharge from industries (specifically Belfast Freezing Works), minimal access, no or minimal birds and insufficient riparian planting (native). Also noted for this site was concern for runoff from the road. Monitors noted that the riparian zone was well planted and established on the southern end but not yet established on northern end (Figure 14). The water quality was described as “nice and clear” at confluence with Kā Pūtahi. The Pā harakeke on site was also noted with the harakeke described as “beautiful”. Actions to restore mahinga kai include: riparian planting with native plant species, improved access and protection from road runoff.

Figure 14. Looking downstream at STYX06 / Marshlands Road, Pūharakekenui.

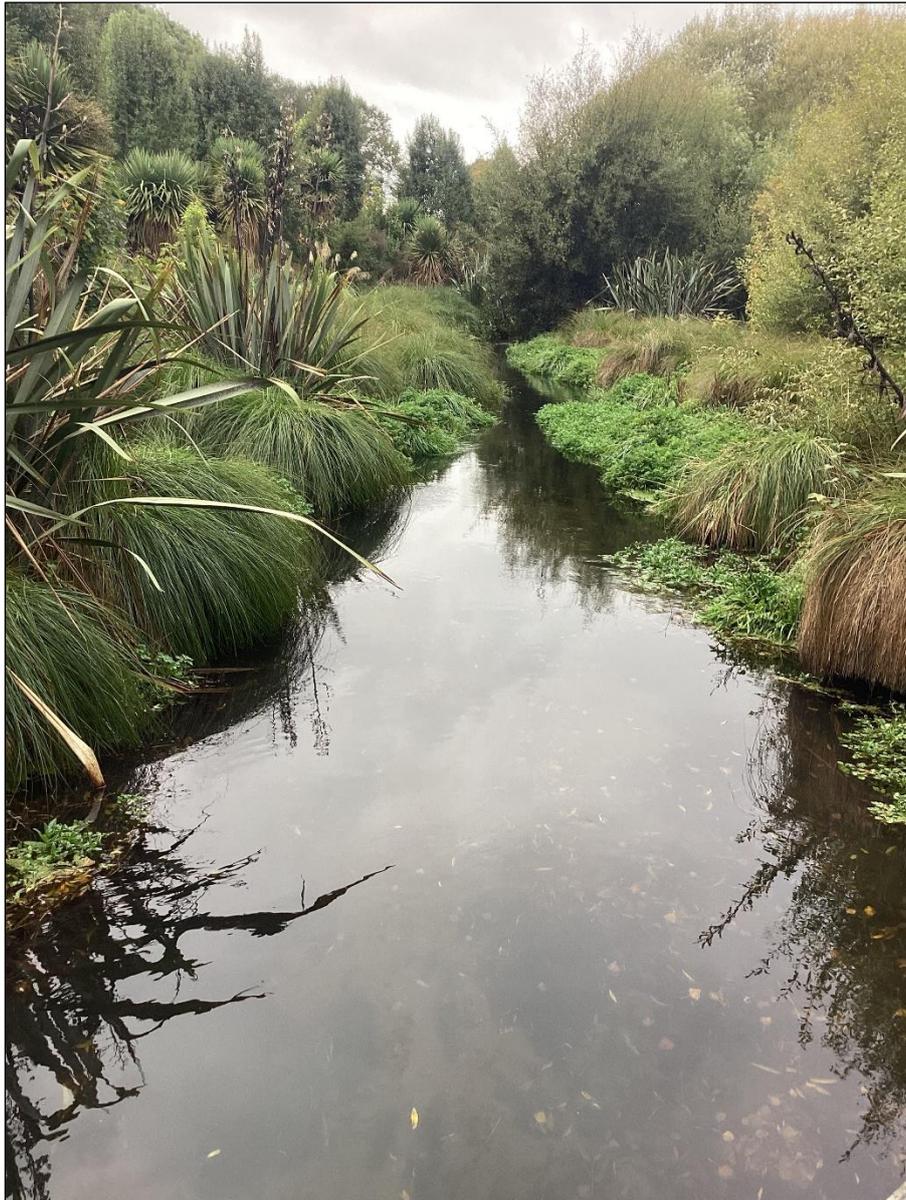
Recorded vegetation comprised high rates of native plant species due to the planted reserve, but also reasonable number of introduced plant species due to private land located alongside the site. Numbers of fish species recorded were low and numbers of bird species were roughly mid-range. Identified issues of concern shared with other sites included: rubbish, minimal access, weeds and plant overgrowth, sediment and silt (including as result of earthquakes), and insufficient riparian planting (native). Monitors noted that the reserve was nice and well planted, but that sediment was of particular concern for this area, as was the untidiness of the paths (Figure 15). Blackberry was noted to be strangling some areas. Actions to restore mahinga kai include: monitoring and maintaining weeds and other plantings, removal of sediment and keeping walkways tidy.

Figure 15. Looking downstream at STYX09 / Ōuruhia Reserve, Kā Pūtahi.

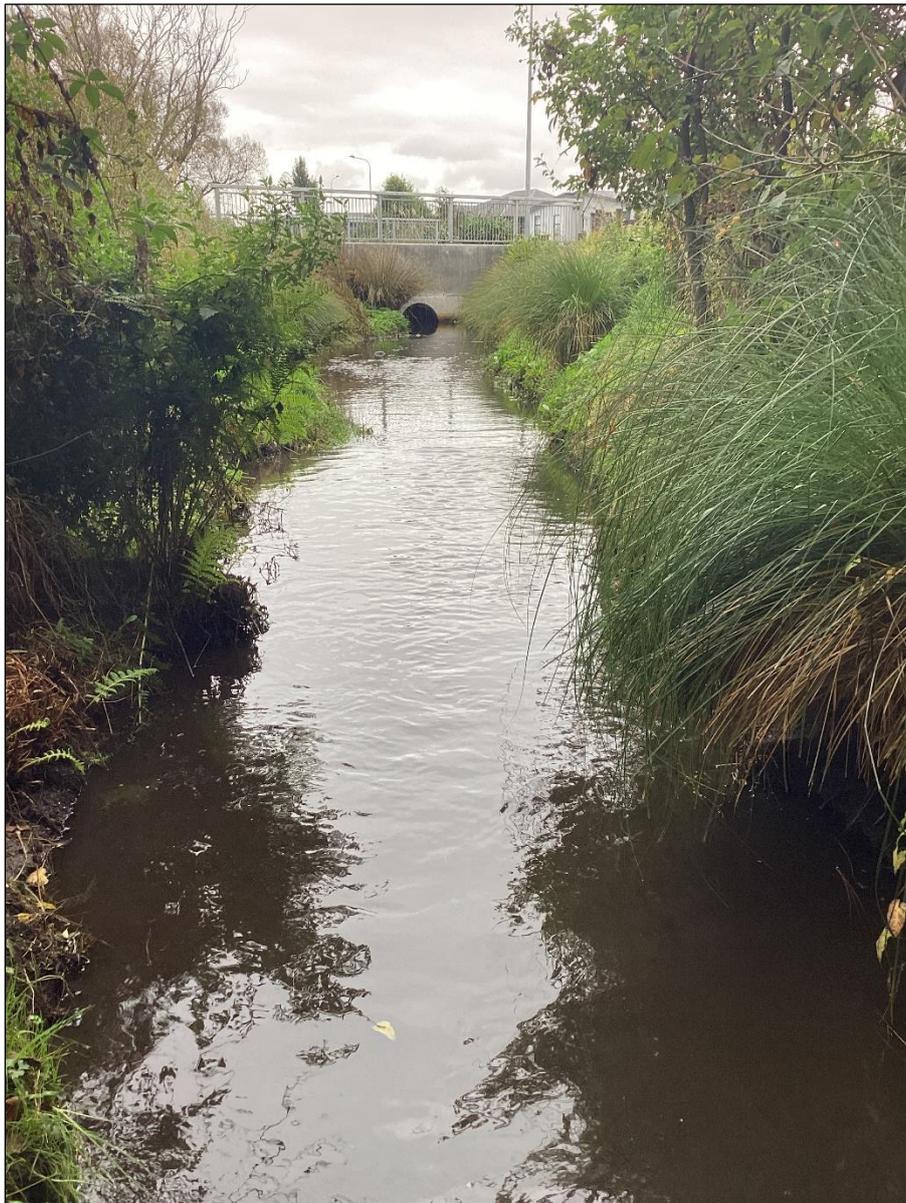
The SOT scores for STYX04 / Blakes Road, Kā Pūtahi were either 2 (poor values) or 3 (moderate values). The overall health score from the CHA monitoring was 2.6 (poor to moderate values). Scores across the other CHA categories were at or below this rating, with a higher score of 3 (moderate values) for habitats and riverbank use/development. Recorded vegetation comprised high rates of native plant species due to the planting associated with the establishment of the recent subdivision, but also a reasonable number of residual introduced plant species due to the former land use as farmland (Figure 16). Numbers of fish species recorded was low but on par with two other sites. Numbers of bird species were the lowest recorded and the reason for this is unclear. Identified issues of concern shared with

other sites included: perceived discharge from industries (specifically noted as Belfast Freezing Works; no specified discharge point was recorded), cows close to river and/or effluent runoff, spraying of grass and weeds, land use related runoff (fertilisers), weeds and plant overgrowth and discharge from construction sites (ongoing as part of the subdivision development). Monitors noted that there was minimal canopy cover and it was particularly concerning that the waterway is overgrown with swamp willow and celery. Actions to restore mahinga kai include: monitoring and maintaining weeds and other plantings, and improved access.

Figure 16. Looking upstream at STYX04 / Blakes Road, Kā Pūtahi.

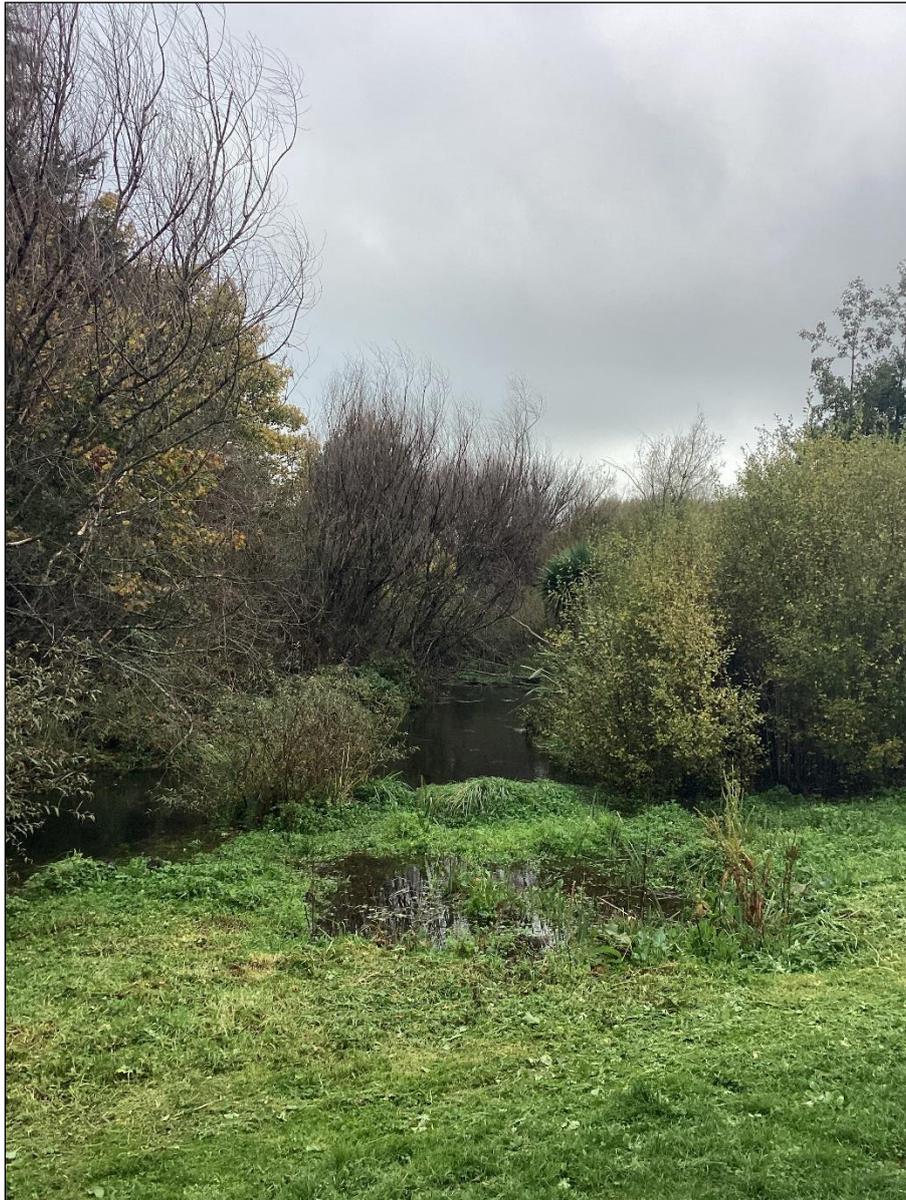
Recorded vegetation comprised mid-range rates of native plant species and higher numbers of introduced plant species, with a lot of exotic grasses and weeds observed in riparian margins, and oxygen weed in the river (Figure 17). The number of fish species recorded was low but on par with two other sites (STYX06 / Marshlands Road, Pūharakekenui and STYX04 / Blakes Road, Kā Pūtahi). The number of bird species was the highest recorded in the catchment. Identified issues of concern shared with other sites included: weeds and plant overgrowth, construction sites (discharge), direct stormwater discharge into river, and insufficient riparian planting (native). Monitors noted an unknown discharge of water 5 m west of the railway bridge as well as potential sediment runoff from the construction site occurring on the north side of the site. Monitors also noted that there was good access to natural springs. Actions to restore mahinga kai include: monitoring and maintaining weeds and other plantings, improved access, and investigation of the source of the discharge near the railway bridge.

Figure 17. Looking downstream at STYX19 / Redwood Springs, Pūharakekenui.

- The source of the discharge observed near the railway at STYX19 / Redwood Springs, Pūharakekenui must be identified and investigated.
- Discharge from construction sites must be regularly monitored for compliance with erosion and sediment control plans and any relevant contamination control plans.
