Port Hills Fish Communities

April 2023

Prepared for:
Christchurch City Council

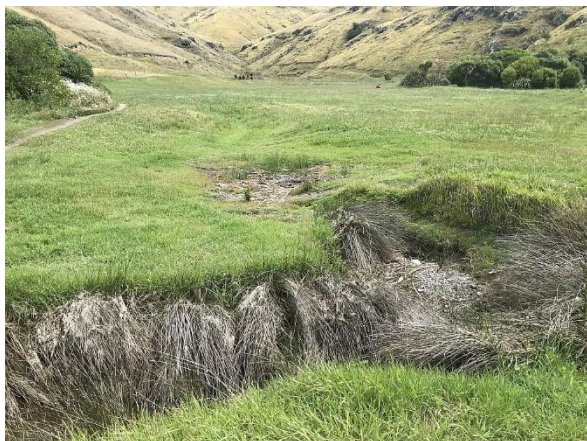
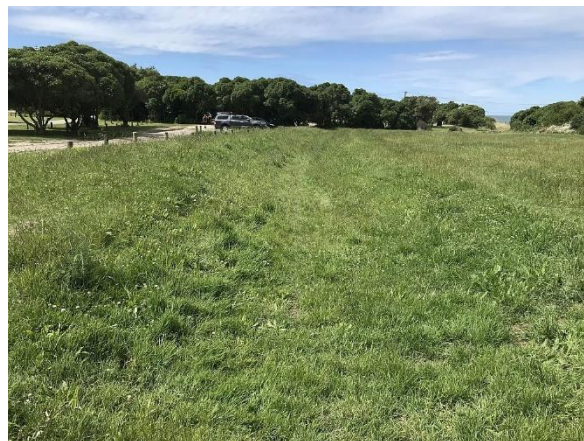
There was no surface water or residual pools present that could provide fish habitat along Korara Stream (Figure 2). The channel was entirely covered in terrestrial grass species, indicating the waterway flows only in response to rain events. No attempt was made to sample fish, due to a lack of aquatic habitat.

Figure 2: Dry channel at Site 1 (Korara Stream).

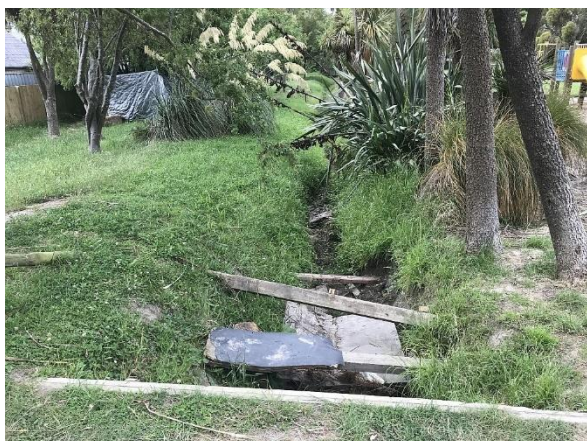
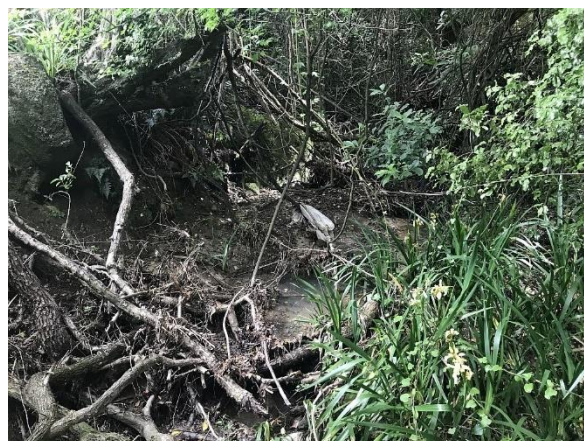
The downstream extent of Site 2 commenced immediately upstream of the confluence with Sumner Stream. The sampling reach flowed along the northeast margin of Sumnervale Reserve. Potential fish habitat comprised a handful of shallow pools, with varying degrees of cover from overhanging long grass, cobbles, and boulders (Figure 3). There was a dry section between Sites 2 and 3 that had been observed flowing during the initial site reconnaissance. This dry section would present a fish passage barrier during low flows.

Site 3 was further upstream in the reserve, amongst native plantings that provide good waterway shade (Figure 3). High quality pool habitat was abundant, with plenty of fish cover in the form of boulders, cobbles, and woody debris. Natural barriers were present along reach, but they are likely passable by strong climbing fish species.

Figure 3: Sumnervale Stream at Site 2 (left) and Site 3 (right).

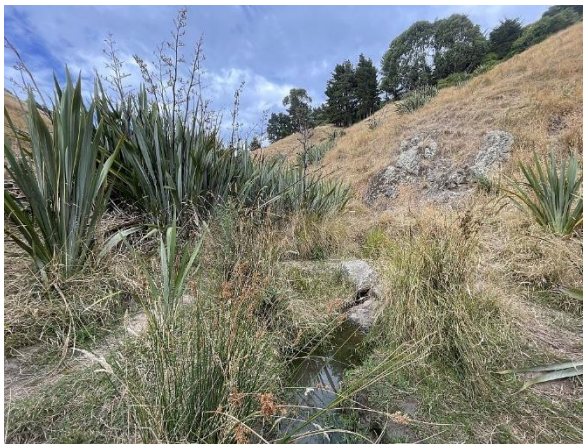
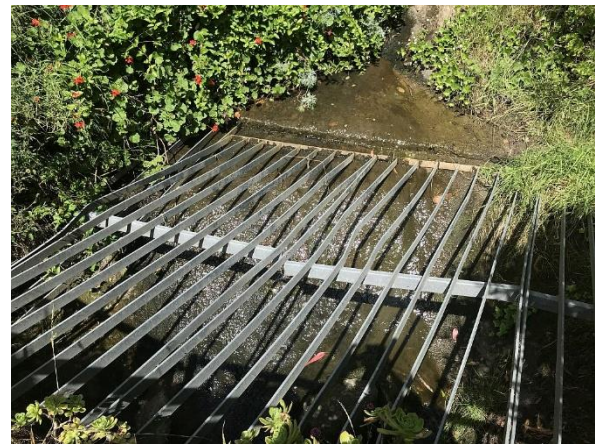
The downstream extent of the sampling reach was approximately 25 m upstream of Richmond Hill Road. The terrain is steep, resulting in several small natural barriers through the reach. Only strong climbing fish species would be able to navigate these barriers. The waterway was dominated by moderately deep pools connected by shallow runs and small cascades. There was plenty of fish cover in the pools, including wood, boulders, and cobbles (Figure 4). The channel is quite incised at some points. Native trees and shrubs provide high levels of waterway shade, interspersed with some more open sections. Downstream, there is a steep concrete culvert that would be a fish barrier for poor climbers (Figure 4). The metal trash rack on the upstream end of the culvert also creates a lip that may be difficult for fish to pass. Moving downstream approximately 200 m to the bowling green, the channel is concrete lined, the flow is shallow, and there is no fish cover. This concrete-lined section is also likely to present a barrier to many fish species.

Figure 4: Site 4, Richmond Hill Waterway, showing the fish sampling reach (left) and downstream culvert entrance identified as a fish barrier (right)

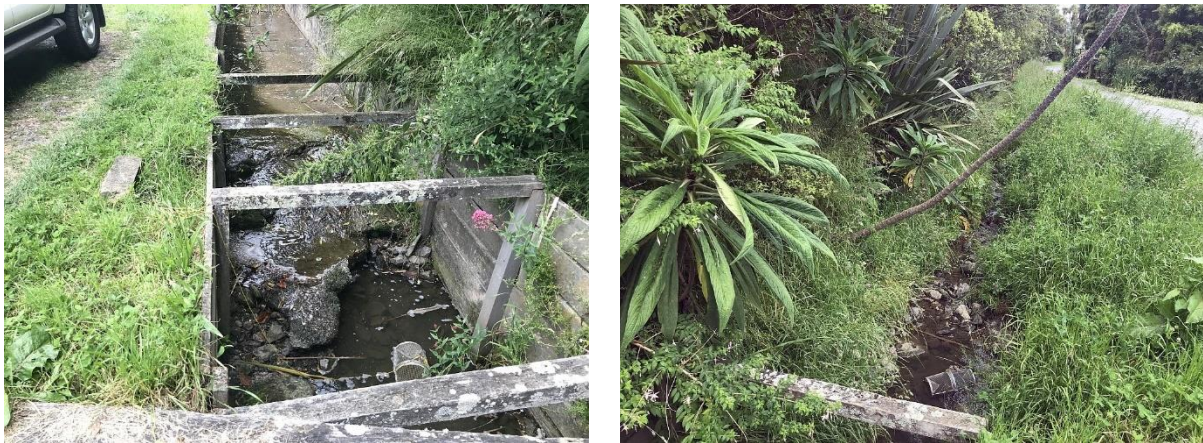
The sampling reach was commenced a short distance upstream of a concrete sump with an approximately 1.5 m vertical drop, which flows into a piped network. The pipes and vertical drop present a very high risk to fish passage. The waterway has sections that are concrete lined and other natural sections with cobble substrate (Figure 5). Potential fish habitat is present in the form of shallow pools in the natural sections and areas of broken lining in the concrete-lined sections. Overhanging grass provides reasonable fish cover along the natural section of waterway, although the grass is regularly trimmed.

Figure 5: Site 5 (Mt Pleasant Waterway), showing minnow traps set in pools located in the broken concrete lining (left) and in a section with natural lining (right).

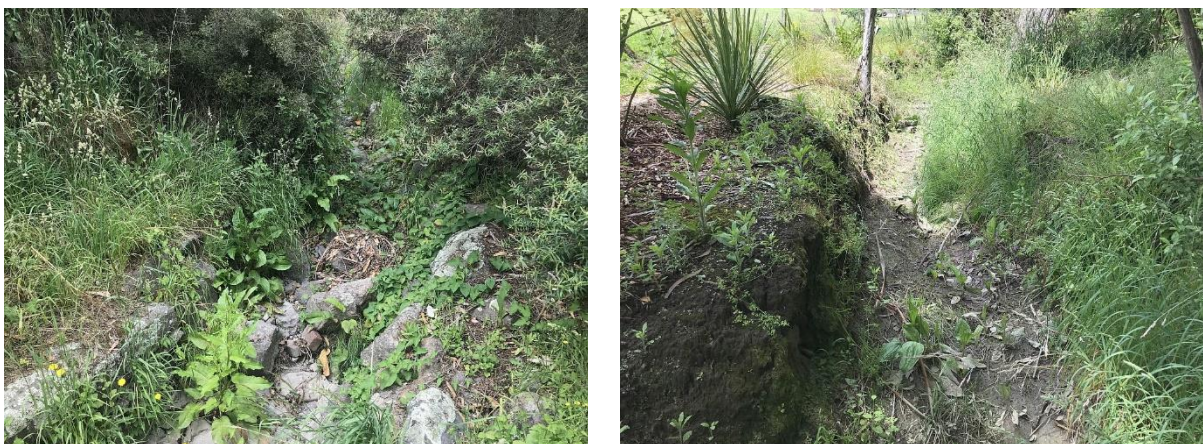
The waterway was dry, with no residual pools that could provide potential fish habitat during dry periods (Figure 6). The channel was covered in terrestrial plants, indicating a lack of flow permanence. Therefore, fish sampling was not practical at this location.

The waterway was dry within the proposed sampling reach within the reserve area (Figure 6), and the channel downstream was too shallow to trap. Spotlighting was also impractical due to a lack of surface flow and poor access. The large pond near Port Hills Road could have been trapped, but it was not banded kōkopu habitat. Previous sampling of the pond at Port Hills Road found inanga, shortfin eel (*Anguilla australis*), and common bully (*Gobiomorphus cotidianus*) were present (NZFFD record number 110842). Therefore, no fish sampling occurred.

Figure 6: Dry waterways at Site 6, Butts Valley Drain (left) and Site 7, Avoca Valley Drain (right).

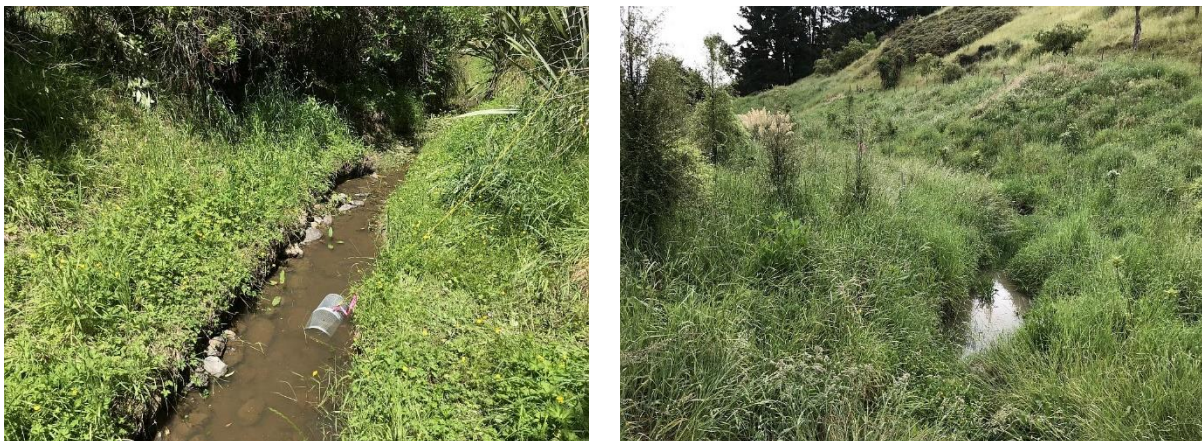
The downstream end of the sampling reach began approximately 30 m upstream from the entry to the reserve. The waterway meanders through the reserve, surrounded by regenerating native trees and shrubs. The channel form is characterised by slow runs and pools (Figure 7). Shallower run habitat flowed over semi-terrestrial vegetation such as buttercup (*Ranunculus* sp.), indicating that the pools likely become isolated during drier months. These shallow sections are potential fish barriers to poor climbers under the observed flow conditions and the fish passage risk would increase under drier conditions. Some deeper pools hold potential as fish habitat. The substrate was a mixture of mud and embedded cobbles. Periphyton and aquatic snails indicate that the waterway has held water for some time.

The downstream end of the sampling reach site was a large pool at the start of the reserve. The waterway meanders through the reserve, with the banks vegetated with long grass and young native plantings (Figure 7). The channel form was comprised of pools and very slow runs. The channel was generally narrow and very incised in parts. The pools likely become disconnected during the drier months, given the shallow water depths in the runs between them. Some small natural steps could prevent upstream passage for fish that are poor climbers. The substrate was dominated by fine sediments (<2 mm diameter). We attempted to sample higher in the catchment, among the established native bush, but there was no periphyton or aquatic invertebrates present, indicating a lack of flow permanence.

Figure 7: The left image is Site 8 (Victory Drain) and the right image is Site 9 (Victory Drain Branch No. 1).

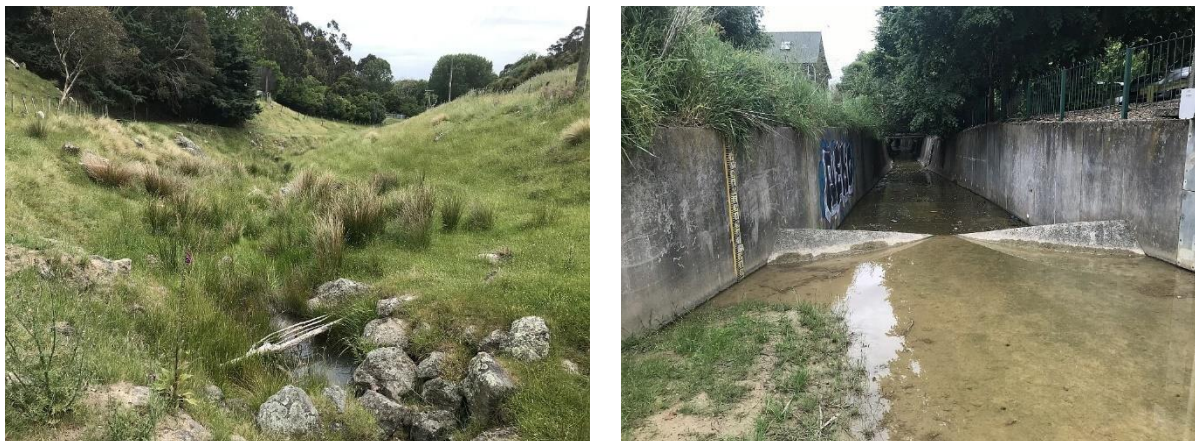
The downstream extent of the sampling reach was approximately 90 m upstream from the driveway to 160 Bowenvale Avenue. The sampling reach meanders along the valley floor, with aquatic habitat comprising pools with varying connectivity (Figure 8). Surface flow was very shallow at some sections through a rush-dominated wetland. There are some substantial natural drops that may limit fish passage. Some pools were quite deep, providing

high quality habitat, with cover provided by large boulders, wetland vegetation, and long filamentous algae. Beyond the valley floor, the valley is vegetated in mostly pasture grass, which was being actively grazed by sheep. Further downstream, the channel is concrete-lined, with minimal water depth, which presents a barrier to fish passage (Figure 8).

Figure 8: Site 10 (Sibleys Drain), showing the fish sampling reach (left) and downstream concrete-lined reach (right) identified as a fish barrier.

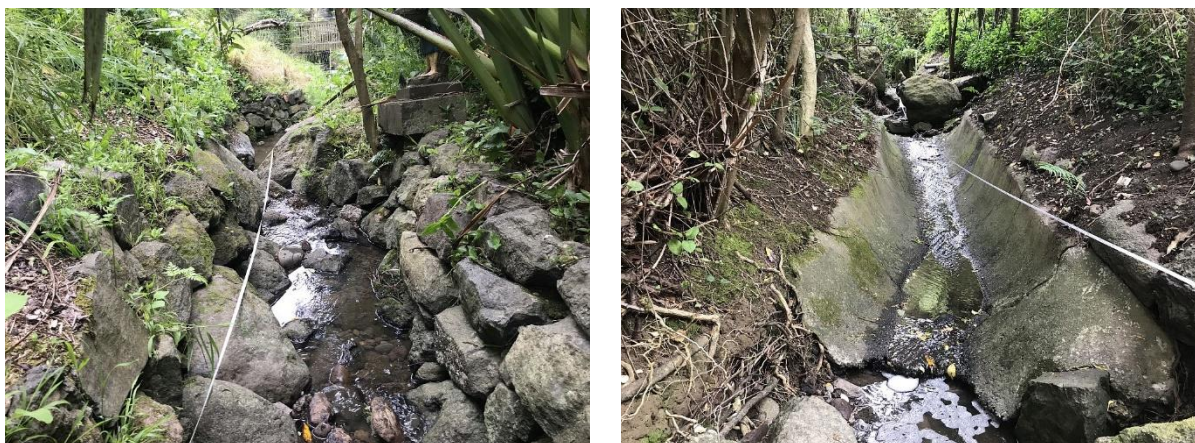
There is a long, piped section of the waterway downstream, which had very shallow water depths (1 cm deep). Several medium to high-risk barriers to fish passage occur along the sampling reach, including some natural drops and other short sections of concrete lining with shallow water depths (Figure 9). Aquatic habitat was a combination of pool, run, and riffle. Flood debris was abundant, indicating stormflow several weeks prior. Pool habitat was excellent quality. There was high levels of shading from the native tree canopy, and high levels of fish cover from boulders, cobbles, wood, and overhanging vegetation. Residents reported that the waterway dried to a trickle over summer, however freshwater snails on rocks indicated that there had been water present for some time.

Figure 9: Site 11 (Patchetts Drain), showing sections of waterway with natural stone rock lining (left) and concrete lining (right).

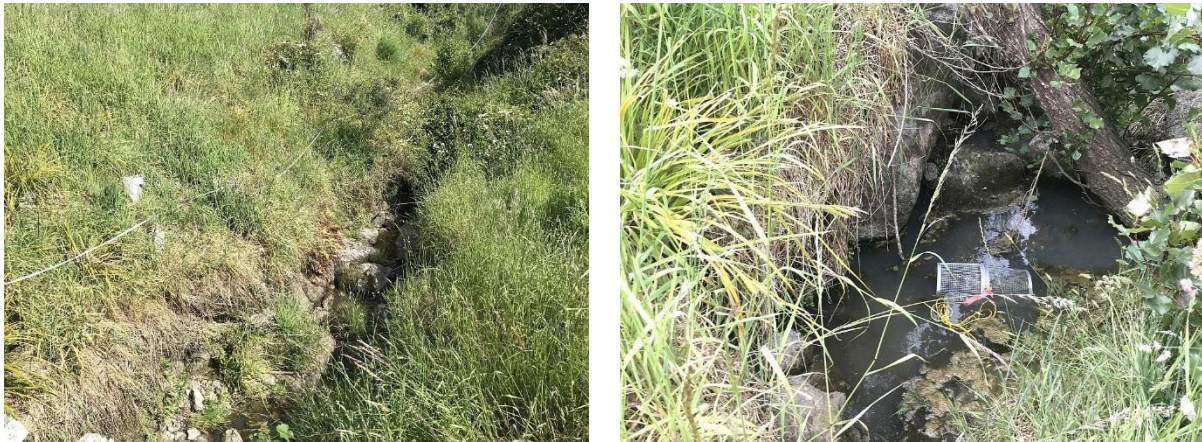
The downstream extent of the sampling reach was immediately upstream of Governors Bay Road. Several small natural barriers are present along reach, which would exclude poor climbing species. However, the observed the barriers were of equivalent or less risk to fish passage than the numerous natural and artificial fish barriers present downstream of Governors Bay Road. Aquatic habitat is dominated by pools, some of which were deep and provide high quality habitat, with abundant boulder, cobble, and overhanging vegetation cover (Figure 10). The water was slightly turbid. Long brown filamentous algae was abundant in open sections upstream. The waterway is highly incised, with steep banks providing shade. The banks have been recently planted with young native trees, shrubs, flaxes, and sedges, which will provide good shade over time.

Figure 10: Site 12 (Cass Bay Stream), showing the fish sampling reach (left) and minnow trap in a pool (right).

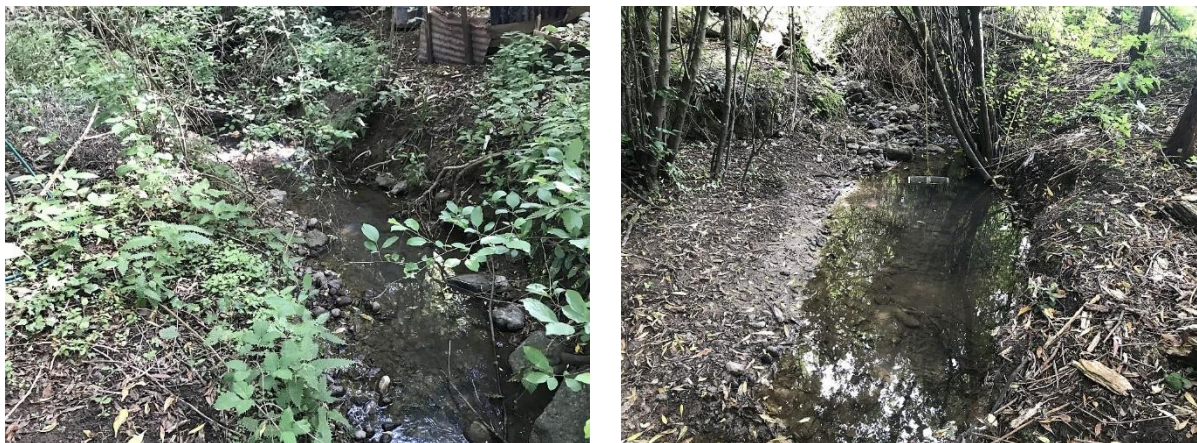
For Sites 13 and 14, the waterway meanders through reserve land that is vegetated with native trees and shrubs, providing good shade to the stream (Figure 11). Several natural fish barriers are present, in the form of natural drops which range from medium to high risk to fish passage. The private culvert between Sites 13 and 14 is also a medium to high risk to fish passage. Aquatic habitat is dominated by small pools, some of which are quite deep and provide high quality habitat. Fish cover is high, provided by boulders, cobbles, and woody debris.

Figure 11: Omaru Stream at Site 13 (left) and Site 14 (right).

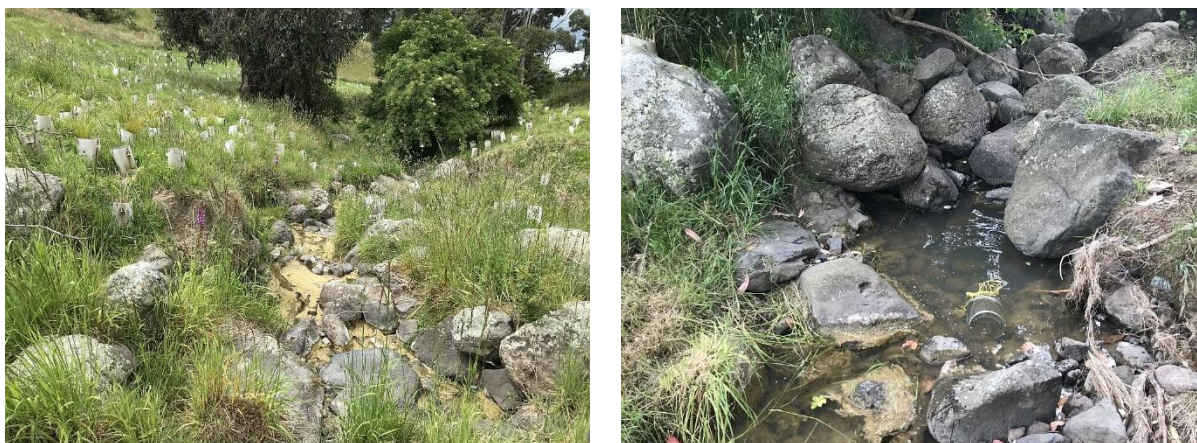
Site 15 is upstream of Governors Bay Road, upstream of a road culvert that is perched and presents a high risk to fish passage. The canopy is much more open than downstream, with low levels of stream shading (Figure 12). As a consequence, long filamentous algae was abundant, covering much of the bed. The reach is steep and boulder-dominated, resulting in several high-risk natural barriers to fish passage. The steep banks have been recently planted with a wide riparian buffer of young native trees, shrubs, and flaxes, which will provide good shade over time. There were some sparse, deep, high-quality pools present. Fish cover is abundant, provided mostly by the large boulders.

Figure 12: Omaru Stream at Site 15, showing an open section with recent native plantings (left) and a minnow trap in pool habitat (right).
